MAP AND CROSS SECTION OF MANTI LANDSLIDE

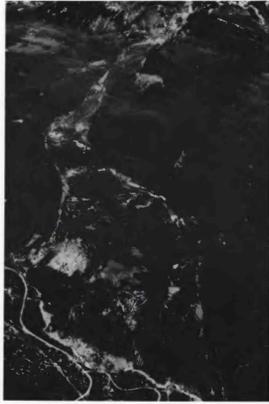
H. VIEW SOUTH FROM NORTH RIM OF CANYON OF ENTIRE LANDSLIDE

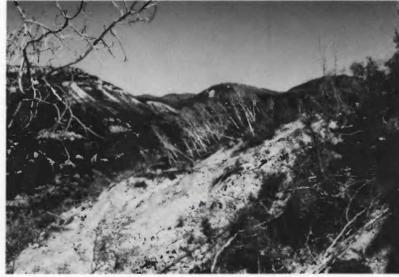
G. SECONDARY SLUMP BELOW LOWER BENCH

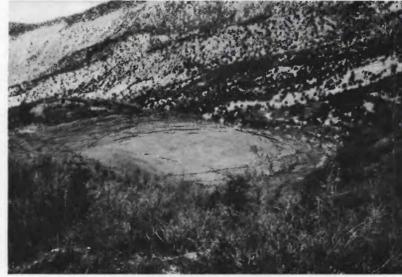
F. COTTONWOOD RESERVOIR

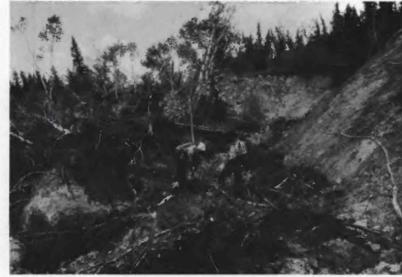
E. SCARP ON RIGHT FLANK OF LANDSLIDE

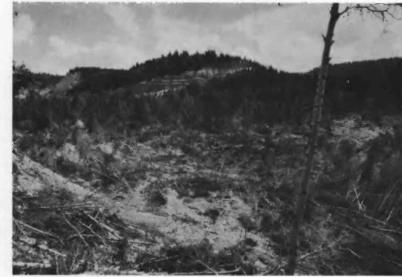
D. UPPER RAMP

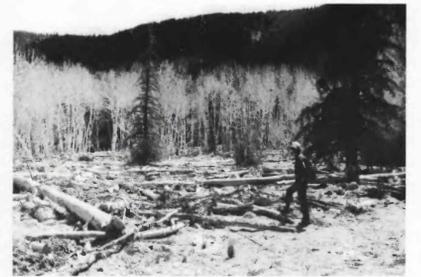
C. DEBRIS-FLOW DEPOSITS

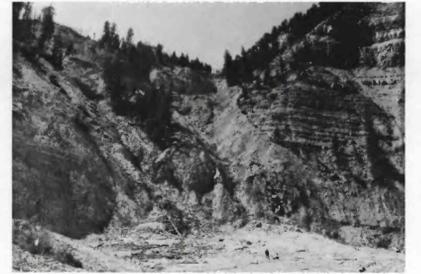
A. VIEW OF UPPER COMPLEX SLUMPS FROM BELOW  
Note smear of deposit from debris-flow to right of center of view. Person on debris-flow deposit in foreground gives scale

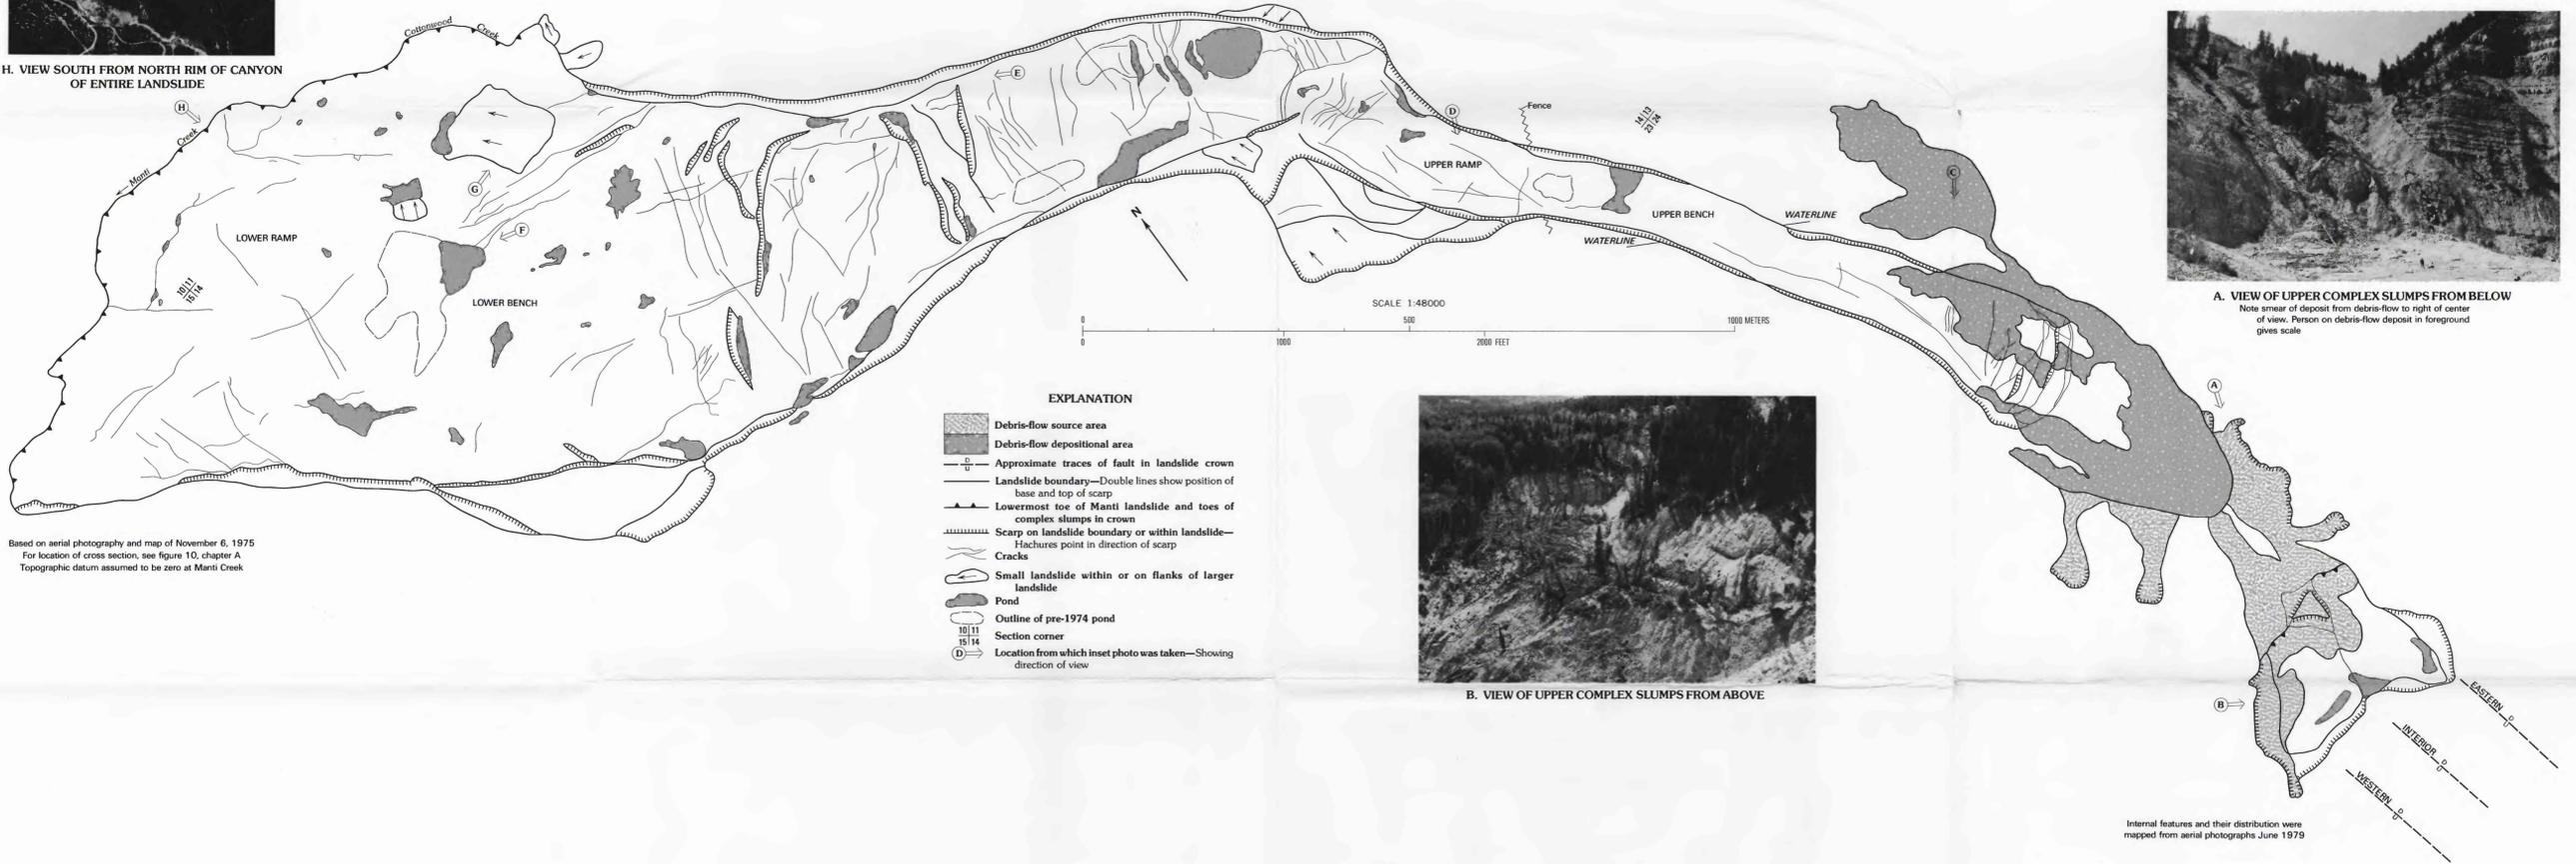
Based on aerial photography and map of November 6, 1975  
For location of cross section, see figure 10, chapter A  
Topographic datum assumed to be zero at Manti Creek

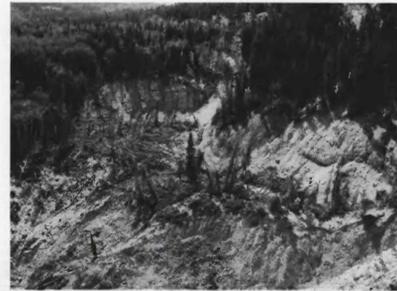
B. VIEW OF UPPER COMPLEX SLUMPS FROM ABOVE
