# The Manti, Utah, Landslide

U.S. GEOLOGICAL SURVEY PROFESSIONAL PAPER 1311

## The Reactivation of the Manti Landslide, Utah

## Physical Properties and Mode of Failure of the Manti Landslide, Utah

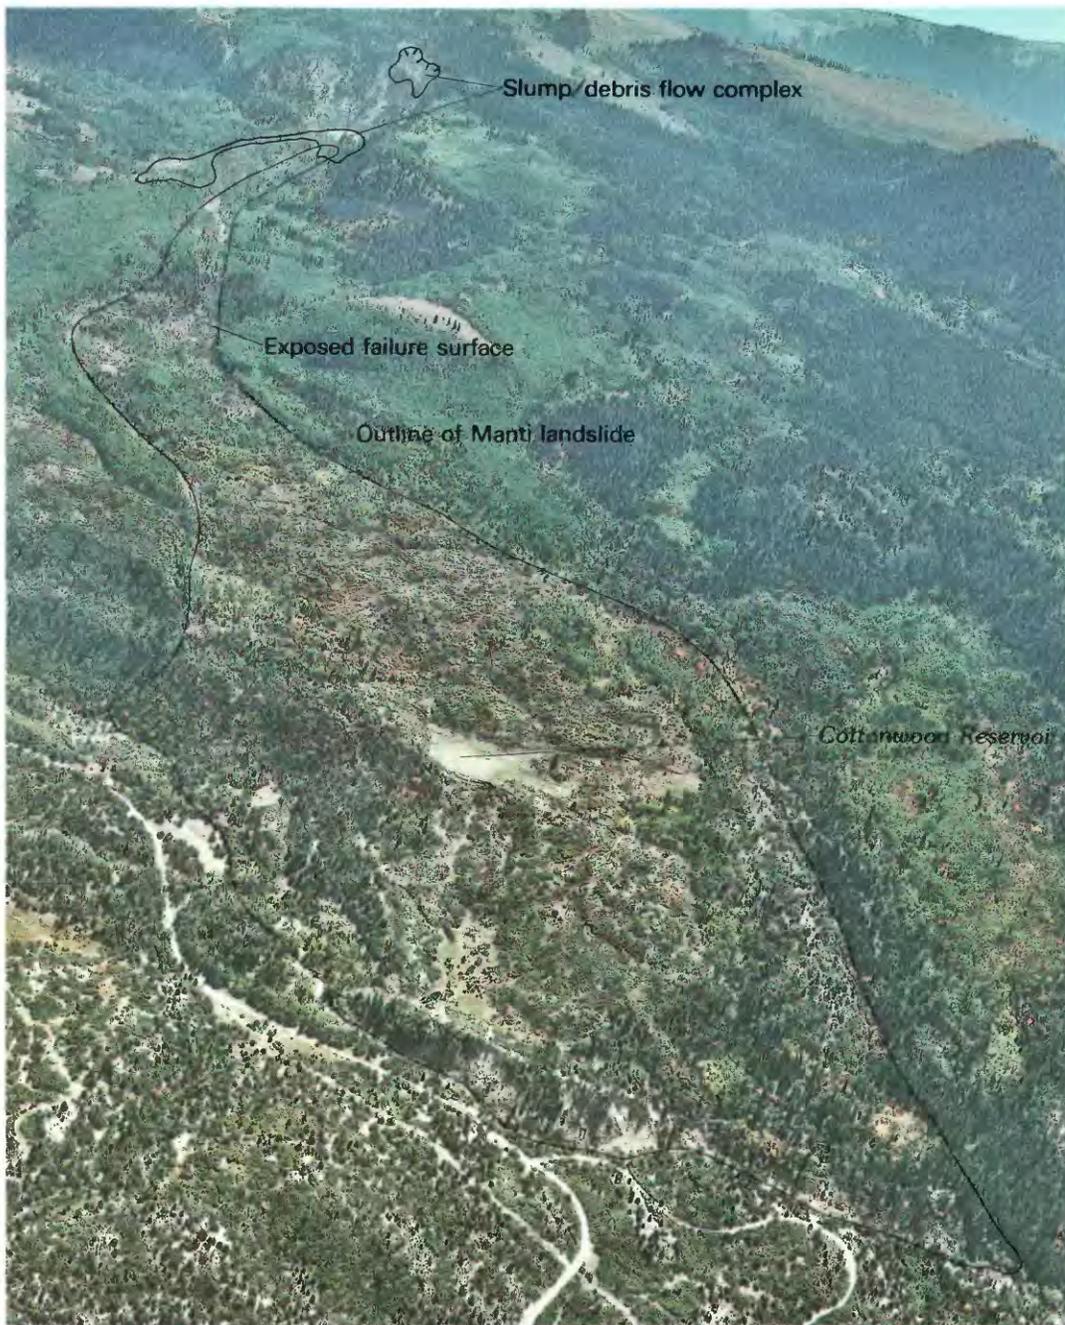
FRONTISPIECE.—Southeast aerial view of the Manti landslide taken on September 19, 1975. The lower part of the landslide, near Cottonwood Reservoir, was moving about 3 m/day, while the upper part was moving about 0.3 m/day (U.S. Forest Service photograph).

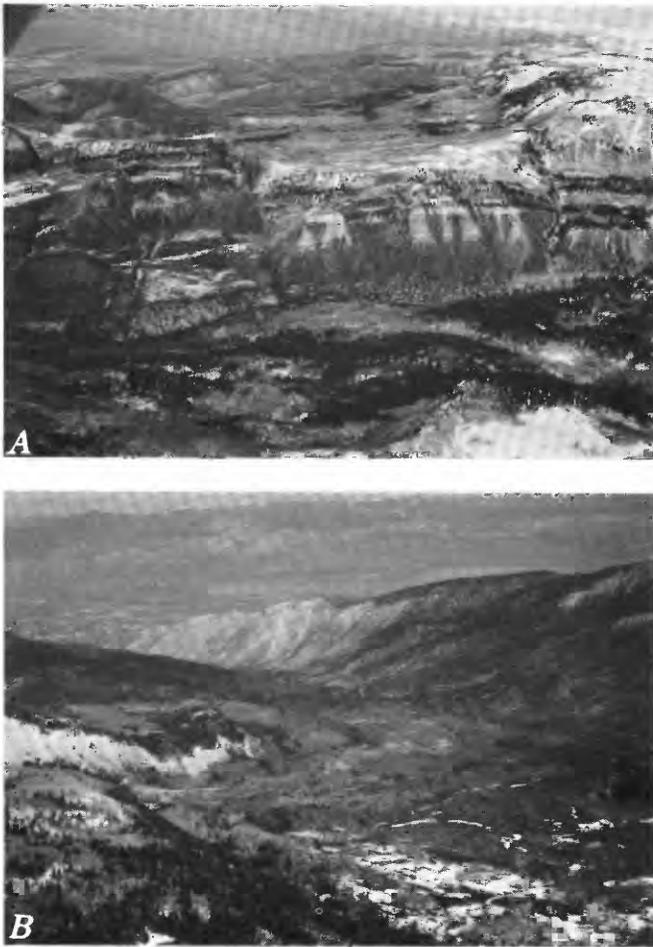
FIGURE 2.—Oblique aerial photographs of a portion of Manti Canyon showing two views of the Wasatch monocline. *A*, View looking north shows the “shoulder graben” which separates flat-lying rocks on the crest of the plateau from dipping rocks of the monocline. *B*, View to the west shows the monocline dipping northwest. Antithetic faults occur in the notches in the ridge line across the upper middle part of the photograph. The Manti landslide is in the lower middle part of the photograph; the topographic reentrant containing the slump/debris complex is out of the view to the left. (Photographs were taken in June 1983.)

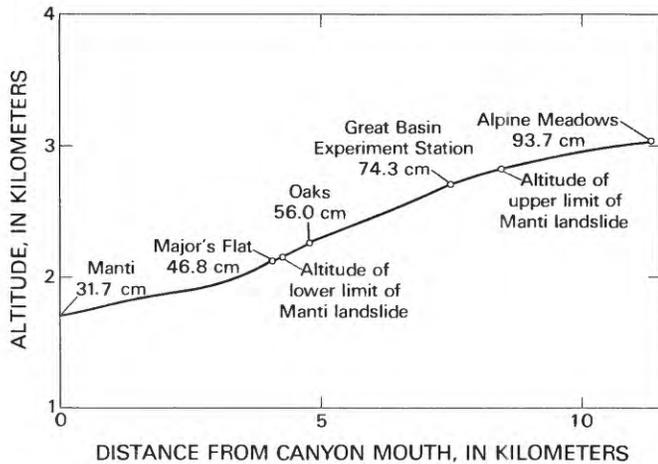
FIGURE 3.—Average precipitation as a function of altitude and distance from canyon mouth for four stations in Ephraim Canyon (10 km northeast of the Manti landslide) and one station at Manti. Data from Ephraim Canyon have been projected to a profile drawn up Manti Canyon. Data for Manti courtesy of Leslie J. Anderson, Manti, Utah. Data for Ephraim Canyon from U.S. Department of Commerce (NOAA).

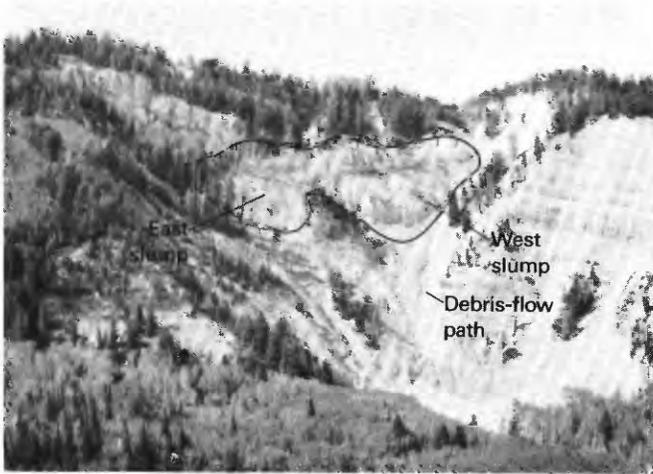
FIGURE 4.—Canyon rim looking south from about 1.7 km away at Burnt Hill. The east and west slumps are separated along the trees in the upper middle of the photograph. A smear of debris on the bedrock in the right side of the photograph marks the former passage of debris-flow episodes from the flanks and toe of the west slump.

The complex slump in the fault zone consists of two discrete slump blocks, one on each side of the interior fault. At their toes, the slumps were separated along the interior fault by a block of intact bedrock that did not fail (figs. 4, 5).

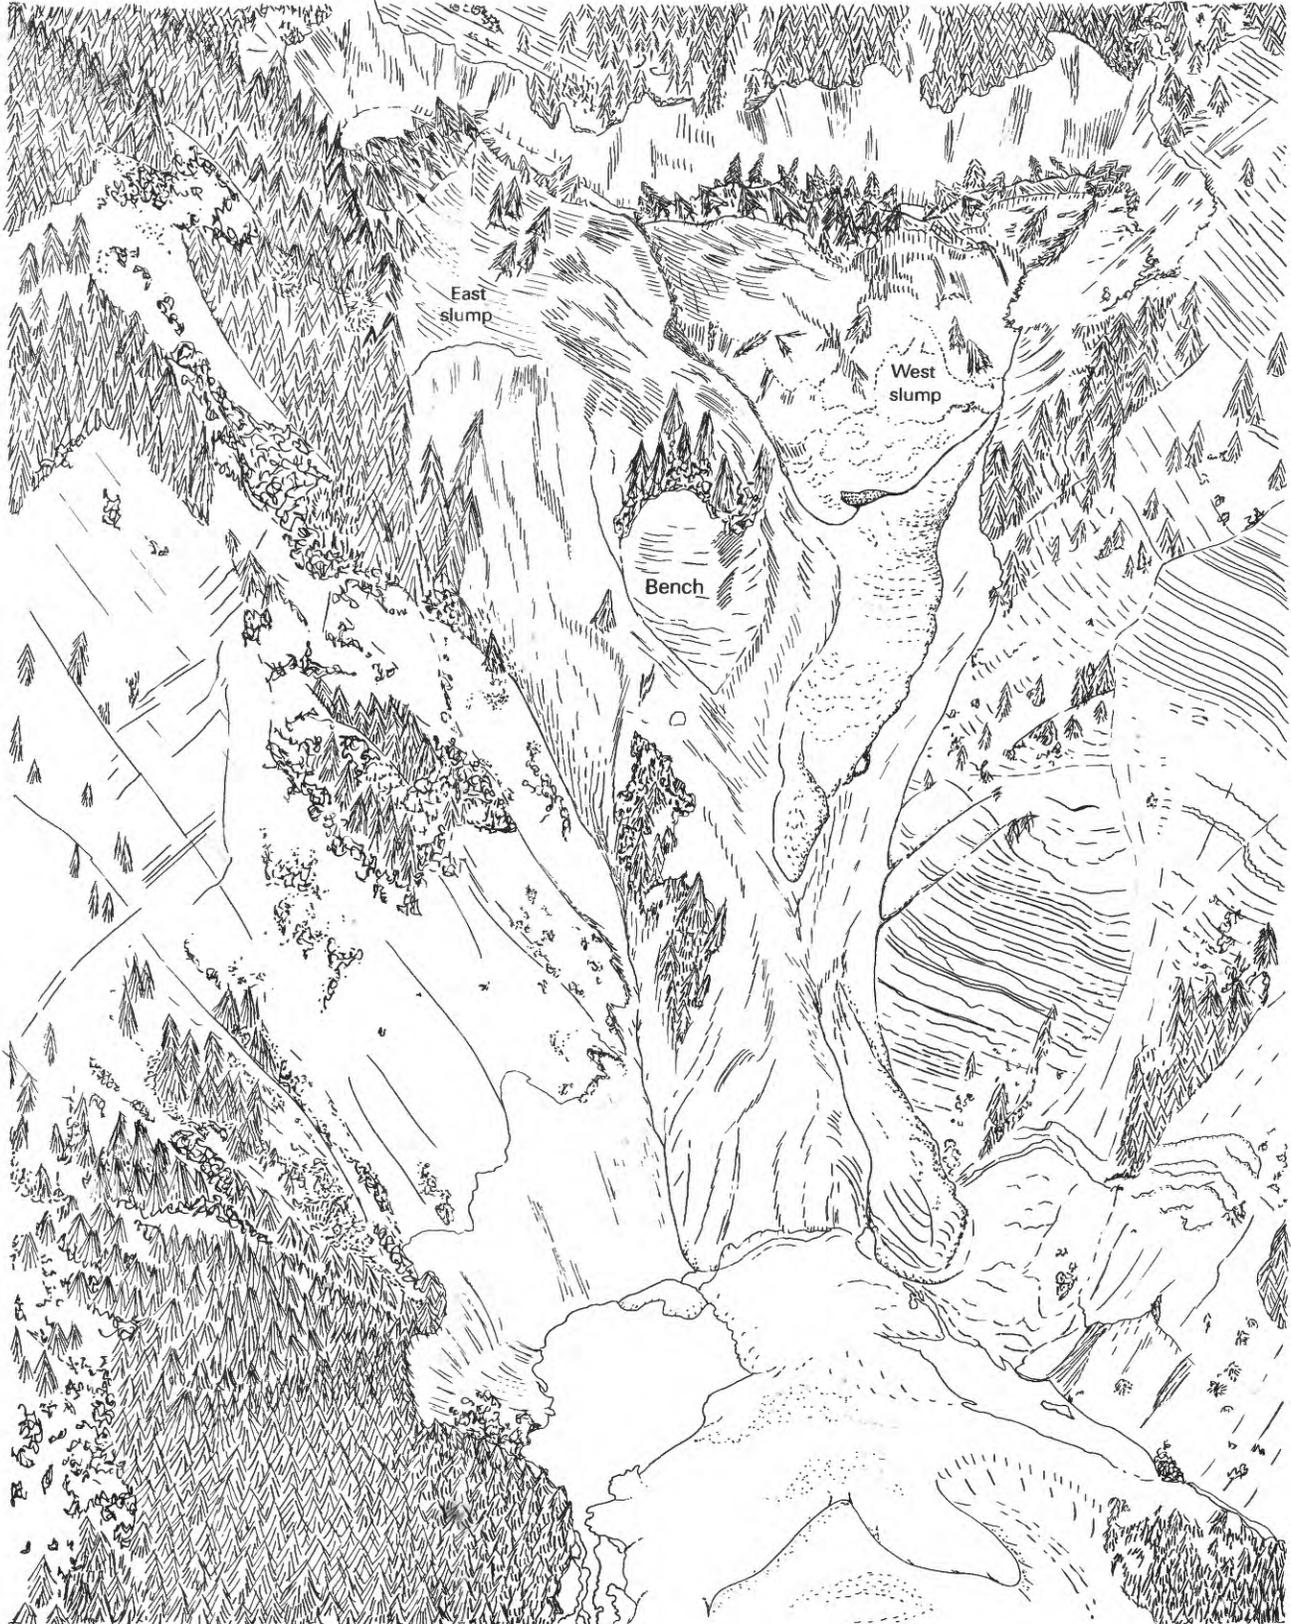
FIGURE 5.—Sketch from a U.S. Forest Service photograph of the slump/debris-flow complex on June 15, 1974. A lobe of moving debris, which had mobilized from the west slump, is shown as it reached the depositional area in the reentrant at the base of the steep slope. The uppermost crack of the reactivated Manti landslide is just outside the lower right corner of the sketch.

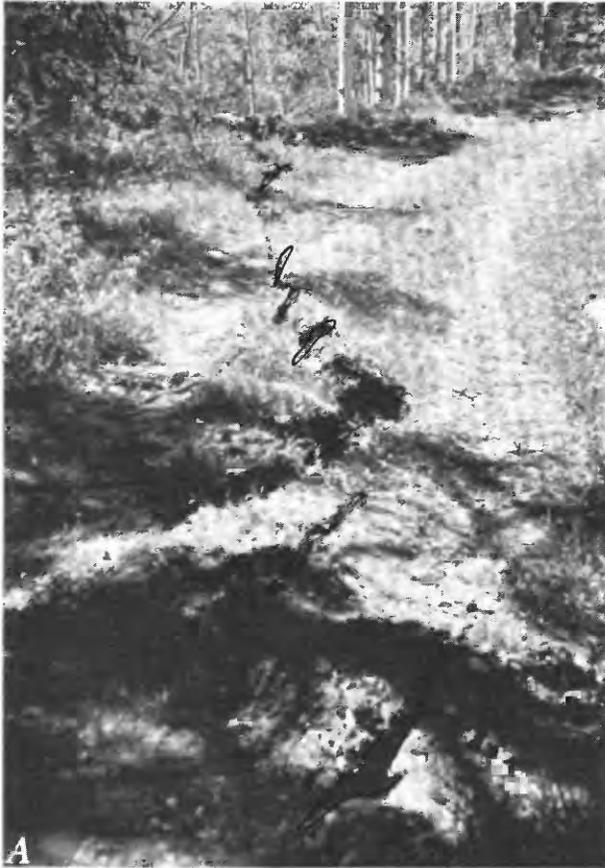
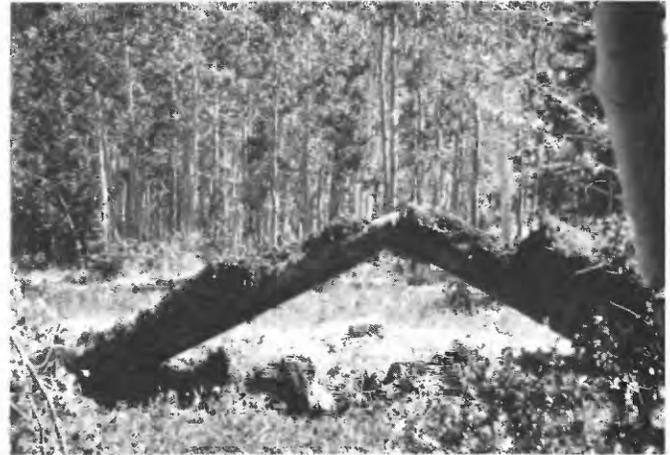
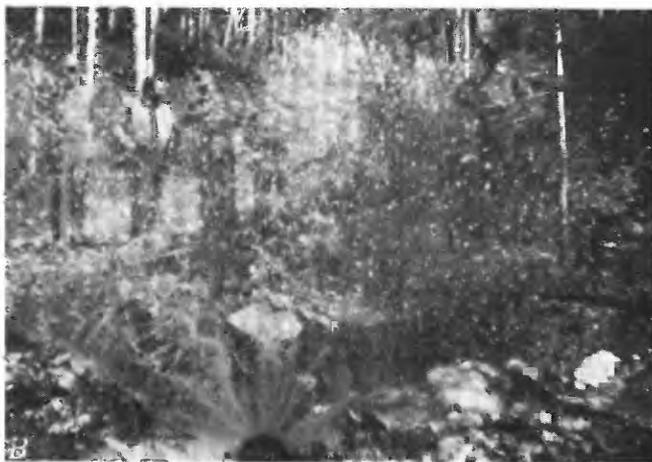
FIGURE 6.—View of initial landslide crack on the right flank of the landslide near the waterline crossing. *A*, Crack began as a series of an echelon cracks that show right-lateral shear. *B*, Waterline on the right flank of the landslide failed by pulling apart. *C*, Outside the limits of the landslide, beyond the left flank, the waterline initially failed by buckling. The waterline was later severed at the crack on the left flank of the landslide. (U.S. Forest Service photographs)

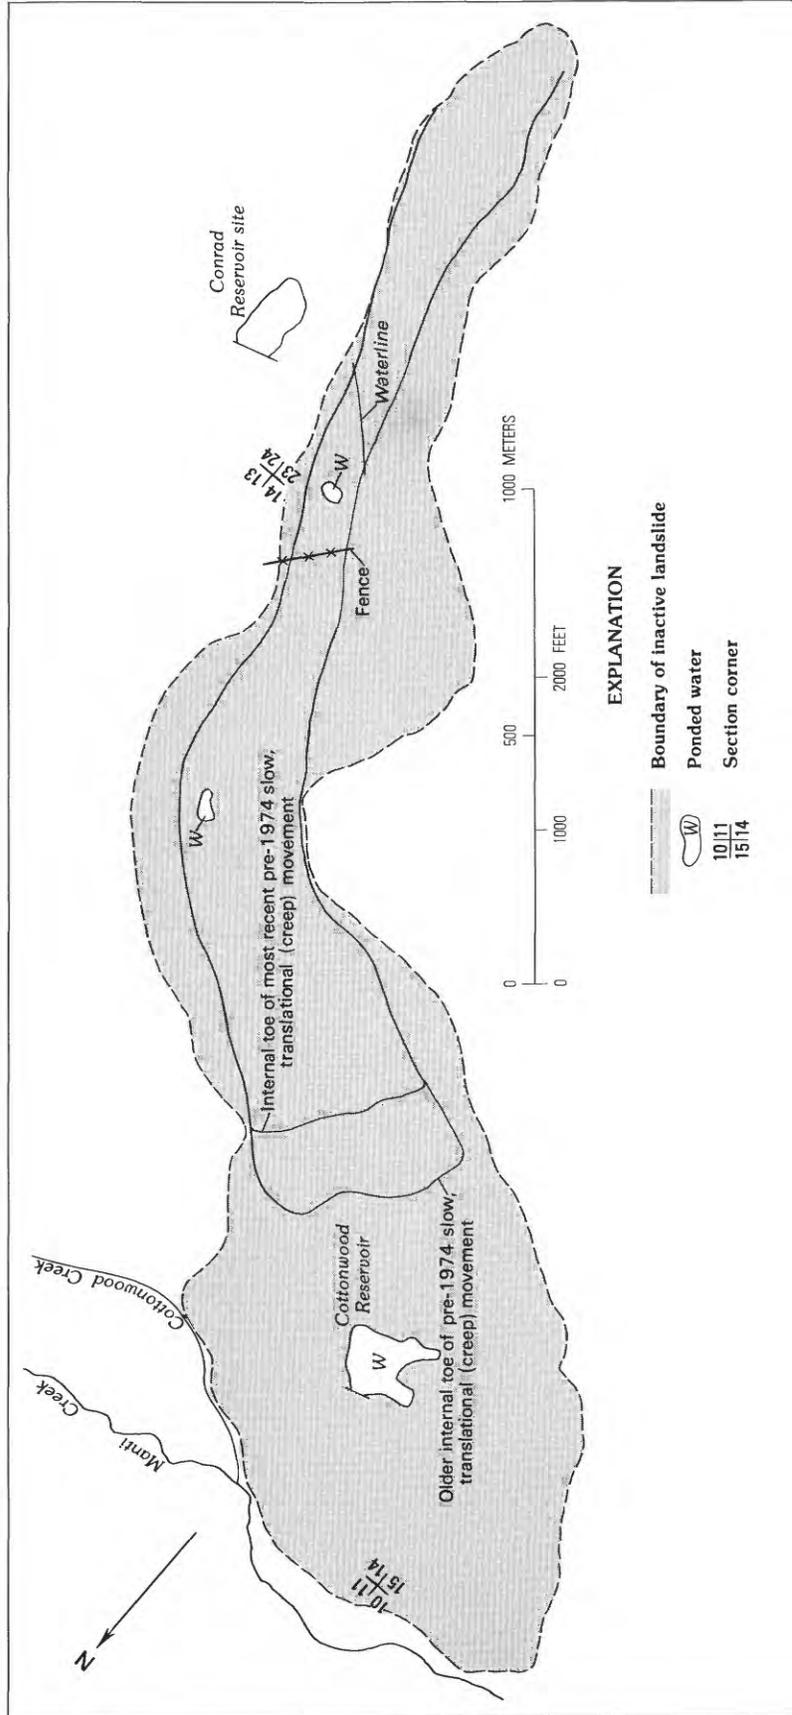
FIGURE 7.—Map drawn from aerial photography of 1950 and 1964 shows the outline of the inactive Manti landslide. Within the boundaries of the inactive landslide is an area that has failed several times since 1939, causing the waterline to break. Shown within the inactive landslide are the inferred boundaries of creep movement.

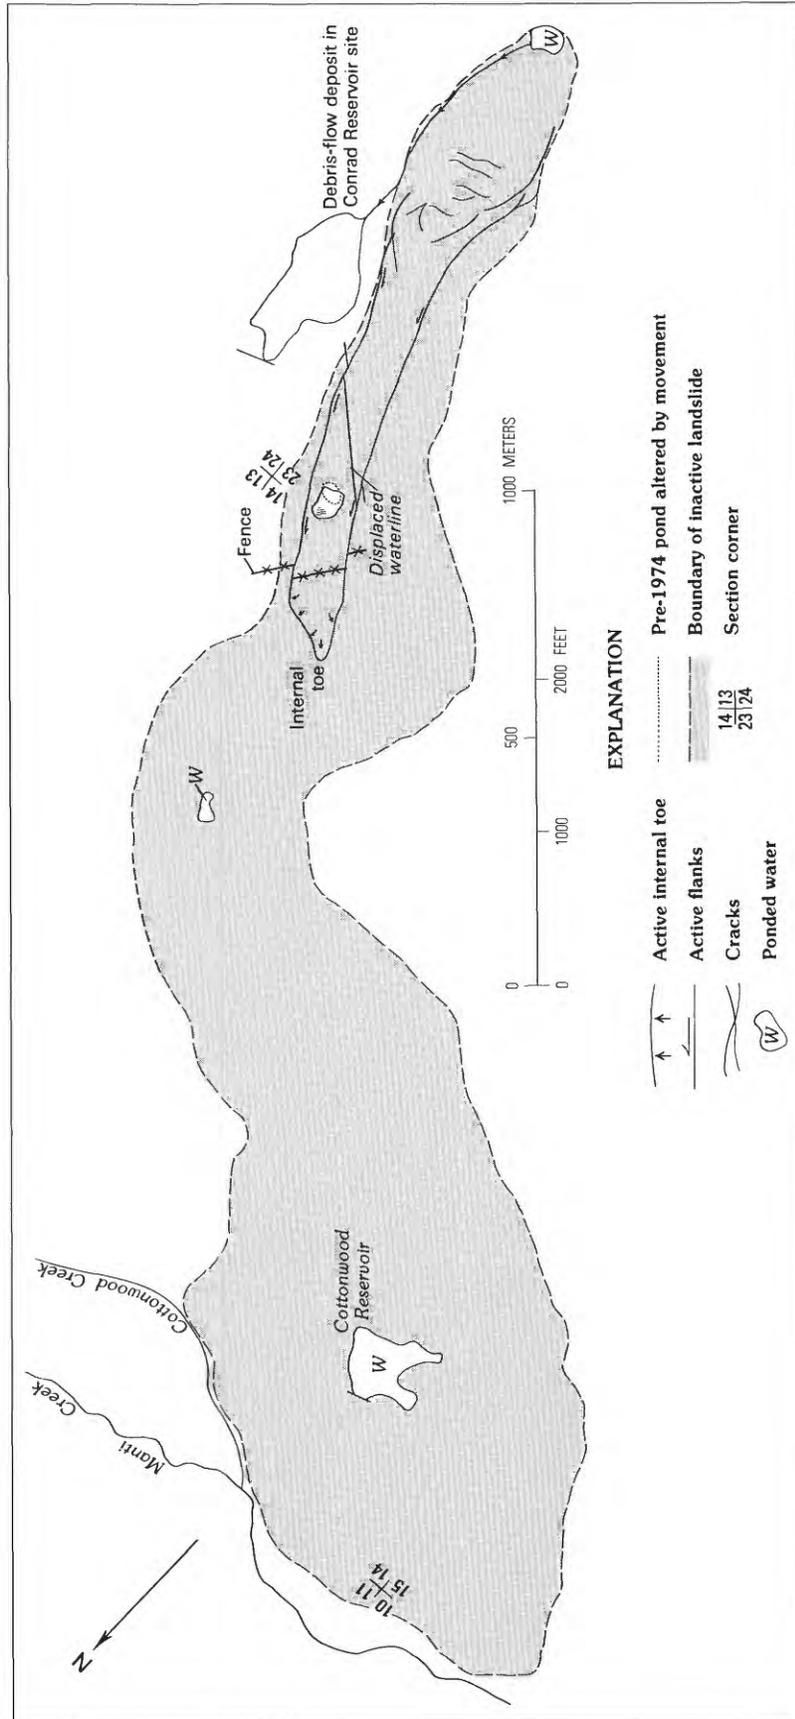
FIGURE 8.—Landslide features as of July 10, 1974. Note that the reactivation in 1974 closely followed the outline of the actively creeping zone shown on figure 7.

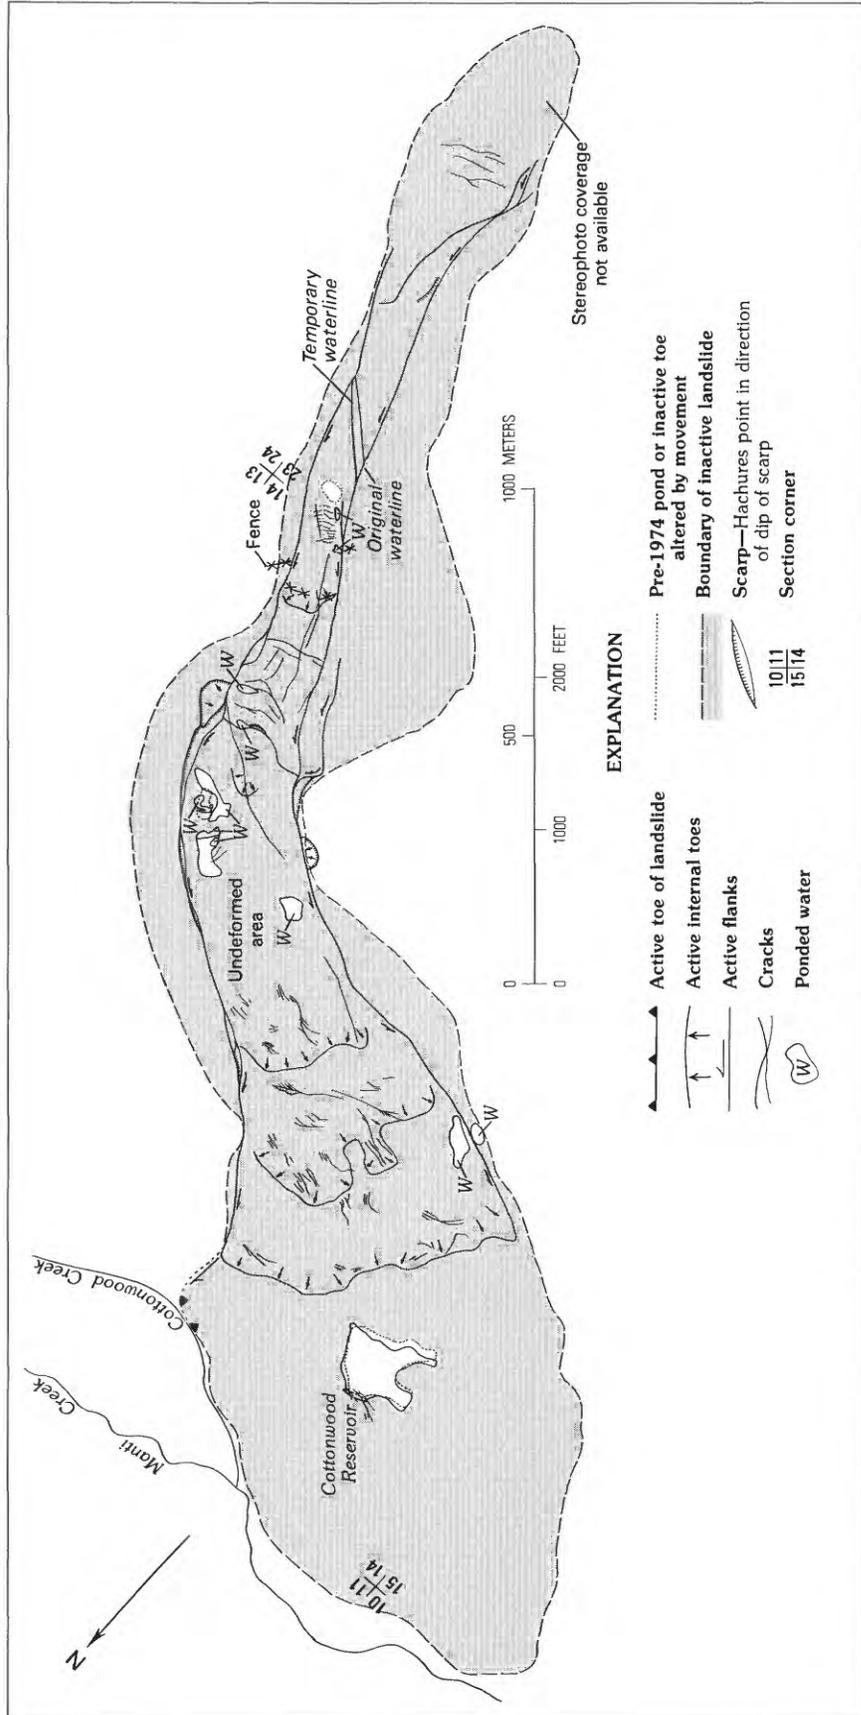
FIGURE 9.—Landslide features as of August 24, 1975. Cracks had been identified in the bank of Manti Creek on June 21, 1975, but the only cracks that were large enough to be visible on aerial photography of August 24 were in the dam of Cottonwood Reservoir. On the right (east) flank, displacement extended all the way to the toe of the landslide and caused ponding of Cottonwood Creek. The beginning of the ponding of Cottonwood Creek was evident on aerial photographs of June 12, 1975. This map portrays the landslide features at about the beginning of rapid failure of the part between Cottonwood Reservoir and Manti Creek.

Figure 9 is a map of landslide features as of August 24, 1975. By that date, the entire landslide, about 3 km long and 800 m wide at the toe, was moving. Cracks were well developed in the upper part of the landslide, and as much as 87 m of displacement had occurred on the fence line on the west flank of the landslide. At the same time, only about 12 m of displacement had occurred at the site of Cottonwood Reservoir; this smaller amount of displacement can be seen on figure 9 by comparing the shoreline in its pre-landslide position (dotted outline) to the shoreline on August 24 (solid outline).

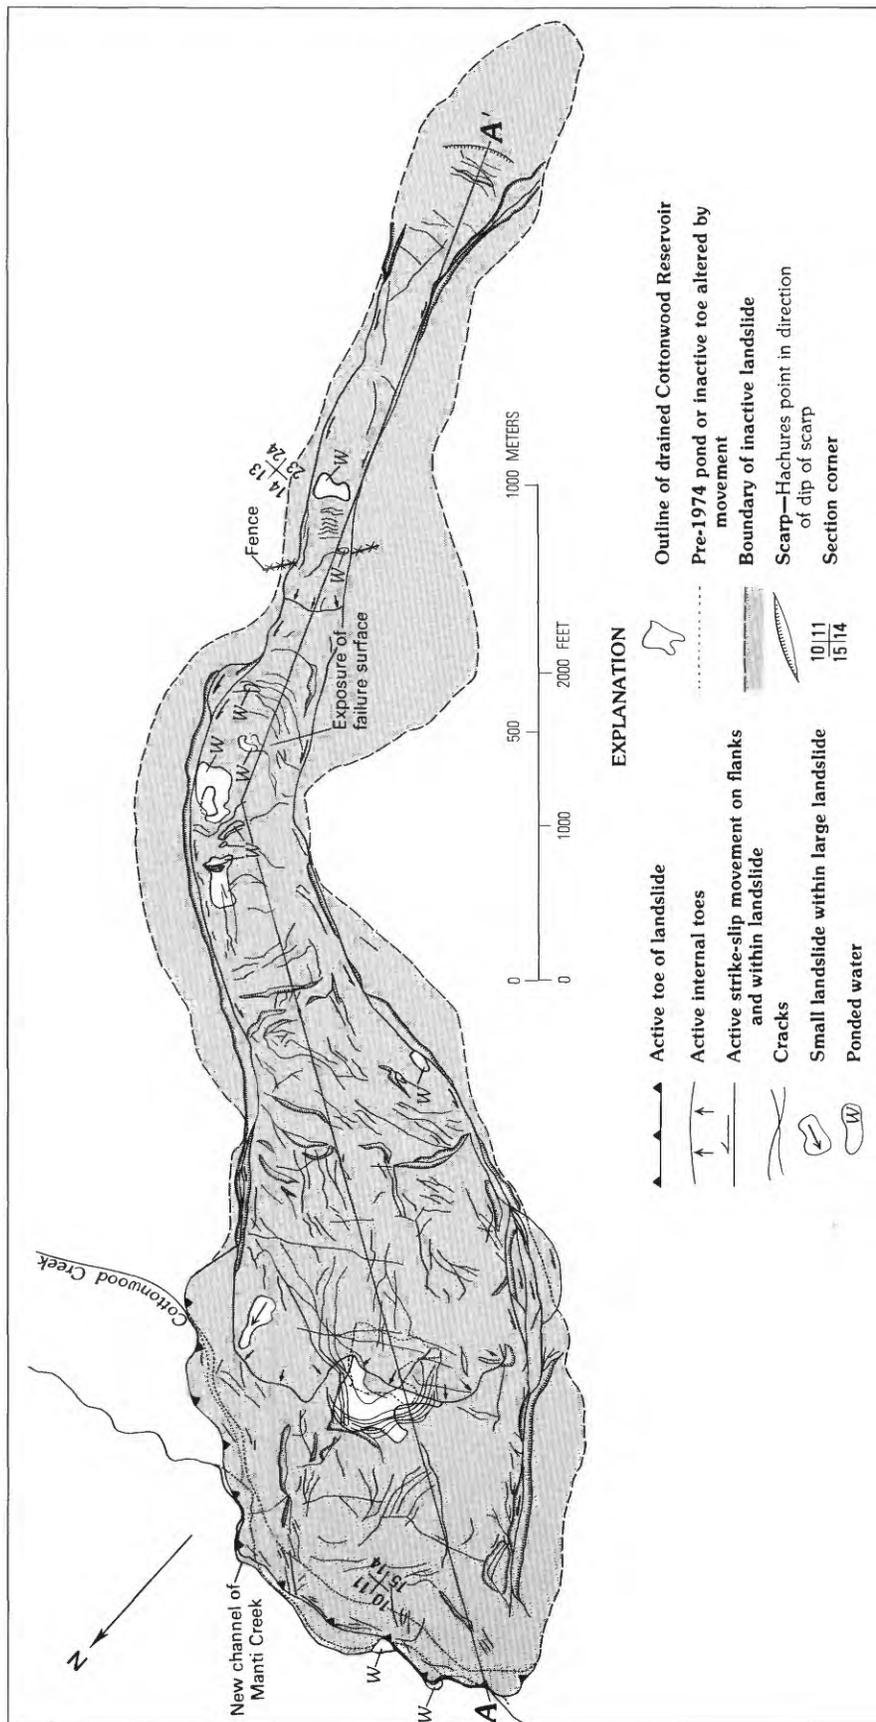
FIGURE 10.—Landslide features as of November 6, 1975. The landslide was at about its maximum extent of development, and displacements since then have been relatively insignificant. Cross section for A-A' is on plate 1.

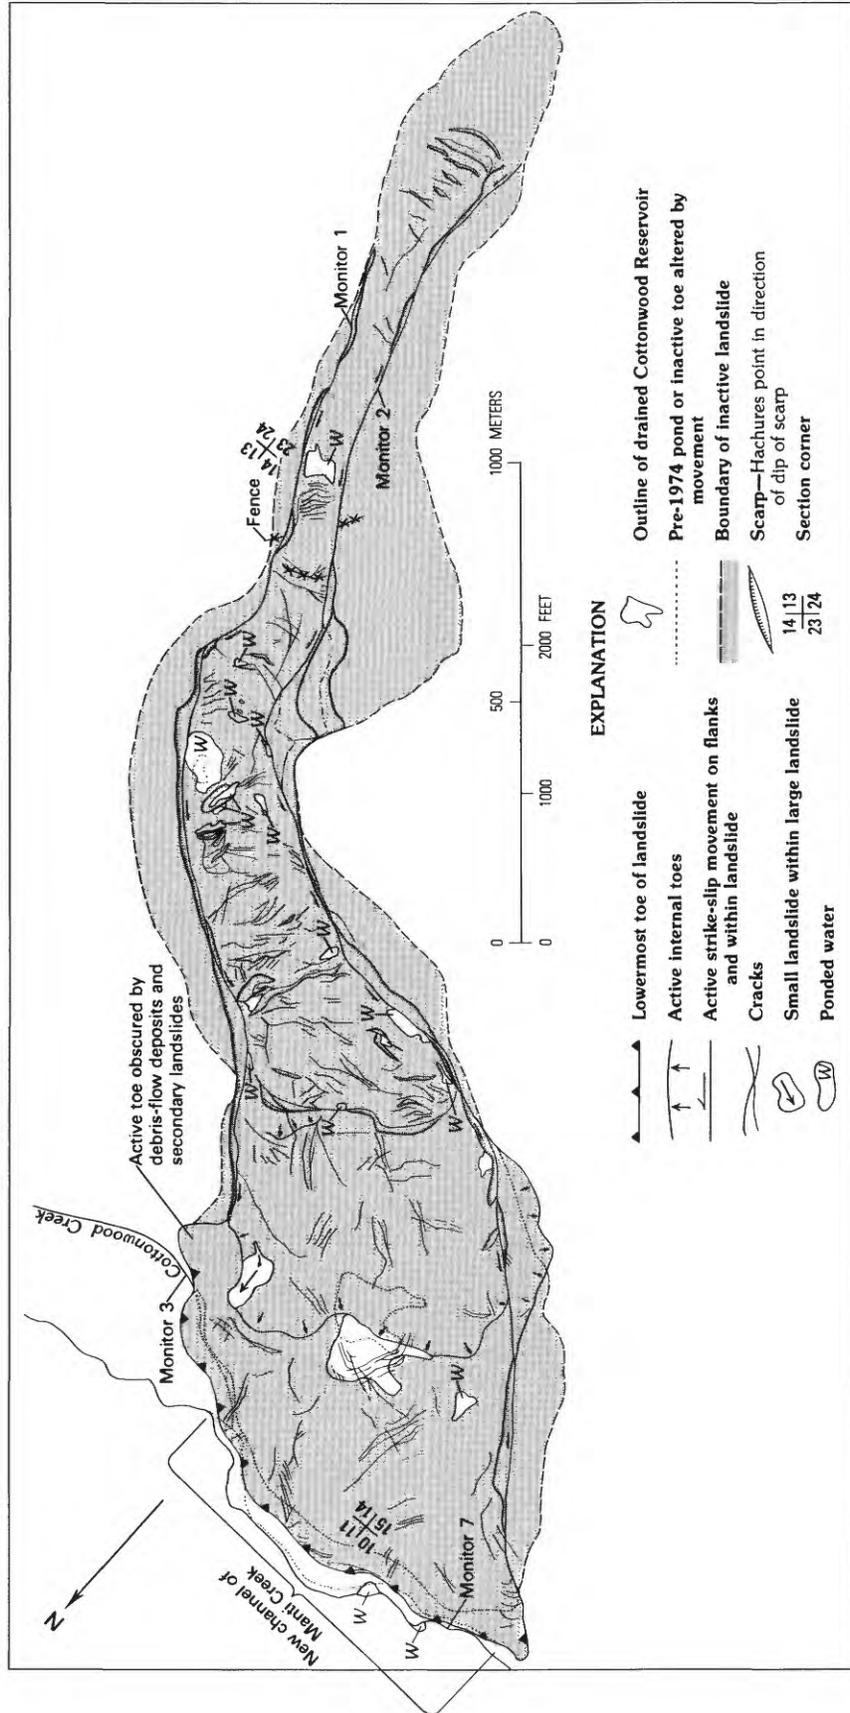
FIGURE 11.—Landslide features as of May 10, 1976. Movement after November 1975 was mostly restricted to local adjustments of landslide debris in various parts of the landslide. Local slumping and debris flows occurred on the lower ramp to the east of Cottonwood Reservoir.

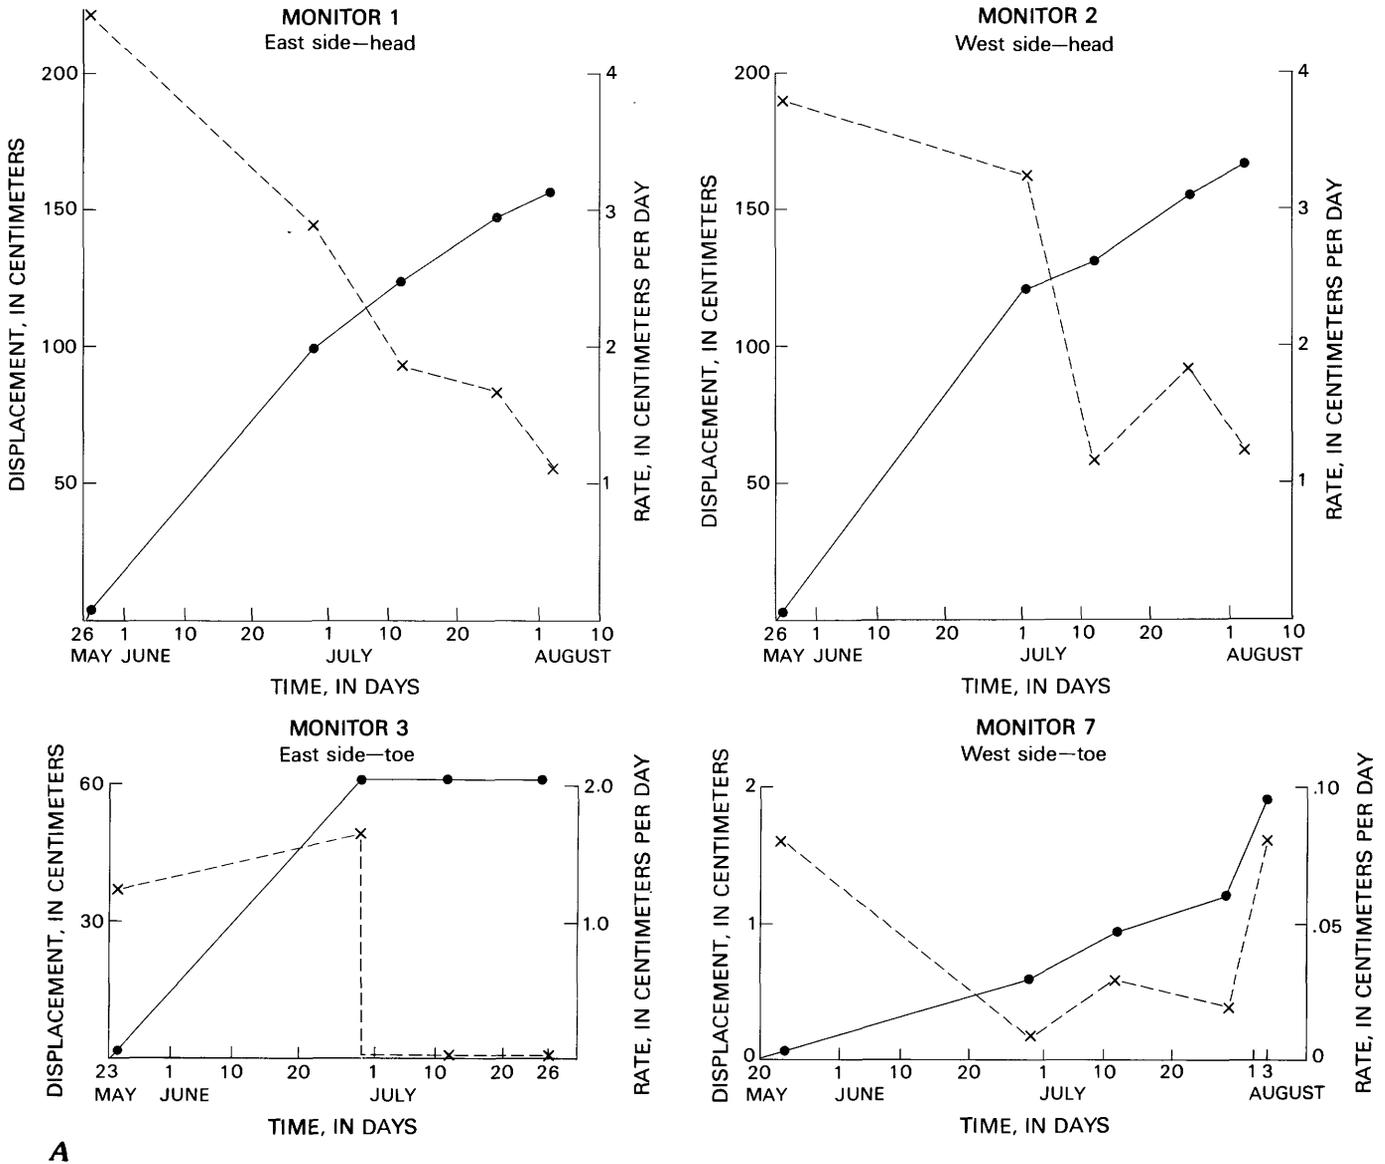
FIGURE 12(above and facing page).—Displacement, displacement rate, and precipitation versus time for specific dates during the period May–August 1976. A, Displacement measurements are from four monitoring stations; these locations are shown on figure 11. Two of the stations (1 and 2) were on the right and left flanks of the landslide near the head; the other two (3 and 7) were on the right and left sides of the toe of the landslide. Displacements are shown by the solid lines; displacement rates are shown by the dashed lines. The diagrams were prepared from data reported by Olson (1976). Note the difference in plotting scale for the displacement data; displacements in the upper part of the landslide were much larger than displacements at the toe. Movement on the east side of the landslide at the toe had stopped by June 29, 1976. On the west side, total displacement was less than 2 cm and may have been only local movement. B, The data for the plot of precipitation versus time were furnished by Lee J. Anderson from a weather station in Manti, Utah. On the average (fig. 3), precipitation at the upper part of the Manti landslide is about 2.3 times that at the city of Manti.

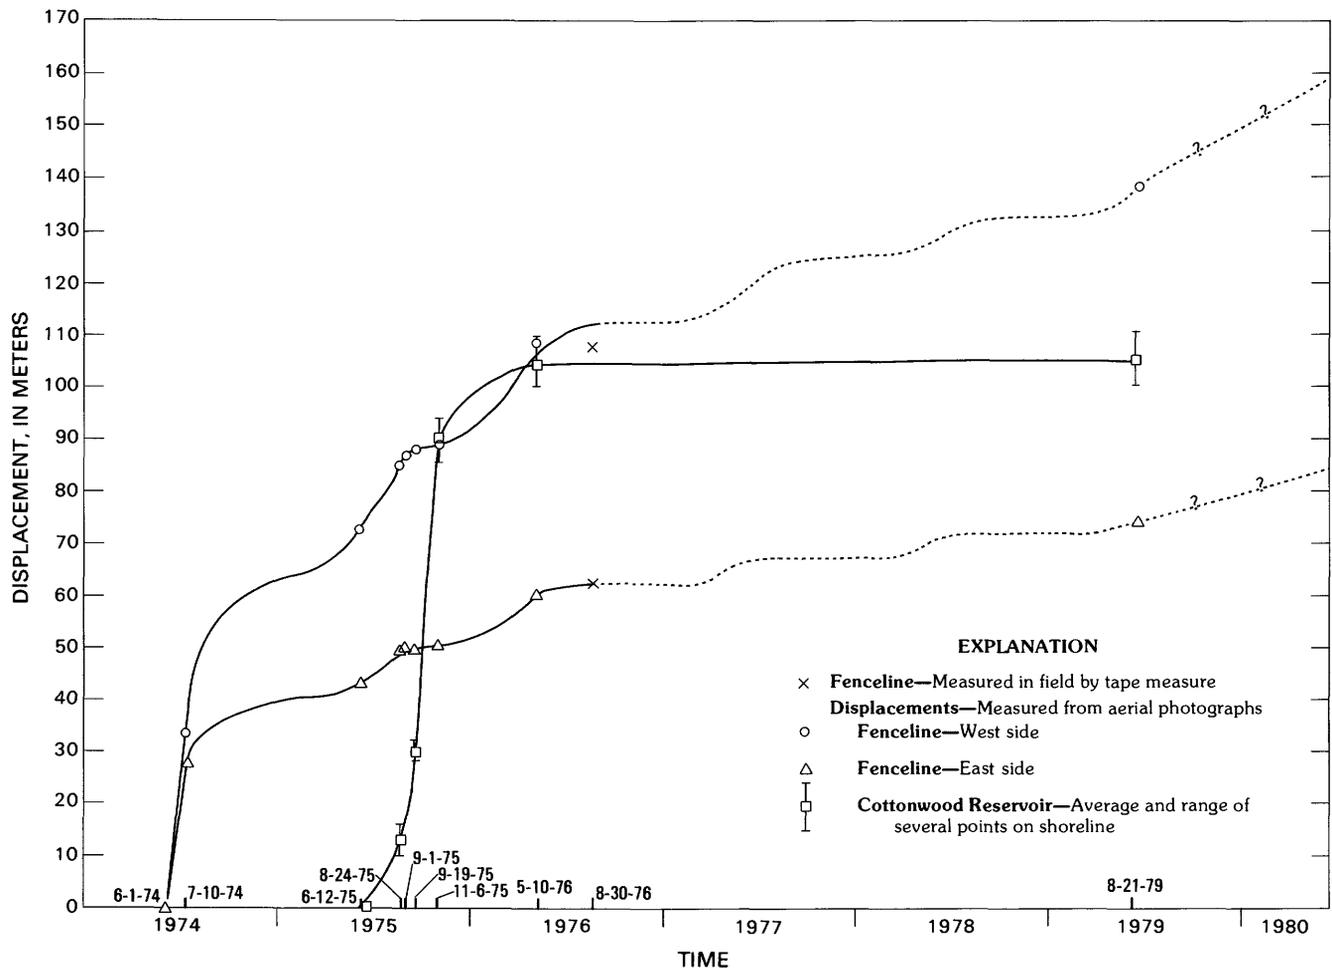
FIGURE 13.—Plot of displacement versus time for three points on the Manti landslide. Two of the points were measured from aerial photographs and checked by tape measurement. They are on the east and west flanks of the landslide at the fenceline crossing in the upper part of the landslide. The other point, measured from aerial photographs, is the average value of several measurements of displacement on the shoreline of Cottonwood Reservoir.

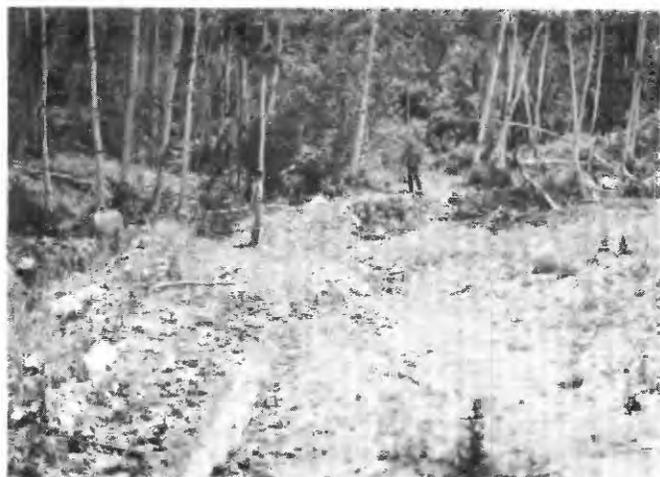
FIGURE 14.—Four meters of offset of road at crossing of the east flank of the landslide near the former waterline crossing. Displacement occurred between the early summer of 1980 and July 30, 1982. Person in the background and camera align with the centerline of the road in its 1980 position. Person in middle ground is on the centerline of the displaced road. (Photograph by G. P. Williams.)

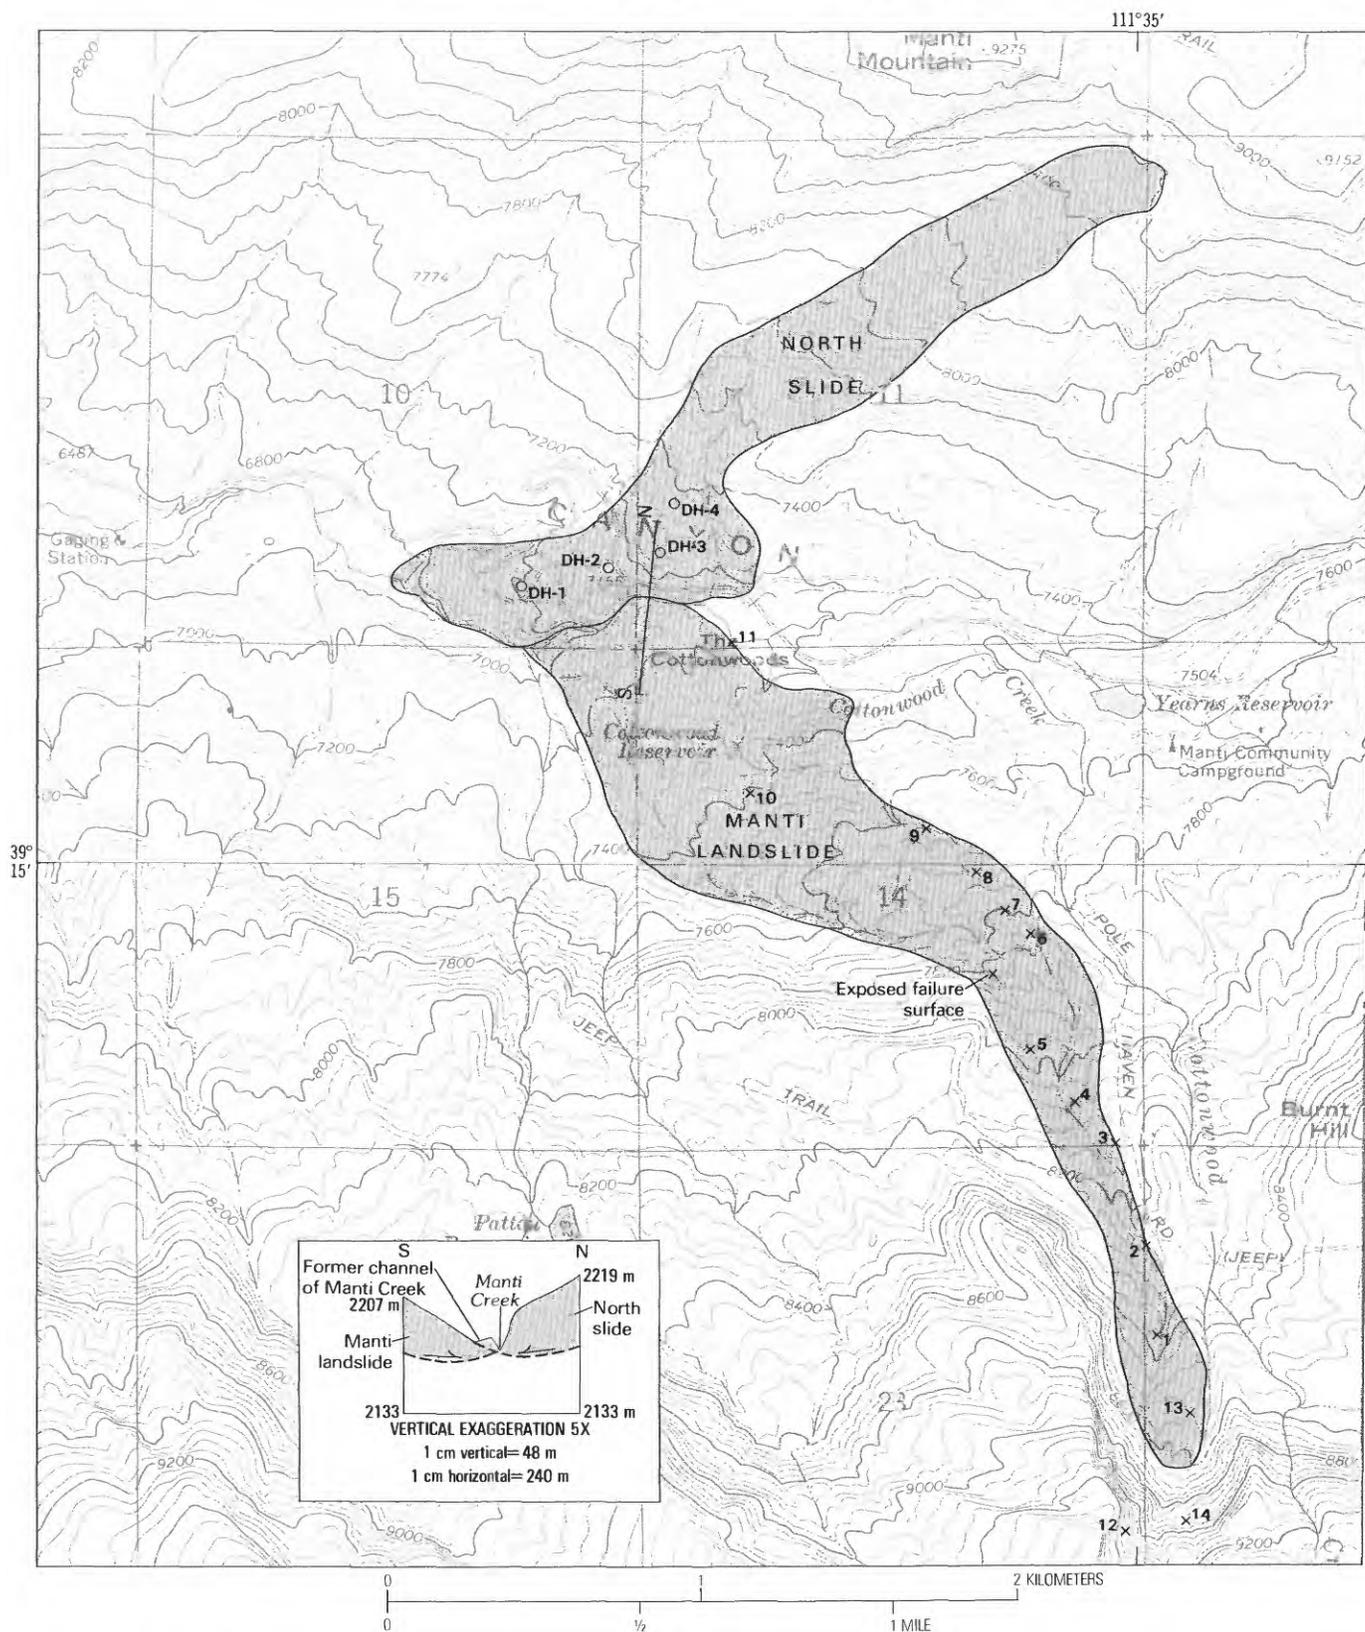
FIGURE 1.—Outline of the inactive Manti landslide and the North slide showing drill-hole locations on the North slide and sample locations on the Manti landslide. Inset cross section (S-N) shows the pre-landslide profile across Manti Creek. Refer to figure 1 (Chapter A, this volume) for a location map of the Manti landslide.

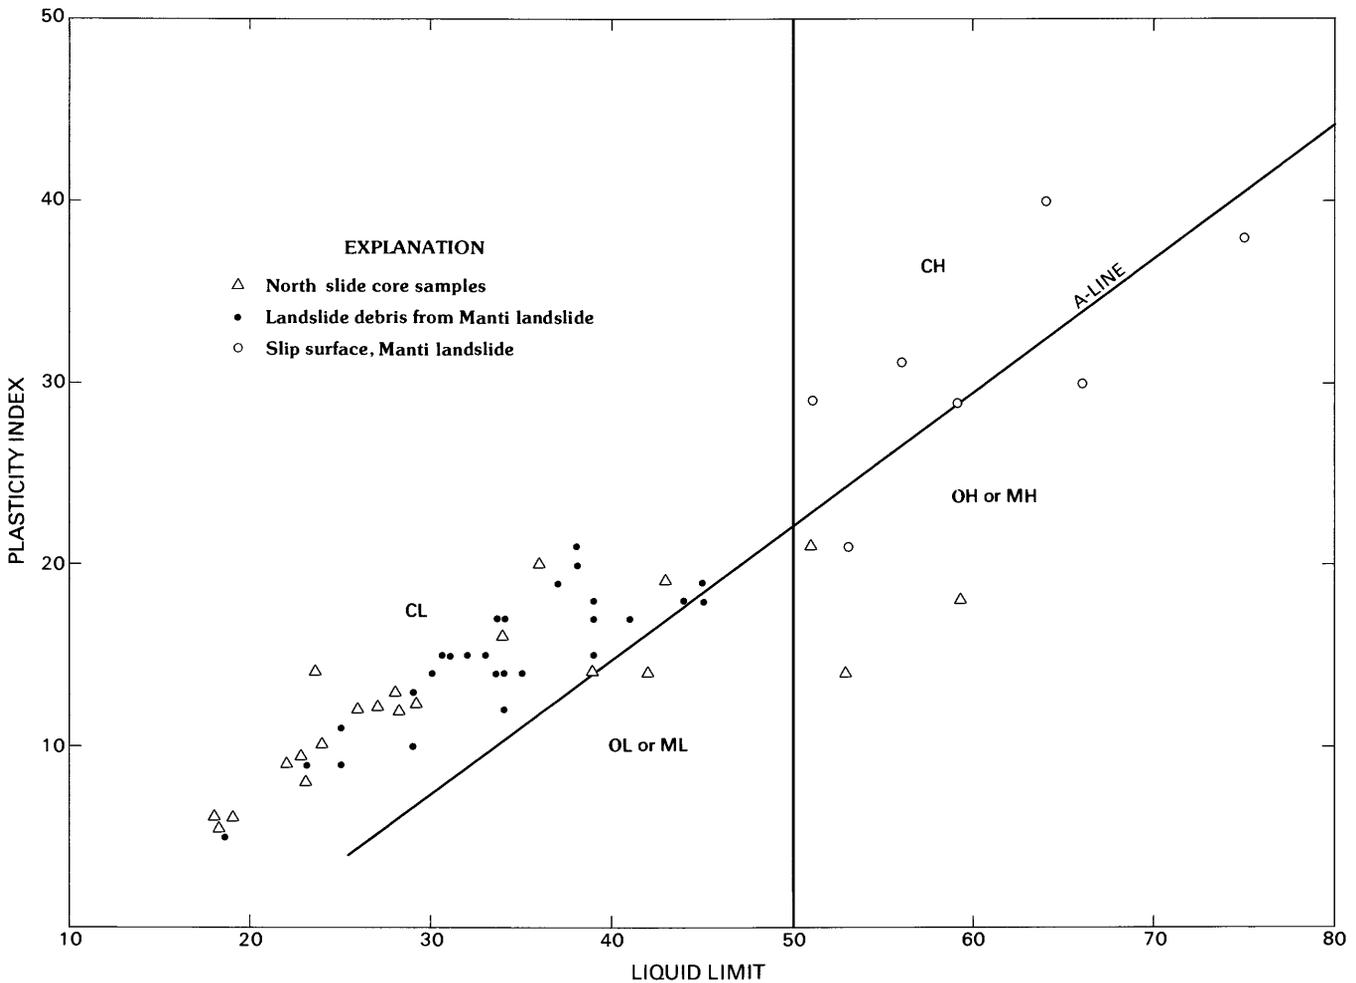
FIGURE 2.—Plasticity chart for samples from the Manti landslide and the North slide. Data for the North slide are from International Engineering Company, Inc. (1976). Definitions of symbols are as follows: CH, inorganic clays of high plasticity; OH or MH, organic silts and clays of medium to high plasticity or inorganic silts; OL or ML, organic silts and clays of low plasticity or inorganic silts and very fine sands with slight plasticity; CL, inorganic clays of low to medium plasticity. Engineering experience has shown that samples of the same genetic soil are represented by points along a line that is roughly parallel to the A-Line.

Atterberg limits, both from samples from the borings in the North slide and from surface samples of the Manti landslide, are plotted on figure 2. Liquid limits (LL) of the slide debris generally range from 18 to 45; the plasticity index (PI) ranges from 5 to 20. Samples plot above the A-line, and the fine fraction of the debris classifies as clays of low plasticity. Three samples of debris from the borings in the North slide had liquid limits greater than 50, one of which was from a slickensided zone. Average Atterberg limits for all 48 samples of landslide debris are LL 32, PI 14.
