# The Manti, Utah, Landslide

U.S. GEOLOGICAL SURVEY PROFESSIONAL PAPER 1311

## The Reactivation of the Manti Landslide, Utah

## Physical Properties and Mode of Failure of the Manti Landslide, Utah

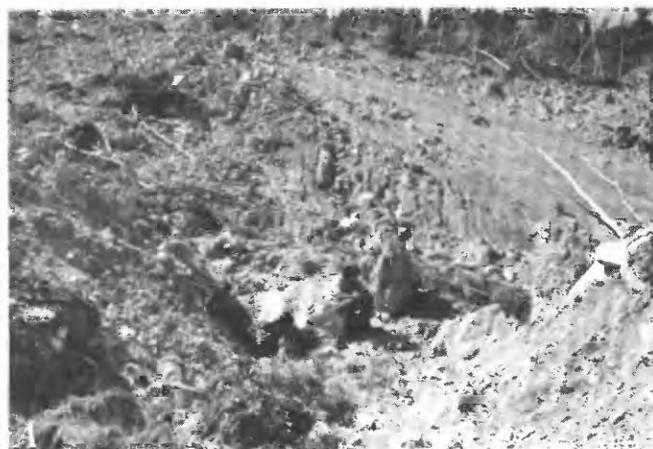
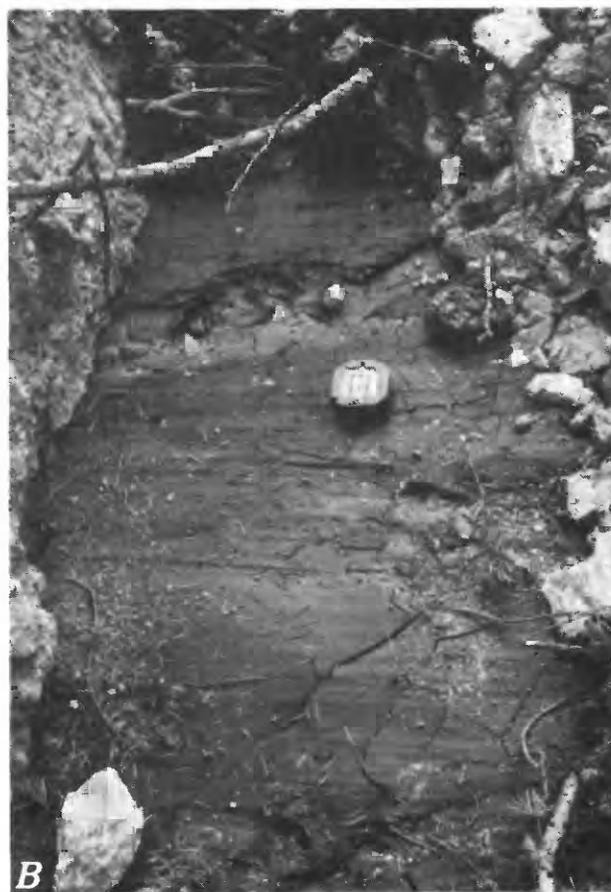
FIGURE 3.—Views of the exposed failure surface on the upper ramp. *A*, View looking south of large area of exposed, but weathered, failure surface. In lower left of the photograph, block samples containing the failure surface are being removed for testing. *B*, Closeup view of failure surface that was exposed between two large blocks of landslide debris. Note the absence of coarse material on the slip surface. Gravel-size fragments are abundant within 1–2 cm below the surface and can be seen just above and slightly left of the Brunton compass.

On the upper ramp below the upper bench, the landslide separated and exposed a portion of the failure surface (see Chapter B, fig. 3, this volume; pl. 1, fig. D). The separation had been preceded by extensional cracks at right angles to the direction of movement. By November 6, 1975, the landslide had pulled apart over a zone about 150 m wide.

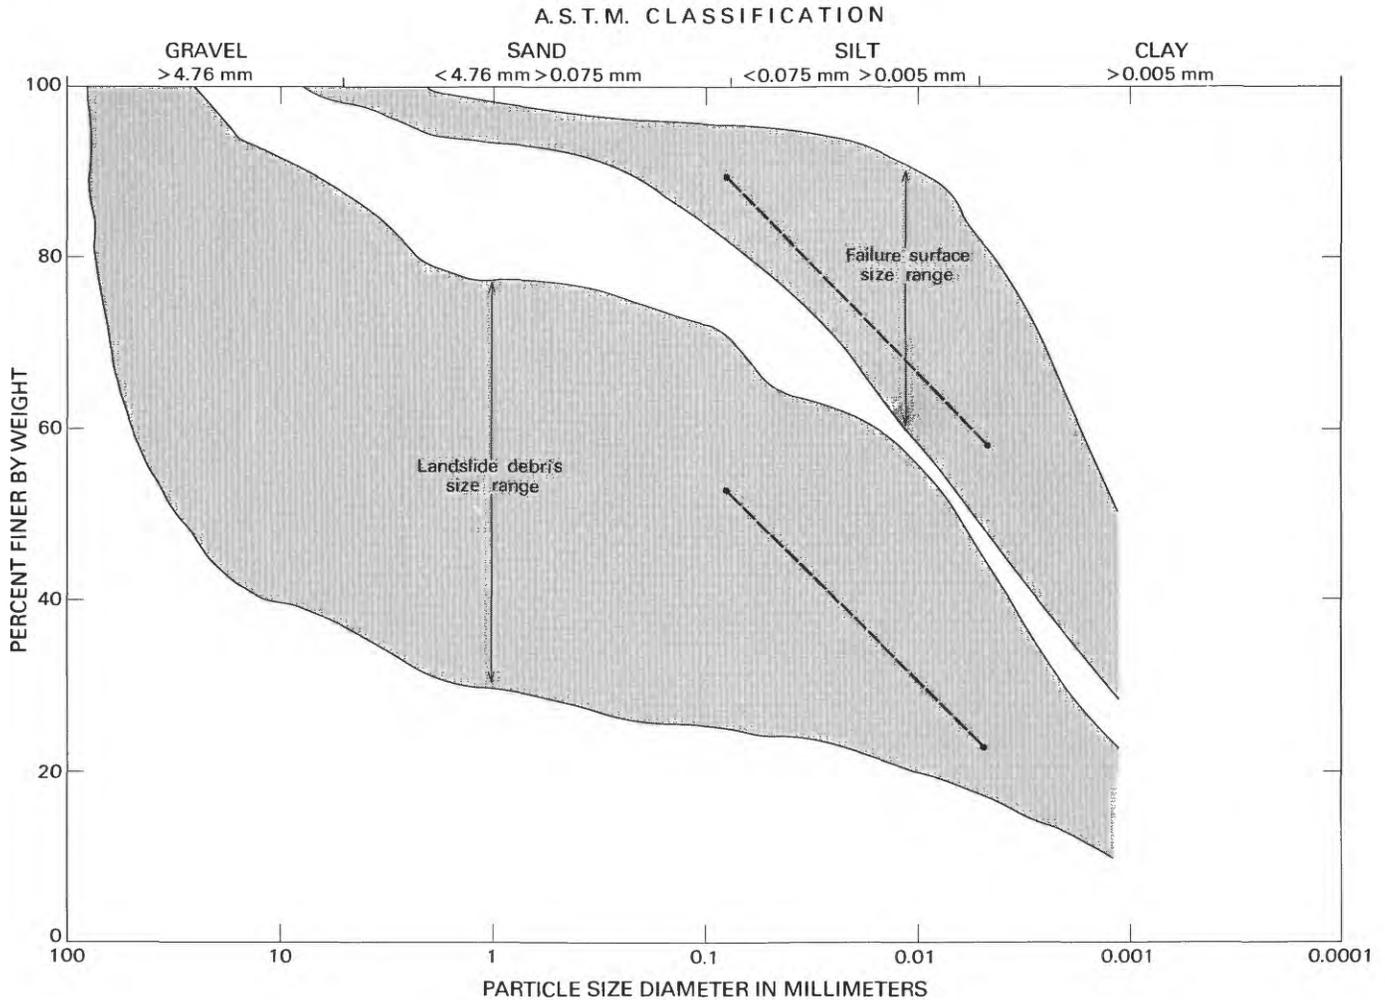
FIGURE 4.—Cumulative curves of range of gradation for 10 samples of landslide debris (samples 2-11, table 1) and 8 samples of slip-surface materials. Dashed lines connect points for average amounts of clay-size and clay-plus-silt-size fraction. Note that the slopes of the dashed lines are about parallel. Thus, the principal difference between the materials is the absence of a coarse fraction in the slip-surface samples.

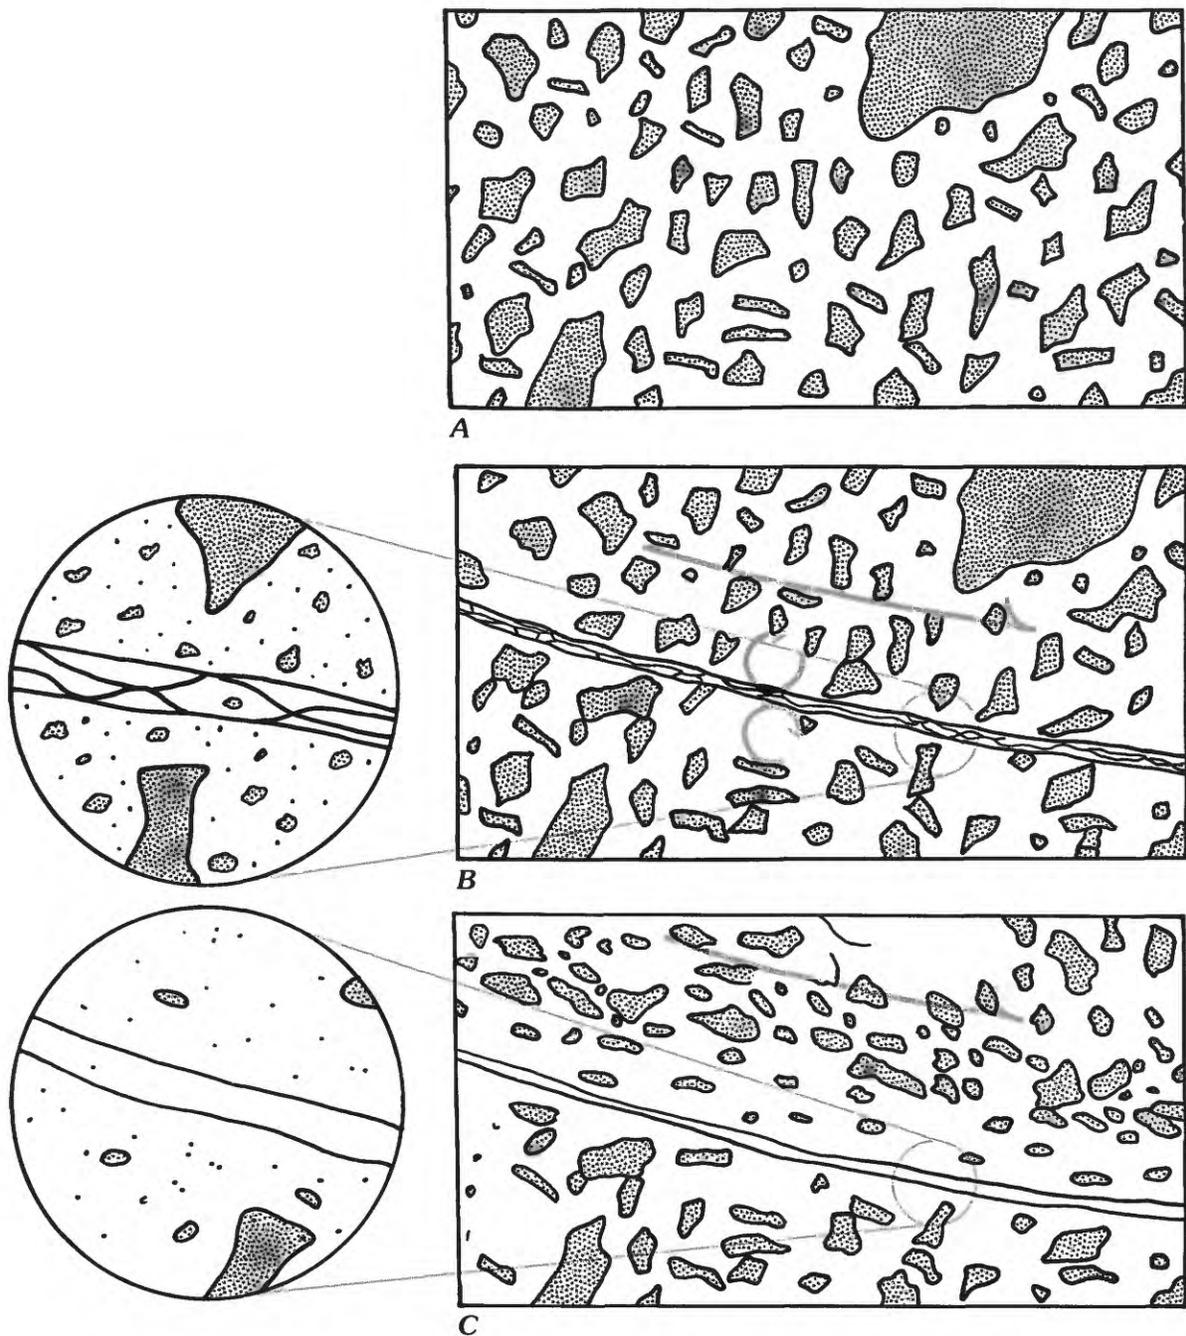
FIGURE 5.—Sketch of two stages in the process of mechanical depletion of the coarse fraction from a failure surface. *A*, Prior to failure, coarse clastics are scattered throughout the material. *B*, As a failure surface propagates through the material, the coarser clastics rotate out of the failure zone. *C*, With continuing displacement, a thin failure surface evolves that is depleted of sand and coarser size material. In places where the failure surface is exposed, multiple failure surfaces can be found by digging. In each case, the failure surface is no more than 1 cm thick and contains no coarse clastics. (Sketch modified from Wahlstrom and Nichols, 1969.)

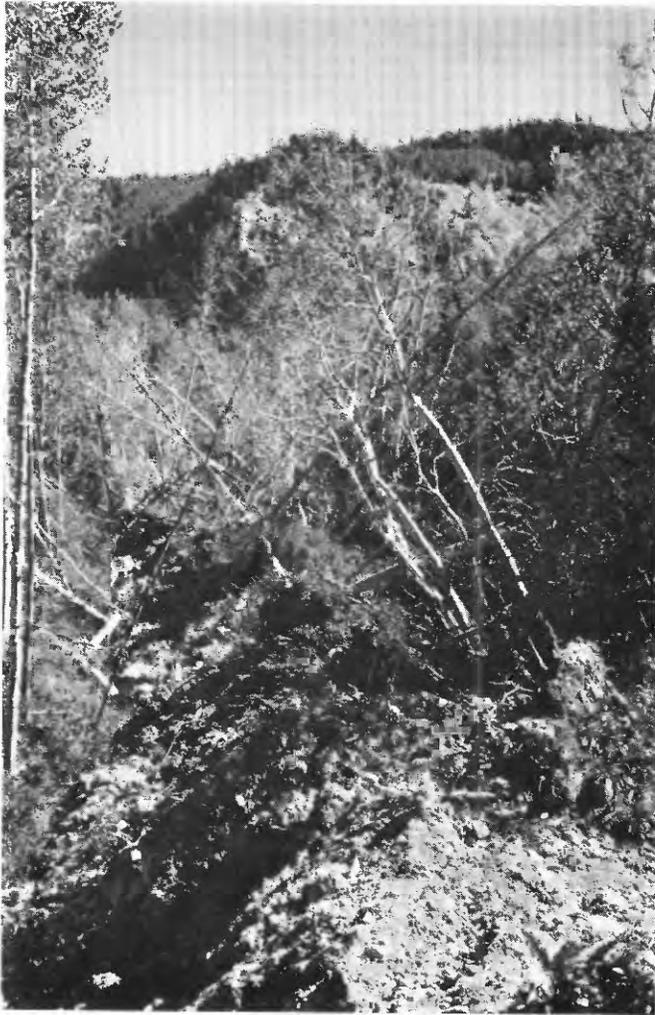
FIGURE 6.—Outward-facing scarp on the right flank of the upper part of the landslide. Displacement resulted in the failed debris being elevated about 3 m above the undisturbed surface outside the landslide.

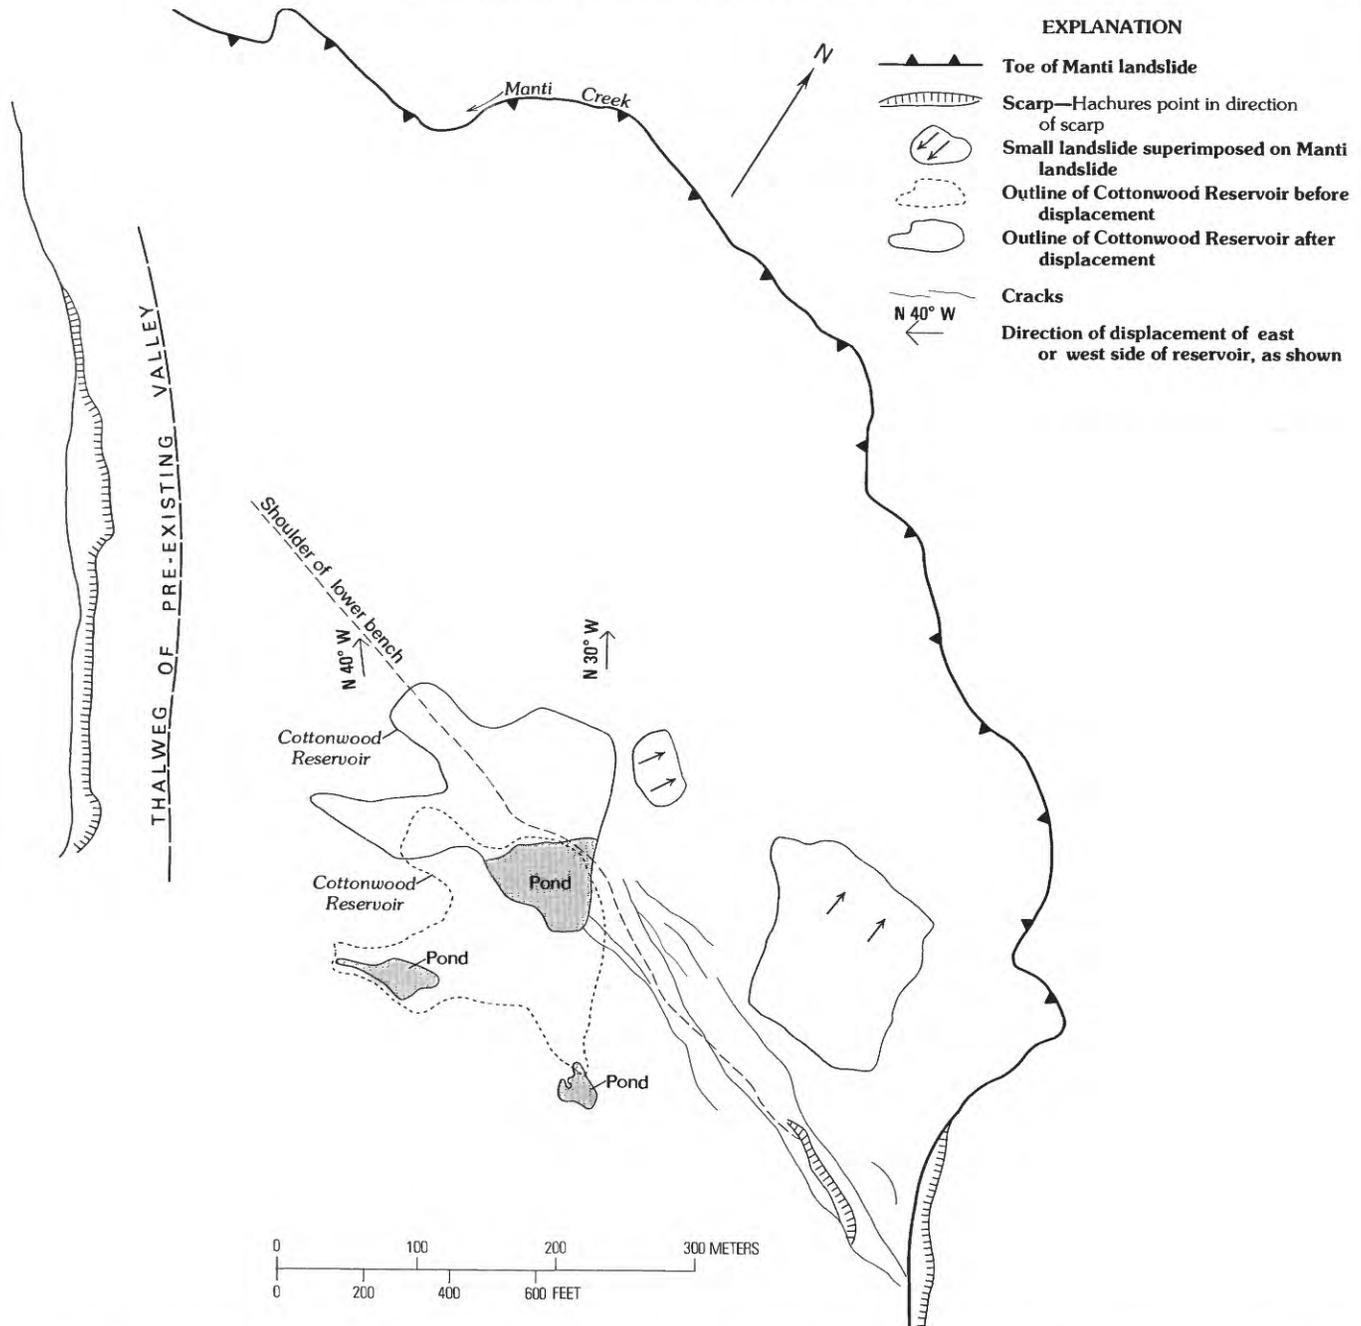
FIGURE 7.—Displacement of Cottonwood Reservoir over the shoulder of the lower bench. The solid outline of the reservoir is its pre-failure location, and the dotted outline is its position on June 21, 1979. The arrows show the difference in direction of displacement of the east and west sides of the reservoir.

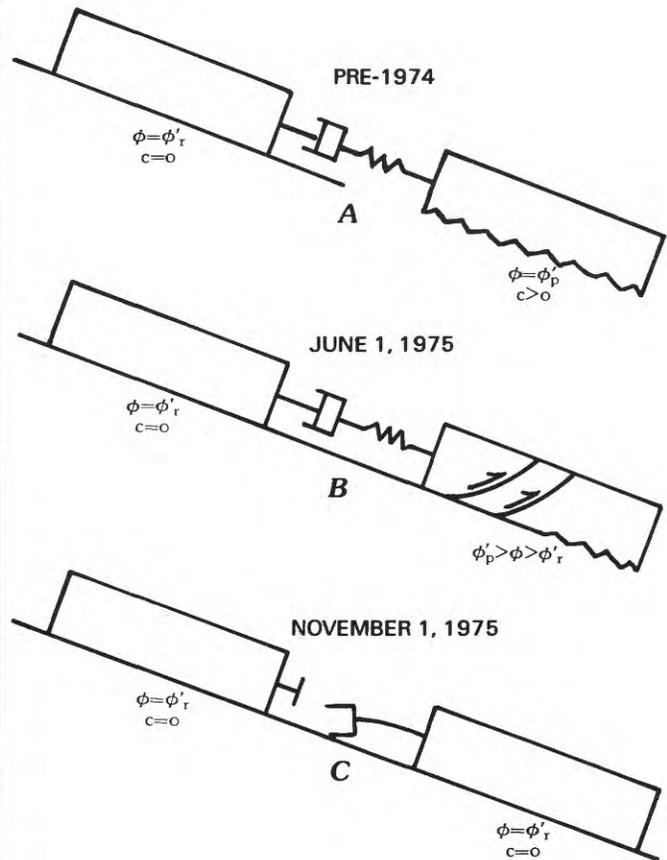
FIGURE 8.—Schematic model for reactivation of the Manti landslide. A, Before reactivation, the upper portion of the landslide before reactivation was creeping at a rate of less than 4 cm/yr. A small amount of strain energy was being stored in the toe of the movement zone (for location, see Chapter A, fig. 8, this volume). The stored strain energy increased dramatically after reactivation in early June 1974. The strength of the upper part of the landslide was at a residual value, while the strength of the lower part was at or near a peak value. B, Displacement of as much as 70 m had occurred in the upper portion of the landslide before movement was recognized in the lower portion. Internal toes were forming in response to extreme loading from upslope. The strength parameters of the lower portion were progressively reduced from a peak value of about  $\phi'_p \approx 30^\circ$  with an unknown amount of cohesion to a residual friction of  $\phi'_r \approx 12^\circ$ . C, Lower portion of the landslide has a well-developed failure surface, and strength has been reduced to residual values throughout the failure surface. Lower portion of the landslide near Cottonwood Reservoir was moving at about 3.1 m/d at the same time the upper part was moving at about 0.3 m/d. The landslide separated on the upper bench, and the two portions of the landslide were moving independently and no longer in physical contact.

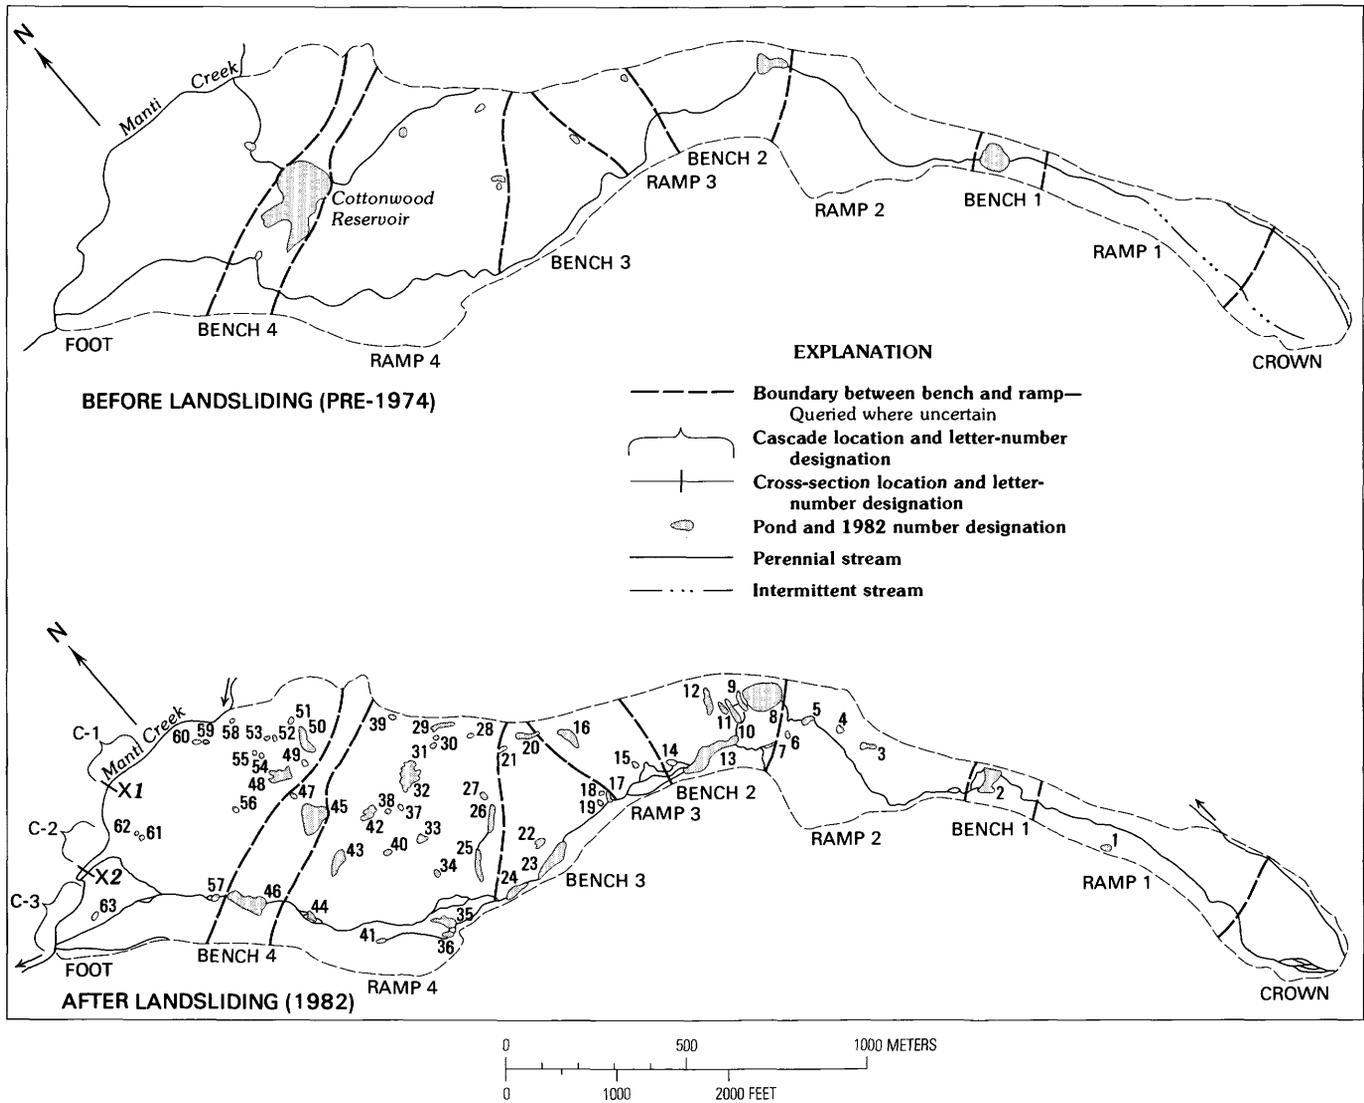
FIGURE 1.—Outline and principal hydrologic features of the Manti landslide. Pre-1974 map is based on aerial photography and on U. S. Geological Survey topographic maps (1982 physiographic regions shown for comparison); 1982 map is based on field observations and on 1979 aerial photography.

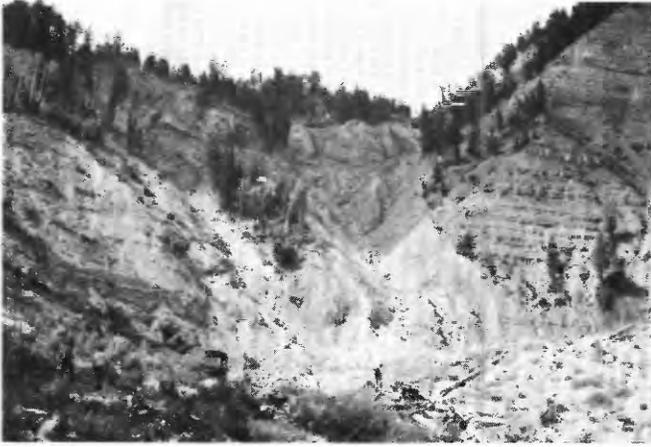
FIGURE 2.—Cliff at head of landslide, showing gullies that periodically carry debris flows and that perennially carry surface water. People in foreground indicate scale. Photograph taken July 1982.

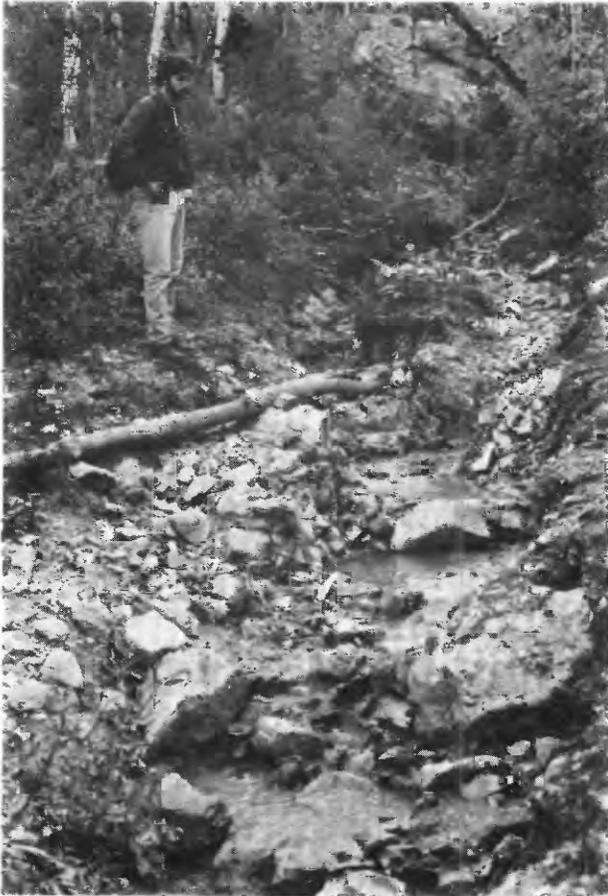
FIGURE 3.—Upstream view of the western drainageway on the landslide, about at lower boundary of ramp 1, September 1982.

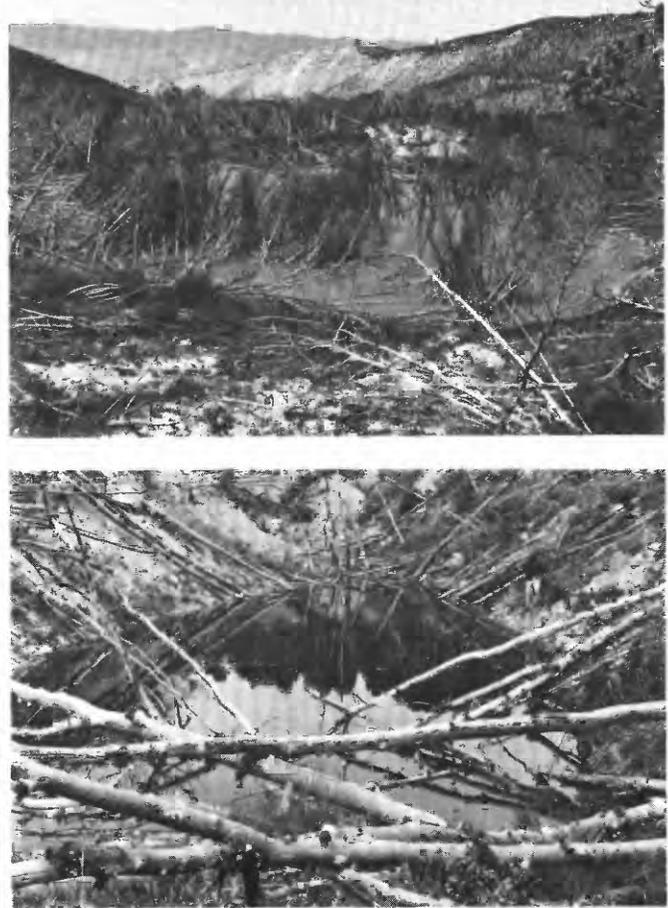
FIGURE 4.—Pond 8 (upper photograph, looking downslide, July 1982) and pond 10 (lower photograph, looking perpendicular to slide direction, September 1982).

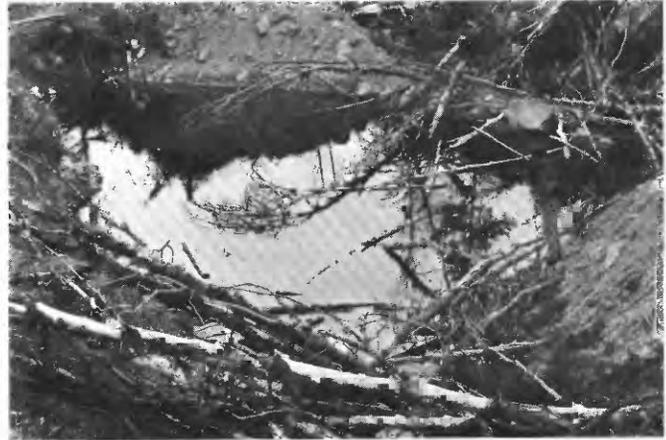
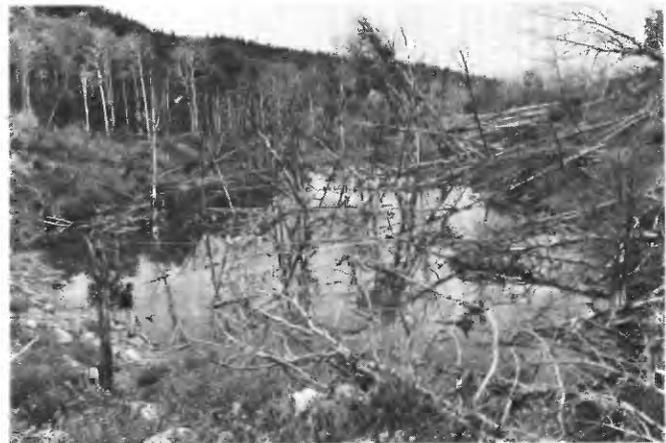
FIGURE 5.—Ponds 22 (upper photograph) and 23 (lower photograph), September 1982. Pond 22 is a closed pond but topographically is several meters higher than the nearby pond 23, an open pond.

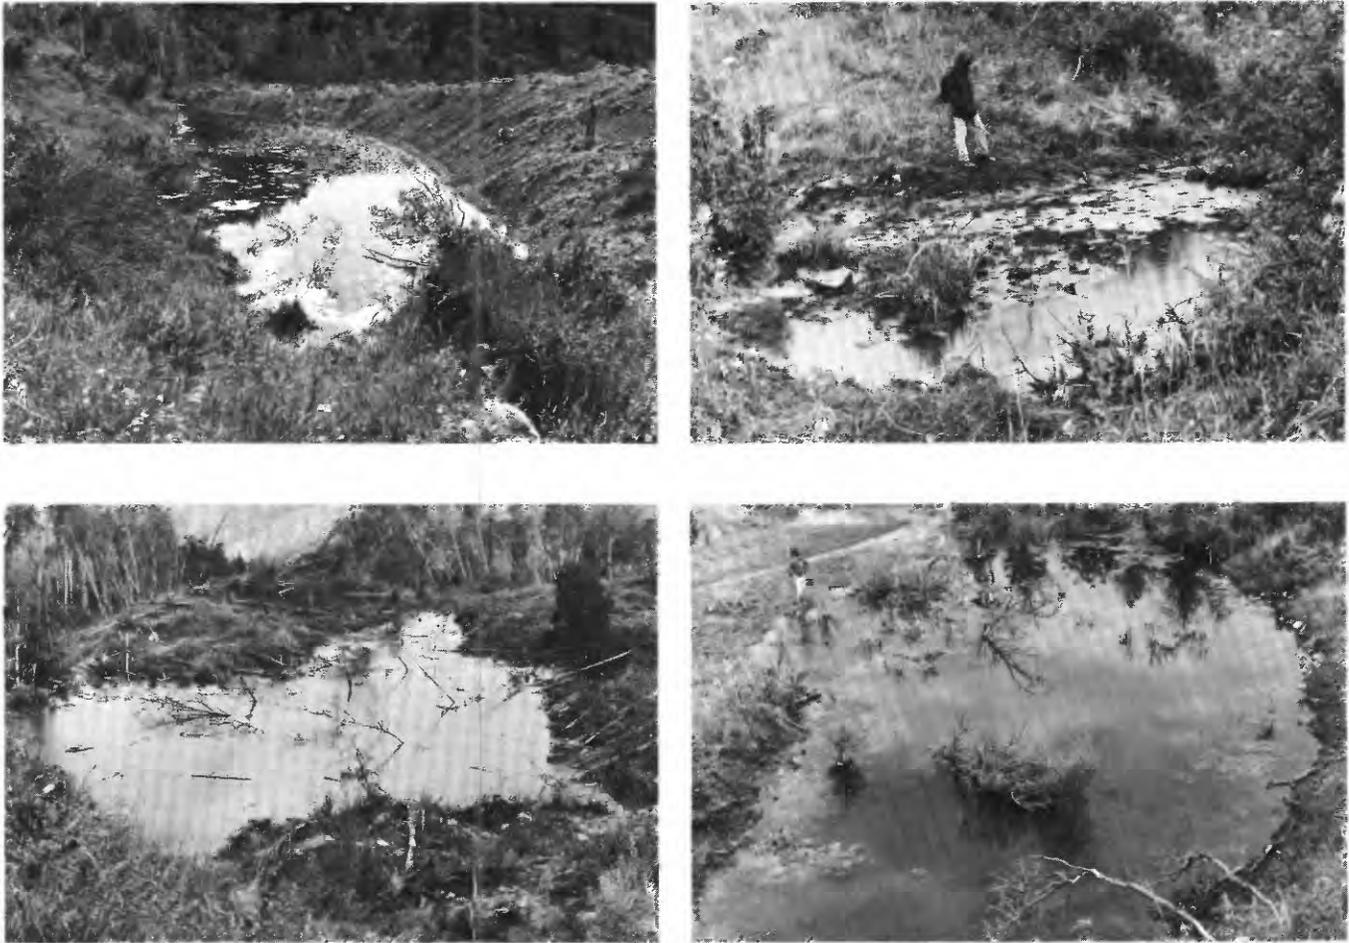
FIGURE 6.—Representative ponds of ramp 4: pond 25 (upper left), 35 (upper right), 37 (lower left), and 44 (lower right). Photographs taken September 1982 except that of pond 25, which was taken July 1982.

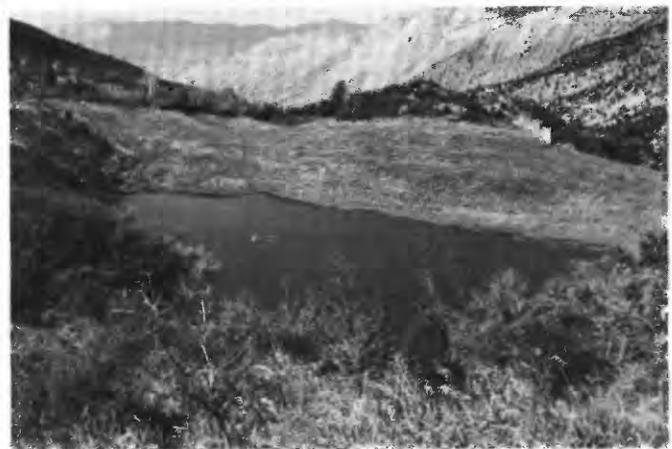
FIGURE 7.—Downslope view of pond 45, the post-1976 remains of Cottonwood Reservoir, October 1982. Lightly vegetated area covering entire width of photograph along far edge of pond is exposed bed of former reservoir.

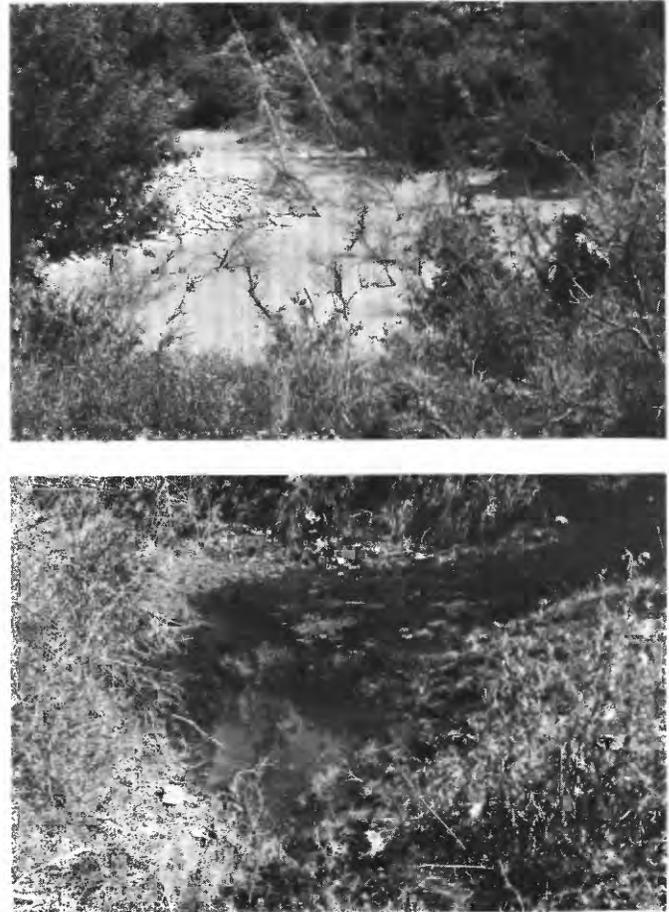
FIGURE 8.—Typical ponds of the foot: pond 50 (upper photograph, July 1982) and pond 55 (lower photograph, October 1982).

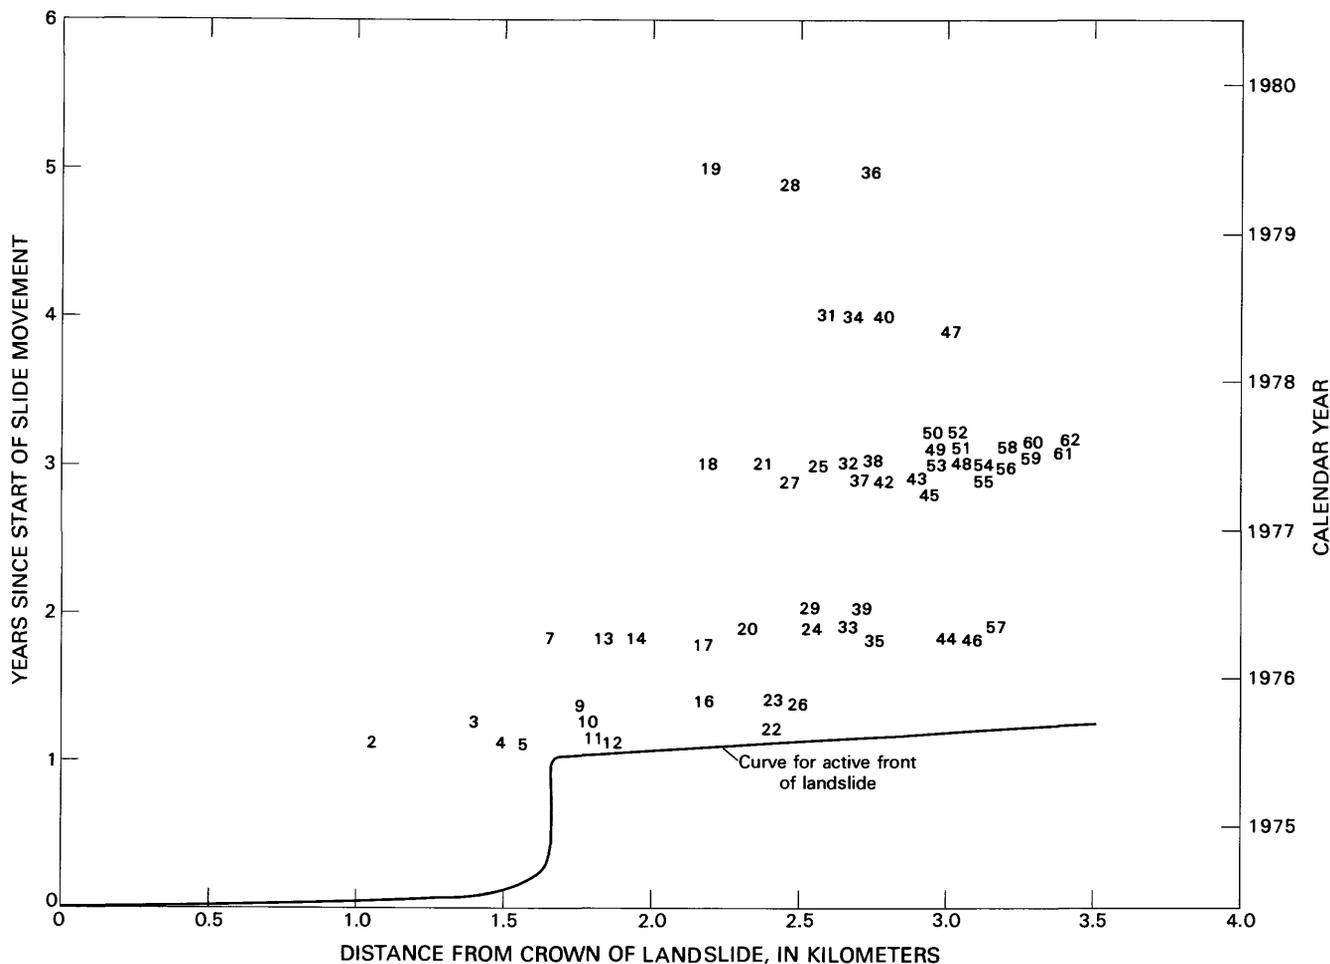
FIGURE 9.—Dates of pond establishment as a function of distance along the landslide. Plotted numbers are pond numbers (fig. 1).

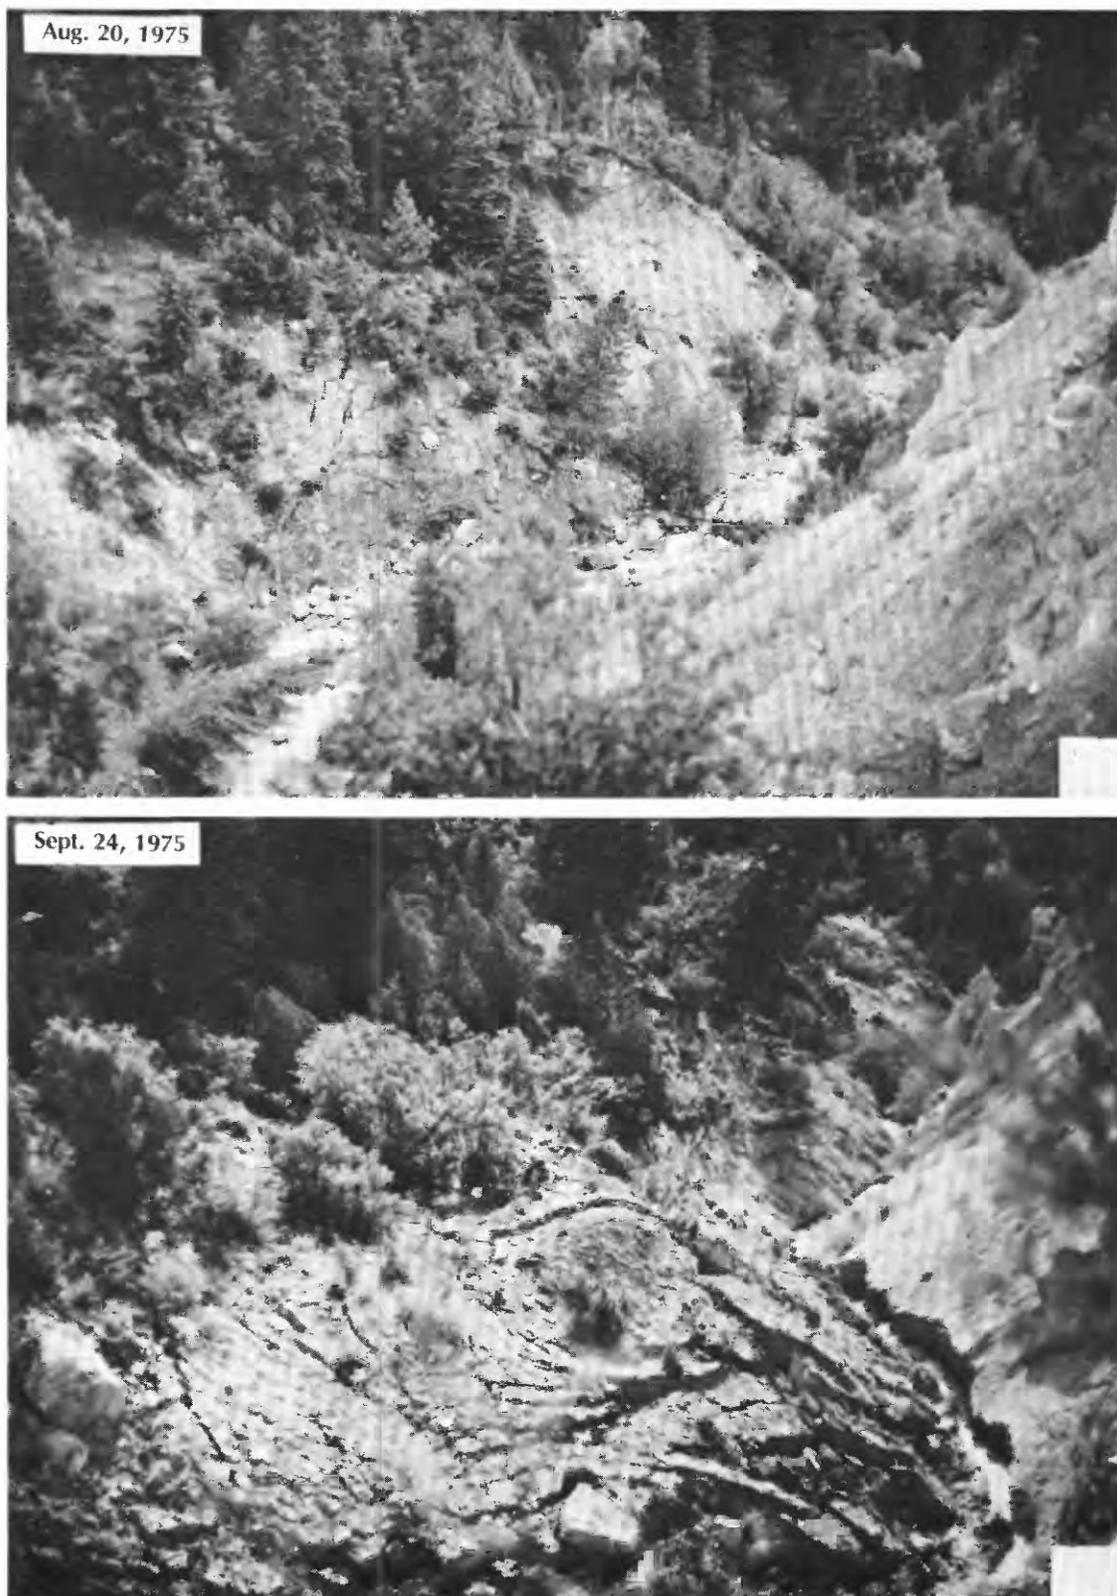
FIGURE 10.—Time-sequential photographs showing sediment introduction at a site in the downstream part of the Manti Creek slide reach, looking downstream. North is to the right. Photographs by Earl P. Olson, U.S. Forest Service.

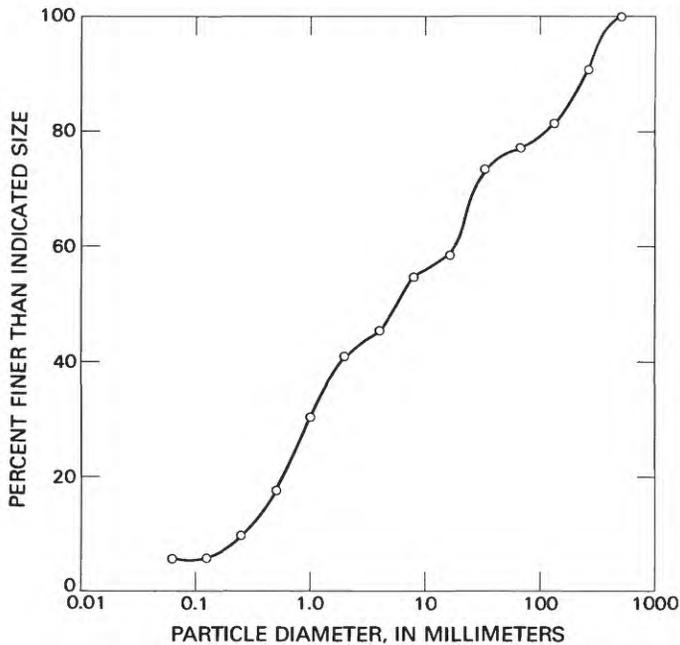
FIGURE 11.—Representative size-frequency distribution of toe sediment, Manti landslide.

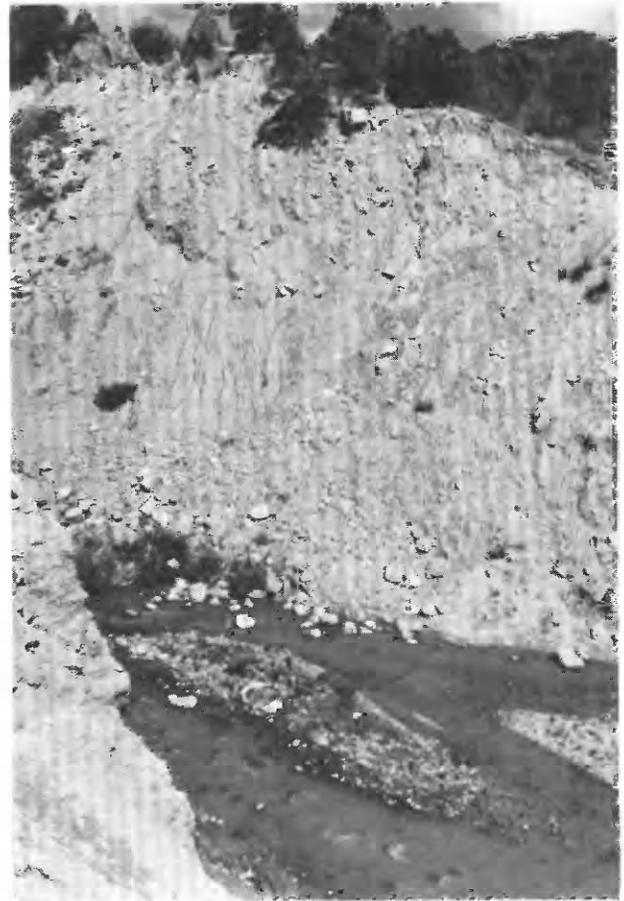
FIGURE 12.—Toe of landslide and Manti Creek about midway along the slide reach, July 1982. The steep left bank shown here is about 25 m high.

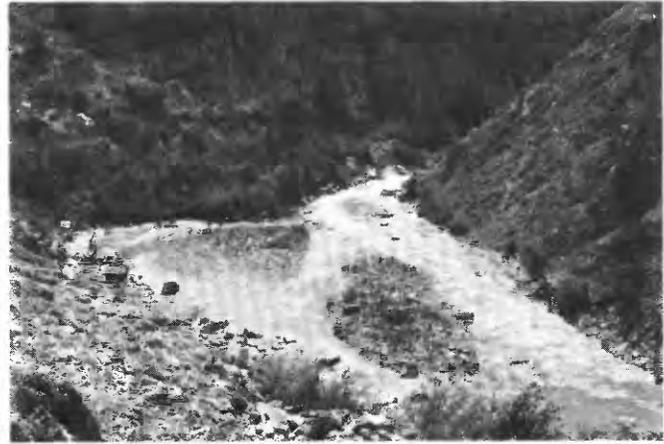
FIGURE 13.—Downstream view of braided section that separates cascade 1 from cascade 2, July 1982.

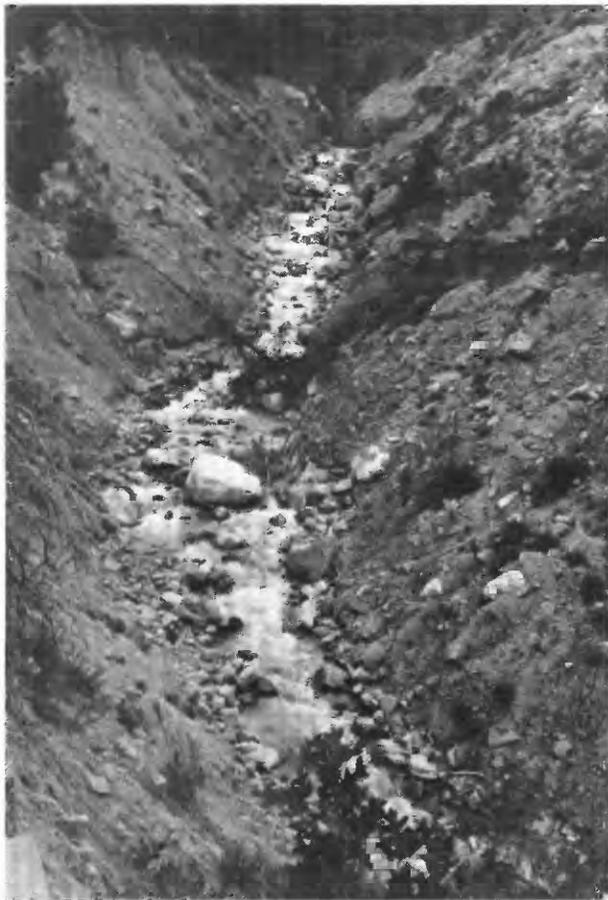
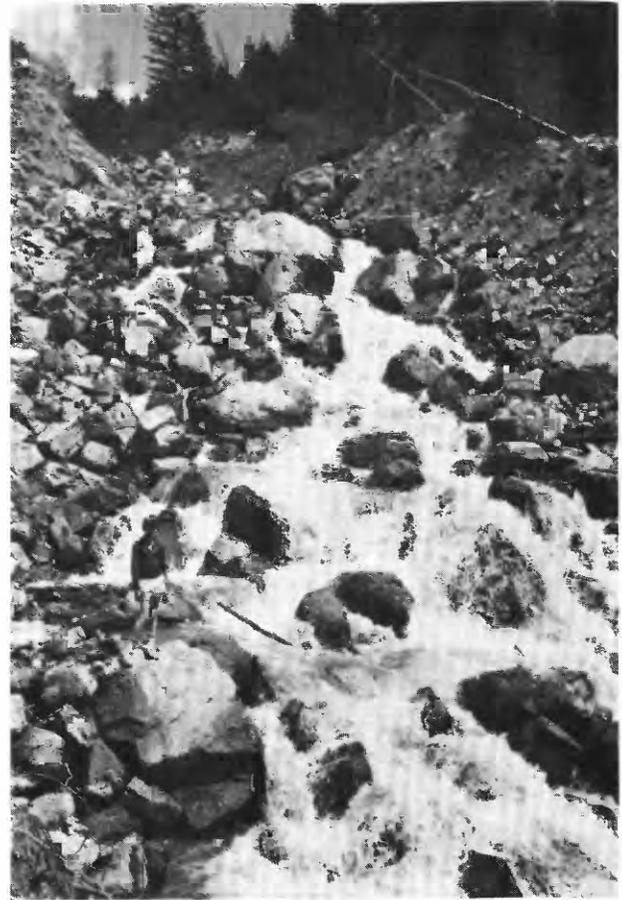
FIGURE 14.—Upstream views of parts of cascade 1 (left photograph) and cascade 3 (right photograph), July 1982.

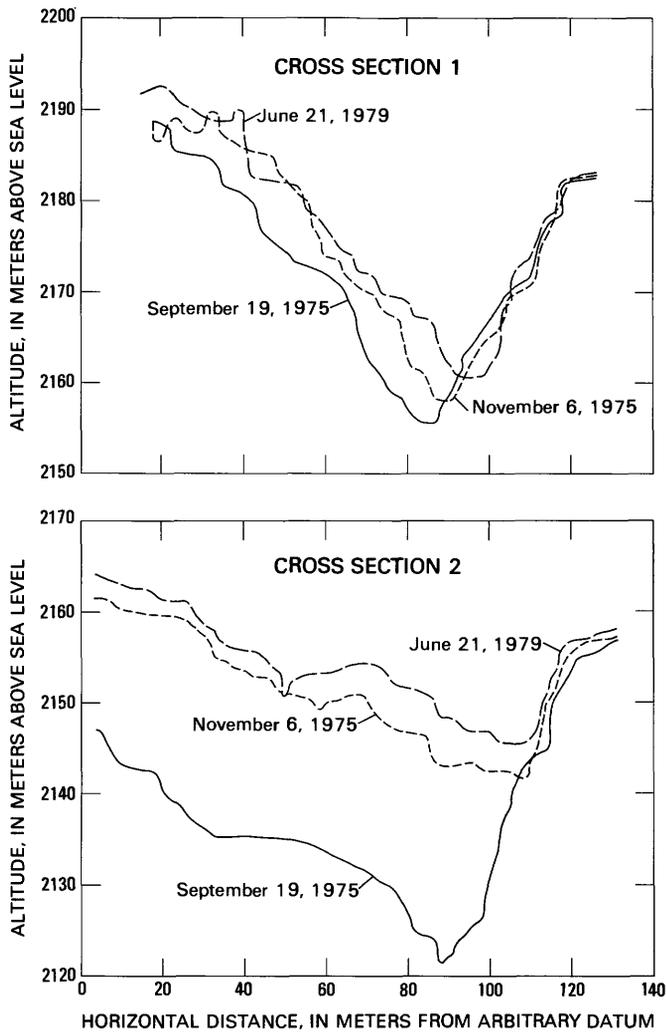
FIGURE 15.—Cross-sectional changes on Manti Creek at selected times. Landslide encroached from left side. Locations of cross sections are shown in figures 1 and 16.

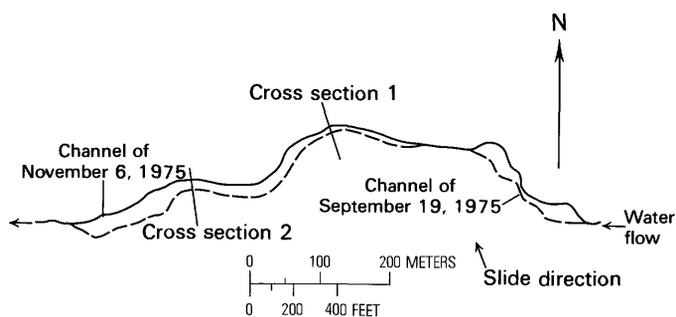
FIGURE 16.—Lateral displacement of Manti Creek slide reach from September 19 to November 6, 1975.

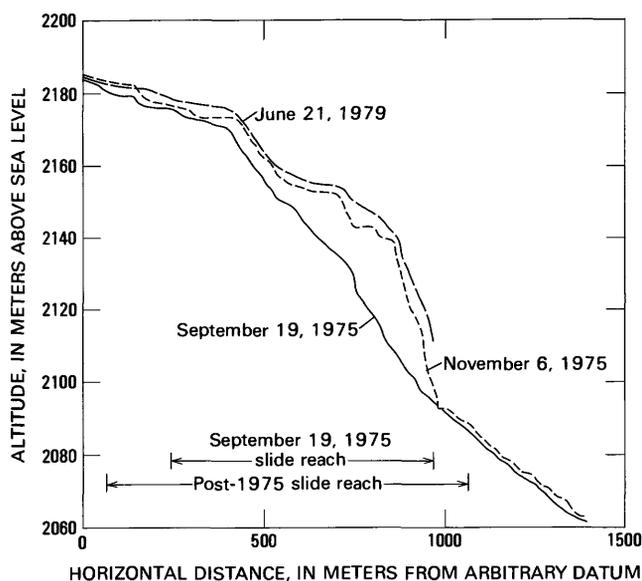
FIGURE 17.—Longitudinal profiles of Manti Creek in the vicinity of the landslide.

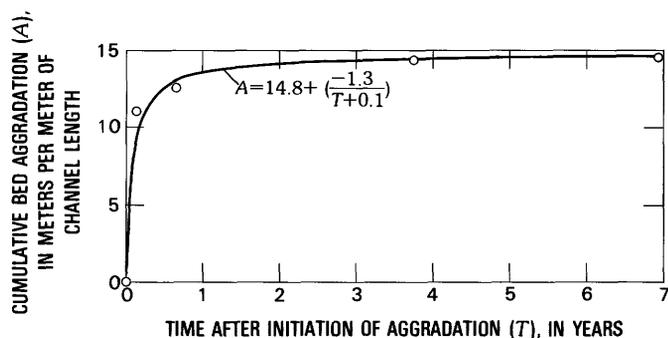
FIGURE 18.—Cumulative Manti Creek aggradation as averaged over the slide reach, for the first 7 years after the onset of aggradation (September 19, 1975, to July 28, 1982).

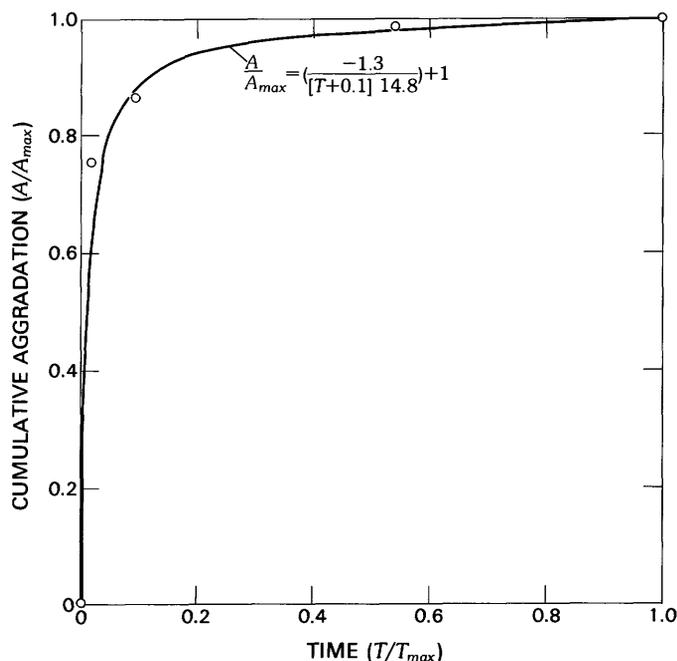
FIGURE 19.—Standardized plot of cumulative Manti Creek aggradation (averaged over the slide reach) versus time. Data are same as those used for figure 18.

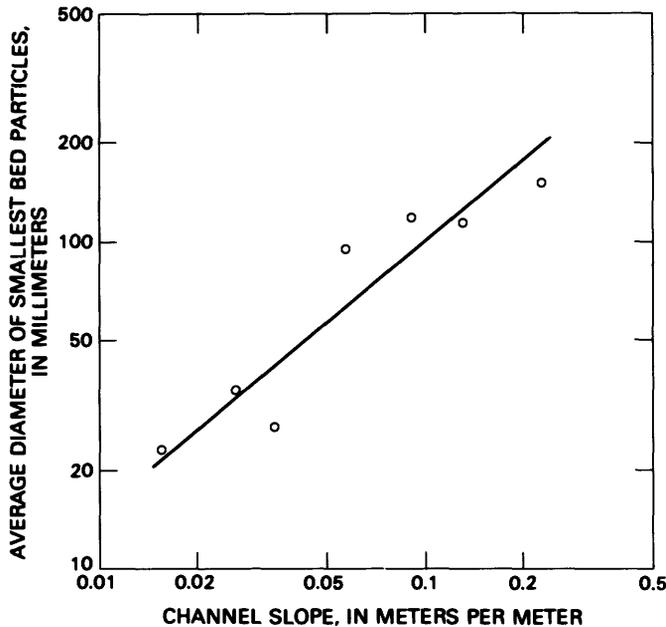
FIGURE 20.—Geometric mean diameter of smallest bed particles as a function of local channel slope in the various subreaches of the Manti Creek slide reach. Fitted line is the reduced major axis.

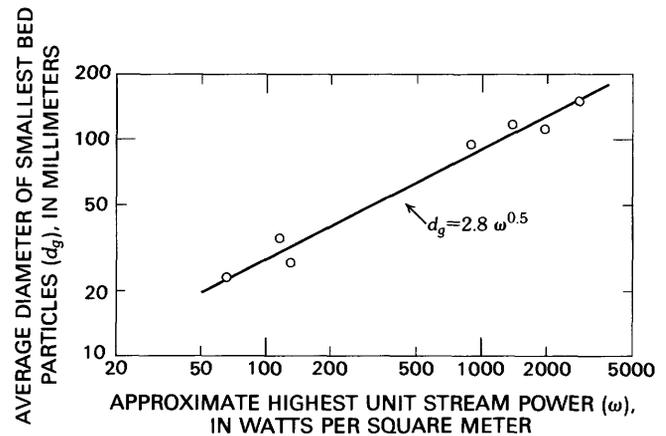
FIGURE 21.—Average smallest bed-material diameter as a function of approximate highest unit stream power that acted on the post-slide streambed. Line fitted by least squares.
