Physical Properties of the Surface Materials at the Viking Landing Sites on Mars

U.S. GEOLOGICAL SURVEY PROFESSIONAL PAPER 1389

By H.J. MOORE, R.E. HUTTON, G.D. CLOW, and C.R. SPITZER

*A summary of the results of
the Physical Properties Investigation
of Viking Landers 1 and 2 during
the Viking 1975 project*

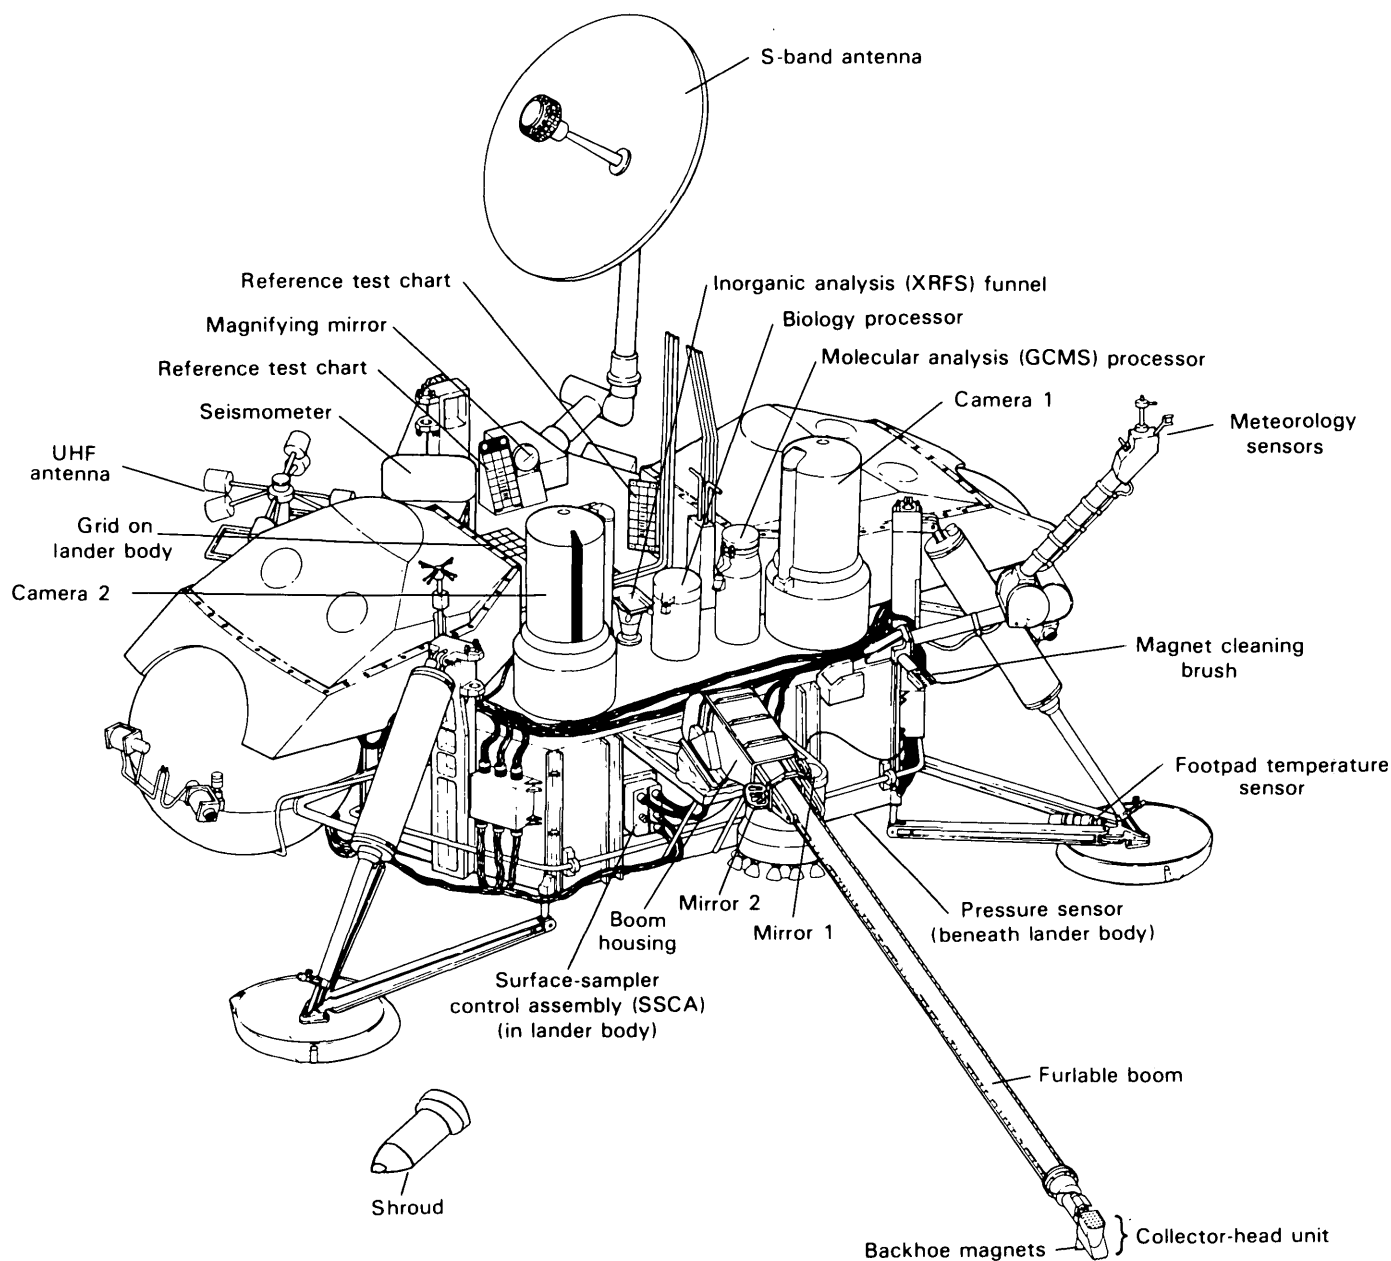
FIGURE 3.—Viking lander showing locations of visible parts of components of surface-sampler subsystem and science experiments. Analytical instruments are mounted within the prismatic body; sample processors and delivery ports are labeled. All three biology instruments used the

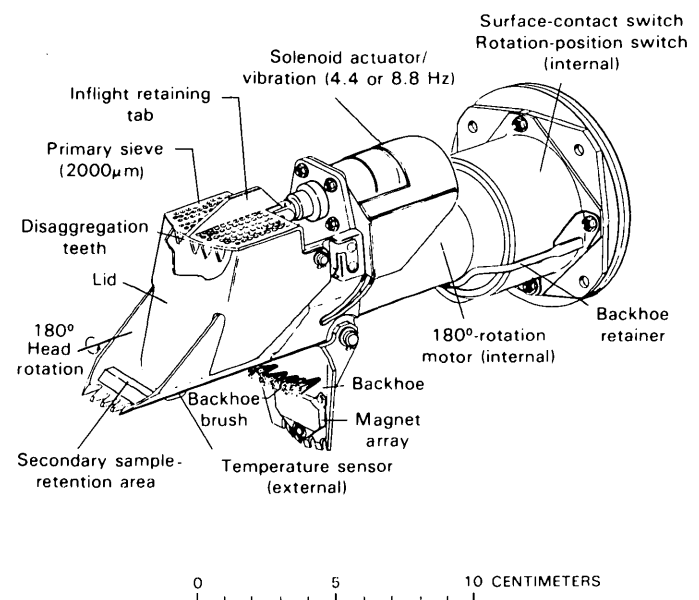
FIGURE 4.—Surface-sampler collector head. Collector head is in upright position. Upright collector-head unit rotates upward through 10° during touchdown on surface. This rotation actuates a switch which turns off elevation motor upon surface contact and 10° rotation. Backhoe tip is initially held in retainer but spring deploys it to indicated position when collector head rotates. Solenoid retracts rod and thereby rotates lid to open position for sample acquisition; lid is closed by spring. Upper lid contains 2.0-mm screen for sample processing. Entire collector head can be rotated to inverted position with backhoe upward.

face has wire brushes with which to acquire samples from a veneer of loose material on rock outcrops. Two magnets, which could be cleaned by a wire brush attached to the lander body, are mounted in the backhoe to attract the magnetic fraction in the surface materials. Collector-head temperatures were measured with a platinum resistance thermistor mounted in a metal holding plate on the base of the lower fixed jaw. The absolute accuracy of the thermistor temperatures was found by experience to be ± 3 percent of the temperature measured from 0°C and the range was $(-)$ 129°C to $(+)$ 177°C . Temperature resolution, constrained by telemetry, was 0.72°C . Near the collar, the collector head rotates upward. Upon surface contact during sampling, this upward rotation of about 10° actuates a switch that cuts off the power to the elevation motor in order to stop the downward motion of the collector head and boom. This rotation acts against a spring and requires about 10 N of force on the backhoe. Surface-sampler positions in azimuth, elevation, and extension were measured with potentiometers so that the achieved positions could be compared with commanded positions. Additionally, motor currents of the acquisition assembly could be measured and these measurements are discussed below.

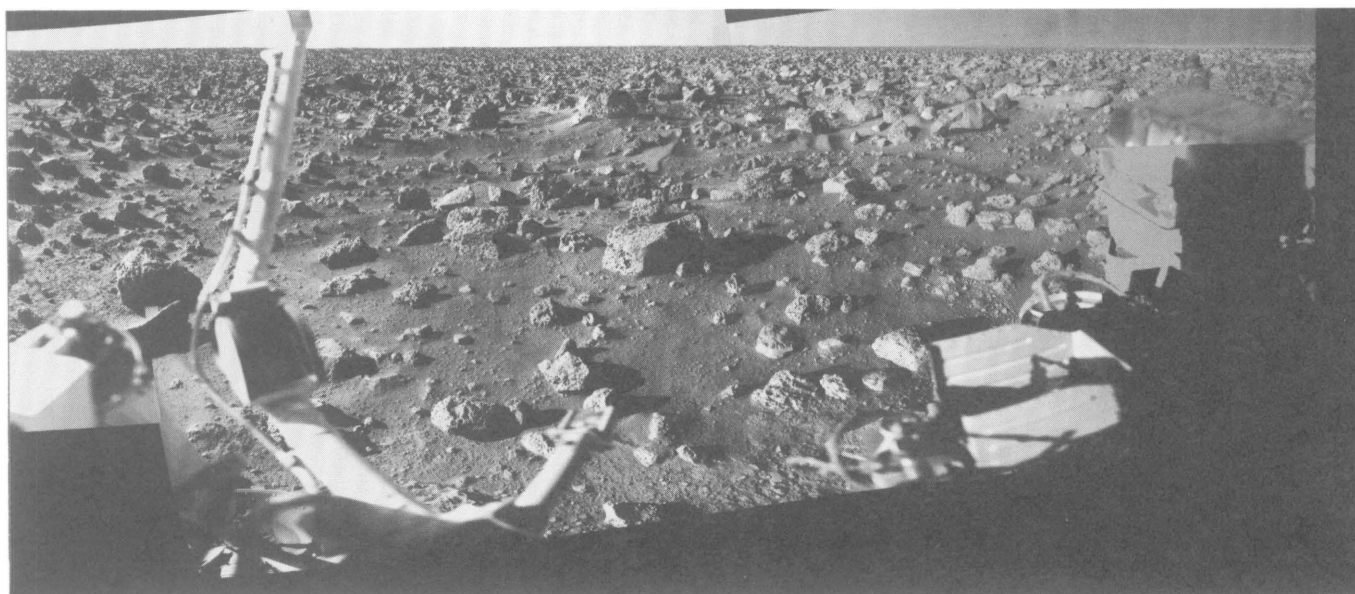
A

FIGURE 12.—Panoramas and sketches of Lander 2 site showing abundant rocks. Rocks are generally larger than those at Lander 1 site. A, Mosaic of camera 1 pictures. B, Mosaic of camera 2 pictures. Sketches show locations of selected features in panoramas; rocks indicated by number correspond to numbered rocks shown on plate 2; names of sample site areas (Alpha, Beta, and so on) also correspond

does not have the myriad of small craters (figs. 11 and 12). Additionally, at the Lander 1 site, large tracts of dunelike drifts appear to be superposed on a rocky substrate (fig. 11). Closer inspection of the Lander 1 pictures reveals other characteristics of the rocky surfaces and drifts (Binder and others, 1977). On the local horizon, rims of distant and near impact craters rise above the surroundings; large blocks of ejecta can be resolved on the rims of the closer ones. In other sectors, dunelike forms with crossbeds etched by wind erosion (Mutch and others, 1976a,b) lend a harsh, eerie aspect to the scene. Drifts

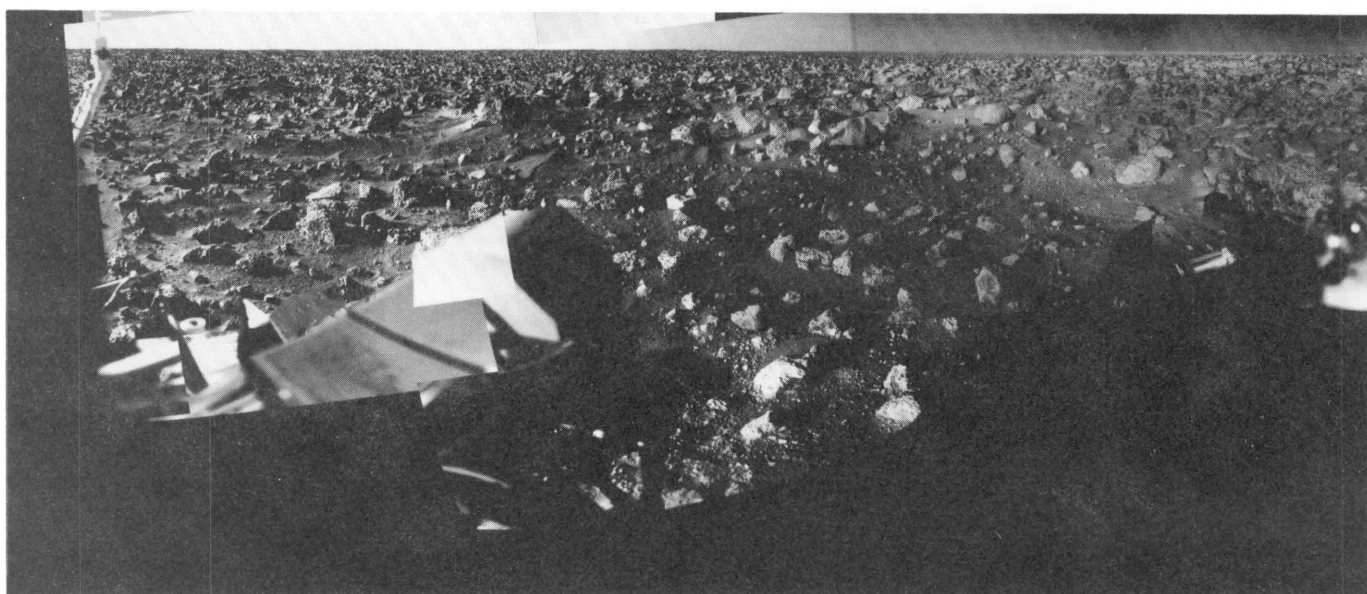
B

FIGURE 12.—Continued.

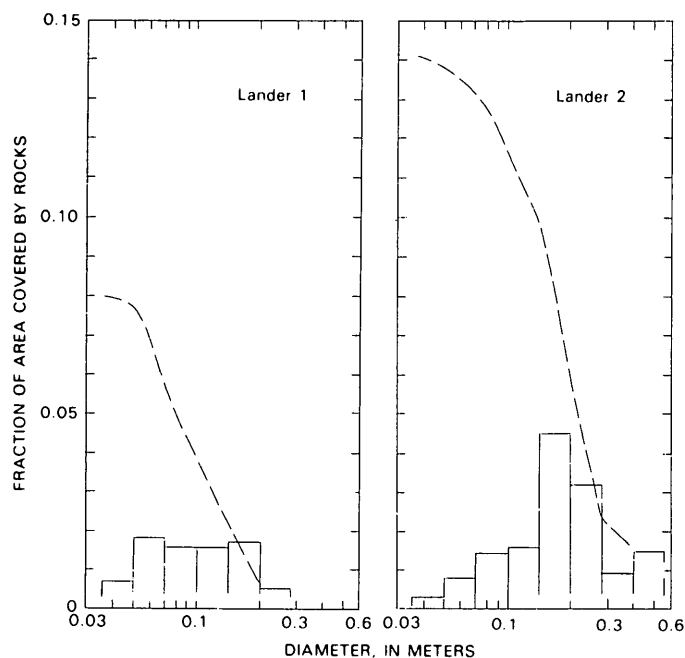
FIGURE 13.—Fraction of area covered by rocks with intermediate diameters larger than 3.5 cm for the sample fields of Lander 1 and Lander 2. Data for plots obtained from 1:10 scale maps of sample fields. Cumulative frequencies shown by dashed line.

Rocks, with intermediate diameters 3.5 cm and larger, make up a significant part of the sample field and, as noted previously, are particularly abundant in the right-hand part of the sample field (pl. 1A). They occupy about 8 percent of the area that includes the entire sample field and the region immediately in front of the lander (fig. 13). Most of this area is represented by rocks between 5 and 20 cm for which the area of rocks in each diameter (D) increment of $\sqrt{2} D$ is about 1.7 percent. Cumulative frequencies increase rapidly from $0.15/\text{m}^2$ for rocks > 20 cm to $14/\text{m}^2$ for rocks > 3.5 cm (fig. 14). Incremental frequen-

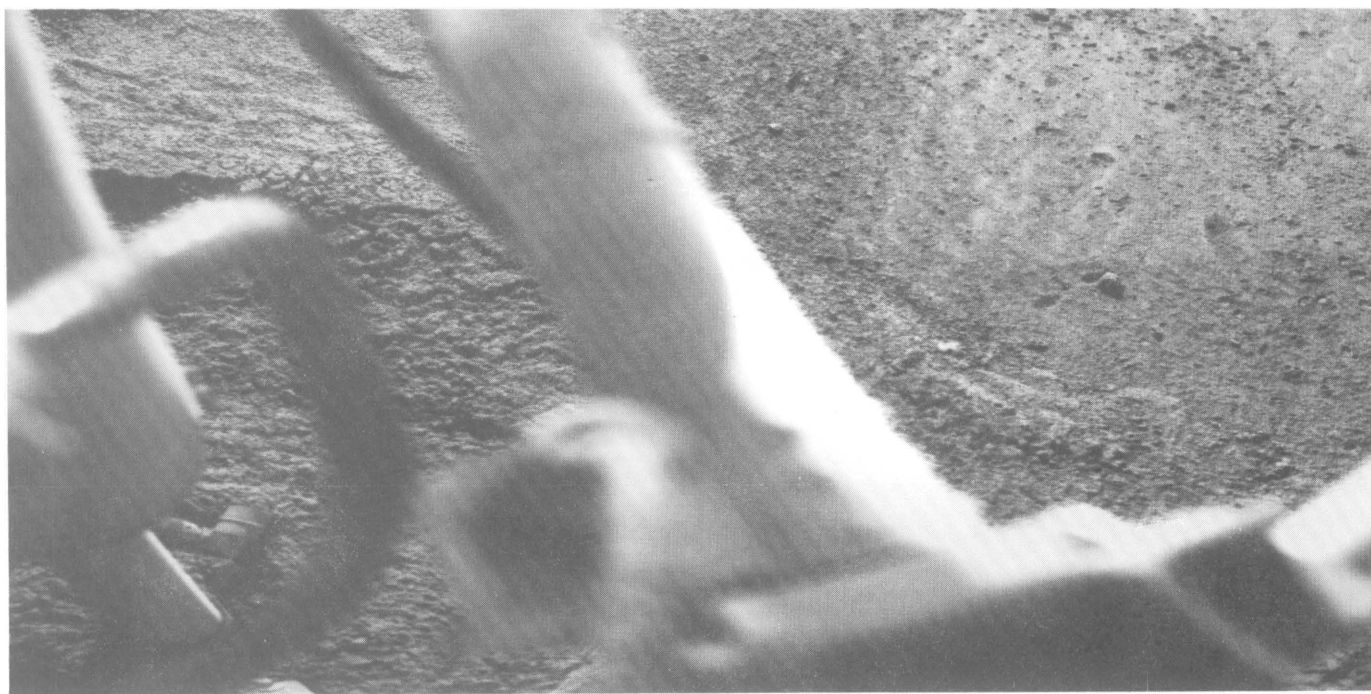
**B**

FIGURE 16.—Penetration of footpads 3 and 2 of Lander 1. *A*, Footpad 3 penetrated about 0.036 m into blocky material and is unburied. Note surface is littered with small rocks and clods in contrast with drift material in figure 16*B*. Rock at upper left is 8 cm wide (frame 12A001/000). *B*, Primary strut at left slants down toward center of footpad 2, which is buried in drift material; base of footpad is about 0.165 m below surface. Light-gray meteorology boom (near center)

and post of magnet cleaning brush (at right) converge to form a V-shape in picture. Note arcuate scarp, 0.30 m long, produced by faults (between primary strut and meteorology boom) at upper left; small concentric depression below scarp is surface expression that outlines the buried rim of footpad. Note monoclinical folds of surface (between meteorology boom and post of brush and in lower right corner) and open fractures (in lower right corner) (frame 11A079/012).

(≈ 0.07 cm) to diameters about 7.0 cm. Judging from shadows cast by the footpad in a number of pictures, footpad 3 penetrated blocky material to approximately 0.036 m (table 6). Evidence for deformation of the surface, such as open fractures and displaced wedges of cohesive material, is nonexistent, but such deformations could be present and hidden by the skirt of the footpad. According to both the stroke gauge and estimates of footpad travel, the amount of stroke of leg 3 is 0.083 m (table 6). The response of drift material to footpad 2 during landing was entirely different from that of blocky material to footpad 3. As shown in figure 16B, footpad 2 is completely buried and the base of the footpad is 0.165 m below the surface. A circular vertical scarp, produced by down-faulting of material on the footpad side, is present at distances of about 0.2 m from the perimeter of the buried footpad (pl. 1A). Within the circular scarp, lumpy masses of drift material fill the footpad to levels above the juncture of the primary and secondary struts. Beyond the scarp the deformed surface forms small stubby arcuate anticlines. A sinuous monocline, which may have resulted from footpad penetration, extends toward the right from the scarp (pl. 1A). The amount of stroking of leg 2 is smaller than that of leg 3. According to the gauge, stroke is 0.032 m; and, according to footpad travel, stroke is 0.028 m. Footpad 1 is obscured by the lander body so that its penetration is unknown; but, the stroke gauge of leg 1 is visible. The amount of stroke of leg 1 is 0.07 m.

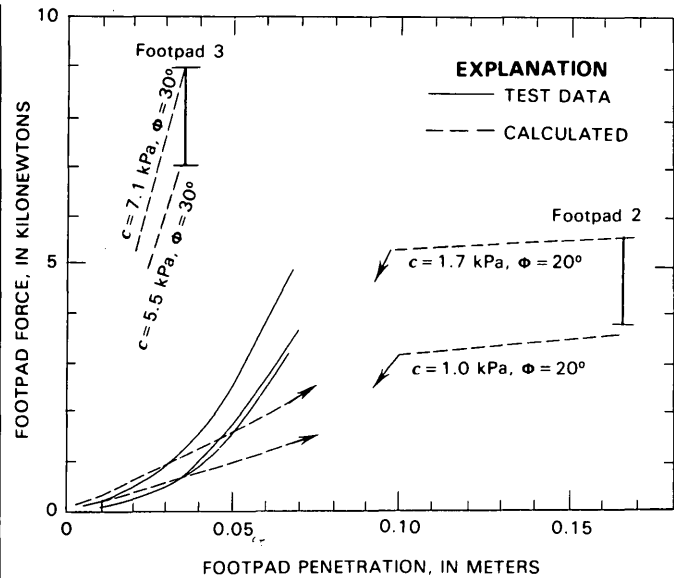
FIGURE 17.—Forces on footpads and footpad penetrations of Lander 1. Vertical I-bars indicate estimated forces and penetrations of footpads 3 and 2 during landing. Calculations of forces on footpads 3 and 2 based on assumed coefficients of sliding friction of 0-0.5 (see supplemental section on "Analysis of landing data"); penetrations were obtained from Lander photographs. Solid lines indicate static forces on footpad and footpad penetration scaled to Mars conditions from 1/8-scale tests. Dashed lines indicate static-bearing forces for materials with indicated cohesions (c) and angles of internal friction (ϕ) computed using static-bearing capacity equation for circular footings, failure by general shear, and densities of 1,200-2,000 kg/m³. Space between arrows on dashed lines represent penetrations of footpad 2 where cross-sectional areas change in a complicated way because of footpad skirt (see fig. 2).

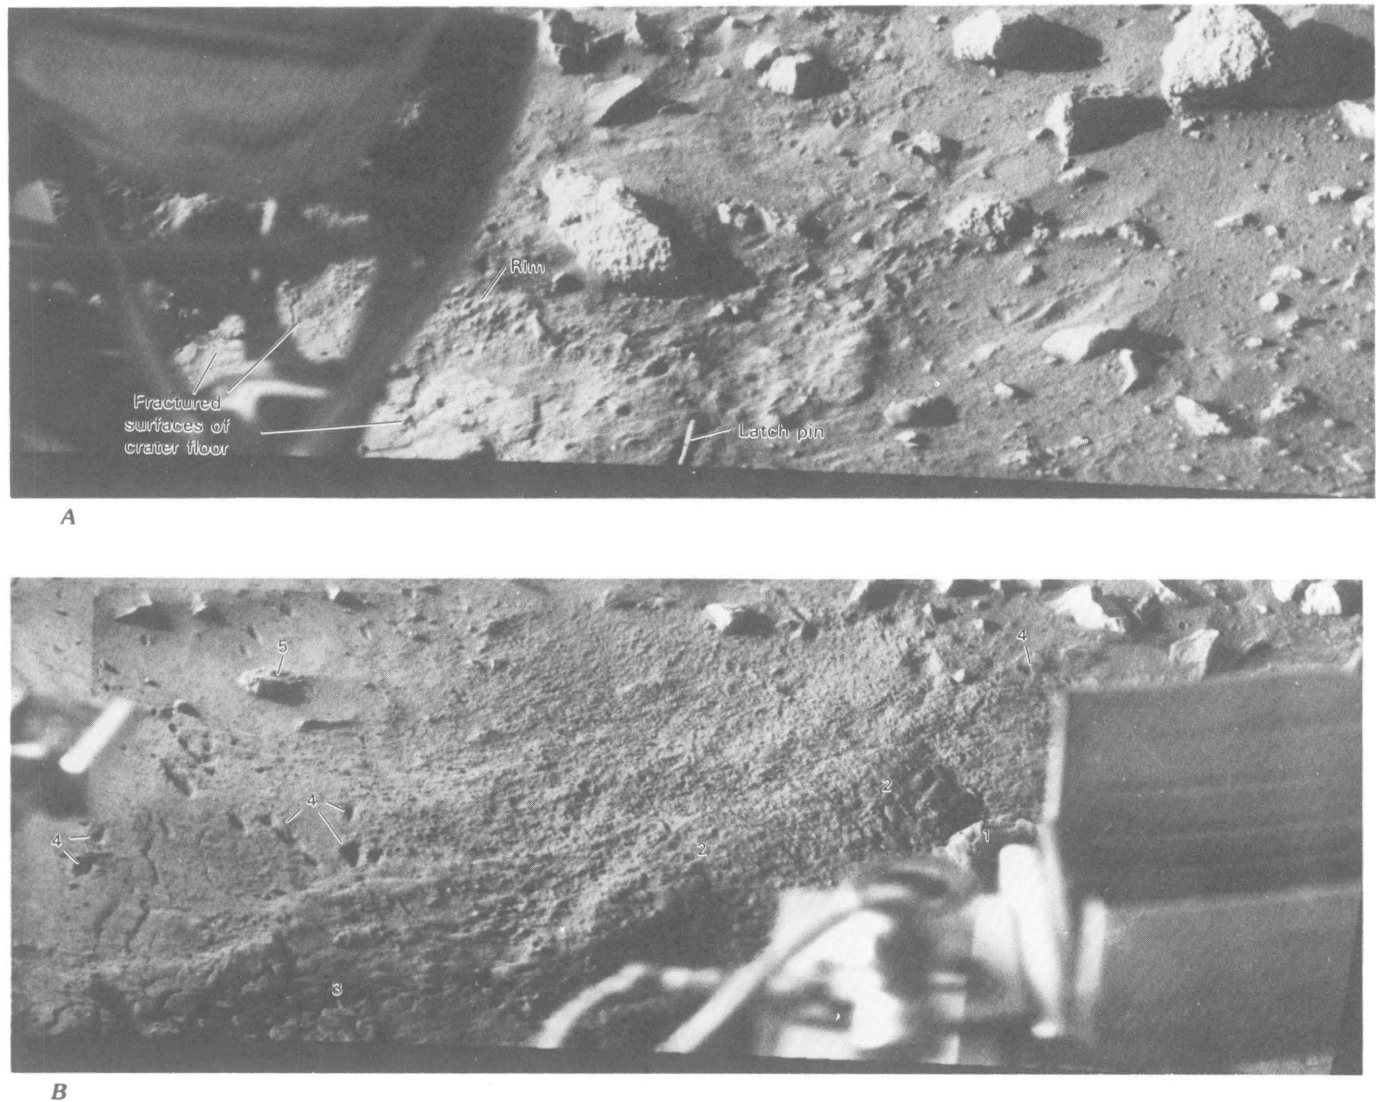
FIGURE 22.—Engine-exhaust erosion by Lander 1. *A*, Crater produced by engine-exhaust gases on right side of engine 2. Base of surface sampler and its mounting bracket are at left part of picture. Note fractured surfaces of material of the flat crater floor (beneath surface-sampler base). Rod-shaped object in rim of erosion crater is the surface-sampler latch pin lying within the impact crater it produced. Note

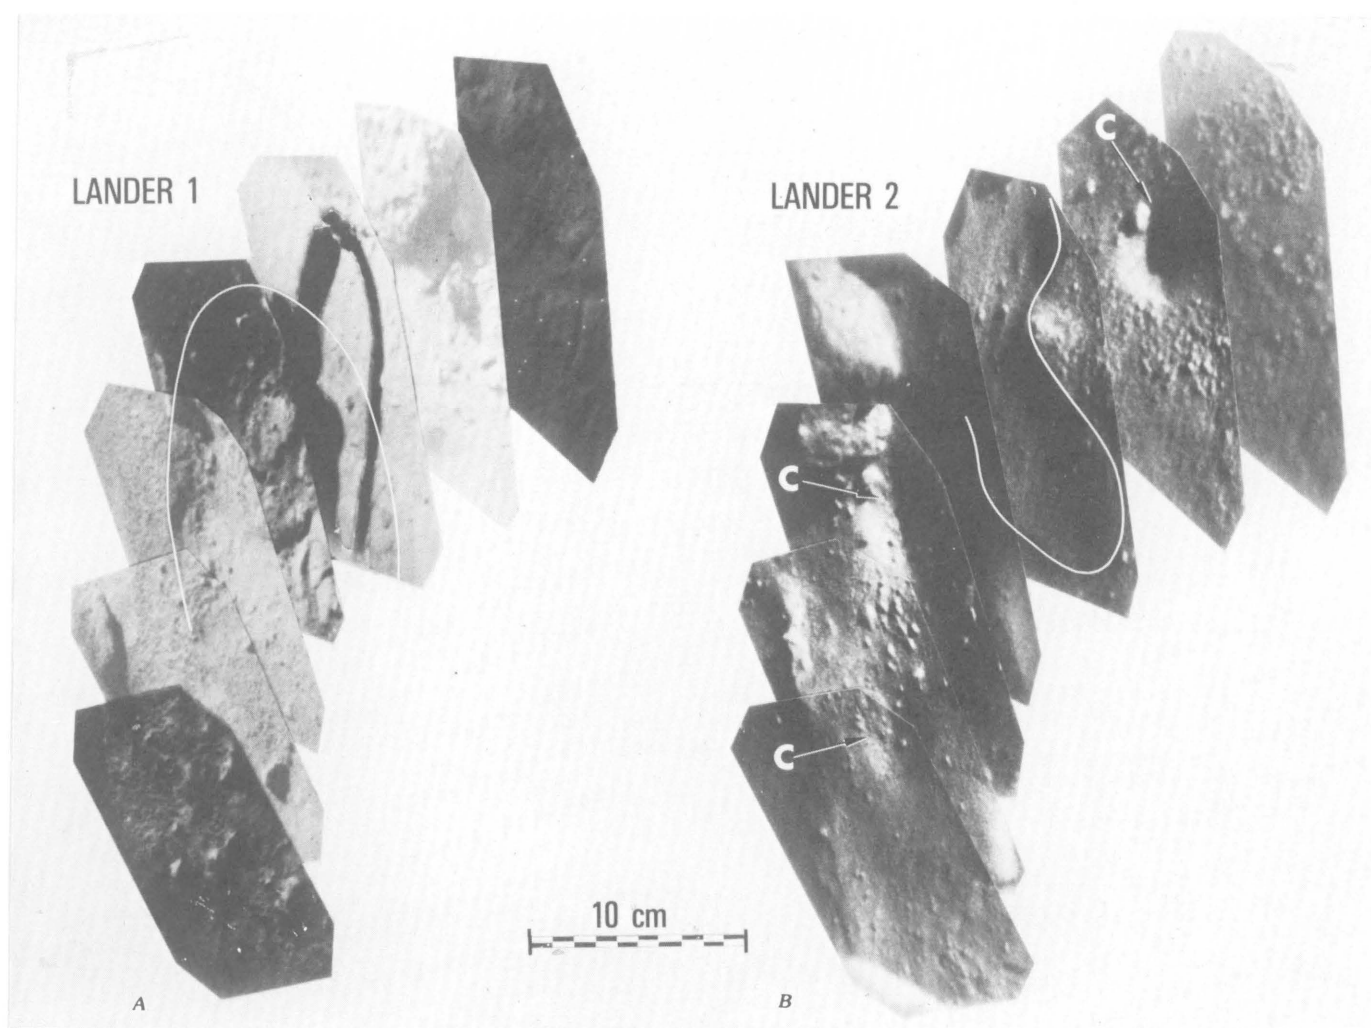
FIGURE 24.—Mosaics of pictures to right of engines 2 of Viking Landers 1 and 2 taken with mirror 2 on boom housing. Approximate location of pictures indicated in figure 23. Radial symmetry suggests that areas covered by mosaics are chiefly within rim of larger erosion crater. A, Surface near Lander 1 is dominated by crescent-shaped crater (outlined in white) about 1 cm deep and centered about 0.3 m from engine centerline; 8-cm rock occurs in upper part of second and third frames from top; dark area in third frame from top is shadow of a spacecraft part; note residue of lumps, clods, and fractured chunks

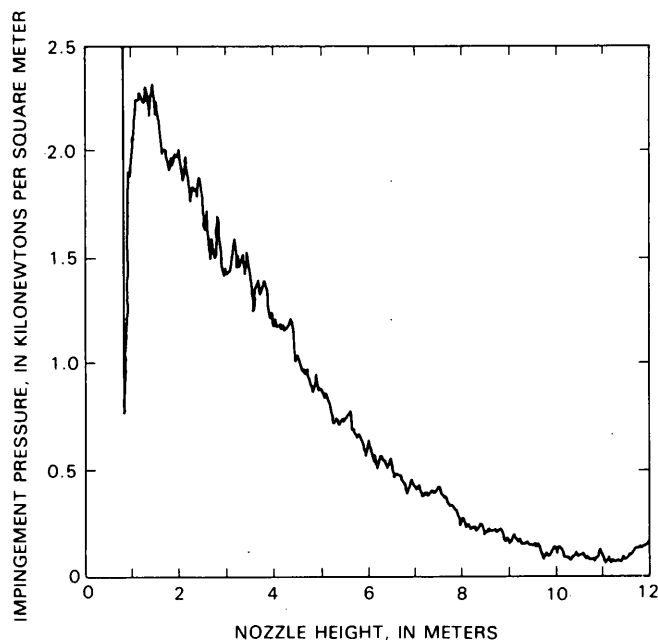
FIGURE 26.—Centerline-impingement pressures related to nozzle heights for Viking lander terminal-descent engine (Romine and others, 1973; White Sands Test Facility Phase II, Test 11K).

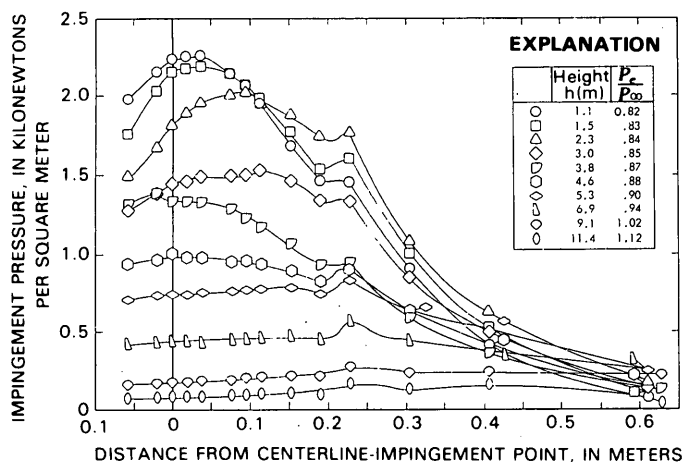
FIGURE 27.—Impingement pressure related to distance from centerline-impingement point for Viking lander terminal-descent engine (Romine and others, 1973; White Sands Test Facility Phase II, Test 11K).

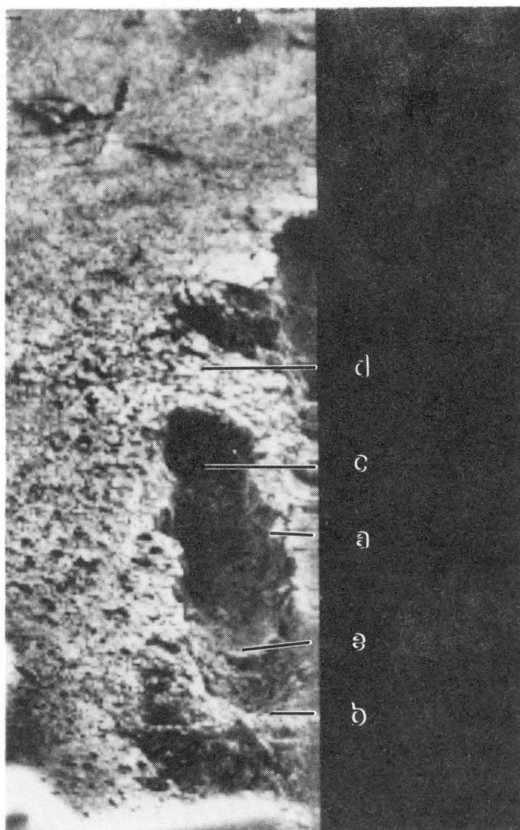
FIGURE 31.—Physical Properties 1 trench excavated by Lander 1 on Sol 41. Note steep walls (a), lumpy tailings (b), bench near tip (c), rim and domed surface (d), and highly reflective surface (e). Trench is 6 to 7 cm wide and 48 cm long from tip to rim crest of tailings (frame 12C043/183).

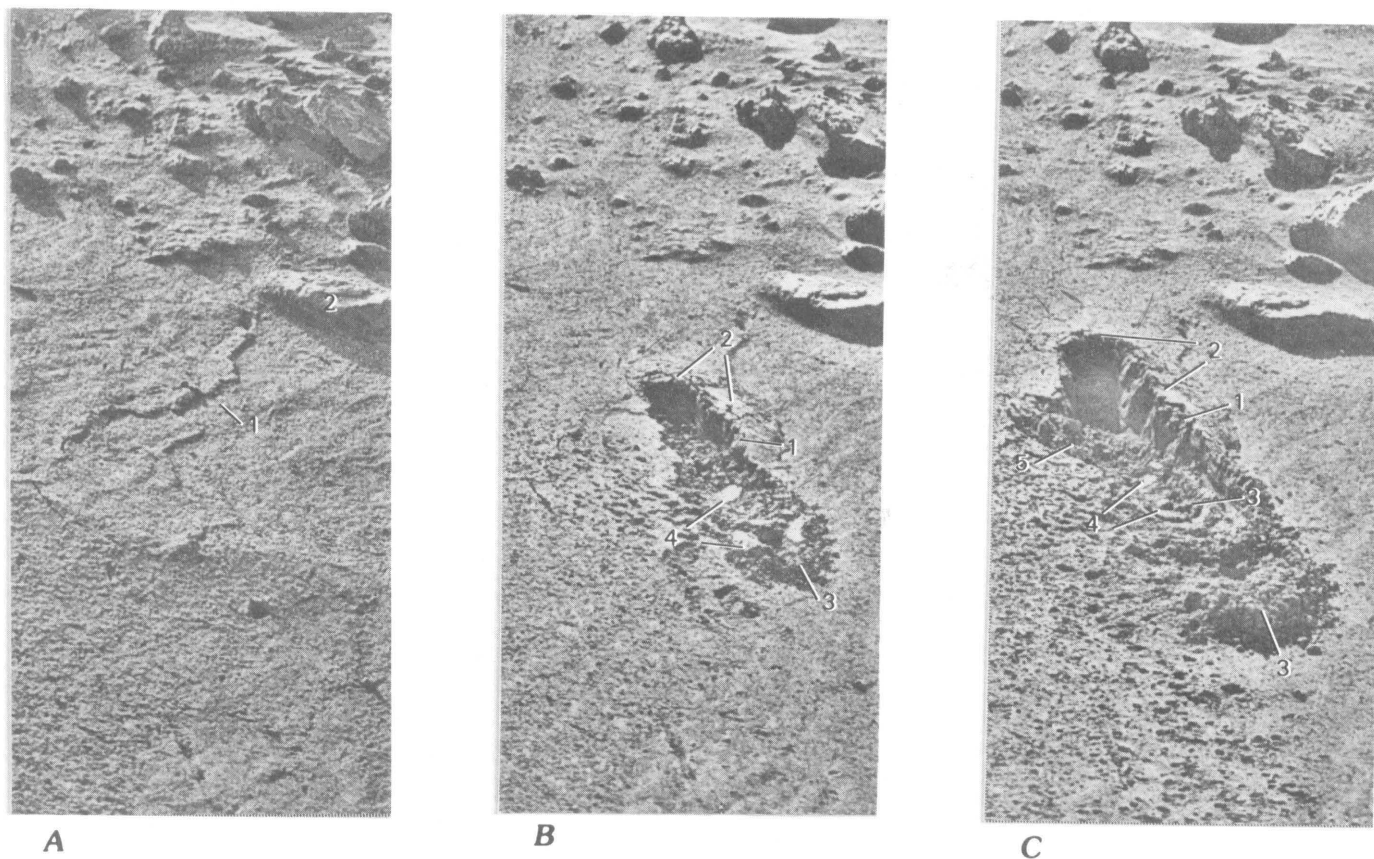
FIGURE 32.—Drift material of Sandy Flats, first sample trench (Biology 1), and first sample trench for Inorganic Chemical Analysis Experiment (XRFS 1). First sample for Molecular Analysis Experiment (GCMS 1) came from this area but no pictures of the trench were taken by Lander 1. A, Surface before samples were acquired is rock free; sinuous ridges (1) may be surface expressions of crossbedding; pre-sample stereometric measurements showed that rock 1 (2) (Shadow; see pl. 14) would not interfere with sample acquisition. Rock 1 is 18 cm wide (frame 11A055/008). B, Biology 1 trench showing steep walls

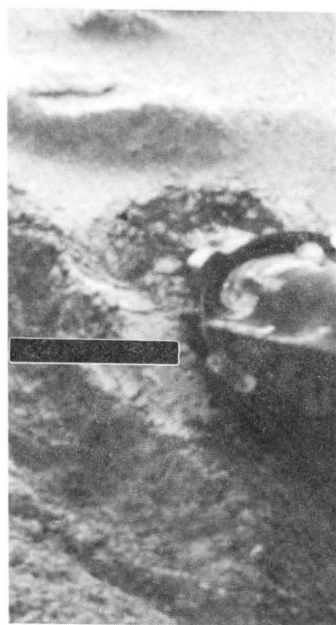
FIGURE 33.—Collector head was completely filled with drift material before end of the acquisition stroke. Resulting trench after retraction of collector head is Physical Properties 6. Temperatures measured by sensor on base of lower fixed jaw were recorded throughout a diurnal cycle. Bar to left of boom is 10 cm long (frame 11E041/343).

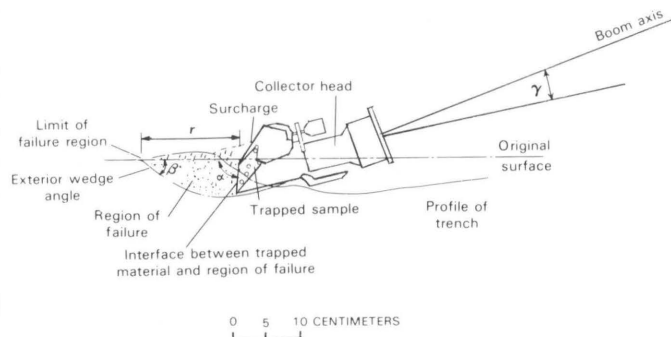
FIGURE 34.—Model used in analysis of sample trenches. Force exerted by collector head on surface material is assumed to be transmitted across a planar surface between trapped sample in collector head and material immediately in front of trapped sample. Locations of exterior wedge angle (β), rake angle (α), and collector-head rotation angle (γ) are indicated. Measure of limit of failure region is r . (See later supplemental section on "Analysis of sample trenches and surface-bearing tests.")

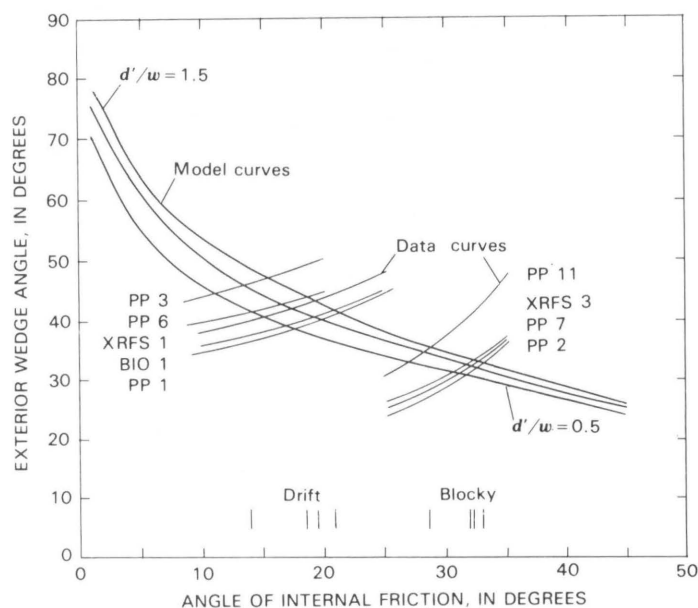
FIGURE 35.—Exterior wedge angles of region of failure predicted from theoretical model of plowing (McKyes and Ali, 1977) for three depth-to-width ratios as a function of angle of internal friction (model curves) and exterior wedge angles as a function of assumed angles of internal friction for sample trenches in drift material and blocky material of Lander 1 (data curves). Estimate of angle of internal friction corresponds to intersection of model curves and data curve at d'/w value appropriate for trench. Note that average for drift material is about 18° and for blocky material is about 31° . Equations and details of procedures appear in supplemental section on "Analysis of sample trenches and surface-bearing tests." Letters and numbers refer to trenches excavated for the Physical Properties Investigation (for example, PP 3), Biology Experiment (BIO 1), and Inorganic Chemical Analysis Experiment (for example, XRFS 3); trench locations are shown in plate 1; trench profiles appear in supplemental section on "Outline maps, profiles, and data on trenches"; see also tables 38 and 39.

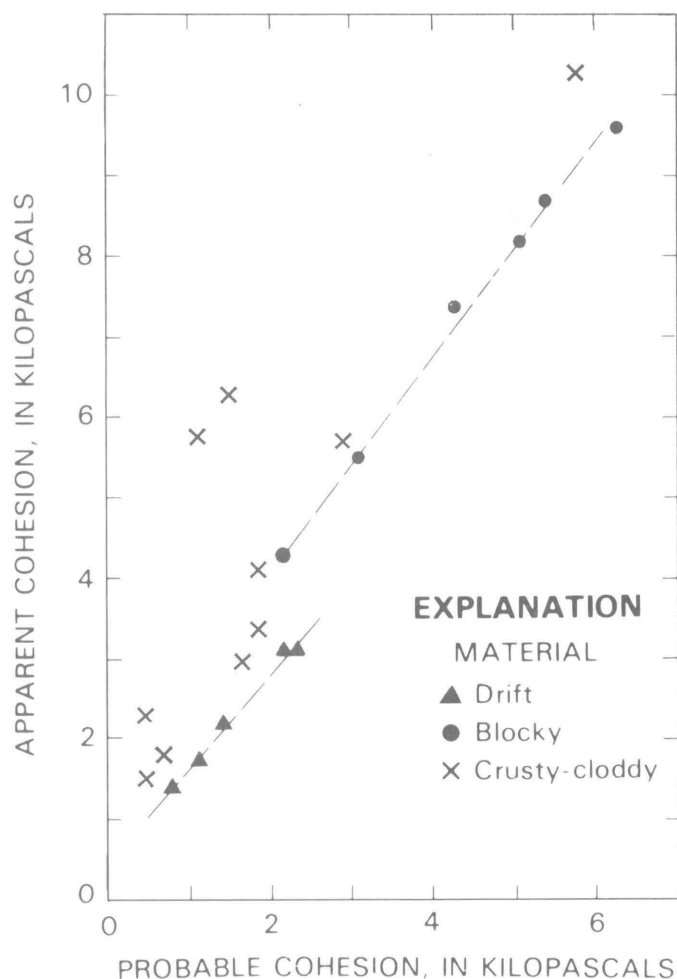
FIGURE 36.—Comparison between apparent cohesions and probable cohesions for sample trenches in drift, blocky, and crusty to cloddy materials. Apparent cohesions calculated with plowing model of Wismer and Luth (1972) for pure cohesion (wet clay). Probable cohesions calculated with plowing model of McKyes and Ali (1977). Note linear relations (dashed lines) for drift material and blocky material. Linear relation for crusty to cloddy material is poor. Graph used to estimate probable cohesions from apparent cohesions for trenches with insufficient data for analysis by model of McKyes and Ali (1977).

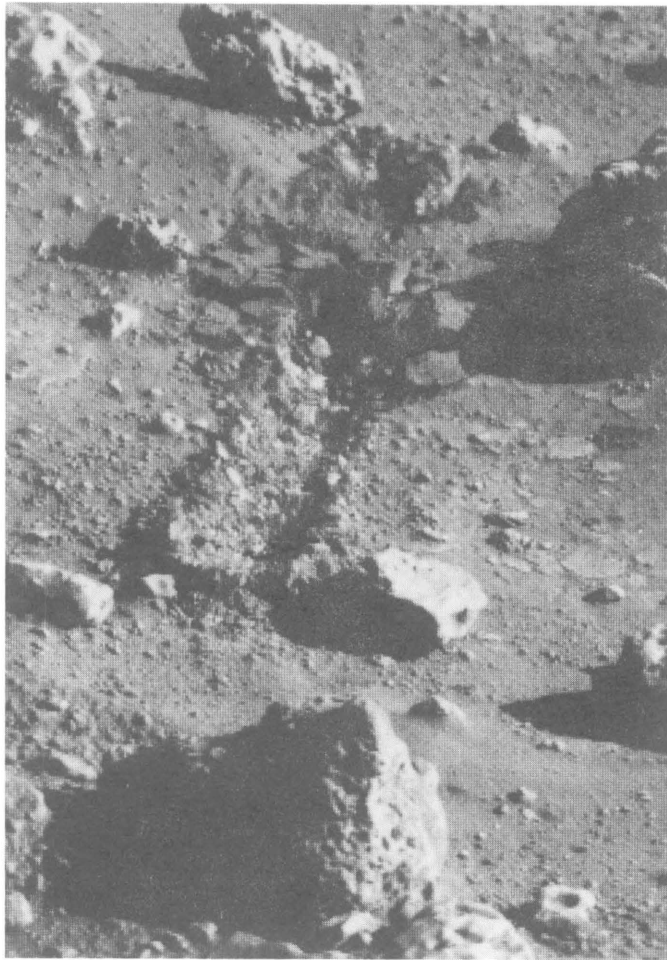
FIGURE 40.—Trench in cloddy material (XRFS 3). Note surface around tip of trench has been broken into angular clods as much as 0.07 m wide and 0.03 m thick. Tailings of this trench and others at Lander 2 site are poorly developed. Width of trench is about 7 cm (frame 22C045/57).

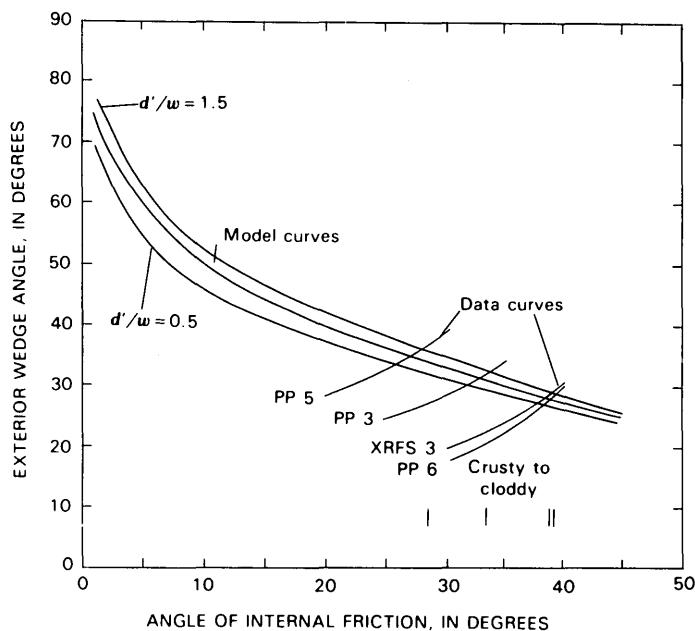
FIGURE 42.—Exterior wedge angles of region of failure predicted from theoretical model of plowing (McKyes and Ali, 1977) for three depth-to-width ratios as a function of angle of internal friction and exterior wedge angles as a function of assumed angles of internal friction for sample trenches in crusty to cloddy material of Lander 2. Estimate of angle of internal friction corresponds to intersection of model-curve and data curve at d'/w values appropriate for trench. Loci of calculated values are obtained by calculating wedge angles from assumed angles of internal friction. Note that average is near 35° . Equations and details of procedures appear in supplemental section on "Analysis of sample trenches and surface-bearing tests." Letters and numbers refer to trenches excavated for the Physical Properties Investigation (for example, PP 5) and Inorganic Chemical Analysis Experiment (XRFS 3); trench locations are shown in plate 2; trench profiles appear in supplemental section on "Outline maps, profiles, and data on trenches"; see also tables 40 and 41.

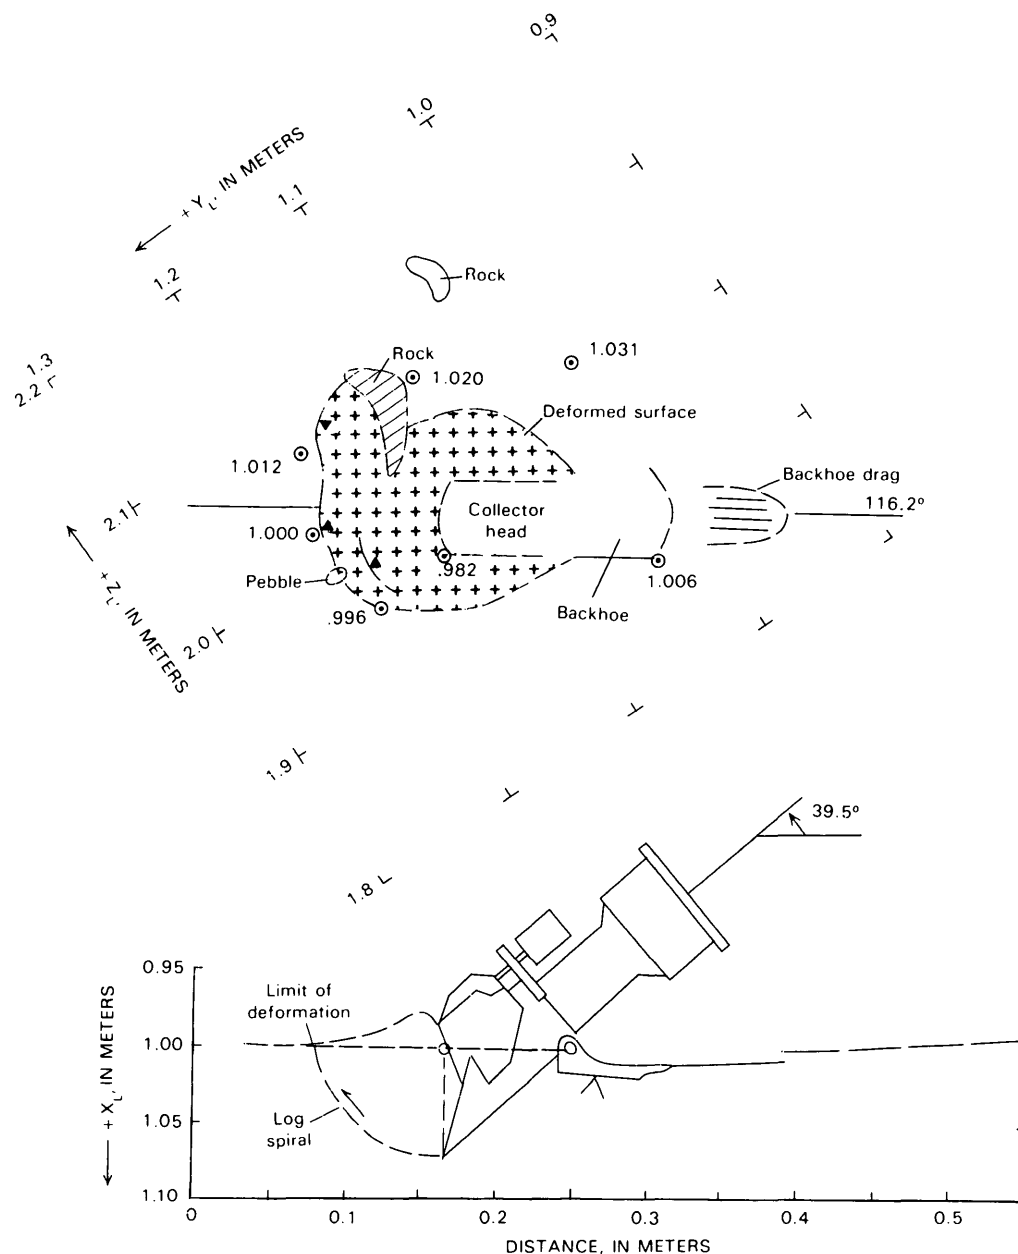
FIGURE 45.—Map and profile of surface-bearing test on drift material (see fig. 44). Note pebble and V-shaped tip of rock. Dashed lines outline disturbed surface. Solid triangles indicate monoclines. Exterior wedge angle and depth-to-width ratio indicate that angle of internal friction is approximately 17° . Numbers by open circles with dots indicate elevations in meters in direction of $+X_L$ axis. Surface-sampler elevation angle is 39.5° ; surface-sampler azimuth is 116.2° .

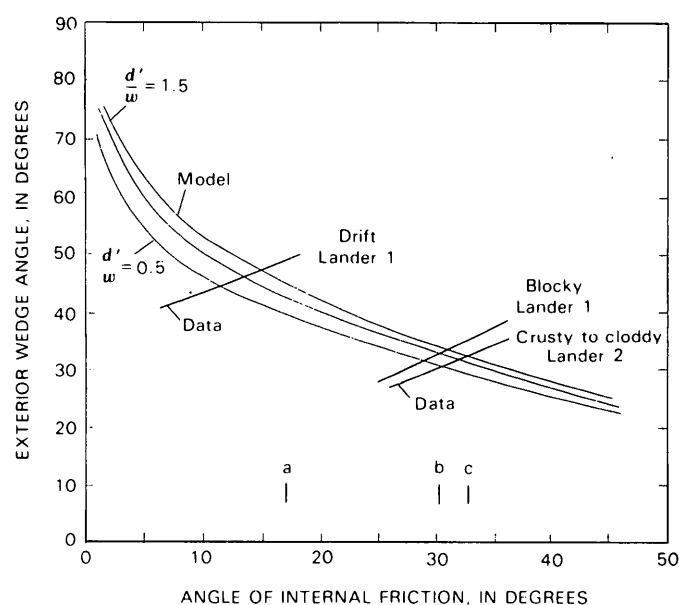
FIGURE 46.—Exterior wedge angles of the region of failure predicted from theoretical model of plowing (McKyes and Ali, 1977) for three depth-to-width ratios as a function of angle of internal friction and exterior wedge angles as a function of assumed angles of internal friction for surface-bearing tests. Estimate of angle of internal friction corresponds to intersection of model curves and data curve at depth to width ratio (d'/w) appropriate for test. Estimated angles of internal friction are: (1) Drift material 17° (a, Lander 1); (2) Blocky material 30° (b, Lander 1); and (3) Crusty to cloddy material 32° (c, Lander 2).

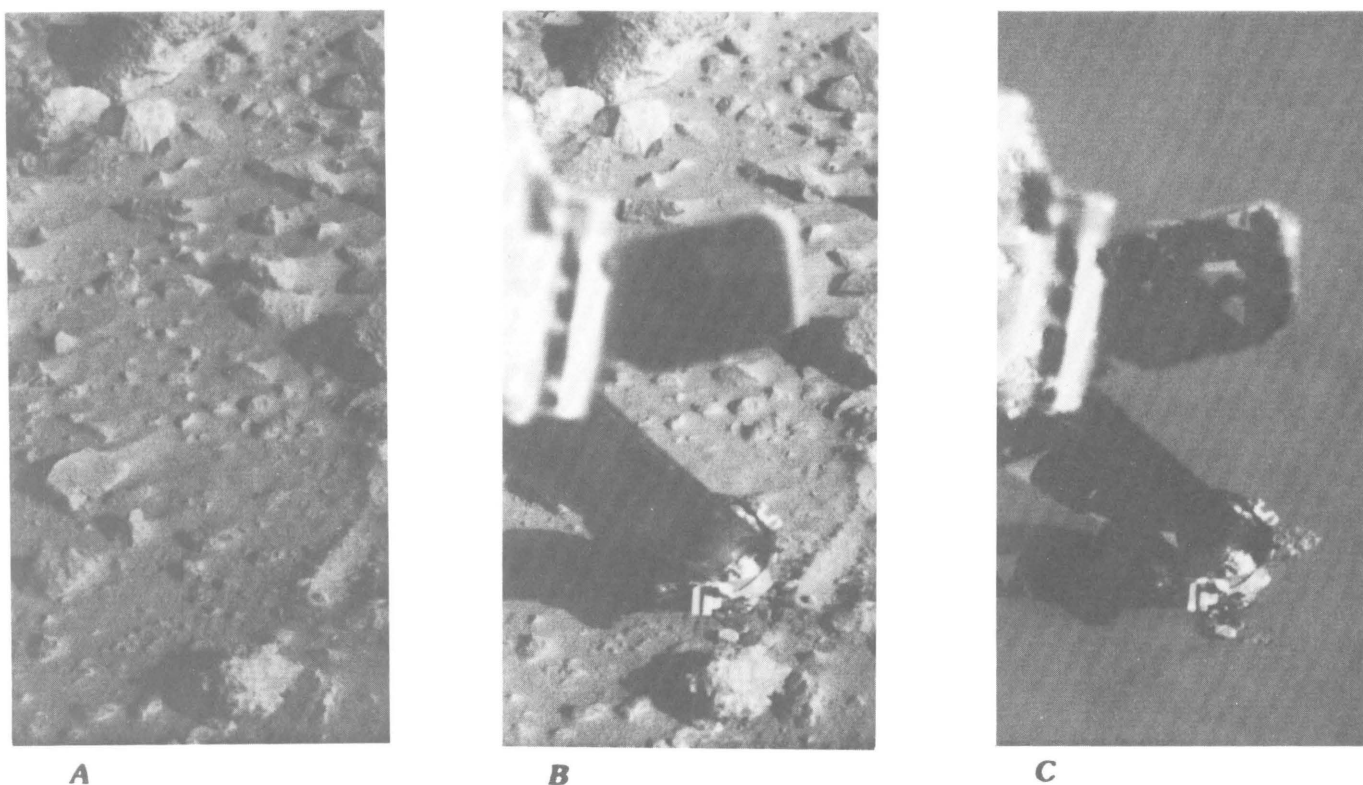
FIGURE 48.—Surface-bearing test on blocky material (Lander 1). *A*, Surface before test. Note heterogeneous appearance of surface with rocks and blocky units. Trench and tailings from XRFS 4 sample (Sol 177–180) acquisition at lower right. Rock at bottom right center is 8 cm wide (frame 12H179/611). *B*, Collector head inserted in blocky material. Note that lid of collector cannot be seen, which indicates

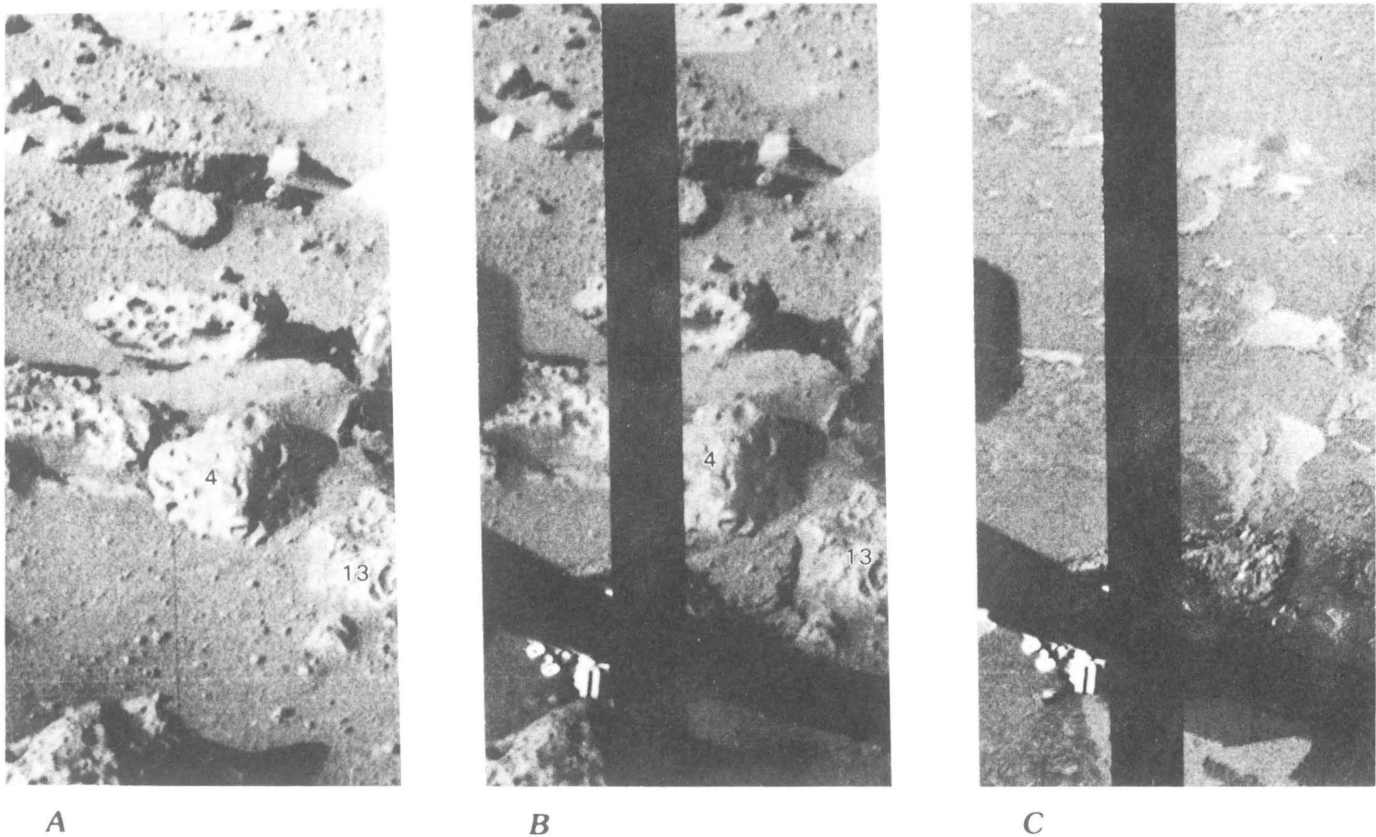
FIGURE 50.—Surface-bearing test on crusty to cloddy material (Lander 2). *A*, Surface before test. Note rocks near center (rock 4) and to right (rock 13). Rock 4 is 18 cm wide (frame 22H014/594). *B*, Collector head inserted in crusty to cloddy material. Note surface material has been thrust over edge of rock 13 and adjacent surfaces. Dark band represents missing data of picture (frame 22H030/595).

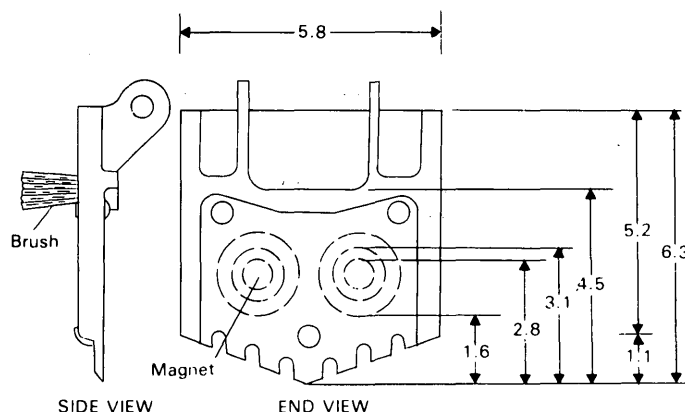
FIGURE 52.—Dimensions (in centimeters) of surface-sampler backhoes, Viking Landers 1 and 2.
