Physical Properties of the Surface Materials at the Viking Landing Sites on Mars

U.S. GEOLOGICAL SURVEY PROFESSIONAL PAPER 1389

By H.J. MOORE, R.E. HUTTON, G.D. CLOW, and C.R. SPITZER

*A summary of the results of
the Physical Properties Investigation
of Viking Landers 1 and 2 during
the Viking 1975 project*

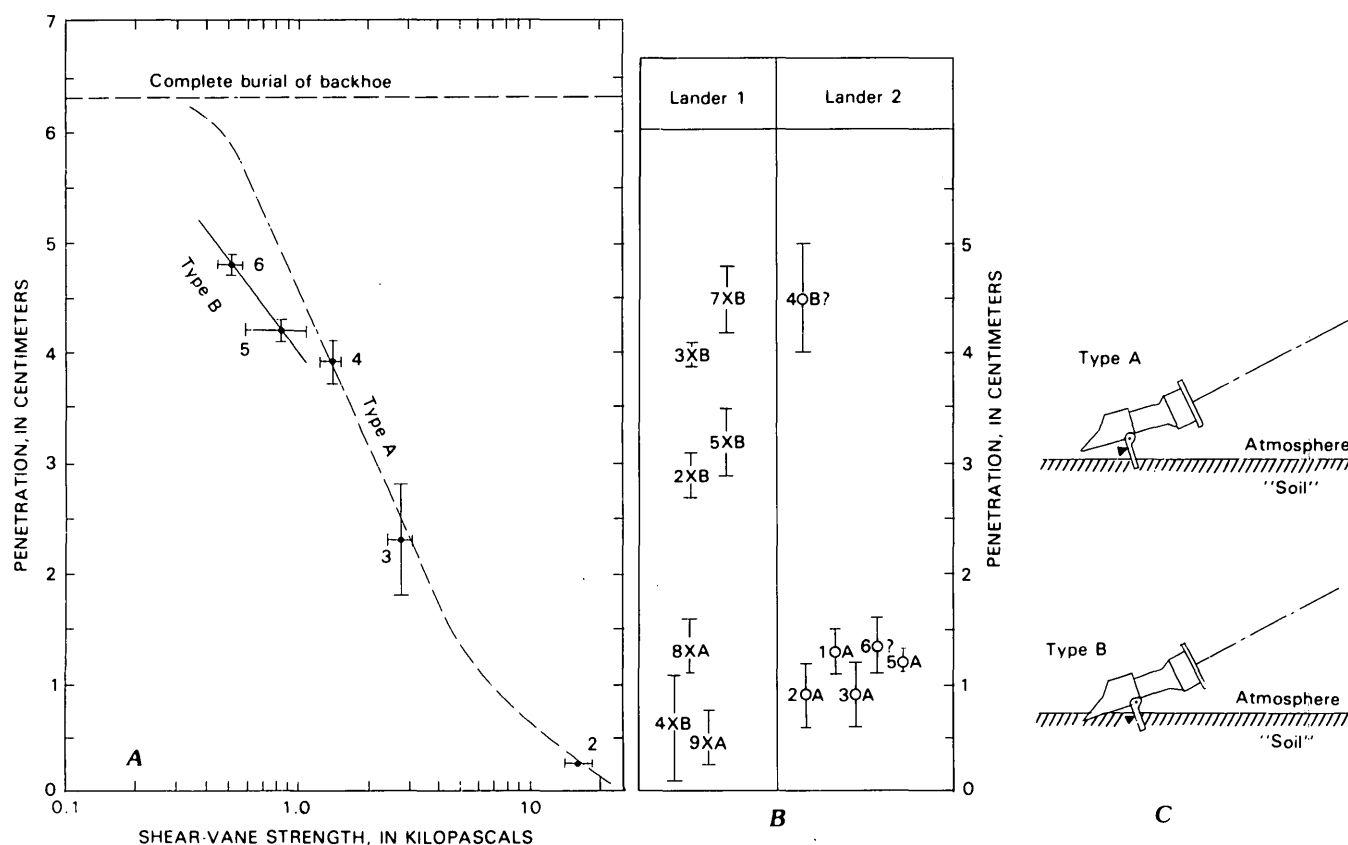
FIGURE 53.—Two types of backhoe touchdowns, A and B; their amounts of penetration in soil, relation of penetration to shear-vane strength, and results for Mars. A, Comparison between backhoe penetration and shear-vane strength for tests using the Science Test Lander and lunar nominal material. Numbers correspond to tests

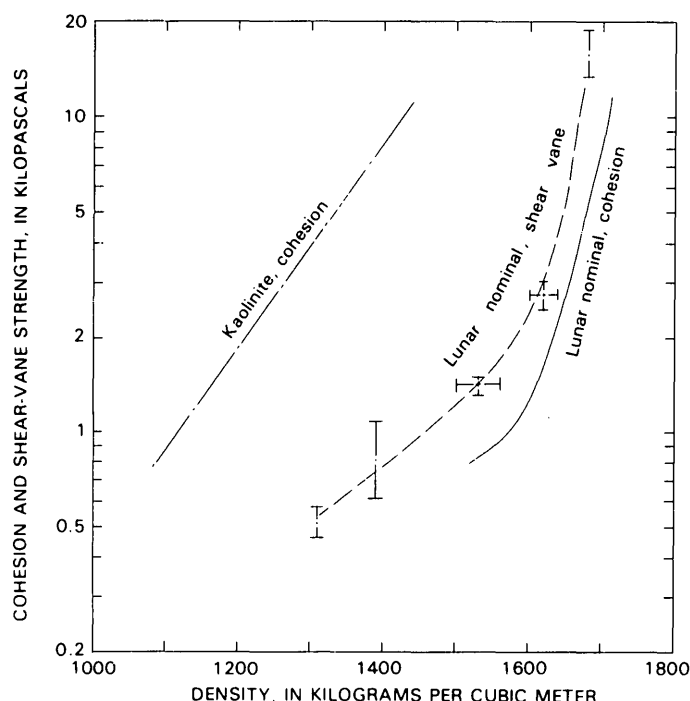
FIGURE 56.—Comparison between cohesions of lunar nominal material from triaxial tests (Ko, 1971) and shear-vane strengths of lunar nominal material as a function of density. Note that shear-vane strengths are about twice as large as cohesion for a given density. Cohesions of kaolinite from triaxial tests are included for comparison.

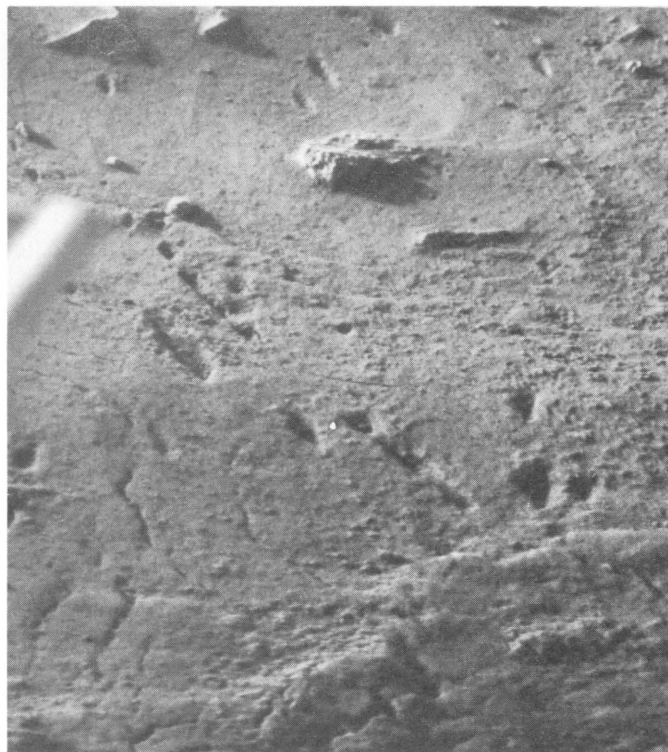
FIGURE 57.—Impact craters and pits in drift material produced by fragments propelled by engine-exhaust gases during landing. Note low to nonexistent rims of craters and pits and small fragments in craters and pits as well as on surface. Alignments and elongations of craters and pits are radial to engines 1 and 2 (frame 11A022/004). Rock in top center of photograph is approximately 8 cm wide.

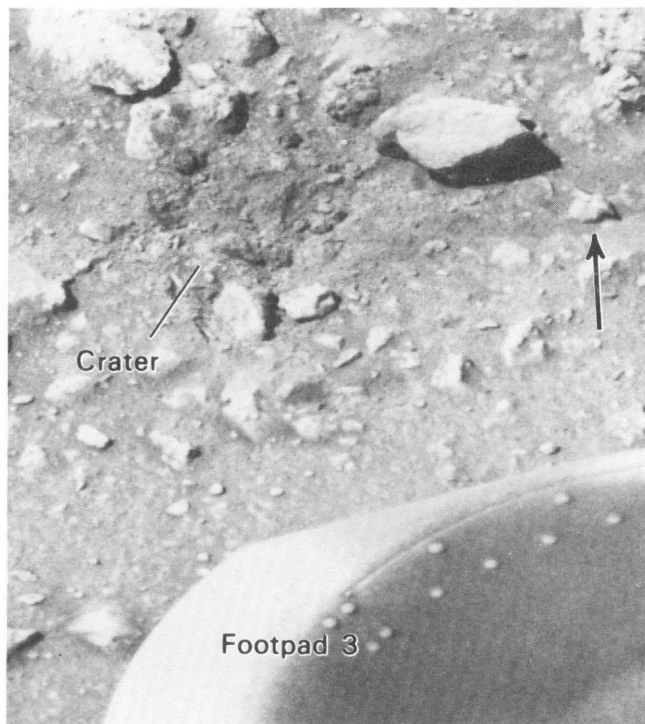
FIGURE 58.—Impact crater in blocky material produced by ejection of shroud unit on Lander 1, which hit the surface at 3.6 m/s. Crater is 0.1 m in diameter. Note irregular hummocky floor and wide range of sizes of ejecta. Small ejected fragment, 2.5 cm wide, at right (arrow) is about 0.16 m from center of crater (frame 12A013/002).

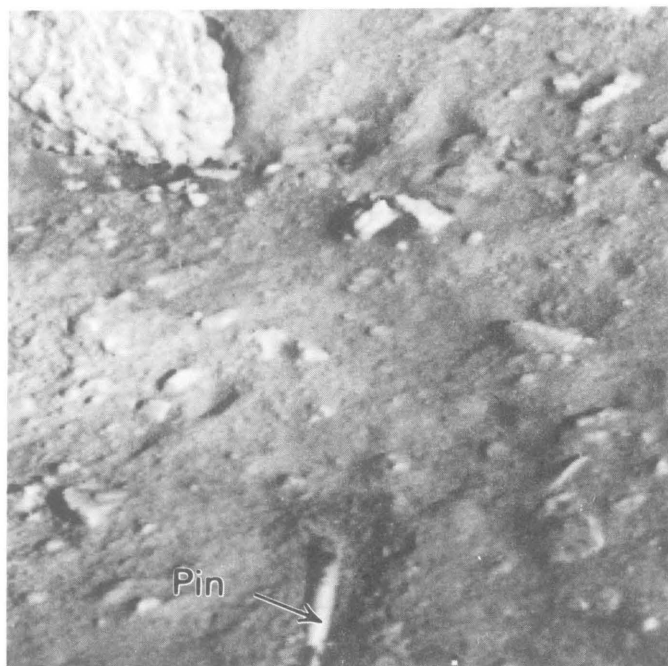
FIGURE 59.—Crater produced by impact of restraint or latch pin (arrow) on rim of crater that was produced by engine-exhaust gases, Lander 1. Rim and elongate crater about 10 cm long, 2.4 cm wide, and 0.6 cm deep (frame 12A081/012).

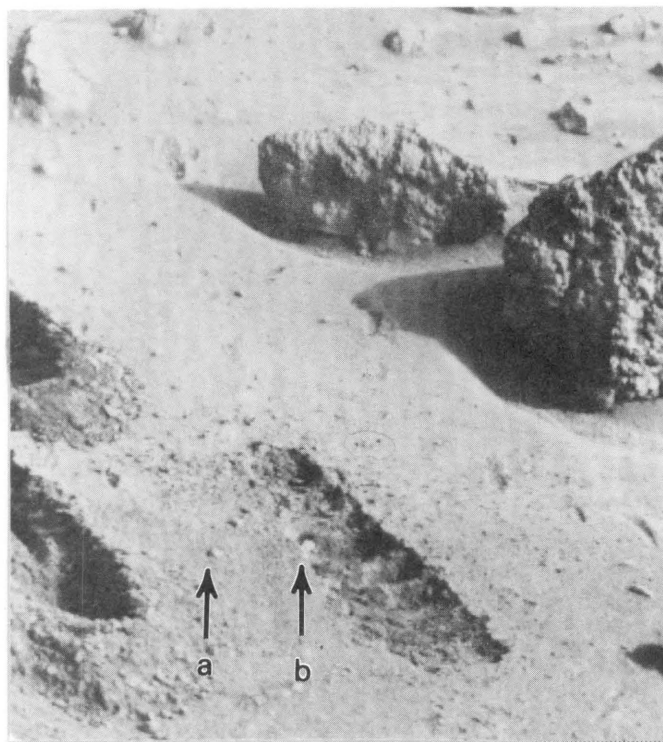
FIGURE 62.—Results of Sol 280 impact experiment on Mars, Lander 1. Largest two fragments impacted undisturbed drift material (a) and disturbed material of mineral-abundance test (b). Fragments, about 1 cm wide, impacted at 2.52 m/s. Fragment (a) penetrated $\frac{1}{4}$ - $\frac{1}{2}$ of its diameter and fragment (b) penetrated $\frac{1}{2}$ -1 of its diameter. Drift material is not a fluffy, low-density, granular material because fragments only penetrated small amounts. Mineral-abundance test disturbed area is about 6 cm wide (frame 11D034/281).

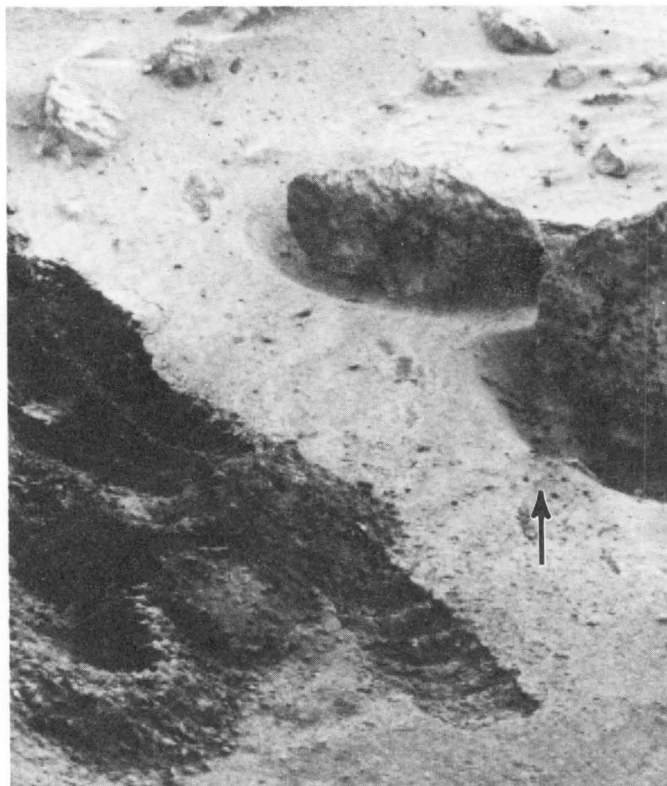
FIGURE 63.—Results of Sol 350 impact experiment on Mars, Lander 1. Largest fragment (arrow) is about 0.45 cm wide but others are about 0.3 cm to below resolution of pictures (0.15 cm). Fragments appear to have penetrated $\frac{1}{2}$ or less of their diameters. Pretest surface shown in figure 62. Free-fall velocities were about 2.5 m/s (frame 11E082/351).

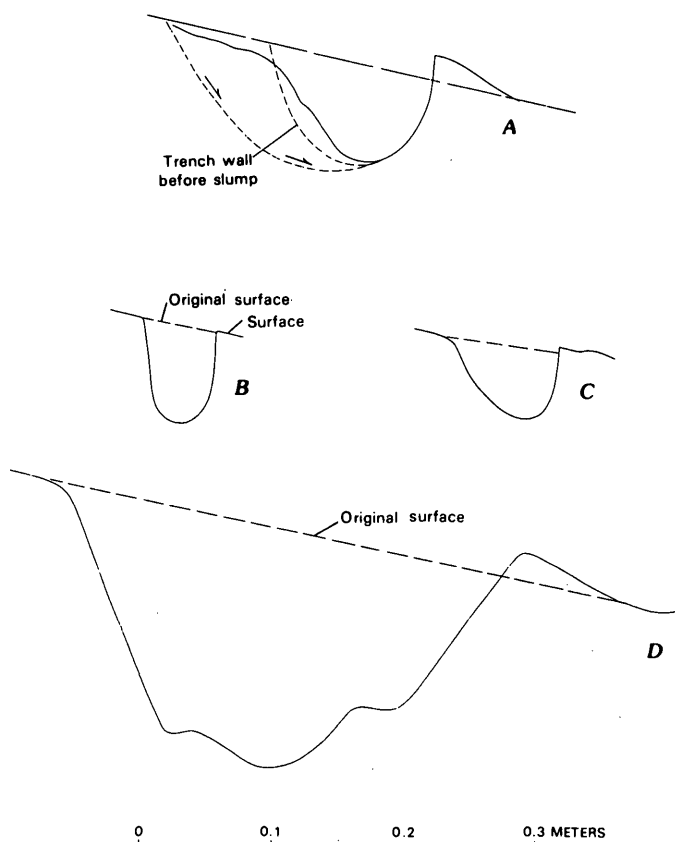
FIGURE 64.—Profiles of three trenches in drift material at right angles to the surface-sampler azimuth planes. *A*, Left wall of trench excavated by Lander 1 on Sol 8 appears to have slumped (see fig. 32C). Reconstructed trench wall shown by short dashed line. Original local surface shown by long dashed line. *B*, Side walls of tip of trench excavated by Lander 1 on Sol 41 did not slump. *C*, Failure of trench in *B* may have occurred midway along left side of trench; scarp midway along right side may be surface expression of incipient failure (see fig. 31). *D*, Slope of left wall of Deep Hole 1 has not failed despite larger relief (see fig. 65A). Scale for all three profiles is the same; there is no vertical exaggeration.

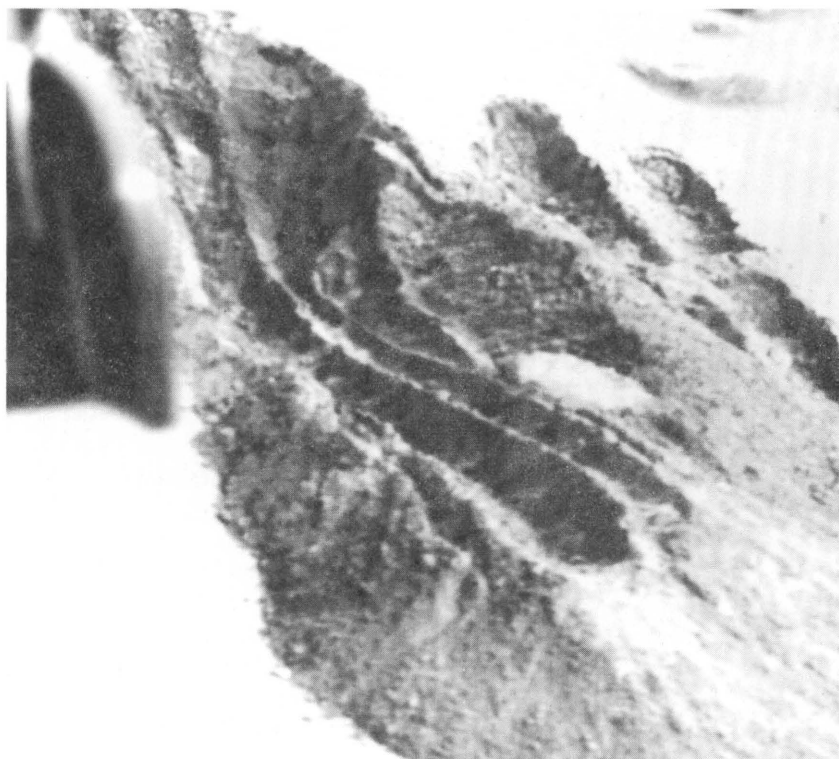
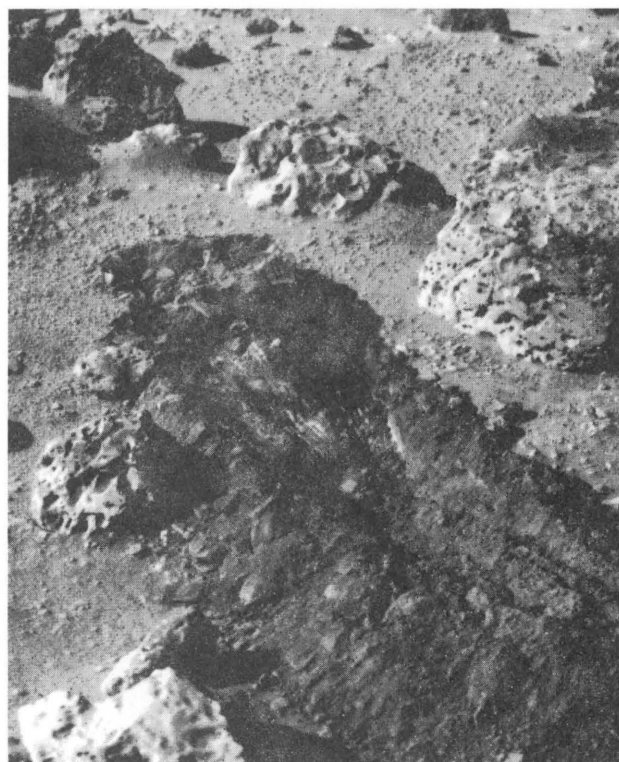
FIGURE 65.—Deep holes excavated on Mars. *A*, Deep Hole 1 of Lander 1 was excavated in drift material by backhoe using 48 retraction strokes. Trench is about 0.22 m deep, 0.30 m wide, and 1.6 m long. Maximum relief of longest slope of left wall is about 0.18 m; slope is about 68°. Note rock, 0.15 m wide, in tailings (frame 11C134/221). *B*, Deep Hole 2 of Lander 1 was excavated in blocky material by backhoe using 47 retraction strokes. Trench is about 0.10 m deep, 0.30 m wide, and 1.10 m long. Note blocky appearance of tailings which include some rocks (frame 12G079/488). *C*, Deep Hole 1 of Lander 2 was excavated in crusty to cloddy material by backhoe using 48 retraction strokes. Trench is about 0.12 m deep, 0.27 m wide, and 0.80 m long. Note slabs of crusts near tip and clods and rocks in tailings (frame 21G061/512).

In general, the walls of trenches in other materials appear to be stable although a minor amount of slumping has occurred in the upper walls of Deep Hole 2 of Lander 1 and Deep Hole 1 of Lander 2 (fig. 65B and C). Except for the minor failures, the walls of the deep holes and smaller trenches appear to be stable; therefore, the cohesions in table 26 are lower limits.

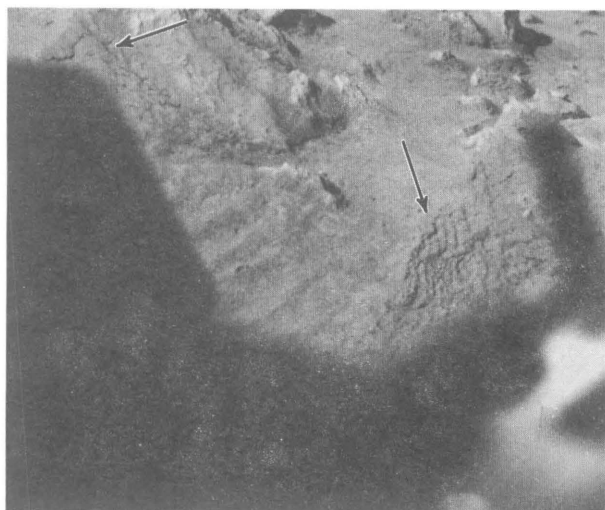
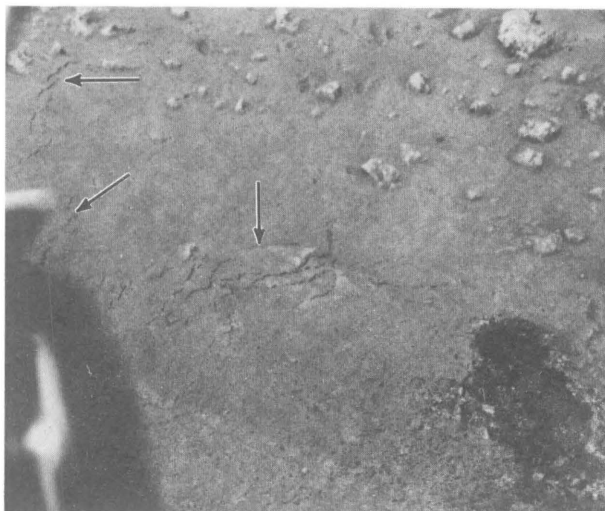
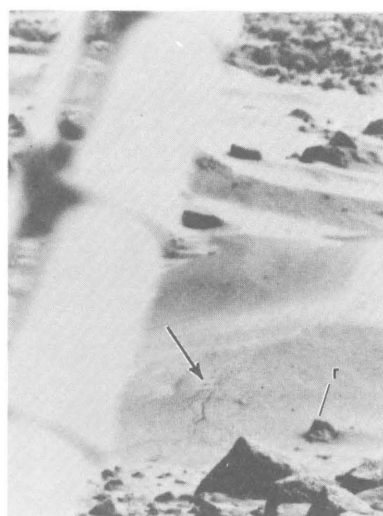
FIGURE 67.—Open fractures in drift material, Lander 1. A, Open fractures (arrows) in drift material on surface to left of stroke gauge, and in upper left. Arrows are about 10 cm long (frame 11A144/025). B, Open fractures (arrows) in drift material to left of Sol 8 trench (frame 11A069/009). Trench is about 10 cm wide. C, Open fractures (arrow) can be seen on lee face of drift beyond sample field. Rock (r) is about 10 cm wide (frame 11C162/239).

The absence of slopes of drift material as steep as 68° with 2.5 m of relief may be, partly, the result of local planes of weakness. Wind erosion has etched drift material revealing cross laminations, and the cross laminations alone indicate variable mechanical properties. In other places the presence of a thin crust also implies variable cohesions. Finally, exposures of drift material show that drift material is, at least locally, fractured in directions that form large angles with the cross laminations, and these fractures, which are open, imply zero cohesion on the scale length of the fractured areas (0.5–1.0 m) (fig. 67).

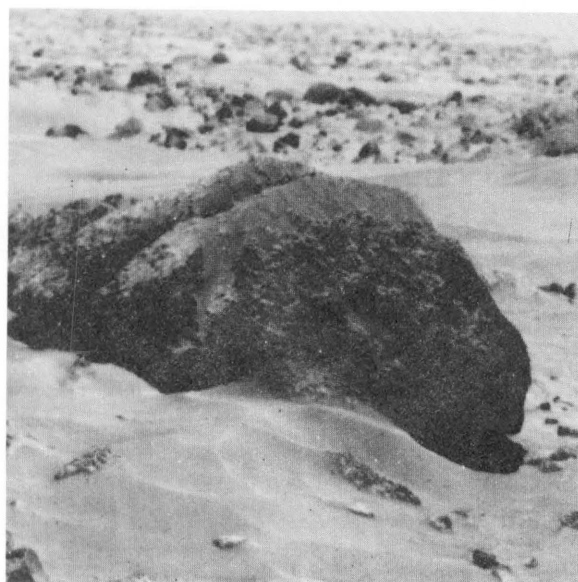
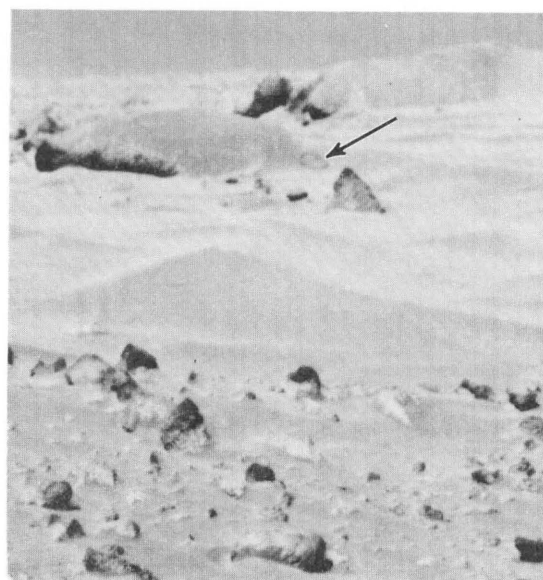
FIGURE 68.—Natural slope failures of drift material have occurred on leeward sides of large rocks. *A*, Surface near base of large rock called Big Joe prior to slope failure (frame 11B162/072). Big Joe is 8–10 m from Lander 1 and 1 m high. *B*, Slope failure at base of Big Joe (arrow).

Natural slopes of drift material failed at two places. The first failure occurred between Sols 74 and 183 near the leeward base of the rock called Big Joe (figs. 68A and B), which is 8–10 m to the left of Lander 1. The second failure occurred about 1 martian year later between Sols 767 and 771 near the leeward base of a rock called Whale (figs. 68C and D) which is about 25 m from the lander. It is probably significant that both slides occurred in late summer ($L_s = 148$) during periods of reduced atmospheric pressure (Hess and others, 1980), high average surface and air temperatures (Kieffer, 1976; Ryan and Henry, 1979), and

The slope failure near the leeward base of Big Joe, which is close enough to be described, appears to have occurred along a plane within the drift material (fig. 68B). Both the runout and visible parts of the exposed scarp appeared to be more or less uniform in thickness. The runout appeared to be about 0.012–0.017 m thick (2–3 pixels) and the scarp about 0.006–0.012 m (1–2 pixels). Although the apparent distance from the scarp to the toe of the runout was 0.37 m and the apparent slope was 36°, the viewing conditions require that this distance is too small and this slope angle is too large. Judging from shadows cast by the drift here and elsewhere, the slope was probably about 30°; the distance from the scarp to the toe of the runout would then be about 0.47 m and the runout would be about 0.23 m along slope. Natural slopes of drift material, where measurable in and near the sample field, are usually less than 30°. Slopes are commonly

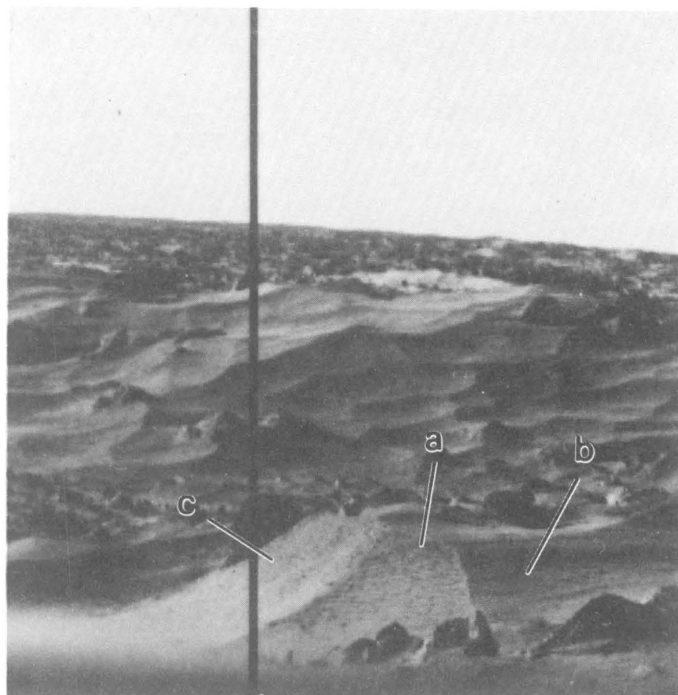
FIGURE 69.—Drift about 10 m behind Lander 1. Drift is about 0.4 m high. a, Note bright outline of crest above nearest (right) steep face; the outline may represent steep scarp of surface crust about (1 cm thick). b, Nearly horizontal bands on face and flanks are layers etched into relief by deflation. c, Dark streaks parallel to slope of left face may be residue of runouts from slope failures. Drift is too far away for accurate measurements of slopes of face (frame 11B098/040). Dark vertical line is missing data.

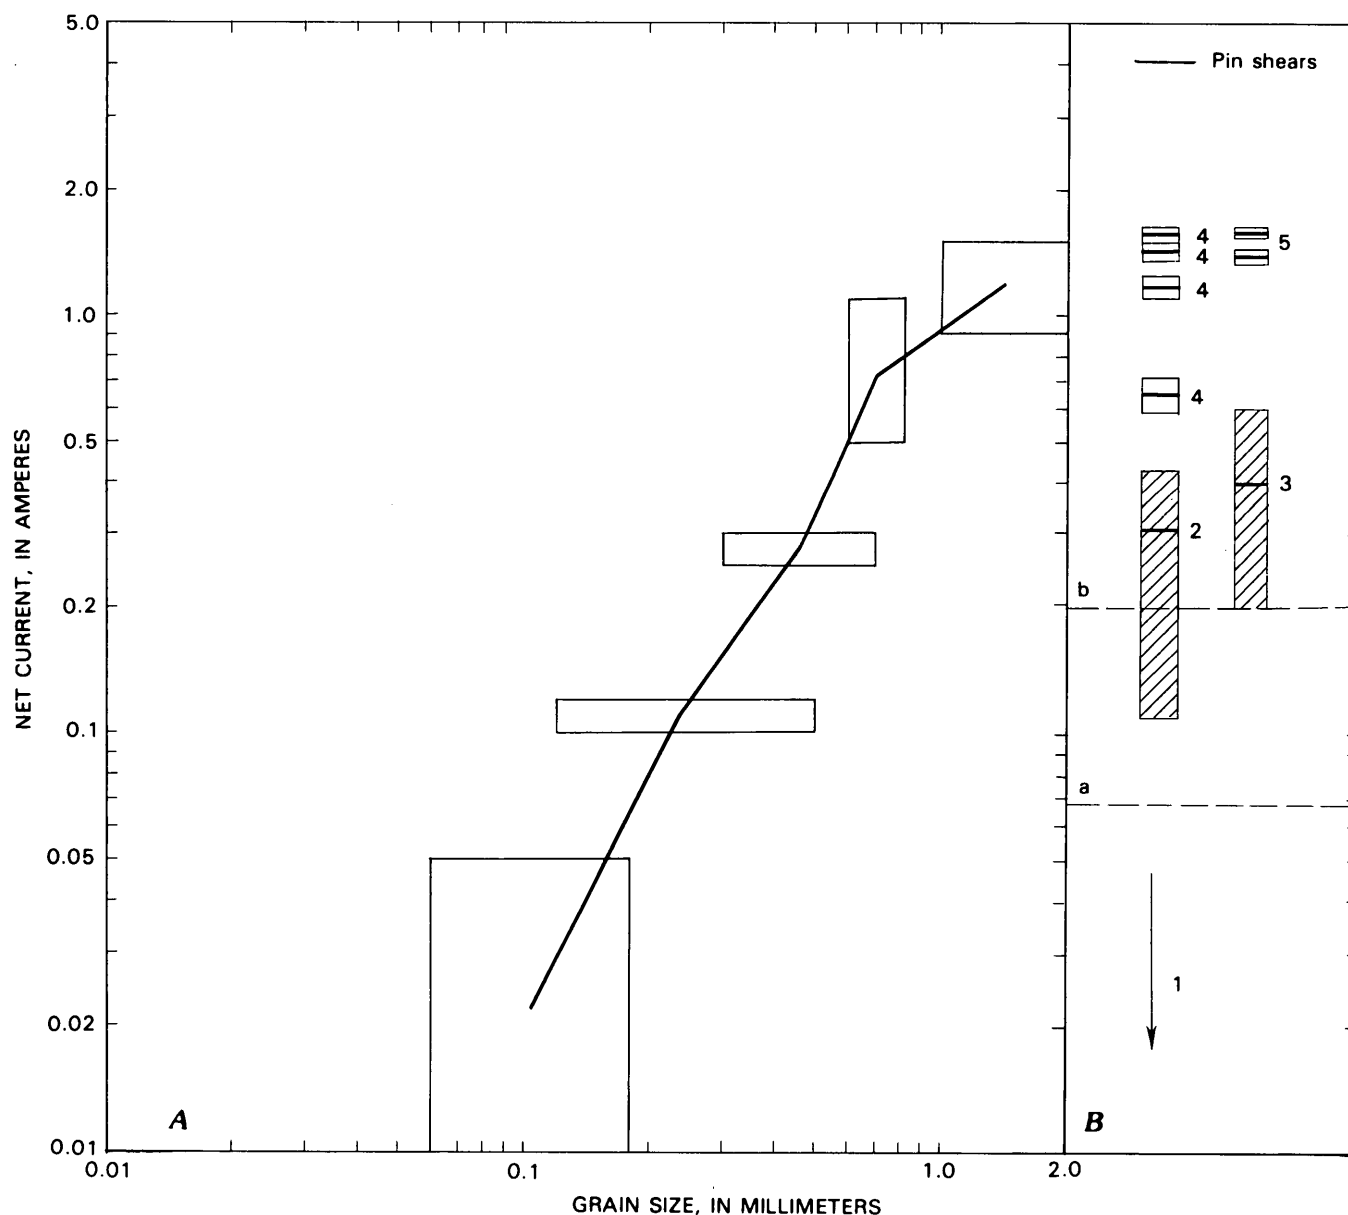
FIGURE 73.—Relation between grain size of comminuted materials and comminutor motor currents on Earth and on Mars. *A*, Terrestrial tests showing relation between grain size of well-sorted samples and net or increase in comminutor motor currents. Widths of boxes indicate range of grain size used in tests; heights of boxes indicate range of net currents; heavy solid line connects centers of boxes. *B*, Viking results: (a) standard error for SSCA no-load currents of Lander 1, (b) standard error for SSCA no-load currents of Lander 2; (1) current increase from SSCA record for drift material is smaller than

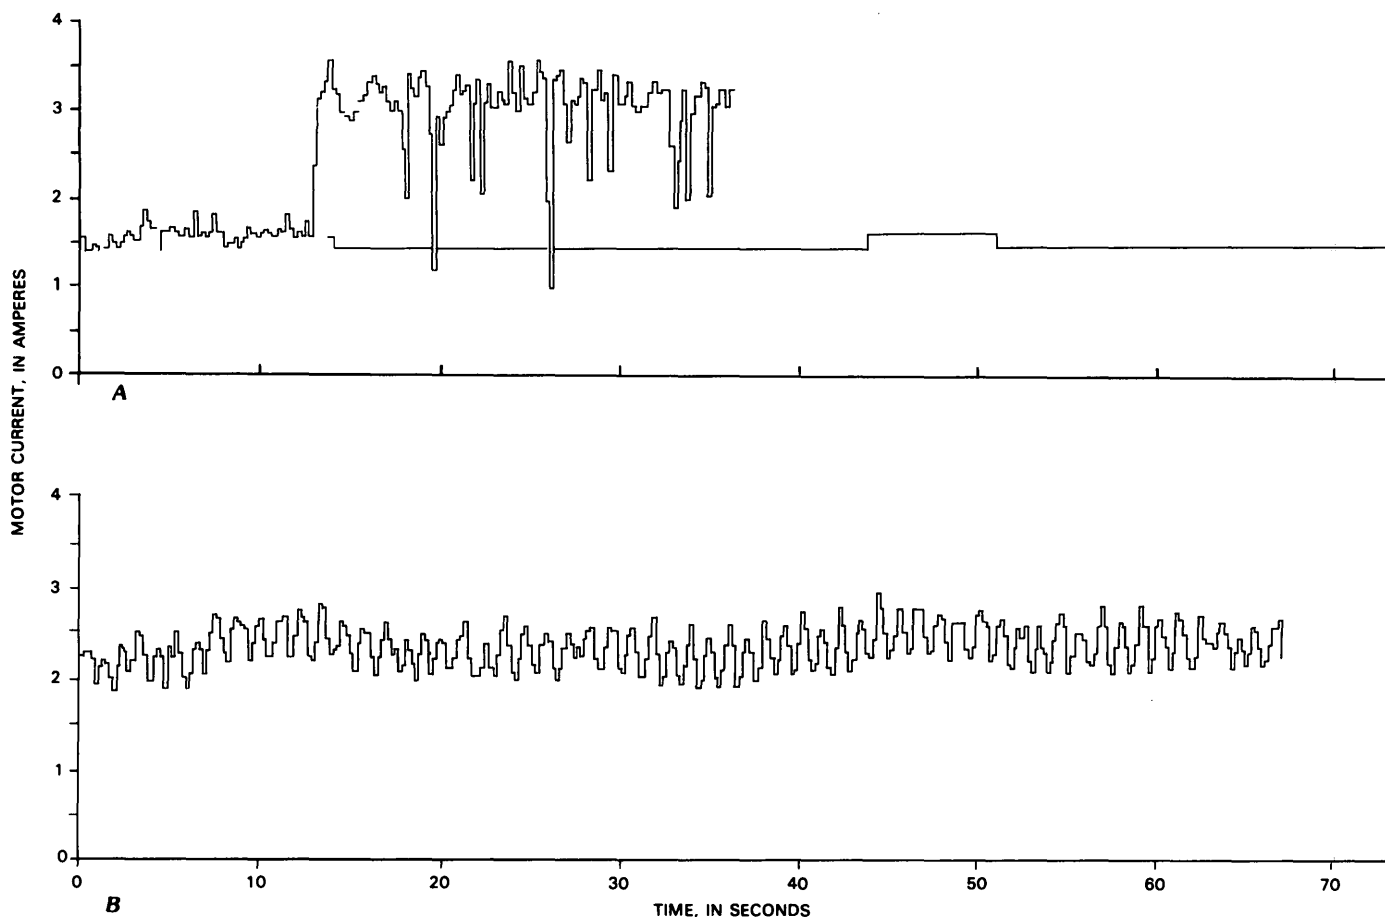
FIGURE 77.—Motor-current records for loaded comminutors from Format 5. *A*, Lander 1 (Sol 608) while crushing blocky material from Rocky Flats. Increase in current above no-load condition (see fig. 76) for Lander 1 is about 1.4–1.6 A. *B*, Lander 2 (Sol 522) while crushing

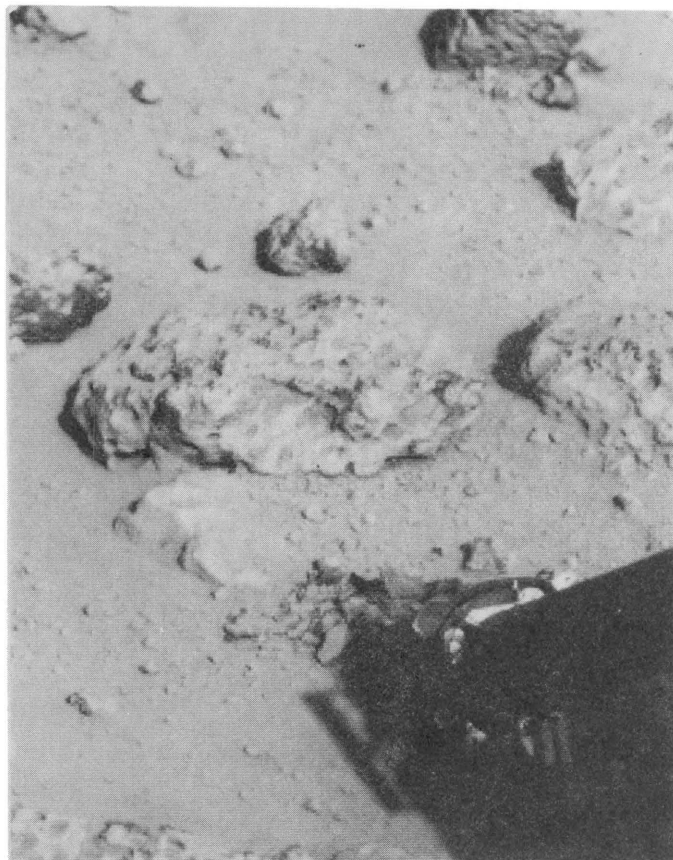
FIGURE 79.—Collector head of Lander 2 inserted in crusty to cloddy material during diurnal temperature measurements. Shadow of camera 2 is cast along azimuth of boom and collector head (frame 21E236/405). Large rock (rock 14) in center of picture, just beyond collector head, is about 22 cm wide.

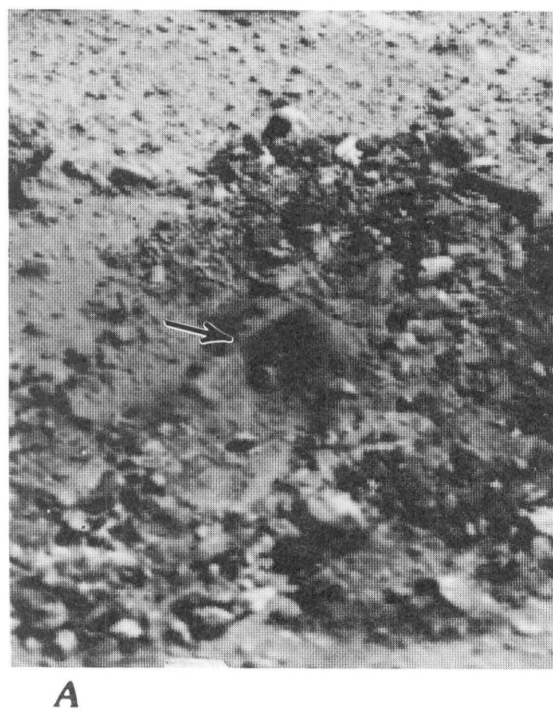
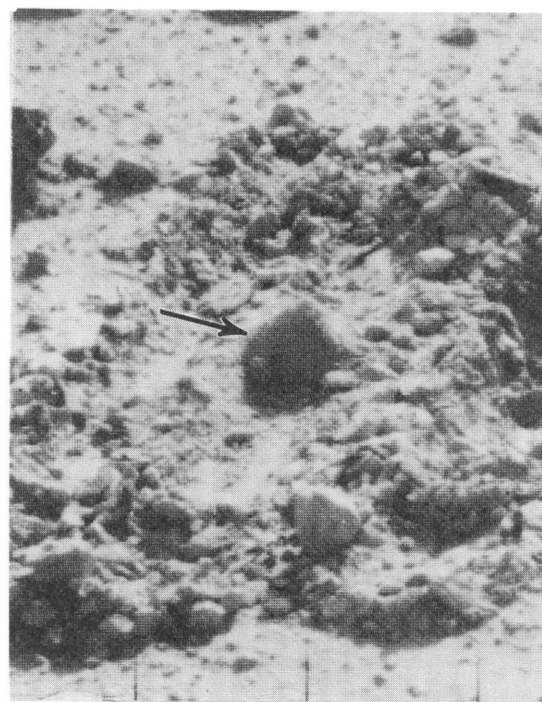
FIGURE 83.—Conical piles 1 and 3 of Lander 2. *A*, Conical pile 3 (approximately 1.4 cm high) shortly after emplacement. Note halo of dark material around pile (frame 21H032/595). *B*, Conical piles 1 and 3 after 734 and 545 sols of exposure to martian wind and other processes.

Halo of dark material around pile 3 is no longer visible. Pile 1 is approximately 4.5 cm high (frame 21I117/1140). *C*, Conical pile 1 after 787 sols of exposure to martian environment shows little or no change in size or form (frame 21I136/1193).

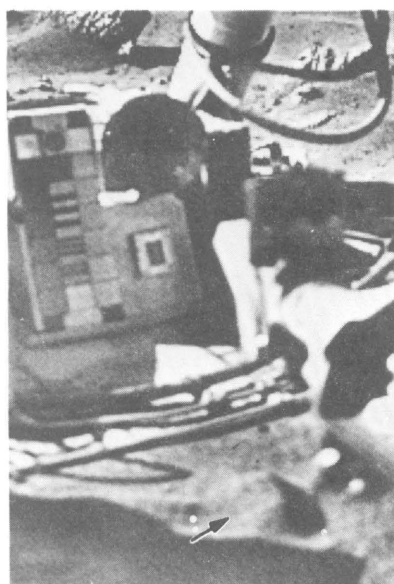
A

FIGURE 84.—Conical pile 2 (arrow) of Lander 2. *A*, Conical pile 2 (approximately 3–4 cm high) after 9 sols of exposure to martian winds and other processes (frame 22H046/604). *B*, Conical pile 2 appears unscathed despite 582 sols of exposure to martian winds (frame 22I129/1177).

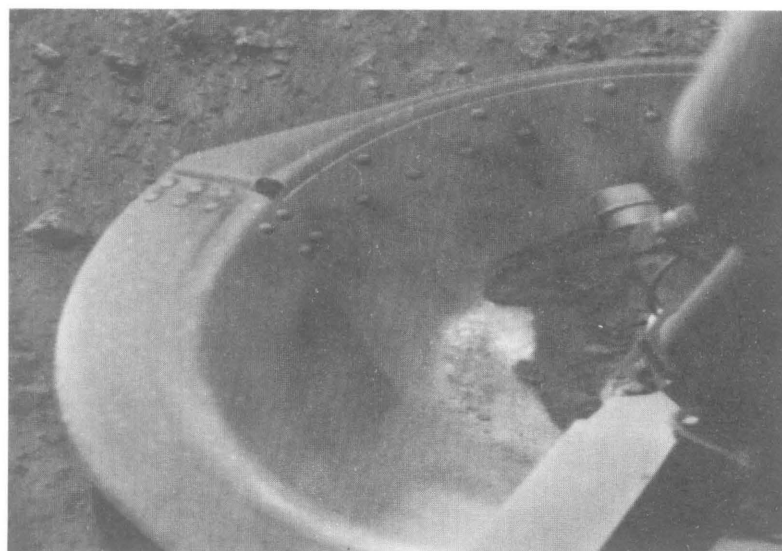
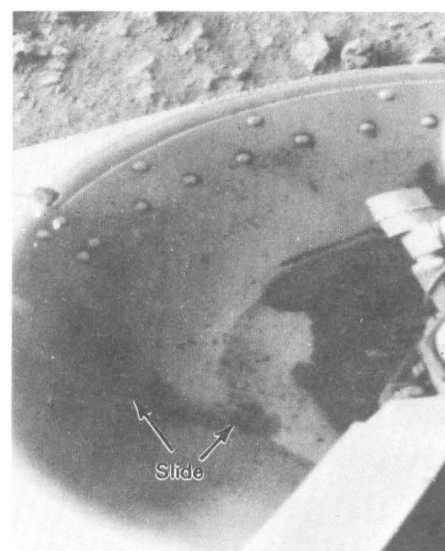
FIGURE 86.—Changes in footpad 3 (radius 0.206 m) of Lander 1. *A*, Footpad 3 immediately after landing. Note thin veneer of fine-grained material on walls, halo of fine-grained material on floor, and core of mixed coarse and fine-grained material (frame 12A001/000). *B*, Footpad 3 after 476 sols on Mars. Note deltoid-shaped patch on left; materials have moved from left part of floor of footpad. Coarse ob-

much as 0.7 cm (fig. 86A). The walls, which are inclined between 38° and 48° , were covered with a veneer of fine-grained material and a thicker patch with lumps or clods with diameters as much as 0.3 cm. On Sol 171, changes on the inner walls were obvious—patches of uncovered metal had appeared. By Sol 347, much of the wall material was removed but deltoid-shaped patches were present on

opposite sides of the footpad (fig. 86B). Parts of the floor were cleared of fine-grained material. The coarsest objects on the floor did not appear to have moved. Subsequent changes were little. Three clods or lumps, 0.1–0.3 cm wide, appeared on the left wall where none were previously present. Lumps that slid down the inner walls appeared by Sol 580 (fig. 86C). These lumps probably

originated as the result of surface-sampler activities because the boom and collector head passed over and near footpad 3 on Sols 430, 431, and 550 during sample acquisitions. Added droppings are found on the surface near footpad 3. The material of the deltoid-shaped patch began sliding between Sols 476 and 580 and continued beyond the period of surface-sampler activities. Comparison of pictures taken on Sols 836 and 921, well after the sampler was parked, show that additional material slid down the wall. The thicknesses of the sliding units were about 0.3 cm.

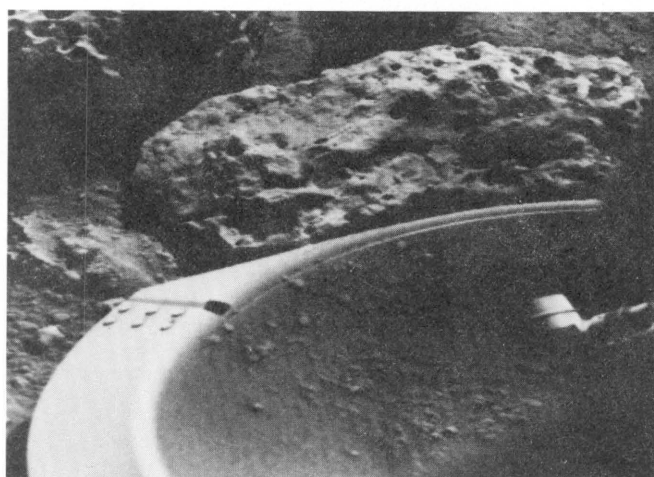
The distribution of fine-grained material and clods in footpad 3 of Lander 2 changed little or not at all (figs. 87A and B). Although illumination conditions varied from picture to picture, all resolvable lumps and objects as much as 0.7 cm wide were visible in pictures of footpad 3 from Sol 0 to Sol 1140. No sliding or movement of material appears to have occurred despite the fact that slopes of the footpad walls range from about 38° to 50° . Some fine-grained material may have moved from the upper out-board rim. A thin skiff of fine-grained material was deposited on the skirt well after landing, but once

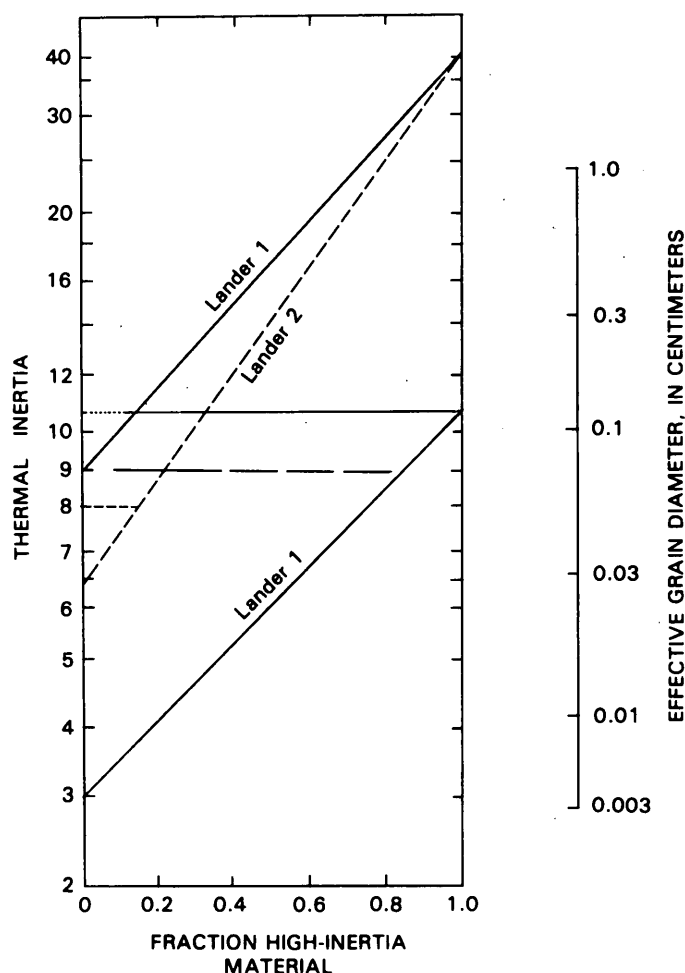
FIGURE 91.—Thermal inertias of material surfaces with one or more components on martian surfaces. Thermal inertias derived from orbital thermal measurements of Viking landing sites 1 and 2 are 9 ± 0.5 and 8 ± 1.5 (in 10^{-3} cgs units), respectively. One-component model of cohesionless material implies effective grain diameters of about 0.08 cm (Lander 1) and 0.06 cm (Lander 2). Two-component model for Lander 2 (short-dashed lines) has 15 percent rock ($I=40$) and 85 percent matrix material ($I=6.3$). Diagonal short-dashed line connects $I=40$ and $I=6.3$; length of horizontal short-dashed line from $I=8$ to diagonal short-dashed line corresponds to 15 percent (0.15 fraction) rock. Three-component model for Lander 1 has 15 percent drift material ($I=3$) and 85 percent remaining material with $I=10.8$; remaining material has 12 percent rock ($I=40$) set in matrix of blocky material ($I=9.2$). Lower diagonal solid line connects $I=10.8$ and $I=3$; length of horizontal long-dashed line from $I=9$ to lower diagonal line corresponds to 85 percent (0.85 fraction) of remaining high inertial material. Upper diagonal solid line represents remaining high inertial material and connects $I=40$ and $I=9.2$; length of dotted horizontal line from $I=10.8$ corresponds to 12 percent (0.12 fraction) rocks; length of horizontal solid line corresponds to 88 percent (0.88 fraction) of blocky materials in remaining material (modified from Kieffer and others, 1977.)

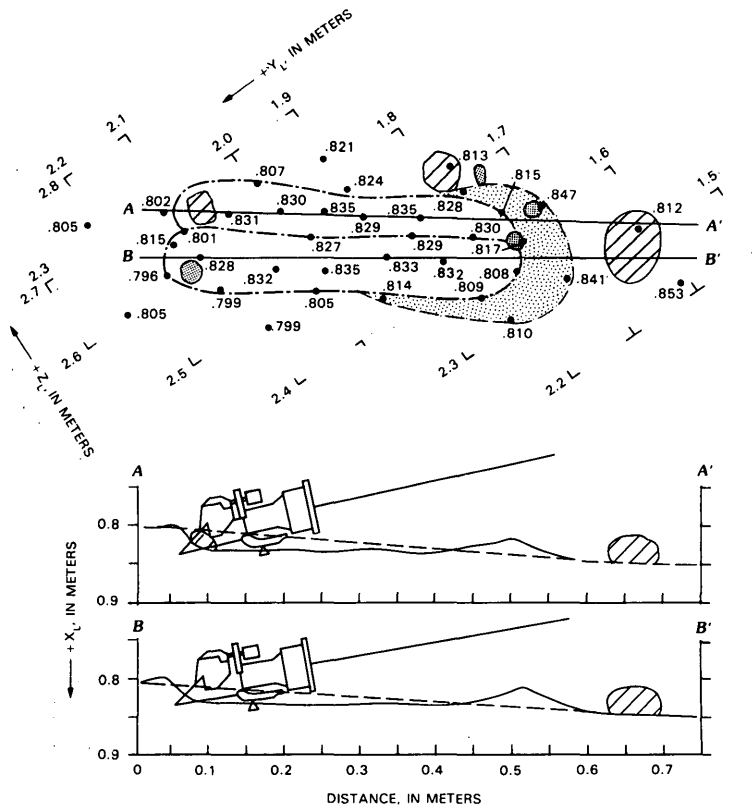
FIGURE 133.—Map and profiles of trenches in Spalling Valley (near rock 15) excavated for pile of coarse fraction by Lander 2 on Sol 145. No Format 5 motor-current record. (See XRFS 5, table 41, item 5; stereoscopic pictures: frames 22C160/146, 21C159/146, 22C162/146, and 21C161/146.)

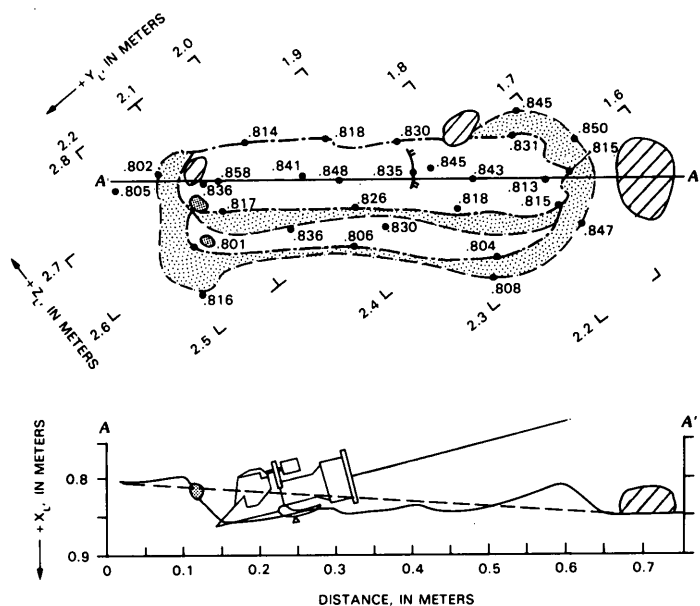
FIGURE 134.—Map and profile of trenches in Spalling Valley (near rock 15) excavated by Lander 2 on Sol 161. No Format 5 motor-current record. (See XRFS 6, sample U-3, table 41, item 9; stereoscopic pictures: frames 22C202/161, 21C200/161, 22C203/161, and 21C201/161.)

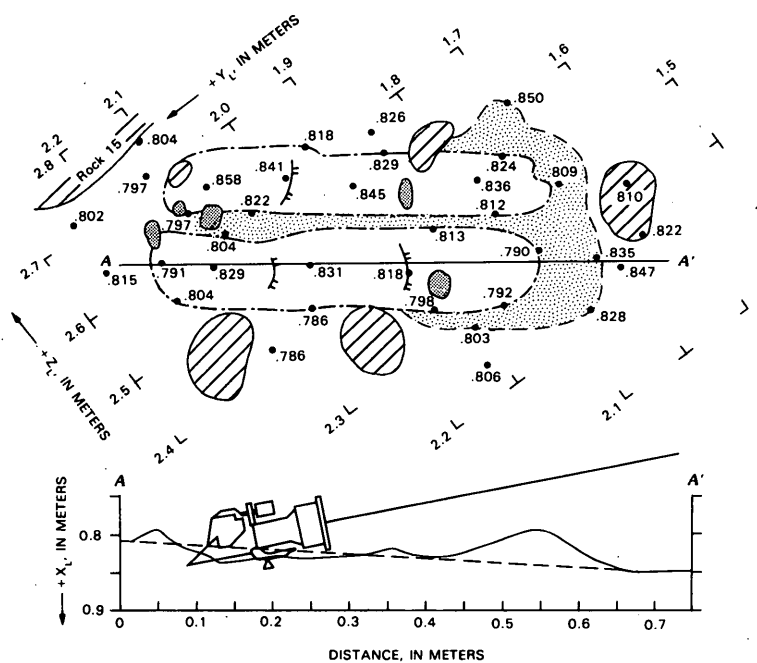
FIGURE 135.—Map and profile of trenches in Spalling Valley (near rock 15) excavated for pile of coarse fraction by Lander 2 on Sol 172. No Format 5 motor-current record. (See XRFS 7, table 41, item 11; stereoscopic pictures: frames 22G099/524 and 21G061/512.)

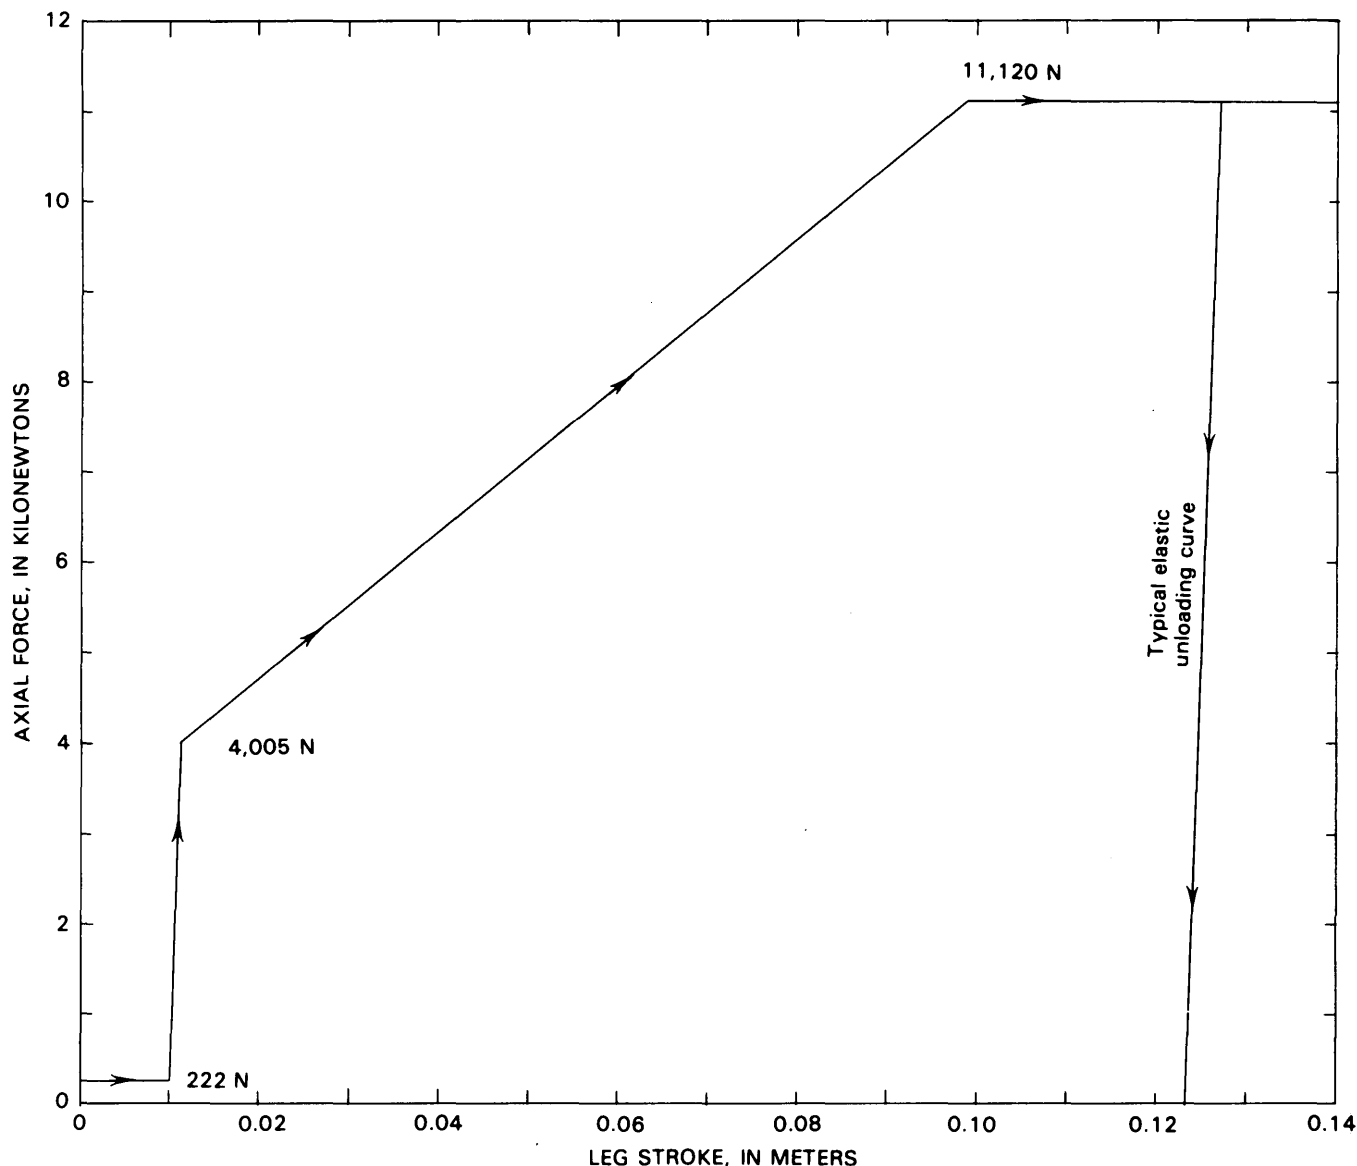
FIGURE 152.—Relation between static axial force and leg stroke for Viking Lander main strut. Initial forces during stroking result from compression of weak spring. Forces from 4,005 to 11,120 N result from crushing of honeycomb tube-core cartridges in primary-strut
