Physical Properties of the Surface Materials at the Viking Landing Sites on Mars

U.S. GEOLOGICAL SURVEY PROFESSIONAL PAPER 1389

By H.J. MOORE, R.E. HUTTON, G.D. CLOW, and C.R. SPITZER

*A summary of the results of
the Physical Properties Investigation
of Viking Landers 1 and 2 during
the Viking 1975 project*

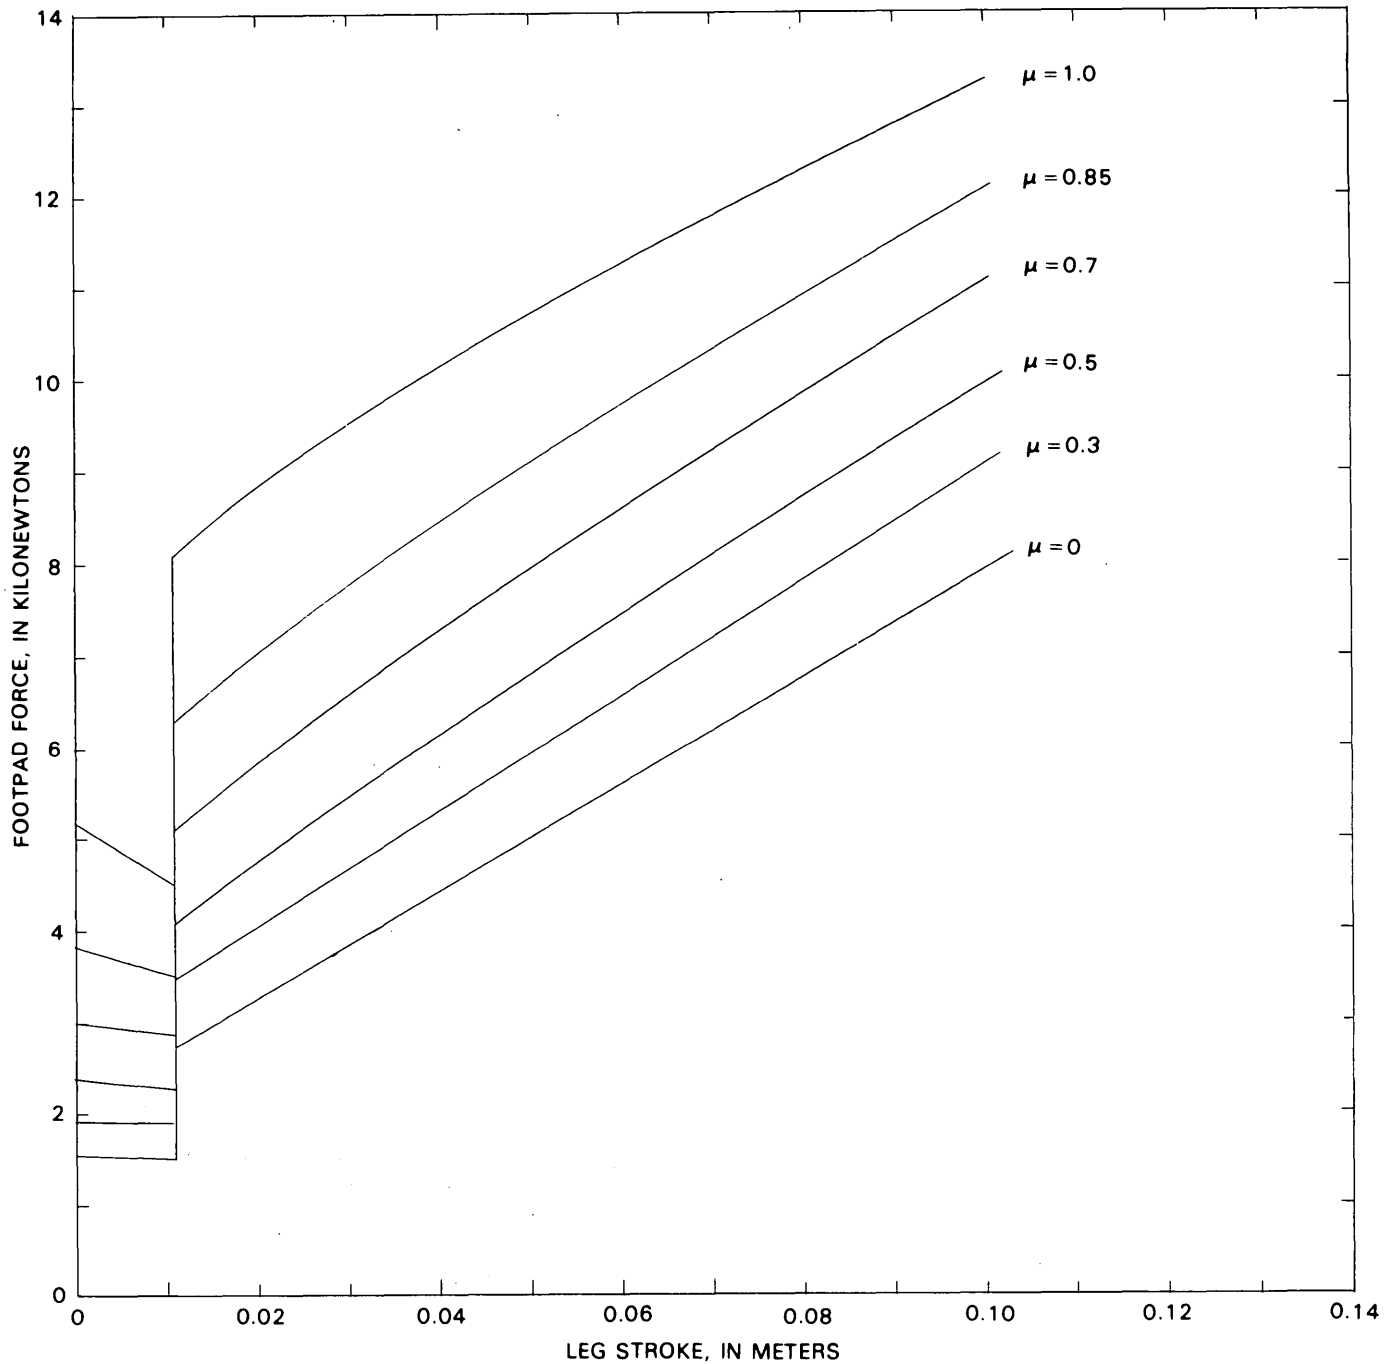
FIGURE 154.—Relation between force on footpad (F_p) in the direction of penetration and leg stroke for six coefficients of friction (μ). Vertical line corresponds to rapid rise in axial forces from 222 to 4,005 N (see fig. 152).

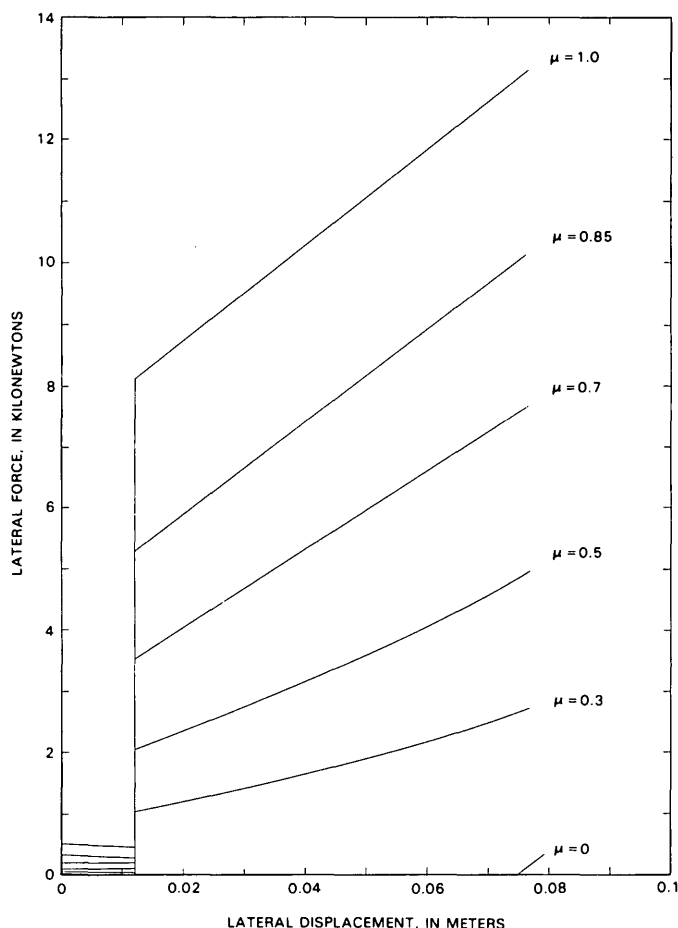
FIGURE 155.—Relation between lateral force (F_R) on footpad and lateral translation of footpads for six coefficients of friction (μ). Vertical line corresponds to rapid rise in axial forces from 222 to 4,005 N (see fig. 152).

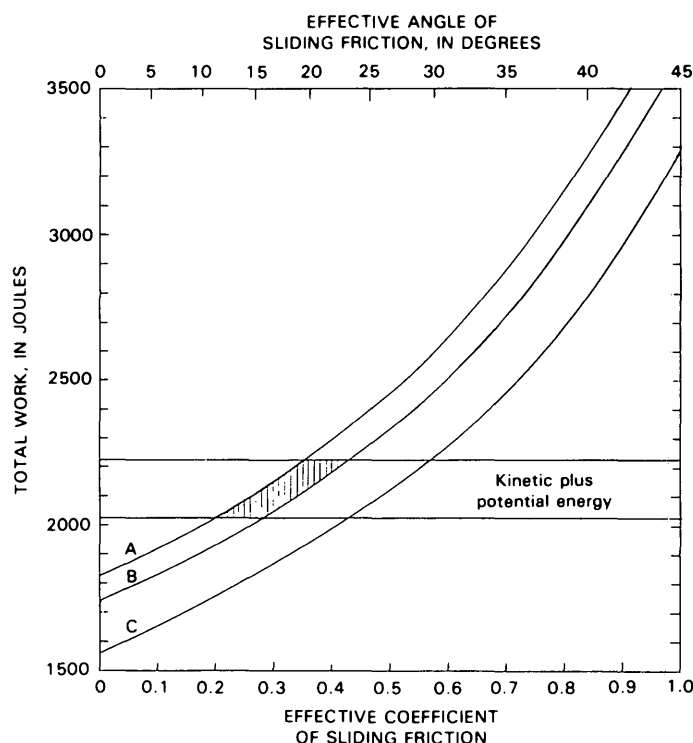
FIGURE 156.—Total work performed on primary-strut shock absorbers by decaying engine thrusts and by footpads as a function of the effective coefficient of sliding for Lander 1. Horizontal lines represent range of energy that must be absorbed as work by these factors. Curves A and B are best estimates of total work (see table 44). Curves A, B, and C show dependence of total work on force-penetration relations assumed for the penetration of footpad 2 (using equations 52, 51, and 50, respectively). Best estimates of range of effective coefficients of sliding friction correspond to range of intersections of curves A and B with horizontal energy lines (shaded area).

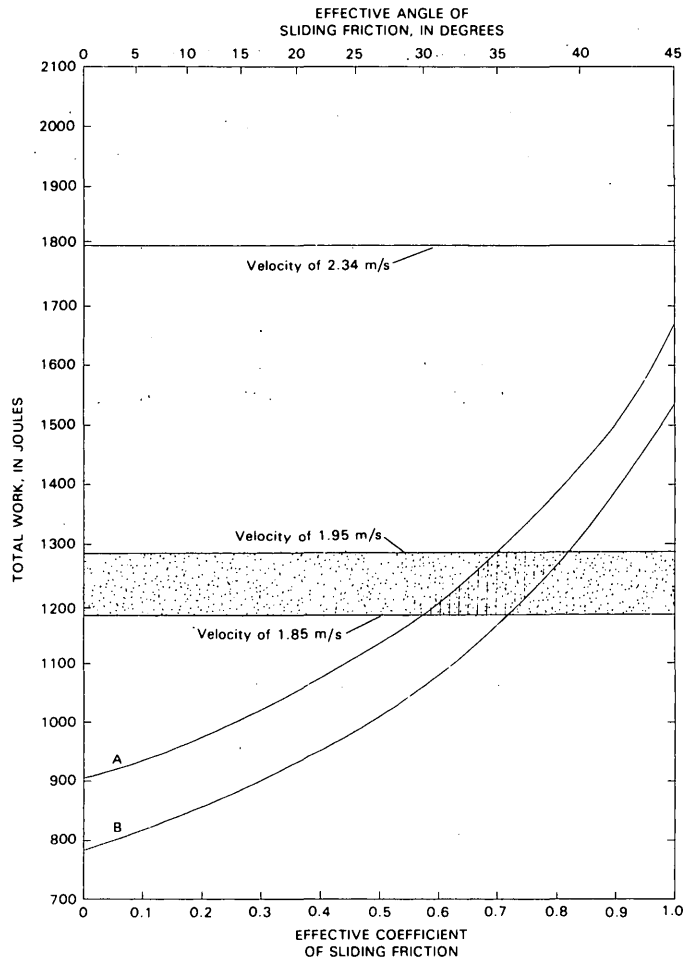
FIGURE 157.—Total work performed on primary-strut shock absorbers by decaying engine thrusts and by footpads as a function of the effective coefficient of sliding for Lander 2. Horizontal lines indicate range of energy that must be absorbed by work. Curves A and B are best estimates of total work (see table 45). Because footpads 2 and 3 struck rocks on landing, implied effective coefficients of friction (lined area) are unreliable. Dotted area represents most probable range of kinetic and potential energy of Lander 2.
