Verification of Roughness Coefficients for Selected Natural and Constructed Stream Channels in Arizona

U.S. Geological Survey Professional Paper 1584

Prepared in cooperation with the
Flood Control District of Maricopa County

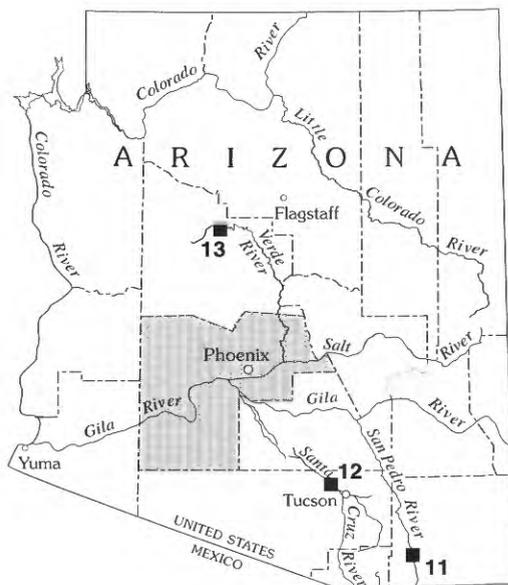
Figure 1. Study area and *n*-verification sites in Maricopa, Pima, Cochise, and Yavapai Counties, Arizona.

The purpose of this report is to present verified Manning's roughness-coefficient values for 37 discharge measurements at 14 selected stream sites in Arizona (fig. 1). The information includes geometry and roughness characteristics of the 14 sites. The selected sites represent a wide range of channel conditions that include unstable alluvial channels, high-gradient boulder-strewn channels, and manmade flood-control channels. Of the sites presented, five were published in previous *n*-value assessment reports and are included herein to increase the range of stream types and transferability of the information (Barnes, 1967; Aldridge and Garrett, 1973).

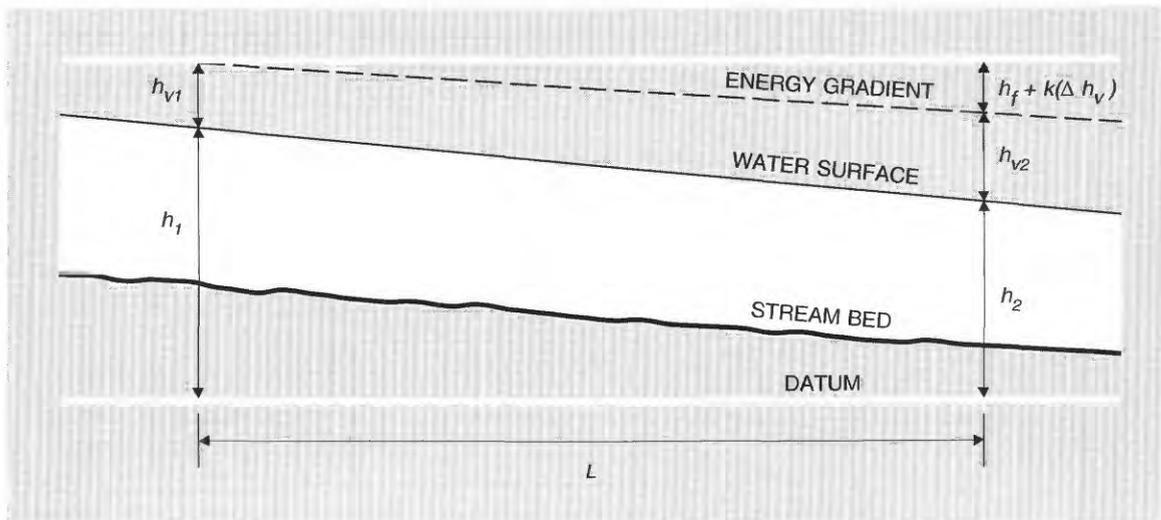
PLAN VIEW

PROFILE VIEW

The equation was developed for conditions of *uniform flow* in which the water-surface slope and energy gradient are parallel to the streambed, and the area, depth, and velocity are constant throughout the reach. Equation 3 is assumed for nonuniform reaches if the energy gradient is modified to reflect only the losses resulting from boundary friction (Barnes, 1967). The energy equation for a nonuniform stream channel reach between sections 1 and 2 (fig. 2) is:

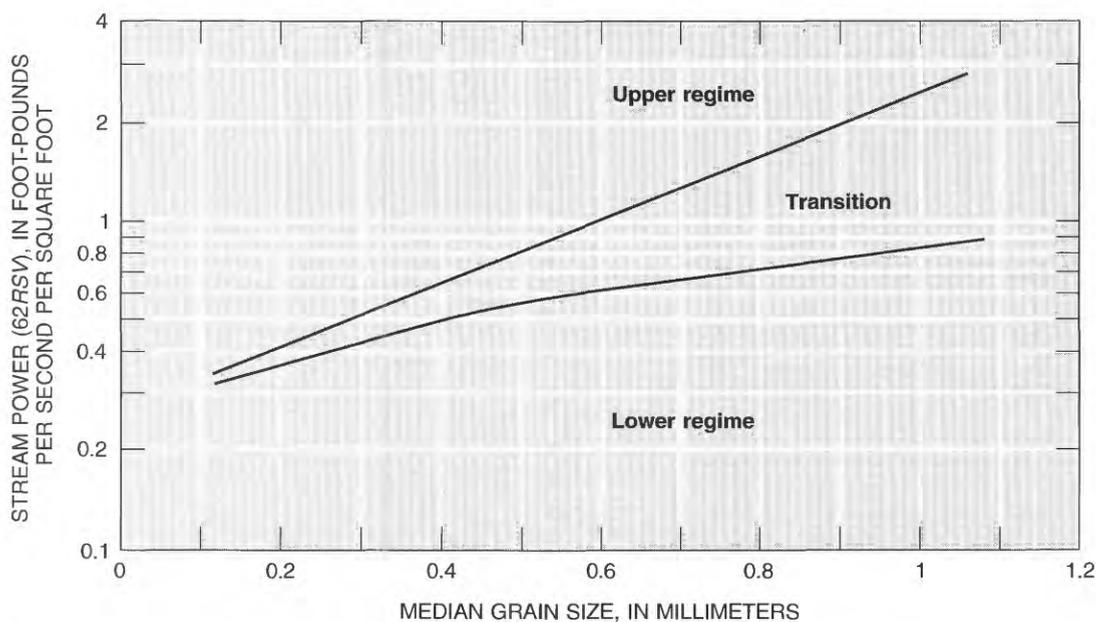
Figure 3. Relation of stream power and median grain size to form of bed roughness. (Modified from Benson and Dalrymple, 1967.)

On the basis of criteria presented by Simons and Richardson (1966) and Benson and Dalrymple (1967), upper-regime flow conditions were exhibited for all verification measurements that were made in sand-dominated streams (sites 6 and 12, fig. 1). In addition to the uncertainties associated with changing boundary conditions for sand channels, the possibility of intermittent antidune formation and subsequent collapse of the antidunes could result in intermittent surging of the water surface along the banks of the channel. The surges may result in super elevation of high-water marks that normally are surveyed when the flow subsides. This phenomenon occurred on March 6, 1995, about 1,000 ft upstream from the USGS streamflow-gaging station at Hassayampa River near Morristown. Discharge was about 9,000 ft³/s, and the authors witnessed trains of large antidunes (about 6 ft from trough to crest) that were forming and collapsing at regular intervals. The collapse resulted in a surge of the water surface along the channel banks of more than 1 ft in elevation. Following collapse of the antidunes, the flow would return to plane-bed conditions until another train of antidunes formed.

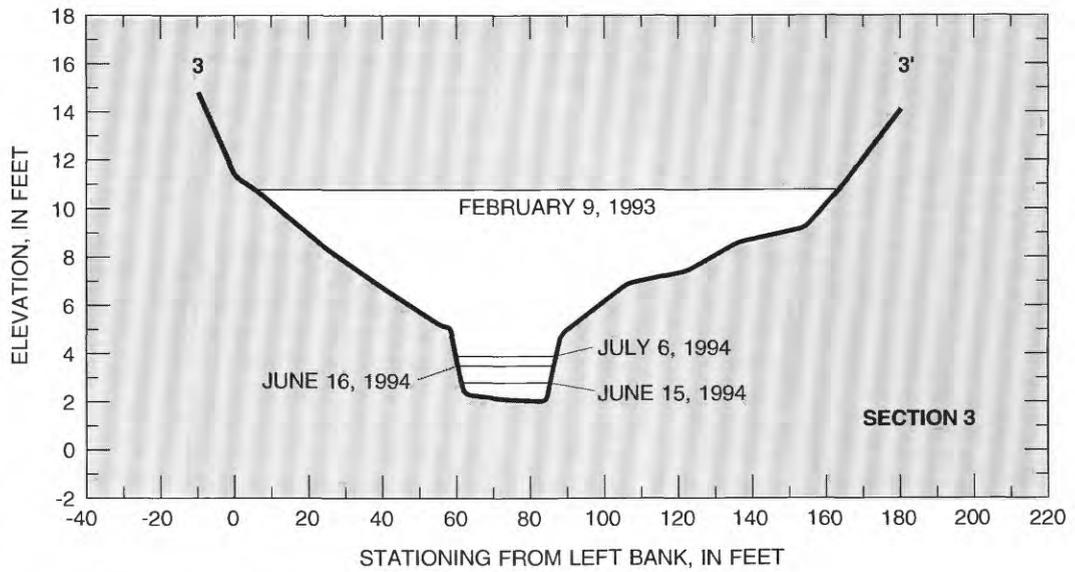
Figure 4A. Cross-section 3, Hassayampa River near Arlington.

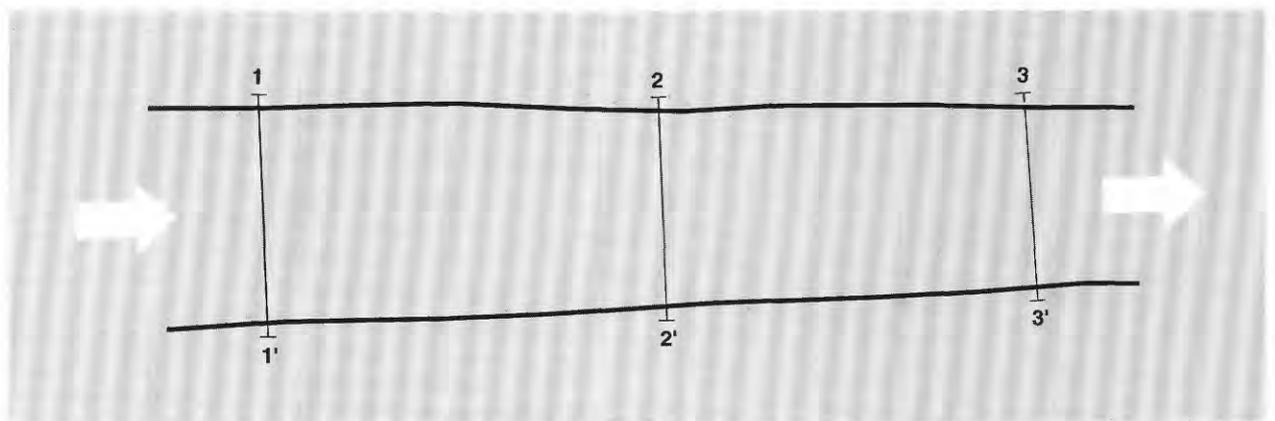
Figure 4B. Plan view, Hassayampa River near Arlington.

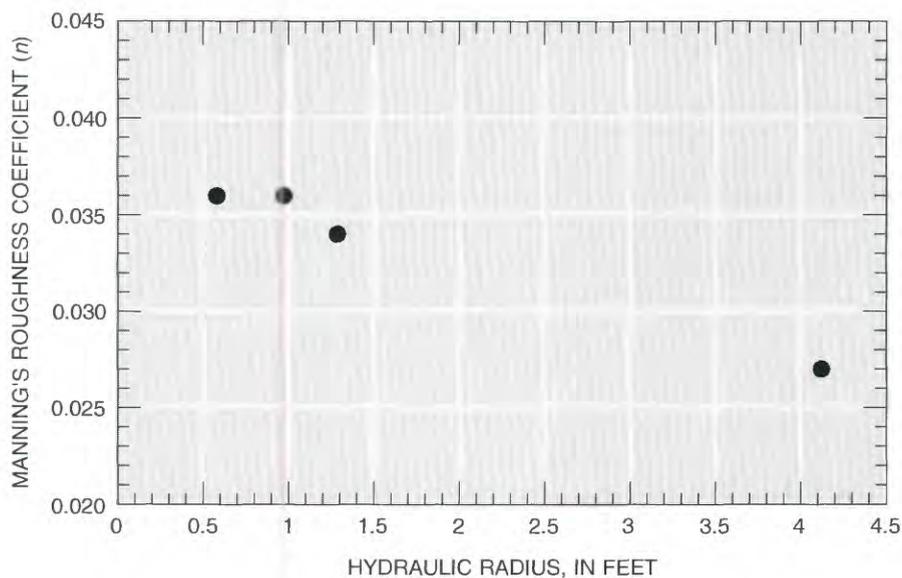
Figure 4C. Manning's n and hydraulic radius, Hassayampa River near Arlington.

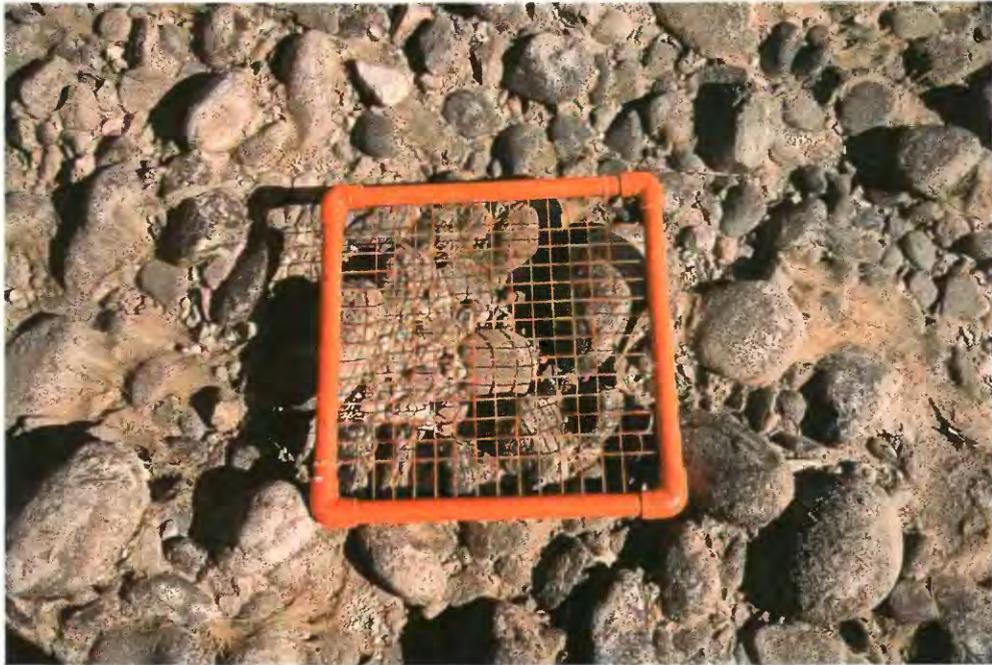
Figure 4E. View of typical bed material for low-flow channel, Hassayampa River near Arlington. The square grid (painted orange) has an outside dimension of 1.5 feet and an internal grid spacing of 1 inch.

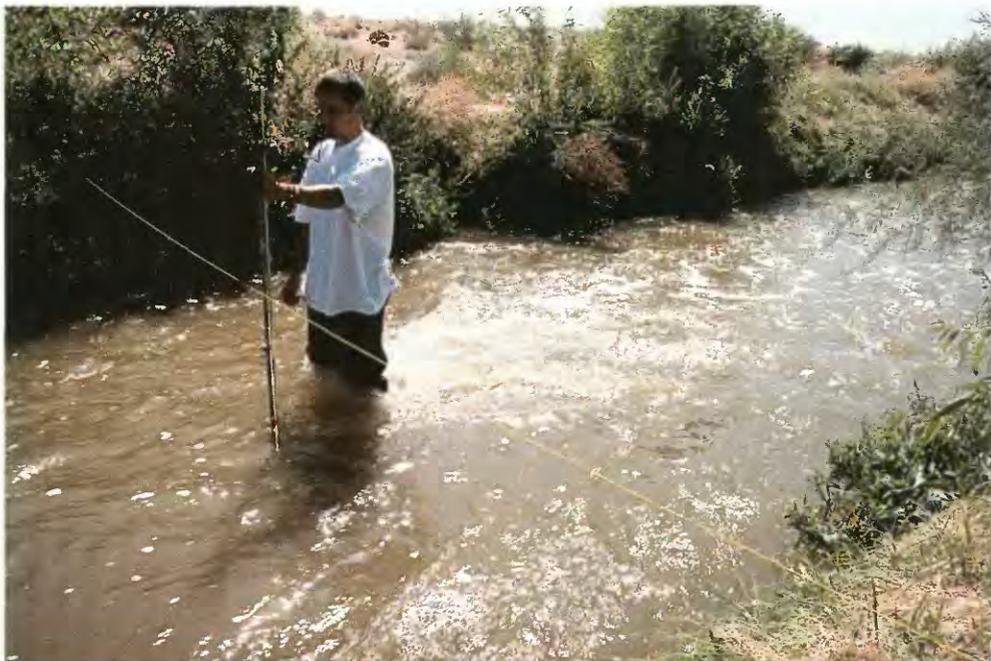
Figure 4F. View from right bank showing a current-meter measurement made in the low-flow channel, Hassayampa River near Arlington.

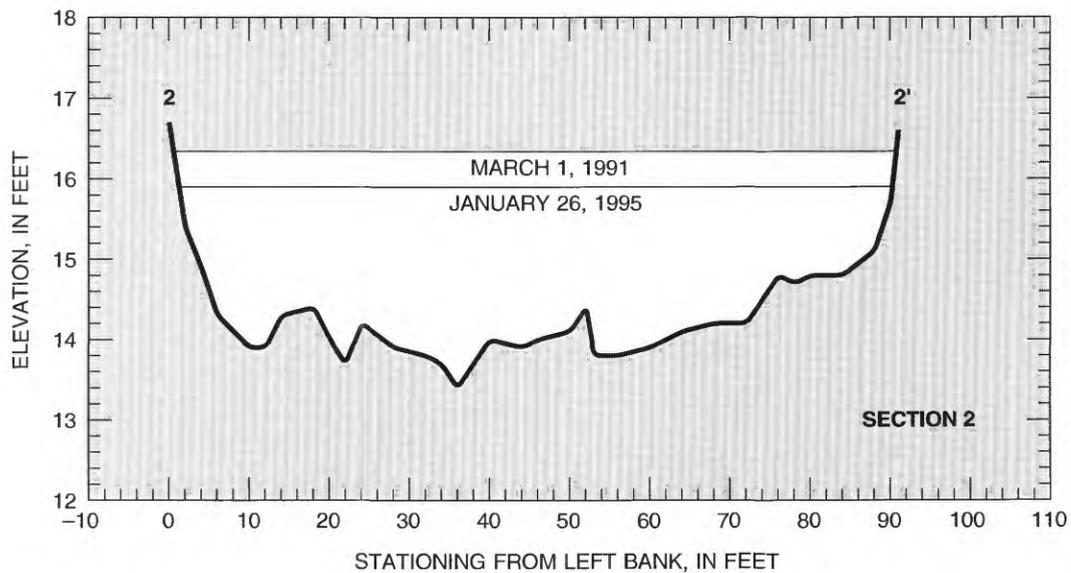
Figure 5A. Cross-section 2, Skunk Creek above Interstate 17.

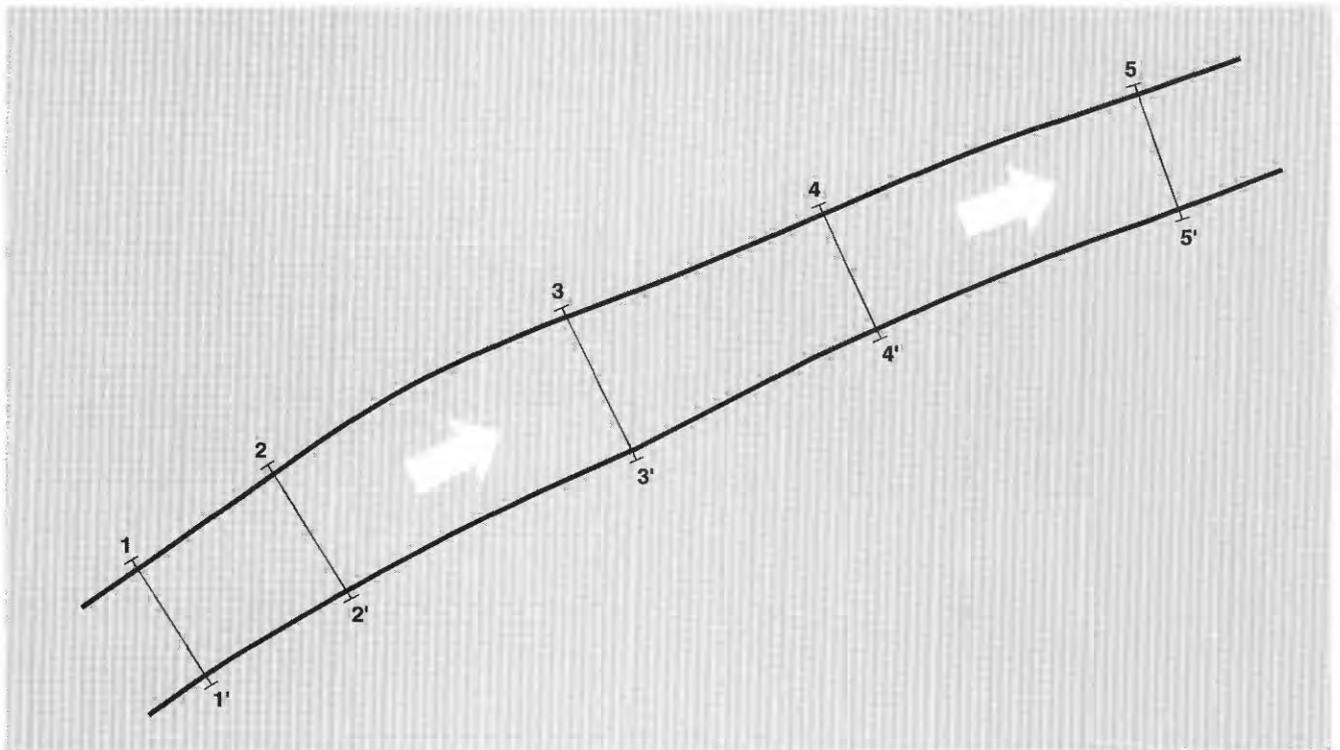
Figure 5B. Plan view, Skunk Creek above Interstate 17.

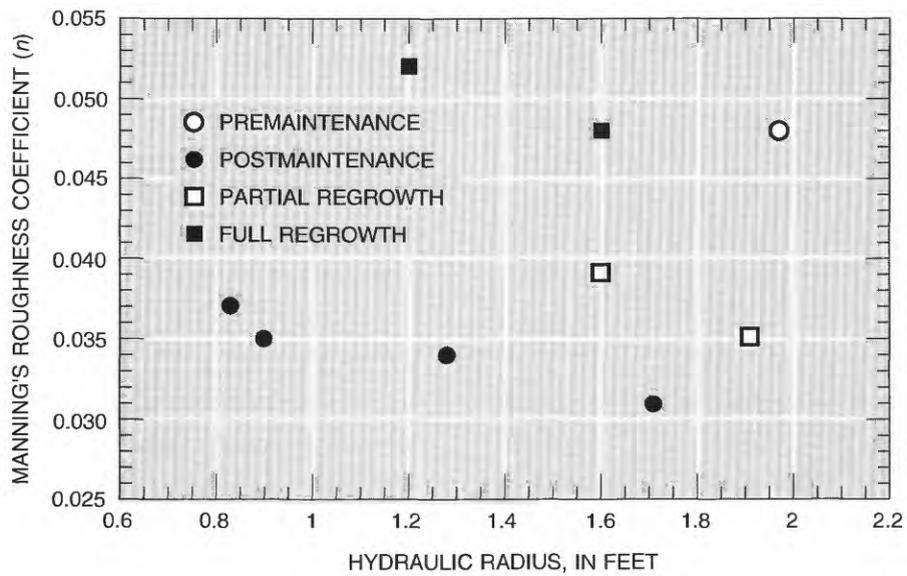
Figure 5C. Manning's n and hydraulic radius, Skunk Creek above Interstate 17.

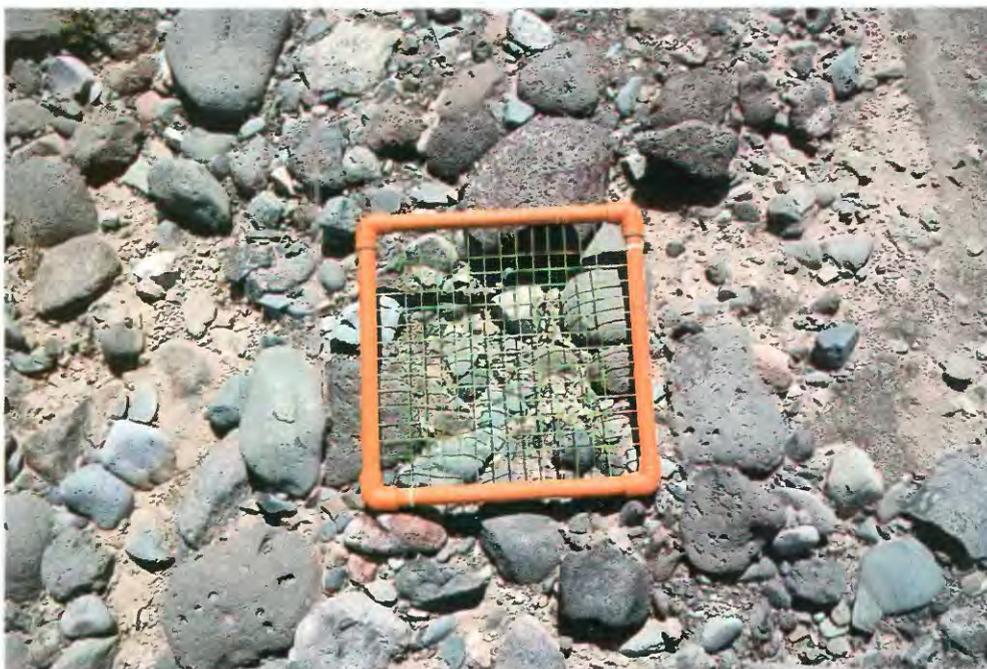
Figure 5E. View of typical bed material in channel reach, Skunk Creek above Interstate 17. The square grid (painted orange) has an outside dimension of 1.5 feet and an internal grid spacing of 1 inch (painted green).

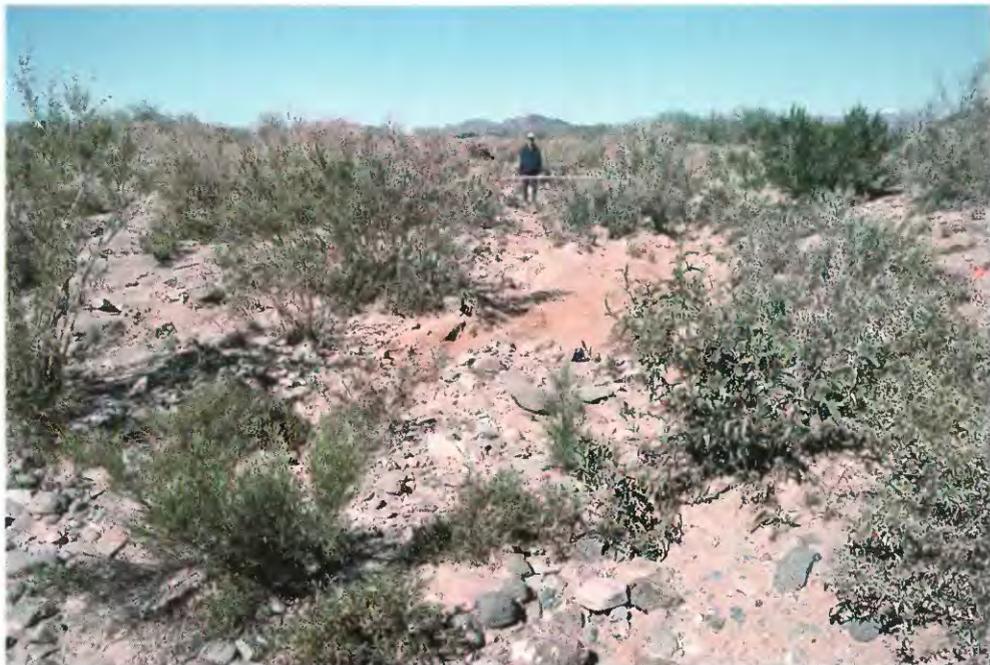
Figure 5G. View from midchannel looking upstream following flow of March 1, 1991, Skunk Creek above Interstate 17. Vegetation was little affected by flow.

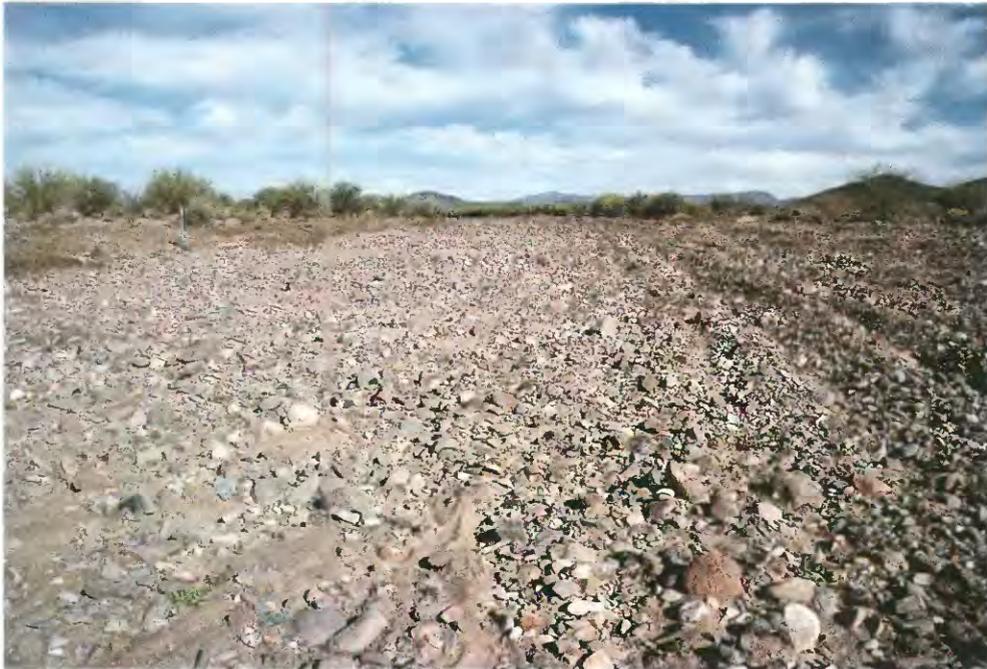
Figure 5H. View from midchannel and bottom of reach looking upstream following artificial maintenance of the channel vegetation, May 23, 1994, Skunk Creek above Interstate 17. The crest-stage gages were installed in surveyed cross sections to aid in obtaining accurate water-surface elevations and profiles.

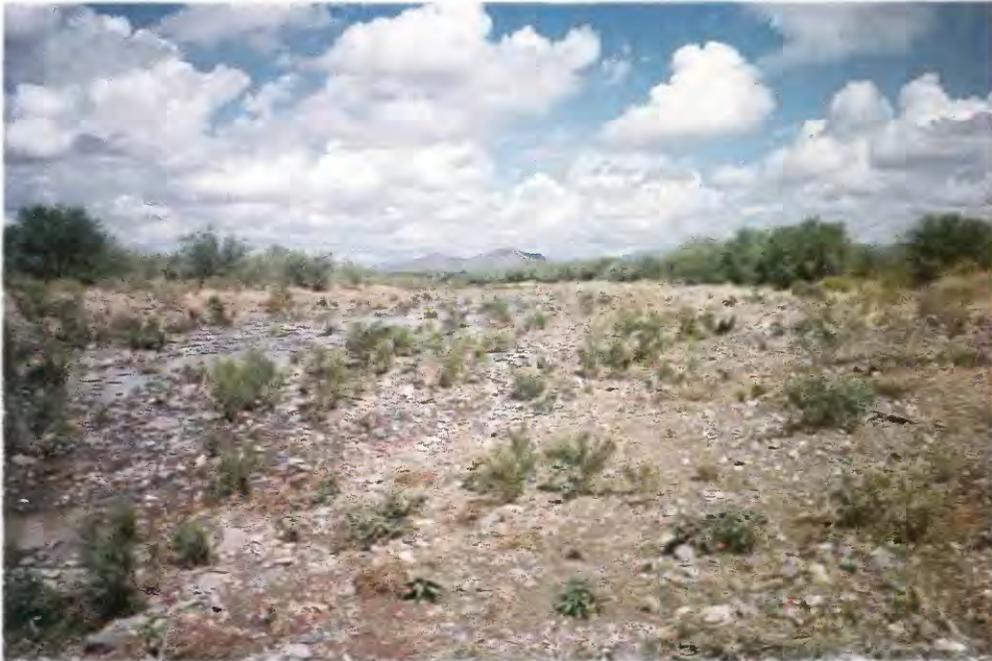
Figure 5J. View from midchannel looking upstream at regrowth of vegetation, Skunk Creek above Interstate 17. The brush is about 2 feet in height and was little affected by flow.

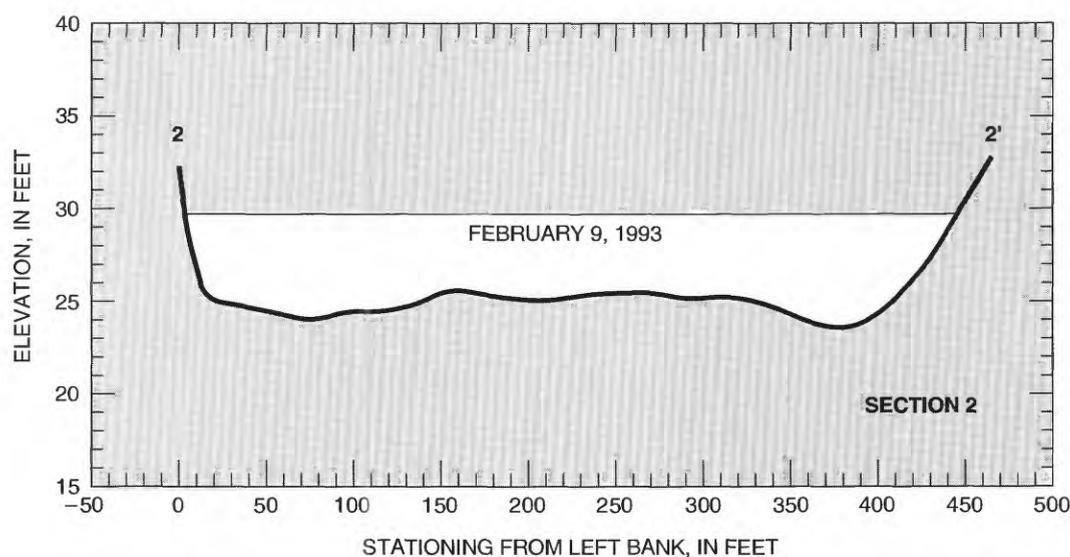
Figure 6A. Cross-section 2, Agua Fria River below New Waddell Dam.

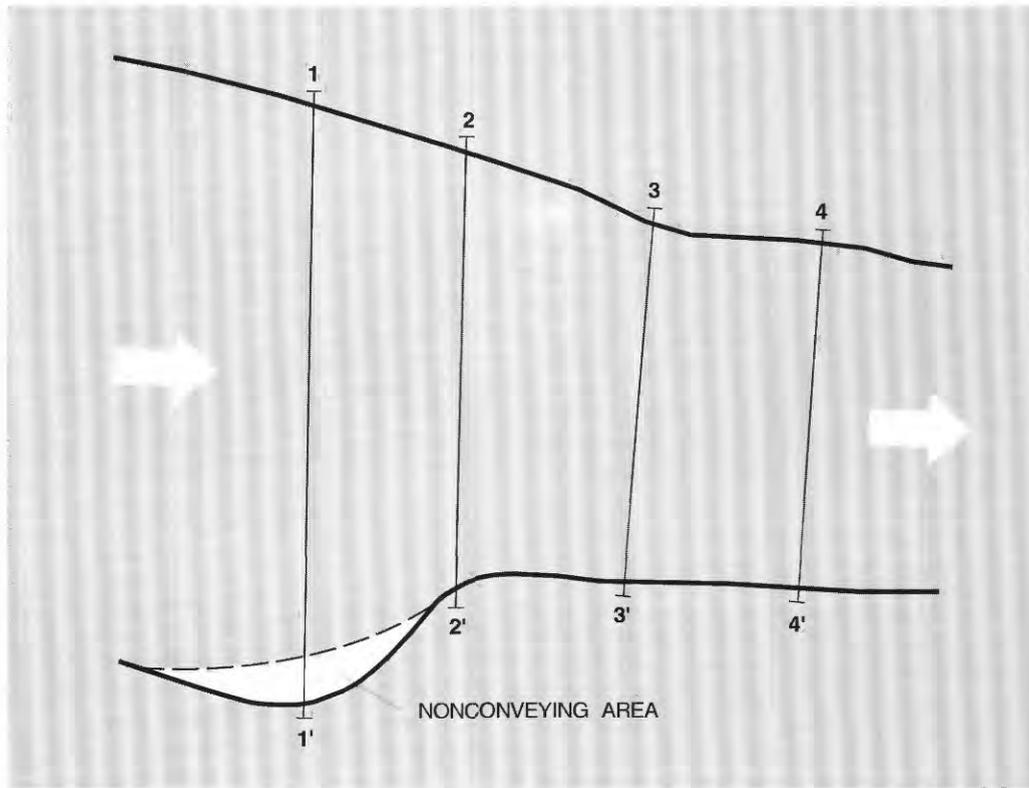
Figure 6B. Plan view, Agua Fria River below New Waddell Dam.

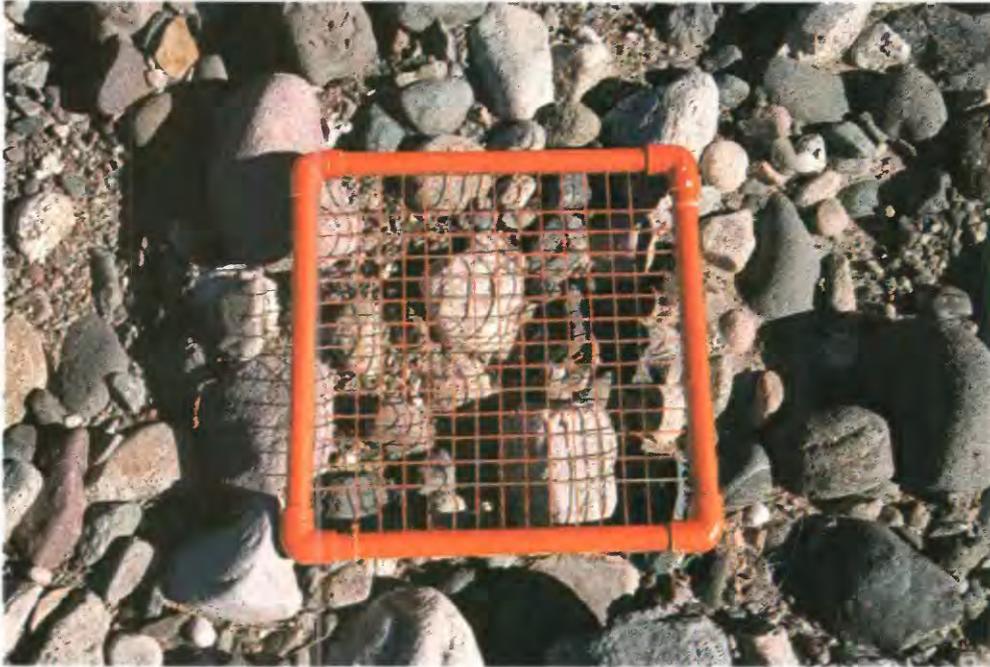
Figure 6D. View of typical bed material in channel reach, Agua Fria River below New Waddell Dam. The square grid (painted orange) has an outside dimension of 1.5 feet and an internal grid spacing of 1 inch.

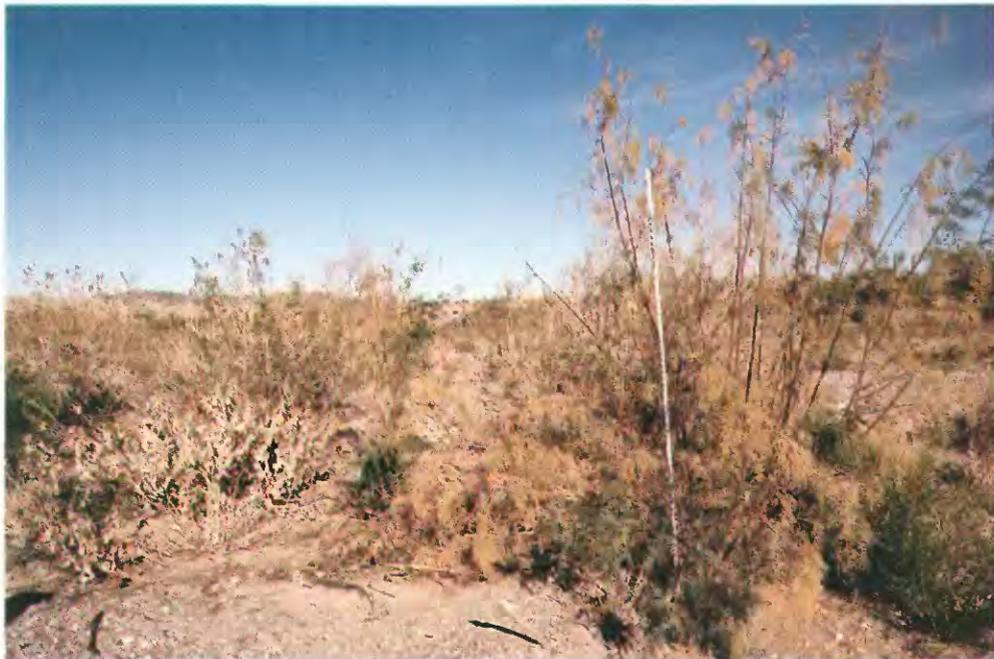
Figure 6G. View from midchannel in cross-section 2 of typical vegetation in the reach, Agua Fria River below New Waddell Dam. Length of measuring rod, 6 feet. Photograph taken at time of survey on May 19, 1993.

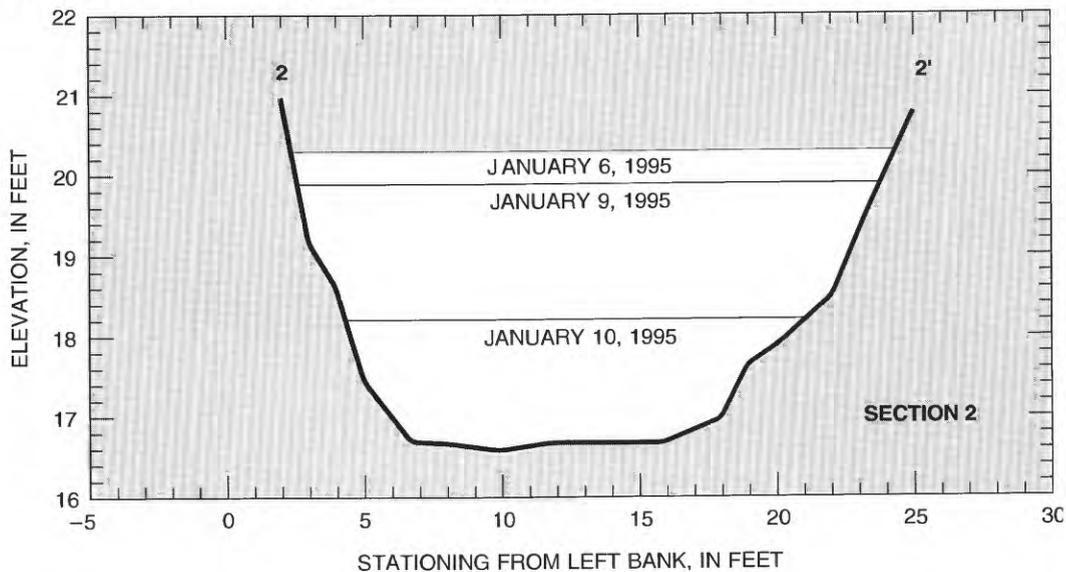
Figure 7A. Cross-section 2, Cave Creek above Deer Valley Road.

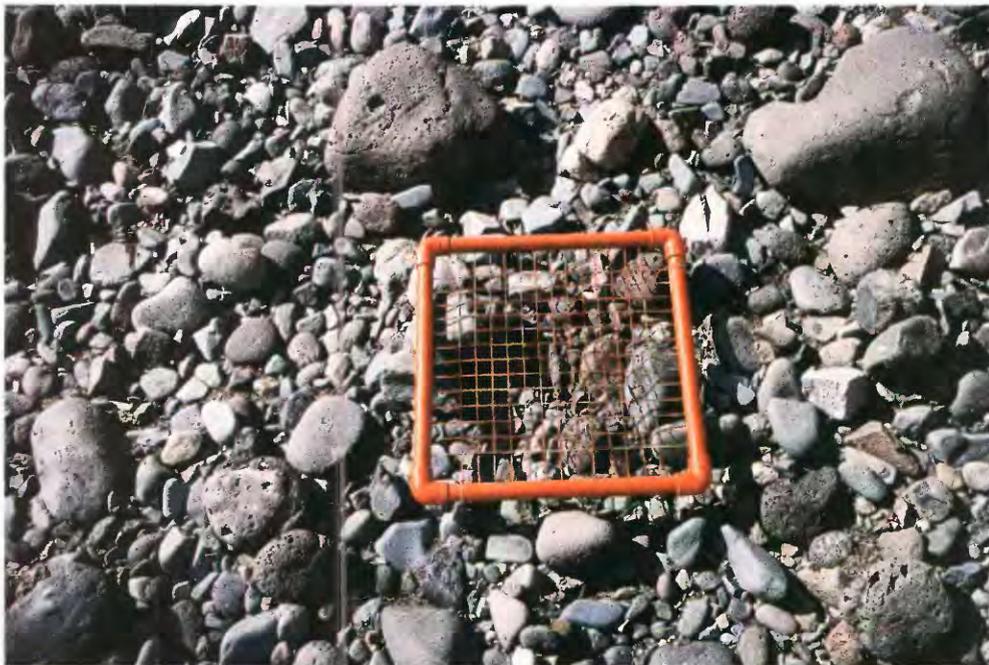
Figure 7E. View of typical bed material in channel reach, Cave Creek above Deer Valley Road. The square grid (painted orange) has an outside dimension of 1.5 feet and an internal grid spacing of 1 inch.

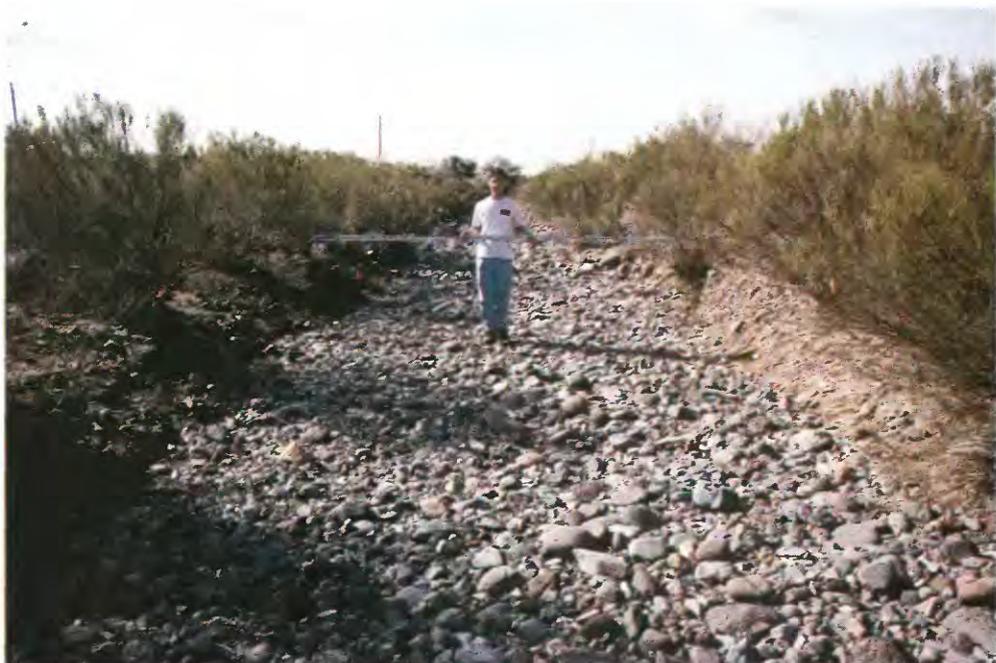
Figure 7G. View from top of reach looking downstream, Cave Creek above Deer Valley Road. Rod indicates water-surface elevation for the peak flow of January 6, 1995.

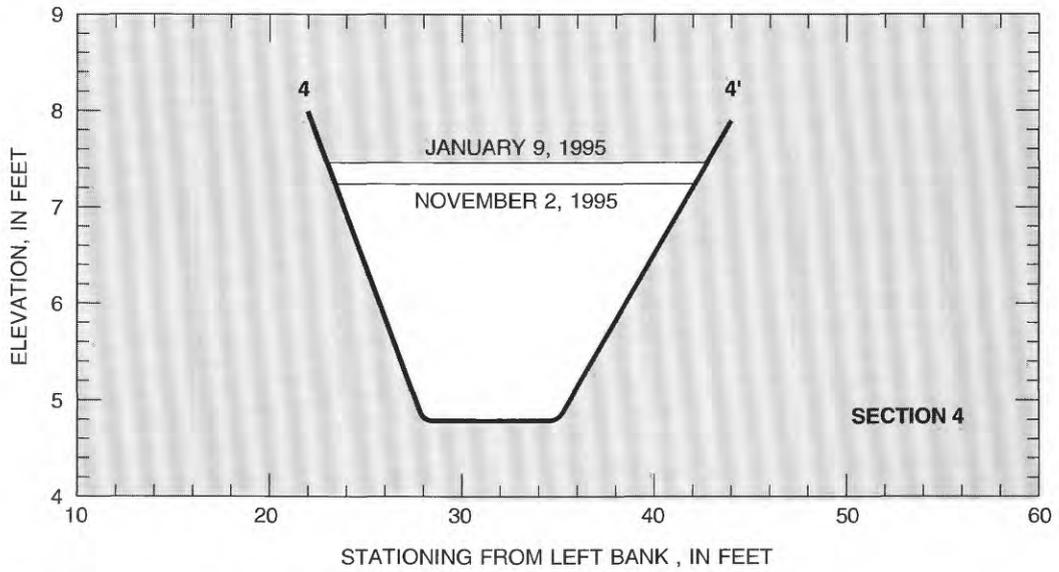
Figure 8A. Cross-section 4, Cave Creek below Cave Buttes Dam.

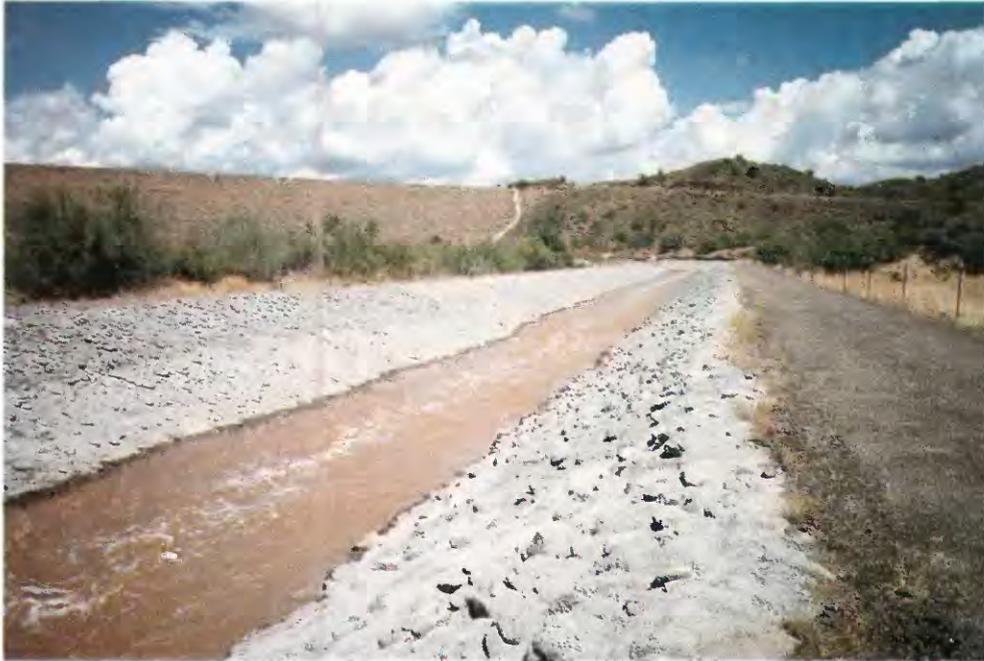
Figure 8D. View from cross-section 7 looking upstream toward transition from subcritical to supercritical flow, Cave Creek below Cave Buttes Dam.

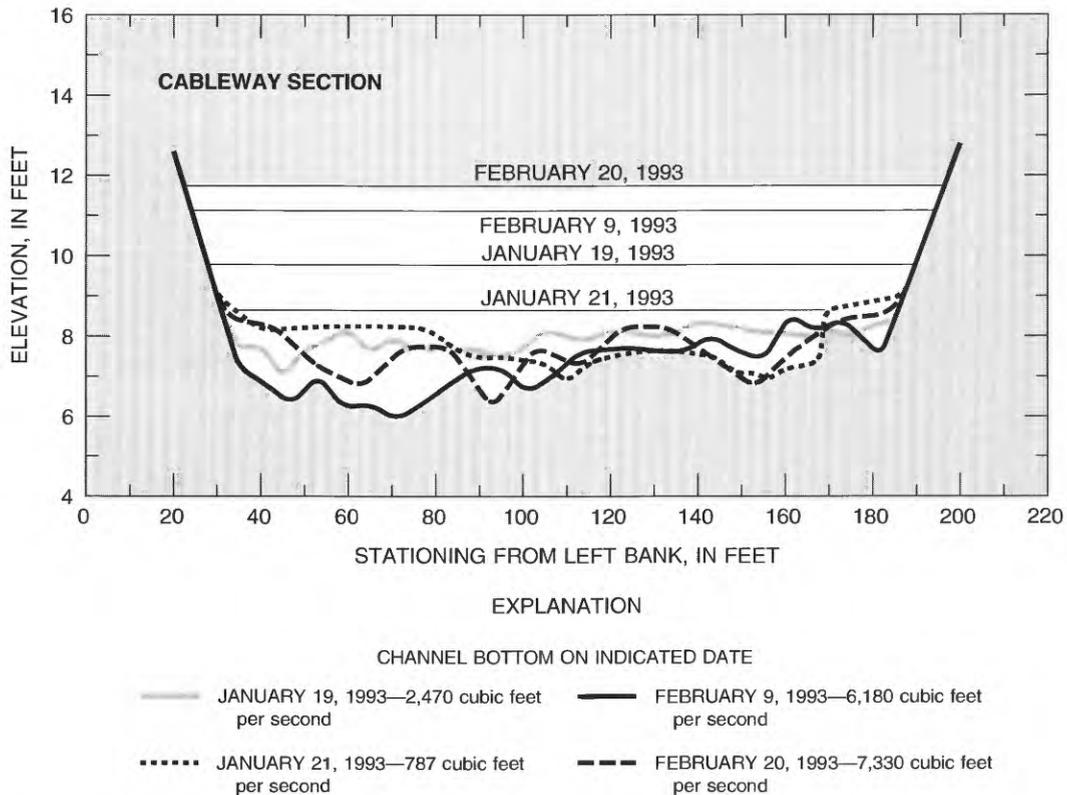
Figure 9A. Cableway cross section, bed geometry for each current-meter measurement, and water-surface elevations, Hassayampa River near Morrystown.

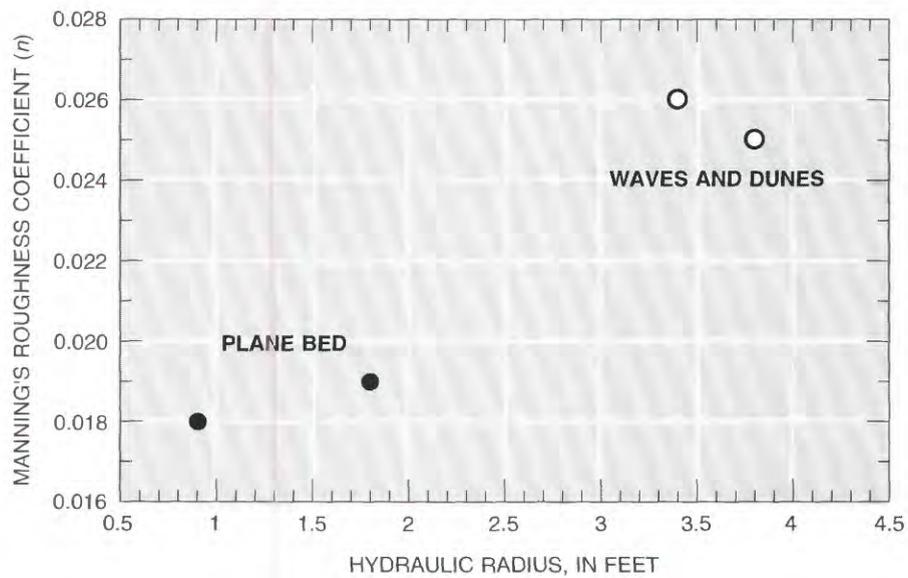
Figure 9C. Manning's n and hydraulic radius, Hassayampa River near Morristown.

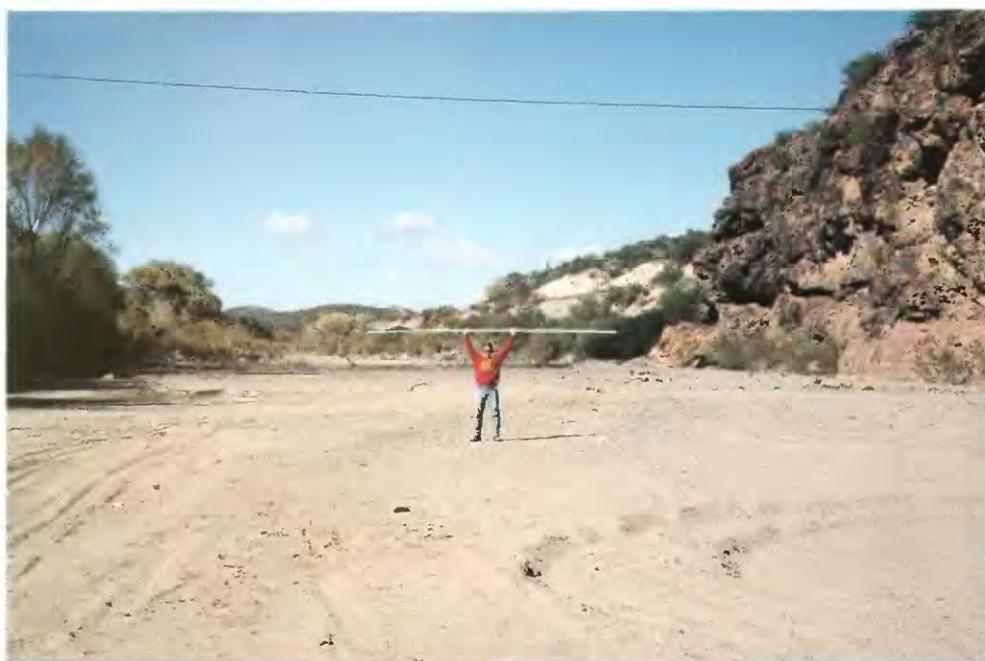
Figure 9E. View upstream from midchannel during no-flow period, Hassayampa River near Morrystown. Rod indicates water-surface elevation for the peak flow of January 8, 1993.

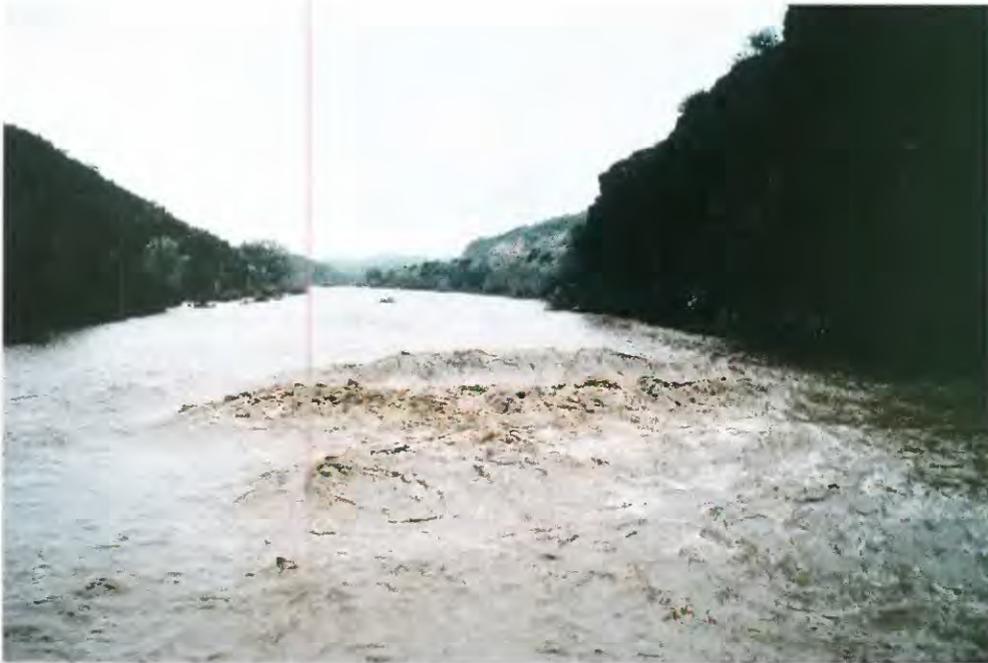
Figure 9F. View from cableway looking upstream during flow of February 9, 1993, Hassayampa River near Morristown. Disturbance is a wave propagating slowly downstream and is indicative of hydraulic characteristics in alluvial channels during upper-regime flow conditions.

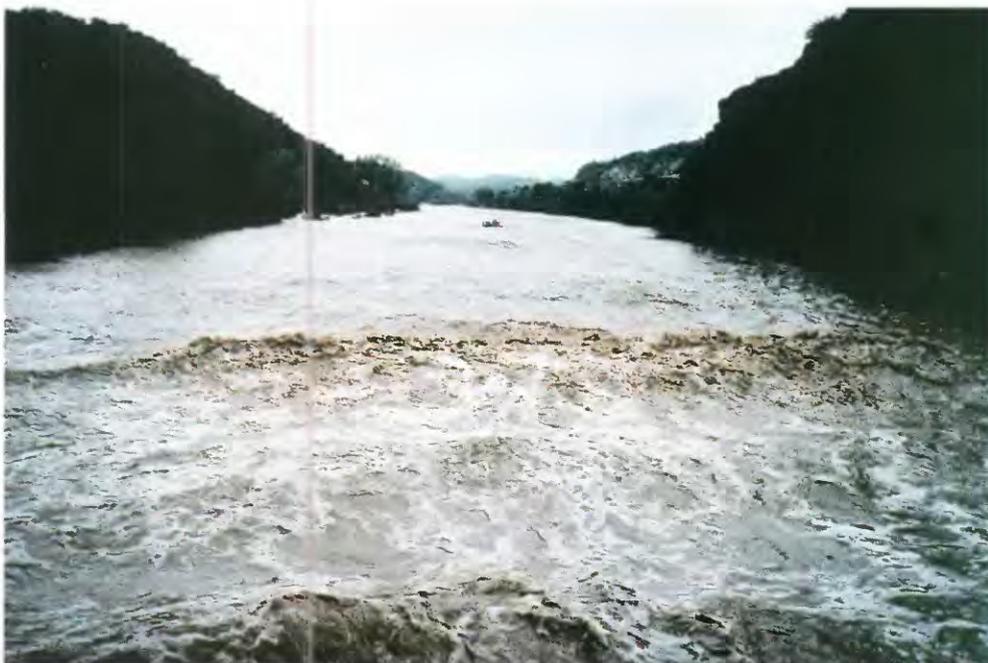
Figure 9G. View from cableway looking upstream during flow of February 9, 1993, Hassayampa River near Morristown. Disturbance is a wave propagating slowly downstream and is indicative of hydraulic characteristics in alluvial channels during upper-regime flow conditions. Photograph taken soon after photograph shown in figure 9F.

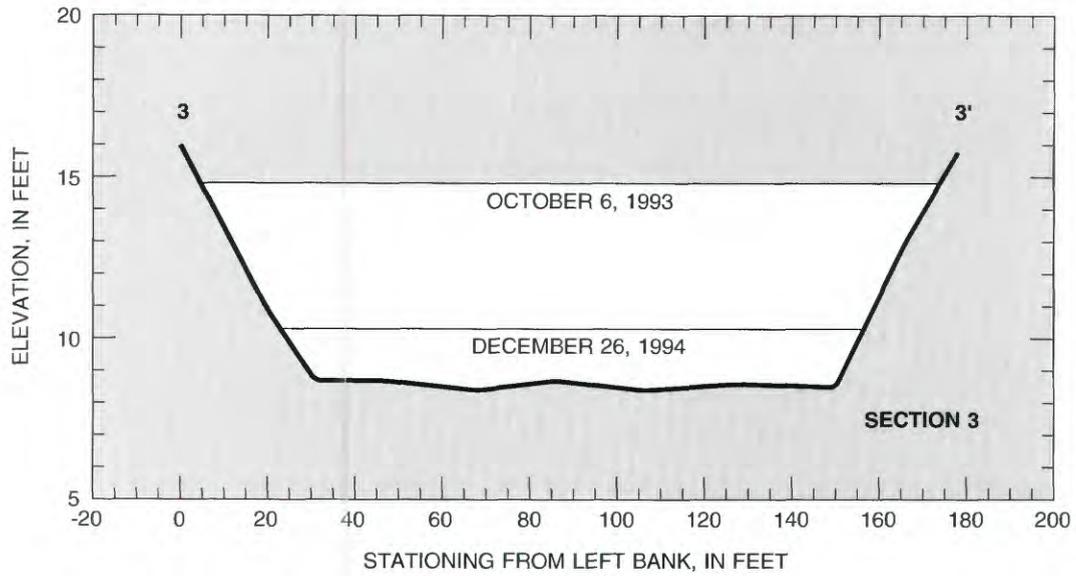
Figure 10A. Cross-section 3, Indian Bend Wash above Curry Road.

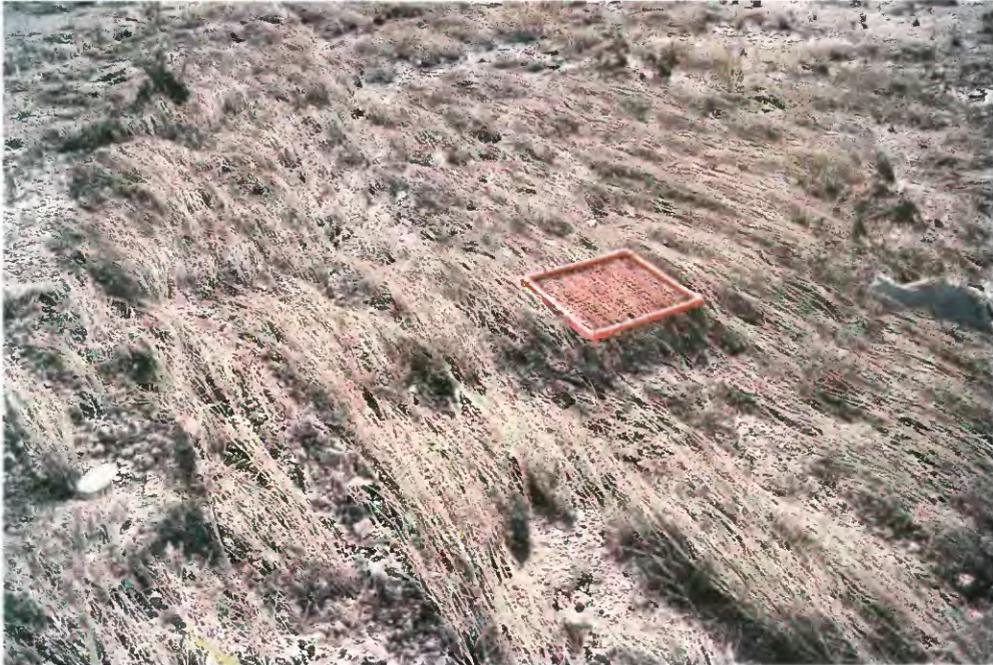
Figure 10D. View from midchannel looking downstream at laid-over grass following flow of October 6, 1993, Indian Bend Wash above Curry Road. The square grid (painted orange) has an outside dimension of 1.5 feet and an internal grid spacing of 1 inch.

Remarks: The grass generally was laid over following the flow on October 6, 1993, and in a direction parallel to flow, whereas the sparse brush appeared to be little affected by the flow. Postflow conditions indicate that the flow of December 26, 1994, did not significantly affect either the brush or the grass. Suspended-sediment concentration was 365.4 mg/L at a discharge of about 500 ft³/s on September 28, 1995, and was considered wash load. As the drainage area is mainly urbanized, this wash-load condition probably is indicative of suspended-sediment concentrations for most flows at this site (Fossum and Davis, 1996).

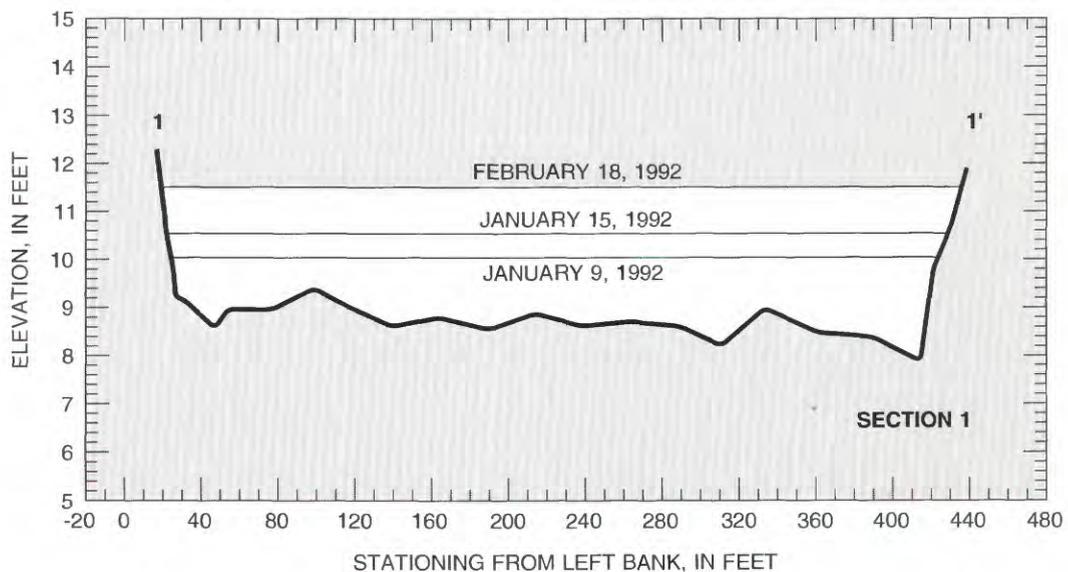
Figure 11A. Cross-section 1, Salt River above Interstate 10.
