Verification of Roughness Coefficients for Selected Natural and Constructed Stream Channels in Arizona

U.S. Geological Survey Professional Paper 1584

Prepared in cooperation with the
Flood Control District of Maricopa County

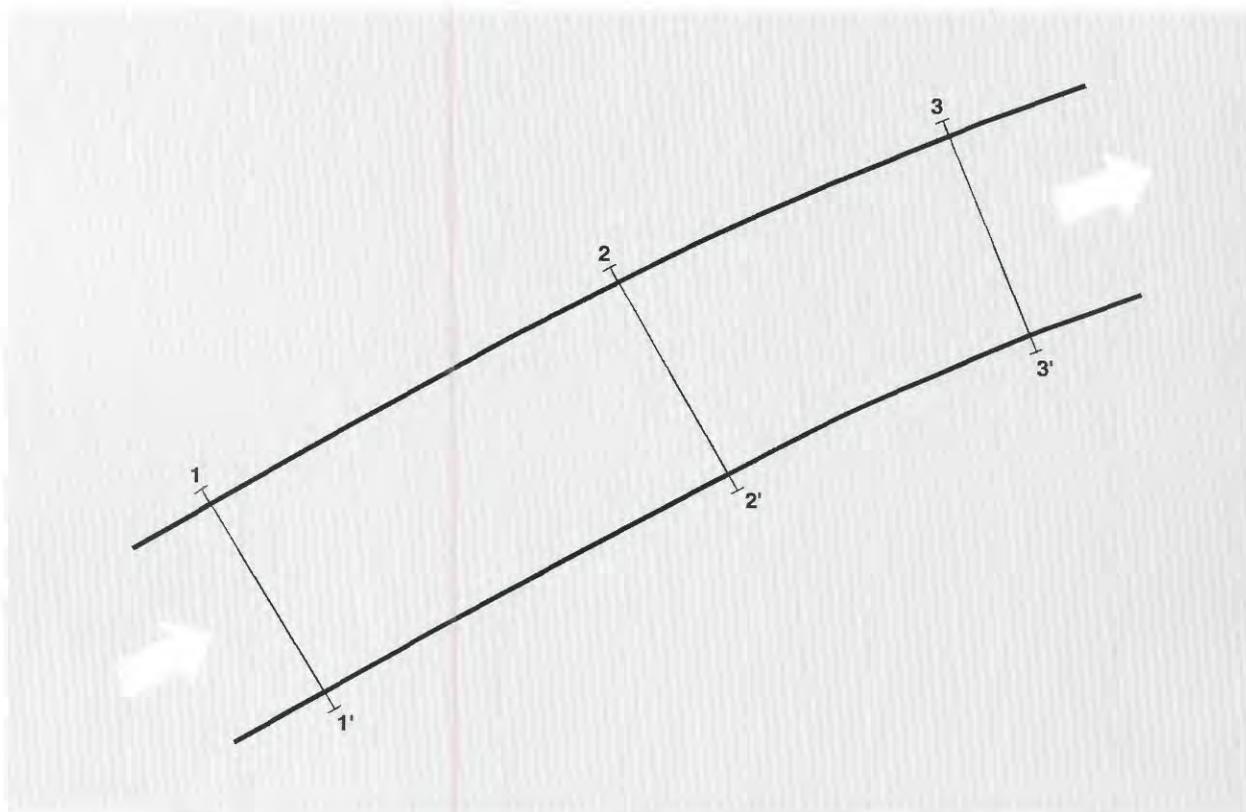
Figure 11B. Plan view, Salt River above Interstate 10.

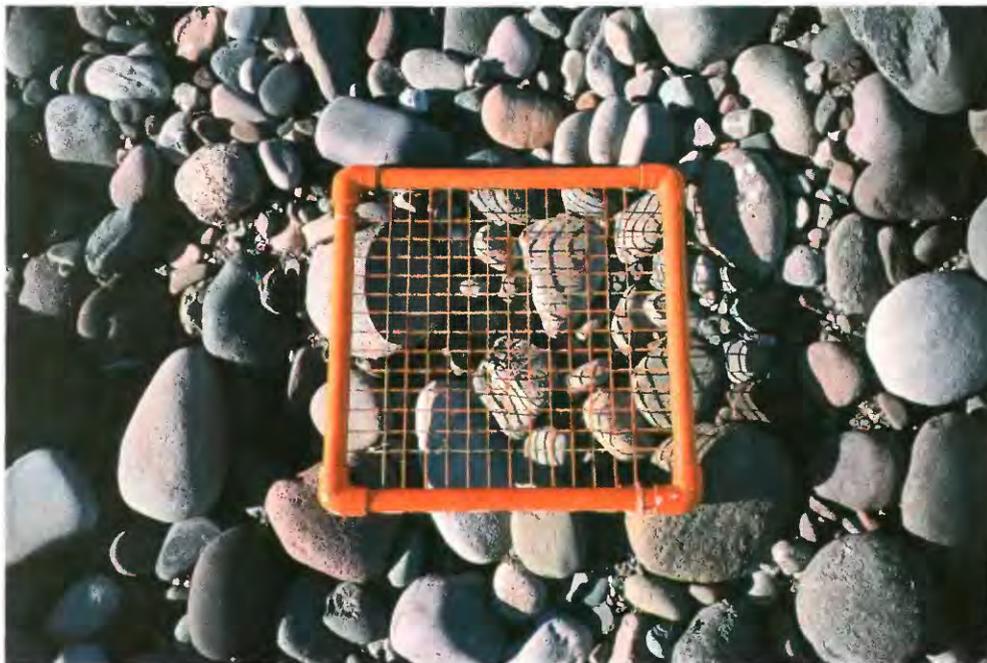
Figure 11E. View of typical bed material in channel reach, Salt River above Interstate 10. The square grid (painted orange) has an outside dimension of 1.5 feet and an internal grid spacing of 1 inch.

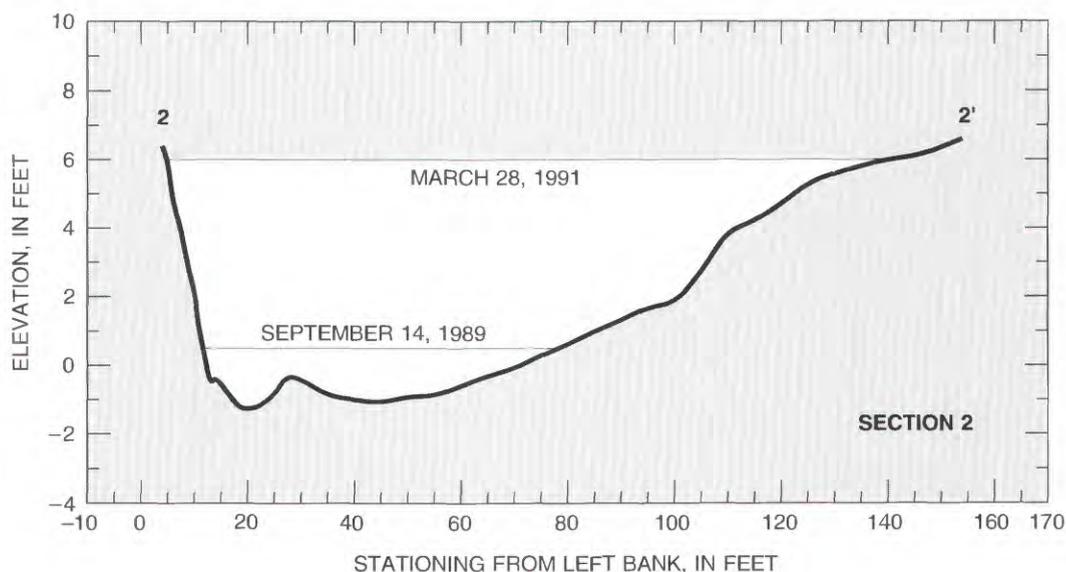
Figure 12A. Cross-section 2, Verde River below Beeline Highway.

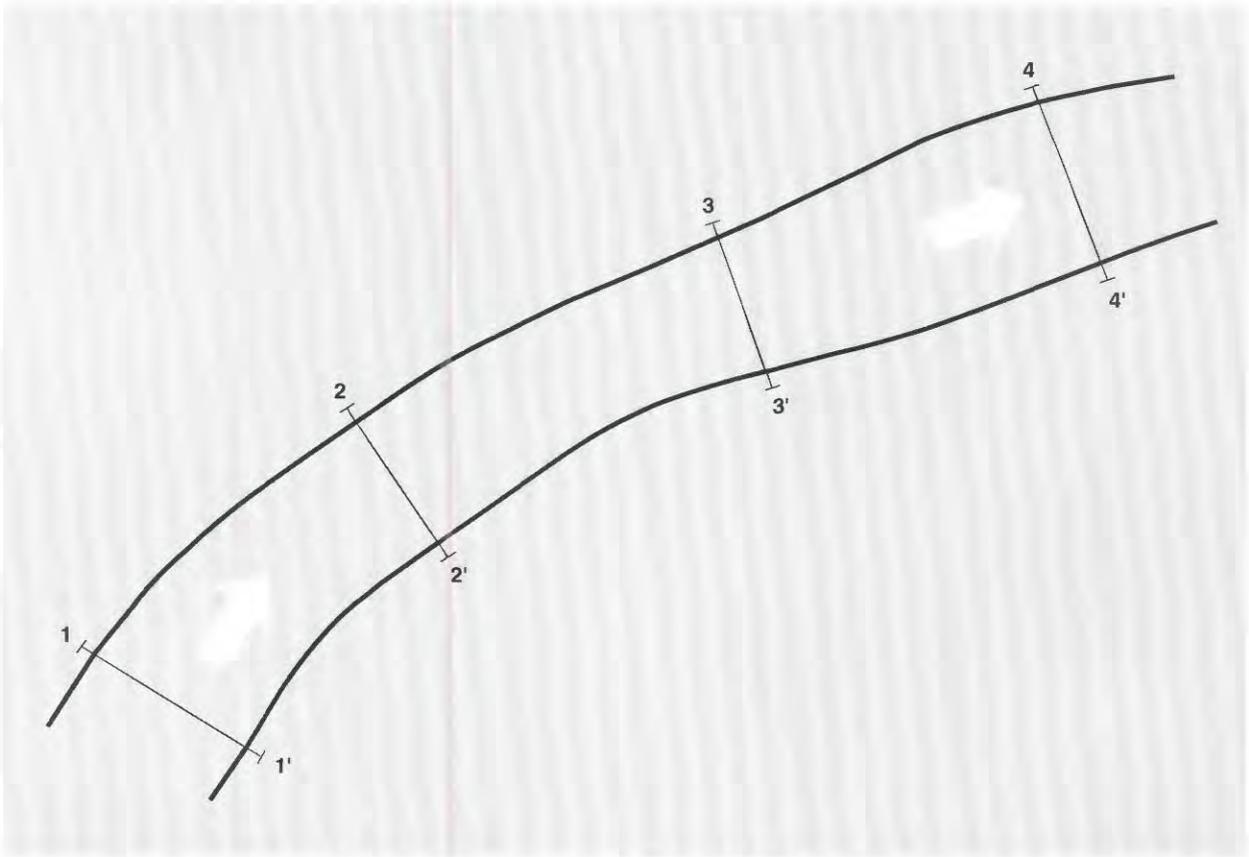
Figure 12B. Plan view for flow of March 28, 1991, Verde River below Beeline Highway. The reach in which the low-flow verification measurement was made is between cross-sections 1 and 2.

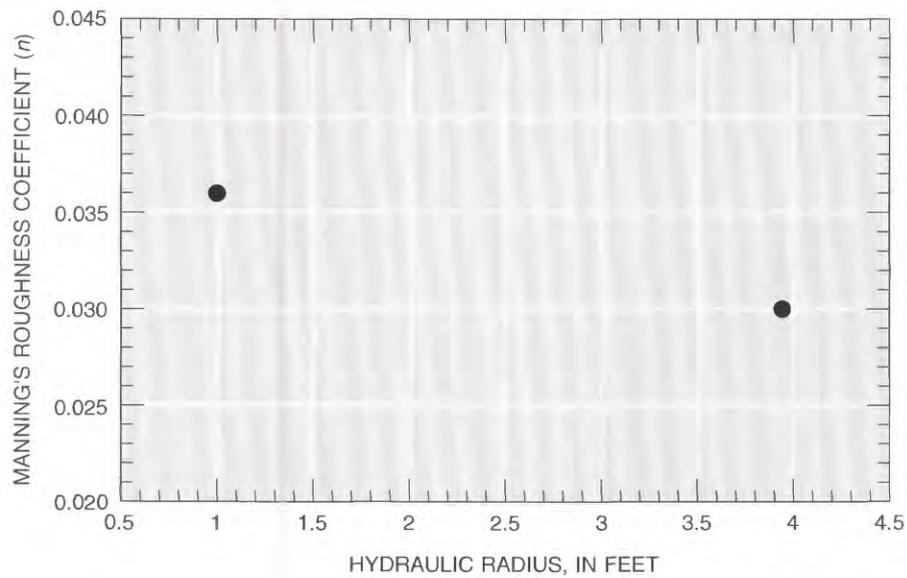
Figure 12C. Manning's n and hydraulic radius, Verde River below Beeline Highway.

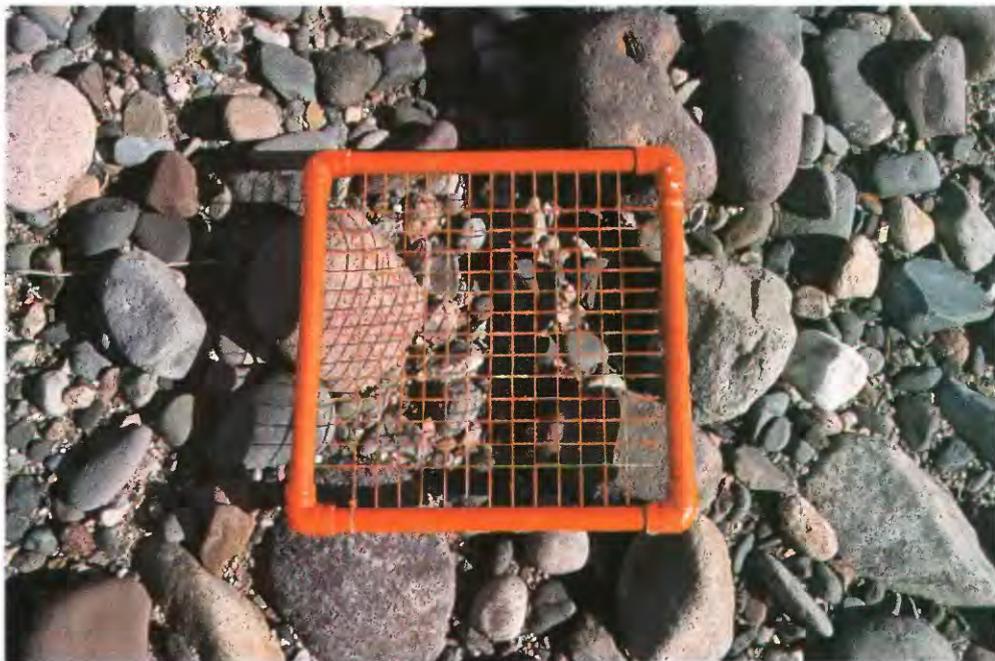
Figure 12E. View of typical bed material, Verde River below Beeline Highway. The square grid (painted orange) has an outside dimension of 1.5 feet and an internal grid spacing of 1 inch.

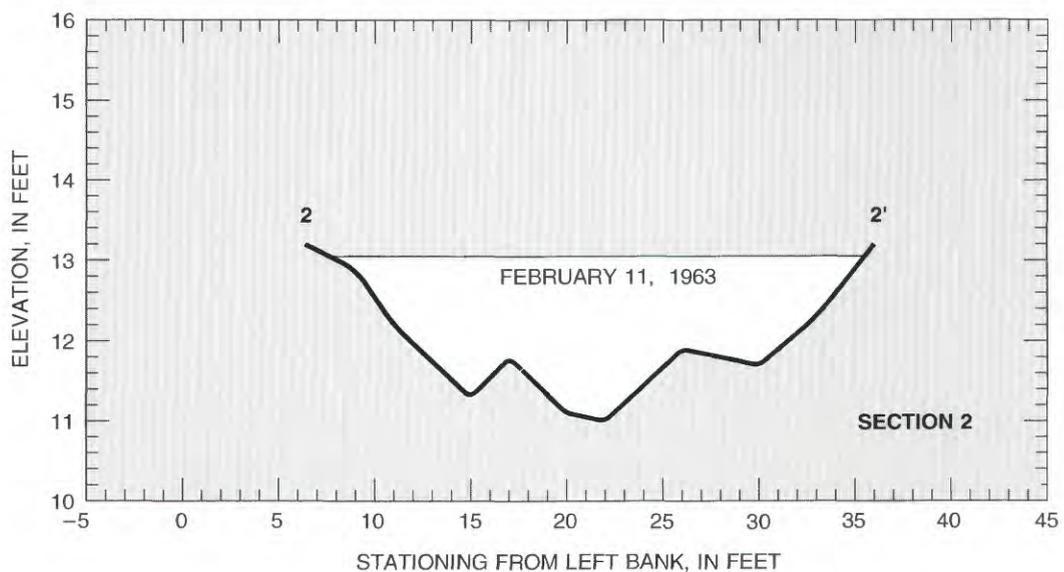
Figure 13A. Cross-section 2, West Fork Sycamore Creek near Sunflower.

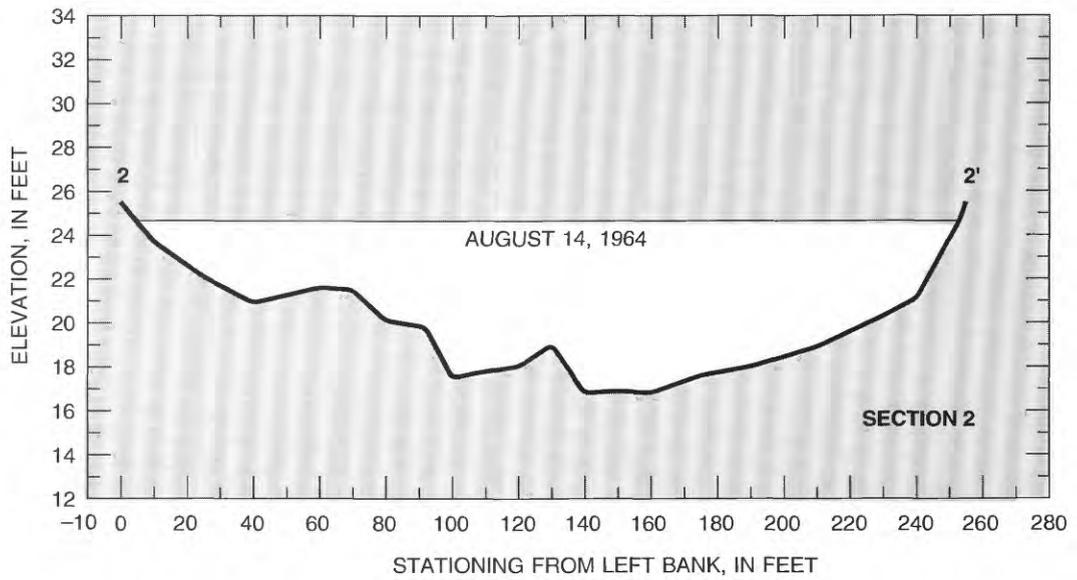
Figure 14A. Cross-section 2, San Pedro River near Charleston.

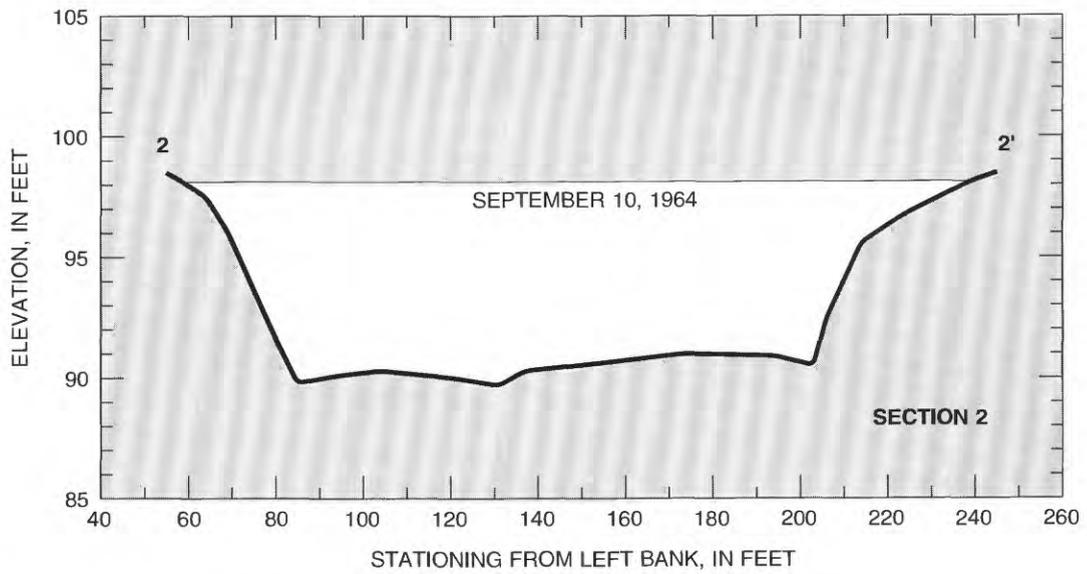
Figure 15A. Cross-section 2, Santa Cruz River at Cortaro.

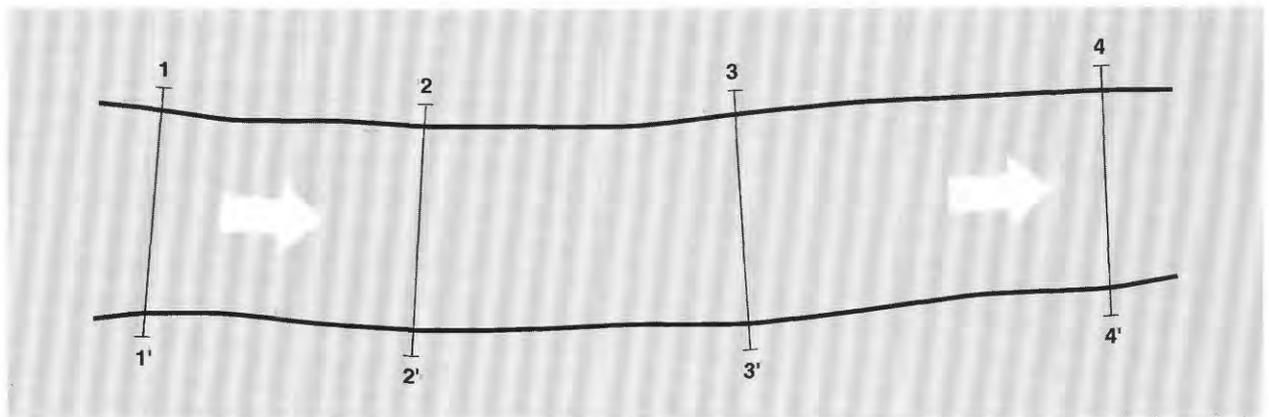
Figure 15B. Plan view, Santa Cruz River at Cortaro.

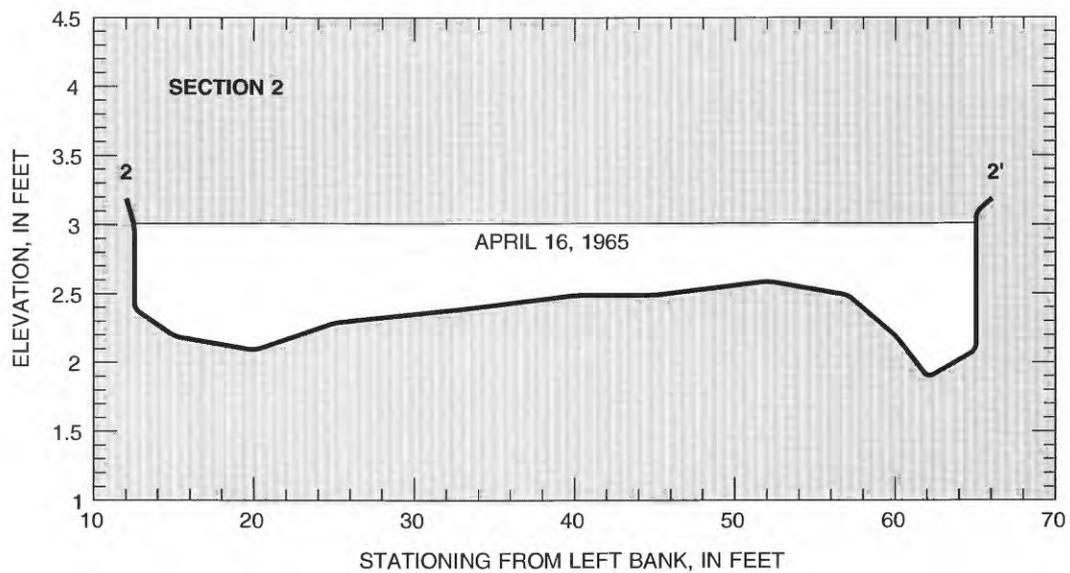
Figure 16A. Cross-section 2, Verde River near Paulden.

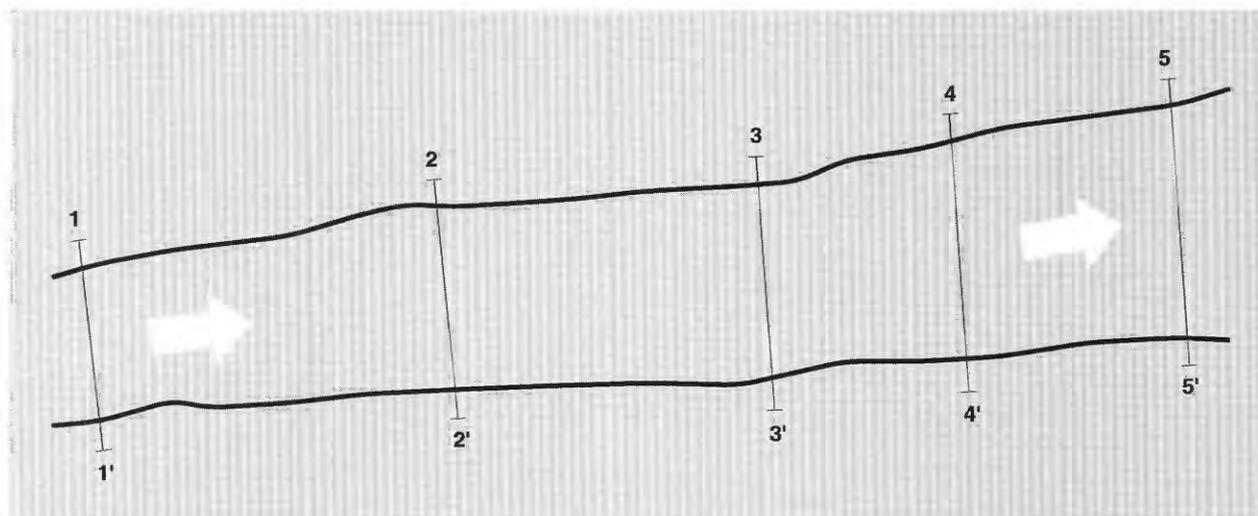
Figure 16B. Plan view, Verde River near Paulden.

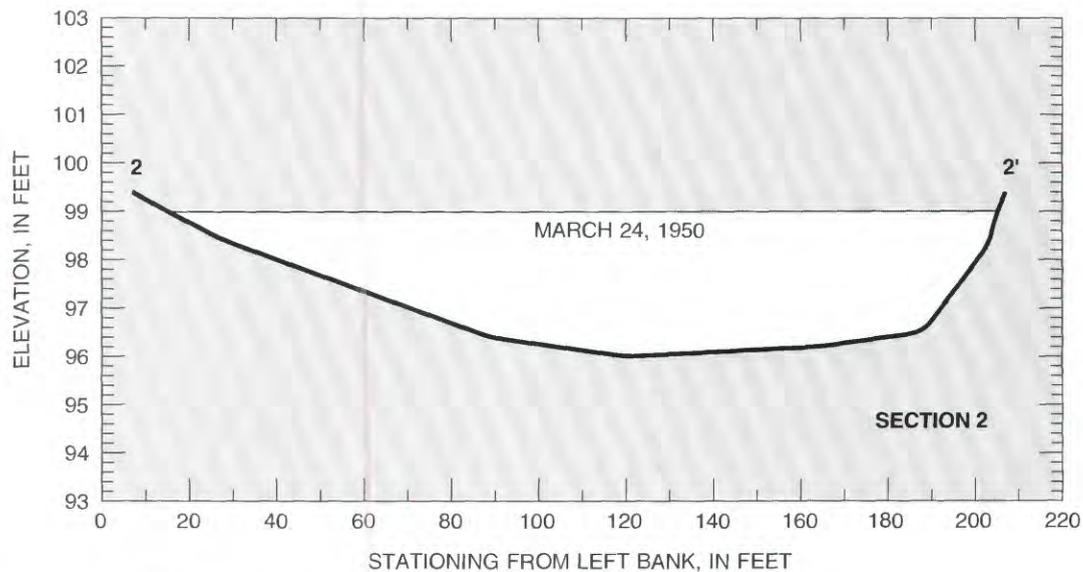
Figure 17A. Cross-section 2, Salt River below Stewart Mountain Dam.

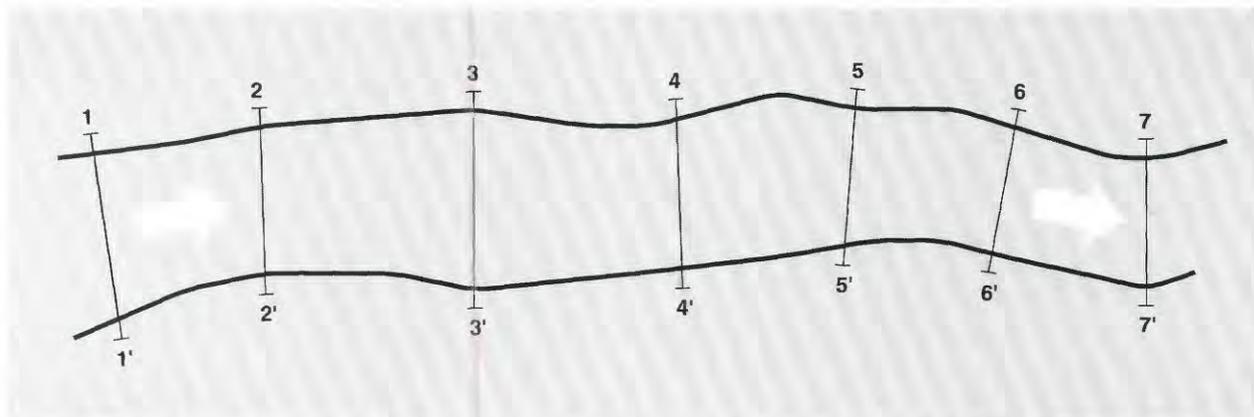
Figure 17B. Plan view, Salt River below Stewart Mountain Dam.

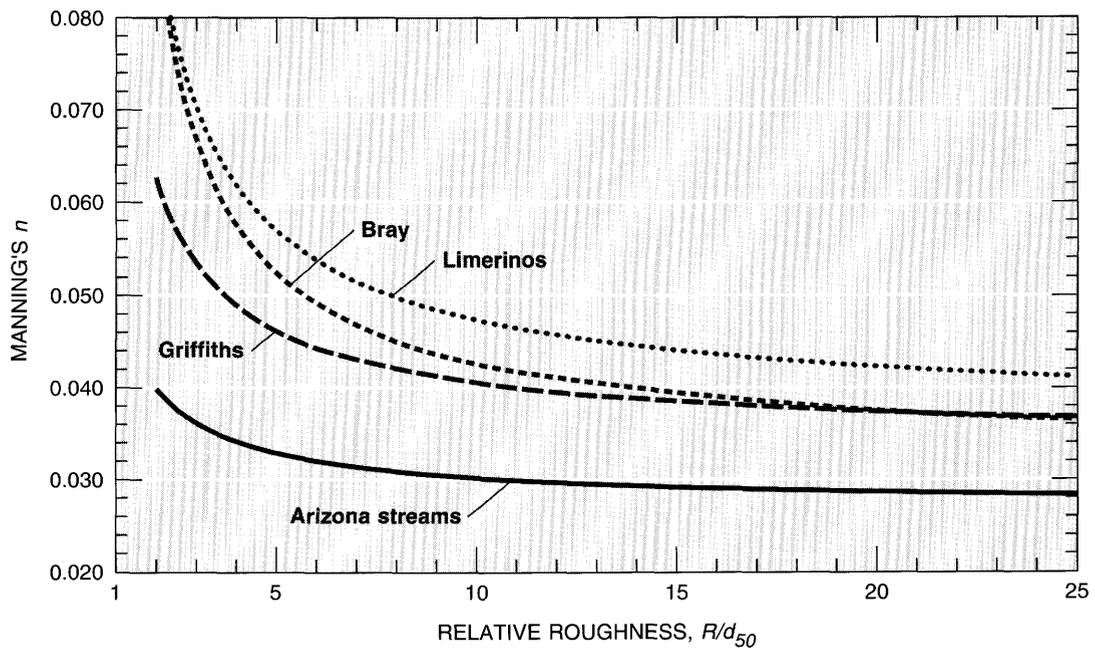
Figure 18. Relation of Manning's n and relative roughness for gravel-bed stream channels in Arizona and throughout the world. All trend lines are plotted for values of d_{50} equal to 0.30 foot, and values of R range from 0.6 to 7.5 feet.

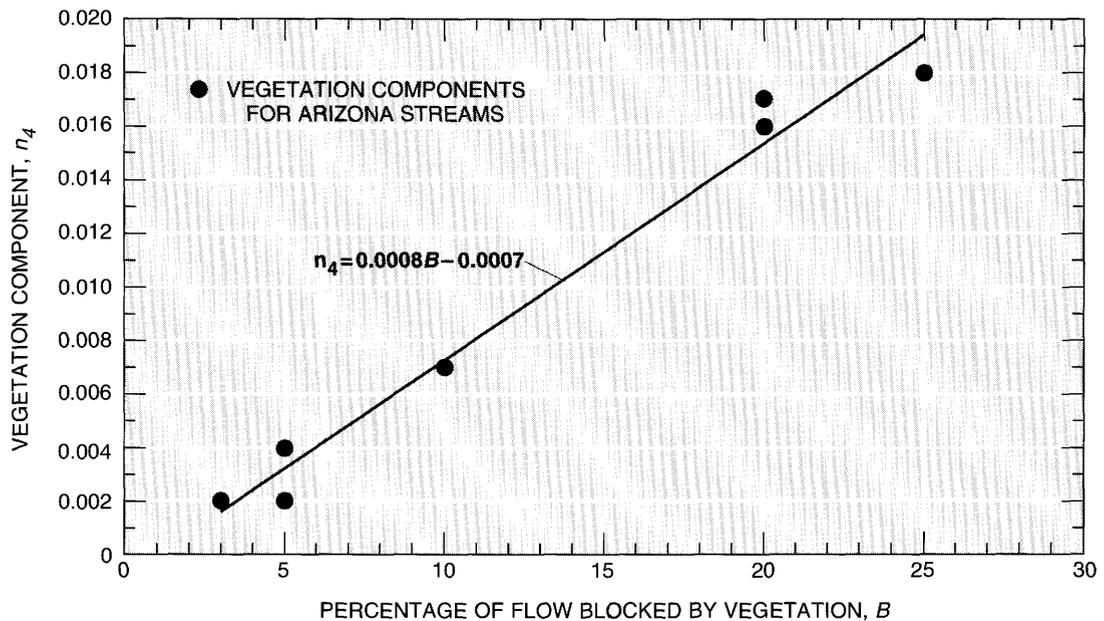
Figure 19. Relation of vegetation components for vegetated channels studied and the estimated percentage of flow blocked by vegetation (average vegetation conditions for all cross sections at each site).
