Prepared in cooperation with the  
NEVADA BUREAU OF MINES AND GEOLOGY

# **Landslide-Induced Flooding at Ophir Creek, Washoe County, Western Nevada, May 30, 1983**

**Professional Paper 1617**

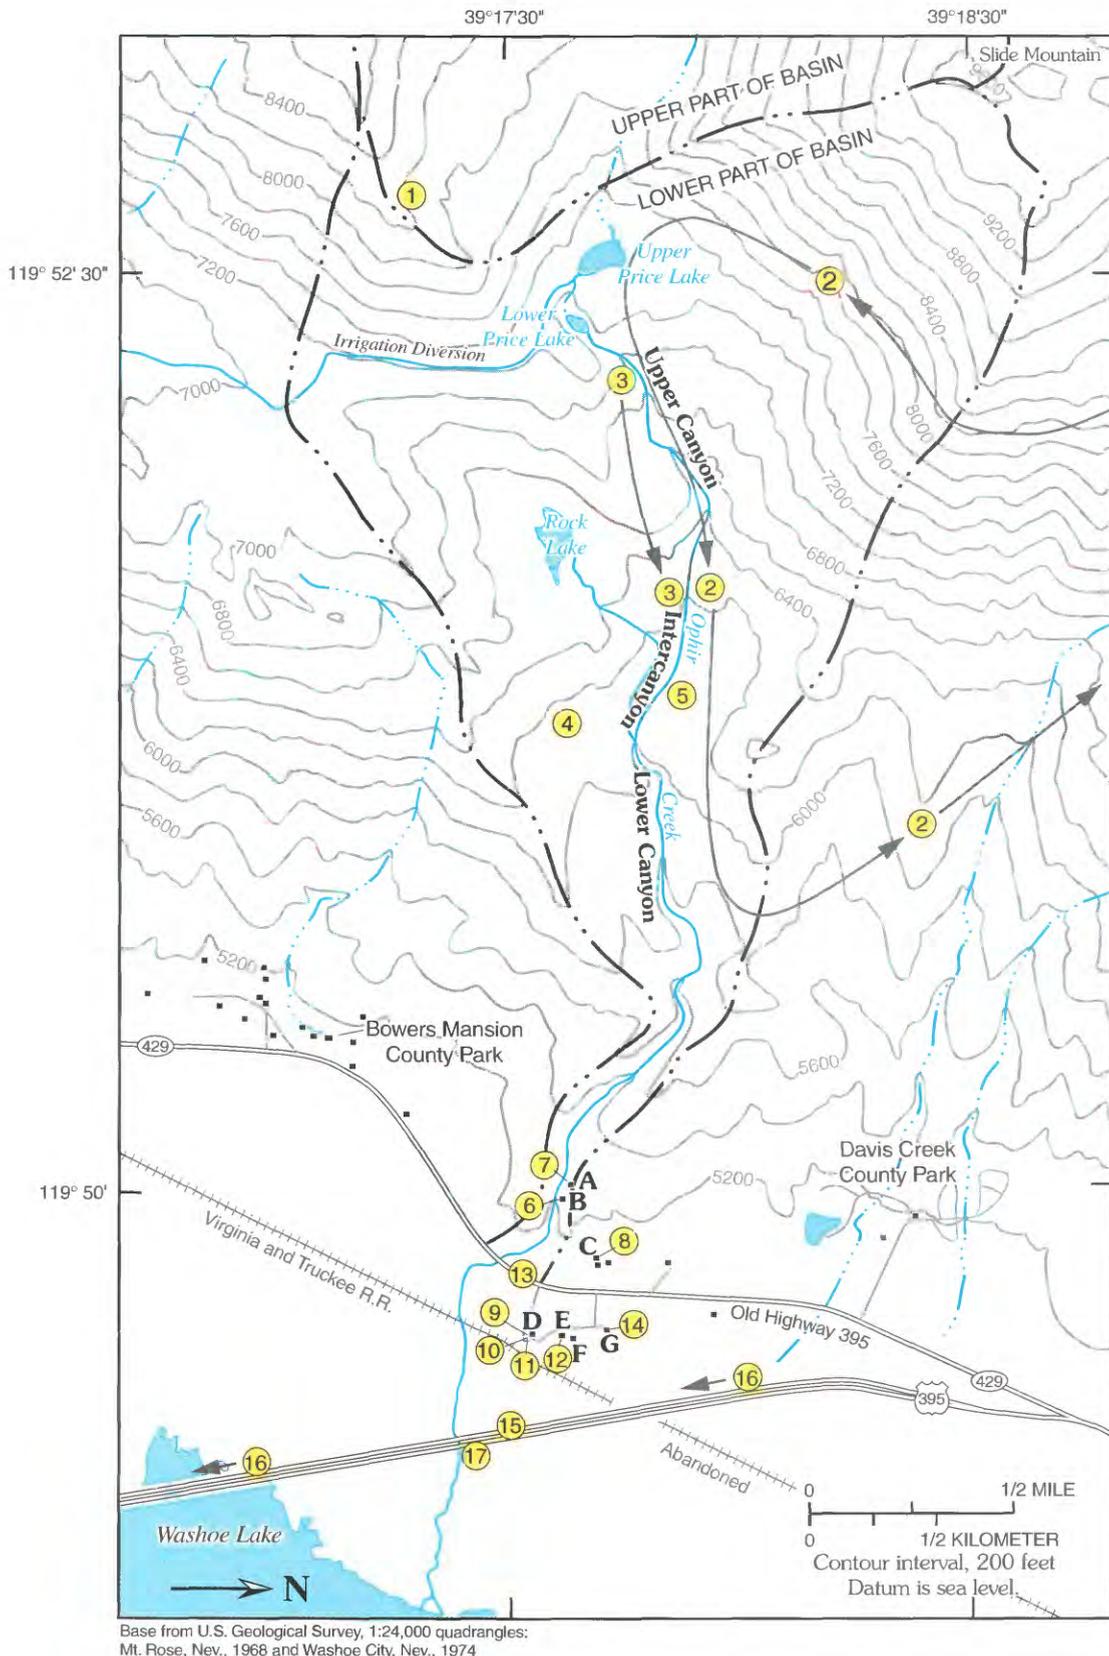
**Figure 2.** Locations of selected eyewitnesses and other features during the May 30, 1983, flood of Ophir Creek, Nevada.

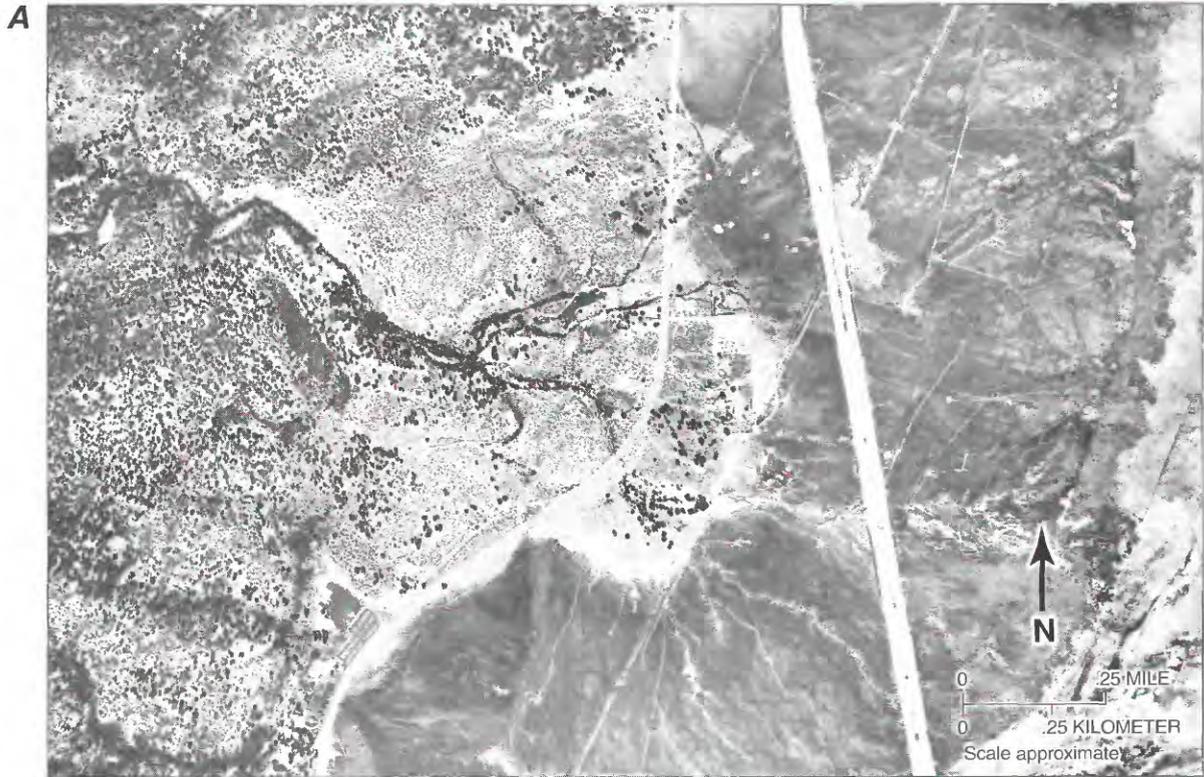
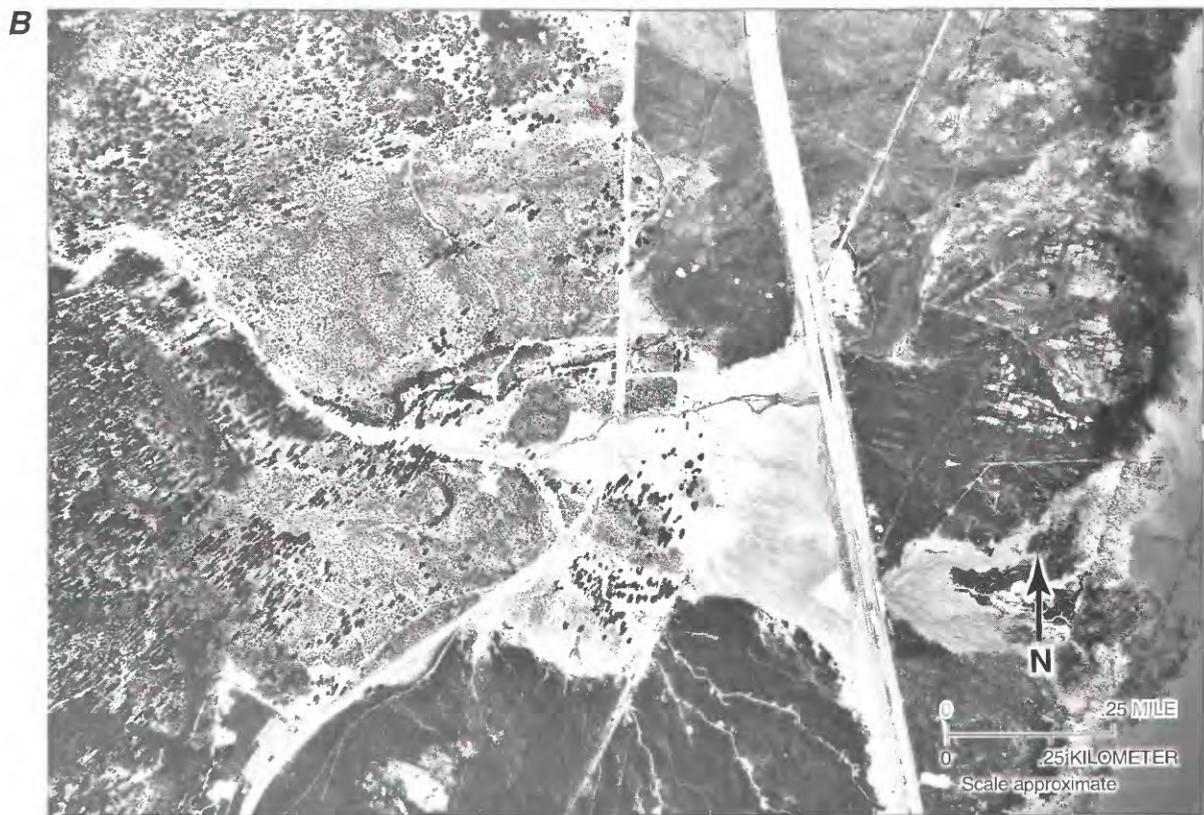
**Figure 3.** Vertical aerial photographs of Ophir Creek alluvial fan, western Nevada: *A*, pre-flood view (U.S. Forest Service photograph, July 15, 1977). *B*, Post-flood view (Nevada Department of Transportation photograph, June 6, 1983).

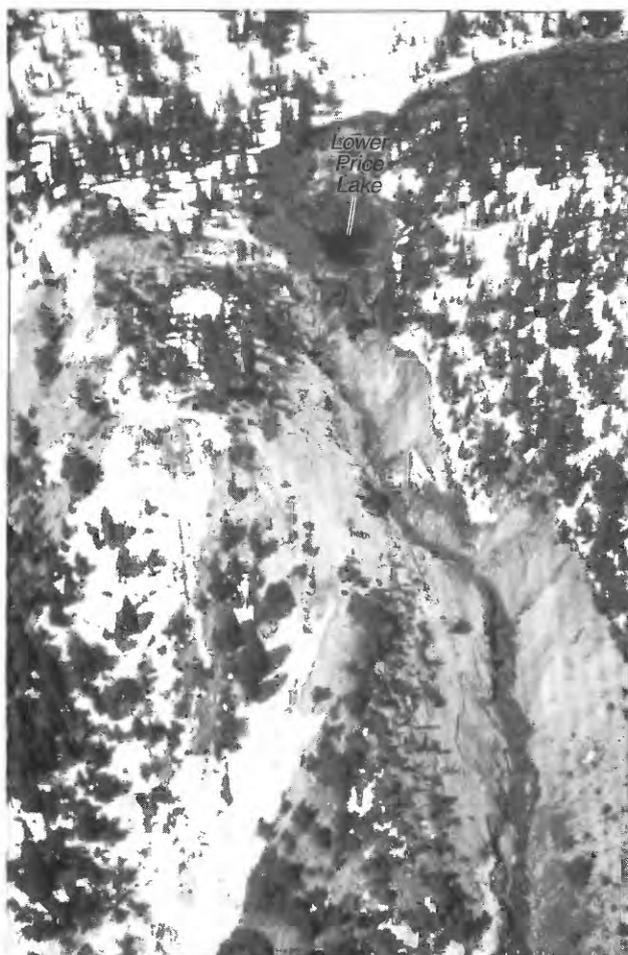
**Figure 5.** Upstream view of upper canyon of Ophir Creek downstream from Lower Price Lake, western Nevada. Oblique aerial photograph by R.L. Jameson, U.S. Forest Service, May 31, 1983.

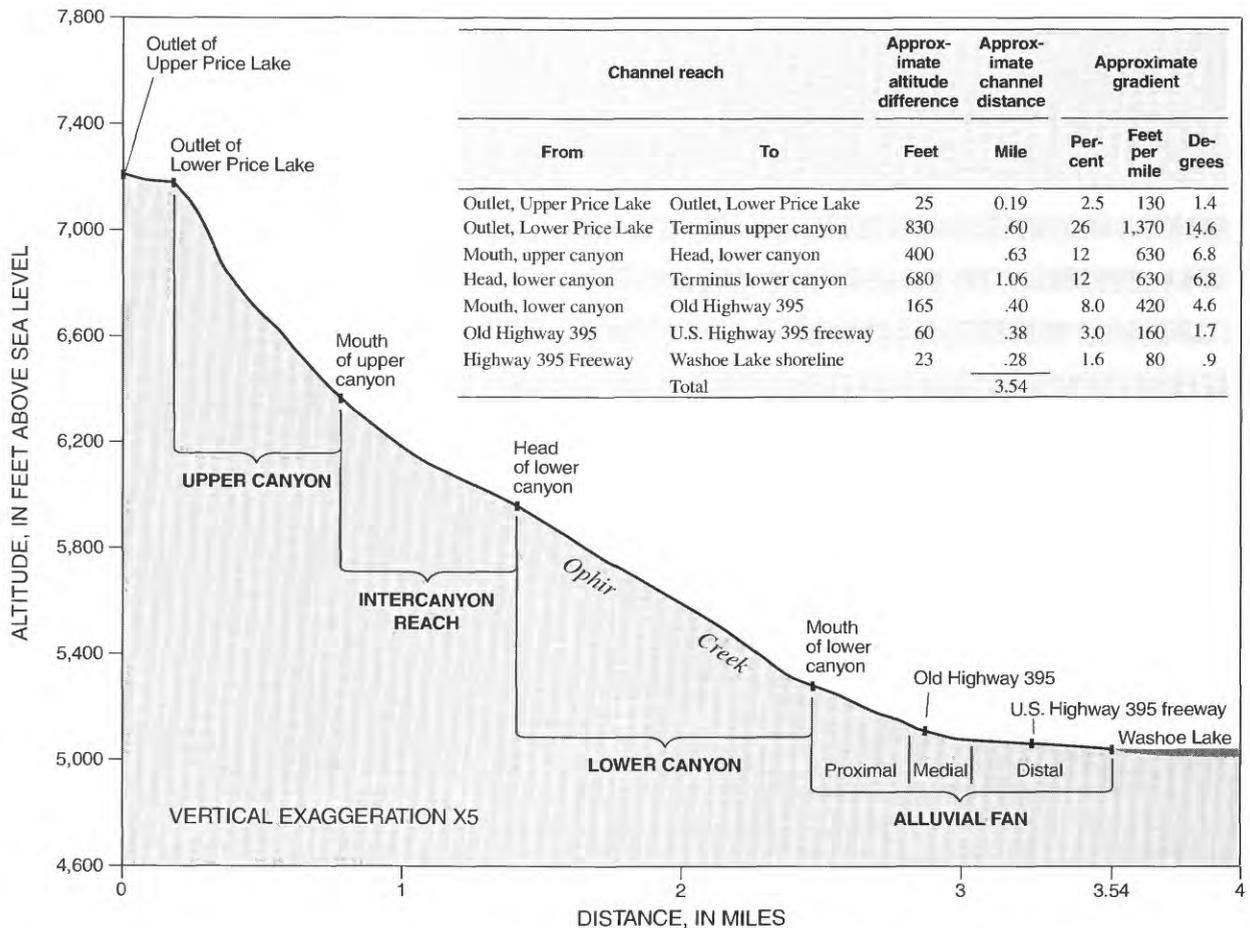
**Figure 6.** Topographic gradients for Ophir Creek, western Nevada. Gradients extracted from topographic information shown on Mt. Rose and Washoe City, Nevada, 7-1/2-minute topographic maps.

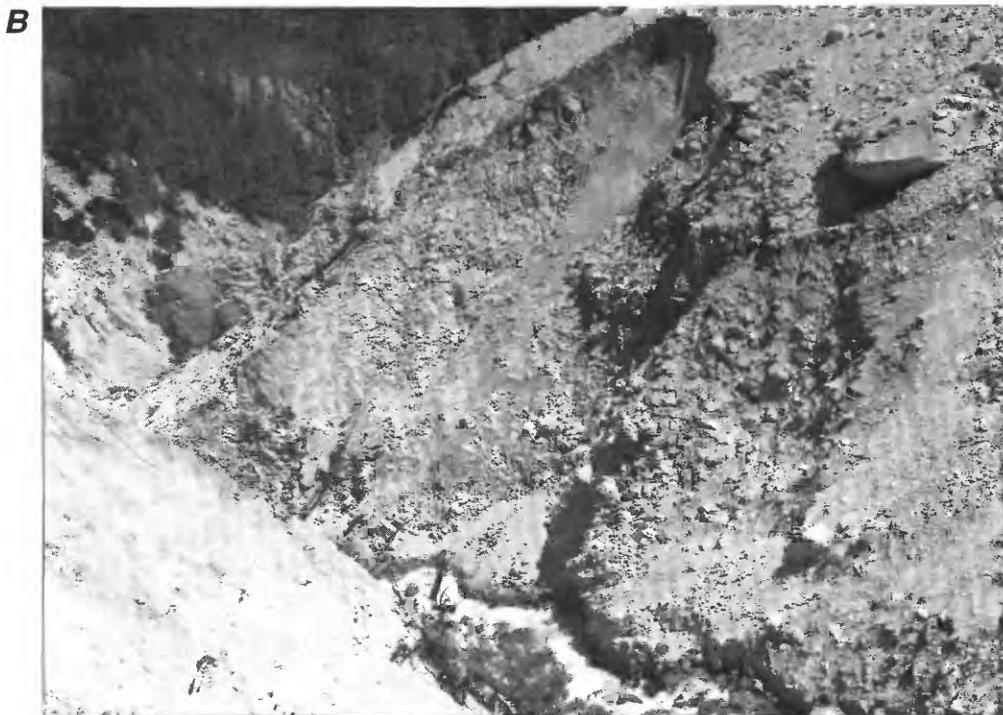
**Figure 7.** Upper canyon of Ophir Creek, Nevada, severely gouged and scoured by the high-energy flow of 1983 flood. *A*, Upstream (westward) aerial view toward Lower Price Lake, photographed June 3, 1983, by Patrick A. Glancy, U.S. Geological Survey. *B*, Close-up view of south canyon wall just downstream from Lower Price Lake, July 27, 1983, photographed by Patrick A. Glancy. Note the widely ranging mix of fragment sizes and the easily erodible character of the debris comprising the canyon walls.

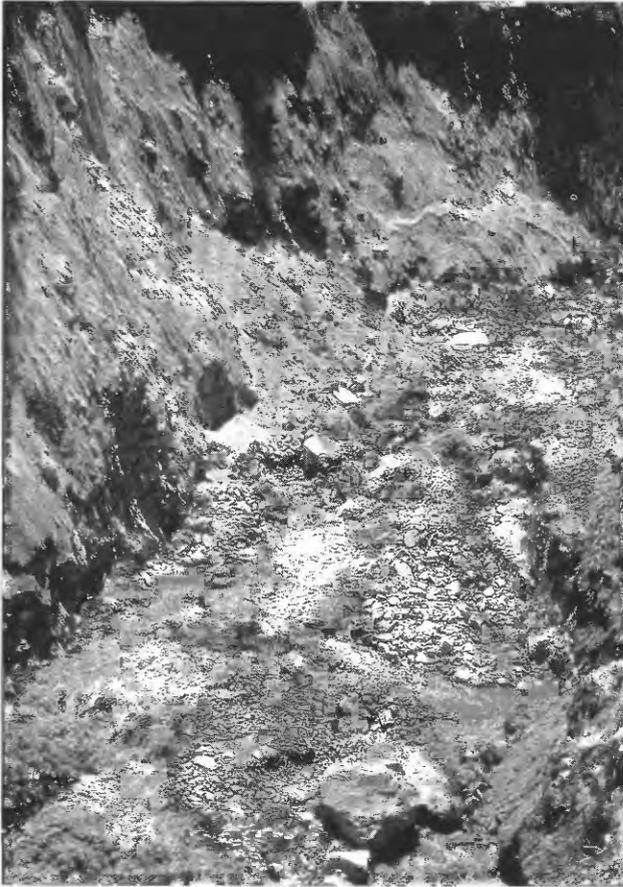
**Figure 8.** Heavily eroded Ophir Creek channel, western Nevada, the day after the flood. Photograph by Kenneth Ganz, U.S. Forest Service, on the morning of May 31, 1983.

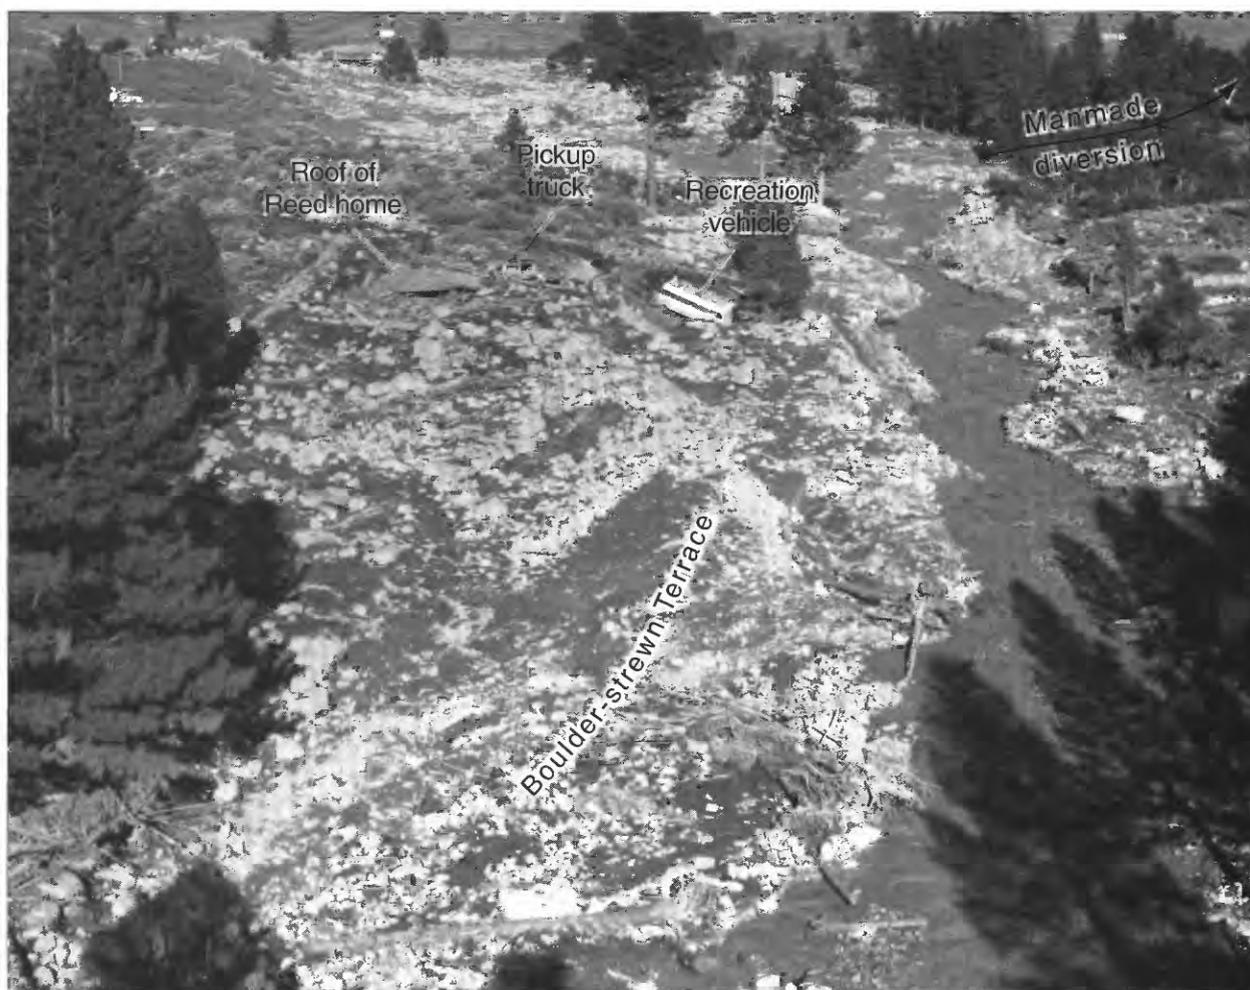
**Figure 9.** Downstream view of Ophir Creek, western Nevada, just below mouth of lower canyon. Ogilvy home behind tree at left; boulder-strewn terrace to left of creek contains displaced wreckage of Reed home. Manmade diversion angles through trees at upper right, across creek from where Reed's damaged recreation vehicle rests. Oblique aerial photograph taken during afternoon of May 30, 1983, by Washoe County Sheriff's Department.

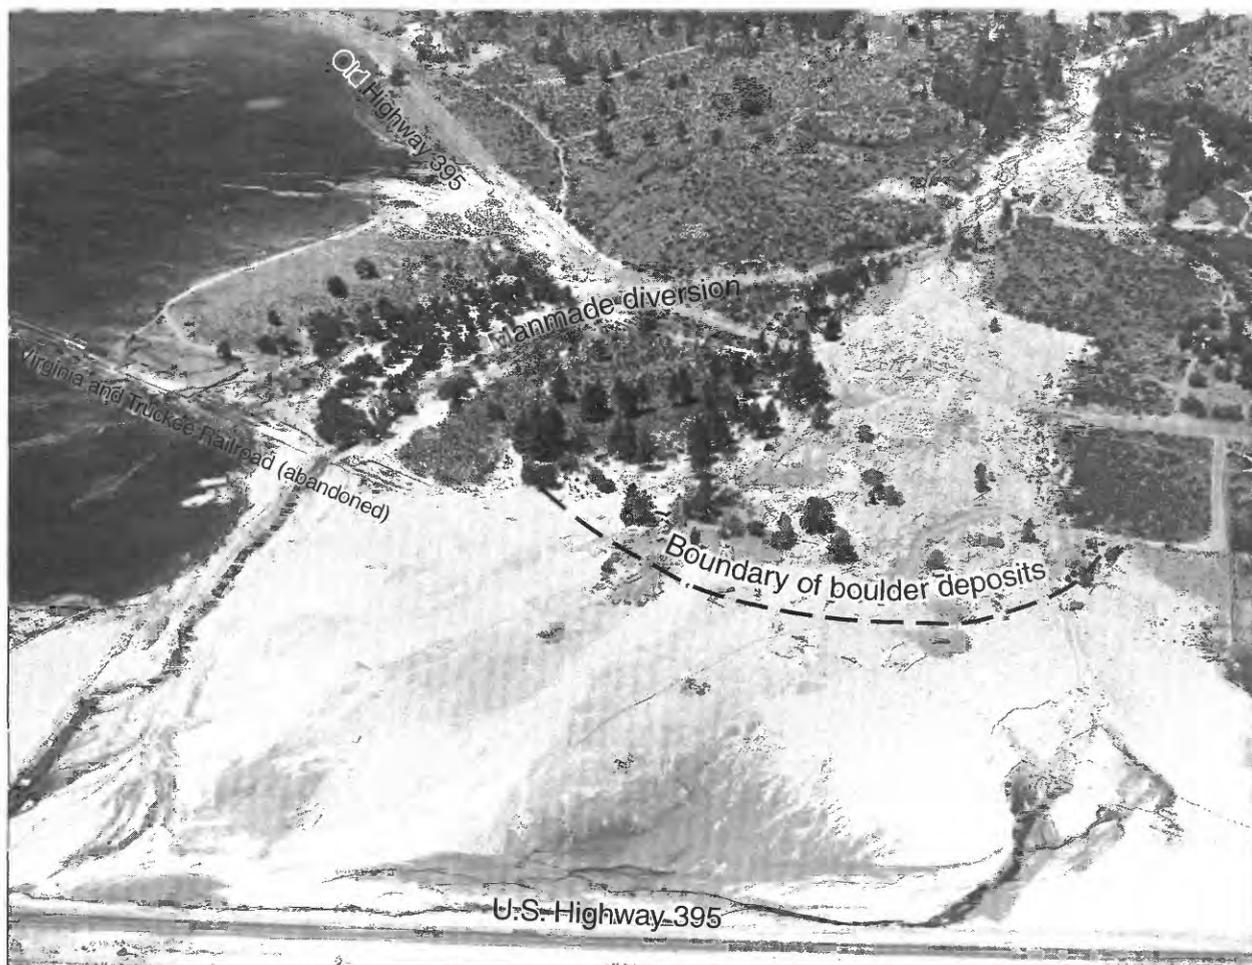
**Figure 10.** Oblique, aerial westward view of Ophir Creek alluvial fan, western Nevada, the major site of sediment deposition by the 1983 flood. Natural alignment of creek channel (lower right) was reestablished to the man-diverted route along left (southeast) part of fan by July 26, 1983, the date of this Patrick A. Glancy photograph.

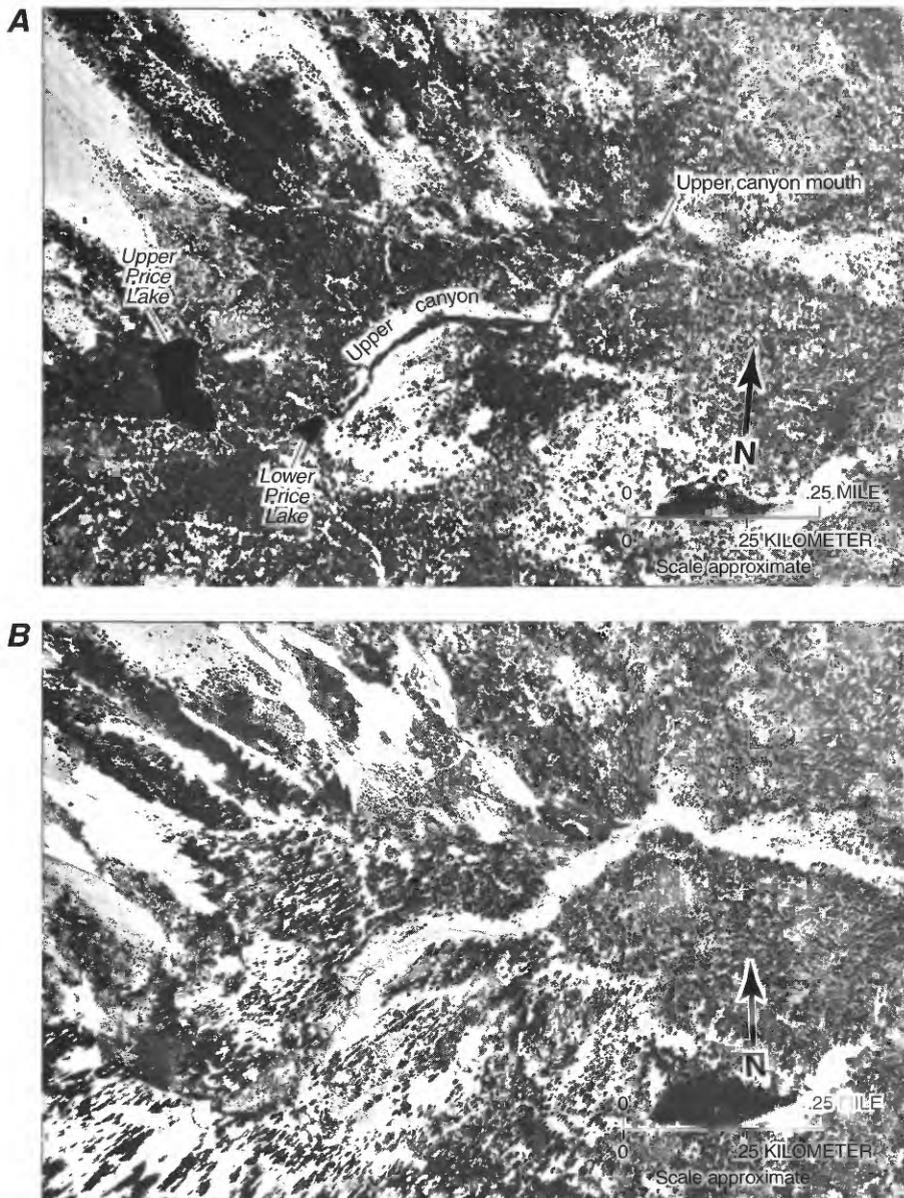
**Figure 11.** Vertical aerial views of Price Lakes and upper canyon of Ophir Creek, western Nevada, before and after the flood: A, U.S. Forest Service photograph of July 15, 1977, before the 1983 flood. B, Nevada Department of Transportation photograph of June 6, 1983, after the flood.

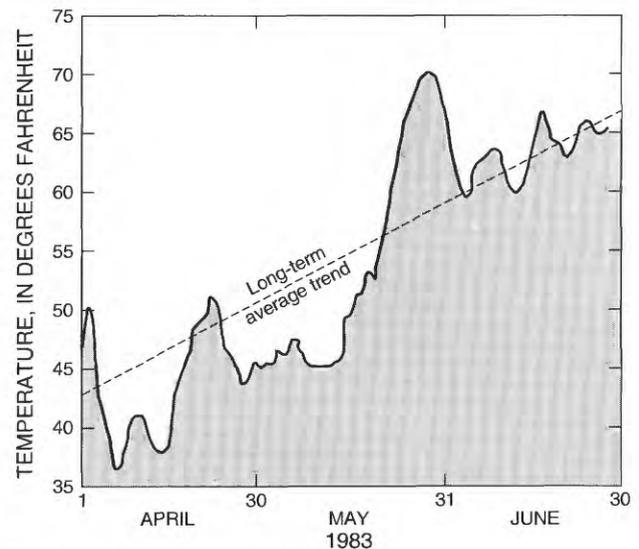
**Figure 12.** Daily mean air temperature at Carson City, Nevada, April 1-June 28, 1983 (Otto Moosburner, U.S. Geological Survey, written commun., 1985).

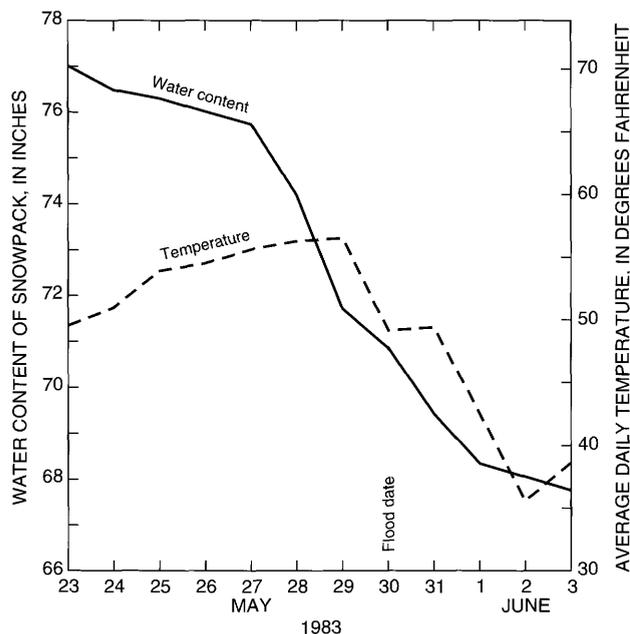
**Figure 13.** Snowpack moisture and average daily temperature in late May and early June of 1983, Mount Rose Ski Area snow-survey station, western Nevada. Data from U.S. Soil Conservation Service, Reno, Nevada.

survey station located on the west flank of Slide Mountain, 1.2 mi northwest of the 1983 landslide. Daily fluctuations in snow-water depth, total precipitation, and minimum, maximum, and average air temperatures were recorded at this site (Mount Rose Ski Area). An analysis of temperature data for the days preceding and following the landslide (fig. 13) shows that a series of abnormally high, daily-average temperatures caused a sudden decrease in the snow-water (snowpack) depth. Beginning on May 23, the average daily temperature increased from 49.6°F to a high of 56.5°F on May 29. During the 5-day period, May 23-27, snowpack was depleted at a rate of about 0.325 in. of water per day (fig. 13). On May 27, the snowpack melted more rapidly; during the following 3 days (28-30), snowpack depletion intensified and averaged about 1.6 in. of water per day. The decrease of snow-water depth during this 3-day period accounts for about 35 percent of the total snowmelt that occurred prior to May 30.

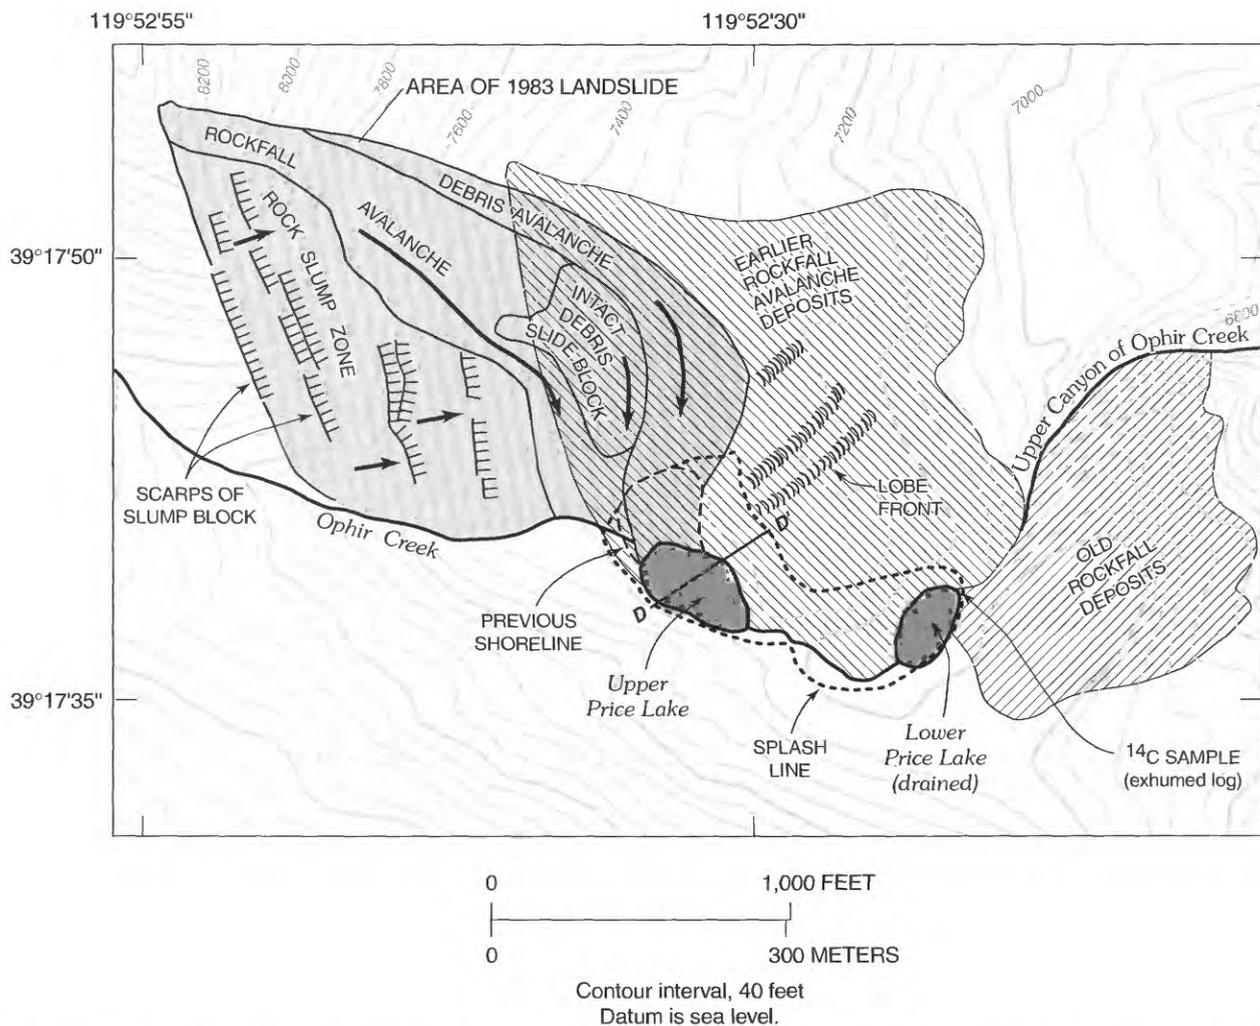
**Figure 14.** Ophir Creek landslide features compiled from pre- and post-1983 aerial photographs. Shows approximate location of cross-section D-D' of figure 21.

The rock slump zone consists of numerous parallel and sub-parallel, rotated, slump blocks that are 300 ft or more wide and several hundred yards long. Each block is bounded by a headscarp, as much as 9 ft in height, which appears to be joint controlled. The scarps trend north-northwestward and extend southward nearly to Ophir Creek; they transect the ridgeline and lie oblique to the hillslope. Maximum downslope movement, as determined from displaced treelines, was about 100 yd. All slumping was confined to unweathered, jointed granodiorite. The failure-surface geometry is not clearly known (Watters, 1983, p. 179-180).

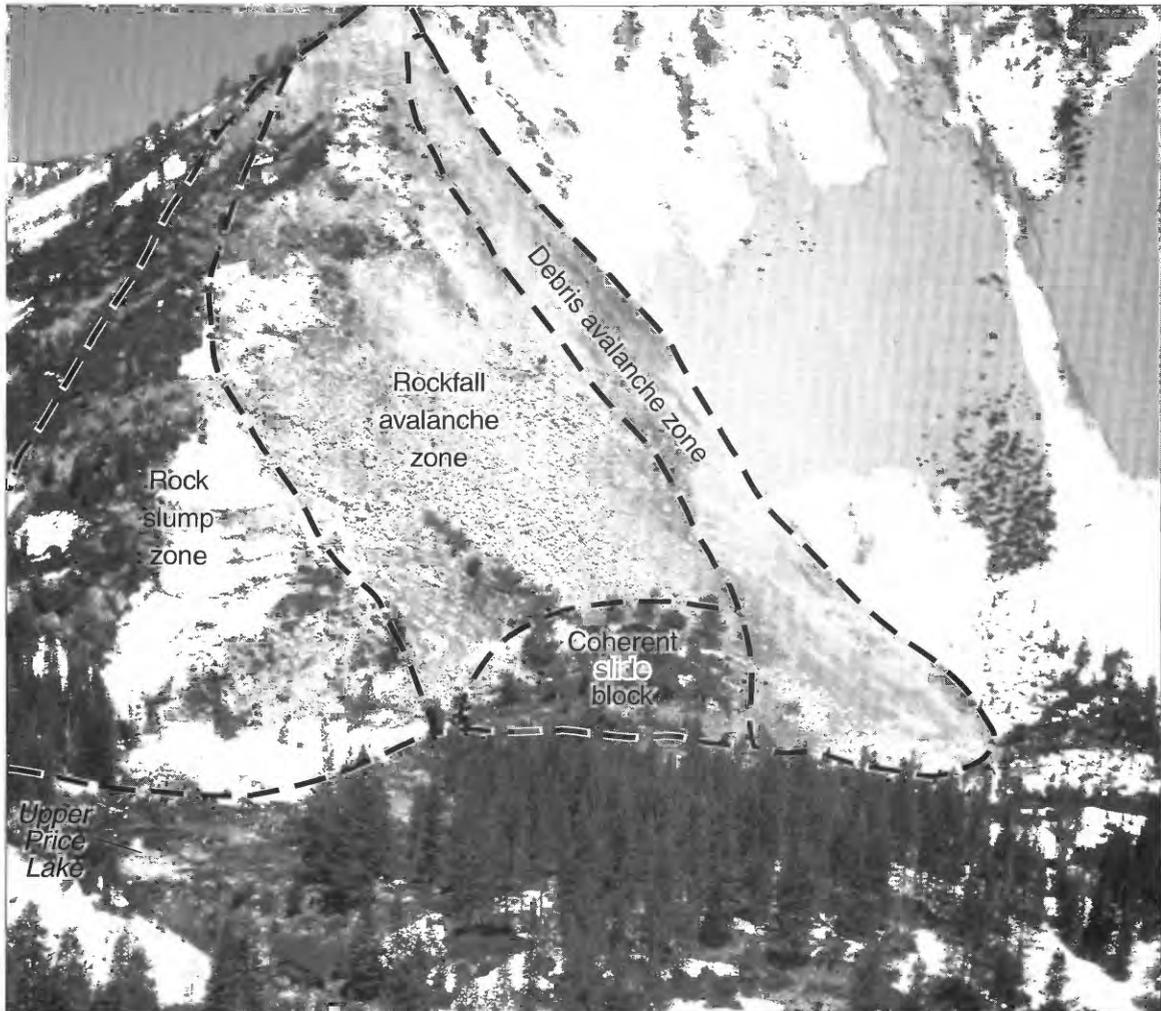
**Figure 15.** North-westward view of 1983 landslide, Ophir Creek, western Nevada; scarps in rock-slump zone are visible in snow at left side of photograph. Oblique aerial photograph by Otto Moosburner, U.S. Geological Survey, on May 31, 1983.

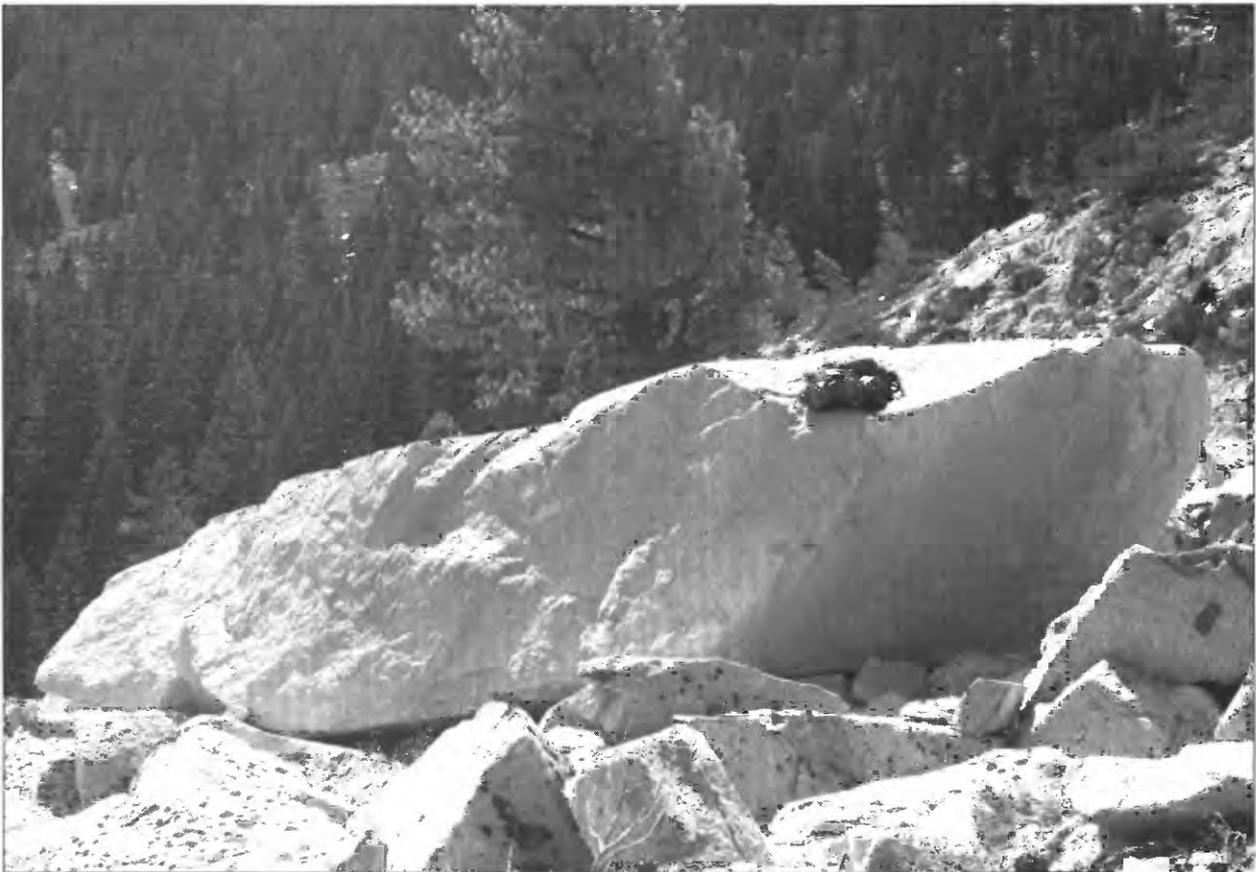
**Figure 16.** One of the largest granitic blocks involved in rockfall-avalanche phase of the 1983 landslide, Ophir Creek, western Nevada; block measures 25x12x8 feet. Backpack is 1-1/2 feet long. September 7, 1983, photograph by Patrick A. Glancy.

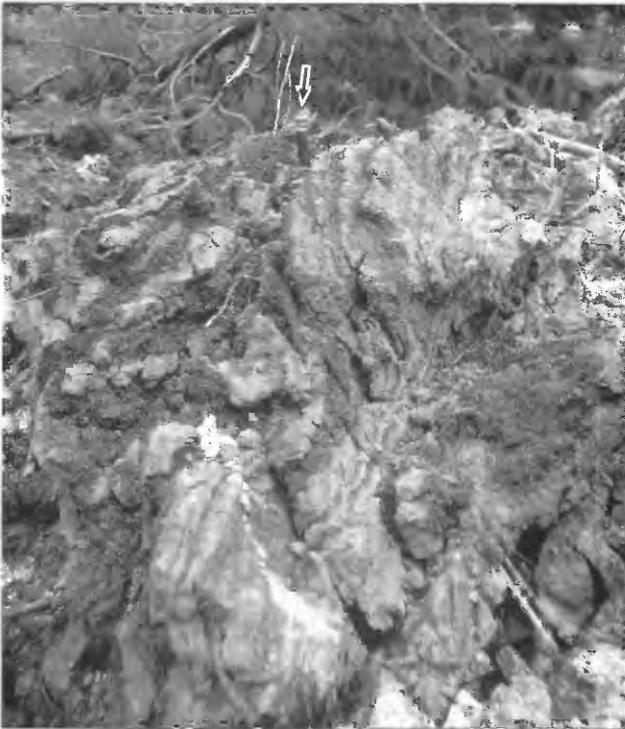
**Figure 17.** Bottom sediments of Upper Price Lake, western Nevada, deformed and uplifted by 1983 landslide. Six-inch knife (arrow) shows scale. Photograph by Patrick A. Glancy, July 27, 1983.

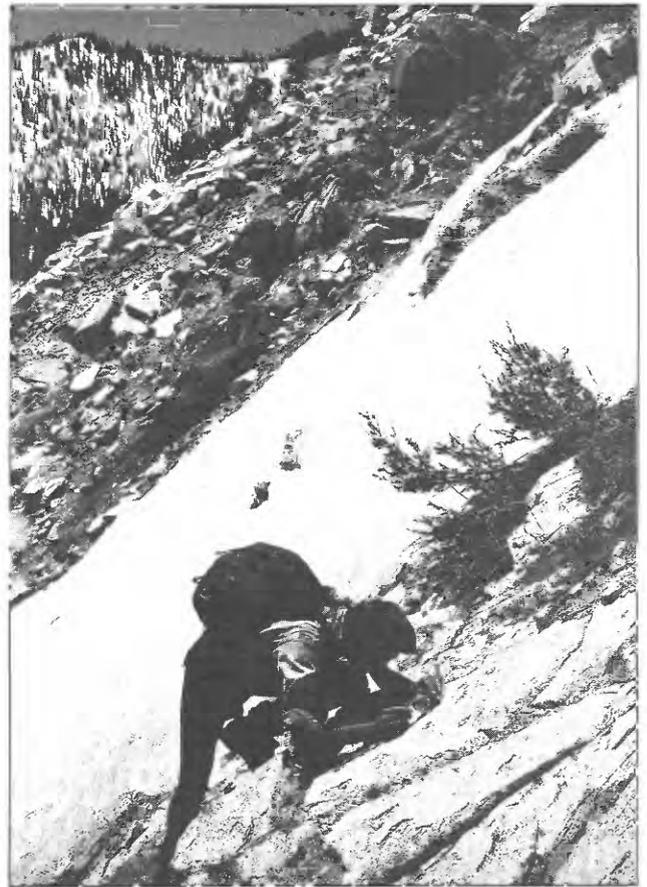
**Figure 18.** Southwestward view of landslide area showing downslope dip of joint surfaces (foreground); northern margin of rockfall-avalanche zone in background. Photograph by John W. Bell, June 7, 1983.

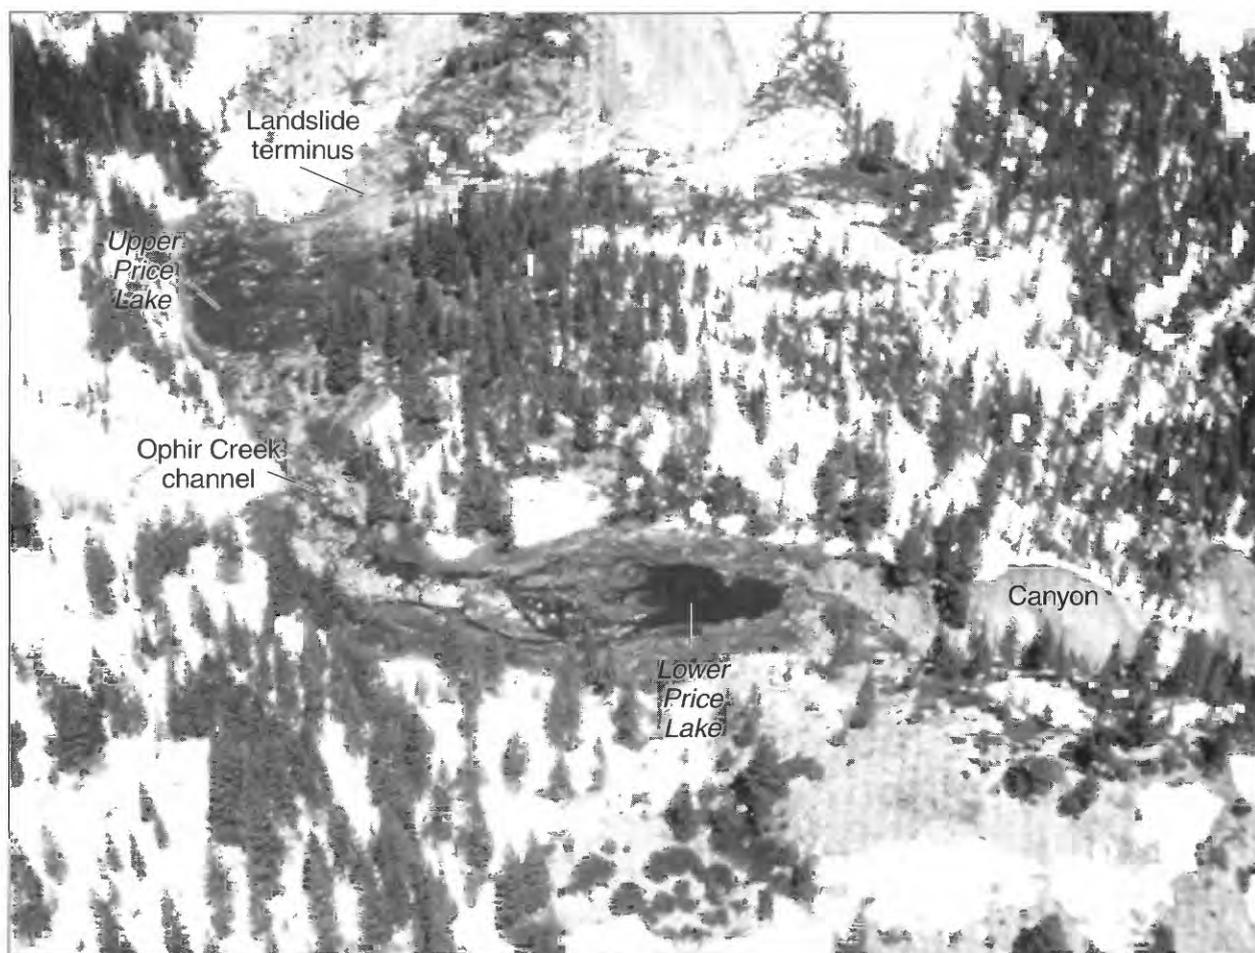
**Figure 20.** View of terminus of 1983 landslide and point of origin of Ophir Creek flood at Upper Price Lake. View also shows Ophir Creek channel connecting Upper Price Lake and Lower Price Lake, and the steep canyon of Ophir Creek just downstream from Lower Price Lake, Nevada. Oblique aerial photograph by Patrick A. Glancy, June 3, 1983.

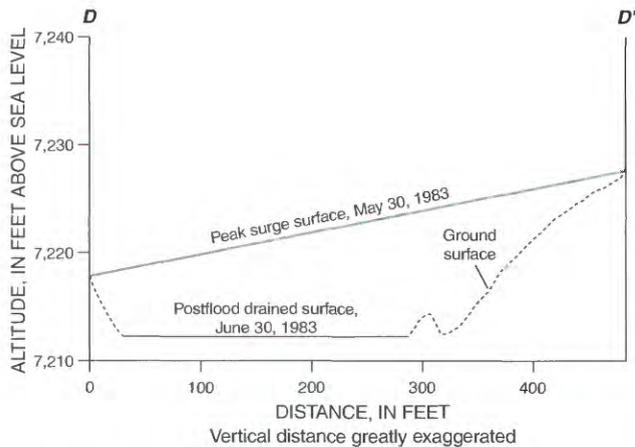
**Figure 21.** Profile, looking upstream, of high-water surface of Upper Price Lake, western Nevada, when expelled by the landslide May 30, 1983. See figure 14 for approximate location of cross section. Adapted from figure 11 of Watters (1983).

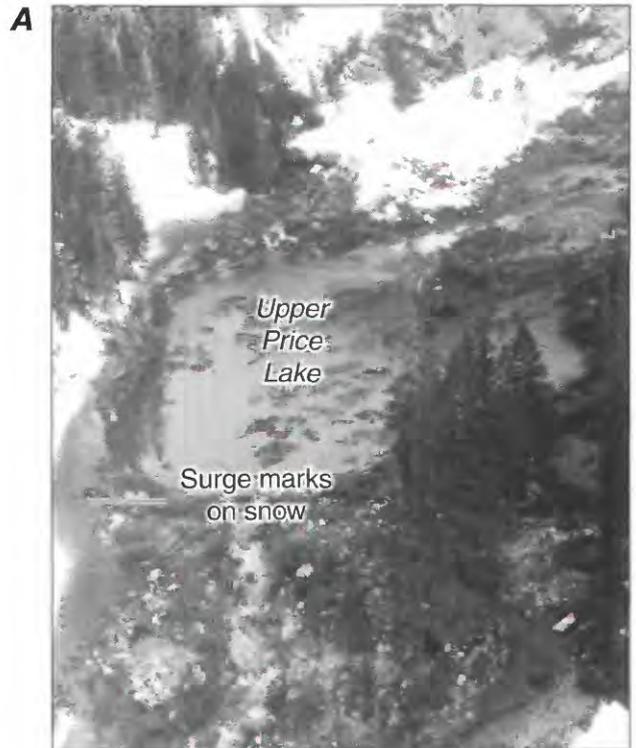
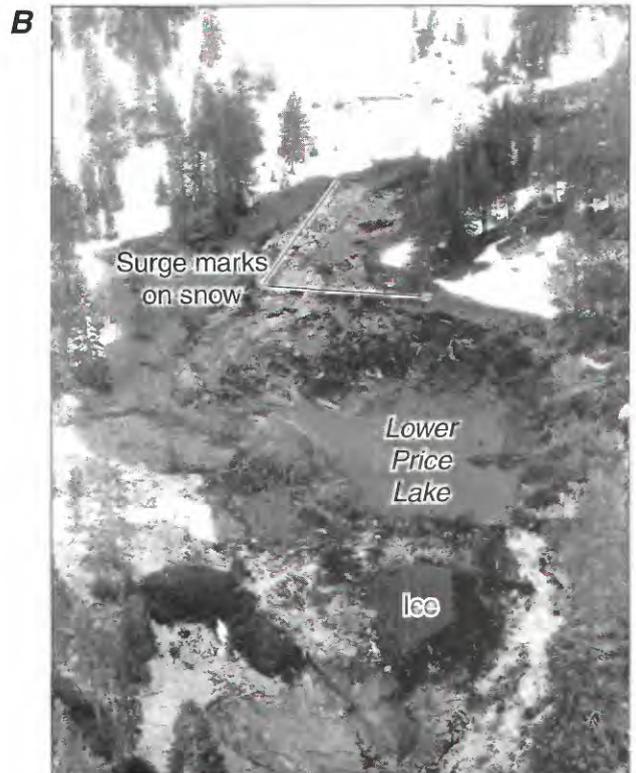
**Figure 22.** Oblique aerial views of Price Lakes, western Nevada, showing muddy surge line on snow, June 3, 1983. A, Upstream view of the outlet of Upper Price Lake. B, Upstream view of Lower Price Lake and upstream reach of Ophir Creek channel. Photographs by Patrick A. Glancy.

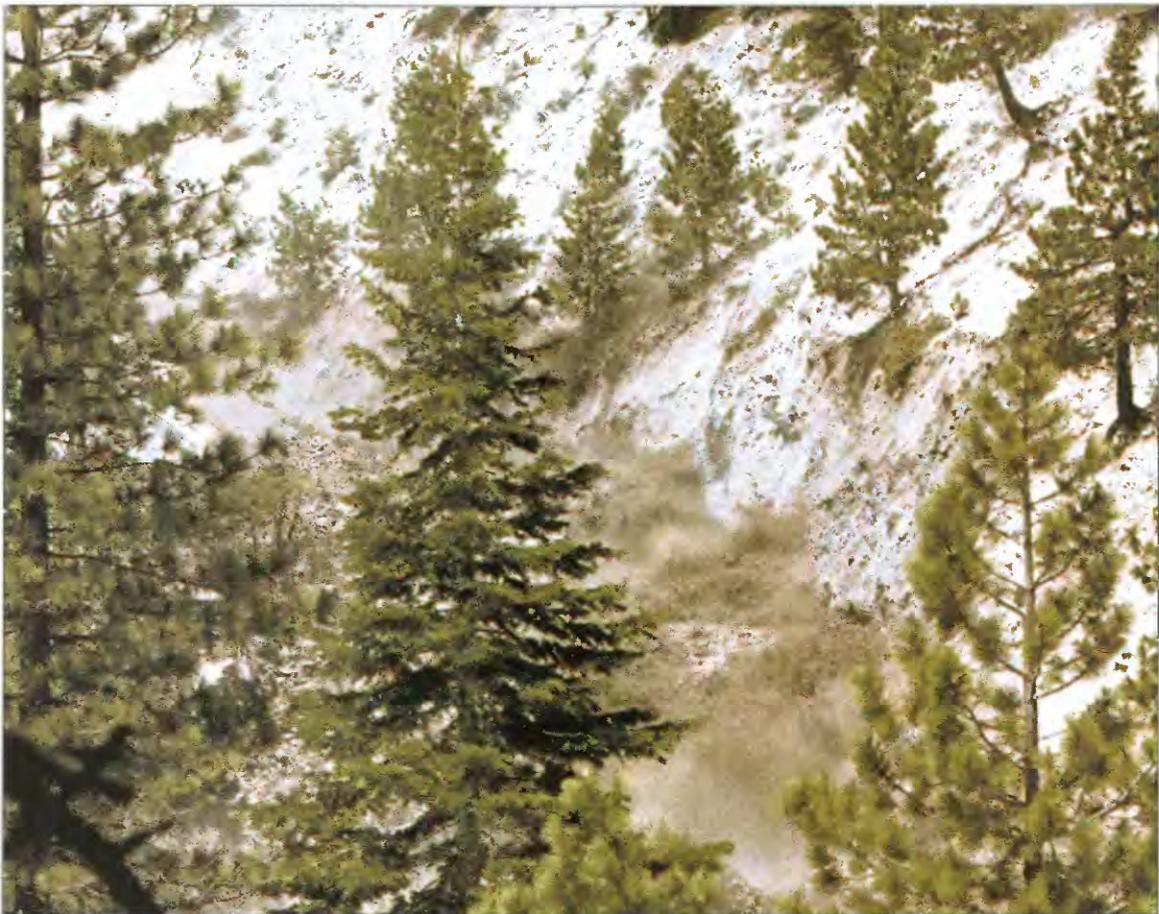
**Figure 23.** Floodflow of Ophir Creek in upper canyon, downstream from Lower Price Lake, at about 11:55 a.m. on May 30, 1983. Note the dark-colored, sediment-entrained, turbulent flow between the trees in right foreground. Photograph taken by hiker James Schumacher.

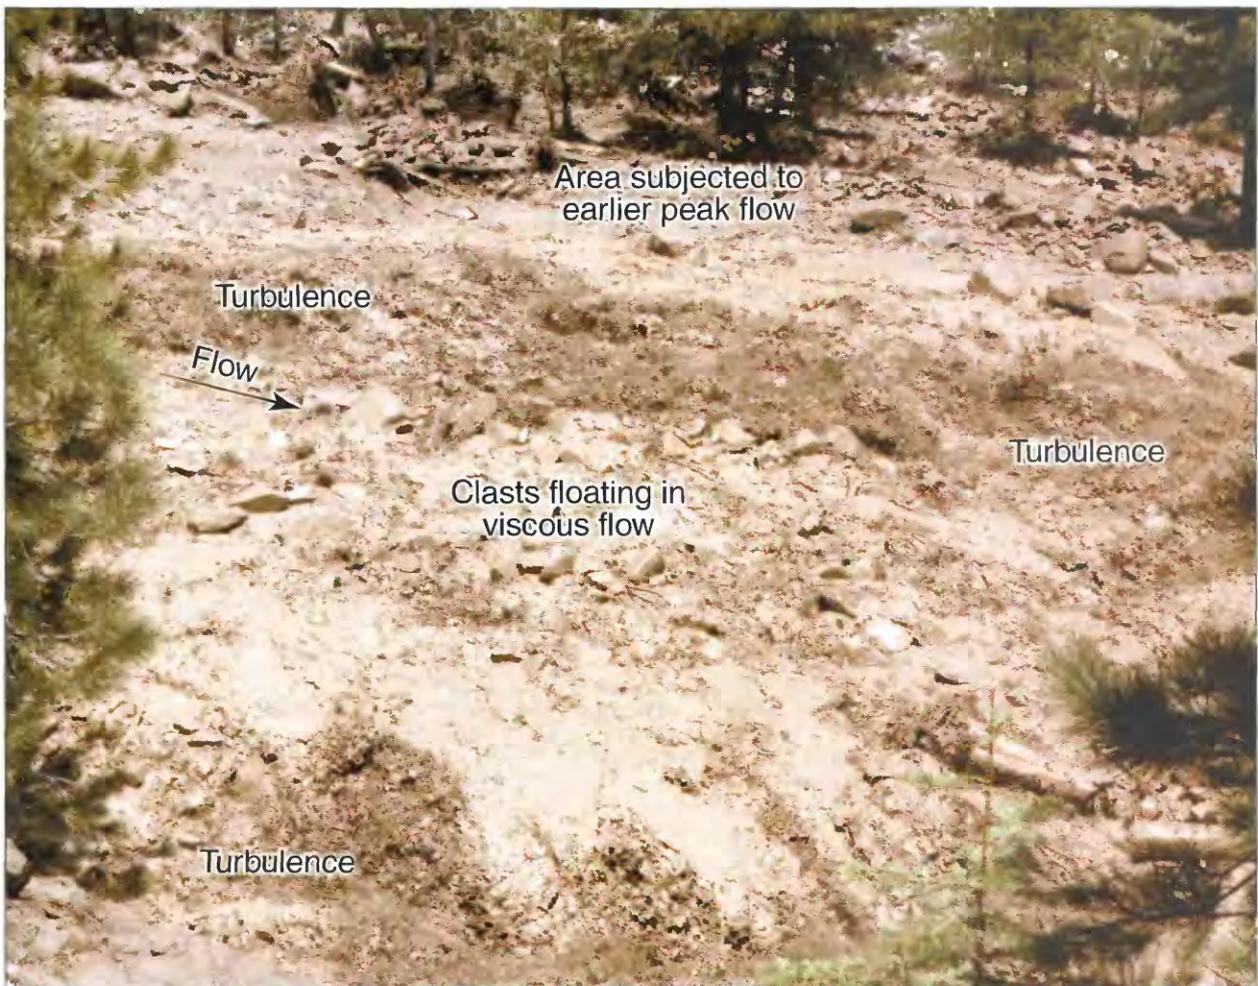
**Figure 24.** Northward view of flood downstream from mouth of upper canyon of Ophir Creek, western Nevada. Photographed by James Schumacher about 10-15 minutes after the photograph in figure 23.
