Prepared in cooperation with the  
NEVADA BUREAU OF MINES AND GEOLOGY

# **Landslide-Induced Flooding at Ophir Creek, Washoe County, Western Nevada, May 30, 1983**

**Professional Paper 1617**

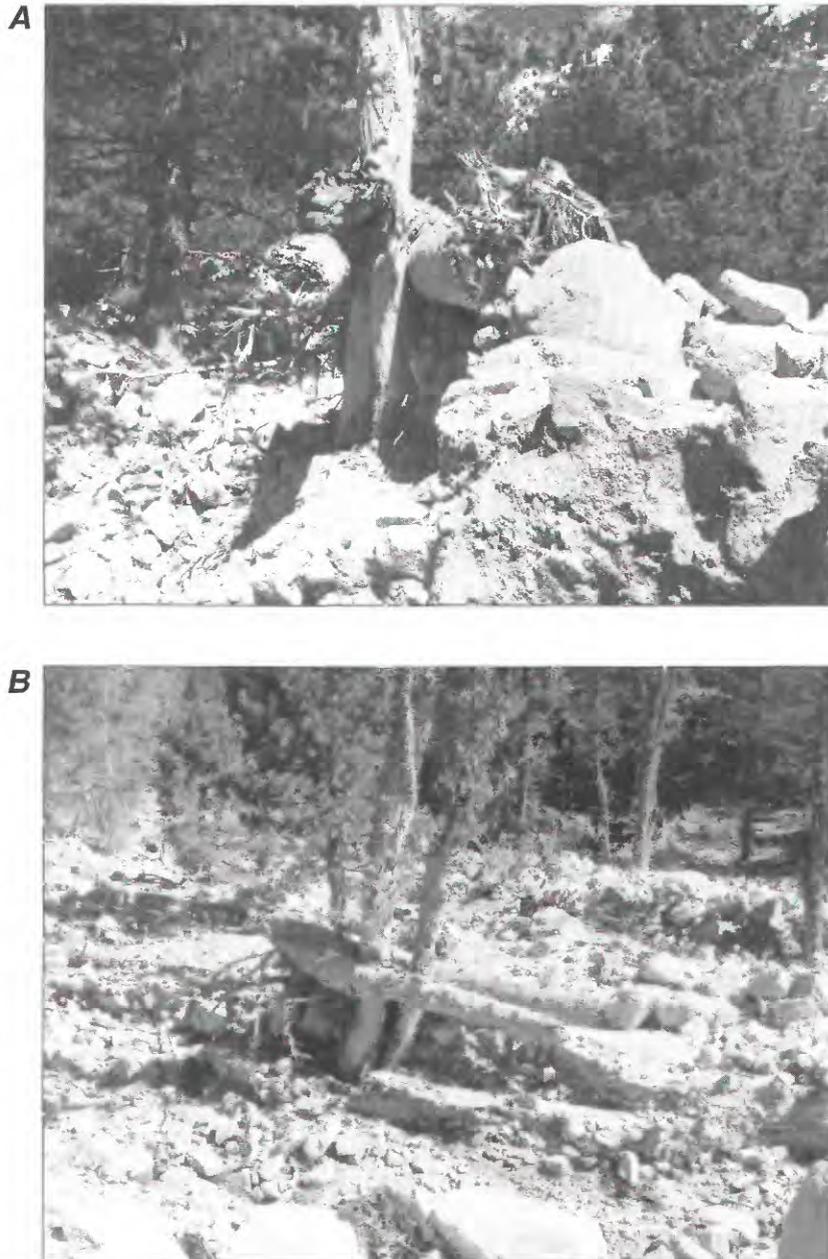
**Figure 25.** Coarse-grained deposits on broad flood plain between upper and lower canyons of Ophir Creek, western Nevada: *A*, trees and bouldery rubble partially bury a standing tree; and *B*, coarse debris mantling the flood-plain surface. The battered crotch of a dismembered tree snared by two living trees suggests the degree of abrasive energy that characterized the flood. Photographs by Patrick A. Glancy, July 27, 1983.

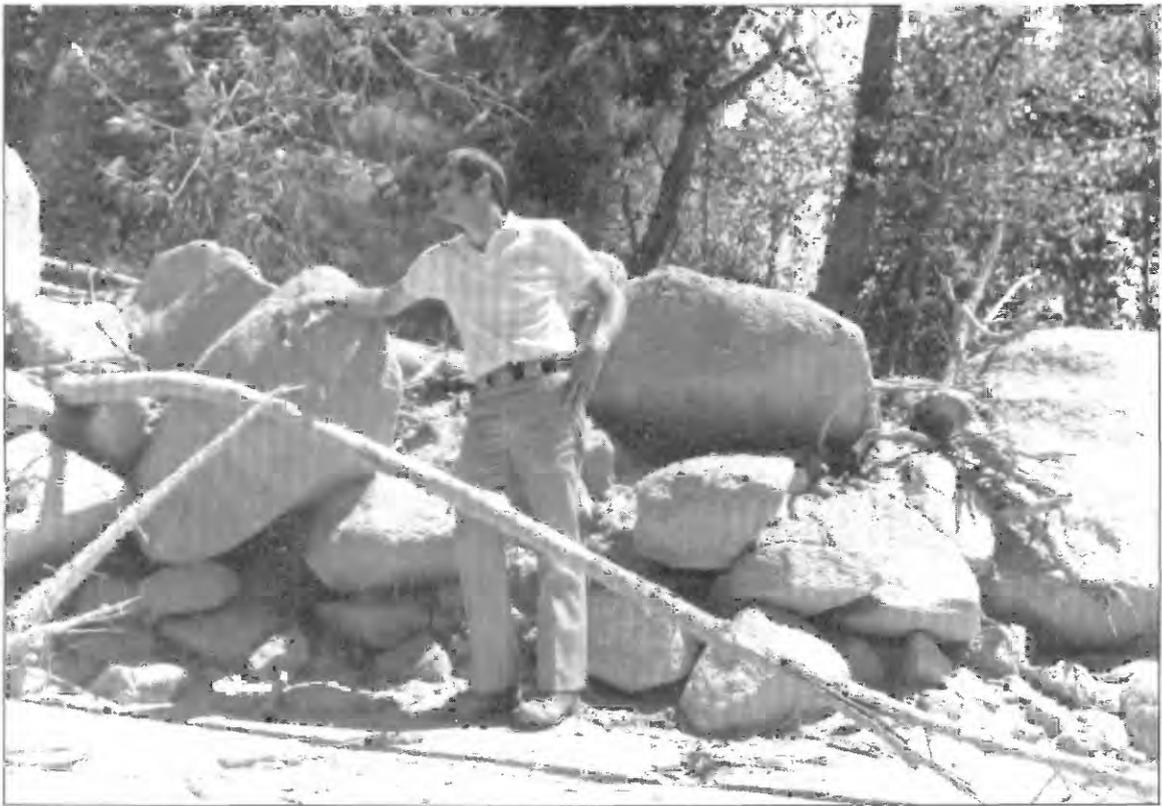
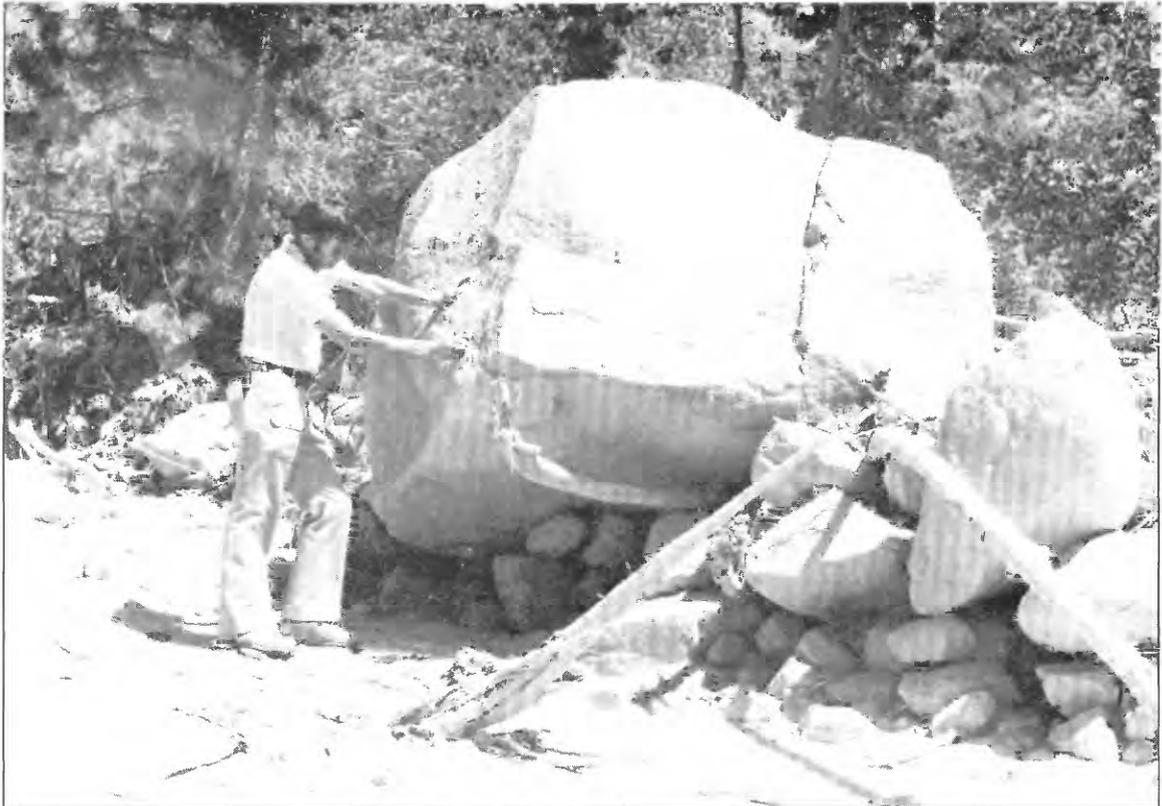
**Figure 26.** Boulder berm on northern edge of flood plain of Ophir Creek, western Nevada, at mouth of lower canyon. *A*, Narrow, elongate berm aligned parallel to the direction of flow; berm composed of chaotically stacked boulders with minimum interstitial fill. *B*, Wide variation in boulder size; clast sizes range from cobble size to more than 6 feet in diameter. Photographed July 14, 1983, by Patrick A. Glancy.

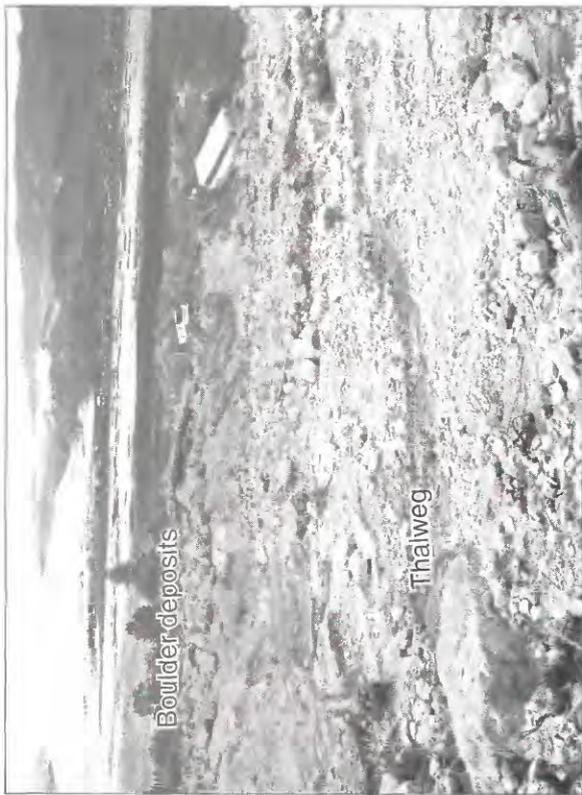
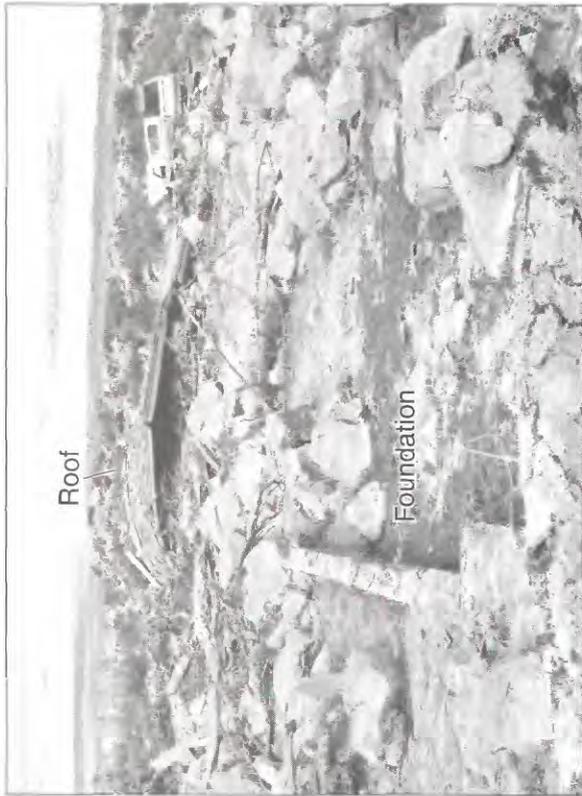
Figure 27. Flood-related reference sites on Ophir Creek alluvial fan.

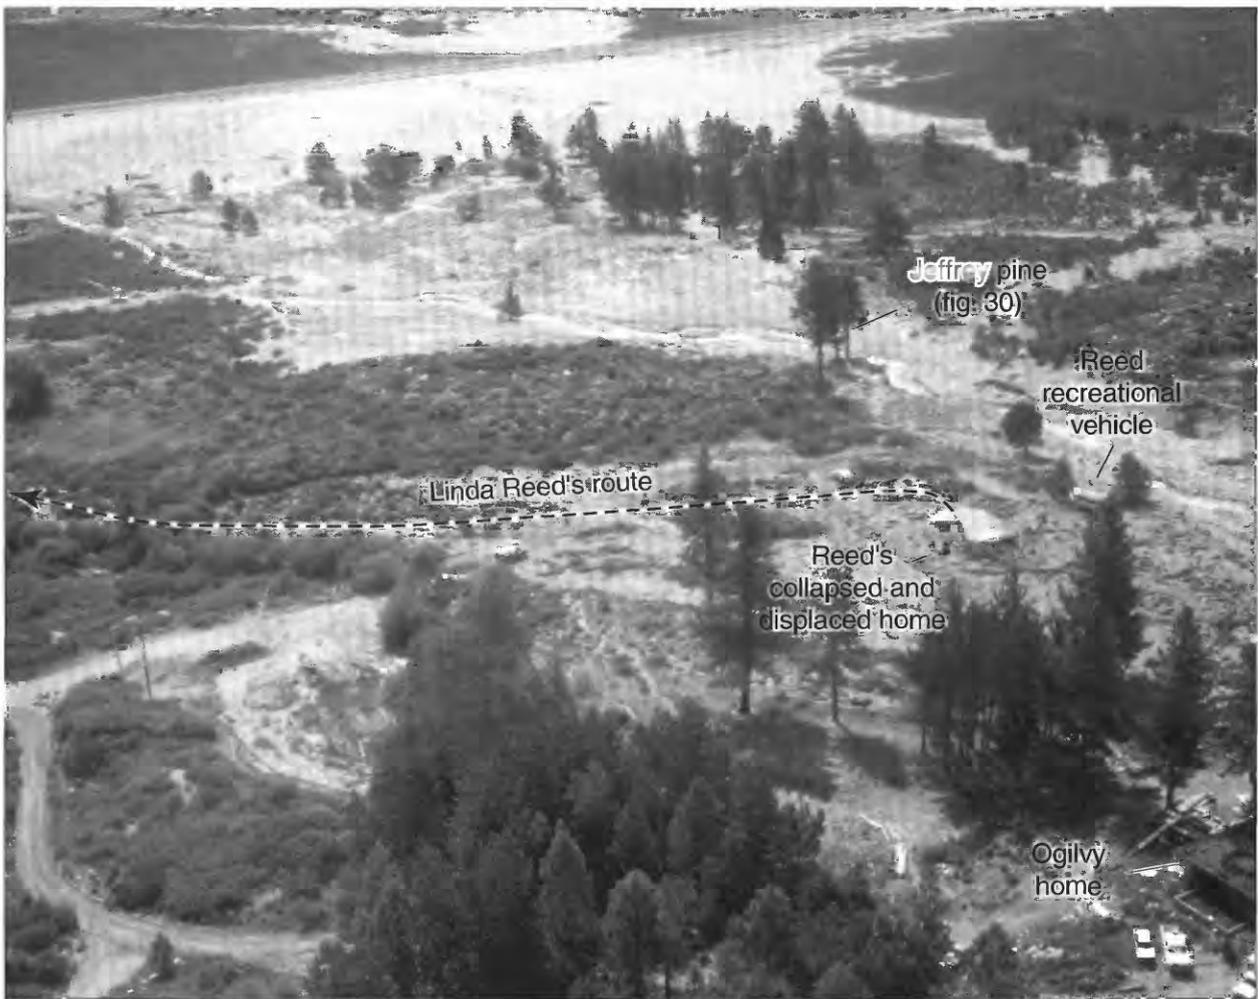
**Figure 29.** Northeastward route of mud-laden matrix fluid that swept away Linda Reed after it overflowed the north-bank terrace of the Ophir Creek alluvial fan, western Nevada. Part of the severely damaged Ogilvy home shown at the lower right corner; Reed's demolished home and damaged motorhome are on terrace at right center. Oblique aerial photograph by Jon O. Nowlin, June 3, 1983.

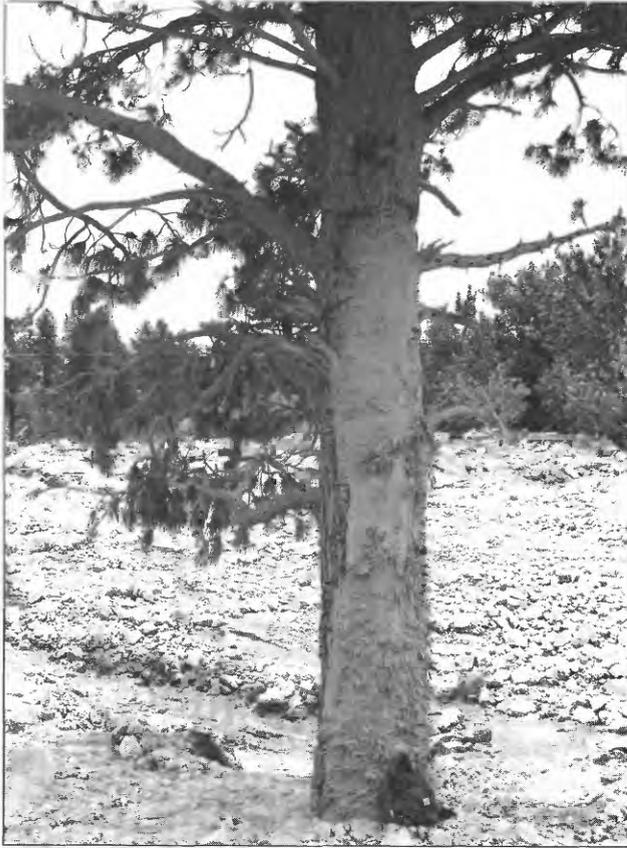
**Figure 30.** Jeffrey pine along the north bank of Ophir Creek (fig. 29), western Nevada, abraded by the flood. Tree records a peak flood-surge height of about 20 feet and is about 100 yards upstream from Old Highway 395. Backpack height is about 1-1/2 feet. Photographed by Patrick A. Glancy June 1, 1983.

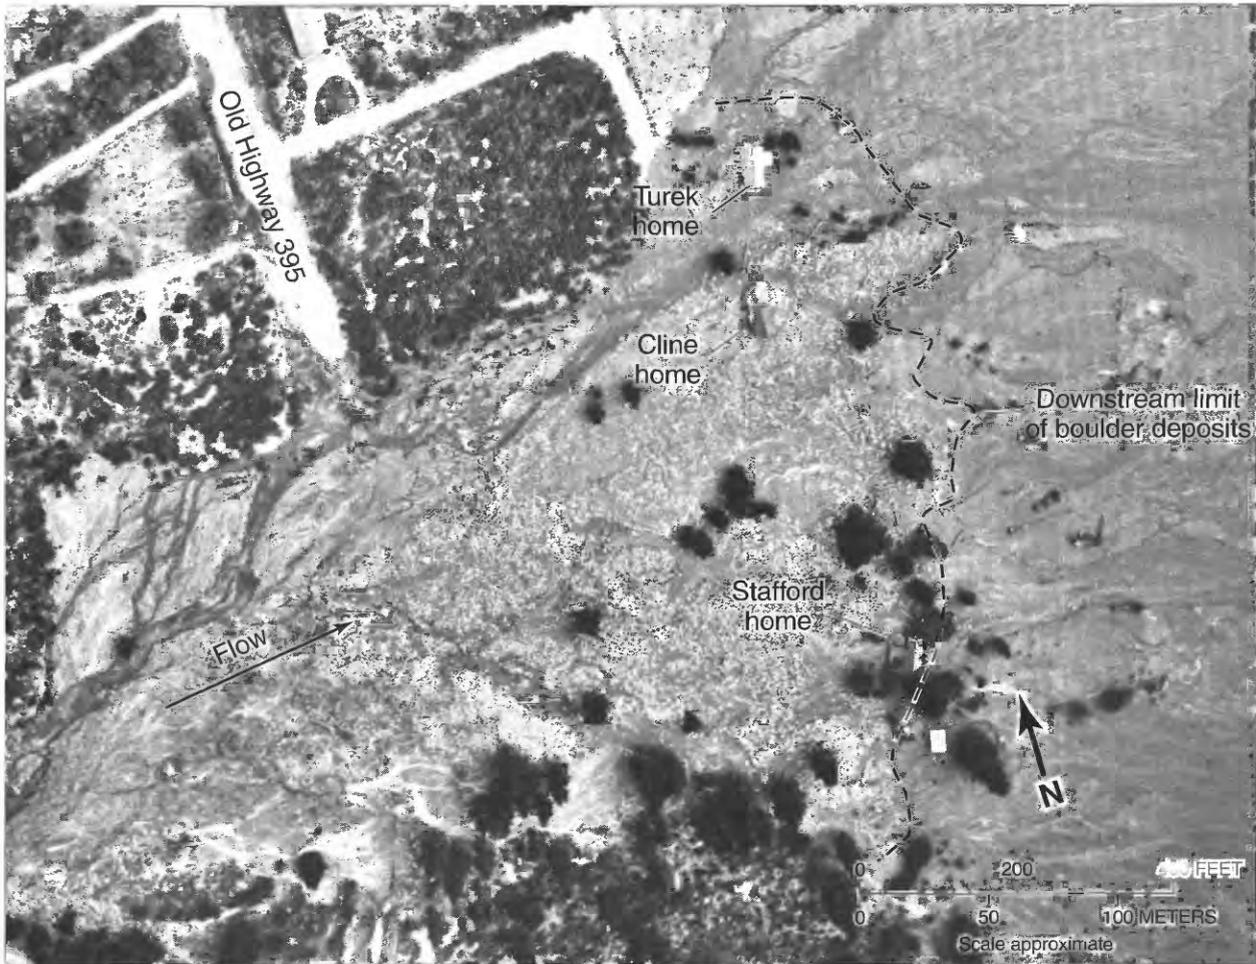
**Figure 31.** Downstream extent of boulder deposition on Ophir Creek fan resulting from the 1983 flood. Turek and Cline homes are separated by new alignment of creek. Stafford home and buildings among trees to south. Vertical aerial photograph by Nevada Department of Transportation, June 1, 1983.

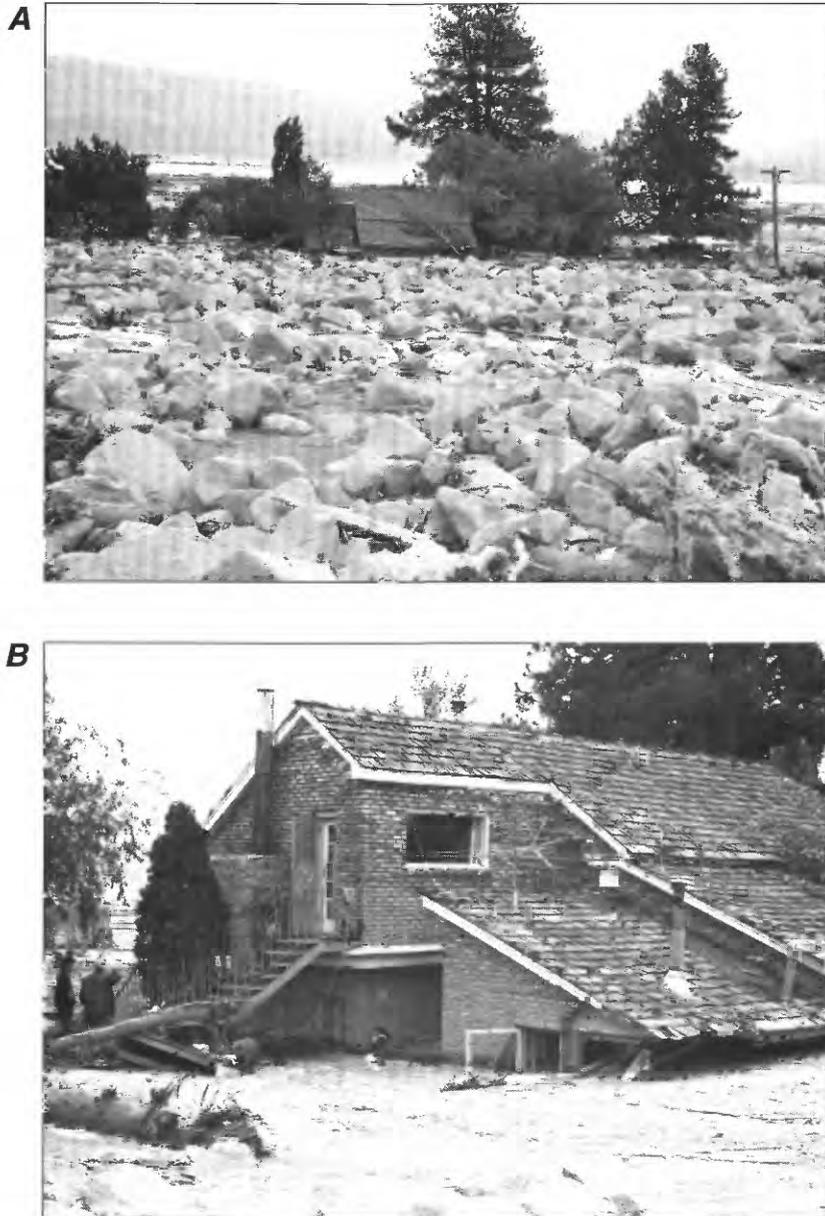
**Figure 32.** Stafford home, June 1, 1983. Photographs show damage caused by Ophir Creek flood, western Nevada: A, View downstream from just below Old Highway 395. B, Southeastward view of north end of house. Photographs by Patrick A. Glancy.

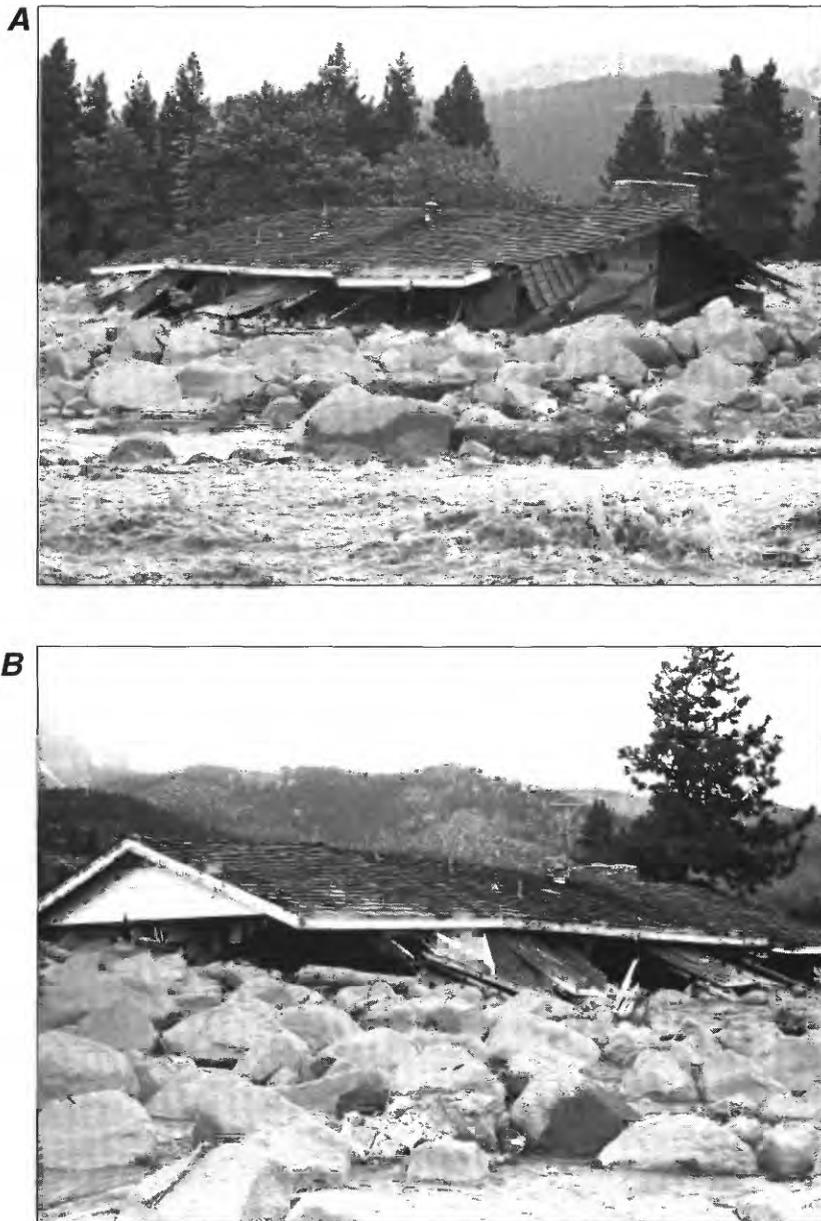
**Figure 33.** Cline home, June 1, 1983. Photographs show damage caused by Ophir Creek flood, western Nevada: *A*, View southwestward showing downstream side of house. *B*, View northwestward showing downstream side of house. Kathleen Cline was ejected from this side of the house by floodflow. Photograph by Patrick A. Glancy.

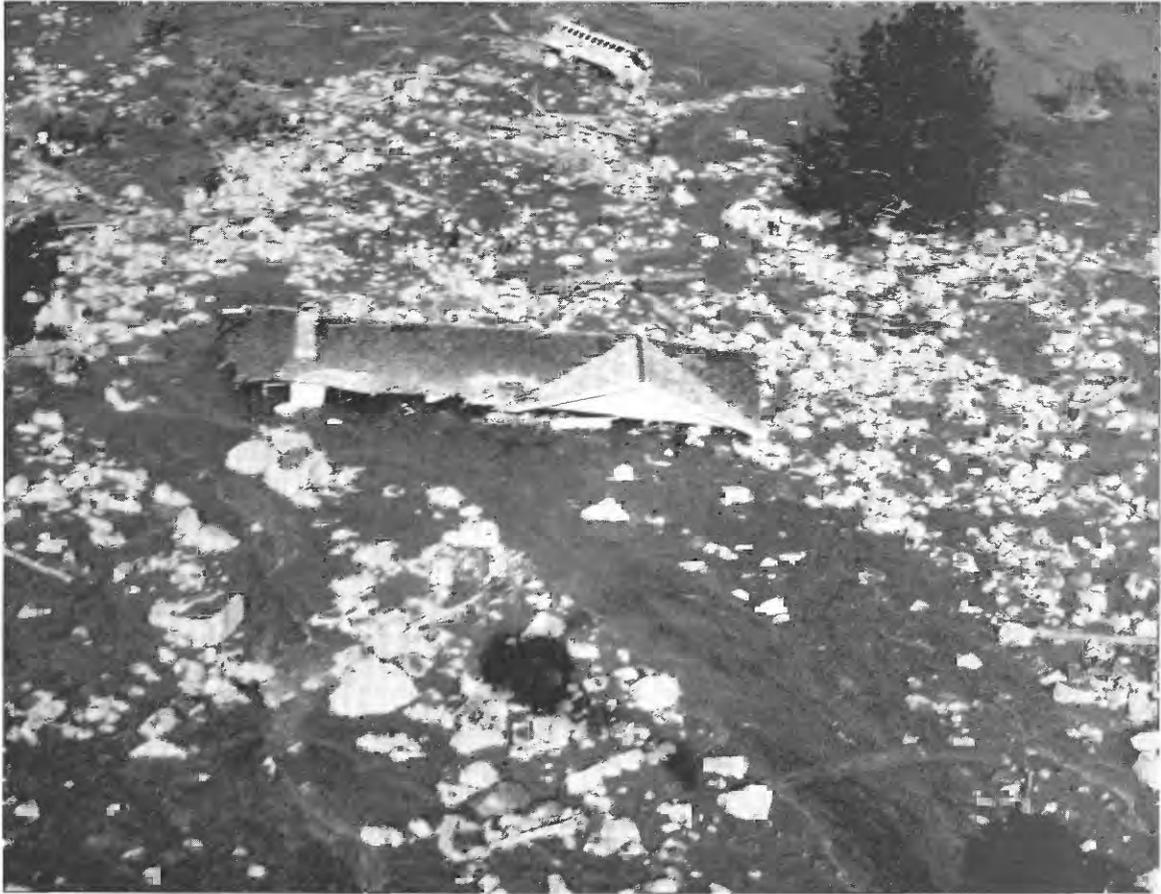
**Figure 34.** Downstream (eastward) view of Cline house. Distal margin of boulder deposits at top of photograph. Oblique aerial photograph taken by Washoe County Sheriff's Department during afternoon of May 30, 1983, after the leading flow surge of the Ophir Creek flood, western Nevada.

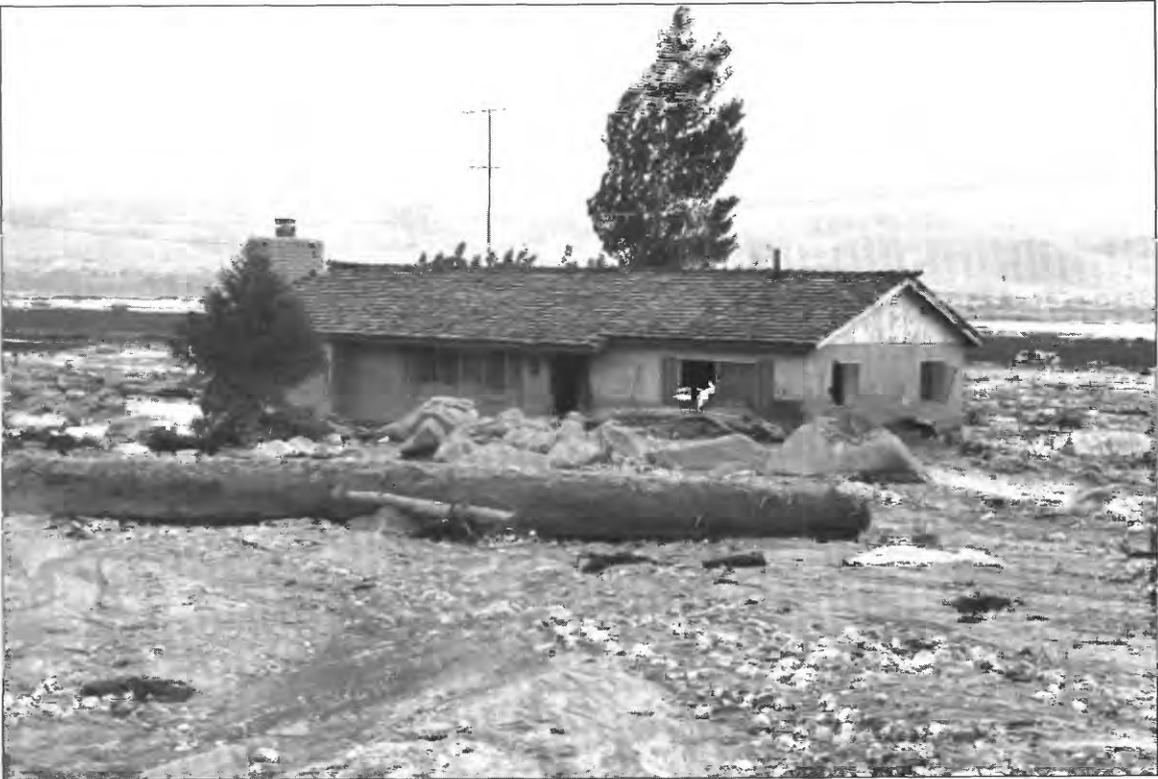
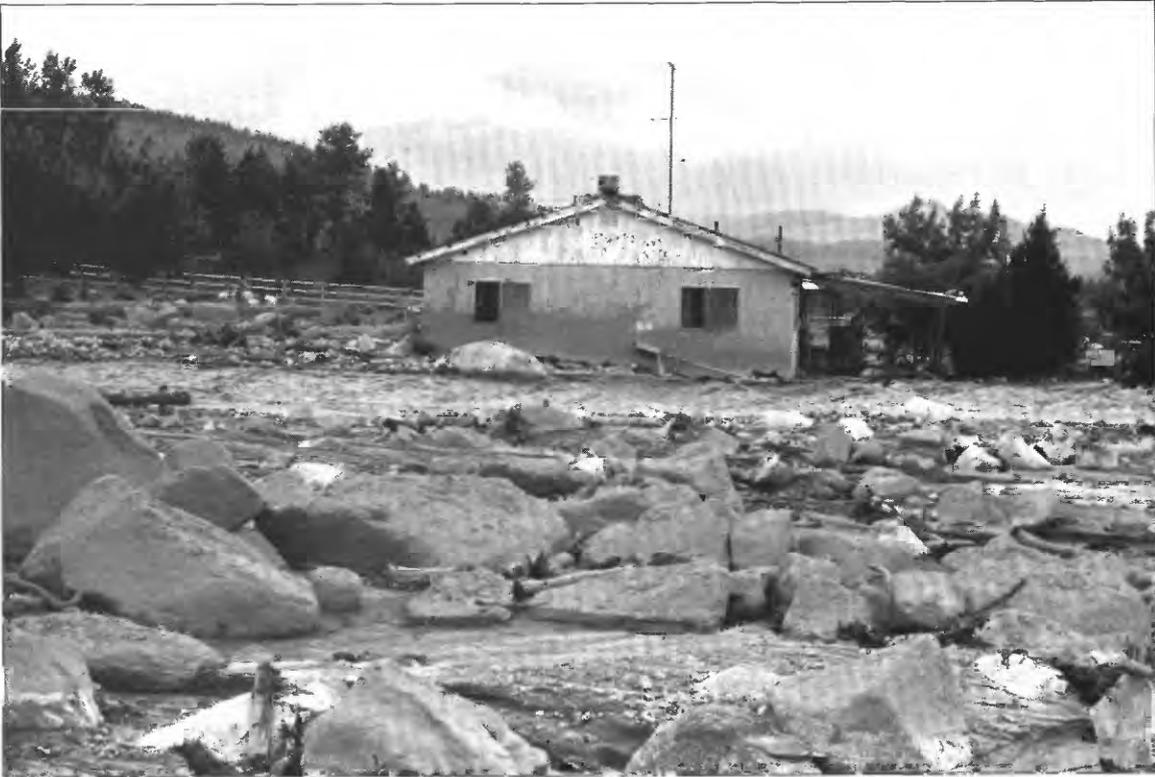
**Figure 35.** Turek home on June 1, 1983. *A*, View downstream to the northeast; *B*, view cross channel to the north. Photographs by Patrick A. Glancy taken after the Ophir Creek flood, western Nevada.

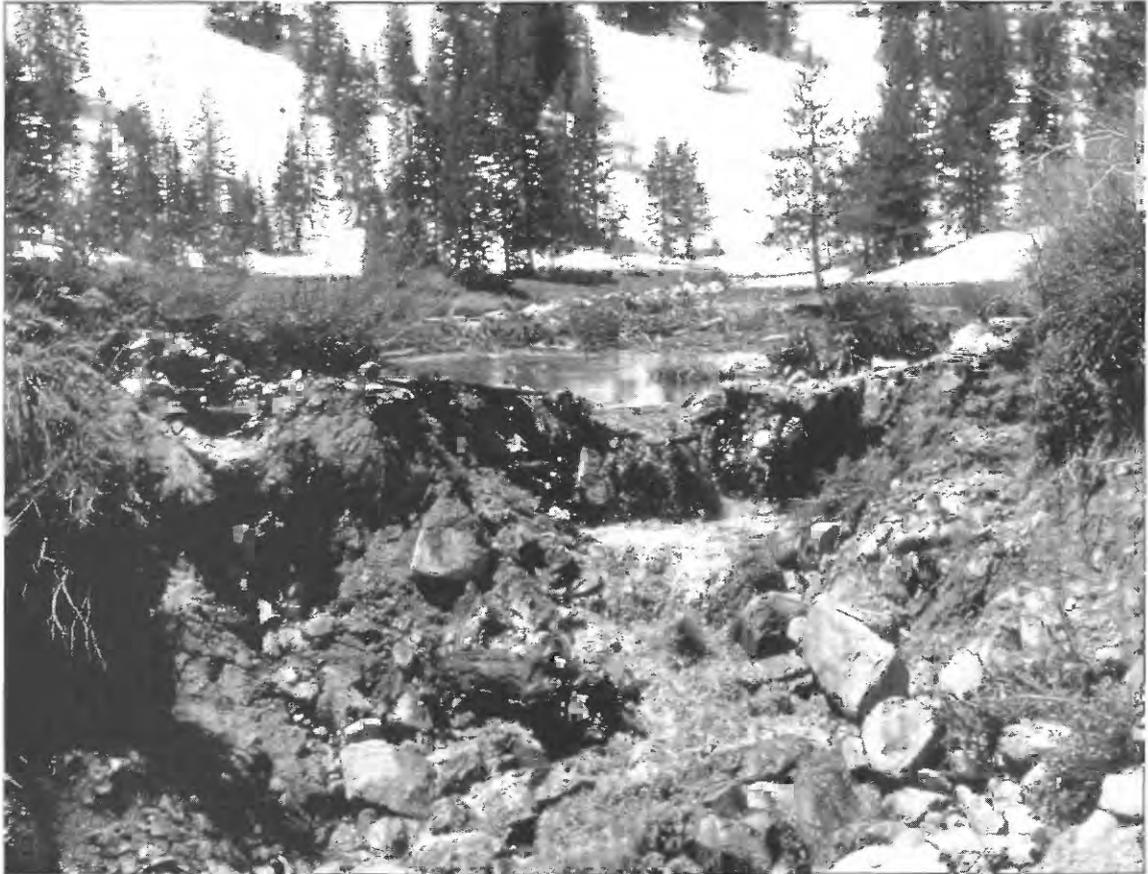
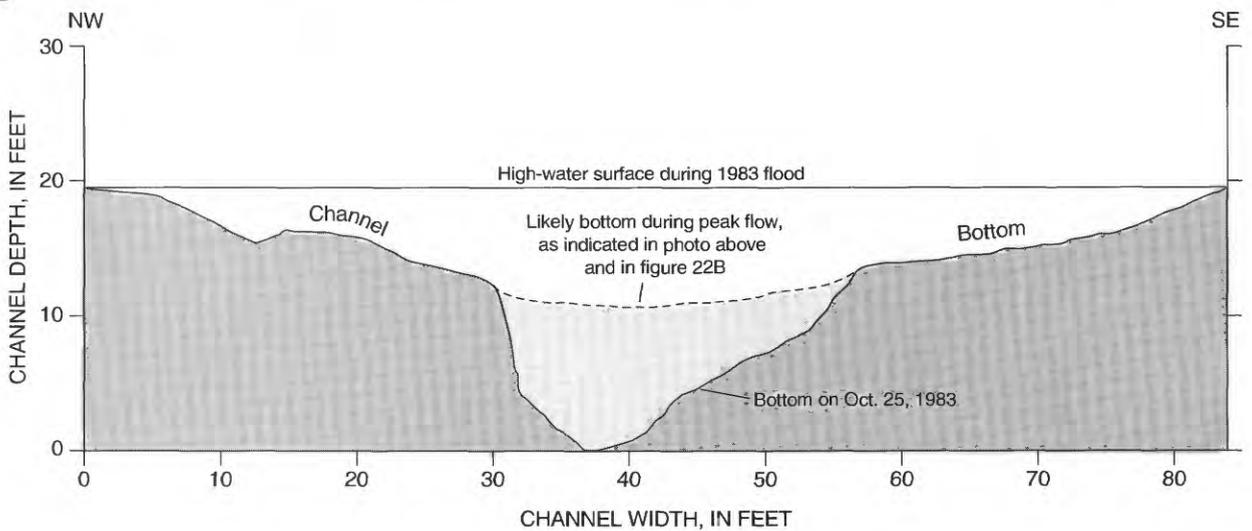
**Figure 36.** Outlet of Lower Price Lake, western Nevada: *A*, Upstream view of breached dam, photographed by R.L. Jameson, U.S. Forest Service, on morning of May 31, 1983. *B*, Downstream view of cross section, as surveyed about 5 months later by Robert R. Squires and Rodney L. Carson, U.S. Geological Survey, October 25, 1983.

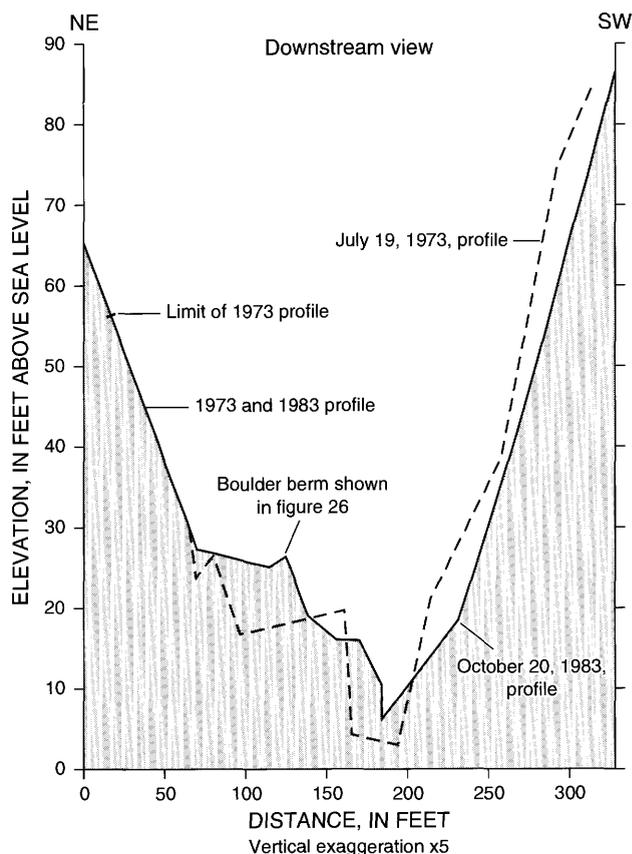
**Figure 37.** Diagrammatic cross sections of Ophir Creek channel, western Nevada, measured near lower canyon mouth before and after the 1983 flood.

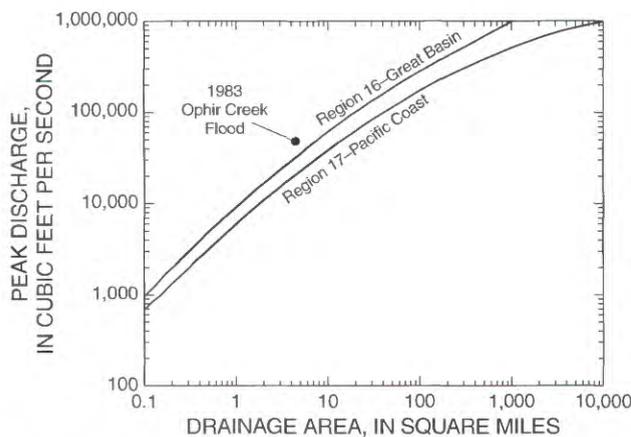
**Figure 38.** Envelope curves for maximum measured floods in relation to the 1983 Ophir Creek flood, western Nevada, (modified from Crippen and Bue, 1977, figs. 18 and 19).

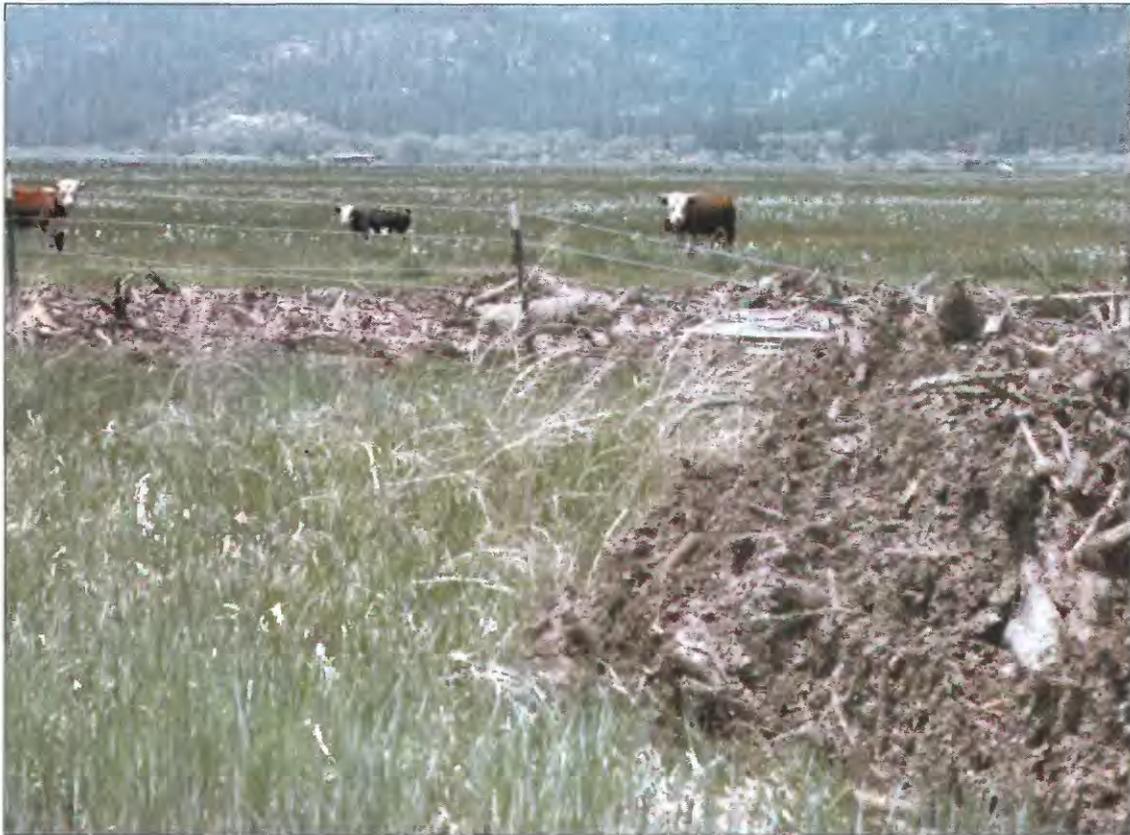
**Figure 39.** Viscous, organic-laden leading edge of floodflow from Ophir Creek, western Nevada, advances southward at about 2 feet per second, parallel to the southbound lanes of U.S. Highway 395 freeway, as photographed by Reed Dopf on May 30, 1983.

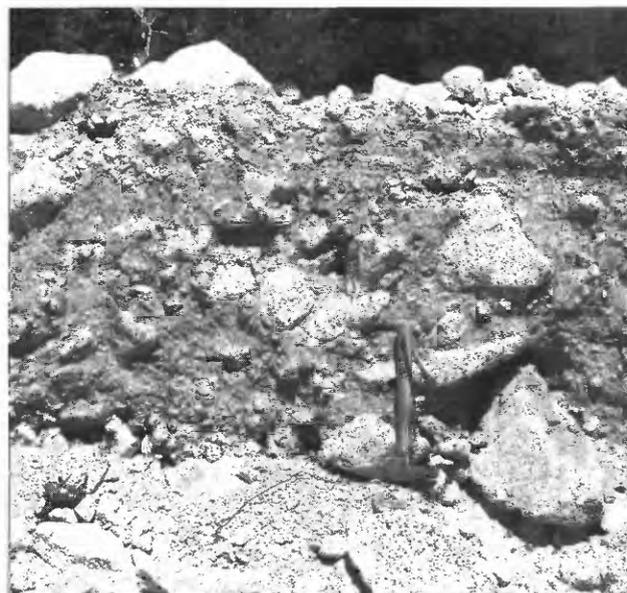
**Figure 41.** Unstratified and unsorted debris deposited by the 1983 flood on broad flood plain between the upper and lower canyons of Ophir Creek, western Nevada. Deposit was exhumed by recessional floodflow and later spring-snowmelt runoff. Hammerhead rests on pre-flood surface. Hammer length, about 1 foot. Photograph by Patrick A. Glancy on August 27, 1983.

The intercanyon depositional reach is partially shown in figure 11. This reach was reconnoitered on August 27, 1983, to assess the volume of sediment deposition. The deposits had an irregular surface and thickness. Postflood erosion of the deposits by snowmelt runoff exposed the variability in thickness along the main channel thalweg. Figure 41 shows the typical character and thickness of these key deposits. The depositional character of the sediments includes a lack of stratification and a presence of matrix support of the coarser clasts. The average deposit thickness throughout this reach was estimated to be about 3 ft; average width of the reach was estimated to be about 200 ft; and the length of the reach, scaled from aerial photographs of June 6, 1983, is 3,000-3,200 ft. The total volume of the deposits is estimated to be 42 to 45 acre-ft (table 7).

Information regarding the distributions of sediment particle sizes in flood deposits improves the understanding of hydraulic-behavioral characteristics of floodflows. Sediment deposits were sampled after the flood at four sites (fig. 43) to characterize particle-size distributions within the deposits. Detailed particle-size data are listed in appendix C, and these data are summarized in table 8. Samples 1 and 2 are duplicates collected from a single site, as are 3 and 4. Photographs of the deposits yielding samples 1-4 (figs. 41 and 44) show the sediment to be unstratified and largely composed of matrix-supported cobbles and boulders.

Abundant large clasts (cobbles and boulders up to 10 ft in diameter, some weighing tons, fig. 40) within the two upstream deposits (figs. 41, 43, and 44) complicated sampling procedures and effectively prevented a true characterization of particle-size distribution within those deposits; therefore, only matrix materials (pebbles and finer grained sediment) of those deposits were sampled (samples 1-4). Samples 5 and 6 were collected from deposits that contained particles no larger than pebbles (particles less than 64 mm diameter); those

Postflood, particle-size data collected from a sediment deposit near the downstream end of the intercanyon reach (samples 1 and 2; tables 8 and 9; figs. 41, 43, and 47) indicate a probable debris-flow genesis for the sediment deposit (Scott, 1988, and Scott and others, 1995). The deposit is unstratified, coarse clasts are randomly distributed and are supported by a fine-

grained matrix (fig. 41), and the sediment matrix is poorly sorted (1.92-2.05  $\phi$ , table 9). However, the time of sediment deposition, with regard to flood stage and flow duration, is unknown. The intercanyon reach was one of net deposition, possibly during the leading peak-flow surge and also probably later during flow recession.

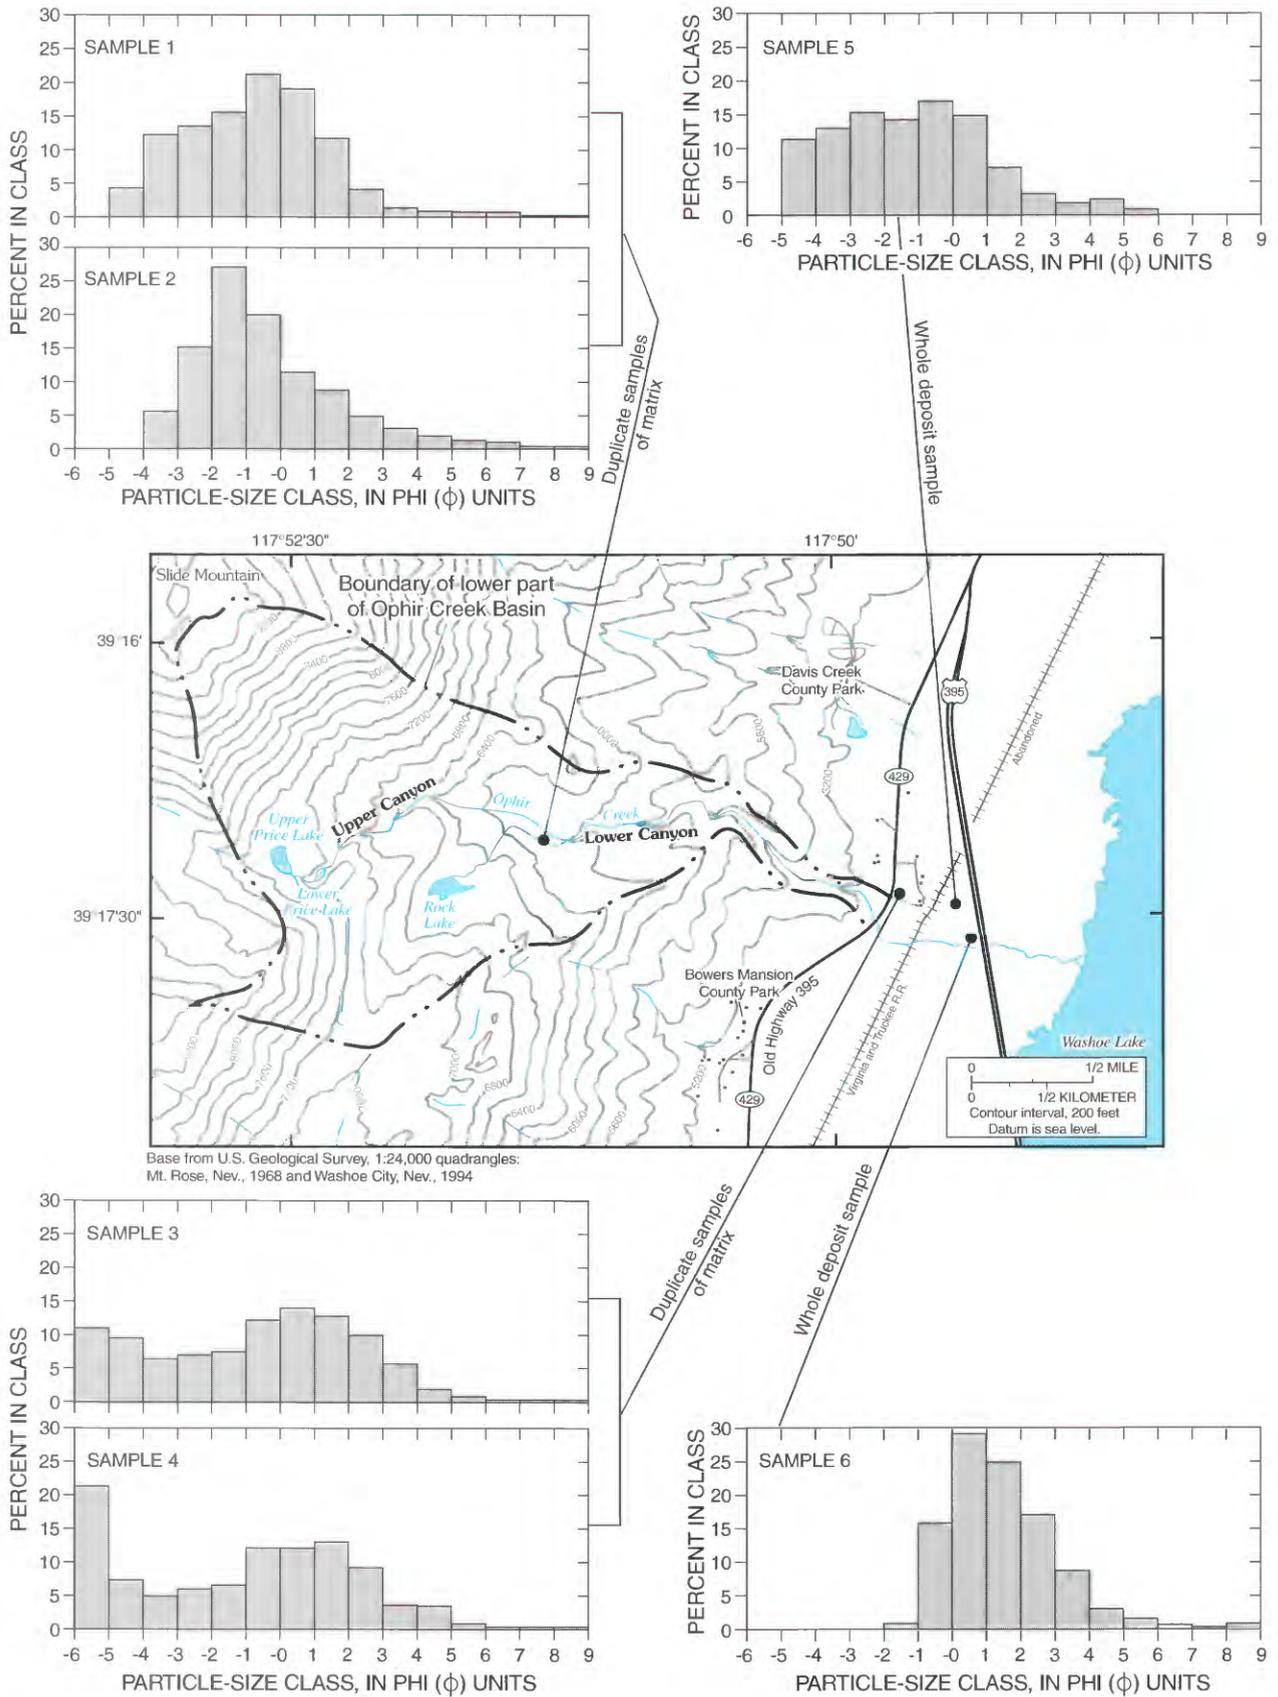
**Figure 43.** Locations of sediment sampling sites and histograms of particle-size distributions of sediment sampled, Ophir Creek Basin, western Nevada.

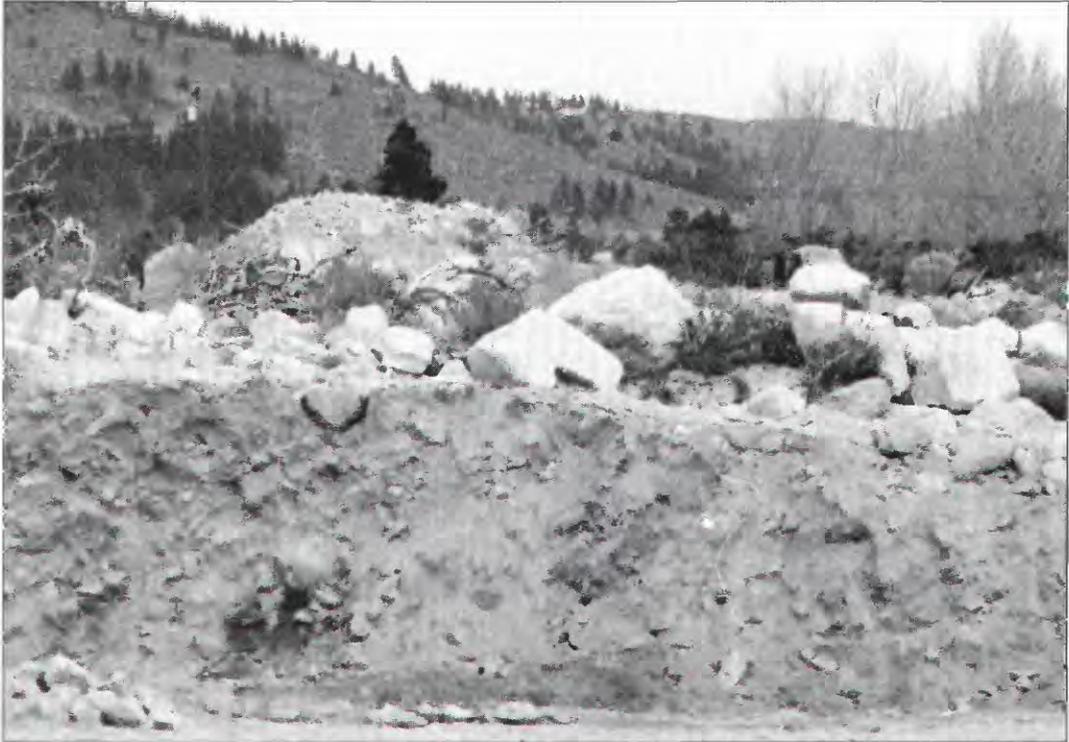
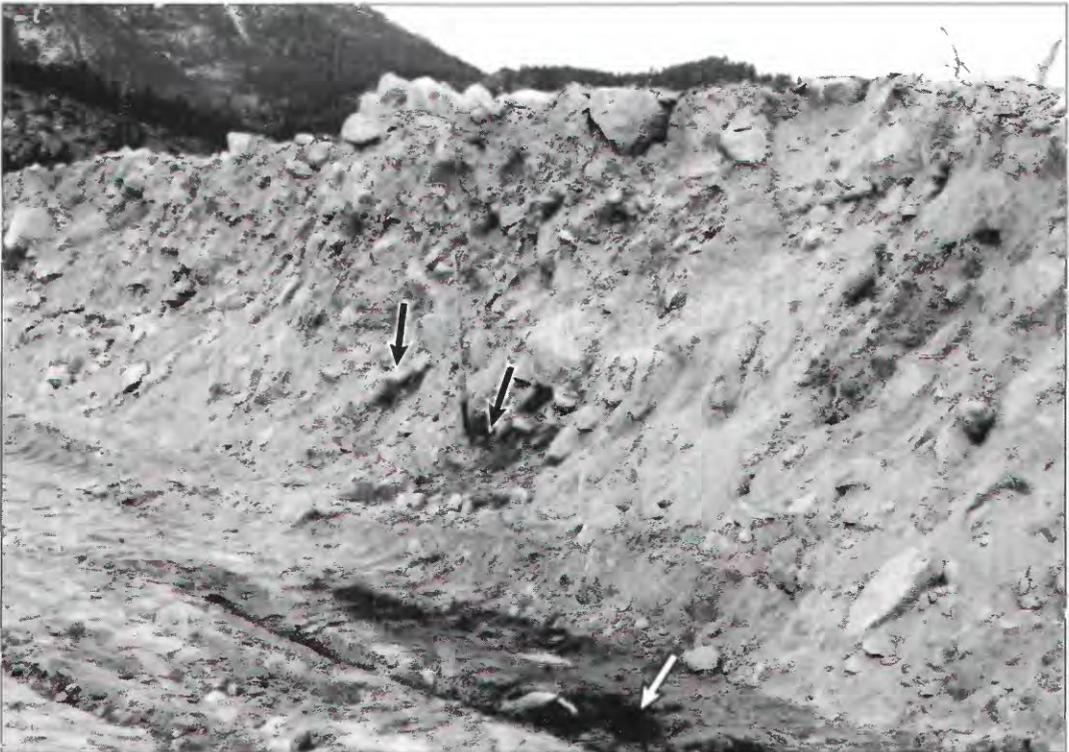
**Figure 44.** Freshly exhumed debris deposits of May 30, 1983, flood on Stafford property just downstream from Old Highway 395, western Nevada. *A*, Northward view of 7-foot-thick deposit. *B*, Northwestward view showing black organic-rich zone (white arrow) on pre-flood land surface, and freshly dug scars (black arrows) marking sites of sediment samples 3 and 4. Shovel length, 4-1/2 feet. Photographed by Patrick A. Glancy, November 16, 1990.

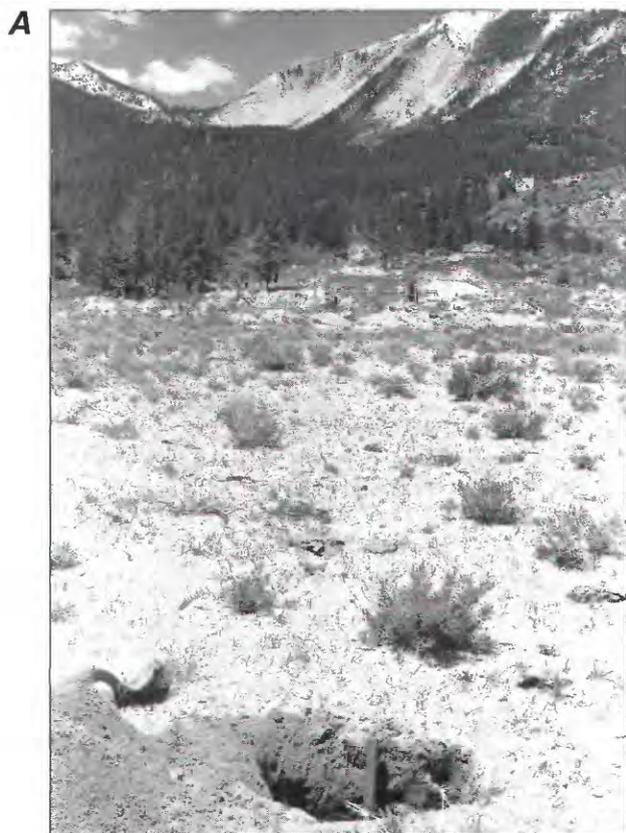
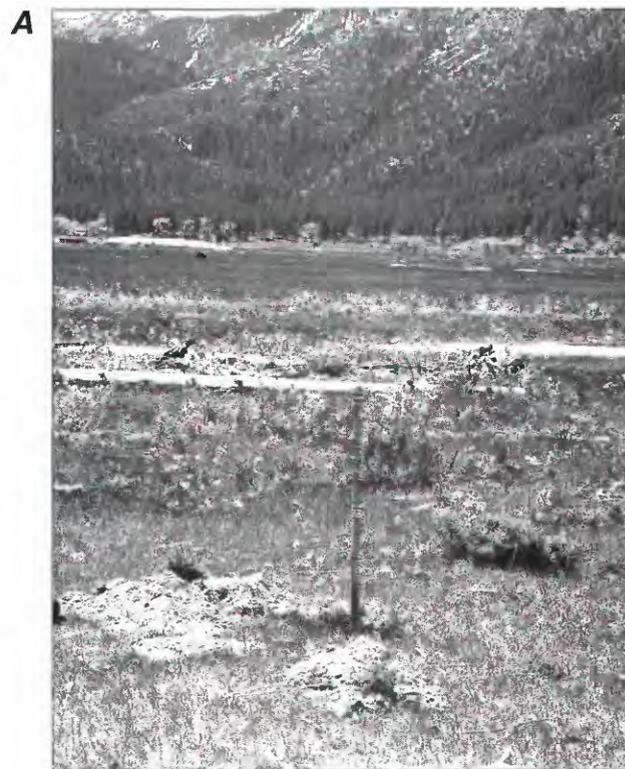
**Figure 45.** Collection site of sediment sample 5 (fig. 43). A, Westward view of Ophir Creek fan, western Nevada; Stafford home in background; sample pit in foreground. B, Sample 5 collected from back and bottom of pit. Pick length, 1-1/4 feet. Flood deposit is several feet thick.
