Prepared in cooperation with the  
NEVADA BUREAU OF MINES AND GEOLOGY

# **Landslide-Induced Flooding at Ophir Creek, Washoe County, Western Nevada, May 30, 1983**

**Professional Paper 1617**

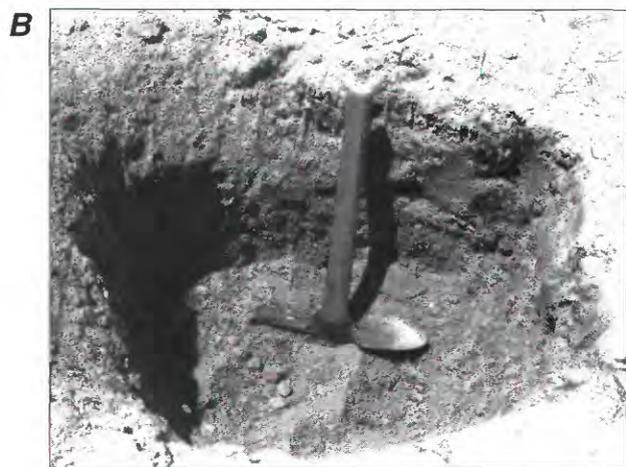
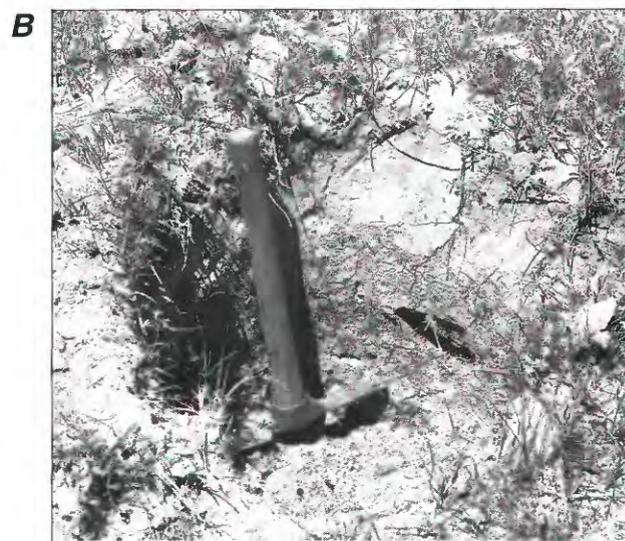
**Figure 45.** Collection site of sediment sample 5 (fig. 43). A, Westward view of Ophir Creek fan, western Nevada; Stafford home in background; sample pit in foreground. B, Sample 5 collected from back and bottom of pit. Pick length, 1-1/4 feet. Flood deposit is several feet thick.

**Figure 46.** Collection site of sediment sample 6 (fig. 43). A, Southwestward view of Ophir Creek fan, western Nevada; shovel in sample pit, 4-1/2 feet long. B, Westward view of sample pit; sample 6 collected from backside of pit about half a foot below land surface; pick length, 1-1/4 feet. Base of deposit is less than 1 foot below pit bottom. Photographed by Patrick A. Glancy on May 22, 1991.

samples from the two downstream sites (figs. 45 and 46), thus, characterize the complete deposits rather than just the finer-grained matrix components.

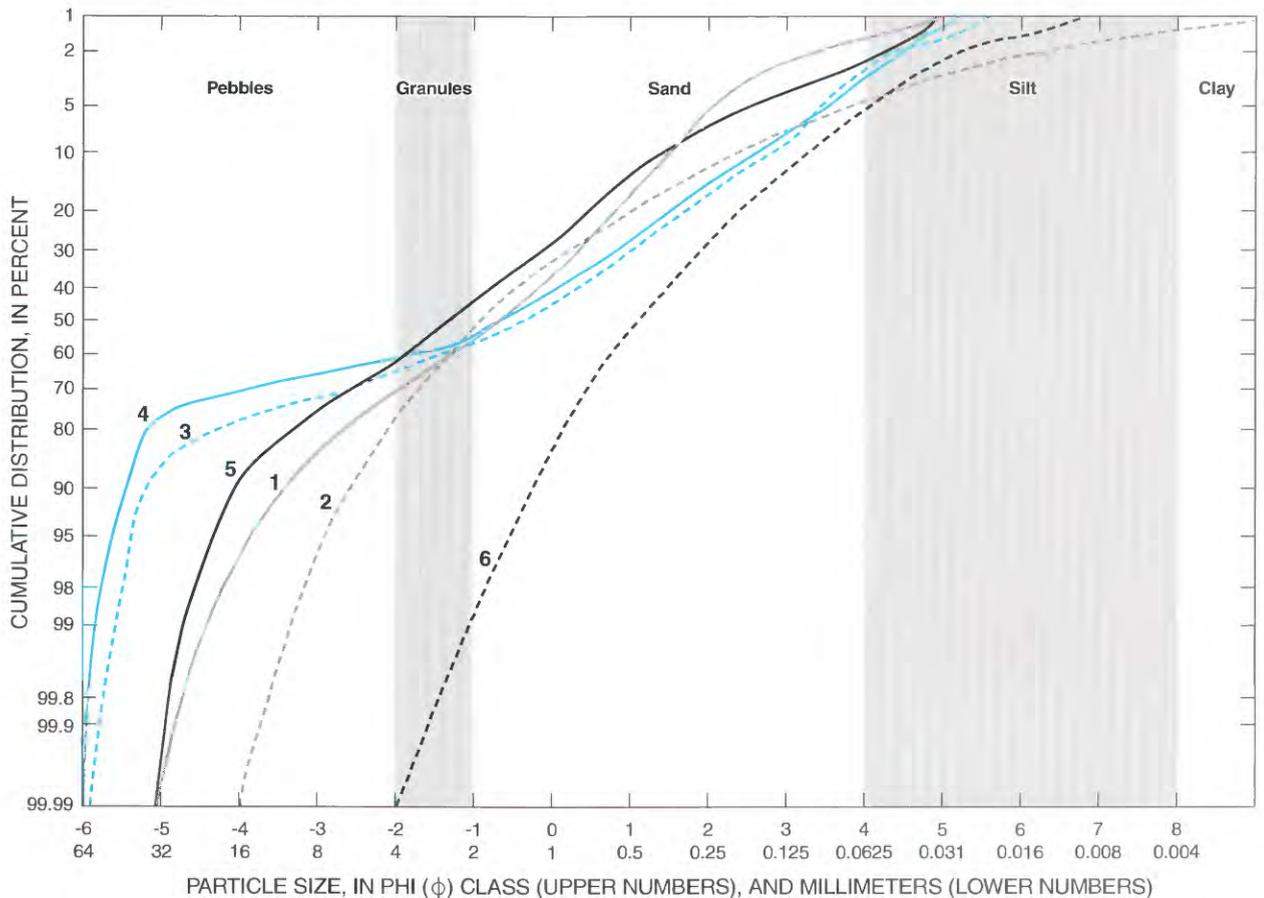
**Figure 47.** Cumulative distribution of particle sizes for samples of sediment deposits, Ophir Creek Basin, western Nevada. Numbers 1–6 are sample numbers (collection sites shown in fig. 43). Particle-size information in tables 8, 9, and appendix C.

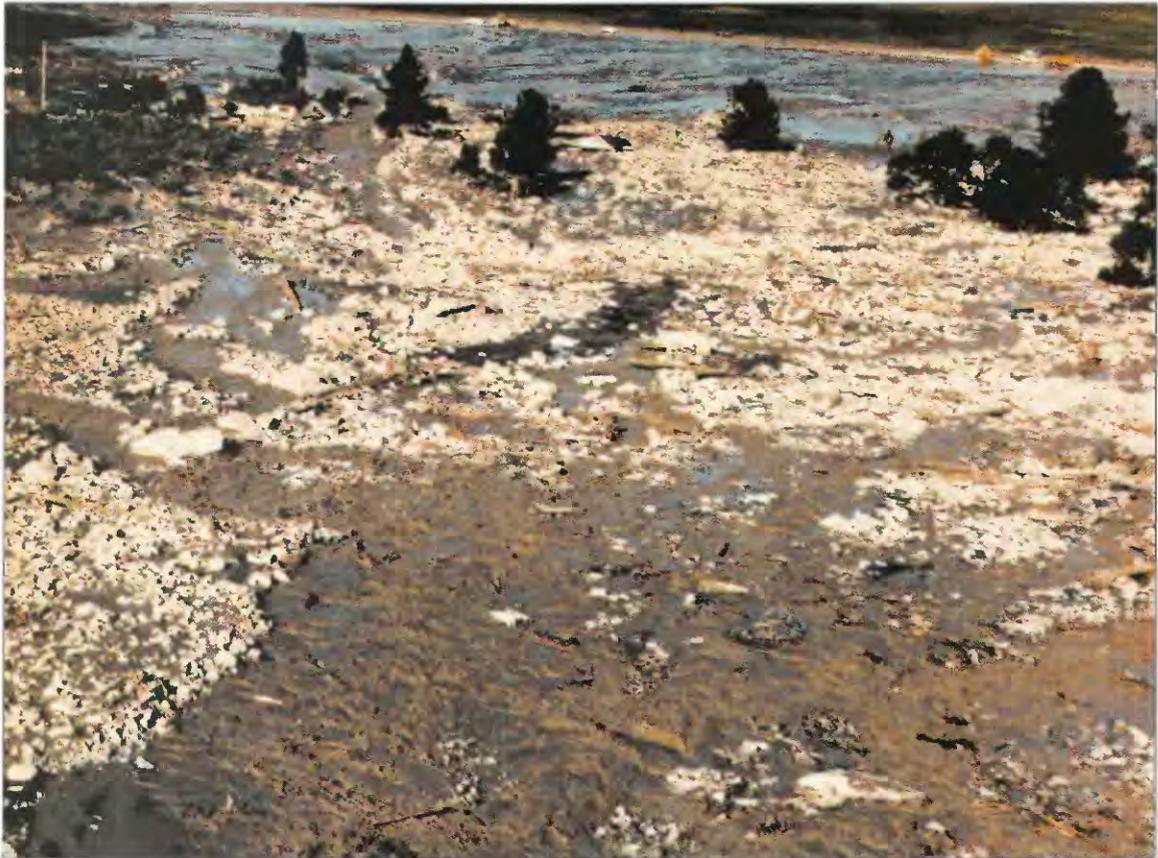
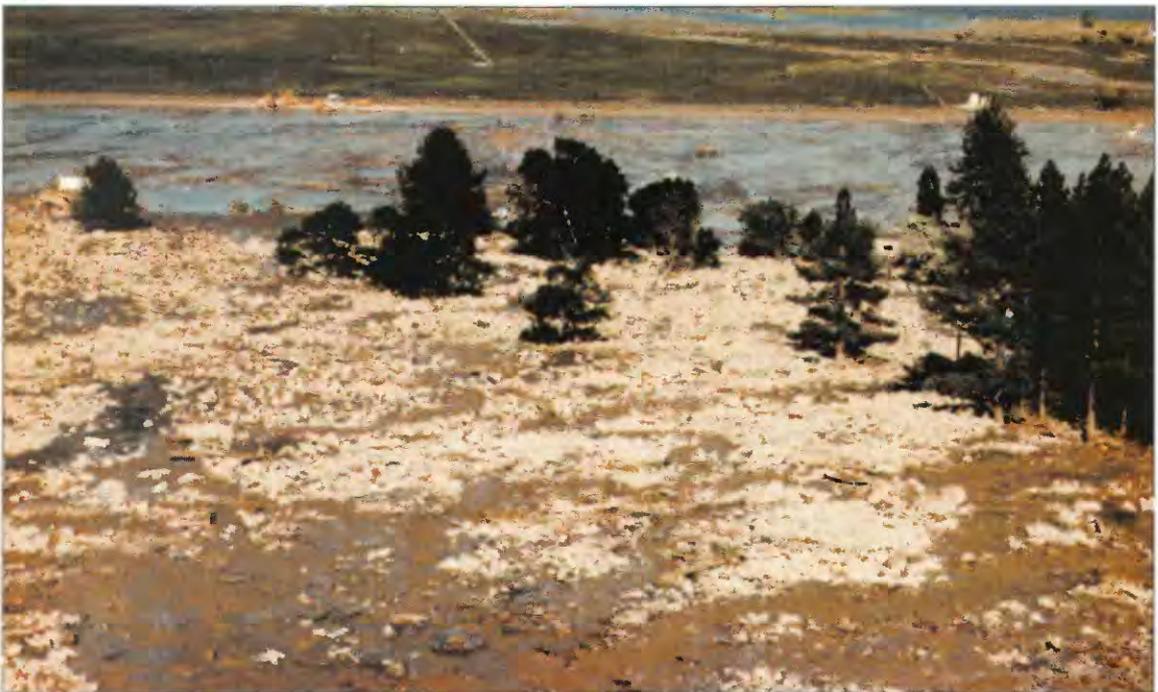
**Figure 48.** Northeastward panorama of boulder- and tree-laden sediment deposits interlaced by recessional Ophir Creek floodflow, at and downstream from Old Highway 395, western Nevada. *A*, Turek home at top left and Cline home near top center. *B*, Part of Cline property at extreme left and Stafford home behind trees at right. Oblique aerial photographs taken by Washoe County Sheriff's Department during afternoon of May 30, 1983.

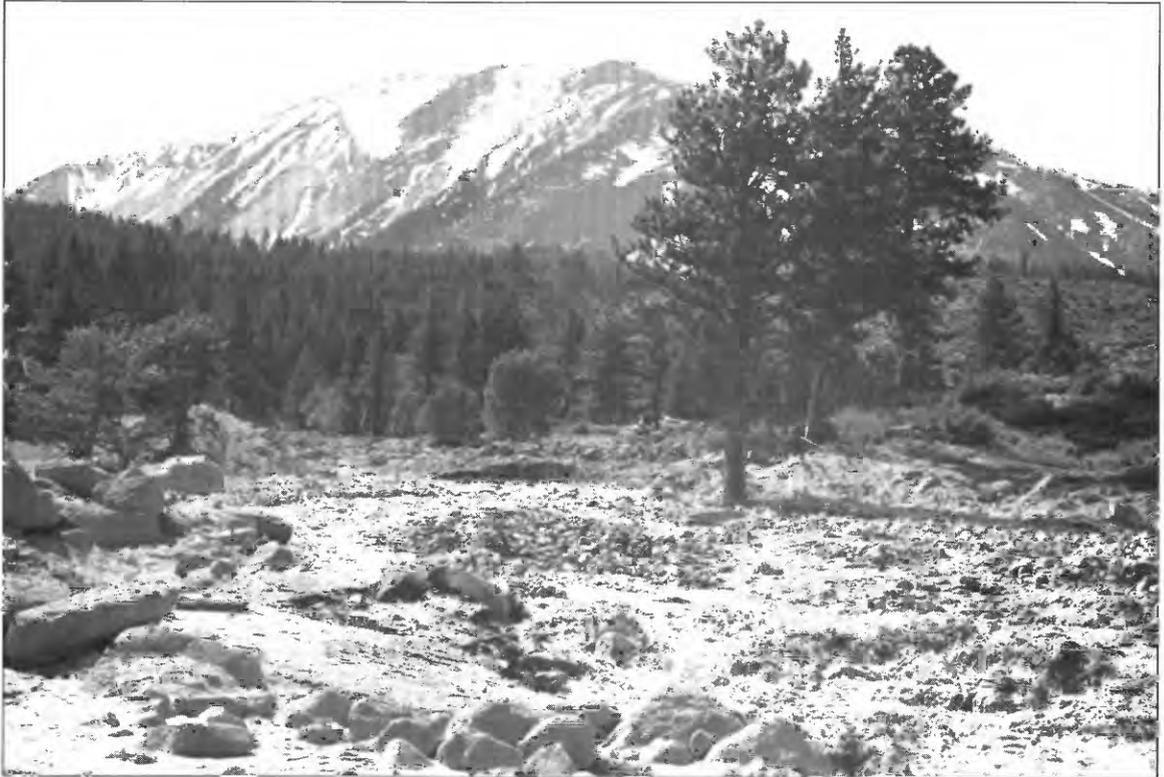
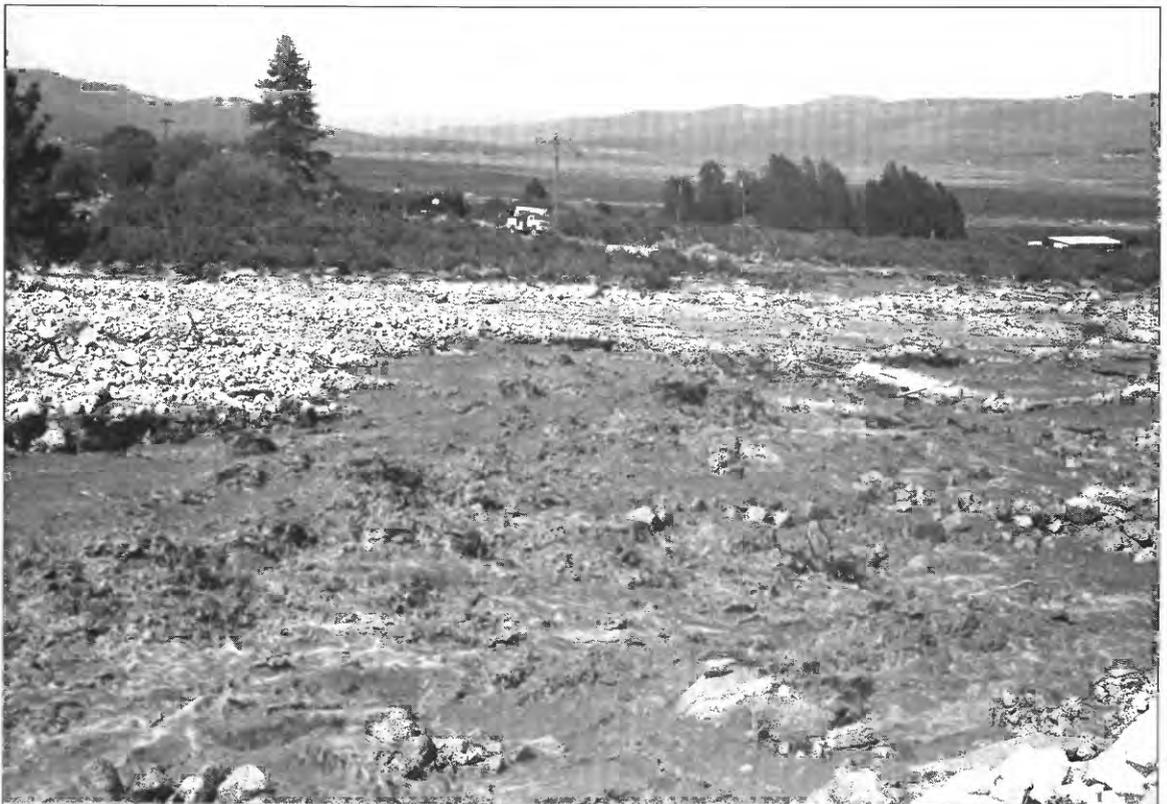
**Figure 49.** The continuation of recessional Ophir Creek floodflow on the afternoon of May 31, 1983, about 27 hours after the peak-flood surge. *A*, Upstream view. *B*, Downstream view, about 100 yards upstream from Old Highway 395, western Nevada. Photographs by Patrick A. Glancy.

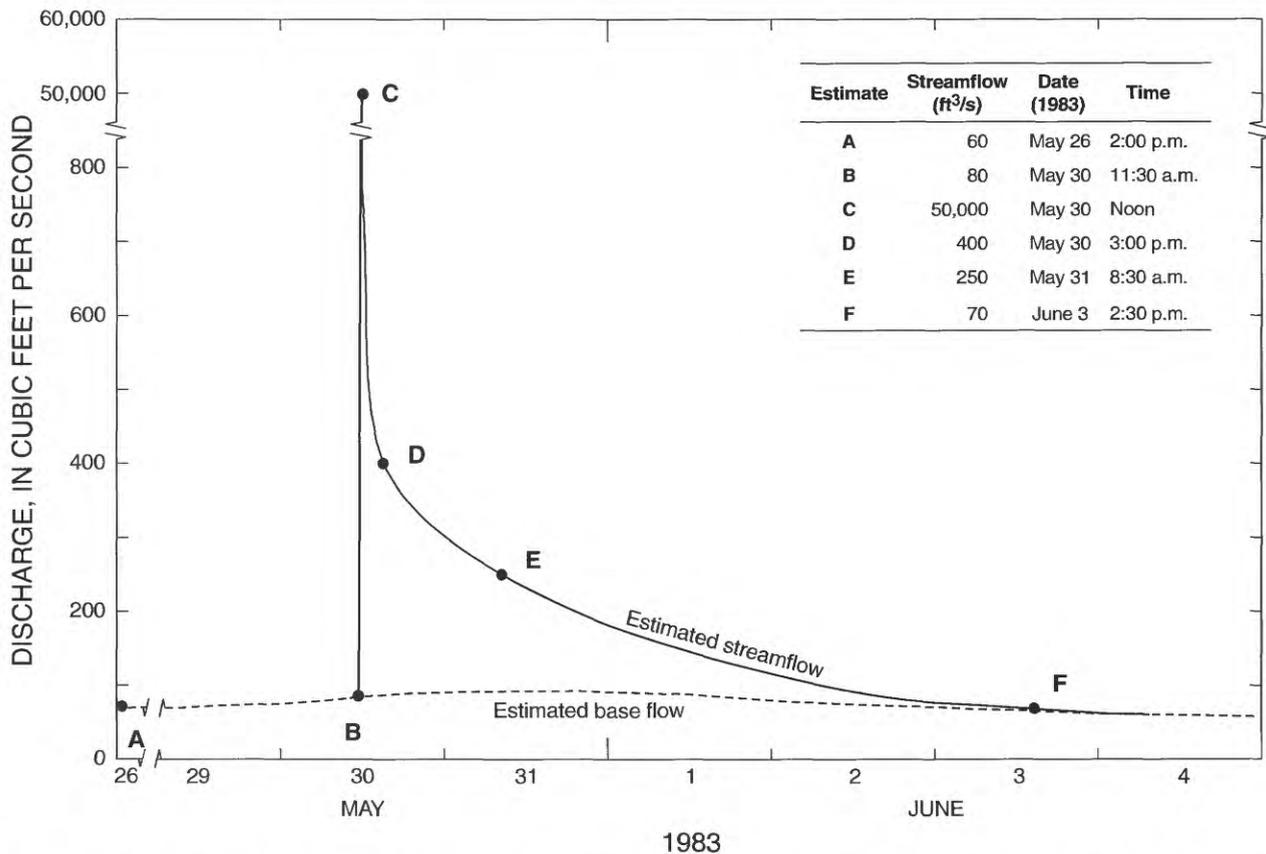
**Figure 50.** Synthetic hydrograph of 1983 Ophir Creek flood, western Nevada. Abbreviation: ft<sup>3</sup>/s, cubic feet per second. Estimate sources: A, Michael Widmer, Washoe County Public Works Department; B, authors; C, indirect measurements by U.S. Geological Survey staff; D, Otto Moosburner, U.S. Geological Survey; E, Otto Moosburner and Robert R. Squires, U.S. Geological Survey; F, Washoe County Public Works Department and Robert R. Squires and Otto Moosburner, U.S. Geological Survey.

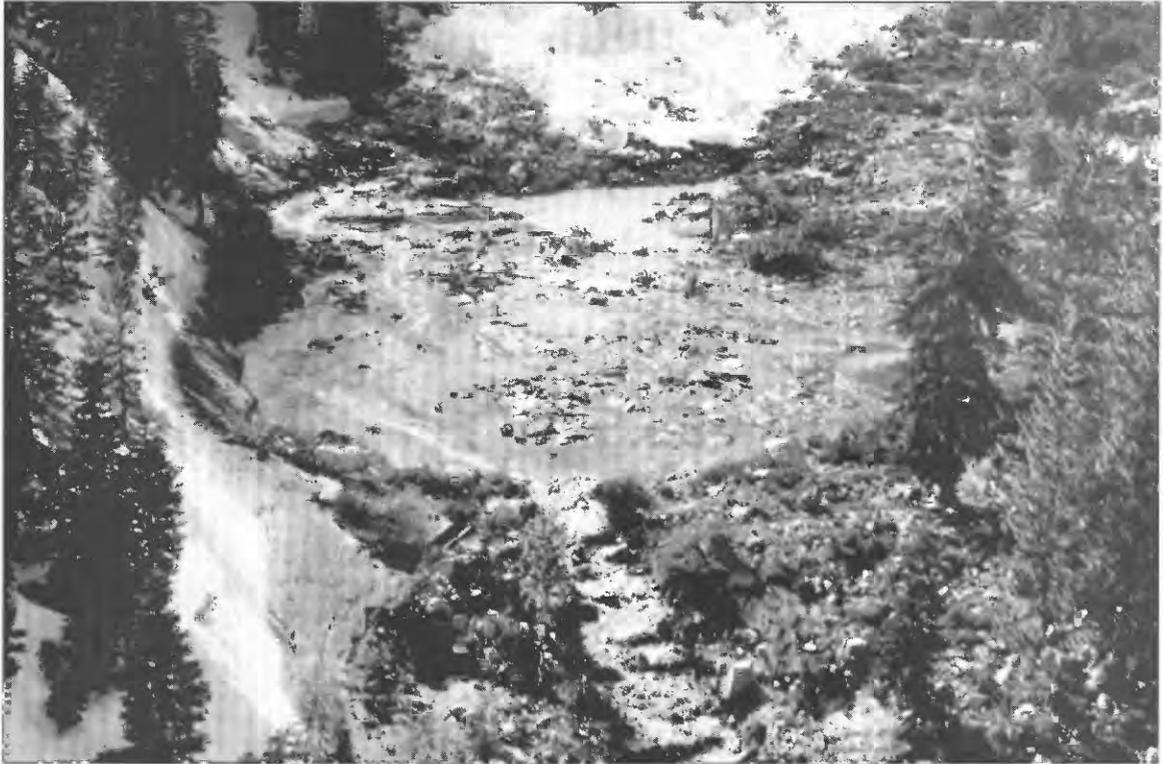
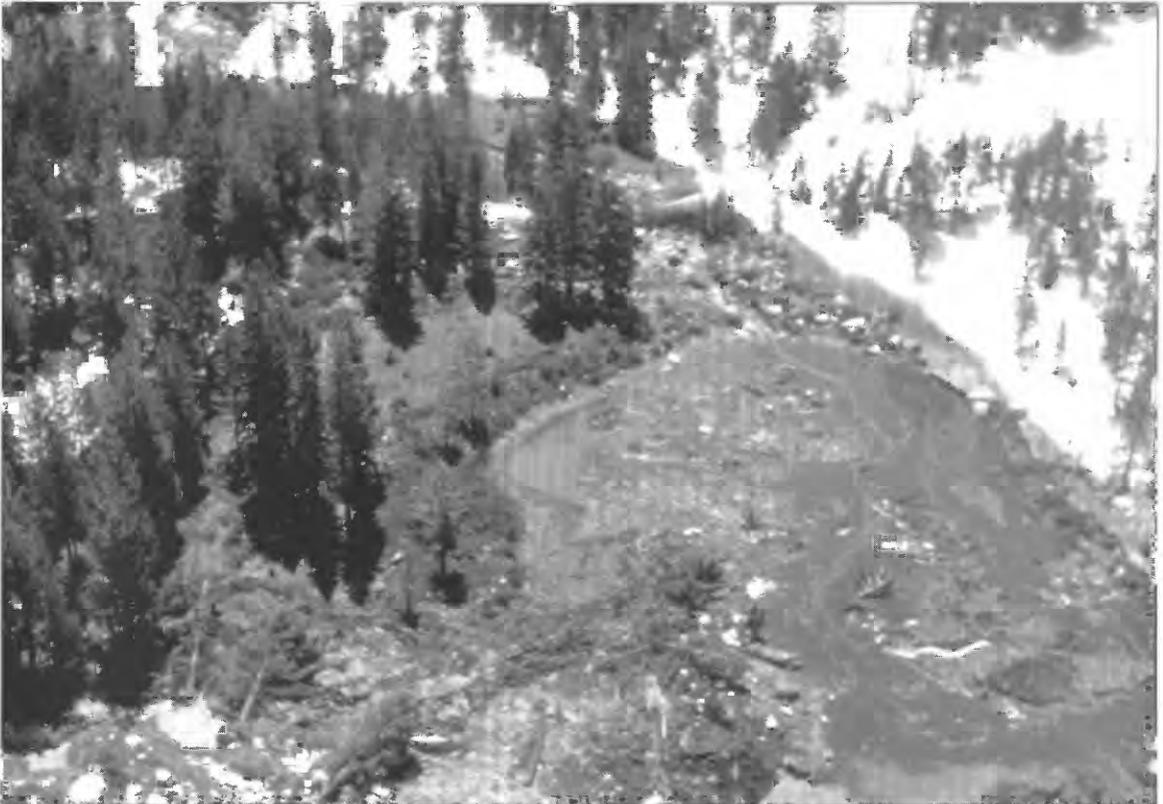
**Figure 51.** Oblique aerial views of the freshly drained bed of Upper Price Lake, Nevada. *A*, Upstream view photographed by Washoe County Sheriff's Department during mid-afternoon, May 30, 1983. *B*, Downstream view photographed by R.L. Jameson, U.S. Forest Service during mid-morning, May 31, 1983.

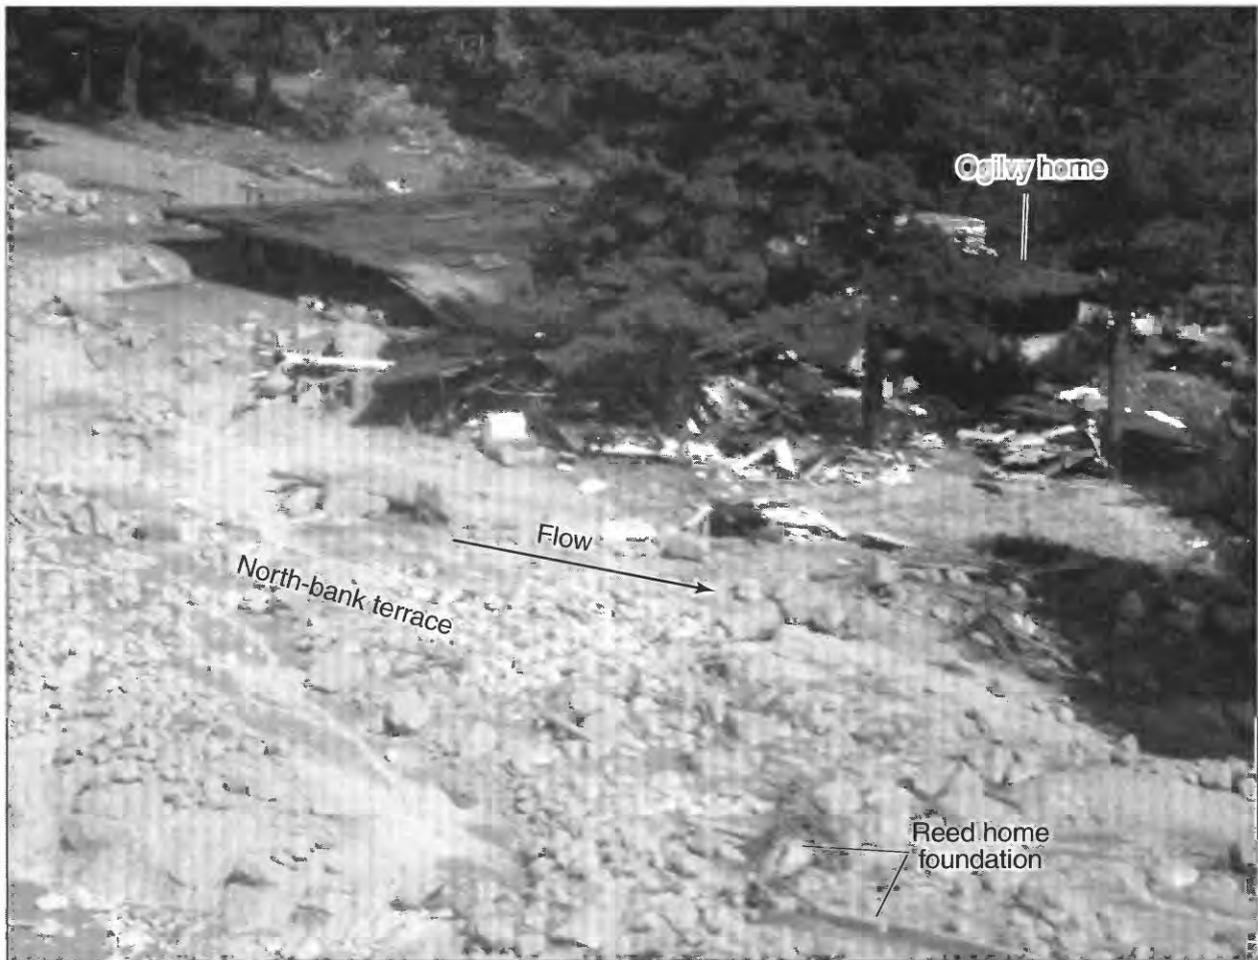
**Figure 52.** Mud-coated north-bank terrace of Ophir Creek just downstream from lower canyon mouth. Badly damaged Ogilvy home in background and foundation of destroyed Reed home at extreme lower right. Boulders covering terrace were deposited by May 30 flood. Oblique aerial photograph by Jon O. Nowlin, U.S. Geological Survey, June 3, 1983.

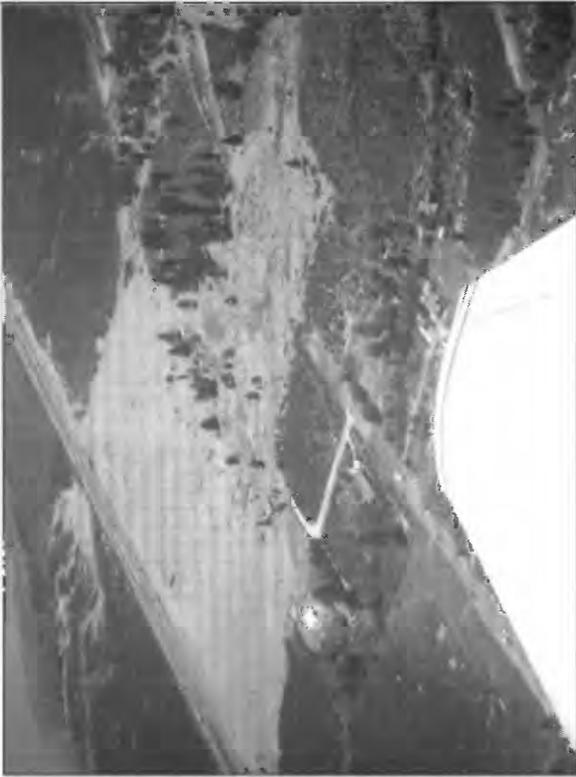
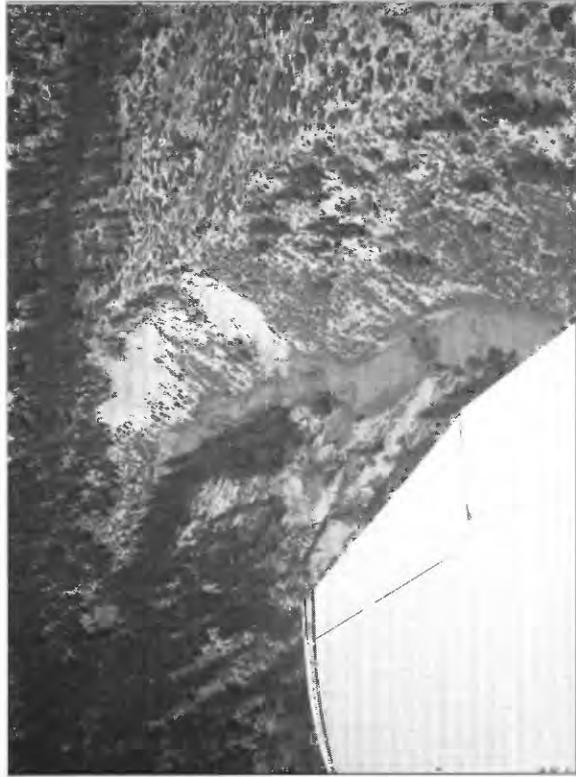
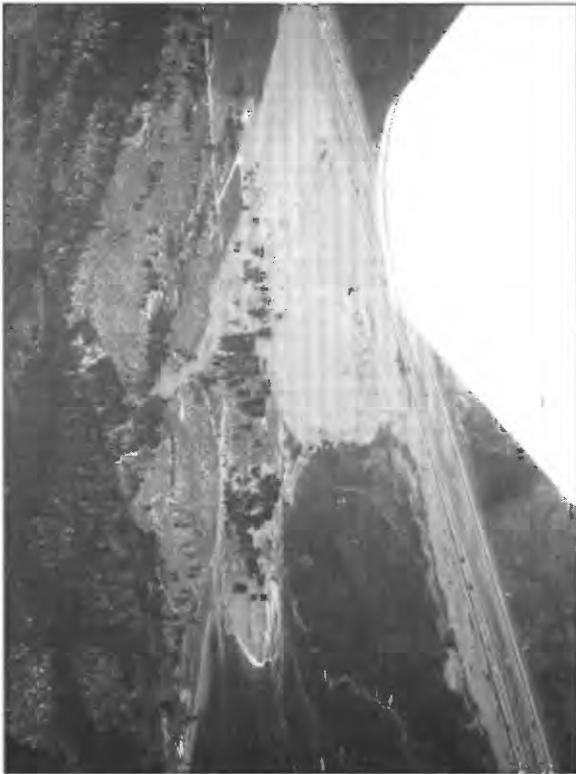
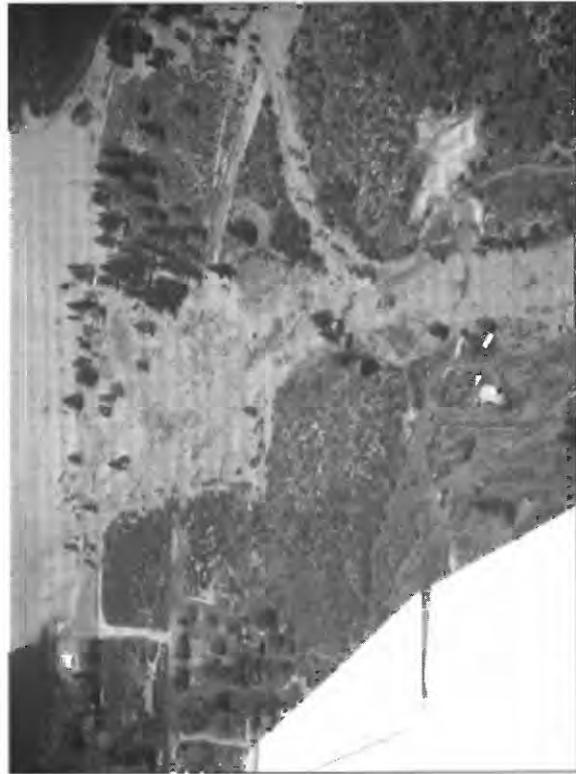
**Figure 53.** Oblique aerial views of Ophir Creek flood, western Nevada, photographed by Mrs. E.H. Thom, May 30, 1983, probably between 12:15 and 1:00 p.m. A, Northwestward, upstream view of alluvial fan. B, Southeastward, downstream view of alluvial fan. C, Eastward, downstream view of medial part of alluvial fan. D, Westward, upstream view of the lower canyon.

The duration of intense sediment transport is uncertain even though the onset is clearly documented by the timing of the arrival of the sediment-laden, leading, peak-flow surge. Oblique aerial photographs (fig. 53) taken by Mrs. E.H. Thom (app. B) show moderately turbulent, viscous, sediment-laden fluid with an overall appearance similar to pancake batter moving through the lower canyon and over the alluvial fan sometime between 12:15 and 1:00 p.m. (the leading flow surge arrived at Old Highway 395 at 12:02). By general appearances, described above, the fluid could be debris flow; if not, it was probably hyperconcentrated flow. Photographic resolution is inadequate to precisely verify the flow mode with confidence. The areally extensive sediment deposits on the Ophir Creek alluvial fan were largely emplaced before the times of these photographs. Therefore, sediment deposition at the time of Mrs. Thom's photographs presumably was mainly thickening the deposits. Sediment deposits in the photographs do not appear to have risen to a level of encroachment on the southbound (westward) lanes of the freeway, as ultimately occurred; southbound highway traffic appears to be moving freely, and at least half a dozen vehicles are parked on the west road shoulder. The leading flow front had likely reached and passed the site where the vertically standing flow front was photographed by Reed Dopf (fig. 39).

Mrs. Thom's photographs of the lower canyon and the proximal and medial parts of the alluvial fan clearly show that the flood is in recession and that flow

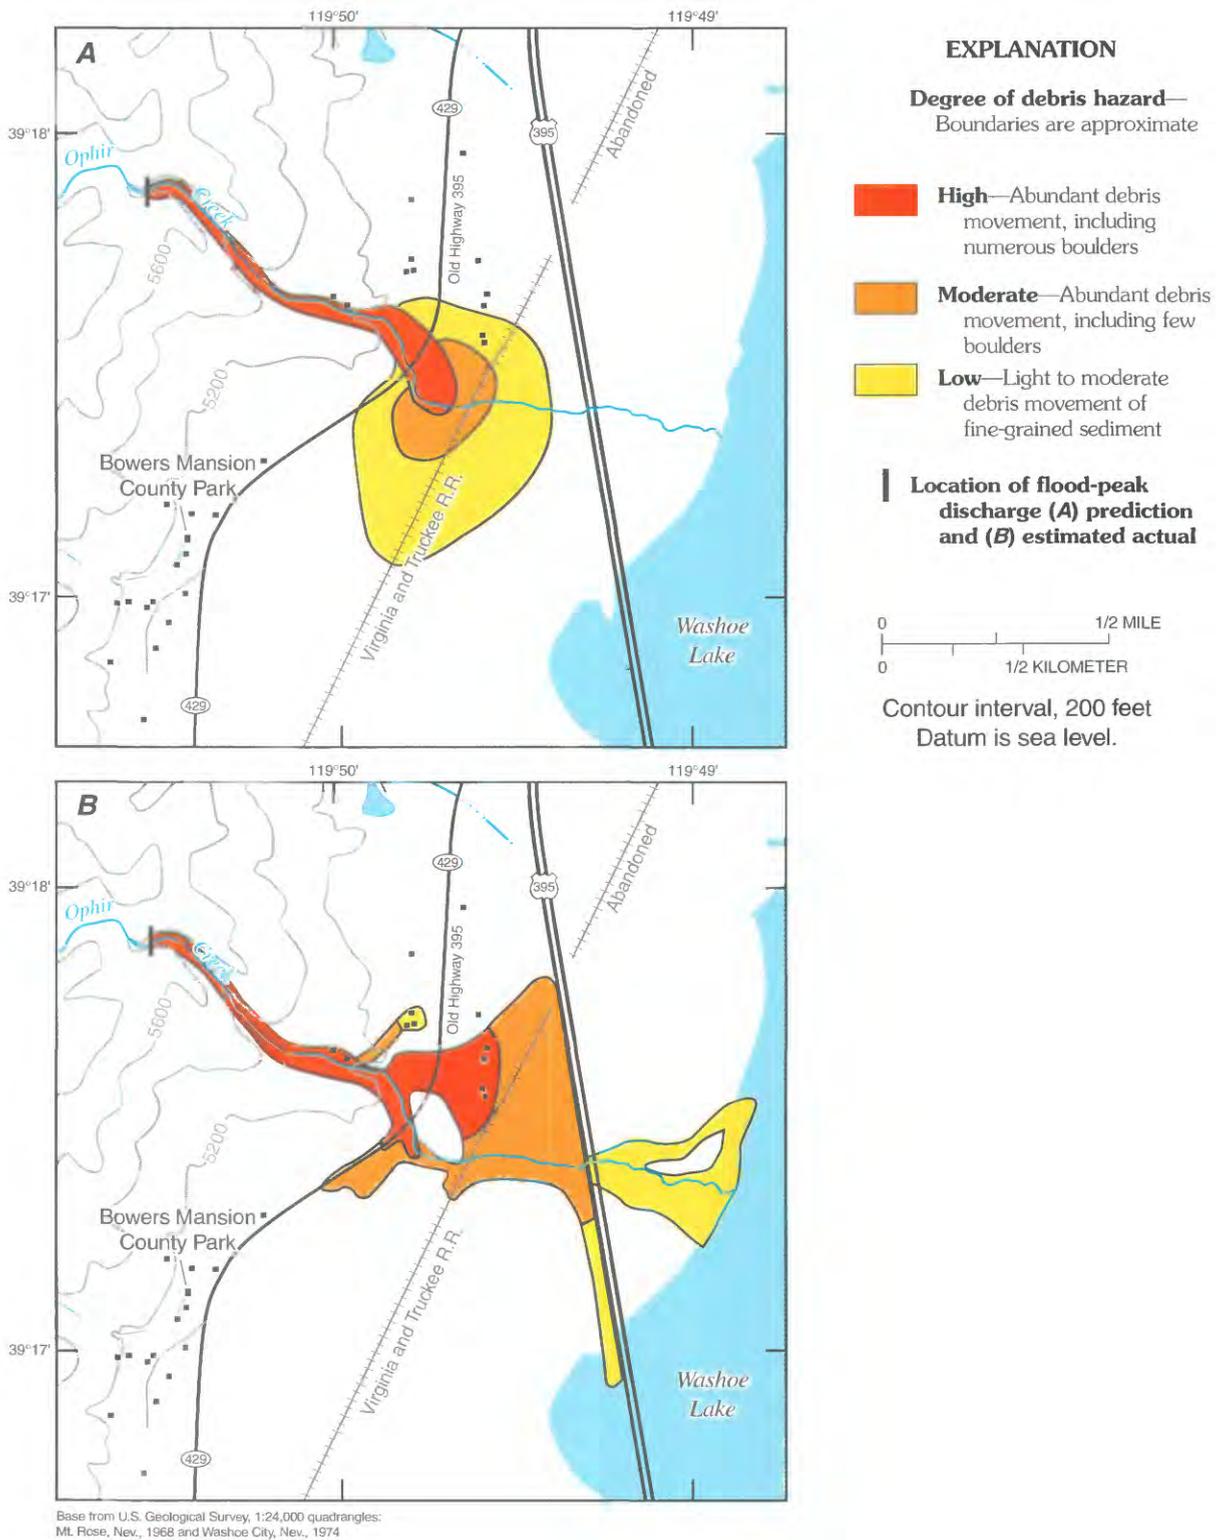
**Figure 54.** Fluvial-debris hazards on the Ophir Creek alluvial fan, western Nevada: A, As predicted by Glancy and Katzer (1977); flood peak, 2,000 ft<sup>3</sup>/s. B, As realized during the May 30, 1983, flood; estimated flood peak, 50,000 ft<sup>3</sup>/s. Abbreviation: ft<sup>3</sup>/s, cubic feet per second.

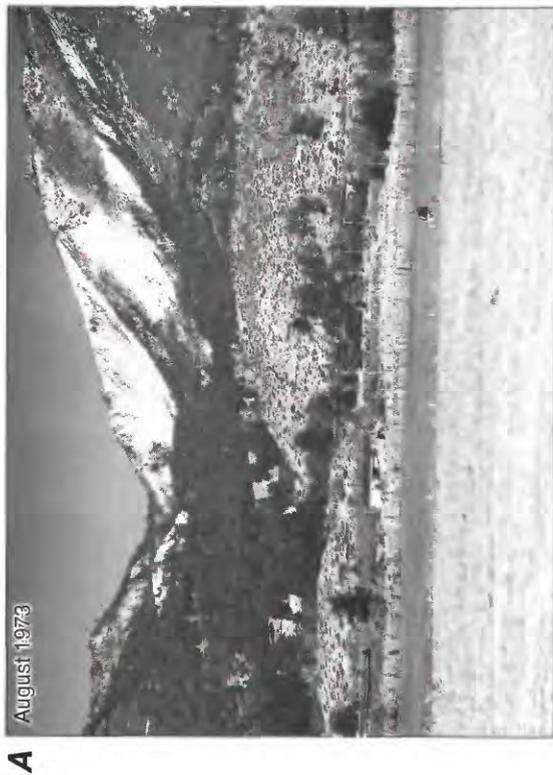
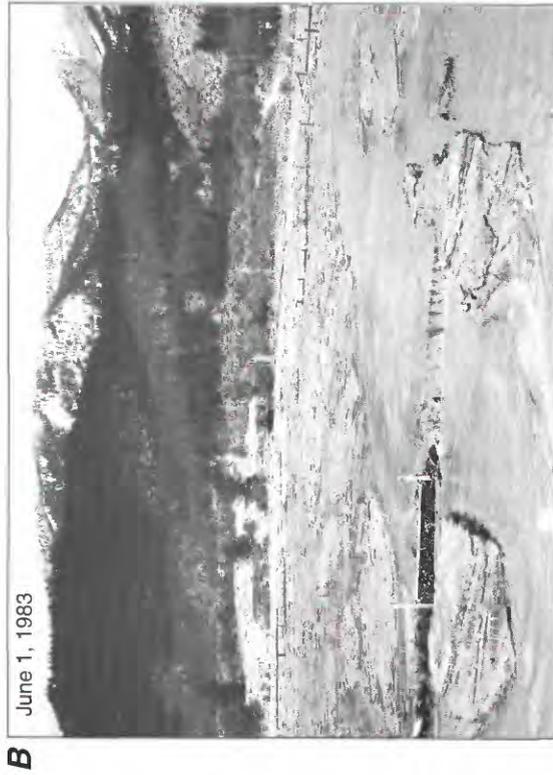
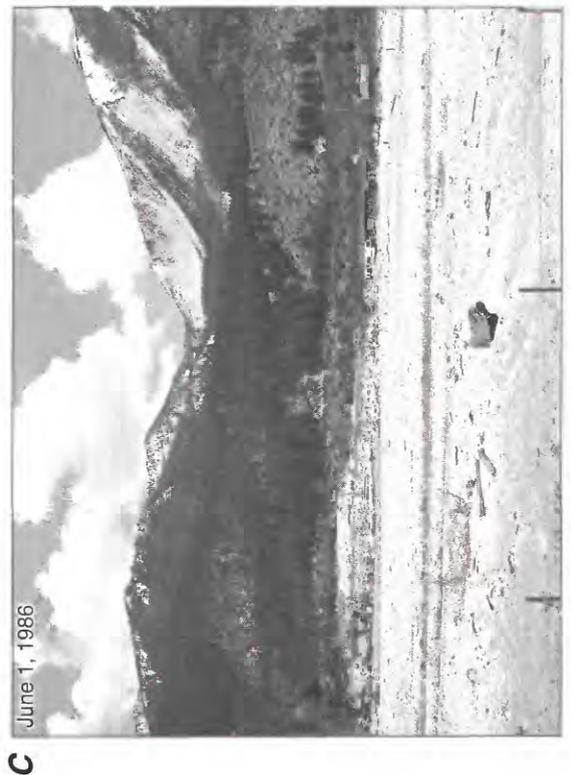
**Figure 55.** Similar upstream views of Ophir Creek alluvial fan from U.S. Highway 395 freeway, western Nevada. *A*, Irrigated pastureland before the flood, late August 1973. *B*, Barren deposits after flood, June 1, 1983. *C*, Sparse beginning of vegetation on fan deposits, June 1, 1986. *D*, Noticeably thickening vegetation on surface, August 31, 1988. *E*, Progressive thickening and growth of vegetation, June 1, 1990. *F*, Healthy growth of dominantly rabbitbrush, May 31, 1992. *G*, Shrub-dominated, nonirrigated surface on May 30, 1993. Cline home at left center and Turek home near center in *A*, *B*, and *C*; replacement for flood-destroyed Cline home at extreme left in *C* and near center in *D*. 1983 landslide area occurred at extreme left of barren face of Slide Mountain. Photographs by Patrick A. Glancy.

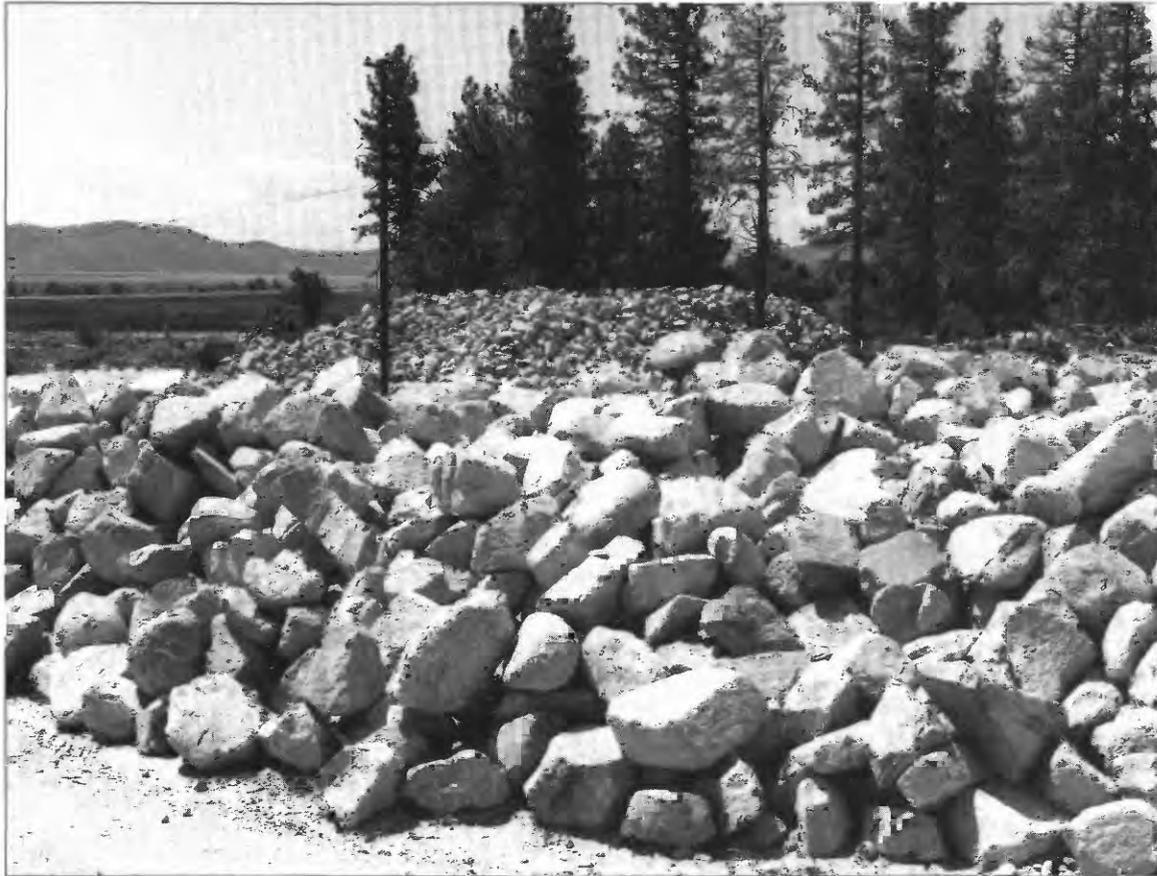
**Figure 56.** Debris deposited on Stafford property by 1983 Ophir Creek flood, western Nevada. Deposits are being excavated and size sorted for commercial use, June 23, 1992. Photograph by Patrick A. Glancy.

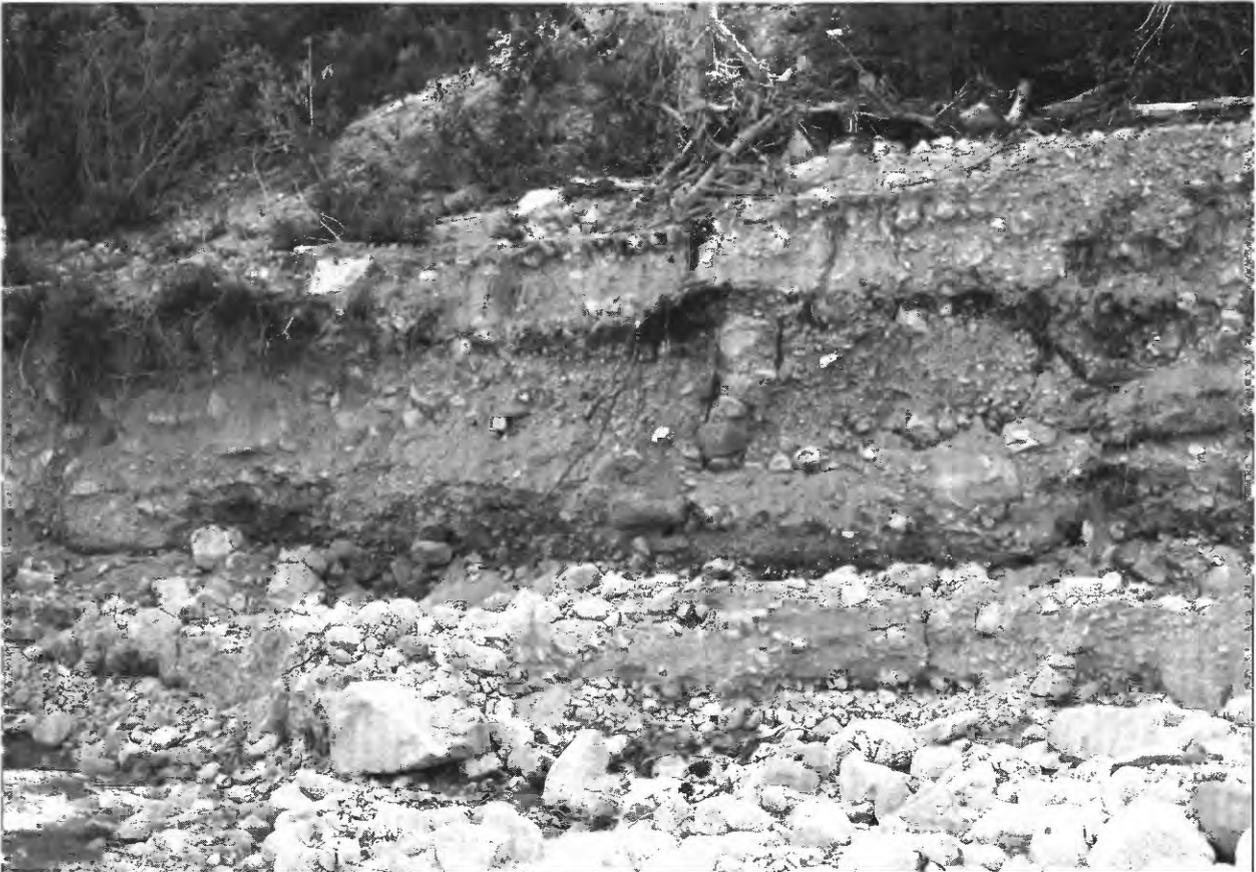
**Figure 57.** Old fluvial deposits near the lower canyon mouth of Ophir Creek, western Nevada, which were exhumed by the 1983 flood. Note dark organic-rich zones exposed within the vertical stream bank—one about a foot above the present streambed, the other about a foot below land surface. Photographed by Patrick A. Glancy on September 8, 1983.
