# **Response of the Upper Animas River Downstream from Eureka to Discharge of Mill Tailings**

By Kirk R. Vincent and John G. Elliott

**Integrated Investigations of Environmental Effects of Historical  
Mining in the Animas River Watershed, San Juan County, Colorado**

Professional Paper 1651

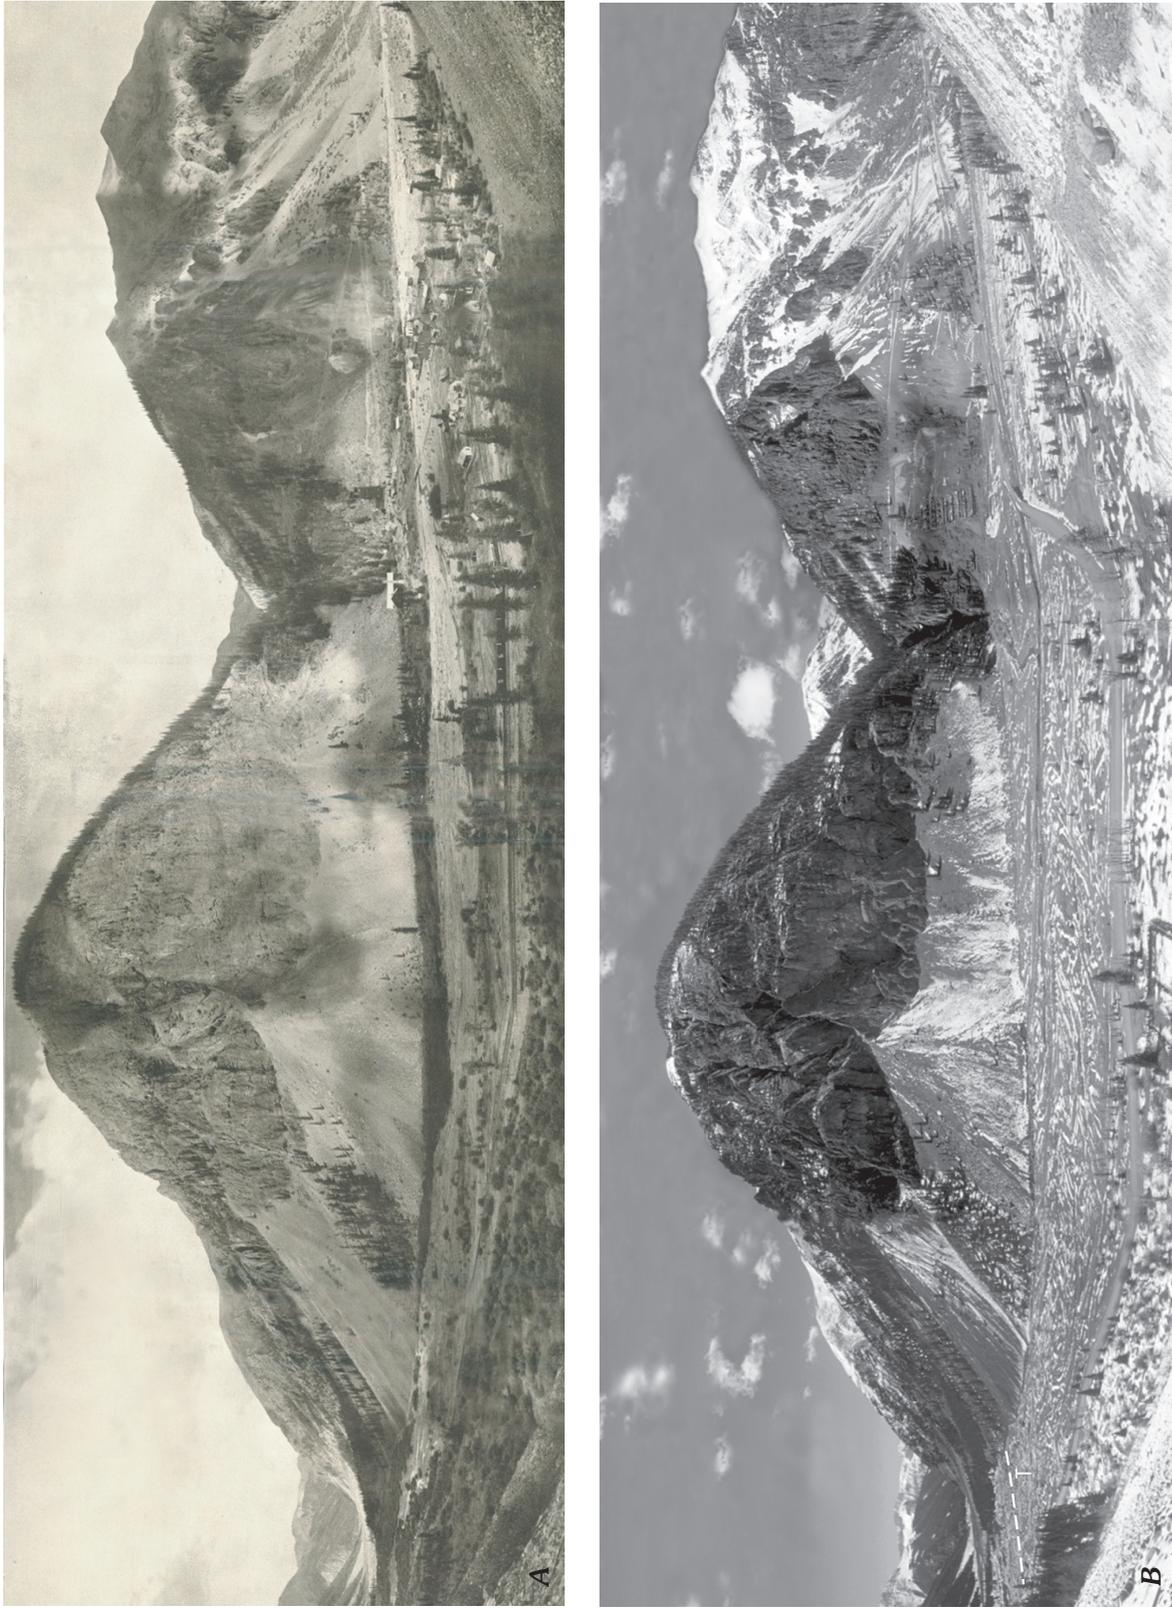
**Figure 2.** Panoramic photographs of Animas River valley near Eureka; mouth of Eureka Gulch visible right of center and Howardsville just out of sight down valley on extreme left. In center of photographs, view looks west. Upper photograph (A) was taken by an unknown photographer in or before 1904 and was published by the *Silverton Standard* (1904). It is provided here courtesy of William Jones. Note buildings of Sunnyside Mill # 2 (AMLI site # 165) and town of Eureka right of center and Silverton Northern train in center foreground. Lower photographic mosaic (B) was taken in 2001 by Kirk Vincent. Our reach B dominates the photograph, and lower portion of reach A is visible on far right. Dashed line and T, location of trench (pl. 6).

We excavated a trench (pl. 6) across the alluvial valley bottom in order to understand from a stratigraphic point of view the following: the prehistorical nature of the Animas River, the historical changes in that system, and the chemistry of fine-grained sediment deposited in the distant and recent past. The location of the trench was at the downstream end of reach B, as indicated in figures 1, 2, 3, and 4B.

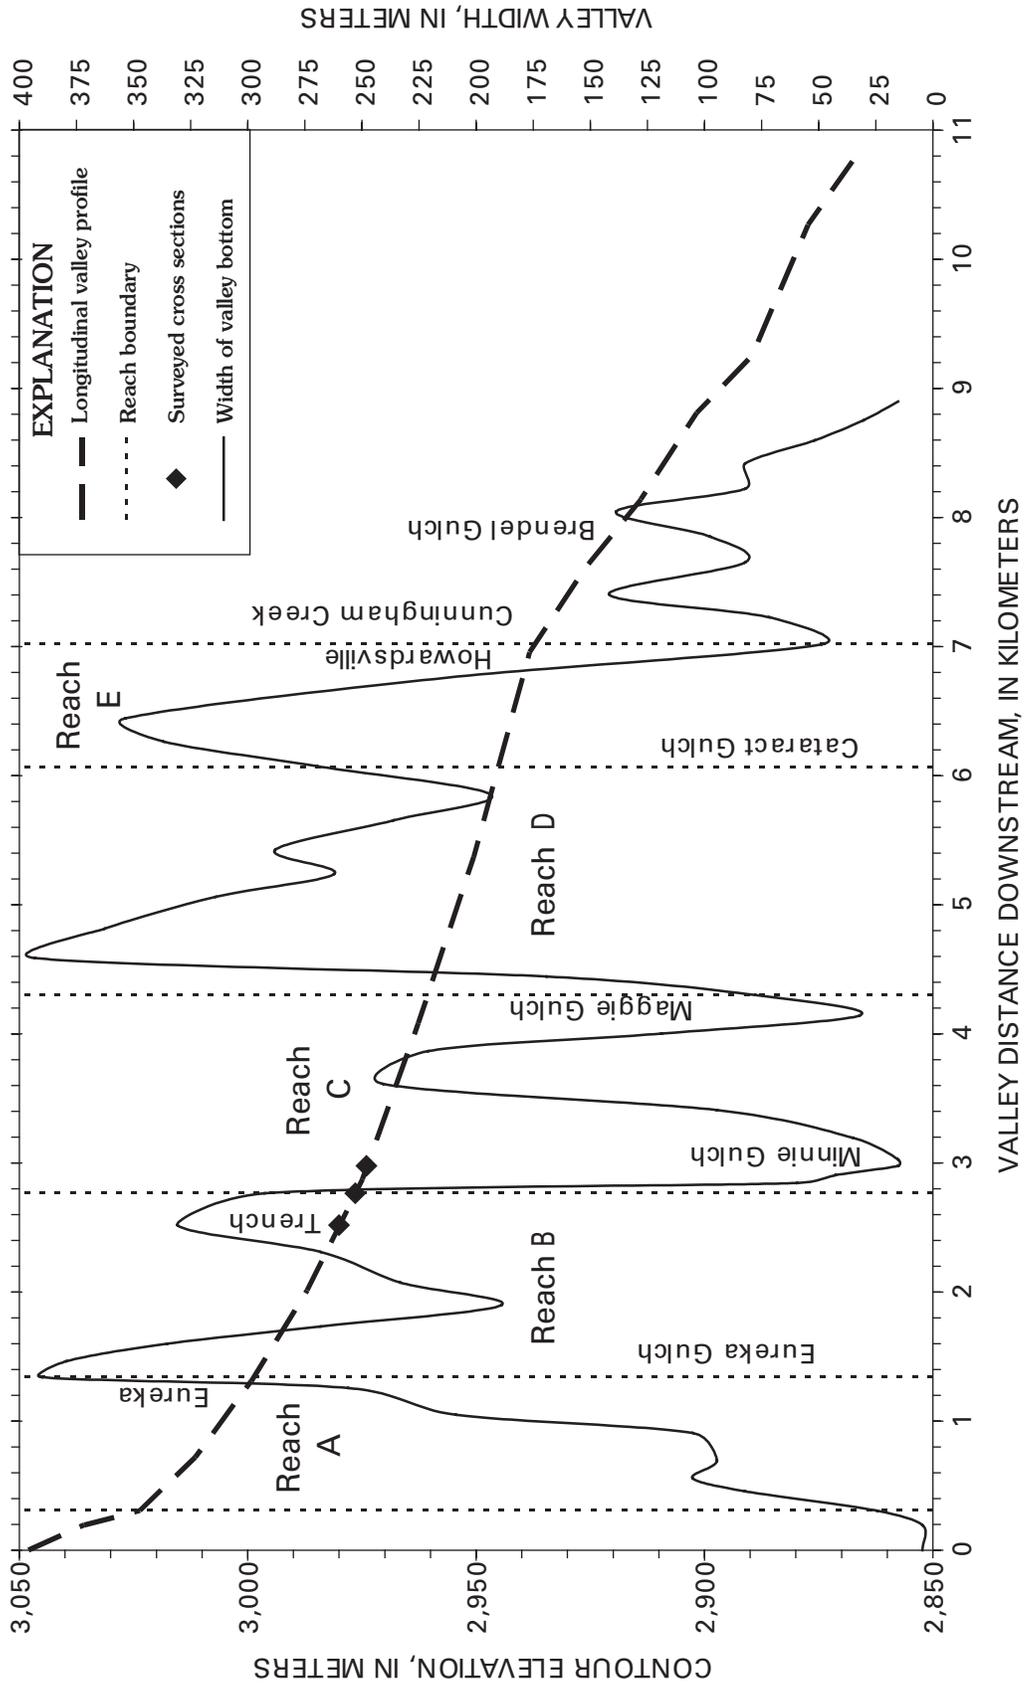
**Figure 3.** Longitudinal profile of upper Animas River study reach, showing the gradient, locations of lettered reaches and the trench (pl. 6), and the spatial variation in width of the valley floor.

A second major pattern is the systematic change in valley gradient. The longitudinal profile of the study reach is fairly smooth and is concave-up (fig. 3), with gradients decreasing down valley from 0.029 m/m in the reach just upstream of the Eureka townsite to 0.008 m/m in the reach at Howardsville. Upstream of the study reach, the river emerges from a steep bedrock canyon, and downstream of Howardsville the river enters another constricted bedrock canyon. Thus, outside of the alluvial study reach the river is bedrock controlled. Inside our study reach the stream has formed itself within its own alluvium (not bedrock controlled), and the stream gradient is not influenced in a major way by the presence of the debris fans. By that we mean there are no inflections in the profile coincident with the debris fan constrictions (fig. 3). In narrower valleys in the region, such as Cement Creek (Vincent and others, this volume), debris fan constrictions have forced the main stream to aggrade upstream of them. This resulted in a segmented longitudinal profile, with the main stream being steep and the streambed being coarse grained on the downstream sides of tributary debris fans. Although the valley gradient was not obviously influenced, the fan constrictions have two consequences. First, the width of any braiding (past or present) was restricted by the narrow space available at the fan constrictions. Second, flow in the wide reaches during major floods must converge as it enters the narrow reaches. This is a partial explanation of the channel patterns as they were in 1998, and in 1951 (fig. 4). The channel was braided with low banks in reaches A and B near Eureka, was confined to a single- or double-thread channel adjacent to the Minnie Gulch and Maggie Gulch debris fans, and was multi-threaded with relatively prominent banks downstream from both fans. The reaches are now discussed individually.

What we refer to as reach A (figs. 3 and 4A) heads at the base of a waterfall in a constricted canyon and extends downstream approximately 0.7 km, past the Eureka townsite, to the Eureka Gulch confluence. The valley floor in reach A is relatively narrow (mean width 170 m) and steep (mean valley slope 0.025 m/m), and the longitudinal profile is strongly concave-up (fig. 3). Elsewhere herein we present evidence

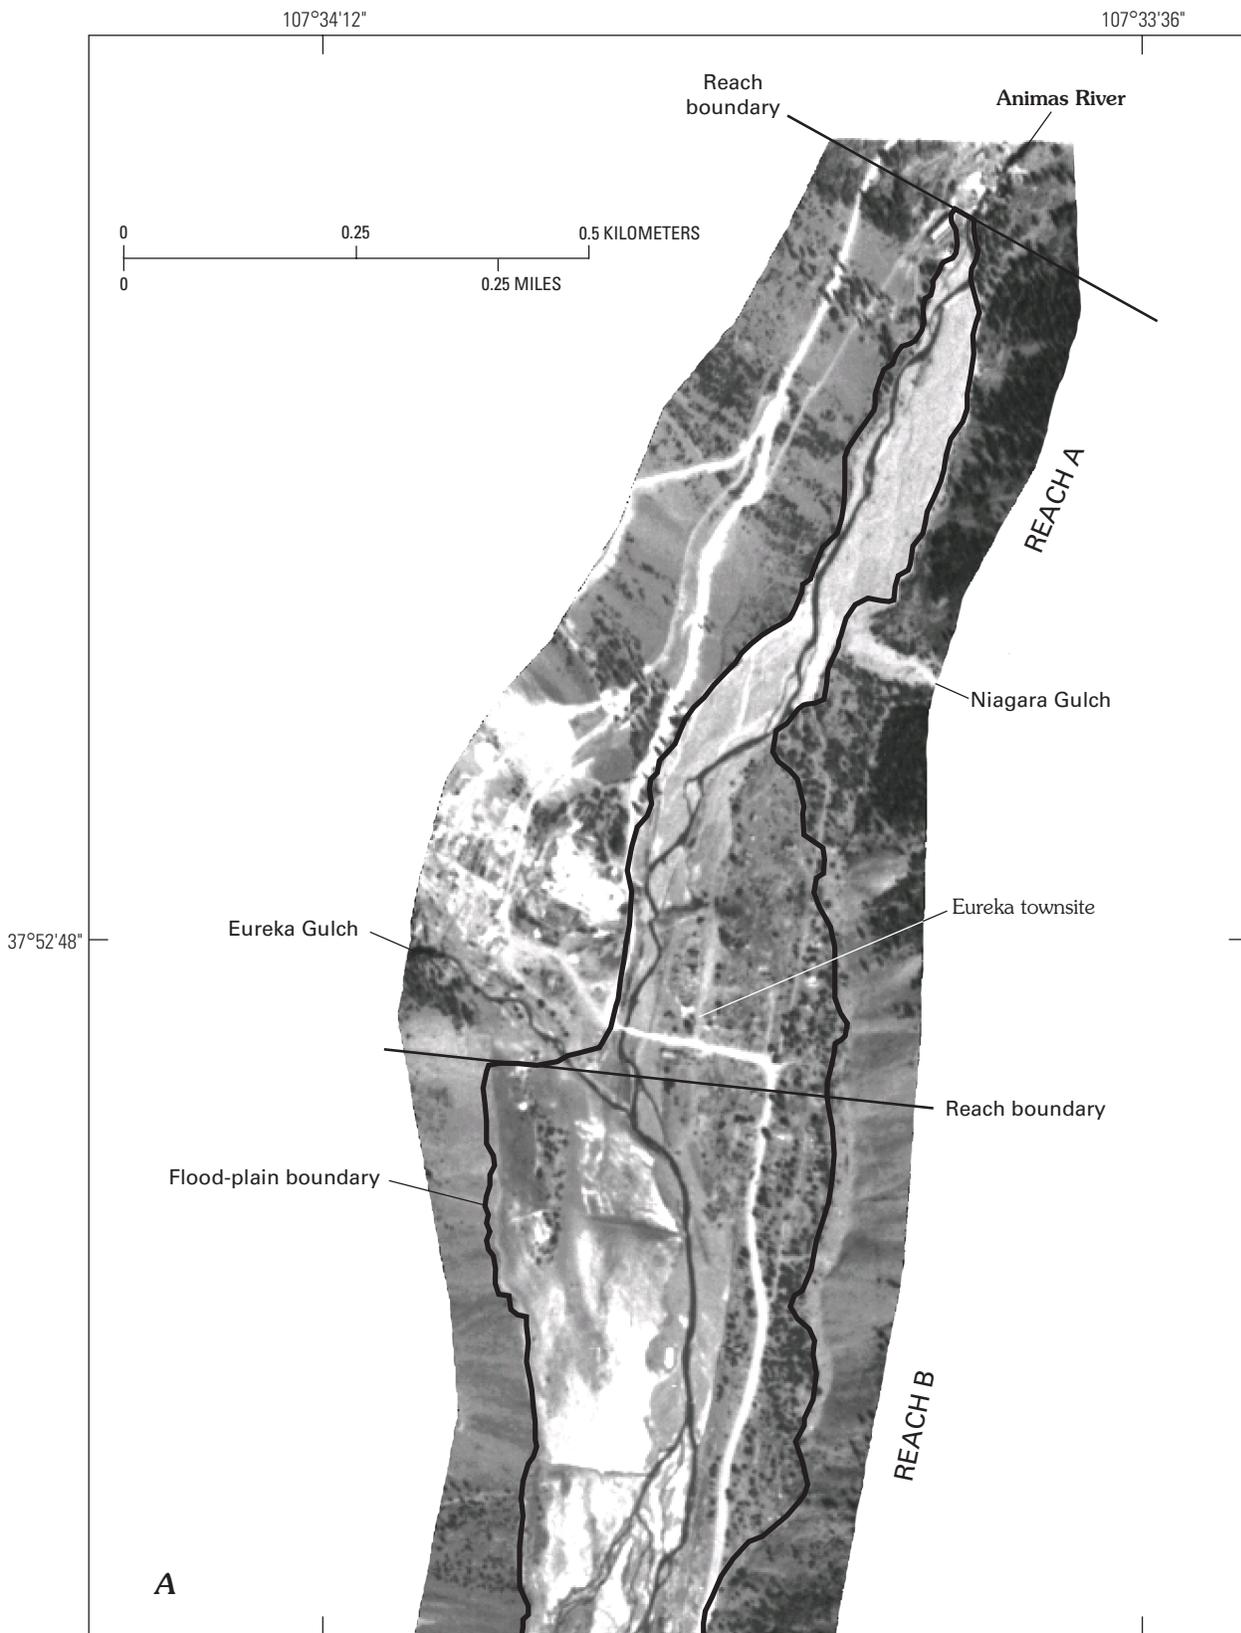
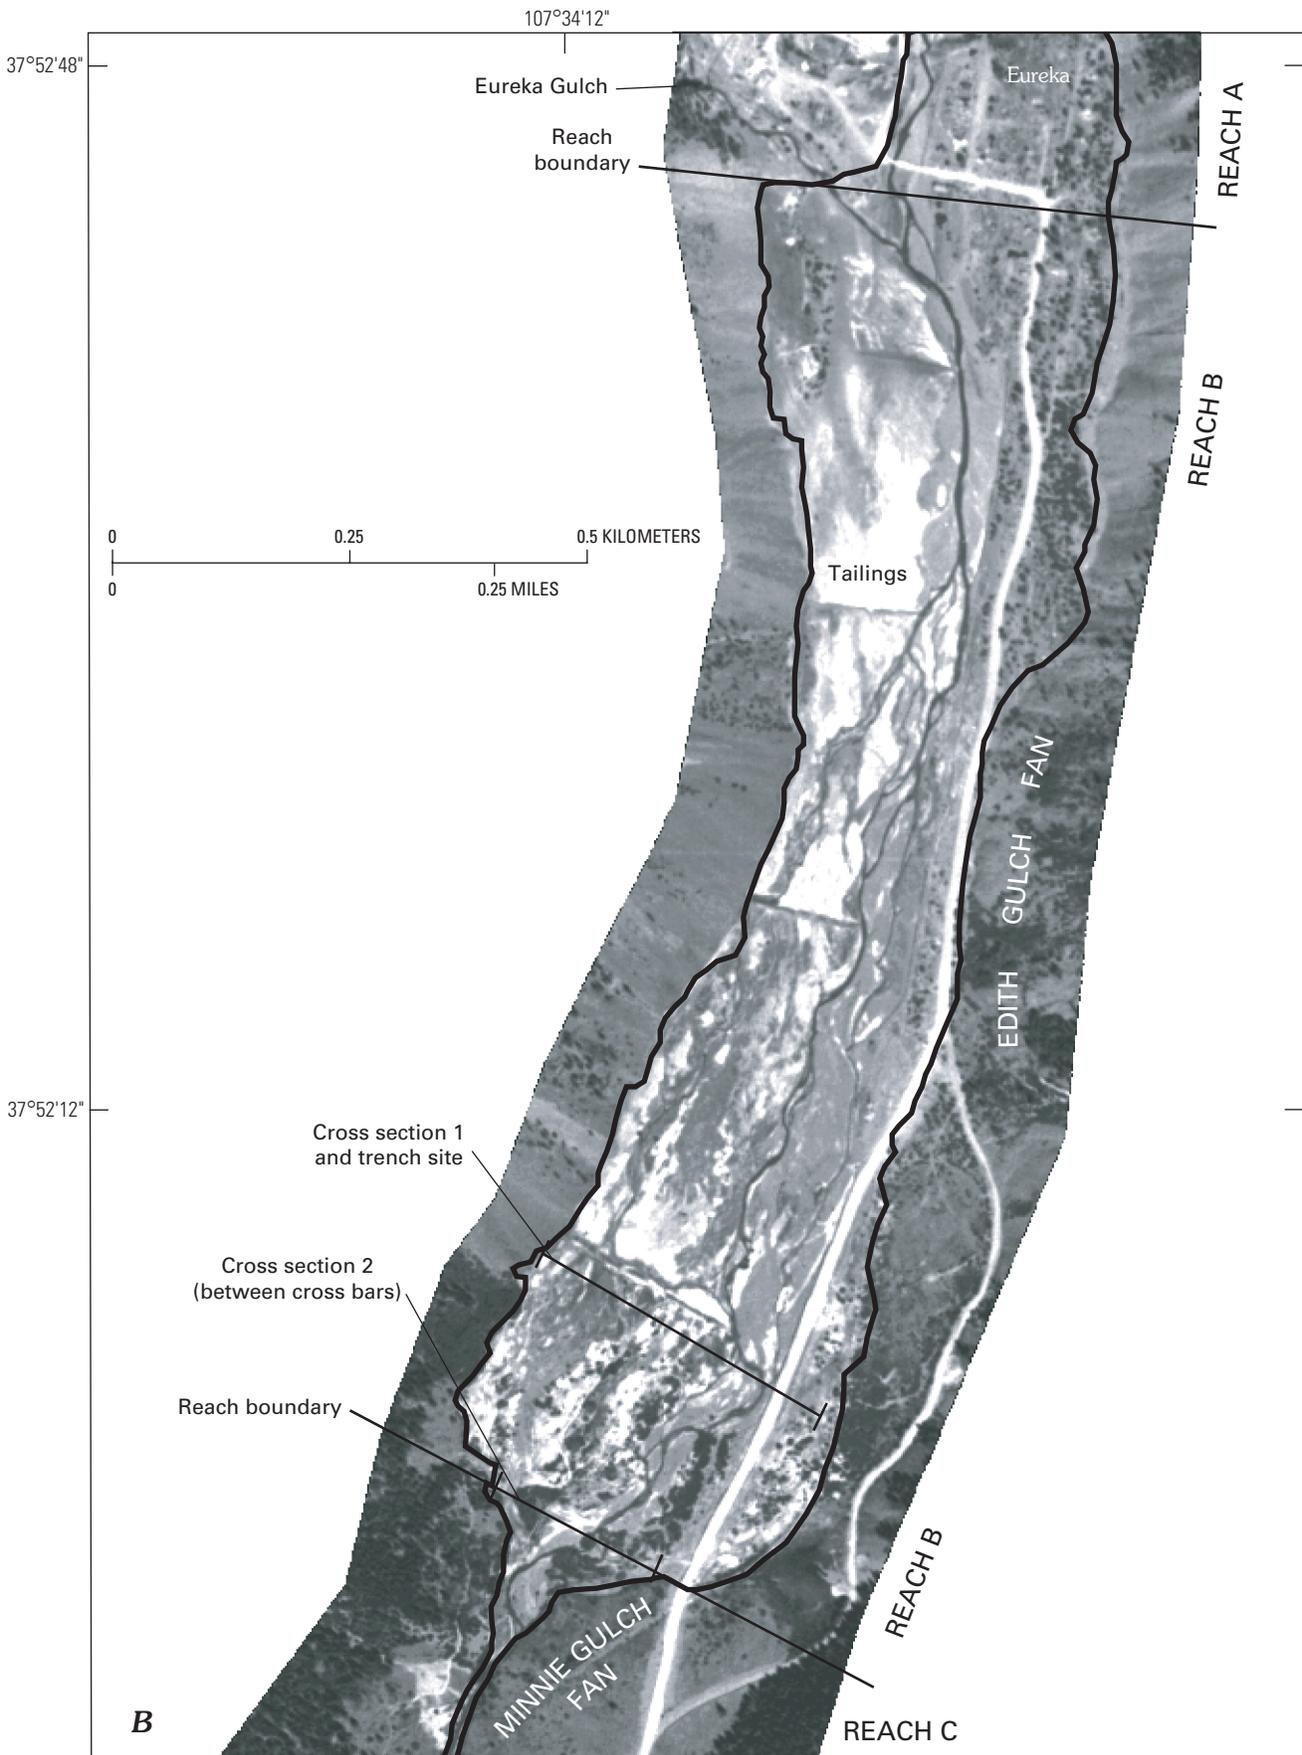
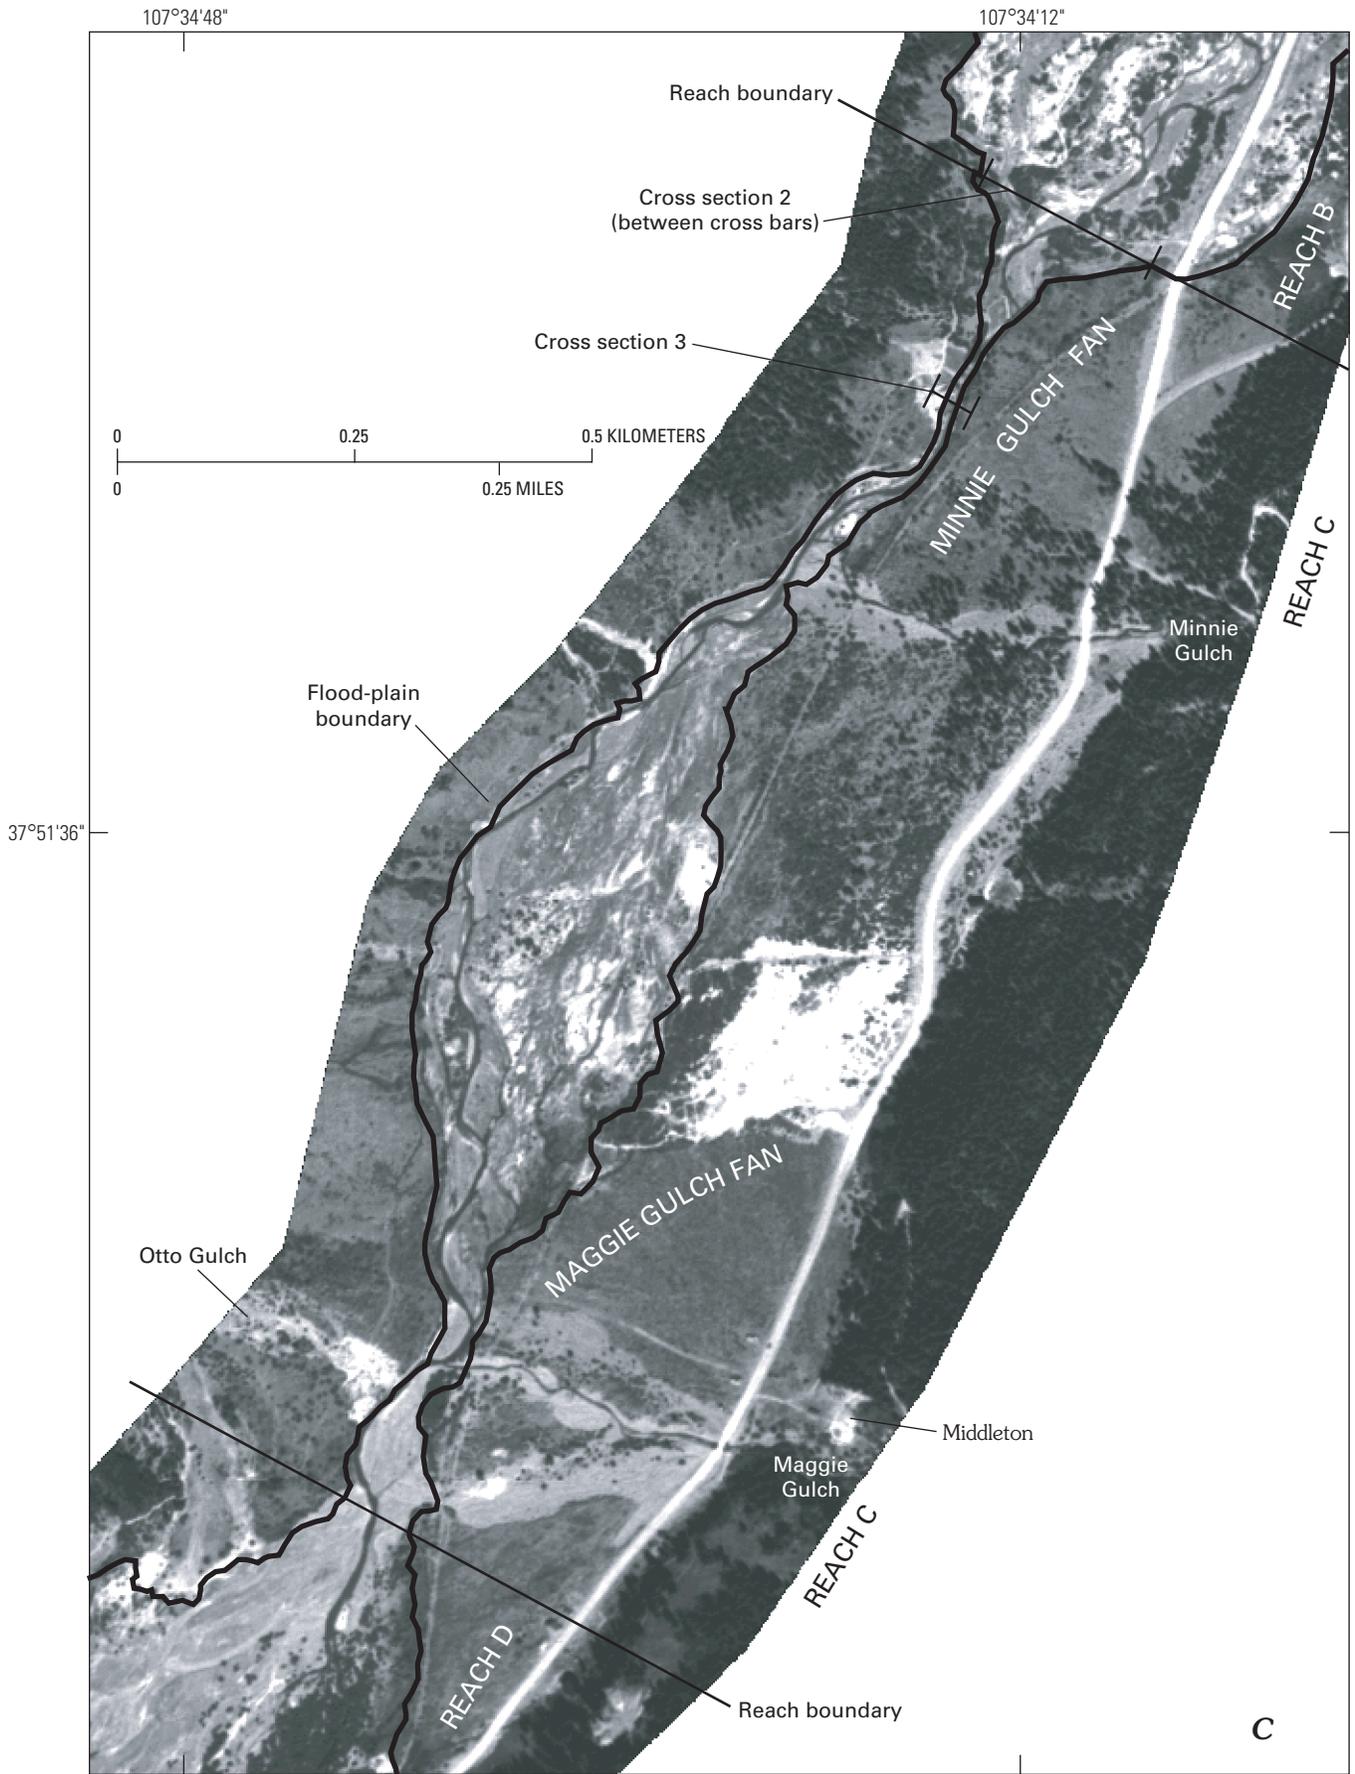
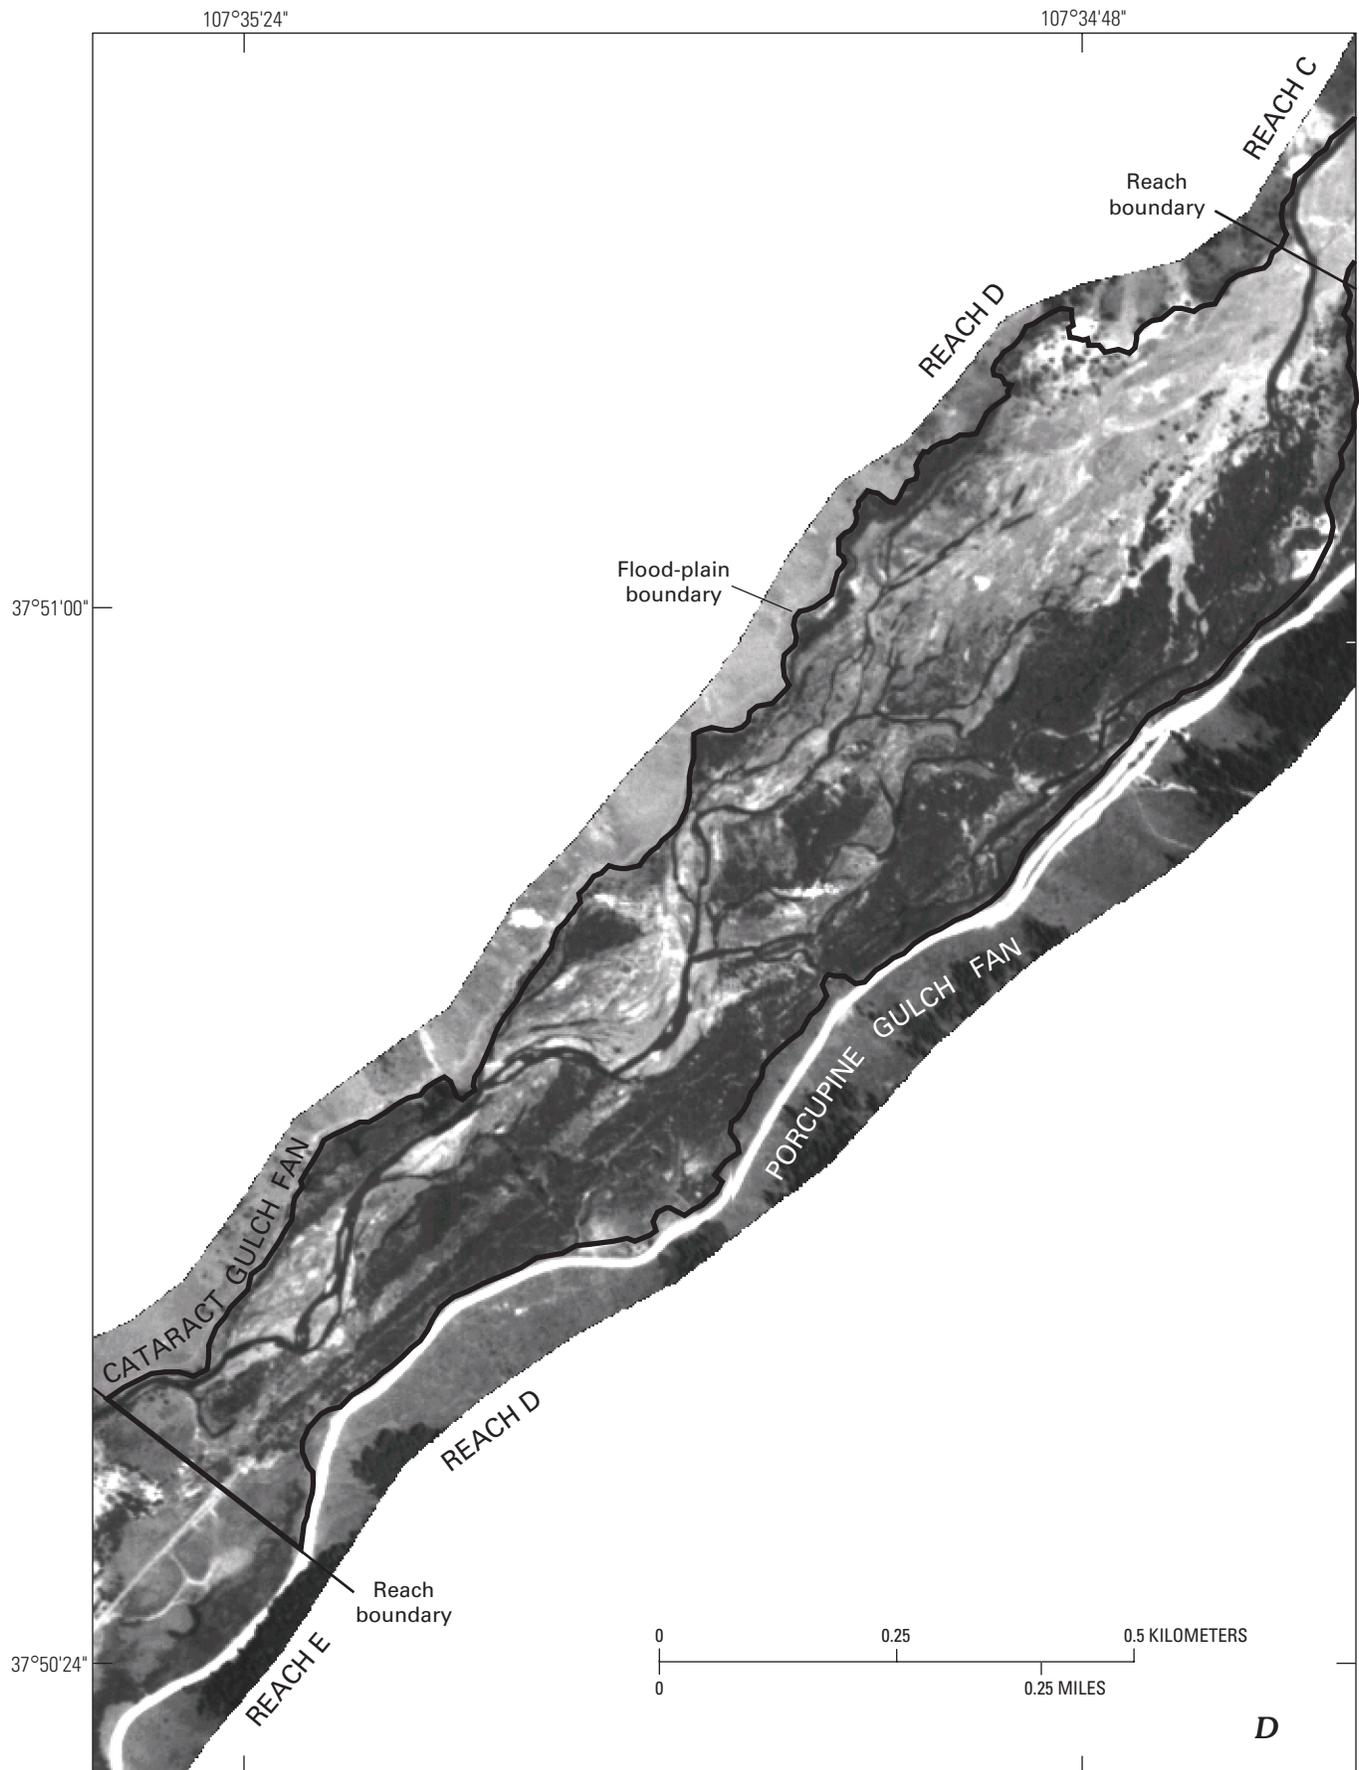
**Figure 4 (above and following pages).** Aerial photographs taken in 1951 of upper Animas River valley. *A*, reach A upstream of Eureka; *B*, reach B from Eureka Gulch to north end of Minnie Gulch alluvial fan; *C*, reach C including constrictions caused by Minnie Gulch and Maggie Gulch fans; *D*, reach D from Maggie Gulch alluvial fan to Cataract Gulch alluvial fan, and upper portion of reach E.

that the Animas River has been, and has the geomorphic tendency to be, fully braided in reach A. The river appears as a single-thread channel on the photograph of figure 4A, however, and that probably is the result of anthropogenic activities. In the field we observed evidence that the streambed had been recently rearranged by heavy equipment upstream of the State Road 110 bridge at the Eureka townsite. That road is visible as a white stripe in figure 4. In order to protect the integrity of the road and bridge (and perhaps the townsite), maintenance crews occasionally rearrange the streambed in order to keep all streamflow passing under the bridge (Rob Robinson, Bureau of Land Management, written commun., 2004). The repetitive nature of that maintenance hints at the sediment transport dynamics of the Animas River in reach A.

Cross section 2 is located 217 m downstream from cross section 1, and along that distance channels begin to converge as they enter the valley floor constriction caused by the two fans (figs. 1 and 4B). At cross section 2, both the channels and flood plain are distinctly different from those upstream in reach B. The channels have transitioned from being braided (multiple shallow channels with largely indistinct banks) to what we call multi-threaded: more than one channel but most having steep and relatively high banks. At cross section 2, the valley floor is about 240 m wide, and about 60 percent of that width consists of flood plain vegetated by willows and

Cross section 3 was located 255 m downstream from cross section 2, and along that distance the fan constrictions cause all channels to converge into one (figs. 1 and 4C). No flood plain was present at cross section 3, and the channel is shaped like a parabola with high banks exposing fan sediment. As there was no clear evidence of bankfull stage at cross section 3, we solved the flow equation for the stage required for the channel to pass a discharge of 17 m<sup>3</sup>/s. We used the surveyed cross-sectional geometry, slope of 0.0084 m/m,  $D_{84}$  of 20 cm, and equation 1. The result is that a flow top-width of 11 m, maximum depth of 1.14 m, and mean depth of 0.75 m will convey 17 m<sup>3</sup>/s.

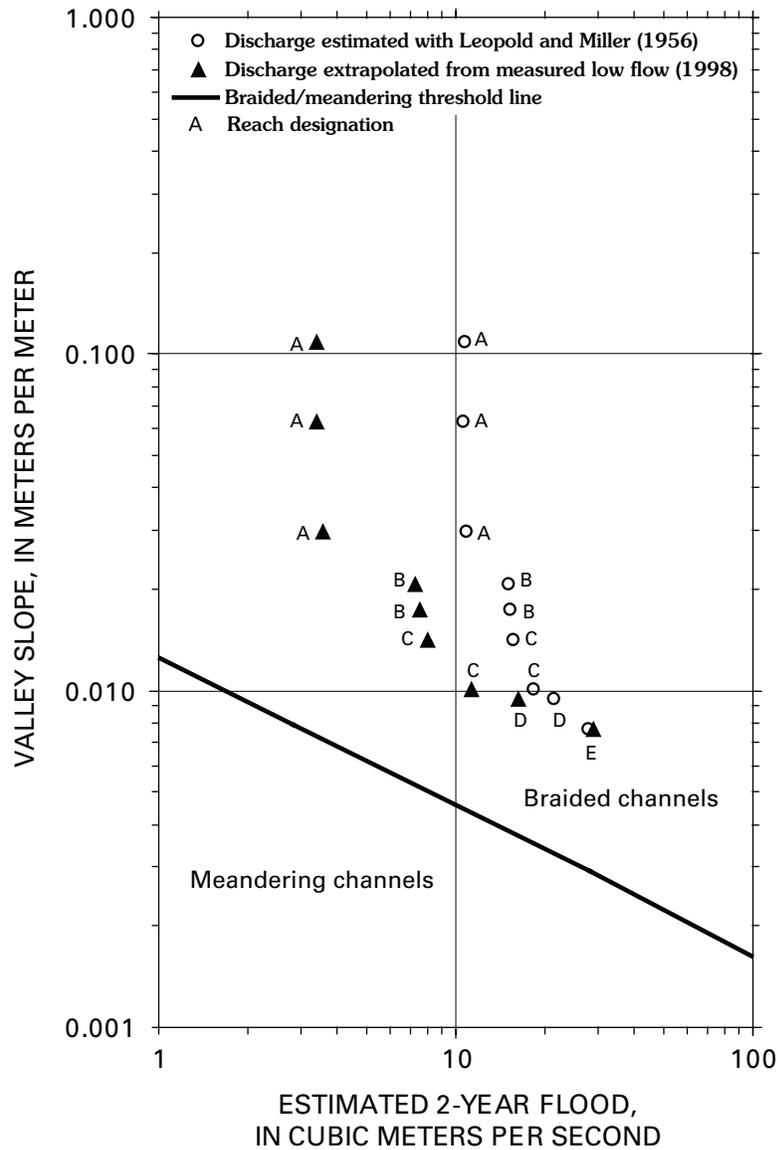
**Figure 5.** Threshold relation between valley slope and bankfull discharge for braided and meandering streams, modified from Leopold and Wolman (1957). The 2-year discharge for the Animas River was used as a proxy of bankfull discharge.

We tested our assumptions by using the calculated bankfull discharge near the trench site (fig. 1). As discussed in the section titled, "Channel Conveyance," a bankfull discharge of  $17 m^3/s$  was estimated by calculating the flow needed to overtop the active bars at the trench site and at cross section 2. The combined assumptions that bankfull discharge was equivalent to  $Q_2$ , and that an exponent of 0.8 in equation 7 was appropriate for the study area, result in a discharge of  $15 m^3/s$  that closely approximates the bankfull discharge determined using field measurements. Use of the exponent of 1.8 results in a discharge of  $7.5 m^3/s$ , a low value, as expected; but the important issue at hand is that we not grossly overestimate bankfull discharge and erroneously place the results into the braided field of figure 5.

Data for all study reaches plot above the threshold line in figure 5, within the field for braided streams. Data for reaches A and B plot the highest on the diagram. In conclusion, the Animas River in the study area was likely never a classical, single-thread meandering stream, and this is certainly true for the reaches near Eureka. This simple comparison with data for other streams suggests that the Animas River has the propensity to be multi-threaded, or fully braided where not confined by alluvial fans or dense brush on the flood plain. We next addressed the channel pattern issue by exploring the sediment transport dynamics.

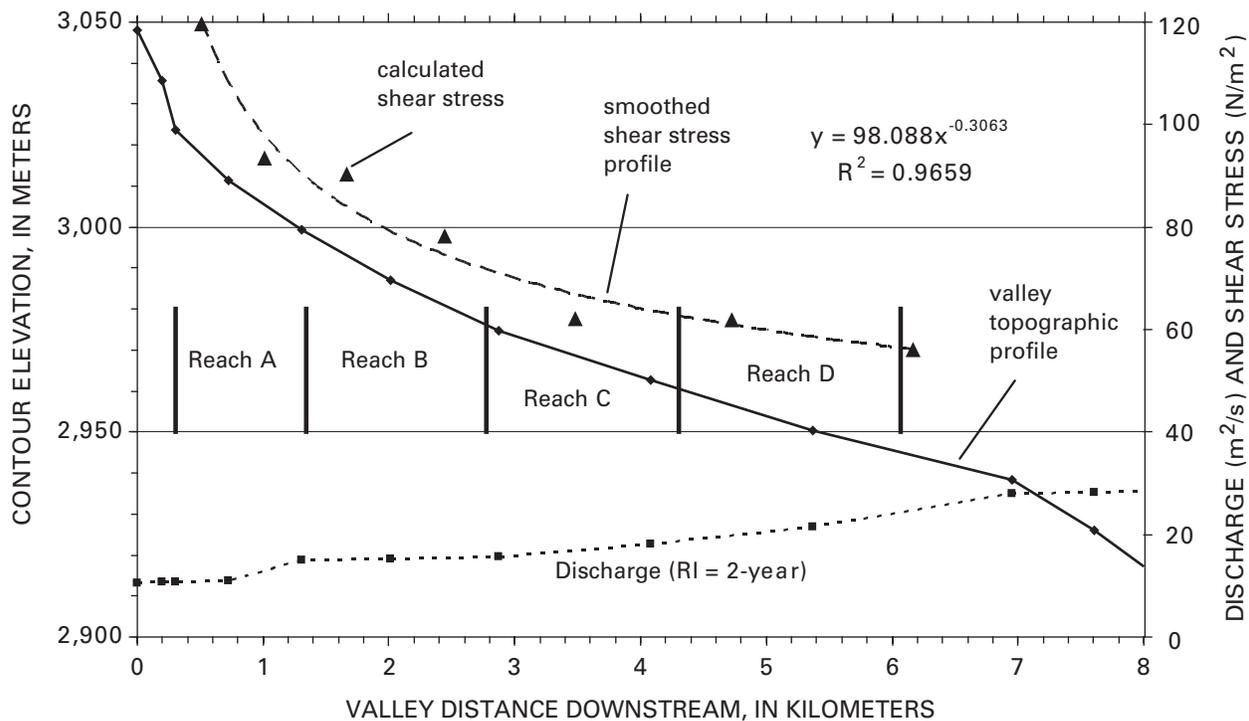
**Figure 6.** Pattern of boundary shear stress for a hypothetical single-thread channel conveying a flow with 2-year recurrence interval (RI).

Flow depths were calculated using equation 1, and the discharge and width specified for each subreach using the approach discussed in the preceding paragraph. The depth nearly doubled, increasing from 0.41 m near the head of reach A to 0.74 m at the downstream end of reach D. The boundary shear stresses for the hypothetical flow, calculated using equation 3, decreased by more than half through the study area. The calculated shear stress values for each subreach are shown in figure 6, along with a smoothed profile emphasizing that most of the decrease occurred within reaches A and B. Uniform sediment transport in our hypothetical channel requires uniform boundary shear stress, and this was not achieved. If sediment were in transport at the upper end of reach A, then sediment must deposit as boundary shear stress decreases downstream. The necessity for sediment deposition would be exacerbated if tributary streams also delivered sediment to the trunk stream.

In order to demonstrate the general magnitude of sediment deposition, we calculated hypothetical bed load sediment transport rates using equation 6. Sediment transport rates decreased by 86 percent, from 316 m<sup>3</sup>/hr near the head of reach A to 43 m<sup>3</sup>/hr at the downstream end of reach D. Most of that decrease occurred within reaches A and B, and we considered changes in sediment transport in reaches C and D to be essentially not detectable. An estimate of deposition rate was made by subtracting the transport rate in a subreach from that

in the subreach just upstream. Technically the results are for the solid-volume of particles, so a porosity of 30 percent was used to convert particle-volume to bulk-volume of the deposit. The deposit was assumed to spread out uniformly over the width and length of a subreach. The results were a deposition rate of about 4 cm/hr in the lower half of reach A, and less than 1 cm/hr in the lower half of reach B. If the hypothetical flow were sustained, the channel in the lower half of reach A would be full of gravel in about 10 hours, and the channel in the lower half of reach B would be full in about 2 days. Recall that as a daily mean discharge, the flow with 2-year recurrence interval was equaled or exceeded at the stream gauge approximately 0.14 percent of the time on average (table 2), or 12 hours per year. When channels fill with gravel, flow is forced around the deposit, and a braiding pattern is the inevitable result.

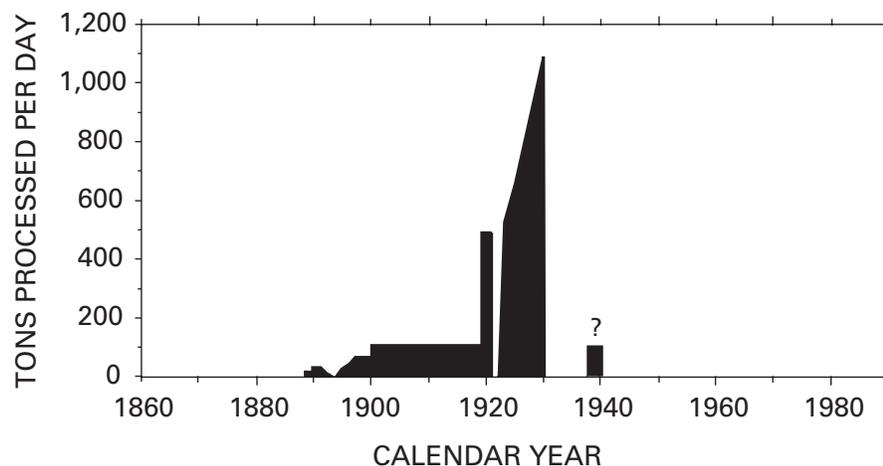
**Figure 7.** Combined ore processing rates for the succession of mills in the town of Eureka and in Eureka Gulch. These rates (from Bird, 1986; Marshall, 1996; and Sloan and Skowronski, 1975) were quoted in “tons,” which presumably means U.S. short tons. (To convert short tons to metric tons, multiply by 0.907; ?, production rate uncertain.)

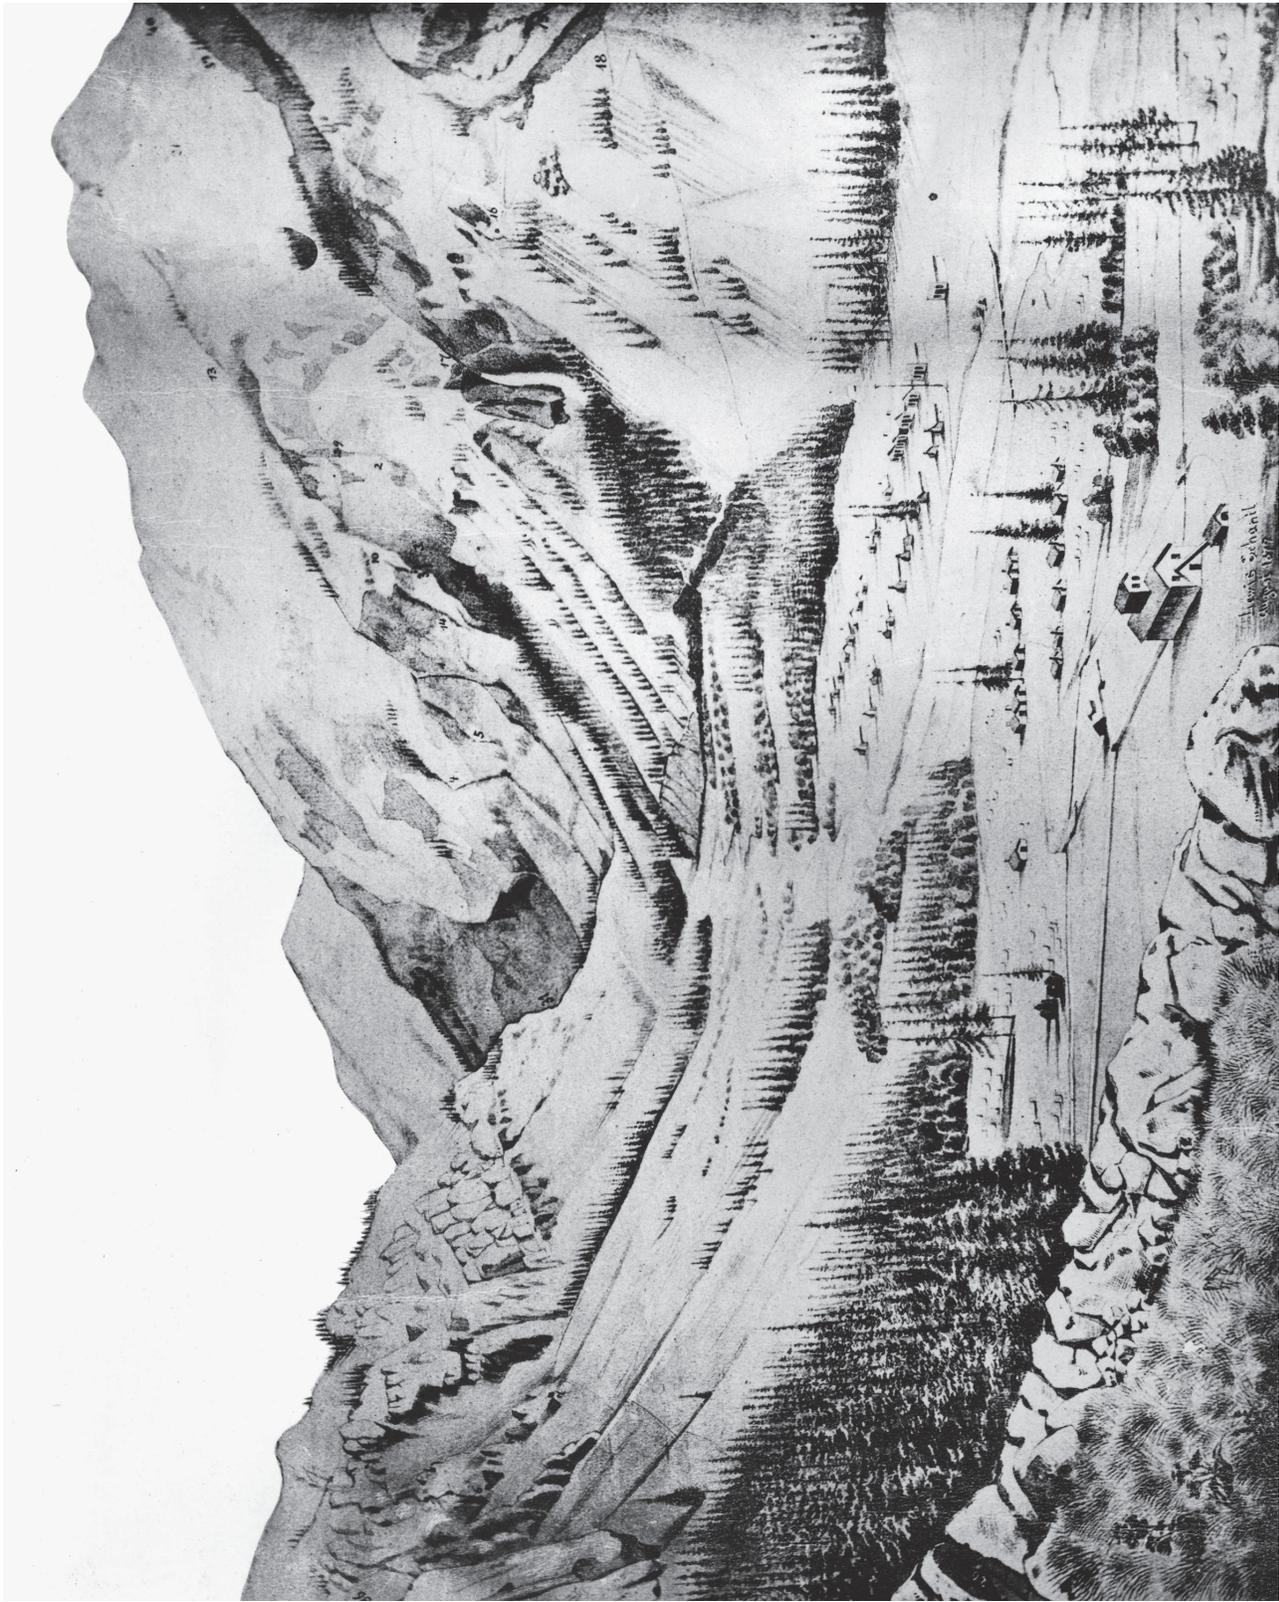
**Figure 8.** Reproduction of photograph taken by P.A. Felt of Eureka in 1877. Denver Public Library Western History Collection No. X-11438, used with permission. The view is north, up the Animas River, and shows reach A.

The earliest picture of the study reach that we were able to find is a print based on a photograph taken in 1877 (fig. 8) and shows reach A and the town of Eureka (fig. 4A), which was established in 1876. The title on the print gives the 1877 date and states that it was “photographed by P.A. Felt.” The picture was clearly reproduced using a printing press, and therefore the accuracy of the image depends in part on the method used to transfer the photograph to the printer’s plates (Ostroff, 1981). Certain lithographic plates were made directly from negatives, similar to the way photographic prints are made, and the result was a highly accurate image (although an artist could make changes like adding clouds). Other plates were wood engravings made by either tracing directly or copying by eye from a photograph, and the results were variable in accuracy (Ostroff, 1981). Based on the high contrast and absence of gray-tone range, we believe the image in figure 8 was printed from a wood engraving. We compared the cliffs and strips of trees in center-left background to photographs (see fig. 2) and found they were rendered accurately. For that reason, we believe figure 8 accurately depicts the Animas River as it was in 1877. Felt took the photograph 1 year after Eureka was established and 6 years after miners arrived in the area. Before 1877 it is likely the miners had only two impacts of potential significance to this discussion. One was the cutting of trees for firewood and building material, and indeed what appear to be tree stumps are visible in center foreground of figure 8. No tree stumps are visible adjacent to the channel, however, so apparently the Animas River in reach A was not previously lined with riparian trees. The second impact was the use of beaver as a food source, and their likely
