# **Response of the Upper Animas River Downstream from Eureka to Discharge of Mill Tailings**

By Kirk R. Vincent and John G. Elliott

**Integrated Investigations of Environmental Effects of Historical  
Mining in the Animas River Watershed, San Juan County, Colorado**

Professional Paper 1651

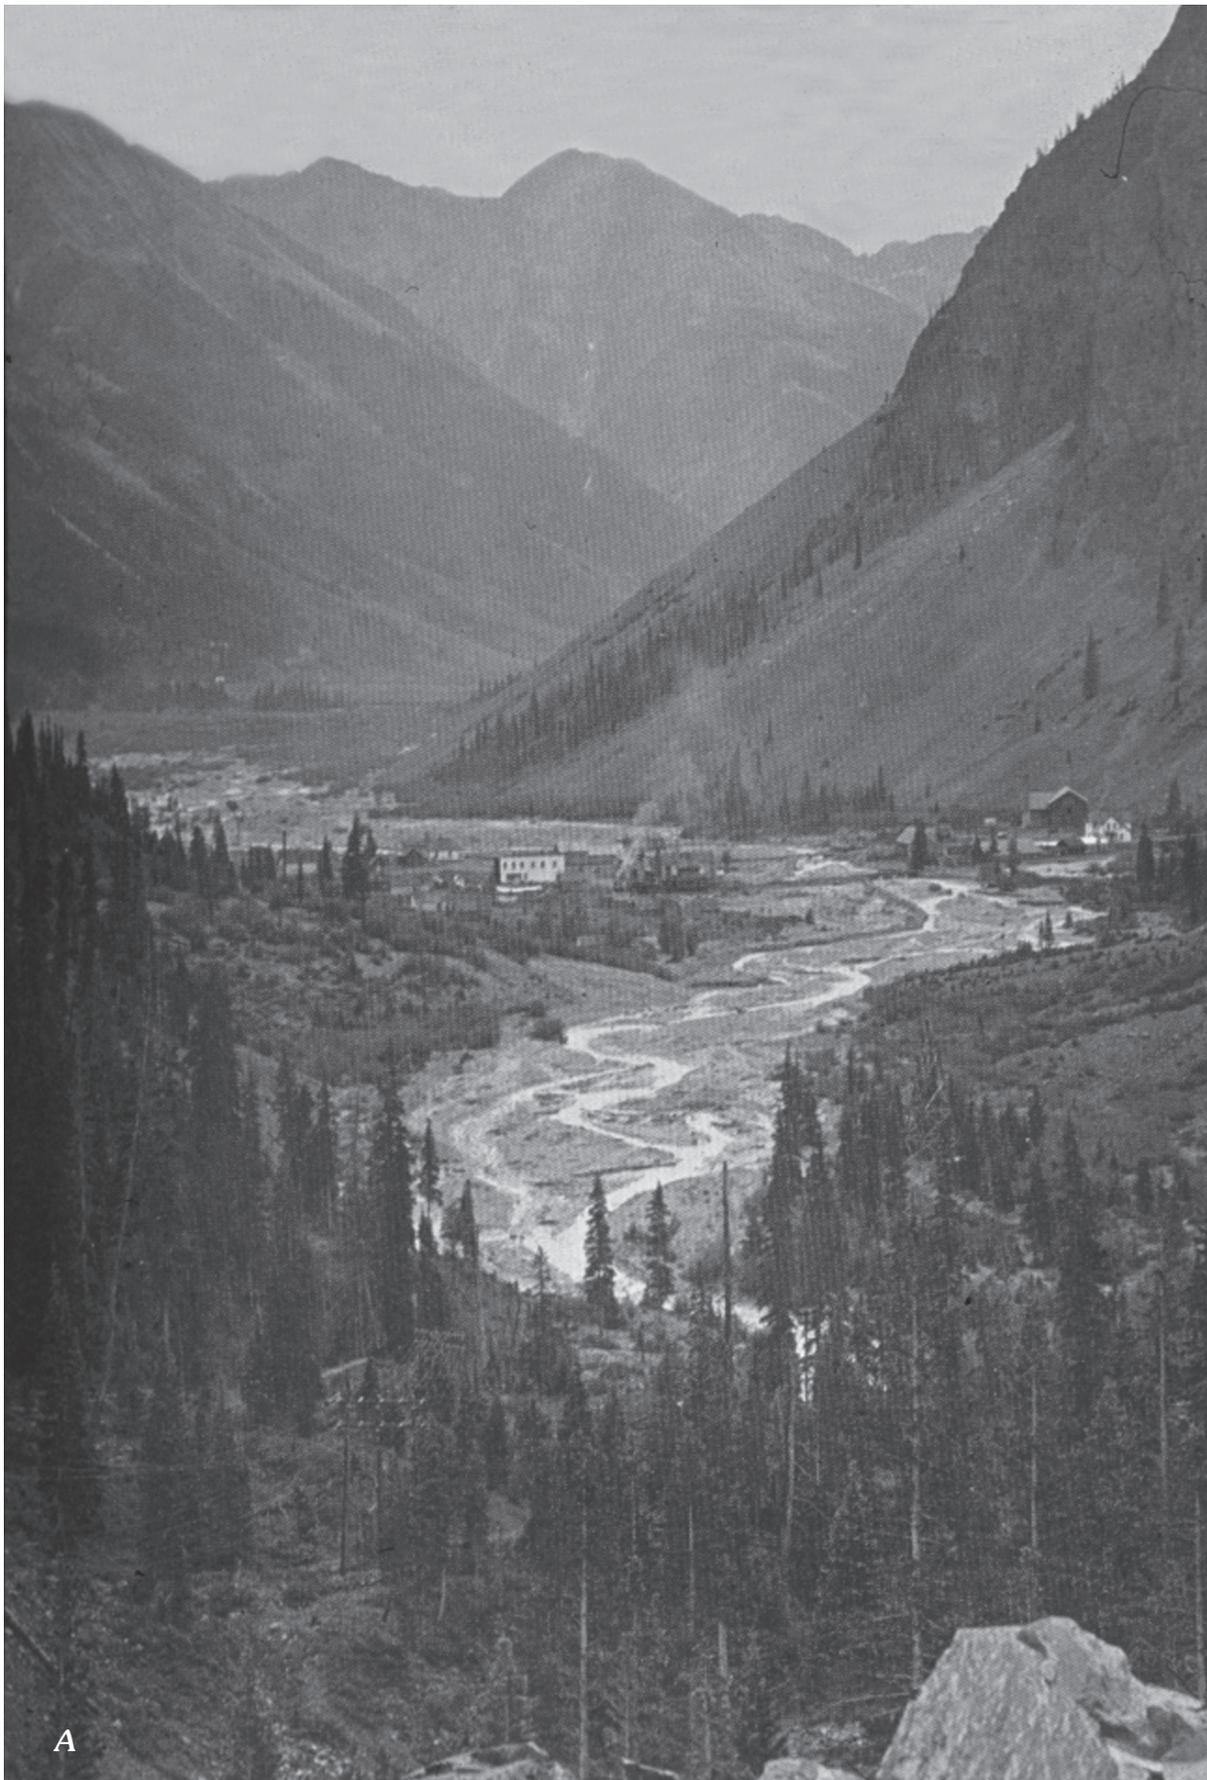
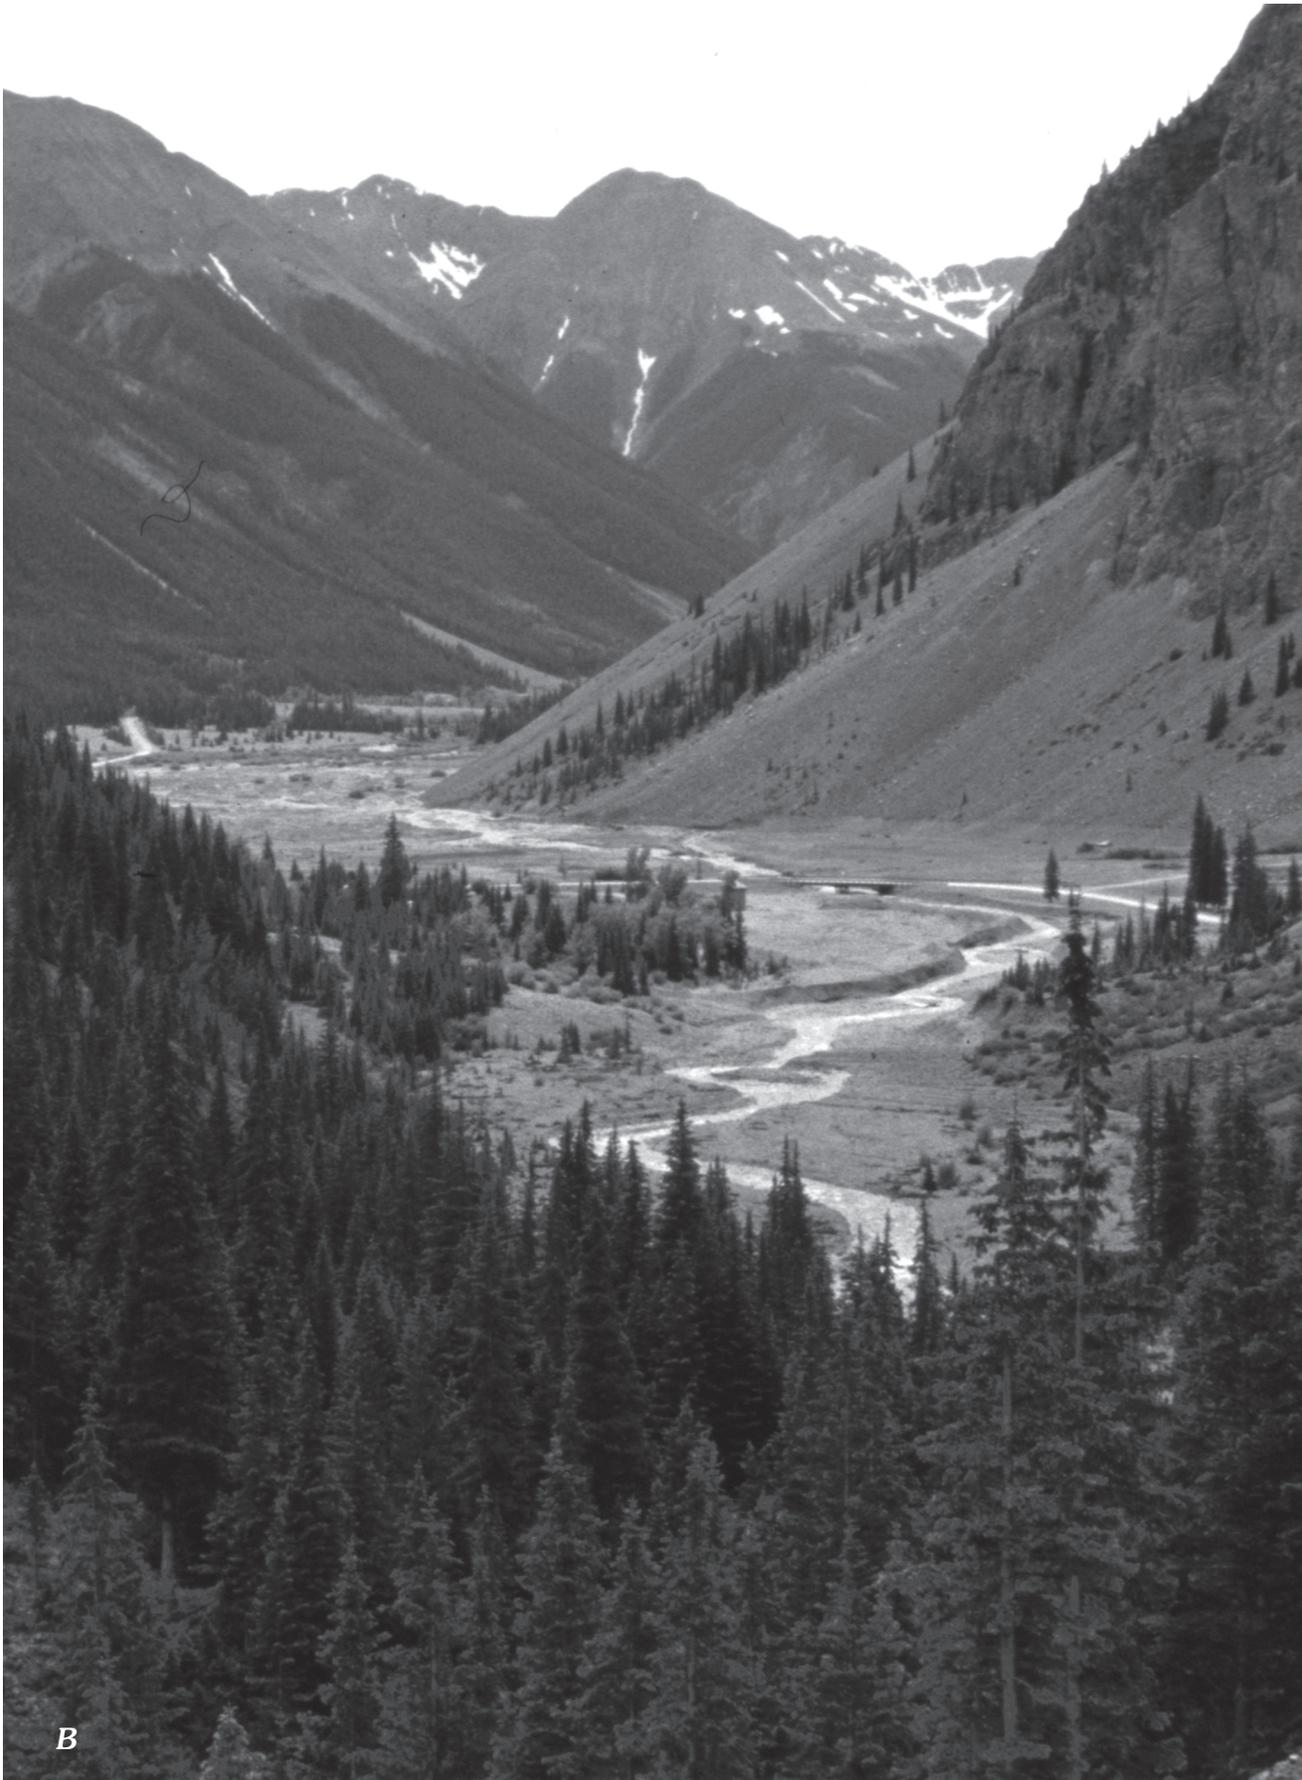
**Figure 9 (following two pages).** Photographs showing reaches A and B of the Animas River, taken from the Silverton Northern Railroad grade looking downstream at Eureka. *A*, Photograph taken in 1906 by George L. Beam, reproduced courtesy of Sundance Publications. *B*, Repeat photography by Kirk Vincent in 1999, from approximately the same location as *A*.

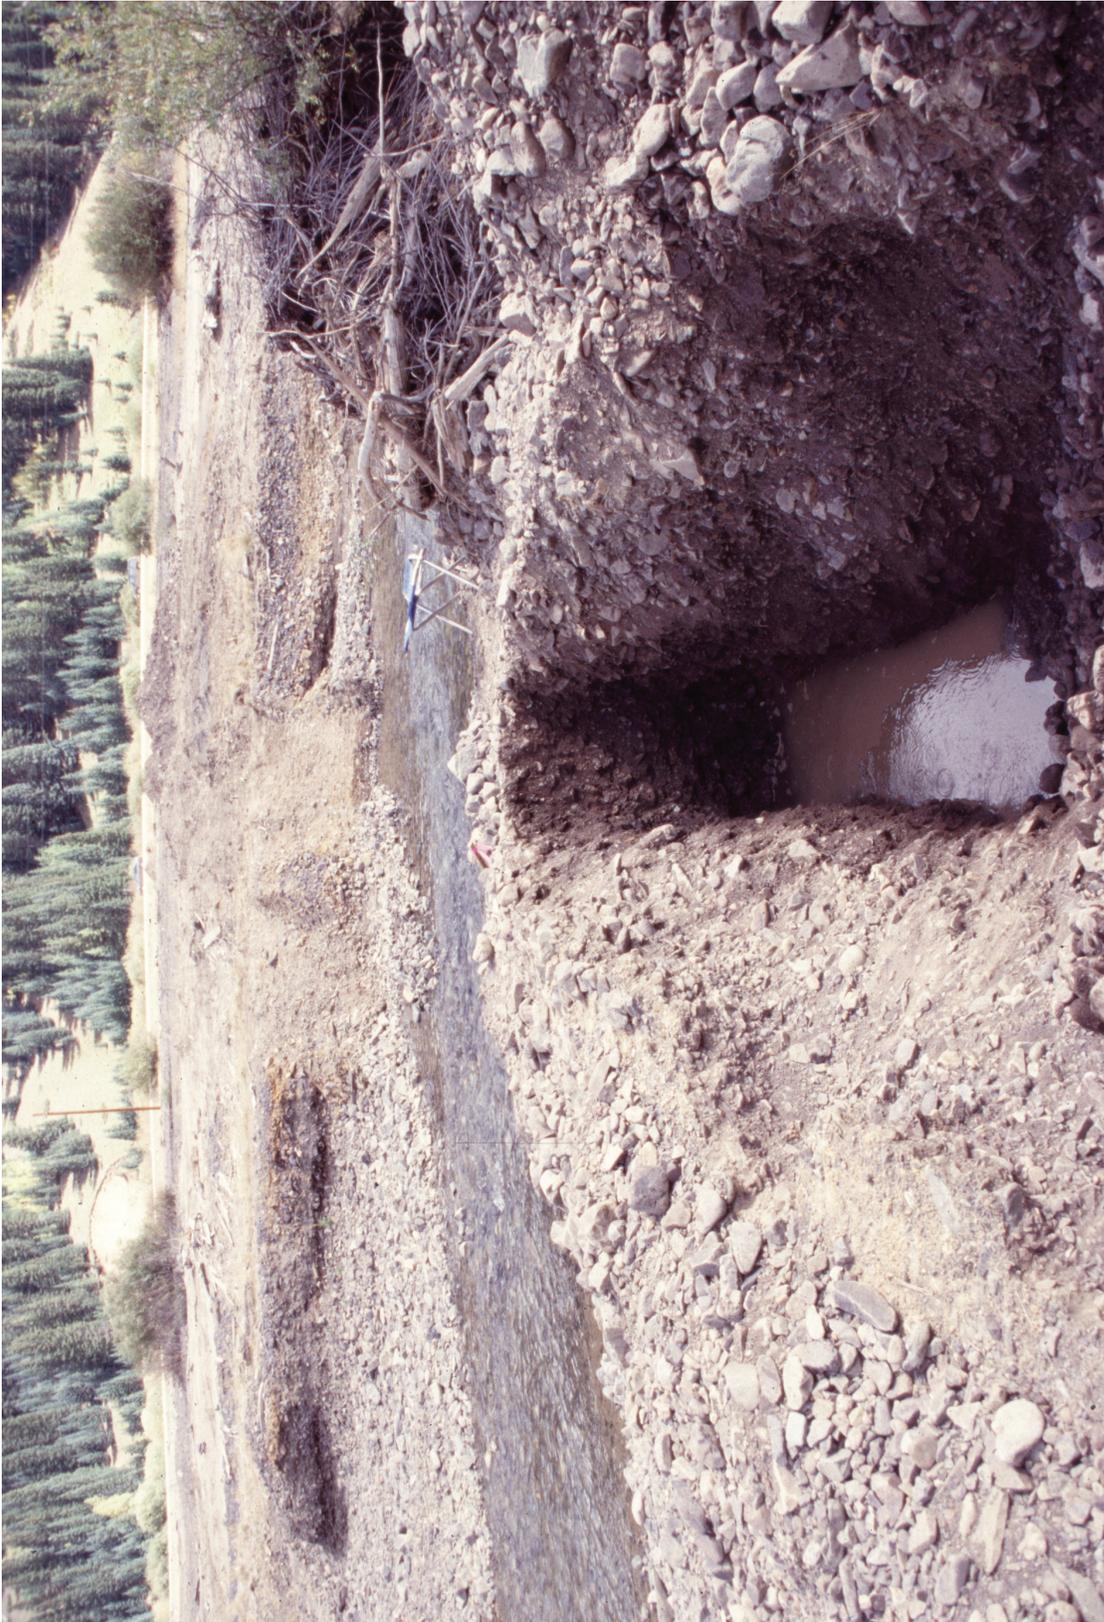
**Figure 10.** Photograph of a section of the stratigraphic trench (near 156 m on pl. 6), showing the ground-water table 1.6 m below the level of that thread of the stream in late September 1998. View is looking east down the trench transect, with Colorado State road 110 visible in the background. The trench was located at the downstream end of reach B, as indicated in figures 1 through 4.

The trench was excavated using a trackhoe in September of 1998. For practical reasons the trench was excavated and studied in “skip sections” (fig. 10), such that short (10–30 m long) sections of the transect were excavated, studied, and backfilled. Then the intervening sections were excavated to complete the stratigraphic log of plate 6. One reason that the trenching was feasible is that the water table of the shallow alluvial aquifer was on average 1.5 m below the streambed at the time of excavation (fig. 10). An electric pump connected

Figure 10 is an appropriate vehicle for starting the discussion of the valley bottom stratigraphy for several reasons. The ground-water table was below the level of (and thus disconnected from) the stream during that period of late-season base-flow conditions. In late July 1998 the water table was observed to be about 1 m below the ground surface in a test pit (at horizontal distance 187 m, pl. 6), and 2 months later it had dropped to about 2.2 m below the ground surface at that location when the trench was excavated. The water in the stream was not infiltrating, and thus not recharging the shallow ground water in a significant way, because the streambed was completely coated and sealed by an algal mat. The algal mat evidently formed during the summer because the streambed had no shade. The mat was also fragile. After the trackhoe rolled over a channel (shown at 275 m on plate 6) one time, all of the stream water in the channel abruptly drained into the subsurface. Understanding the connection or disconnection of surface water and shallow ground water is essential to tracer dilution studies such as that of Kimball and others (this volume). They did not detect a gain in discharge within the braided reach upstream of the trench during their August 1998 tracer dilution study, which is consistent with our field observation of the surface water/ground water disconnection.

Locally the gravel and sand deposits were stained or cemented by compounds of manganese and iron (fig. 10; pl. 6). Typically the coatings and cement were bluish black (SPB 2.5/1) in color. The cemented or discolored zones were irregular in shape, with the only generalities being they were typically laterally elongate and the tops of the zones were usually located from 0.5 to 1 m below the ground surface. The bottoms of zones were located as much as 1 m above the ground-water surface (as it was at the time of trenching), or extended down to or beneath the ground-water surface. Thus the zones were generally restricted to within the elevation range of annual fluctuations of the water table. The boundaries of the cemented or discolored zones were not restricted to changes in hydraulic conductivity of the host sediment. Locally the boundaries conformed to stratigraphic contacts or internal bedding, but locally the boundaries also crosscut stratification or ended within a bed. The cementing compounds were precipitated from the alluvial ground water after deposition of the host gravel, much of which is historical in age. A portion of the surface of the gravel flood plain was also locally bluish black in color, as indicated on plate 6. In those locations the tops of surficial stones had continuous, 1-mm thick varnish-like coatings, which evidently precipitated from stream water or temporarily ponded water. These blackened gravel bars were evident in the 1945 aerial photographs.

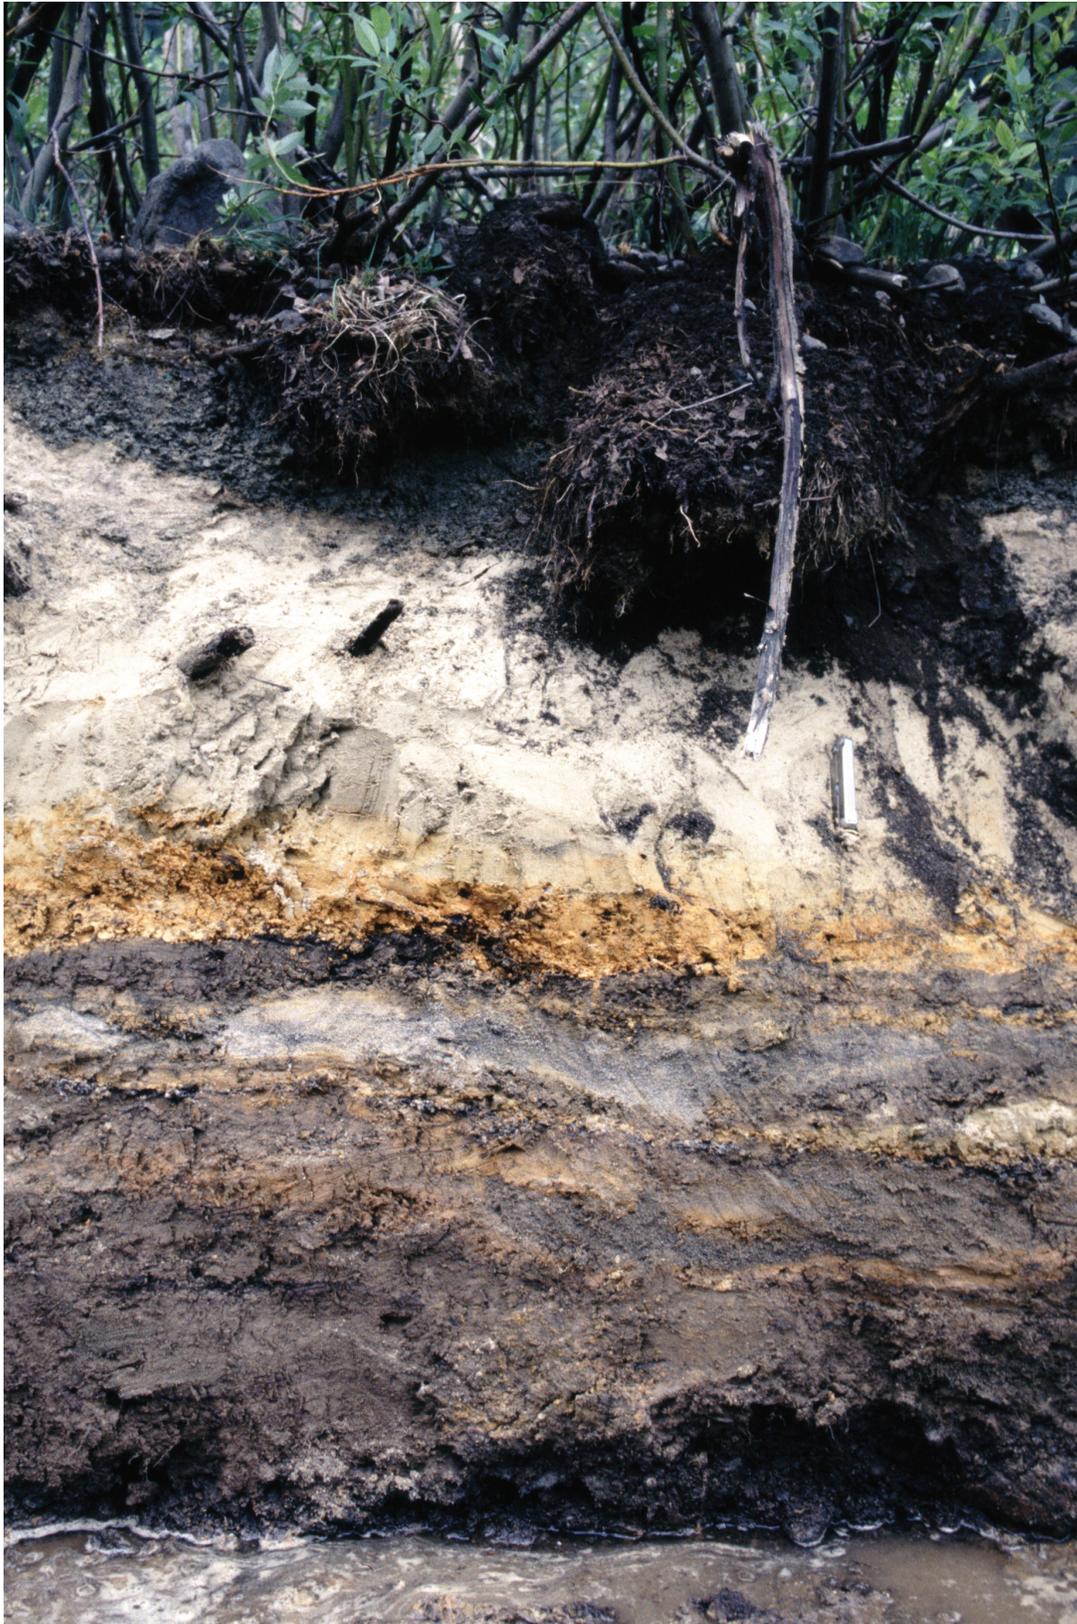
**Figure 11.** Fresh exposure of flood-plain sediment located near the trench site. The base of the 1-m high exposure was composed of dark-brown sandy silt. The middle of the exposure was composed of sandy silt containing very thin beds of fine-grained tailings. The top of the exposure was composed of thin to medium-thick beds of yellowish-brown, white, and olive-colored fine-grained tailings.

Tailings became disseminated within streambed gravel in the subsurface (pl. 6) during aggradation, and are also found as easily identifiable beds at the ground surface (fig. 11). As a direct result of the presence of tailings, the concentrations of zinc (fig. 14) and other metals (table 8) are dramatically elevated compared to those of prehistorical sediment, whereas vanadium and other elements are more dilute. Streamflows have been reworking the tailings (table 9), and have transported between 70 and 80 percent of the tailings originally produced out of our study area (table 10). Of the tailings that remain in our study area, on the order of 10 percent exists as distinct beds of fine-grained tailings at the ground surface (table 10). If the assumptions of our calculations are correct,

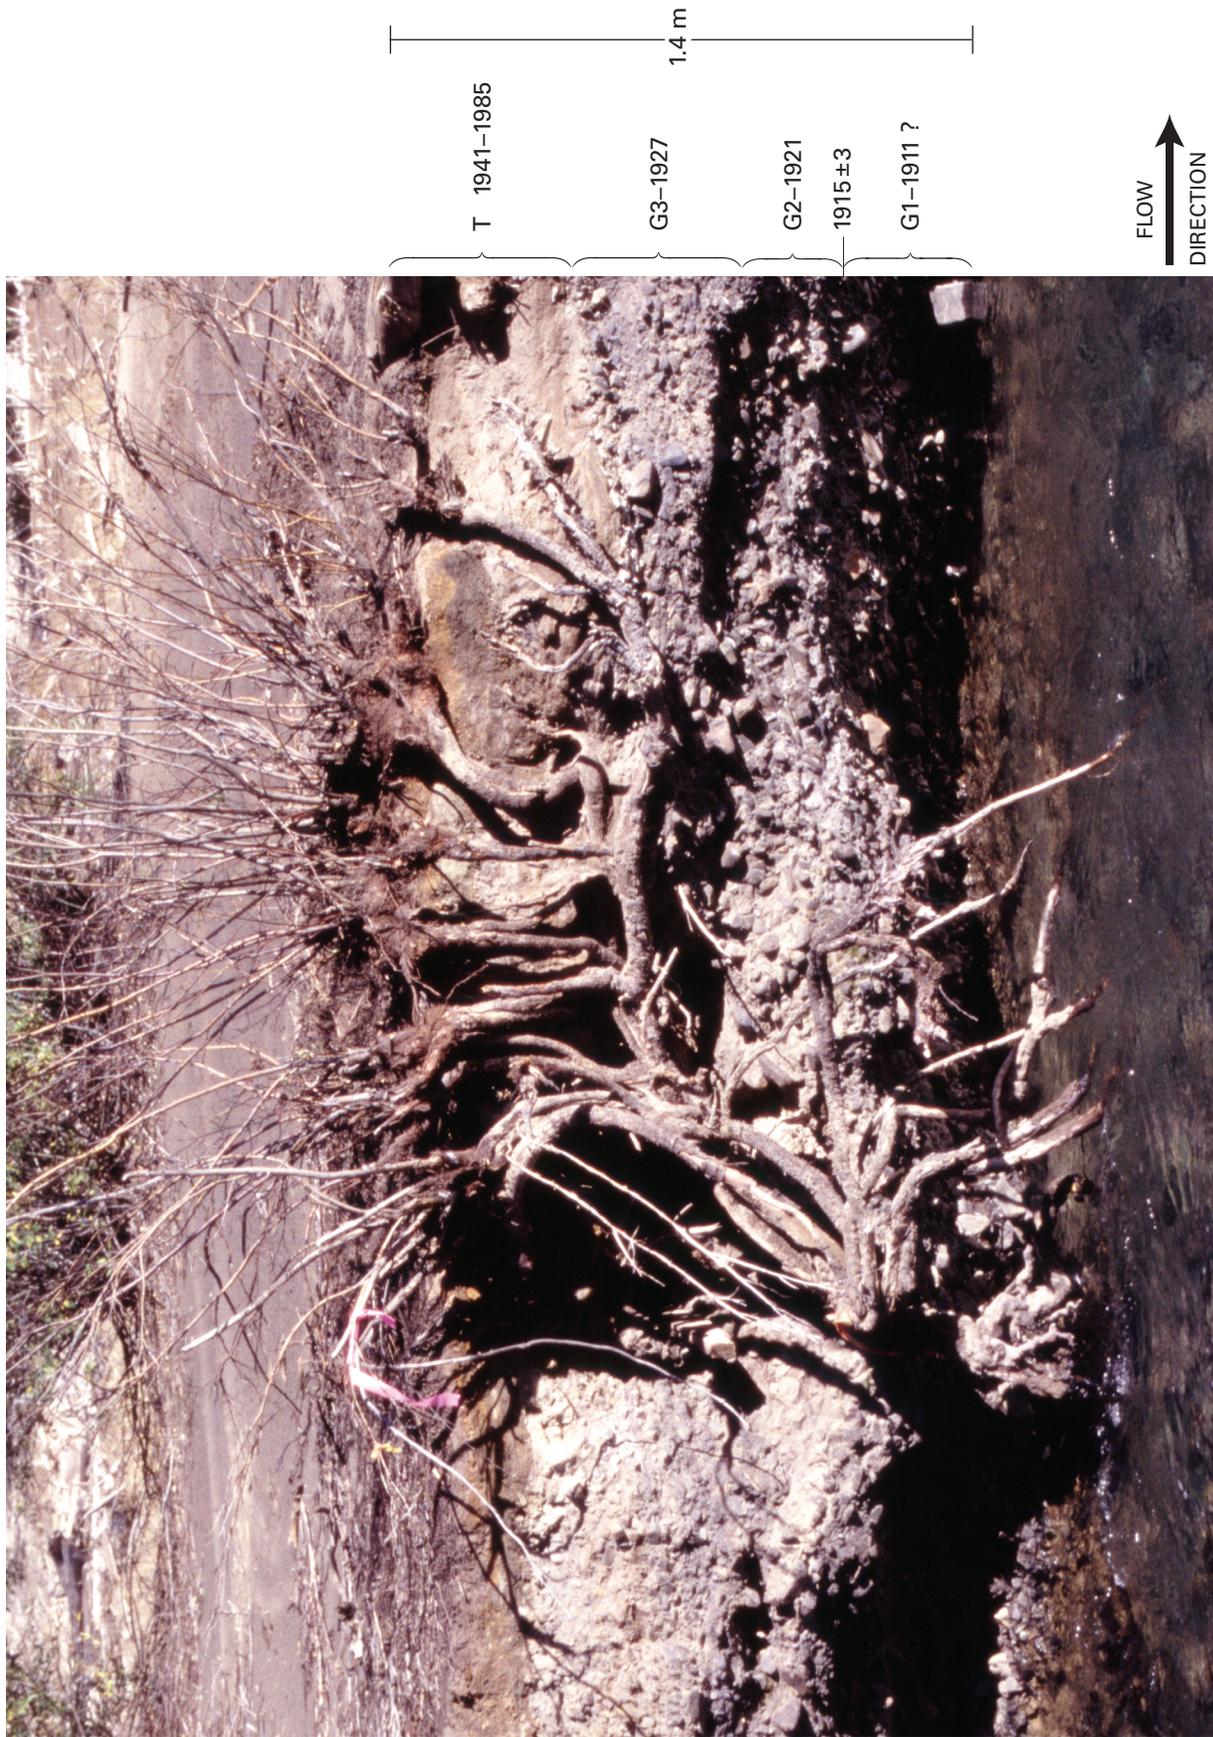
**Figure 12.** Recently exposed willow bush that had been repeatedly pushed over and covered by sediment, only to resprout. Labeled dates are based on growth-ring analysis discussed in text. Willow was located about 100 m downstream of the trench (pl. 6).

Important age constraints were derived from a pair of willows that had been pushed over by flood waters, covered by sediment, and subsequently resprouted. This occurred repeatedly, and one of the plants is illustrated in figure 12. The plants were discovered alive and recently exhumed and exposed in a streambank 100 m downstream of the trench site. The stratigraphy at that site consisted of three gravel beds (labeled G1 to G3) covered by a stratified bed of fine-grained tailings (labeled T). The tailings are thicker on the downstream side of the plant (fig. 12) than on the upstream side. Analysis of plant growth rings has long been used to determine the timing of tissue damage (scarring or bending) or burial, and thus the age of causal events such as floods. (See, for example, Sigafos, 1964; Scott and others, 1997.) Mike Scott of the USGS analyzed the growth rings of 10 slabs cut from the two willow plants (written commun., 1999) allowing the following conclusions to be made. The willow shown in figure 12 sprouted in 1915 ( $\pm 3$  years) on a gravel bar close to the present level of the stream. Thus the gravel at the base of the section (G1) was deposited before that, perhaps

during the 1911 flood of record. The previously undisturbed plant stems were permanently bent downstream around 1920; thus, gravel bed G2 may have been deposited during the 1921 flood that is known to have caused damage in the area. Plant tissue from within gravel bed G3 showed signs of burial by 1929; thus, bed G3 may have been deposited during the large 1927 flood recorded at the Durango gauge. The aggradation of gravel at the site occurred during or shortly after the introduction of large quantities of coarse-grained tailings, and perhaps coincidentally during the period of huge production of fine-grained tailings (fig. 7). Willow stems showed signs of slowed growth caused by some disturbance around 1941, 1949, possibly in the late 1950s, between 1970 and 1974, and during the first half of the 1980s. Thus the fine-grained tailings shown in figure 12 may have been deposited from suspension during the floods of 1949, 1957, 1973, and 1985. One other disturbance must be accounted for. At some point lateral migration of the stream, or incision, exhumed and presumably stressed the plants; this may have occurred during the 1973 or 1985 floods.

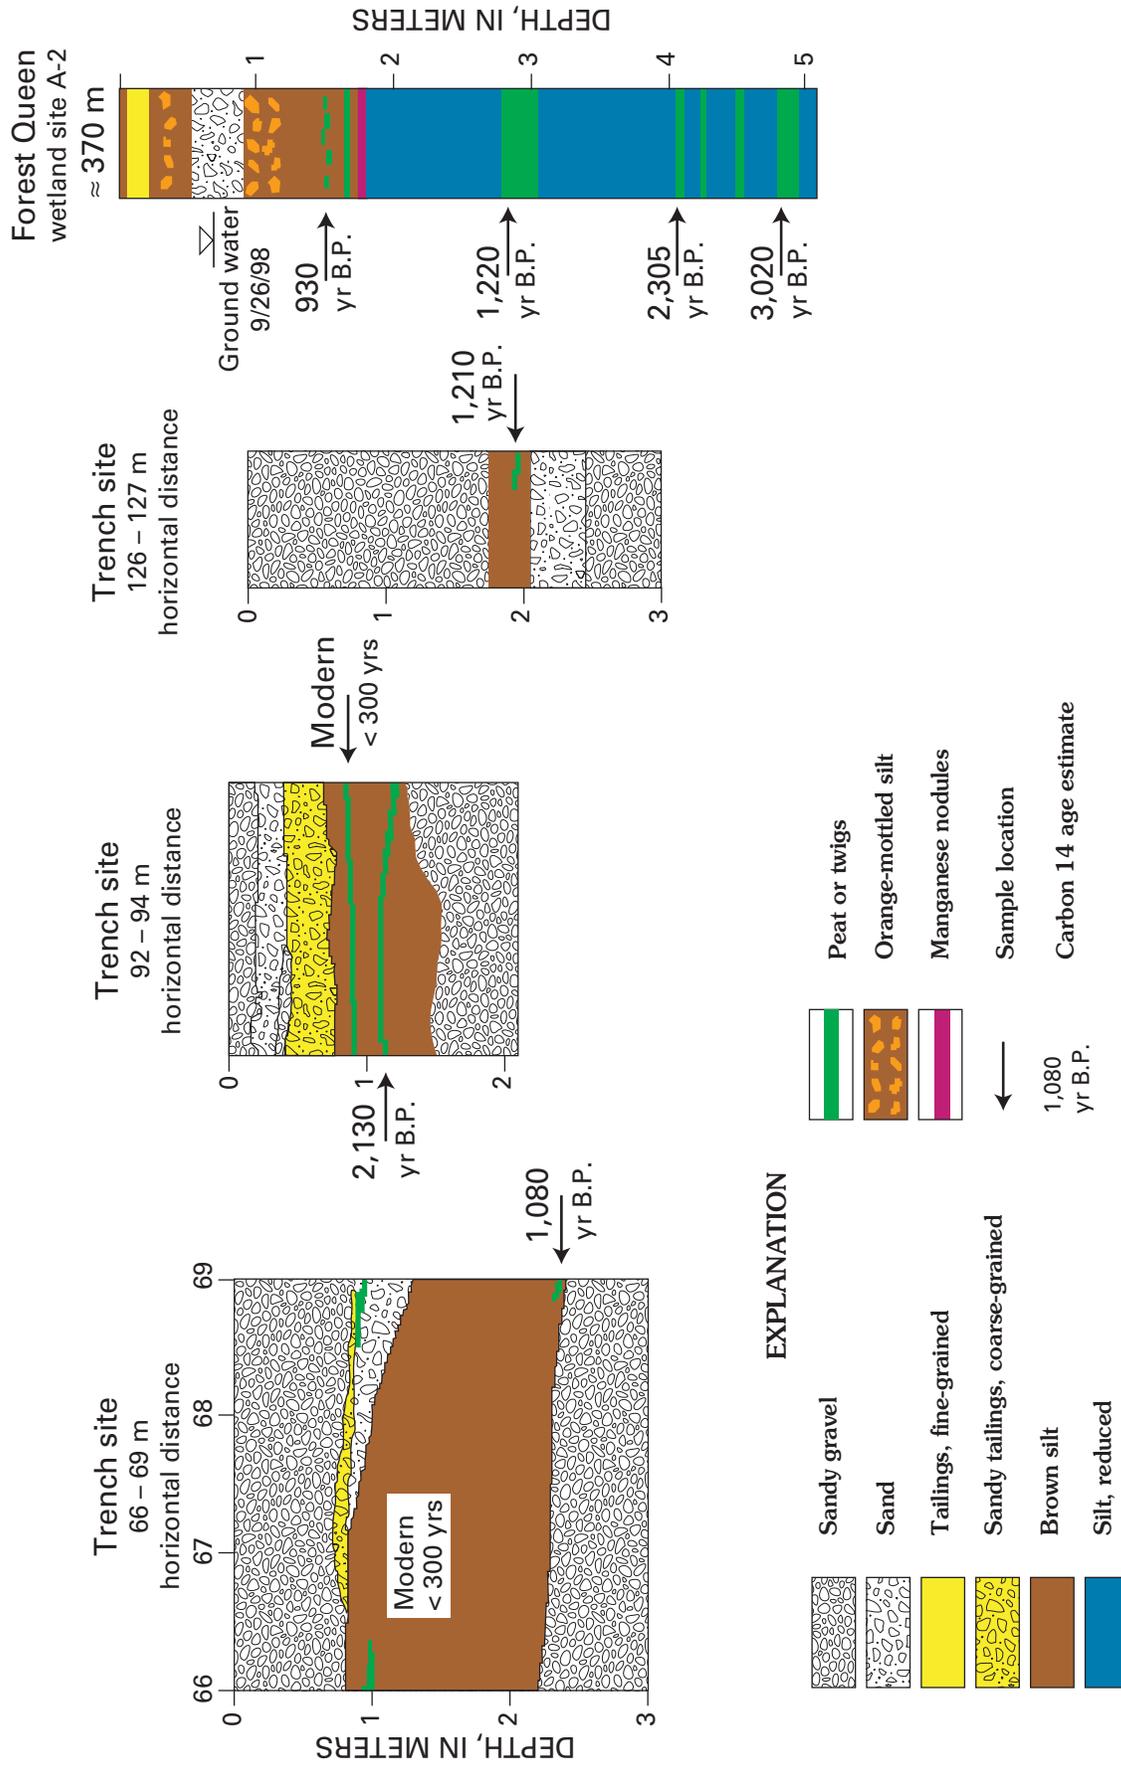
Figure 13. Summary of dated stratigraphy of the Animas River valley flood plain near the trench site (pl. 6).
