## E367

**STAMPING** E 367 1987

**NGS PID** PY0968

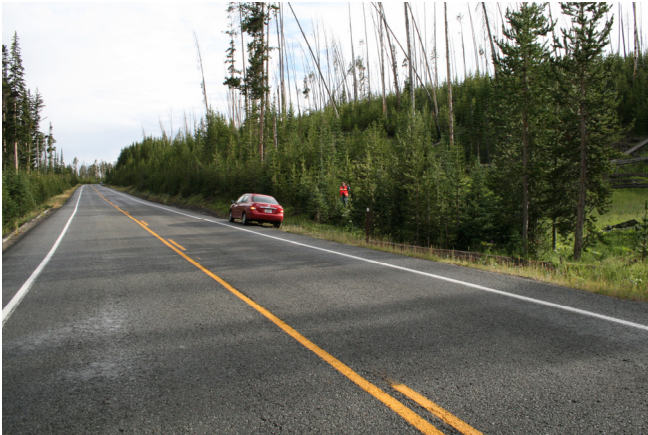
Looking southwest along highway at bench mark (beneath person). Storm drain marker is visible in foreground.

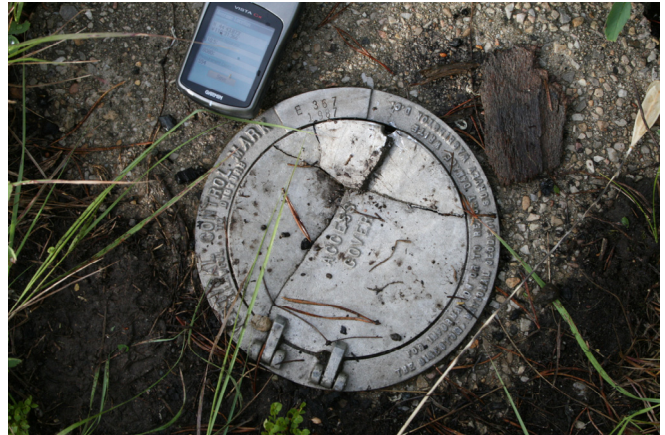
**DESCRIPTION** Proceed 2.6 km (1.60 mi) west along the Canyon-Norris highway from the junction at Canyon Village. Bench mark is 13.1 m (43.0 ft) south of a storm drain (although the drain is overgrown and can't be seen from highway, it is marked on both sides of the road by brown markers), 10.7 m (35.1 ft) west of the centerline of the highway, and about 0.5 m above the highway. Access to datum point is had through a 5-inch logo cap. The access cover is broken and difficult to open, but steel rod appears undisturbed.

Close up of bench mark.

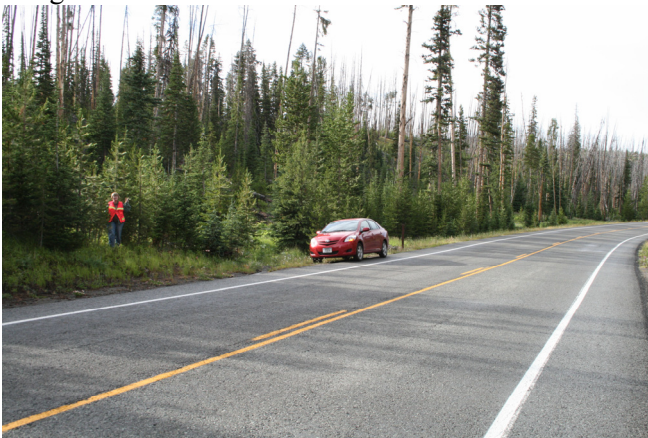
Looking northwest along highway at bench mark (about 6 feet behind person). Storm drain marker is visible in the foreground.
