# Geomorphic Response of the Sandy River, Oregon, to Removal of Marmot Dam

Professional Paper 1792

U.S. Department of the Interior  
U.S. Geological Survey

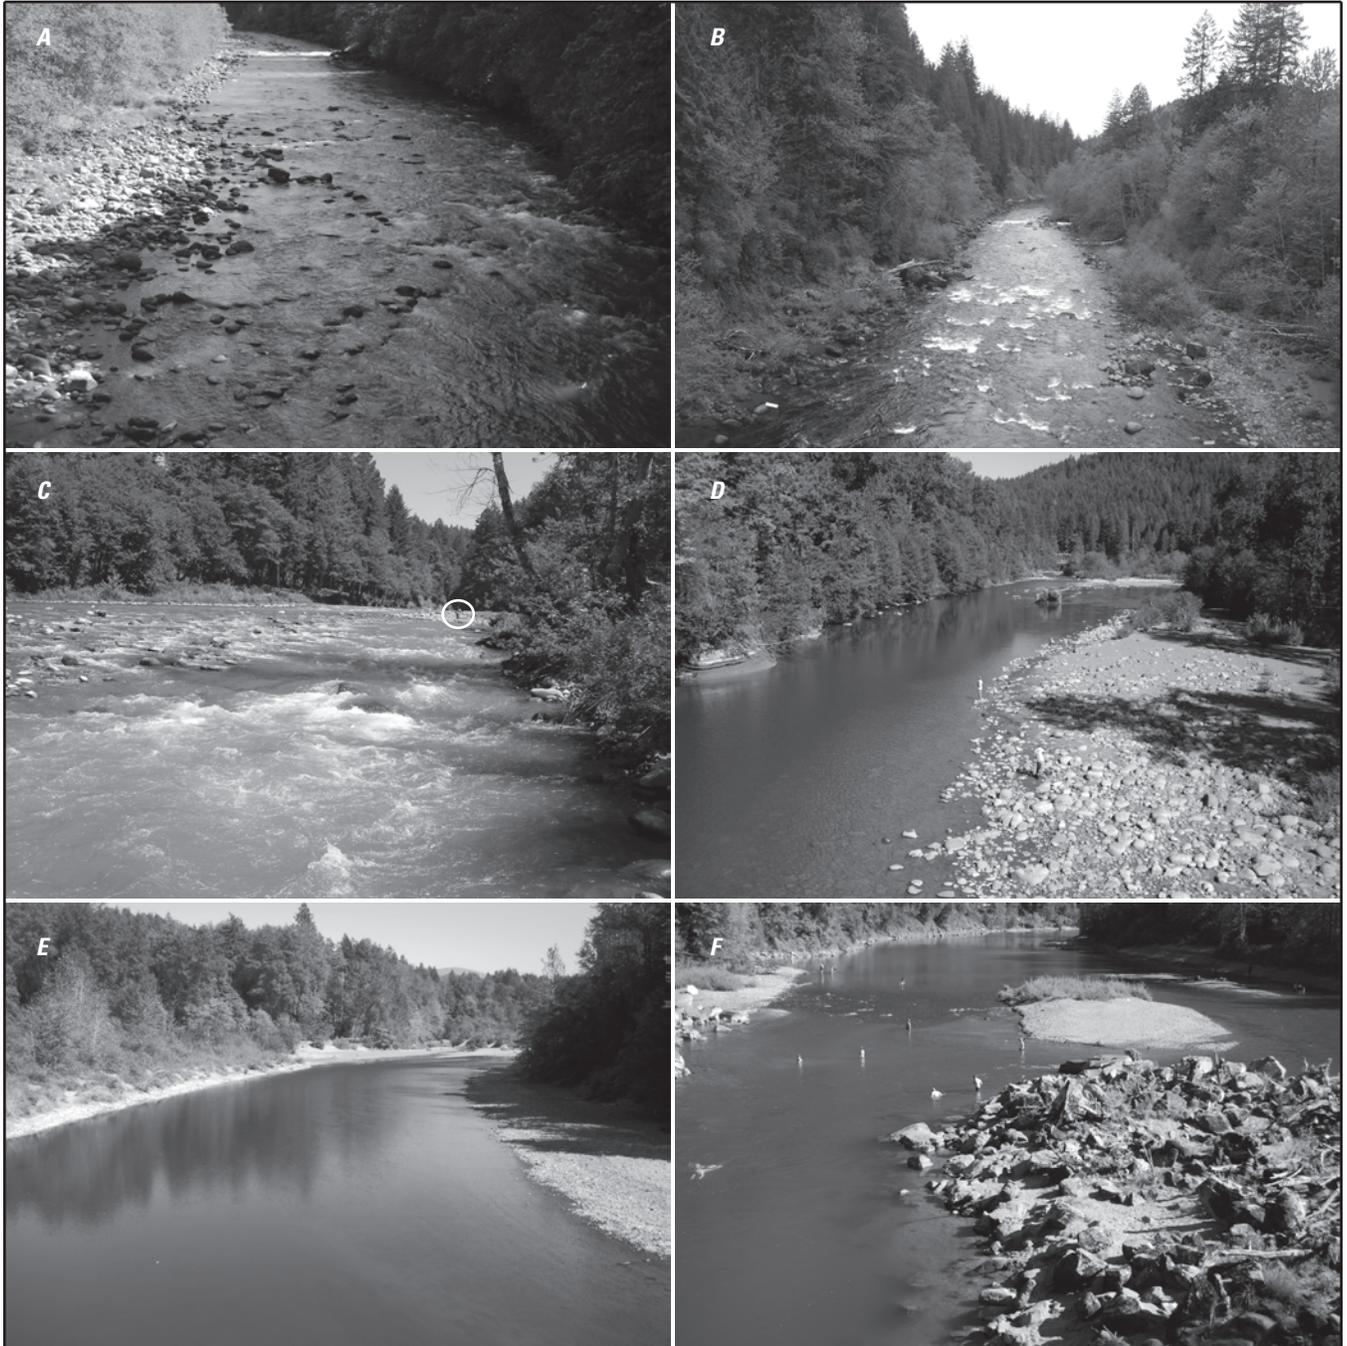
**Figure 4.** Photographs of reaches of Sandy River discussed in text (see figure 1). *A*, Brightwood looking upstream; wetted channel width approximately 25 meters (m). *B*, At Marmot Dam looking downstream; wetted channel width approximately 25 m. *C*, Near Revenue Bridge looking upstream; wetted channel width about 40 m, note person (in circle) for scale. *D*, Dodge Park looking downstream; wetted channel width about 30 m, note people for scale. *E*, Stark Street Bridge looking upstream; wetted channel width about 45 m. *F*, Troutdale looking upstream; wetted channel width about 50 m, note people for scale.

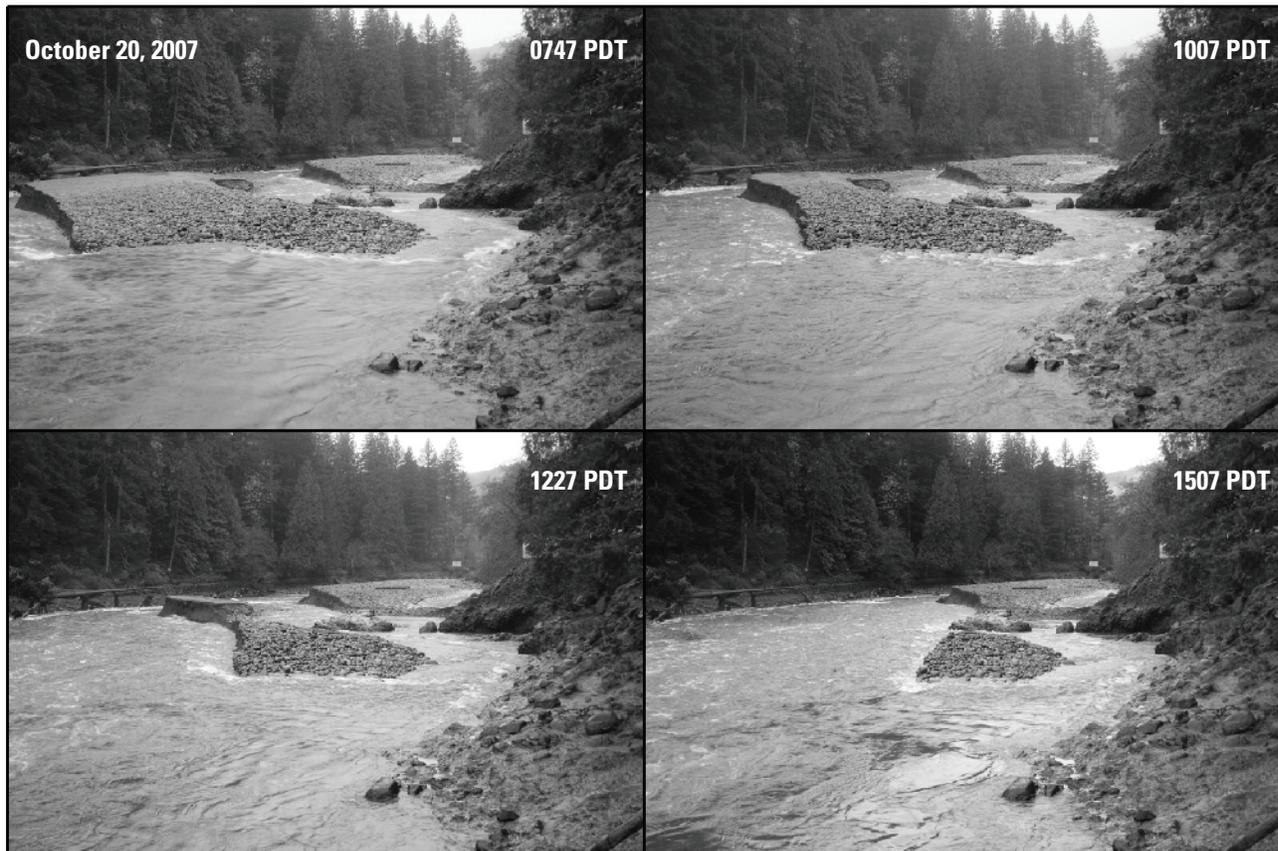
**Figure 11.** Time-lapse images of reservoir erosion following breaching of Marmot Dam. The first photograph is from the morning following breaching (see also Major and others, 2010). View is downstream from the north (right) side of the reservoir about 300 meters upstream of the dam site. Times shown are Pacific Daylight Time (PDT).

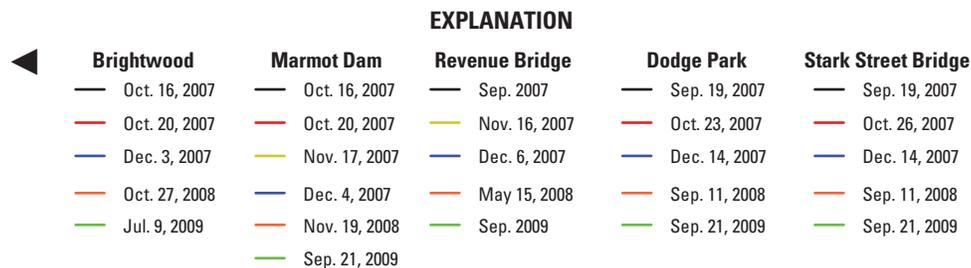
**Figure 21.** Time series of channel cross-section changes based on soundings at various measurement stations following breaching of Marmot Dam. See figure 1 for station locations.

In the second year after breaching, as the rate of reservoir erosion declined markedly, the channel reach immediately below the dam site incised, resulting in net erosion of sediment from the depositional wedge (table 4). Erosion was mainly in the 0.5-km reach downstream of the cofferdam site where deposition had been greatest (figs. 14, 19, 24). This erosion was caused largely by stormflows in November 2008 and January 2009 (fig. 12). Differences between channel surveys in 2008 and 2009 showed as much as 1.5 meters of channel incision over a several-hundred-meter-long reach immediately downstream of the dam site (figs. 14, 19, 24), and channel soundings at the Marmot Dam measurement station showed a lowering of the mean bed elevation of as much as 0.6 m between December 2007 and September 2009 (figs. 20, 21).
