# Documenting the Stages and Streamflows Associated With the 2011 Activation of the New Madrid Floodway, Missouri

Chapter E of  
**2011 Floods of the Central United States**

By Todd A. Koenig and Robert R. Holmes, Jr.

Professional Paper 1798–E

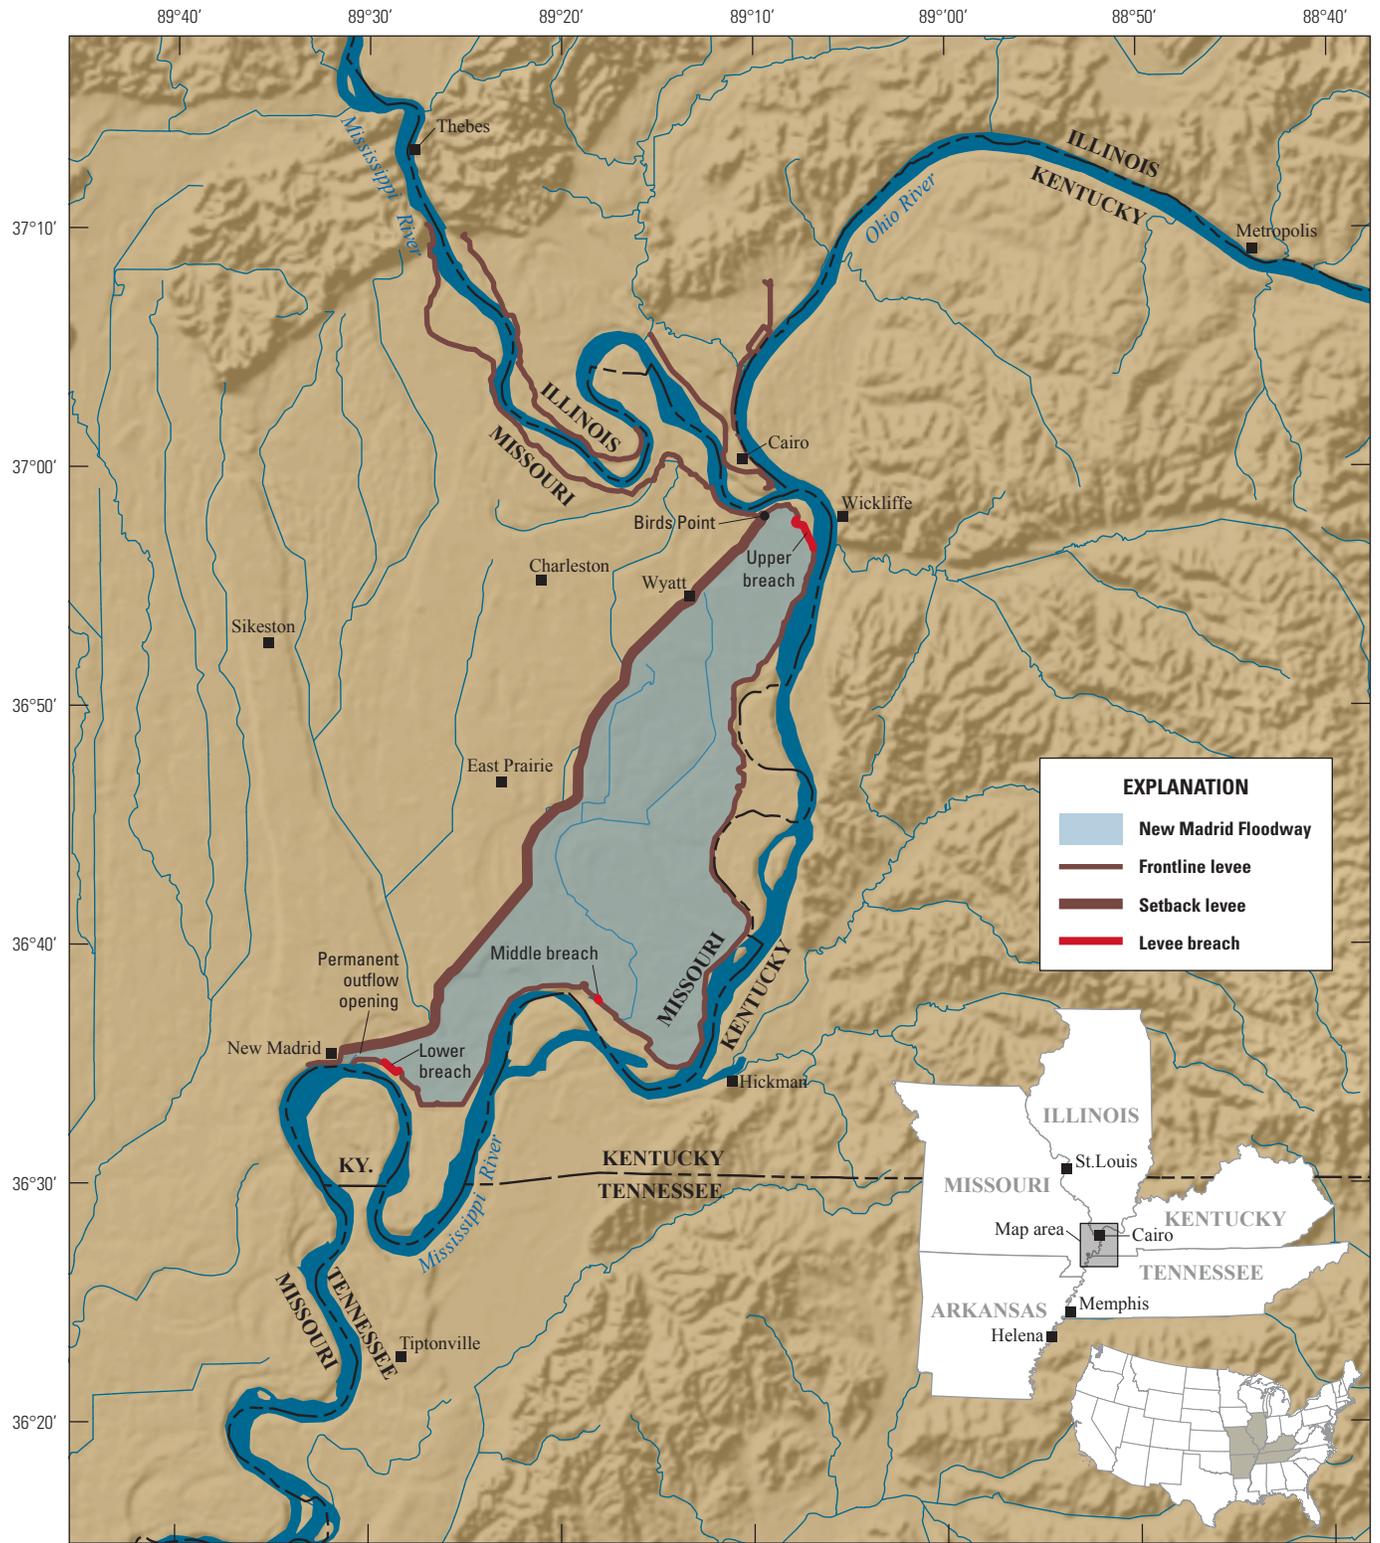
Figure 1. The New Madrid Floodway study area.

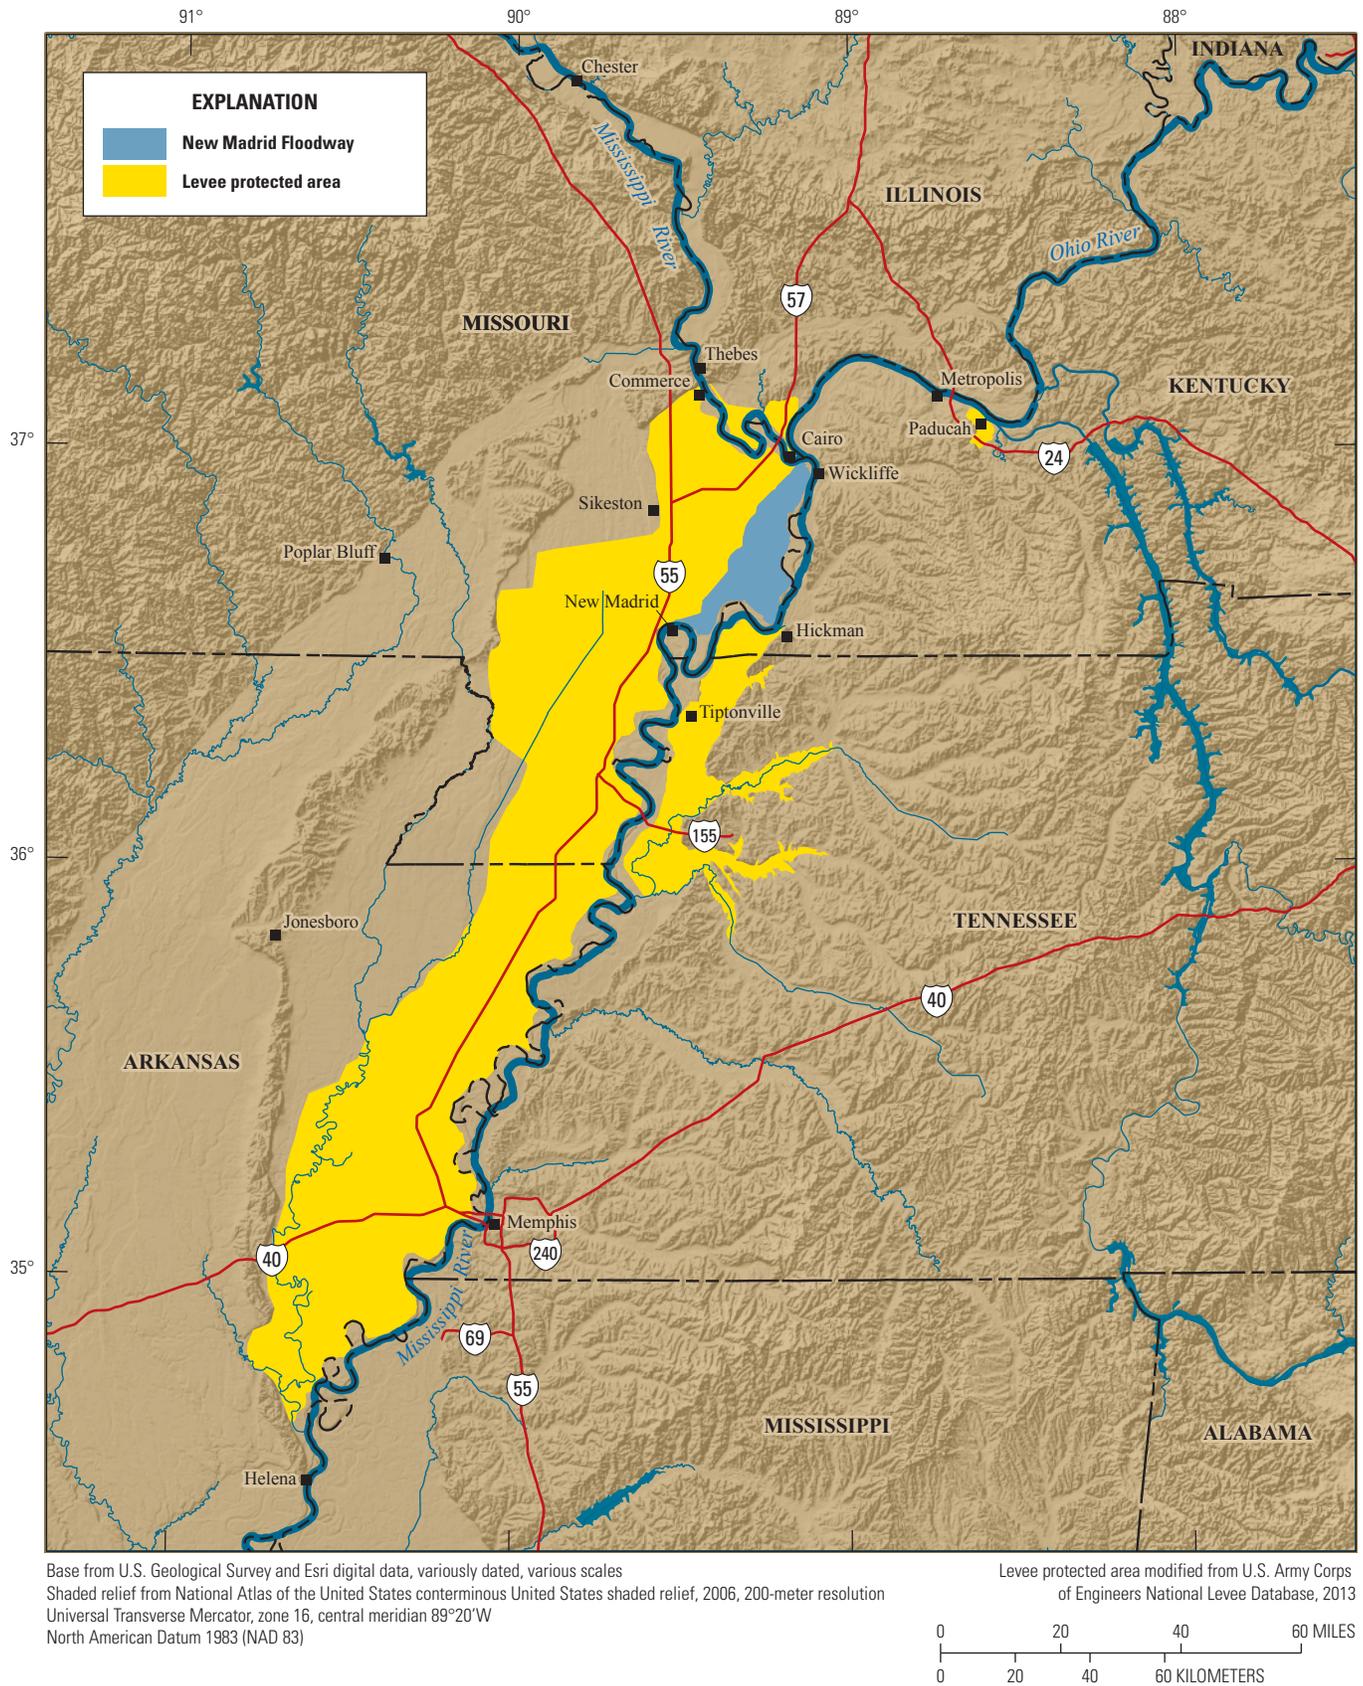
**Figure 2.** Low-lying areas adjacent to the Mississippi and Ohio Rivers protected by the New Madrid Floodway.

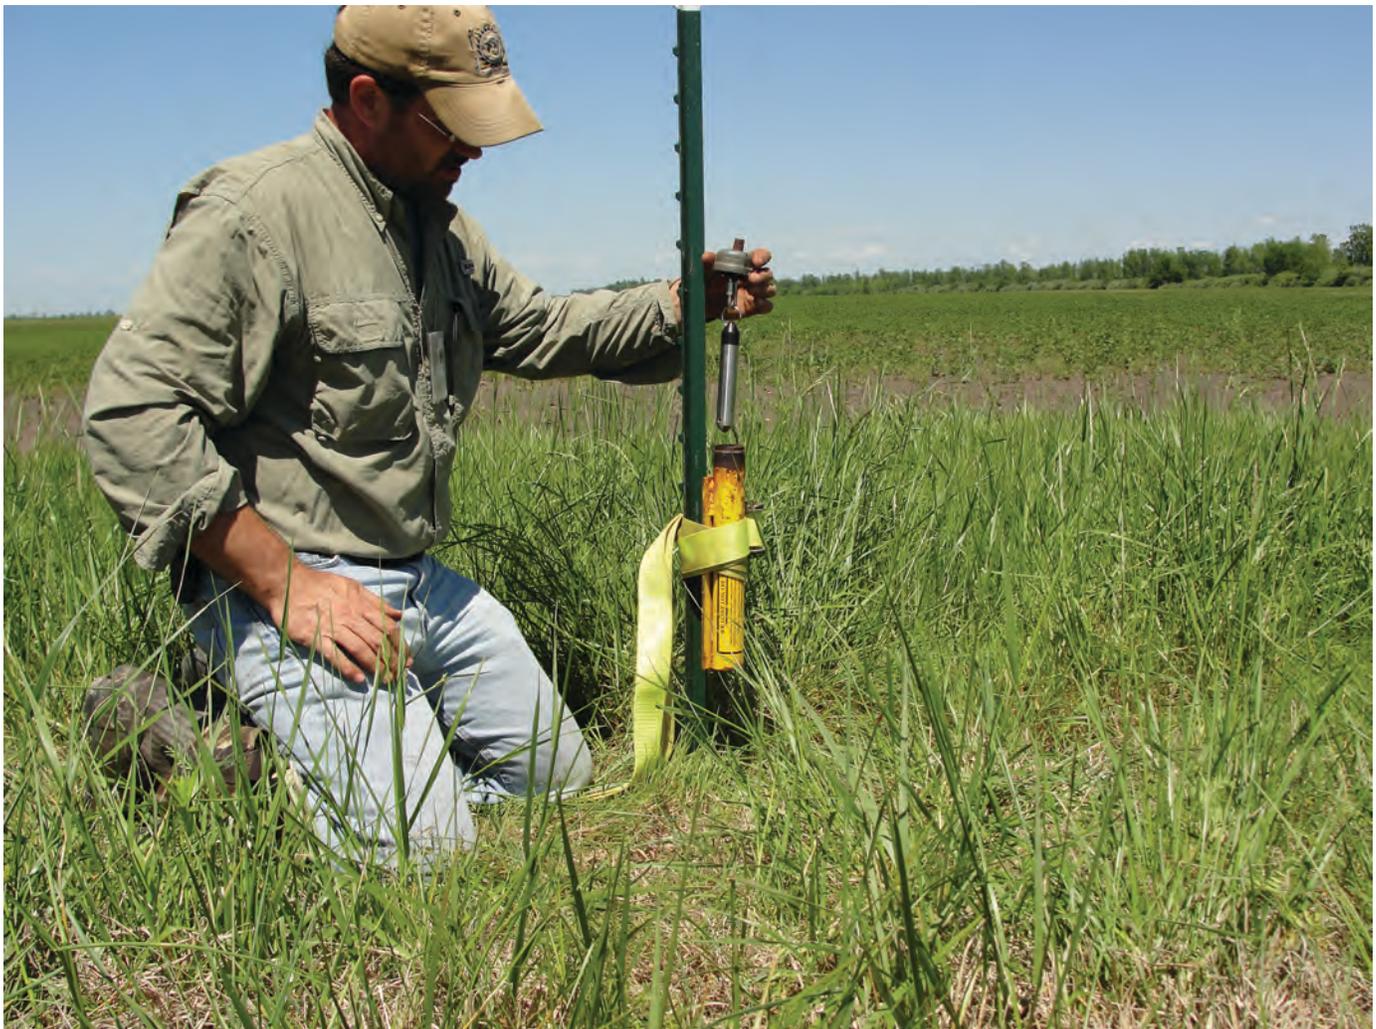
**Figure 3.** U.S. Geological Survey hydrologist installing a submersible pressure transducer in the New Madrid Floodway.

On April 28 and 29, 2011, USGS personnel placed 38 SPTs for sensing rising stage in the floodway (fig. 4). Six SPTs were placed in areas already inundated by backwater from the floodway's natural opening near New Madrid, Mo. and another five were placed in locations that became submerged prior to floodway activation on May 2. The remaining 27 SPTs were placed in locations that were not submerged until the activation. Three primary factors affected the choice of locations for the SPTs:

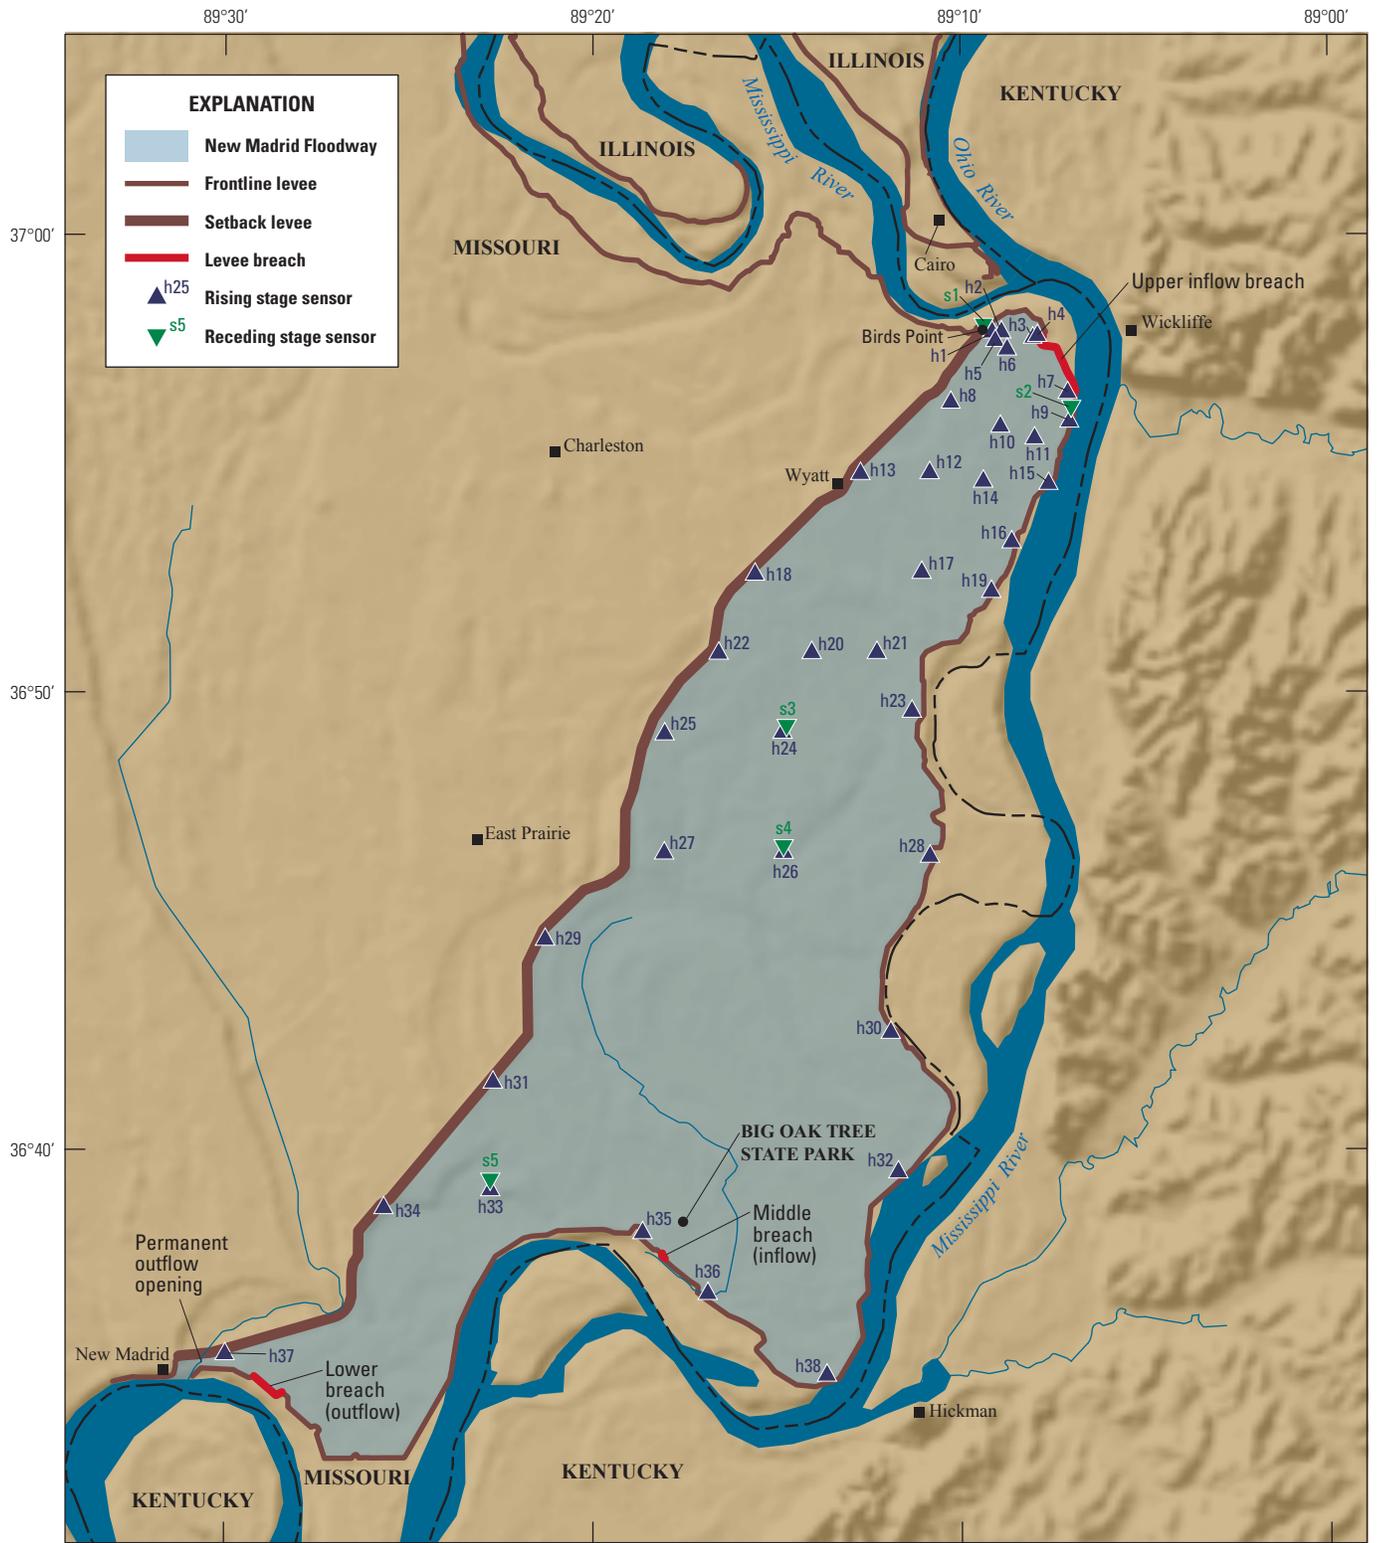
**Figure 4.** Map of the New Madrid Floodway showing 43 water level recording locations.

number 365757089090901 (fig. 4, map site number h1), were dry until floodway activation caused faster water level rises.

In addition to the patterns mentioned already, the data include noticeable concurrent small rises across many SPTs, which may indicate a rain event. As previously noted, users also may notice the empty dataset from station number 364629089105201 (fig. 4, map site number h28), indicating that this sensor was never submerged at all.

- Map site number corresponding to locations in figure 4 map.
- 15-digit USGS station number for finding data on NWISweb.
- Latitude and longitude of the station location.
- Elevation of the SPT sensor.
- Date/time sensor first became submerged.
- Peak water-surface elevation, and the date and time of occurrence.
- Uncertainty associated with each dataset.

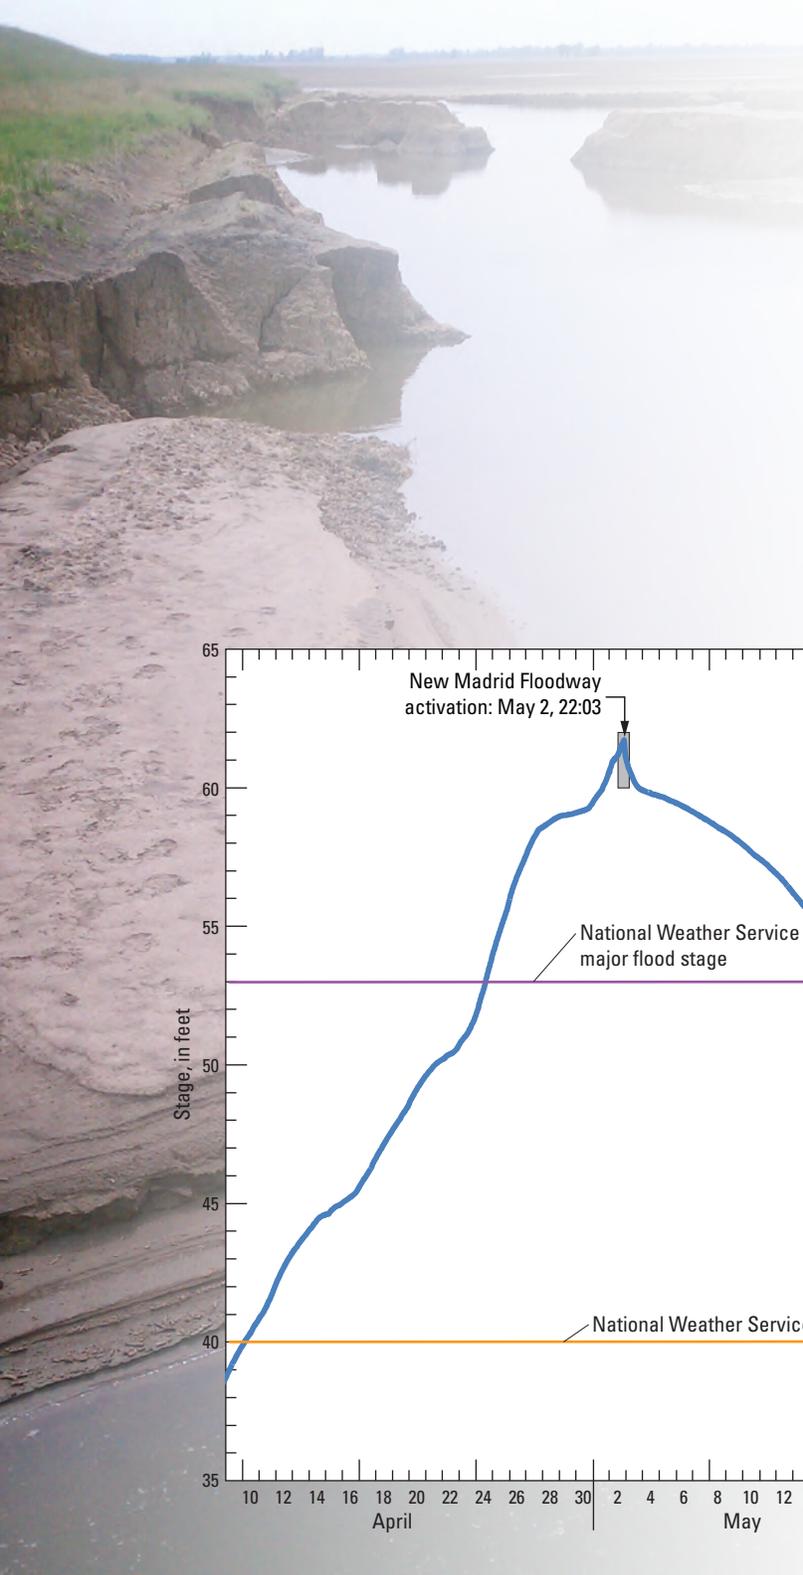
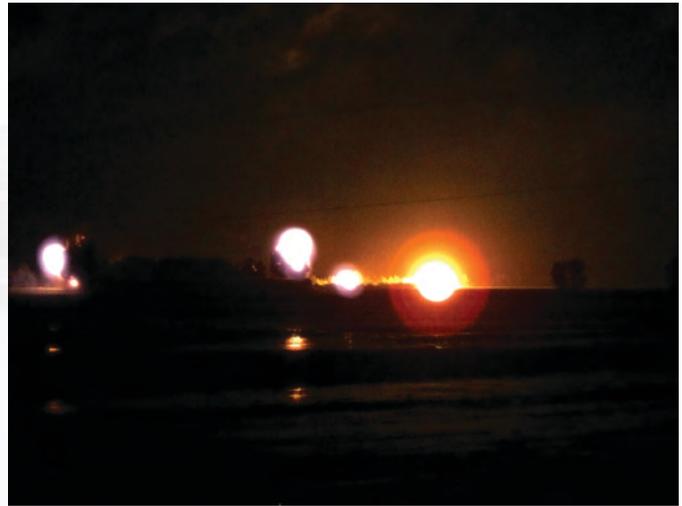
**Figure 5.** Detonation of the upper inflow fuse-plug levee near Birds Point at 10:03 p.m. on May 2, 2011.

The USACE activated the floodway by detonating explosives just after 10:00 p.m. on May 2, 2011, within a 9,000-foot section of levee at the upstream end near Birds Point (Camillo, 2012, p. 118, fig. 5). The activation of the floodway lowered the river stage at Cairo, Ill. by more than 0.4 feet in the first hour and nearly 1 foot in the first 6 hours (fig. 6). Comparisons of satellite images taken 7 months before the flood and 1 week after the activation of the floodway (fig. 7) demonstrate the immense capacity of the floodway as well as the extensive overbank flooding that existed during the period.

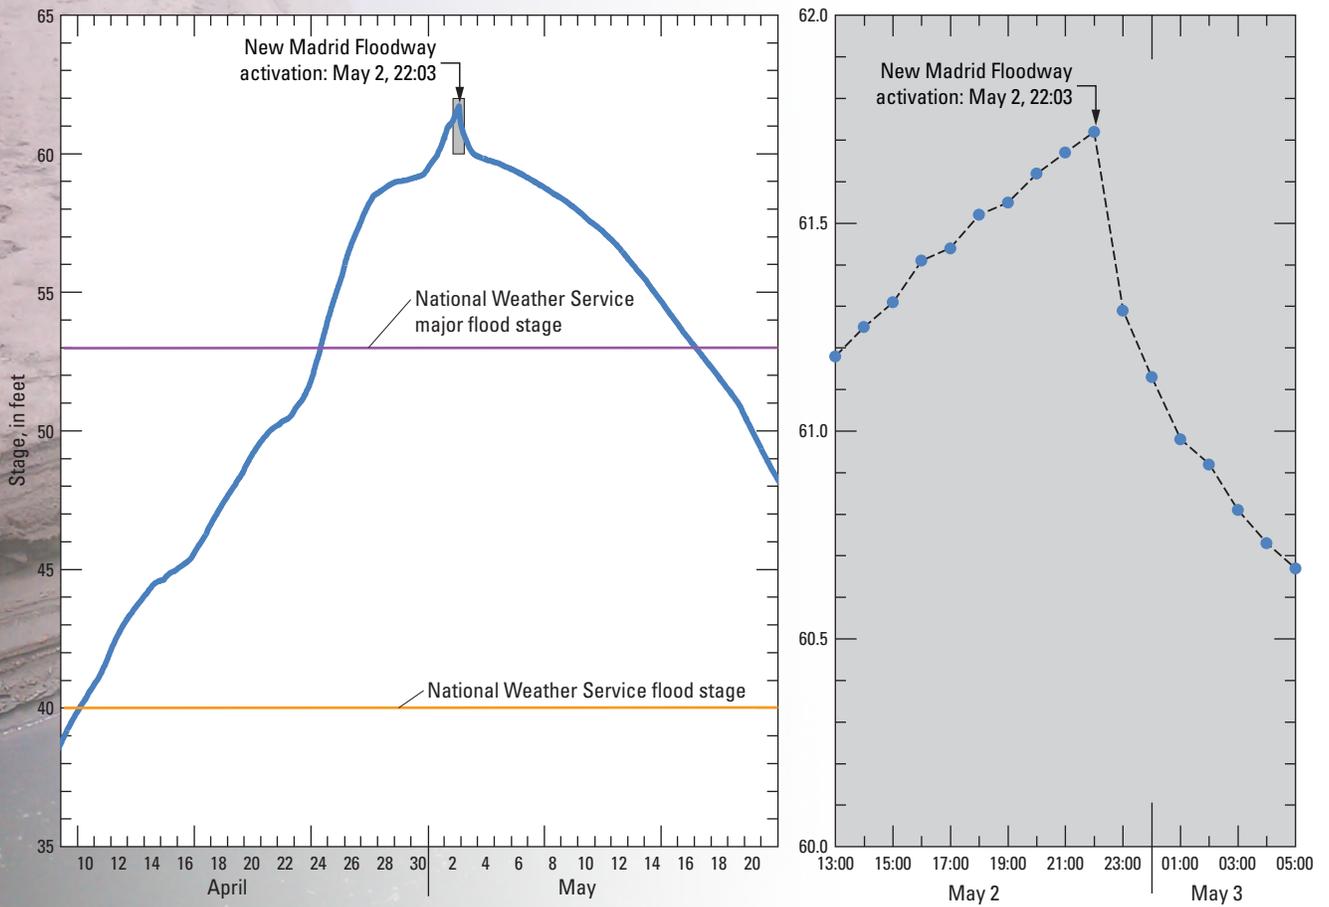
**Figure 6.** Stage hydrograph for the Ohio River at Cairo, Illinois (station number 365939089084601). Data from Jeanne Burns, U.S. Army Corps of Engineers, Hydraulics Branch, written commun., 2012.

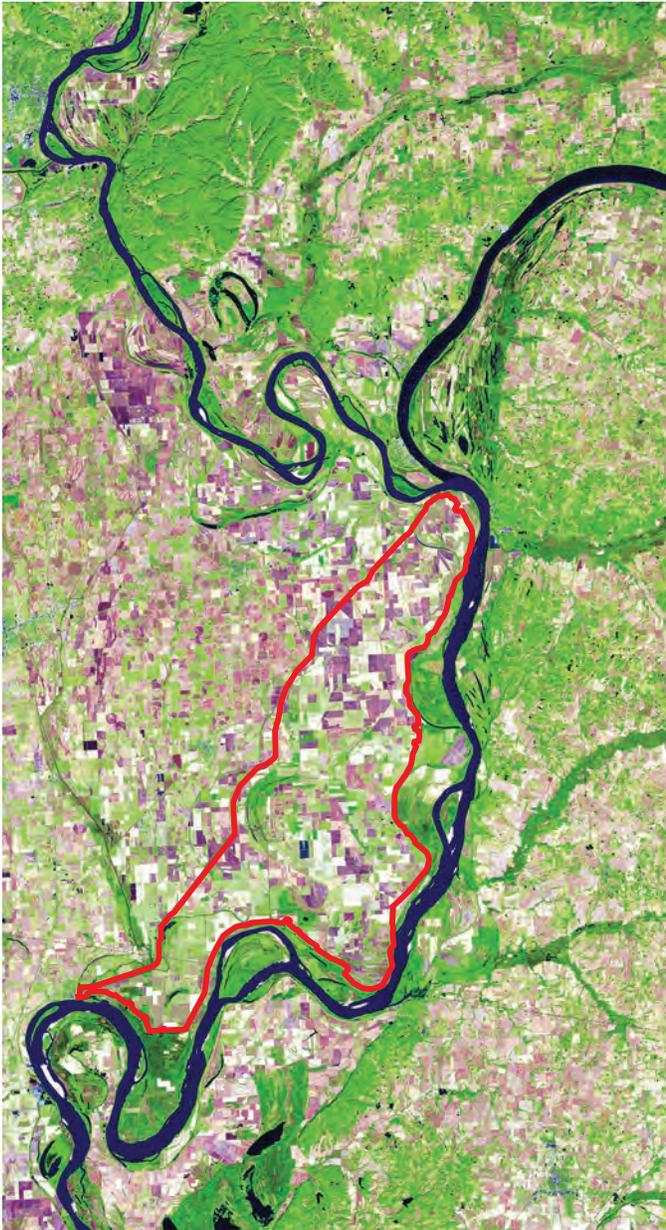
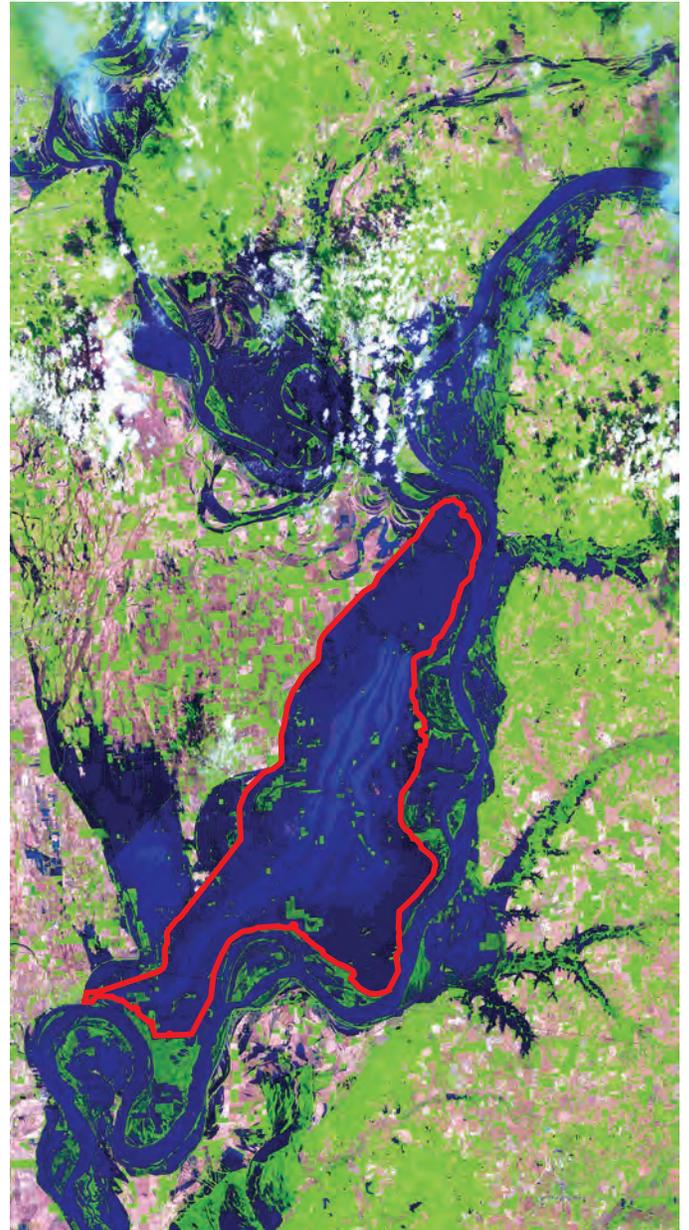
**Figure 7.** Landsat satellite images showing the Ohio and Mississippi River confluence and New Madrid Floodway A, on October 14, 2010, before the 2011 floods and B, on May 10, 2011, after the activation of the floodway.

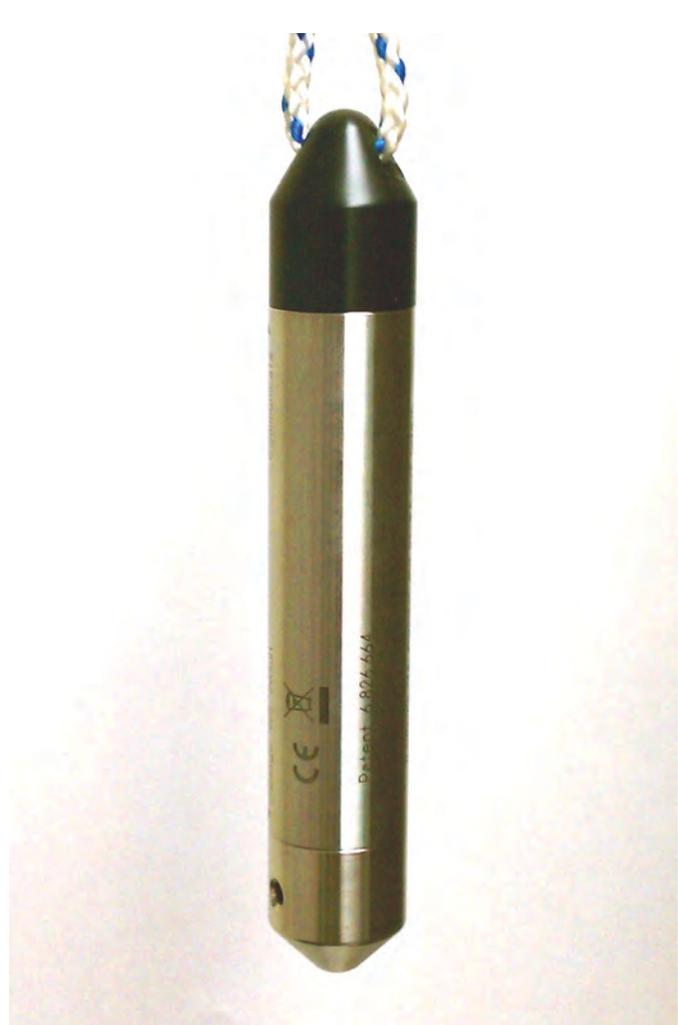
**Figure 8.** Submersible pressure transducer similar to that used in the New Madrid Floodway.

A typical SPT used in this study contains a ceramic pressure sensor, battery, storage memory, and optical interface, all within a factory-sealed, stainless steel container. An SPT is suspended inside a protective steel pipe with openings at the top and bottom to allow water to move freely around the SPT. A closeup photo of a typical SPT is shown in figure 8. Each SPT measures the absolute pressure surrounding the sensor at the nose of the SPT. The absolute pressure includes both water pressure and the barometric pressure above the water. Subtracting the barometric pressure from each absolute pressure reading results in a water pressure value that can be mathematically converted to water depth above the sensor (McGee and others, 2005). If the elevation of the sensor is known with some level of accuracy, then the water elevation throughout the time period can also be established with similar accuracy. The resulting dataset contains a time series of water elevation from the moment that each SPT became submerged until it stopped recording or the water receded below the sensor.

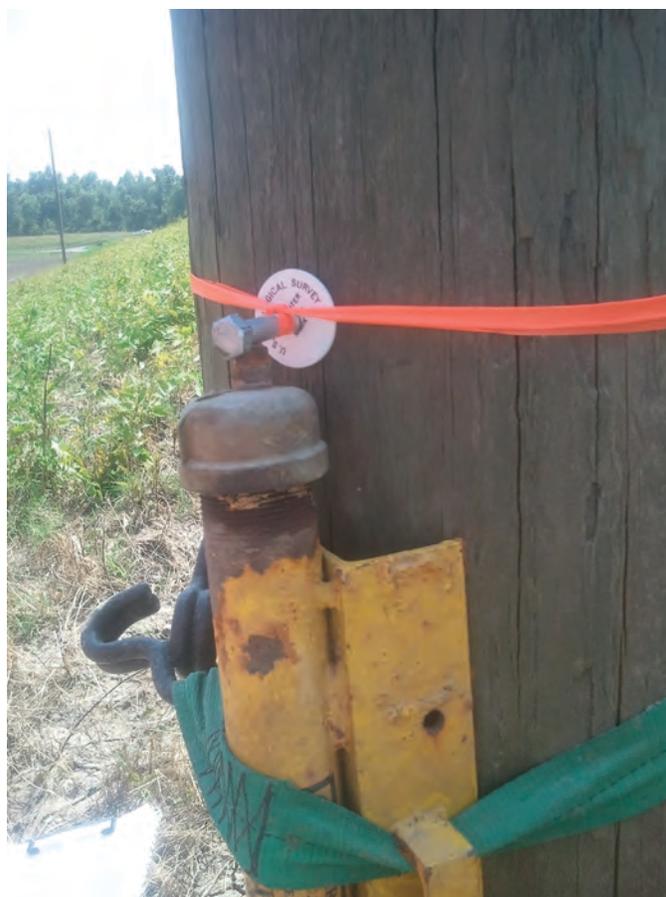
**Figure 9.** A lag bolt used to mark the location and elevation of a recovered submersible pressure transducer.

As the water levels in the floodway receded, recovery of the SPTs began in late May 2011 and concluded in mid-July 2011. During recovery, USGS personnel established durable reference marks that were surveyed to establish the elevation of each SPT (fig. 9). Photos and notes also were recorded and archived for each location.

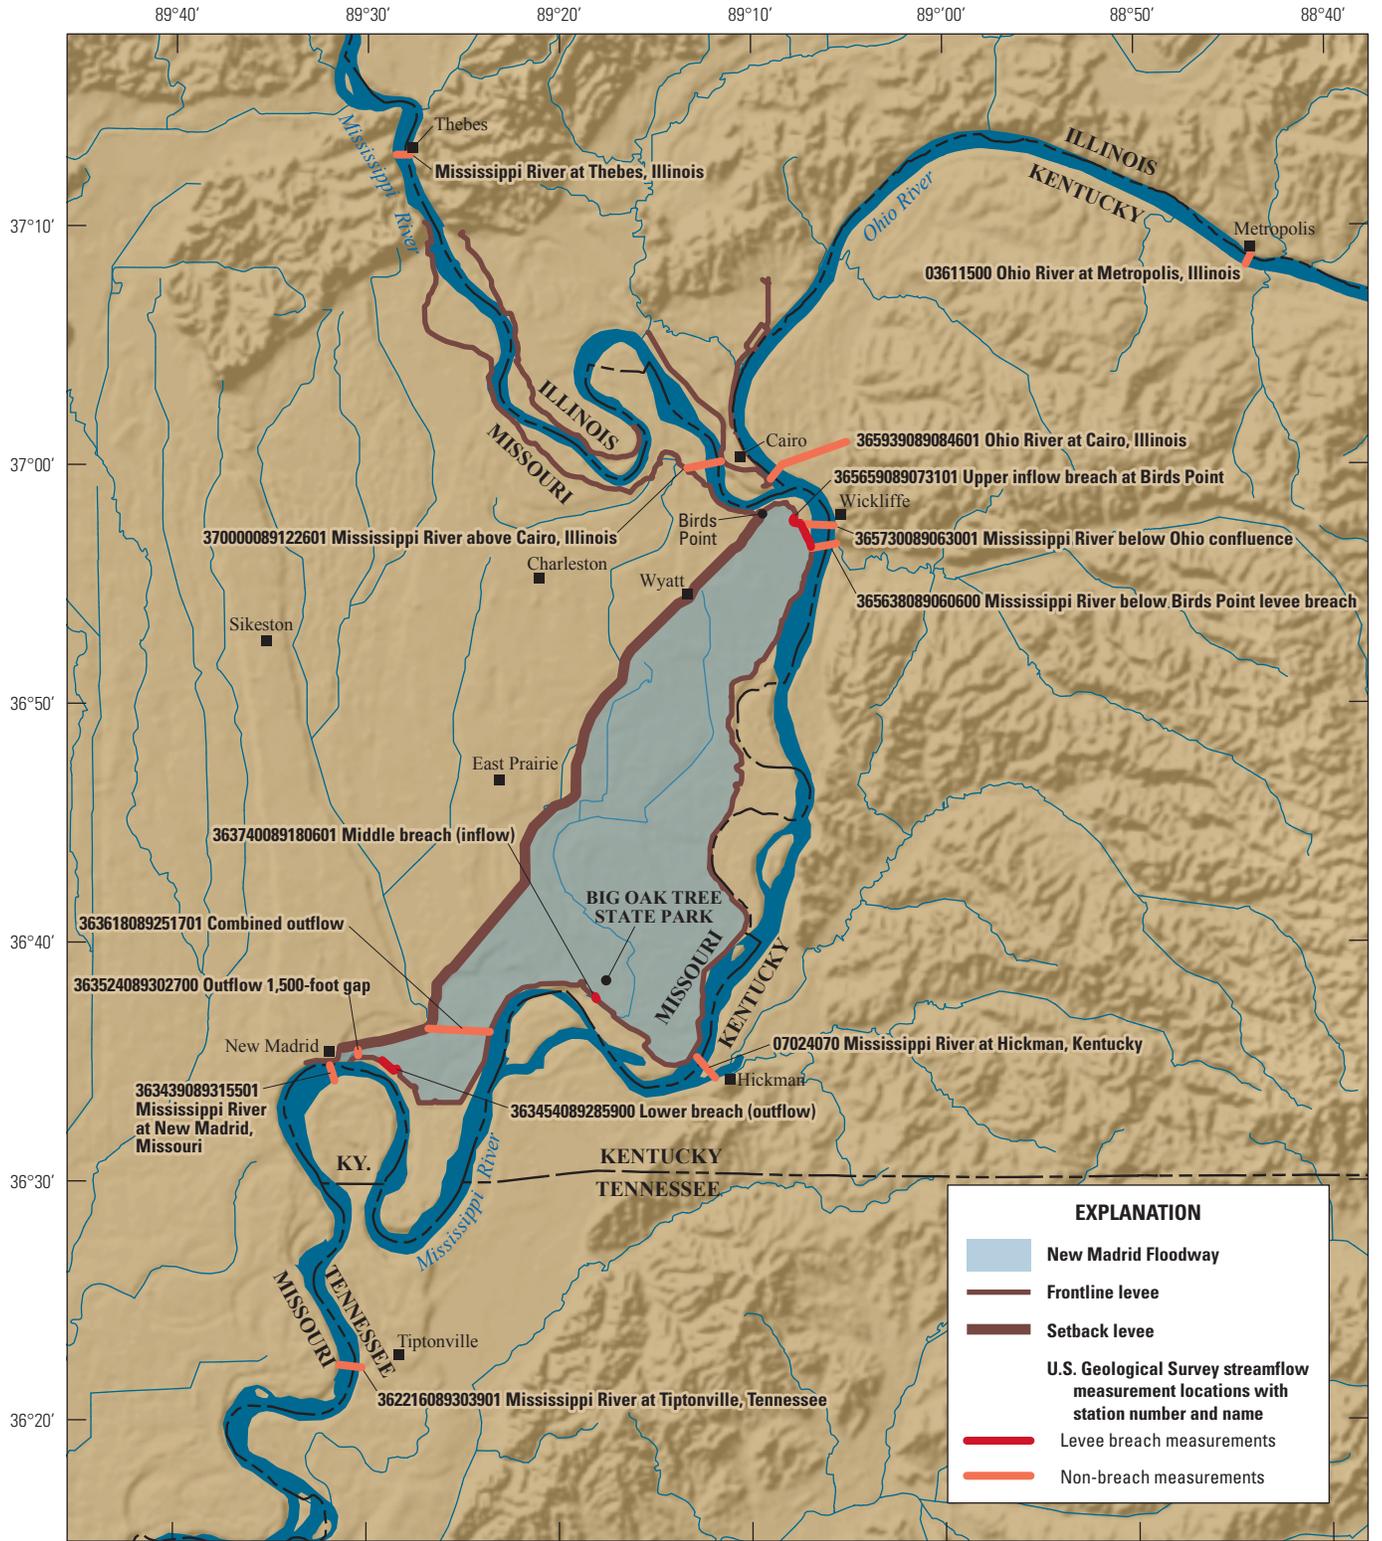
Figure 10. Approximate locations of streamflow measurements from April 28 to June 14, 2011, in and near the New Madrid Floodway.

As the Mississippi and Ohio Rivers approached record flood levels in 2011, hydrodynamic measurements, including water velocity, depth, and streamflow rate, became indispensable for flood management and navigational safety while forming an important dataset for scientific study. The USGS deployed field crews to make frequent (sometimes daily) measurements of velocity, depth, and streamflow at key locations in and around the floodway. These locations included the inflow and outflow points of the floodway and several locations on the main stems of the Mississippi and Ohio Rivers, including flow across the adjacent floodplains (fig. 10).

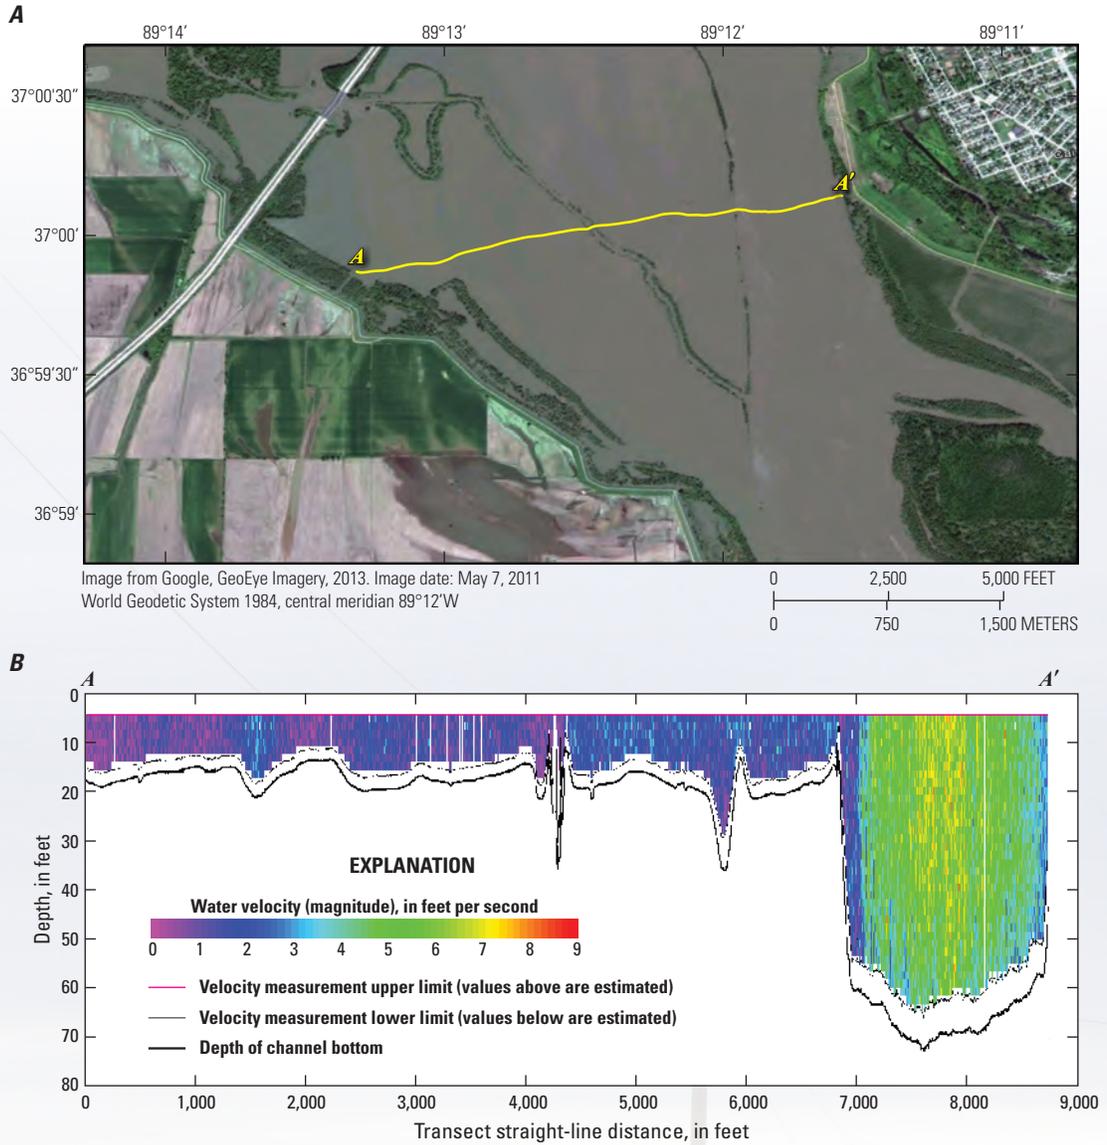
**Figure 11.** Example acoustic measurement transect at the Mississippi River above Cairo, Illinois (station number 370000089122601) including *A*, May 1, 2011 transect path drawn over May 7, 2011 satellite imagery (inundation similar to May 1), and *B*, cross-section graph of water velocity magnitudes collected during the transect.

Data from a typical ADCP measurement are shown in figure 11. As the downward-looking ADCP travels across the water surface, sound waves transmitted by the device are reflected by scatterers (typically suspended sediment) from the water column back to the device. The frequency shift detected by the ADCP in the return signal indicates the speed of the particles and thus the speed of the water at locations

throughout the water column (Mueller and Wagner, 2009). The device also can determine water depth by listening for stronger return signals off the streambed. Cross section width also is determined by measuring boat speed and direction. By collecting and compiling these data, the ADCP software provides detailed riverbed profiles and three-dimensional velocity profiles at many locations in the cross section as the boat moves across the river. When streamflow measurement is desired, velocity measurements in each small subsection of the flow are multiplied by the area of each section and then summed for the entire cross section to compute a total streamflow in the river. A complete discussion of ADCP theory, as well as how these data are collected and presented, is provided by Mueller and Wagner (2009).

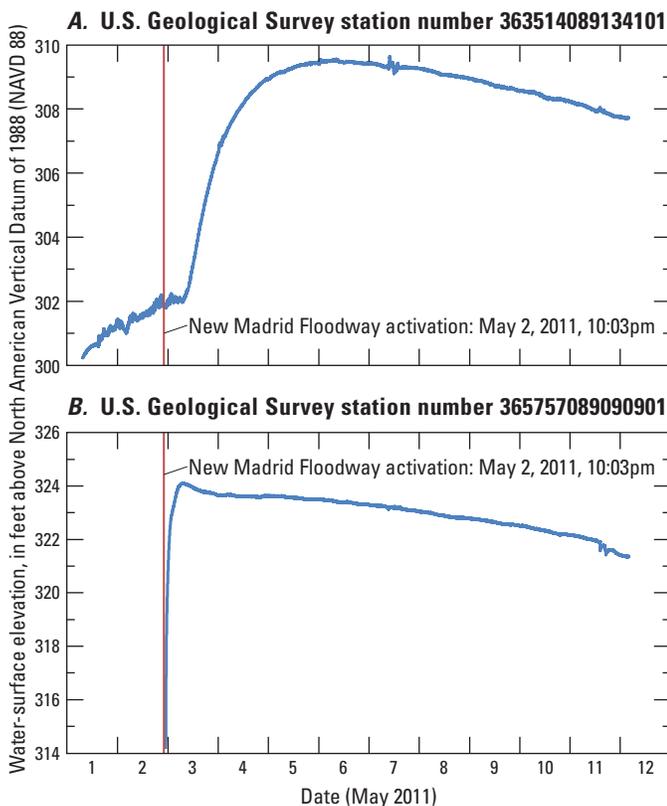
**Figure 13.** Water-surface elevation hydrographs for *A*, station experiencing natural backwater effects prior to New Madrid Floodway activation and *B*, station experiencing first submersion resulting from New Madrid Floodway activation.

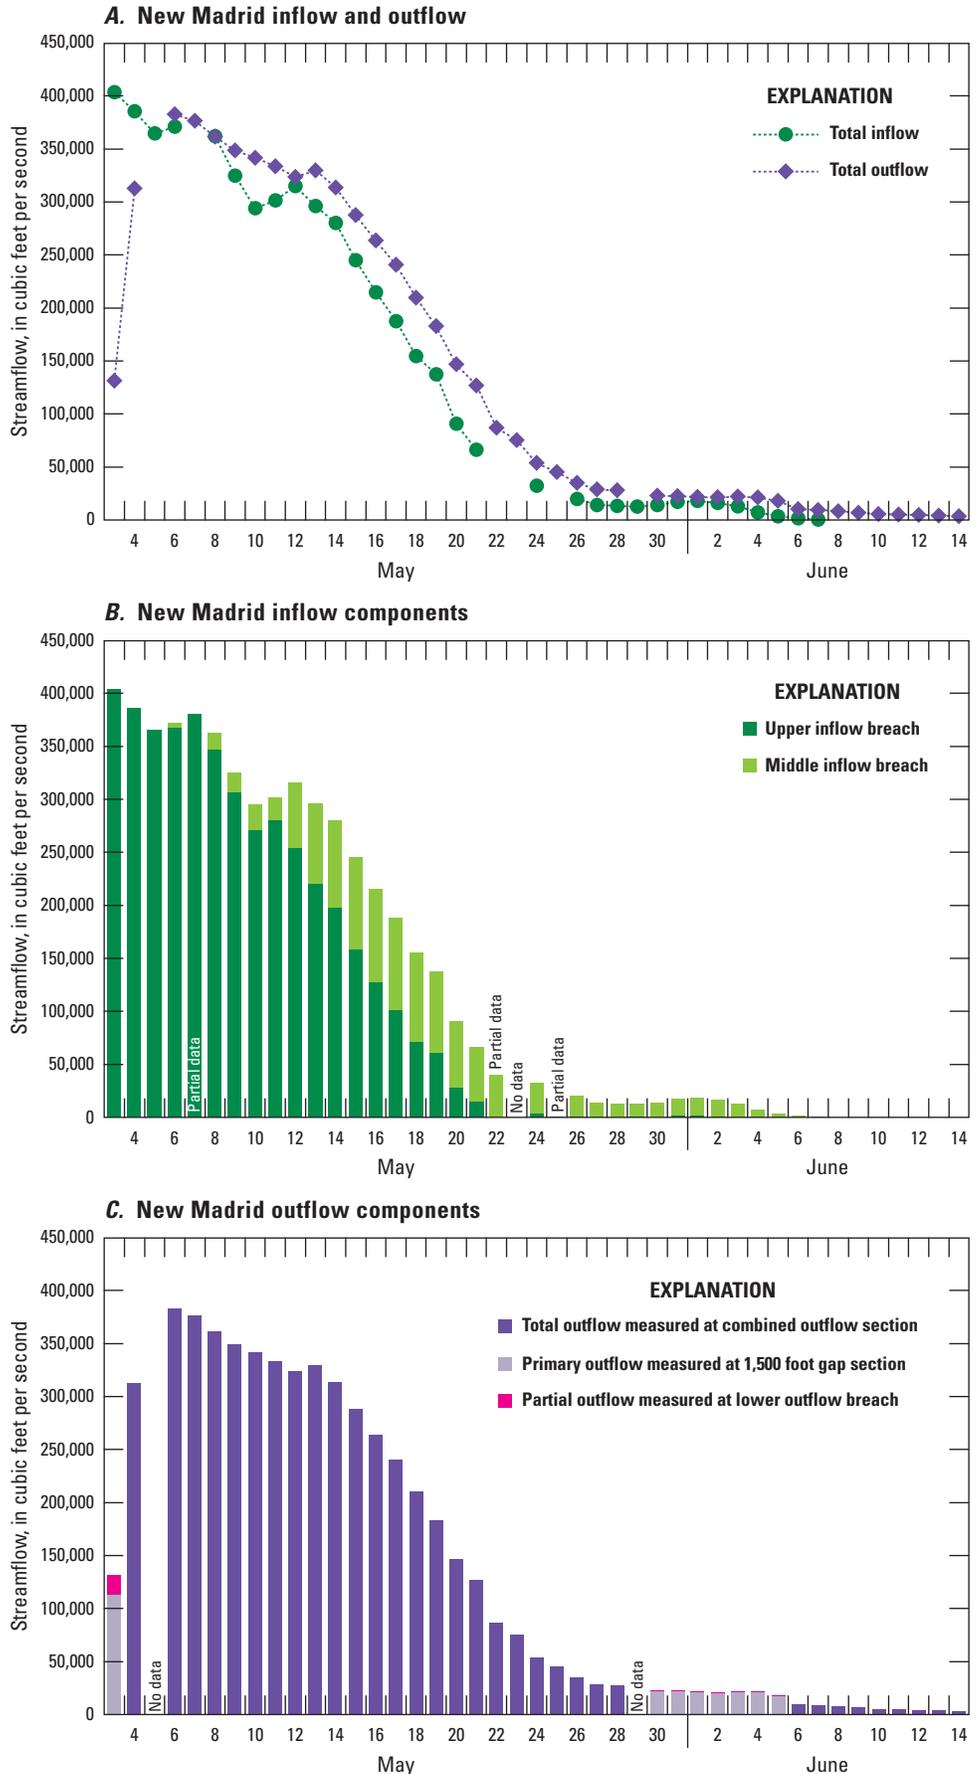
**Figure 14.** Hydrographs of the New Madrid Floodway showing *A*, a comparison of the total inflows and total outflows, *B*, the components of the total inflow, and *C*, the components of the total outflow.

The hydrographs in figure 14 depict the total inflows versus total outflows through the floodway from the end of April, just prior to activation, until mid-June when the diversion flow ceased. Data used to create these graphs are available on the USGS Flood Information Web site at [http://water.usgs.gov/floods/events/2011/BPNM/data\\_archive/](http://water.usgs.gov/floods/events/2011/BPNM/data_archive/) and the USGS NWISweb Web site at <http://waterdata.usgs.gov/>.

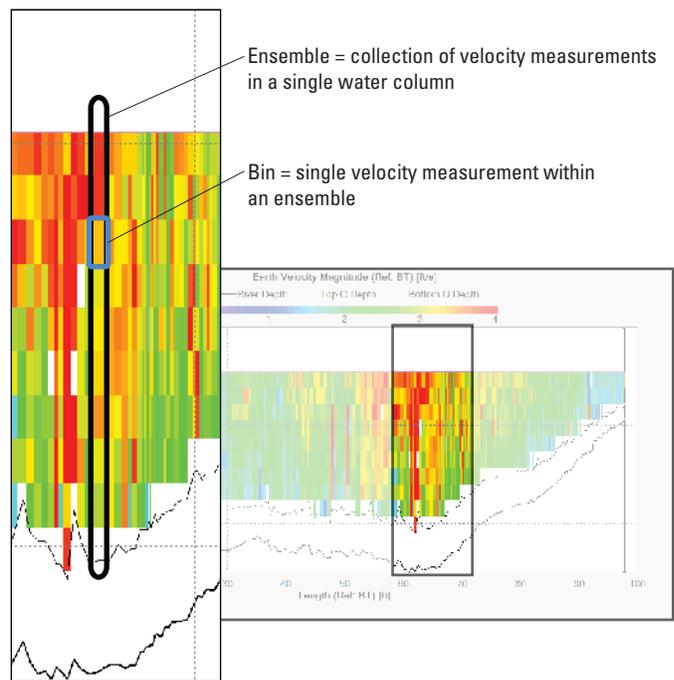
**Figure 15.** A typical acoustic Doppler current profiler measurement ensemble and bin.

transect, which is a single pass across the measurement section in a direction perpendicular to the flow. Each transect file is organized into ensembles and bins as shown in figure 15. An ensemble is a column of water from the surface to the streambed whose width is the distance that the measuring boat travels in about 1 second (typically on the order of a few inches to a few feet). The ADCP records many ensembles as it crosses a river from one bank to the other, with ensembles getting taller as the depth increases and wider as boat speed increases. These ensembles are divided into depth bins, representing individual velocity measurements by the ADCP at different depths as shown in figure 15.
