# Geomorphic Changes Caused by the 2011 Flood at Selected Sites Along the Lower Missouri River and Comparison to Historical Floods

Chapter H of  
**2011 Floods of the Central United States**

Professional Paper 1798–H

By Kyle E. Juracek

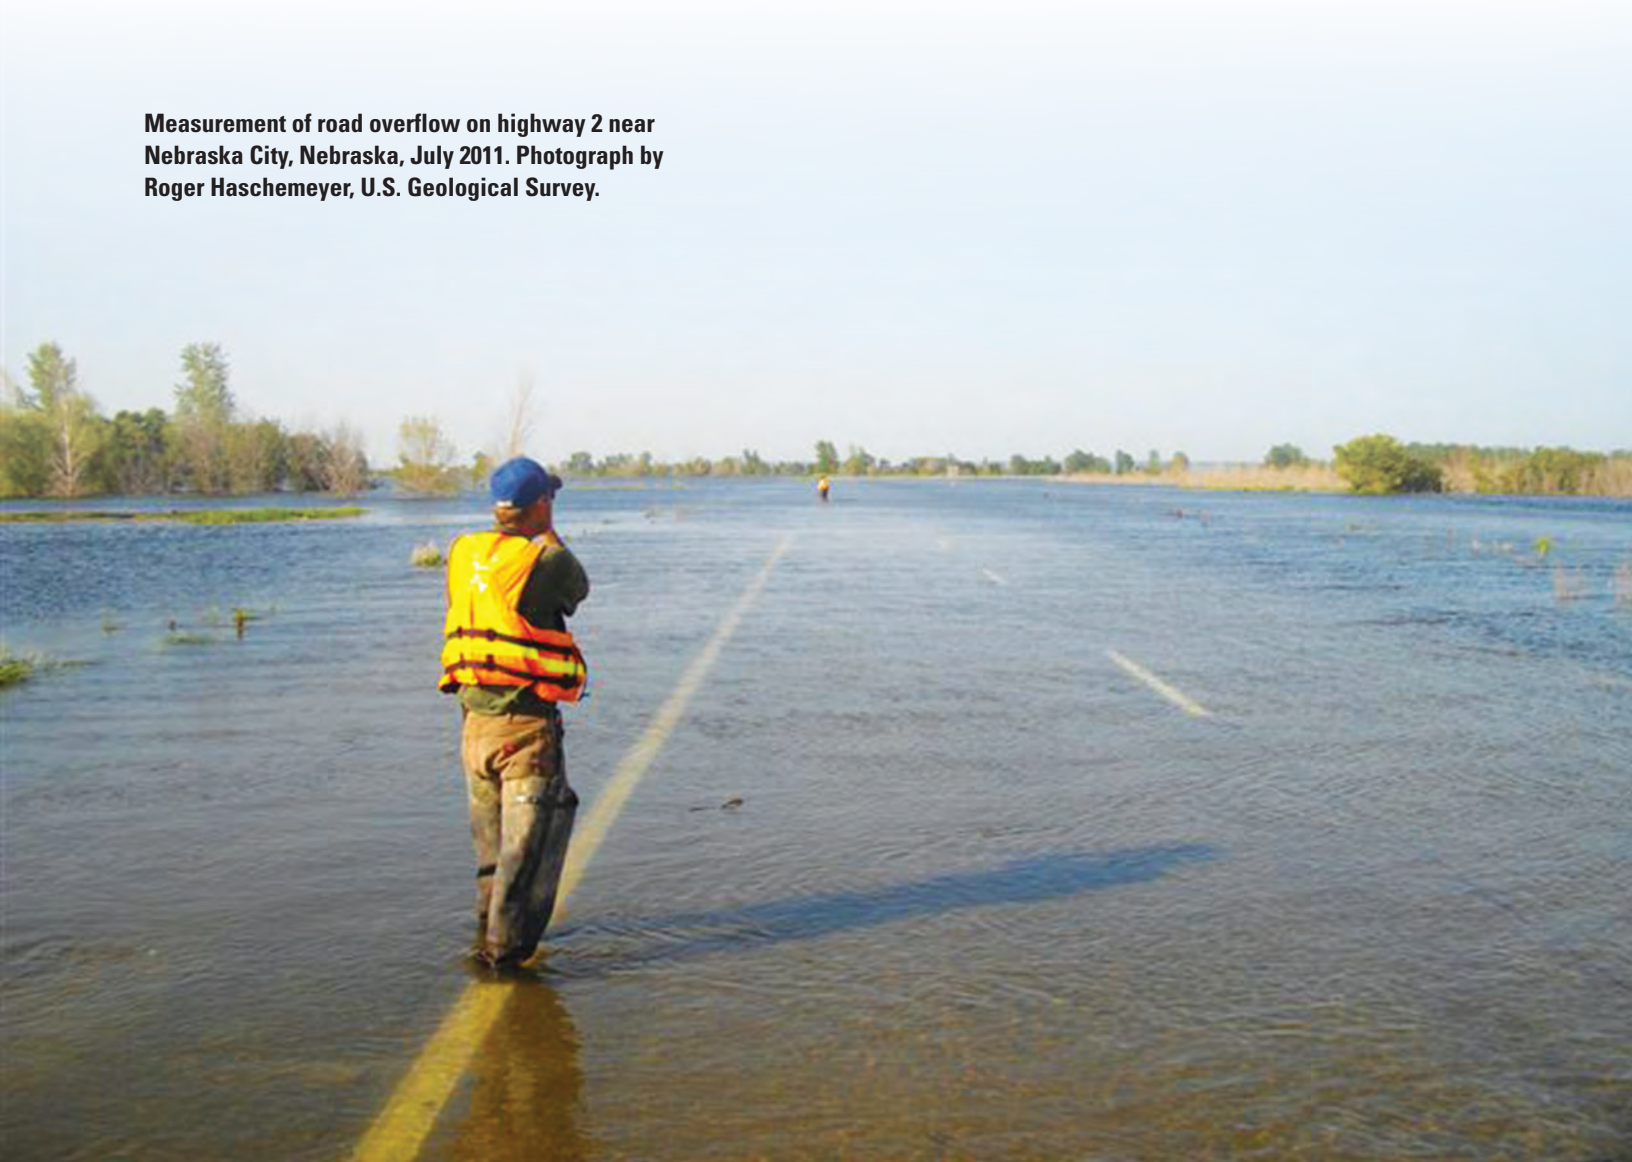
**Measurement of road overflow on highway 2 near Nebraska City, Nebraska, July 2011. Photograph by Roger Haschemeyer, U.S. Geological Survey.**

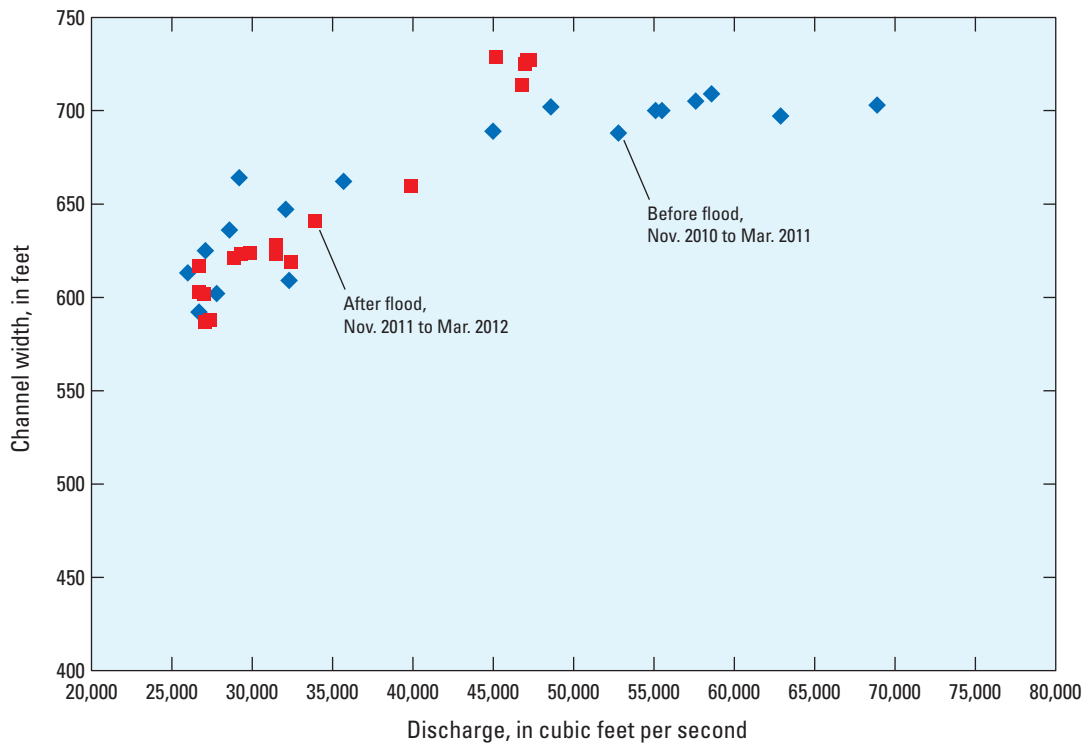
**Figure 3.** Relation between discharge and channel width at the Missouri River at Omaha, Nebraska, streamgauge (station 06610000).

In the following sections, the geomorphic changes caused by the 2011 and other selected historical Missouri River floods are described and compared. Pronounced flood-related changes in channel width were not evident at the selected streamgauge sites for the 2011 flood. For example, a comparison of pre- and post-flood widths for a range of in-channel flows at Omaha is presented in figure 3.

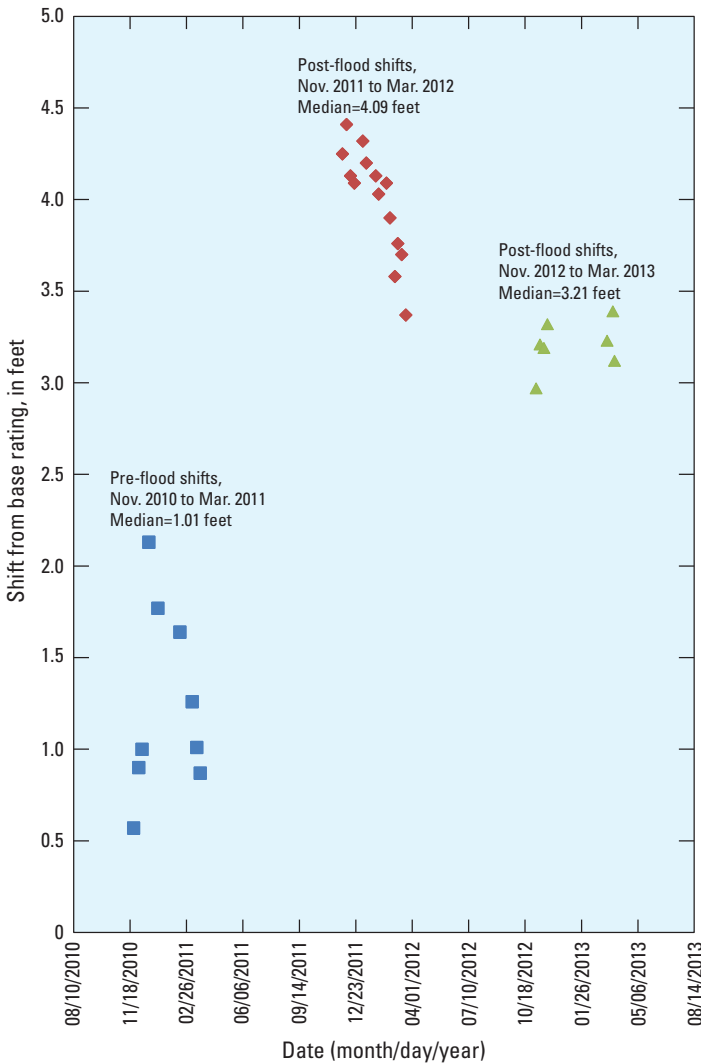
Figure 4. Shifts from the base rating curve before and after the 2011 flood for the Missouri River at Sioux City, Iowa, streamgage (station 06486000).

The 2011 flood at Sioux City caused a pronounced scour of the channel bed. A comparison of the pre-flood shifts (November 2010 to March 2011) with the first set of post-flood shifts (November 2011 to March 2012) indicated a decrease in channel-bed elevation of about 3 ft (fig. 4). Generally consistent shifts from November 2011 through mid-February 2012 indicated a period of relative stability in

channel-bed elevation. Subsequently, decreasing shifts in late February and March 2012 indicated partial recovery of the channel bed (about 0.7 ft) as a result of fill. More than 1 year after the flood, the limited range for the second set of post-flood shifts (November 2012 to March 2013) indicated that, following a total post-flood recovery (fill) of about 1 foot, the channel bed had stabilized (fig. 4). Thus, as of March 2013, channel-bed elevation at this site had not recovered to the pre-flood condition.

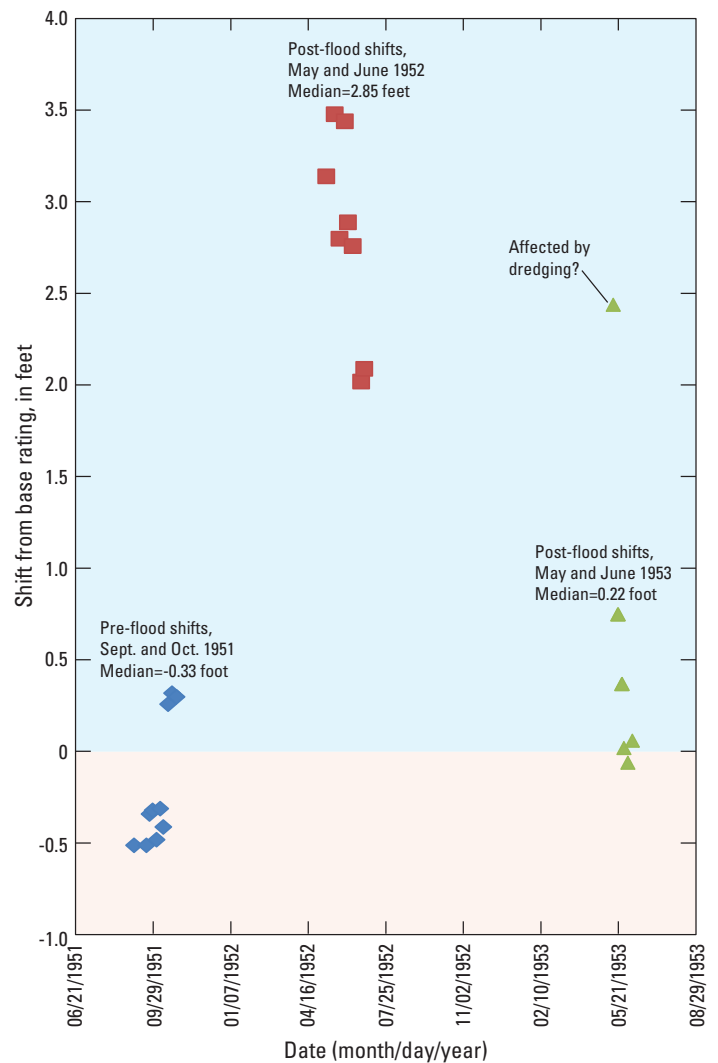
Figure 5. Shifts from the base rating curve before and after the 1952 flood for the Missouri River at Sioux City, Iowa, streamgage (station 06486000).

magnitude and duration of the 2011 and 1952 floods, the initial geomorphic effect on channel-bed elevation was similar. One year after the 1952 flood, the second set of post-flood shifts (May and June 1953) indicated about 2.5 ft of recovery in the channel-bed elevation (fig. 5). By April 1954, the recovery to the pre-flood channel-bed elevation was complete (fig. 2A). A possible explanation to account, at least in part, for the greater recovery in channel-bed elevation in the year following the 1952 flood (compared to the more limited recovery following the 2011 flood) is a more abundant supply of sediment before the completion of most of the Missouri River main-stem dam, channelization, and bank stabilization projects (Meade, 1995; Meade and Moody, 2010). Also, the disturbance associated with the construction of Gavins Point Dam, which began in May 1952, may have provided an additional temporary source of sediment.

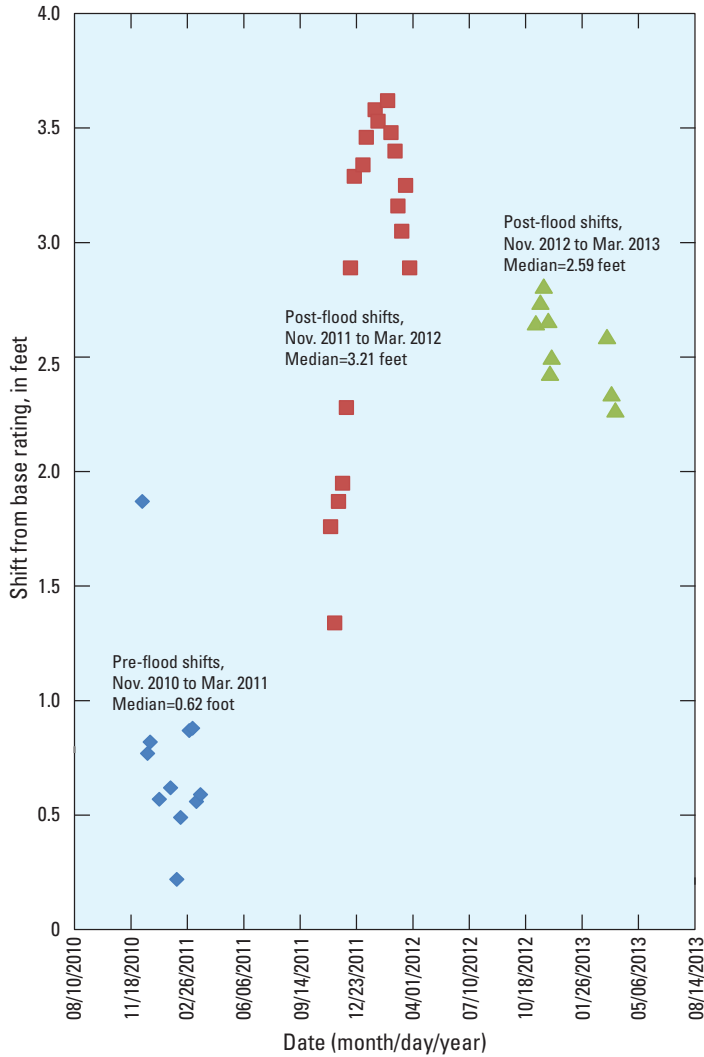
**Figure 6.** Shifts from the base rating curve before and after the 2011 flood for the Missouri River at Omaha, Nebraska, streamgauge (station 06610000).

The 2011 flood at Omaha caused a pronounced scour of the channel bed. Compared to the pre-flood shifts (November 2010 to March 2011), the first set of post-flood shifts (November 2011 to March 2012) indicated a progressive scour of the channel bed from November 2011 to mid-February 2012 at

which time a maximum decrease in channel-bed elevation of about 3 ft was indicated (fig. 6). Thus, at this site, channel-bed scour that presumably initiated during the flood continued for several months after the flood had receded. The continued post-flood scour of the channel bed indicated that bed-material (sand) transport capacity exceeded supplies delivered from upstream. A combination of factors possibly accounted for the limited supply of bed material including sediment storage upstream from Gavins Point Dam, a depletion of readily available sediment by the flood, and a lack of post-flood sediment contributions from tributaries. From mid-February to the end of March 2012, decreasing shifts indicated partial recovery of the channel bed (about 0.7 ft) as a result of fill. More than 1 year after the flood, the second set of post-flood shifts (November 2012 to March 2013) indicated that, with a total fill of about 1 foot, channel-bed elevation was recovering slowly (fig. 6). As of March 2013, the channel-bed elevation had not fully recovered to the pre-flood condition.

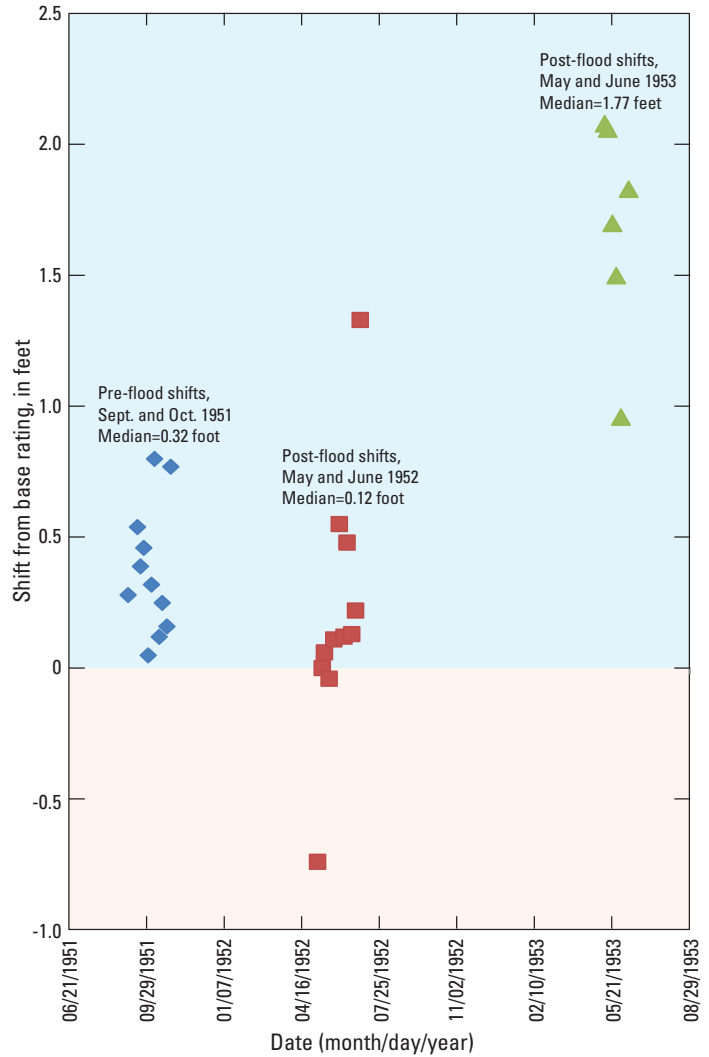
**Figure 7.** Shifts from the base rating curve before and after the 1952 flood for the Missouri River at Omaha, Nebraska, streamgauge (station 06610000).

beginning at the end of the first selected post-flood evaluation period. During this evaluation period, the largest shift (1.33 ft) occurred on June 30, 1952 (fig. 7). Thus, analogous to the pattern determined for the 2011 flood, substantial channel-bed scour occurred after the 1952 flood had receded. Shifts computed for the time interval between the two post-flood evaluation periods (that is, July 1952 through April 1953) documented a scoured channel condition with a bed elevation that generally was about 1.5 ft lower than the pre-flood bed elevation. Unlike at Sioux City, the scoured channel condition persisted into the second post-flood evaluation period (May and June 1953) with no pronounced indication of recovery (fig. 7). In fact, the channel bed never fully recovered to its pre-flood elevation (fig. 2B). The lack of full recovery following the 1952 flood indicated the possibility of a cumulative effect of large floods on channel-bed elevation with time.

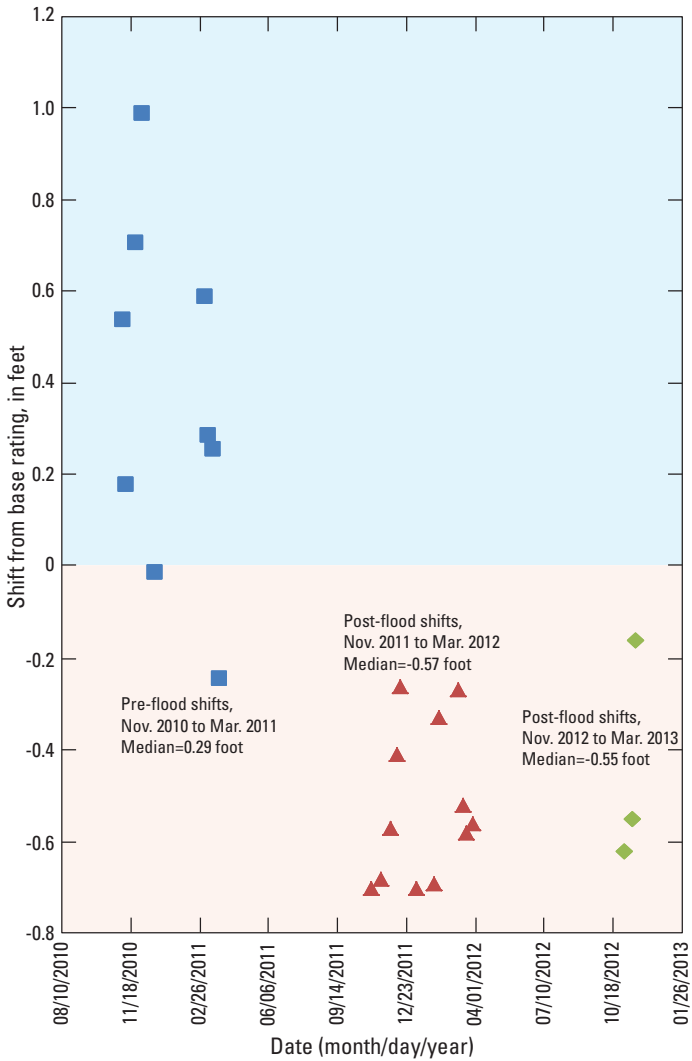
**Figure 8.** Shifts from the base rating curve before and after the 2011 flood for the Missouri River at Kansas City, Missouri, streamgauge (station 06893000).

include the upstream Missouri River and tributaries. For example, the Platte River (of Nebraska) likely was a substantial contributor of bedload to the Missouri River in 2011 (Galloway and others, 2013). Compared to the pre-flood shifts (November 2010 to March 2011), the first set of post-flood shifts (November 2011 to March 2012) indicated an increase in median channel-bed elevation of about 1 ft (fig. 8); however, given the variability in the pre-flood shifts, the stated increase of about 1 ft may over or under represent the actual change in channel-bed elevation caused by the 2011 flood. More than 1 year after the flood, the second set of post-flood shifts (November 2012 to March 2013) were similar thus providing evidence for relative stability in channel-bed elevation at this site following the fill.

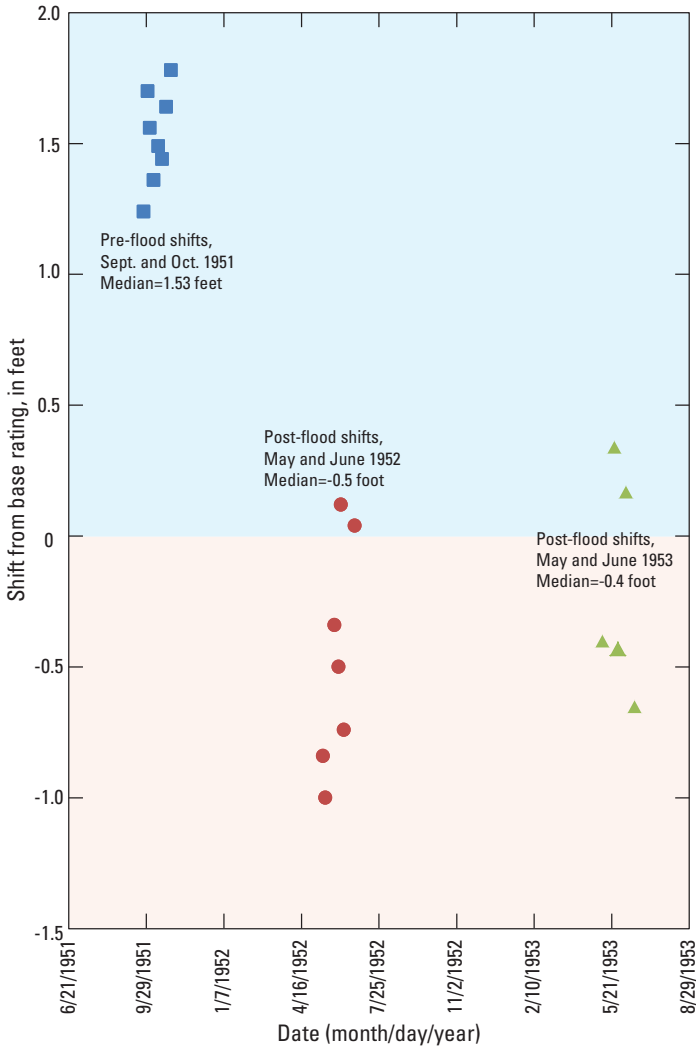
**Figure 9.** Shifts from the base rating curve before and after the 1952 flood for the Missouri River at Kansas City, Missouri, streamgauge (station 06893000).

shifts (May and June 1952), in comparison to the pre-flood shifts (September and October 1951), indicated an increase in channel-bed elevation of about 2 ft (fig. 9); however, because the shifts from November 1951 through March 1952 (not shown) declined to near zero, the fill attributable to the 1952 flood may only be about 0.5 ft. At Kansas City, the 1952 flood was preceded by the larger 1951 flood, which occurred less than 9 months prior. An analysis of shifts immediately before and after the 1951 flood indicated that the 1951 flood scoured a foot or more of bed material at the streamgauge site. Thus, the declining shifts from November 1951 through March 1952 may indicate a progressive recovery from the 1951 flood in the months leading up to the 1952 flood. One year after the 1952 flood, the second set of post-flood shifts (May and June 1953) indicated minimal change. Thus, as of June 1953, the modest fill associated with the 1952 flood persisted.
