Geomorphic Change on the Missouri River During the Flood of 2011

Chapter I of
2011 Floods of the Central United States

Professional Paper 1798–I

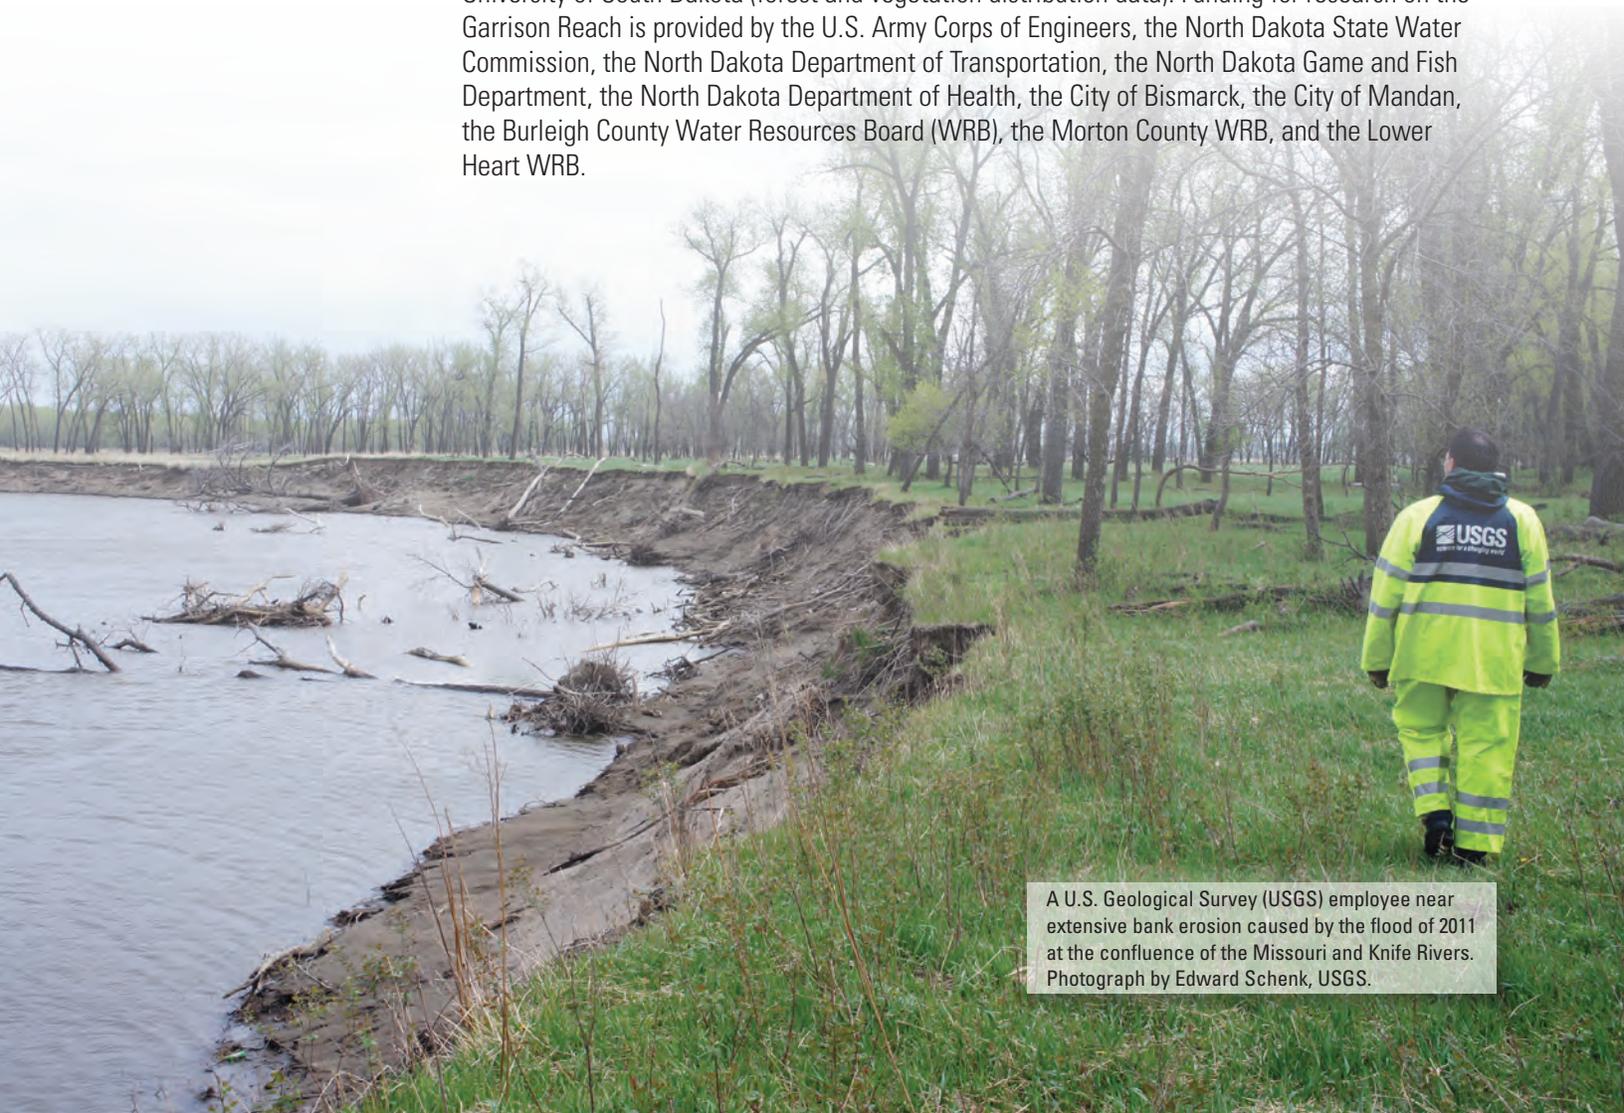
A U.S. Geological Survey (USGS) employee near extensive bank erosion caused by the flood of 2011 at the confluence of the Missouri and Knife Rivers. Photograph by Edward Schenk, USGS.

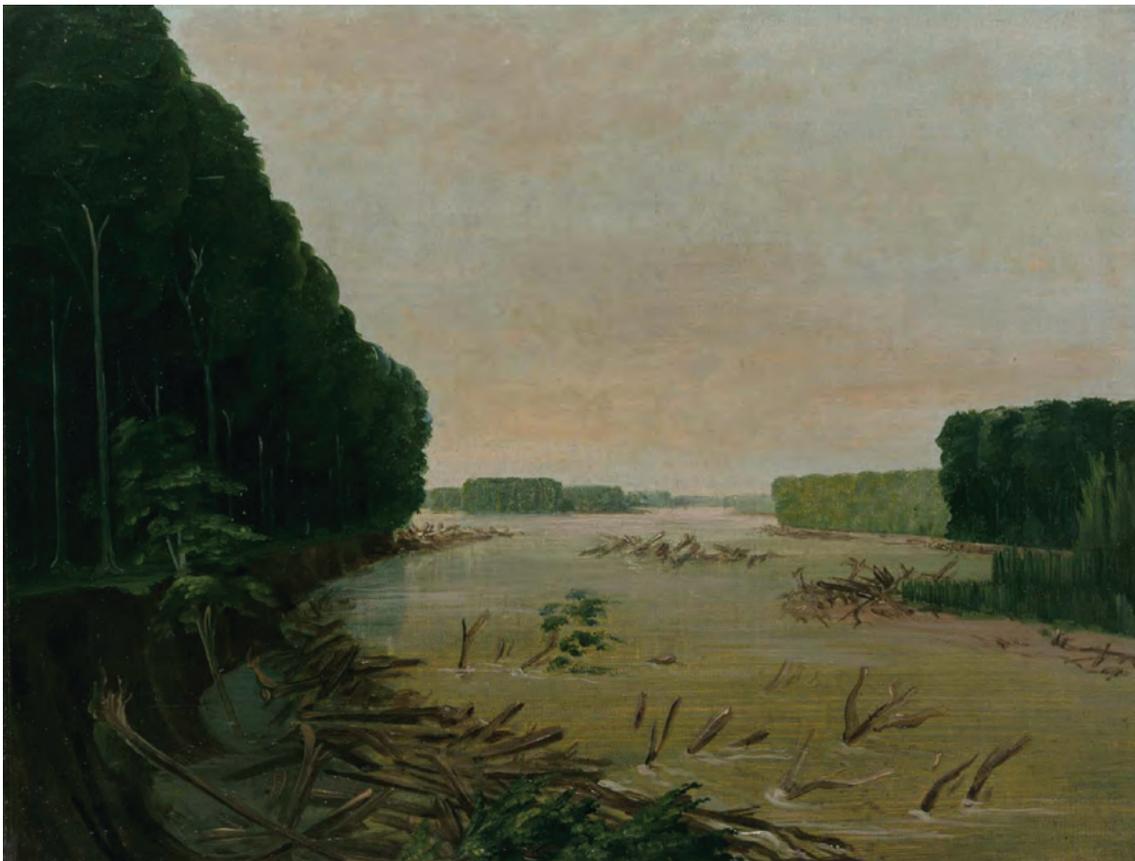
Figure 1. The historical (1832) Missouri River channel including large wood snags, bank erosion, and vegetated islands and banks. “View on the Missouri, Alluvial Banks Falling in, 600 Miles above St. Louis” (George Catlin, 1832, oil on canvas, Smithsonian American Art Museum 1985.66.363.)

The river quickly gained the nickname “The Big Muddy.” It was hazardous to navigate with frequently shifting sandbars and a high concentration of log jams and submerged snags (fig. 1). Despite these hazards, the river was a vital transportation route first used by the Lewis and Clark expedition to access the Northwest Territories and, for a short time, to transport by river paddleboat freight and passenger transport as far upstream as Fort Benton, Montana (Gillespie, 2000). As stated by “Steamboat Bill” Heckmann, “We separated the men from the boys at the mouth of the Missouri. The boys went up the Mississippi and the men went up the Big Muddy [Gillespie, 2000, back cover].”

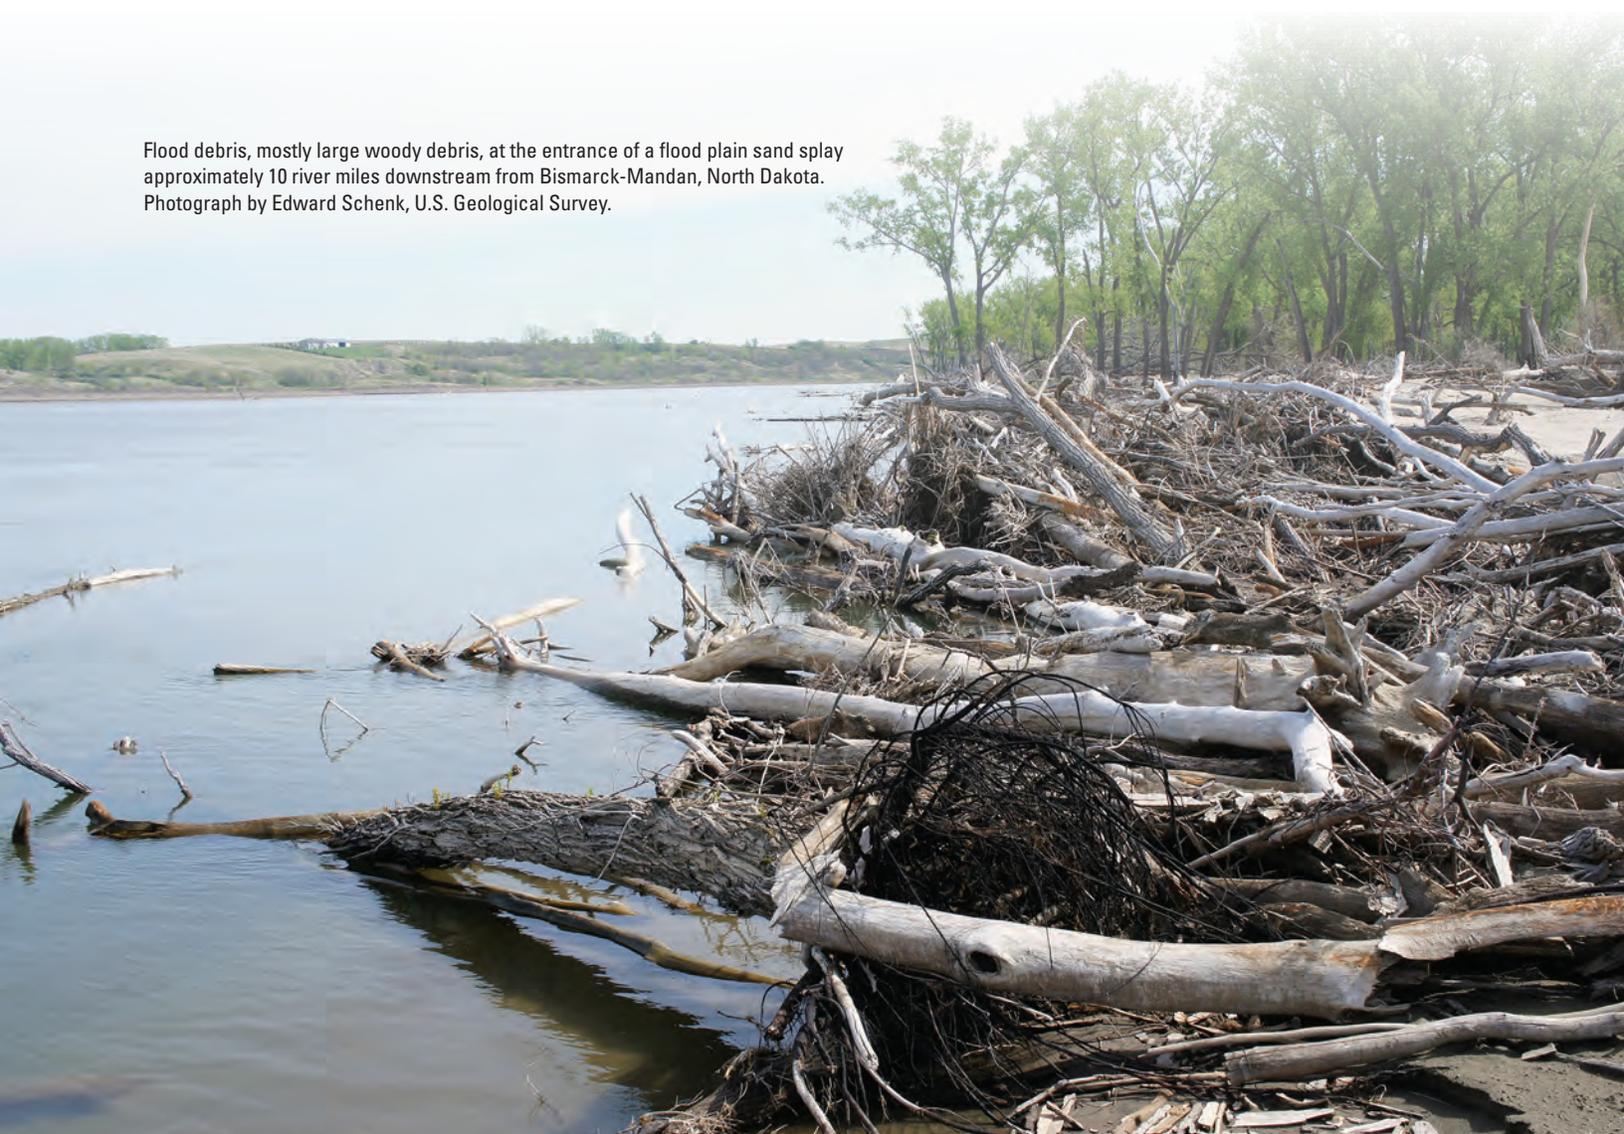
Flood debris, mostly large woody debris, at the entrance of a flood plain sand splay approximately 10 river miles downstream from Bismarck-Mandan, North Dakota. Photograph by Edward Schenk, U.S. Geological Survey.

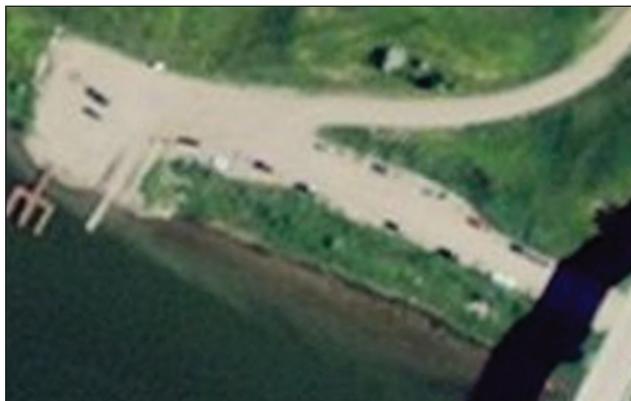
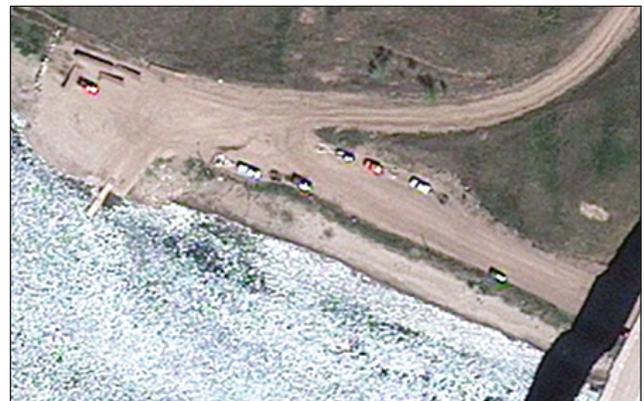
Standard aerial imagery

GeoEye™ imagery from 2012

Figure 4. Comparison of traditional aerial photography and high-resolution satellite imagery provided by the U.S. Geological Survey Northern Prairie Wildlife Research Center and produced by the GeoEye™ satellite platform.

Trends in island and sandbar dynamics were determined by analyzing repeat aerial photography collected between 1950 and 2002 along the Garrison Reach. High-resolution satellite imagery obtained with GeoEye™, RapidEye™, and Quickbird™ platforms was used for the period 2002 to 2012 because of the high quality of this imagery (fig. 4). The satellite imagery is being provided by a partnership with the USGS Northern Prairie Wildlife Research Center in Jamestown, N. Dak. (Larry Strong, U.S. Geological Survey, unpub. data, 2012).

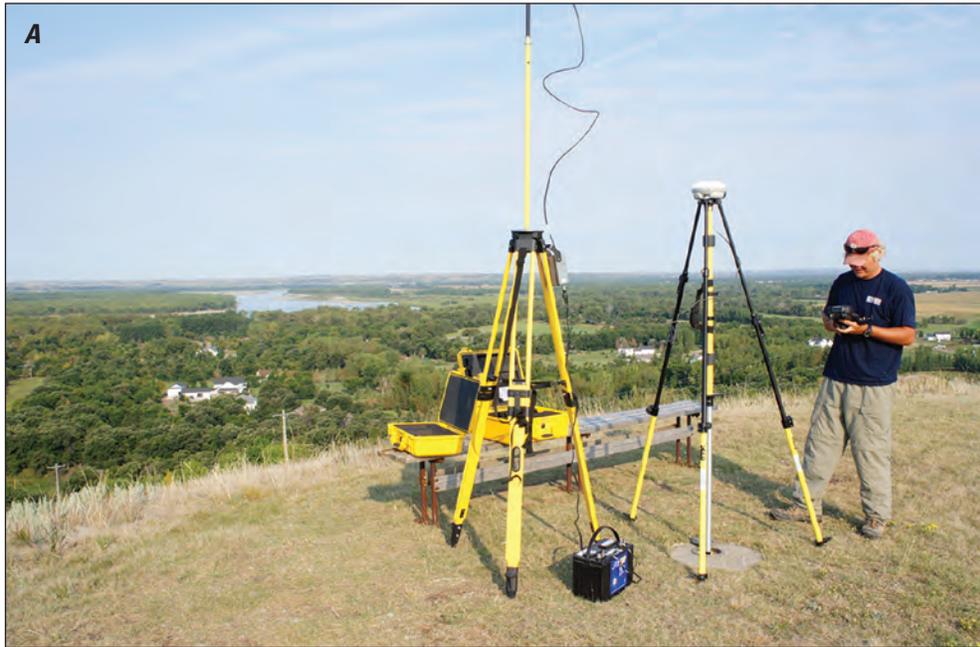
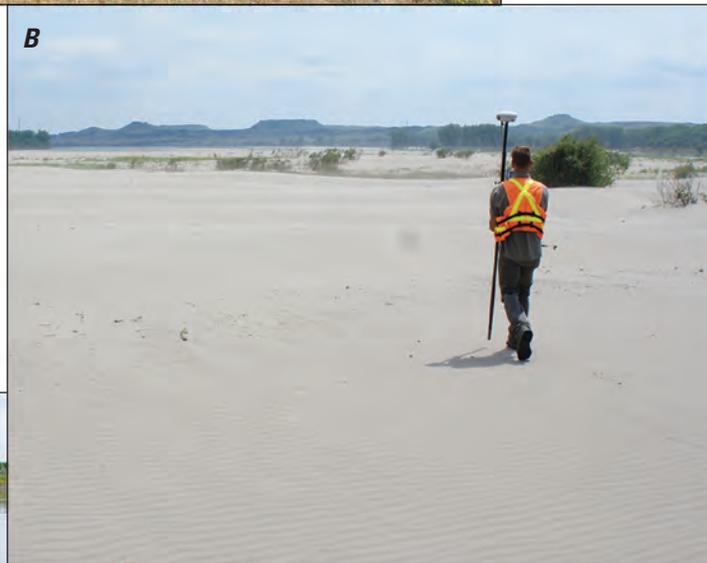
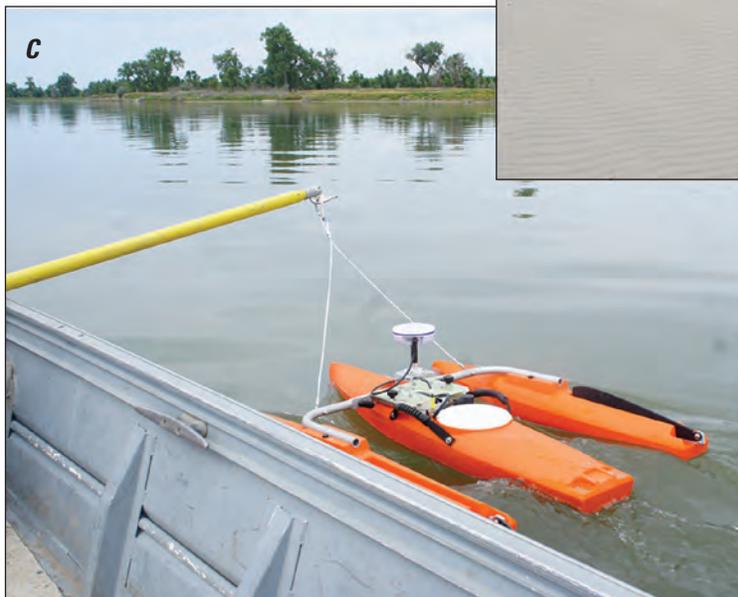
Figure 6. Cross-sectional survey methods *A*, at a real time kinetic (RTK) Global Positioning System (GPS) base station; *B*, walking a sandbar using an RTK mobile unit; and *C*, collecting bathymetry using an Acoustic Doppler Current Profiler (ADCP). Photographs by Edward Schenk, summer of 2012.

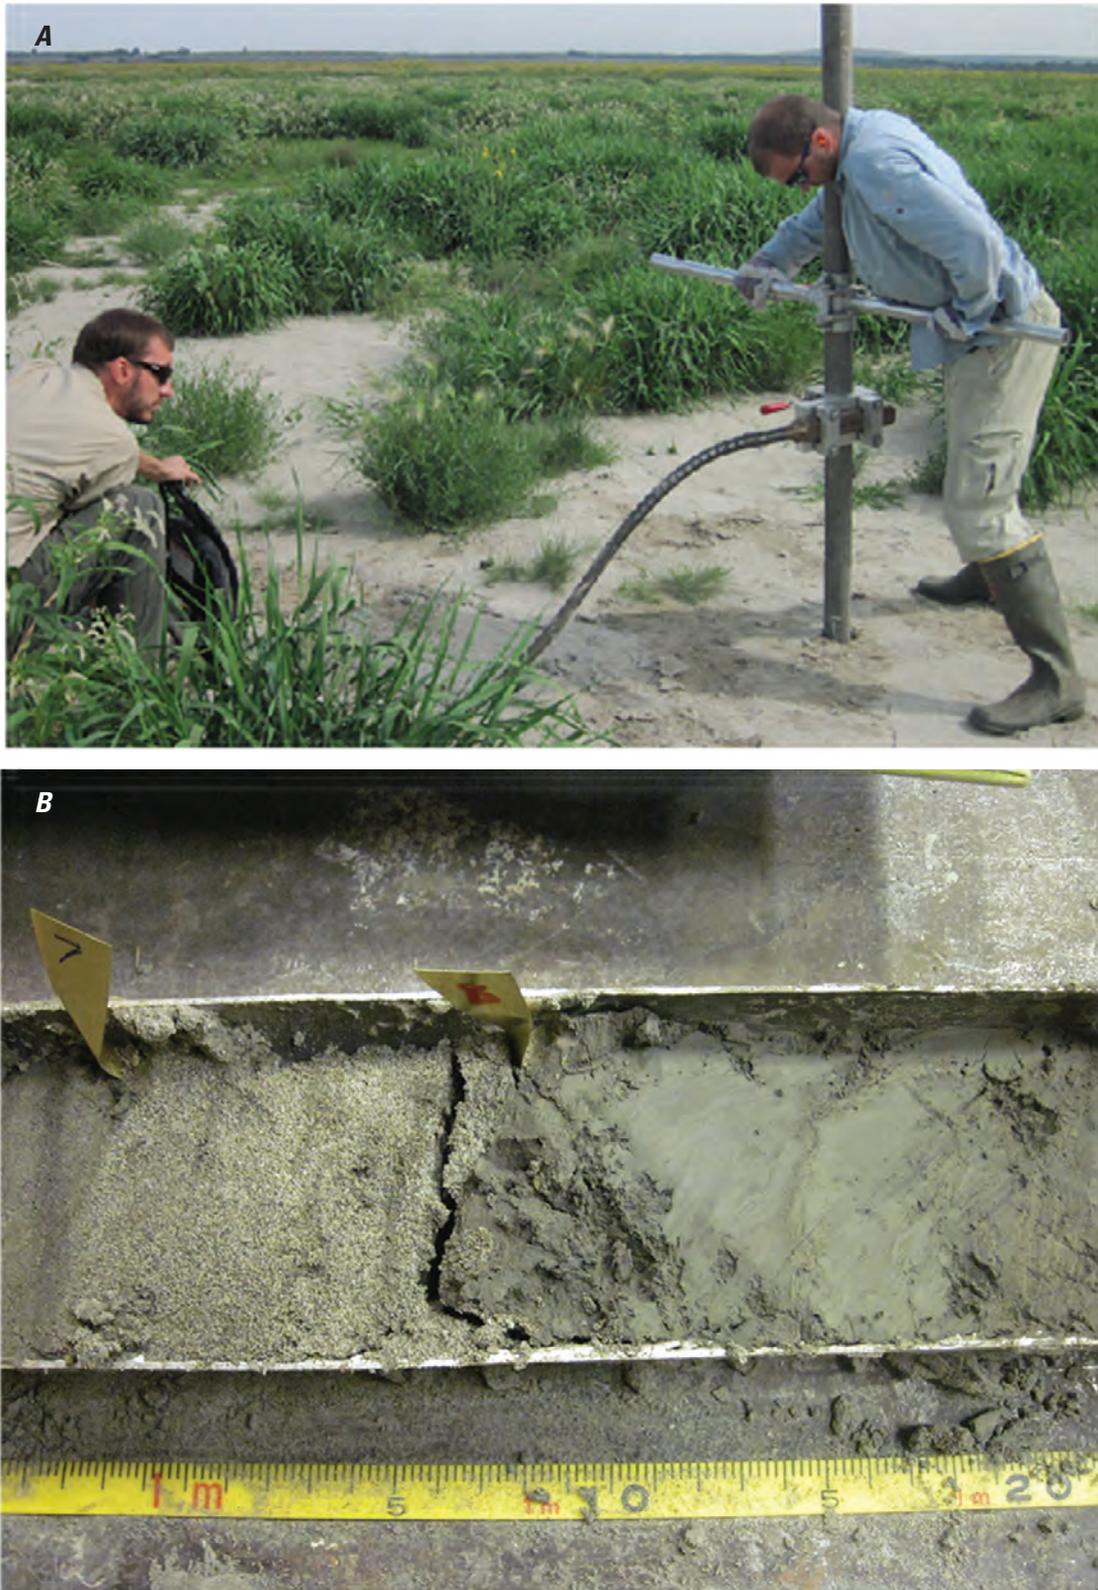
Figure 14. A, a vibracore unit taking a sample near the Lake Oahe delta (photograph by Katherine Skalak, August 2012); and B, an example of a vibracore sample with the pre-flood sediment on the right-hand side of the picture and flood sediment (sand) on the left-hand side. The break between pre-flood and flood sediment is marked by the yellow tag with a red dot (1.07 meters on the tape).

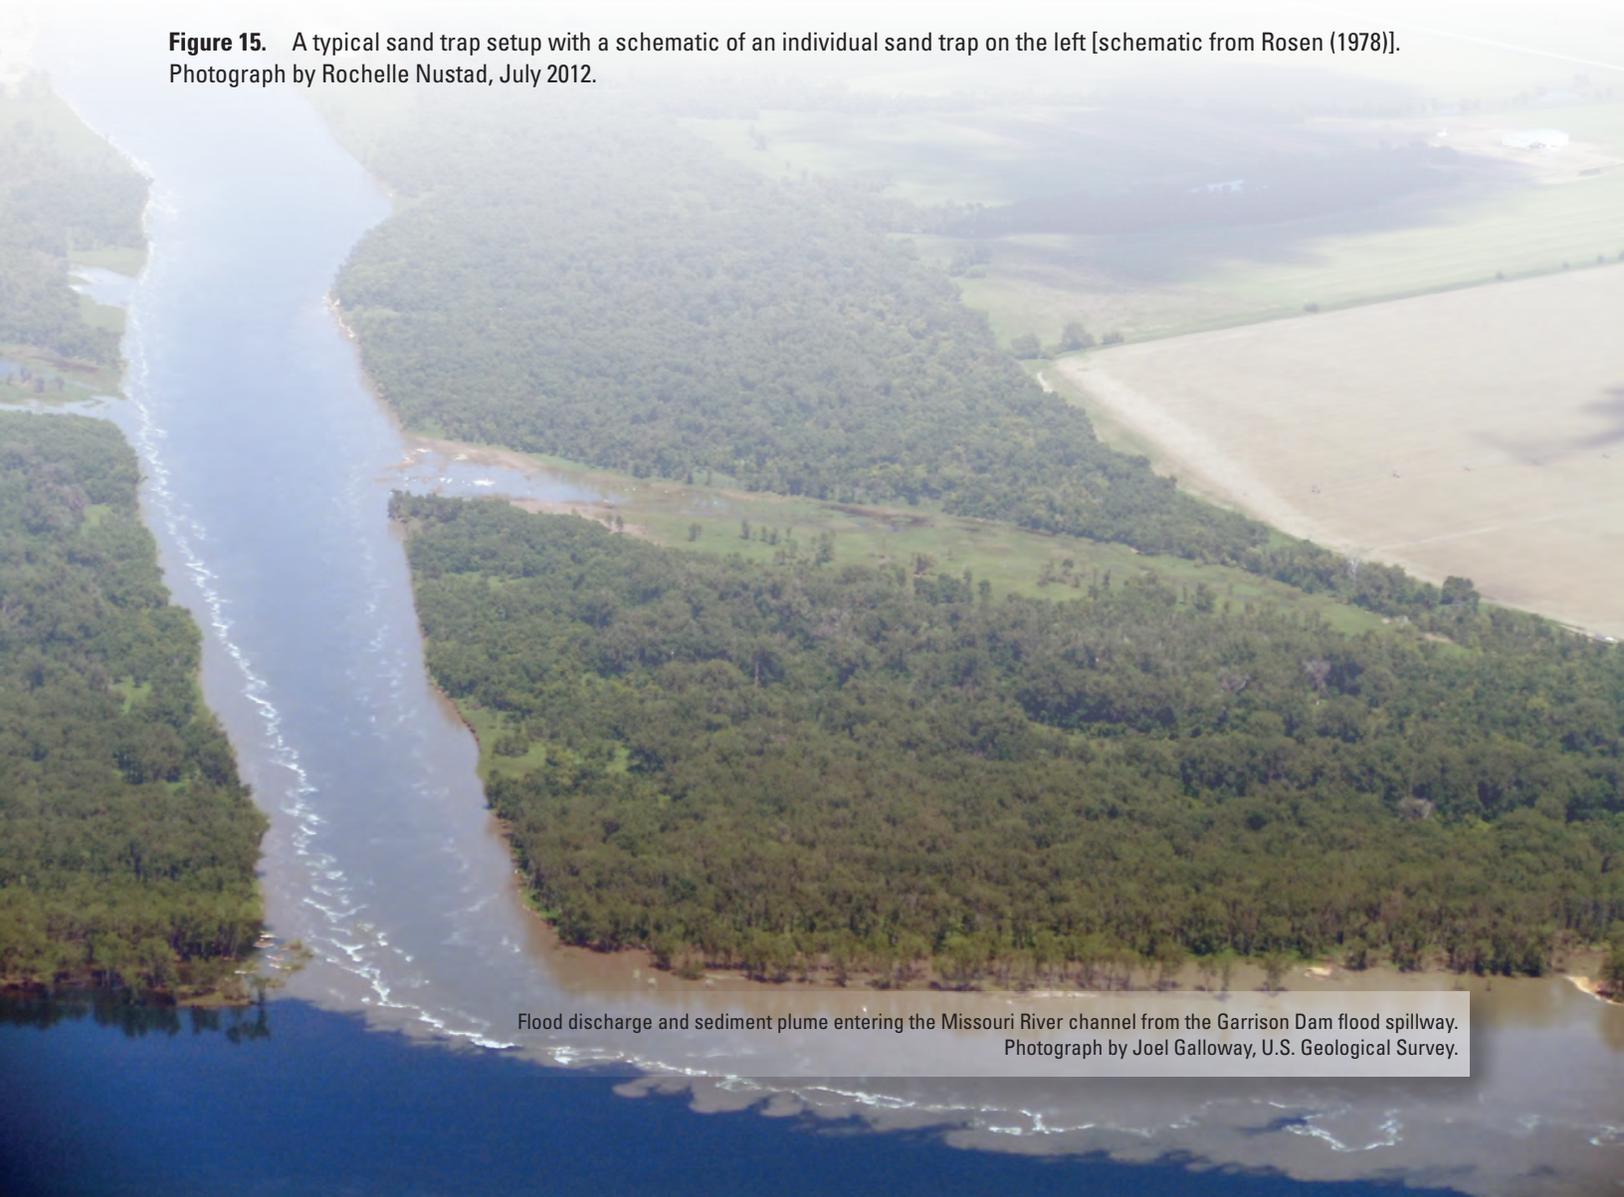
Flood discharge and sediment plume entering the Missouri River channel from the Garrison Dam flood spillway. Photograph by Joel Galloway, U.S. Geological Survey.

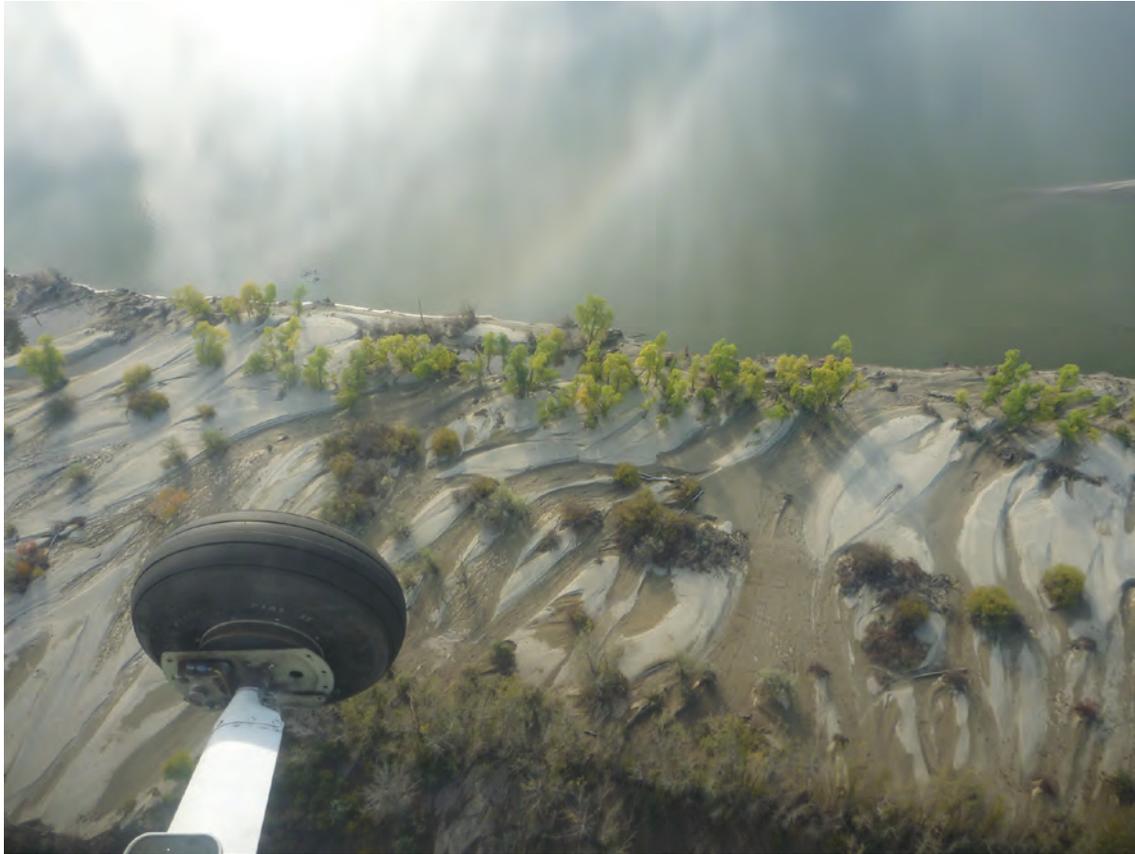
Figure 17. Sand splays downstream from Bismarck-Mandan, North Dakota. The light green trees along the bank are cottonwoods (*Populus deltoides*)—notice the patterns of deposition and scour relative to the vegetation. Photograph by Edward Schenk, October 2011.

The purpose of studying vegetation on the Missouri River is to determine how the vegetation has changed following the flood and how vegetation during the flood created sedimentation and scour patterns on the flood plain, islands, and sandbars (fig. 17).

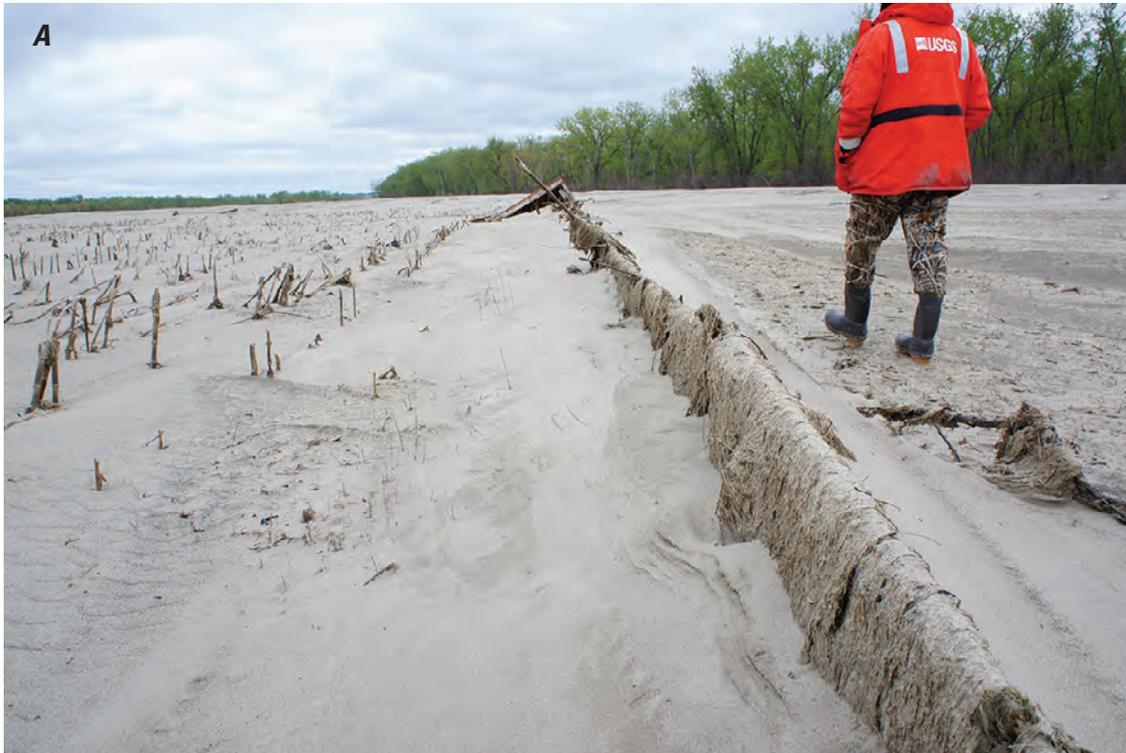
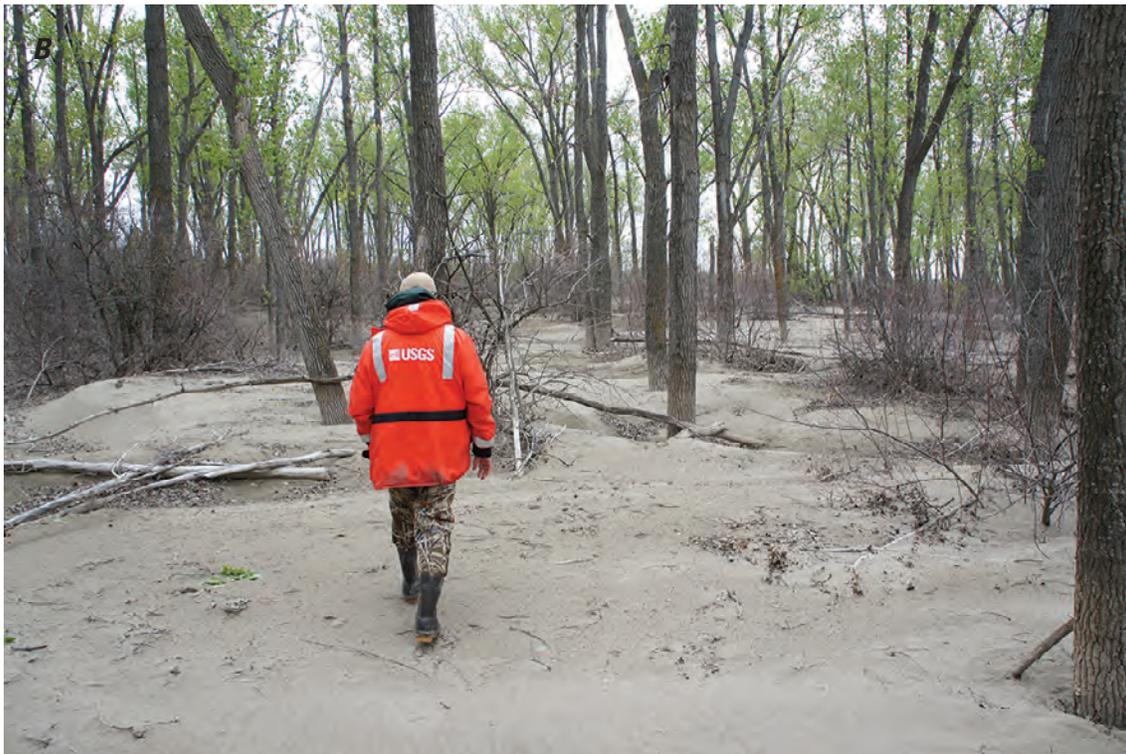
Figure 18. Sand splay depositional patterns related to vegetation. *A*, U.S. Geological Survey employee walking along the top of what was once a fence row, where the top of corn stalks are apparent and *B*, U.S. Geological Survey employee walking along dune structures immediately inside a cottonwood (*Populus deltoides*) forest. The field pictured in the top photo is behind the position of the photographer during the second picture. Note the transition between dunes and the low deposition area in the background as the sand splay enters the forest. Both photographs are in the location noted in the light detection and ranging (lidar) difference model figure (fig. 13). Photographs by Edward Schenk, May 2012.
