Monitoring of Levees, Bridges, Pipelines, and Other Critical Infrastructure During the 2011 Flooding in the Mississippi River Basin

Chapter J of
2011 Floods of the Central United States

Professional Paper 1798–J

By Brenda K. Densmore, Bethany L. Burton, Benjamin J. Dietsch,
James C. Cannia, and Richard J. Huizinga

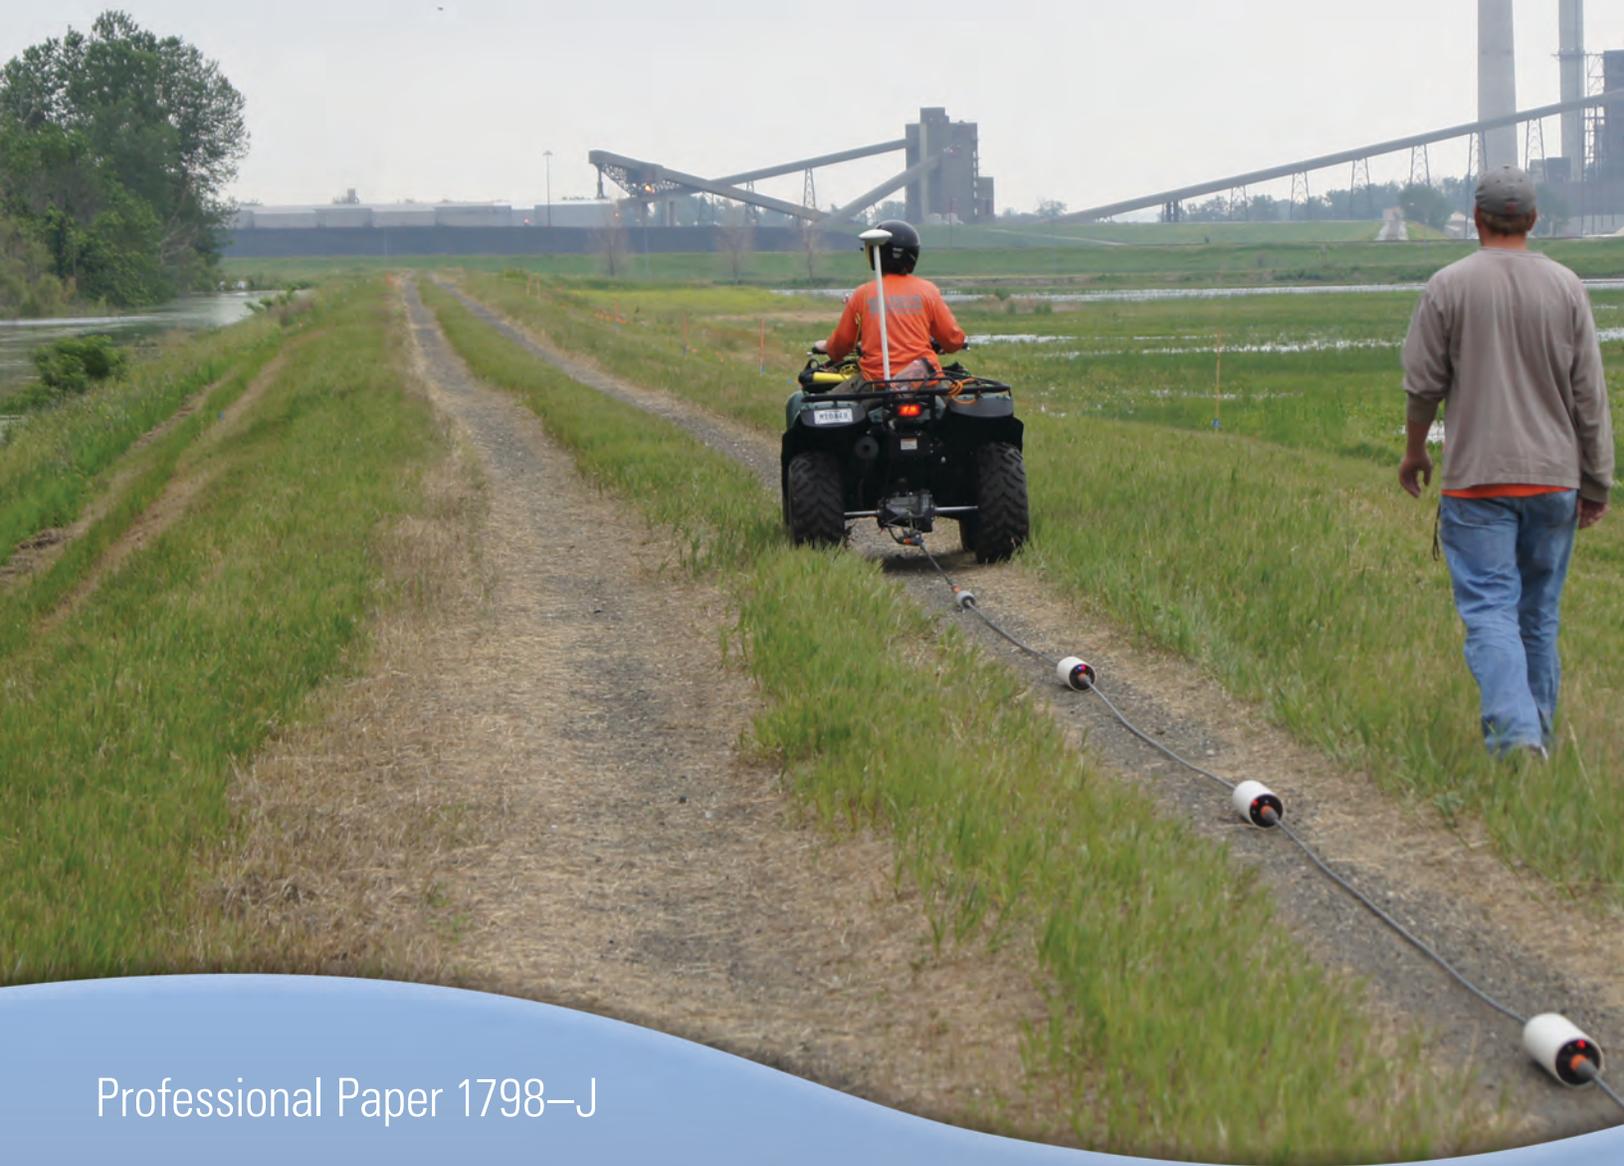
Front cover. U.S. Geological Survey scientists collecting capacitively coupled resistivity data on the levee surrounding the Omaha Public Power District Nebraska City power plant, June 13, 2011. Photograph by Jim Cannia, U.S. Geological Survey (USGS).

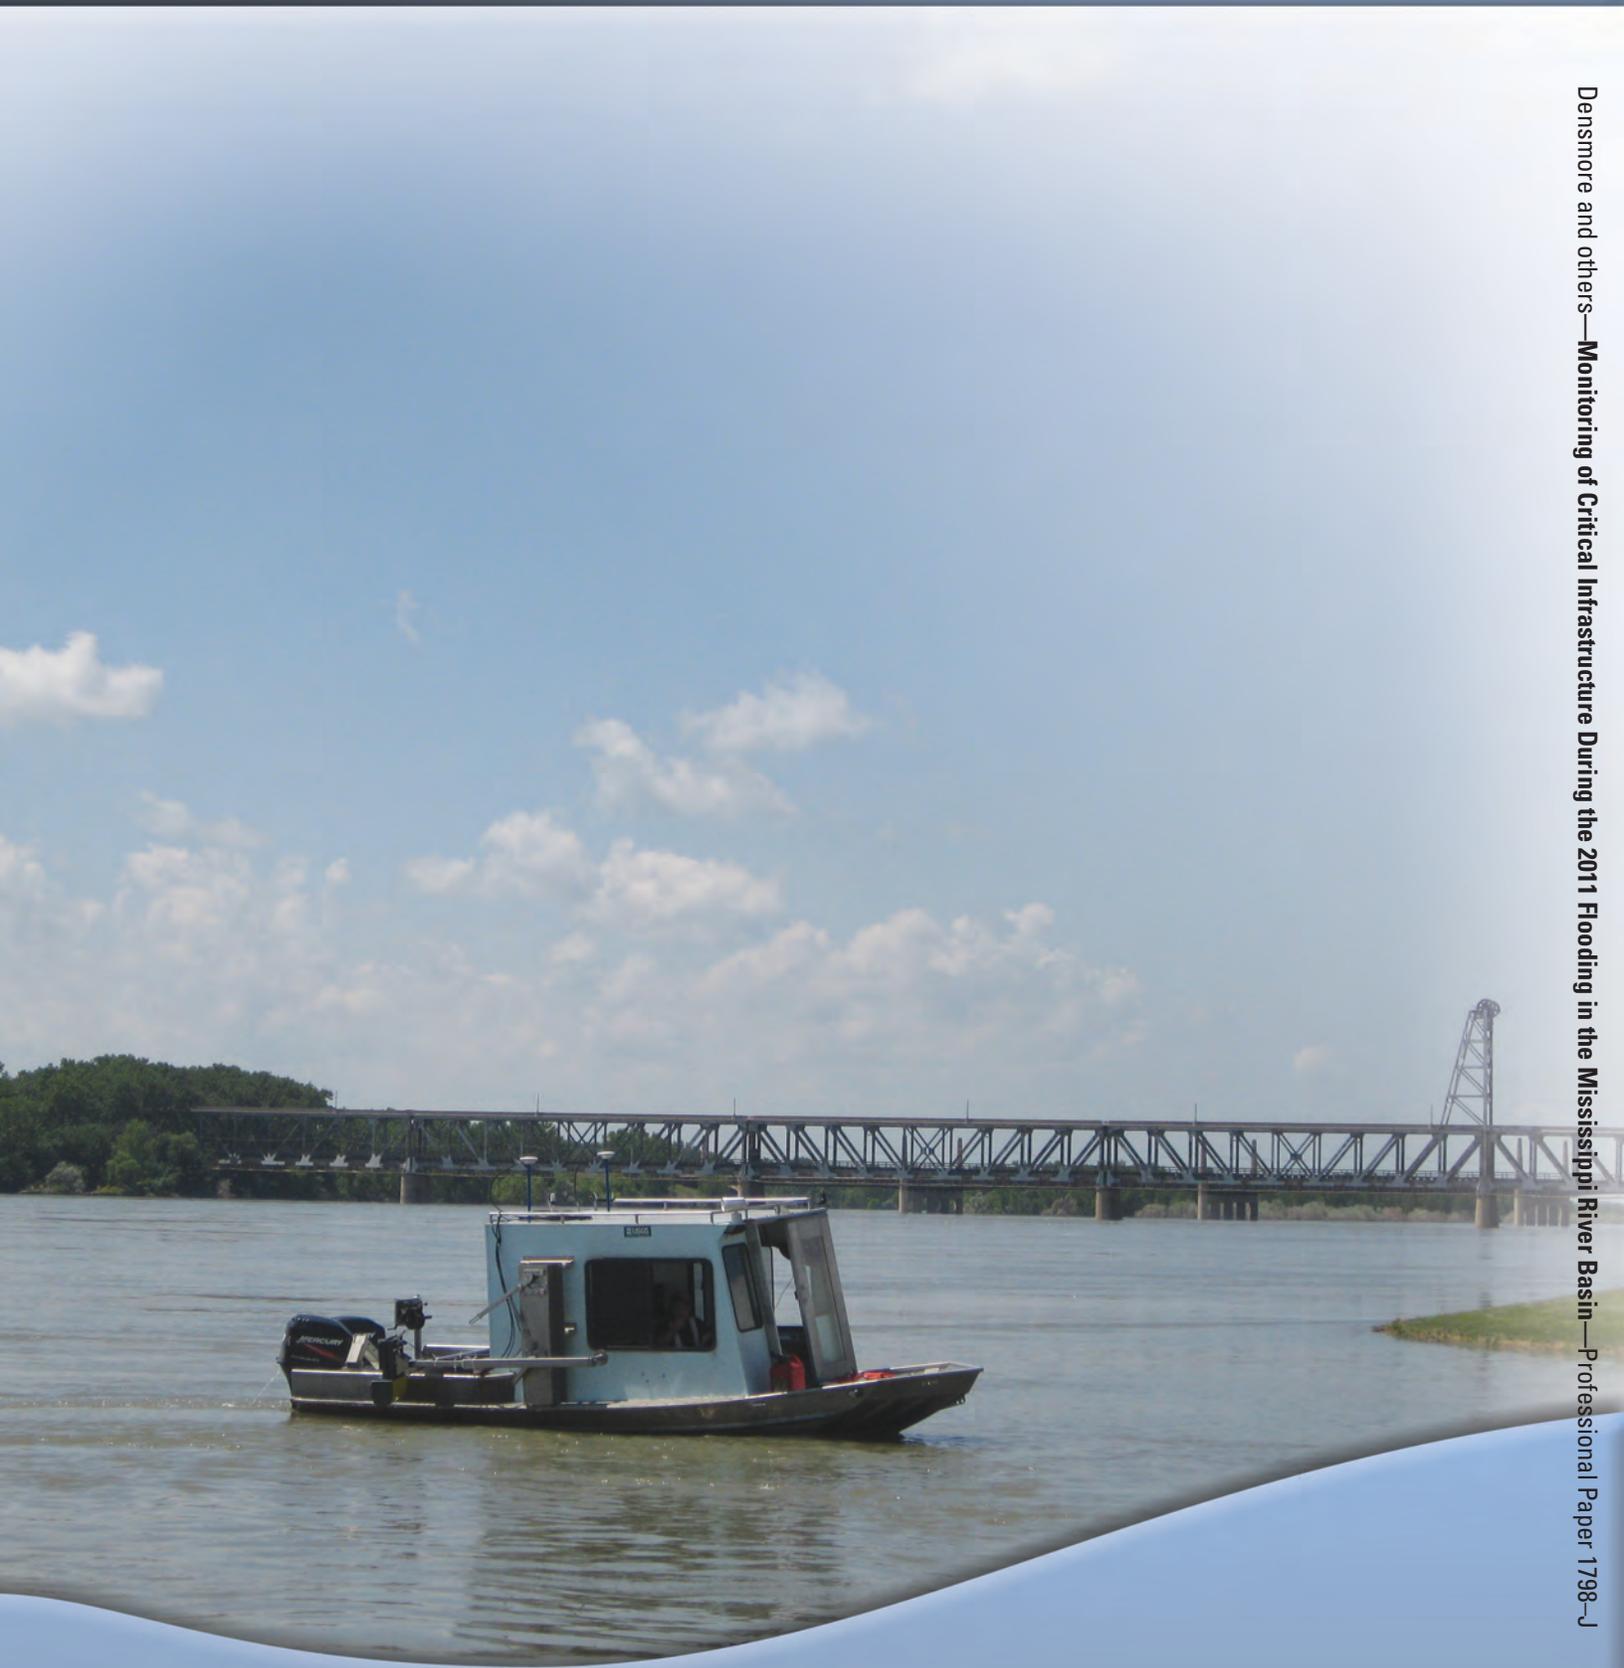
Back cover. Multibeam surveying boat on the Missouri River at Yankton, South Dakota, July 29, 2011, to collect hydrographic survey data of the riverbed around the Yankton Discovery bridge, U.S. Highway 81. Photograph by Benjamin Dietsch, USGS.
