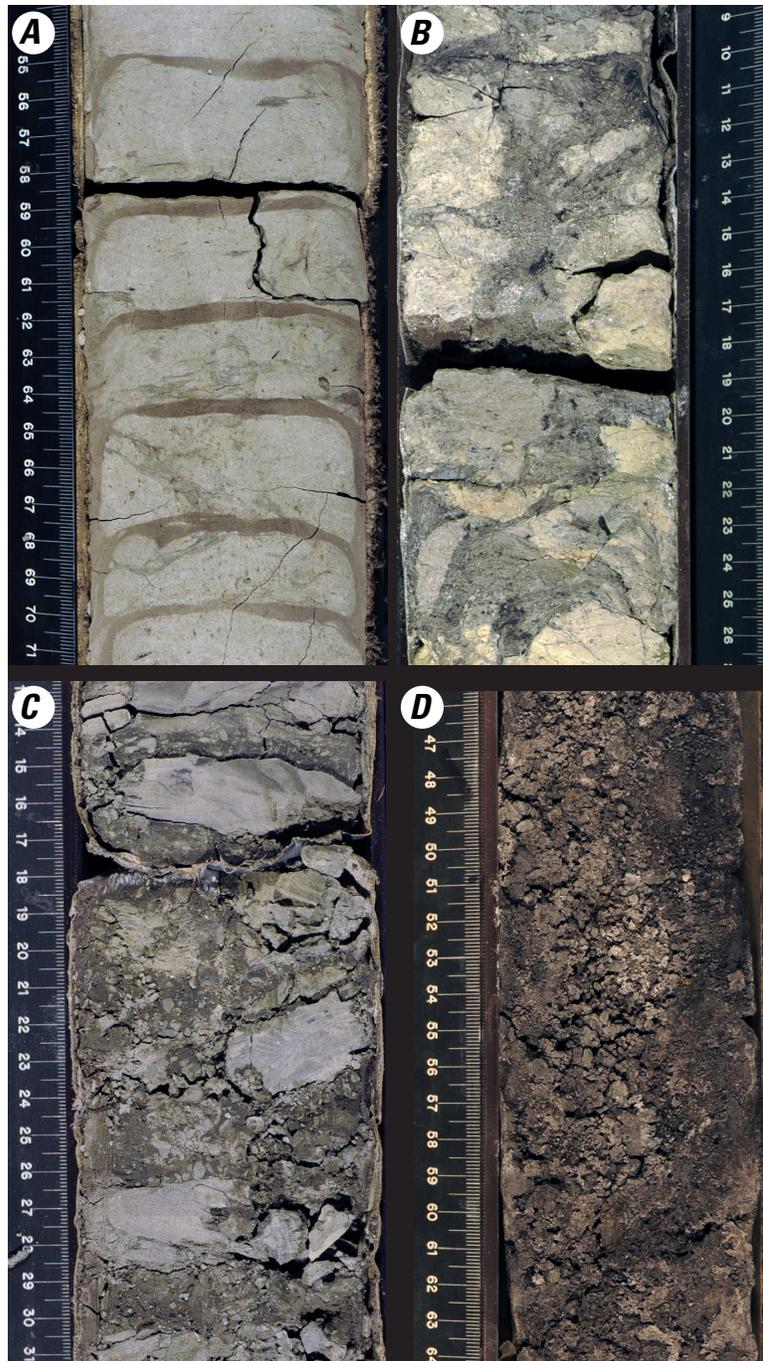
Figure 13. Composite photograph of U.S. Geological Survey cores from the Chukchi Shelf, Alaska, showing examples of damage induced by rotary coring. *A*, Disking and mud impregnation; *B*, fracturing and mud impregnation; *C*, fragmentation and mud impregnation; *D*, disaggregation and mud impregnation. Scales on photograph are in centimeters.
