# Landslides, Floods, and Marine Effects of the Storm of January 3-5, 1982, in the San Francisco Bay Region, California

U.S. GEOLOGICAL SURVEY PROFESSIONAL PAPER 1434

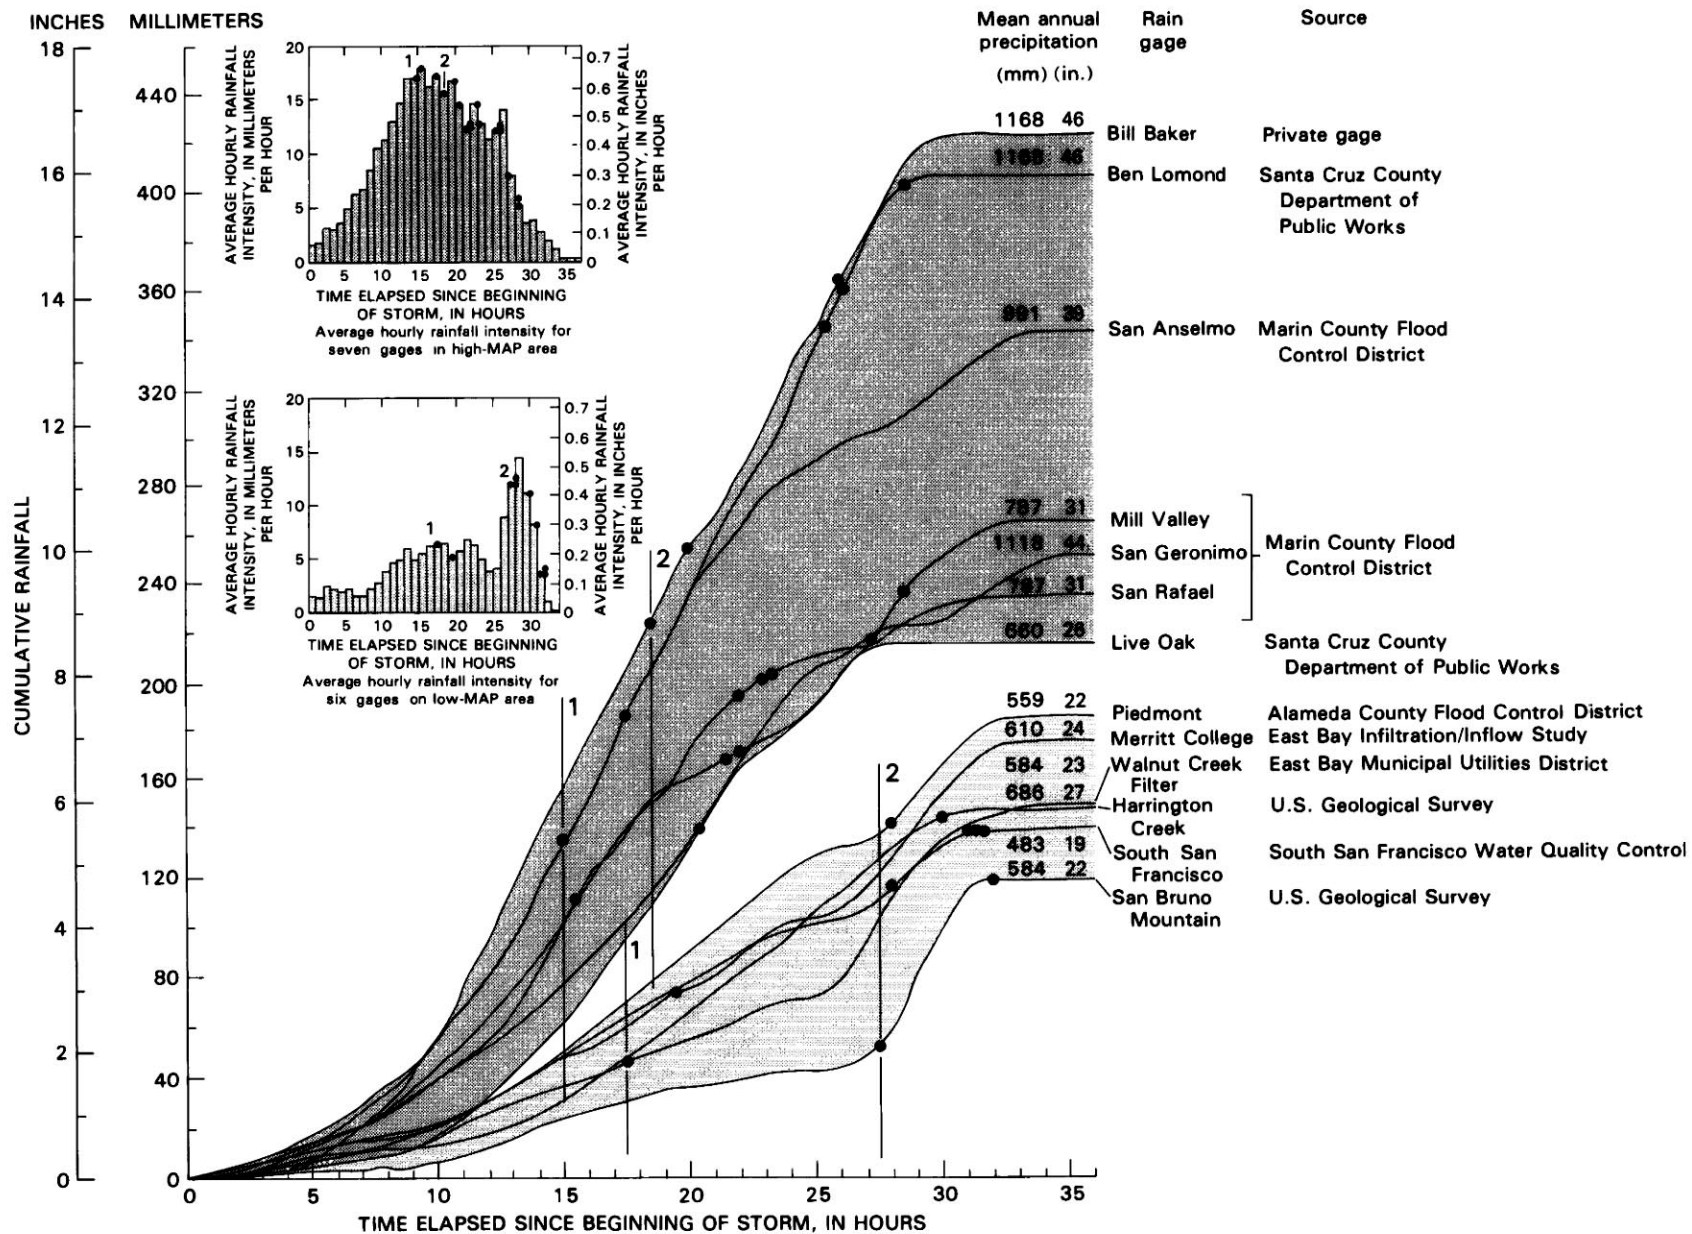
FIGURE 3.1.—Cumulative storm rainfall for 13 continuously recording rain gages used in this study, showing relations between storm rainfall and debris flows in the January 3–5, 1982, storm. Dots denote known times of debris flows near these gages; lines 1 and 2 denote onset of debris-flow activity and onset of abundant debris-flow activ-

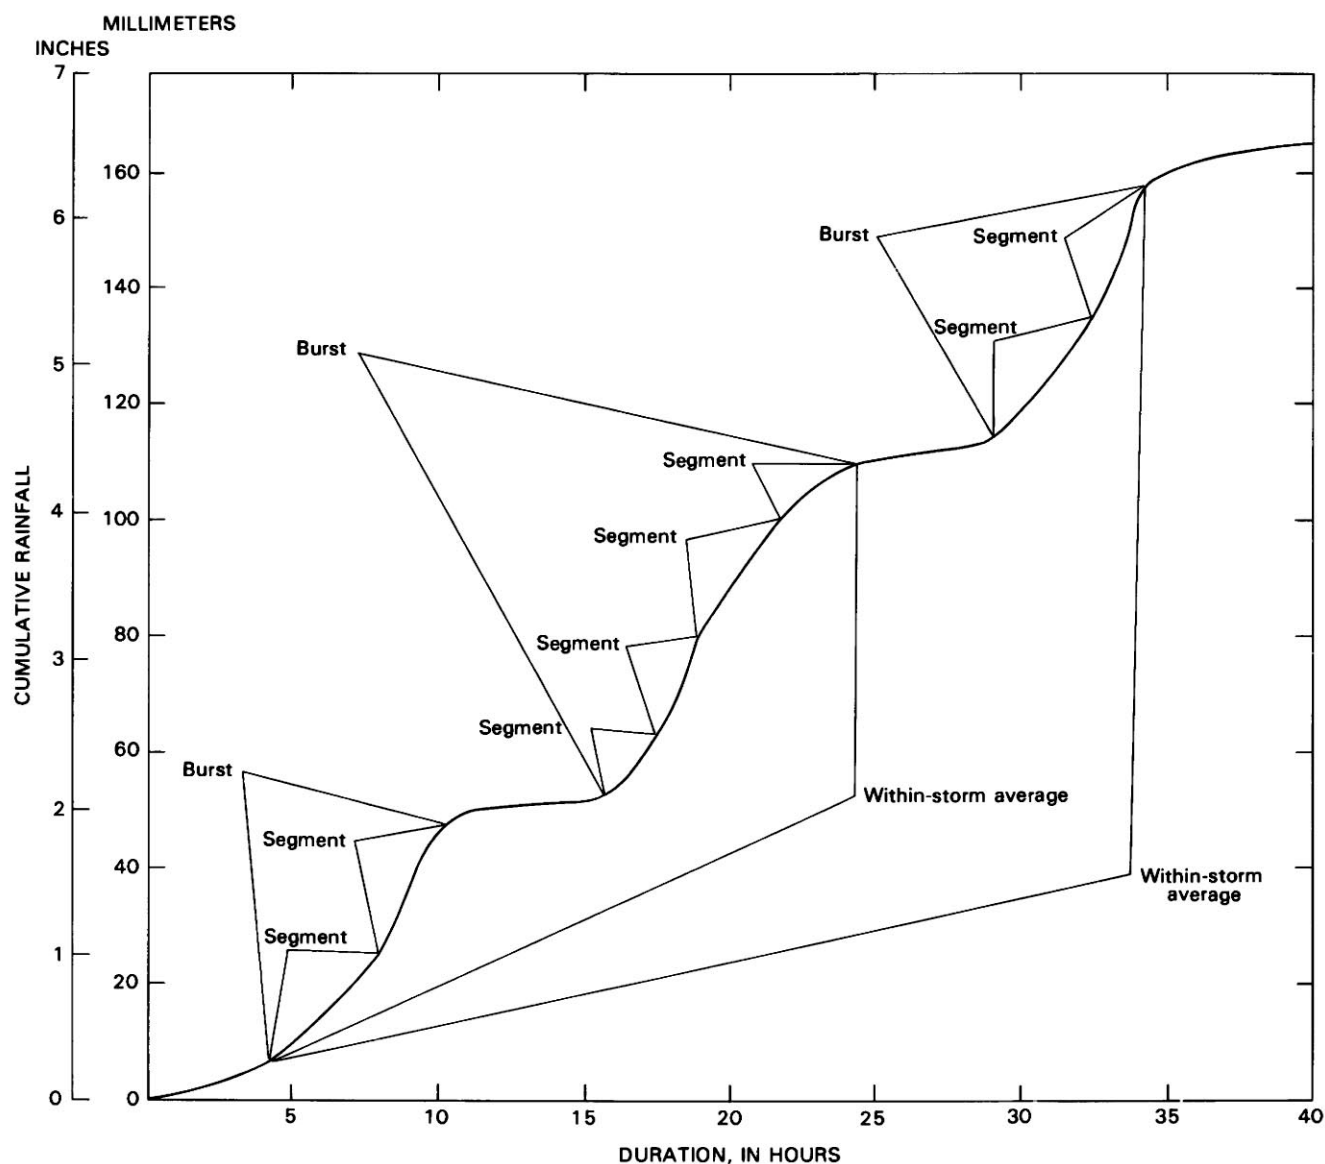
FIGURE 4.1.—Schematic example of an hourly cumulative rain-gage record, showing rainfall parameters measured for this study. Bursts are defined as periods of intense rainfall during the storm, and segments as periods of uniform intensity within bursts. Both bursts and segments are measured from changes in slope of rain-gage trace;

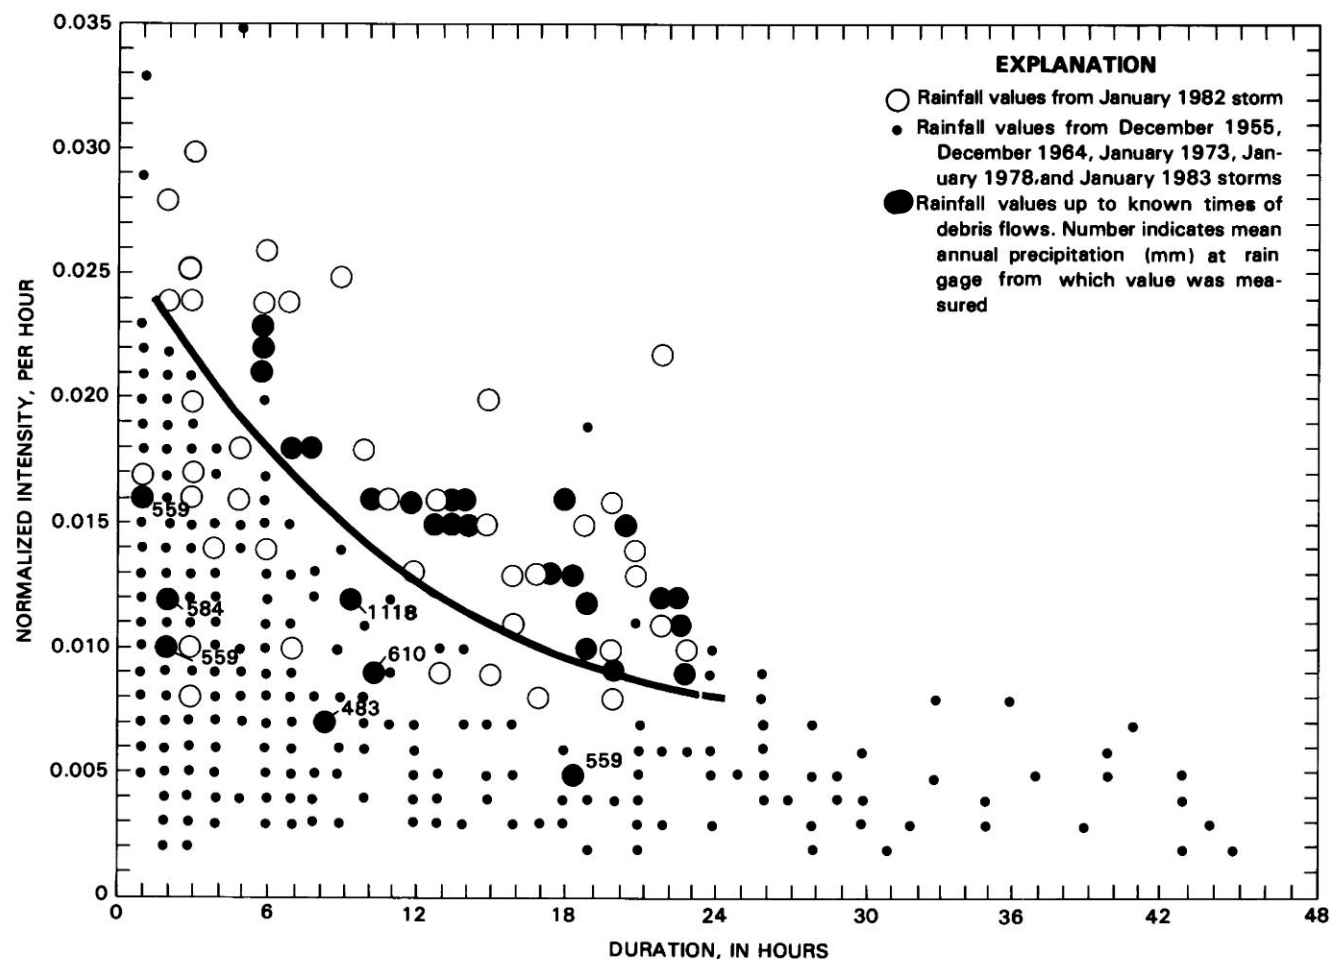
FIGURE 4.3.—Relations among normalized values of storm-rainfall parameters measured from hourly records of six storms in the San Francisco Bay region. Although more than one value may exist at a given point in the plot, only one symbol is shown at that point. Where values measured in the January 1982 storm are identical to those measured in other storms, the symbol for the other storm is shown

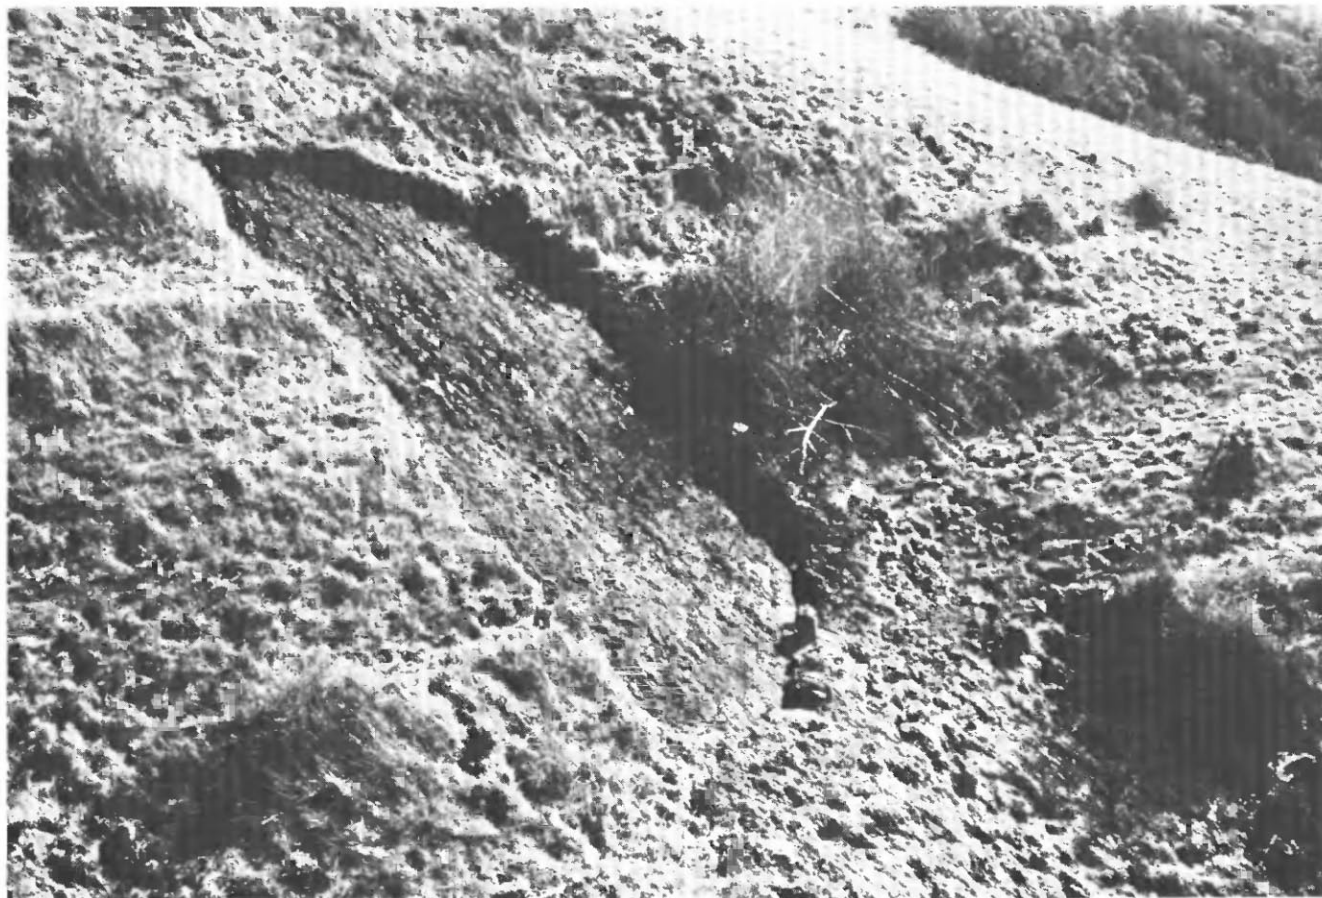
FIGURE 5.4.—Debris flow from the January 26, 1983, storm (13, table 5.1) that originated as a translational slide of soil over a planar bedrock surface. Debris-flow scar is approximately 4 m wide, 8 m long, and from 23 to 40 cm deep on a uniform slope of between 35° and 38°.

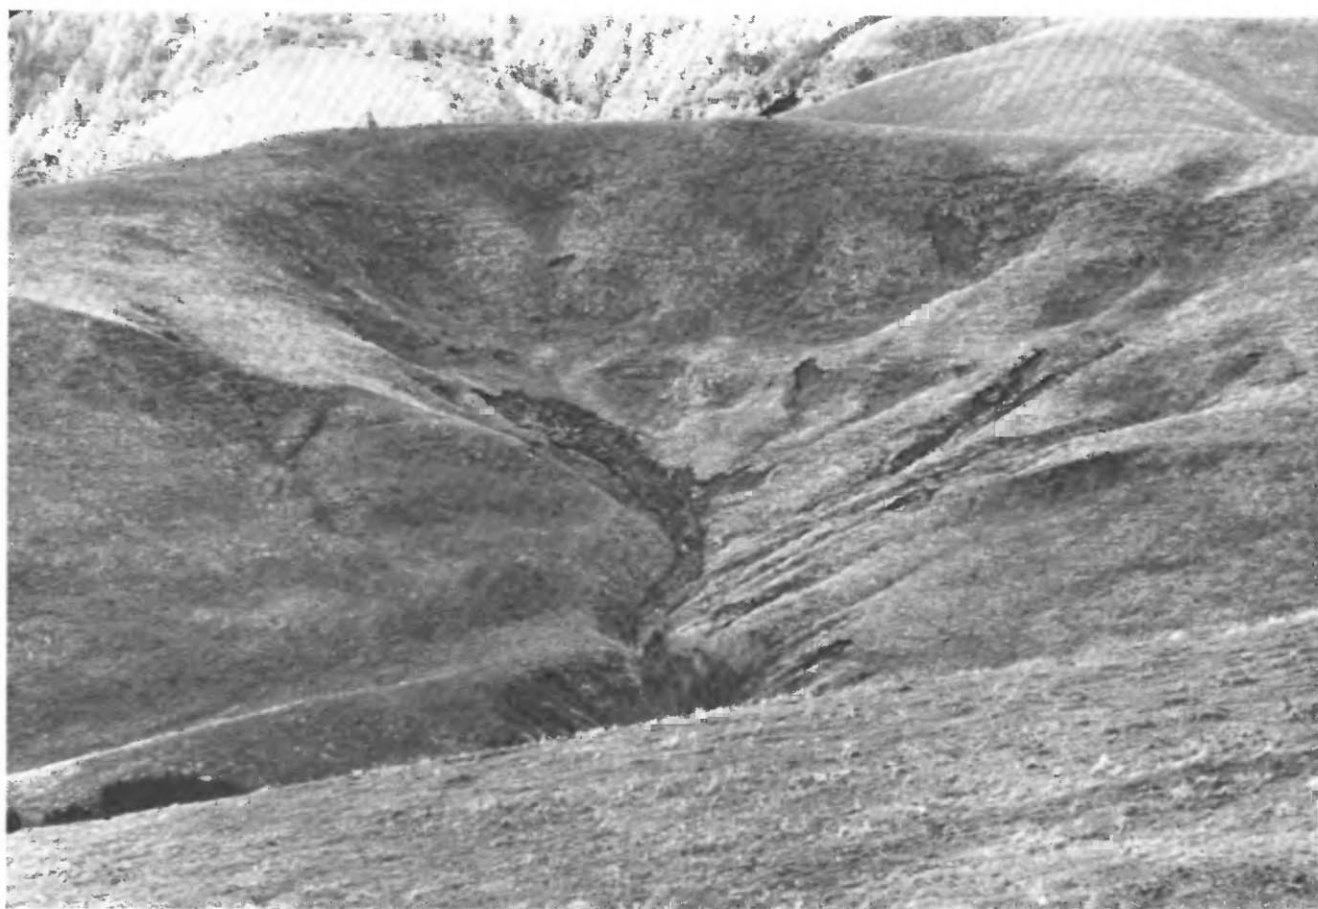
FIGURE 5.5.—Debris flow of February 13, 1979 (4, table 5.1), that originated as a rotational slide within a topographic depression. Note scars of previous debris flows.

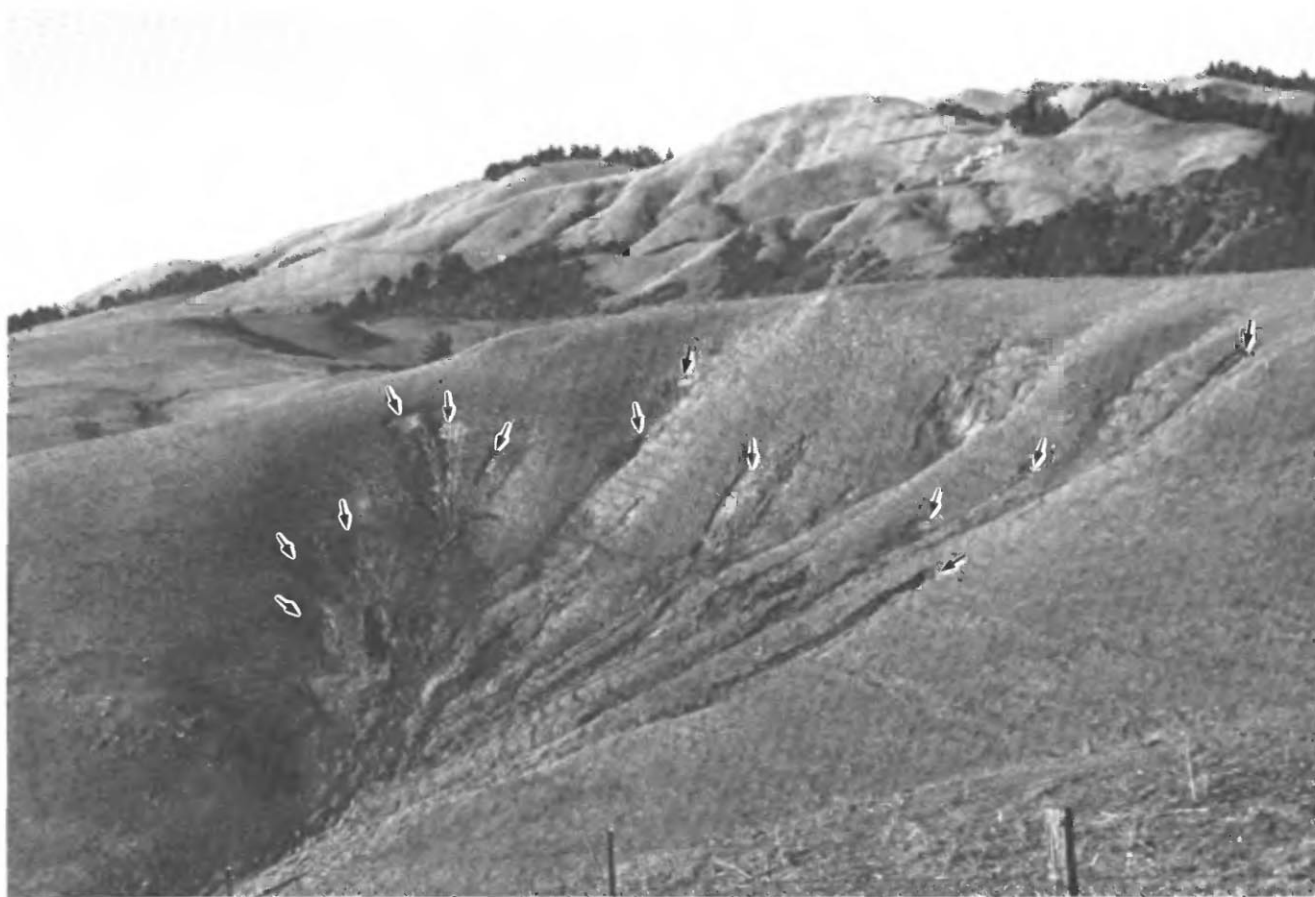
FIGURE 5.8.—Numerous debris flows triggered near La Honda by the January 3–5, 1982, storm. Arrows indicate debris-flow scars. Same hillslope as in figure 5.5.

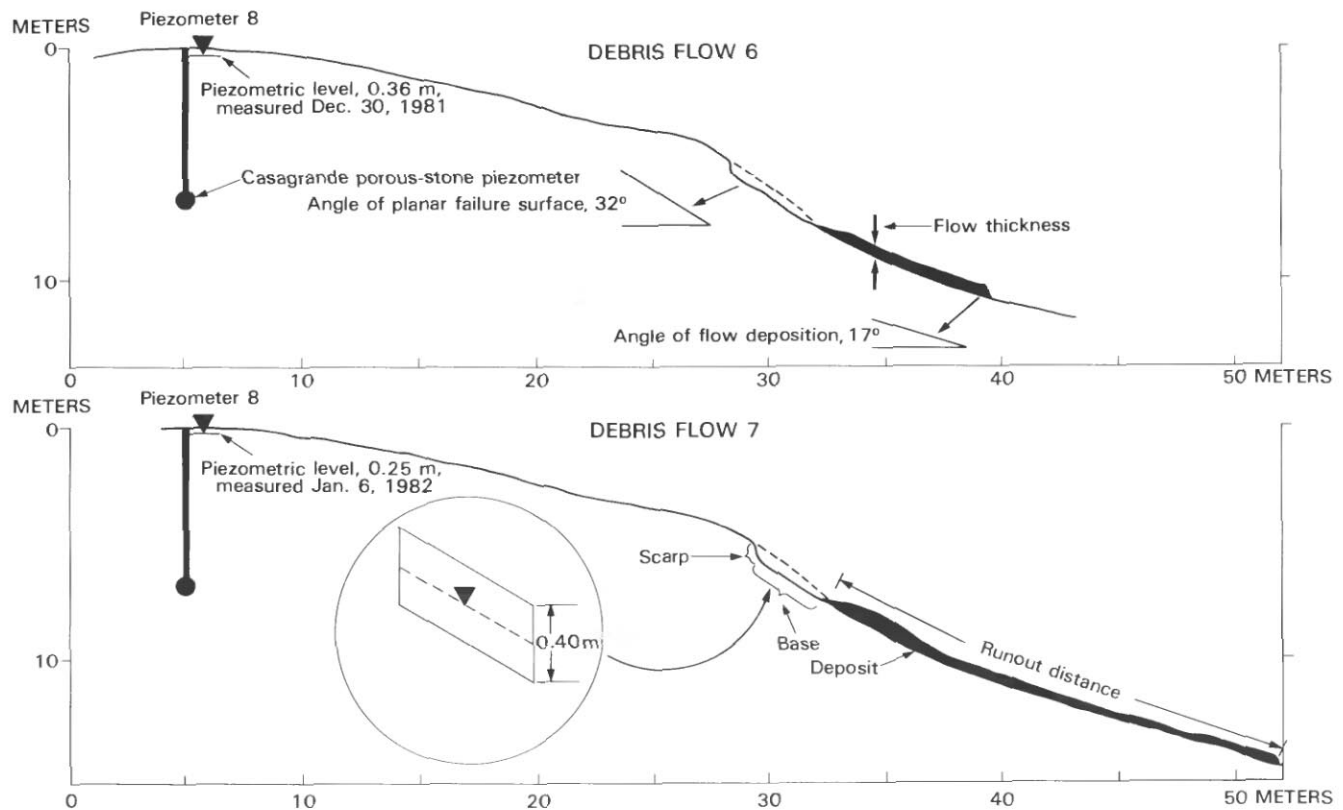
FIGURE 5.9.—Profiles of debris flows 6 and 7 (pl. 3), showing location of piezometer (8, fig. 5.3). Inset shows level of ground water within failure slab equivalent to piezometric level measured nearby on January 6, 1982; actual maximum level in slab is unknown.

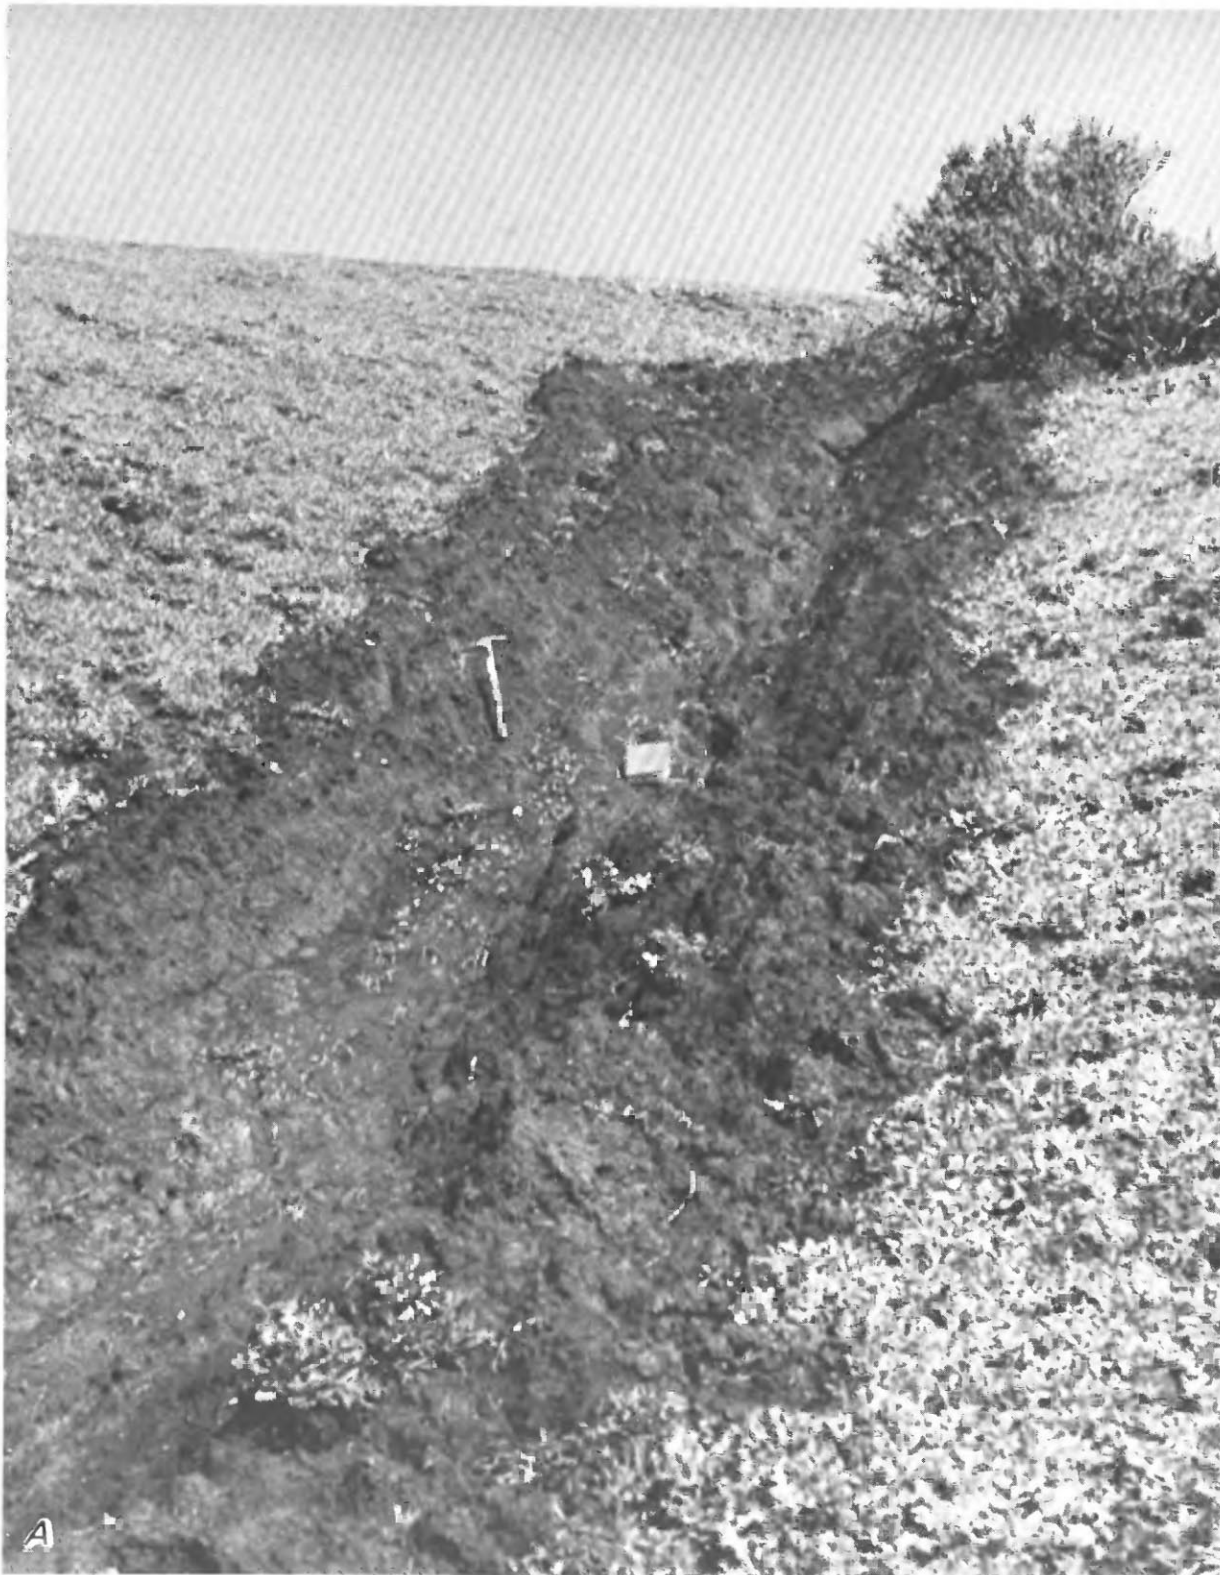
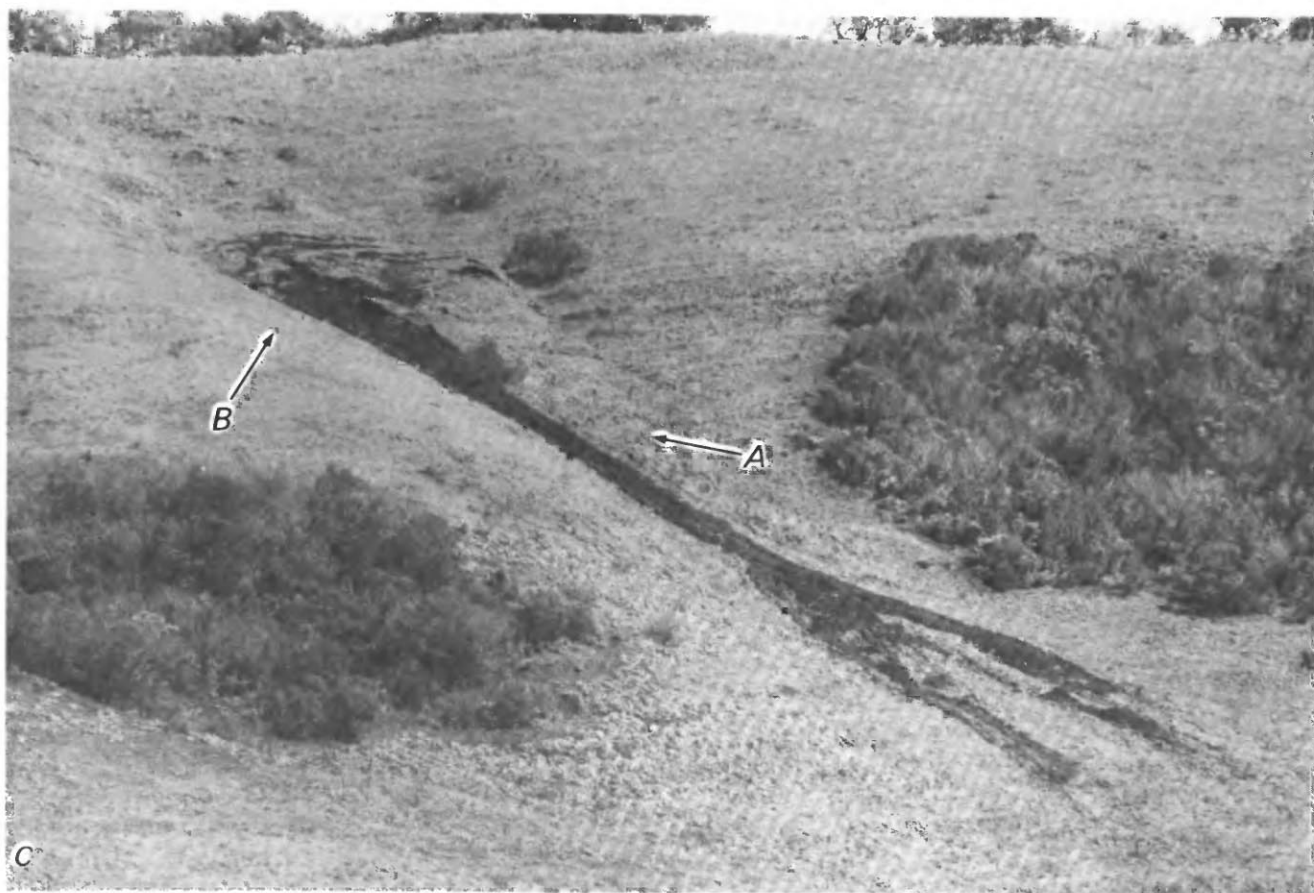
FIGURE 5.10.—Debris flow 3 (pl. 3) triggered January 13–14, 1978, by slumping in regolith within a topographic depression. *A*, Lateral levees bounding channel about midway along debris flow. *B*, Slump and scar at head of debris flow. *C*, Entire debris flow, showing locations of closeups in figures 5.10A and 5.10B.

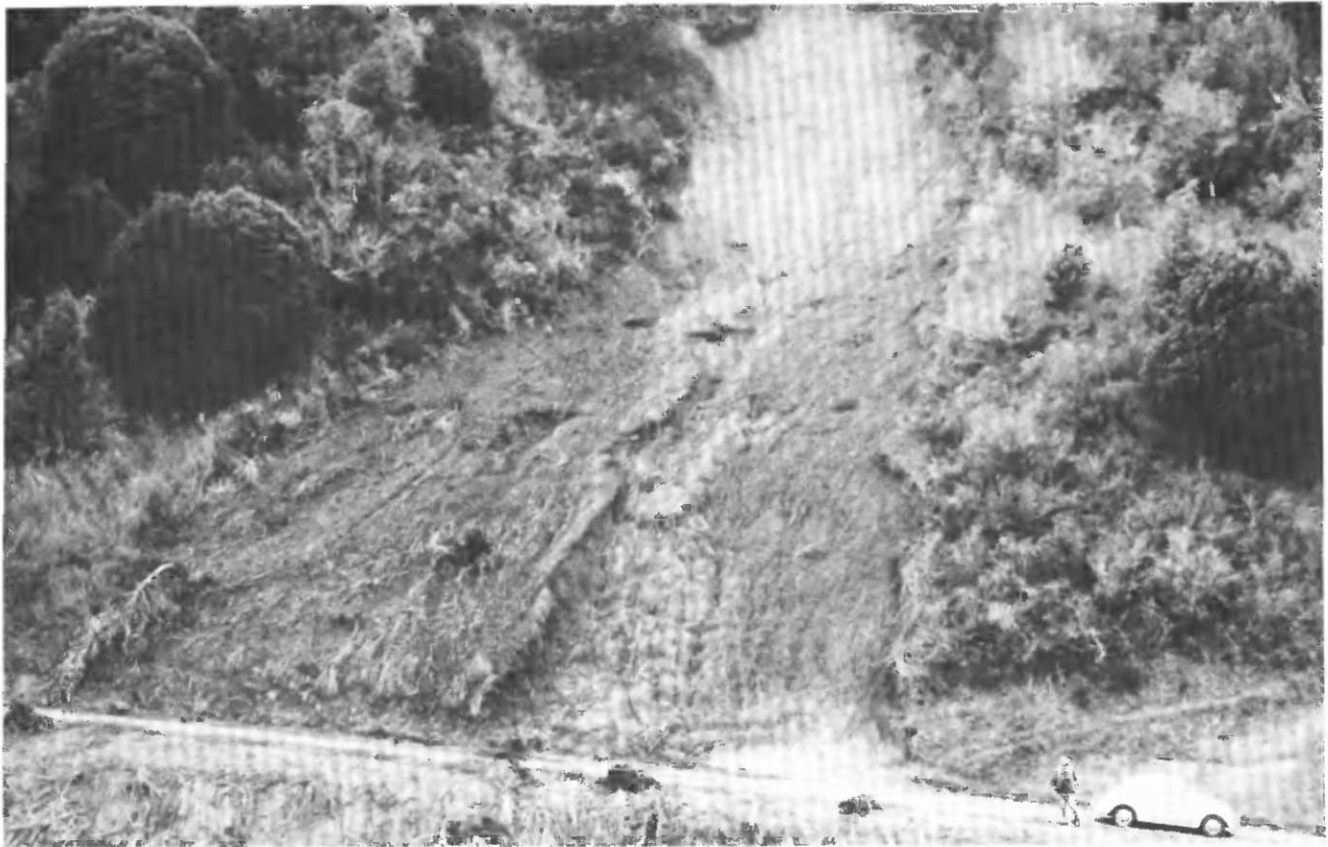
FIGURE 6.3.—Scars and upper part of trail of soil slip/debris flow near Three Peaks; rest of trail extends a short distance downslope below road, then turns abruptly to right down a canyon. Major light-colored soil-slip scar extends from crown downward to break in slope (upper third of view). Trail within view consists of two parts. On right side

of photograph, a shallow (0.5 m) scar extends from major scar to road and from edge of trail to about midway across trail; muddy deposit coats brush along lower edge of trail. On left side, most vegetation has been stripped, trees have been plucked (leaving small scars, such as at left center), and a small tree at edge of trail has been bent over.

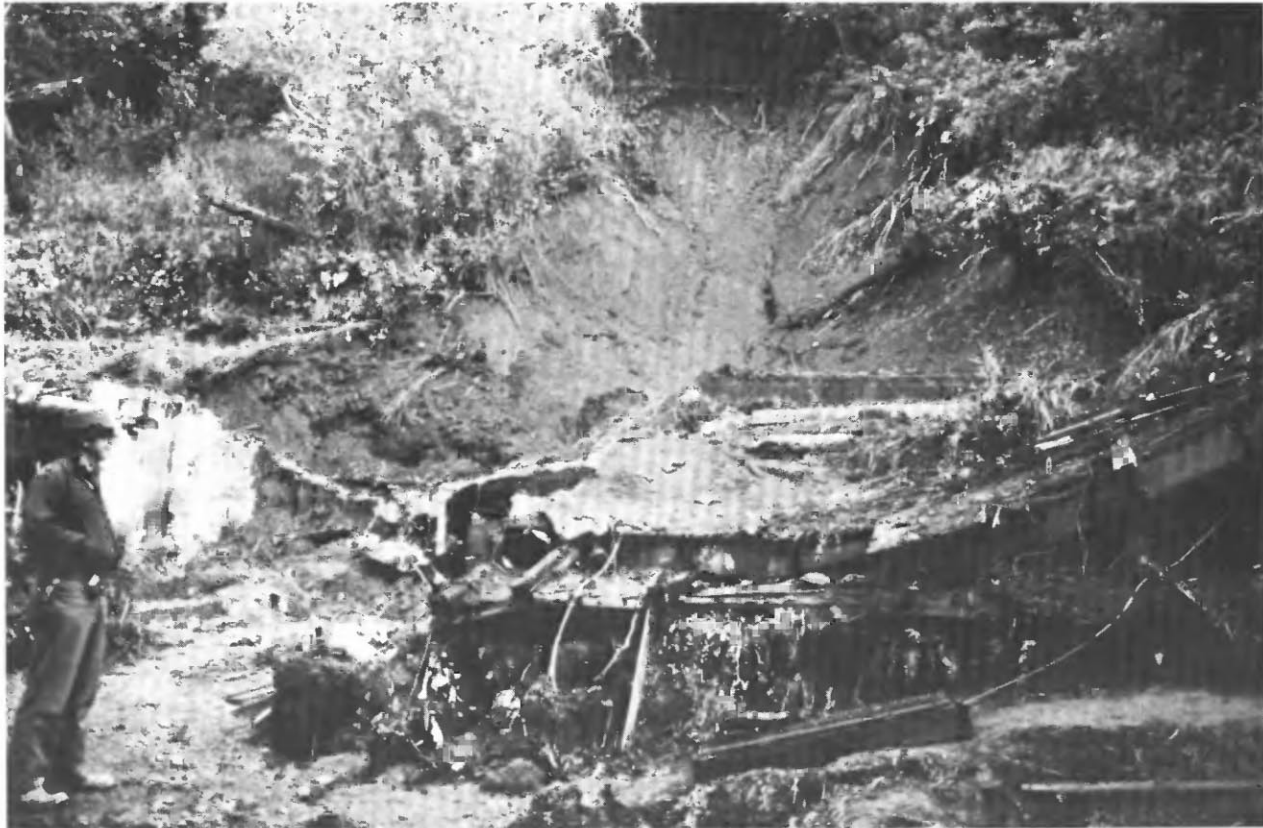
FIGURE 6.4.—Soil-slip scar behind site of destroyed house in Murray Park. Broken concrete wall of basement garage is at left center.

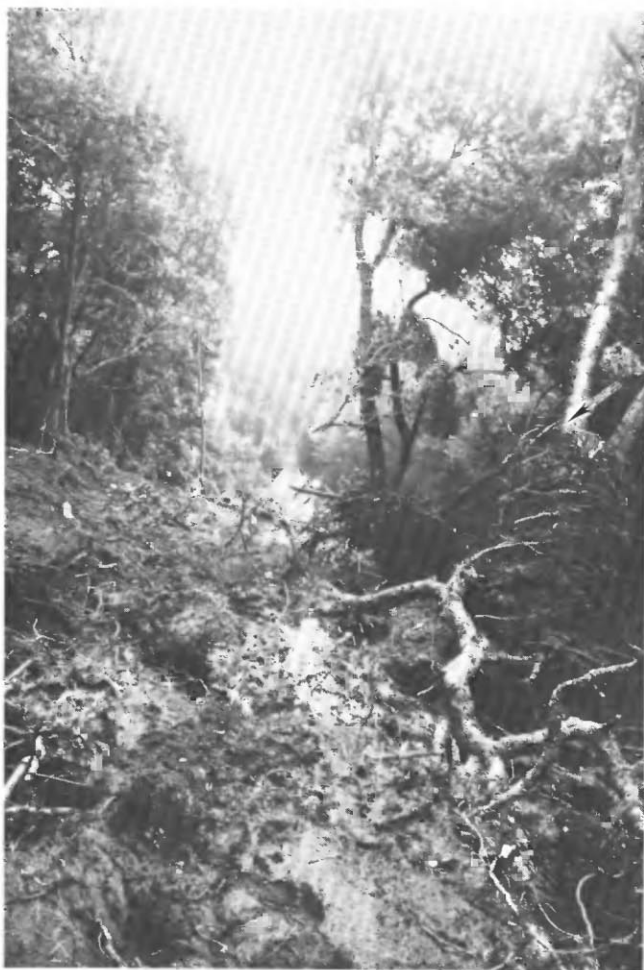
FIGURE 6.5.—View down debris-flow trail in Homestead Valley toward destroyed house (center). Note debris plastered 2 m high against tree at right (top of debris indicated by arrow) and loose branch hanging from tree at center.

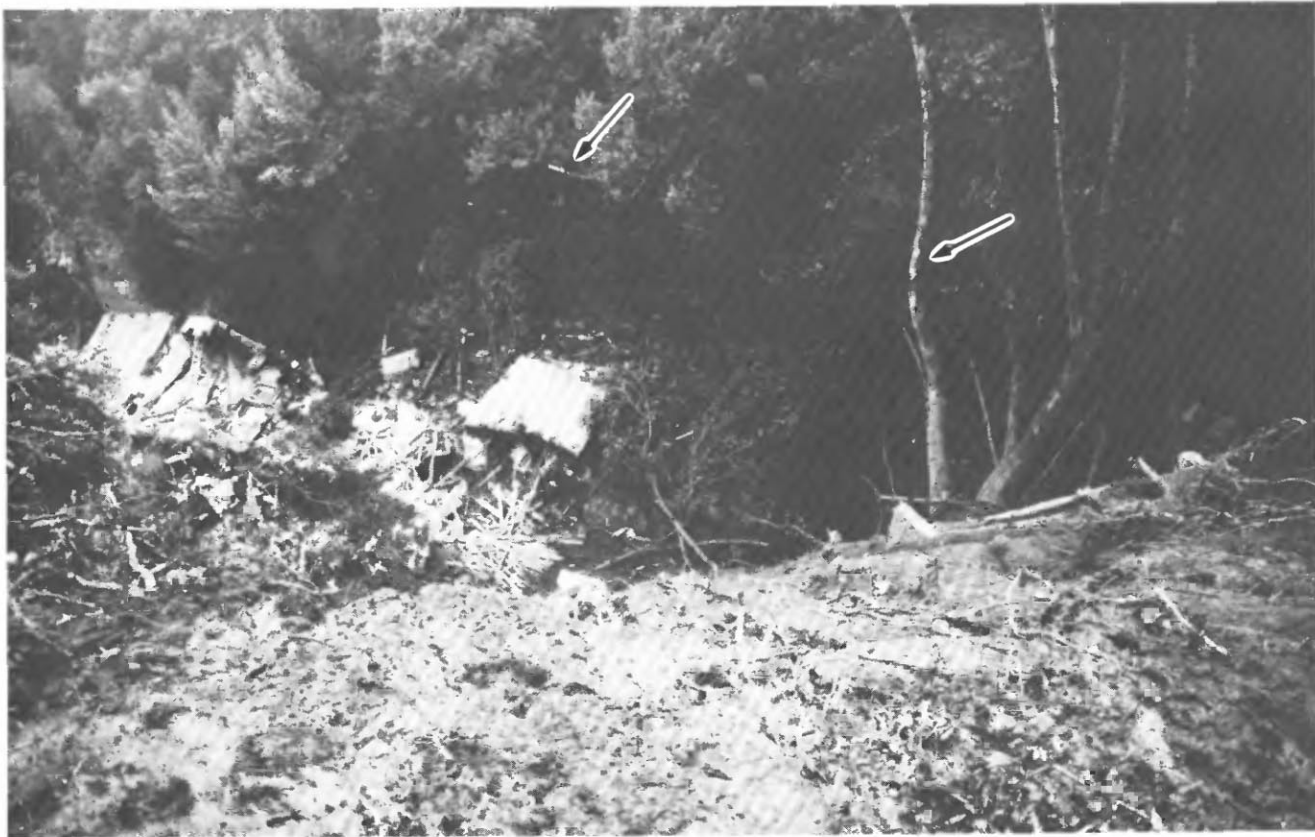
FIGURE 6.6.—Remains of Homestead Valley house resting in canyon bottom, about 45 m from its foundation (at right). Debris-flow trail in foreground. Note impact marks on tree trunk and branches (arrows).

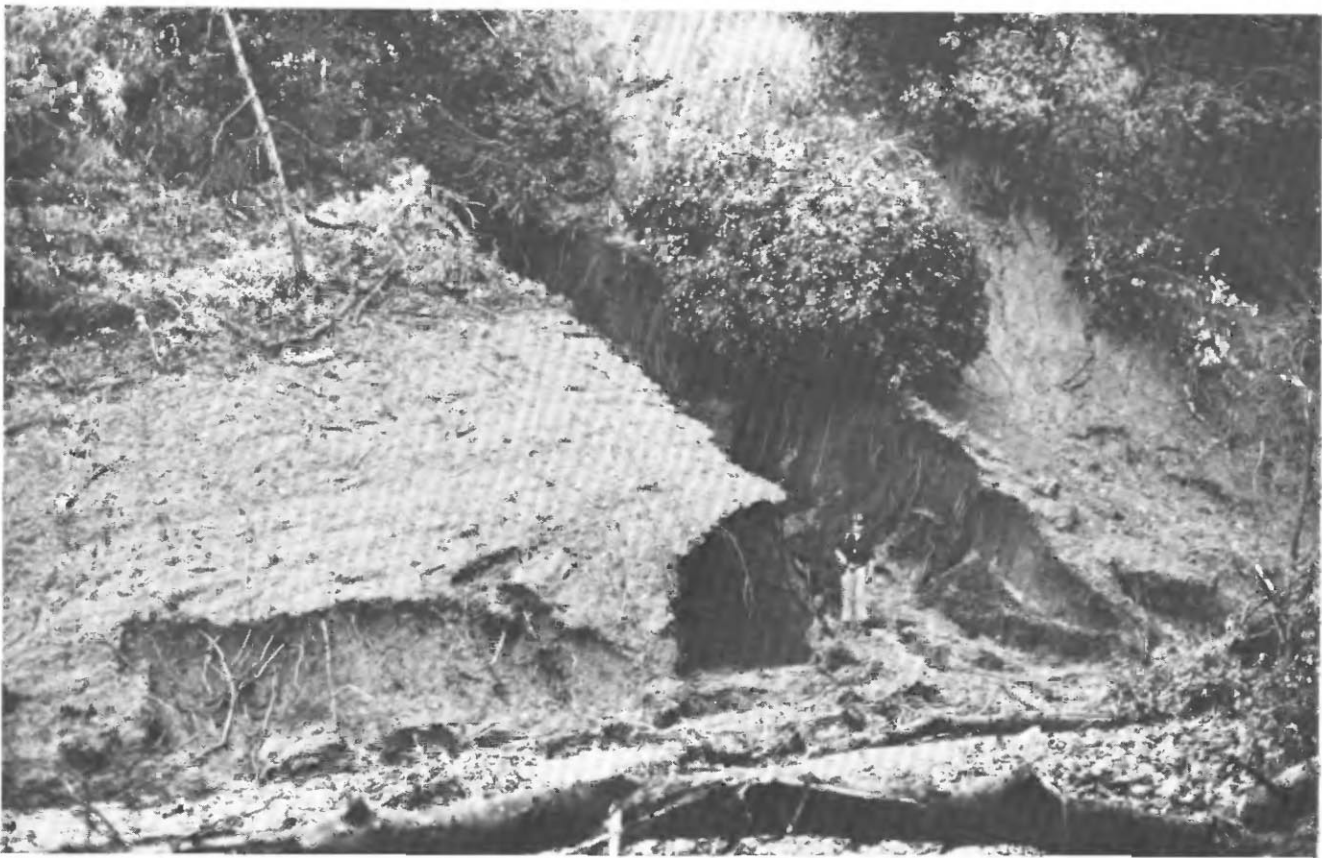
FIGURE 6.8.—Path of debris torrent upstream from Redwood Avenue in Inverness. Path is smooth surface stripped of vegetation; flow traveled from right to left. Note scarp in left foreground truncating soil mantle. Deep gully has been cut by a small tributary. View southward. Photograph by D.G. Herd.

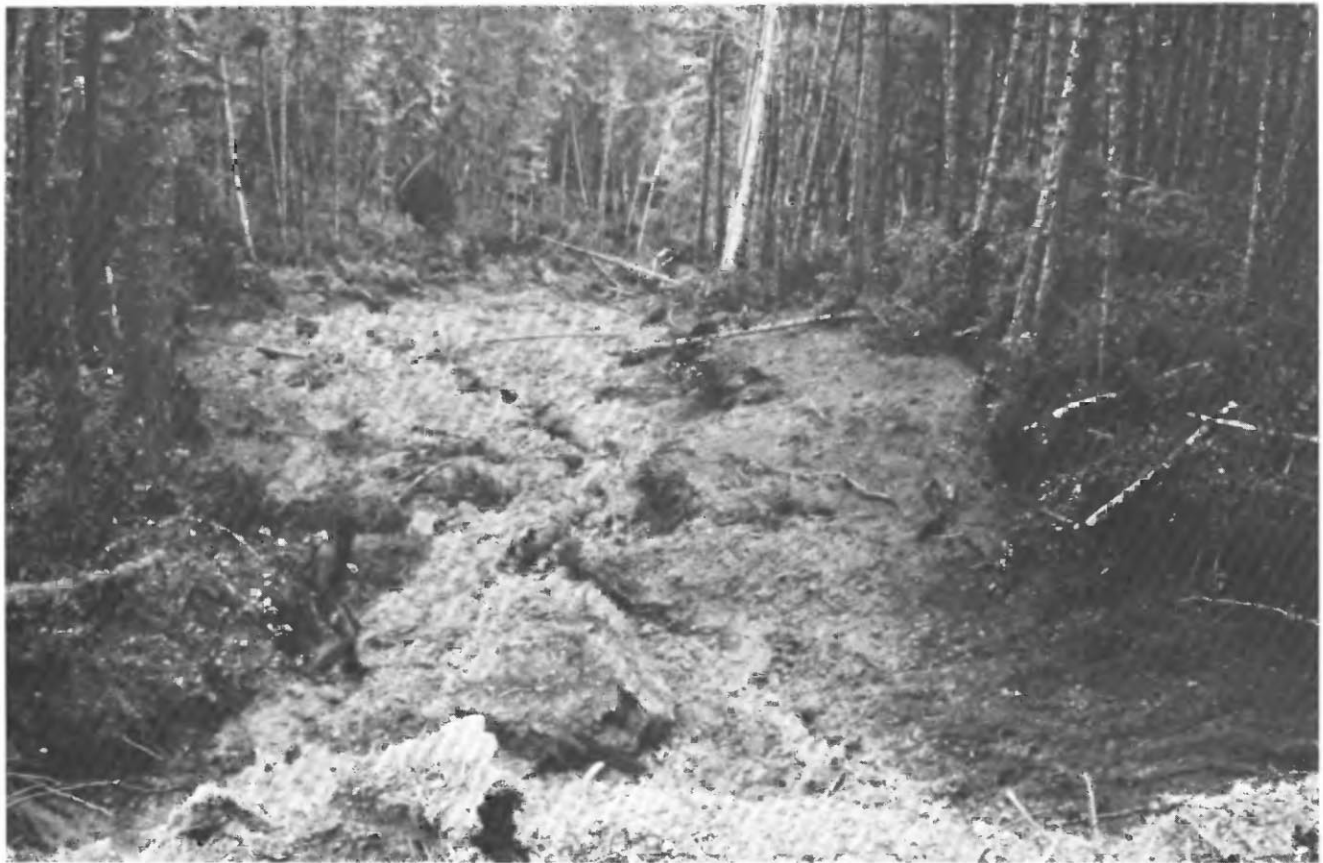
FIGURE 6.9.—Soil-slip scar and head of debris-flow trail in thick Bishop-pine forest, north fork of First Valley, Inverness Ridge. Scar, which is as much as 2.5 m deep, occupies most of lower half of view; dirt road into which scar encroached is in immediate foreground, and debris-flow trail lies in upper half of view. Scar occupies axis of a subtle colluvium-filled swale. View downslope. Photograph by C.M. Wentworth.

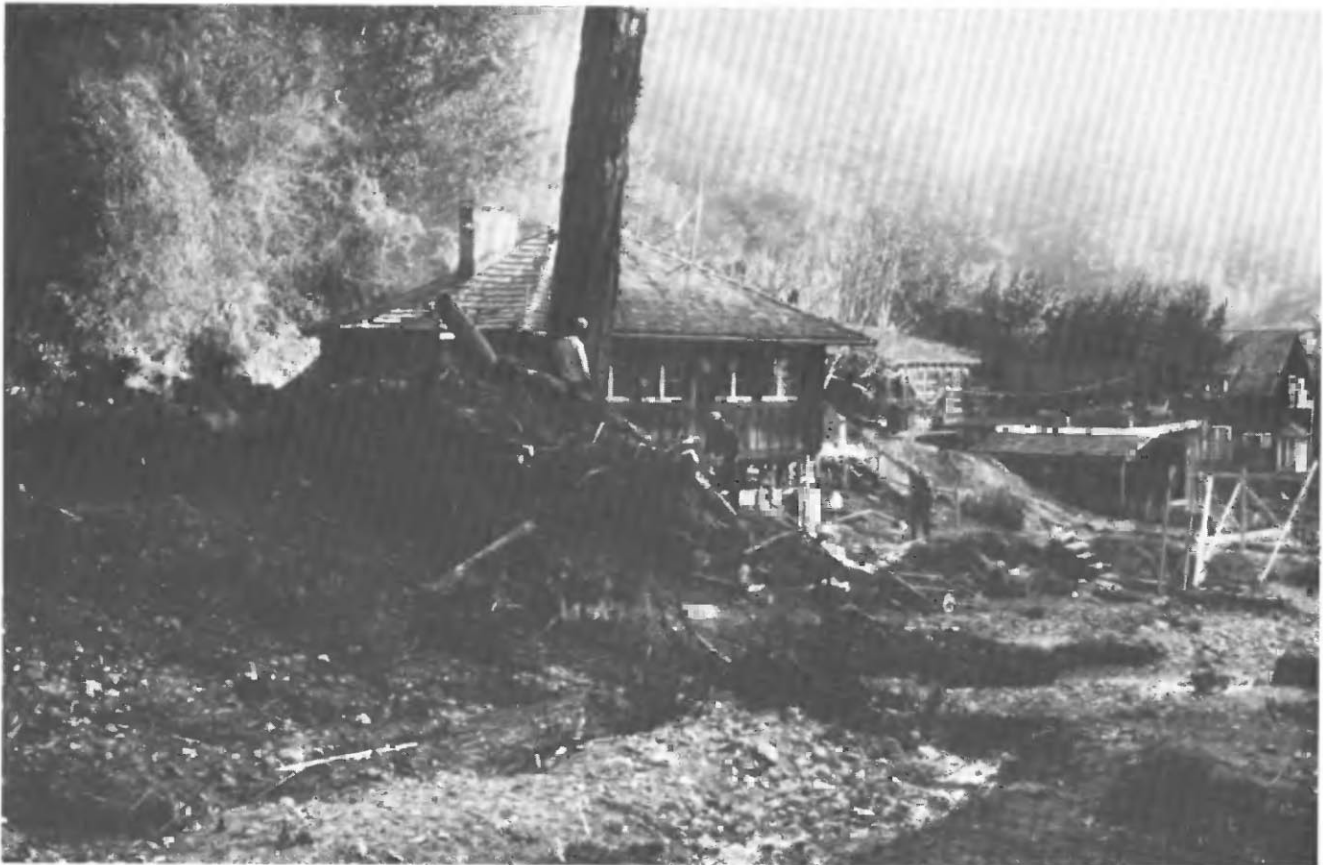
FIGURE 6.10.—Pile of debris at north edge of debris-torrent path in First Valley, Inverness. Single Douglas-fir (1.3 m diam) immediately upstream of house blocked the logs and deflected the debris torrent, so that only the house's deck was destroyed. Immediately upstream, a filter house of the Inverness Water Co., located in center of path, was destroyed. Downstream, large trees were abundant enough to deflect the logs and prevent major damage to buildings. Photograph by S.L. Reneau.

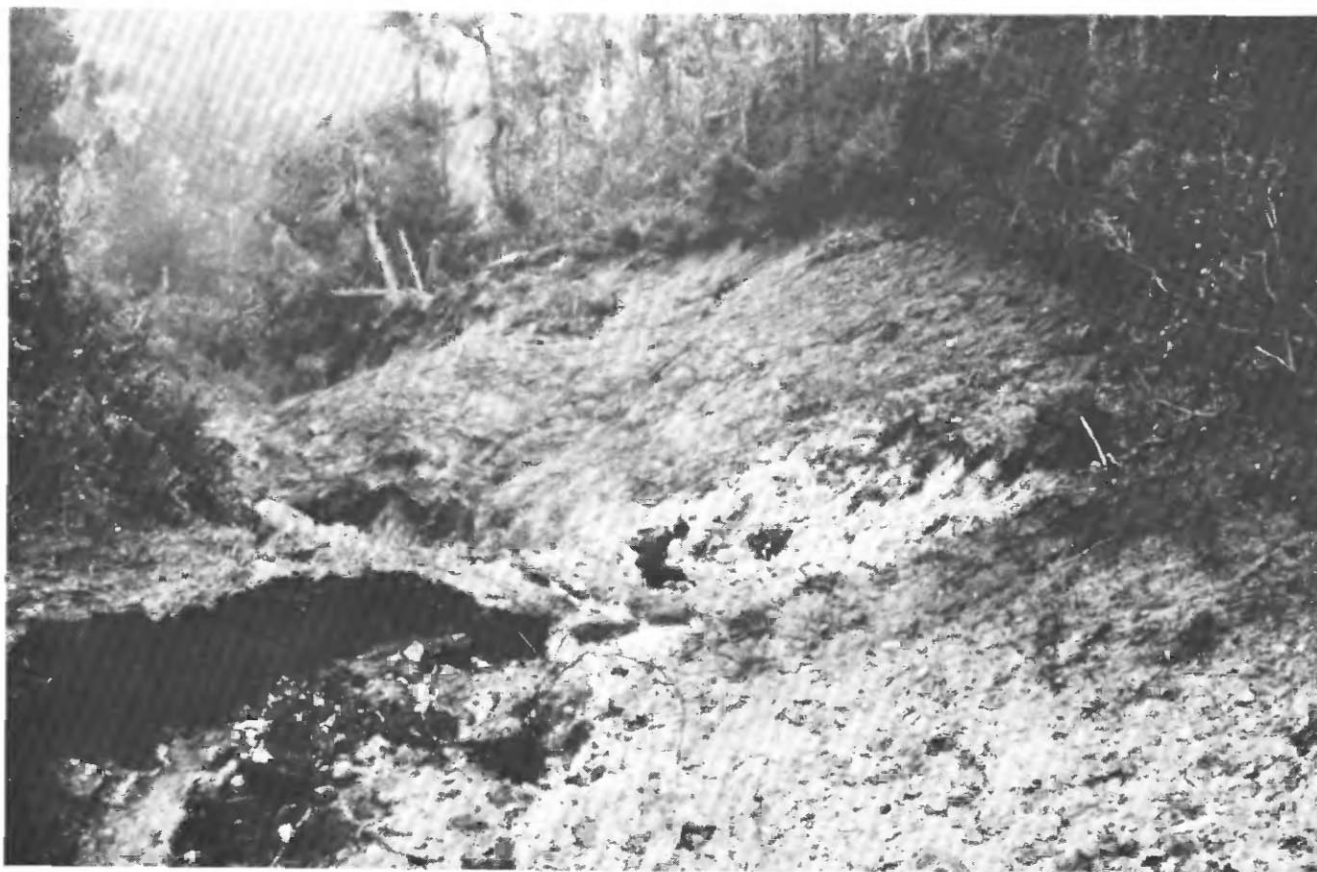
FIGURE 6.11.—Path of debris torrent in north fork of First Valley, Inverness Ridge, showing removal of vegetation and soil mantle. Note that path margin is much higher on right side, owing to banking around a sharp curve. Kneeling man in center for scale. Photograph by C.M. Wentworth.
