# Landslides, Floods, and Marine Effects of the Storm of January 3-5, 1982, in the San Francisco Bay Region, California

U.S. GEOLOGICAL SURVEY PROFESSIONAL PAPER 1434

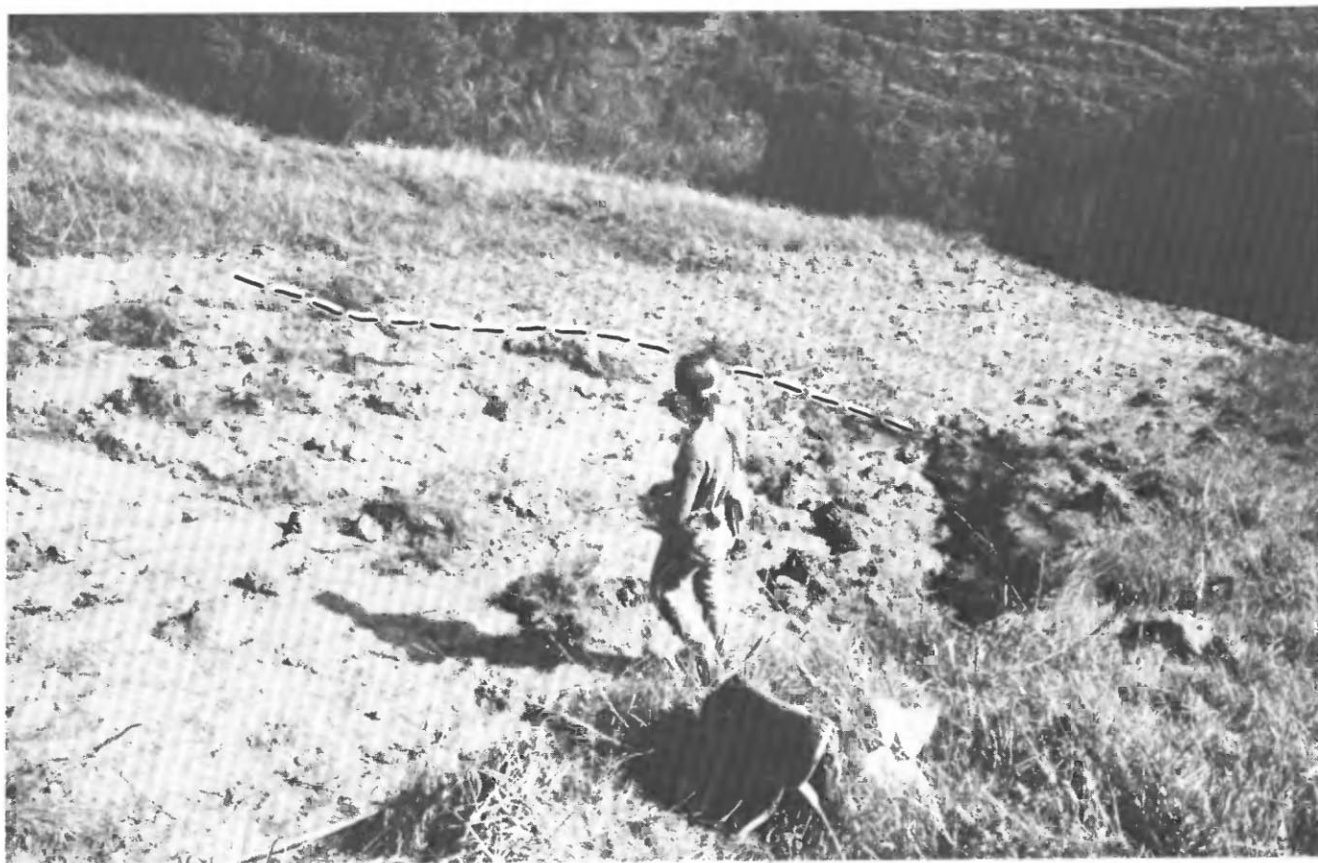
FIGURE 6.13.—Soil slip/debris flow on the Tiburon Peninsula, Marin County. Broad tabular soil-slip scar at left (upslope from dashed line) leads downslope to debris-flow trail of flattened grass that includes scattered remnants of muddy deposit and clumps of sod. Slide mass climbed over steep downslope corner of scar (shadowed, at right center) and left lateral deposits leading from widest part of scar.

Some soil slips left broad sheetlike scars (fig. 6.13), and others narrow pockets (fig. 6.15). Reneau and Dietrich (1987a) have described and analyzed the sizes of scars left by the storm in a study area in Marin County.

Debris flows in grassland typically left only lateral deposits lining a swath of flattened grass that included bits of muddy deposit (figs. 6.13, 6.15, 6.20). Some of these trails showed evidence of subsequent running water, but most appeared to be as they were left by the debris flow. Movement of slurry over grassland appears to have been accomplished by sliding as well as flow (fig. 6.36). Sliding seems to be reasonable, considering the water-laden con-

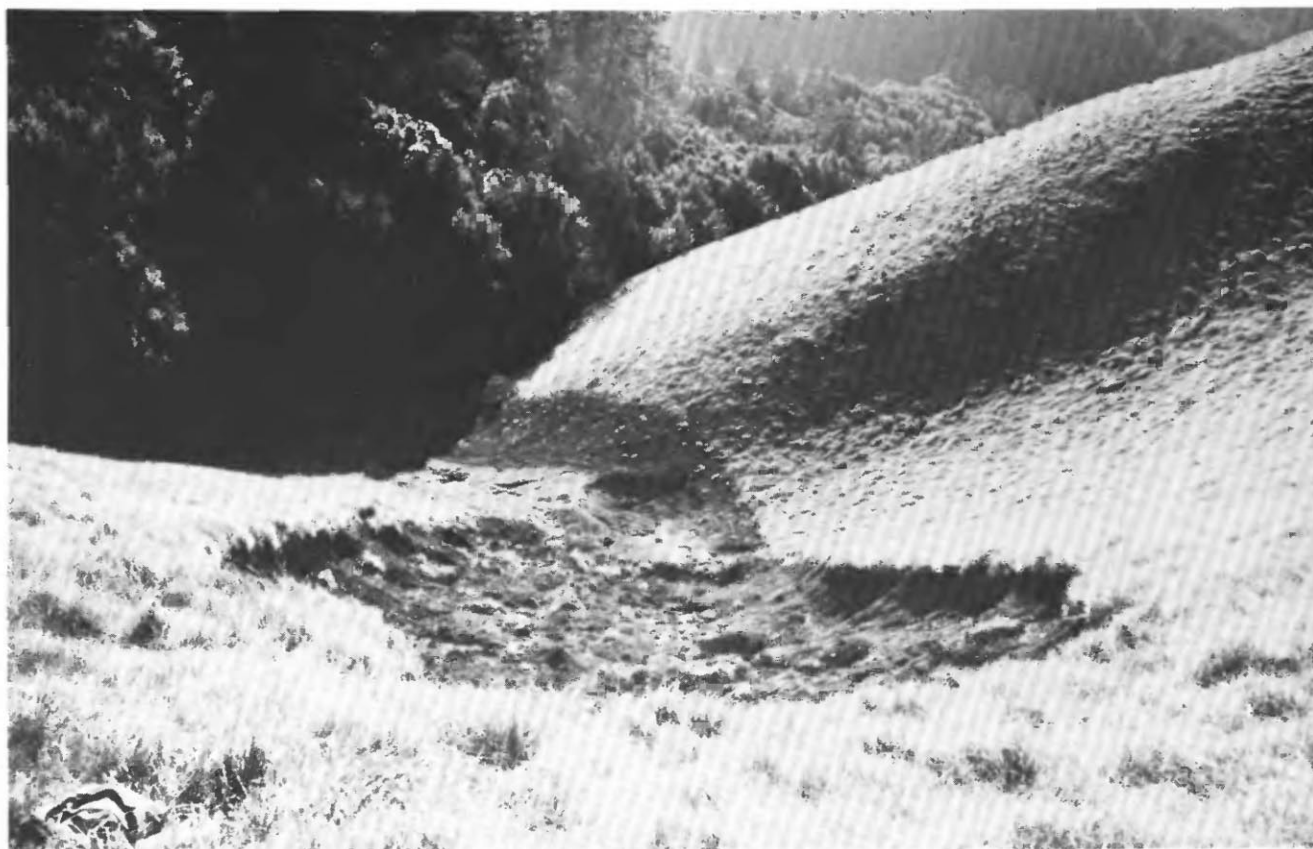
FIGURE 6.14.—View downslope along soil slip/debris flow near Barnabe Mountain, Marin County. Debris-flow trail leading downslope from empty scar climbs right side of its path in making a turn. Knapsack in foreground for scale.

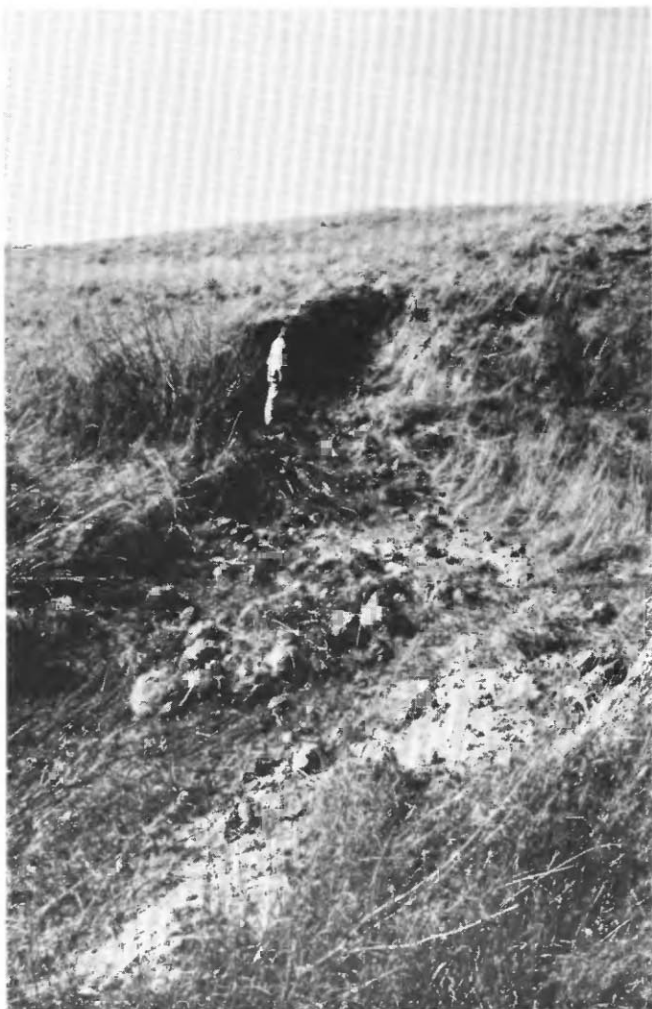
FIGURE 6.15.—Trail of debris flow over grassland, leading from pocket-shaped scar, on the Tiburon Peninsula, Marin County. Note lateral deposit bounding trail, flattened old grass marking trail, and deposits within trail. Young grass standing upright in trail has grown since the event.

The most conspicuous deposits left by the storm were lateral deposits, or levees, lining flow paths (figs. 6.15,

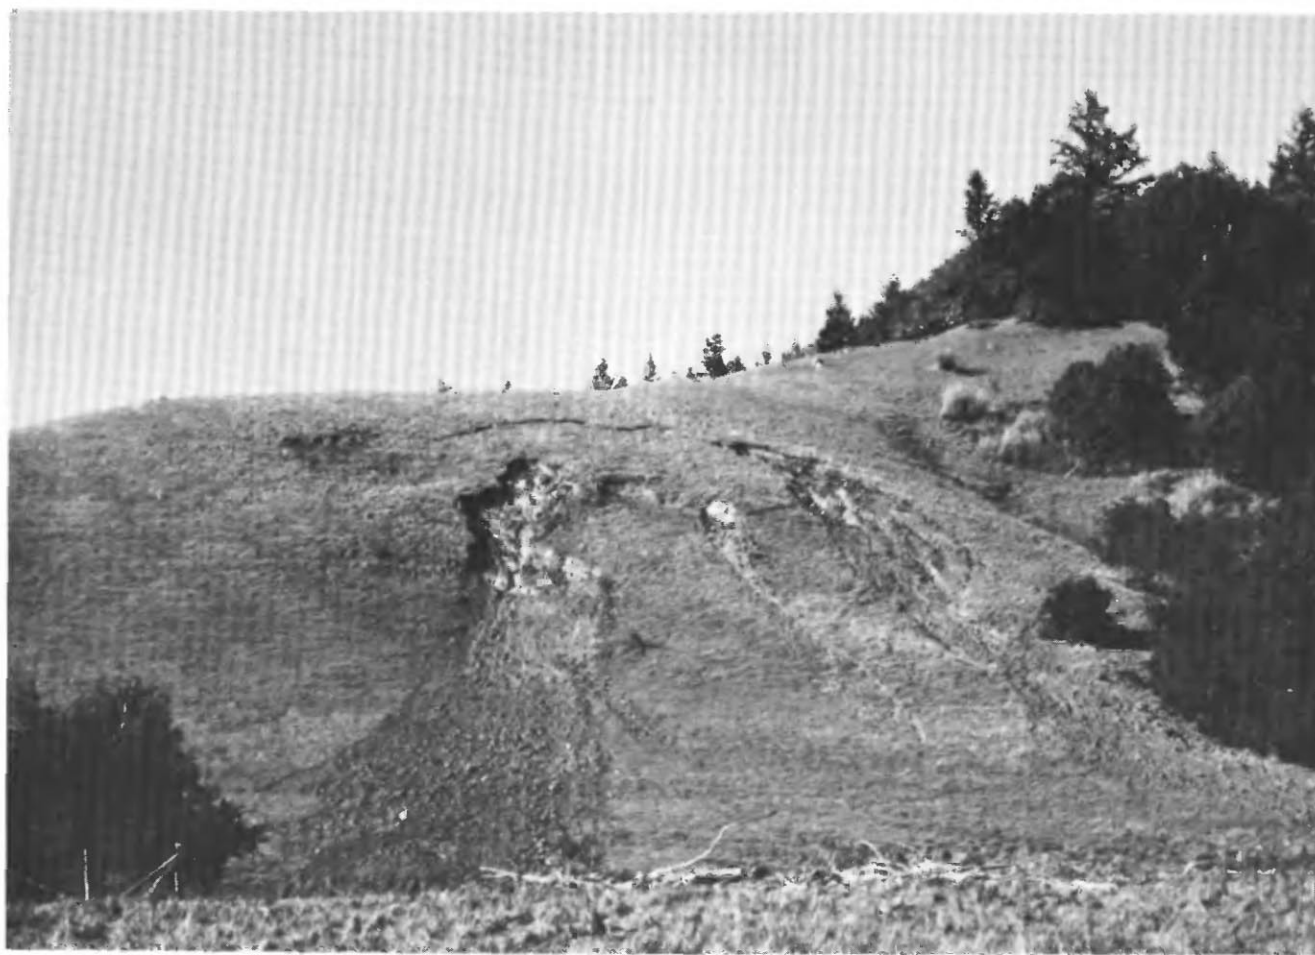
FIGURE 6.19.—Three small debris flows near San Geronimo, Marin County, issue from flank and toe of larger shallow slide. Larger slide, defined by dark cracks at crown and toe, is about 35 m wide.

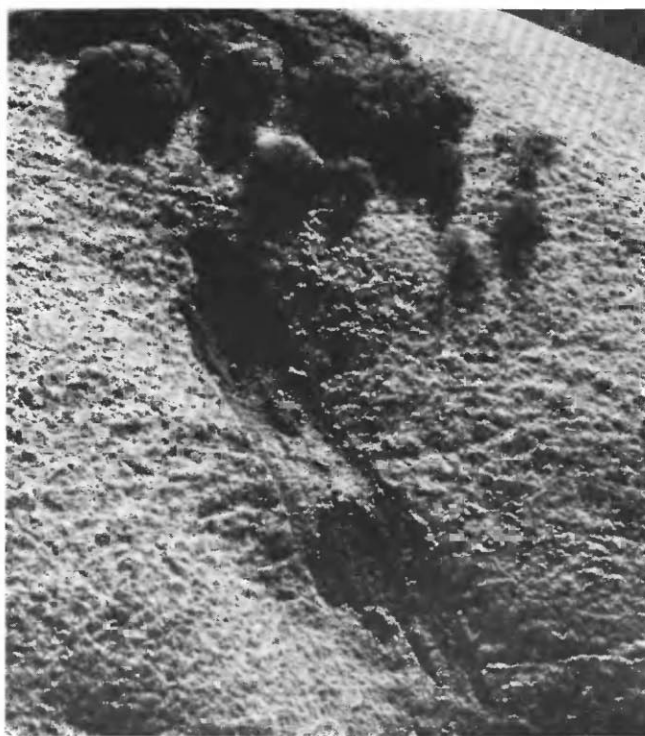
FIGURE 6.20.—Small soil-slip/debris-flow complex near Barnabe Mountain, Marin County. Complex consists of two scars along a debris-flow trail, 3 to 4 m wide. Between scars, trail is defined by lateral deposits.

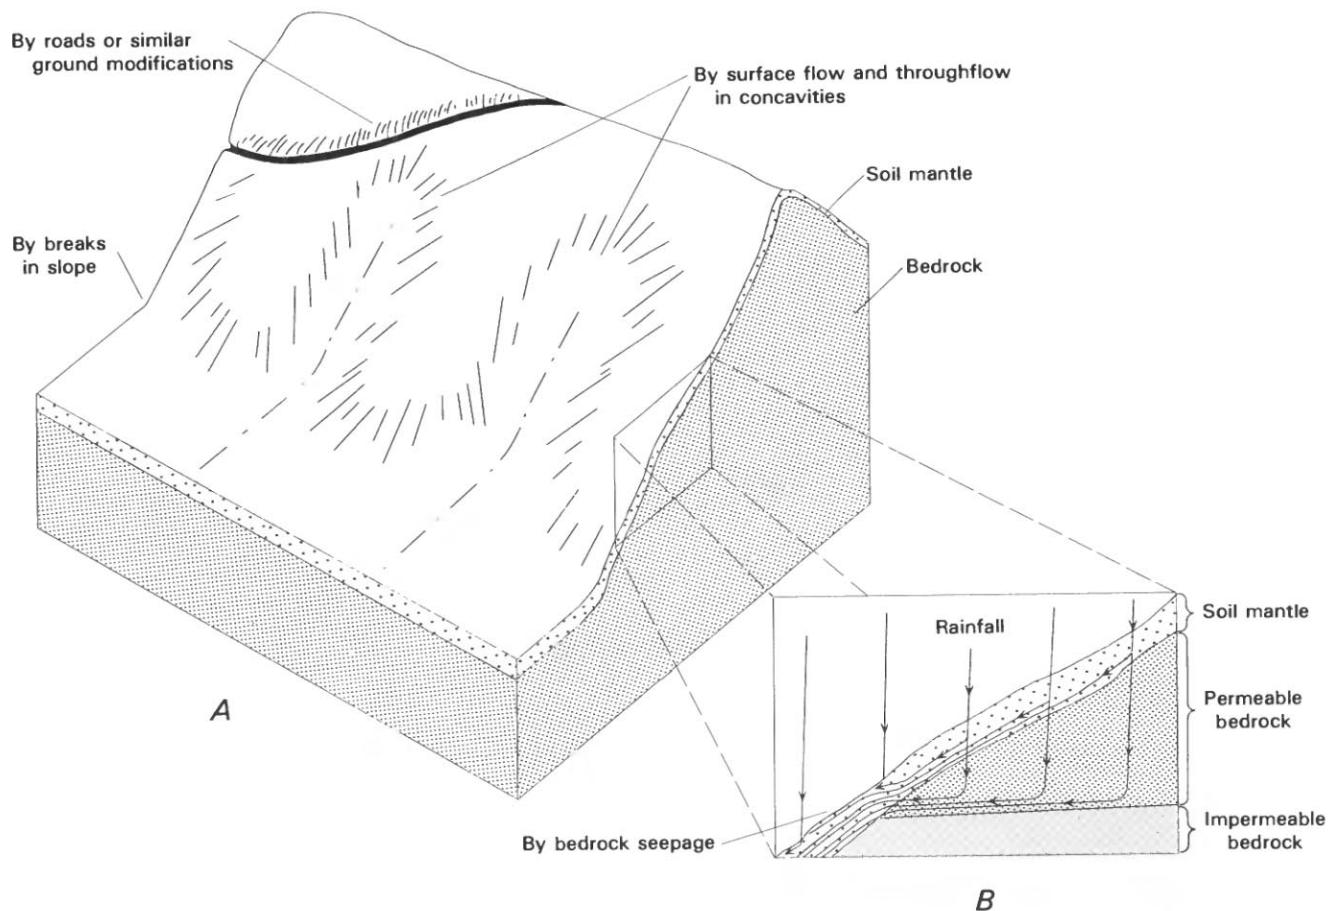
FIGURE 6.21.—Schematic block diagram (A) and cross section (B) showing some means of water concentration in the landscape. Schematic water paths in cross section illustrate throughflow (within soil mantle) and bedrock seepage.

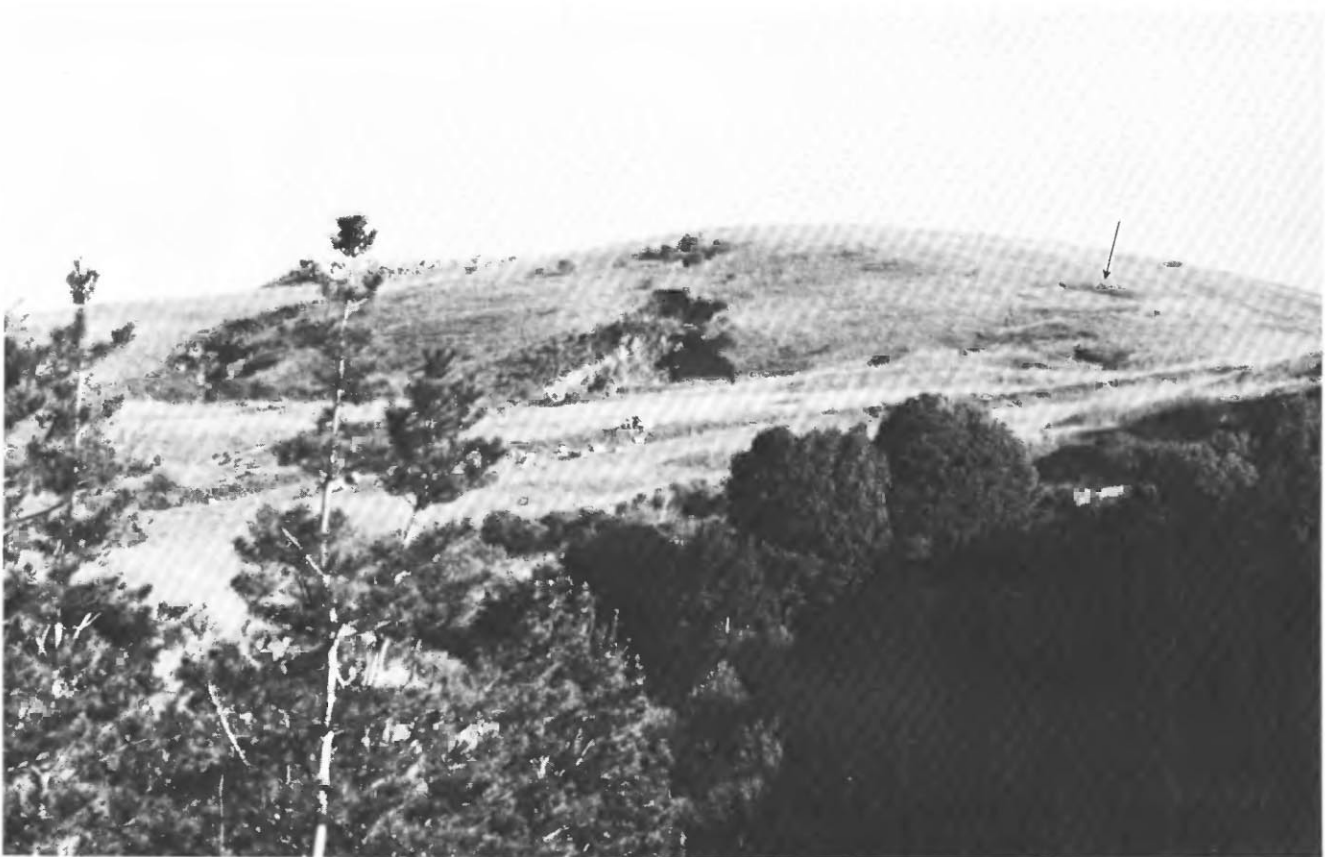
FIGURE 6.22.—Landslides on the Tiburon Peninsula, Marin County, localized along a prominent break in slope that coincides with a contact between permeable bedrock and soil mantle above and impermeable clayey bedrock and soil mantle below. Contact extends about horizon-

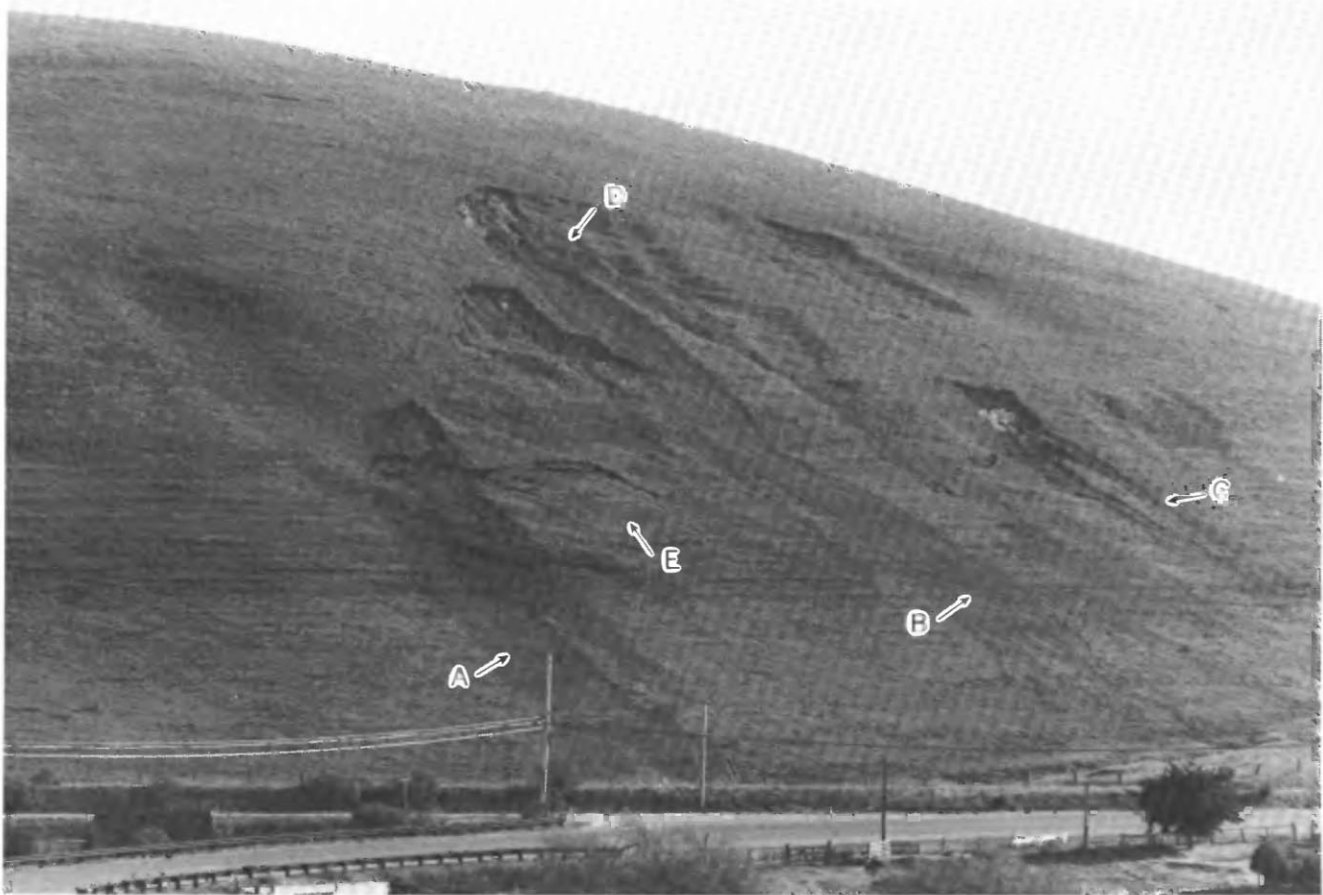
FIGURE 6.23.—Mobilized and nonmobilized shallow landslides induced by the storm on a hillslope near Tomales Bay. Soil slip/debris flows have left trails at A, B, and C, extending downslope from scars; at least one fresh scar (D) developed from a subdued old soil-slip scar. Slide at E has not mobilized; movement is evidenced by fresh cracks at head and bulge at toe. Subtle break in slope that crosses hillside

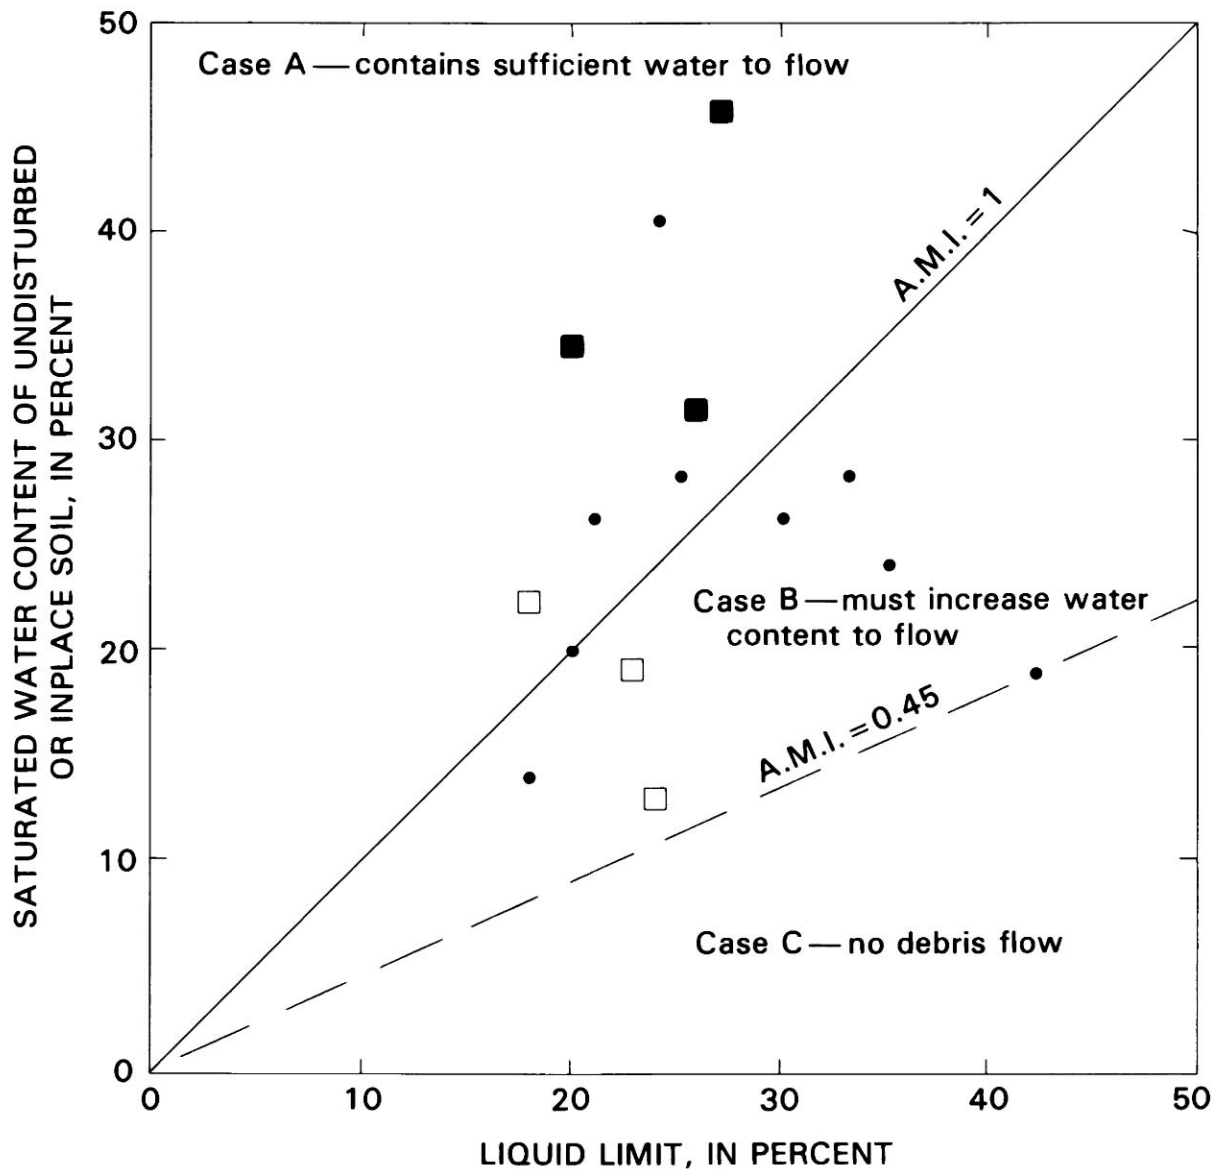
FIGURE 6.26.—Relation between saturated water content and liquid limit for soils in table 6.1 that mobilized as debris flows during the storm. Approximate mobility index (A.M.I.) is ratio of saturated water content to liquid limit. Dashed line, lower limit of A.M.I. for soils that flowed in the storm; upper limit is 1.70. Squares represent soils in two-layer soil slip/debris flows at three sites in Marin County: solid squares, dark surficial soils; open squares, tan subsoils.

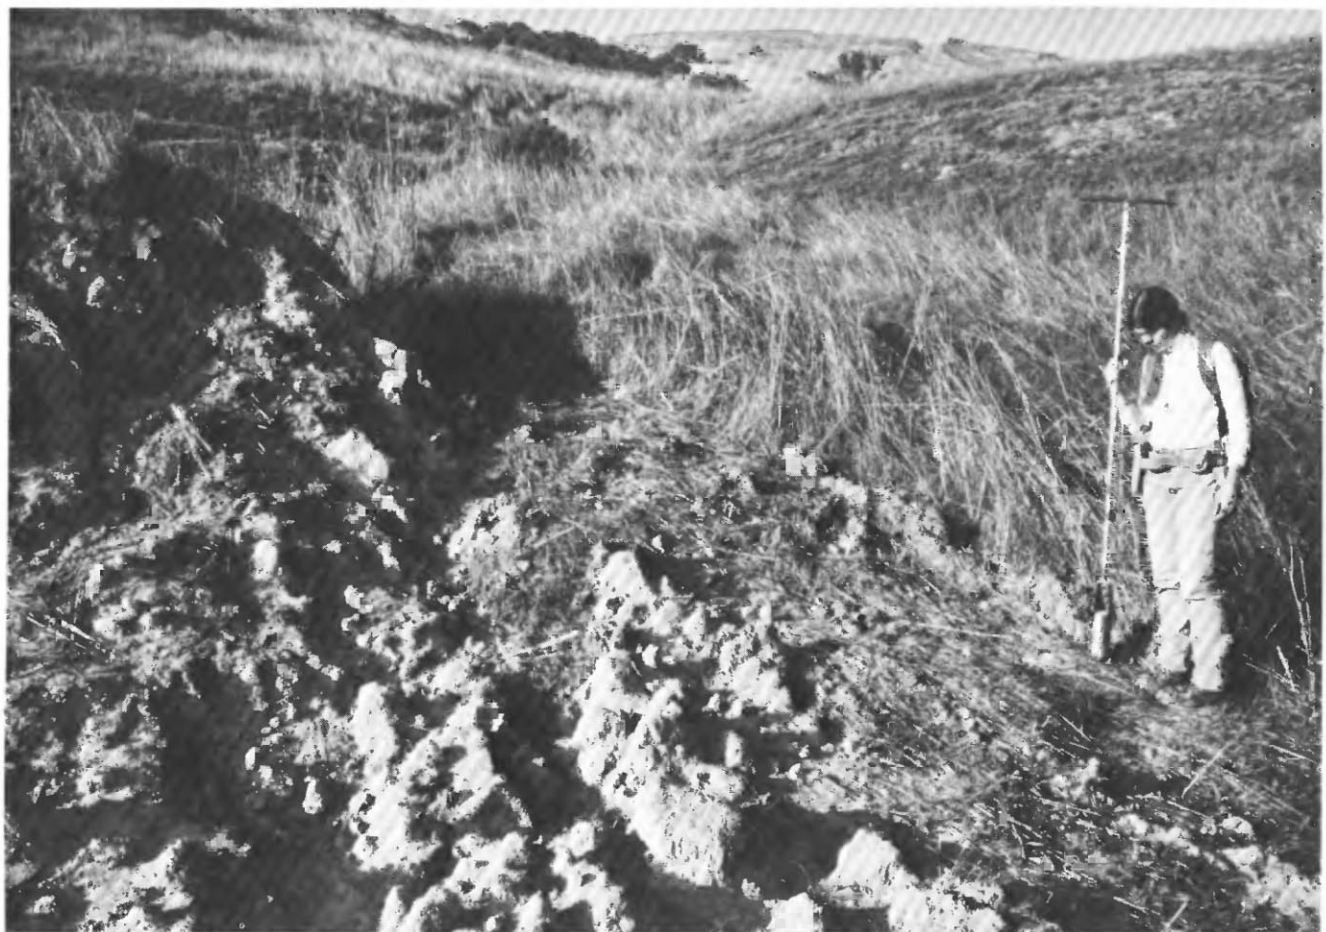
FIGURE 6.33.—Deposits from two-layer soil slip/debris flow near Reed, Marin County. Dark surficial soil forms thin deposit of relatively smooth consistency near auger; underlying tan colluvial soil forms thicker lumpy deposits at bottom center of view.

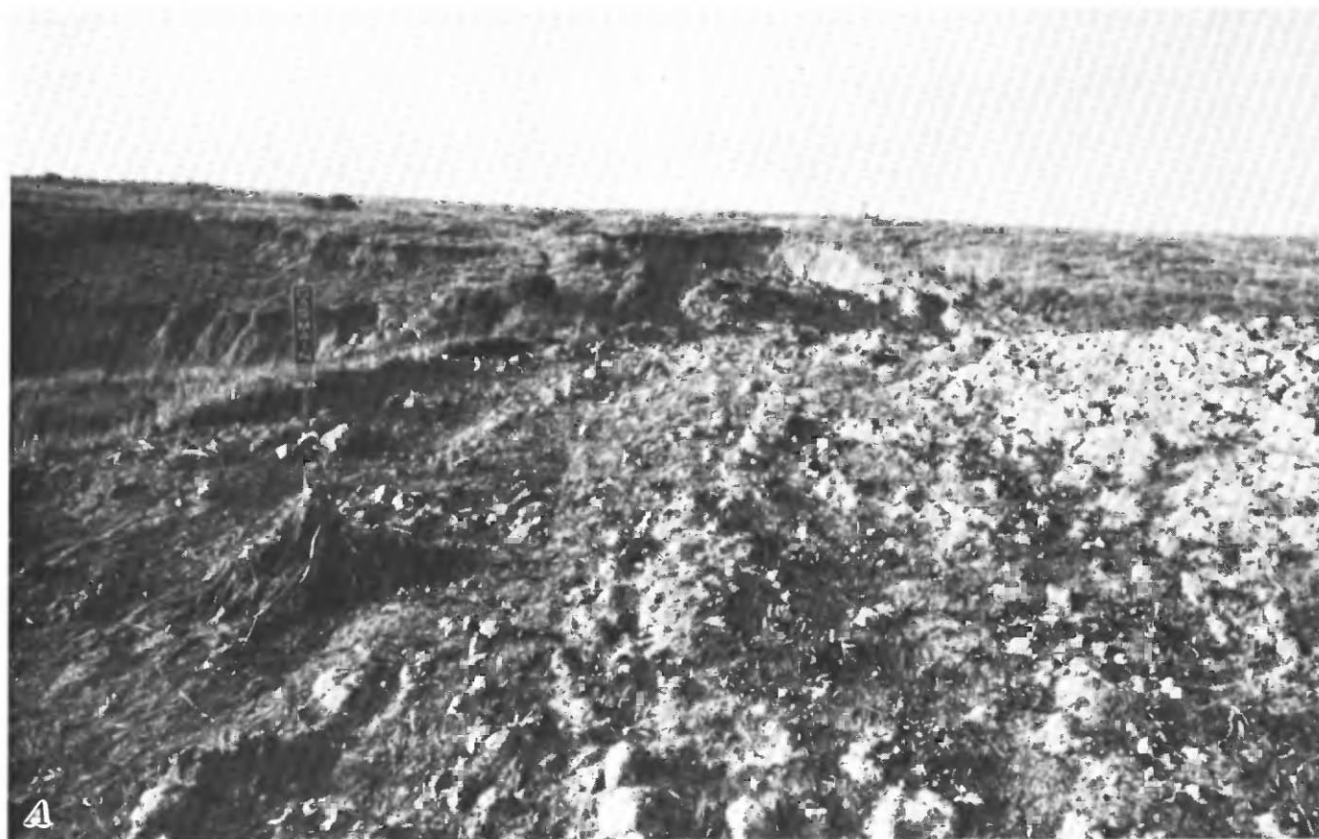
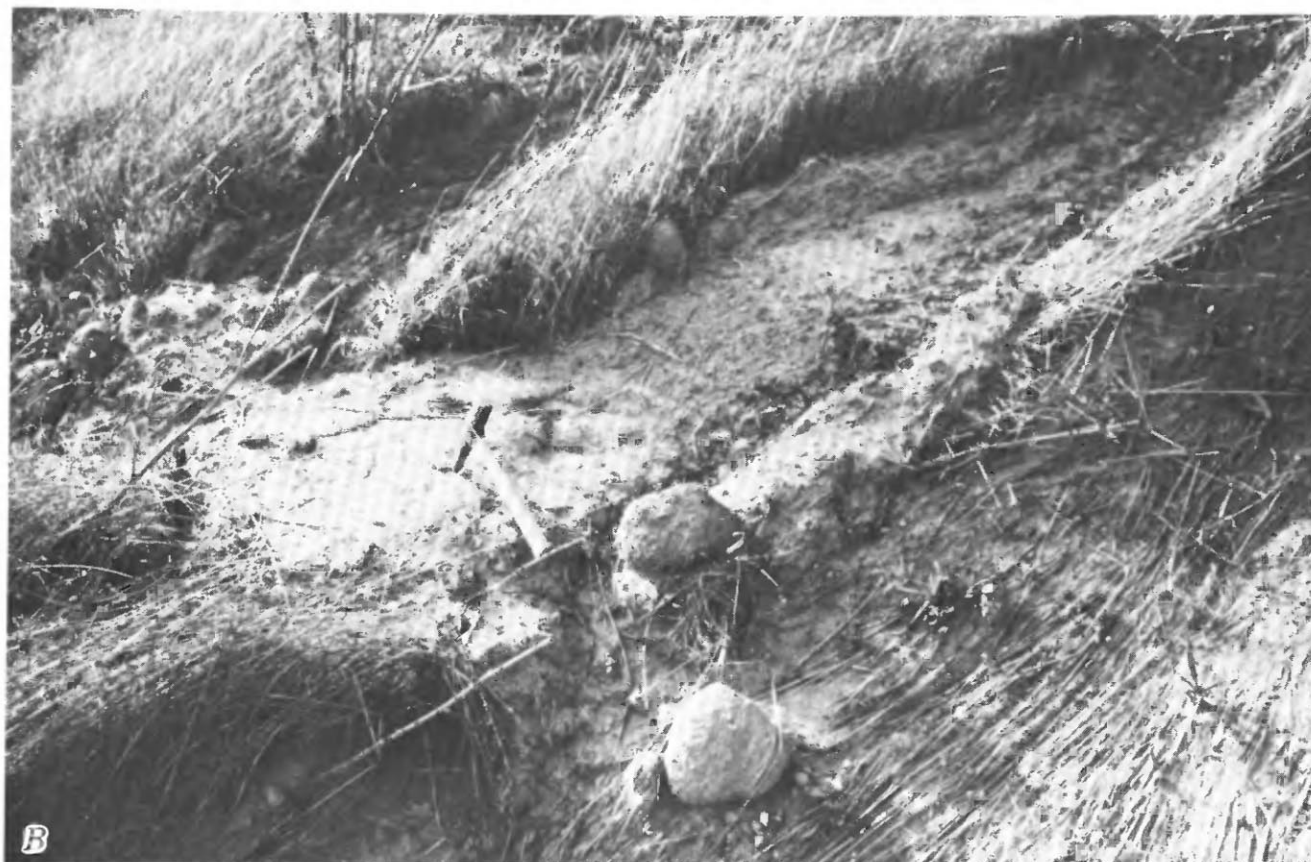
FIGURE 6.34.—Two-layer soil slip/debris flow at site 3 near Reed, Marin County. A, Different debris-flow deposits lead from single soil-slip scar. B, Lateral deposit to left of flagged stake in foreground of figure 6.34A consists of soil from organic upper layer of soil mantle. This deposit

is thinner and smoother than light-colored lumpy deposits to right of flagged stake, which derive from lower horizons of soil mantle. Much light-colored lumpy material remains in and near scar as a disaggregated slump that only partially mobilized.

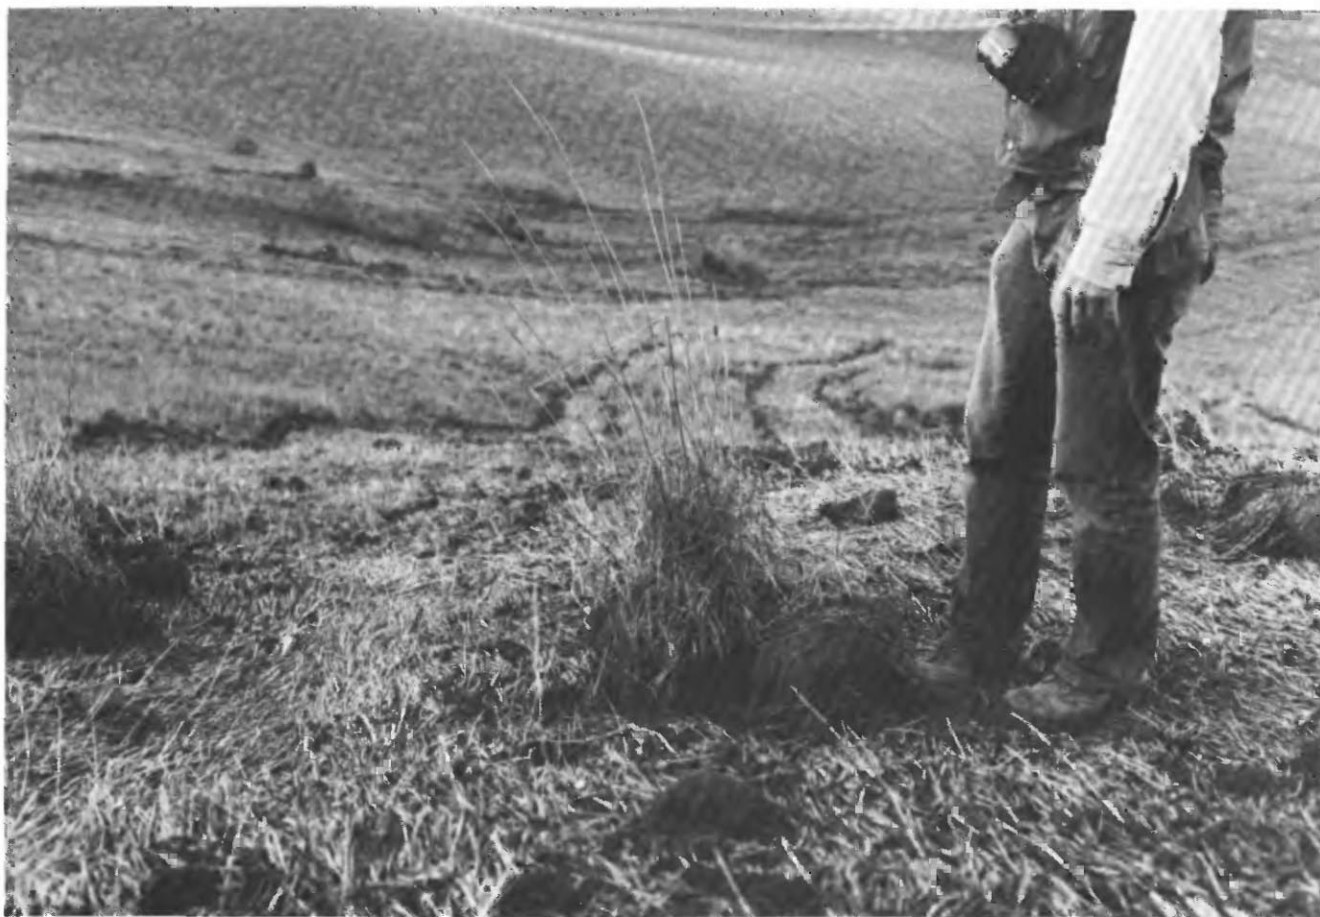
FIGURE 6.36.—Trail of unchannelized debris flow in grassland near Nicasio, Marin County. Upright clump of sod resting on flattened grass suggests that debris flow slid over ground surface; delicate stems of tall dry grass remain undisturbed by their ride tens of meters downslope. Photograph by S.L. Reneau.

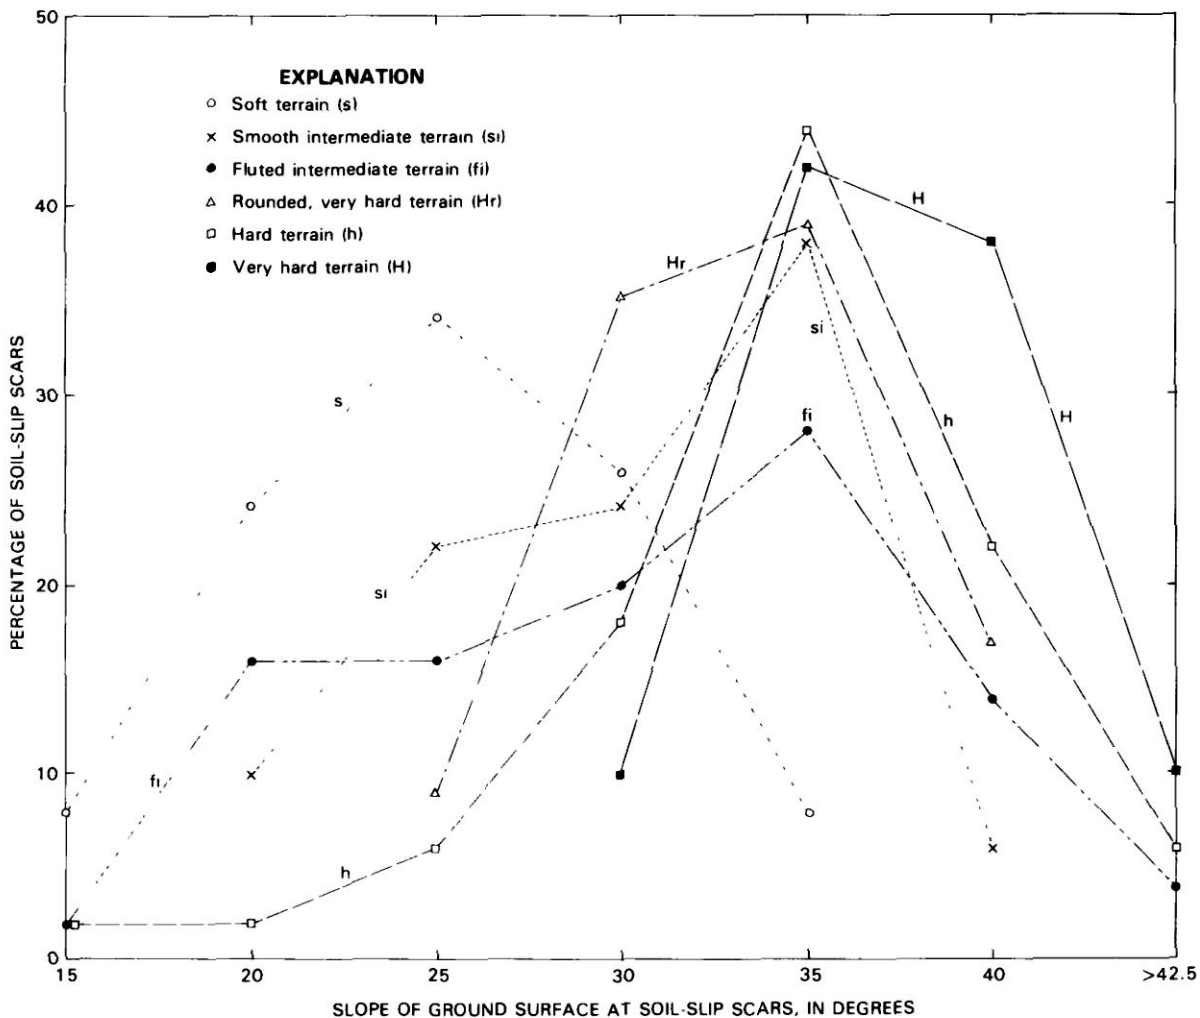
FIGURE 7.6.—Slope of ground surface at soil-slip sources for debris flows formed during the storm in the Hicks Mountain area of western Marin County (pl. 6), plotted by terrain units containing the soil-slip scars. Slope is measured to nearest 5° from spacing of 40-ft contours on 1:24,000-scale topographic map. Slopes are shown for samples of 50 scars in each terrain unit except the rounded, very hard terrain unit, for which only 23 scars are included.

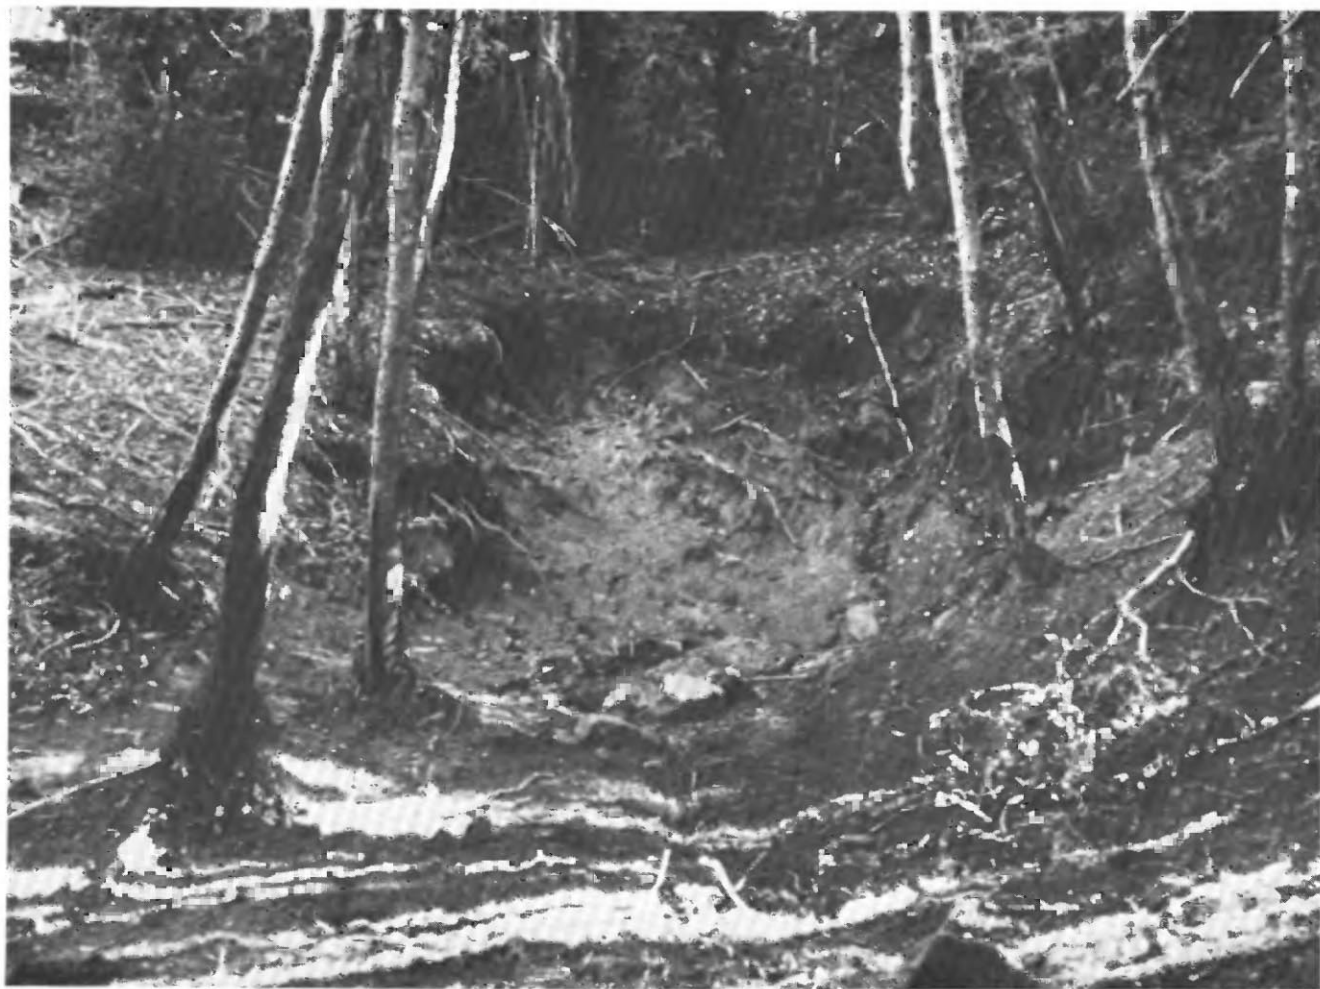
FIGURE 8.1.—View upslope to a small (less than 75 m<sup>3</sup> volume) debris-flow scar in black organic soil and tan weathered sandstone from which a slump mobilized into a debris flow. This flow traveled 45 m before hitting the water-treatment plant at Sempervirens Creek in Big Basin State Park, Santa Cruz County. Scar is about 1 m deep. Note organic debris against base of trees in path at left.

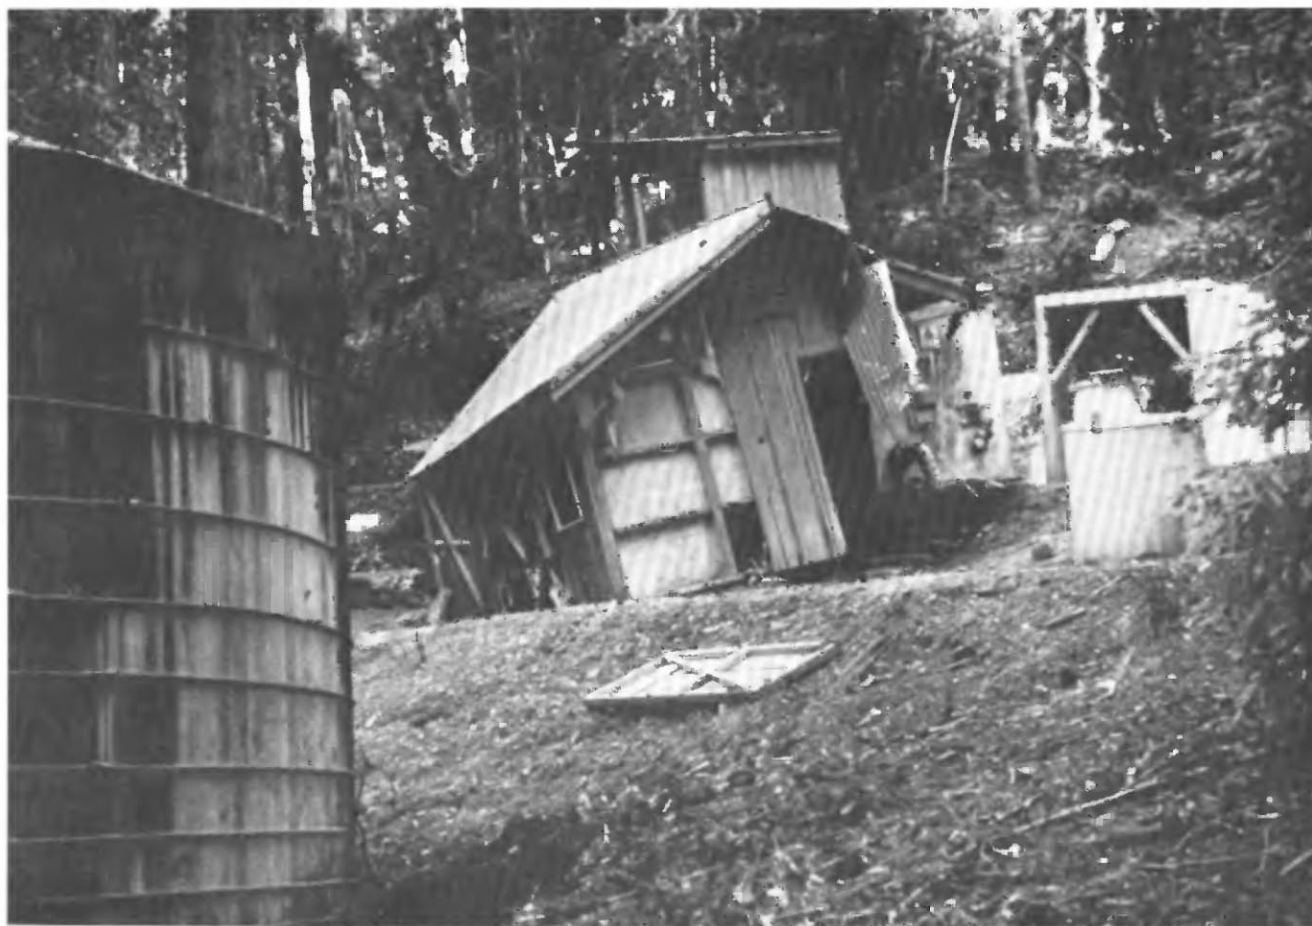
FIGURE 8.2.—Water-treatment plant in Big Basin State Park after impact of debris flow shown in figure 8.1. Plant was moved nearly 7 m from its foundation by debris flow, which was only about 0.6 m thick.

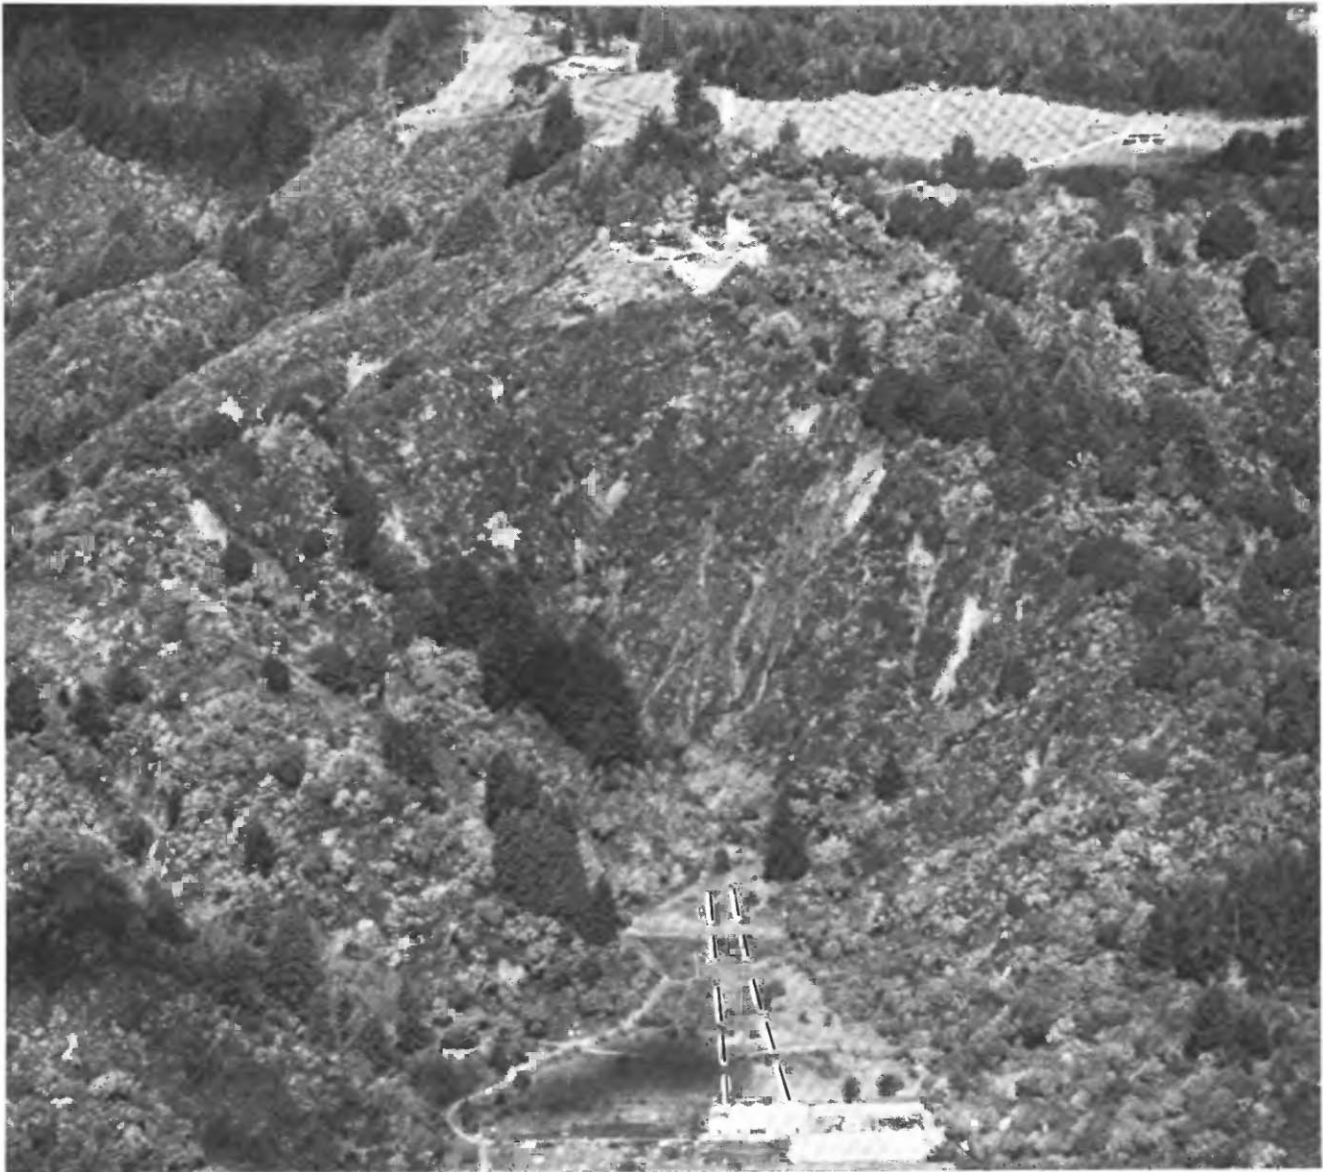
FIGURE 8.4.—Numerous debris-flow scars and tracks on brush-covered hillslopes above Pleasant Valley, Santa Cruz County. These flows coalesced into a single flow track that extended through buildings at bottom of view and 0.3 km beyond. Photograph taken March 25, 1983, after revegetation and grading along valley bottom had obscured main debris-flow track (dashed lines).

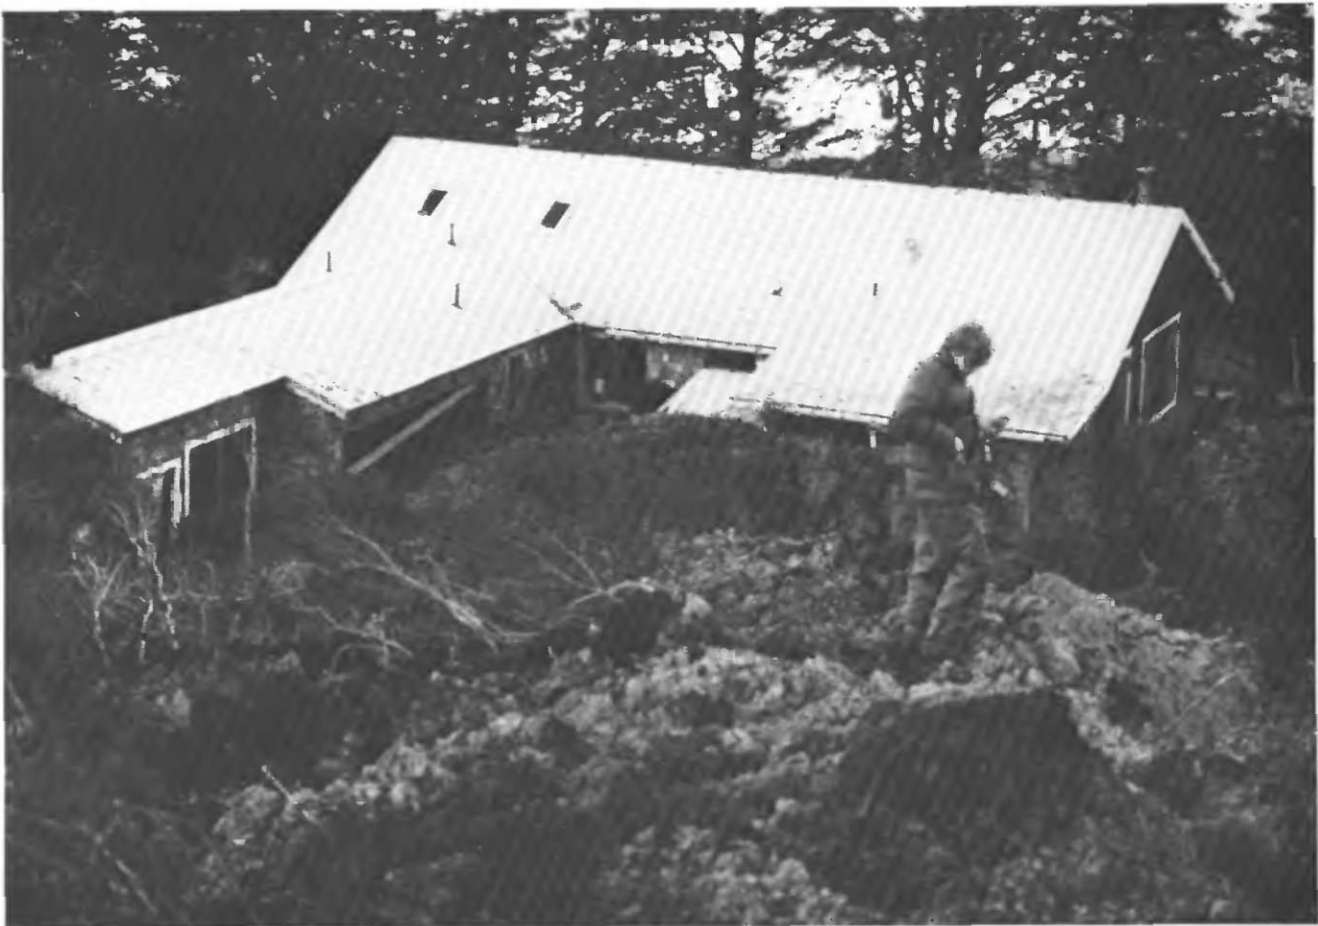
FIGURE 8.5.—Debris flow against house at the Elkus 4-H Ranch, San Mateo County. Near the house, occupants observed the debris flow moving about 1 m/min.
