# Landslides, Floods, and Marine Effects of the Storm of January 3-5, 1982, in the San Francisco Bay Region, California

U.S. GEOLOGICAL SURVEY PROFESSIONAL PAPER 1434

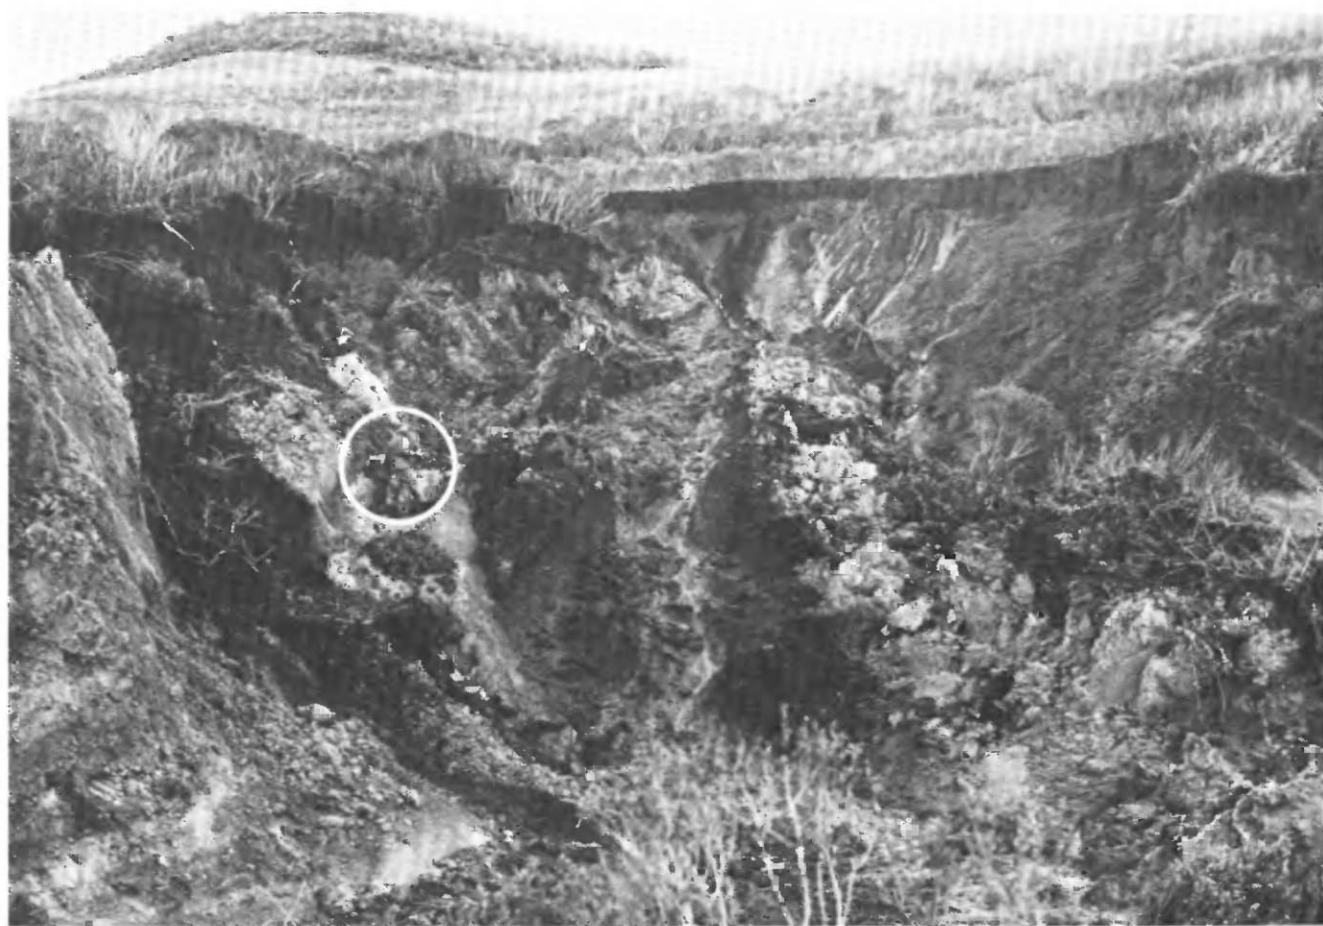
FIGURE 8.6.—Slump at source of debris flow at Elkus 4-H Ranch several days after failure. Abundant subsurface water was issuing from this scarp. Note man (circled) in left center for scale.

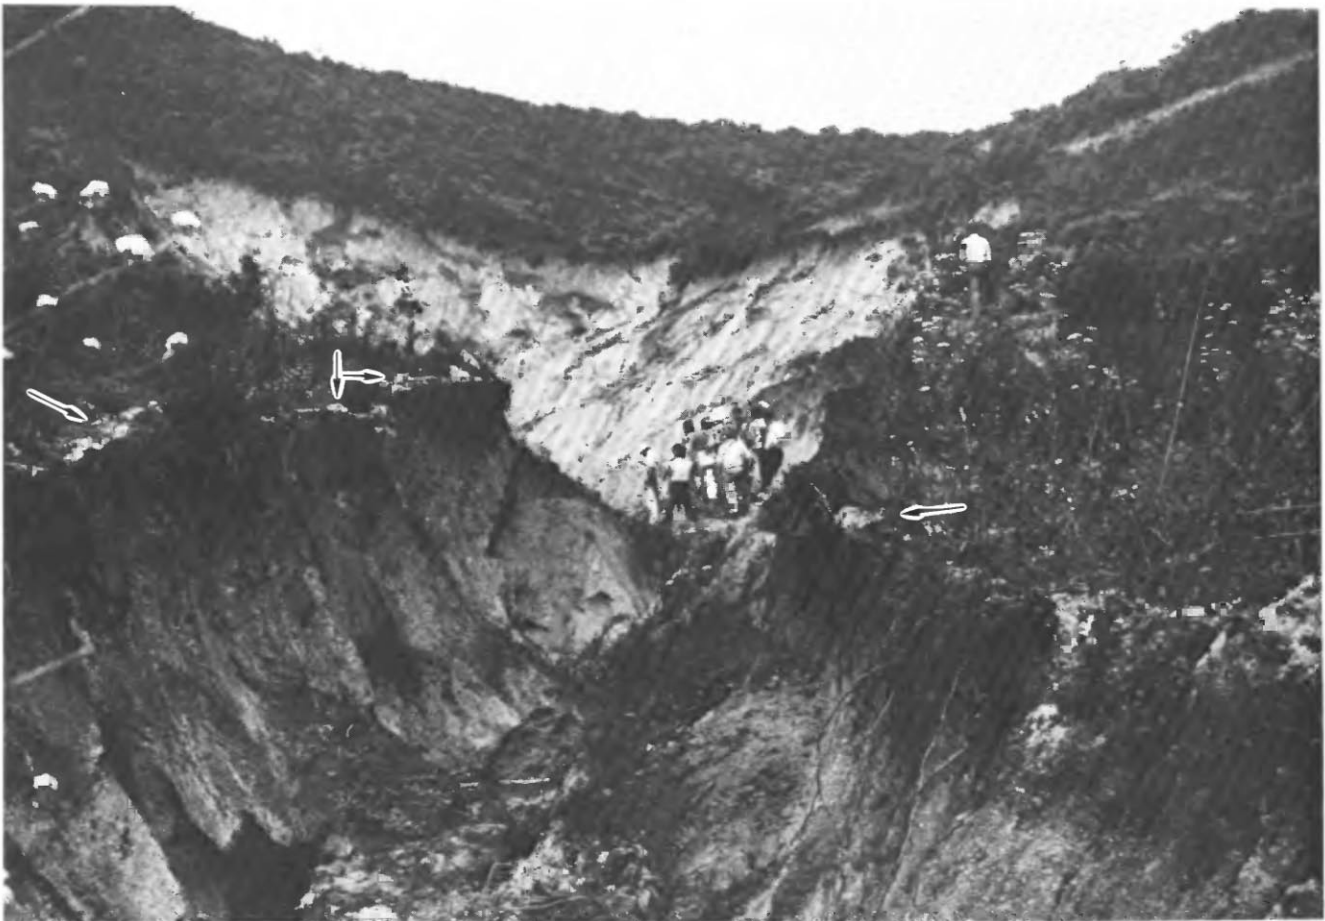
FIGURE 8.7.—Source area and beginning of track of debris flow near Grant Road, Moss Beach, San Mateo County. Light-colored sandy debris (arrows) above walls of gully incised into debris-flow track indicates original level of flow.

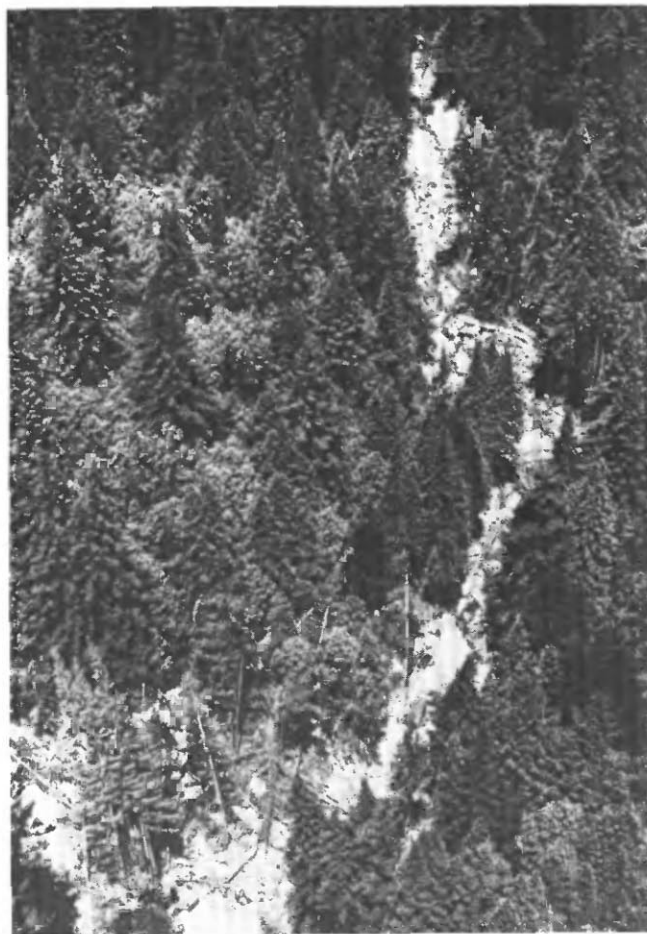
FIGURE 8.9.—Debris-flow track lined with fallen trees, boulders, and sediment in channel along upper part of Fall Creek, San Mateo County. Slump with rotated trees is visible in lower left. Standing trees along the track are about 15 m high. Photograph by Jeffrey Peters.

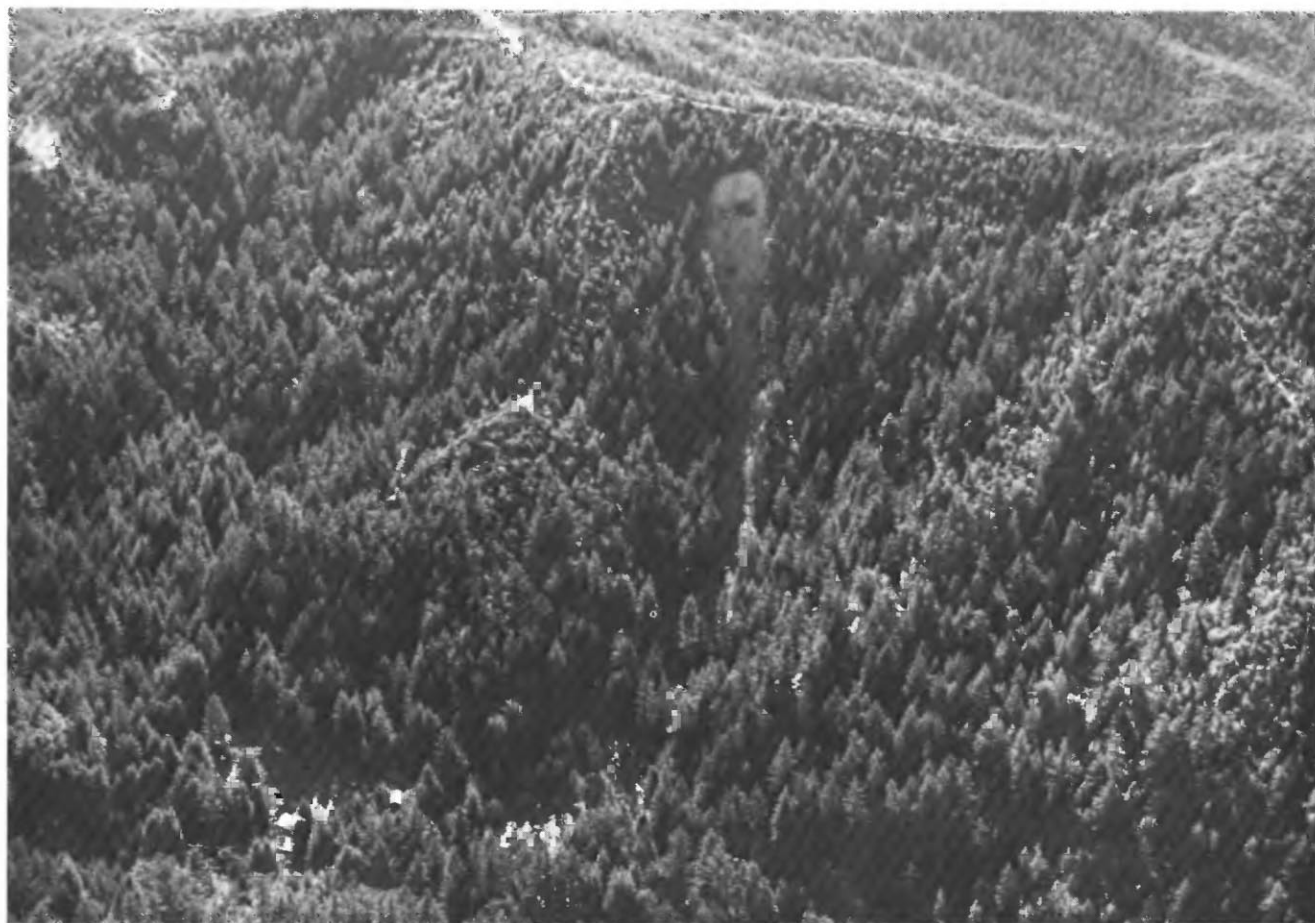
FIGURE 8.11.—Slump/debris flow from north flank of Chalk Mountain toward Whitehouse Creek. This was one of the largest debris flows in the storm; it traveled nearly 0.7 km. Cabins at lower left show scale.

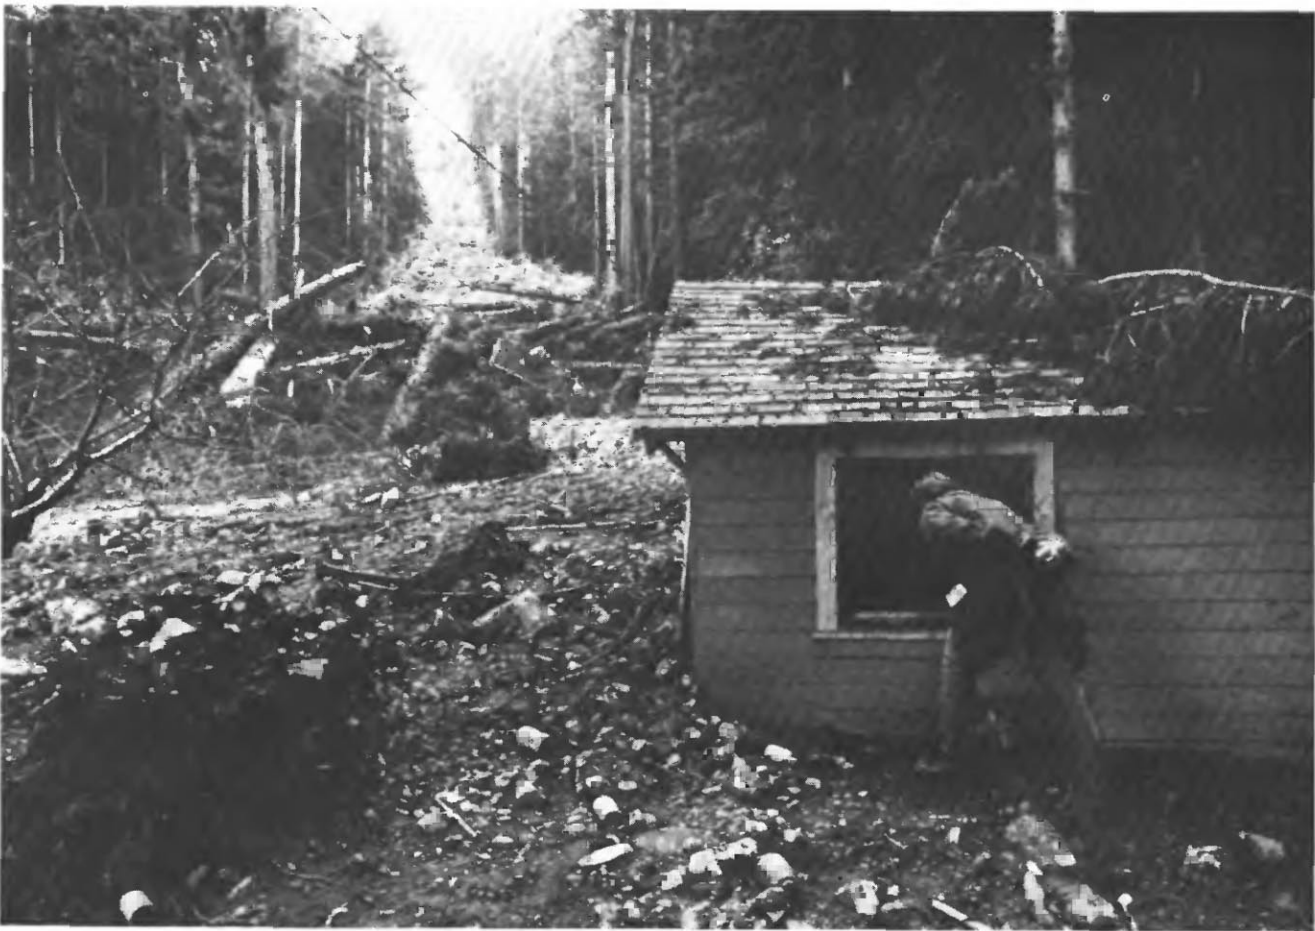
FIGURE 8.12.—Cabin inundated by debris flow near Whitehouse Creek (fig. 8.11) to a depth of 1.2 to 2.4 m (see fig. 8.10 for location). Note track of debris flow and blockage by fallen timber in background.

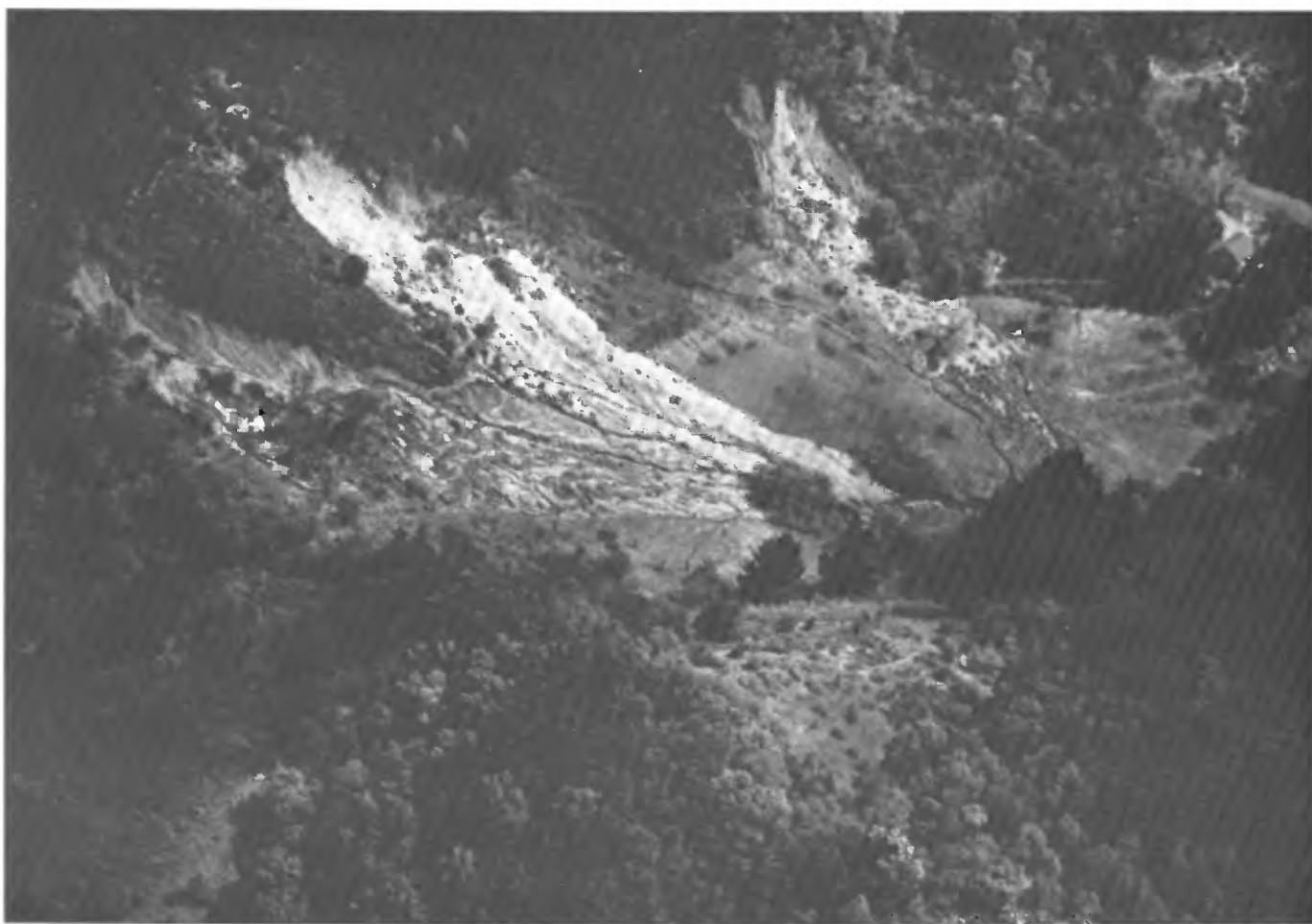
FIGURE 8.14.—Slides at Canham Road that generated debris flows which coalesced into a single debris-flow track in a narrow canyon (out of view) and eventually flowed into Carbonera Creek, Santa Cruz County. Houses at far right show scale.

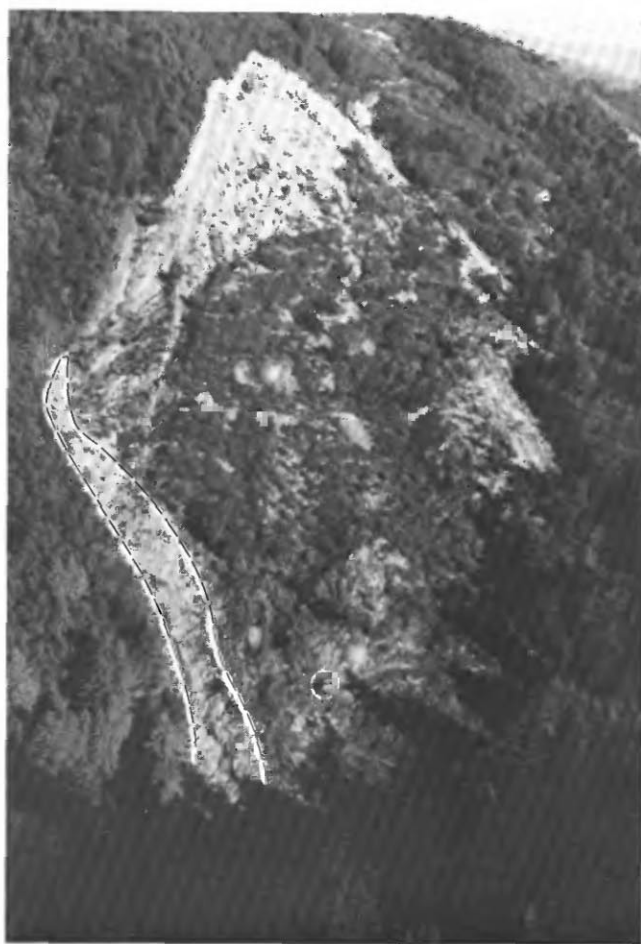
FIGURE 8.19.—Block slide at Love Creek near Ben Lomond, Santa Cruz County, which failed at approximately 1 a.m. P.s.t. on January 5, 1982, killing 10 people and burying 9 homes. This was the largest landslide in the storm, with an estimated volume of 460,000 m<sup>3</sup>. Slide extends about 610 m from crown to toe (in shadows at bottom). The slide triggered several debris flows, the largest of which (indicated by dashed lines on left) flowed rapidly down the margin of the main landslide mass and into the channel of Love Creek (Cotton and Cochrane, 1982). Note bulldozer (indicated by circle) in lower center for scale (site 10, pl. 9).

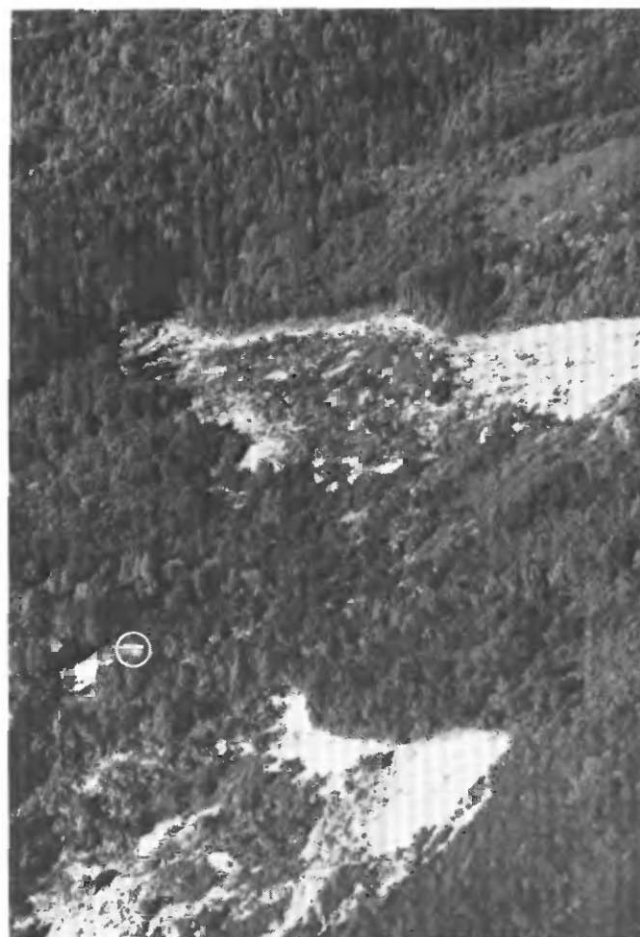
FIGURE 8.20.—Newell Creek block slide (site 11, pl. 9) below and Love Creek block slide above, near Ben Lomond, Santa Cruz County. Movement was toward left. Both slides moved initially along bedding in Monterey Formation on flank of the Scotts Valley syncline (Cotton and Cochrane, 1982). Note house (circled) in left center for scale.

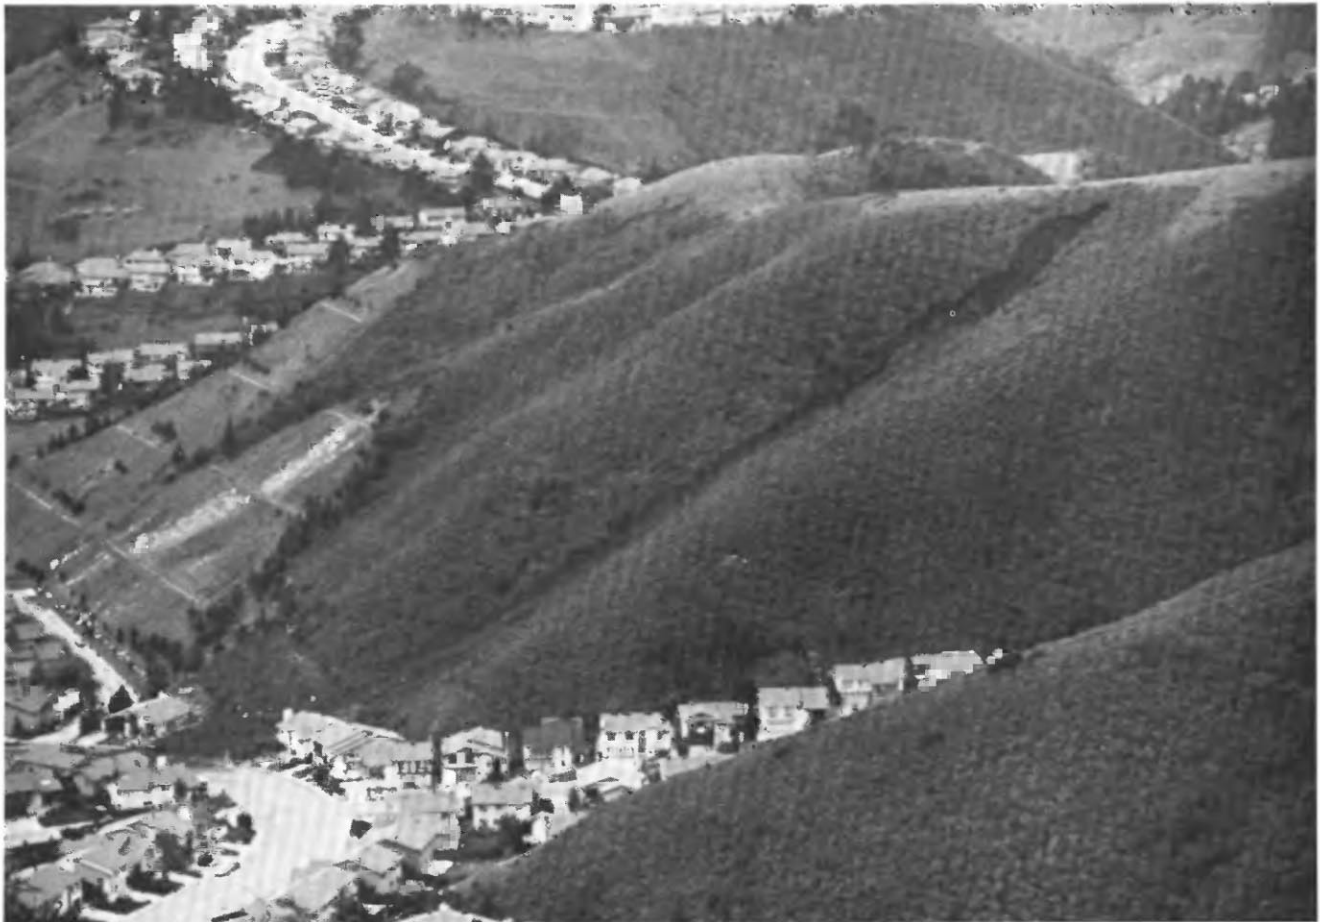
FIGURE 8.21.—Debris flow from brush-covered, concave hillside above Oddstad Boulevard in Pacifica, San Mateo County, where three children were killed and two houses destroyed at about 11:10 p.m. P.s.t. January 4, 1982. Debris and remains of two houses had been removed (lower left) by the time of this photograph (site 4, pl. 8).

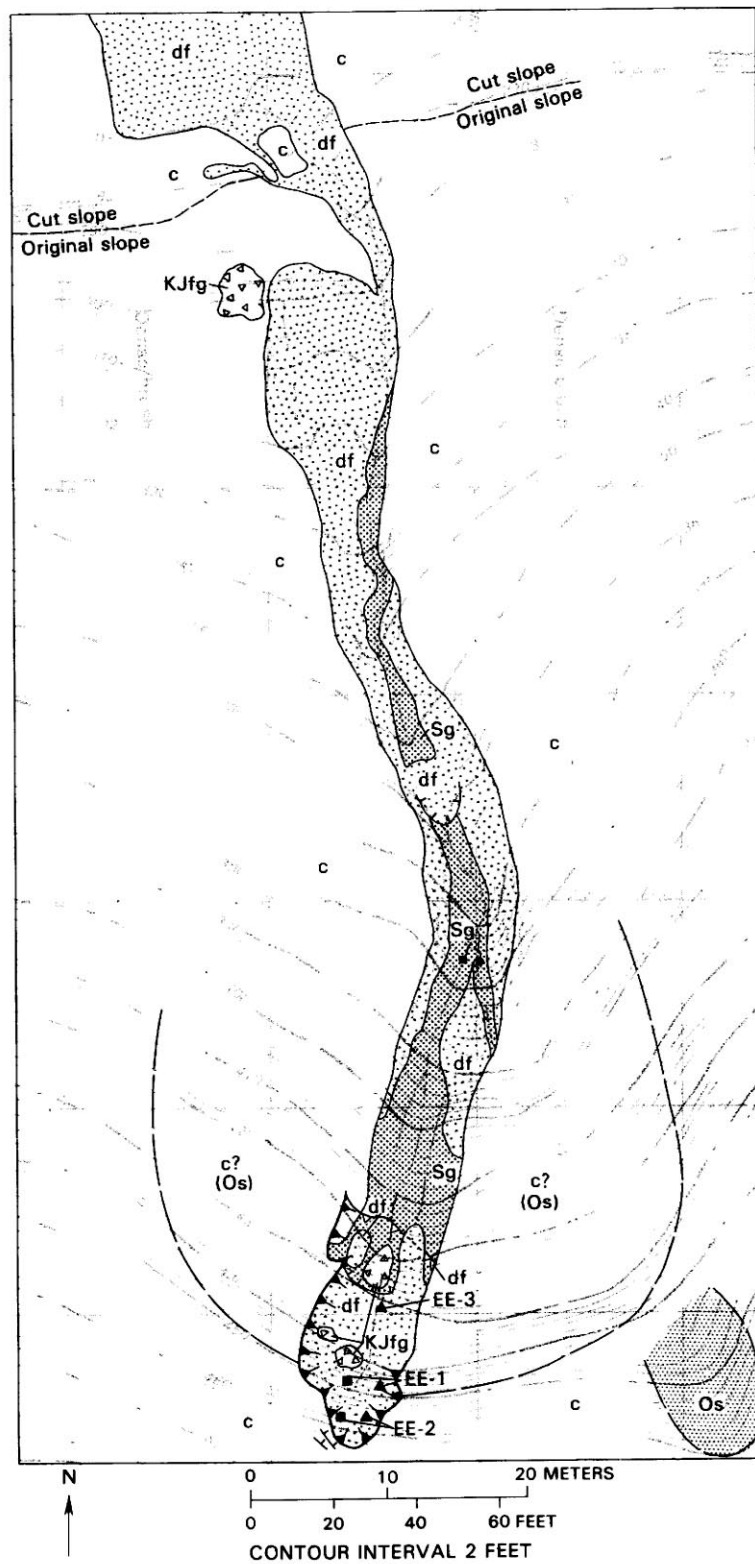
FIGURE 9.5.—Big Bend site, showing landslide in a first-order drainage swale. See figure 9.4 for explanation of symbols. Original topographic base prepared for the city of Pacifica by Hammon-Jensen-Wallen & Associates, Oakland, Calif., 1982.

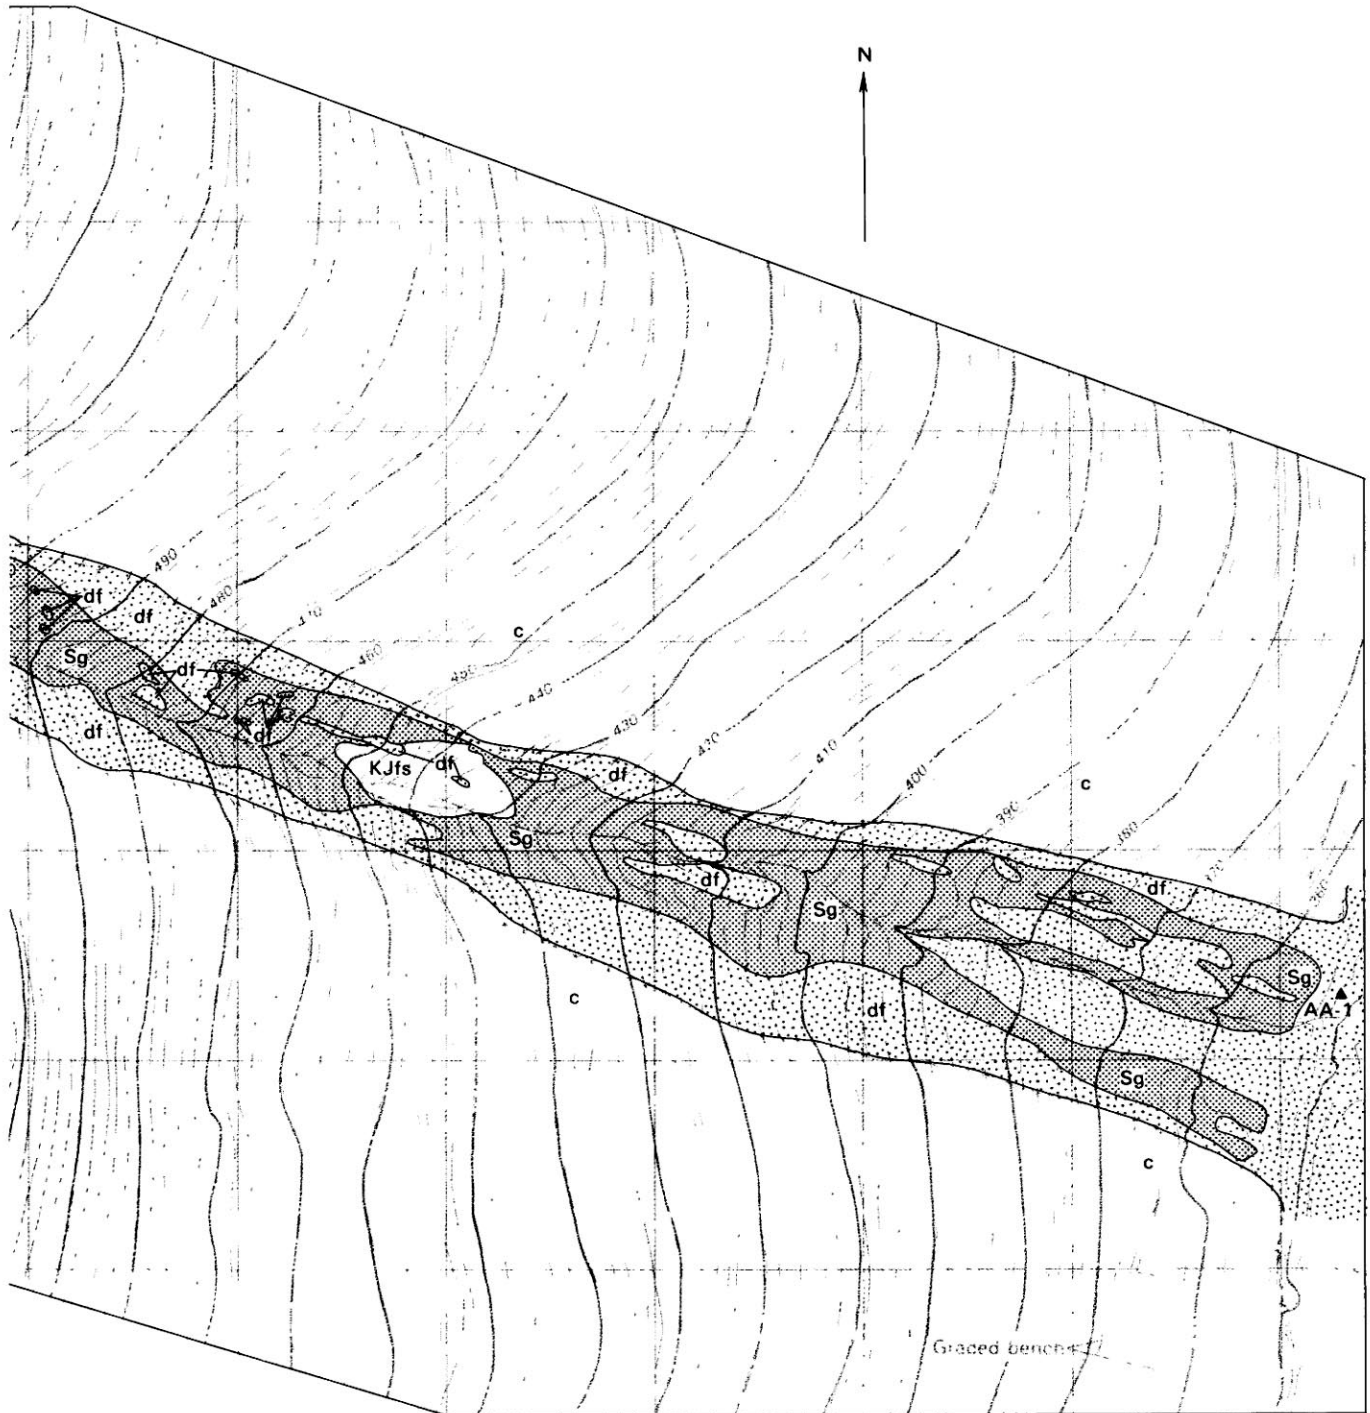
FIGURE 9.6.—Oddstad site, showing landslide on a natural east-facing slope and location of cross section A-A' in figure 9.7. See figure 9.4 for explanation of symbols. Original topographic base prepared for the city of Pacifica by Hammon-Jensen-Wallen & Associates, Oakland, Calif., 1982.

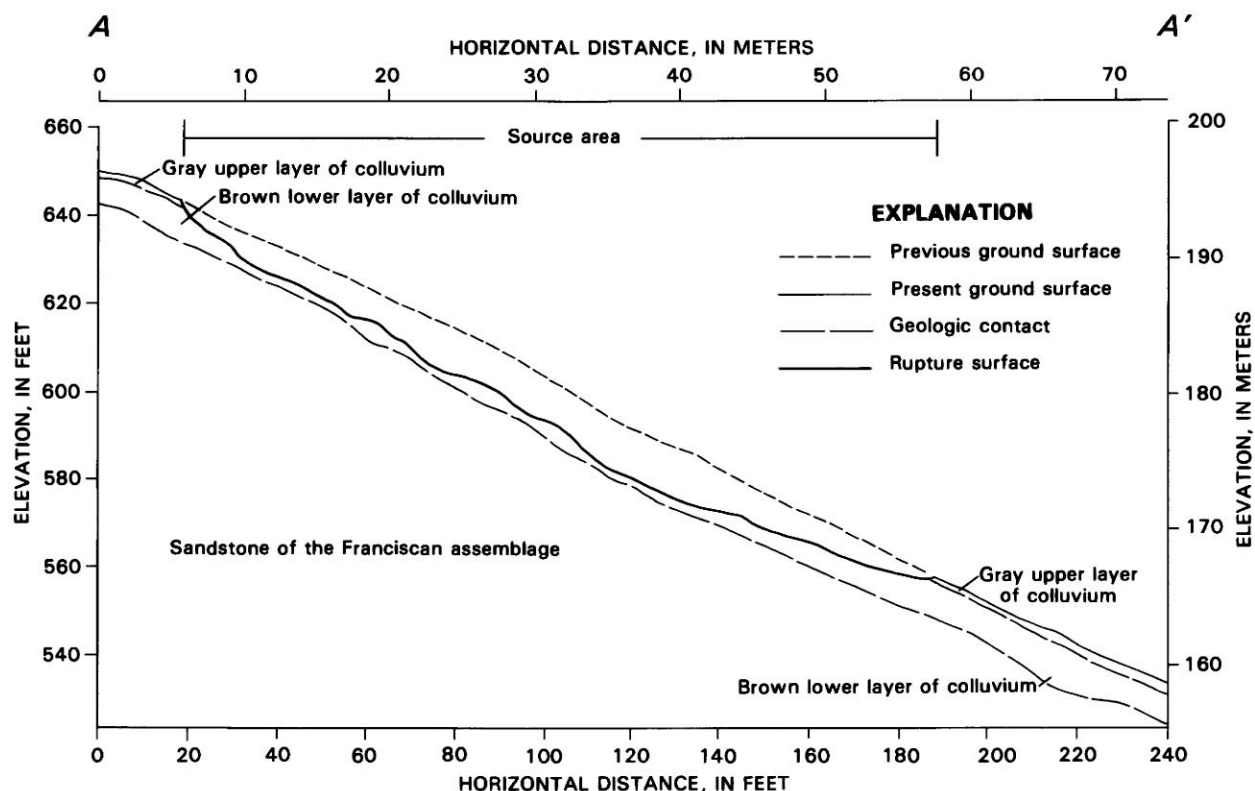
FIGURE 9.7.—Cross section A-A' through source area of debris flow at the Oddstad site. See figure 9.6 for location of cross section.

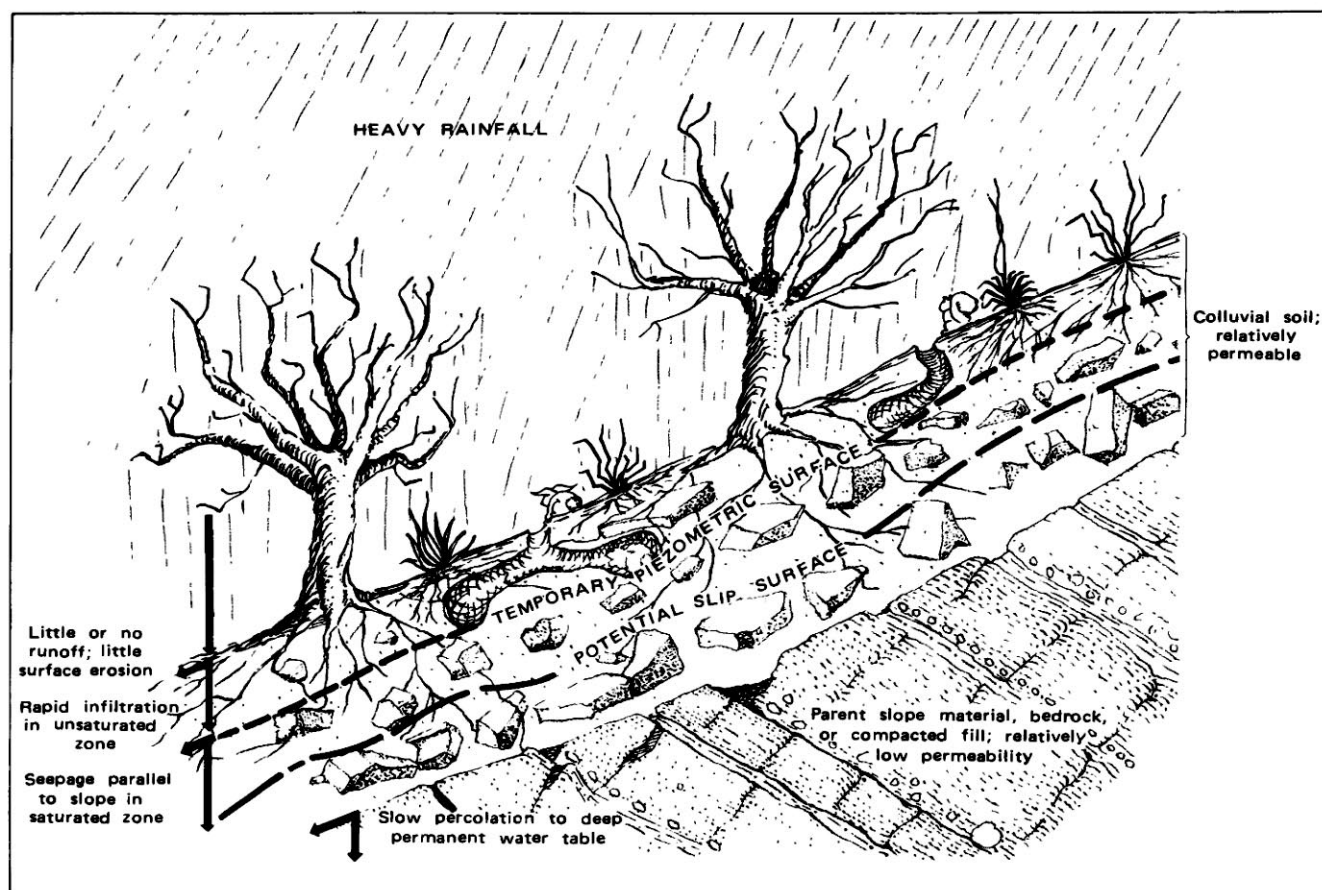
FIGURE 9.11.—Buildup of a perched water table in soil cover during heavy rainfall (from Campbell, 1975, fig. 16).

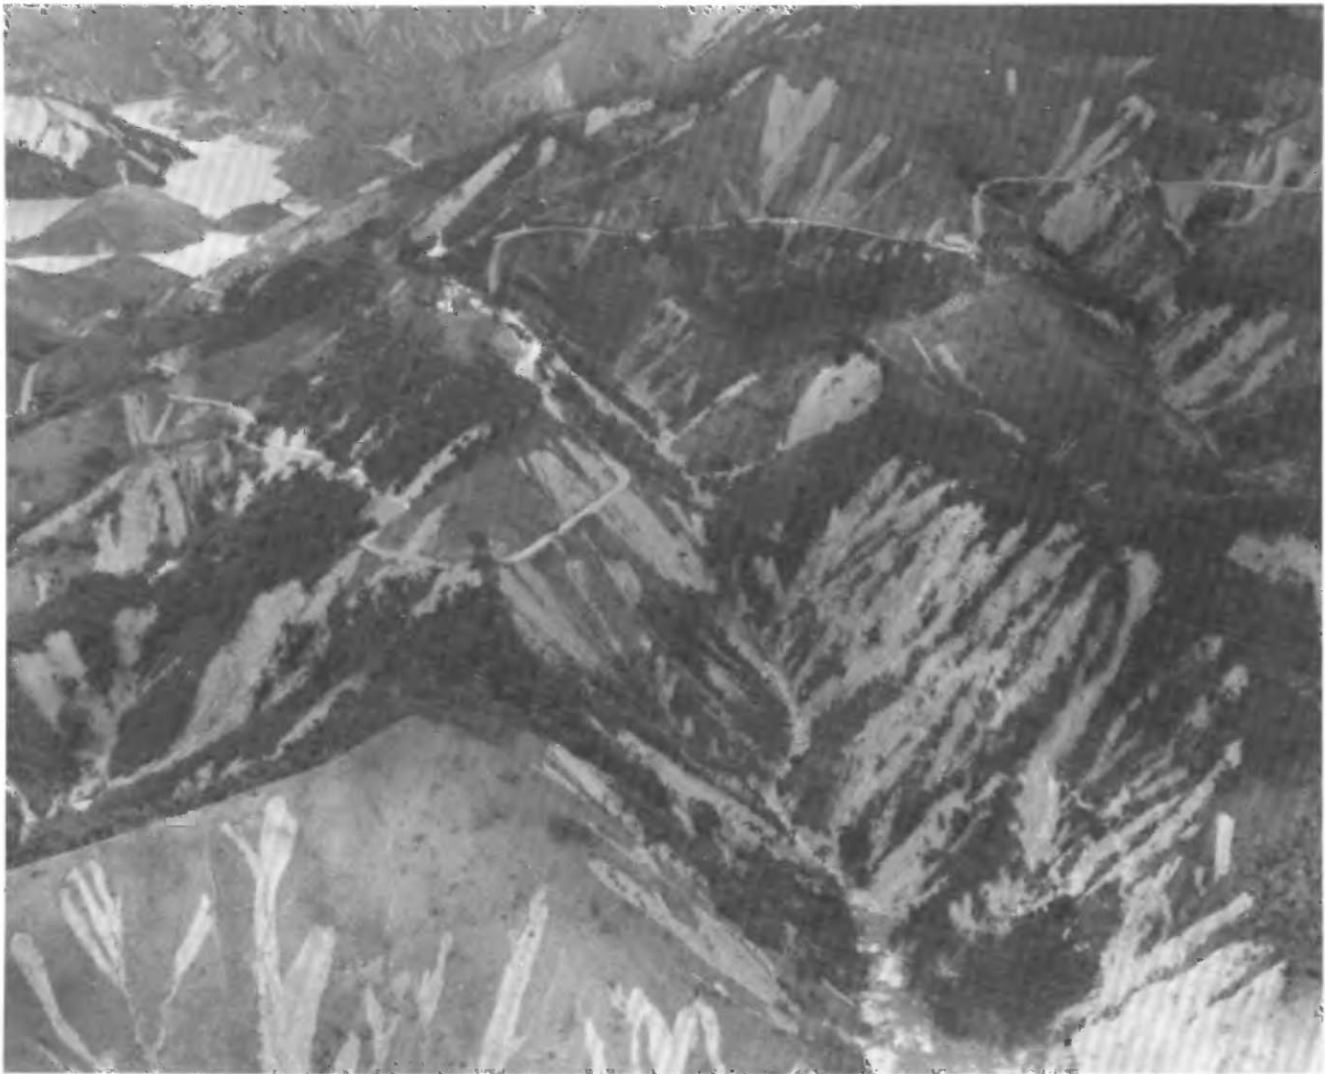
FIGURE 10.3.—Landslides in area of upper part of old road across the Serra das Araras escarpment, Brazil (from Jones, 1973, fig. 20). Analysis of such photographs of areas affected by larger, catastrophic storms suggests that ridgetops and spurs are less susceptible to debris-flow failure than are swales and sideslopes.

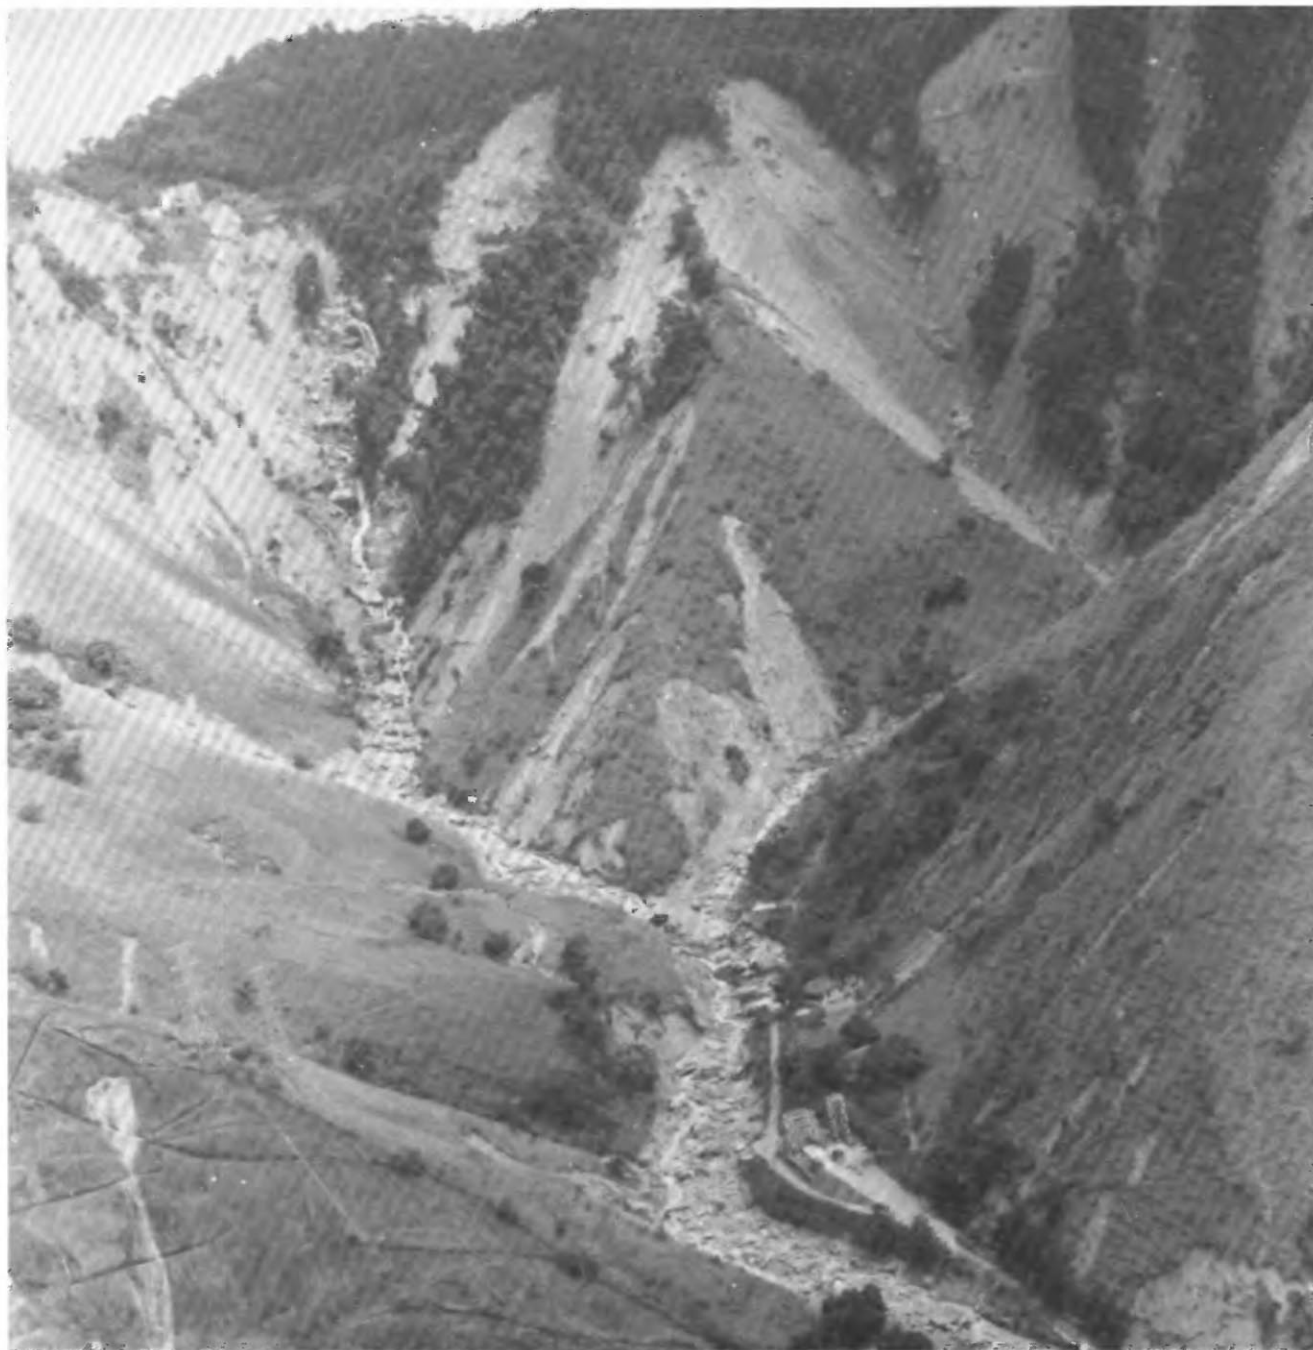
FIGURE 10.4.—Debris flow in Fazenda Creek valley, Brazil (from Jones, 1973, fig. 23). Although ridgetops remain intact most of the time, these “stable” areas may be extremely narrow and occasionally fail.

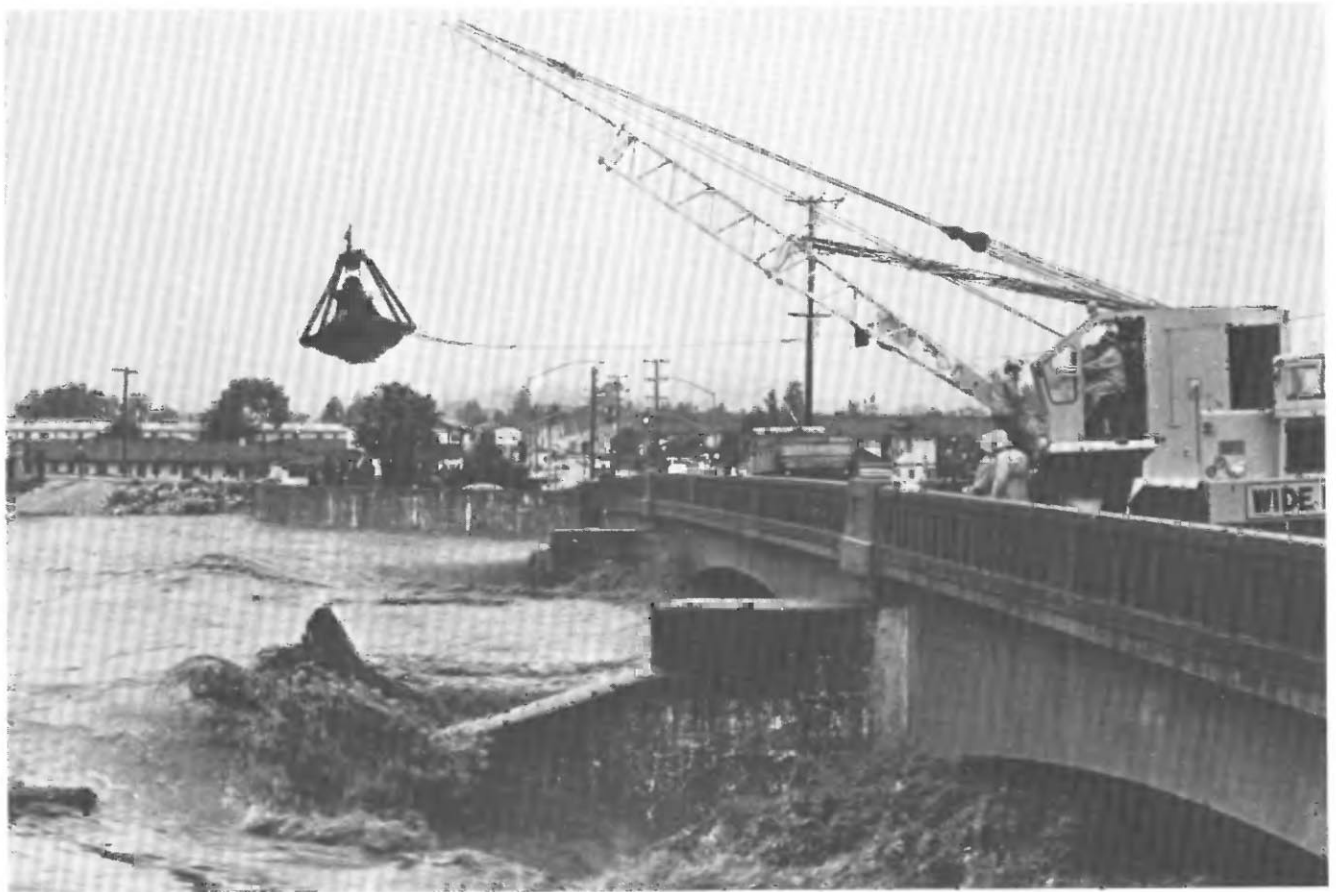
FIGURE 12.2.—Crane working on the Riverside Avenue Bridge on the afternoon of January 4, 1982, removing logs and other debris from the San Lorenzo River in the city of Santa Cruz to prevent logjams from forming. See figure 12.5 for location. Photograph by Pete Amos and Bill Lovejoy, Santa Cruz, Calif., *Sentinel*.

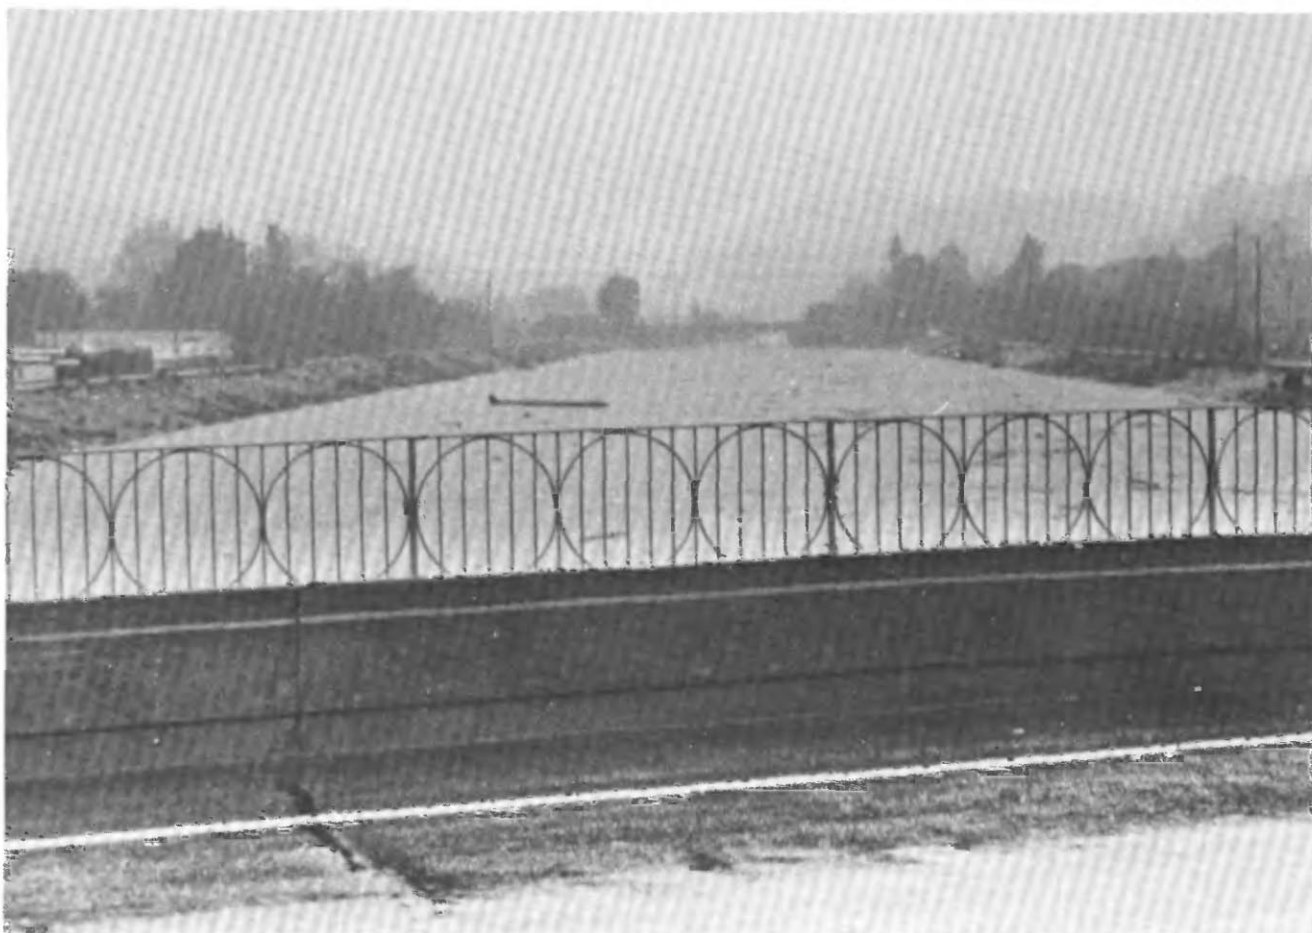
FIGURE 12.4.—San Lorenzo River from the Water Street Bridge in the city of Santa Cruz at 1:00 p.m. P.s.t. January 4, 1982. River came within about 1.7 m of topping the levees here.

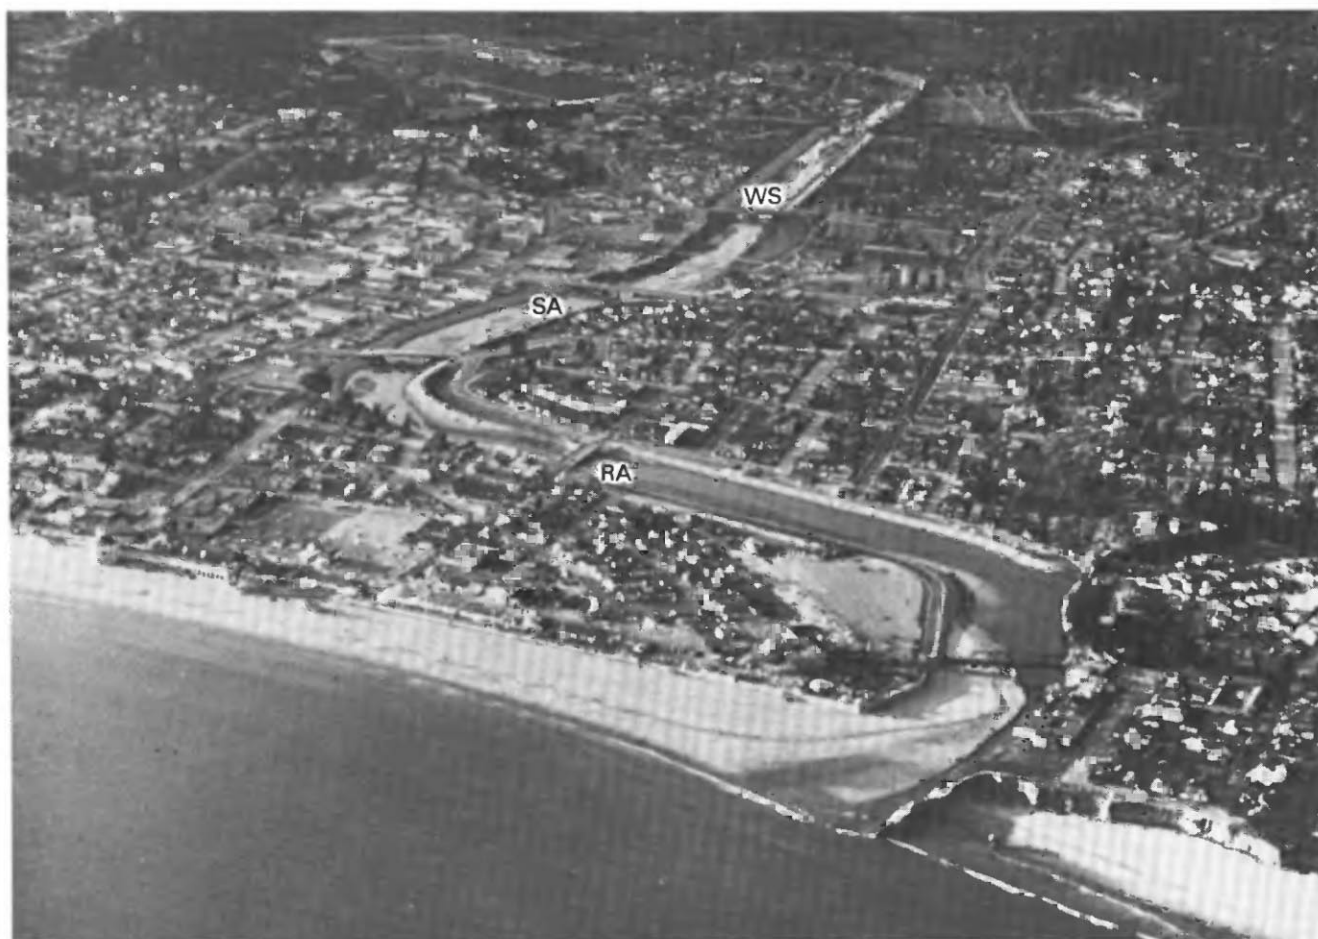
FIGURE 12.5.—San Lorenzo River in the city of Santa Cruz, showing flood-control channel and bridge crossings. RA, Riverside Avenue Bridge; SA, Soquel Avenue Bridge; WS, Water Street Bridge.
