# Landslides, Floods, and Marine Effects of the Storm of January 3-5, 1982, in the San Francisco Bay Region, California

U.S. GEOLOGICAL SURVEY PROFESSIONAL PAPER 1434

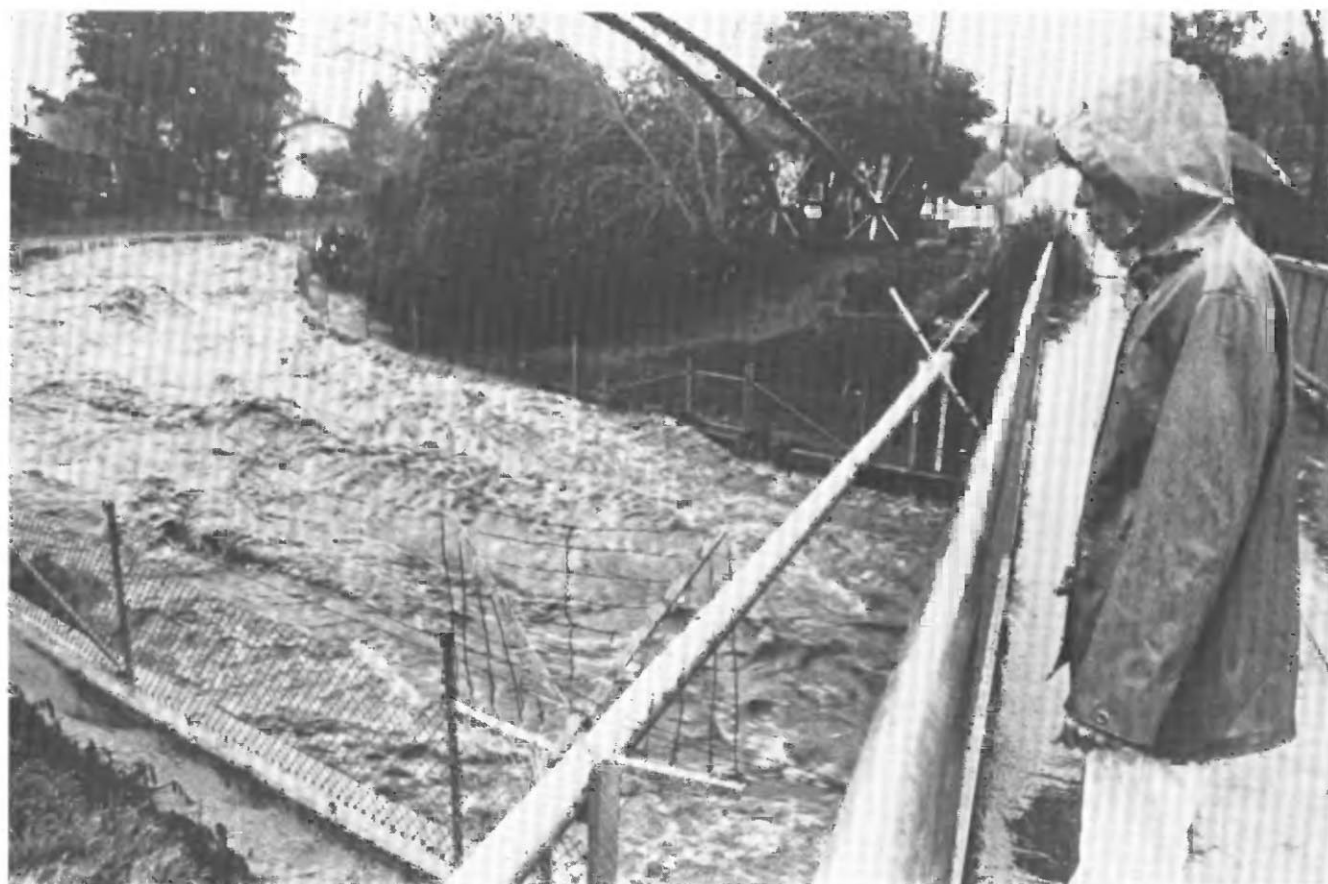
FIGURE 12.6.—Branciforte Creek flood-control channel at peak capacity on the afternoon of January 4, 1982. Photograph by Pete Amos and Bill Lovejoy, Santa Cruz, Calif., *Sentinel*.

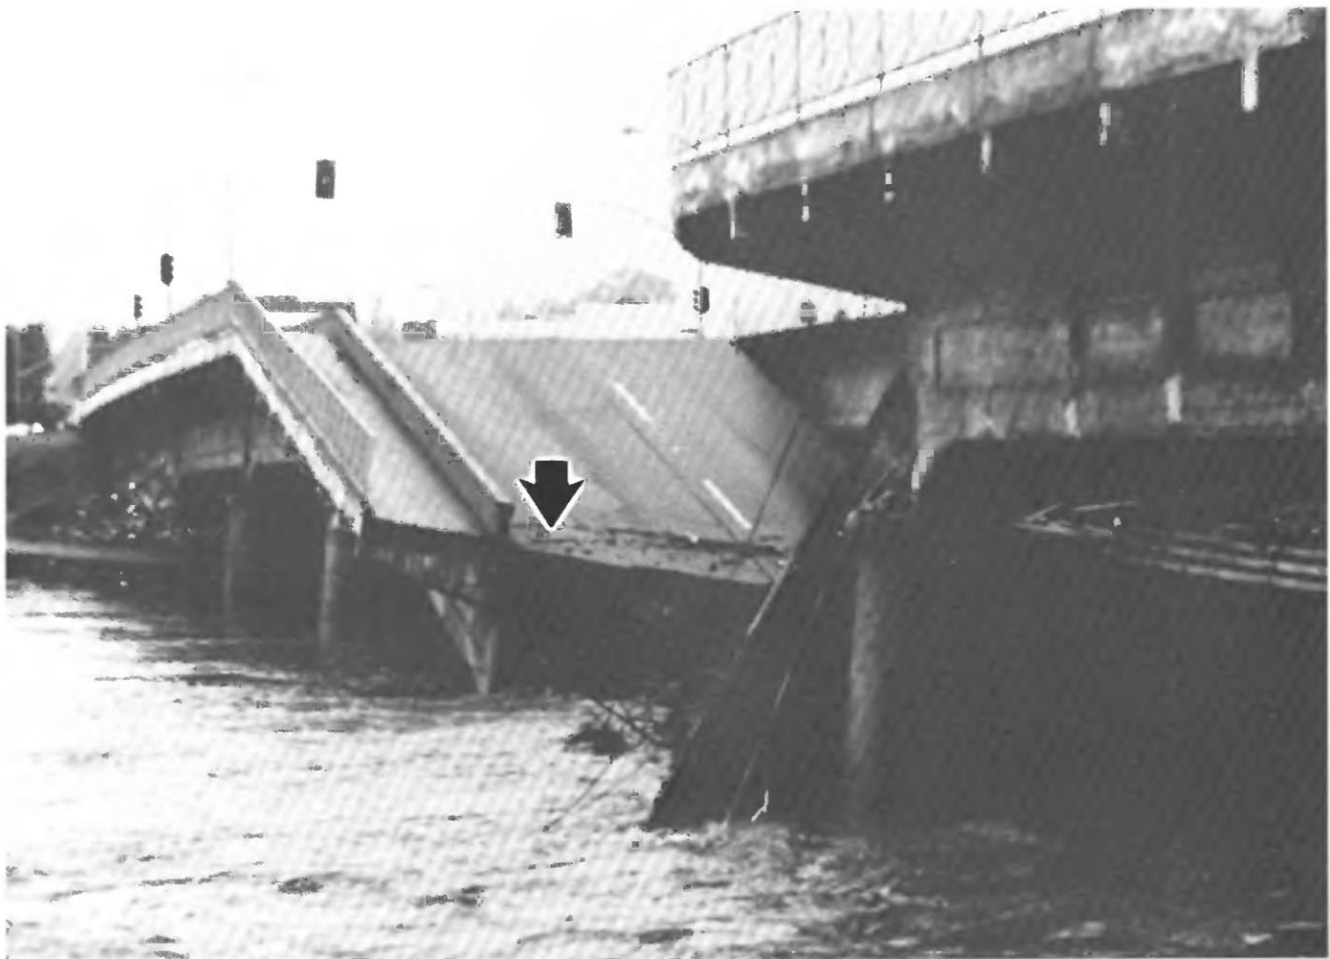
FIGURE 12.7.—Soquel Avenue Bridge in the city of Santa Cruz, showing collapsed span. Scour at confluence of the San Lorenzo River and Branciforte Creek led to subsidence of an older bridge pier. Arrow denotes high-water line.

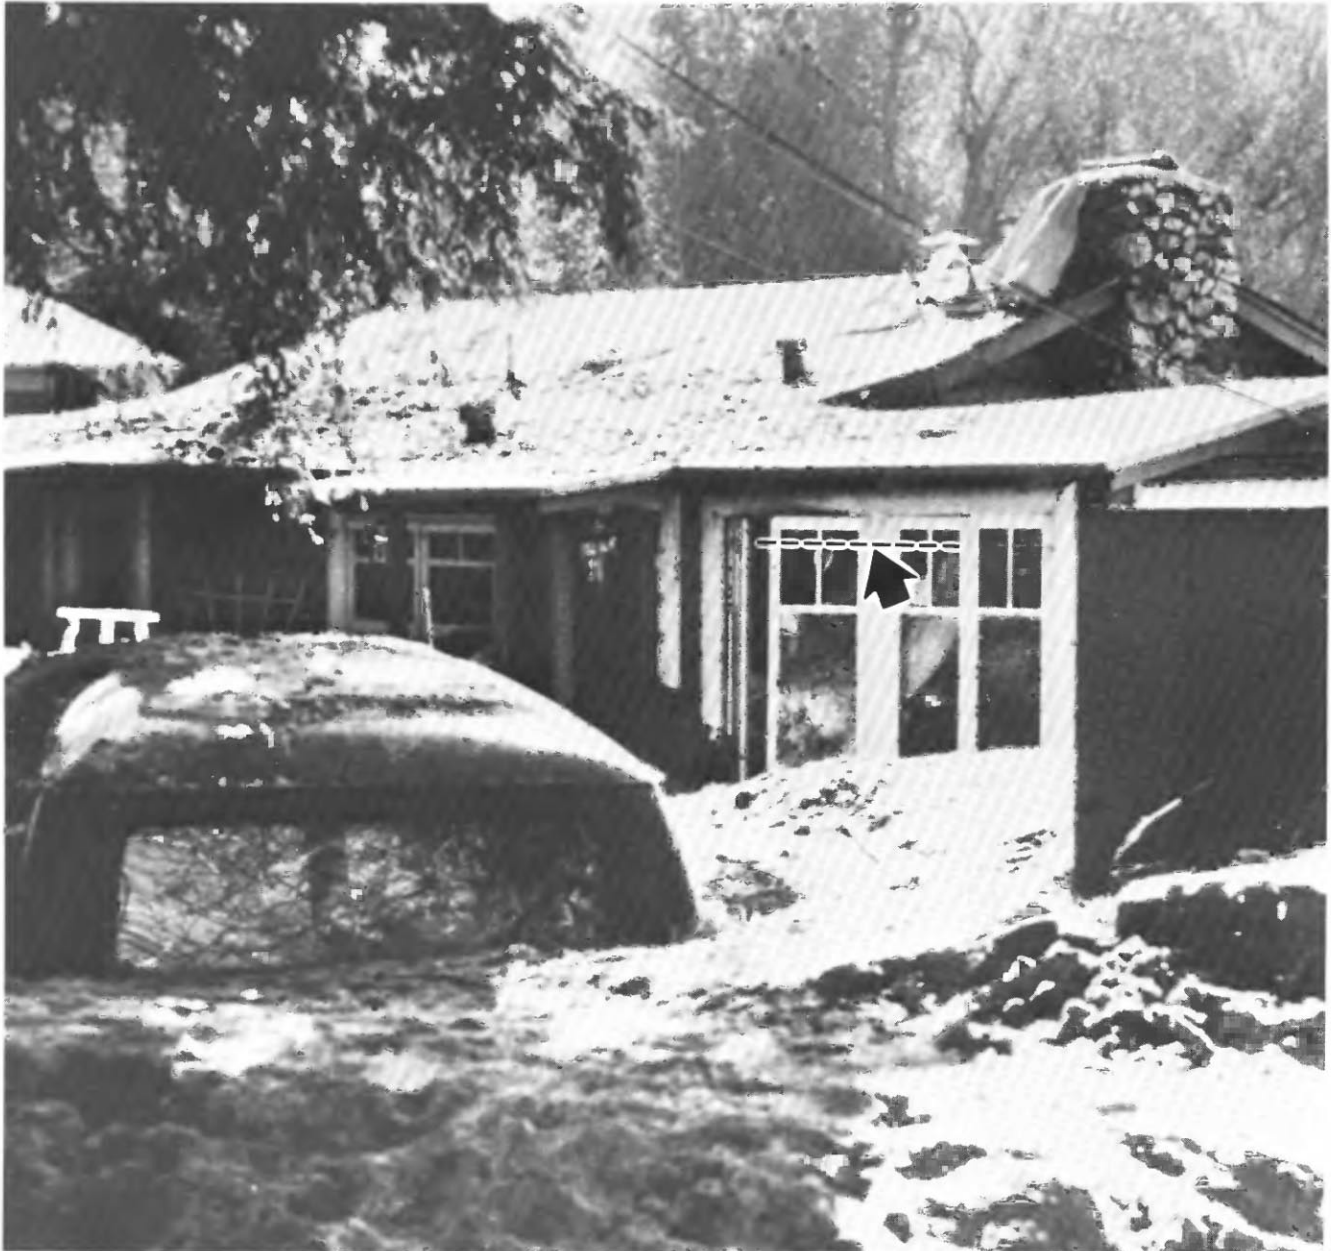
FIGURE 12.9.—Flood level and sand deposits along the San Lorenzo River in Felton Grove. High-water mark (arrow) is about 1 m above sediment fill. This particular area was flooded four times during the period 1970–82.

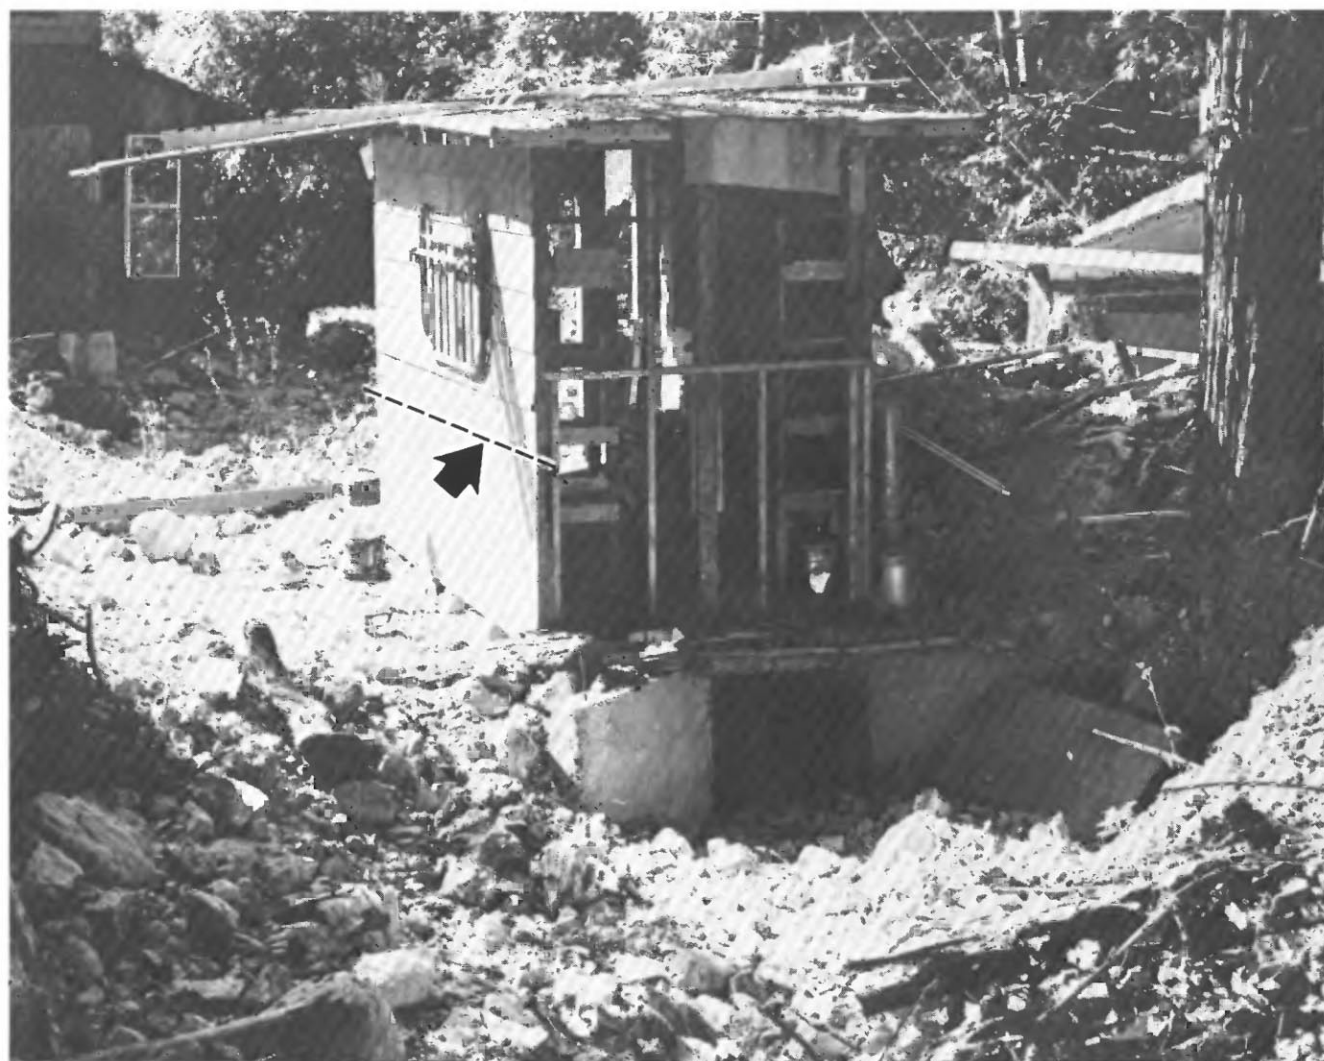
FIGURE 12.10.—Culvert overflow in Lockhart Gulch. This box culvert was totally inadequate to handle the runoff from this small ephemeral stream. At peak discharge, flow was approximately 15 m wide and more than 2 m deep. Arrow denotes high-water mark.

Flood flows on January 4 reached depths of over 2 m at this site and spanned the entire 15 m of the stream bottom (fig. 12.10). The culvert was simply bypassed as flow from the small tributary swept through one home and filled it with debris.

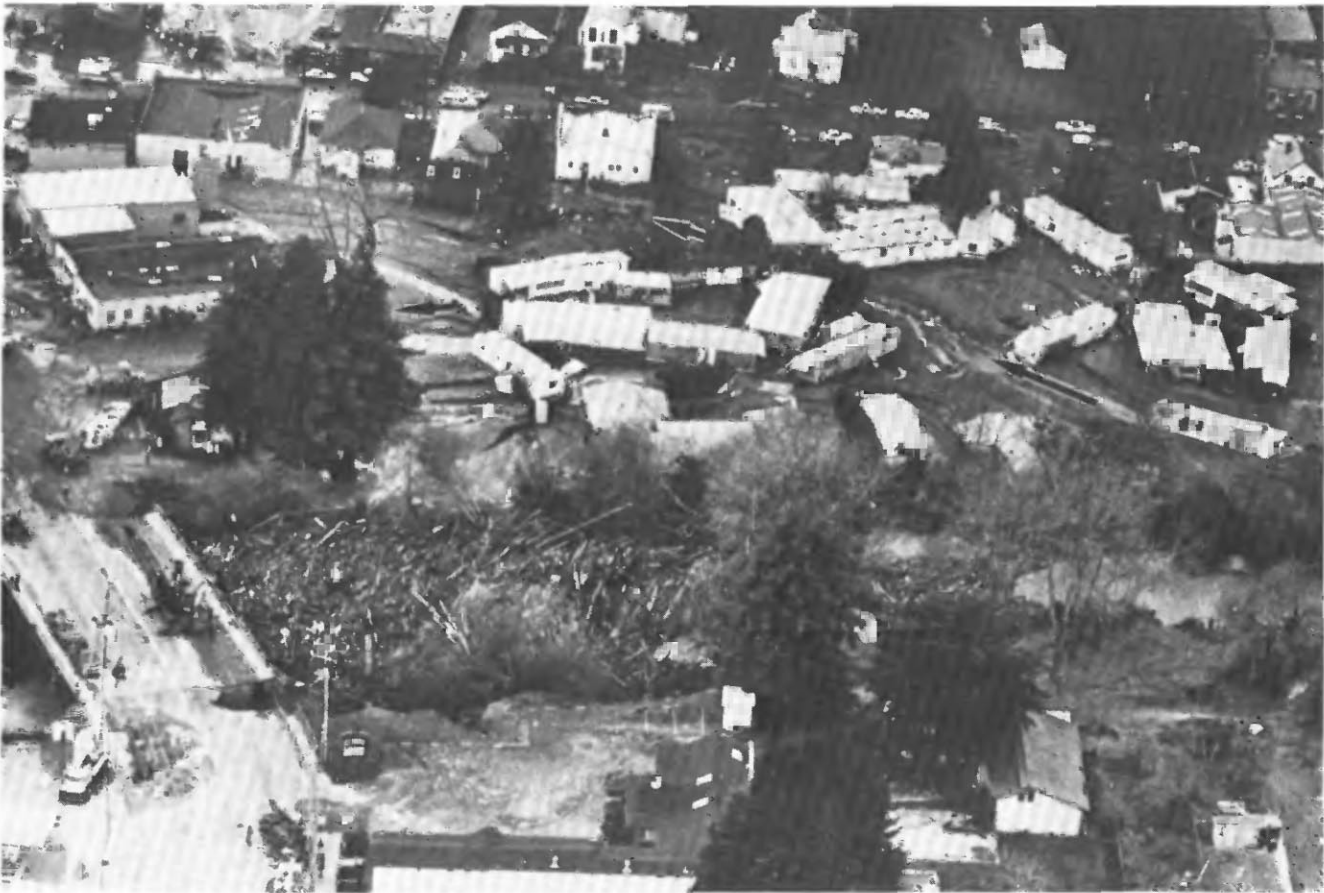
FIGURE 12.11.—Logjam on Soquel Creek and path of diverted floodwaters through the Old Mill Trailer Park (arrows). Photograph by Pete Amos and Bill Lovejoy, Santa Cruz, Calif., *Sentinel*.

By 10:00 p.m. P.s.t. January 4, 1982, the logjam extended the entire width of the creek and about 120 m upstream (fig. 12.11). County fire officials considered using plastic explosives to break up the logjam but, instead, called for a crane from the county. The crane broke down on route and never arrived. Much of the approximately  $275 \text{ m}^3/\text{s}$  of discharge of Soquel Creek was

diverted through the Old Mill Trailer Park and then through the town's main street (figs. 12.11, 12.12). Floodwaters reached depths as great as 1.5 m and left as much as 1.2 m of sand and mud behind. Two mobile-home parks adjacent to the creek received major damage. Trailers were swept off their piers and broken up by logs and other debris (fig. 12.13); only 17 out of the 39 mobile homes damaged were determined to be salvageable. In addition, 58 businesses, 21 homes, the firehouse, post office, library, and Grange Hall were damaged by floodwaters and the debris they left behind (fig. 12.14). The bridge at Soquel Drive sustained an estimated \$270,000 in damage, due principally to scour and roadway collapse at the abutments, but the low structure remained standing and was soon back in use.

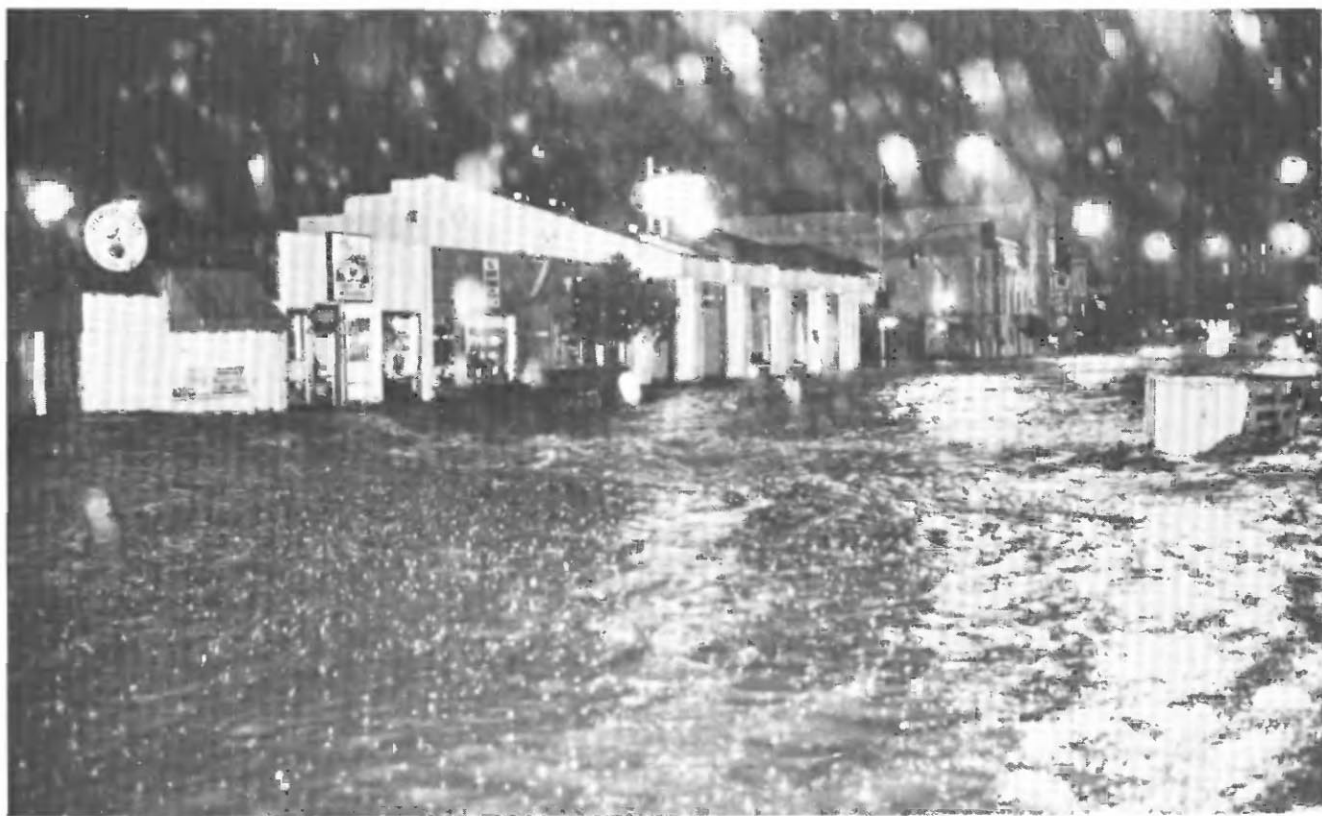
FIGURE 12.12.—Downtown Soquel being inundated by waters of Soquel Creek on the evening of January 4, 1982. Floodwaters rose another meter after this photograph was taken. Photograph by Pete Amos and Bill Lovejoy, Santa Cruz, Calif., *Sentinel*.

about 5:15 p.m., water in the creek had risen high enough that logs and other organic debris were beginning to jam against the underside of the Soquel Drive Bridge, and not until 10:00 p.m. did this logjam divert much of the creek through the downtown area (fig. 12.12).

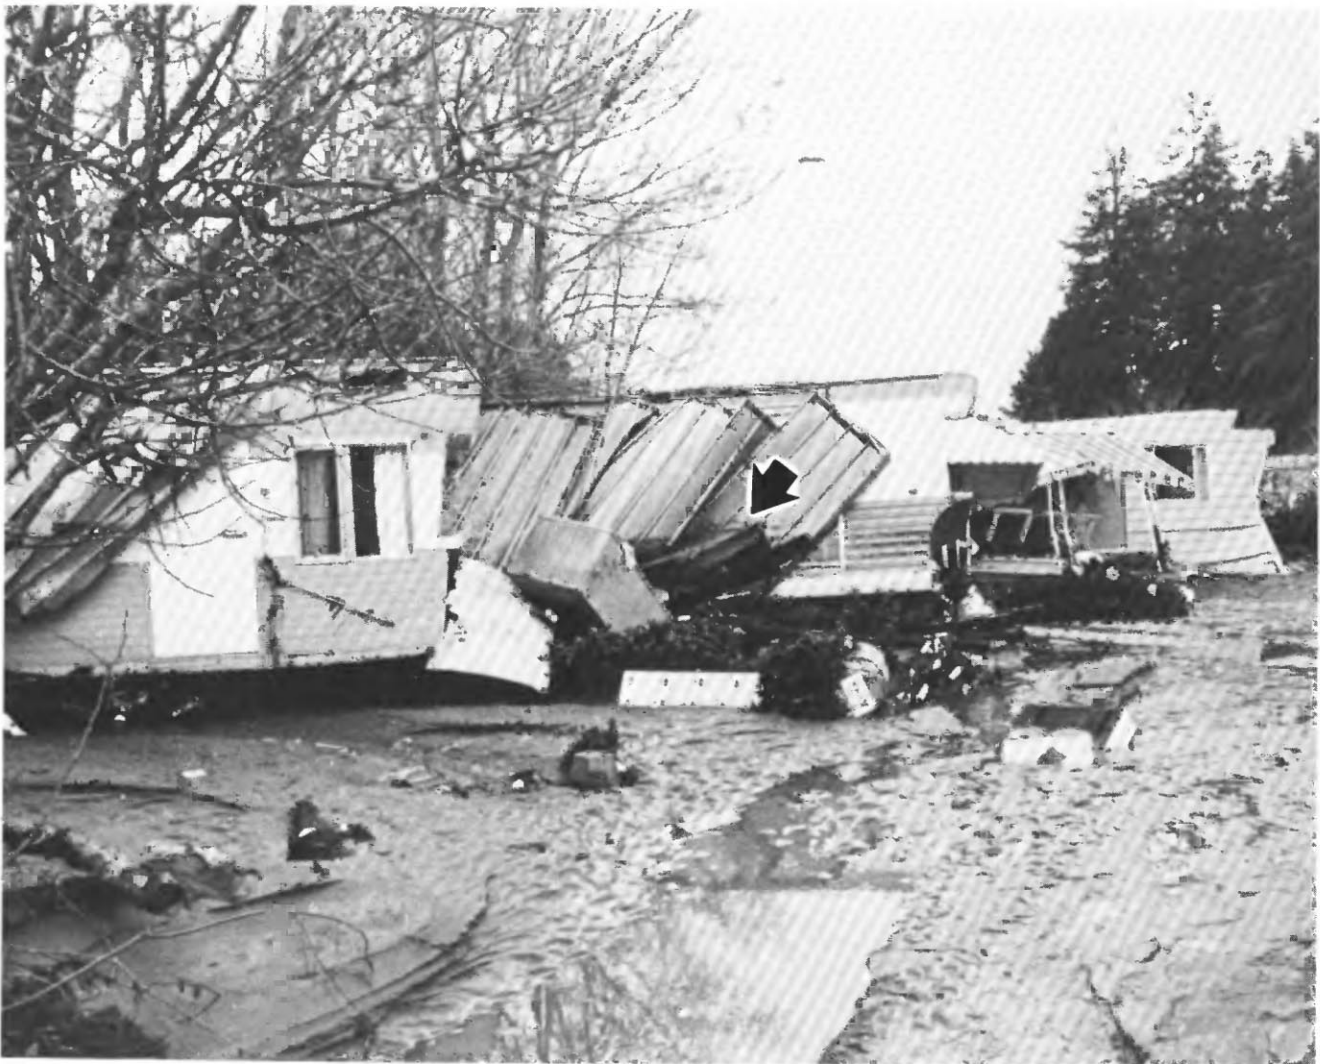
FIGURE 12.13.—Row of damaged mobile homes along Soquel Creek in the Heart of Soquel Trailer Park. Arrow denotes high-water mark.

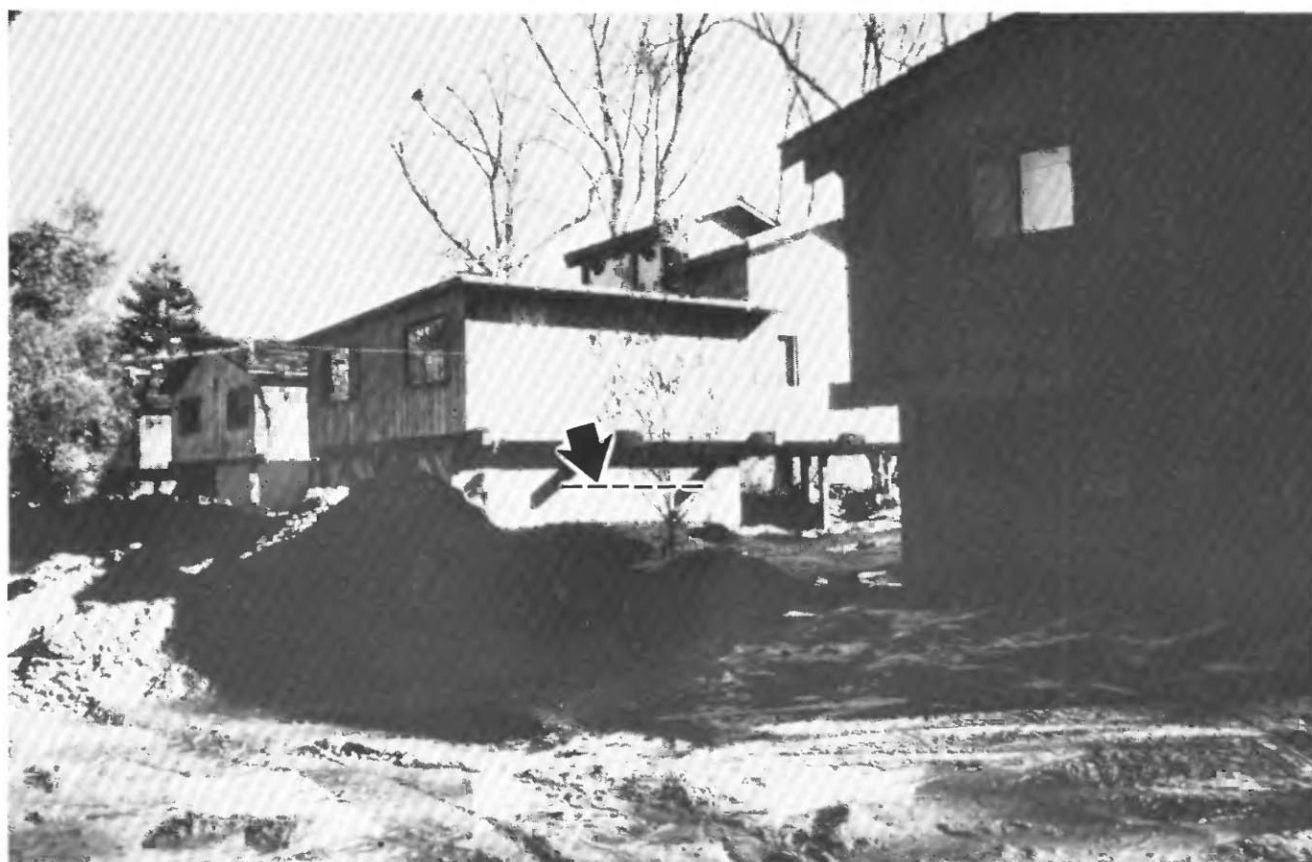
FIGURE 12.16.—Flooding and mud deposition along Soquel Wharf Road. Construction was approved on Soquel Creek flood plain at this site because structures were to be elevated. Arrow denotes high-water mark.

Flooding unrelated to the logjam also occurred 350 m downstream. Homes built within the past 5 years on a flood terrace along Soquel Wharf Road (fig. 12.15), downstream from the Porter Street Bridge, were inundated by more than a meter of water and mud as the creek topped its banks (fig. 12.16). This area had been recognized as flood prone, and specially designed elevated structures had been permitted in recent years. The second-story living structures were not inundated, but the first-floor carports, many of which had been remodeled as solid garages, were damaged by water and mud, as were automobiles.

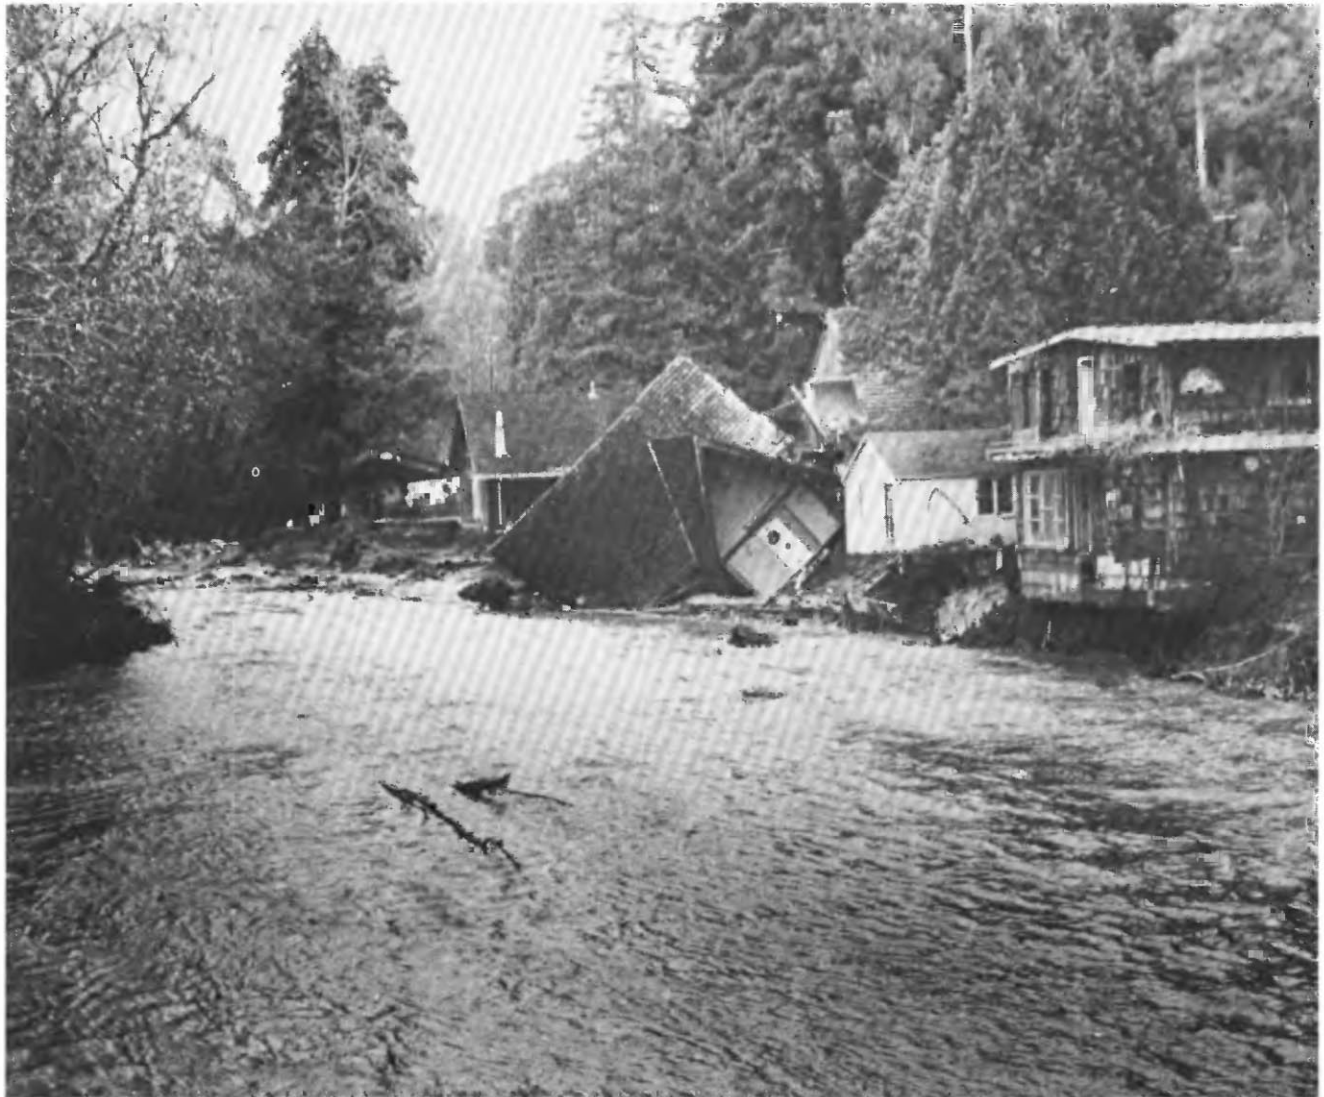
FIGURE 12.18.—View upstream along Aptos Creek from the Spreckels Drive Bridge, showing bank erosion, foundation failure, and house collapse.

Downstream from the California Highway 1 Bridge (fig. 12.17), the 1982 flood inflicted much damage to older homes that had been rebuilt after the 1955 flood and to newer homes that had been built on streamside fill brought in after the 1955 flood. Aerial photographs flown directly after the 1955 flooding show that at that time Aptos Creek meandered in its course between the California Highway 1 Bridge and the Spreckels Drive Bridge, and that two cutbank areas were clear. After those floods, the creek channel was constricted and straightened by fill in these areas, and additional houses were constructed. In January 1982, the two former meanders were again sites of bank cutting. Water levels rose throughout January 4 and began undermining the foundations of the homes along Moosehead and Spreckels Drive at these two sites (figs. 12.17, 12.18). At 7:00 p.m. that evening, foundations started to fail because these houses were built on

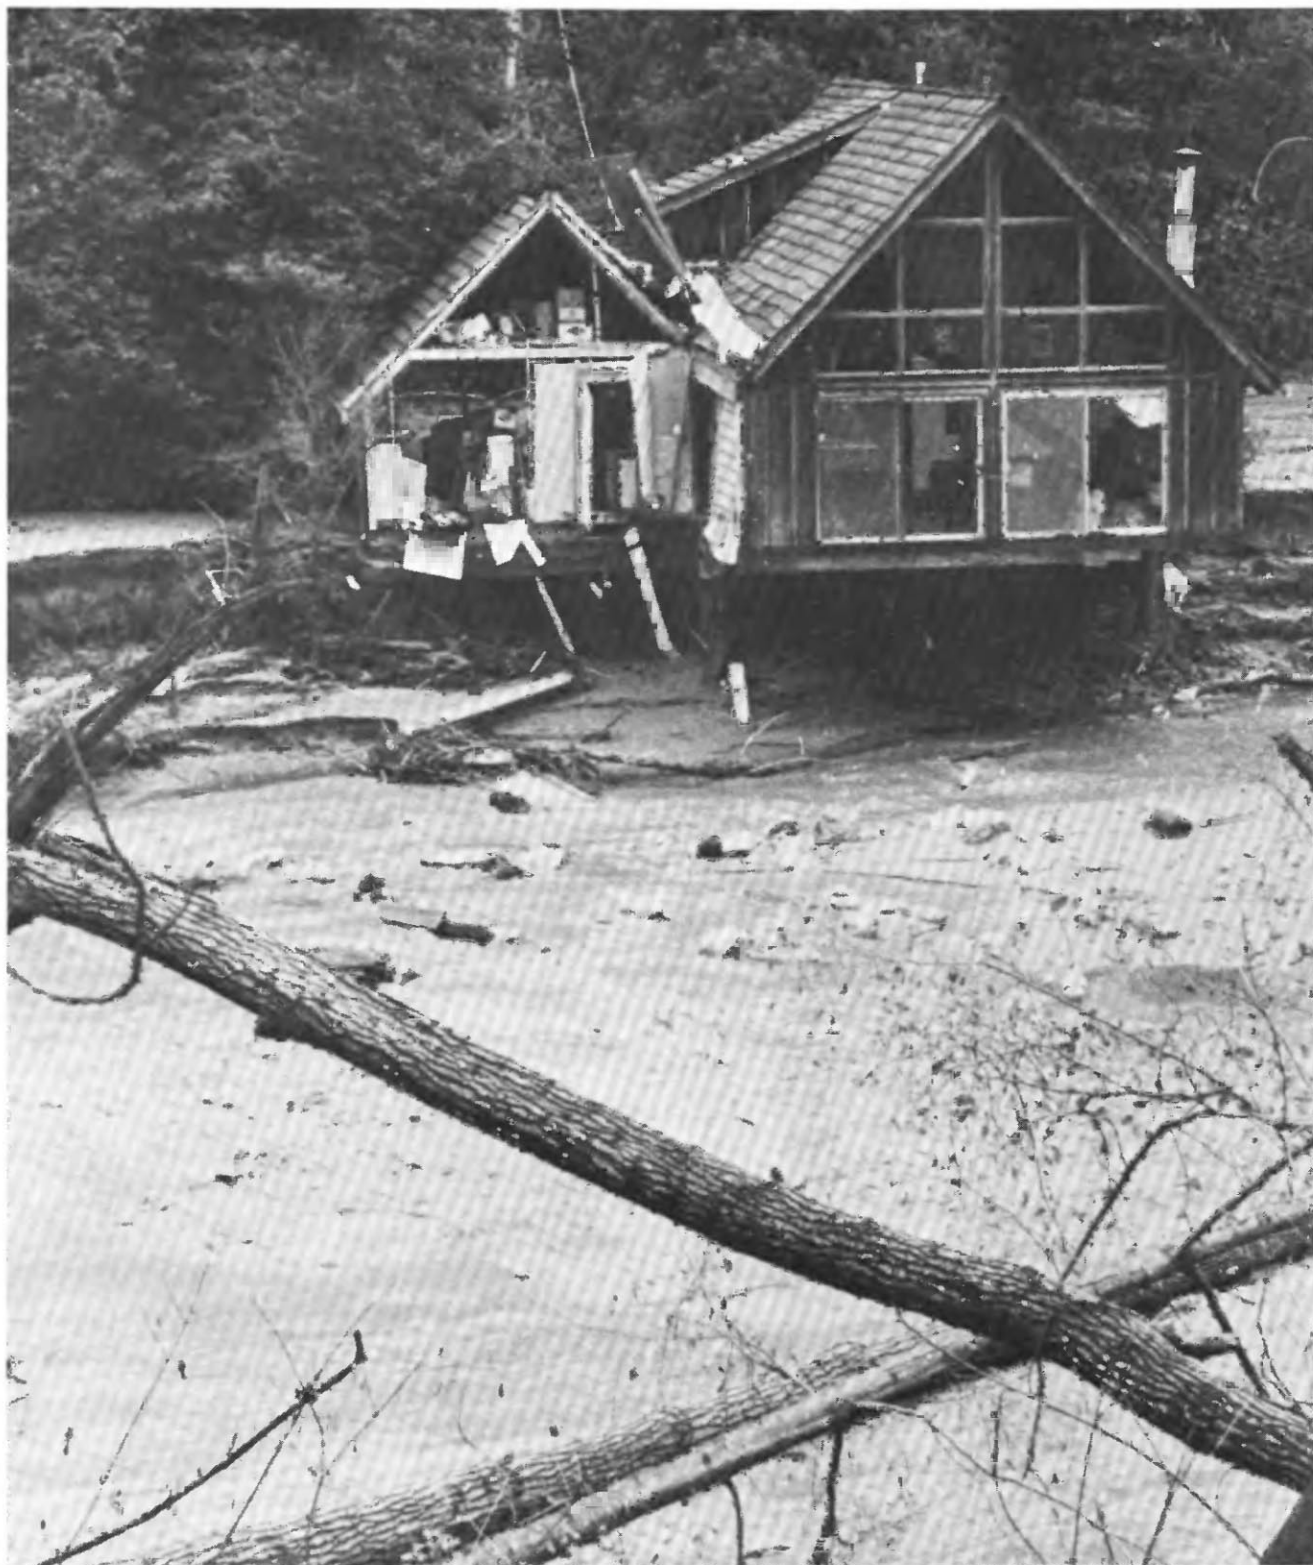
FIGURE 12.19.—Bank erosion from lateral cutting during the January 1982 flood on Aptos Creek. Much of this house fell into the creek and was carried downstream. Bank erosion occurred at this same site during the 1955 flood, and fill was subsequently brought in.

perimeter foundations, which collapsed as the loose fill and unconsolidated flood-plain sediment were eroded, rather than on caissons or piers. At least seven homes sustained major damage. One heavily damaged home had been rebuilt after the 1955 floods. Two other homes broke in half owing to undermining (fig. 12.19); the detached part of one ended up in the creek, and the other floated downstream. A third home on the north bank totally collapsed into the creek at 8:00 p.m.; part of the house ended up on a nearby bridge (fig. 12.20), and the rest floated downstream to the ocean.

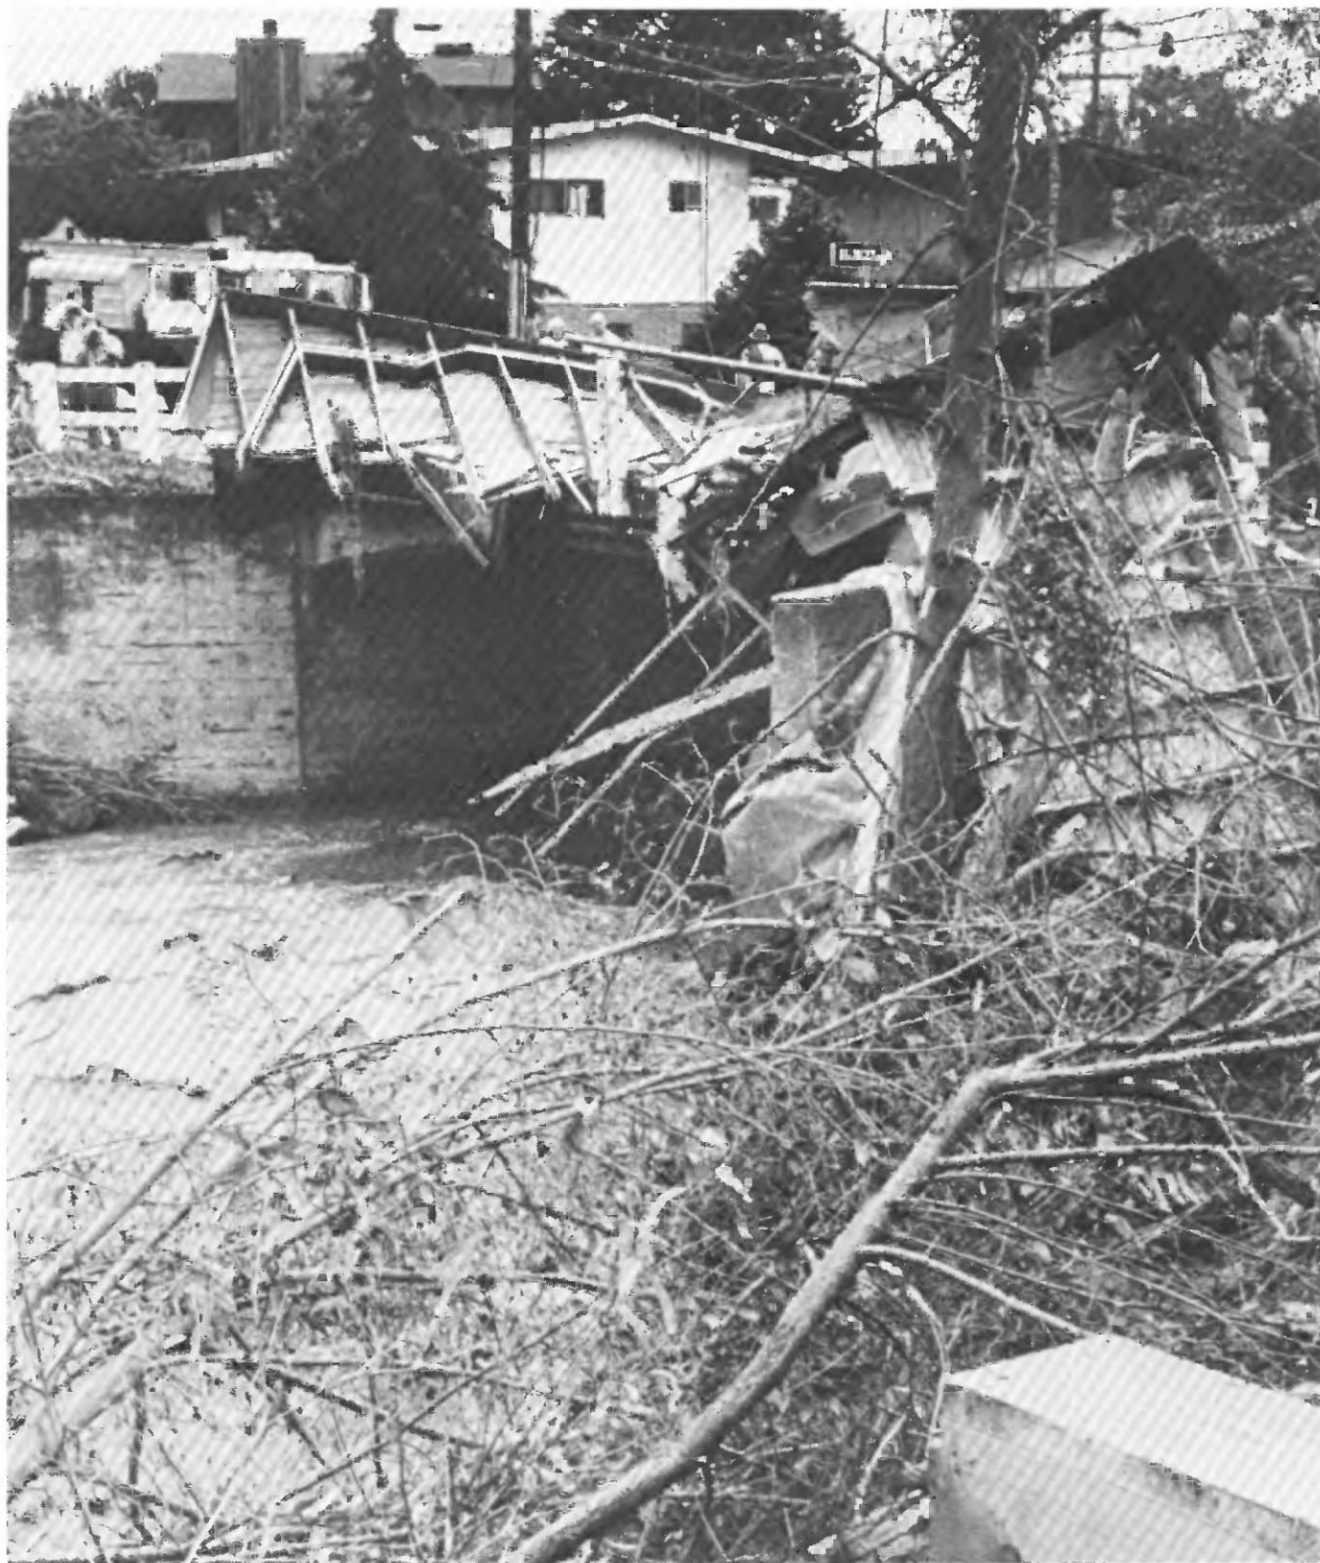
FIGURE 12.20.—Wreckage of a house sits atop the Spreckles Drive Bridge across Aptos Creek. Timber in foreground was part of foundation for another house that was totally destroyed. House was built after 1955 flood in an area where bank erosion had previously occurred.

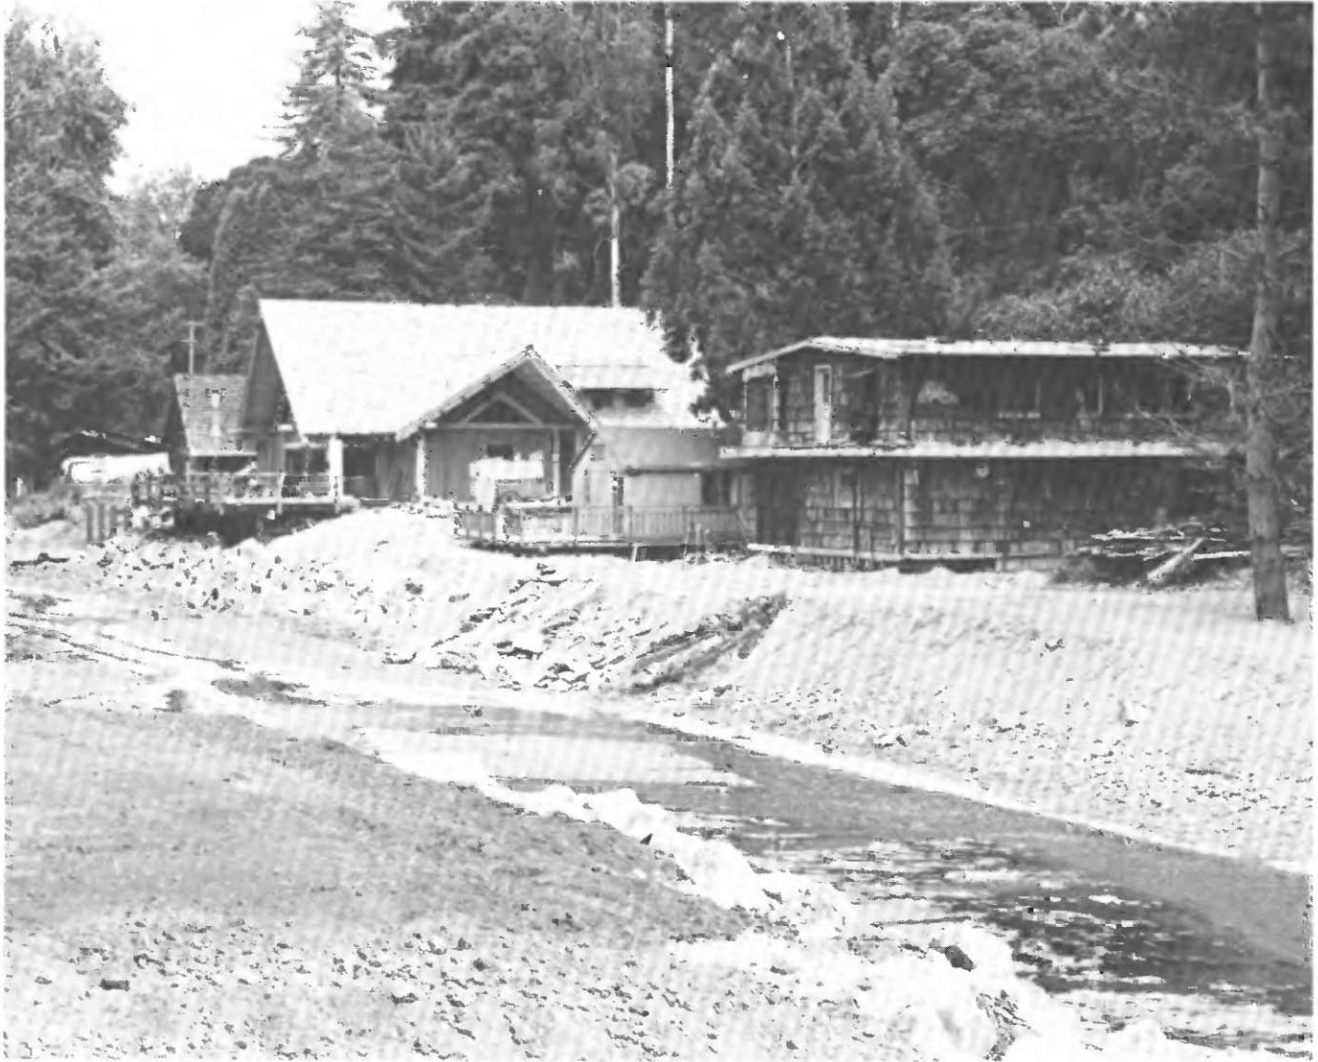
FIGURE 12.21.—View upstream along Aptos Creek from the Spreckles Drive Bridge in August 1982, showing filling and reconstruction that have taken place since the January 1982 flood. Compare with figure 12.18.

Where less than 50 percent of a structure has been damaged or destroyed, local government cannot require relocation, floodproofing, or elevation of a damaged home. Thus, before winter was over, residents applied for emergency permits, dumped fill into the stream channel, poured new foundations, and rebuilt homes (fig. 12.21). Some riprap was brought in to protect the new fill and rebuilt homes, but rocks of the same size had been swept

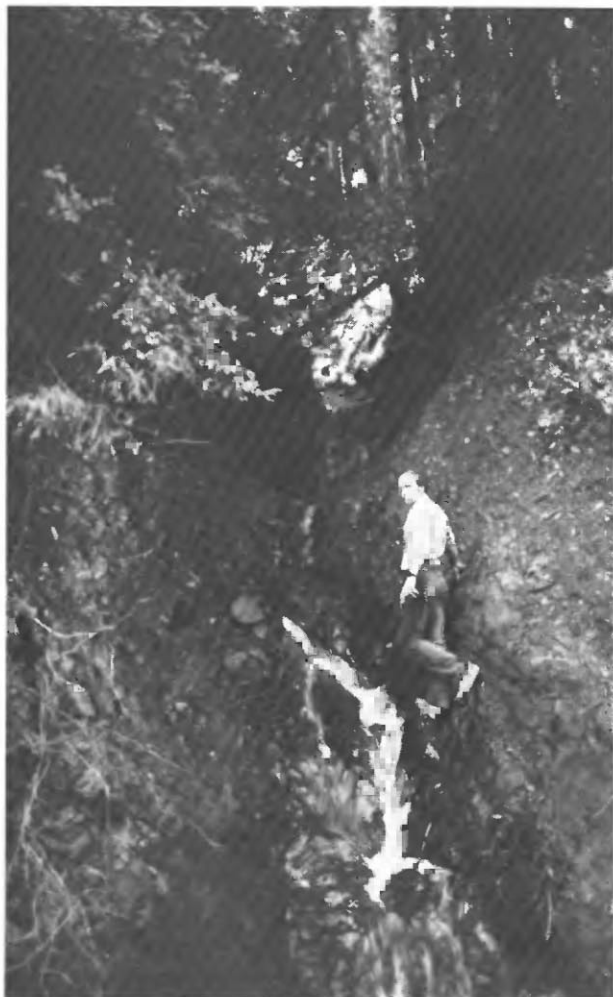
FIGURE 14.3.—Scour in second-order channel near Ben Lomond.

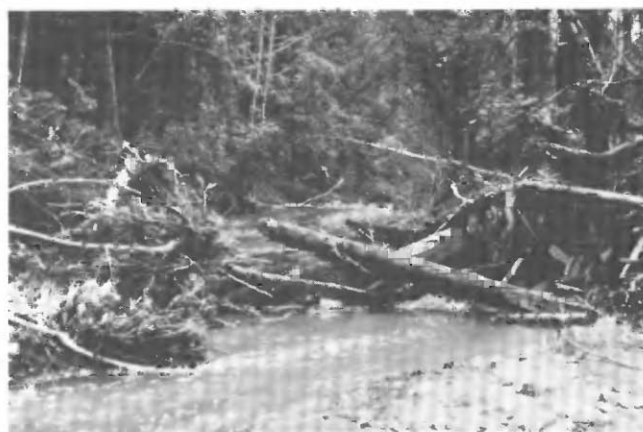
FIGURE 14.4.—Open framework of debris jam near Ben Lomond. Note nondeposition behind debris.

Most small stream channels observed after the storm showed evidence of recent scour (table 14.1). These first- and second-order channels (Strahler, 1954) have drainage areas of less than 0.10 km<sup>2</sup> and local gradients of more than 100 m/km. Many of these channels were scoured through older alluvium, so that underlying bedrock is now exposed (fig. 14.3). Channel fill was prevalent only above artificial constrictions, such as culverts blocked by sediment and by such organic debris as trees and bushes. Most accumulations of organic debris in unconstricted channel reaches formed open frameworks that were ineffective in trapping sediment (fig. 14.4).

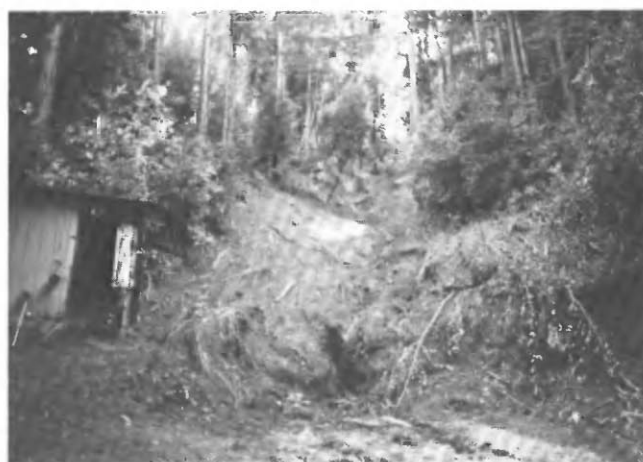
FIGURE 14.5.—Minor channel changes resulting from debris flow near the town of Boulder Creek. Note that most soil and vegetation remains in place upstream of house on left. Downstream deposition resulting from this activity is visible in figure 14.7.

and Swanson (1976). Some debris flows apparently were highly fluid, and although they transported large volumes of sediment through steep reaches, they caused only minimal channel scour (fig. 14.5). In contrast, other in-channel debris flows stripped large amounts of alluvium and colluvium from steep reaches, commonly exposing bedrock and leaving much more obvious scars on the landscape (fig. 14.6). These effects closely resemble the scouring debris flows described by Campbell (1975), as well as the debris torrents described by Swanston and Swanson (1976). Campbell (1975) attributed variations in the erosive potential of debris flows to gradient steepness and, therefore, flow velocity, and to the moisture content of the moving material. Along low-gradient reaches at the mouths of some channels that received debris flows, large volumes of channel fill were spread over wide areas (fig. 14.7).

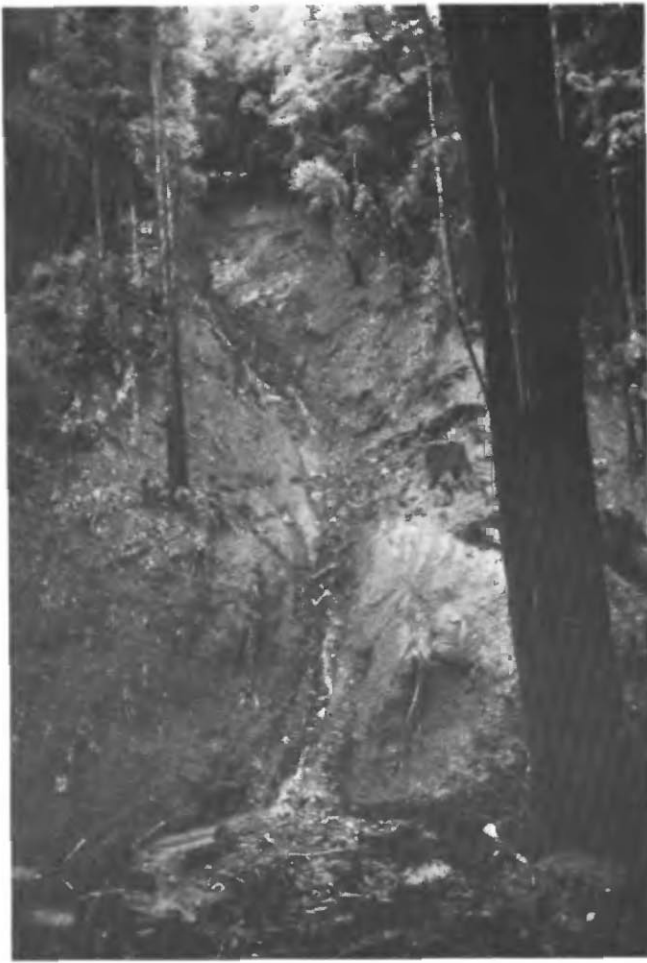
FIGURE 14.6.—Scoured trail of debris flow in San Lorenzo River basin near Ben Lomond. Note removal of large amounts of vegetation and colluvium.

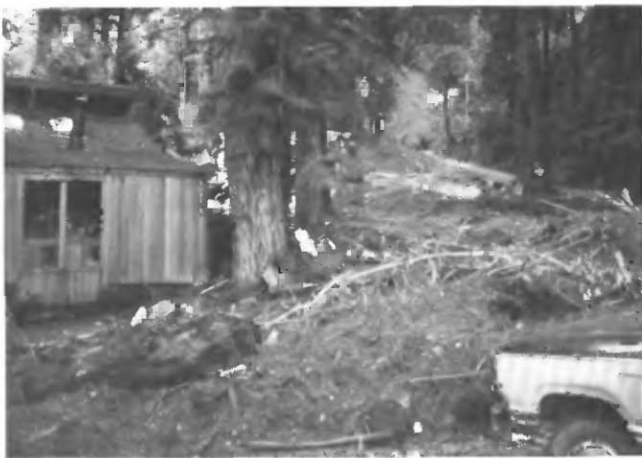
FIGURE 14.7.—Deposition and damage on low-gradient slopes below channel shown in figure 14.5. Despite absence of major channel changes upstream, large amounts of debris were transported through the channel and deposited on the low-gradient slopes shown here.

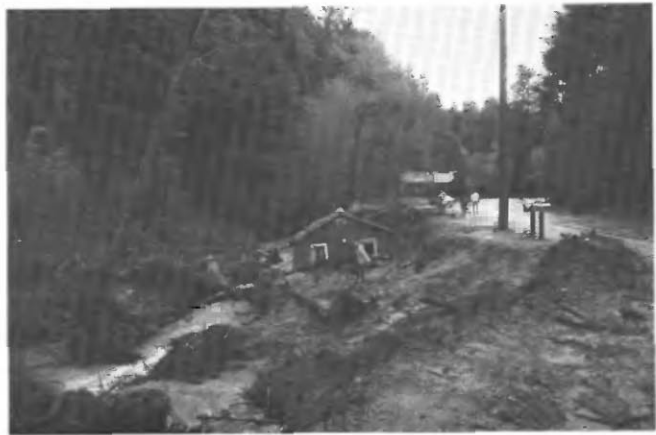
FIGURE 14.8.—Streamside debris slide in Soquel Creek. This slide, which entered the creek from the left side of the photograph, caused locally severe channel changes typical of those observed in many places that received exceptionally intense rainfall.

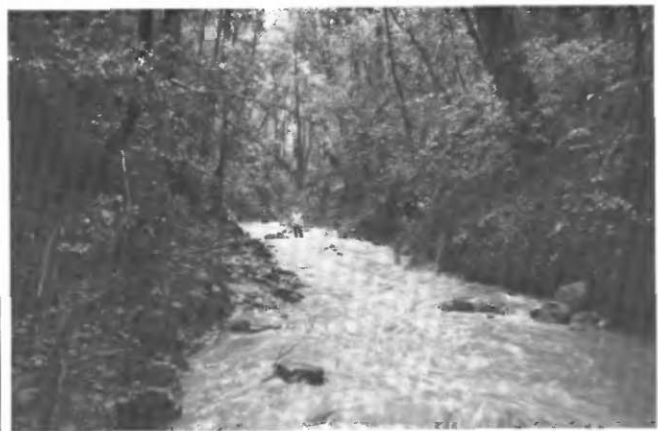
FIGURE 14.9.—Channel of Soquel Creek, 1.4 km downstream of severe channel changes shown in figure 14.8, showing absence of channel effects downstream of streamside landslide. Nonburial of pre-flood bouldery alluvium and minimal effects on riparian vegetation indicate a general absence of channel changes in this reach.

Flood effects in intermediate-order channels varied considerably. Such observations were made primarily along third- and fourth-order channels with drainage areas of 1 to 50 km<sup>2</sup>. Although many reaches along these streams showed little or no effects from the storm, significant channel modification was observed along some reaches (table 14.1). Most of these channel modifications occurred where input of colluvium from large streamside debris slides or large debris flows overwhelmed the sediment-transport capacity of the affected channel (fig. 14.8). These effects were generally confined to the immediate area of colluvial input. In such places, large volumes of introduced colluvium were removed by streamflow with little or no effect on downstream reaches (fig. 14.9).
