# Landslides, Floods, and Marine Effects of the Storm of January 3-5, 1982, in the San Francisco Bay Region, California

U.S. GEOLOGICAL SURVEY PROFESSIONAL PAPER 1434

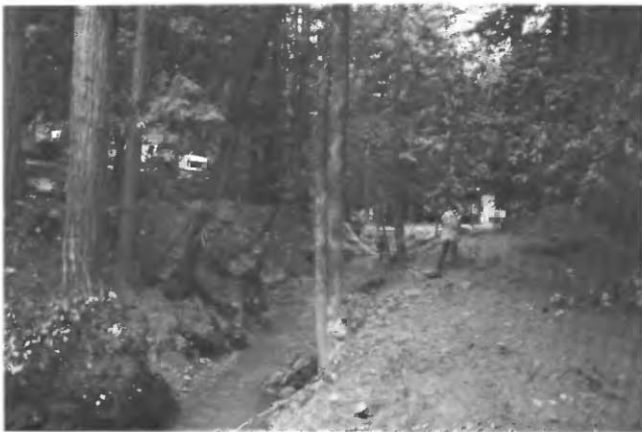
FIGURE 14.12.—Massive flood berms in Lockhart Gulch at study site 24. The sedimentology of the deposits at this site and immediately upstream (fig. 14.11) suggests that the massive deposits along this reach resulted from inchannel debris-flow activity.

In a few areas, such as at study sites 19, 23, and 24, major channel modifications extended beyond the areas immediately adjacent to individual landslides. The deposits in these areas, which were characterized by poorly sorted, angular to subangular cobbles and gravel, suggested inchannel debris-flow activity (figs. 14.11, 14.12).

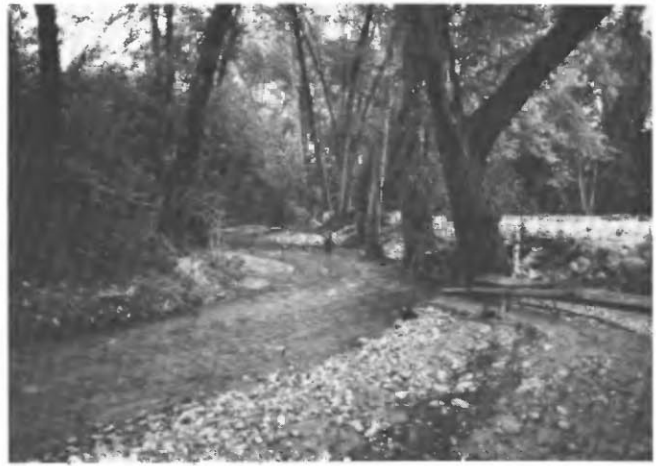
FIGURE 14.13.—Channel fill in Bean Creek at study site 29. Note absence of streambanks and burial of riparian vegetation.

these areas were observed at or near study sites 20, 25, 27, and 29 (figs. 14.13, 14.14). Fluvially reworked deposits consisted predominantly of well-sorted sand and gravel. Naturally extensive deposition appeared to have been augmented by the blocking or overloading of artificial flow constrictions (bridges and culverts) by organic and inorganic debris (fig. 14.15). Some local bank erosion occurred where channel filling was great because stream-flow was affected by landslides and (or) organic debris (fig. 14.16).

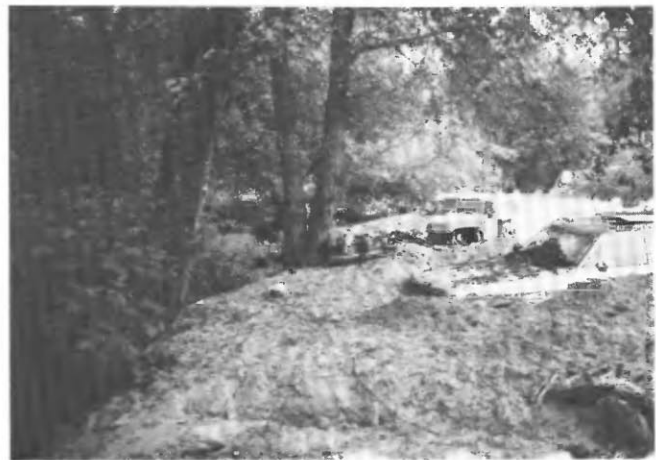
FIGURE 14.14.—Overbank deposits in Bean Creek near study site 29. This area contained some of the thickest overbank deposits observed in the study area.

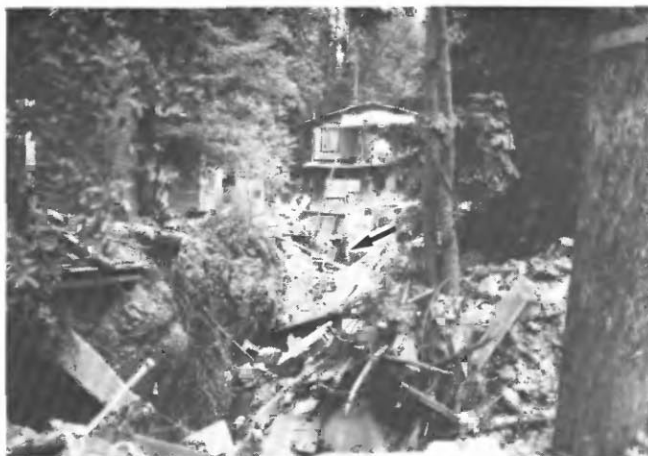
FIGURE 14.15.—Damage to manmade structures along tributary to Lockhart Gulch. The volume of water and debris transported during the storm totally overwhelmed the small box culvert (arrow) and destroyed some streamside structures.

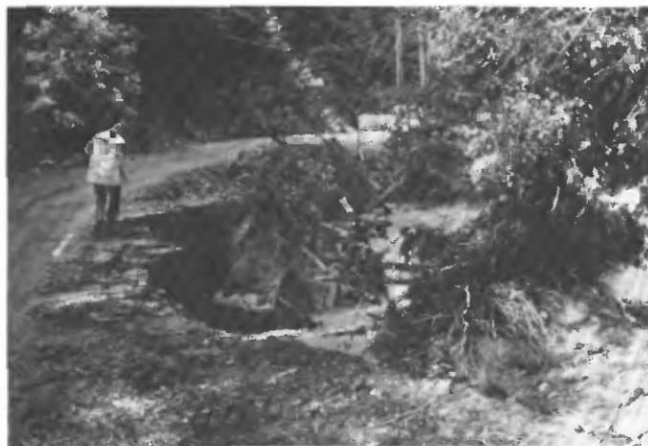
FIGURE 14.16.—Streambank erosion caused by deflection of streamflow by organic debris in Love Creek.

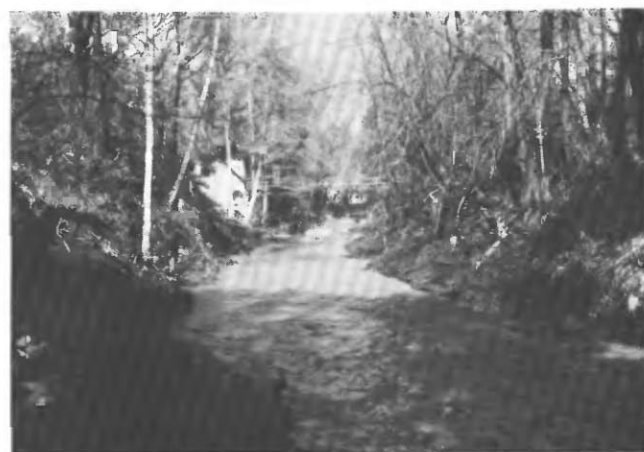
FIGURE 14.17.—Channel widening limited by bedrock along streambanks in Zayante Creek. Although high water along this and many other reaches extended from bank to bank and removed riparian vegetation, it did not cause streamside instability.

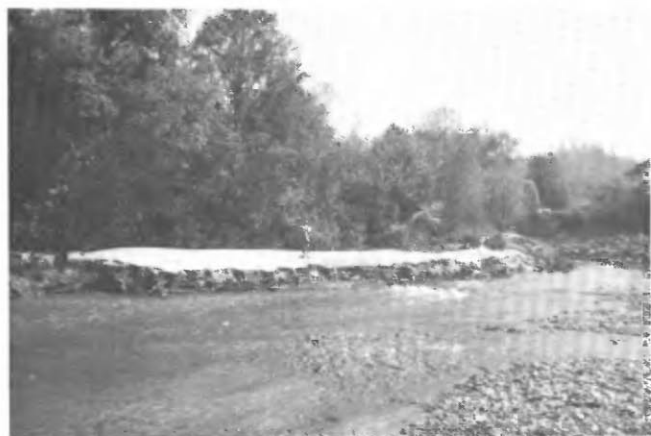
FIGURE 14.18.—Flood berm in downstream reach of Pescadero Creek near study site 40. This berm was typical of many observed along downstream reaches of high-order channels in the study area.

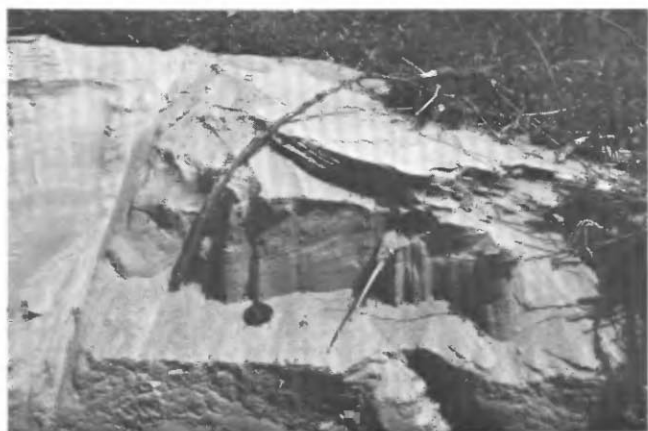
FIGURE 14.19.—Detail of flood berm shown in figure 14.18. This and most other such deposits observed along high-order channels in the study area consisted of well-sorted crossbedded sand. Lens cap for scale.

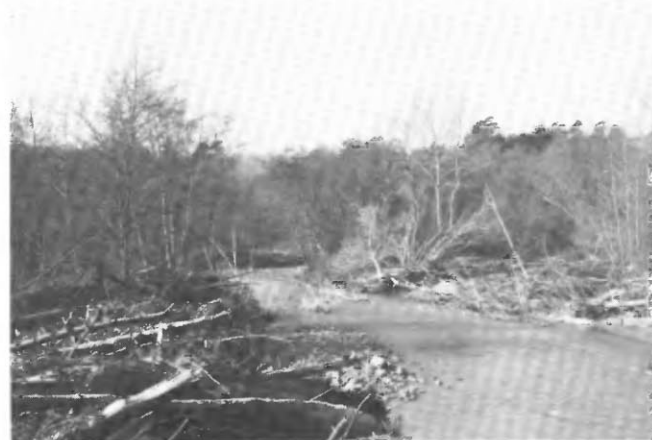
FIGURE 14.20.—Organic debris deposited along downstream reach of Soquel Creek.

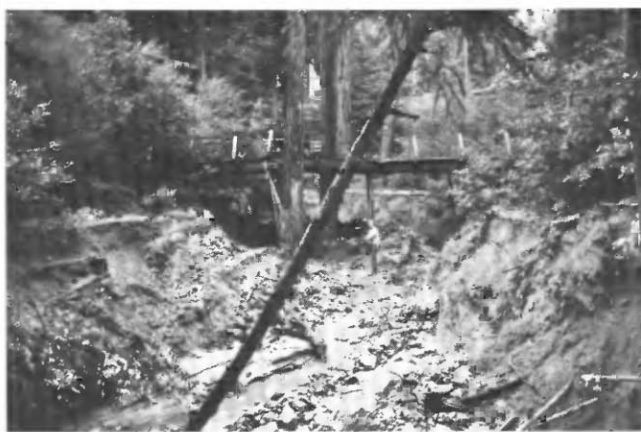
FIGURE 14.27.—Backwater deposits resulting from plugging of culvert at study site 13.

The massive accumulations of sediment behind such flow constrictions as culverts and debris jams indicate that large amounts of sediment were transported through reaches where the flood caused minimal effects on channel geometry or riparian conditions. The amount of sediment transported by one small steep tributary (study site 13, fig. 14.2) was estimated by measuring the amount of sediment deposited behind a small-diameter (1 m) culvert that plugged during the storm (fig. 14.27). High-water marks indicate that the wingwall surrounding this culvert was overtopped by flow and that water was ponded 40 m upstream from the culvert. The flat tops of the backwater deposits, their concordant tops, and the sediment adhering to a tree in the center of the deposit (fig. 14.27) suggest that backwater deposits filled the entire area and that the void now present in the middle represents scour by flow after unplugging of the culvert. Field measurements indicate that approximately 145 m<sup>3</sup> of sediment remained behind the culvert and that, assuming that sediment once filled the void between the flat-topped lateral berms, scour has removed approximately

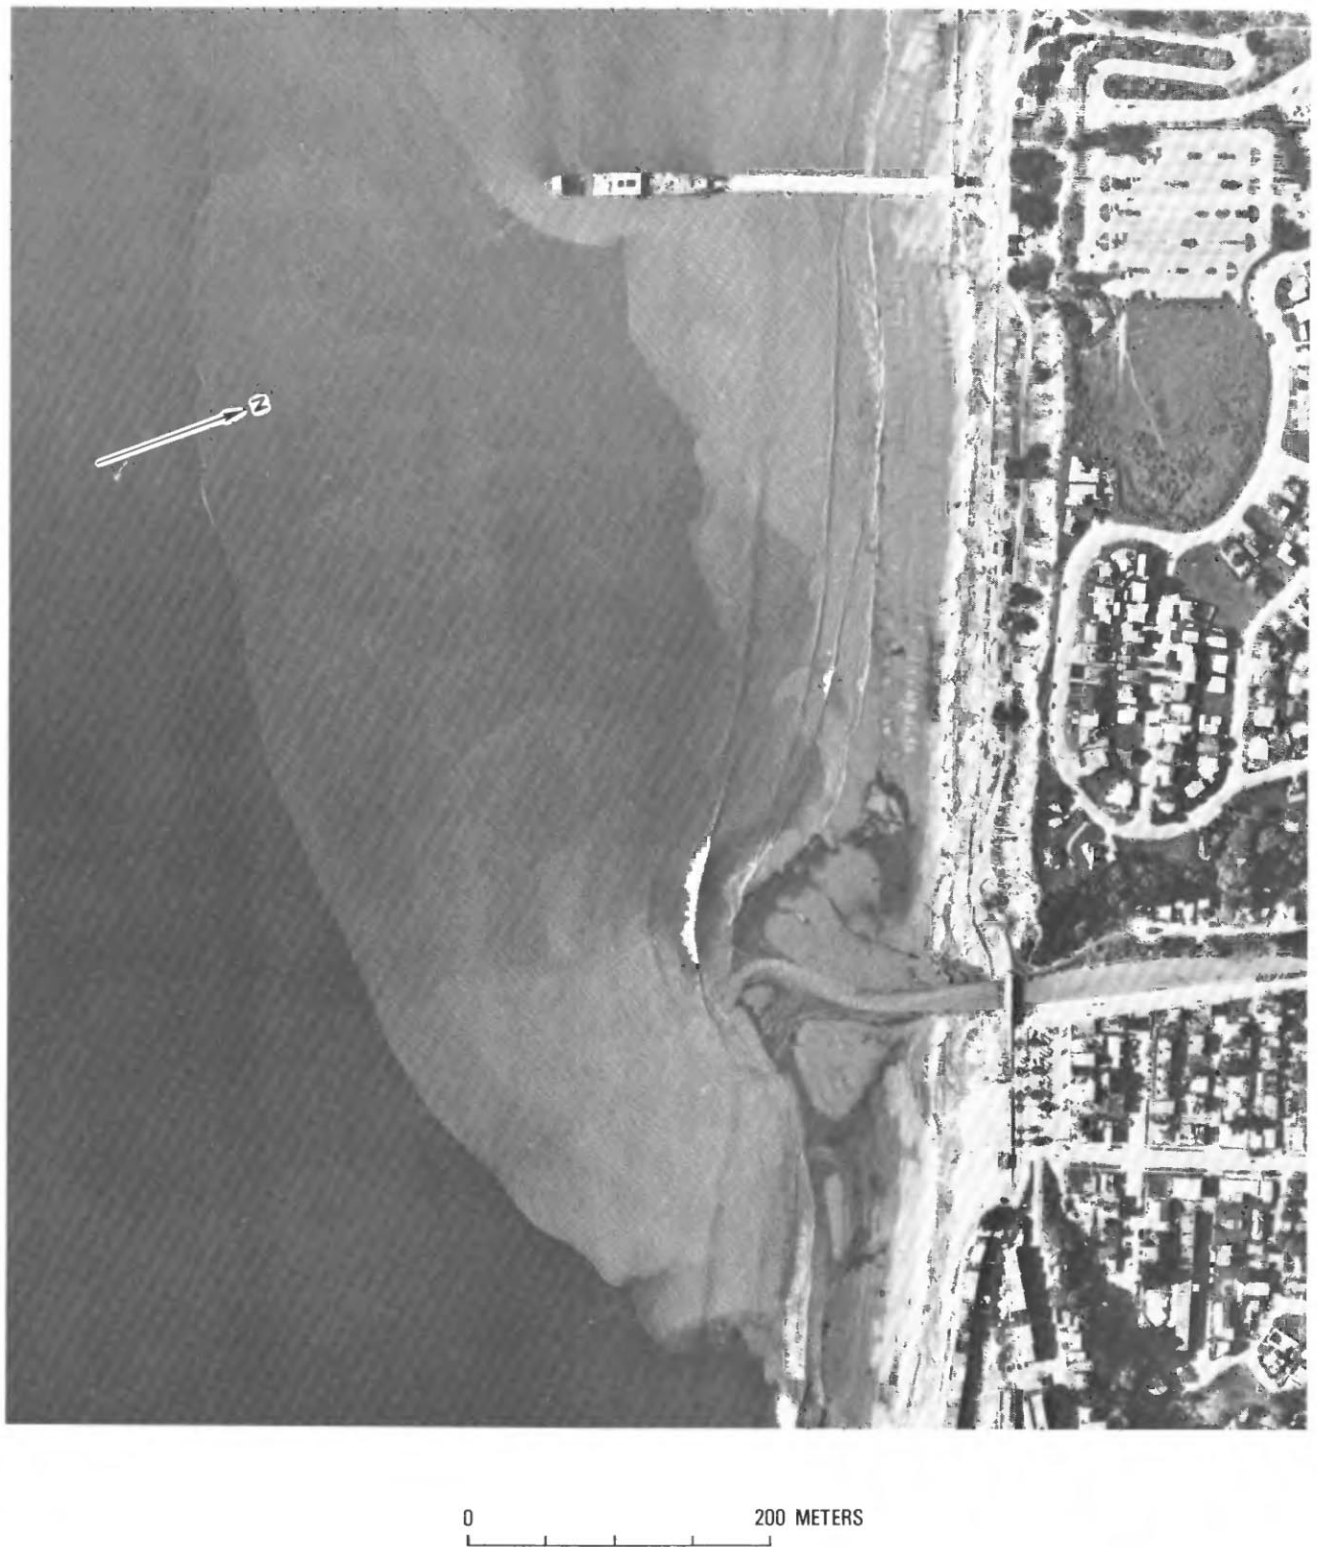
FIGURE 15.5.—Mouth of Aptos Creek on January 7, 1982. Wave height is approximately 0.5 m. U.S. Geological Survey aerial photograph.

Initial northward displacement of the deltaic buildup (fig. 15.5) is consistent with waves traveling from the south-southwest, the direction reported by the Santa Cruz Harbor array. Aerial photographs taken on January 7, 1982 (fig. 15.5), show suspended-sediment plumes deflected to the north at the mouth of Aptos Creek.

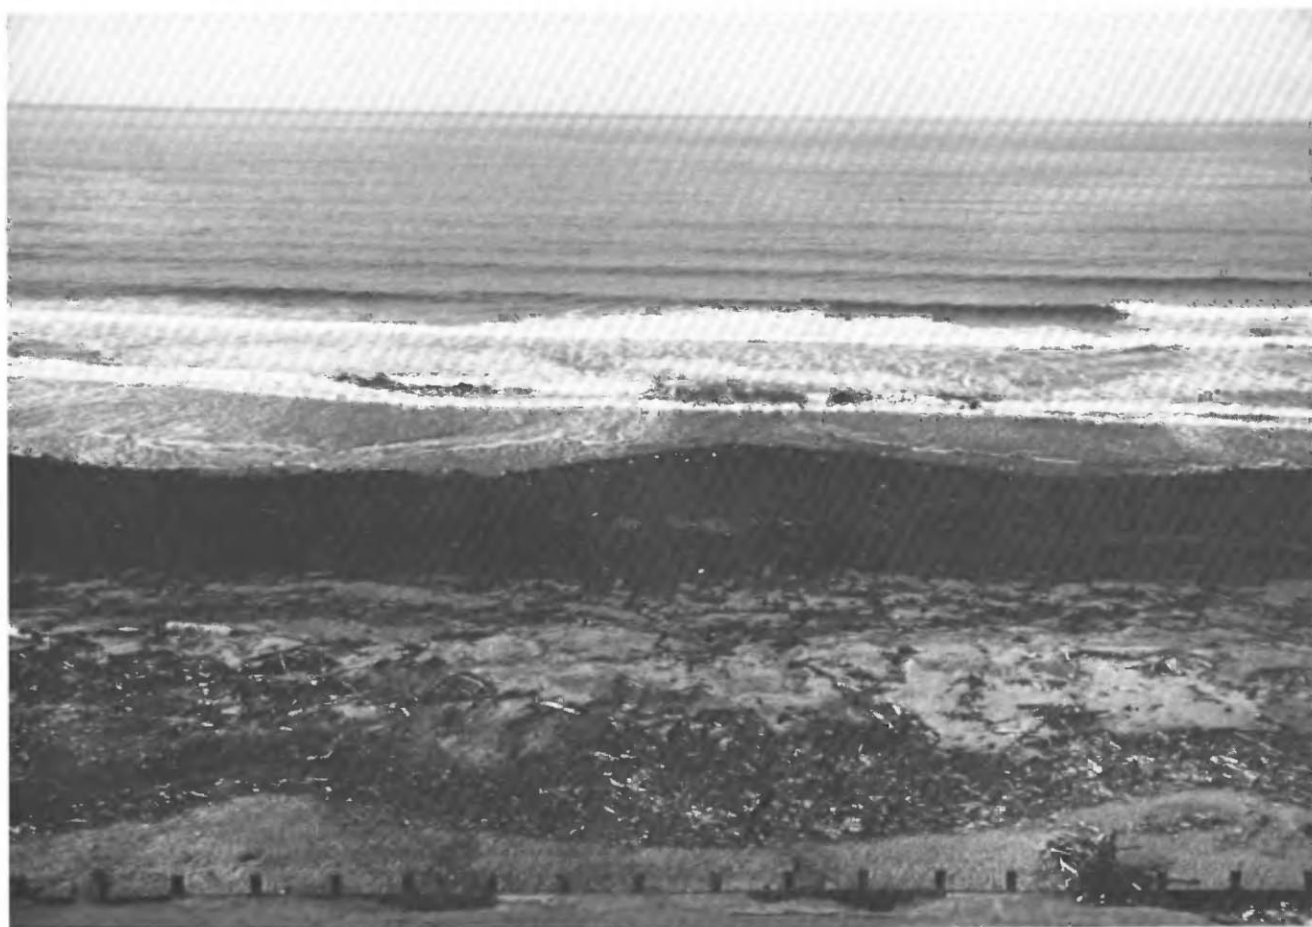
FIGURE 15.6.—Vegetative debris (mainly twigs and branches) deposited on beach face near mouth of Aptos Creek after a winter flood.

Most surficial deposits in the subaerial delta consisted of medium sand, but large areas of this sand were overlain by a deposit, as much as about 30 cm thick, composed primarily of a coarse-textured woodpulp. This woodpulp probably represents the remnants of vegetative debris that was fragmented during its short but active fluvial journey. In addition to the woodpulp, many sticks and logs collected on the beaches and within the sediment adjacent to the creek mouth (fig. 15.6). Scattered pebbles and cobbles were also present on the delta surface.

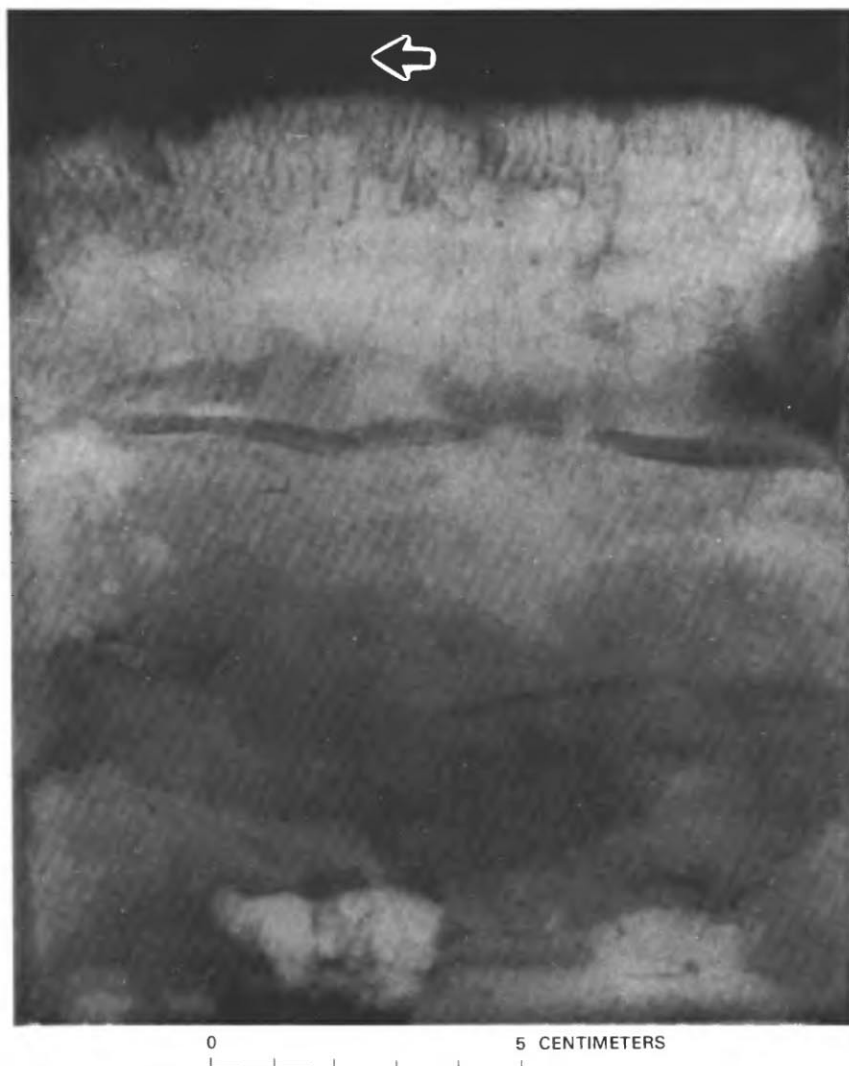
FIGURE 16.20.—X-ray radiograph of core 3 taken on Walker Creek delta along channel margin in September 1982, showing U-shaped burrows in flood layer. Arrow denotes current direction.

The flood deposits remained discernible in cores taken 6 to 9 months after the storm. Most cores showed evidence of biologic reworking, although the degree of bioturbation differed substantially among the various cores. Some cores reflected rapid and intensive colonization by an organism that constructs a U-shaped burrow (fig. 16.20), whereas others showed remarkably little bioturbation (fig. 16.21). The presence of a thin, somewhat mixed sandy layer atop a well-defined layer of clay within a few cores taken in June 1982 off the front of the Walker Creek delta implies introduction of sand by ordinary processes during the 6 months after the storm.
