In August 2019, the U.S. Geological Survey, in cooperation with the Puerto Rico Electric Power Authority, conducted a bathymetric survey of Lago Patillas to update stage-volume data in order to determine the sediment infill rates and to generate a bathymetry map. Water-depth data were collected along predefined lines using single-beam depth sounder and Differential Global Positioning System technology. The study also included delineating a new reservoir shoreline based on 2016–17 light detection and ranging data and the establishment of a new official vertical datum at the reservoir referenced to the Puerto Rico Vertical Datum of 2002 (PRVD02). Survey results indicated that the storage capacity was 12.96 million cubic meters in 2019 at an elevation of 67.55 meters above PRVD02. The mean annual loss of capacity from 1961 to 2019 is 0.08 million cubic meters per year. The point of zero remaining storage of Lago Patillas is projected to be 161 years, ending in 2180.

Supplemental notes:  
 Gómez-Fragoso, J.M., 2021, Bathymetric survey and sedimentation analysis of Lago Patillas, Puerto Rico, August 2019: U.S. Geological Survey Scientific Investigations Map 3471, 1 sheet, <https://doi.

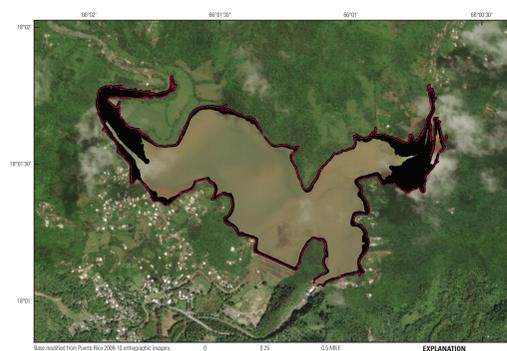
**Figure 3.** Map showing 2016–17 light detection and ranging (lidar) data points between the new conservation pool elevation and spillway elevation for Lago Patillas, Puerto Rico. Aerial orthorectified map of U.S. Army Corps of Engineers, Jacksonville, Florida, Geomatics Section.

To determine the stage-volume relation and create the bathymetric map for Lago Patillas, editing and postprocessing of the data collected across the reservoir were completed using the ArcGIS software developed by Esri (2016). The analysis included three types of survey datasets: (1) 2019 bathymetric survey data, (2) hand-rod measurements of water depth near reservoir branches (also measured in 2019), and (3) 2016 and 2017 lidar point-cloud data, used also to delineate a new reservoir shoreline. Single-beam fathometer data and hand-rod measurement data were adjusted to represent elevations in PRVD02 prior to being merged with lidar data. As stated earlier, a new reservoir shoreline was delineated for Lago Patillas, based on the 2016 and 2017 lidar point-cloud data at the spillway elevation of 67.55 m above PRVD02. Lidar point-cloud data were used to generate the bathymetric map because the data collected

were considered reasonable when looking at lidar-derived ground points at the range of elevations between the new conservation pool elevation of 63.88 m above PRVD02 (64 m above mean sea level) and the spillway elevation of 67.55 m. In addition, lidar data were collected shortly after the new conservation pool elevation was established for Lago Patillas (fig. 3). Lidar point-cloud data were used to fill gaps between the new conservation pool elevation and spillway elevation (63.88 m to 67.55 m). To do this, the lidar data were clipped using the ArcGIS tool Extract LAS by setting the new reservoir shoreline at an elevation of 67.55 m above PRVD02 as the boundary feature. To generate the reservoir bathymetry surface, the aforementioned datasets (Gómez-Fragoso and Rosario, 2021) were combined in ArcGIS and a surface model was generated. The reservoir capacity was calculated at 1.0-m stage intervals from the bathymetric surface to generate a stage-volume curve from the 2019 survey using the data in table 1. In addition, the 2019 results were compared to those of previous USGS surveys completed in 2007 as part of the sedimentation analysis.

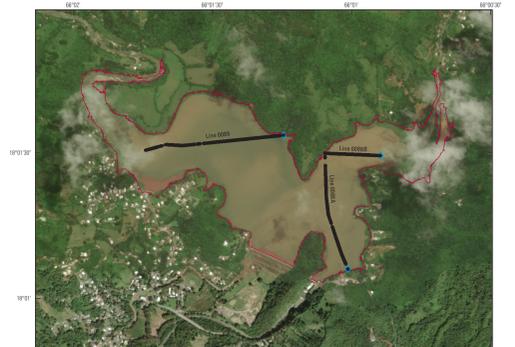
**Figure 6.** Water-depth data points collected at Lago Patillas, Puerto Rico, August 2019, used for the quality-assurance analysis. Aerial orthorectified map of U.S. Army Corps of Engineers, Jacksonville, Florida, Geomatics Section.

The assessment of uncertainties in the sedimentation survey and quality-assurance (QA) checking for the estimation of volume and bathymetric contours was evaluated by comparing the bathymetric surface to the survey of additional transect lines. The location of each transect is shown in figure 6, and these transects were surveyed during the same period in which the data used for the volume calculation were collected. Each water-depth data point was converted to bathymetric elevation, referenced to PRVD02, and smoothed to remove noise, following the same processing used for the 2019 bathymetric survey. The comparison with the bathymetric surface was made by obtaining the bathymetric surface elevation at the same location as the surveyed point (QA transects). Figure 7 shows the comparison between QA-transect points and the 2019 bathymetric surface. The largest differences between the bathymetric surface and the quality-assurance points were mostly on the edges of the reservoir, and line 0089 showed the best match with the surface model. Results from the comparison between the bathymetric surface and the quality-assurance transects also indicated that the vertical accuracy of the bathymetric surface is 1.74 m at a 95-percent confidence level. The median absolute vertical error was about 0.13 m.
