Vulnerability Assessment in and near Theodore Roosevelt National Park, North Dakota

By
Kristen J. Valseth
2021

Suggested citation: Valseth, K.J., 2021, Vulnerability assessment in and near Theodore Roosevelt National Park, North Dakota: U.S. Geological Survey Scientific Investigations Map 3479, pamphlet 9 p., 1 sheet, scale 1:250,000, <https://doi.org/10.3133/sim3479>.

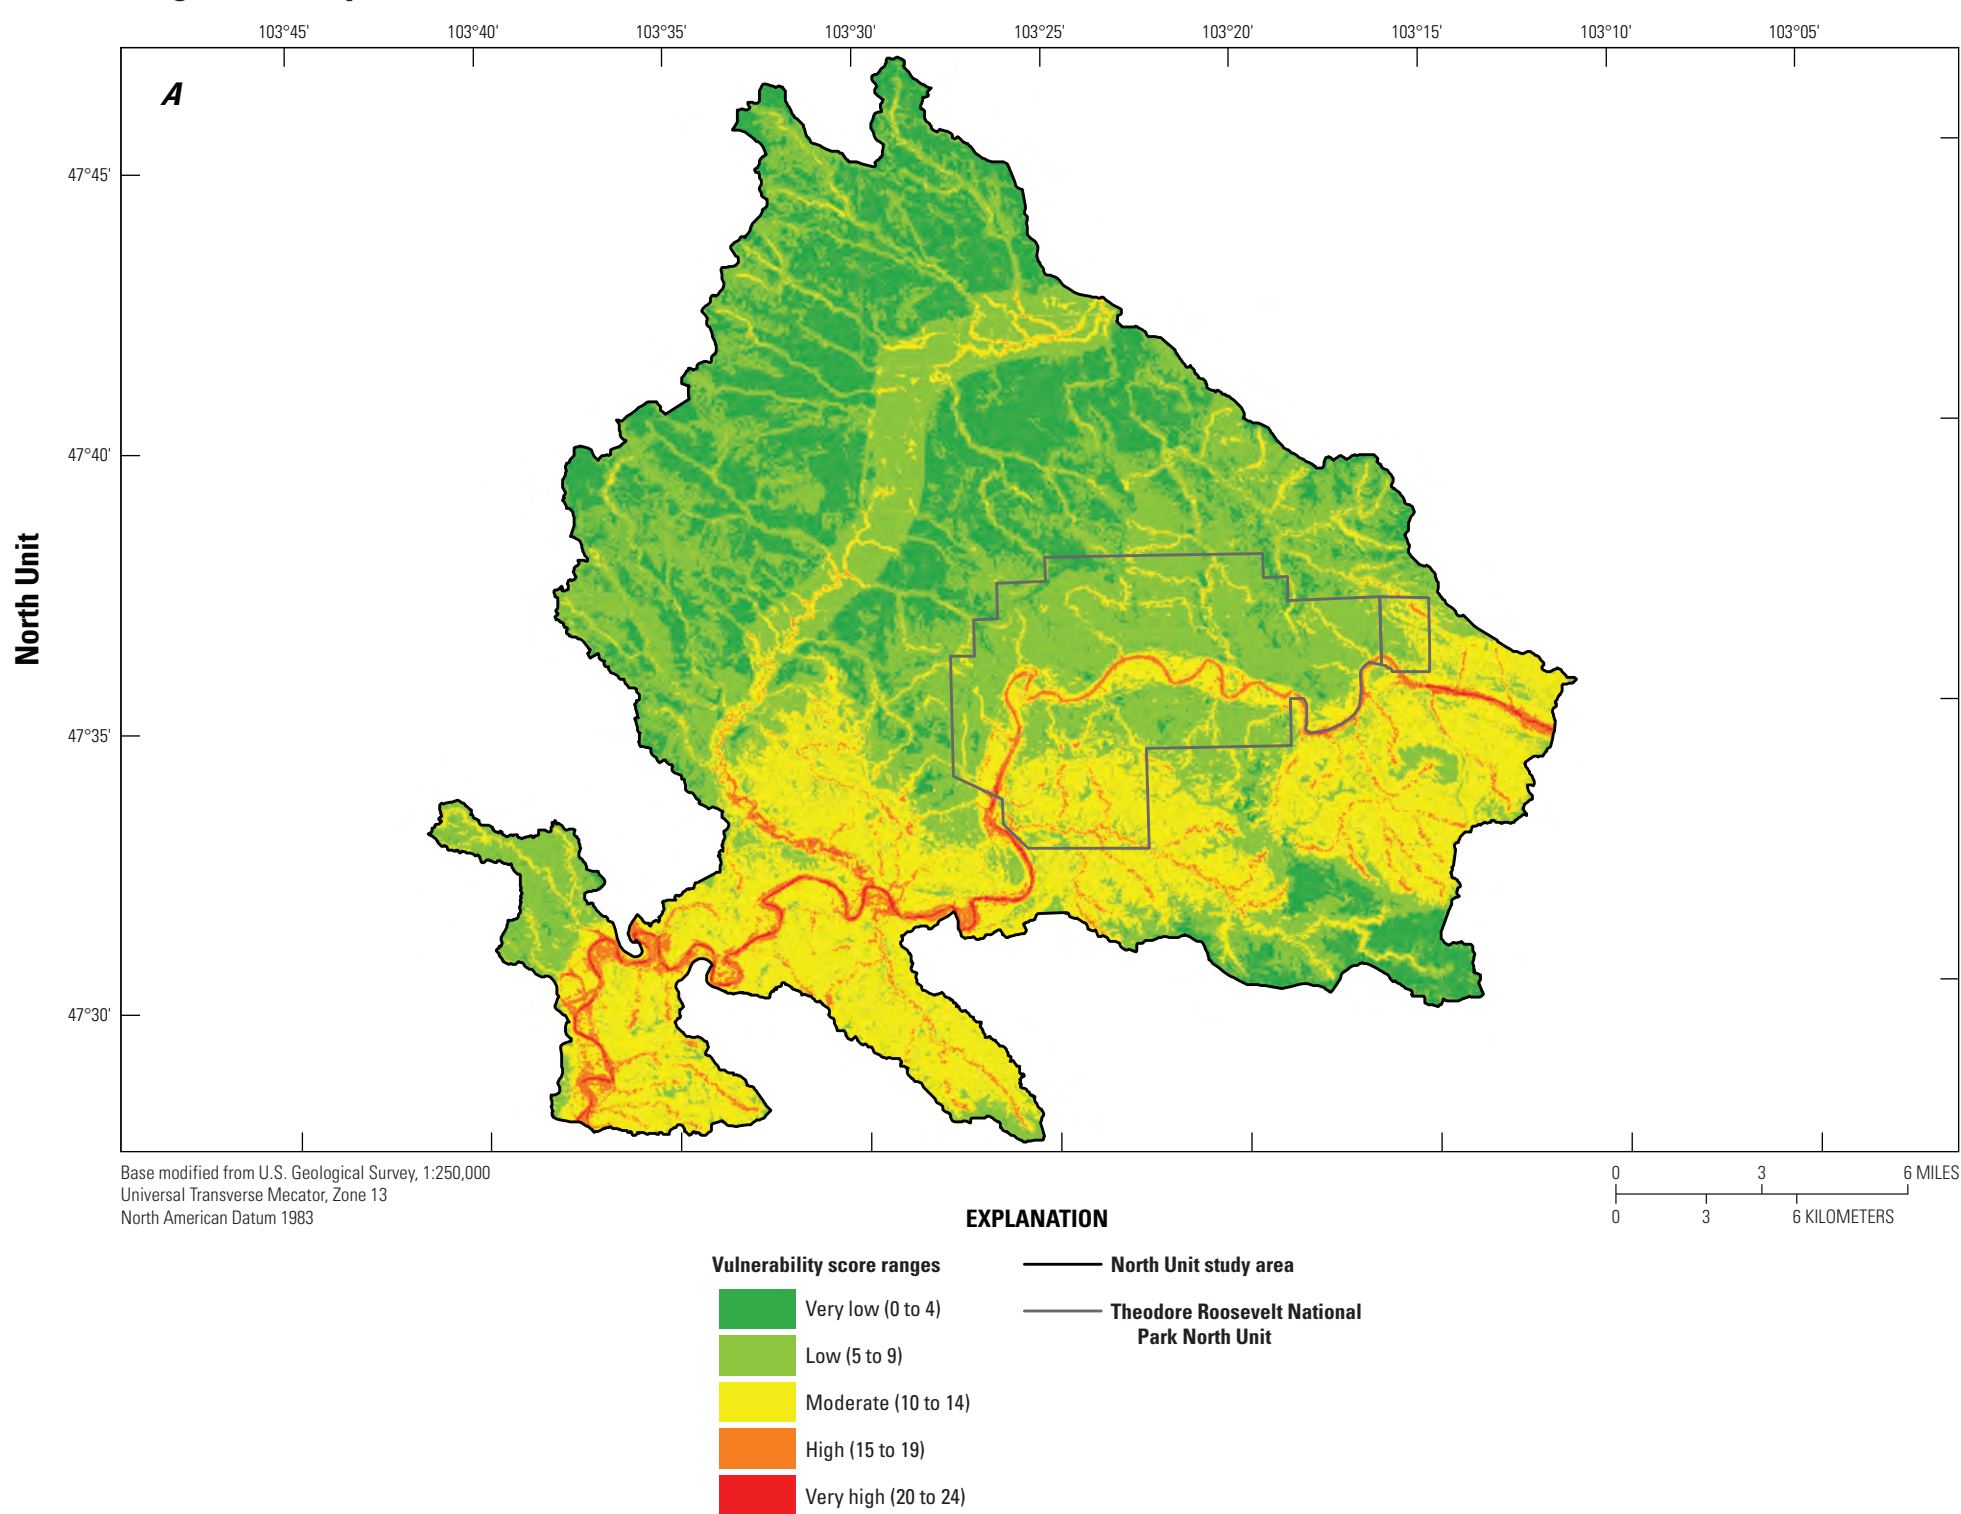
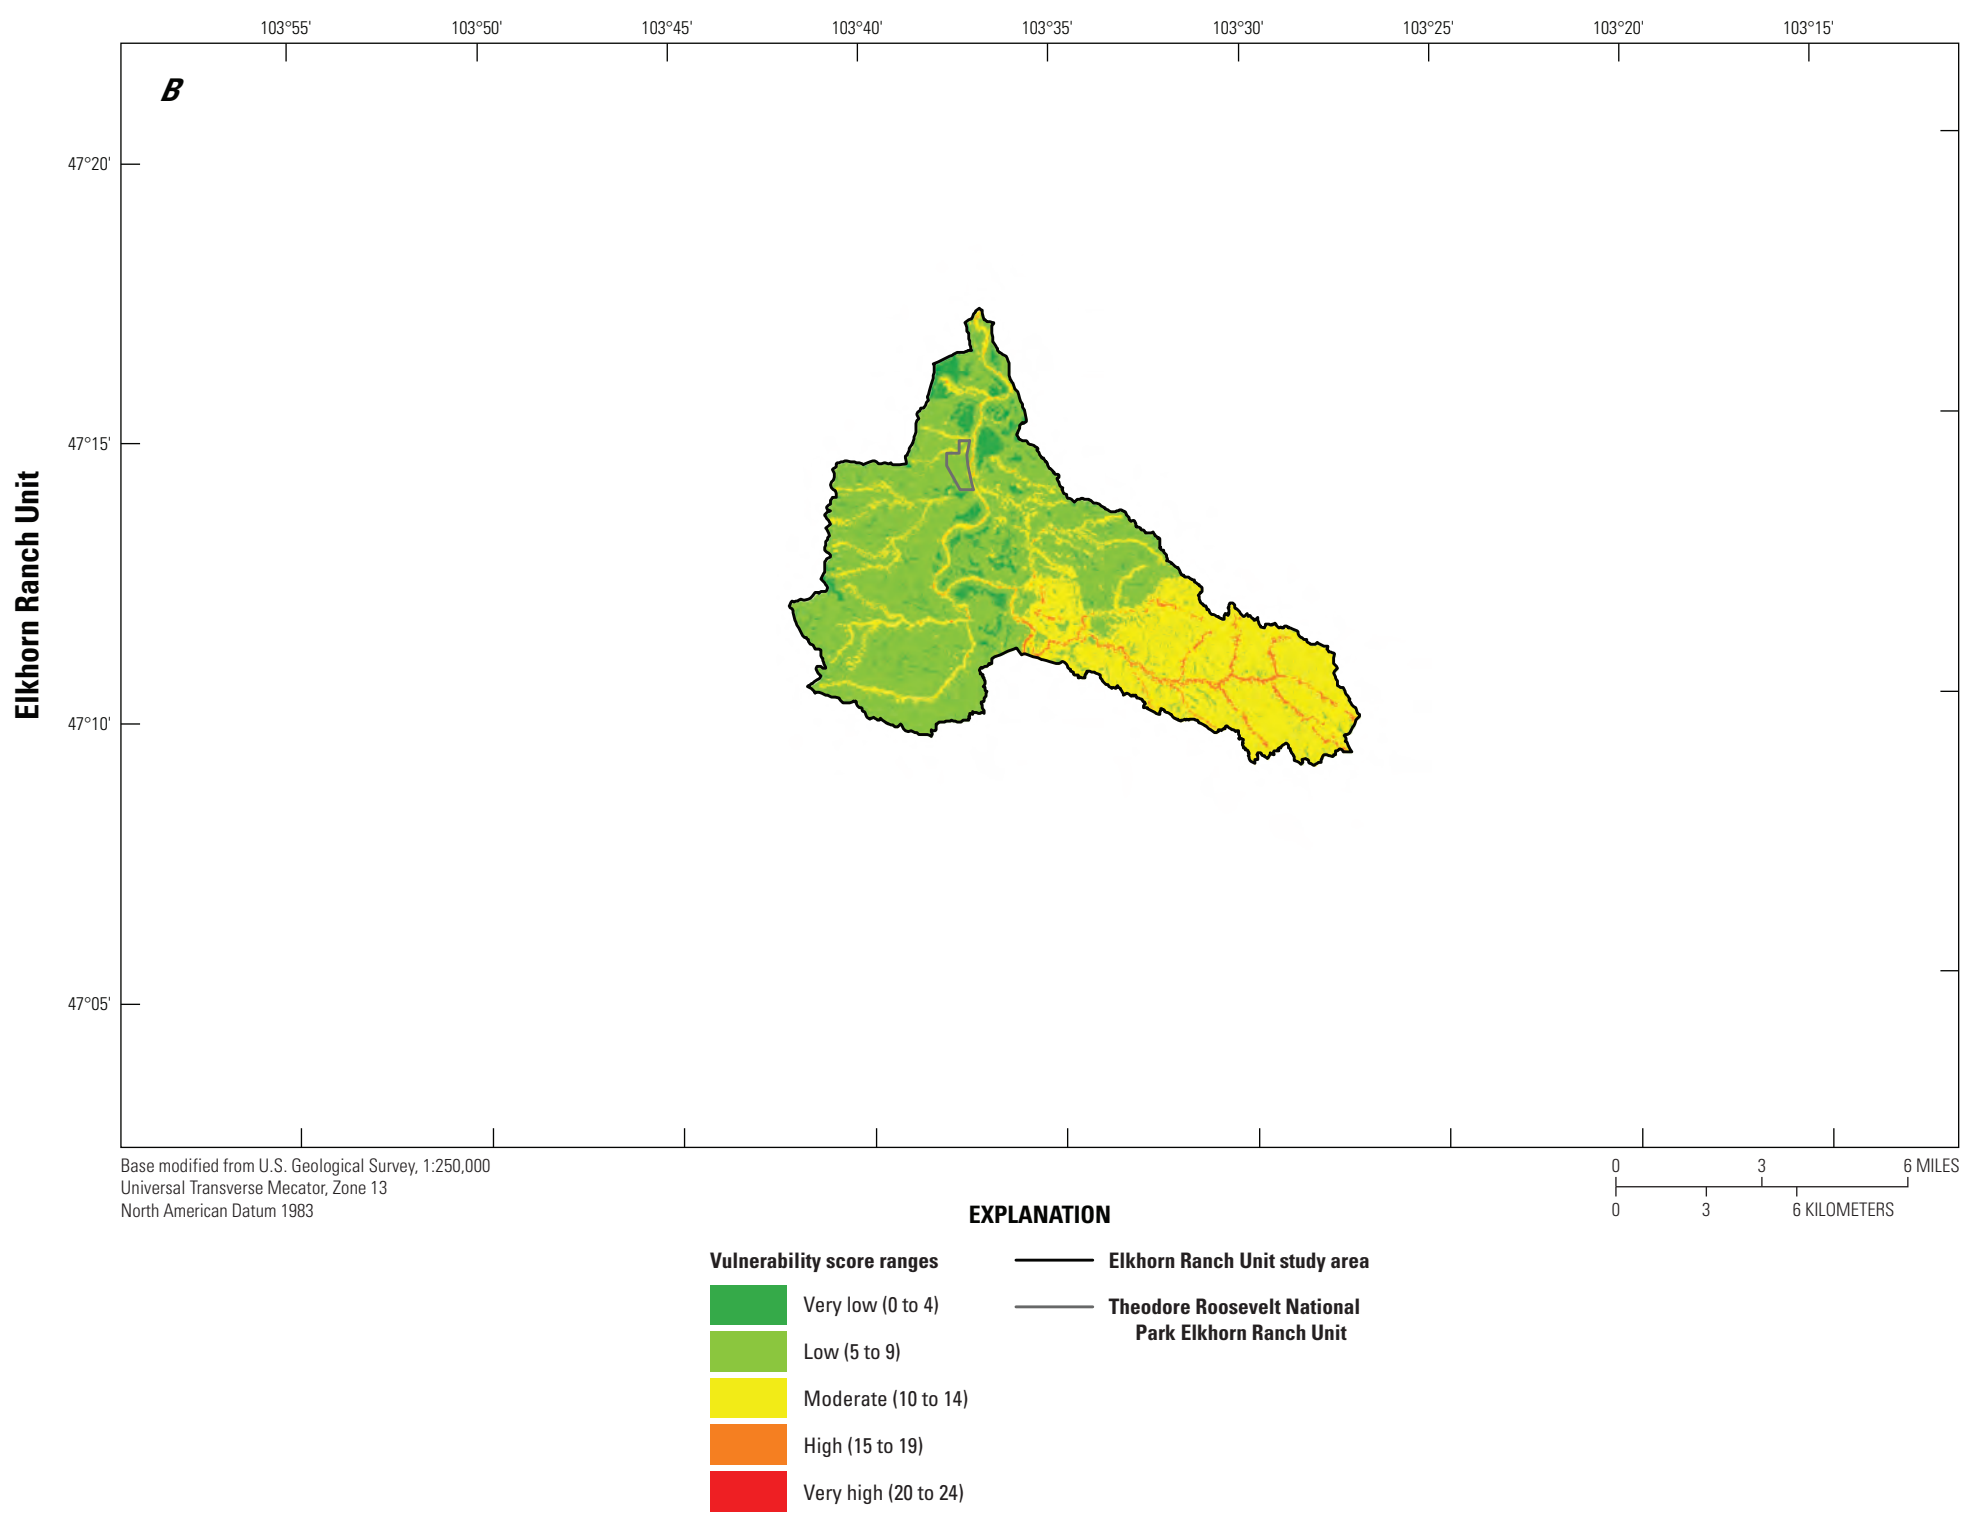
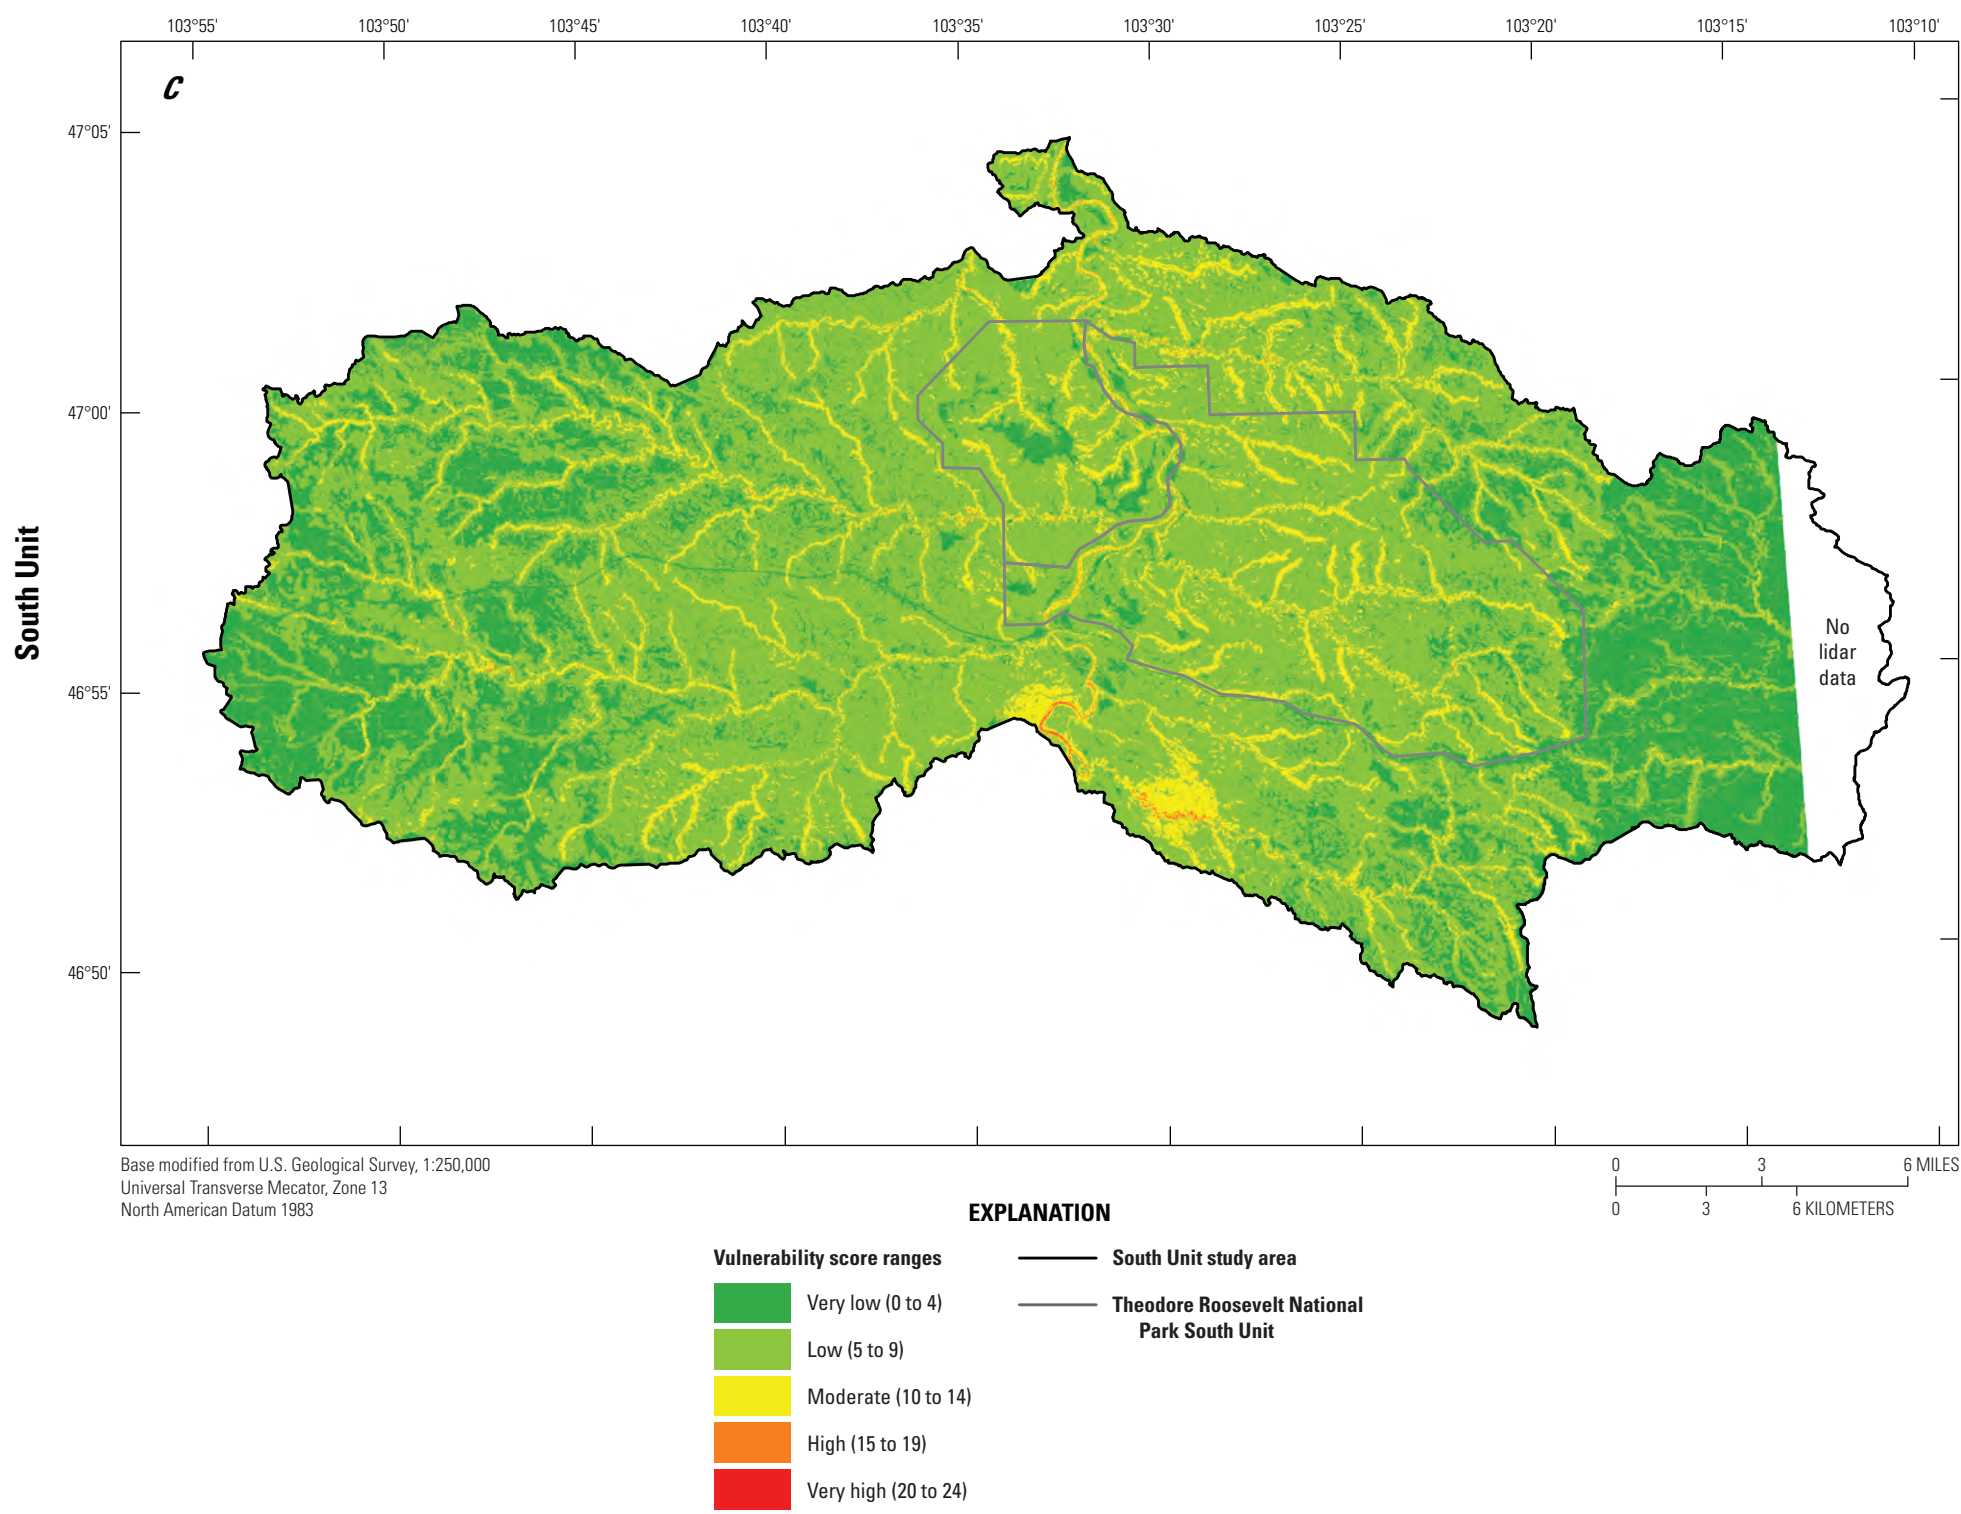
Figure 3. Maps of vulnerability scores for each unit of the study area. A, vulnerability scores within the North Unit; B, vulnerability scores within the Elkhorn Ranch Unit; C, vulnerability scores within the South Unit.

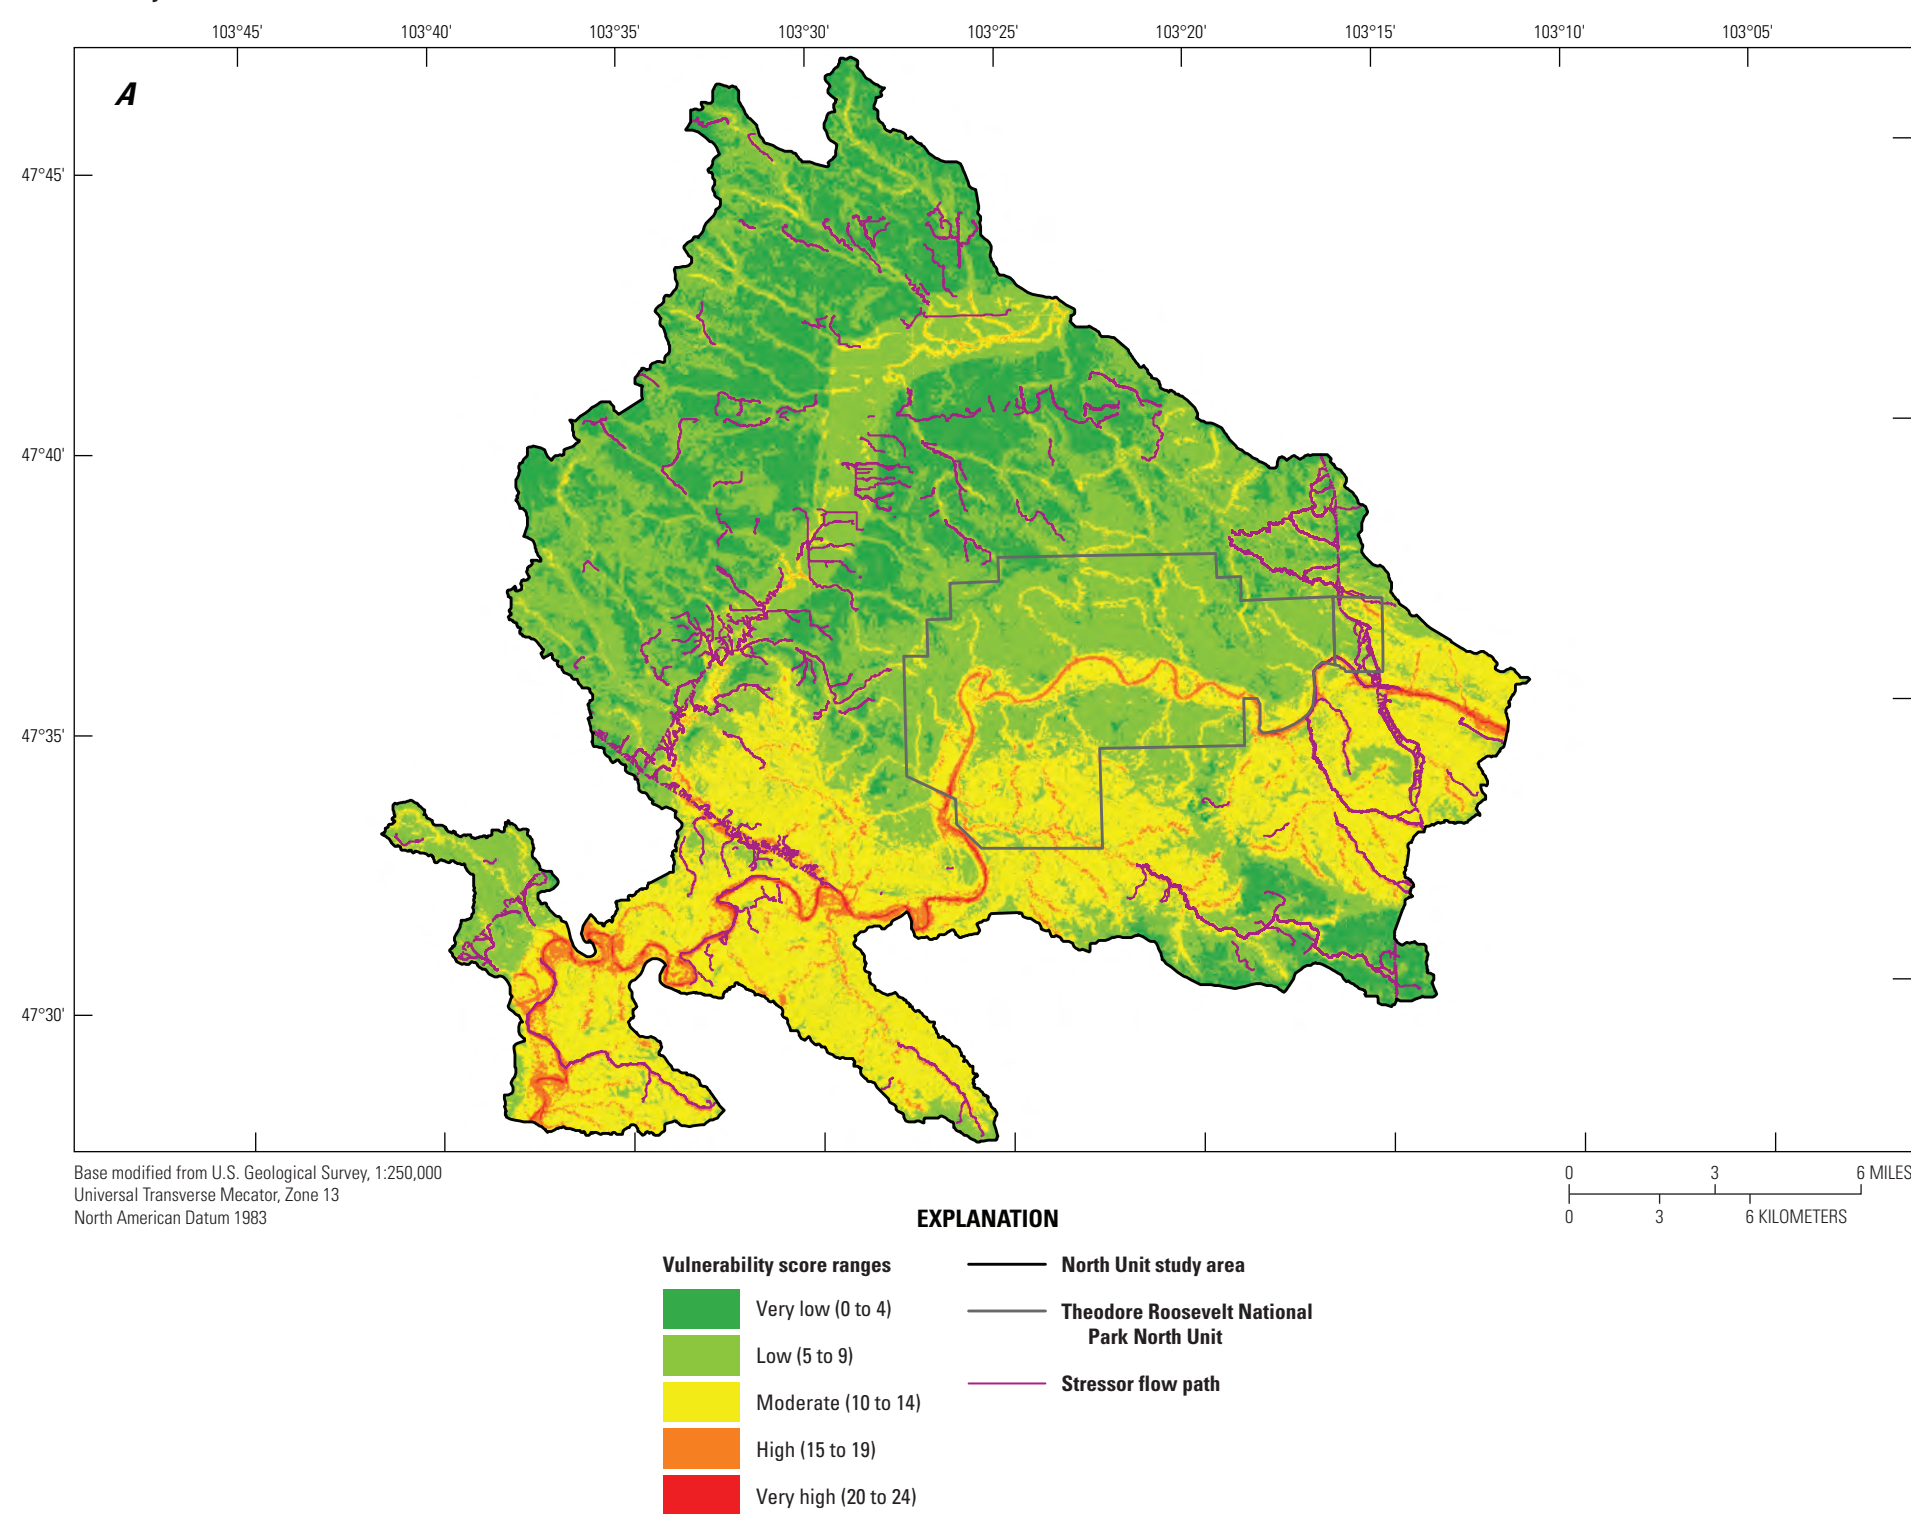
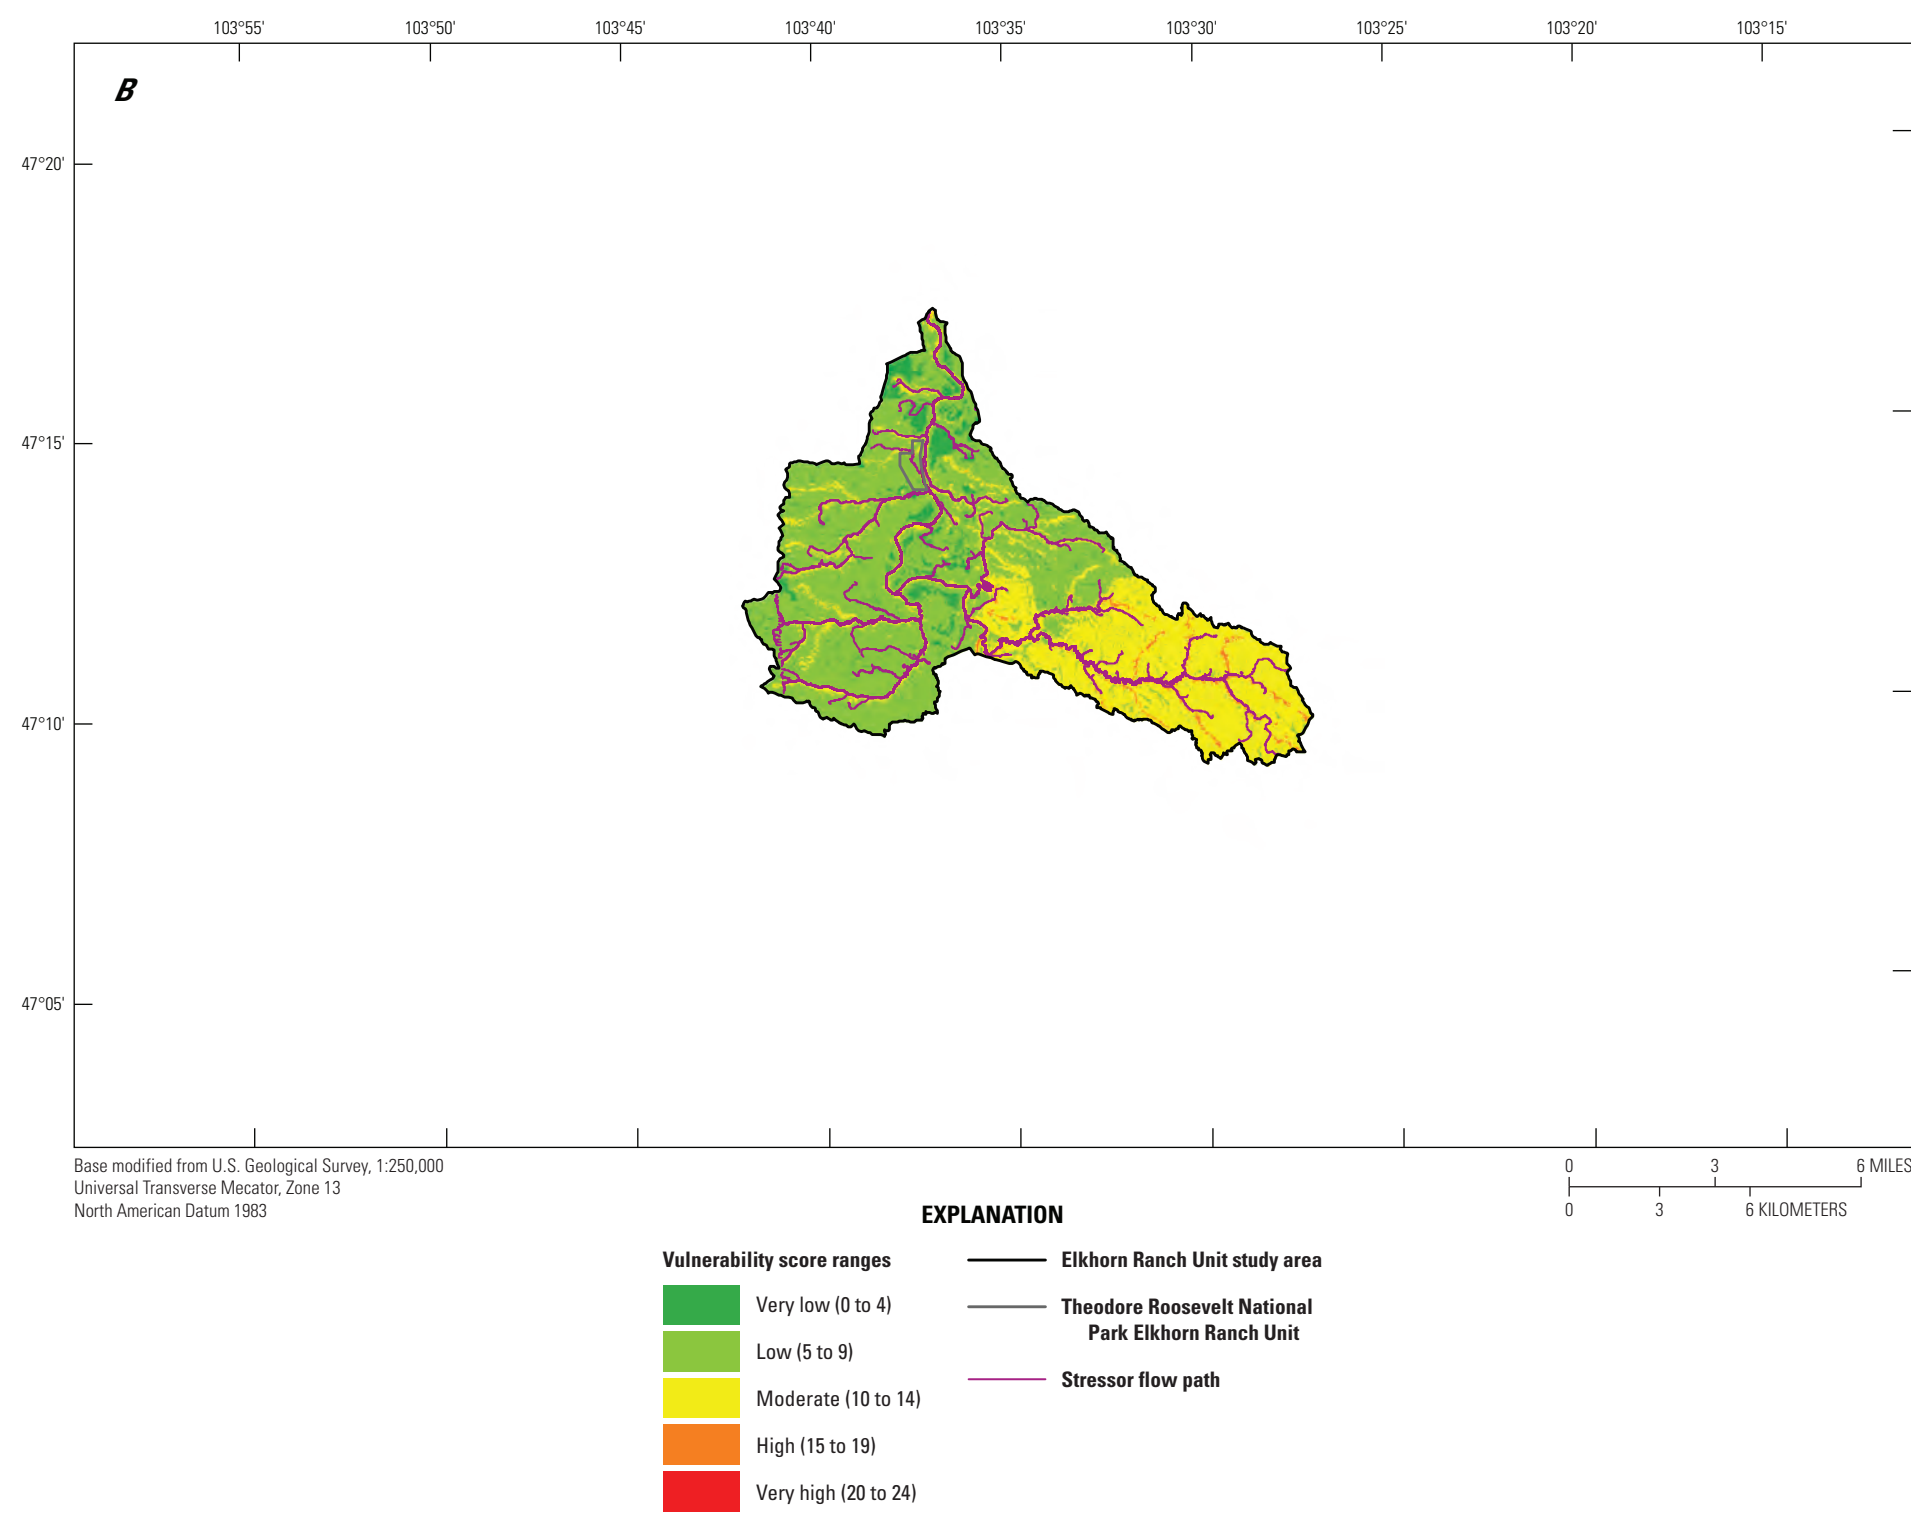
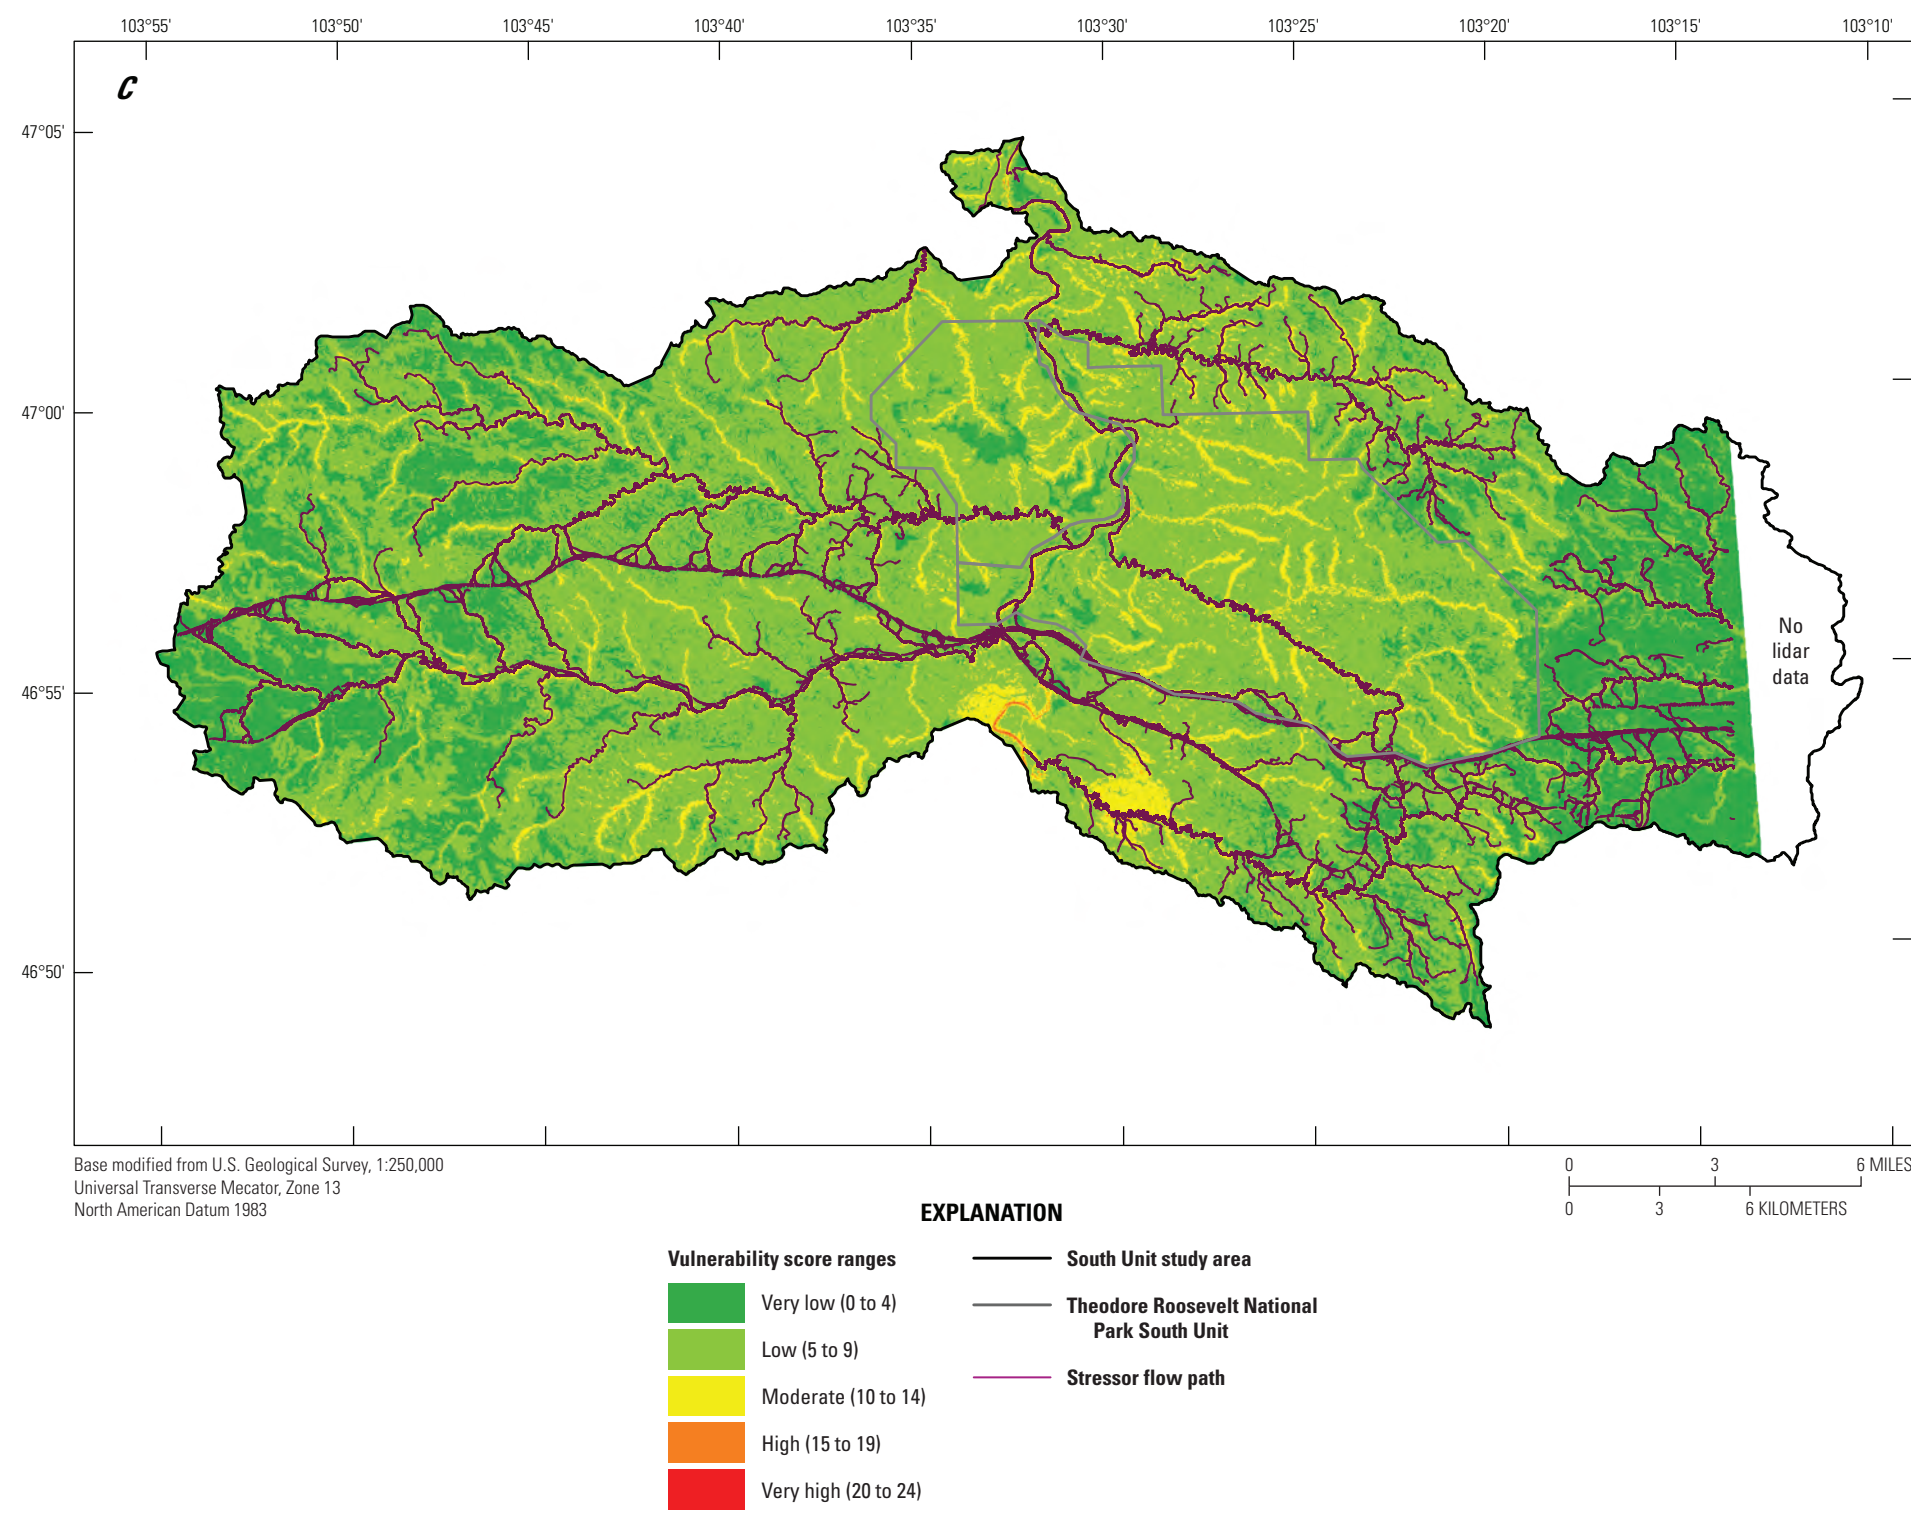
Figure 4. Maps of vulnerability scores and stressor flow paths for each unit of the study area. A, vulnerability scores and stressor flow paths within the North Unit; B, vulnerability scores and stressor flow paths within the Elkhorn Ranch Unit; C, vulnerability scores and stressor flow paths within the South Unit.
