Bathymetric Contour Map, Surface Area and Capacity Table, and Bathymetric Change Map for Maysville Reservoir near Maysville, Missouri, 2019

By
Richard J. Huizinga, Lindi D. Oyley, and Benjamin C. Rivers
2022

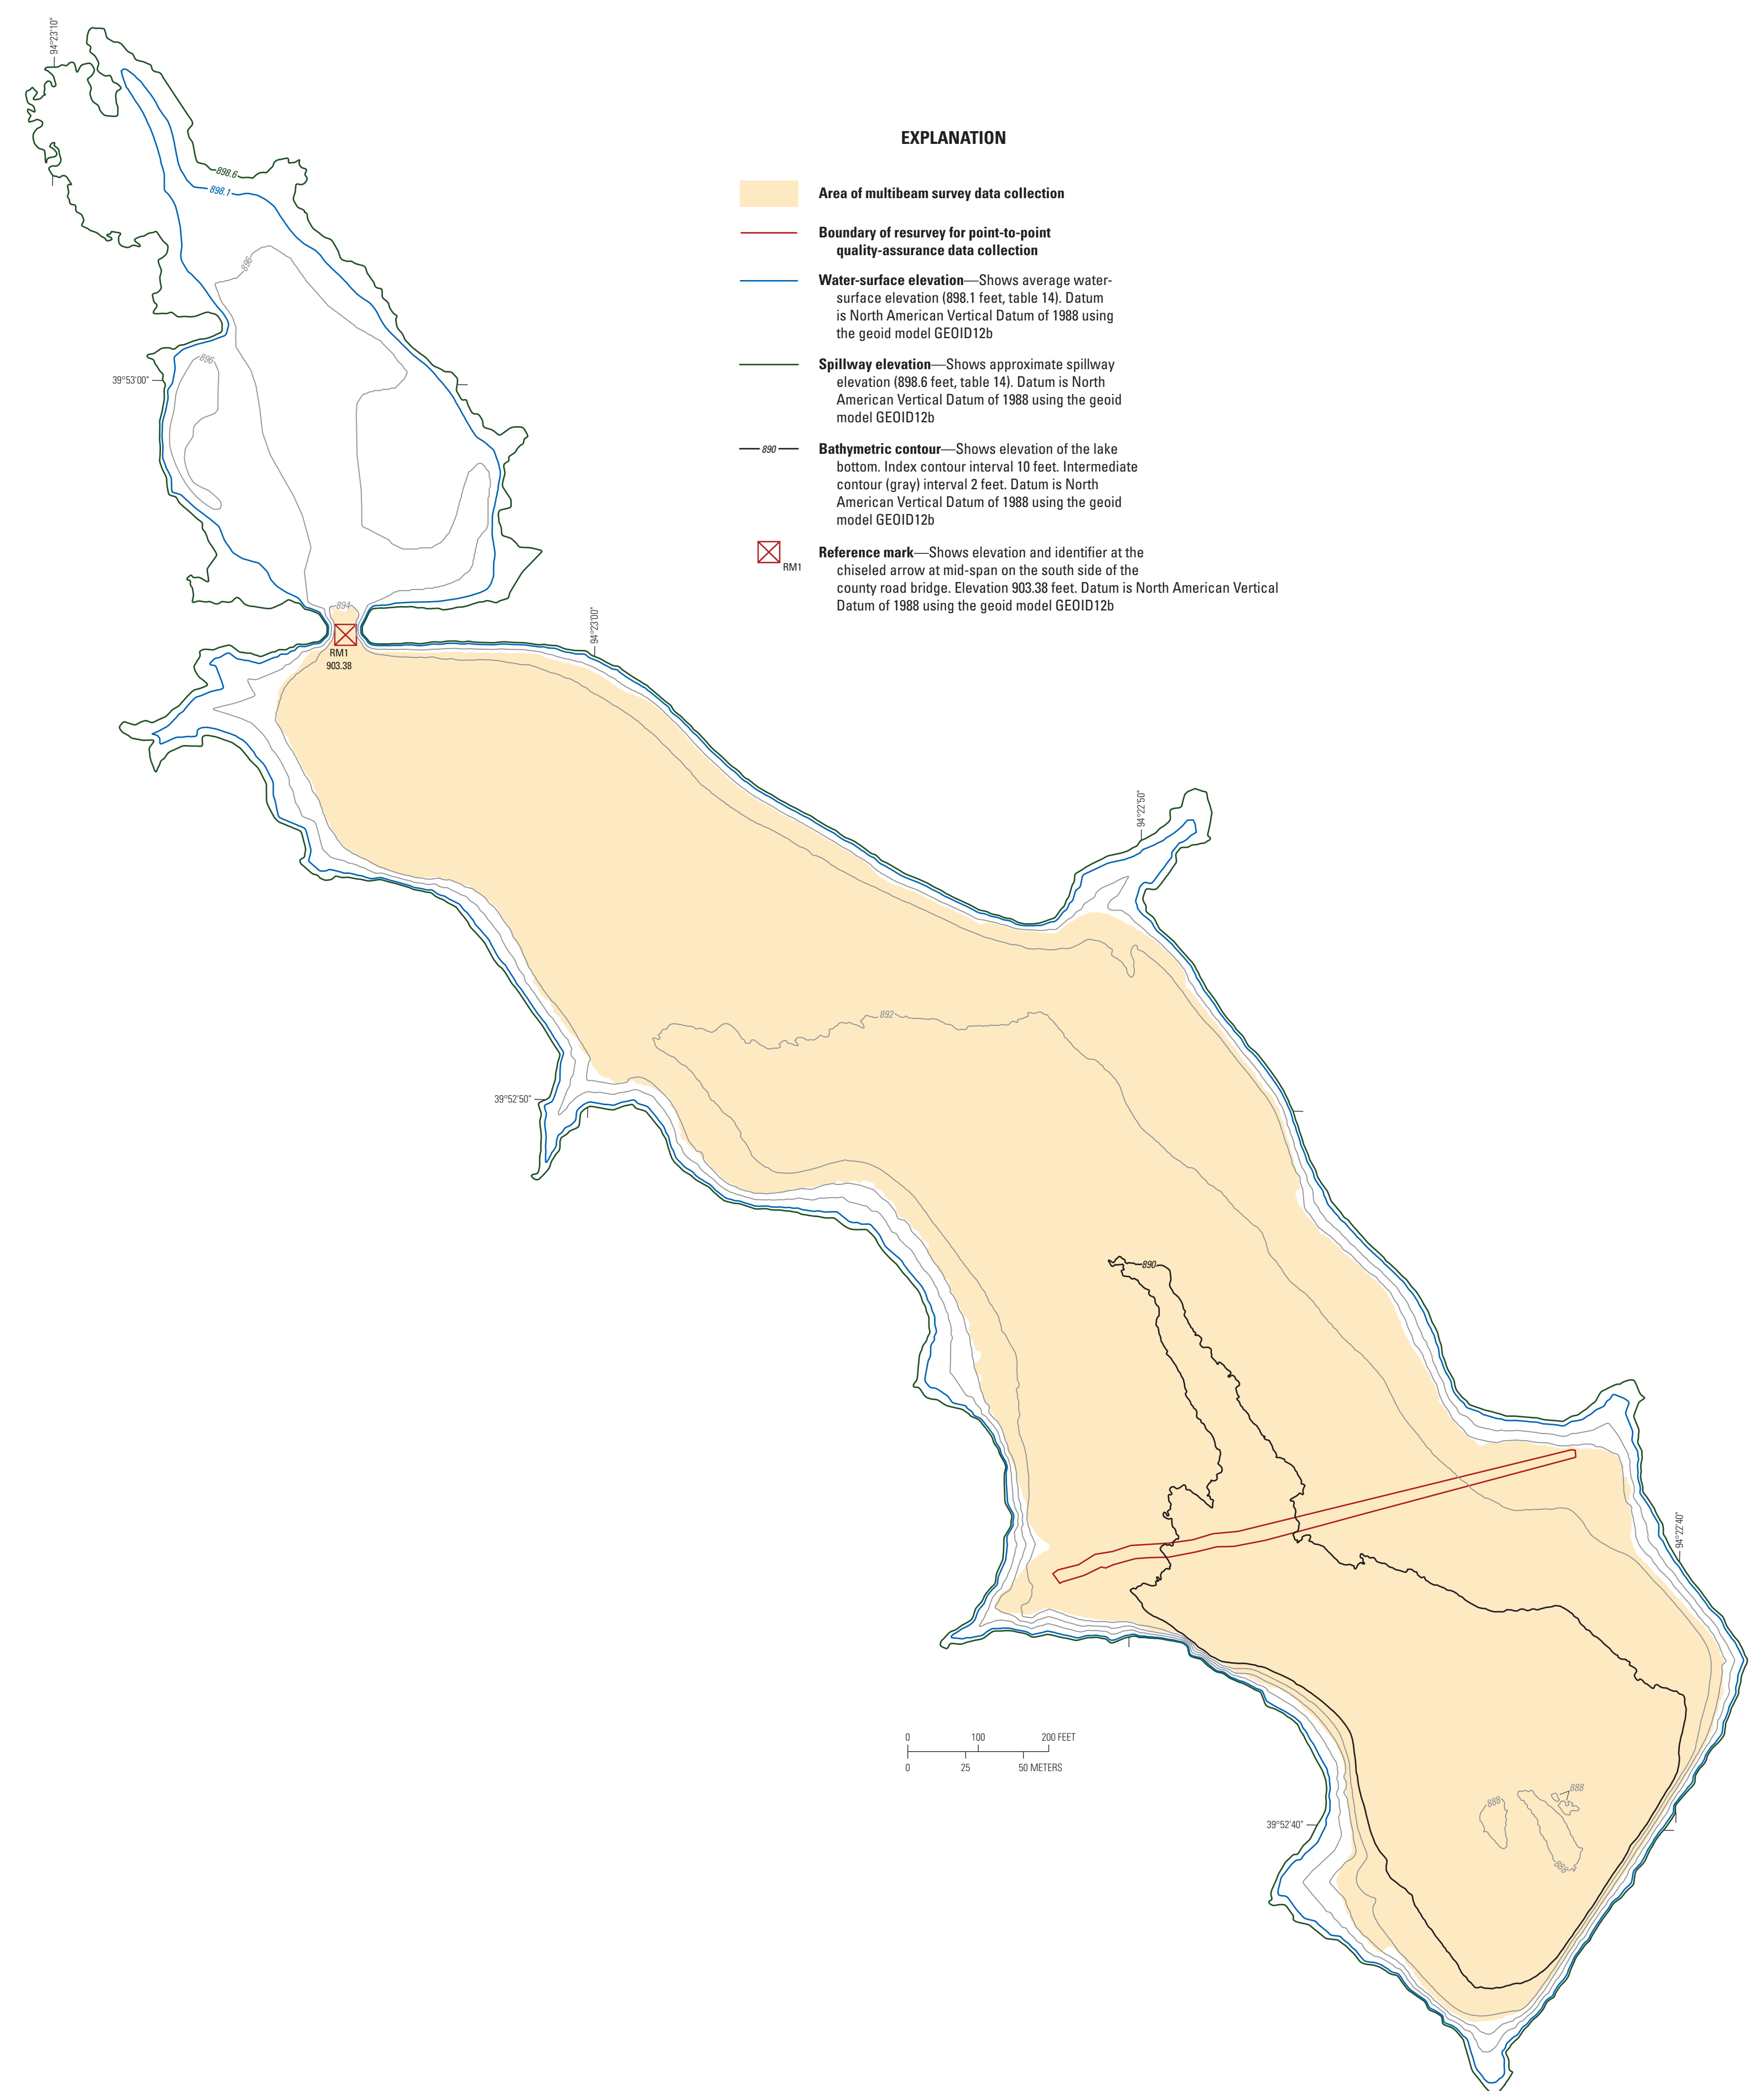
Figure 45. Bathymetric contours for Maysville Reservoir (lake 10; fig. 1; table 1) near Maysville, Missouri, resulting from a survey on September 7, 2019.

[Spillway elevation is about 898.6 feet (fig. 45); the average water-surface elevation during the survey was about 898.1 feet (row shaded in the table)]
