## Landslides Triggered by the 2016–2017 Storm Season, Eastern San Francisco Bay Region, California

By  
Skye C. Corbett and Brian D. Collins  
2023

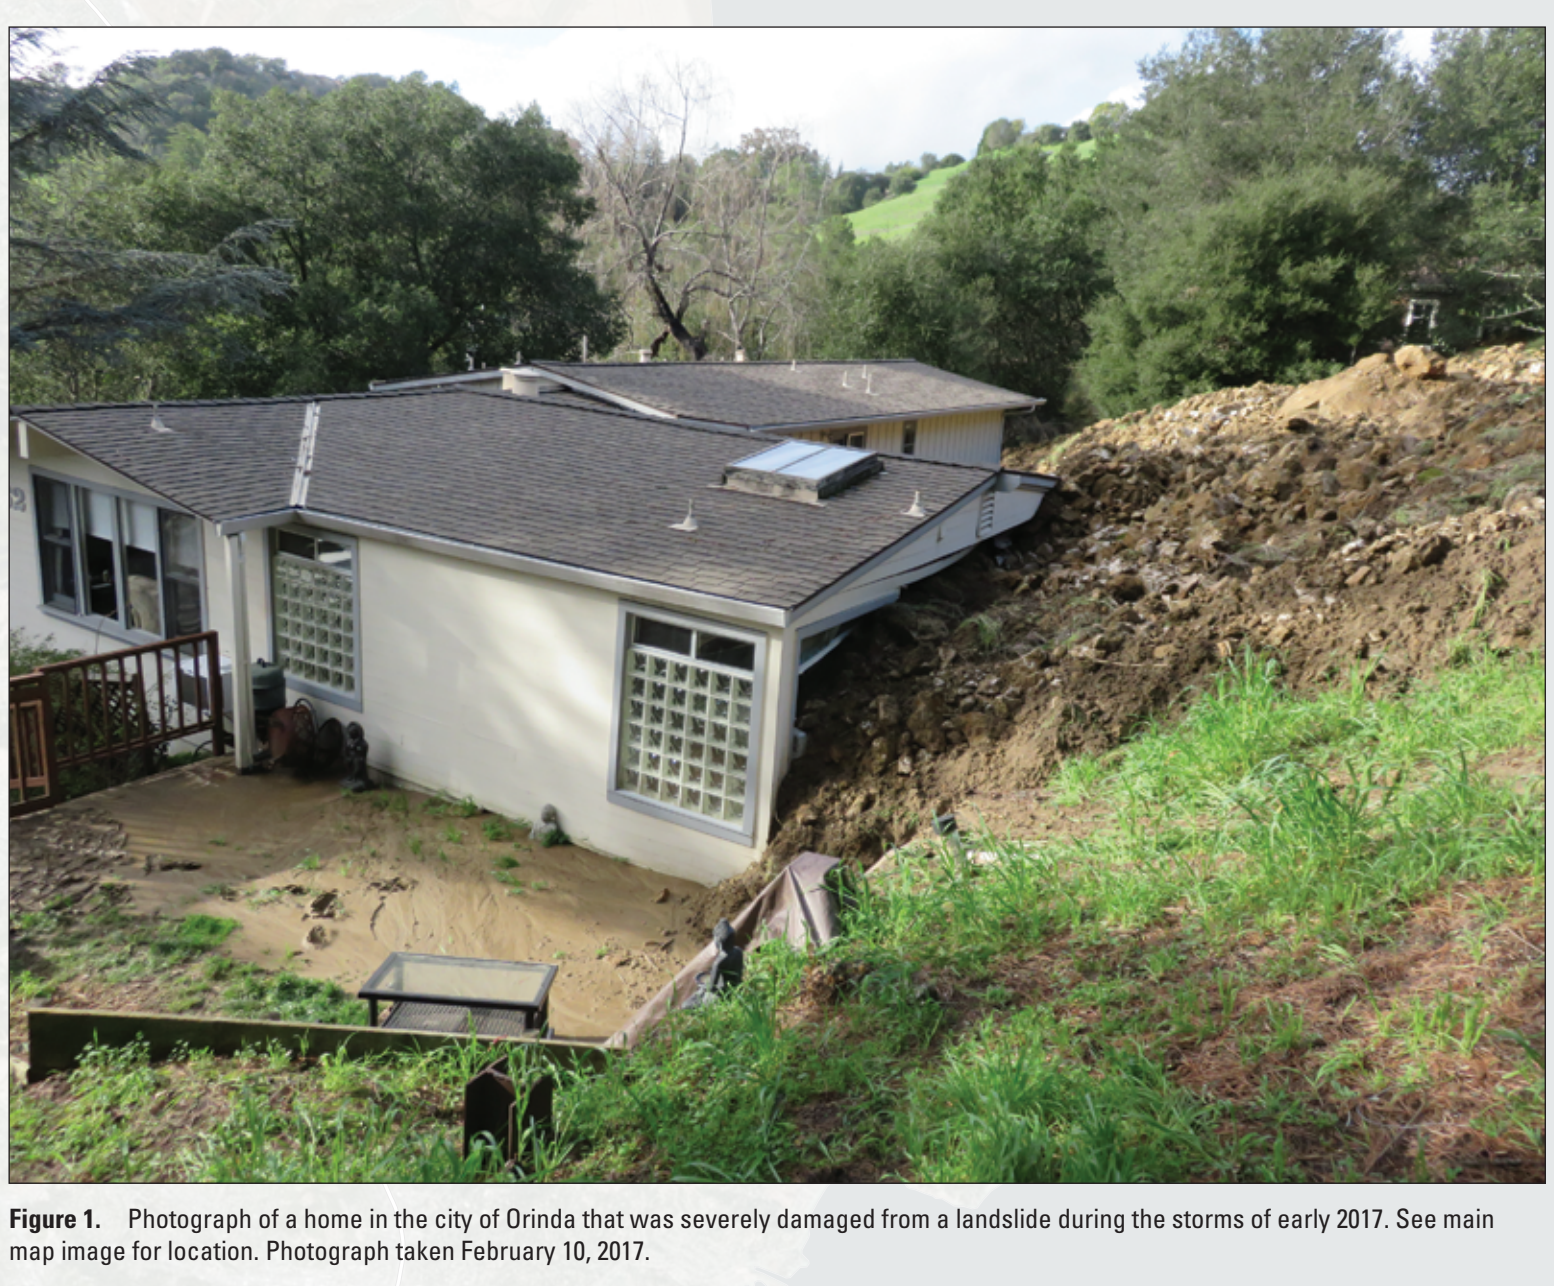
Figure 1. Photograph of a home in the city of Orinda that was severely damaged from a landslide during the storms of early 2017. See main map image for location. Photograph taken February 10, 2017.

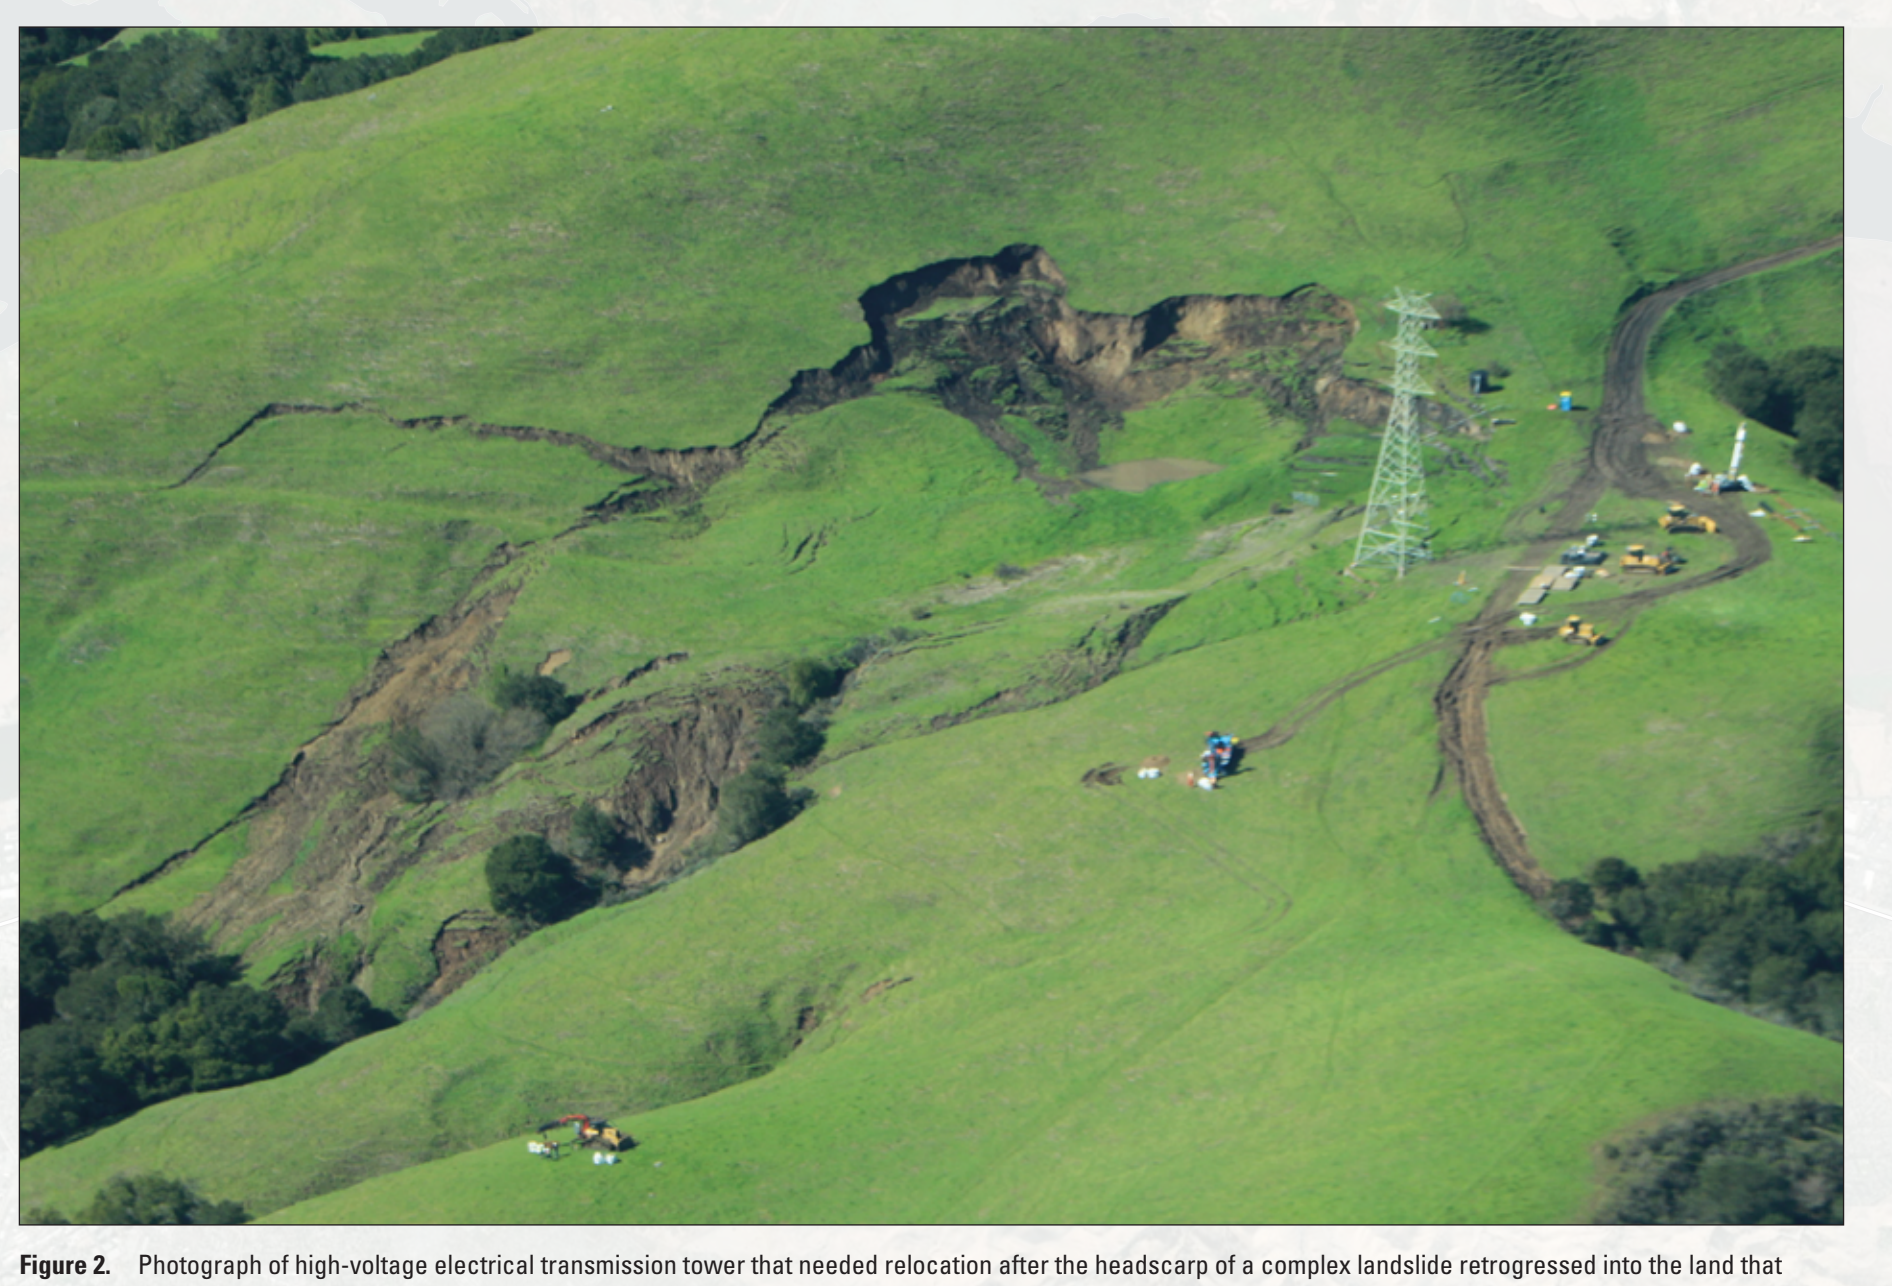
Figure 2. Photograph of high-voltage electrical transmission tower that needed relocation after the headscarp of a complex landslide retrogressed into the land that supported its foundation during the storms of early 2017. See main map image for location. Photograph taken February 23, 2017.

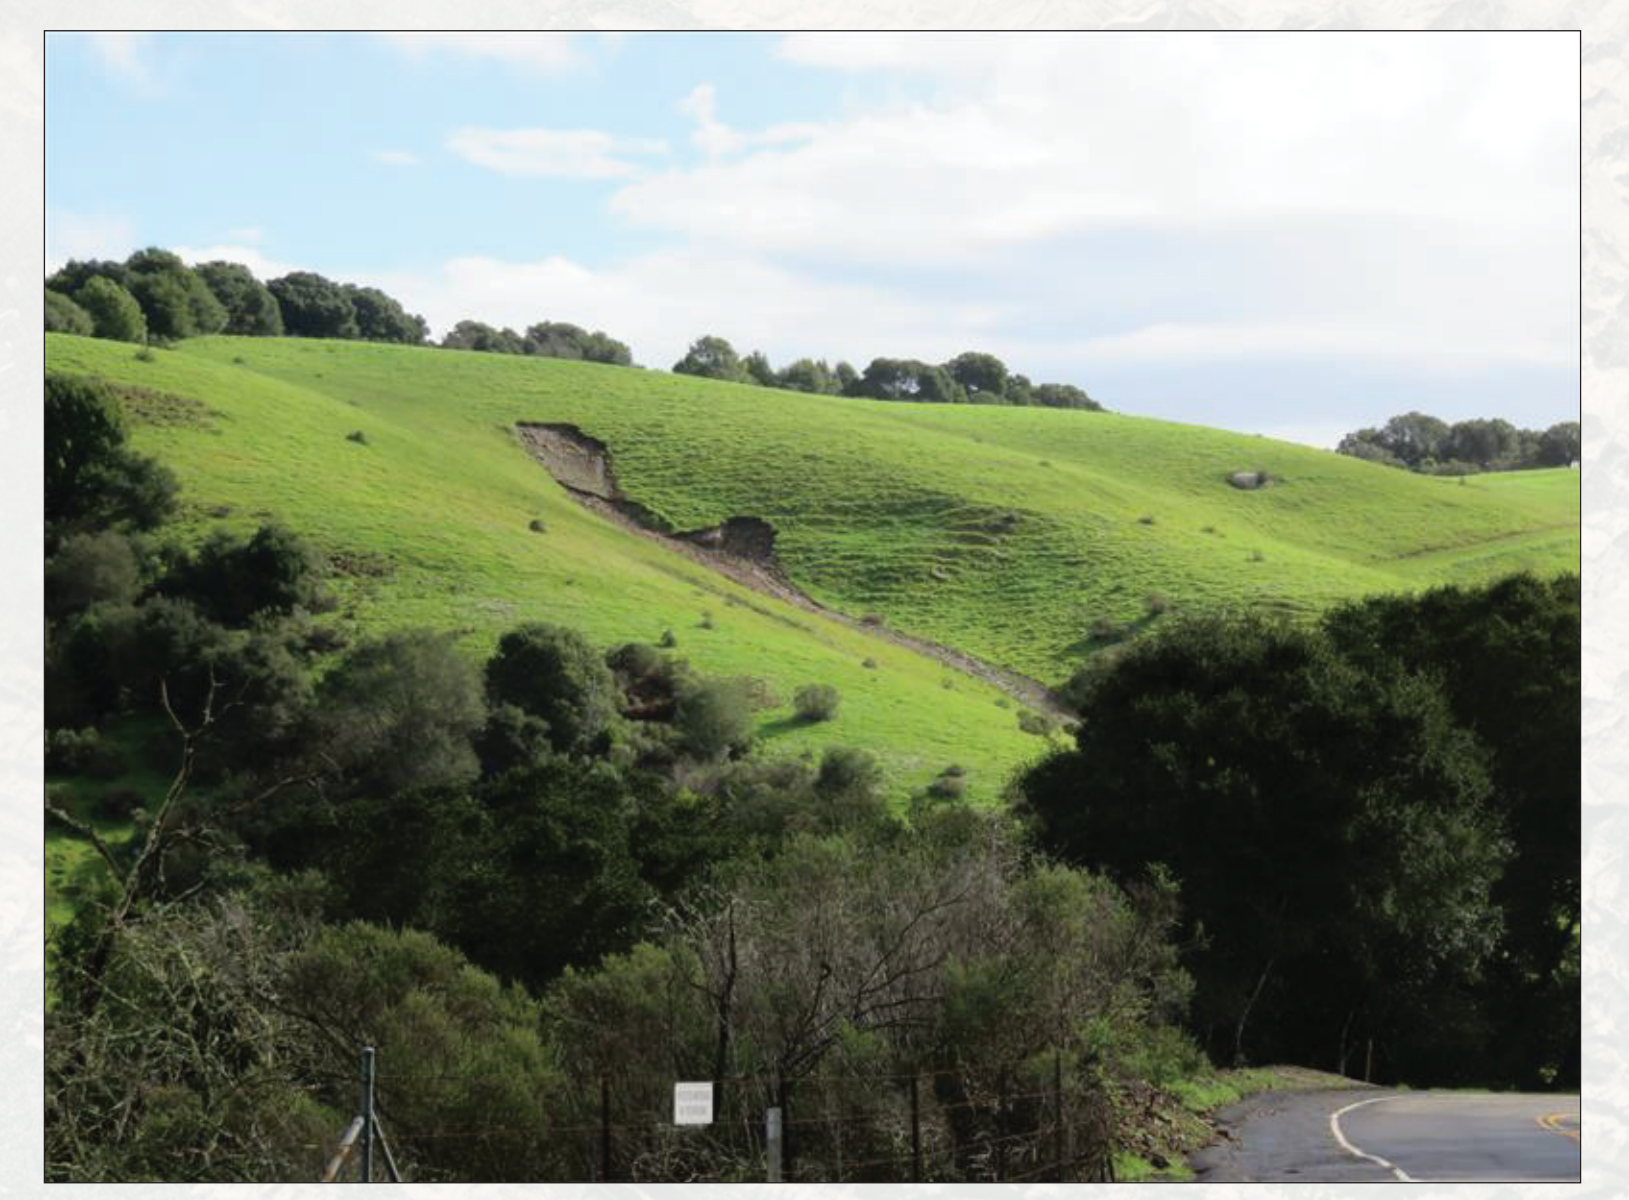
Figure 3. Photograph showing a debris flow, typical of many landslides that occurred throughout open spaces in the San Francisco Bay region during the storms of early 2017. See main map image for location. Photograph taken February 21, 2017.

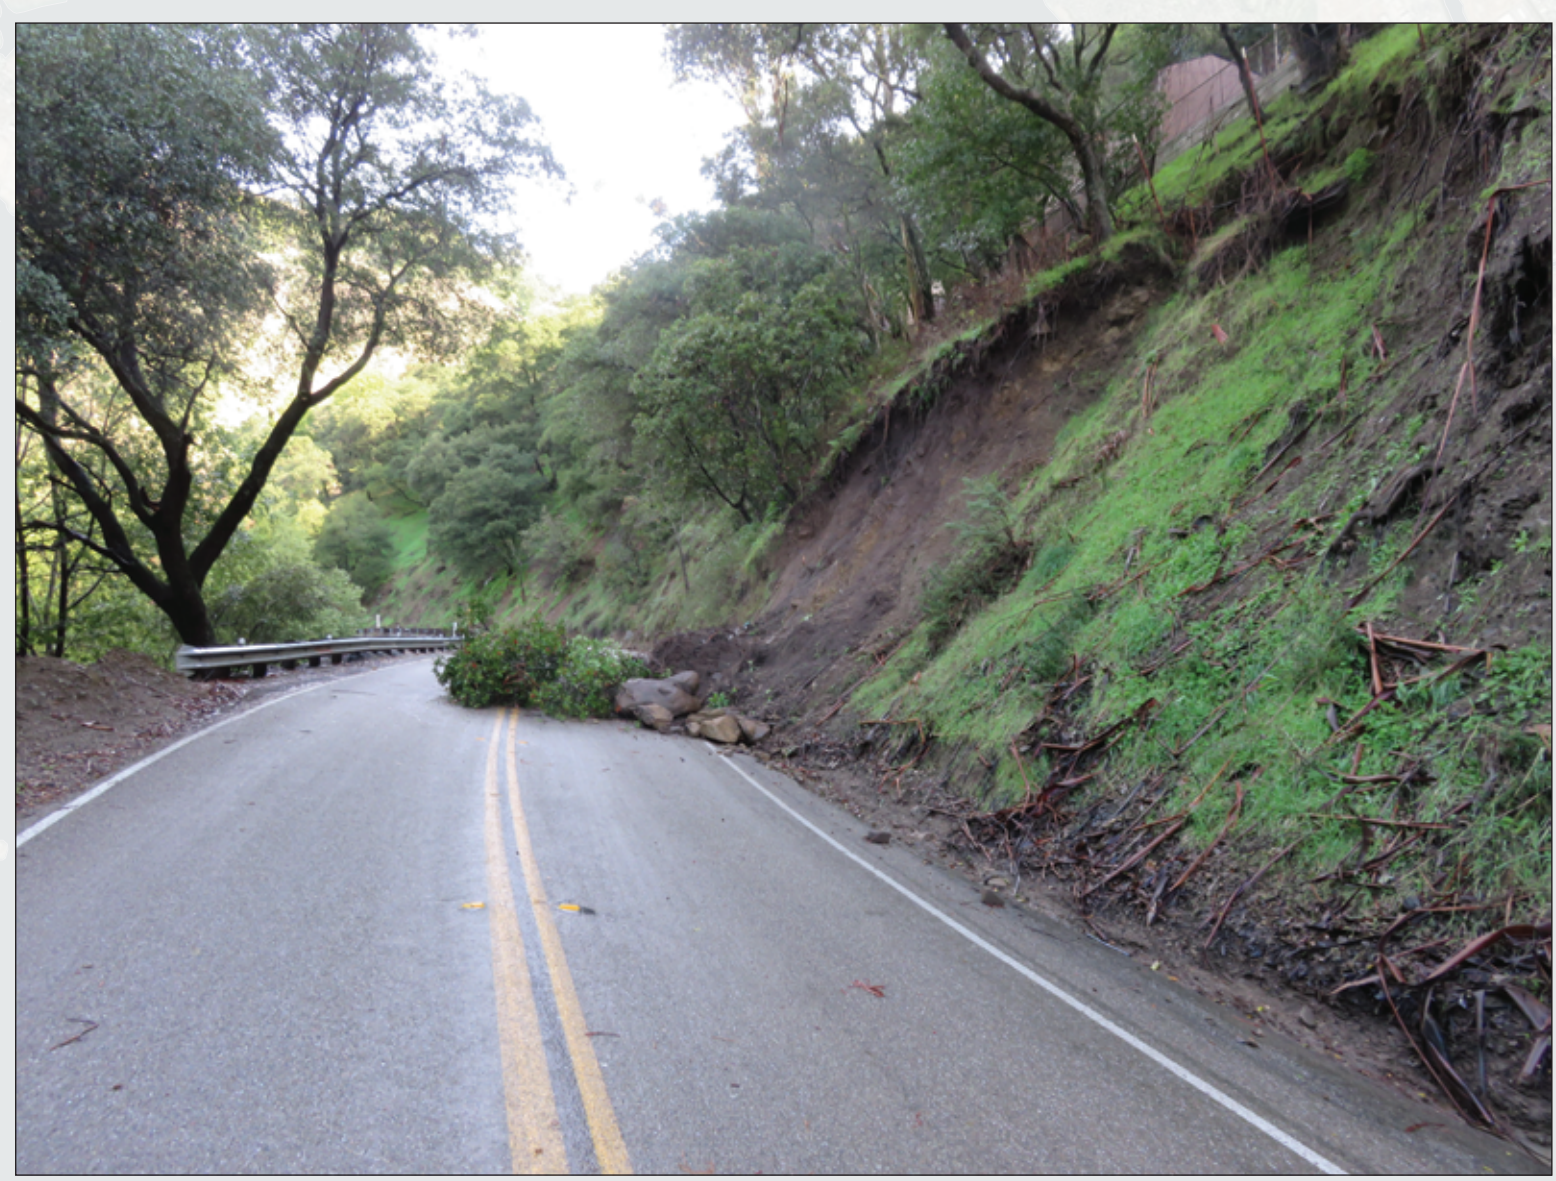
Figure 4. Photograph showing a road partly blocked by a shallow landslide along a steep cut slope, one of many blockages that occurred during the storms of early 2017. Some roads remained blocked for several months as crews worked to stabilize saturated hillslopes. See main map image for location. Photograph taken January 23, 2017.

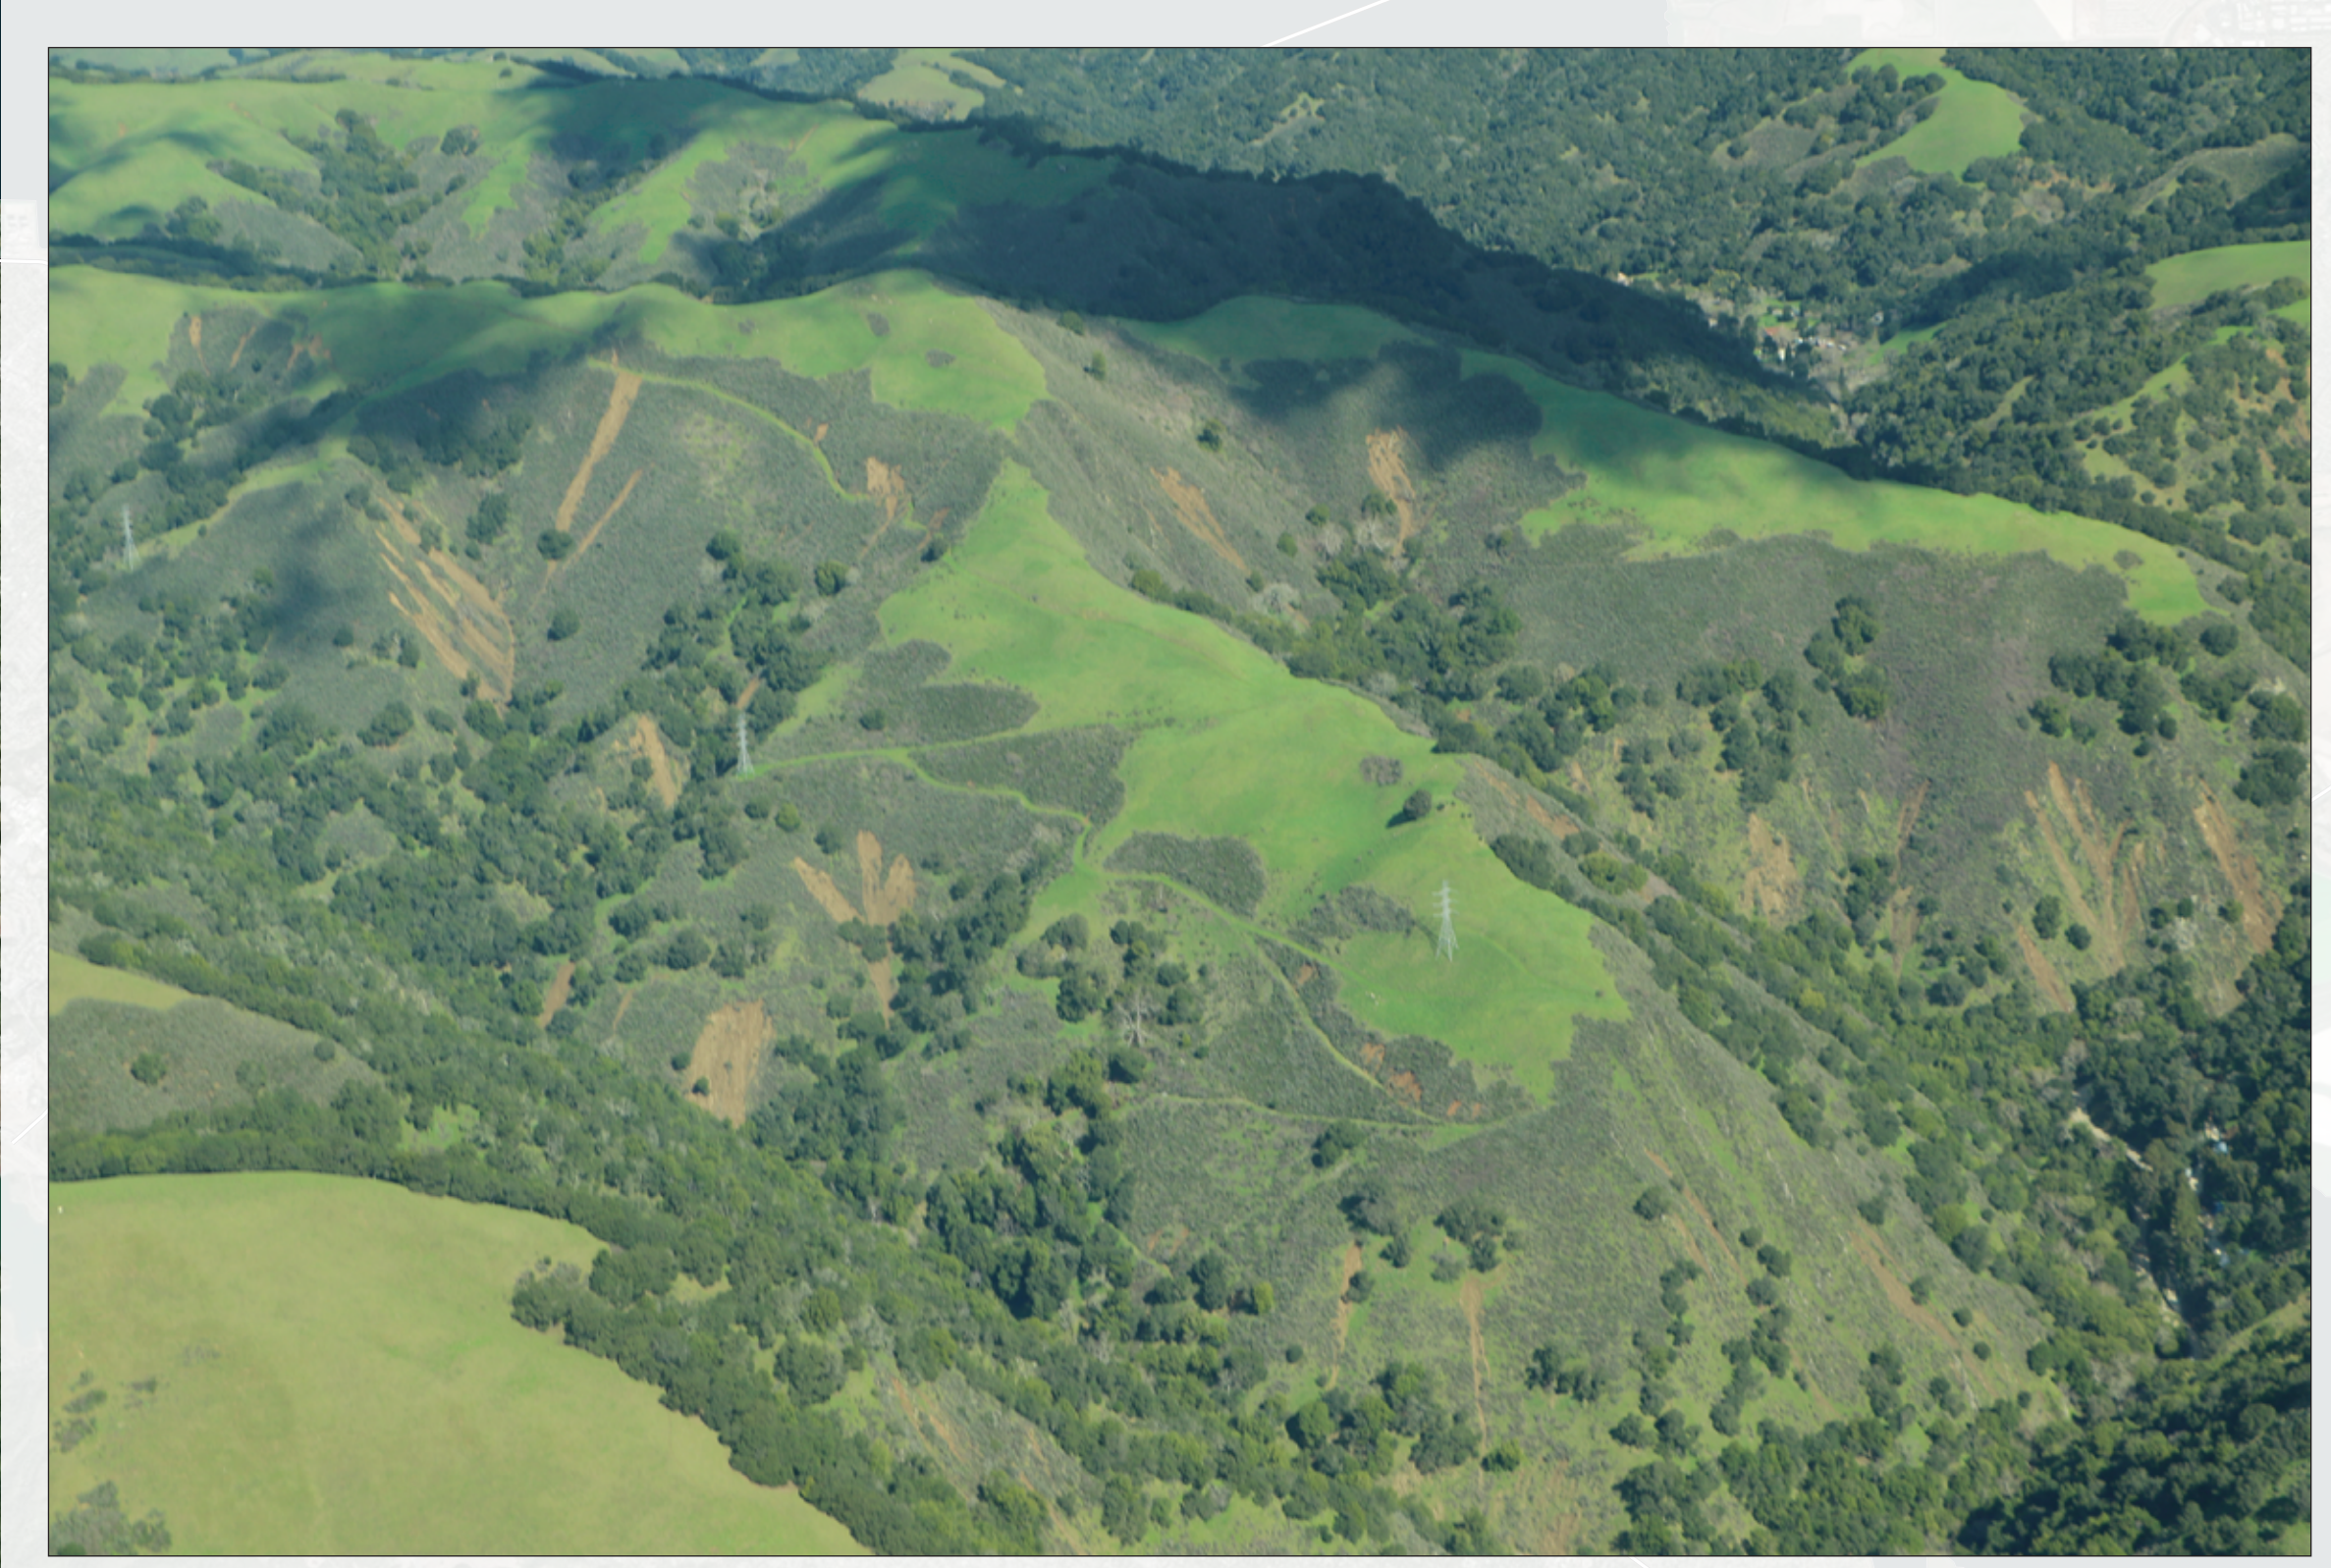
Figure 5. Aerial photograph showing hillslopes decimated by numerous shallow landslides (light brown scars on the hillsides) during the storms of early 2017. Debris from multiple landslide source areas coalesced into drainages and creeks. See main map image for location. Photograph taken February 23, 2017.

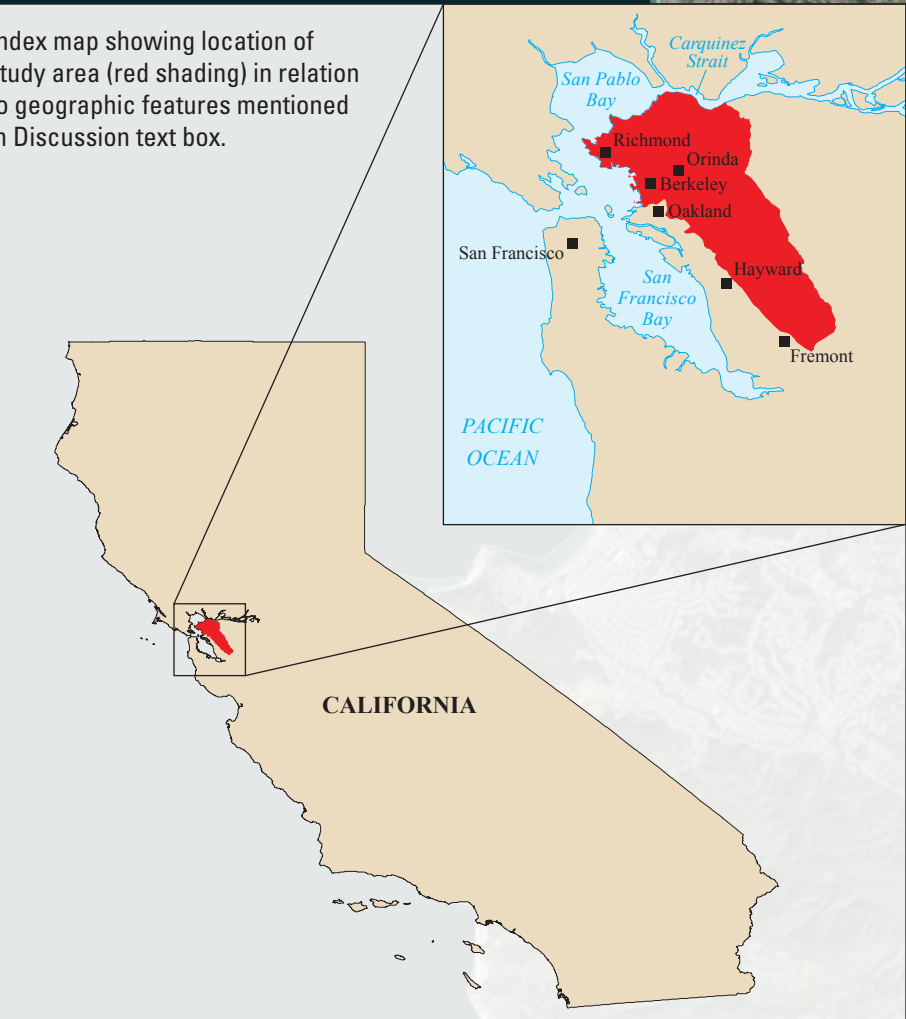
**EXPLANATION**

Landslide headscarp location

Figure number—Showing approximate location where photograph in figure was taken

The winter rainy season of 2016–2017 brought abundant rainfall to the State of California and to the San Francisco Bay region. In January and February of 2017, intense rainfall from strong winter storms saturated soils in the region and triggered thousands of shallow landslides. The highest concentration of these landslides was in the eastern part of the bay region, where landslides in the hills east of the Cities of Richmond, Berkeley, Oakland, Hayward, and Fremont (see main map for locations) damaged homes, displaced a major electrical transmission-line tower, and blocked several heavily traveled roadways.
