# Hydrologic, Ecologic, and Geomorphic Responses of Brewery Creek to Construction of a Residential Subdivision, Dane County, Wisconsin, 1999–2002

Scientific Investigations Report 2004–5156

By William R. Selbig, Peter L. Jopke, David W. Marshall, and Michael J. Sorge

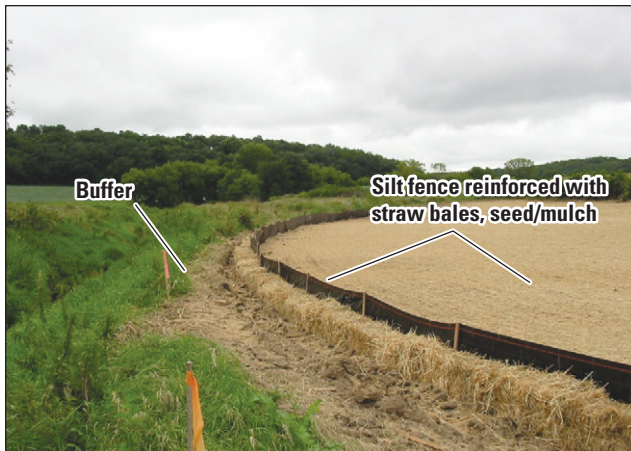
**Figure 3.** Example of erosion-control practices at the St. Francis residential subdivision, Dane County, Wis. (View looking upstream).

soil loss of 7.5 ton/acre/yr. Practices included installing silt fence reinforced with straw bales, maintaining vegetative buffers (fig. 3), sequencing construction, deep tilling to minimize compaction, temporary seeding of soil stockpiles, protecting inlets, emplacing stone tracking pads, and building temporary earthen berms.

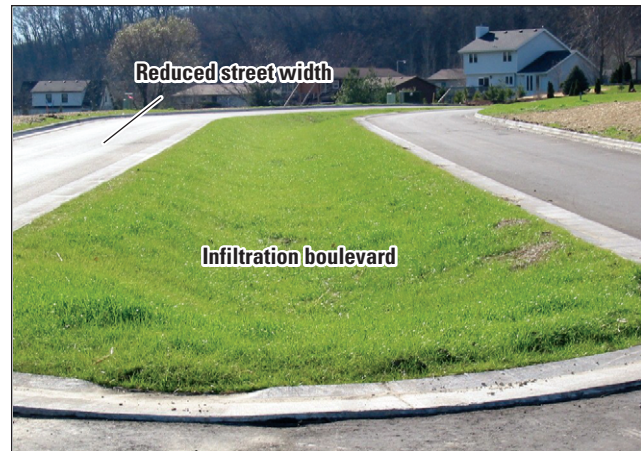
**Figure 4.** Example of stormwater-management practices at the St. Francis residential subdivision, Dane County, Wis.

Stormwater-management practices included grassed swales and boulevards for infiltration and storage of runoff, reduced street widths to minimize impervious cover, protection of present woodlands, two detention and infiltration basins with stone cribs for thermal protection, maintenance of stream buffers, and use of available parkland and open space for runoff storage and infiltration. Figure 4 highlights some of the BMPs used in the development of the study area.

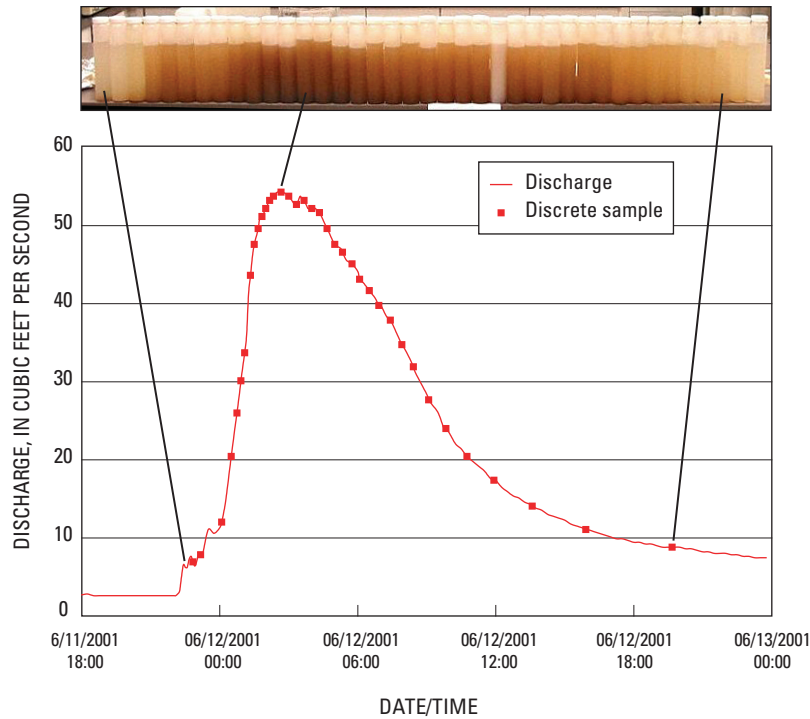
**Figure 6.** Discrete samples collected during a single storm event on Brewery Creek, Cross Plains, Wis. Note how samples change in color (change in sediment concentration) with respect to the rising and receding limb of the hydrograph.

Automated water samplers at each station collected samples for water-quality analyses. Sample collection was activated by a rise in stream level during a storm event. Once a stream-level threshold was exceeded, typically a rise of 0.10 ft above base-flow level, the volume of water passing the station was measured and accumulated at 1-minute increments until a volumetric threshold was reached. At that point, the sampler collected a discrete water sample and the volumetric counter was reset. The process was repeated until the stream level receded below the threshold.

These flow-weighted samples were collected and composited into a single water sample, then split and processed for analysis. A Teflon-coated, stainless-steel churn splitter was used to composite and split samples. Processed samples were placed on ice and taken to the Wisconsin State Laboratory of Hygiene (WSLH) within 48 hours after runoff cessation for determination of concentrations of total and suspended solids. Because each discrete sample was composited into a single event sample, the resulting concentration represents the event mean concentration (EMC). In some cases, individual discrete samples were submitted to the laboratory to gain a better understanding of concentration variations during a storm event. Figure 6 illustrates how discrete samples were acquired over a single storm event.

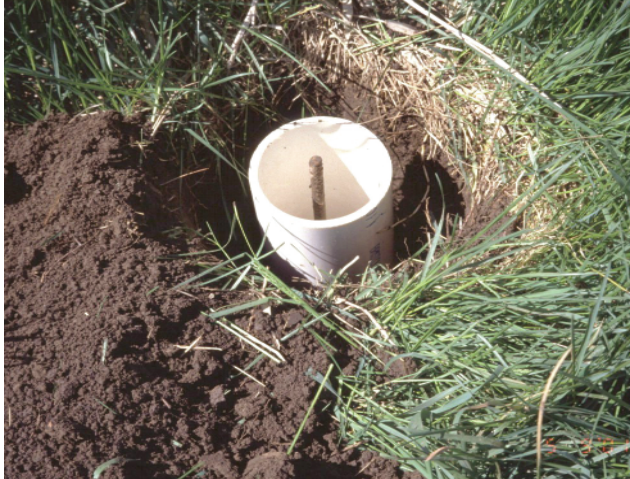
**Figure 8.** Example of permanent monument used in geomorphic assessment to mark cross sections along Brewery Creek, Cross Plains, Wis.

Fourteen cross sections were established with permanent monuments placed in representative locations (fig. 5). Monuments consisted of 4-ft sections of rebar anchored into the ground with 4-in diameter pvc tubes filled with concrete (fig. 8). Annual surveys were conducted by use of a surveyor's level. Survey points included monuments, top of bank, bankfull, bank pins, and water levels.

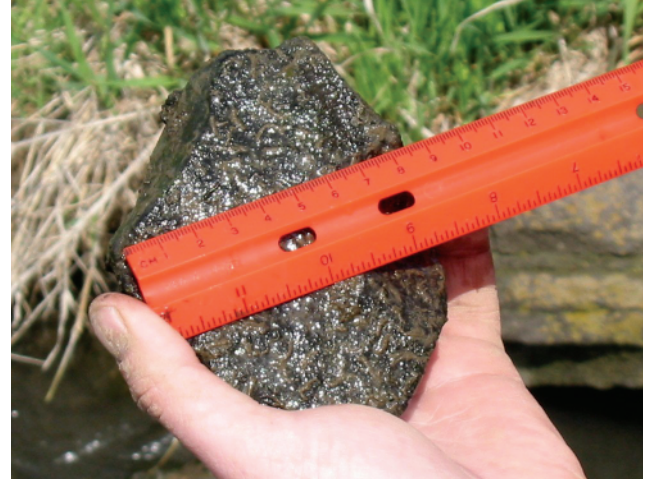
**Figure 9.** Measuring a streambed rock along the intermediate axis as part of a Wolman Pebble Count in Brewery Creek, Cross Plains, Wis.

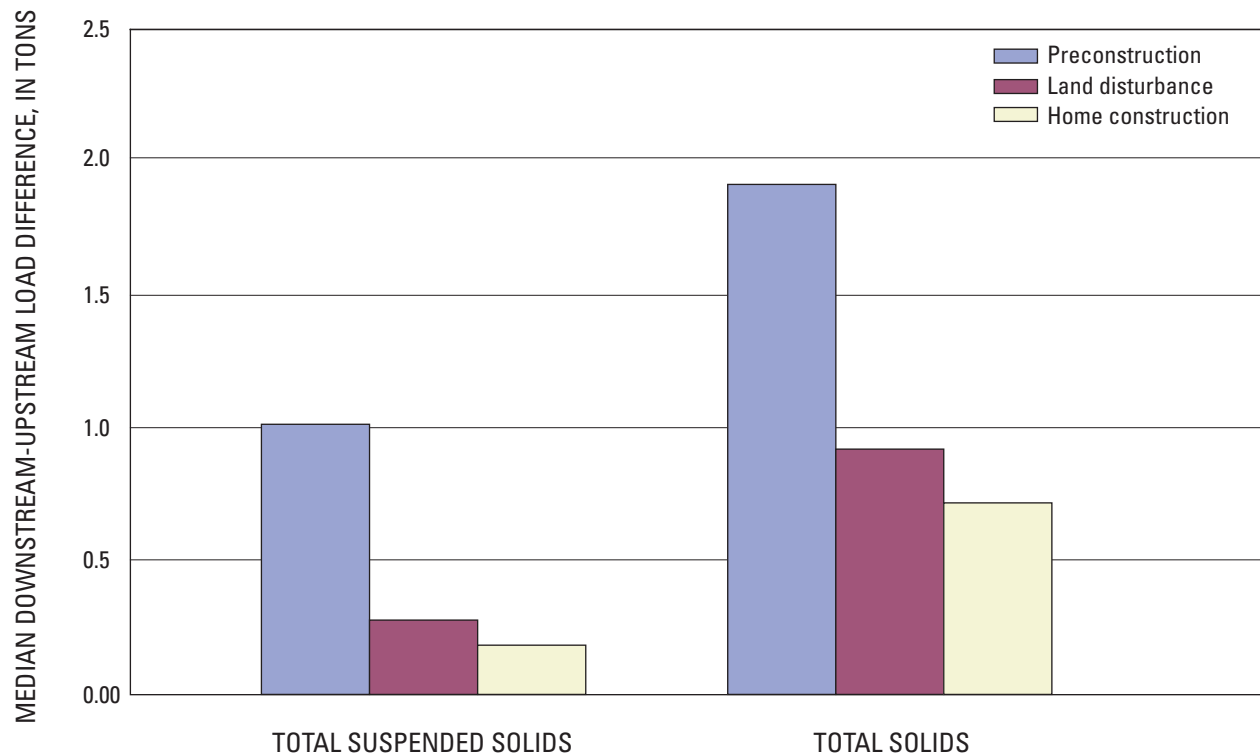
**Figure 10.** Median value of difference between downstream and upstream total solids and total suspended solids load in Brewery Creek during each phase of construction activity at the St. Francis residential subdivision, Cross Plains, Wis.

The difference between downstream and upstream loads was computed for total and suspended solids for the preconstruction, land-disturbance, and home-construction phases. Changes in the magnitude of the differences are believed to be a result of activity in the study area. The erosion-control and stormwater BMPs used at the construction site were effective at limiting the amount of solids load entering Brewery Creek (fig. 10). Each bar represents the median of all differences between the downstream and upstream constituent loads for the preconstruction, land-disturbance, and home-construction storm-runoff periods. Differences in median total solids loads decreased by 52 percent between the preconstruction and land-disturbance phases and 22 percent between the land-disturbance and home-construction phases (fig. 10). Similarly, downstream-upstream differences in suspended-solids loads decreased 72 and 37 percent, respectively (fig. 10).

determine whether the contribution of loads significantly increased or decreased from one phase of construction to the next. The null hypothesis states there is no change in the magnitude of the difference between the upstream and downstream solids load from one phase of construction to the next. The alternative hypothesis suggests there is a significant change in the magnitude of the difference between the downstream and upstream solids load from one phase of construction to the next and this change is related to BMP effectiveness. Results from the test, at the 90-percent confidence level, failed to reject the null hypothesis. The data provide insufficient evidence to report an increase or decrease in solids load from preconstruction levels. Because the test did not indicate a significant increase in solids load, one could imply the BMP systems implemented before and during the land-disturbance and home-construction phases are at least somewhat effective at limiting the amount of solids entrained in runoff from reaching Brewery Creek. This limitation is supported by the reduction in the magnitude of differences between downstream and upstream total solids and total suspended solids load from one phase of construction to the next (fig. 10).

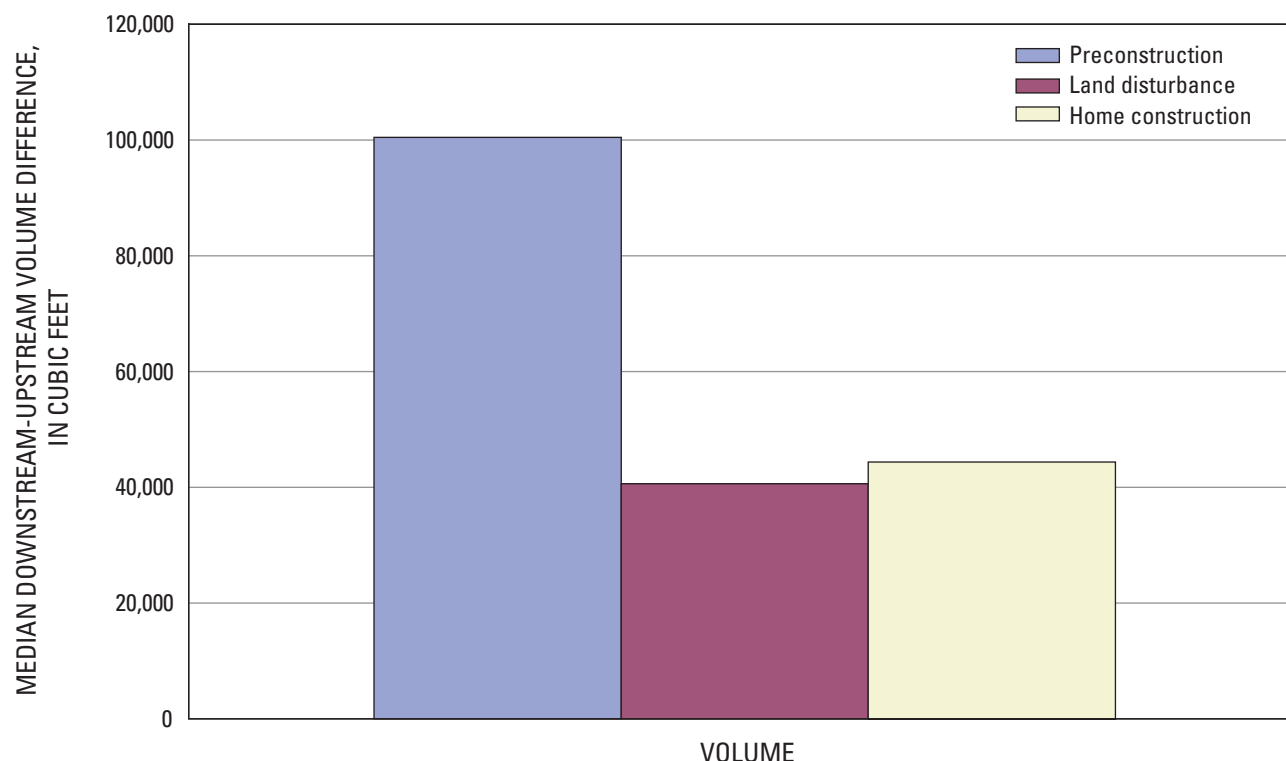
**Figure 11.** Median value of difference between downstream and upstream event volume in Brewery Creek during each phase of construction activity at the St. Francis residential subdivision, Cross Plains, Wis.

Median runoff volumes appeared to increase slightly between the land-disturbance to the home-construction phases (fig. 11); however, statistical tests indicated no significant difference in runoff volume between these two phases. The apparent increase could be due, in part, to the failure of a runoff infiltration pond during the home-construction phase. Overall, the BMPs utilized within the study area were able to reduce the amount of stormwater runoff entering Brewery Creek.

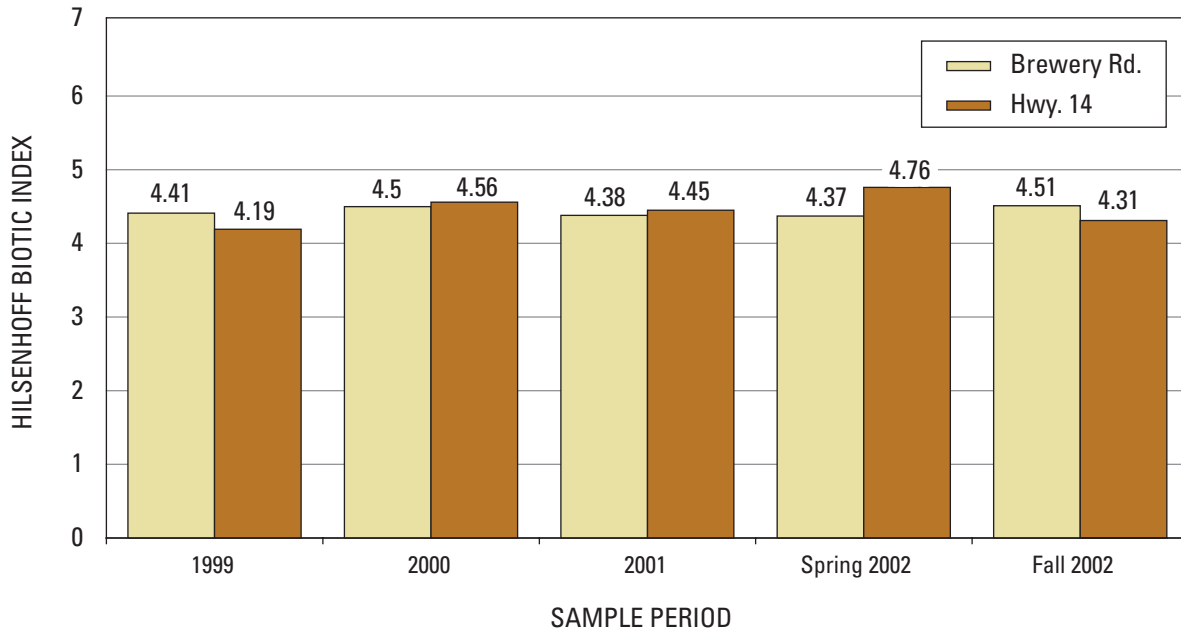
**Figure 12.** Hilsenhoff Biotic Index scores at two locations on Brewery Creek, Cross Plains, Wis.

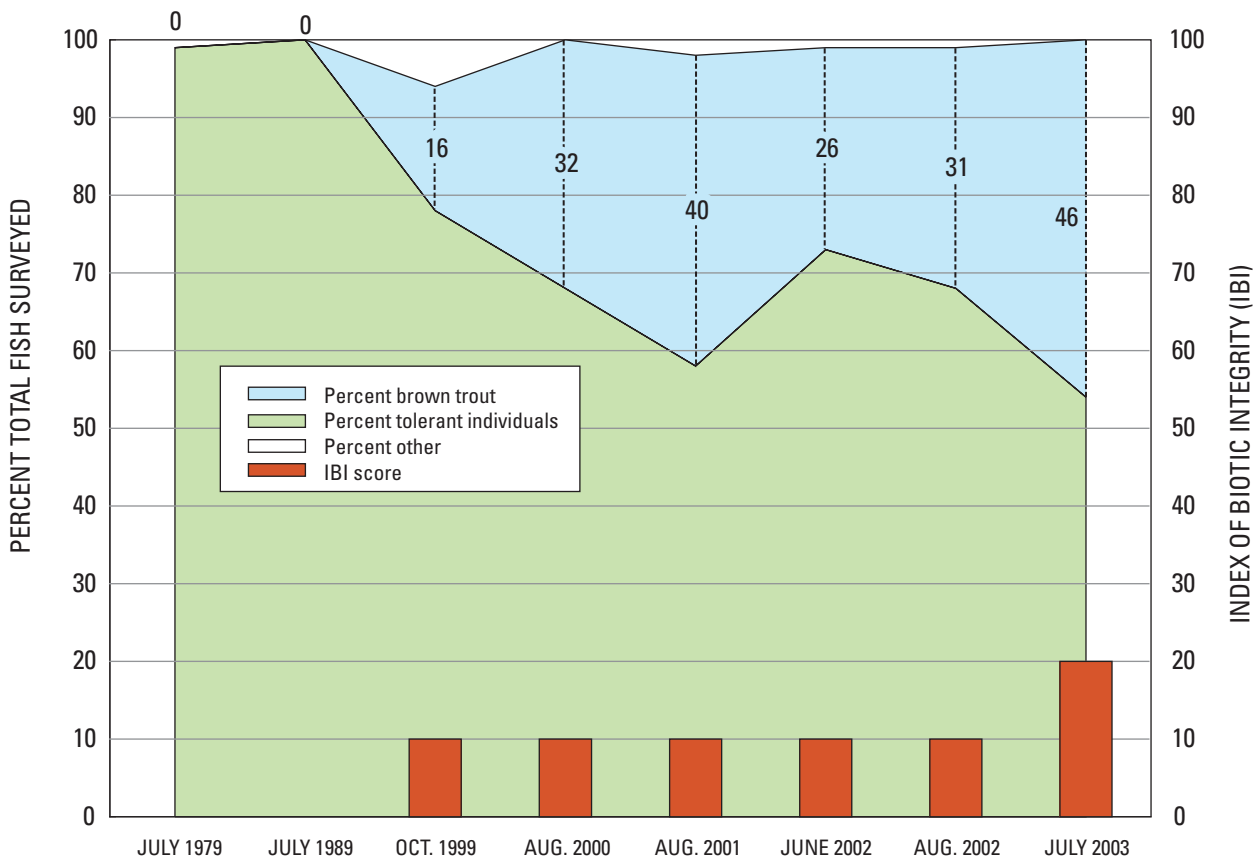
**Figure 13.** Results of fish-shocking surveys and subsequent Index of Biotic Integrity in Brewery Creek, Cross Plains, Wis. (1999–2003). [Pre-1999 data from Fago, 1979; and Wisconsin Department of Natural Resources, 1989].

were found. The proportion of tolerant individuals ranged from 54 percent to 78 percent (fig. 13) and was the primary reason IBI scores remained low throughout the entire study. IBI scores of 10 or 20 (fig. 13) were both within the "poor" range. Brown trout were relatively abundant in Brewery Creek with numbers ranging from 22 to 46 (fig. 14) and percentages ranging from 16 percent to 46 percent (fig. 13). Brown trout size structure was variable during the study, with greater numbers of juvenile individuals from 1999 through 2001 and greater numbers of adults in 2002 and 2003. Trout of legal keeping size (greater than 9 in. long) ranged from 1 out of 37 in 2001 to 15 out of 26 in 2002 and 15 out of 44 in 2003 (fig. 14). The largest brown trout was 15.75 in. long.

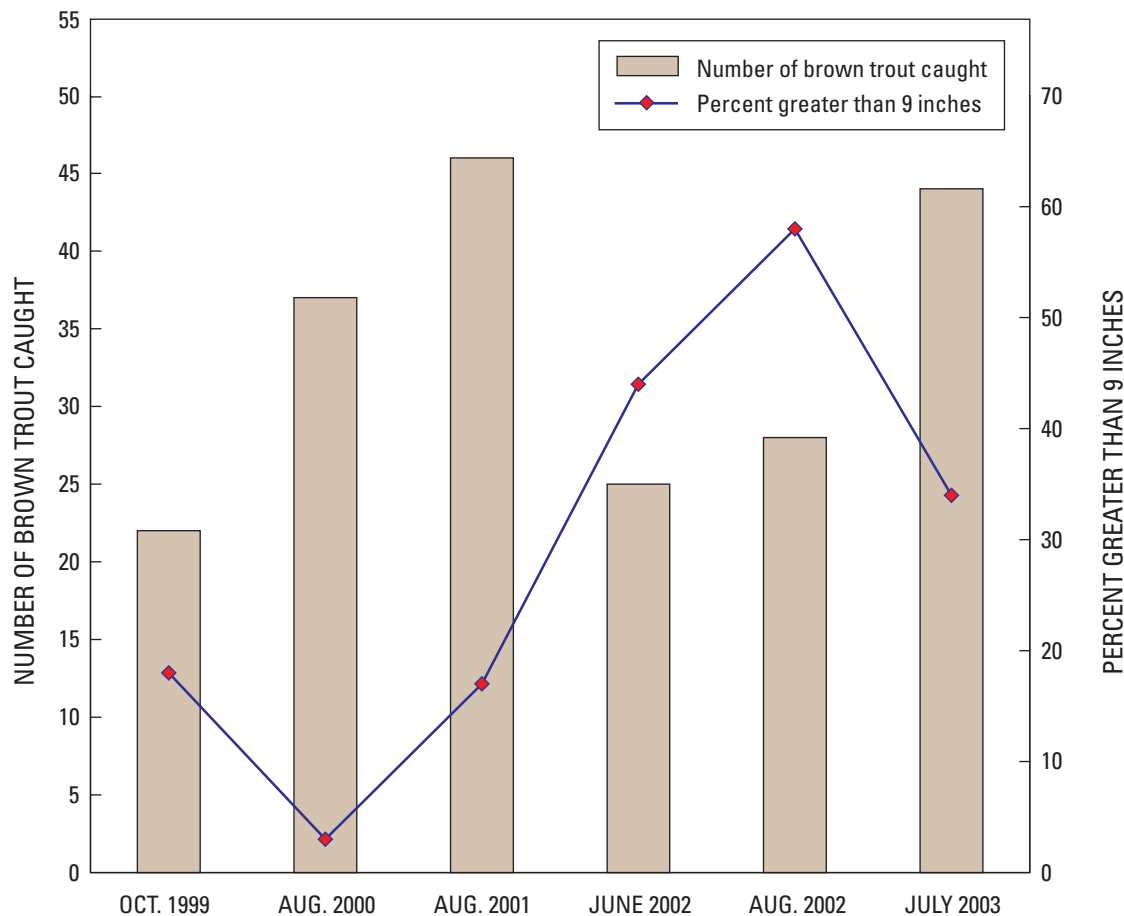
**Figure 14.** Number of brown trout measured during fish-shocking surveys in Brewery Creek, Cross Plains, Wis. (1999–2003).

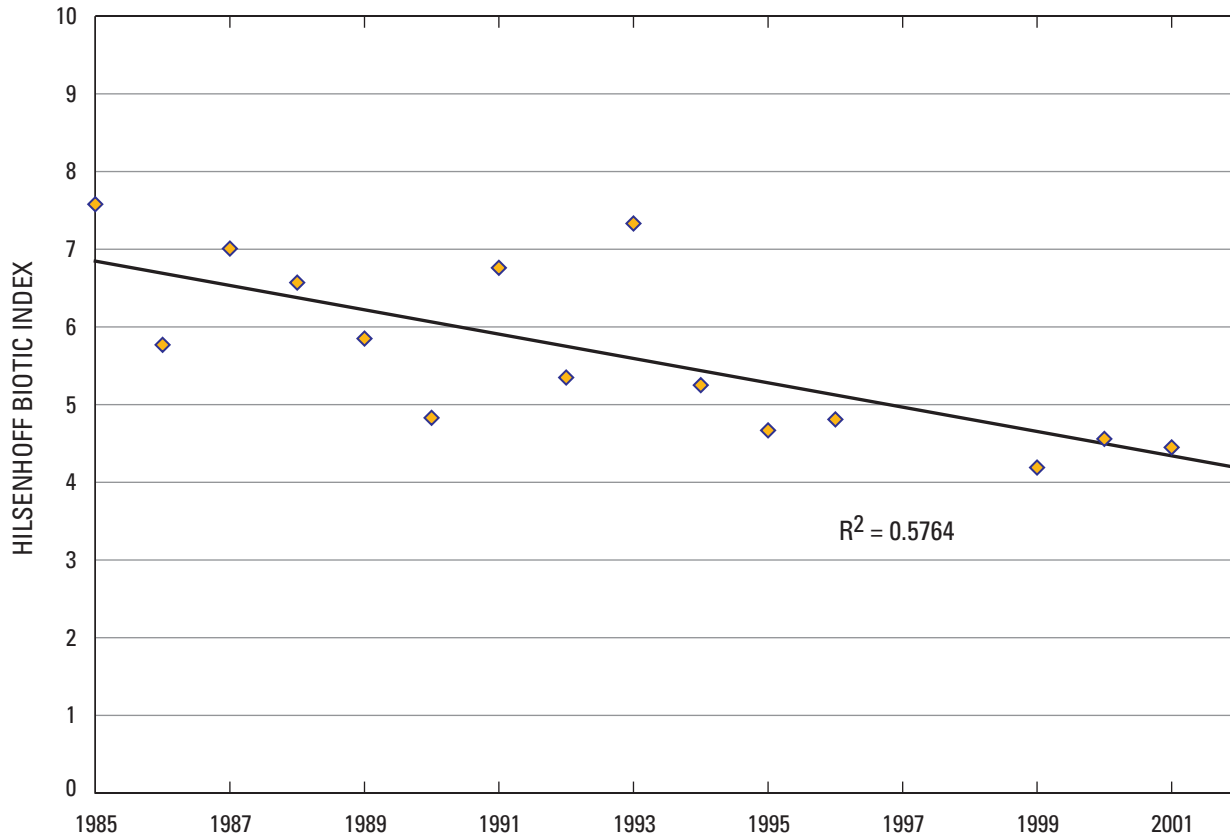
**Figure 15.** Trend in Hilsenhoff Biotic Index scores in Brewery Creek at Highway 14, Cross Plains, Wis. (1985–2002).

phosphorus or suspended-sediment concentrations over time, but ammonia concentrations did decline (Graczyk and others, 2003). This result suggests that organic loading declined. Such a decline is also reflected by a trend ( $R^2 = 0.58$ ) of improved HBI scores (fig. 15). Although fish-community data from Brewery Creek are limited, surveys done before 1990 indicate that the stream was degraded (fig. 13). No trout were found during surveys in 1979 or 1989, and IBI scores were 0 or “very poor”. Beginning in 1999, substantial brown trout numbers were found in every survey, and coldwater IBI scores improved slightly. Although the overall fish community is still considered unbalanced, the recent fish-shocking surveys are consistent with macroinvertebrate collections and indicate improved water quality and habitat conditions in Brewery Creek.

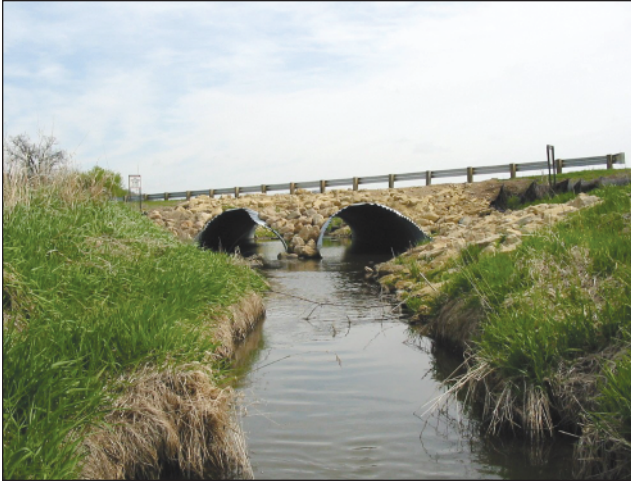
**Figure 16.** Culverts placed in Brewery Creek for road crossing (view looking upstream), Cross Plains, Wis. Note difference between the culverts and the channel width directly downstream.

the overall habitat rating remained “fair”. Installation of the culvert may also have caused changes in mean stream width and depth. These changes were a result of modifications to the stream itself and do not reflect changes caused by surface runoff because of activities in the study area.

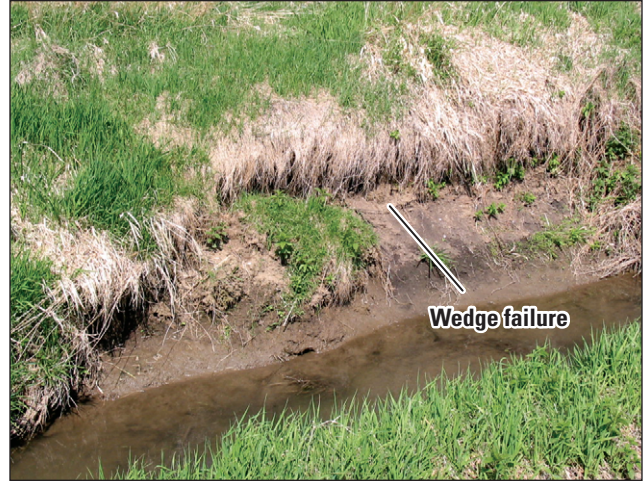
**Figure 17.** Example of gravitational streambank erosion in Brewery Creek, Cross Plains, Wis. Wedge failure leads to mass wasting of bank.

Results of the bank-pin surveys indicated failing banks at most sites. Bank pins in cross sections 1–8 (straightened reach) averaged 43.6 mm of deposition, whereas bank pins at cross sections 9–14 (meandering reach) averaged 26.4 mm of deposition at the conclusion of the study period. Bank material on Brewery Creek is primarily cohesive alluvial silt loam, making exposed banks susceptible to erosion. Although measurements indicated deposition, this was due to bank failure rather than sediment deposition on the banks. Streambank erosion processes are classified into two basic groups: gravitational or mechanical failures and tractive-force failures (O'Neill and Kuhns, 1994). The failing banks on Brewery Creek were indicative of gravitational failure, given low flows and the fine-grained cohesive soils. An example of streambank failure on Brewery Creek is shown in figure 17.

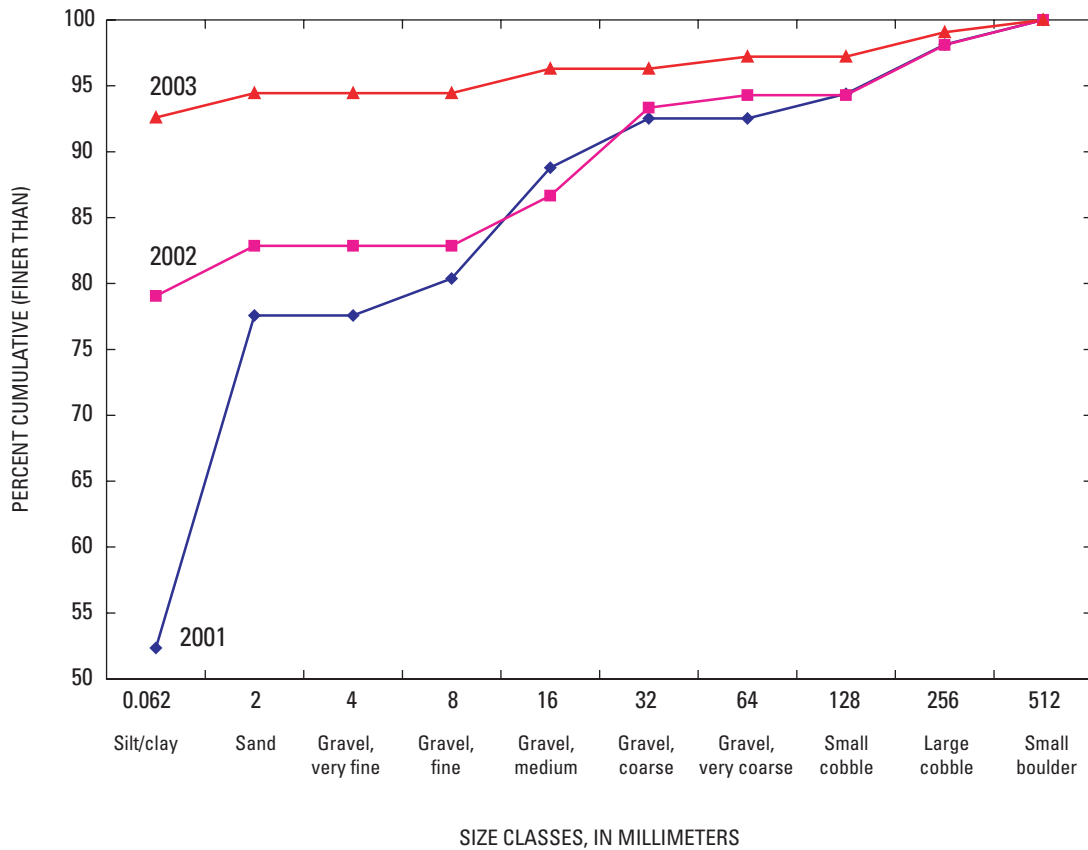
**Figure 18.** Results of Wolman Pebble Count at cross section 13 in Brewery Creek, Cross Plains, Wis. (2001–03).

pebble counts. Based on flow regimes and overall decreases in sediment yield from the construction site, the percentage of fine-grained sediment should have decreased corresponding to flows and constituent loading. In the loess area of the midwestern United States, however, bank material has been reported to contribute as much as 80 percent of the total sediment eroded from incised channels (Simon and others, 1996). Analysis with Rosgen's stream classification indicated that channels were entrenched to slightly entrenched, making them more susceptible to erosion processes.
