# Verification of 1921 Peak Discharge at Skagit River near Concrete, Washington, Using 2003 Peak-Discharge Data

Scientific Investigations Report 2005–5029  
Version 2.0, August 2005

By M.C. Mastin and D.L. Kresch

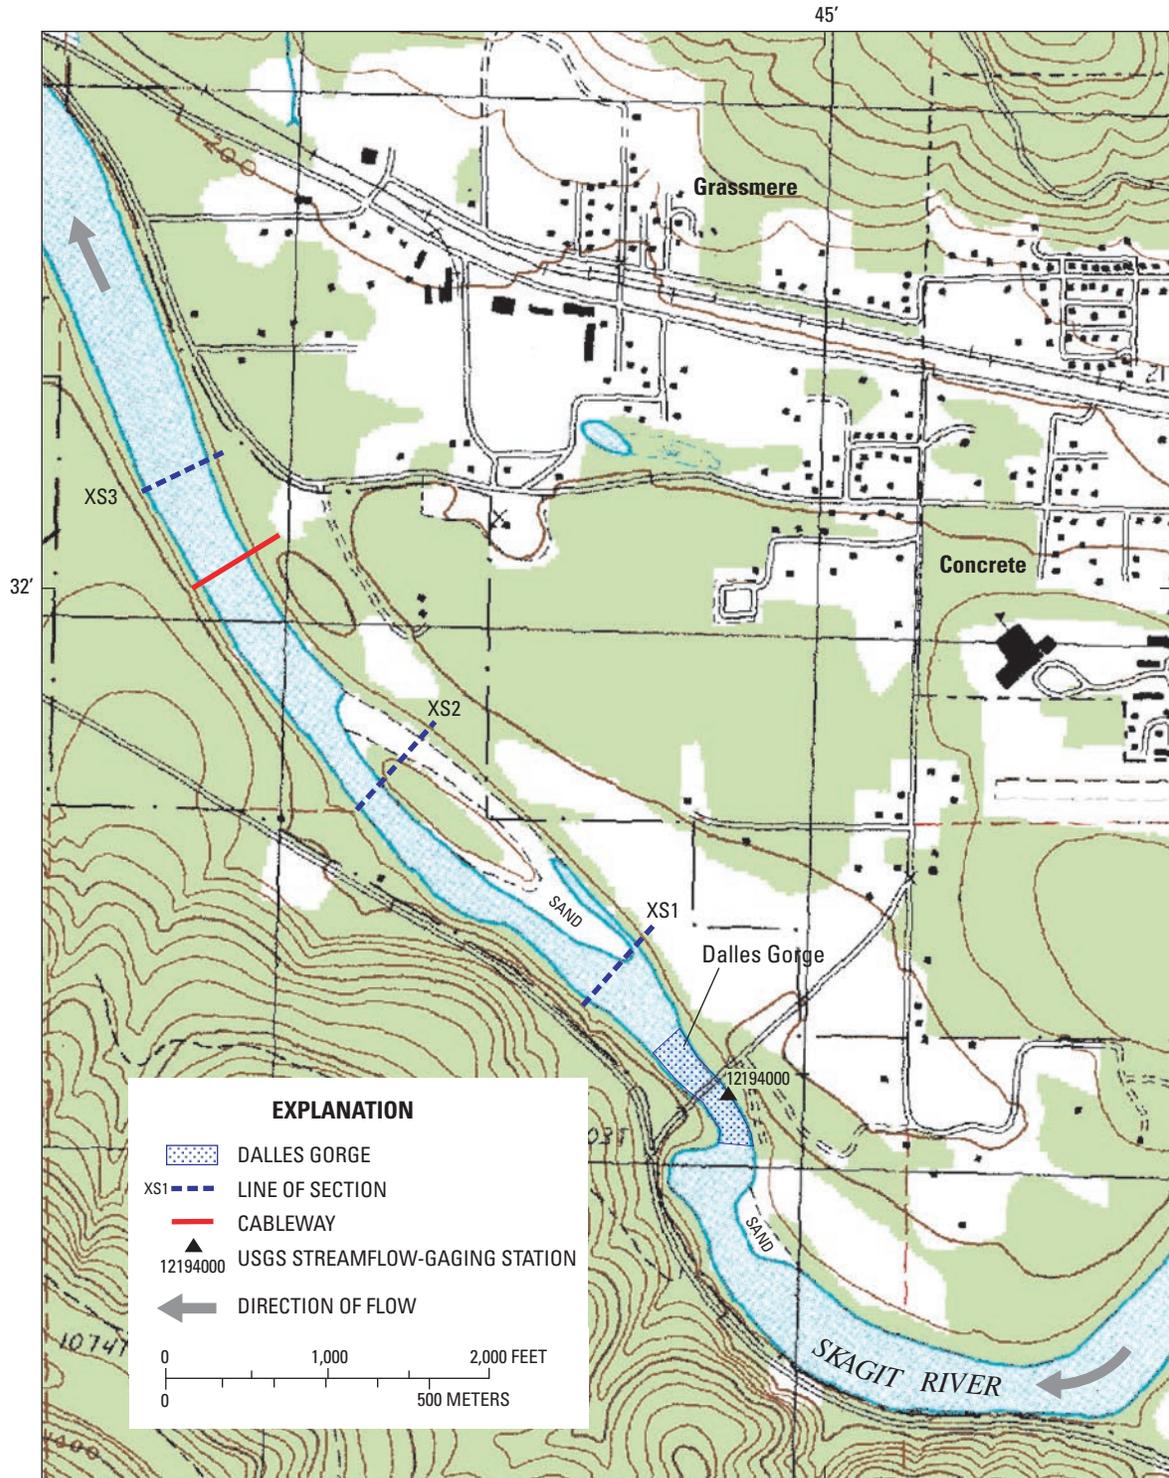
**Figure 1.** Location of cross sections, discharge measurement cableway, Dalles Gorge, and streamflow-gaging station Skagit River near Concrete, Washington.

The reach of Skagit River used for this analysis is essentially the same as the reach used by Stewart for his slope-area measurement (fig. 1, cross sections XS1-XS3). The Skagit River near Concrete gaging station is in Dalles Gorge, a steep-sided bedrock channel, where the river

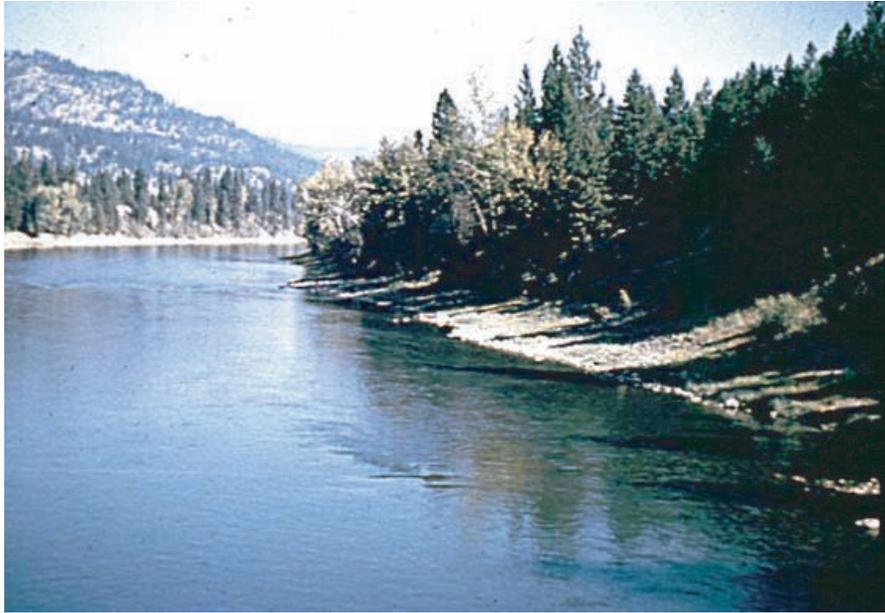
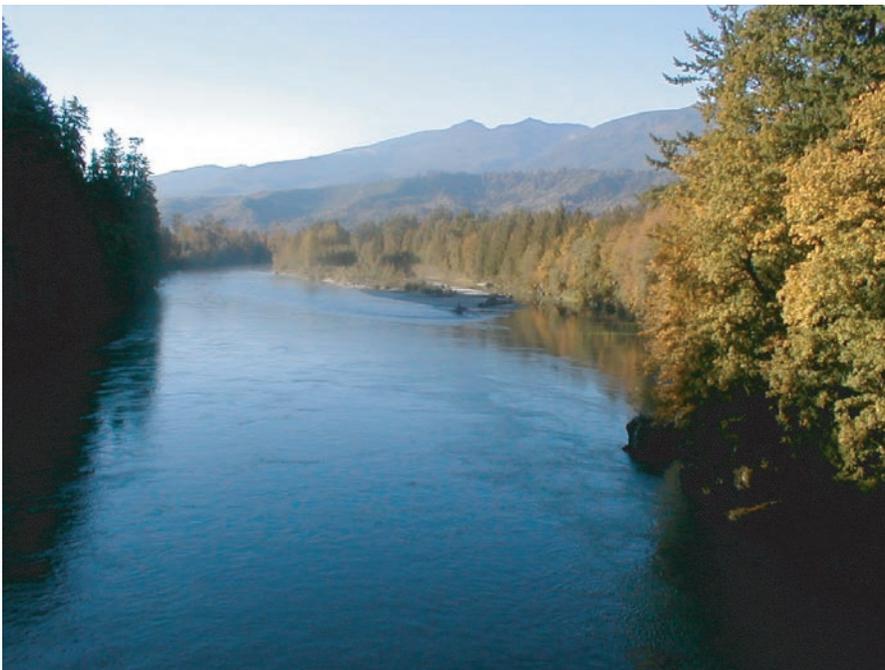
**A.** Clark Fork at St. Regis, Montana, showing cobble bed material and fairly dense vegetation along the banks (Barnes, 1967, p. 24).

**B.** View from Dalles Bridge looking downstream at the upstream end of island at Skagit River near Concrete, Washington, August 2004. (Photograph taken by D. Miller, U.S. Geological Survey, 2004.)

**Figure 5.** Comparison of two  $n$ -verified river reaches with  $n$  values of 0.028.

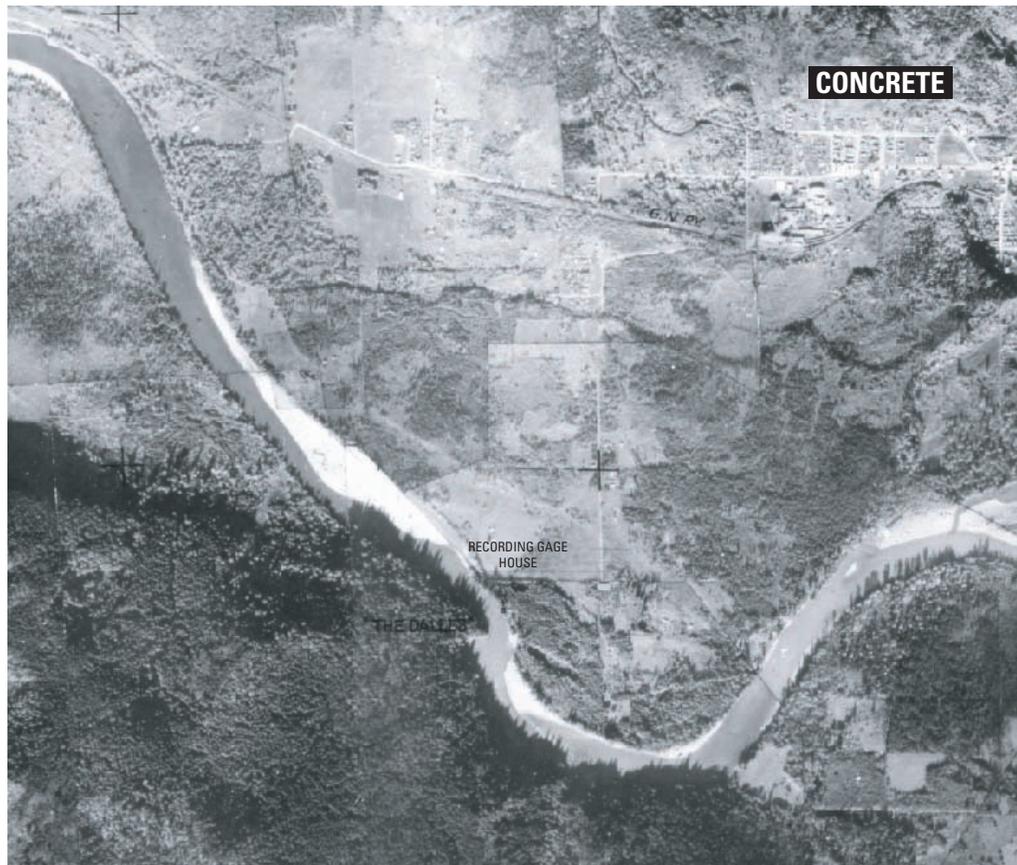
**Figure 6.** Skagit River near Concrete, Washington, recording gage house and barren island/cobble bar in the study reach in 1937 (Skagit County, 2003).

Use of an  $n$  value determined from October 21, 2003, flood data to verify peak discharge of the 1921 flood is valid only if the reach used for both analyses has not changed significantly since 1921. A comparison of historical and current aerial photographs of the reach (figs. 6 and 7) indicates that the reach has not significantly changed. The size and shape of an island near the right (north) bank of the river in the study area reach (left of center in the photographs) has not changed much over time, but the density of vegetation on the island has changed significantly. In the 1937 photograph (fig. 6), the island is bare of vegetation. Historical photographs from 1948 and 1962 show a gradual increase in vegetation

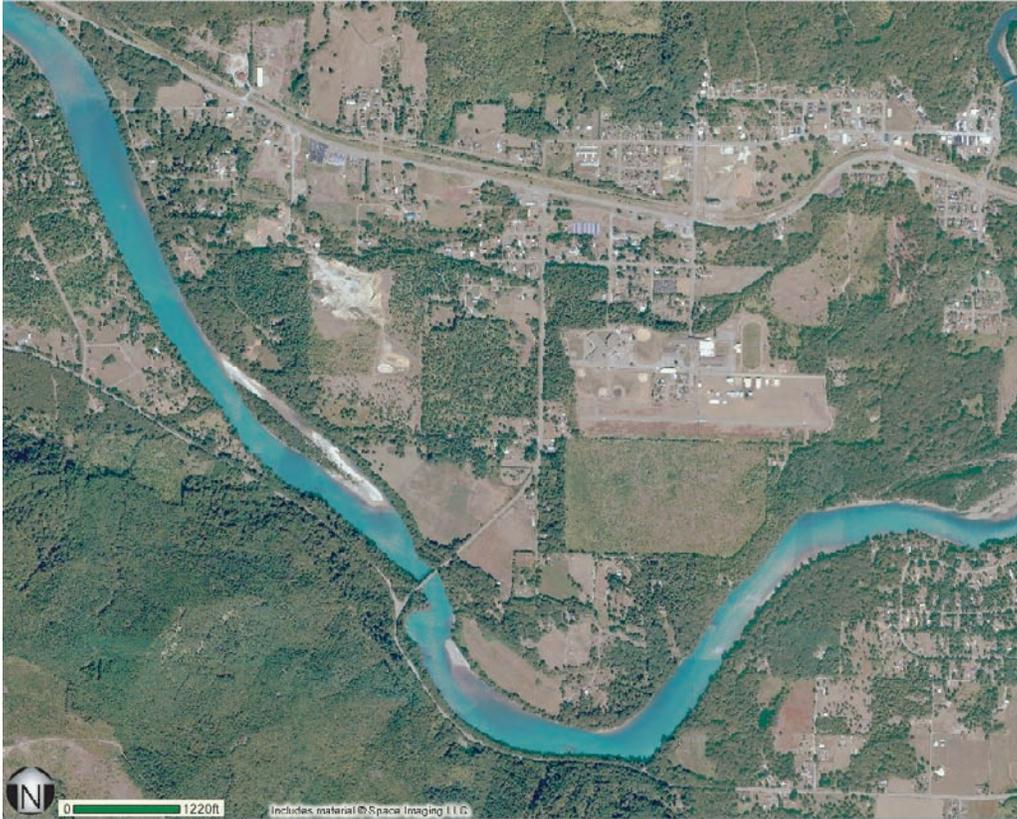
**Figure 7.** Skagit River near Concrete, Washington, and vegetated island/cobble bar in the study reach in 2001 (Skagit County, 2003).

on the downstream part of the island. As of 2004, the downstream part of the island is covered with a dense forest of mostly alders (many more than 2-ft diameter), maples, and cottonwoods.
