# **Environmental Setting, Water Budget, and Stream Assessment for the Broad Run Watershed, Chester County, Pennsylvania**

Scientific Investigations Report 2005-5156

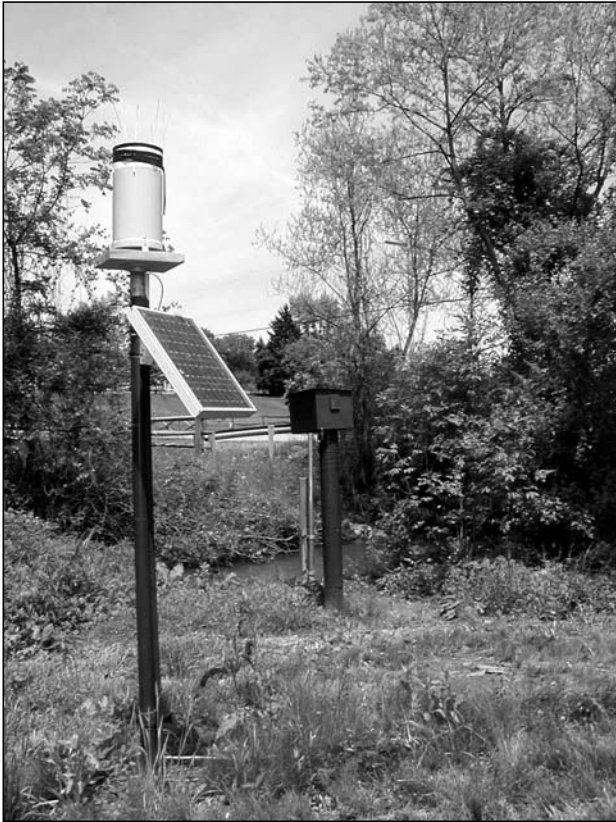
**Figure 6.** View of U.S. Geological Survey streamflow-gaging station 01480638 showing recording precipitation gage with solar panel, gage shelter, and crest-stage gage, Chester County, southeastern Pennsylvania (Photograph courtesy of Craig Thomas, Chester County Water Resources Authority, 2003).

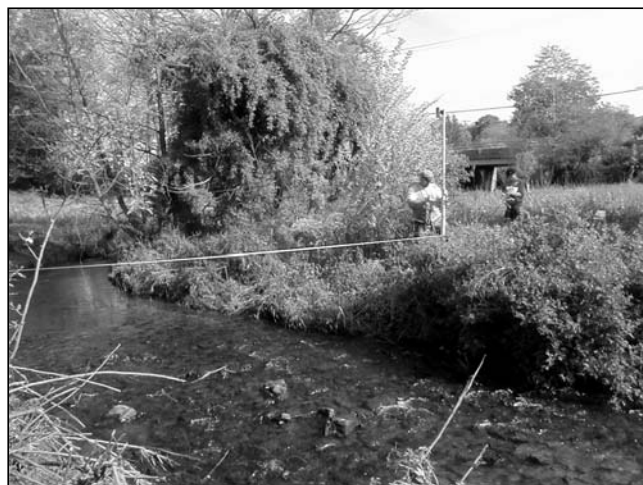
**Figure 7.** U.S. Geological Survey personnel surveying cross section on Broad Run, Chester County, southeastern Pennsylvania (Photograph courtesy of Craig Thomas, Chester County Water Resources Authority, 2003).

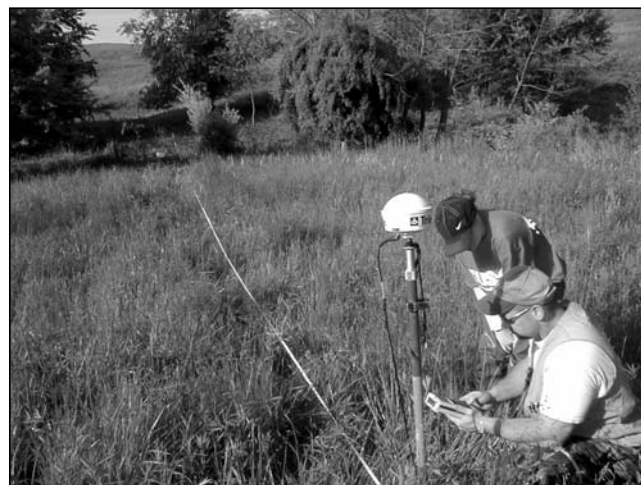
**Figure 8.** U.S. Geological Survey personnel collecting global positioning system data on Broad Run, Chester County, southeastern Pennsylvania (Photograph courtesy of Craig Thomas, Chester County Water Resources Authority, 2003).

and study would be possible (fig. 8). At each cross section, a pebble count, adopted from Wolman (1954), was done to determine the particle-size distribution of the streambed materials (fig. 9). One core sample also was collected at each cross section by excavating materials within a plastic cylinder that had been pressed into the sediment (fig. 10); these sediments were later sieved in the laboratory. Data from these core samples were used to determine the particle-size distribution of materials that were potentially mobile (entrained) during stream-channel formation. Core samples were collected from the downstream third of a point bar at an approximate elevation equal to half the distance between the deepest part of the bankfull channel and the top of the bankfull channel. These core samples were collected on the nearest point bar to the riffle wherein the cross-section survey was completed. If no depositional feature, such as a point bar, was present, core samples were collected from the streambed within the same riffle wherein the cross-section survey was completed. Digital photographs also were taken at each geomorphic study site to document current site conditions, and ancillary data, such as the valley type (Rosgen, 1996), were noted.

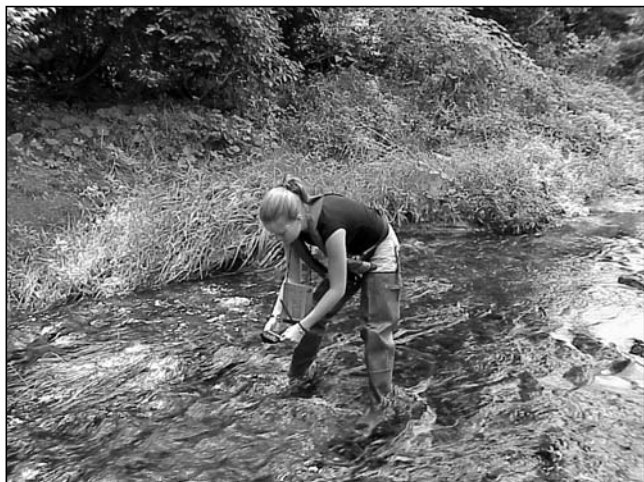
**Figure 9.** U.S. Geological Survey technician making a pebble count, Chester County, southeastern Pennsylvania. (Photograph by P.J. Cinotto, U.S. Geological Survey).

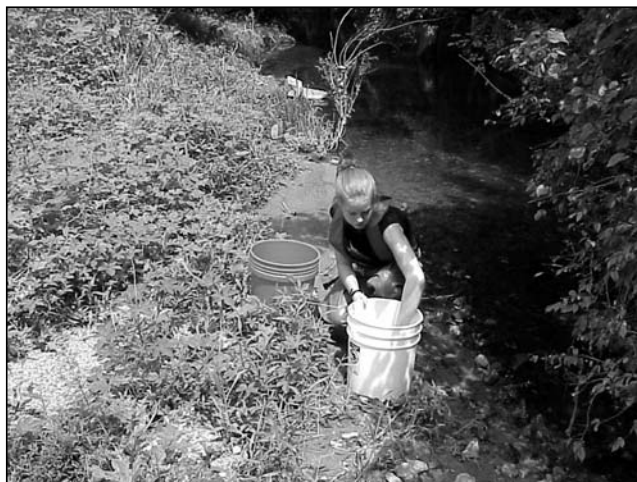
**Figure 10.** U.S. Geological Survey technician collecting core sample, Chester County, southeastern Pennsylvania. (Photograph by P.J. Cinotto, U.S. Geological Survey).

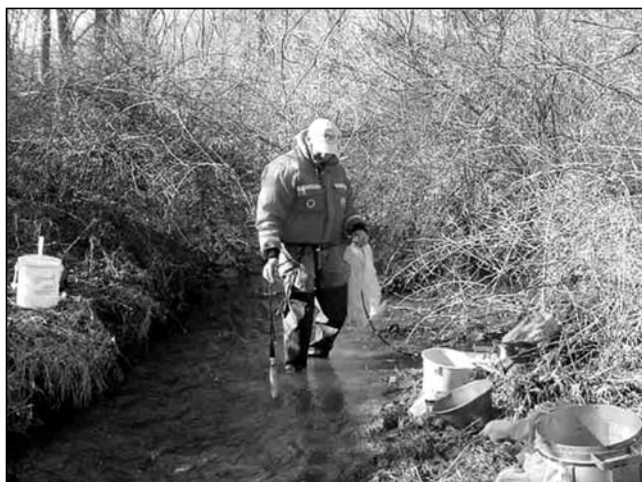
**Figure 11.** U.S. Geological Survey biologist measuring water chemistry of Broad Run, Chester County, southeastern Pennsylvania. (Photograph by P.J. Cinotto, U.S. Geological Survey).

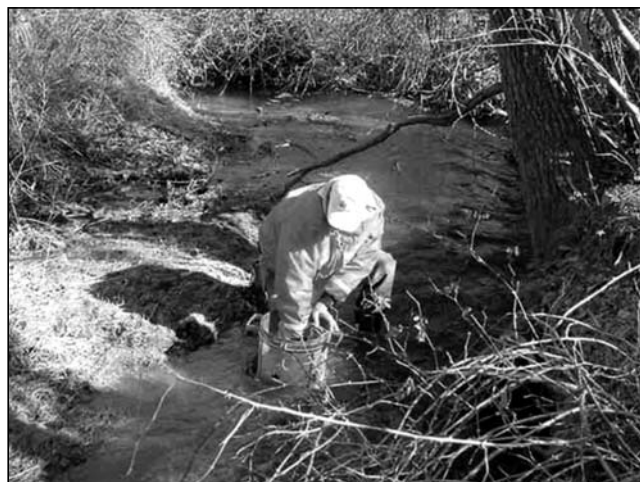
**Figure 12.** U.S. Geological Survey biologist collecting benthic-macroinvertebrate sample from Broad Run, Chester County, southeastern Pennsylvania. (Photograph by P.J. Cinotto, U.S. Geological Survey).

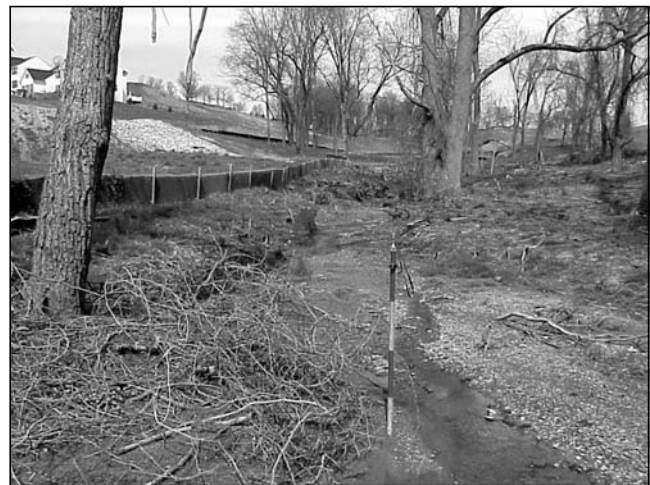
**Figure 15.** C-class stream channel approximately 100 feet upstream of head cut and resultant G-class stream channel on unnamed tributary to Broad Run, Chester County, southeastern Pennsylvania. (Photograph by P.J. Cinotto, U.S. Geological Survey).

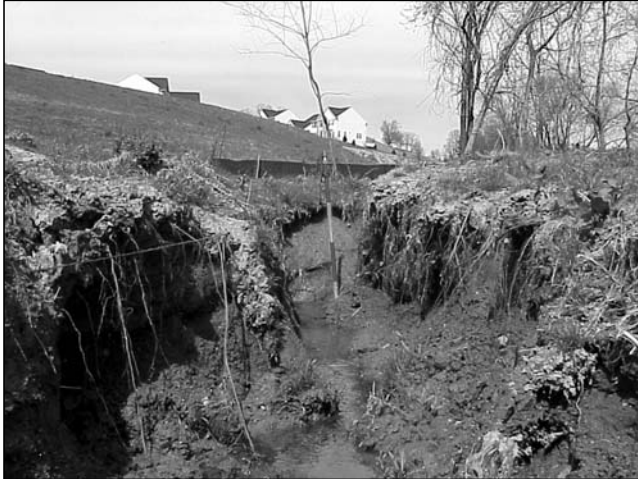
**Figure 16.** Head cut and resultant G-class stream channel on unnamed tributary to Broad Run, Chester County, southeastern Pennsylvania. (Photograph by P.J. Cinotto, U.S. Geological Survey).

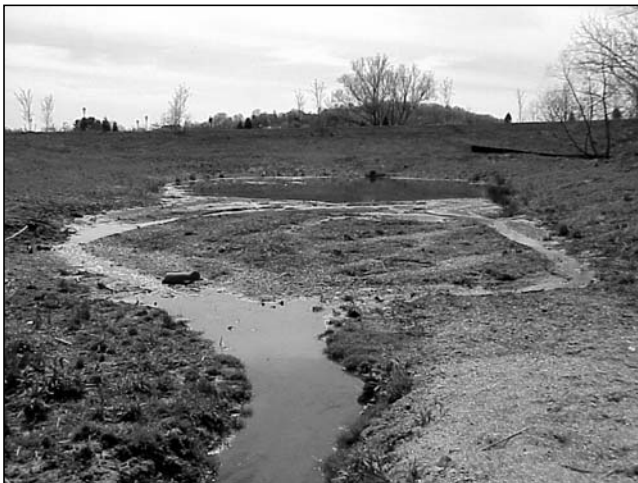
**Figure 17.** Sediment partially resulting from erosion of unnamed tributary to Broad Run filling stormwater-detention basin, Chester County, southeastern Pennsylvania. (Photograph by P.J. Cinotto, U.S. Geological Survey).

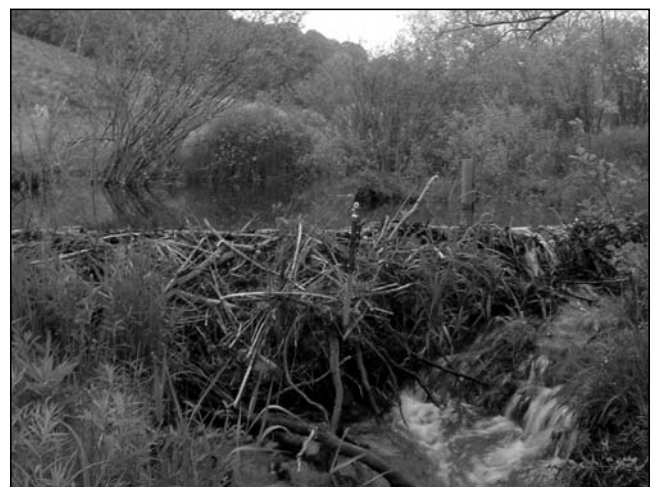
**Figure 18.** Beaver dam on Broad Run, Chester County, southeastern Pennsylvania. (Photograph by P.J. Cinotto, U.S. Geological Survey).

Other natural factors that affect the morphology and stability of Broad Run are type and concentration of **riparian** vegetation, natural flooding, and wildlife. For example, beavers have constructed various dams near the approximate center of the watershed (fig. 18), which cause backwater flooding as well as accelerated bank erosion next to the dam. Water flowing over the dam (fig. 18, right side of photo) will eventually erode the bank if the beavers do not continually patch the breach. Bank erosion near a beaver dam (or other obstruction) is the natural result of a stream trying to bypass an obstacle by taking the path of least resistance; the bank material is easier to erode than the obstruction. Another aspect of beaver dams is that they tend to trap sediment behind them. Because the energy of a flowing stream has the capacity to carry a certain amount of sediment, any sediment that settles out behind the dam will be restored downstream by increased erosion. For this reason, waters exiting a dam or any other environment that limits or removes sediment from the stream are termed “sediment starved.” In time, because of downstream erosion, the stream class may change accordingly from a non-entrenched class of C or E to an entrenched class of G or F. Removal of woody riparian vegetation by beavers also can make the effected areas susceptible to accelerated bank erosion. Typical beaver-felled trees in a wetland adjacent to Broad Run, newly created by backwater flooding, are shown in figure 19. Even though beavers can seriously affect the stream-channel morphology, they also create a very diverse and important habitat, form wetlands that can filter many pathogens from the water column, and create areas of emergent vegetation.

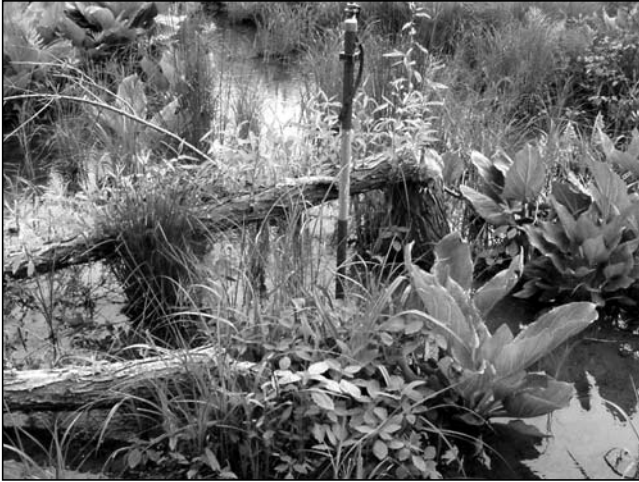
**Figure 19.** Beaver-felled trees in wetland on Broad Run, Chester County, southeastern Pennsylvania. (Photograph by P.J. Cintonno, U.S. Geological Survey).

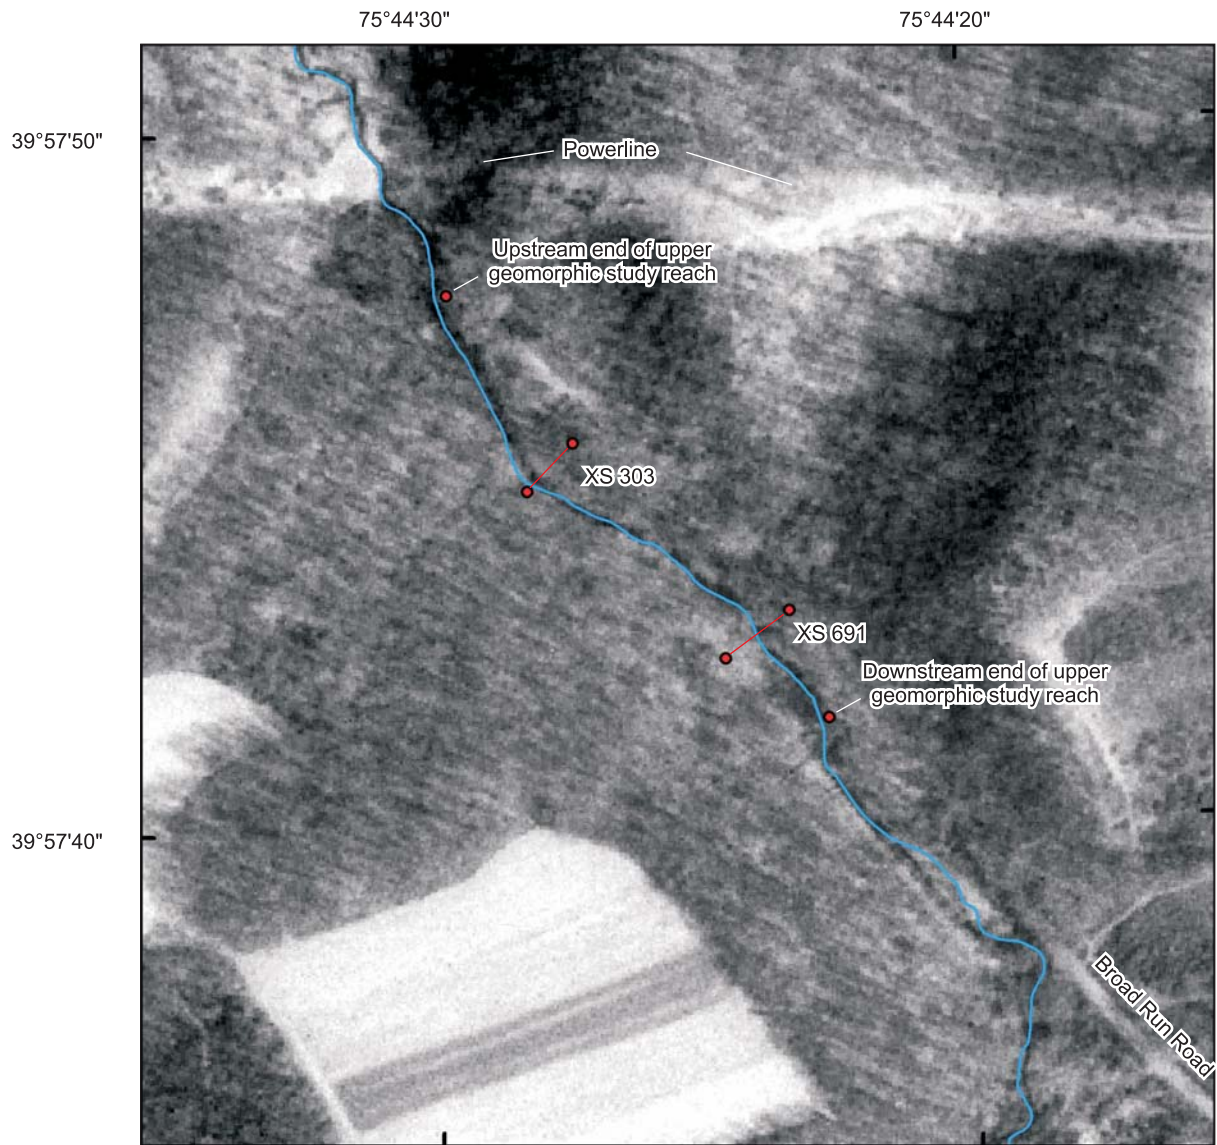
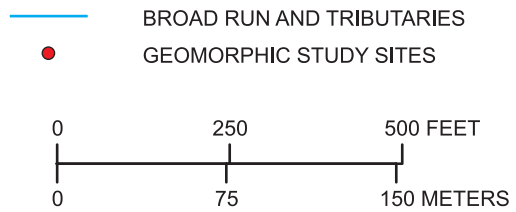
Figure 21. Upper geomorphic study reach on Broad Run, Chester County, southeastern Pennsylvania.

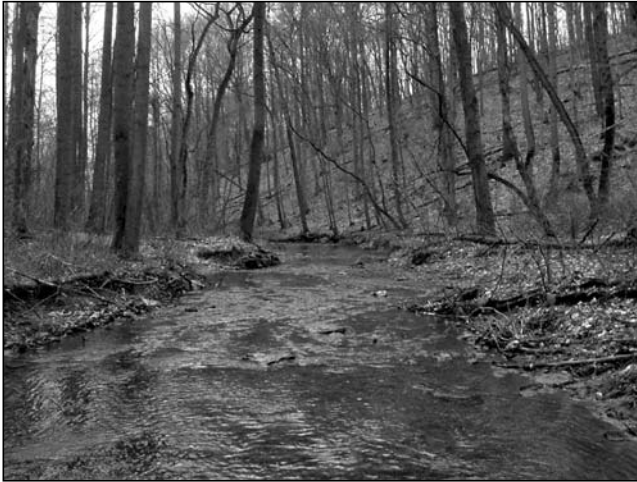
**Figure 22.** Representative view looking downstream at upper geomorphic study reach on Broad Run, Chester County, southeastern Pennsylvania. (Photograph by P.J. Cinotto, U.S. Geological Survey).

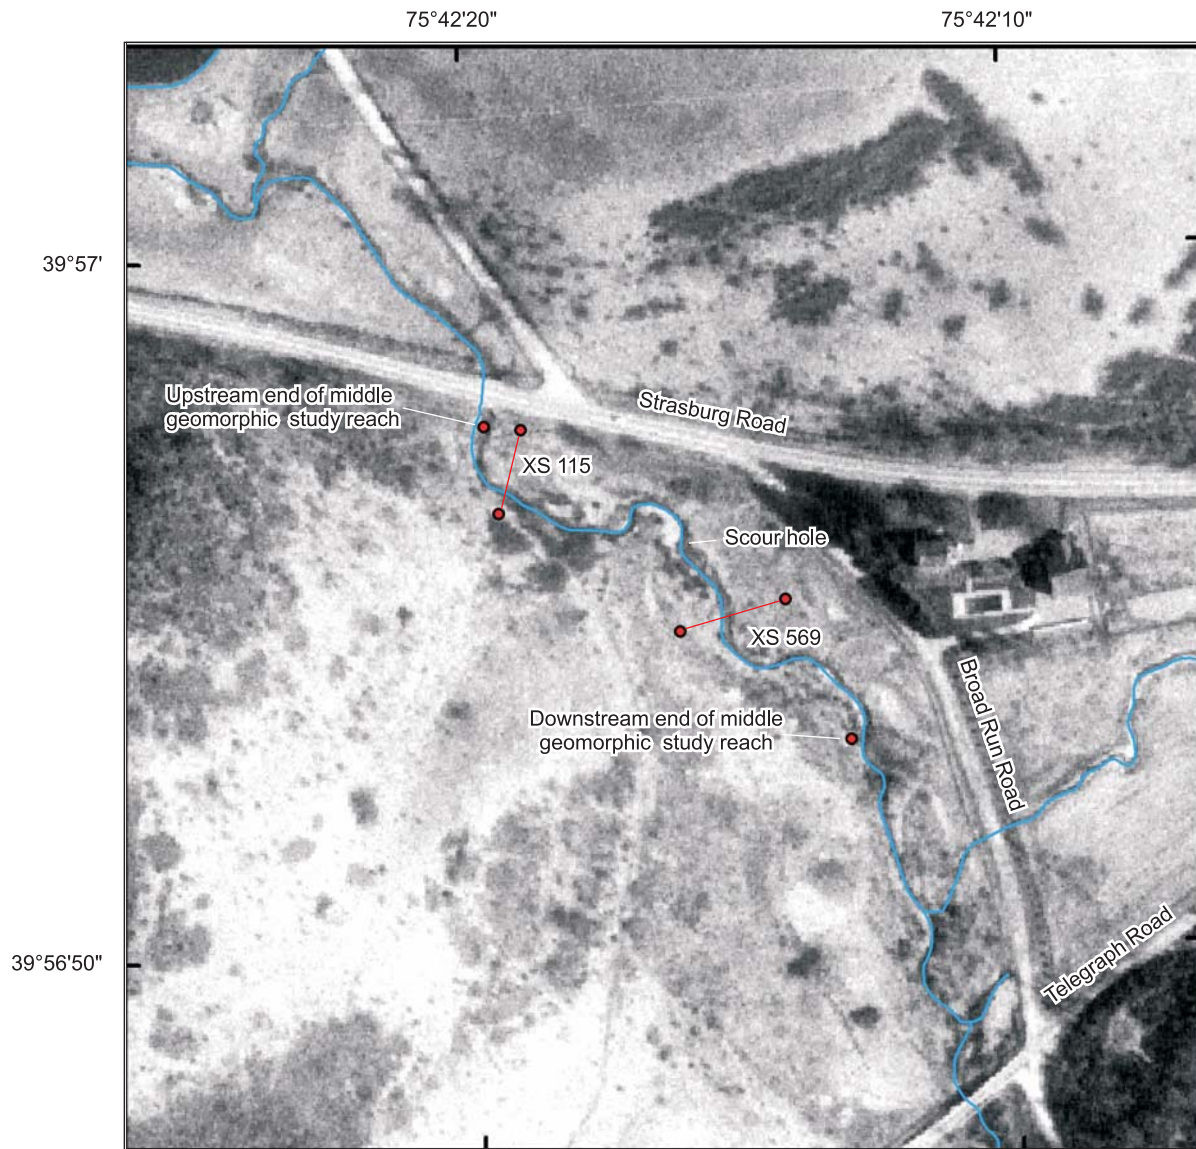
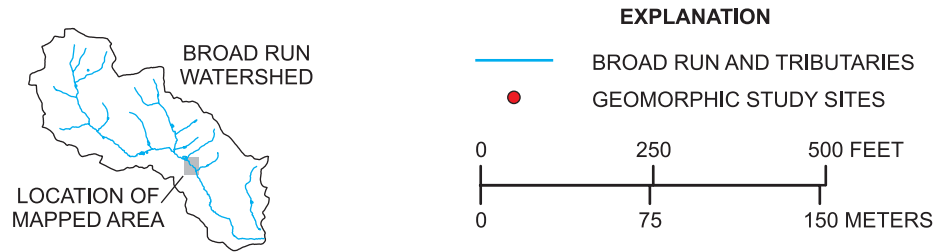
**Figure 23.** Middle geomorphic study reach on Broad Run, Chester County, southeastern Pennsylvania.

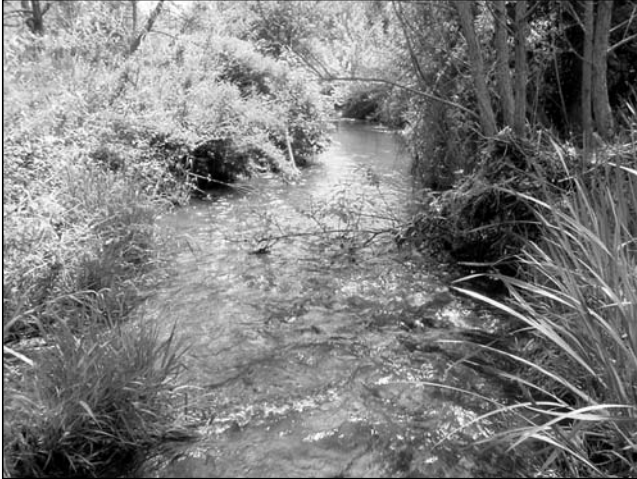
**Figure 24.** Representative view looking downstream at middle geomorphic study reach on Broad Run, Chester County, southeastern Pennsylvania. (Photograph by P.J. Cinotto, U.S. Geological Survey).

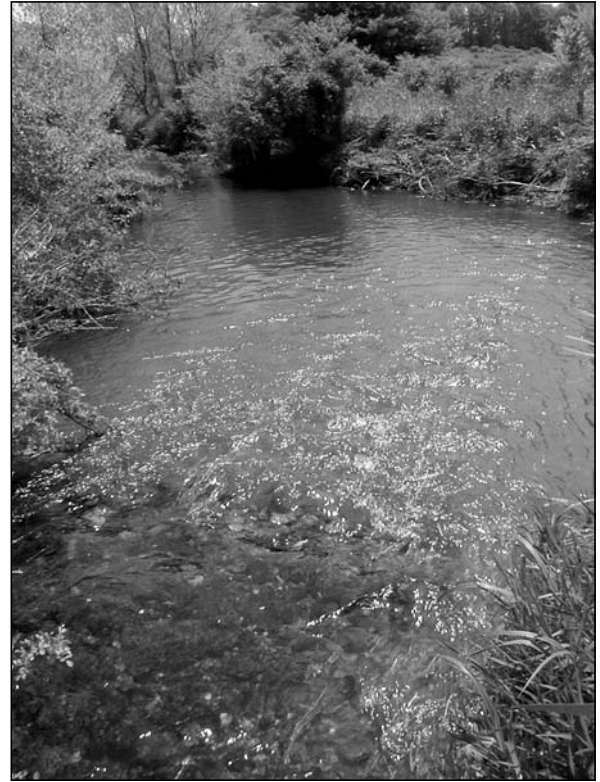
**Figure 26.** View looking downstream at scour hole in streambed of middle geomorphic study reach on Broad Run, Chester County, southeastern Pennsylvania. (Photograph courtesy of Craig Thomas, Chester County Water Resources Authority, 2003).

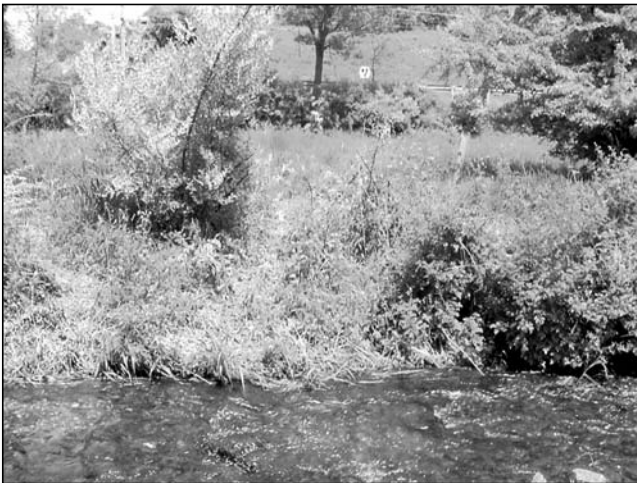
**Figure 25.** View of left bank and available flood plain, middle geomorphic study reach on Broad Run, Chester County, southeastern Pennsylvania. (Photograph by P.J. Cinotto, U.S. Geological Survey).

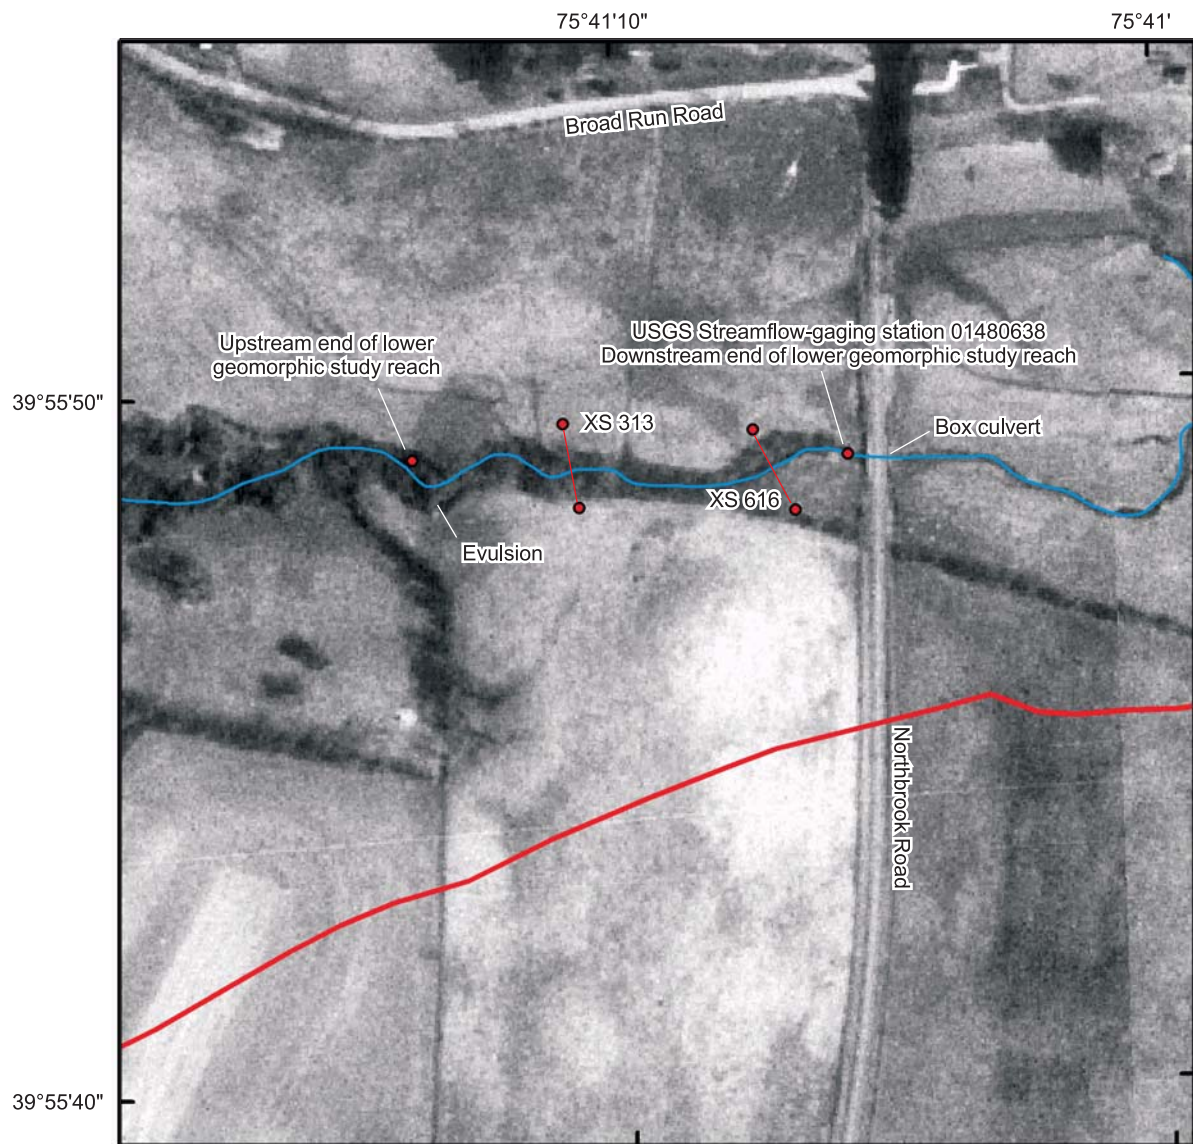
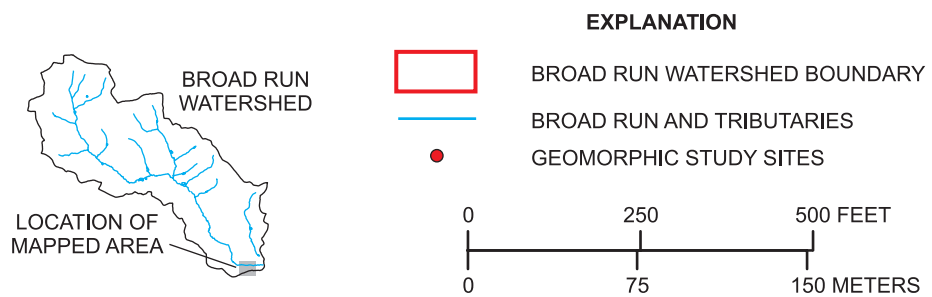
**Figure 27.** Lower geomorphic study reach on Broad Run, Chester County, southeastern Pennsylvania.

Some additional regulation of higher flows is also likely due to the box culvert carrying Northbrook Road over Broad Run (fig. 27). Because overbank flooding must occur before this structure reaches capacity (fig. 31), and because the culvert does not cause a contraction during lower flows, the box culvert likely does not contribute substantially to initial overbank flooding along the lower geomorphic study reach. However, once this culvert fills completely with water and reaches its capacity to transmit water (pressure flow), the flow of additional flood water will be severely impeded as elevated approach roadways in the flood plain begin to act as a dam. This effect will continue to cause greater depths of flooding

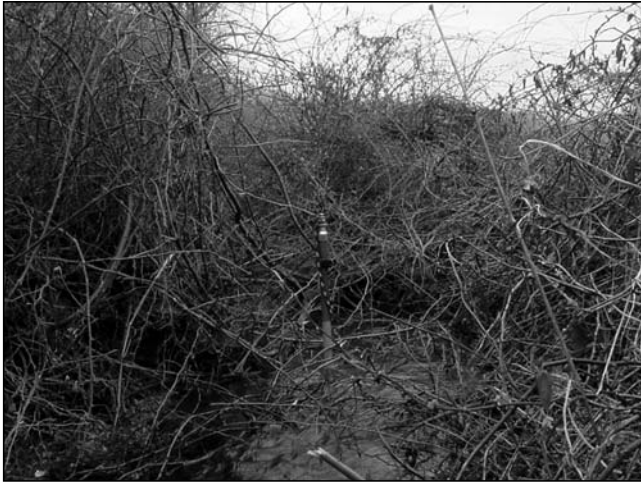
**Figure 28.** View looking upstream, approximately 100 feet downstream from cross-section 311, on lower geomorphic study reach, Broad Run, Chester County, southeastern Pennsylvania. (Photograph by P.J. Cinotto, U.S. Geological Survey).

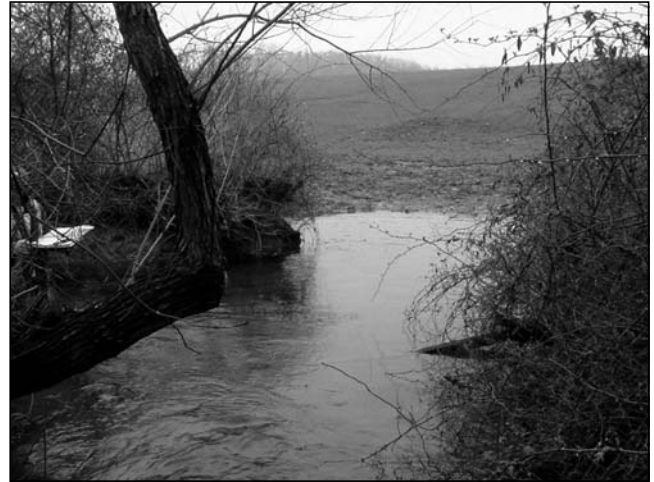
**Figure 30.** View looking toward right bank, with large evulsion, on lower geomorphic study reach of Broad Run, Chester County, southeastern Pennsylvania. (Photograph by P.J. Cinotto, U.S. Geological Survey).

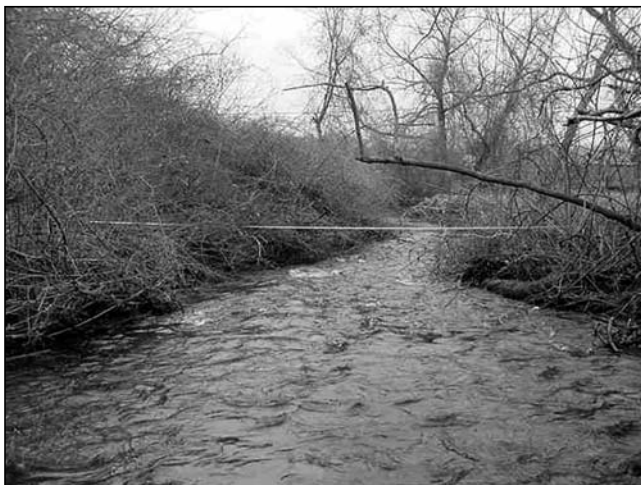
**Figure 29.** View looking downstream at cross-section 616, just above Northbrook Road, on lower geomorphic study reach, Broad Run, Chester County, southeastern Pennsylvania. (Photograph by P.J. Cinotto, U.S. Geological Survey)

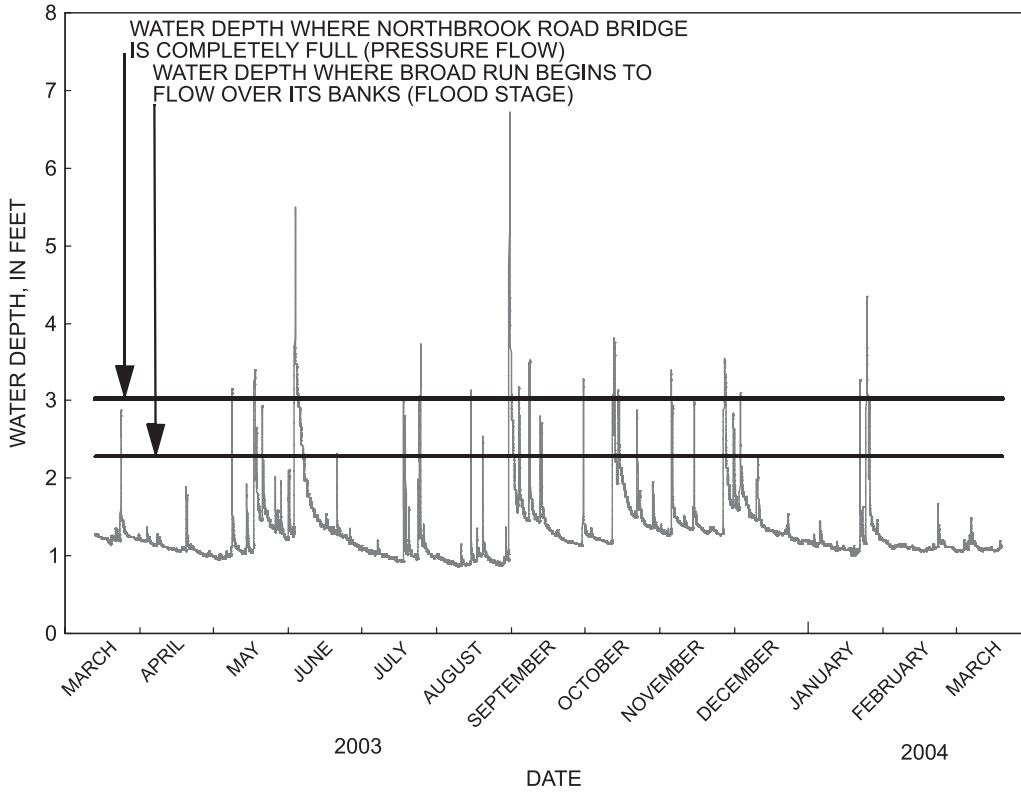
**Figure 31.** Water depth at U.S. Geological Survey streamflow-gaging station 01480638 (Broad Run at Northbrook), Chester County, southeastern Pennsylvania, April 1, 2003, to March 31, 2004, showing depth of initial flooding and depth at which downstream box culvert is at full capacity.

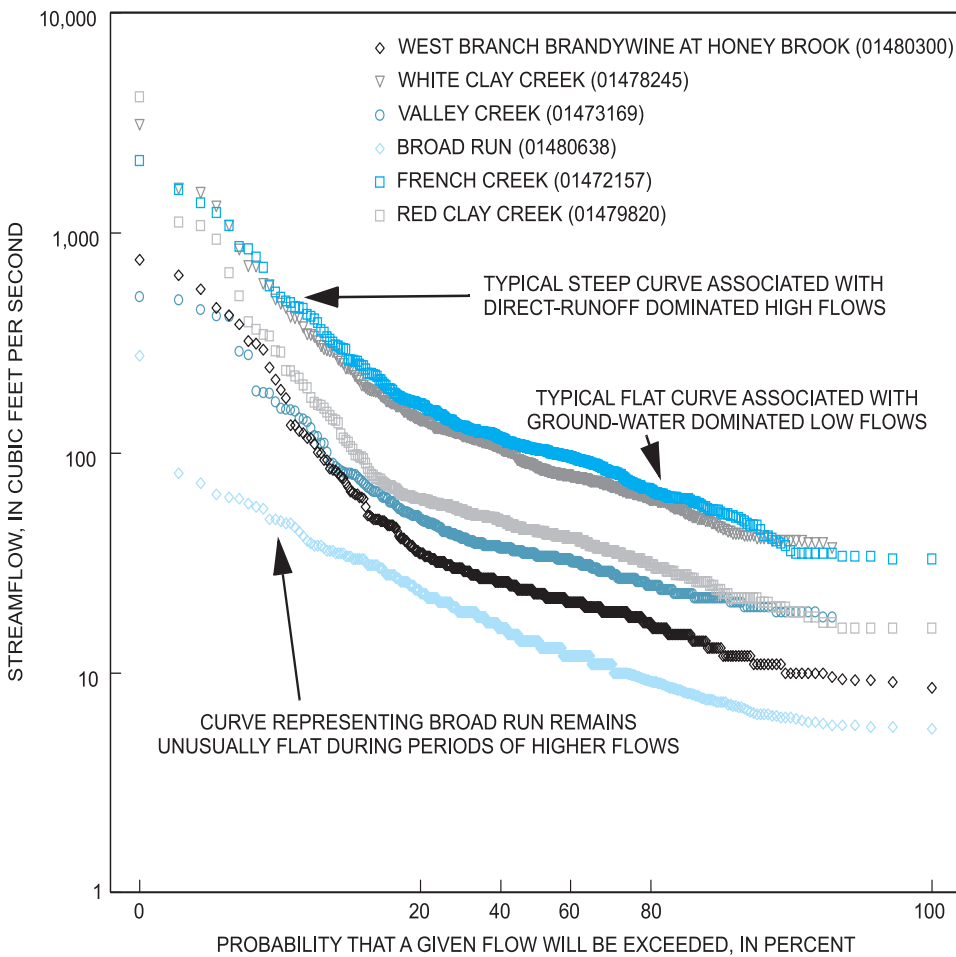
**Figure 32.** Flow-duration curves for Broad Run and five other regional streams, Chester County, southeastern Pennsylvania.
