Effects of Roads and Well Pads on Erosion in the Largo Canyon Watershed, New Mexico, 2001–02

Scientific Investigations Report 2006–5039

By Anne Marie Matherne

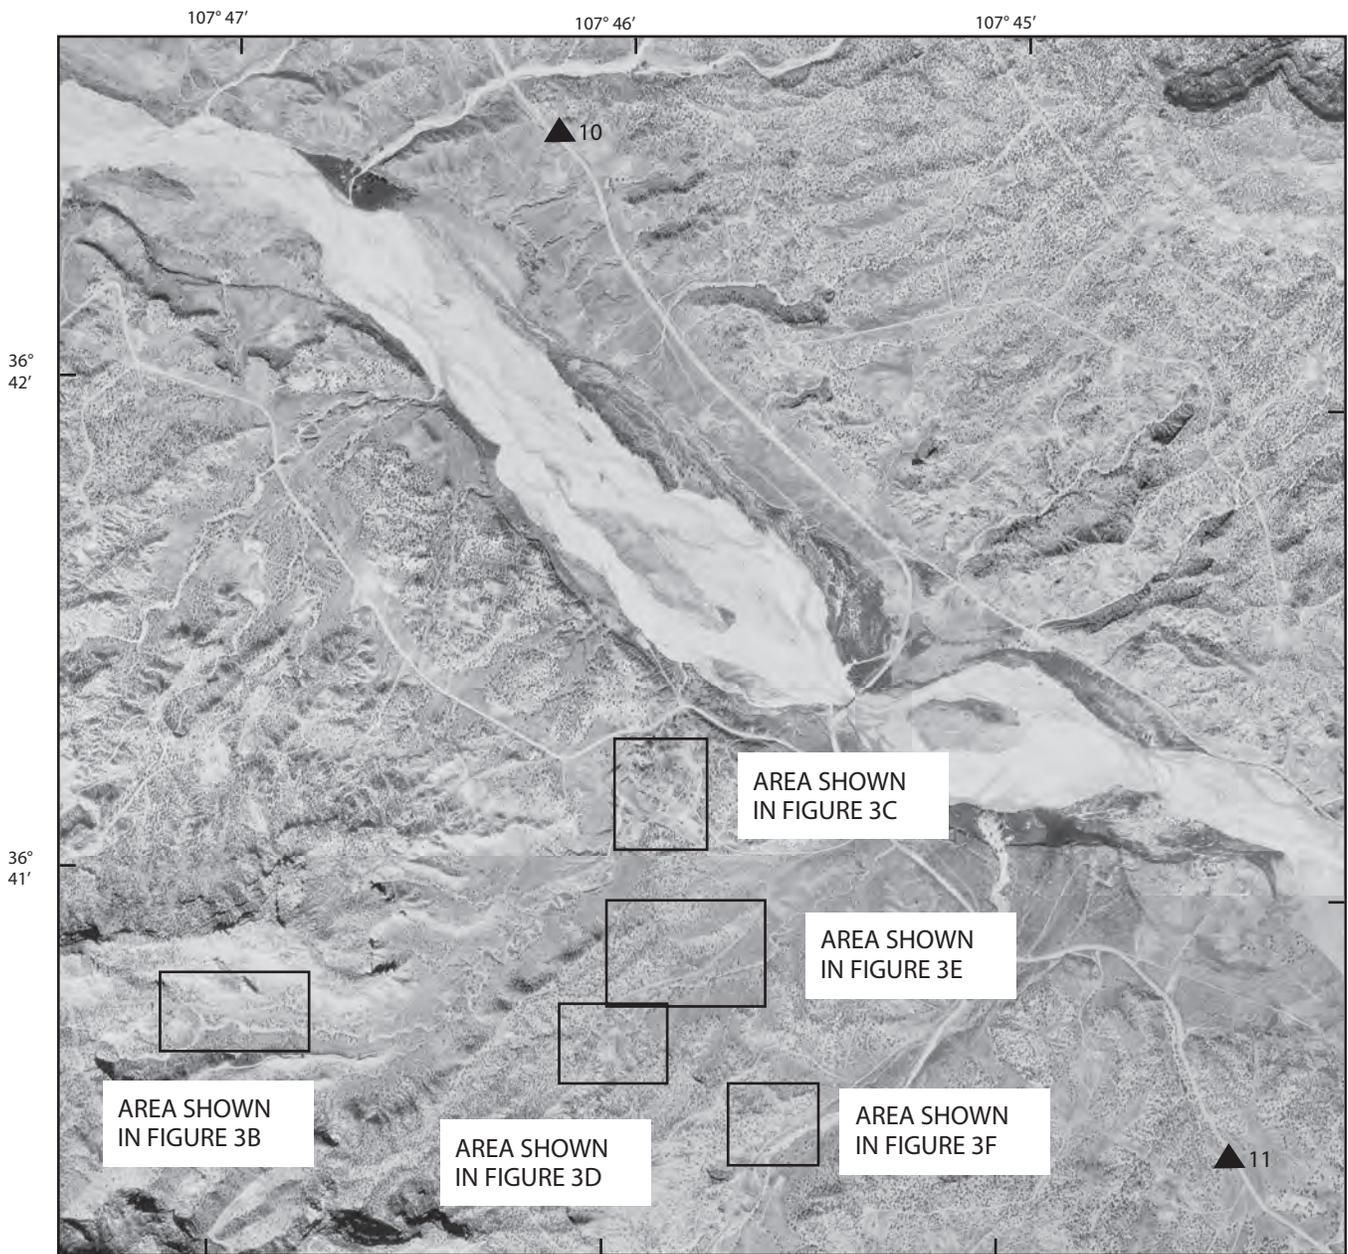
Figure 3A. Location of sediment dams in the Harris Canyon area.

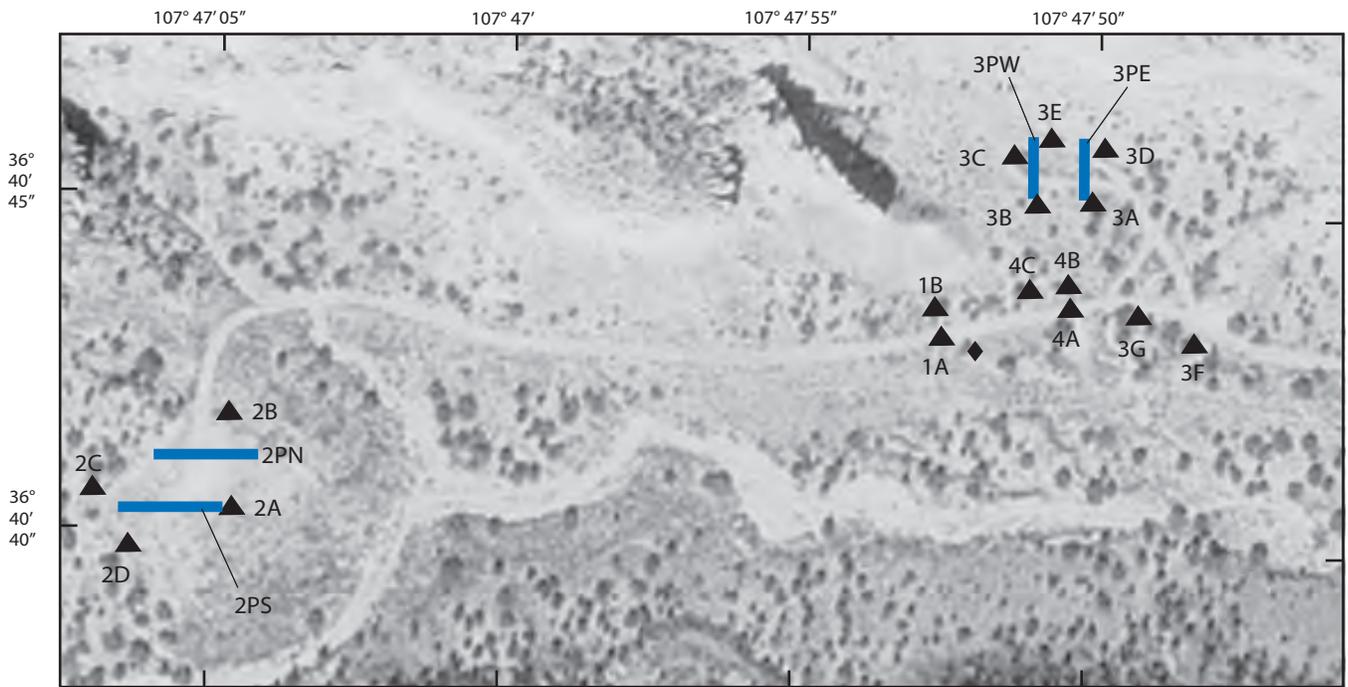
Figure 3B. Location of sediment dams 1A, 1B, 2A–2D, 3A–3G, and 4A–4C, precipitation gage installed for study, and transects 2PN, 2PS, 3PW, and 3PE, in the Harris Canyon area.

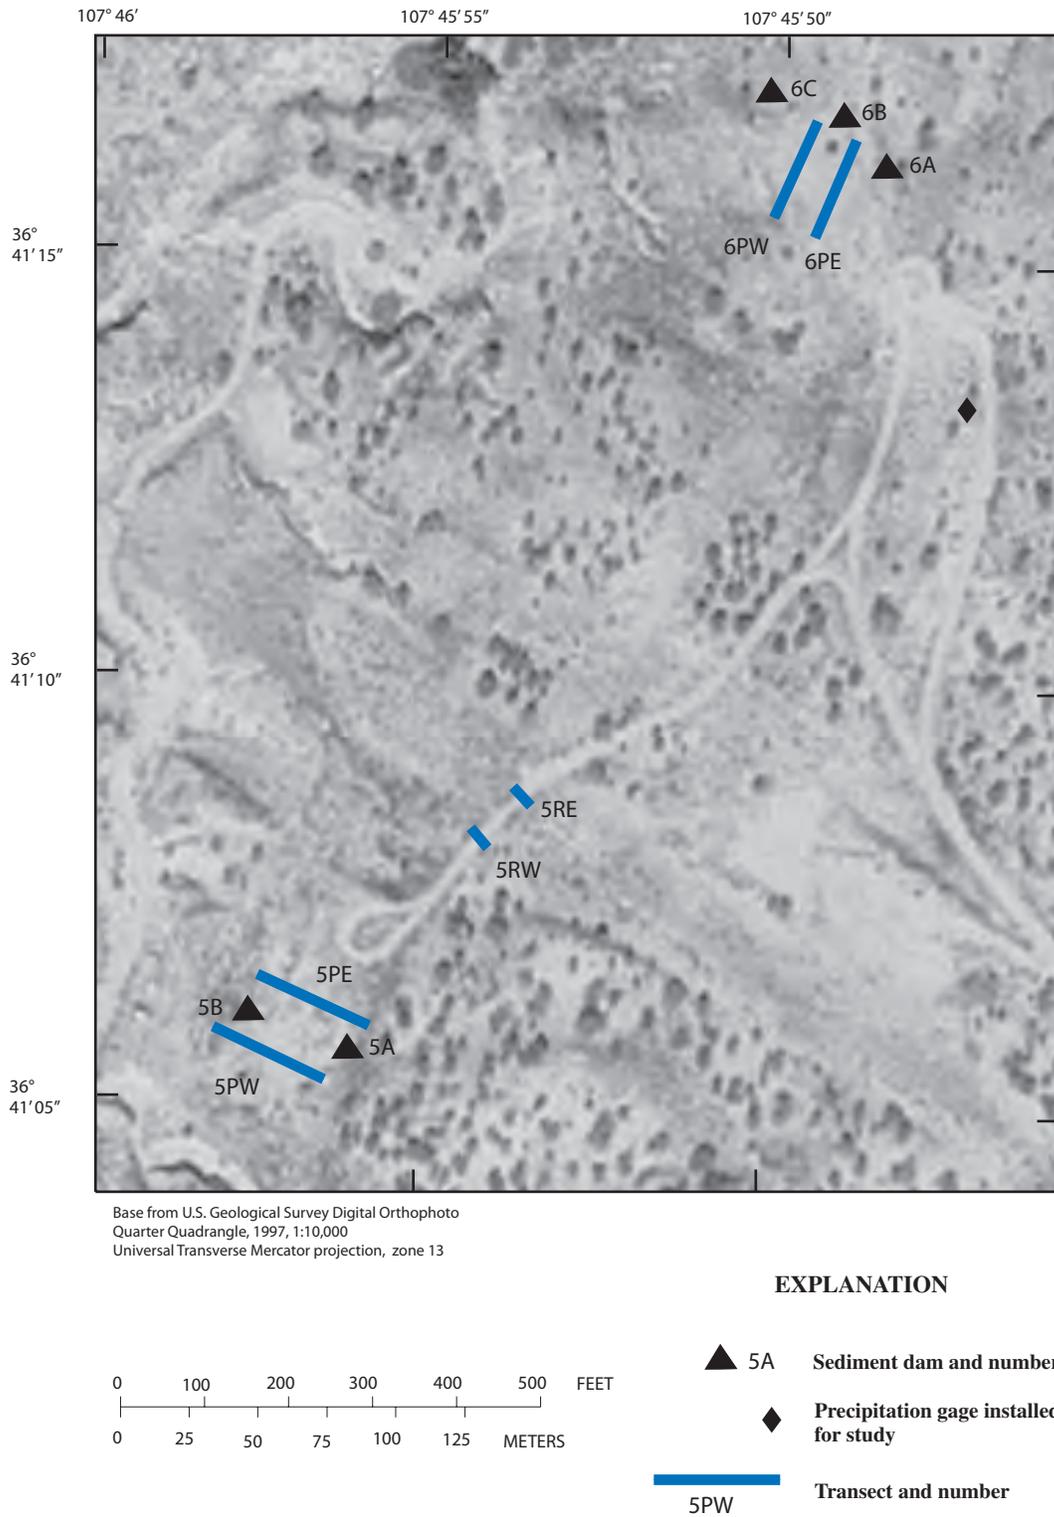
Figure 3C. Location of sediment dams 5A, 5B, and 6A–6C, precipitation gage installed for study, and transects 5PE, 5PW, 5RE, 5RW, 6PE, and 6PW, in the Harris Canyon area.

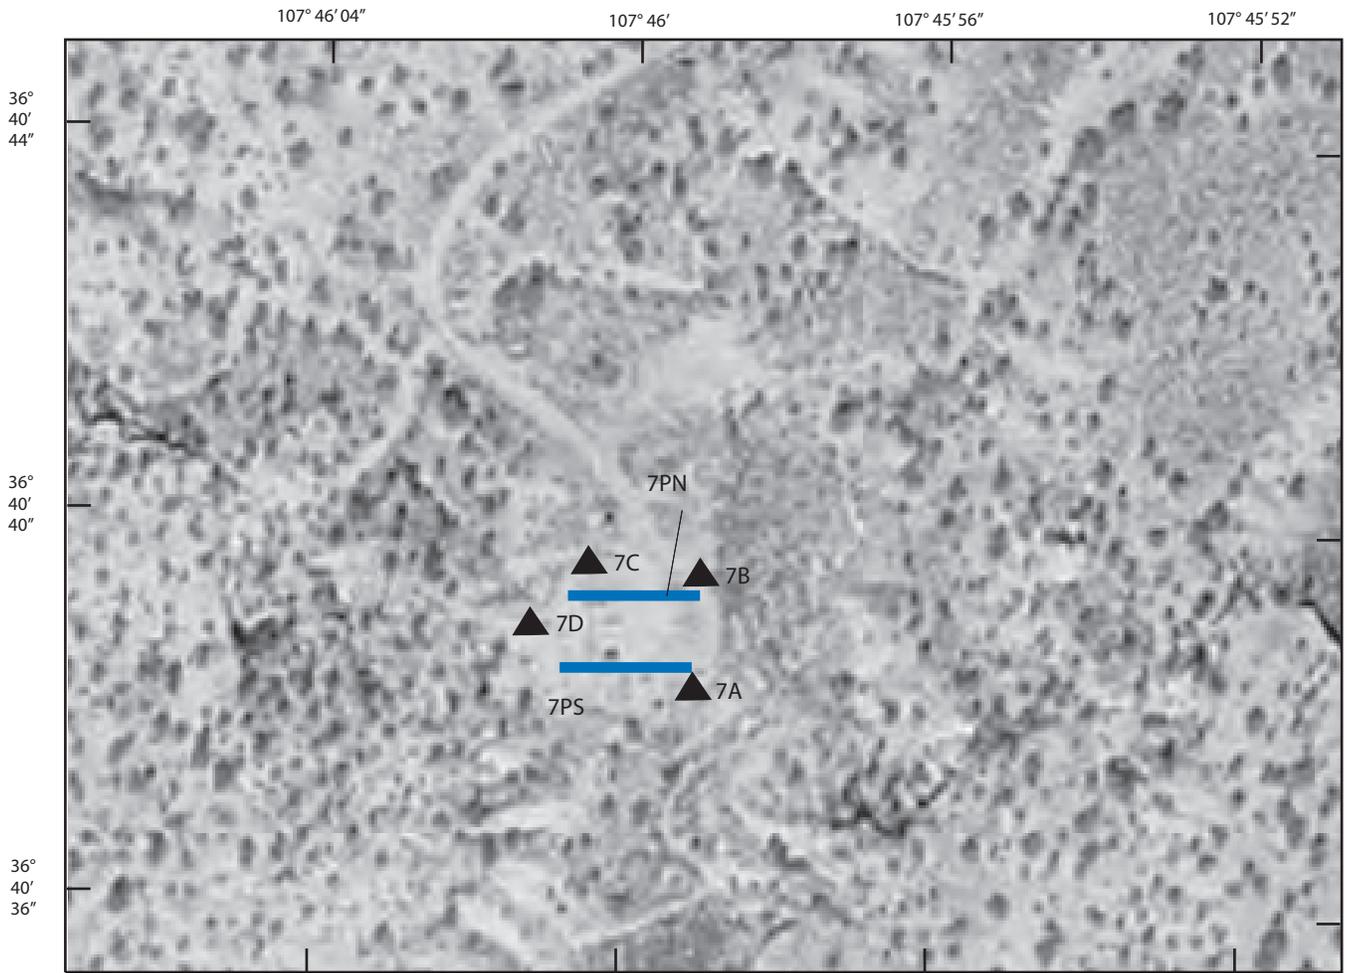
Figure 3D. Location of sediment dams 7A–7D and transects 7PN and 7PS, in the Harris Canyon area.

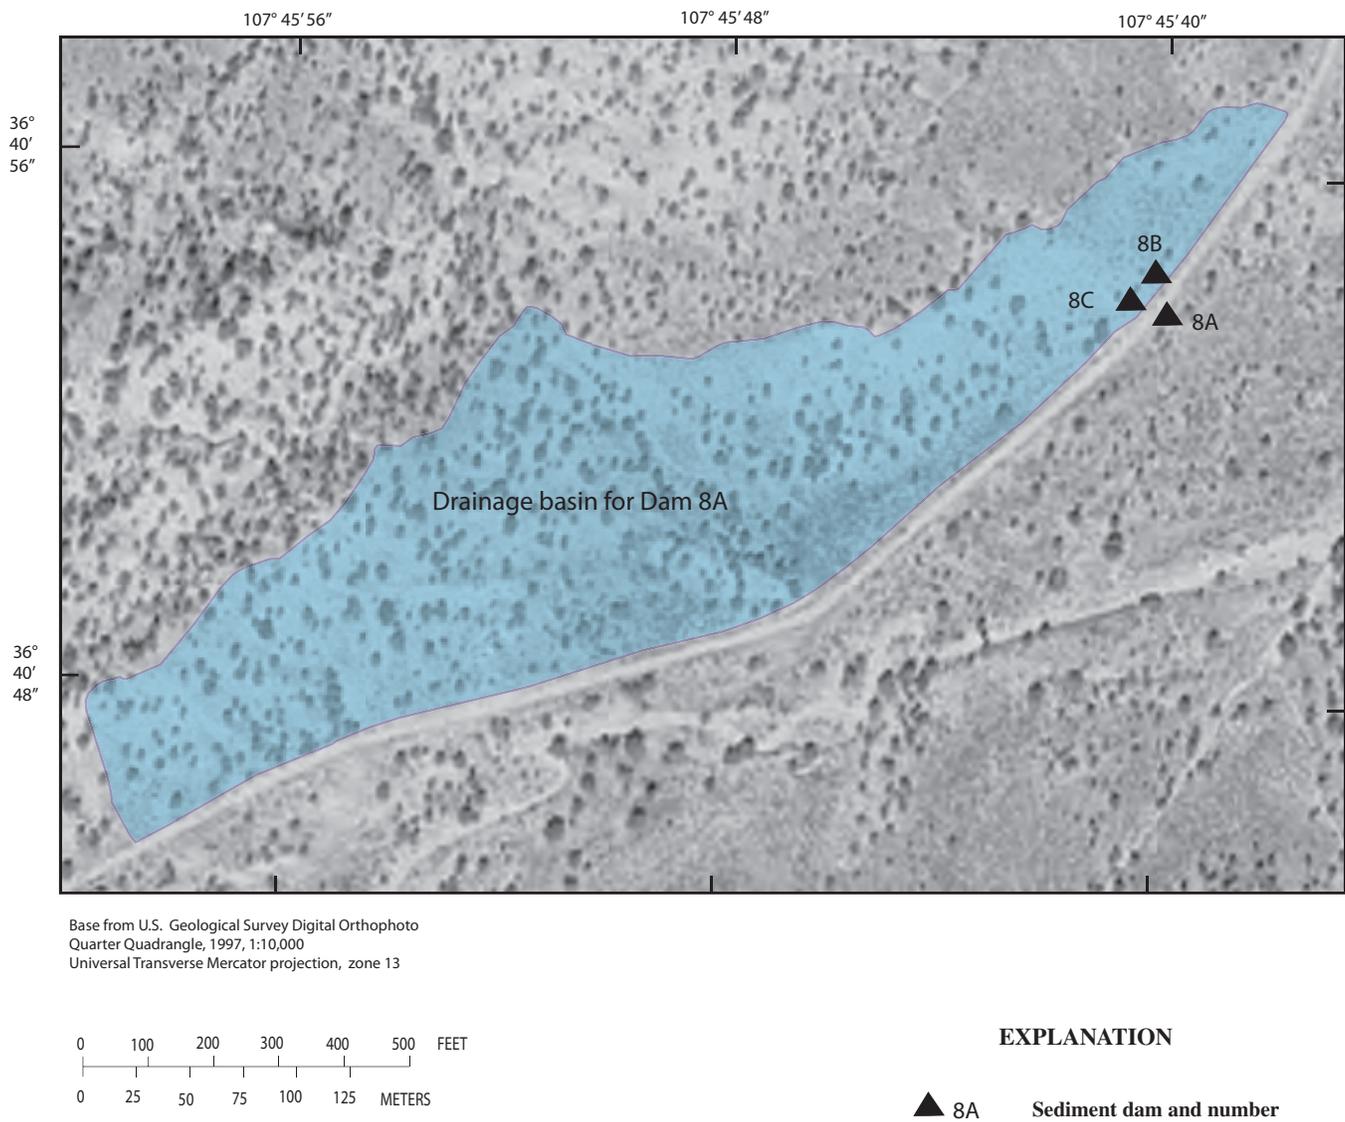
Figure 3E. Location of sediment dams 8A–8C and drainage basin for dam 8A in the Harris Canyon area.

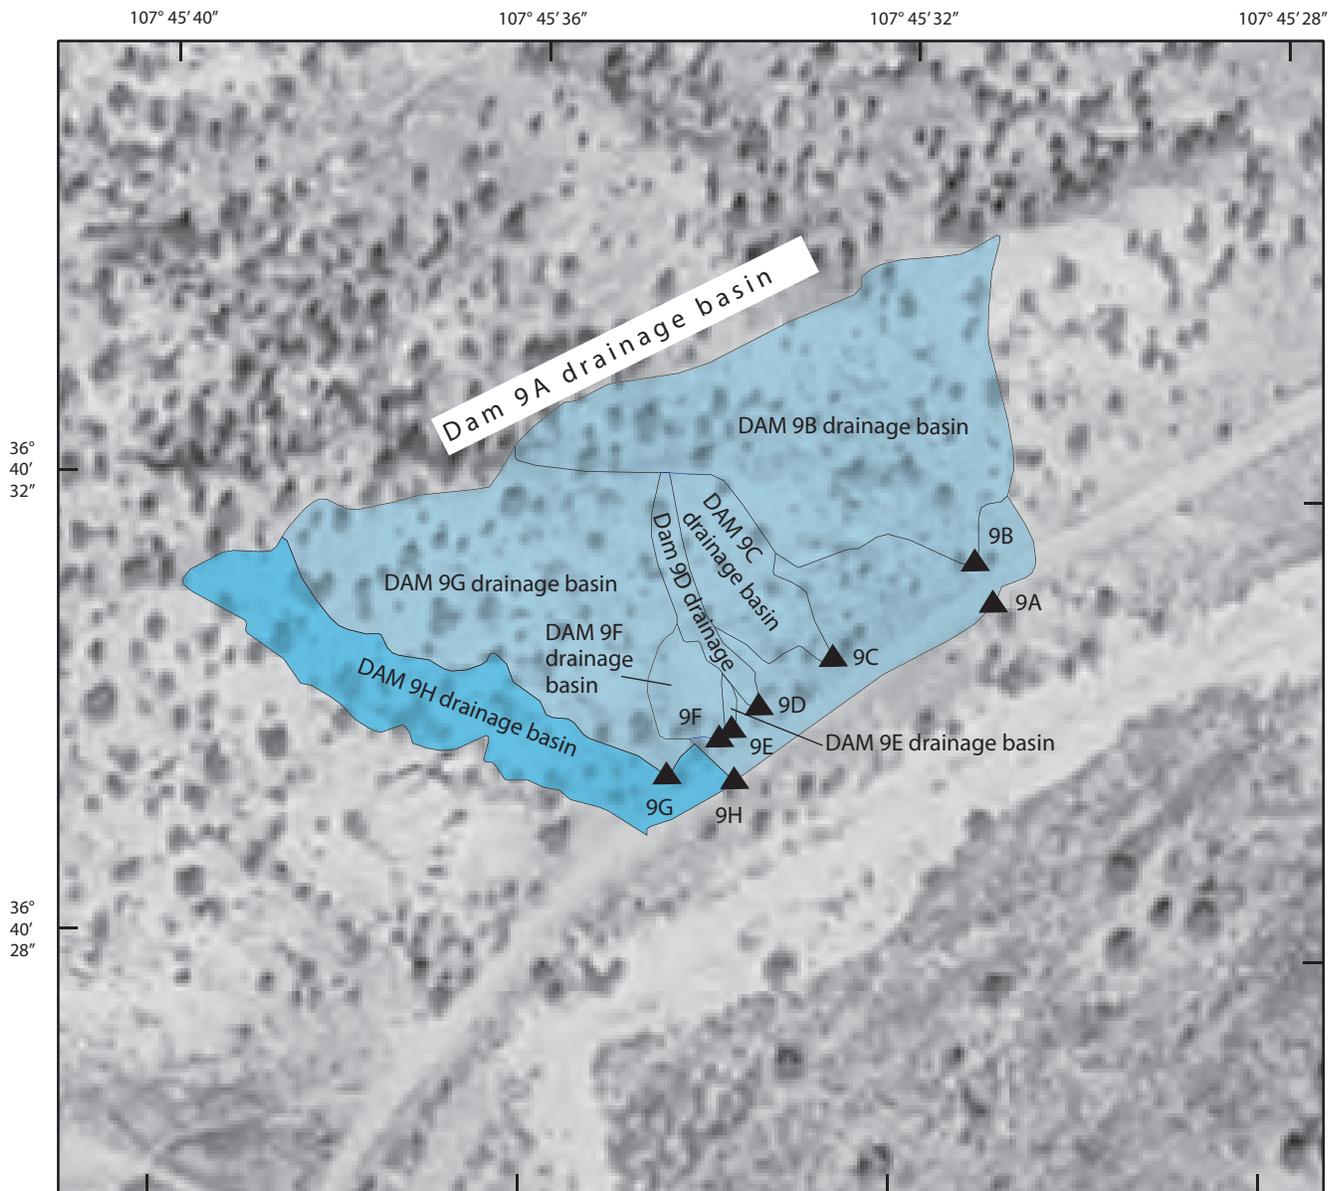
Figure 3F. Location of sediment dams 9A–9H and corresponding drainage basins in the Harris Canyon area.

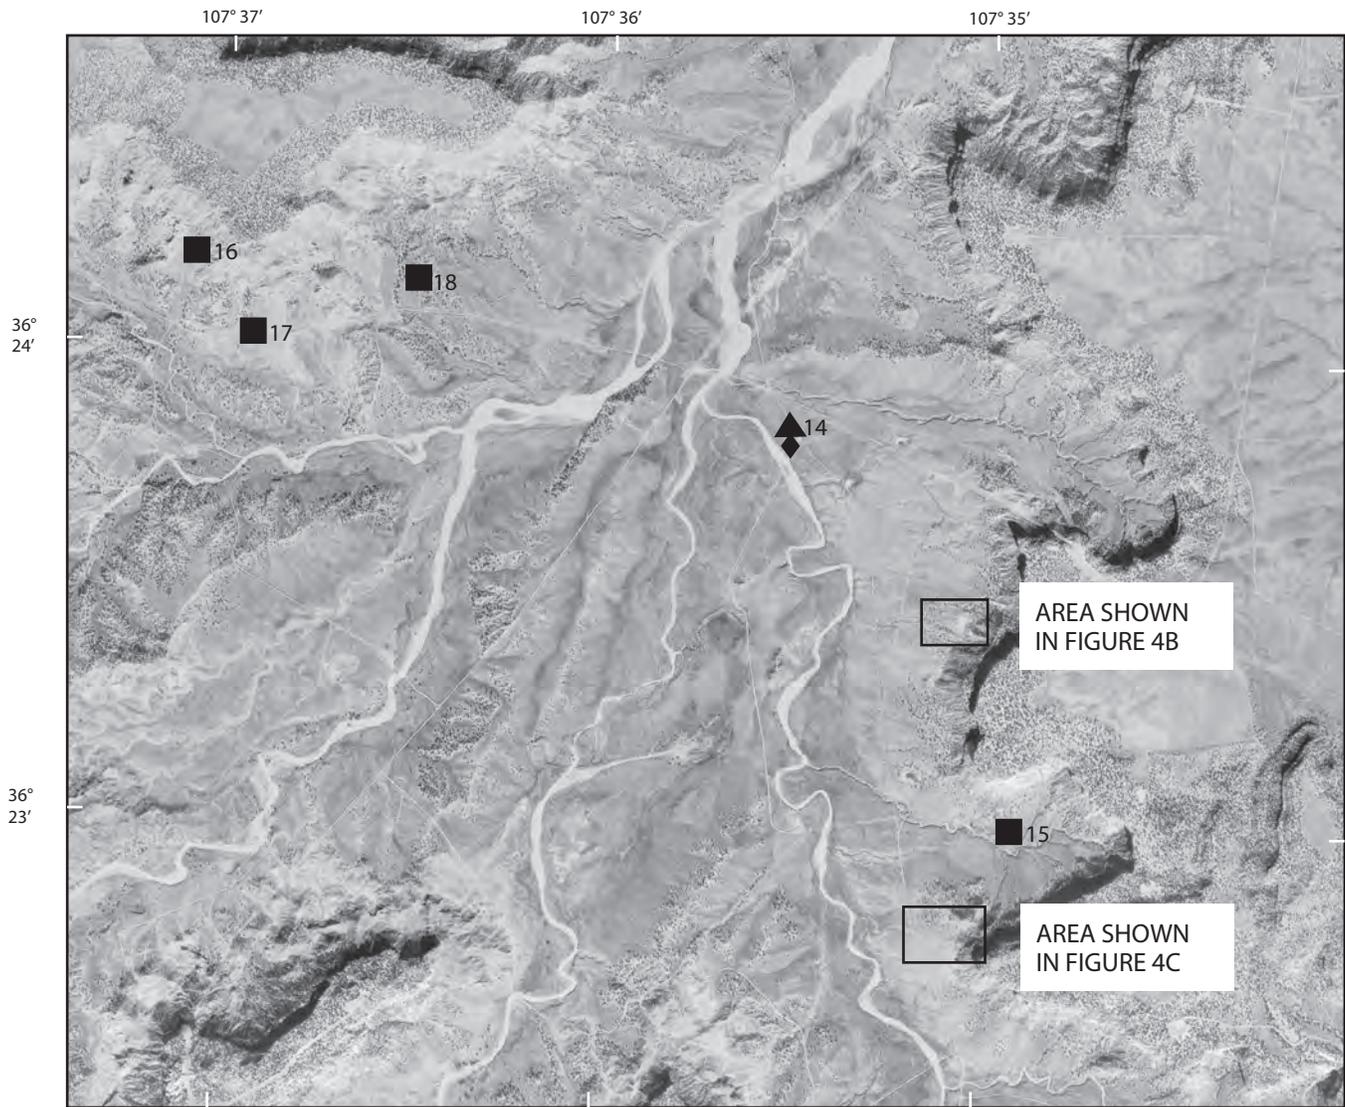
Figure 4A. Location of sediment dams, precipitation gage installed for study, and transects in the Palluche Canyon area.

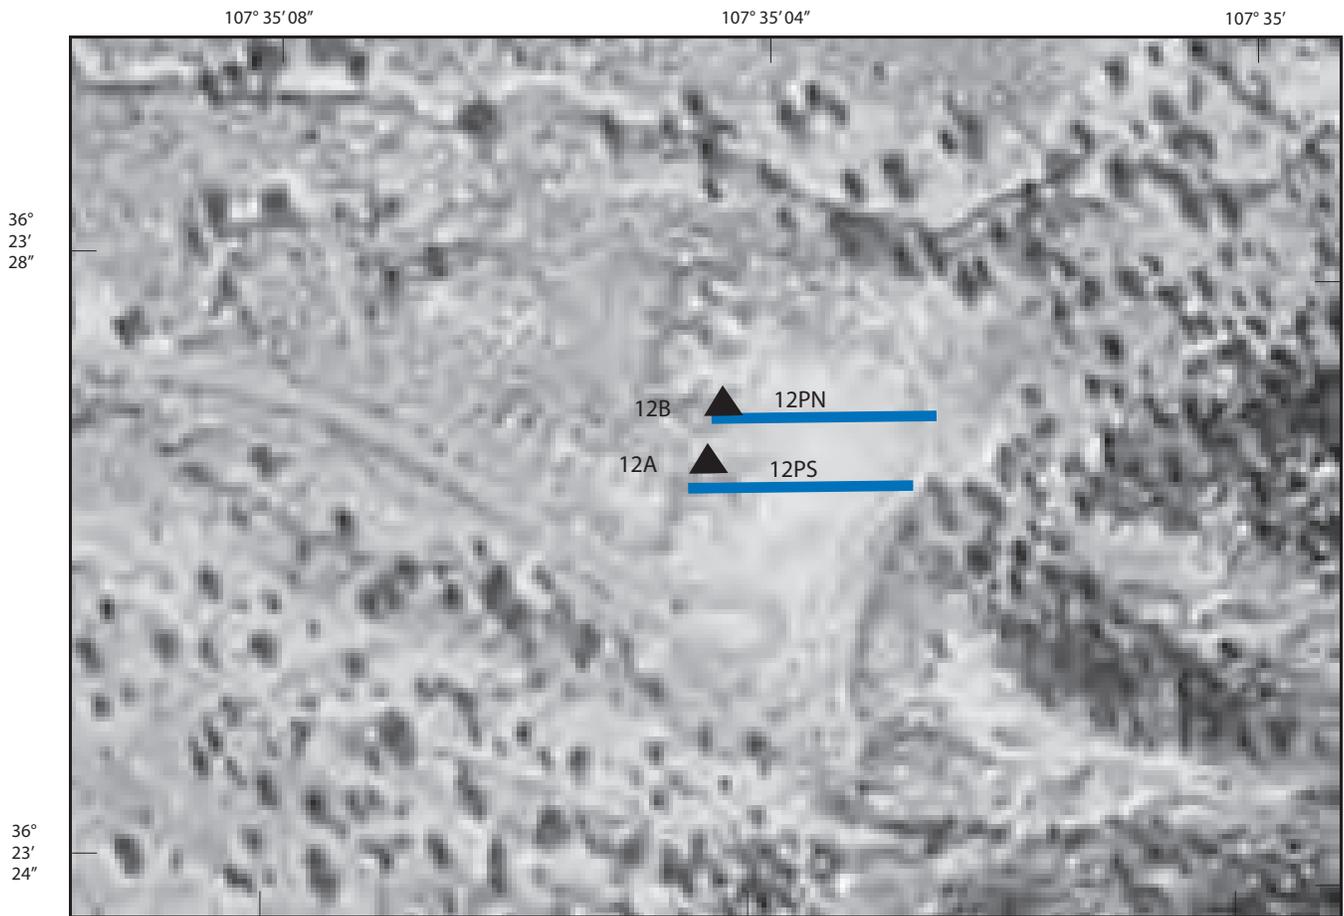
Figure 4B. Location of sediment dams 12A and 12B and transects 12 PN and 12PS in the Palluche Canyon area.

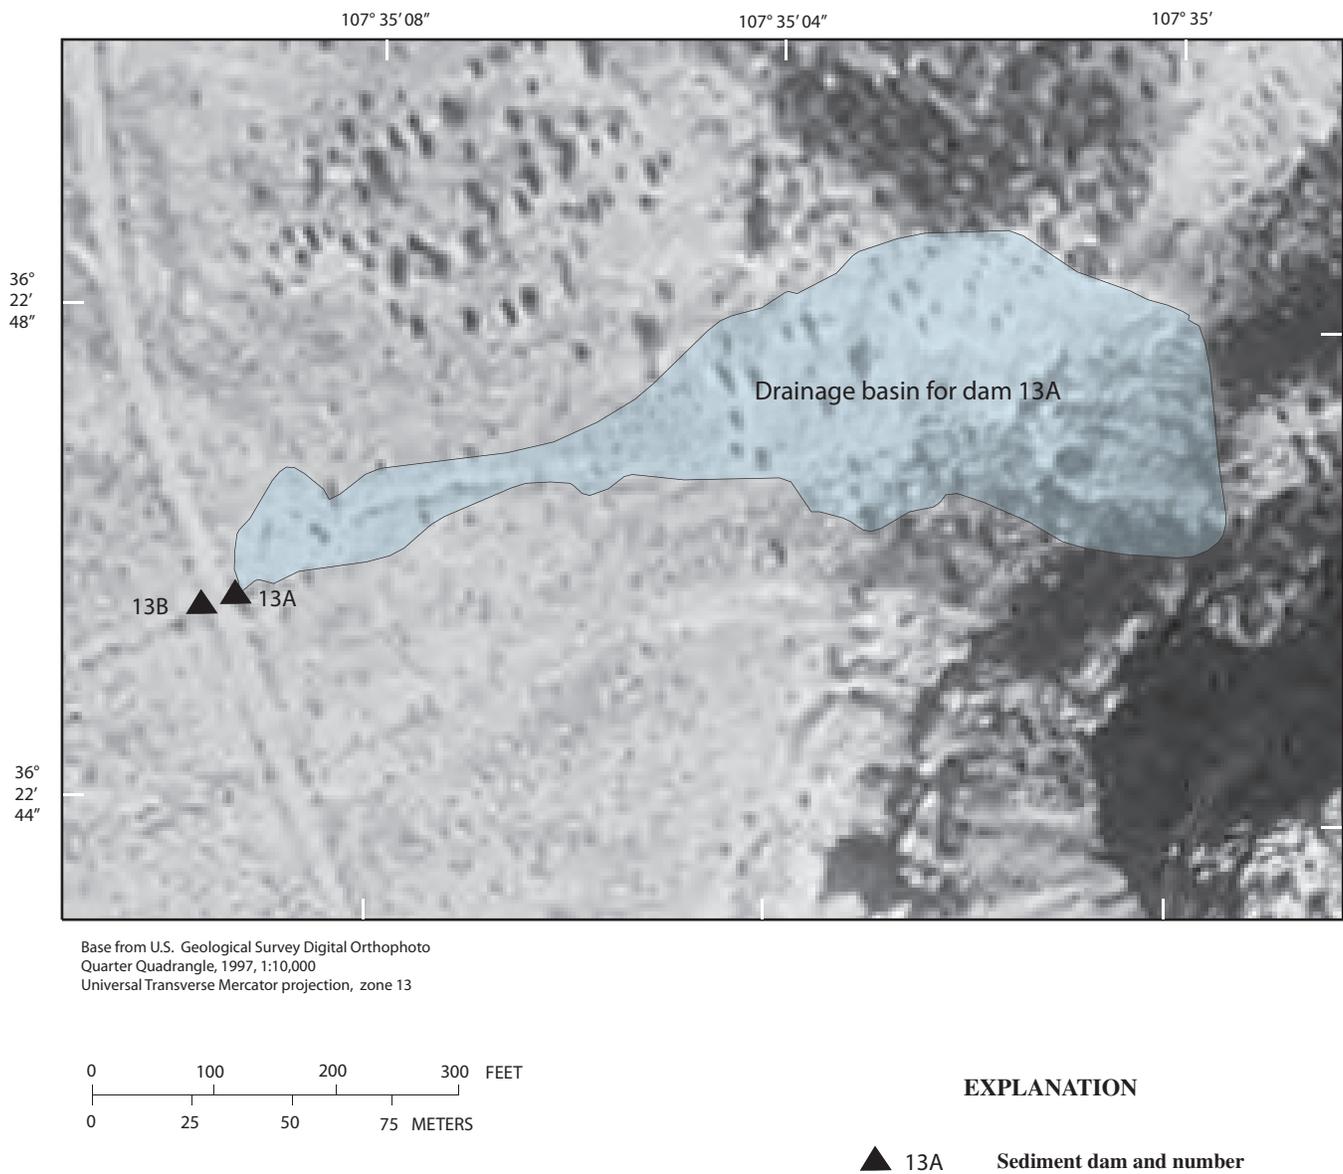
Figure 4C. Location of sediment dams 13A and 13B and drainage basin for dam 13A in the Palluche Canyon area.

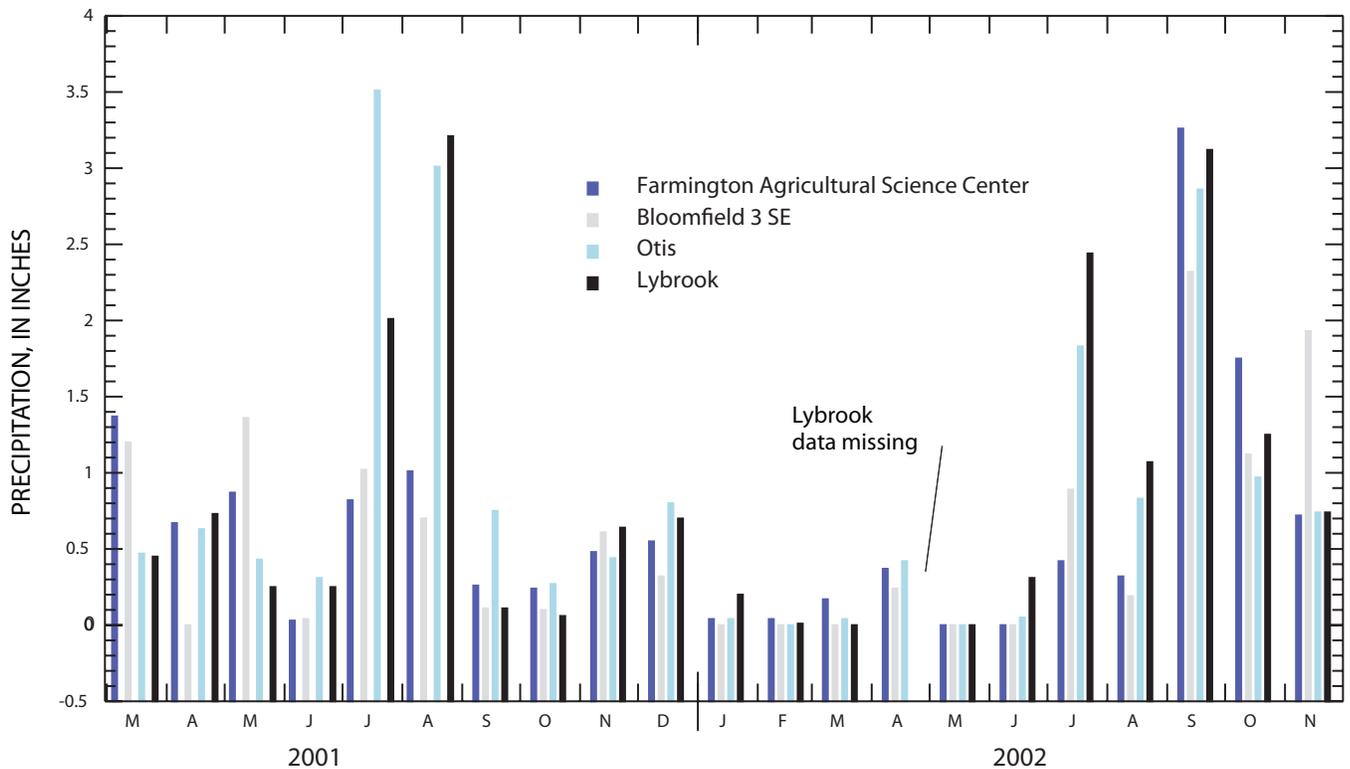
Figure 5. Total monthly precipitation at the Farmington Agricultural Science Center, Bloomfield 3 SE, Otis, and Lybrook National Weather Service cooperative climatological stations, March 2001–November 2002. Data obtained from Western Region Climate Center, 2004.

Precipitation at four National Weather Service climatological stations (fig. 1) for the 2001-02 study period generally followed the seasonal monsoonal pattern but with an unusually dry spring in 2002 and little rain recorded for the first 6 months of that year (fig. 5). Mean annual precipitation at the four stations was below normal for 2001-02 (table 2). During 2001 precipitation was generally of low intensity. During the 2002 monsoon season, however, precipitation of high intensity fell several times. The first high-intensity precipitation that fell in the Palluche Canyon area on July 9, 2002, totaled 0.82 in., with a maximum intensity of 0.71 in./hr. The second high-intensity precipitation that fell on July 23, 2002, in the Harris Canyon area totaled 1.4 in. over about 4 hours, with a maximum intensity of 0.68 in./hr. Although precipitation data were not recovered for tipping-bucket rain gages in the Harris Canyon area in August 2002 due to an equipment malfunction, data from the four National Weather Service climatological stations and from the Palluche Canyon area tipping-bucket rain gage indicate sparse precipitation. Three major rains fell during September 2002, the largest a storm totaling 0.47 in. over 32 minutes near the end of the month.

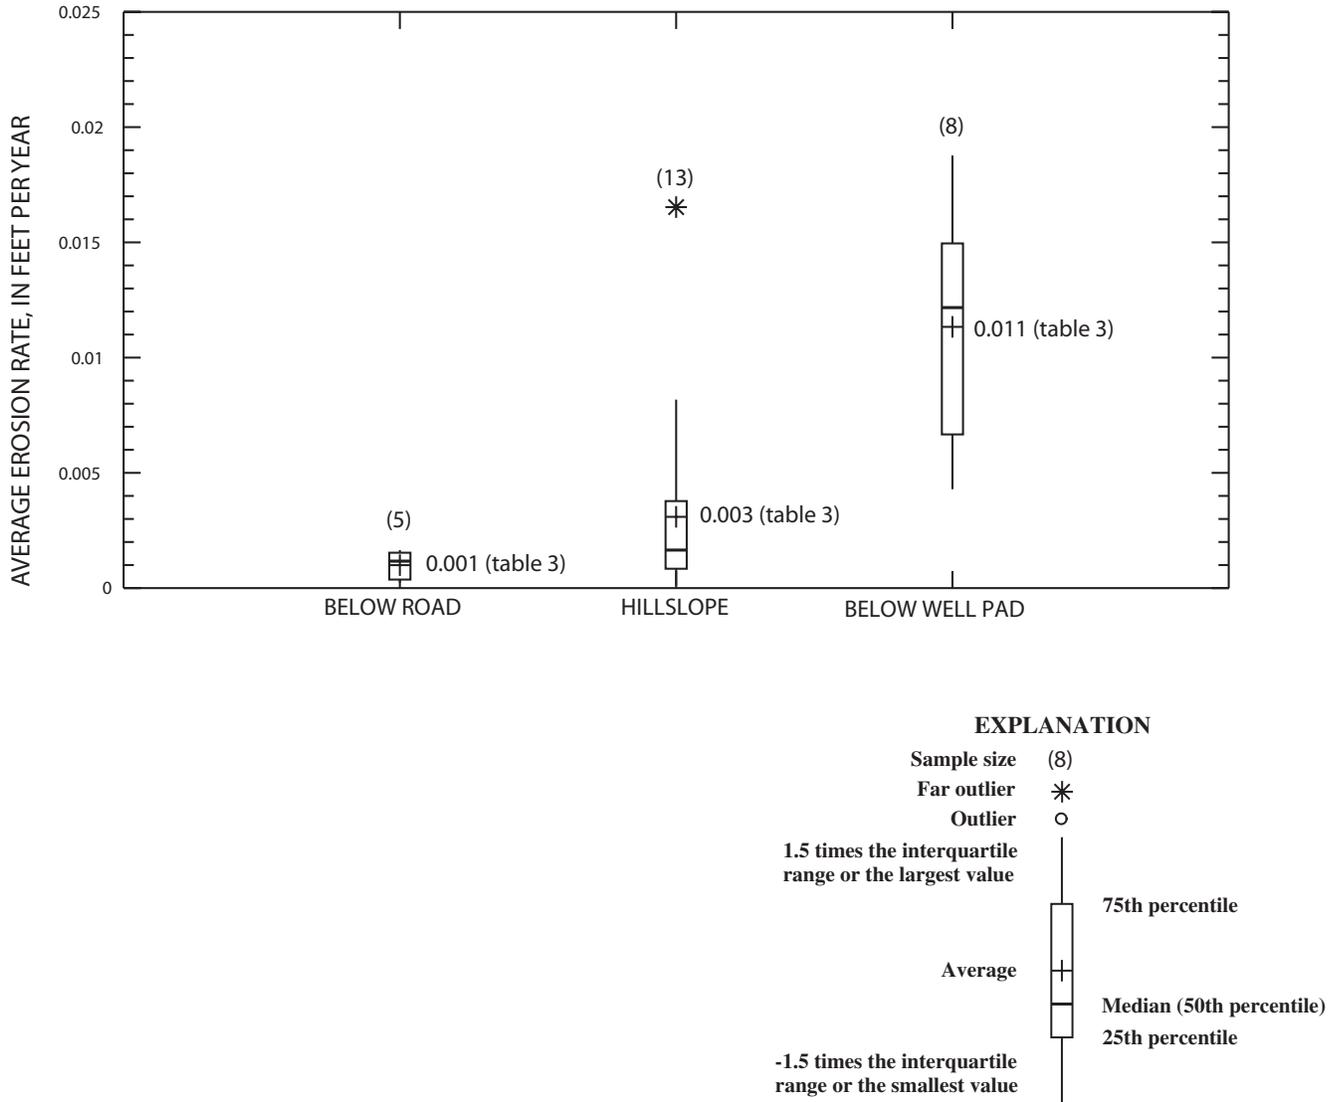
Figure 6. Average erosion rates for drainage areas located below roads, on hillslopes, or below well pads.

cantly related to average erosion rate (R^2 (adjusted) = 30 percent, $p = 0.003$). The parameters percent bedrock and contributing area significantly relate to each other (R^2 (adjusted) = 78 percent, $p = 0.000$), so a multiple linear regression of these two parameters to estimate erosion rate does not improve the regression. Because of the complex physical environment and difficult sampling conditions, the final data set consisting of measurements from 26 dams (table 1) was insufficient to draw relationships between erosion rates and selected geomorphic parameters. However, the average erosion rate differs significantly for dams in certain landscape positions. The average erosion rate normalized by drainage area was about 0.001 ft/yr below roads, 0.003 ft/yr on hillslopes, and 0.011 ft/yr below well pads (fig. 6; table 3). With use of a two-sample t-test to compare the means of two populations of samples with unequal variances, there was no significant difference in the average erosion rate for dams located on hillslopes and below roads, whereas average erosion rates for dams below well pads were significantly larger than for dams in the other two landscape positions.

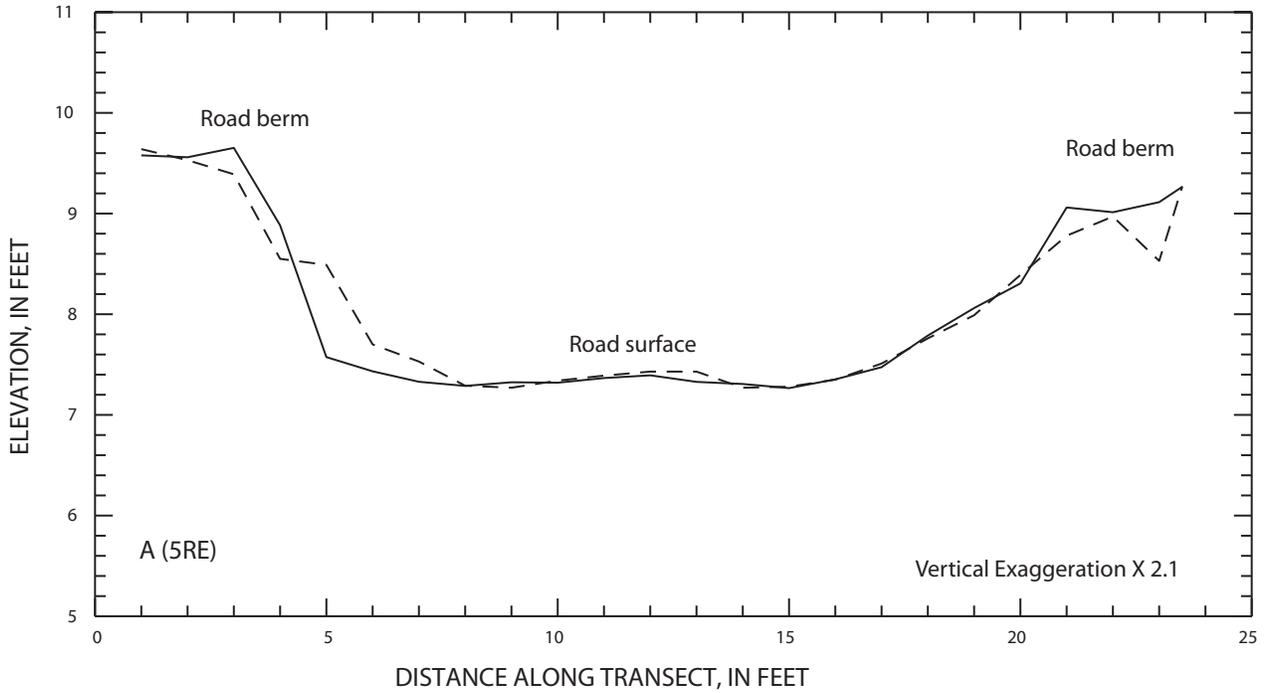
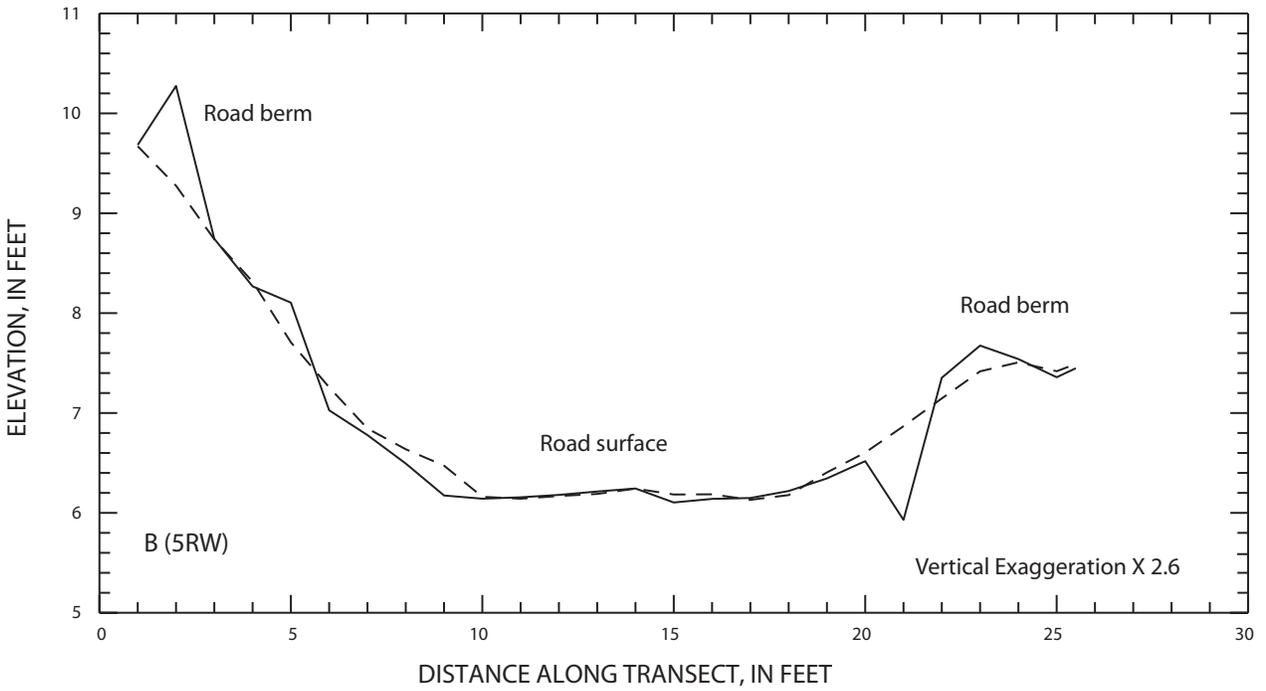
Figure 7. Land-surface changes for transects (A) 5RE and (B) 5RW in the Harris Canyon area, June 28, 2001–November 20, 2002. Transect locations shown in figure 3C. View is to the northeast.

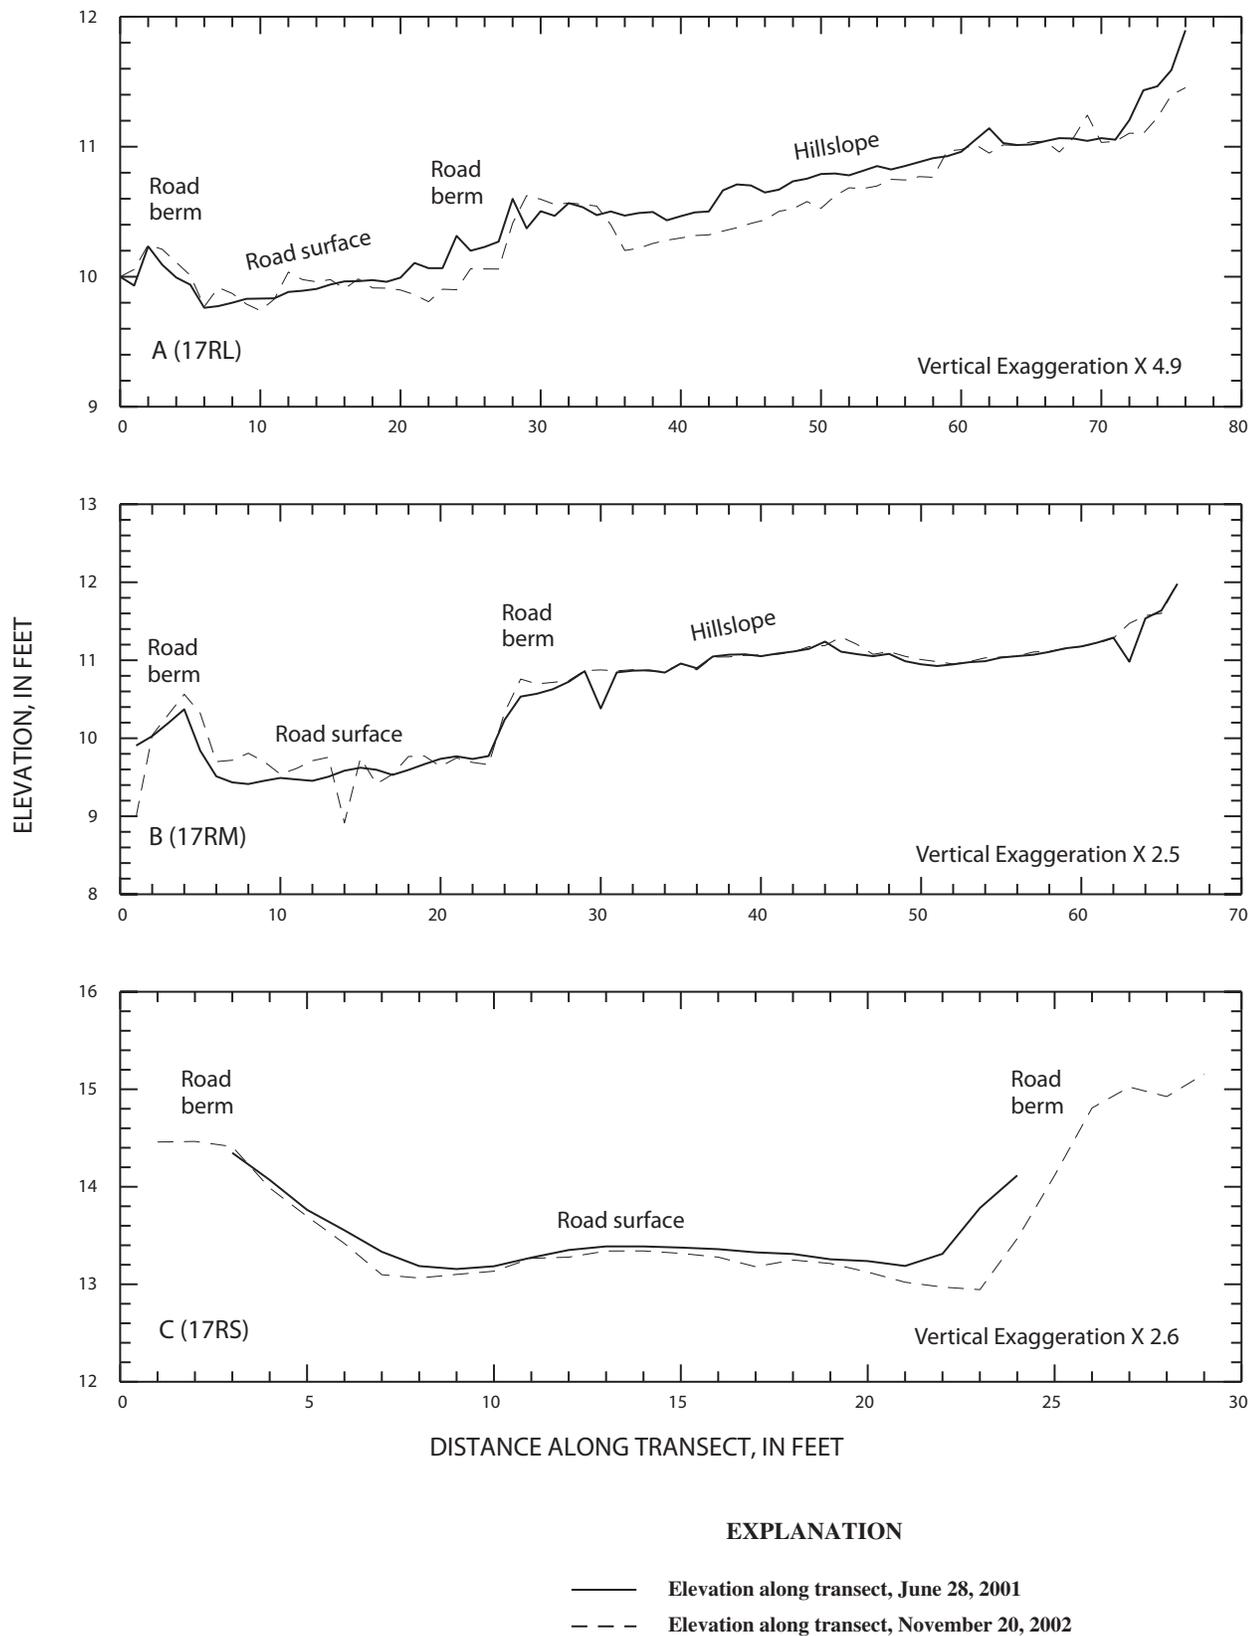
Figure 8. Land-surface changes for transects (A) 17RL, (B) 17RM, and (C) 17RS in the Palluche Canyon area, June 28, 2001–November 20, 2002. Transect locations shown in figure 4A. View is to the west.

thest upslope transect and 17RS is the farthest downslope transect. Site 17 was chosen because silt, identified by color, was observed during field reconnaissance to have been transported from the weathered outcrops across a hillslope with a 2-percent gradient and deposited across and on the far side of the road. The three transects together support sediment movement downslope toward the road; a larger volume of movement was noted in steeper portions. The transects also indicate erosion and transport of sediment downslope and along the road once the sediment reaches the road.

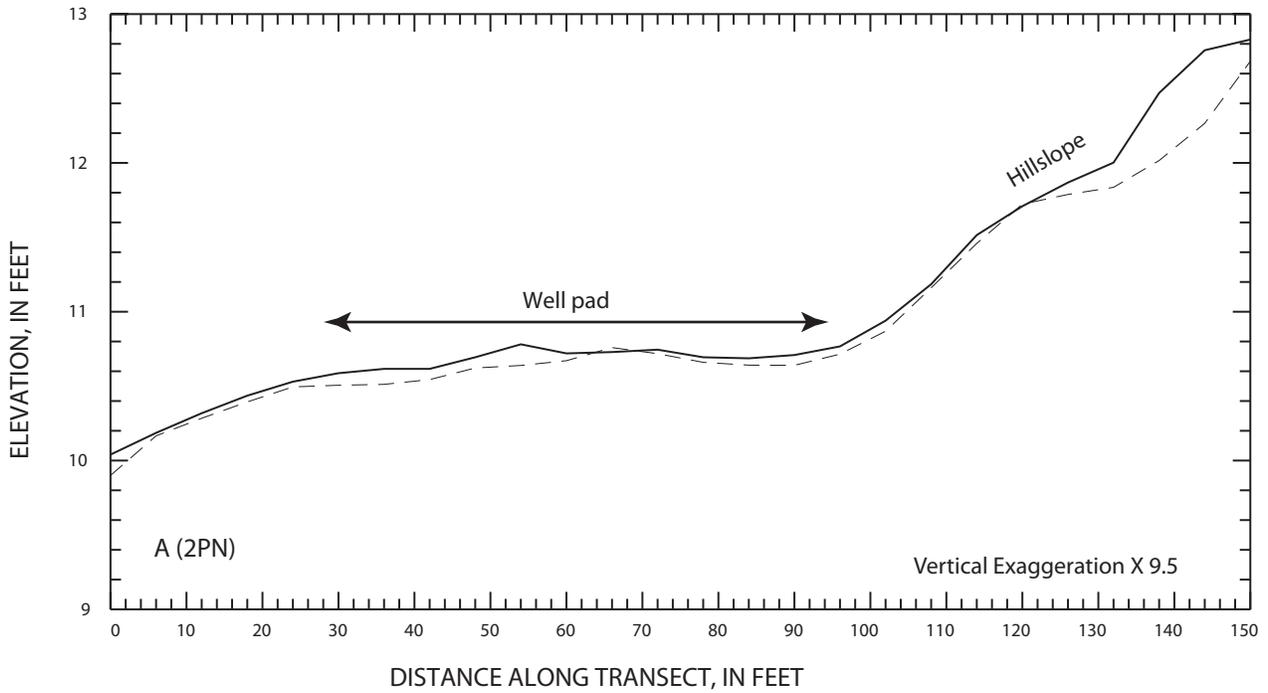
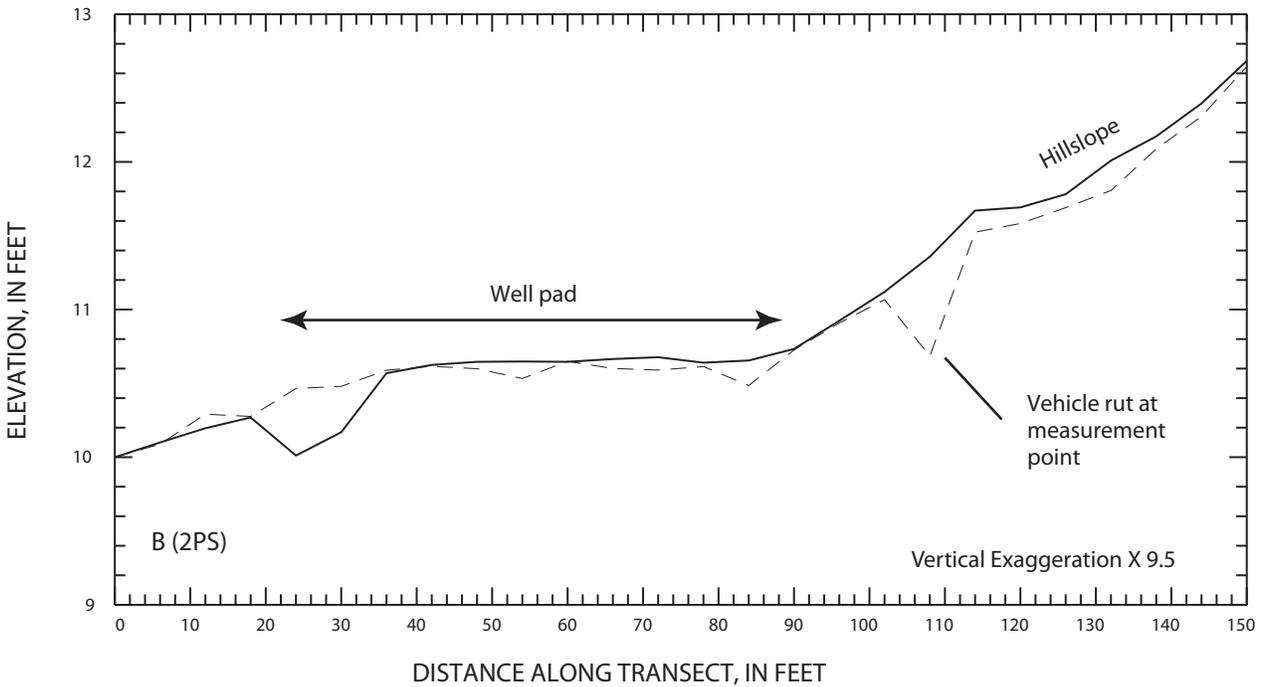
Figure 9. Land-surface changes for transects (A) 2PN and (B) 2PS, in the Harris Canyon area, June 28, 2001–November 20, 2002. Transect locations shown in figure 3B. View is to the south.

Well-pad transects 2PN, 2PS, 5PE, 5PW, 6PE, and 6PW (figs. 9, 10, and 11), in the Harris Canyon area, were located on sandy material. The site 2 well pad (fig. 3B), the head of a side canyon, lies downslope from colluvial sediment deposits and bedrock cliffs that potentially can supply large volumes of sediment. A loss of sediment from June 28, 2001, to November 2002 generally was shown for transects 2PN and 2PS from the hillslope above the pad and from the pad, although some sediment was deposited in transect 2PN on the pad (fig. 9). Erosion from the downslope edge of the pad is shown in transect 2PN, whereas deposition is shown in transect 2PS. The pattern of net gain and loss of sediment between successive surveys suggests downslope transport and redeposition of sediment from the hillslope, over the surface of the well pad, and down the well-pad edges.
