Effects of Roads and Well Pads on Erosion in the Largo Canyon Watershed, New Mexico, 2001–02

Scientific Investigations Report 2006–5039

By Anne Marie Matherne

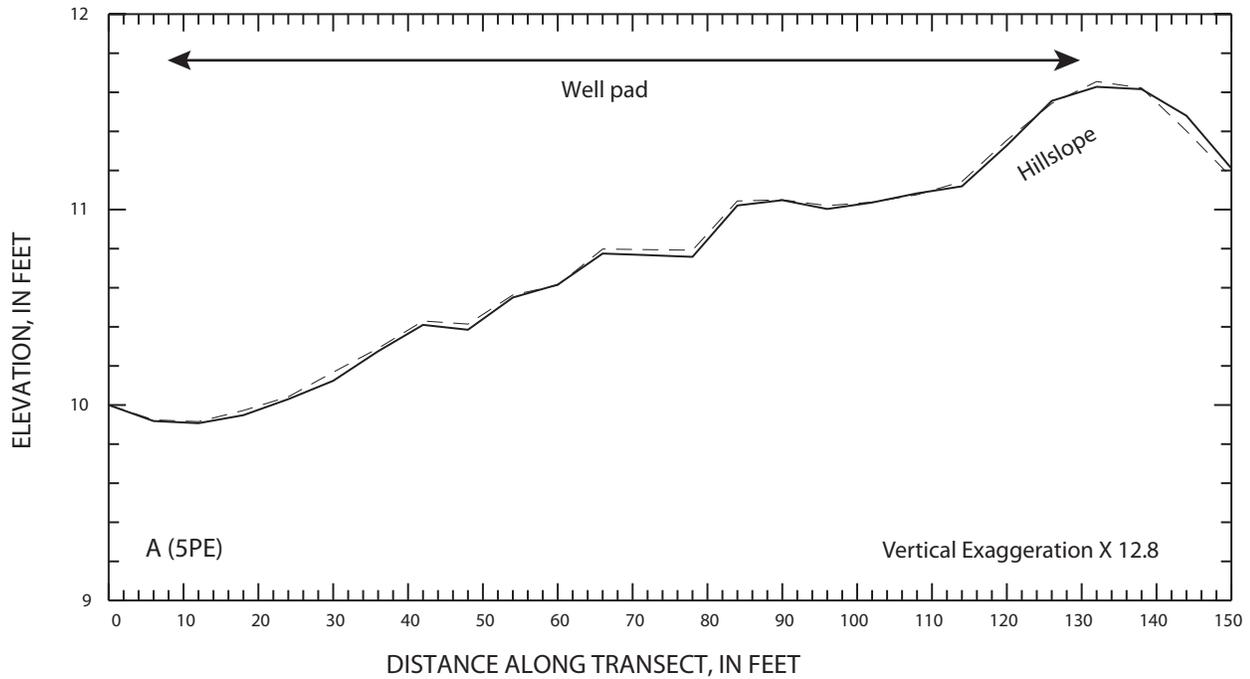
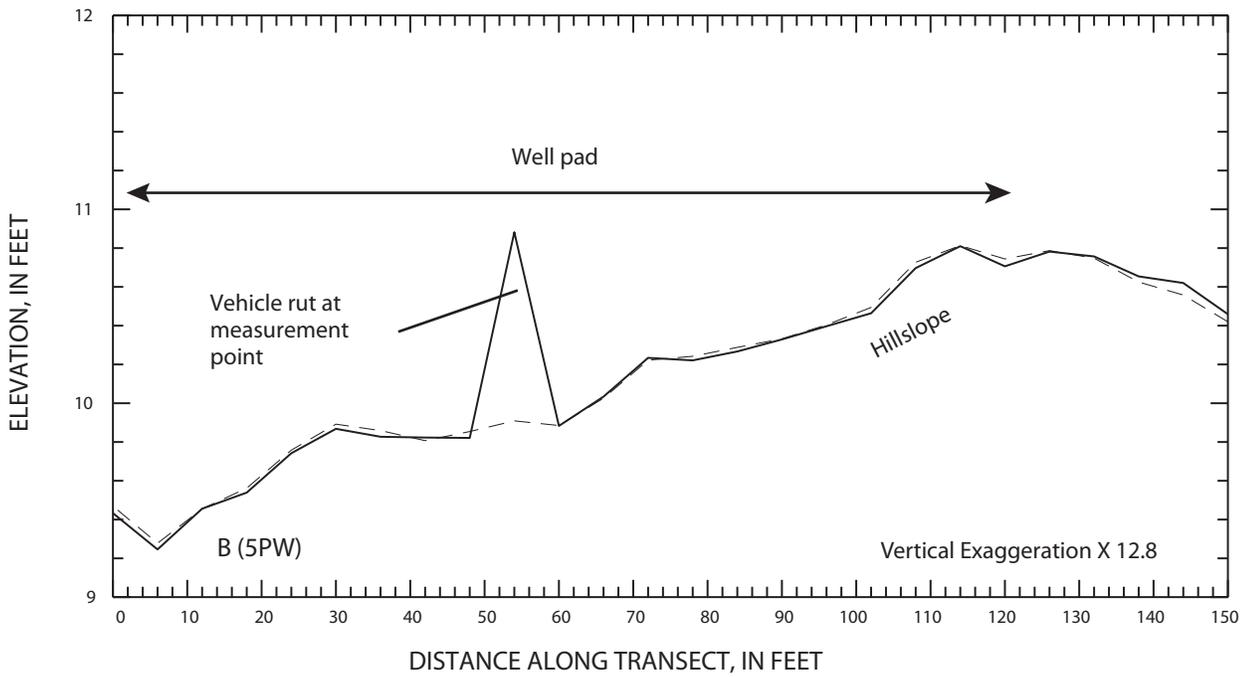
Figure 10. Land-surface changes for transects (A) 5PE and (B) 5PW in the Harris Canyon area, June 28, 2001–November 20, 2002. Transect locations shown in figure 3C. View is to the northeast.

Well-pad transects 2PN, 2PS, 5PE, 5PW, 6PE, and 6PW (figs. 9, 10, and 11), in the Harris Canyon area, were located on sandy material. The site 2 well pad (fig. 3B), the head of a side canyon, lies downslope from colluvial sediment deposits and bedrock cliffs that potentially can supply large volumes of sediment. A loss of sediment from June 28, 2001, to November 2002 generally was shown for transects 2PN and 2PS from the hillslope above the pad and from the pad, although some sediment was deposited in transect 2PN on the pad (fig. 9). Erosion from the downslope edge of the pad is shown in transect 2PN, whereas deposition is shown in transect 2PS. The pattern of net gain and loss of sediment between successive surveys suggests downslope transport and redeposition of sediment from the hillslope, over the surface of the well pad, and down the well-pad edges.

An intervening low area separates the site 5 well pad from the nearby hillslope, and the site 6 well pad is adjacent to a sandy embankment (fig. 3C). In transects 5PE and 5PW, a fairly stable surface configuration and some downslope sediment movement and redeposition at the edges of the well pads are shown, with the exception of vehicle ruts in the surface at transect 5PW (fig. 10). The site 6 well pad showed a similarly stable surface configuration between the first and second transect surveys (June 28, 2001, and May 7, 2002; not shown). Increases in surface elevation caused by earth movement during construction are shown in transects 6PE and 6PW (fig. 11), which compares the first and the third survey.

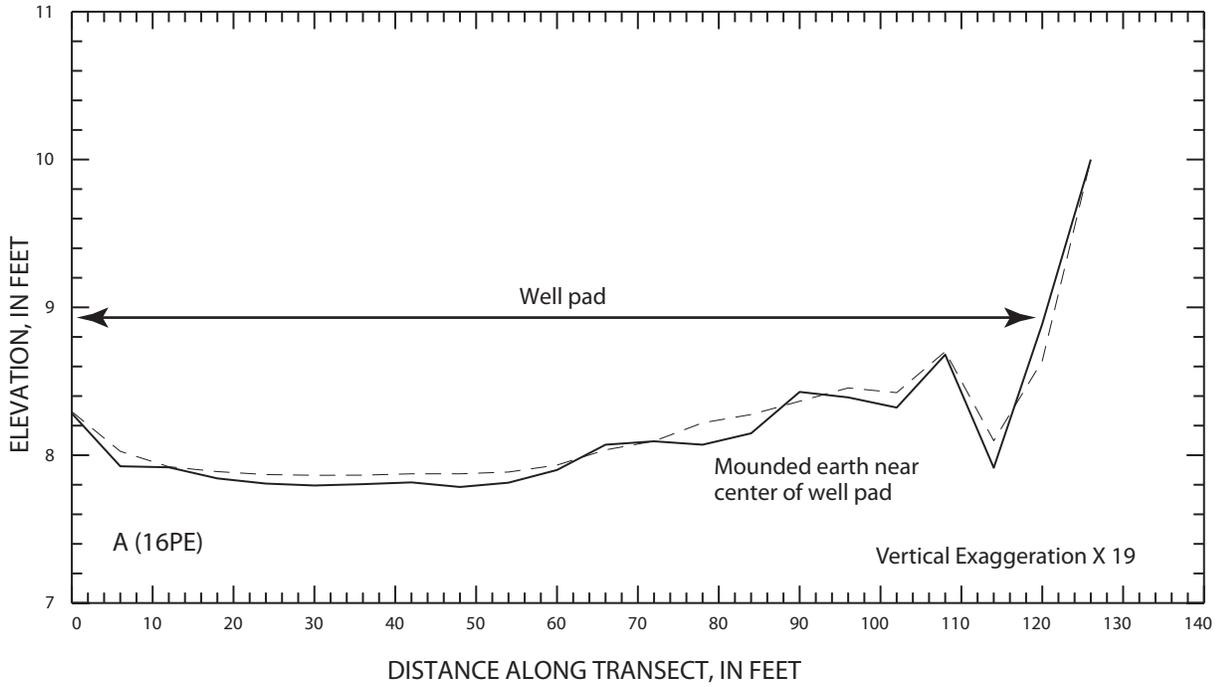
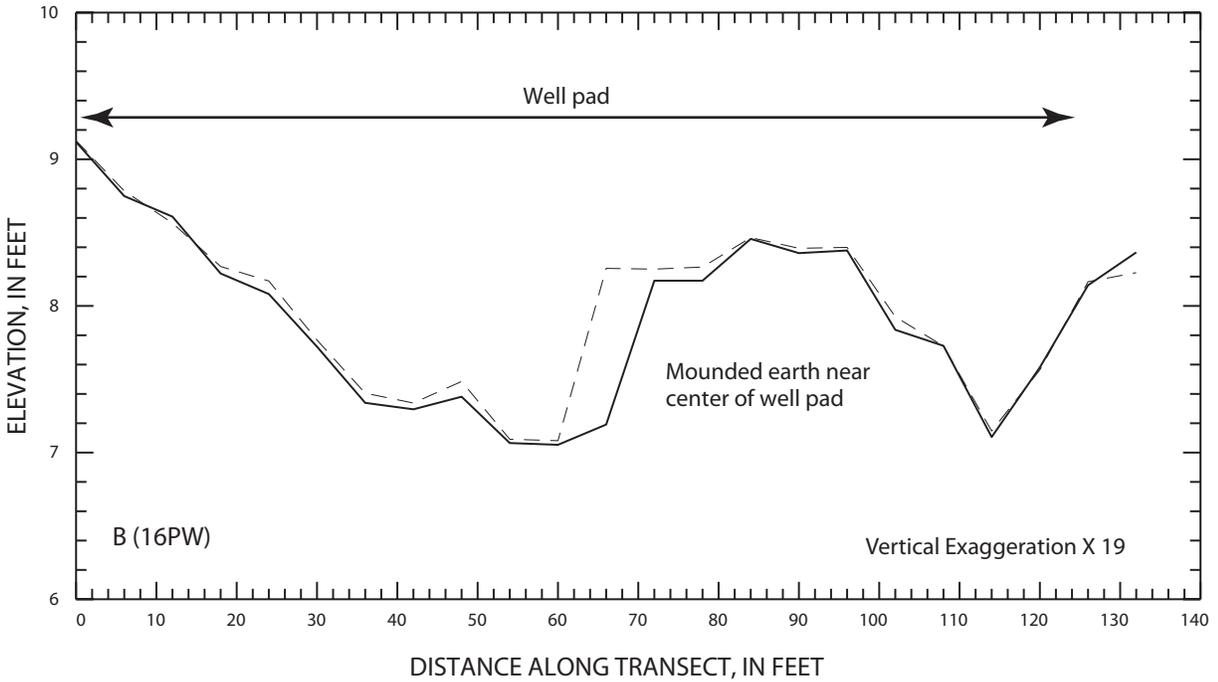
Figure 12. Land-surface changes for transects (A) 16PE and (B) 16PW in the Palluche Canyon area, June 28, 2001–November 20, 2002. Location of site 16 shown in figure 4A. View is to the northwest.

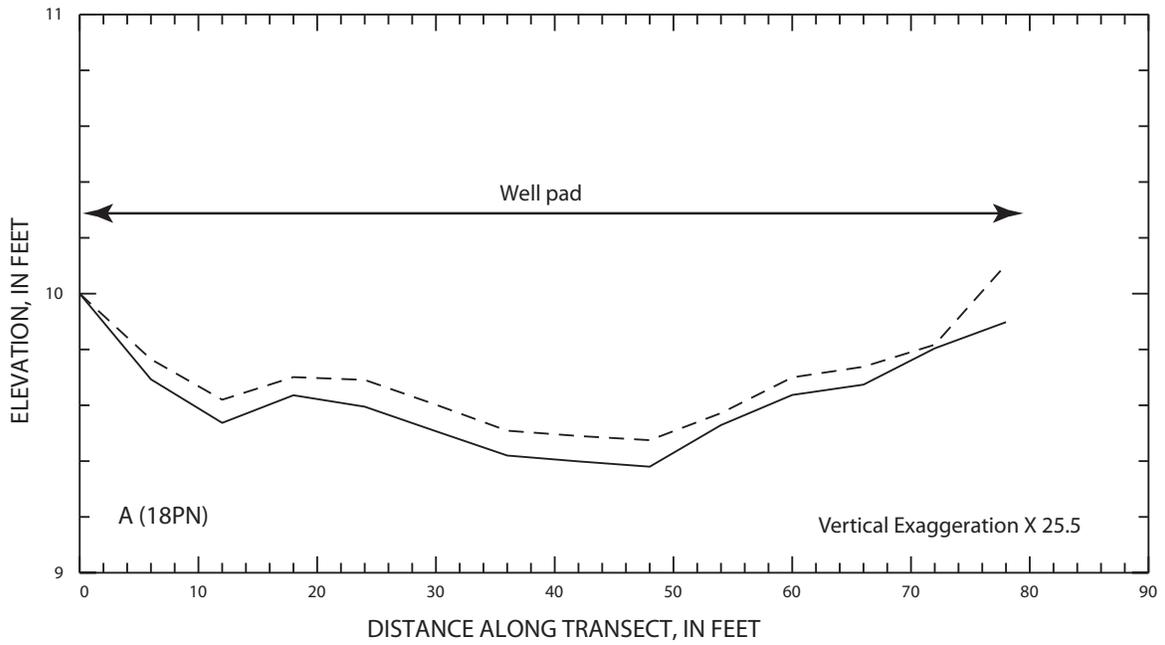
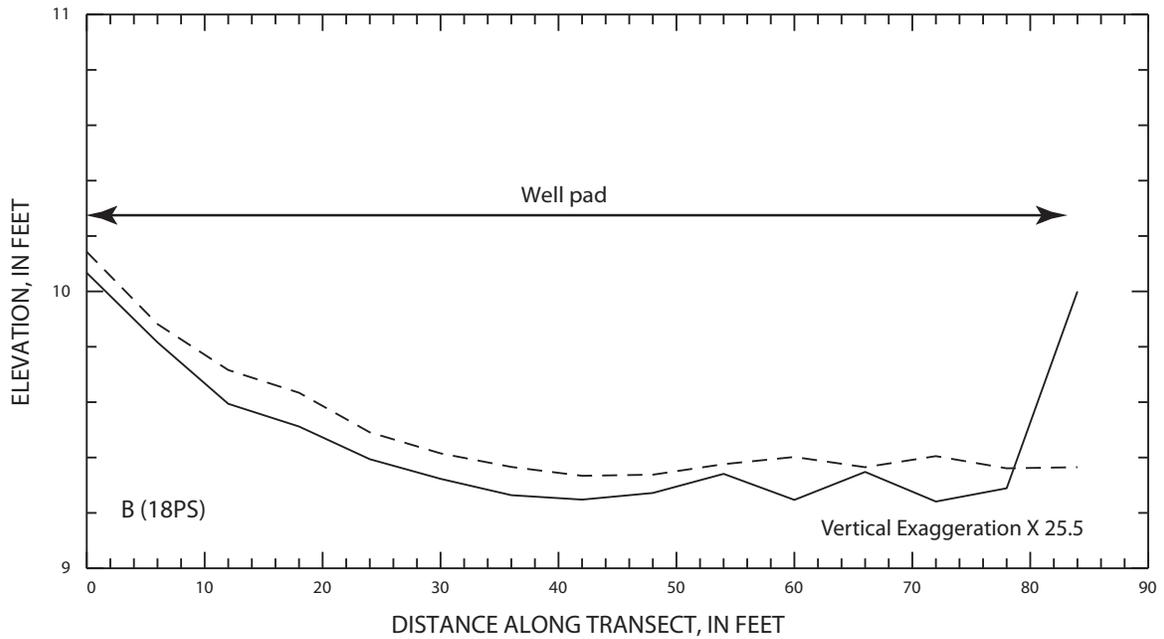
Figure 13. Land-surface changes for transects (A) 18PN and (B) 18PS in the Palluche Canyon area, June 28, 2001–May 4, 2002. Location of site 18 shown in figure 4A. View is to the south.

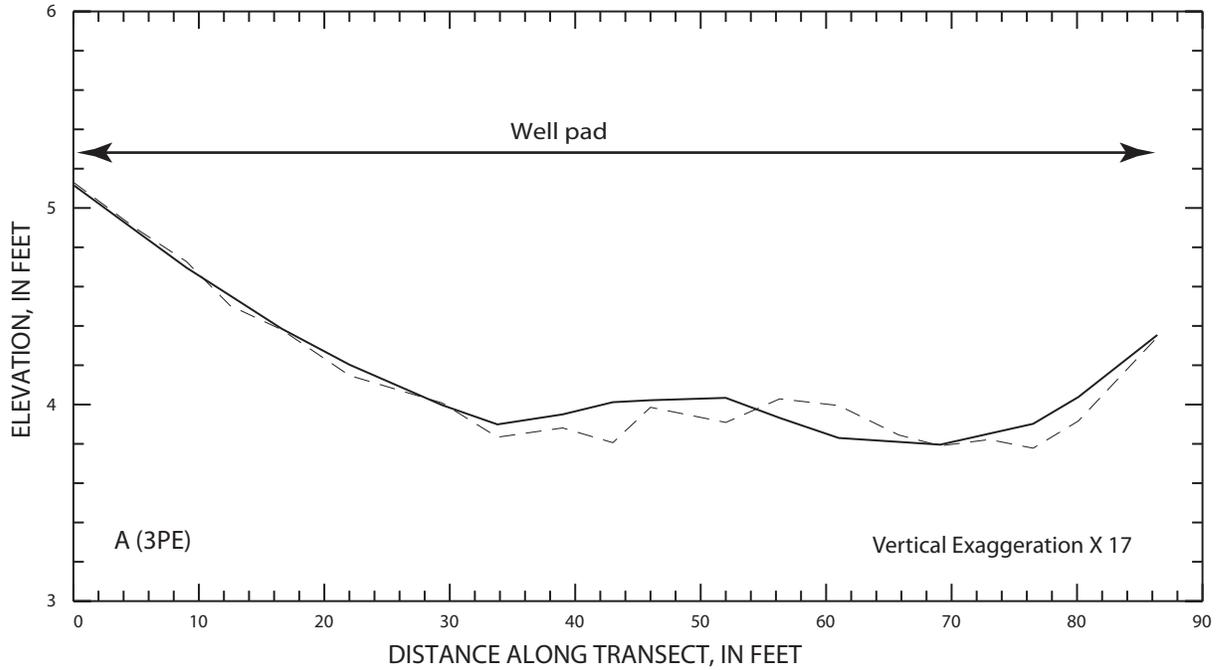
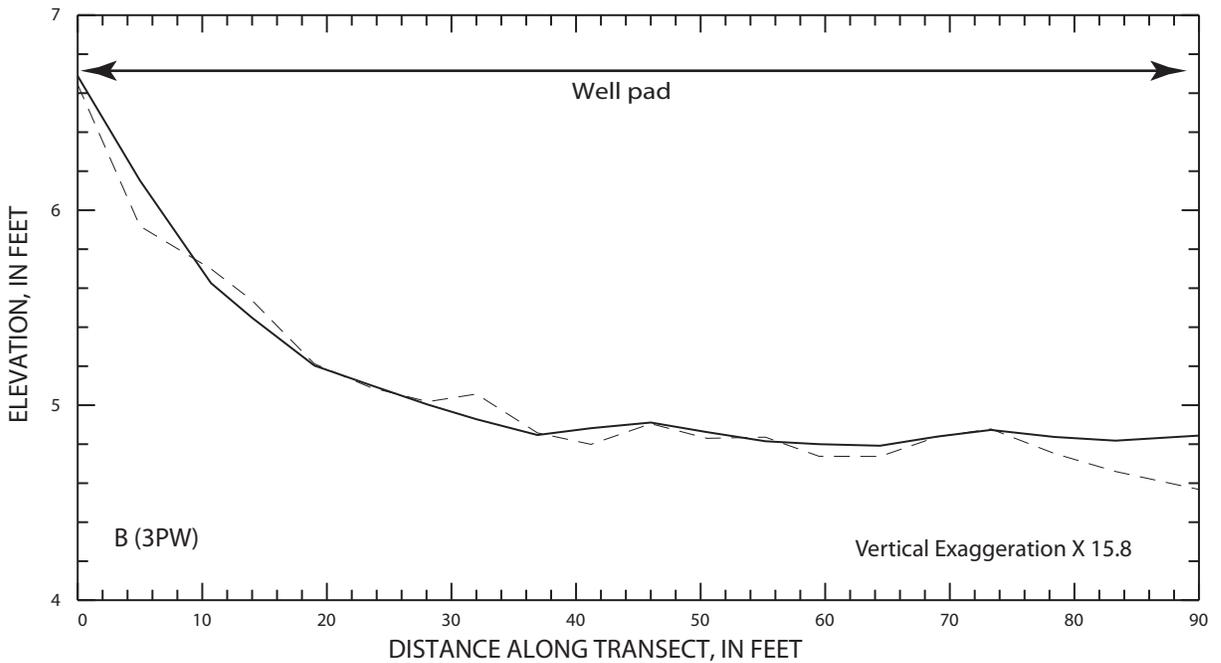
Figure 14. Land-surface changes for transects (A) 3PE and (B) 3PW in the Palluche Canyon area, June 28, 2001–November 20, 2002. Transect locations shown in figure 4A. View is to the west.

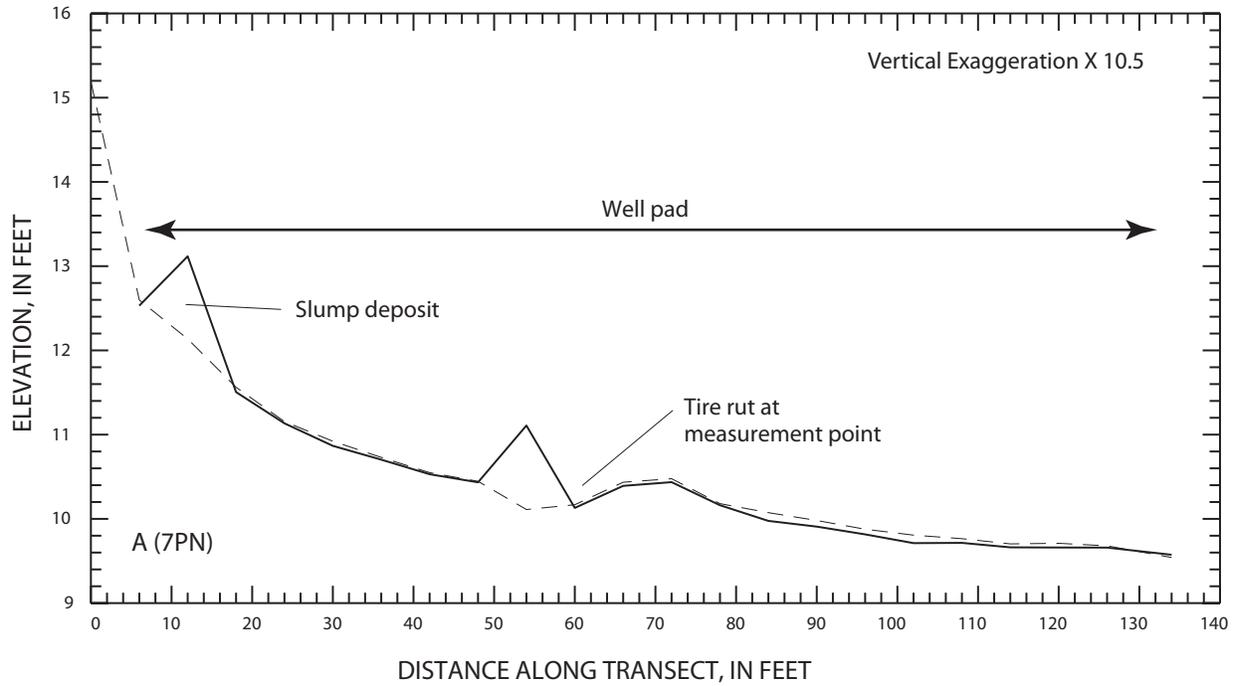
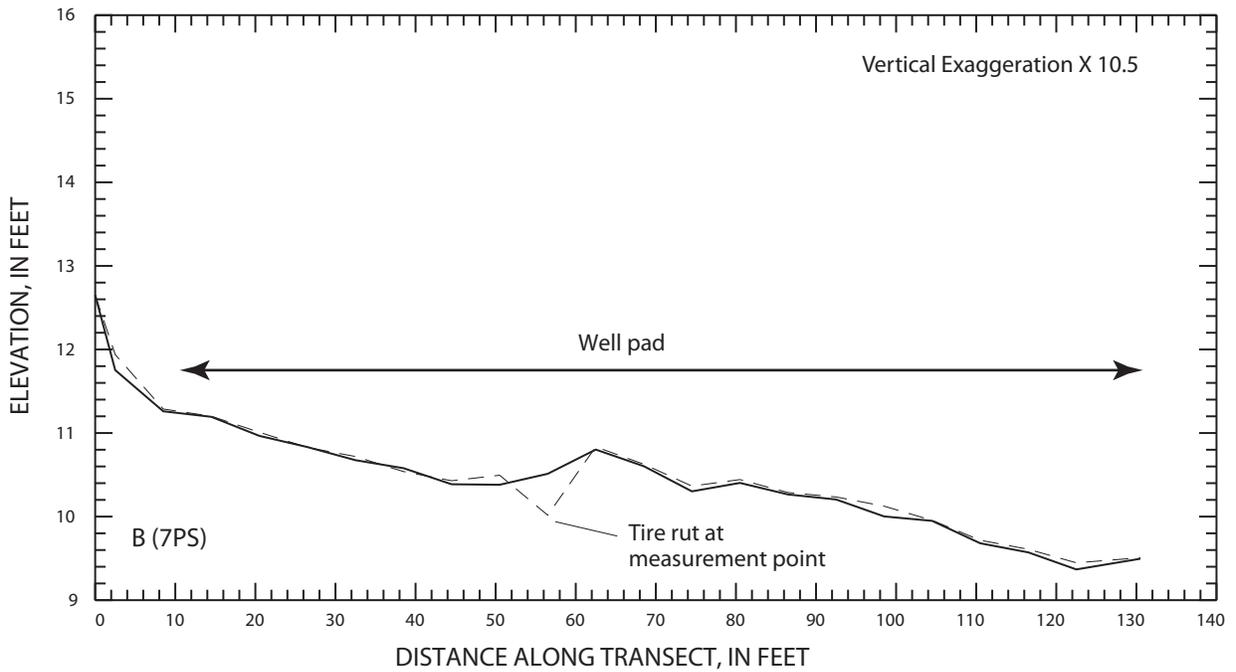
Figure 15. Land-surface changes for transects (A) 7PN and (B) 7PS in the Harris Canyon area, June 28, 2001–November 20, 2002. Transect locations shown in figure 3D. View is to the south.

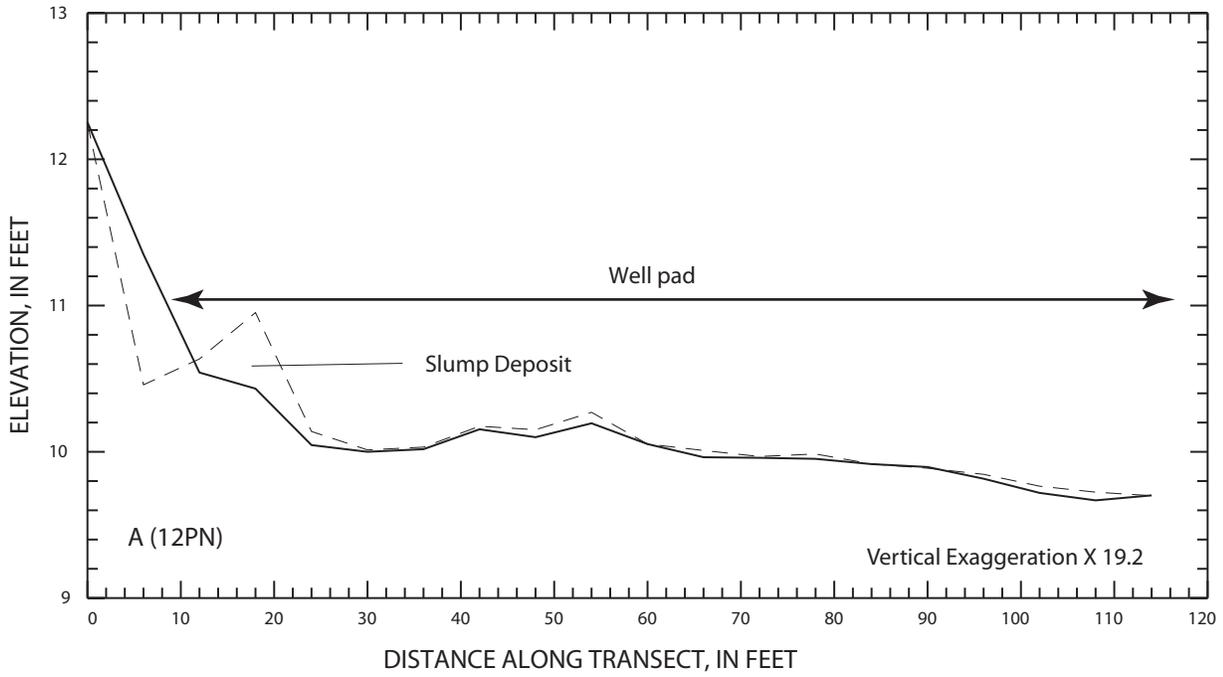
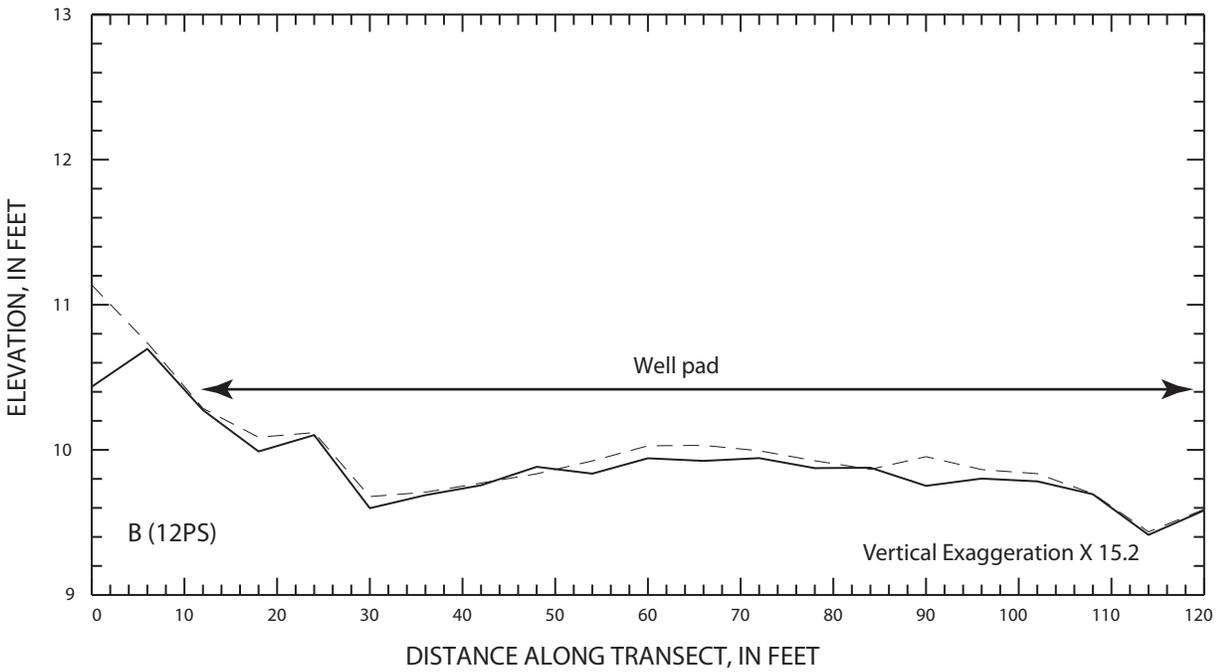
Figure 16. Land-surface changes for transects (A) 12PN and (B) 12PS in the Palluche Canyon area, June 28, 2001–November 20, 2002. Transect locations shown in figure 4B. View is to the south.

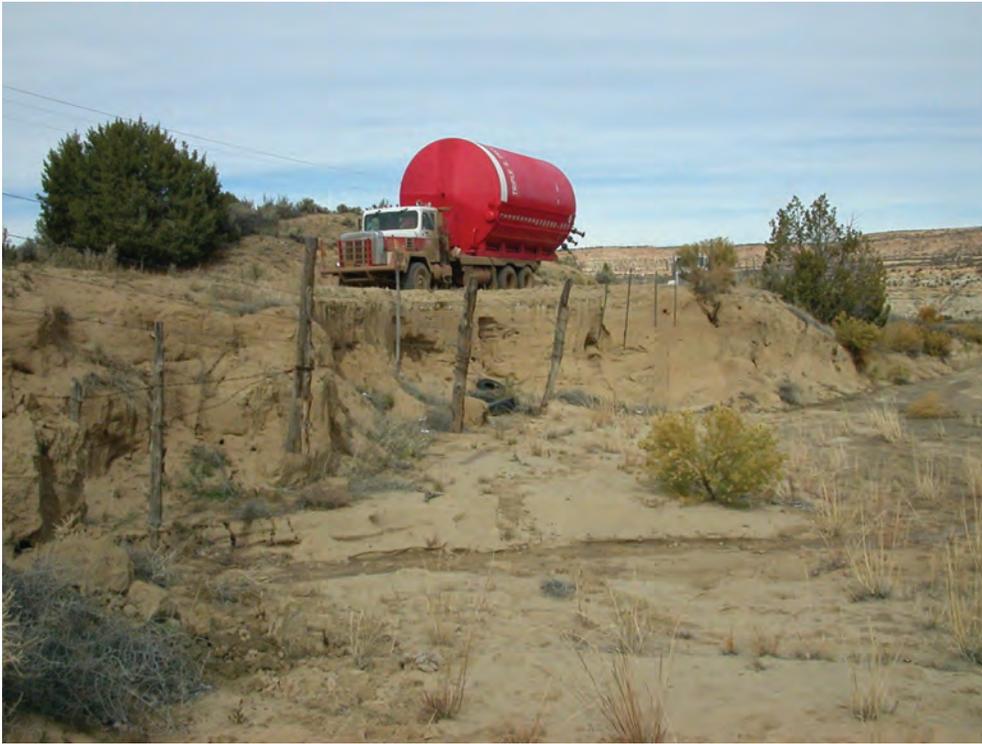
Figure 18. Truck on road above area of focused bank erosion. Note the fence posts hanging from fence wire. Road is near site 9, Harris Canyon area. View is to the northeast.

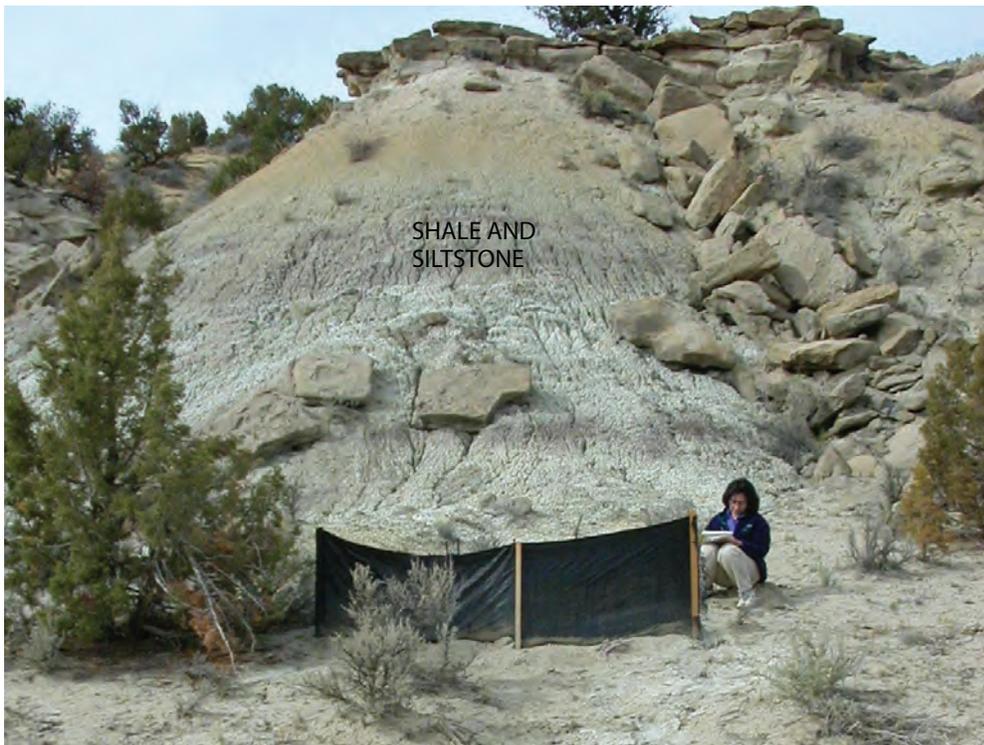
Figure 19. Sediment dam 9D and weathered shale and siltstone in the drainage contributing area, Harris Canyon area. Location of dam 9D shown in figure 3F. View is to the northwest.

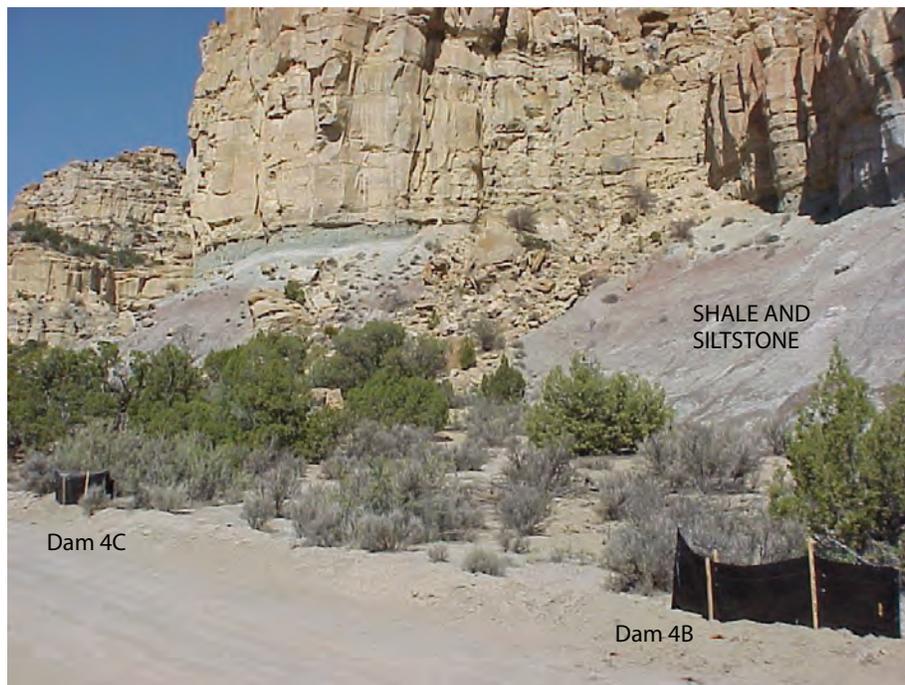
Figure 20. Weathered shale and siltstone in drainage contributing areas of sediment dams 4B and 4C in the Harris Canyon area. Locations of dams 4B and 4C shown in figure 3B. View is to the northwest.

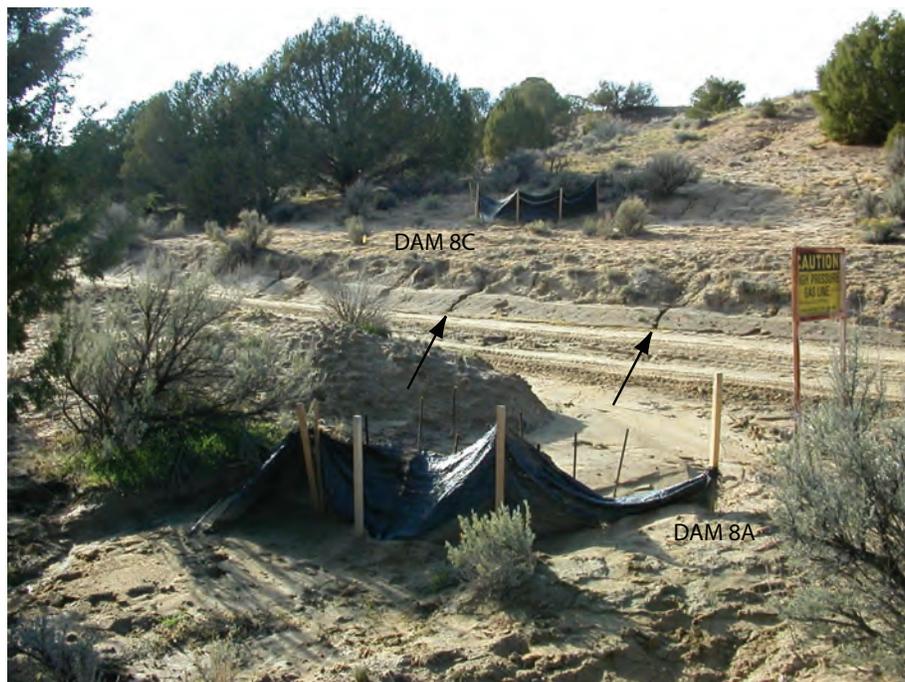
Figure 21. Areas (indicated by arrows) where headcuts in the upslope road berm near sediment dams 8A and 8C have extended beyond the road berm and up the hillslope, Harris Canyon area. Locations of dams 8A and 8C shown in figure 3E. View is to the northwest.

intercepted by and transported along the road (figs. 3E and 3F) to an outlet point (fig. 21, dam 8A; fig. 25, dam 9A). The outlet point may be a new or pre-existing drainage at some distance down the road from the numerous small drainages contributing runoff to the road. Sediment is deposited on the road from accumulated runoff originating from a segment of the hillslope. This accumulated runoff and sediment are channeled by the road bed to a single outlet point on the downslope side of the road (figs. 21 and 25). Because flow from the hillslope drainages is concentrated into a larger flow along the road, the potential erosive capacity of the runoff is magnified, the degree of magnification depending on the slope and topography at the point. The second way in which roads facilitate erosional processes is in providing focal points for the initiation of erosion on freshly exposed or disturbed surfaces. Road berms, created when level roads are cut into hillslopes, provide oversteepened slopes on which enough potential energy is available to initiate headcut erosion during runoff. Headcut erosion occurs naturally on weathered surfaces where rills form at slope breaks and erode headward. Periodic grading of the roads sustains the heights of the berms and maintains the potential energy needed to initiate rill formation and headcut erosion. In contrast to roads adjacent to hillslopes, roads through flatter landscapes, such as parts of the Palluche Canyon area, show little evidence of headcut erosion extending upslope from road berms.

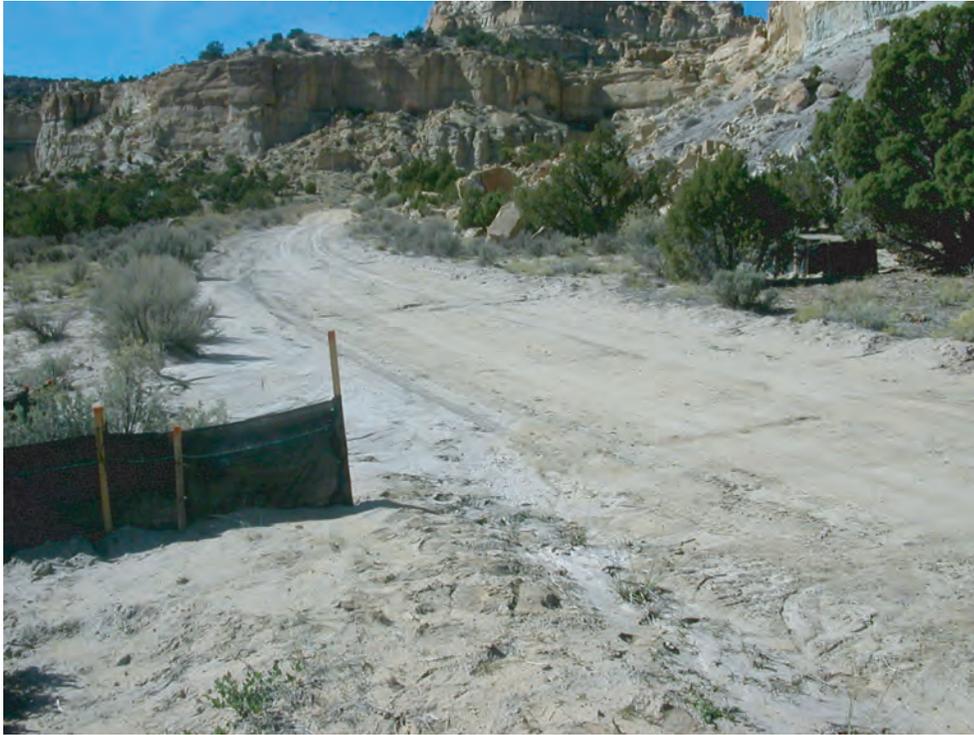
Figure 22. Color of sediment on road near sediment dam 1A indicating source of runoff as the weathered shale and siltstone (shown in the upper right of photograph), Harris Canyon area. Locations of dams 1A and 1B shown in figure 3B. View is to the west.

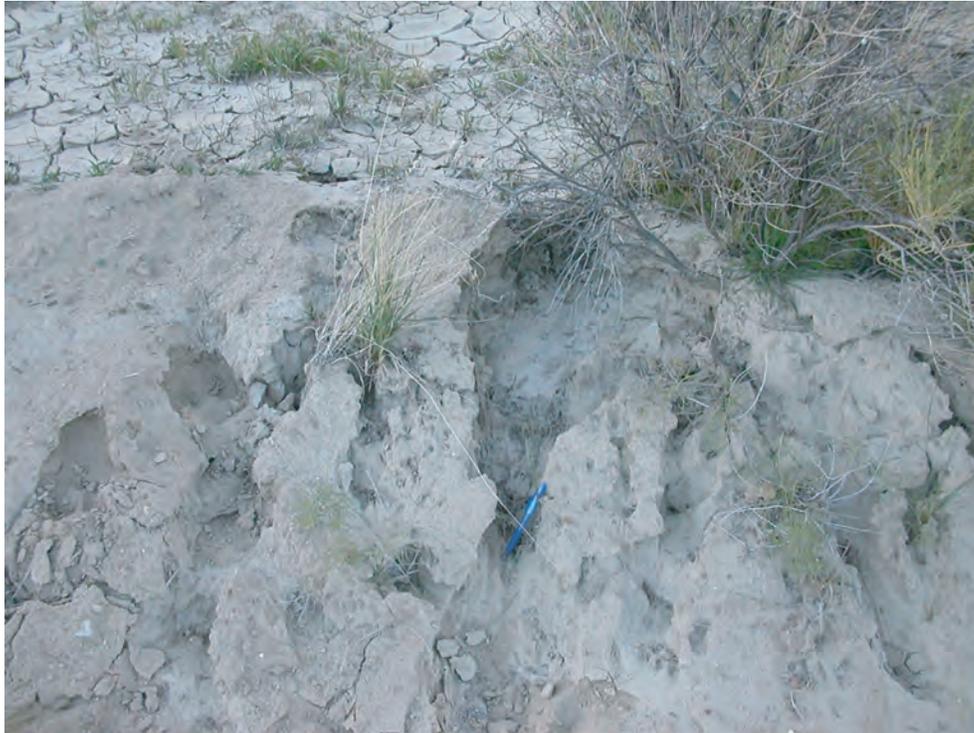
Figure 23. Mud cracks (in upper left of photograph) as evidence of ponding and sediment deposition behind the road berm at site 4. Headcuts, formed in the road berm where runoff overflowed the berm, do not extend upslope from berm. Pen in middle foreground for scale. Near site 4 in the Harris Canyon area.

At many locations, road-berm cuts reached only a few tenths of a foot headward from the road berm and were fed by downward movement of sediment from the area upslope from the cut (fig. 23). Some cuts, however, were observed to have eroded headward for several feet, forming a distinct channel (fig. 21). The principal input of runoff to roads parallel to contour was focused by established rills or channels on the adjacent

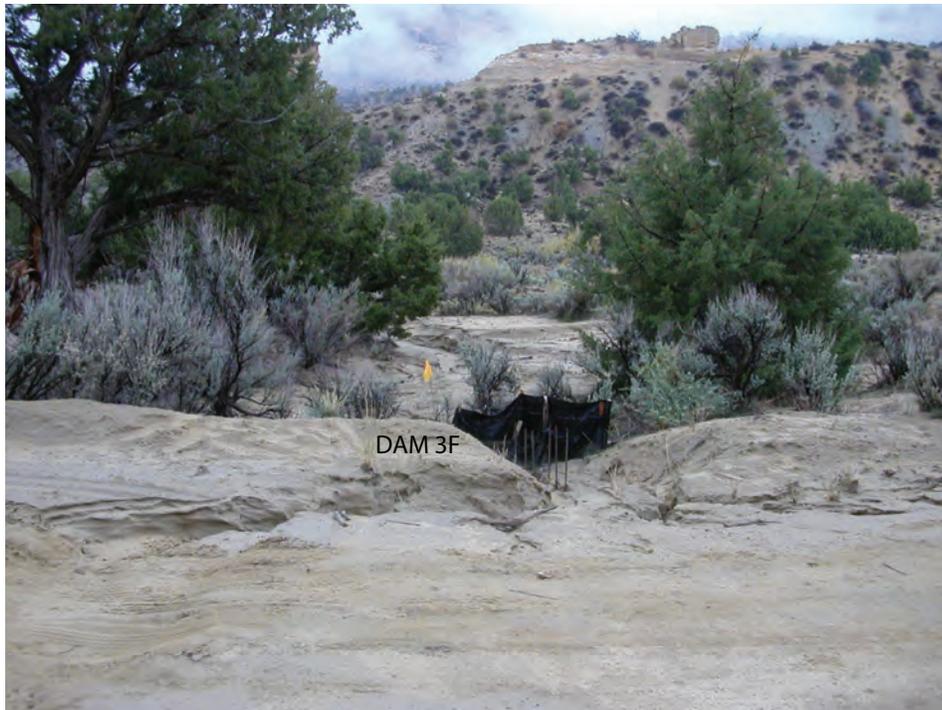
Figure 24. Sediment dam 3F installed at the downslope edge of a road on a pre-existing drainage in the Harris Canyon area. The channel deepened and widened, with concurrent deterioration of the road edge, over the 2-year course of this study. Location of dam 3F shown in figure 3B. View is to the south.

Most of the locations at which dams could be placed to trap sediment draining from roads were selected because they were established drainage channels (fig. 24). For rainfall of smaller magnitude and intensity these dams worked well, but rainfall of larger magnitude and intensity (large enough to integrate flow paths in the entire drainage area) generated large volumes of runoff that overwhelmed the capacity of these dams (fig. 25), caused erosion along the sides and back of the dam, and contributed to deepening of the channel below the road. The erosive force associated with large magnitude and intensity runoff was at times sufficient to erode the downslope edge of the road surface. During one rainfall, focused flow through the dam caused development of a channel below the road that was not present when the dam was established. No erosion rates were estimated for the larger runoff events that breached dams.

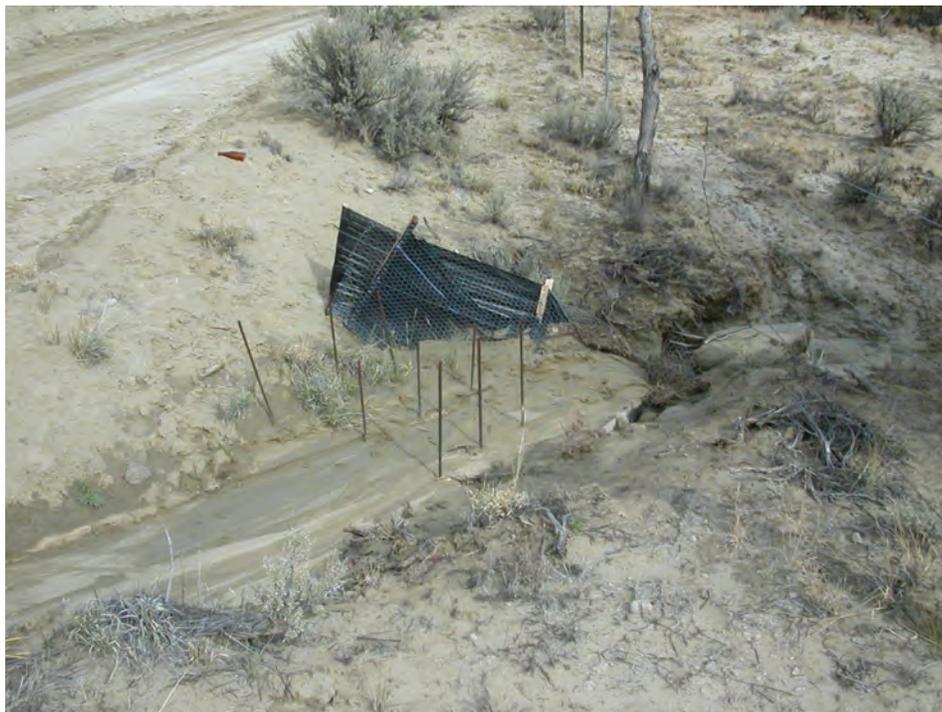
Figure 25. Sediment dam 9A overwhelmed by high runoff and partially buried in transported sediment. Location of dam 9A, in the Harris Canyon area, shown in figure 3F. View is to the east.

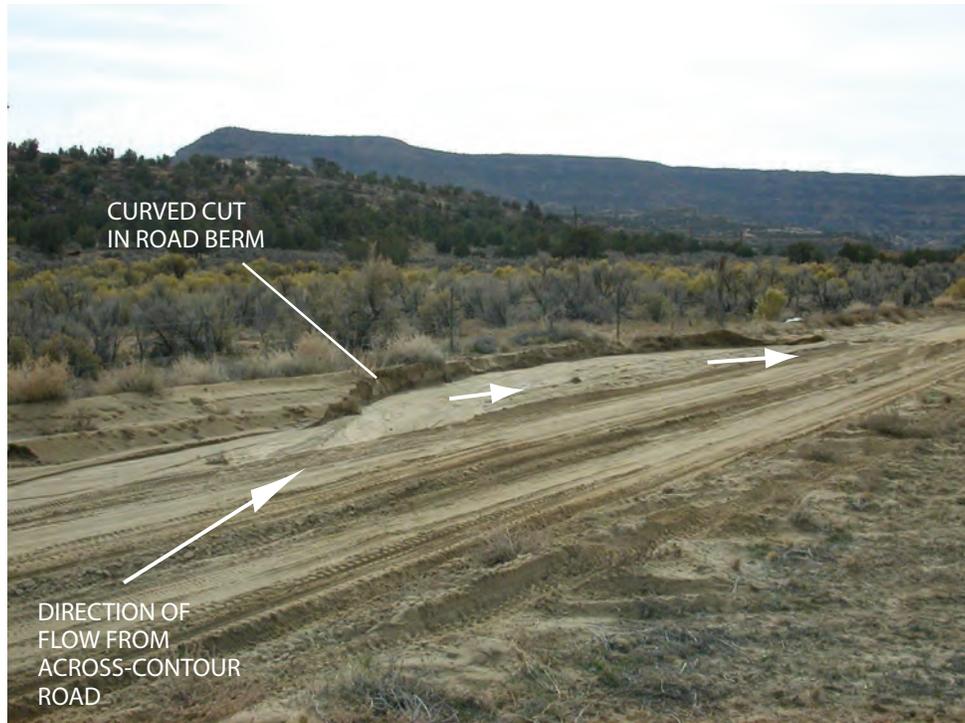
Figure 26. Splay deposit, formed from sediment transported along across-contour road and subsequently eroded by runoff, forms the curved cut in berm of parallel-contour road. Across-contour road connects from lower left of photograph, Harris Canyon area. View is to the southwest.

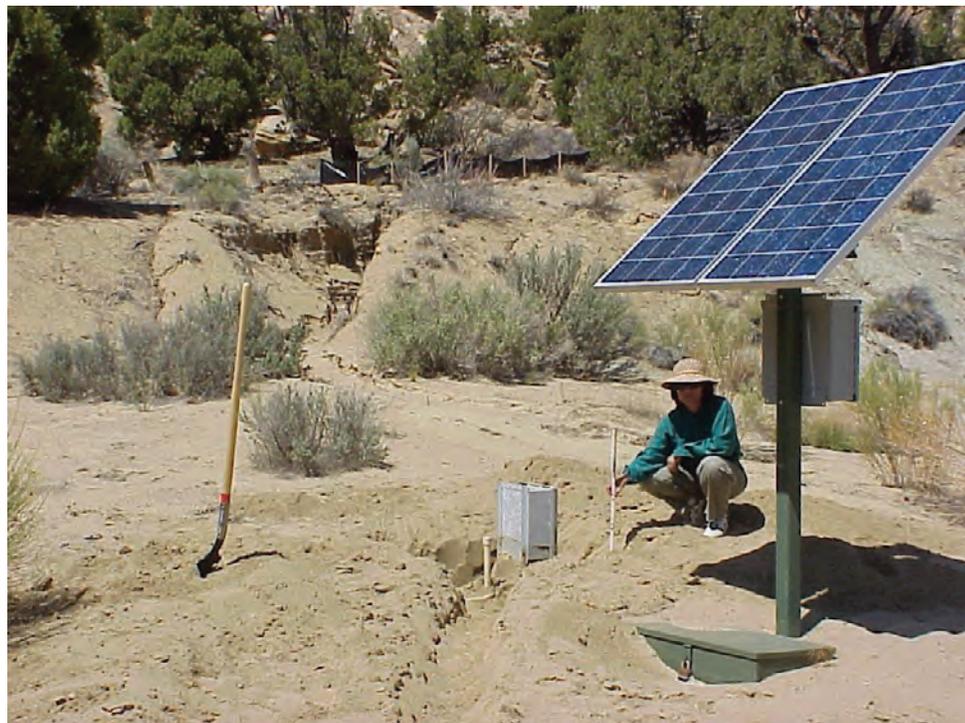
Figure 27. Sediment erosion from upslope pad berm near sediment dam 2C redeposited on the pad, partially burying oil and gas industry equipment. Location of dam 2C in Harris Canyon area is shown on figure 3B. View is to the southwest.

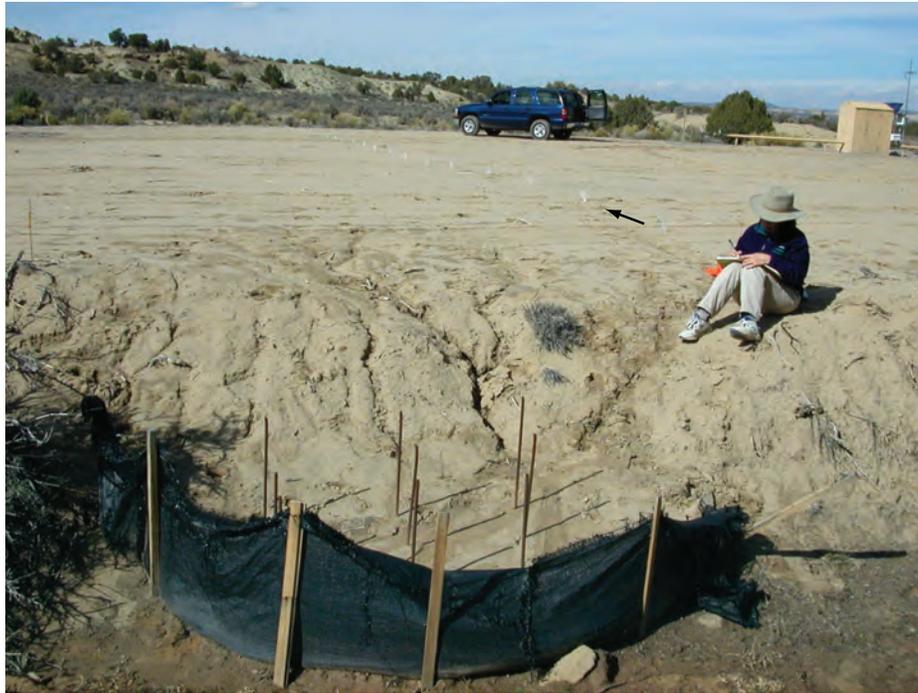
Figure 28. Sediment dam 5A and headcuts eroded into downslope pad berm. Headward erosion has extended the headcuts up onto the surface of the well pad. Transect 5PNE whisker flagging crosses the well pad behind author and in front of vehicle (arrow points along transect). Location of dam 5A in Harris Canyon area shown in figure 3C. View is to the northwest.

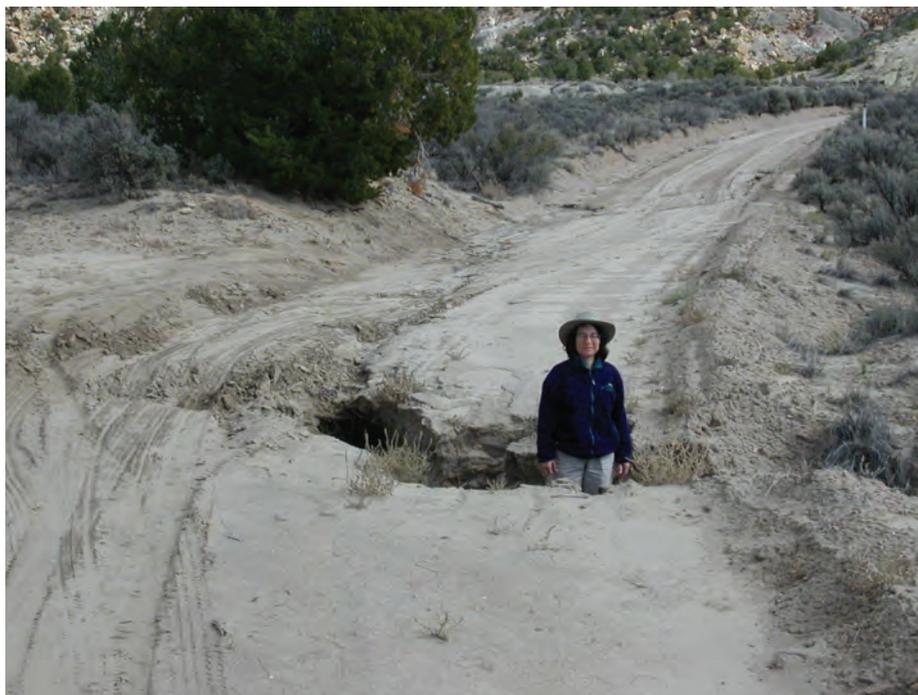
Figure 29. Author standing in a channel cut by focused runoff near site 12 in the Palluche Canyon area. Location of site 12 shown in figure 4B. View is to the southwest.
