Flood of April 2-4, 2005, Delaware River Main Stem from Port Jervis, New York, to Cinnaminson, New Jersey

Scientific Investigations Report 2007-5067

**U.S. Department of the Interior
U.S. Geological Survey**

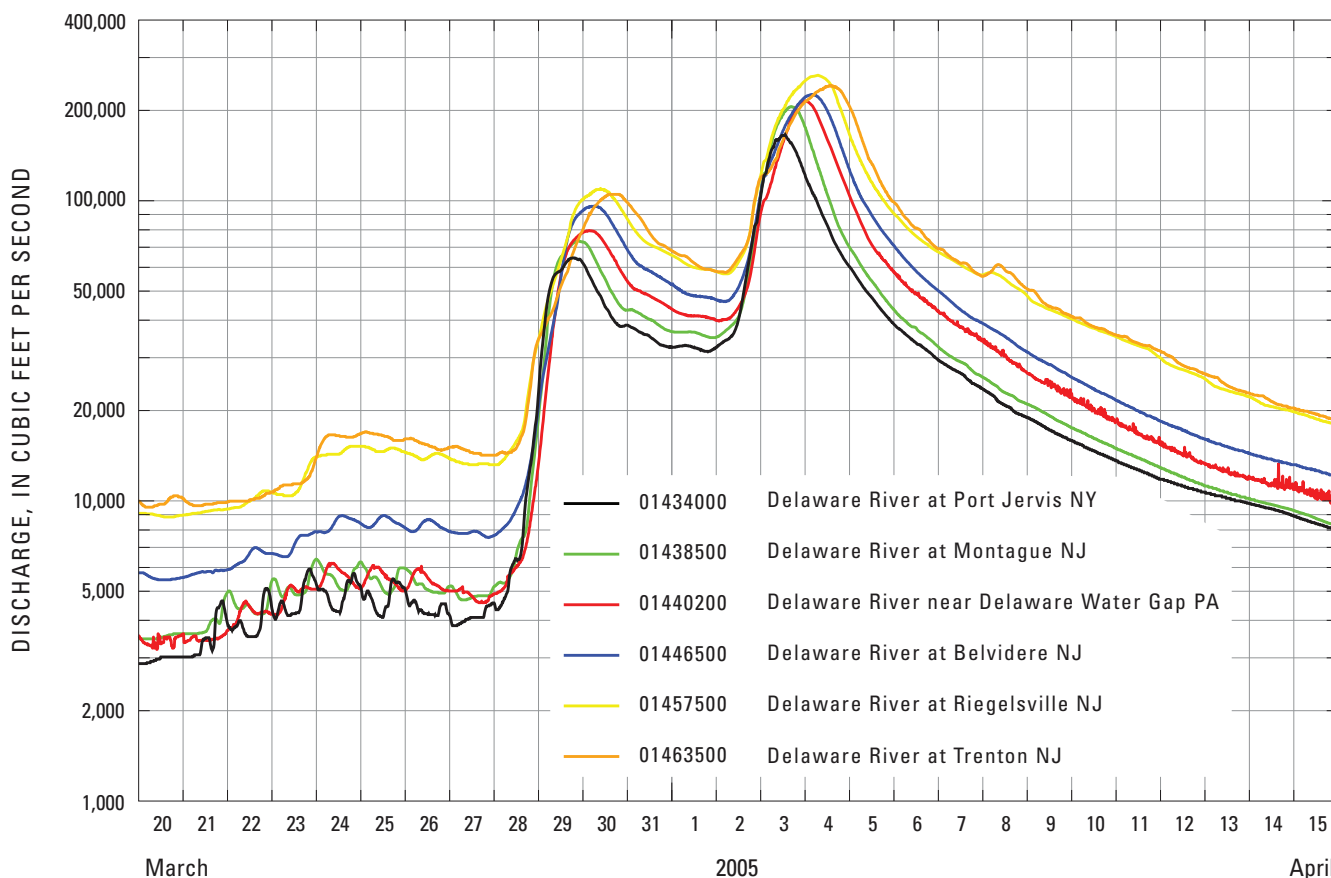
Figure 4. Hydrographs showing streamflow at six continuous-record streamflow-gaging stations on the Delaware River, March 20 to April 15, 2005.

The initial rise in streamflow from the March runoff caused the Delaware River to reach a preliminary peak flow on March 29-30, 2005 (fig. 4). The recession of that peak was slowed slightly by additional snowmelt as temperatures became warmer. The flow had decreased by 50 percent in 3 days, but was still from 300 to 360 percent greater than the monthly mean March flow when the second rainfall began on April 2. The resulting second peak on April 2-4 more than doubled the first, as the basin was vulnerable to any additional rainfall.

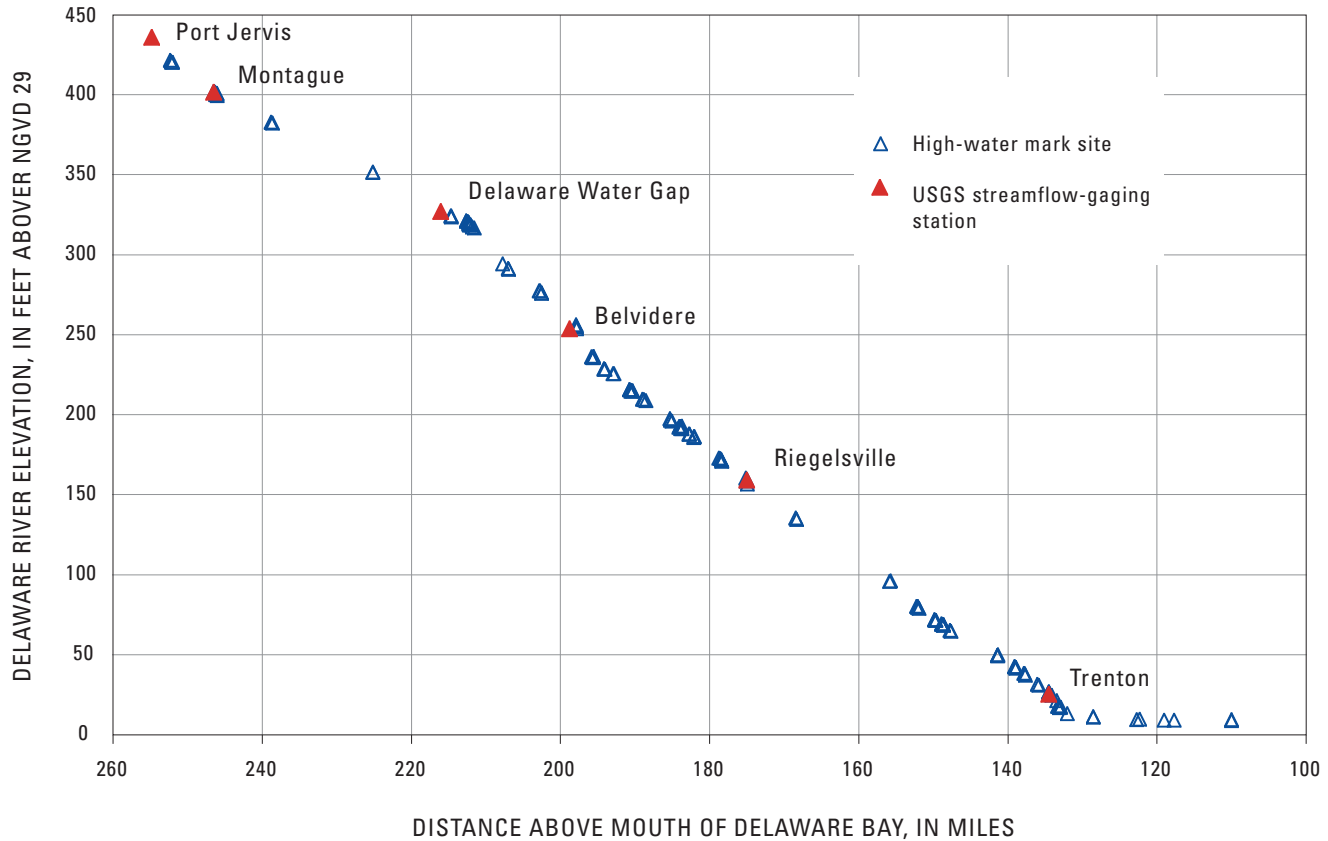
Figure 5. Delaware River peak elevations at U.S. Geological Survey (USGS) streamflow-gaging stations and high-water mark sites, April 2-4, 2005.

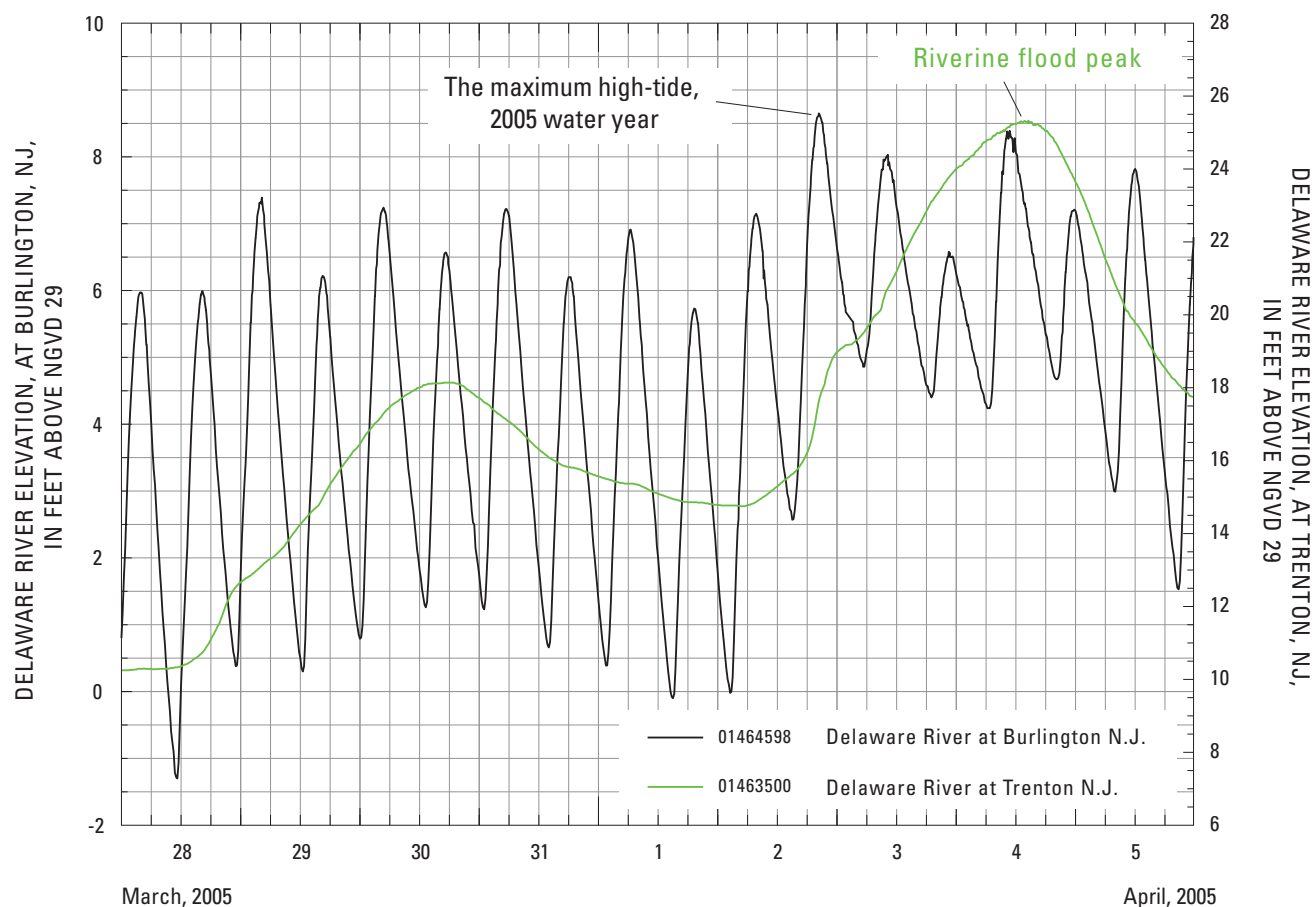
Figure 6. Hydrographs showing tide cycles on the Delaware River at Burlington, New Jersey, and stream elevations on the Delaware River at Trenton, New Jersey, March 28 to April 5, 2005. (NGVD 29, National Geodetic Vertical Datum of 1929)

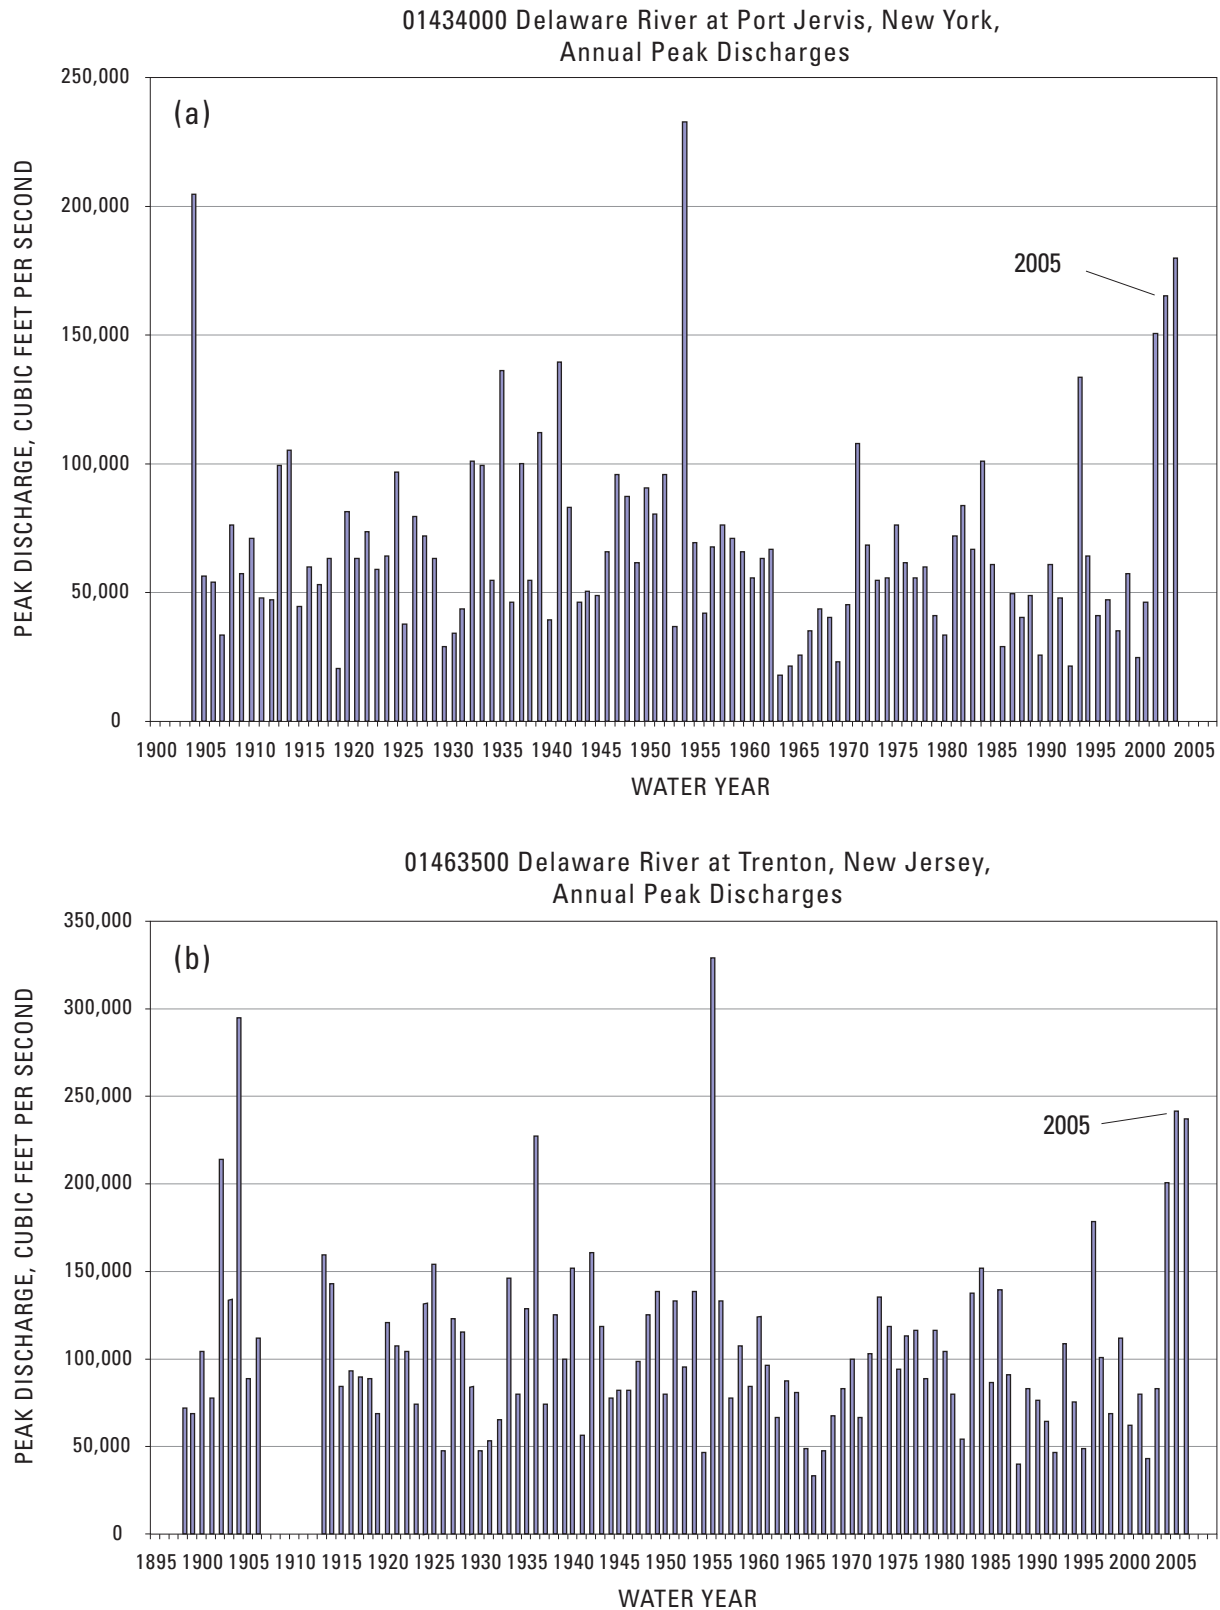
Figure 7. Annual peak discharges for the Delaware River at (a) Port Jervis, New York, and (b) Trenton, New Jersey for the respective periods of record. (Water year is defined as 12-month period from October 1 through September 30, and is designated by the calendar year in which it ends. Thus, the year ending September 30, 2002, is called the “2002 water year.”)

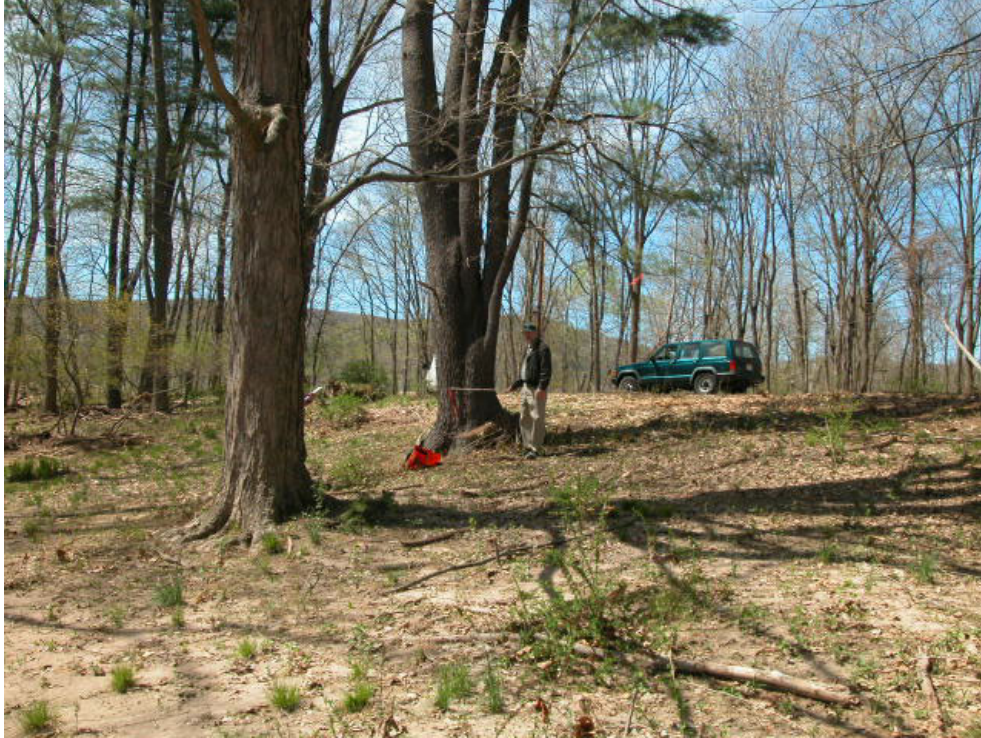
High-water mark PA 1.1 (lat 41° 20' 59.0", long 74° 43' 22.0"), at an elevation of 420.3 feet above NGVD 29, is a good seed line on a 3-foot diameter tree, 3.4 feet above the ground, and was marked with a metal USGS washer and nail.

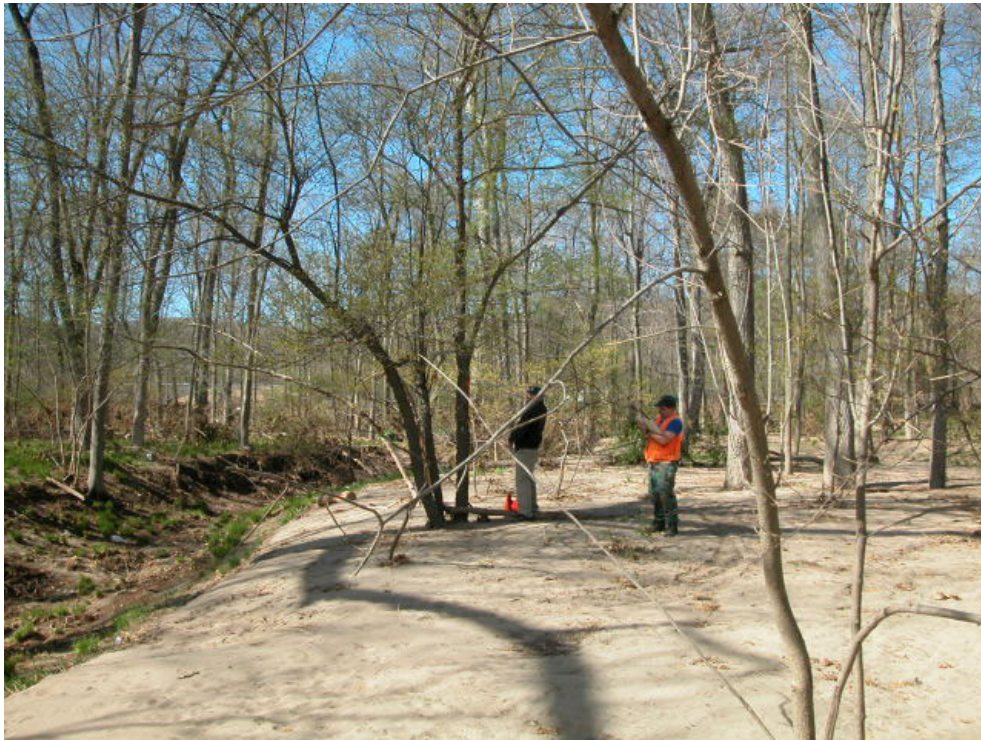
High-water mark PA 1.2 (lat 41° 20' 59.0", long 74° 43' 19.0"), at an elevation of 420.5 feet above NGVD 29, is a good seed line on a 3-inch diameter tree, 3.3 feet above the ground, and was marked with a metal USGS washer and nail.

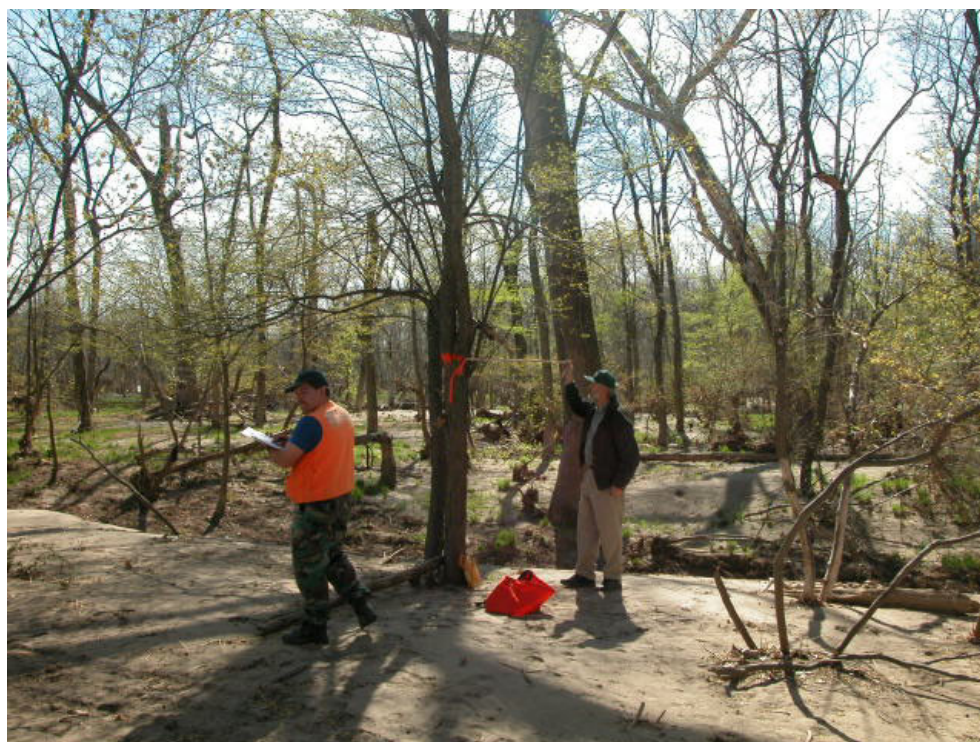
High-water mark PA 1.4 (lat 41° 20' 56.0", long 74° 43' 24.0"), at an elevation of 418.8 feet above NGVD 29, is a good seed line on a 7-inch diameter tree, 6.4 feet above the ground, and was marked with a metal USGS washer and nail.

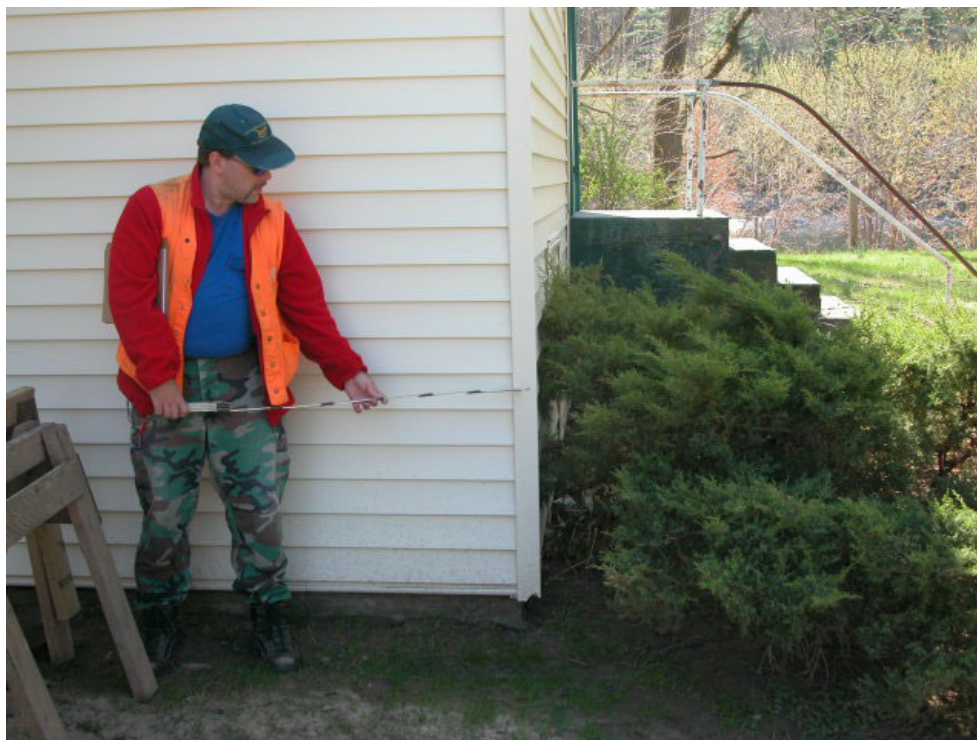
High-water mark PA 2.1 (lat 41° 18' 36.1", long 74° 47' 46.1"), at an elevation of 401.8 feet above NGVD 29, is an excellent mud line on a house, 2.6 feet above the ground, 1,400 feet upstream from the US Route 206 bridge, and was marked with a black marker line.

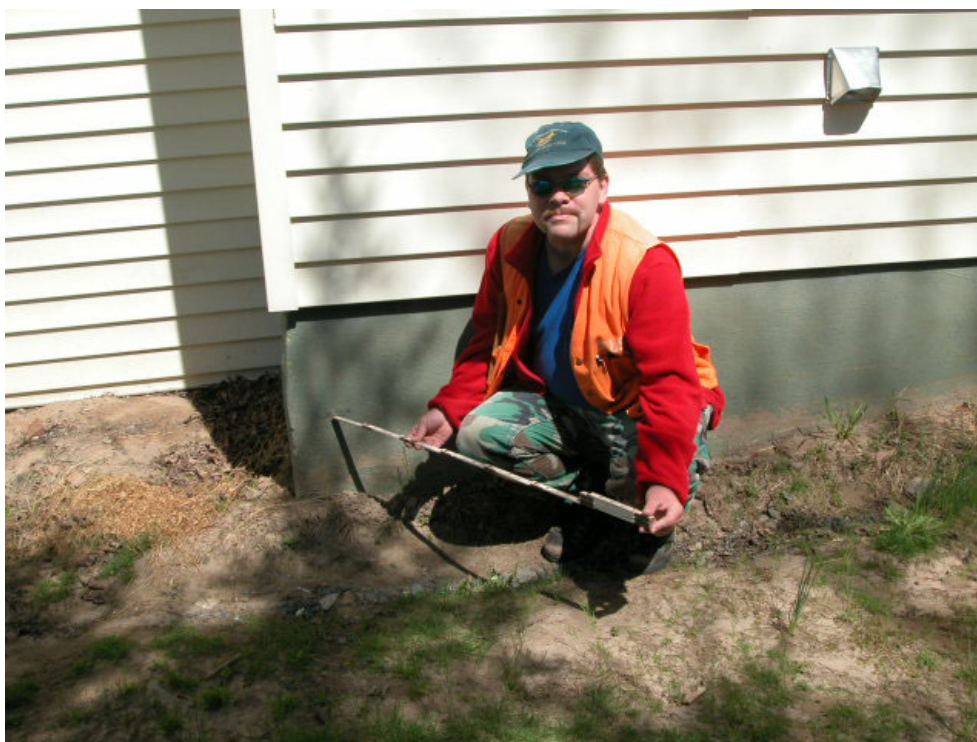
High-water mark PA 2.2 (lat 41° 18' 35.8", long 74° 47' 45.7"), at an elevation of 401.9 feet above NGVD 29, is an excellent mud line on a house, 0.8 feet above the ground, 1,400 feet upstream from the US Route 206 bridge, and was marked with a black marker line.

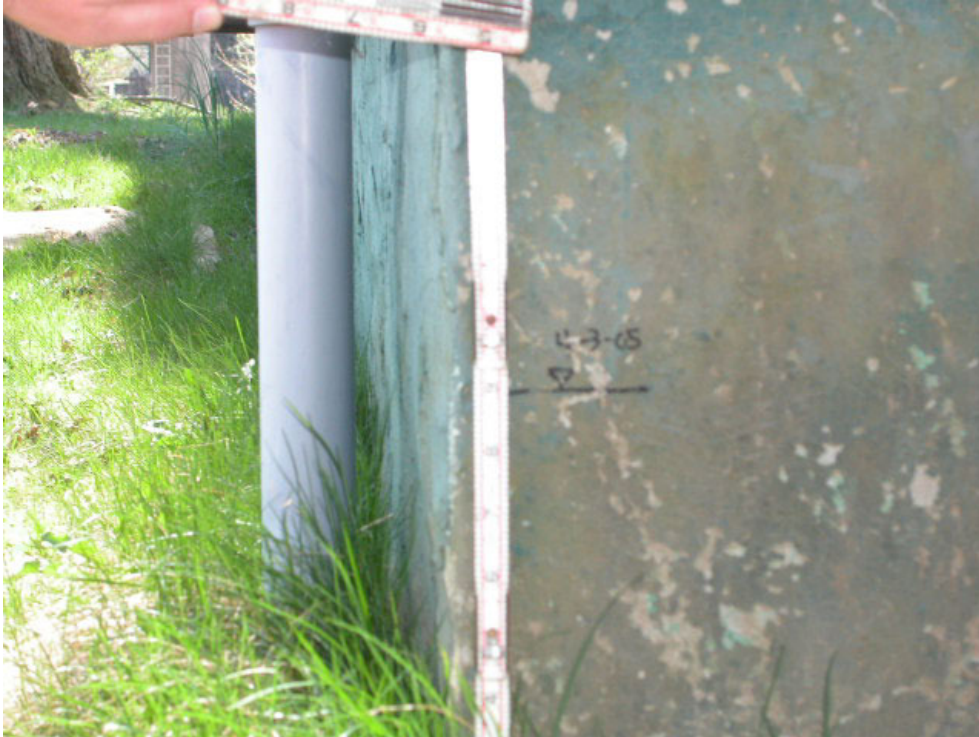
High-water mark PA 2.3 (lat 41° 18' 36.3", long 74° 47' 45.5"), at an elevation of 402.0 feet above NGVD 29, is an excellent seed line on a house, 0.9 feet above the ground, 1,400 feet upstream from the US Route 206 bridge, and was marked with a black marker line.

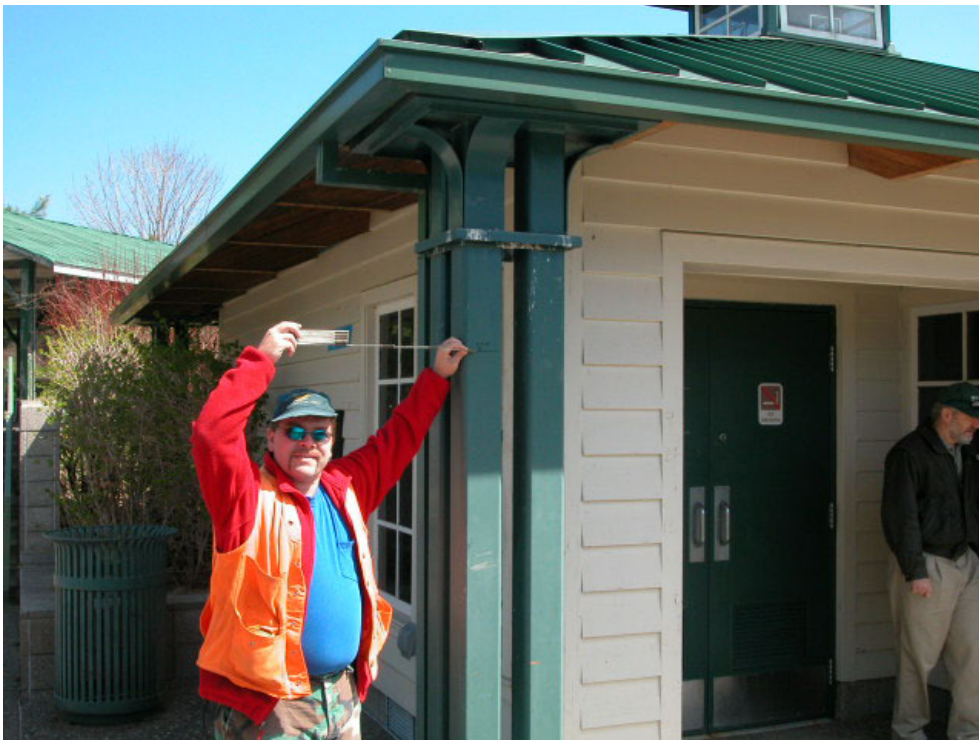
High-water mark PA 2.4 (lat 41° 18' 36.5", long 74° 47' 43.4"), at an elevation of 402.0 feet above NGVD 29, is an excellent mud line on a first aid building, 5.2 feet above the ground, 1,600 feet upstream from the US Route 206 bridge, and was marked with a black marker line.

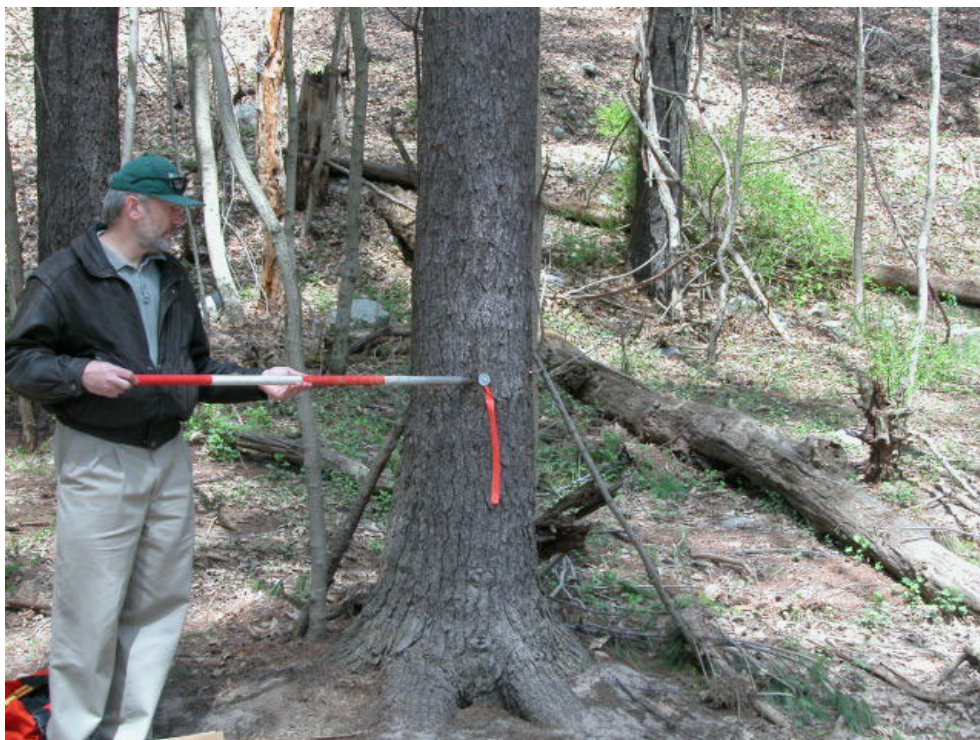
High-water mark PA 2.5 (lat 41° 18' 30.0", long 74° 48' 01.0"), at an elevation of 401.1 feet above NGVD 29, is a good seed line on a 1.2-foot diameter tree, 3.6 feet above the ground, and was marked with a metal USGS washer and nail.

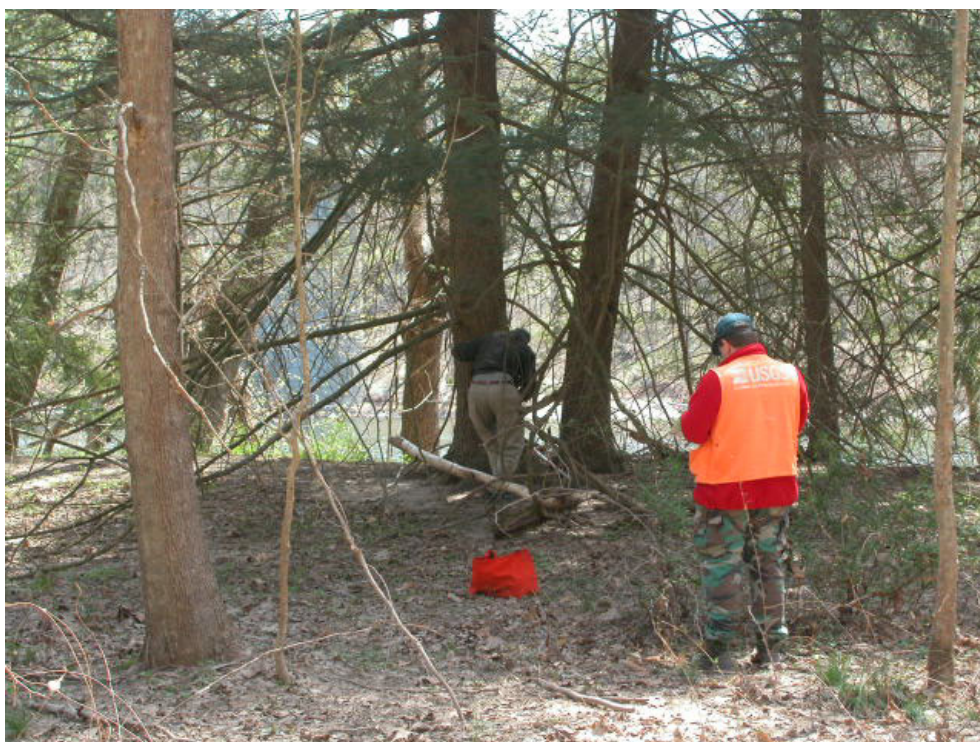
High-water mark PA 2.6 (lat 41° 18' 26.0", long 74° 48' 07.0"), at an elevation of 400.9 feet above NGVD 29, is an excellent seed line on a 1.7-foot diameter tree, 3.4 feet above the ground, and was marked with a metal USGS washer and nail.

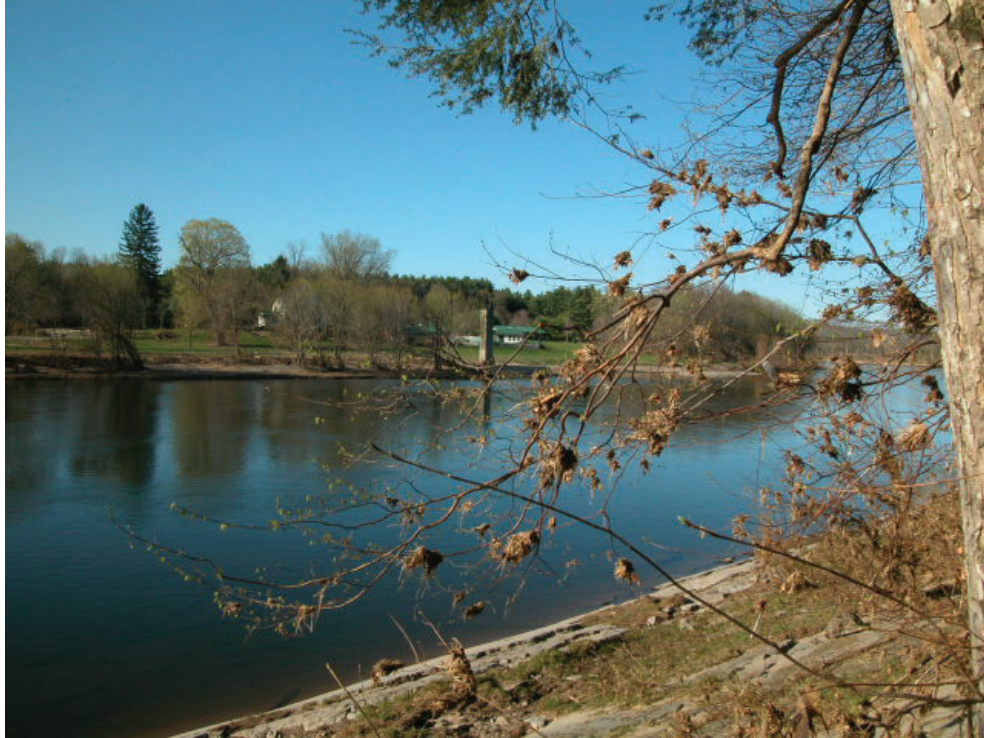
High-water mark NJ 1.1 (lat 41° 18' 29.2", long 74° 47' 45.4"), at an elevation of 401.7 feet above NGVD 29, is a fair seed line on a 1-foot diameter tree, 1.2 feet above the ground, 1,200 feet upstream from the US Route 206 bridge, and was marked with a metal USGS washer and nail.

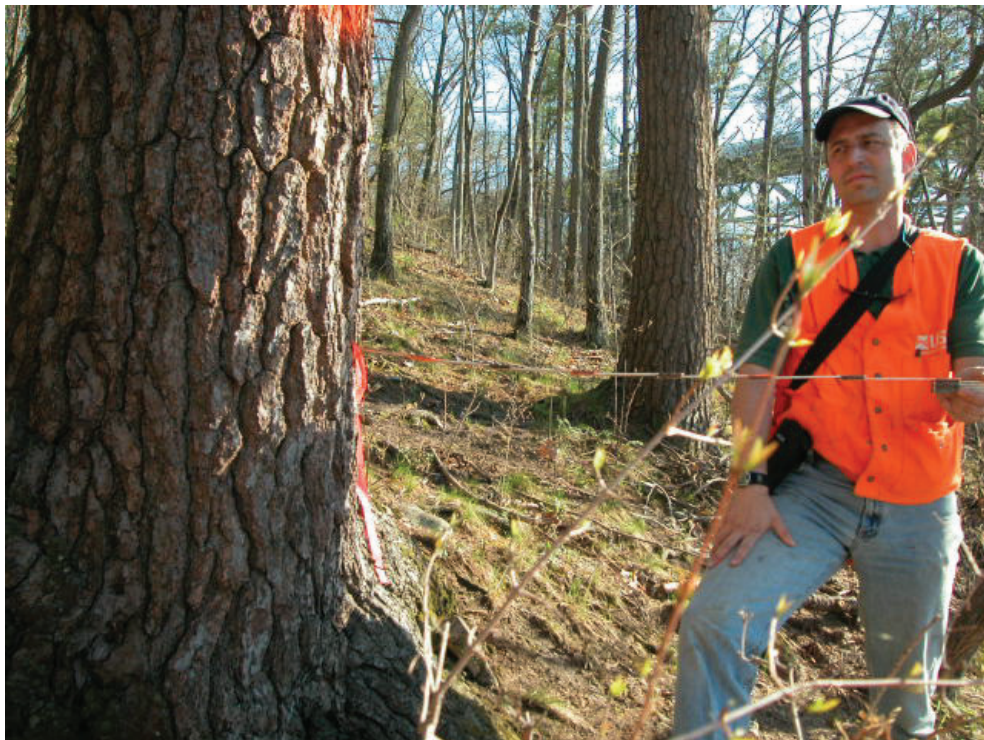
High-water mark NJ 1.2 (lat 41° 18' 24.3", long 74° 47' 55.4"), at an elevation of 400.2 feet above NGVD 29, is a fair seed line on a 2-foot diameter tree, 2.8 feet above the ground, 270 feet upstream from the US Route 206 bridge, and was marked with a USGS metal washer and nail.

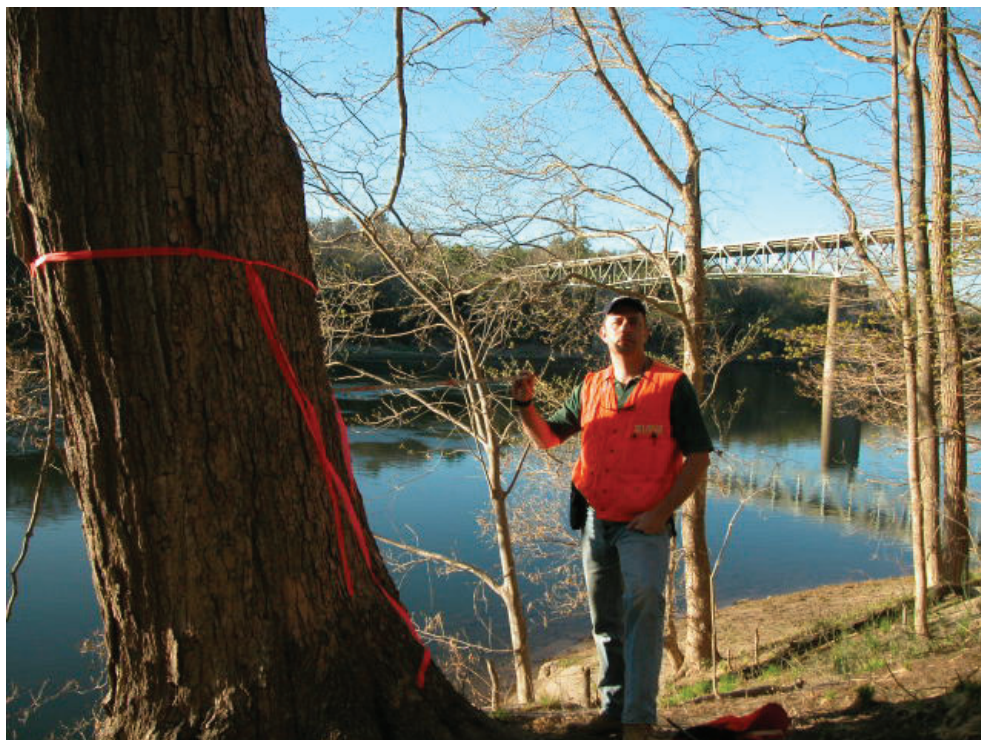
High-water mark NJ 1.3 (lat 41° 18' 18.3", long 74° 48' 03.2") at an elevation of 399.3 feet above NGVD 29, is a poor seed line on a 3-foot diameter tree, 5.0 feet above the ground, 500 feet downstream from the US Route 206 bridge, and was marked with a USGS metal washer and nail.

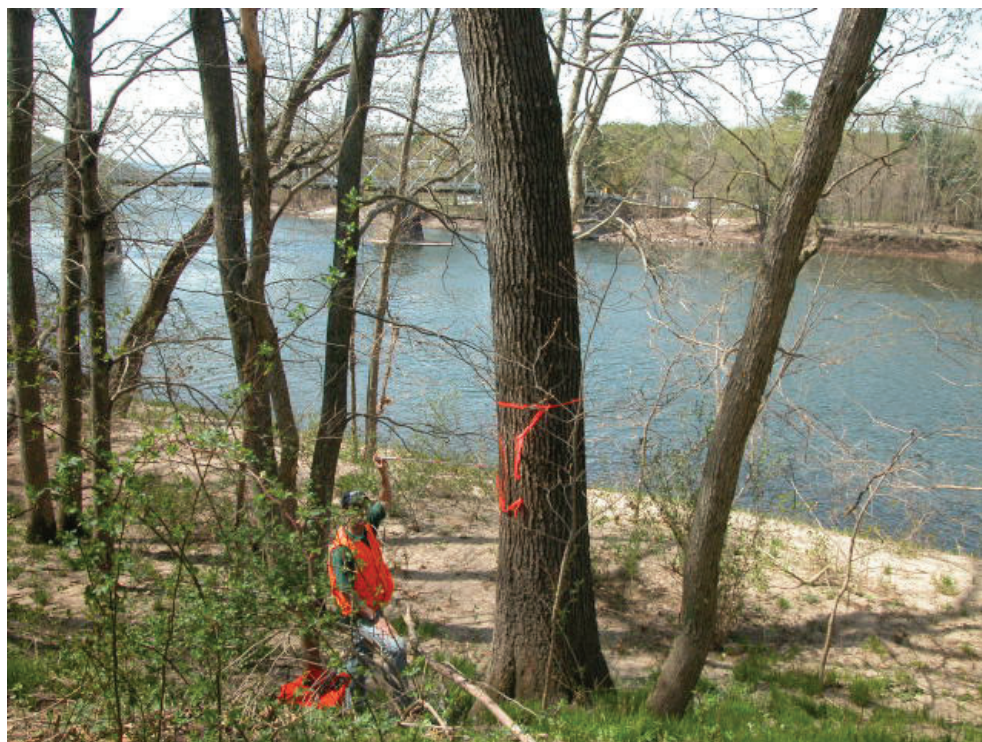
High-water mark NJ 2.1 (lat 41° 13' 15.9", long 74° 51' 30.7"), at an elevation of 382.60 feet above NGVD 29, is an excellent seed line on a 2-foot diameter tree, 6.3 feet above the ground, 400 feet upstream from the Dingmans Ferry bridge, and was marked with a metal USGS washer and nail.

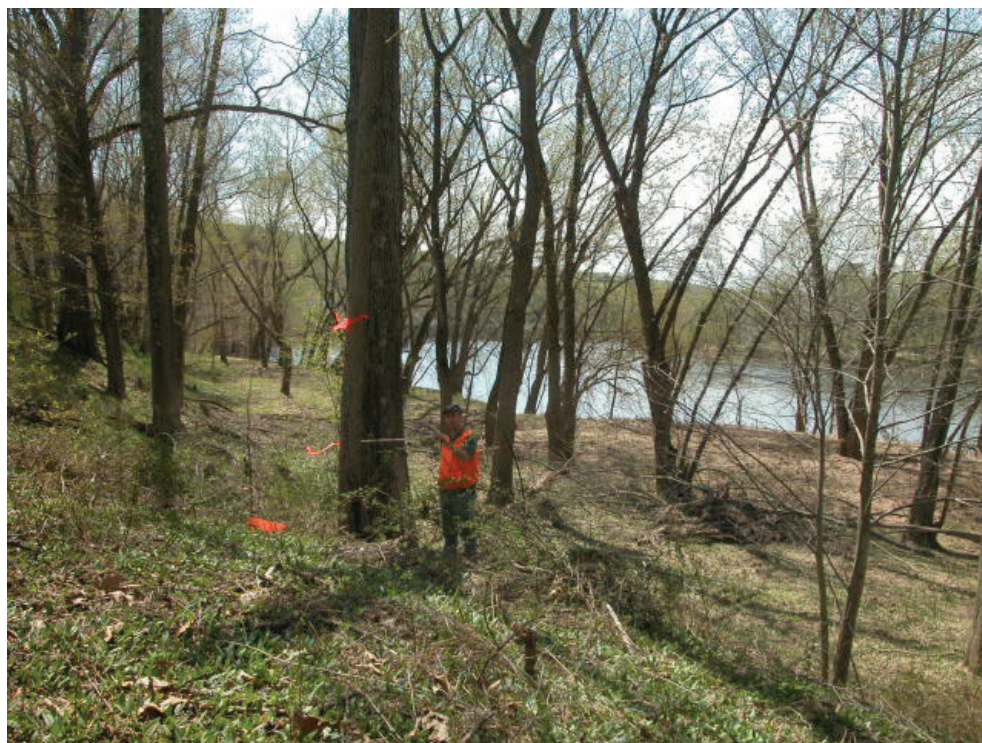
High-water mark NJ 2.2 (lat 41° 13' 23.6", long 74° 51' 35.1"), at an elevation of 382.9 feet above NGVD 29, is a good seed line on a 0.7-foot diameter tree, 3.5 feet above the ground, 1,200 feet upstream from the Dingmans Ferry bridge, and was marked with a metal USGS washer and nail.

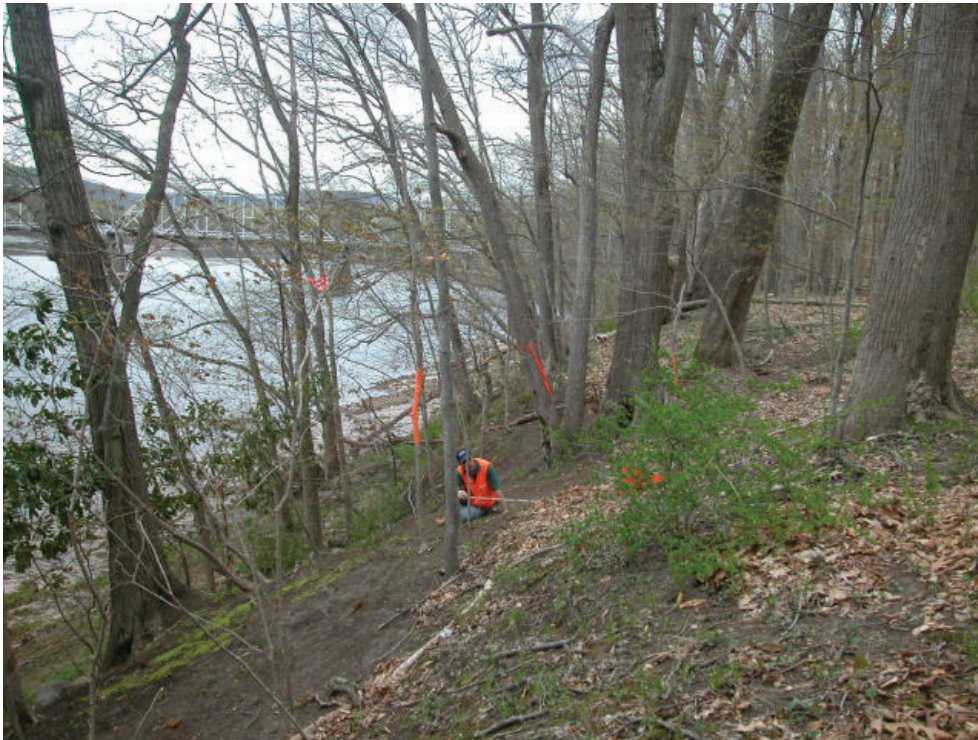
High-water mark NJ 2.3 (lat 41° 13' 06.6", long 74° 51' 30.3"), at an elevation of 382.3 feet above NGVD 29, is a poor wash line on the ground, 600 feet downstream from the Dingmans Ferry bridge, and was marked by painted rebar with orange flagging.

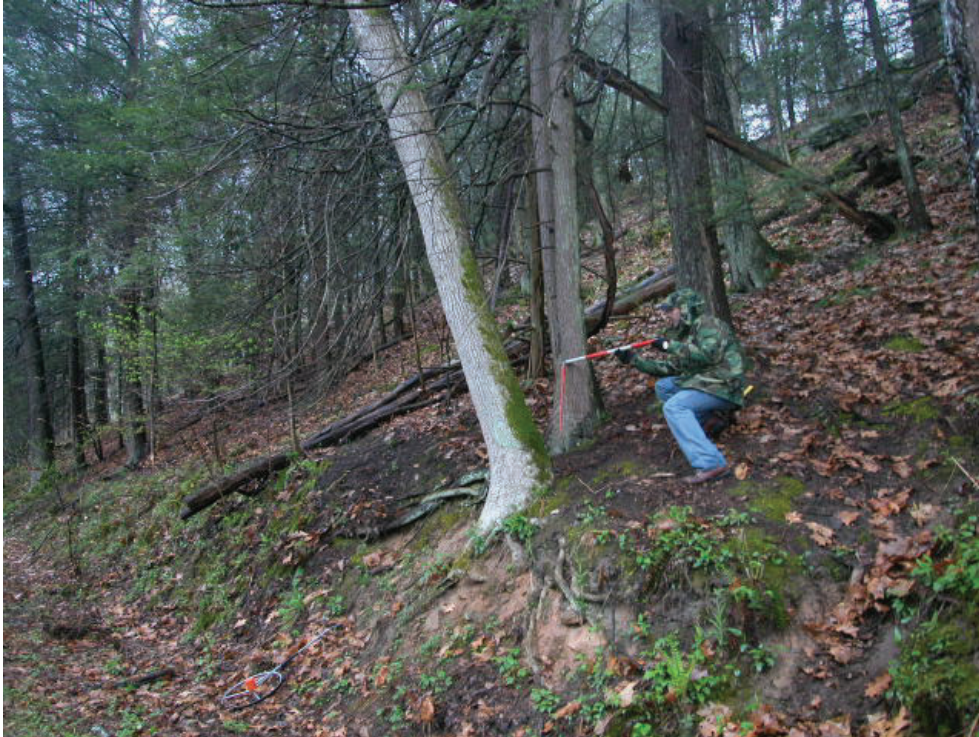
High-water mark NJ 3.1 (lat 41° 05' 54.6", long 74° 58' 02.3"), at an elevation of 351.6 feet above NGVD 29, is a poor seed line on a 1.4-foot diameter tree, 2.6 feet above the ground, on the right bank of Flat Brook, 700 feet upstream from the mouth of Flat Brook, and was marked with a metal USGS washer and nail.

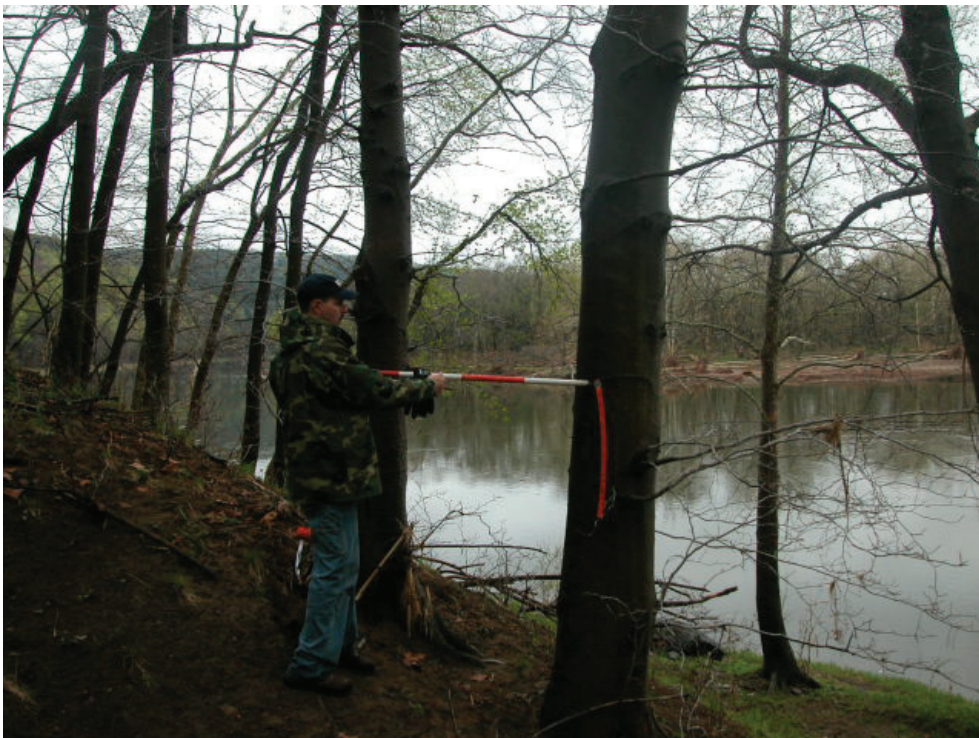
High-water mark NJ 3.3 (lat 41° 05' 49", long 74° 58' 04"), at an elevation of 351.5 feet above NGVD 29, is a fair seed line on a 1.3-foot diameter tree, 6 feet above the ground, 400 feet downstream from the mouth of Flat Brook, and was marked with a metal USGS washer and nail.

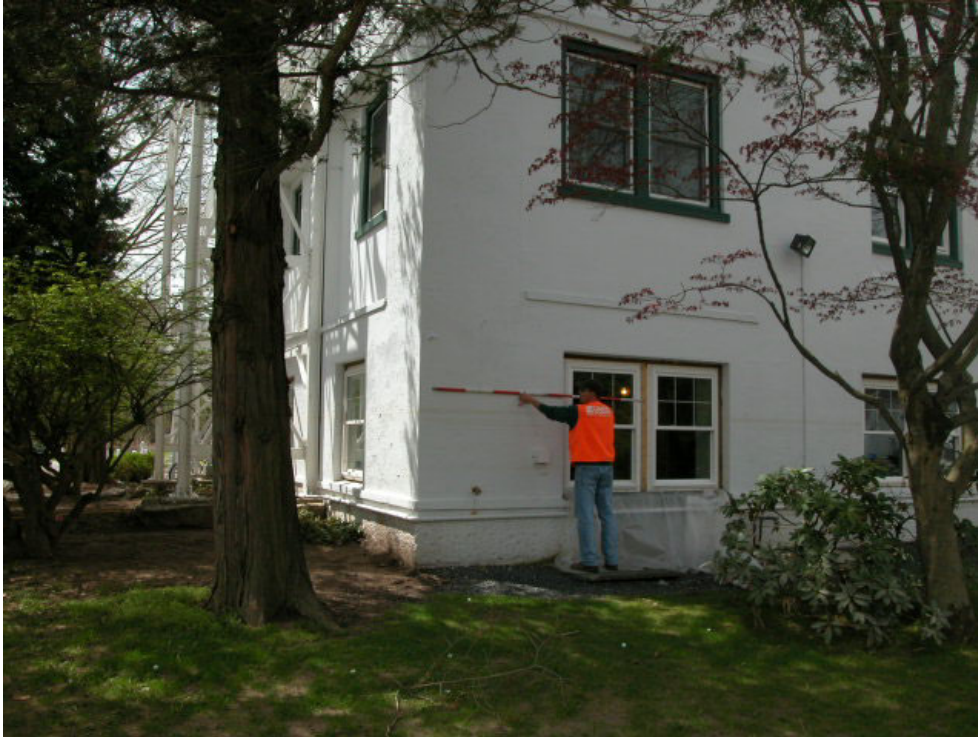
High-water mark PA 5.1 (lat 41° 00' 23.2", long 75° 06' 36.7"), at an elevation of 323.7 feet above NGVD 29, is an excellent mud line on a building (Shawnee Inn), 5.8 feet above the ground, and was marked with a metal USGS washer and nail.

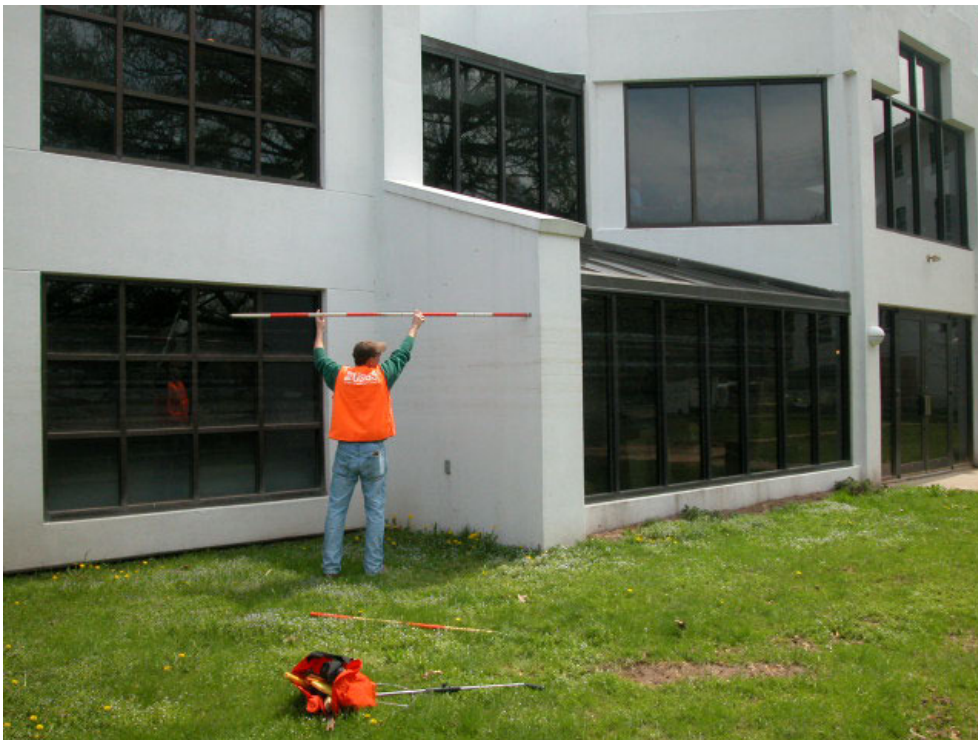
High-water mark PA 5.2 (lat 41° 00' 23.5", long 75° 06' 39.7"), at an elevation of 324.2 feet above NGVD 29, is an excellent mud line on a building (Shawnee Inn), 6.8 feet above the ground, and was marked with a metal USGS washer and nail.

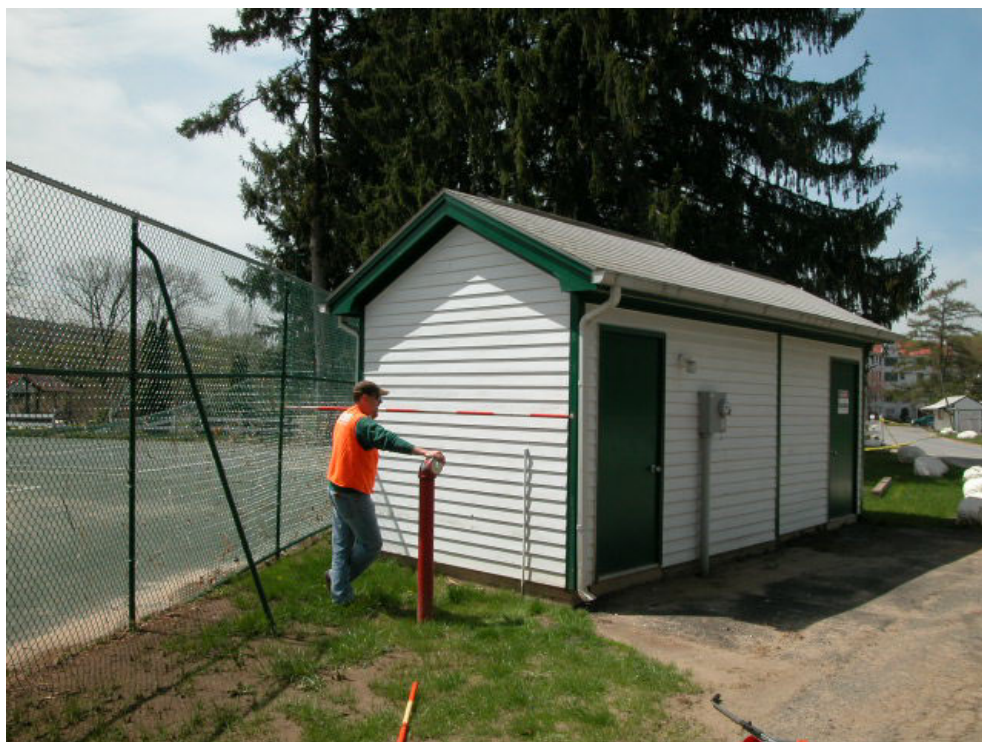
High-water mark PA 5.3 (lat 41° 00' 23.8", long 75° 06' 30.6"), at an elevation of 324.3 feet above NGVD 29, is an excellent mud line on a building (pool maintenance shed), 5.2 feet above the ground, near the Shawnee Inn, and was marked with a metal USGS washer and nail.

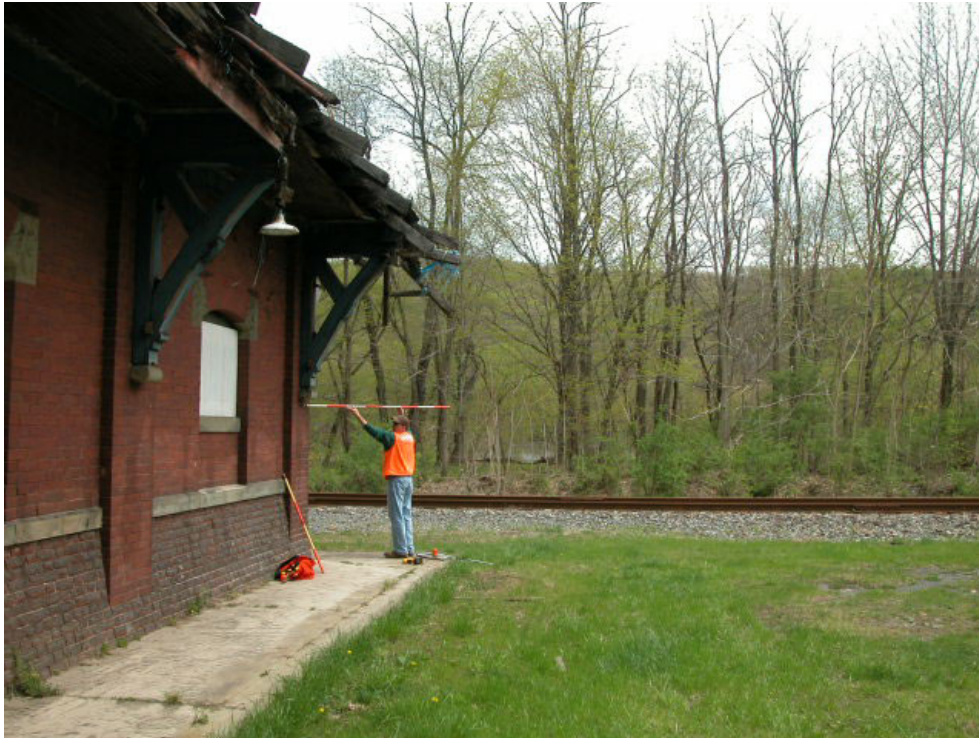
High-water mark PA 6.1 (lat 40° 58' 55.0", long 75° 08' 12.5"), at an elevation of 321.0 feet above NGVD 29, is an excellent mud line on a railroad train station, 6.4 feet above the ground, just upstream from Interstate Route 80, and was marked with a metal USGS washer and nail.
