Flood of April 2-4, 2005, Delaware River Main Stem from Port Jervis, New York, to Cinnaminson, New Jersey

Scientific Investigations Report 2007-5067

**U.S. Department of the Interior
U.S. Geological Survey**

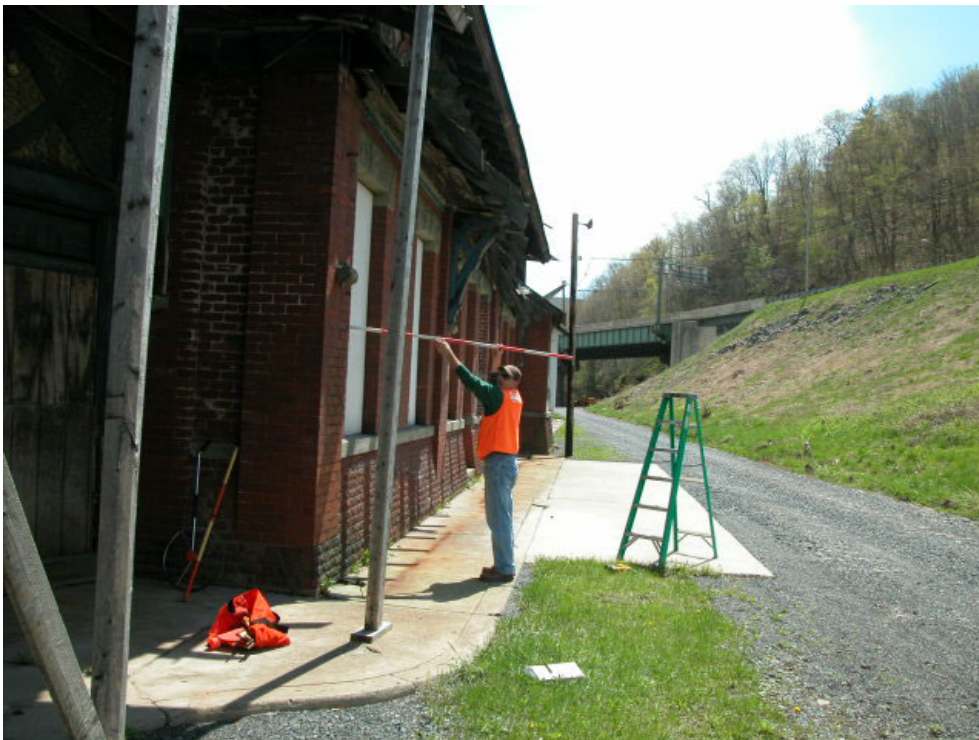
High-water mark PA 6.2 (lat 40° 58' 56.9", long 75° 08' 12.4"), at an elevation of 321.1 feet above NGVD 29, is an excellent mud line on a railroad train station, 6.8 feet above the ground, just upstream from Interstate Route 80, and was marked with a metal USGS washer and nail.

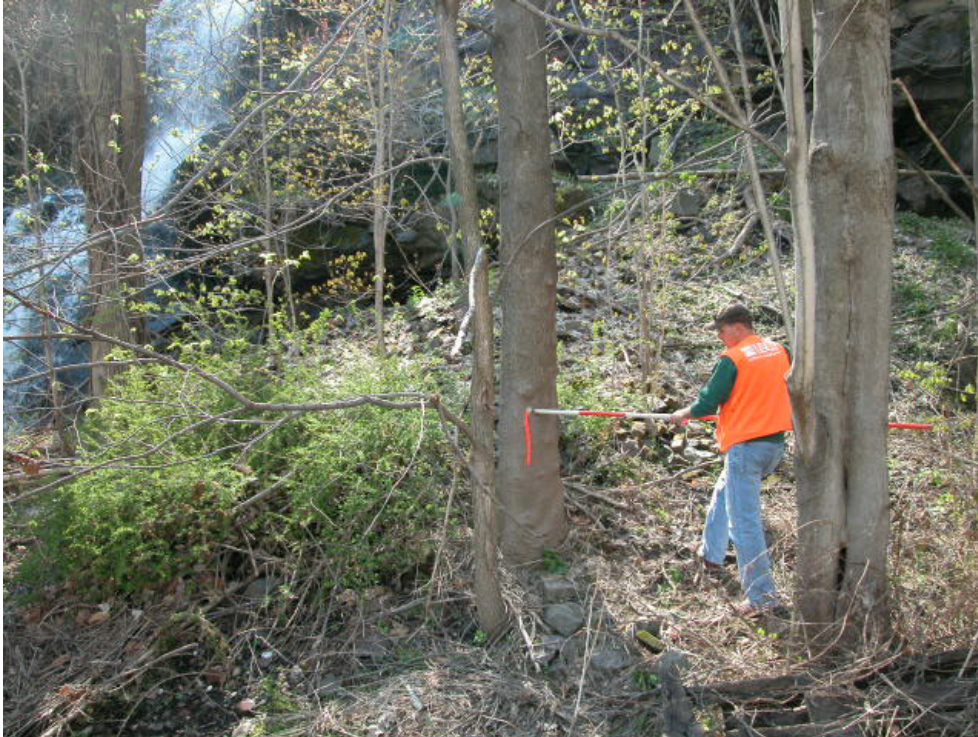
High-water mark PA 6.3 (lat 40° 58' 41.5", long 75° 08' 15.6"), at an elevation of 320.1 feet above NGVD 29, is an unrated debris line on a 1.4-foot diameter tree, 3.5 feet above the ground, 900 feet downstream from Interstate Route 80, and was marked with a metal USGS washer and nail.

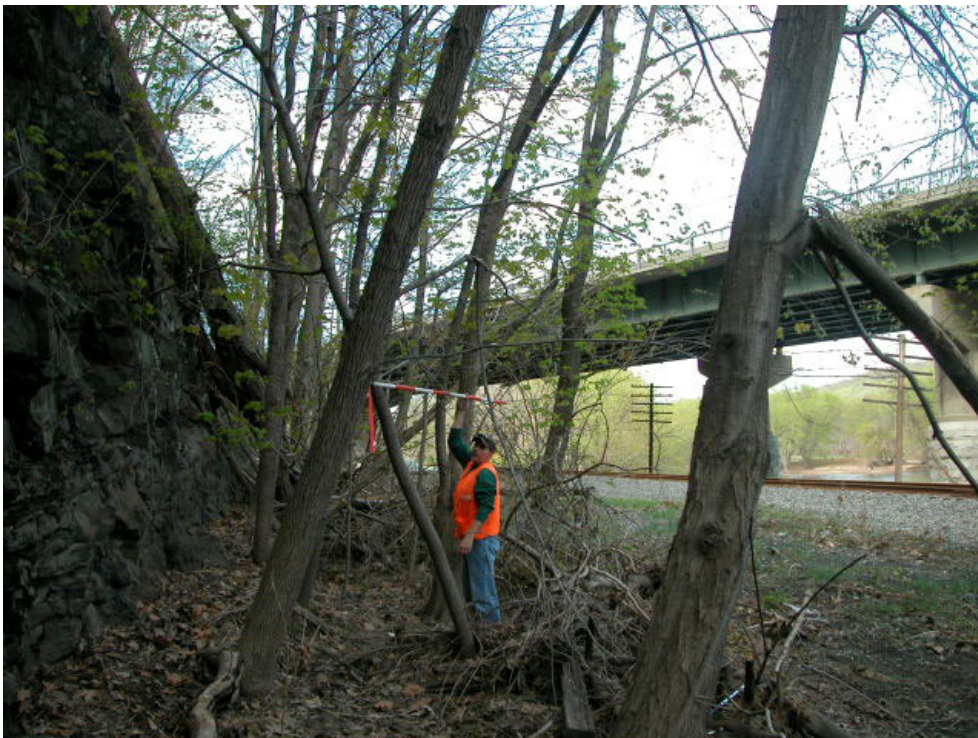
High-water mark PA 6.4 (lat 40° 58' 47.9", long 75° 08' 14.3"), at an elevation of 320.8 feet above NGVD 29, is a good seed line on a 0.8-foot diameter tree, 7.0 feet above the ground, 265 feet downstream from Interstate Route 80, and was marked with a metal USGS washer and nail.

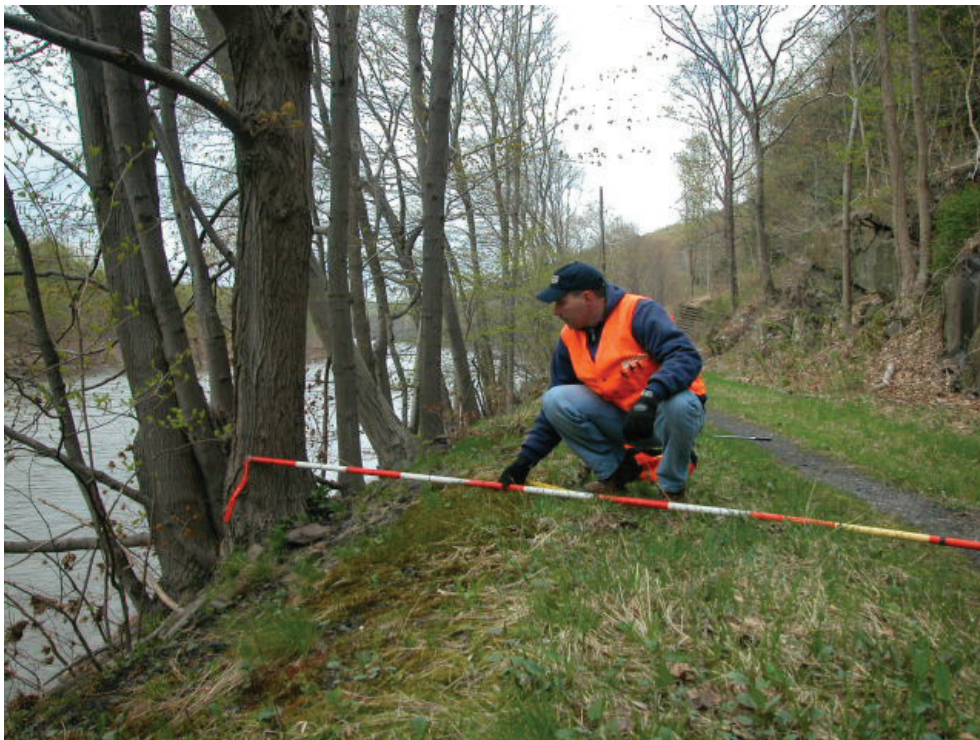
High-water mark NJ 4.1 (lat 40° 58' 39.5", long 75° 08' 04"), at an elevation of 319.4 feet above NGVD 29, is a good seed line on a 1.3-foot diameter tree, 1.0 feet above the ground, 3,220 feet upstream from USGS reference mark 241, and was marked with a metal USGS washer and nail.

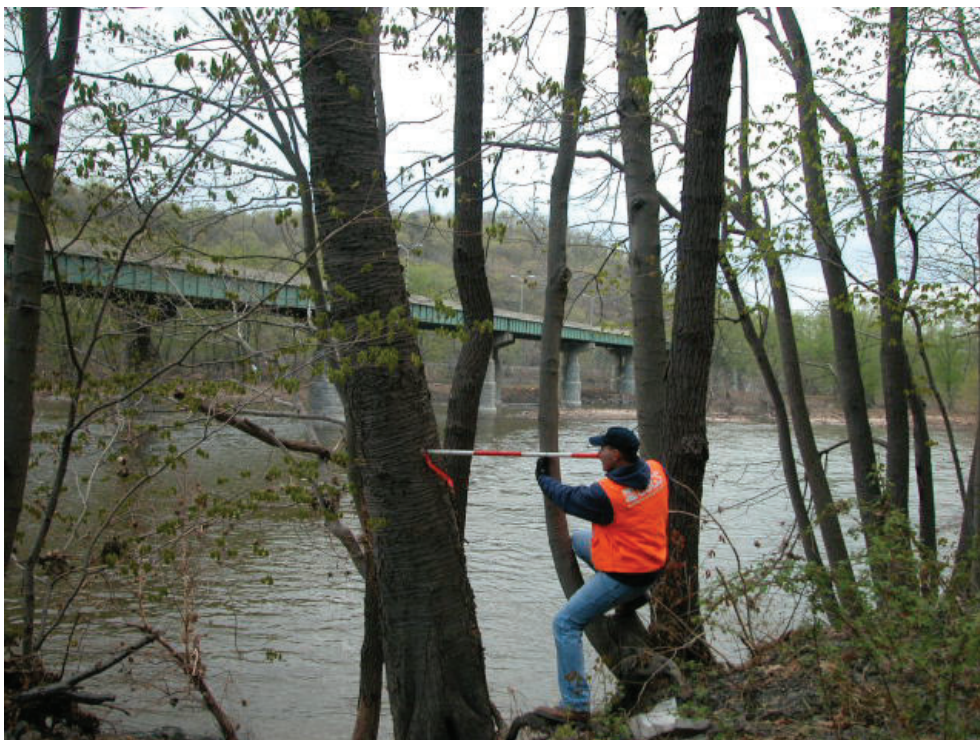
High-water mark NJ 4.2 (lat 40° 58' 36.0", long 75° 08' 05.0"), at an elevation of 319.3 feet above NGVD 29, is a good seed line on a 2-foot diameter tree, 6.5 feet above the ground, 2,900 feet upstream from USGS reference mark 241, and was marked with a metal USGS washer and nail.

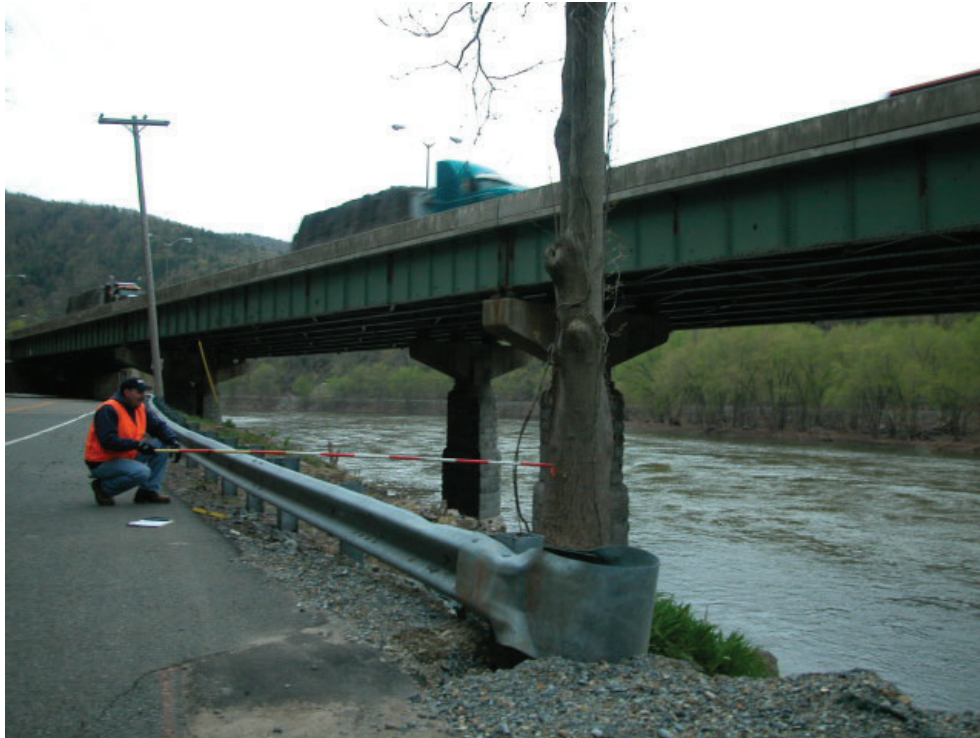
High-water mark NJ 4.3 (lat 40° 58' 34.0", long 75° 08' 05.6"), at an elevation of 318.5 feet above NGVD 29, is a good seed line on a 2-foot diameter tree, 2.6 feet above the ground, 2,550 feet upstream from USGS reference mark 241, and was marked with a metal USGS washer and nail.

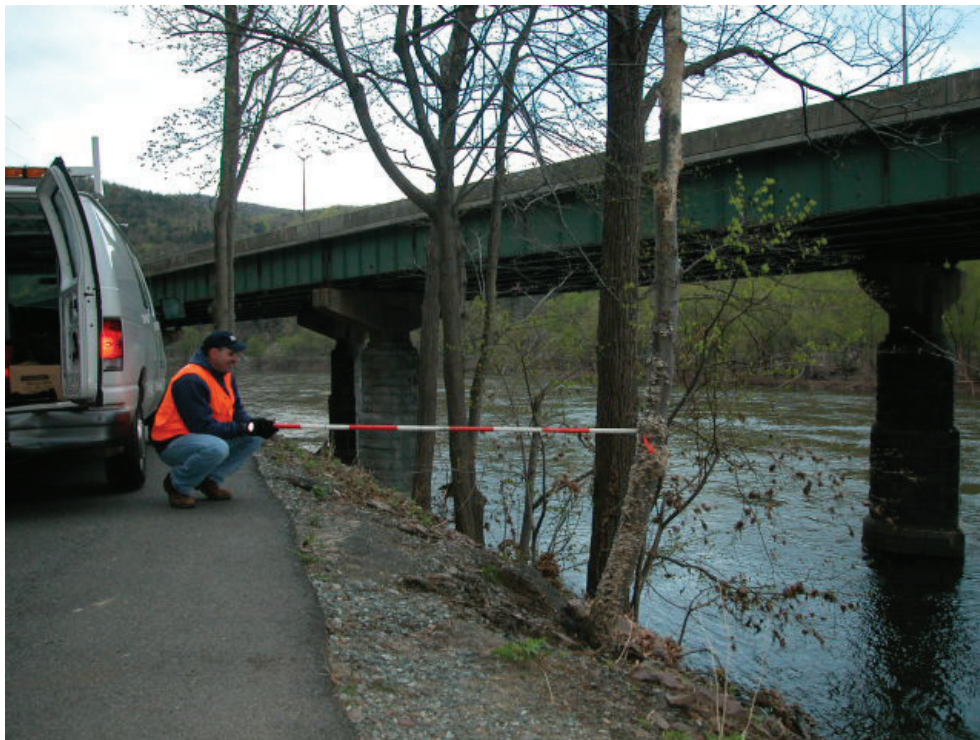
High-water mark NJ 4.4 (lat 40° 58' 35.0", long 75° 08' 05.4"), at an elevation of 319.3 feet above NGVD 29, is a good seed line on a 0.5-foot diameter tree, 4.5 feet above the ground, 2,650 feet upstream from USGS reference mark 241, and was marked with a metal USGS washer and nail.

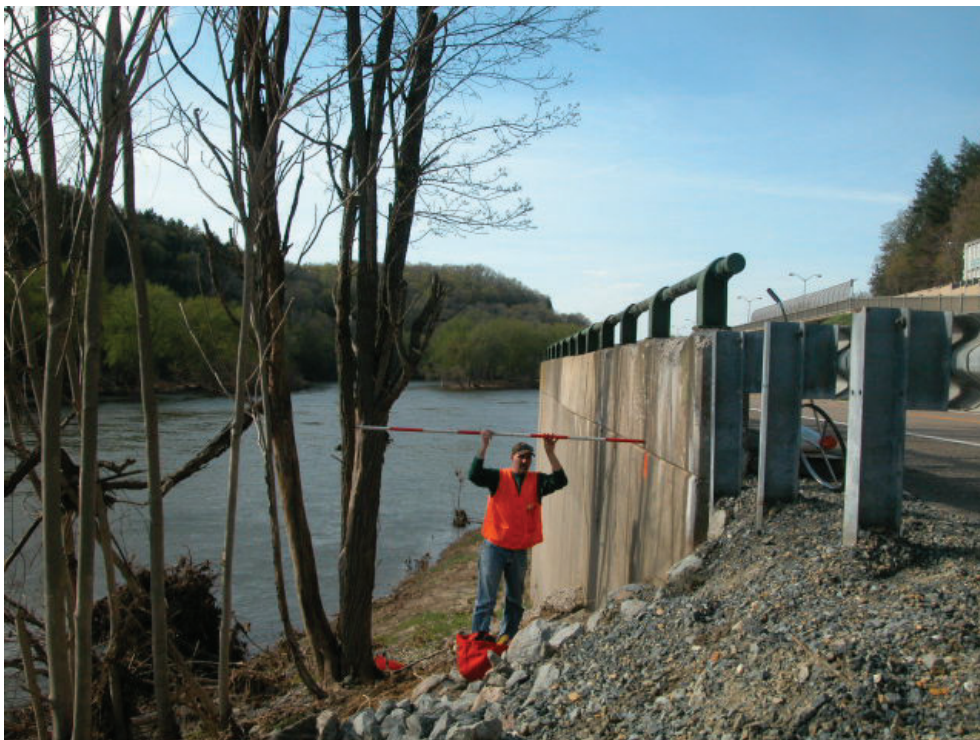
High-water mark NJ 4.5 (lat 40° 58' 27.2", long 75° 08' 05.0"), at an elevation of 318.7 feet above NGVD 29, is a good seed line on a retaining wall, 5.0 feet above the ground, 1,710 feet upstream from USGS reference mark 241, and was marked with a drill hole and orange paint.

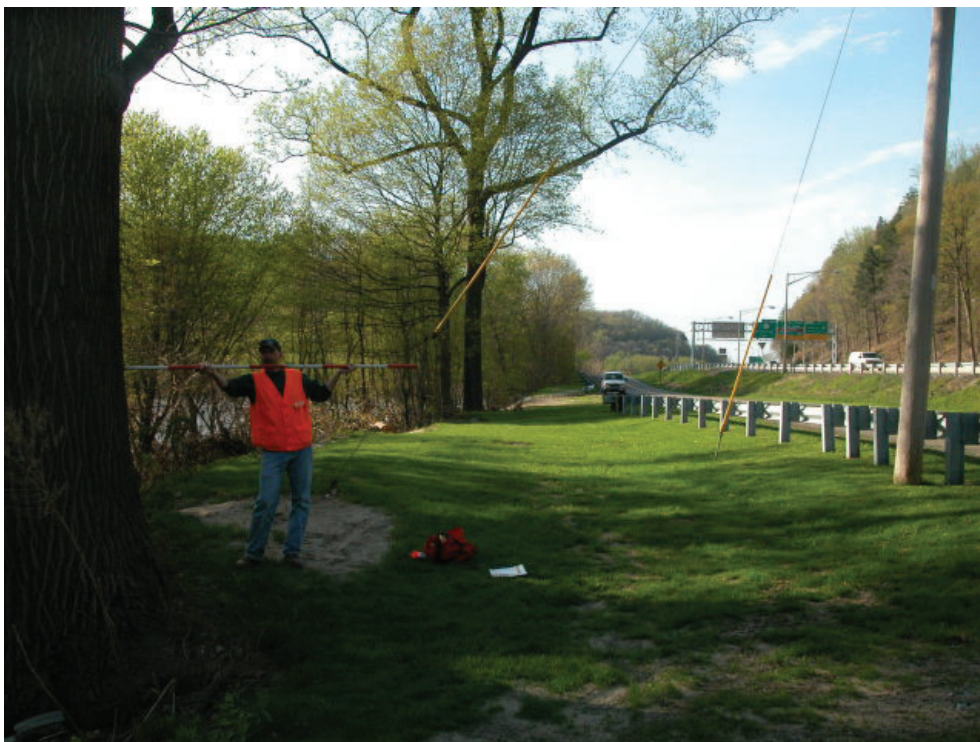
High-water mark NJ 4.6 (lat 40° 58' 19.8", long 75° 07' 59.9"), at an elevation of 317.2 feet above NGVD 29, is a good seed line on a 3.7-foot diameter tree, 5.2 feet above the ground, 860 feet upstream from USGS reference mark 241, and was marked with a metal USGS washer and nail.

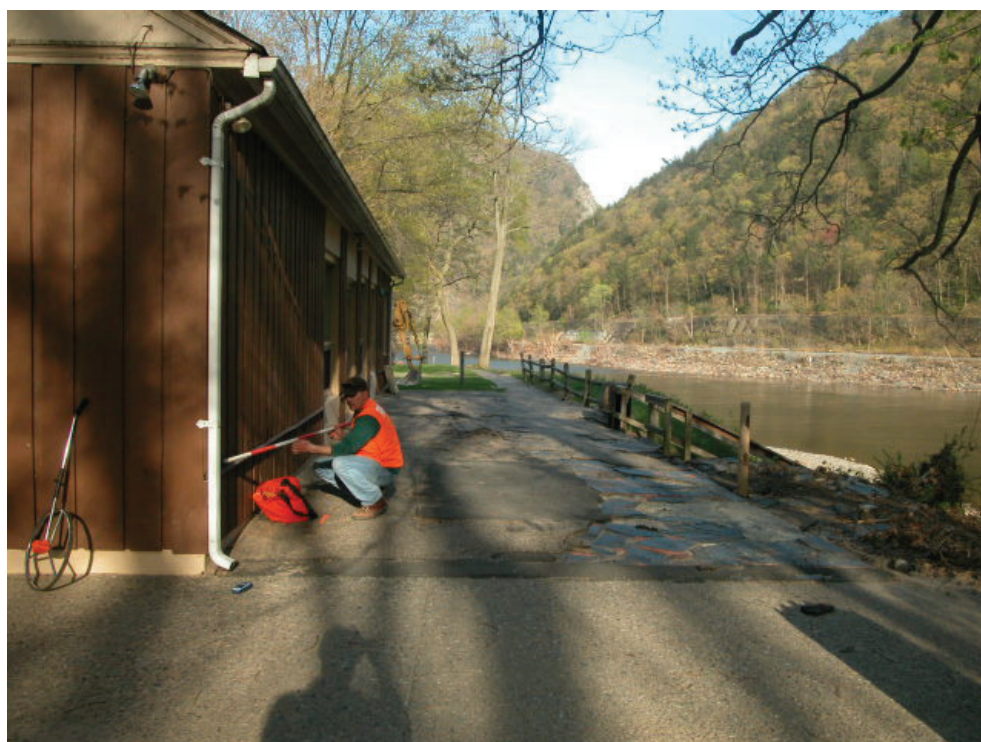
High-water mark NJ 4.7 (lat 40° 58' 12.0", long 75° 07' 48.0"), at an elevation of 316.6 feet above NGVD 29, is an excellent mud line on a building, 2.1 feet above the ground, 320 feet downstream from USGS reference mark 241, and was marked with a metal USGS washer and nail.

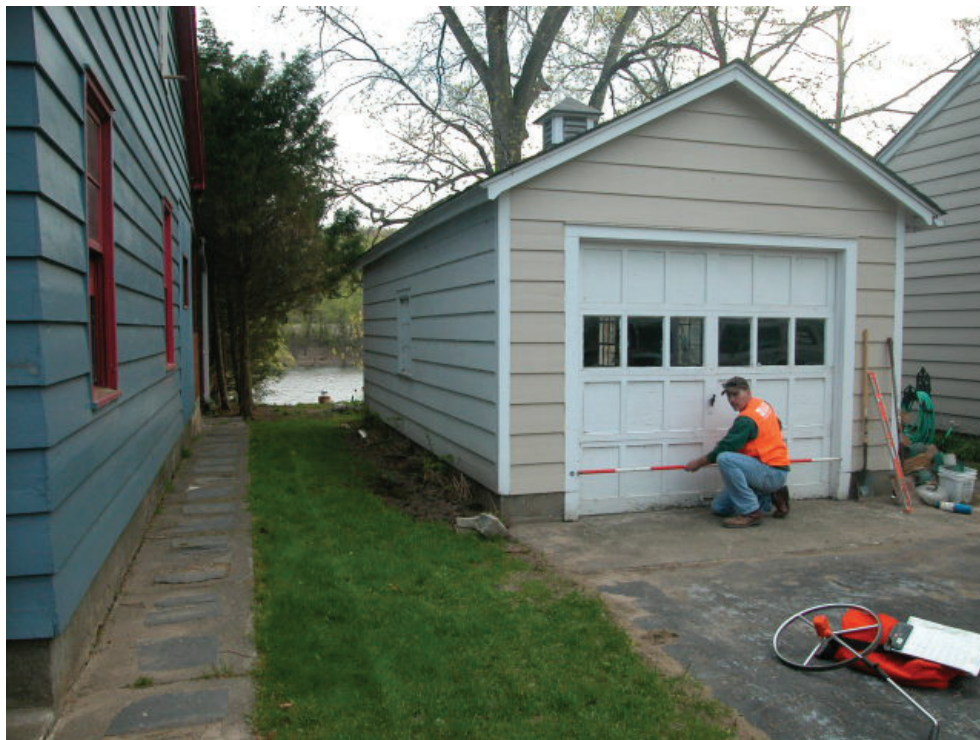
High-water mark NJ 5.1 (lat 40° 55' 07", long 75° 05' 07"), at an elevation of 291.6 feet above NGVD 29, is an excellent mud line on a garage, 1.2 feet above the ground, 2,100 feet downstream from the Columbia-Portland bridge, and was marked with a metal USGS washer and nail.

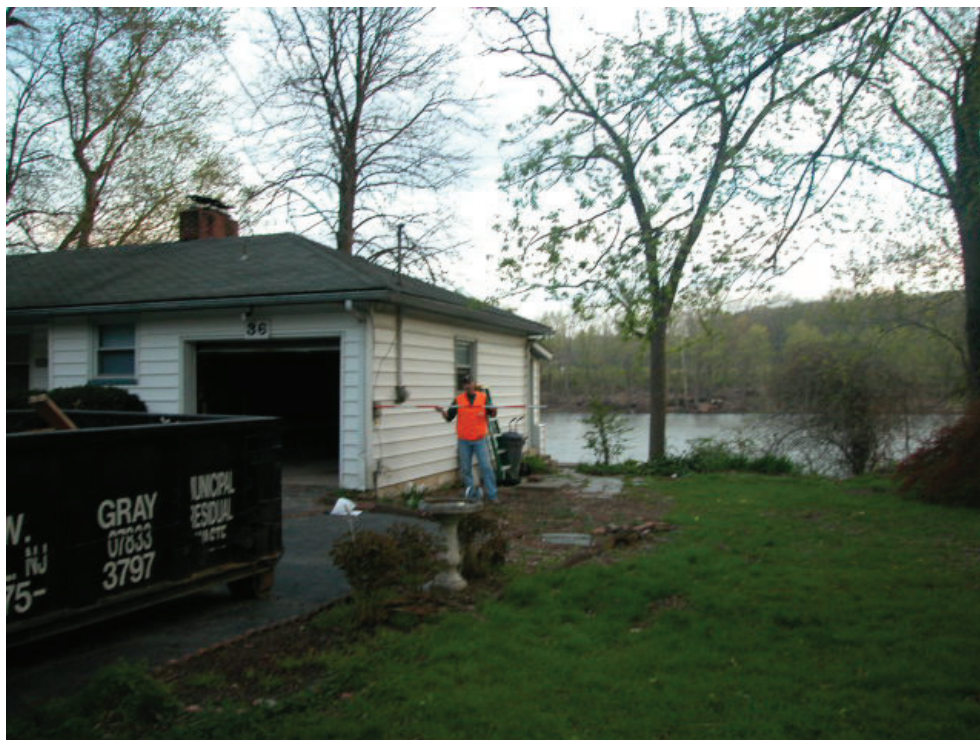
High-water mark NJ 5.2 (lat 40° 55' 01", long 75° 04' 57"), at an elevation of 290.9 feet above NGVD 29, is an excellent mud line on a garage, 4 feet above the ground, 3,000 feet downstream from the Columbia-Portland bridge, and was marked with a black marker line.

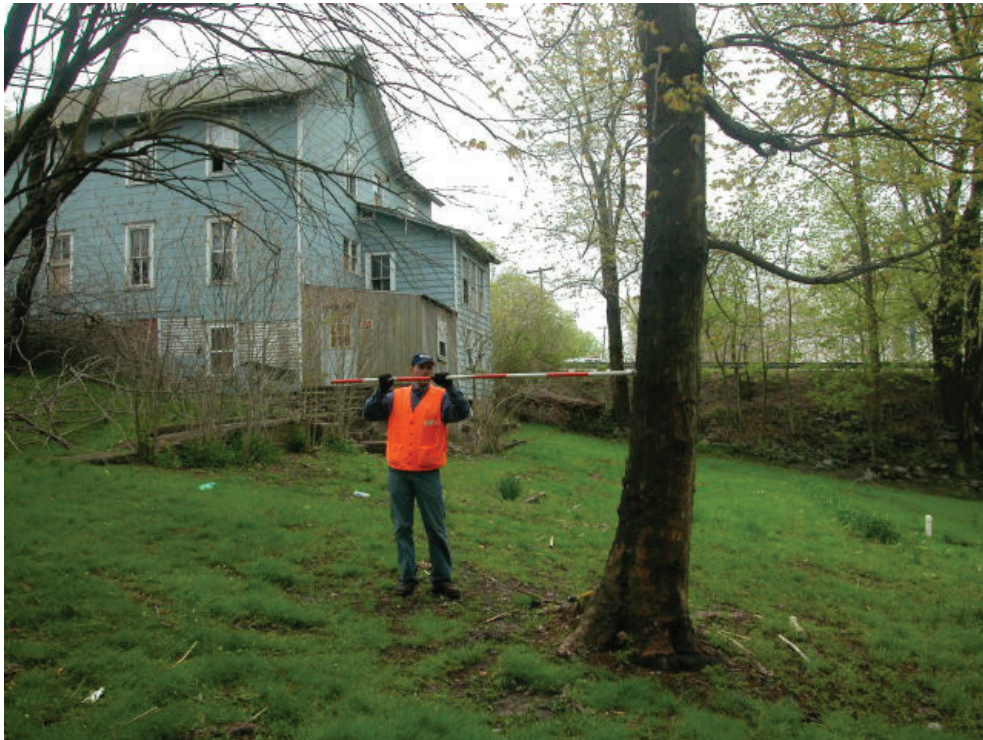
High-water mark NJ 5.3 (lat 40° 55' 31", long 75° 05' 40"), at an elevation of 294.4 feet above NGVD 29, is a good seed line on a 1.4-foot diameter tree, 6 feet above the ground, 1,520 feet upstream from the Columbia-Portland bridge, and was marked with a metal USGS washer and nail.

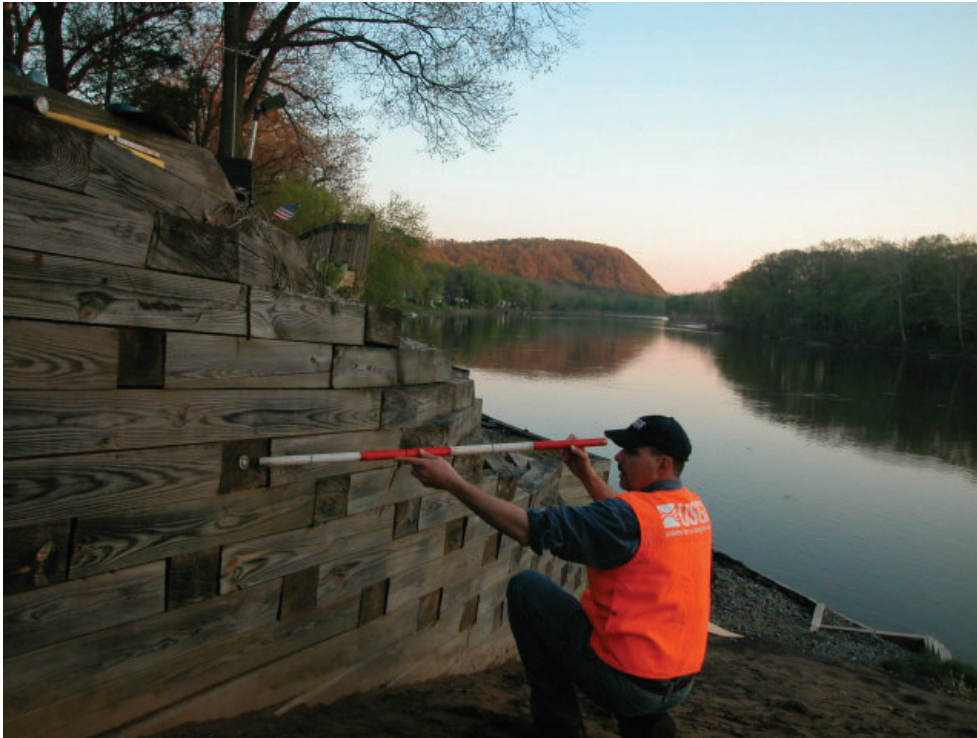
High-water mark NJ 6.1 (lat 40° 52' 08.0", long 75° 03' 01.0"), at an elevation of 277.4 feet above NGVD 29, is a fair debris line on a retaining wall, 2.5 feet above the ground, across from Thomas Island, near Pine Tree Lane, and was marked with a metal USGS washer and nail.

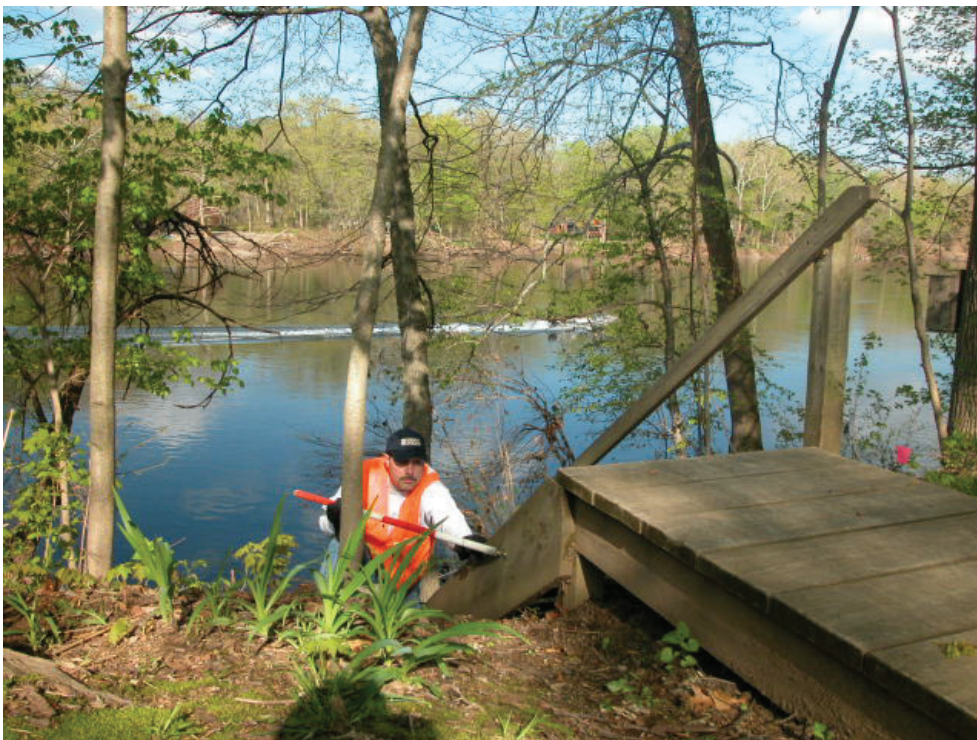
High-water mark NJ 6.2 (lat 40° 52' 04.0", long 75° 02' 59.8"), at an elevation of 277.47 feet above NGVD 29, is a good seed line on steps, 1.0 feet above the ground, across from Thomas Island, near Watergap View Avenue, and was marked with a metal USGS washer and nail.

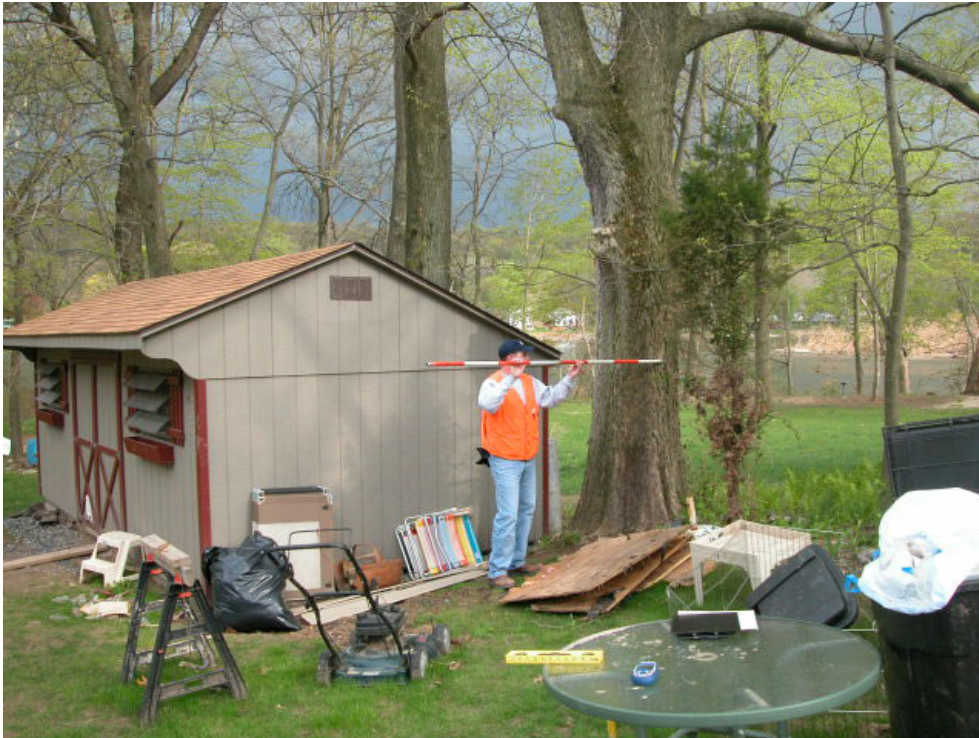
High-water mark PA 8.1 (lat 40° 51' 52.0", long 75° 03' 13.63"), at an elevation of 275.8 feet above NGVD 29, is an excellent mud line on a 2.5-foot diameter tree, 4.3 feet above the ground, at bend in Kovar Lane, and was marked with a metal USGS washer and nail.

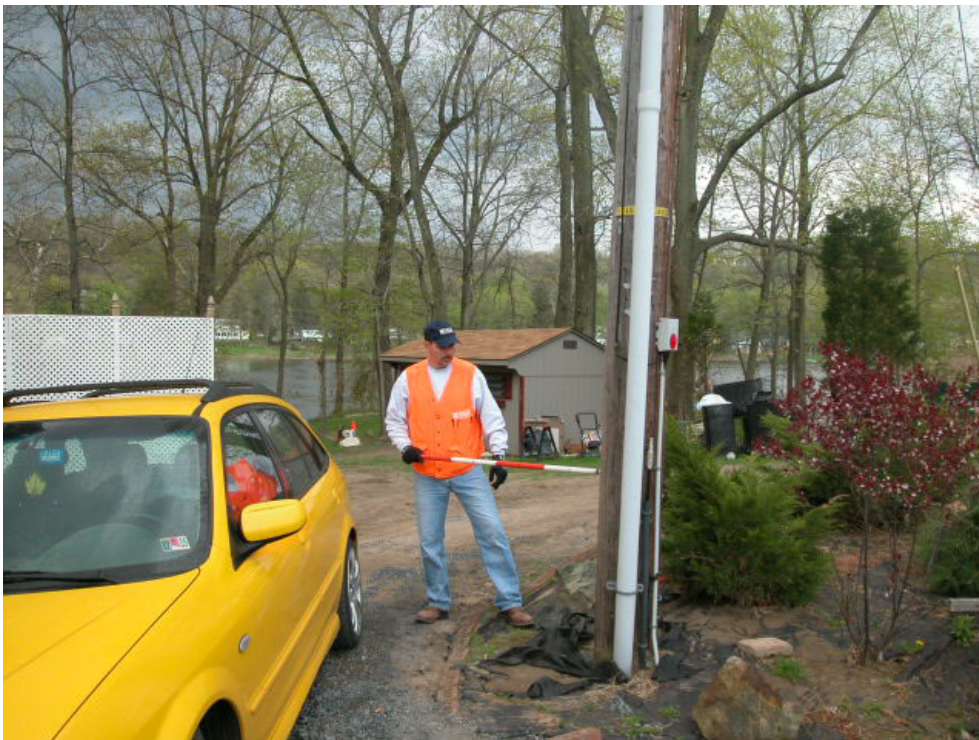
High-water mark PA 8.2 (lat 40° 51' 52.5", long 75° 03' 14.1"), at an elevation of 276.1 feet above NGVD 29, is a good seed line on a telephone pole, 3.4 feet above the ground, at bend in Kovar Lane, and was marked with a metal USGS washer and nail.

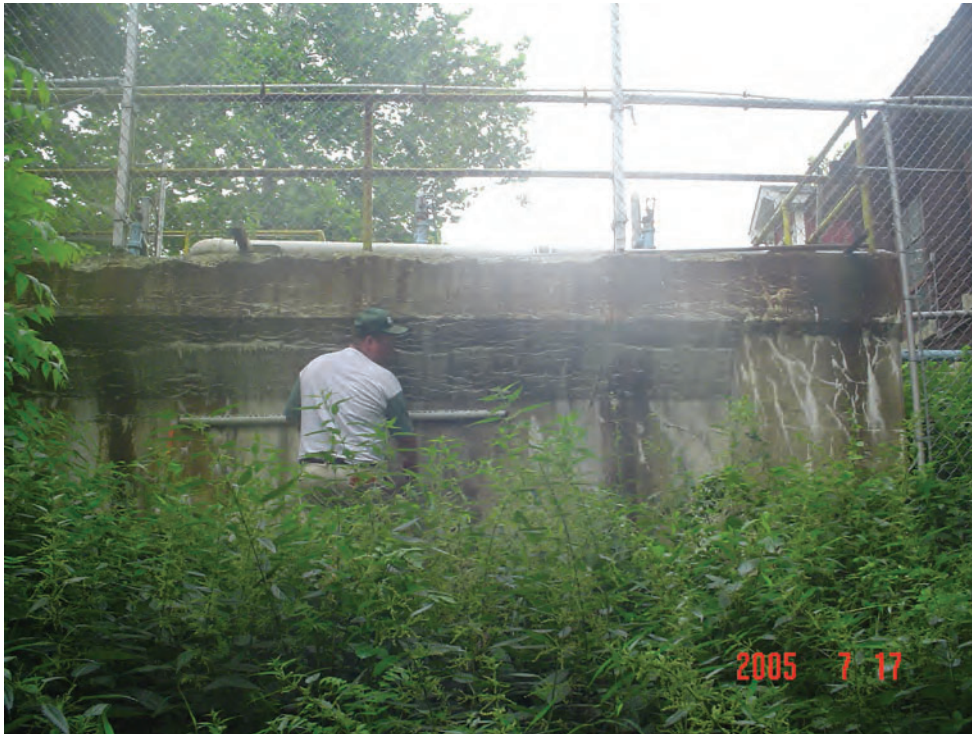
High-water mark NJ 7.1 (lat 40° 49' 49.5", long 75° 05' 04.6"), at an elevation of 256.2 feet above NGVD 29, is a good seed line on a wall, 4 feet above the ground, 500 feet upstream from the Water Street bridge, and was marked with a metal USGS washer and nail.

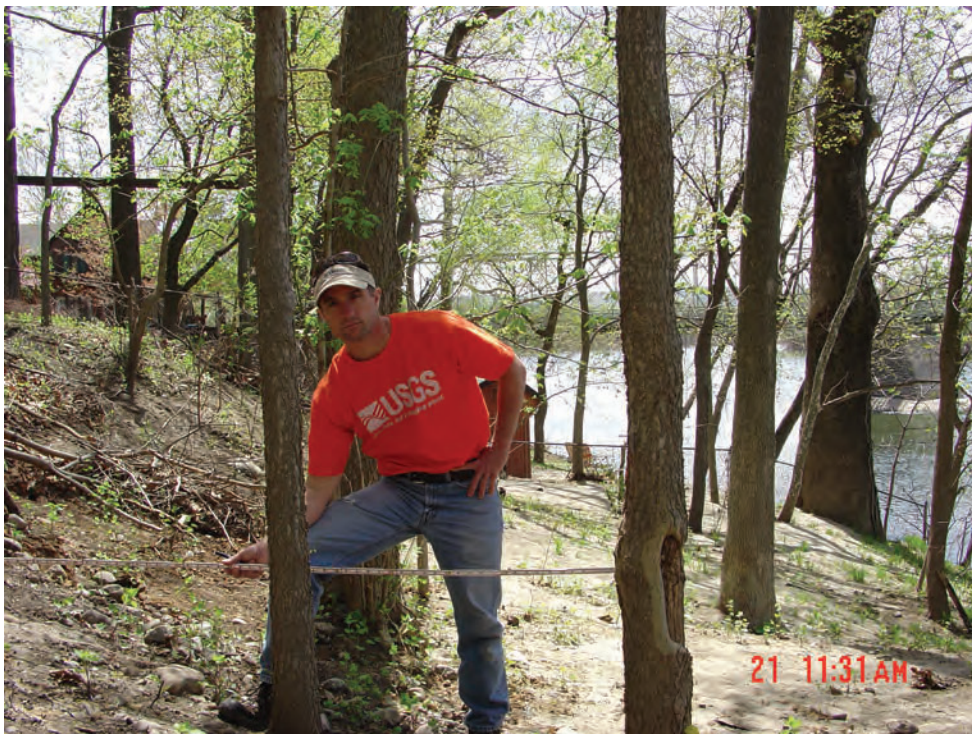
High-water mark NJ 7.2 (lat 40° 49' 47.5", long 75° 05' 02.5"), at an elevation of 256.2 feet above NGVD 29, is a poor debris line on an 8-inch diameter tree, 2.4 feet above the ground, 280 feet upstream from the Water Street bridge, and was marked with a metal USGS washer and nail.

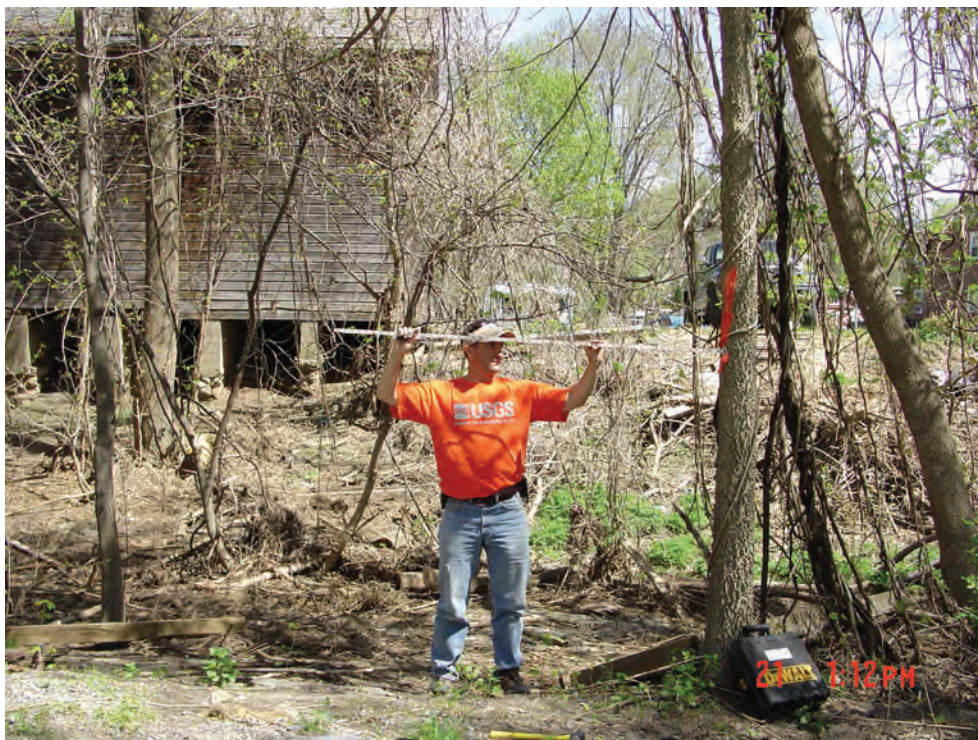
High-water mark NJ 7.3 (lat 40° 49' 40.7", long 75° 04' 55.7"), at an elevation of 253.6 feet above NGVD 29, is a fair debris line on an 10-inch diameter tree, 4.9 feet above the ground, 500 feet downstream from the Water Street bridge, and was marked with a metal USGS washer and nail.

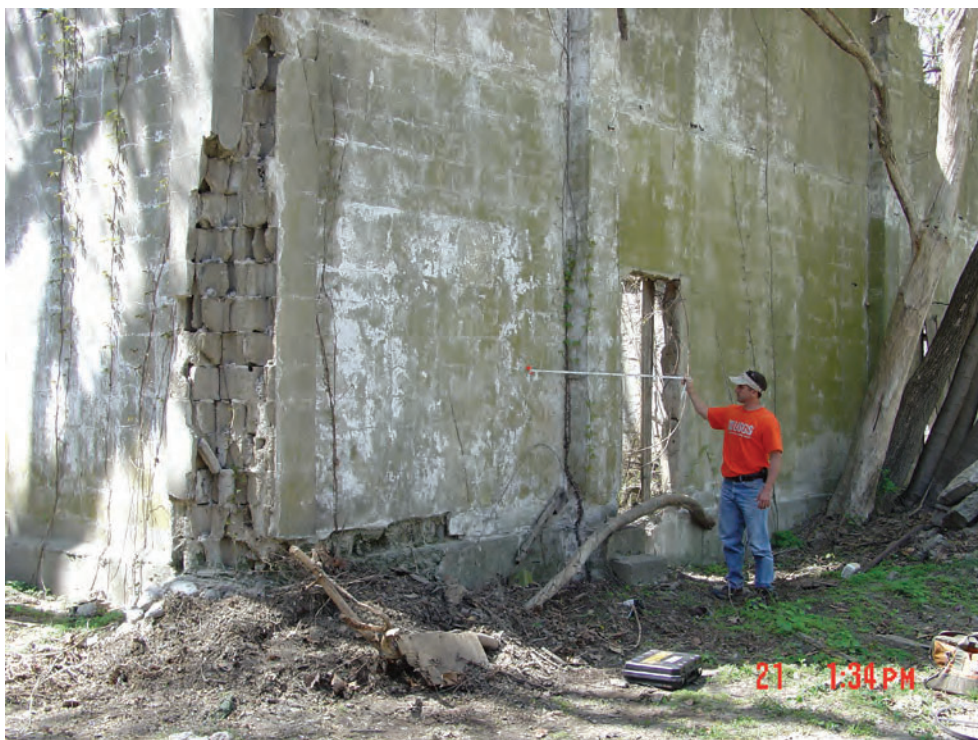
High-water mark NJ 7.4 (lat 40° 49' 42.8", long 75° 04' 55.8"), at an elevation of 255.0 feet above NGVD 29, is a good seed line on an abandoned building, 5.5 feet above the ground, 300 feet downstream from Water Street bridge, and was marked with a metal USGS washer and nail.

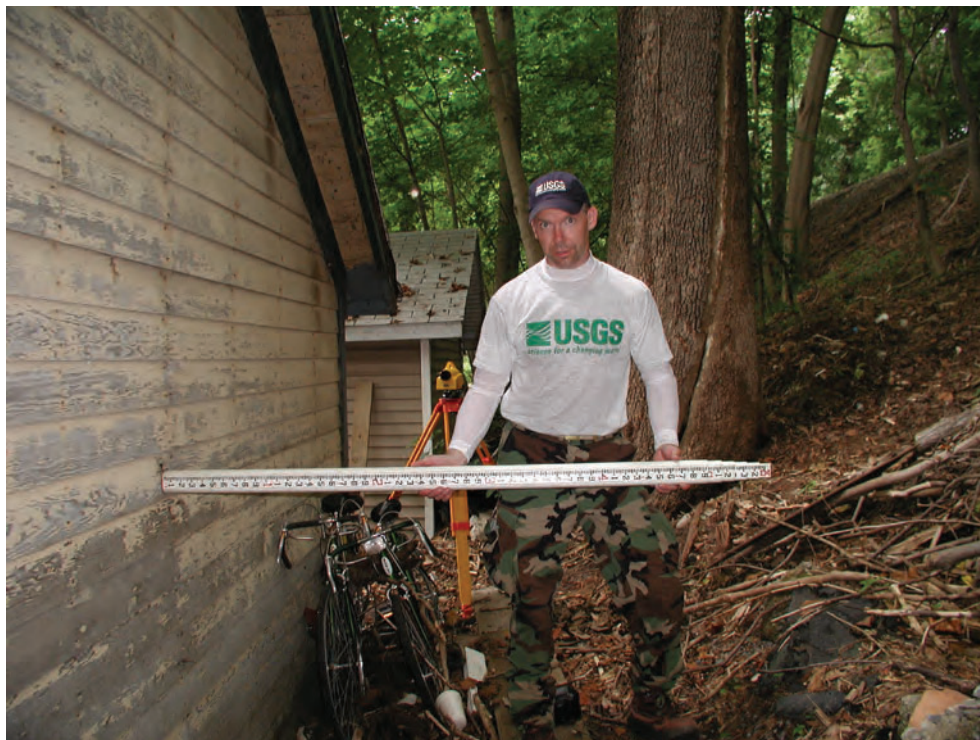
High-water mark NJ 8.1 (lat 40° 48' 13", long 75° 05' 55"), at an elevation of 235.9 feet above NGVD 29, is an excellent seed line on a building, 5 feet above the ground, 590 feet upstream from the intersection of Foul Rift Road and Van Emburgh Court, and was marked with a black marker line.

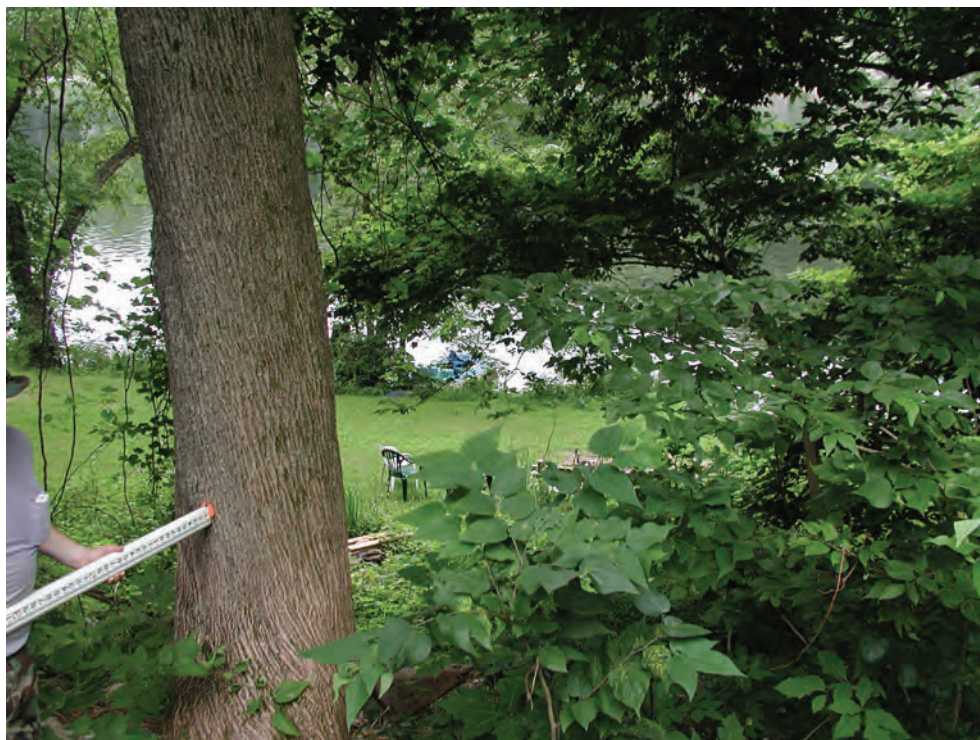
High-water mark NJ 8.2 (lat 40° 48' 18", long 75° 05' 58"), at an elevation of 236.1 feet above NGVD 29, is a good seed line on a 2-foot diameter tree, 3.5 feet above the ground, 1,120 feet upstream from the intersection of Foul Rift Road and Van Emburgh Court, and was marked with a metal USGS washer and nail.

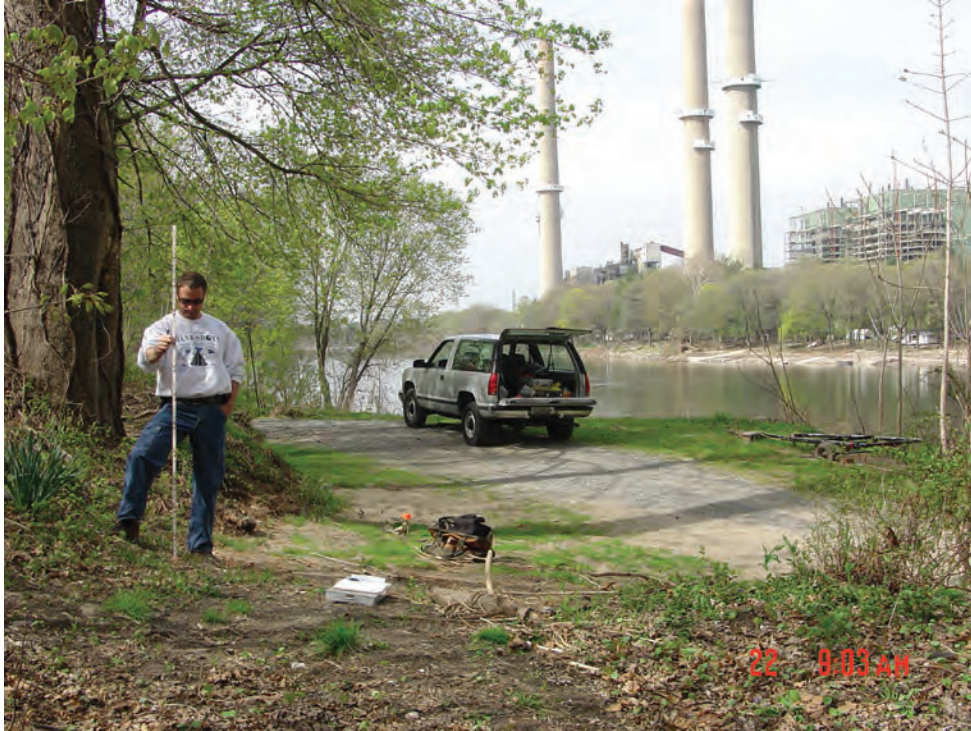
High-water mark NJ 8.3 (lat 40° 47' 58.7", long 75° 05' 55.7"), at an elevation of 236.5 feet above NGVD 29, is a good debris line on the ground, 900 feet downstream from the intersection of Foul Rift Road and Van Emburgh Court, and was marked with a metal rebar.

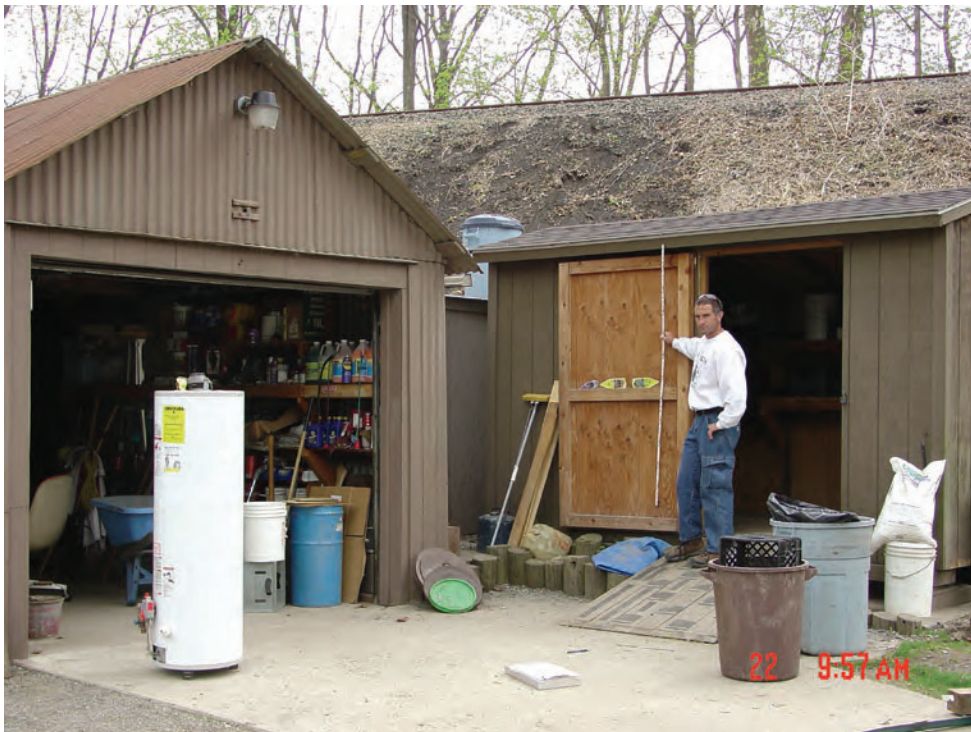
High-water mark NJ 8.4 (lat 40° 48' 06", long 75° 05' 53"), at an elevation of 235.7 feet above NGVD 29, is a poor seed line on a shed, 0.6 feet above the shed floor, just downstream from the intersection of Foul Rift Road and Van Emburgh Court, and was marked with a black marker line.

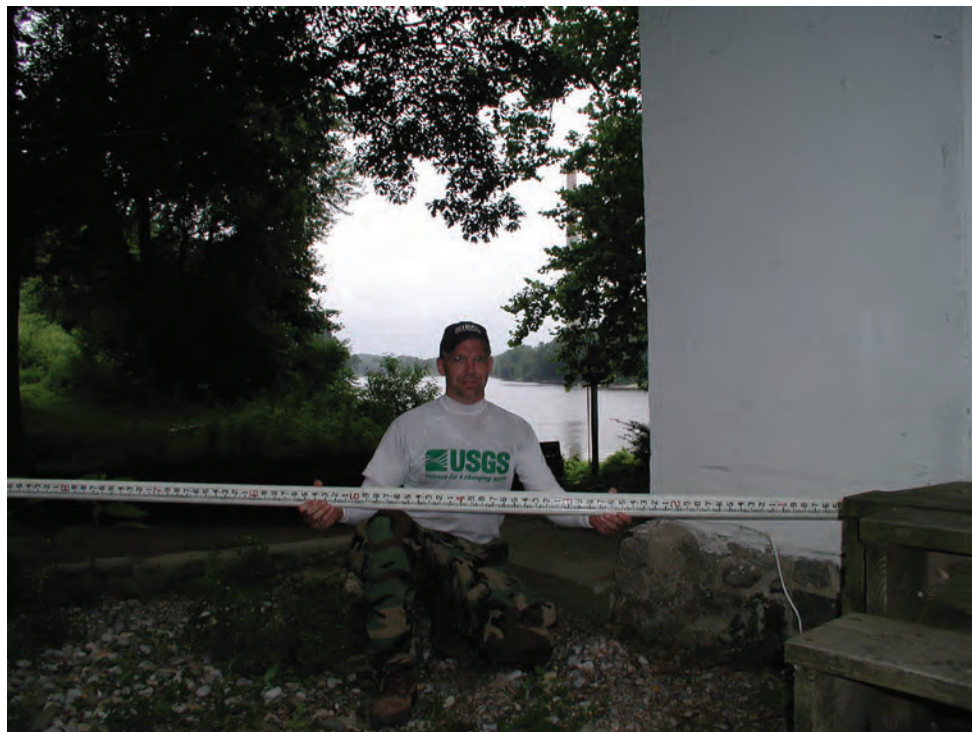
High-water mark NJ 8.5 (lat 40° 48' 00", long 75° 05' 55.5"), at an elevation of 235.8 feet above NGVD 29, is a poor mark on a house (location of mark given by resident), 1.8 feet above the ground, 900 feet downstream from the intersection of Foul Rift Road and Van Emburgh Court, and was marked with a black marker line.

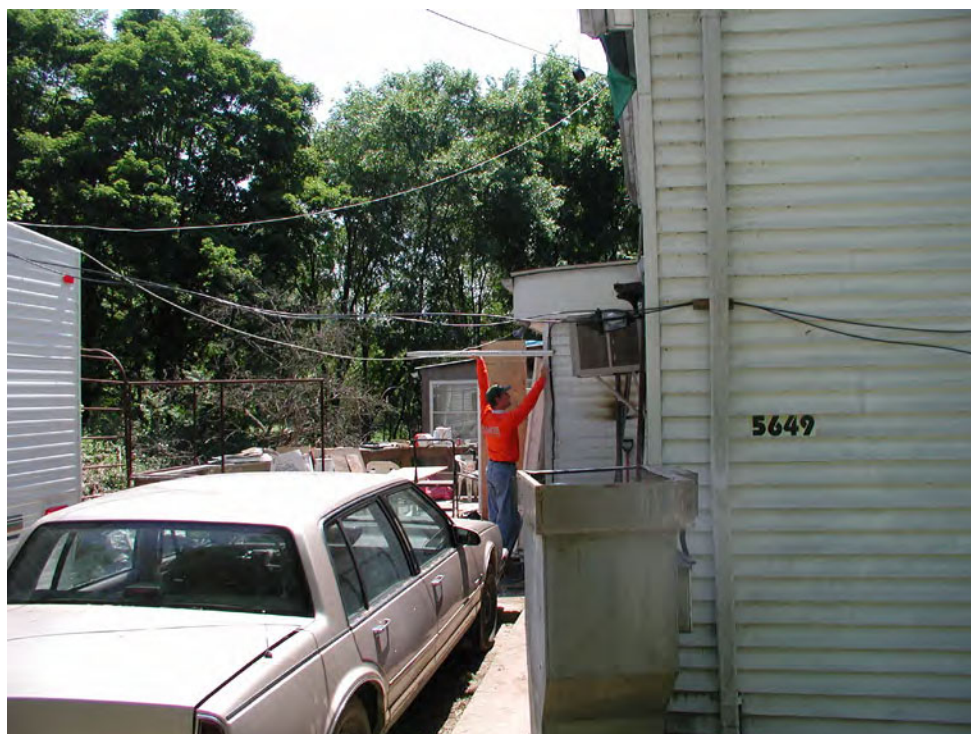
High-water mark PA 9A.1 (lat 40° 47' 22.0", long 75° 07' 14.4"), at an elevation of 228.6 feet above NGVD 29, is an excellent mud line on a house on DePues Road, 6.9 feet above the ground, just downstream from Oughoughton Creek, and was marked with a metal USGS washer and nail.

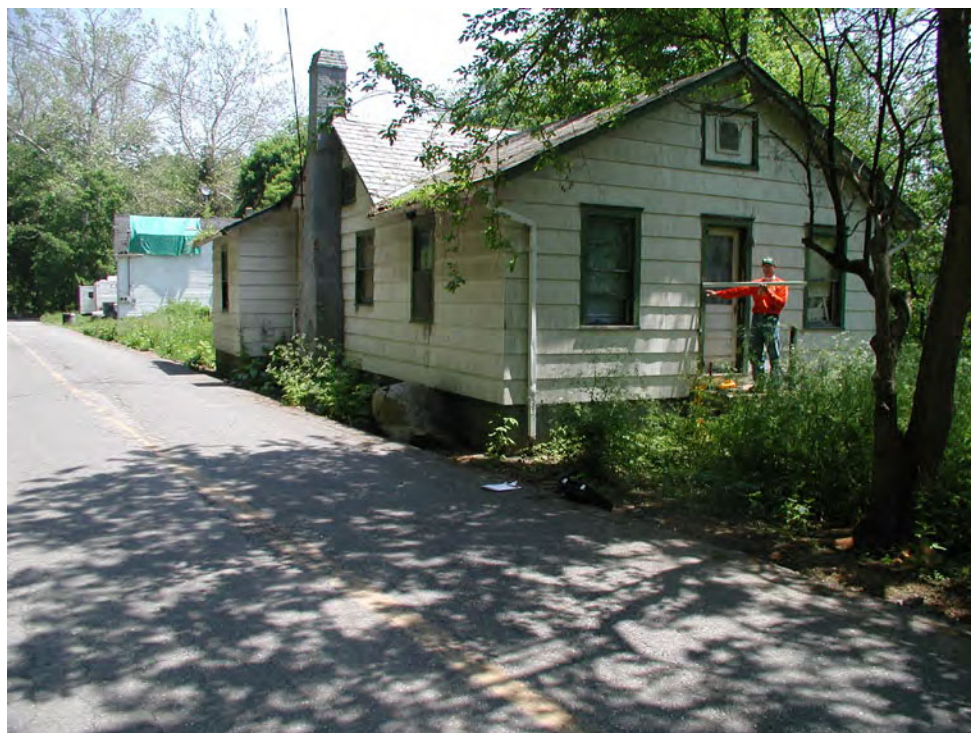
High-water mark PA 9A.2 (lat 40° 47' 20.9", long 75° 07' 16.0"), at an elevation of 228.3 feet above NGVD 29, is a good mud line on door of a house on DePues Road, 7.0 feet above the ground, just downstream from Oughoughton Creek, and was marked with a black marker line.
