Flood of April 2-4, 2005, Delaware River Main Stem from Port Jervis, New York, to Cinnaminson, New Jersey

Scientific Investigations Report 2007-5067

**U.S. Department of the Interior
U.S. Geological Survey**

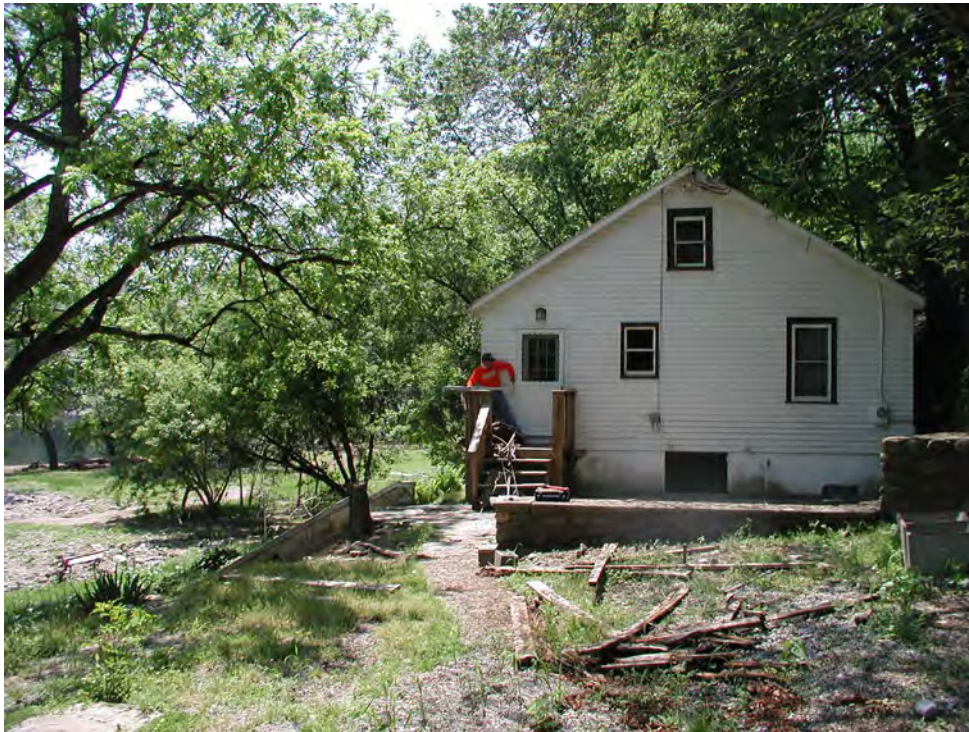
High-water mark PA 9A.3 (lat 40° 47' 19.1", long 75° 07' 17.9"), at an elevation of 228.5 feet above NGVD 29, is an excellent seed line on a house on DePues Road, 7.2 feet above the ground, just downstream from Oughoughton Creek, and was marked with a nail (no USGS washer). NOTE: In case house is demolished, mark was transferred to 2-foot diameter tree 39.5 ft northwest of house, and marked with a USGS washer and nail.

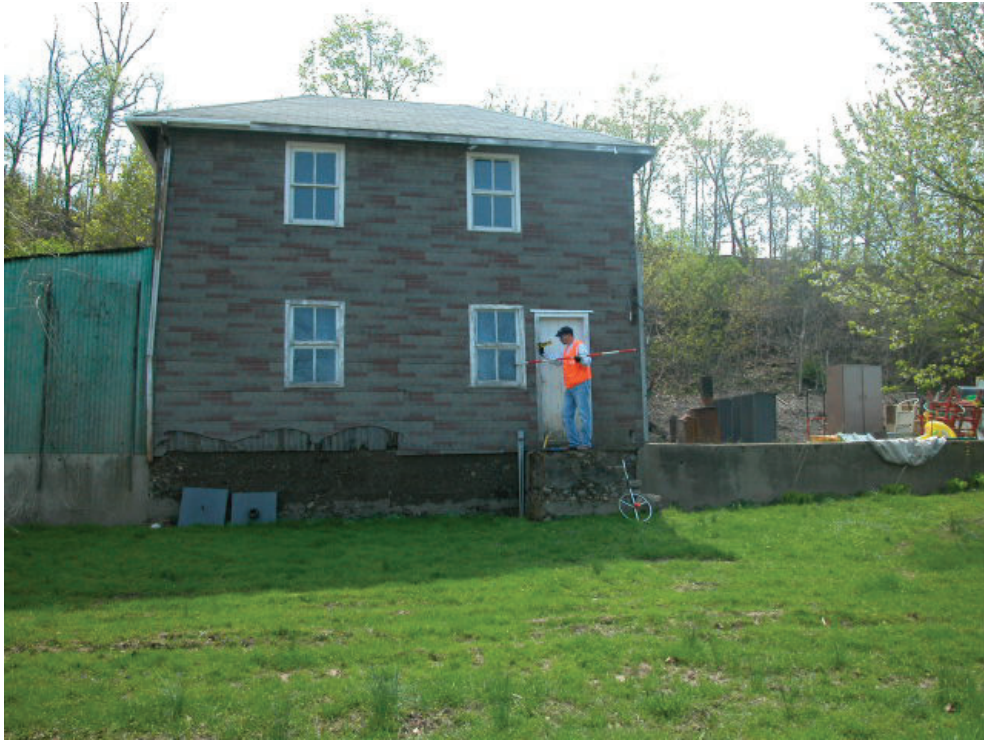
High-water mark NJ 9.1 (lat 40° 46' 27", long 75° 07' 50"), at an elevation of 225.7 feet above NGVD 29, is an excellent mud line on a house, 7.7 feet above the ground, 0.14 miles upstream from Buckhorn Creek, and was marked with a black marker line on window.

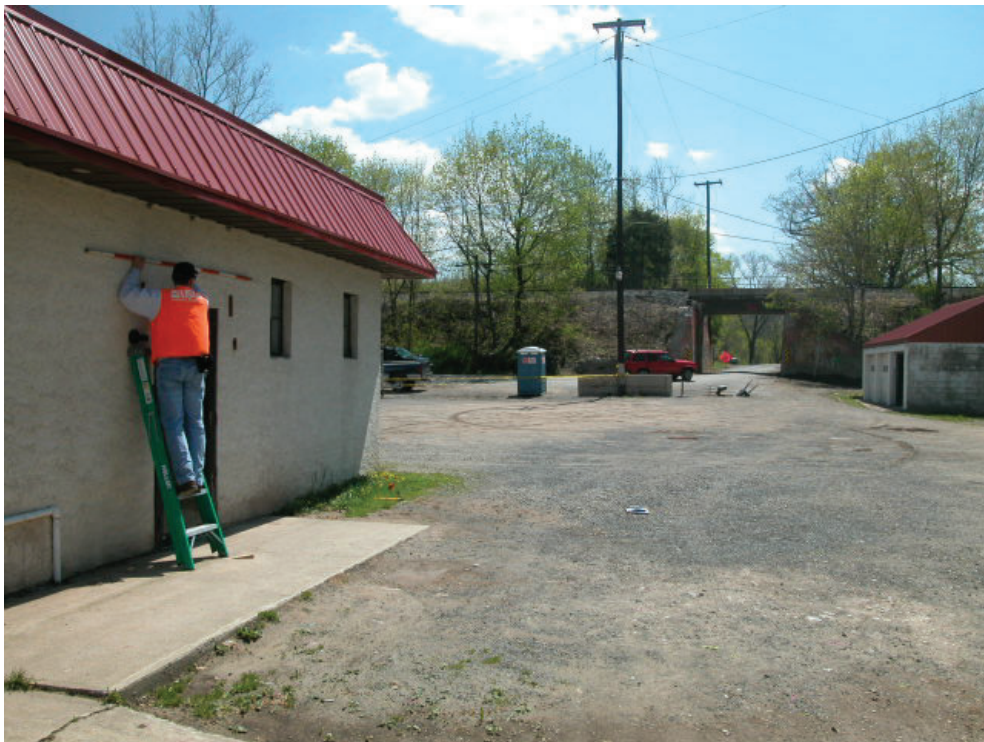
High-water mark NJ 9.2 (lat 40° 46' 25", long 75° 07' 55"), at an elevation of 225.8 feet above NGVD 29, is an excellent mud line on a building, 8.2 feet above the ground, 0.07 miles upstream from Buckhorn Creek, and was marked with a metal USGS washer and nail.

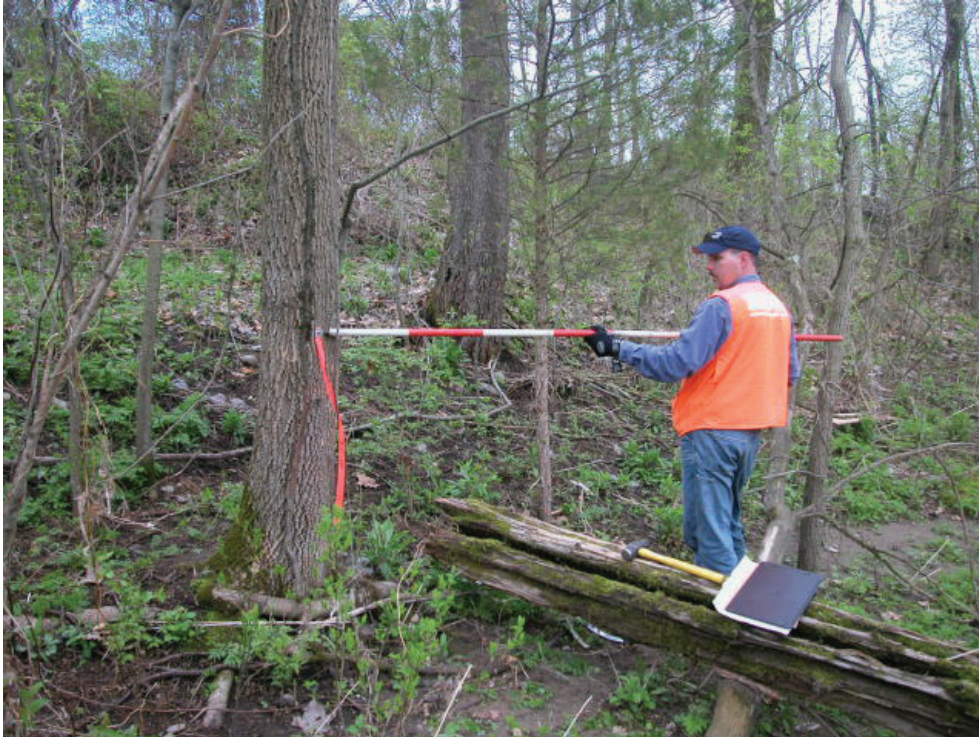
High-water mark NJ 10.2 (lat 40° 46' 26", long 75° 10' 23"), at an elevation of 214.8 feet above NGVD 29, is an excellent seed line on a 1-foot diameter tree, 3.8 feet above the ground, opposite the mouth of Martins Creek, and was marked with a metal USGS washer and nail.

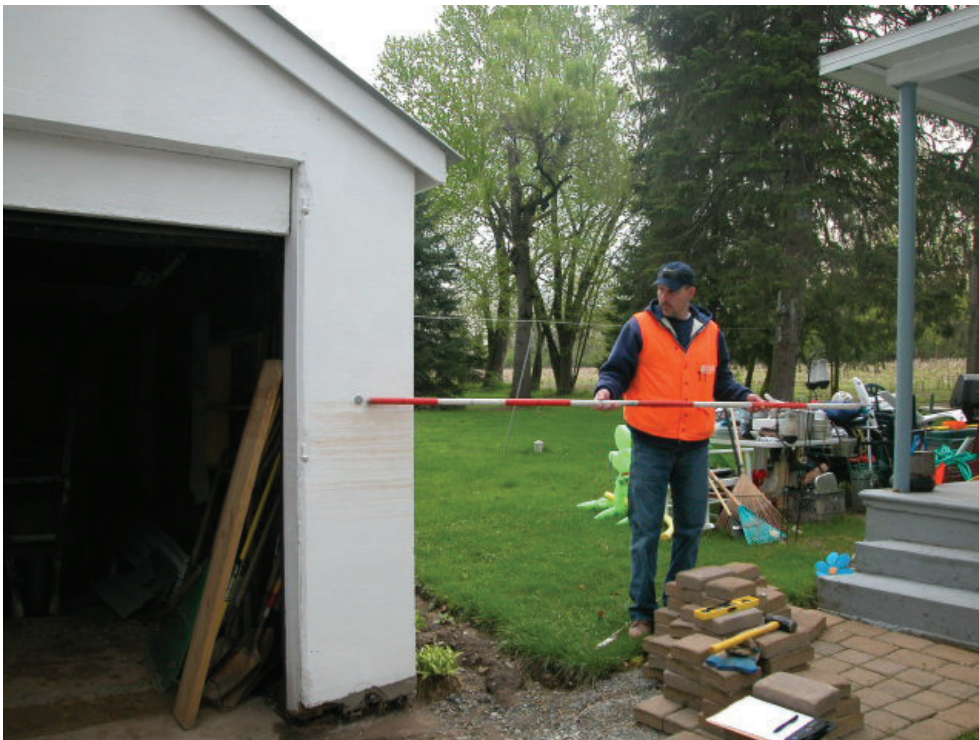
High-water mark NJ 10.3 (lat 40° 46' 33.5", long 75° 10' 17.8"), at an elevation of 215.6 feet above NGVD 29, is an excellent mud line on a garage, 4.6 feet above the ground, at the end of Broad Street, and was marked with a metal USGS washer and nail.

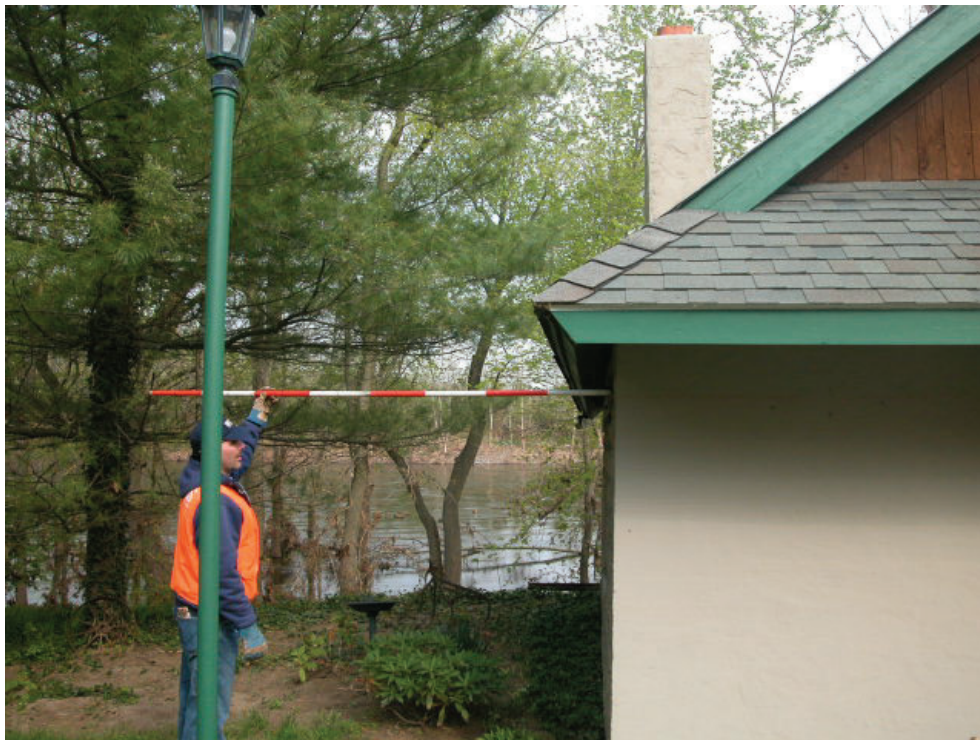
High-water mark NJ 10.4 (lat 40° 46' 32.9", long 75° 10' 18.5"), at an elevation of 215.8 feet above NGVD 29, is an excellent mud line on a garage, 6.7 feet above the ground, at the end of Broad Street, and was marked with a metal USGS washer and nail.

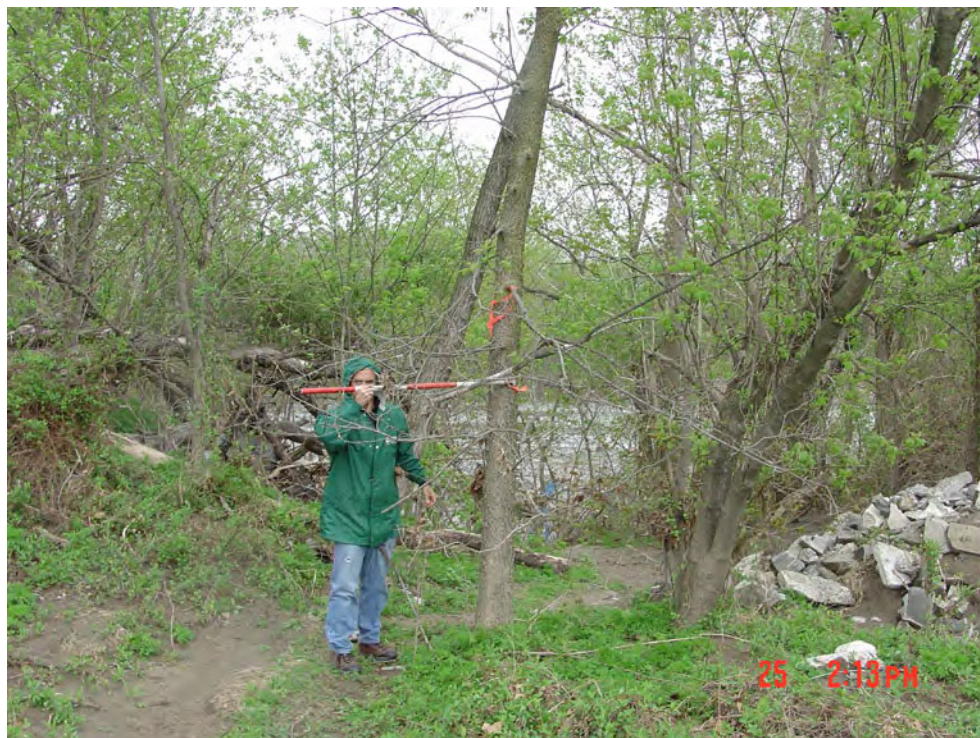
High-water mark PA 10.1 (lat 40° 46' 31.5", long 75° 10' 31.4"), at an elevation of 215.2 feet above NGVD 29, is a good debris line on a 6-inch diameter tree, 5.5 feet above the ground, just downstream from Martins Creek, and was marked with a metal USGS washer and nail.

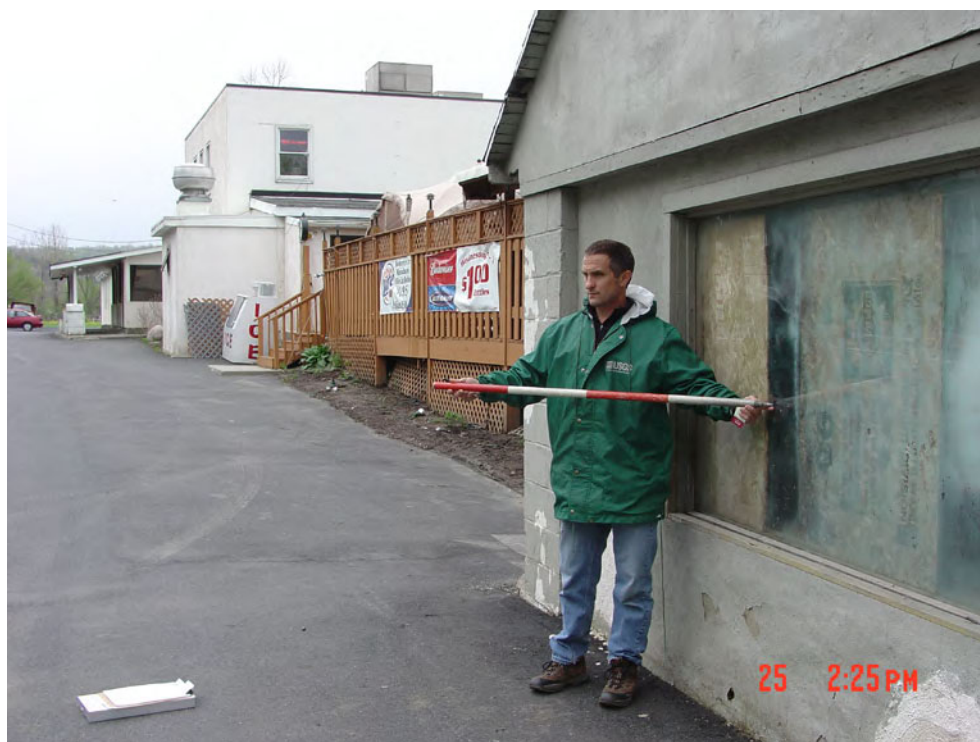
High-water mark PA 10.2 (lat 40° 46' 20.7", long 75° 10' 40.3"), at an elevation of 214.8 feet above NGVD 29, is an excellent seed line on window of building on PA State Route 611, 3.8 feet above the ground, 0.3 miles downstream from Martins Creek, and was marked with a black marker line.

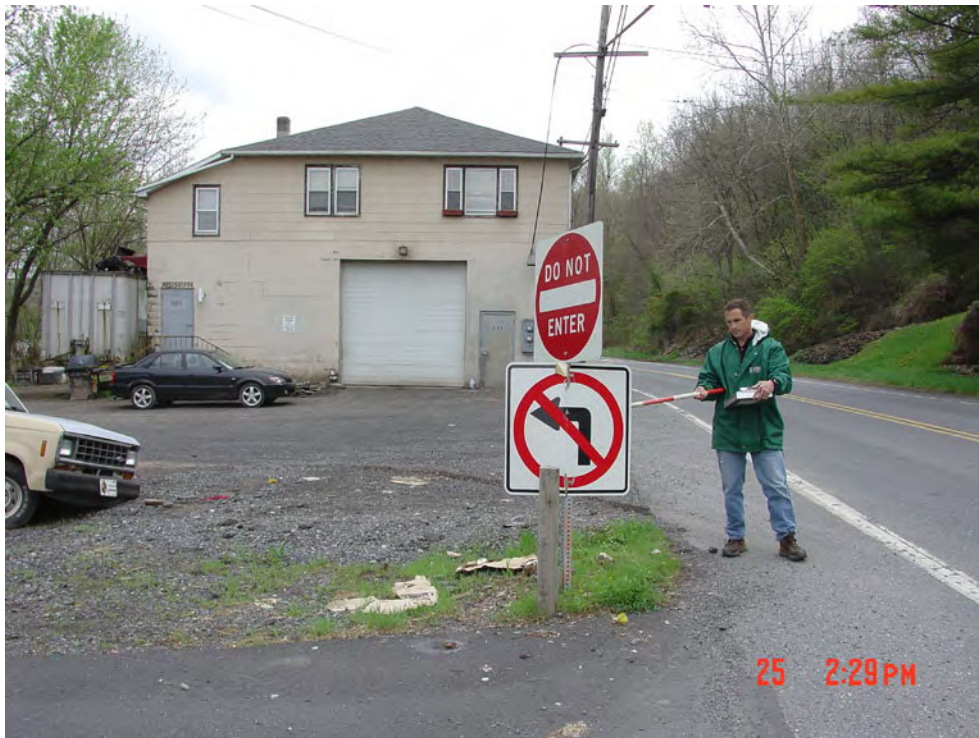
High-water mark PA 10.3 (lat 40° 46' 20.0", long 75° 10' 41.1"), at an elevation of 214.9 feet above NGVD 29, is a good mud line on the back of a street sign, 3.4 feet above the ground, 0.3 miles downstream from Martins Creek, and was marked with a black marker line.

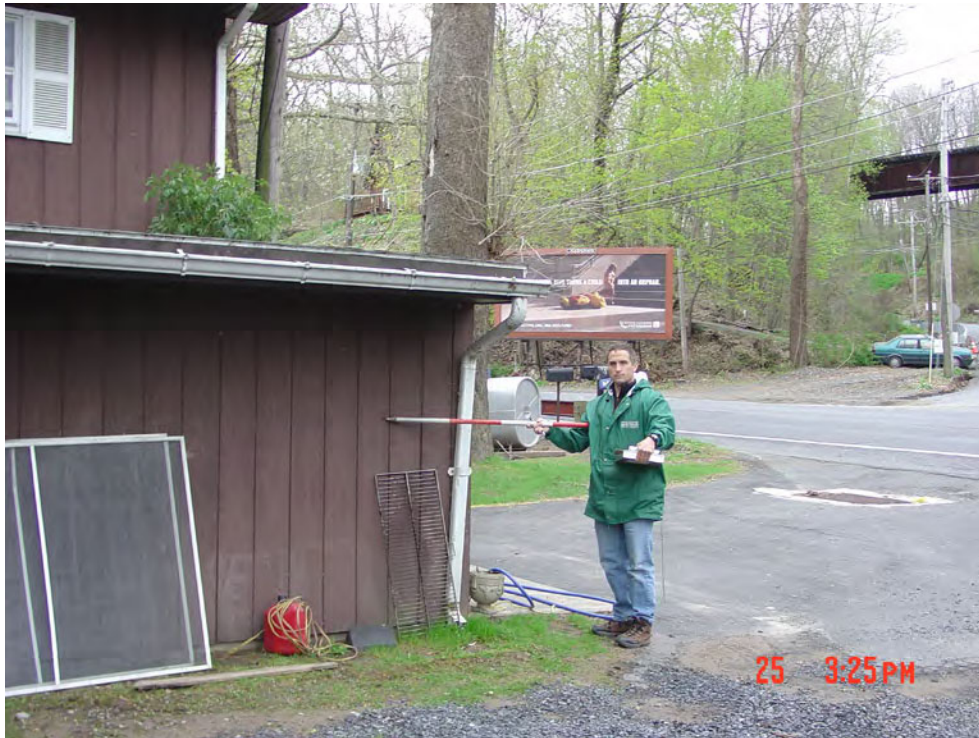
High-water mark PA 11.1 (lat 40° 45' 10.8", long 75° 11' 49"), at an elevation of 208.9 feet above NGVD 29, is an excellent seed line on a building on PA State Route 611, 4.1 feet above the ground, 0.5-miles downstream from Mud Run, and was marked with a black marker line.

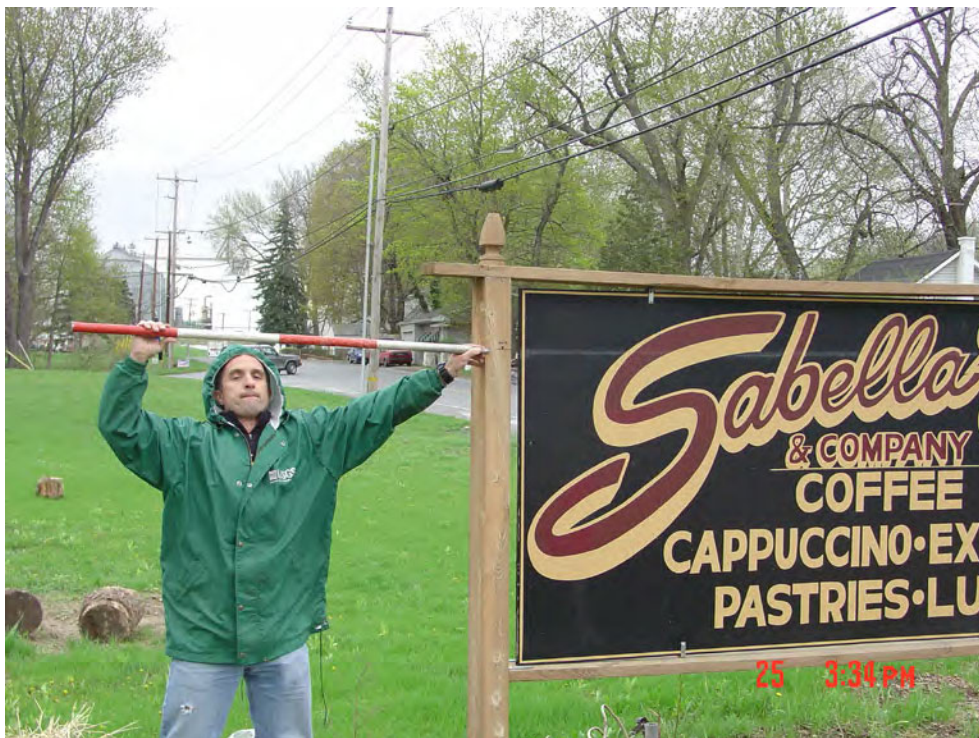
High-water mark PA 11.2 (lat 40° 45' 25.6", long 75° 11' 32.4"), at an elevation of 209.3 feet above NGVD 29, is an excellent mud line on a business sign on PA State Route 611, 5.7 feet above the ground, 0.1 miles downstream from Martins Creek, and was marked with a black marker line.

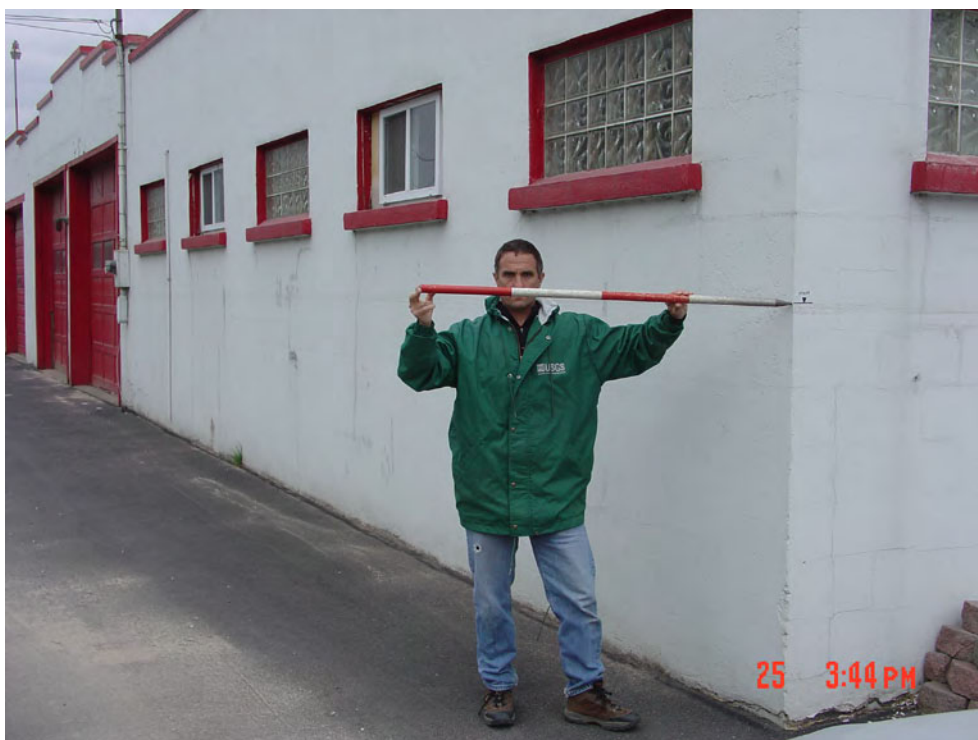
High-water mark PA 11.3 (lat 40° 45' 29.7", long 75° 11' 21.9"), at an elevation of 209.7 feet above NGVD 29, is an excellent mud line on a building, 5.0 feet above the ground, 200 feet upstream from Martins Creek, and was marked with a black marker line.

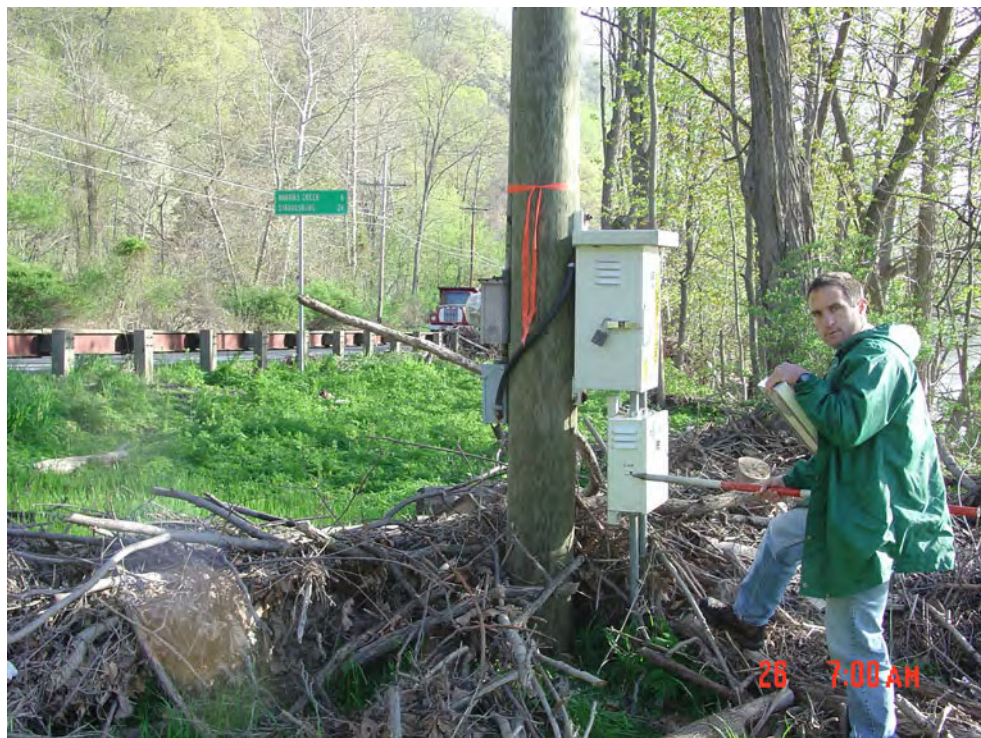
High-water mark PA 12.1 (lat 40° 42' 44.7", long 75° 11' 46.4"), at an elevation of 197.6 feet above NGVD 29, is an excellent mud line on an electric equipment box on a utility pole on PA State Route 611, 2.8 feet above the ground, 1.7 miles upstream from Lehigh River, and was marked with a black marker line.

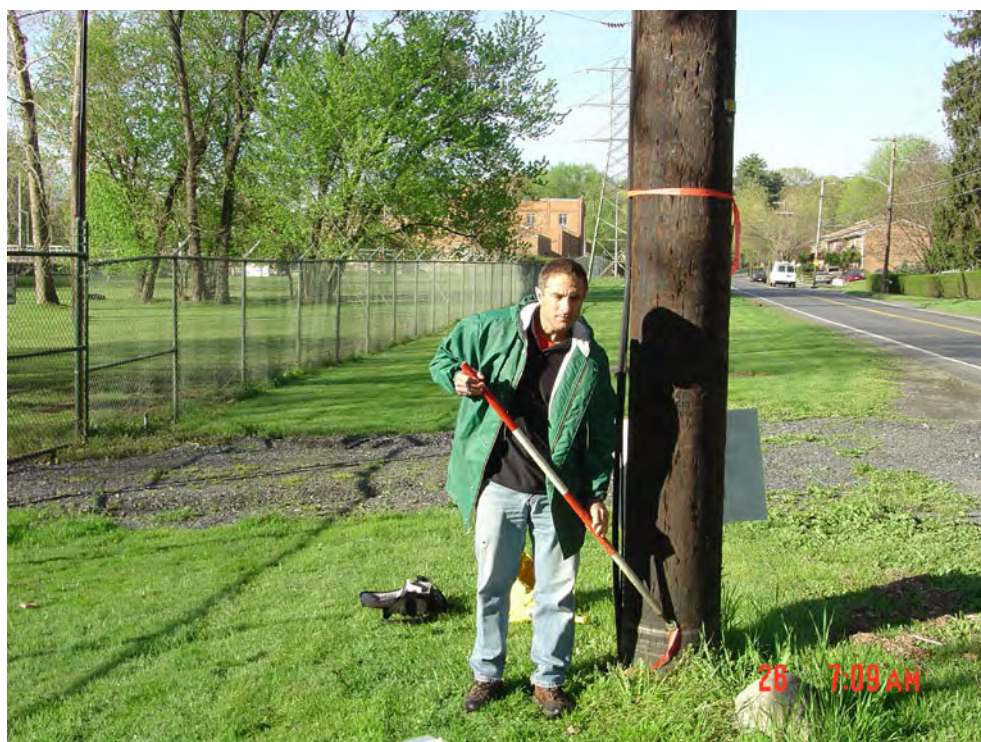
High-water mark PA 12.2 (lat 40° 42' 41.5", long 75° 11' 48.8"), at an elevation of 196.5 feet above NGVD 29, is an excellent mud line on a utility pole on PA State Route 611, 0.9 feet above the ground, 1.6 miles upstream from Lehigh River, and was marked with a metal USGS washer and nail.

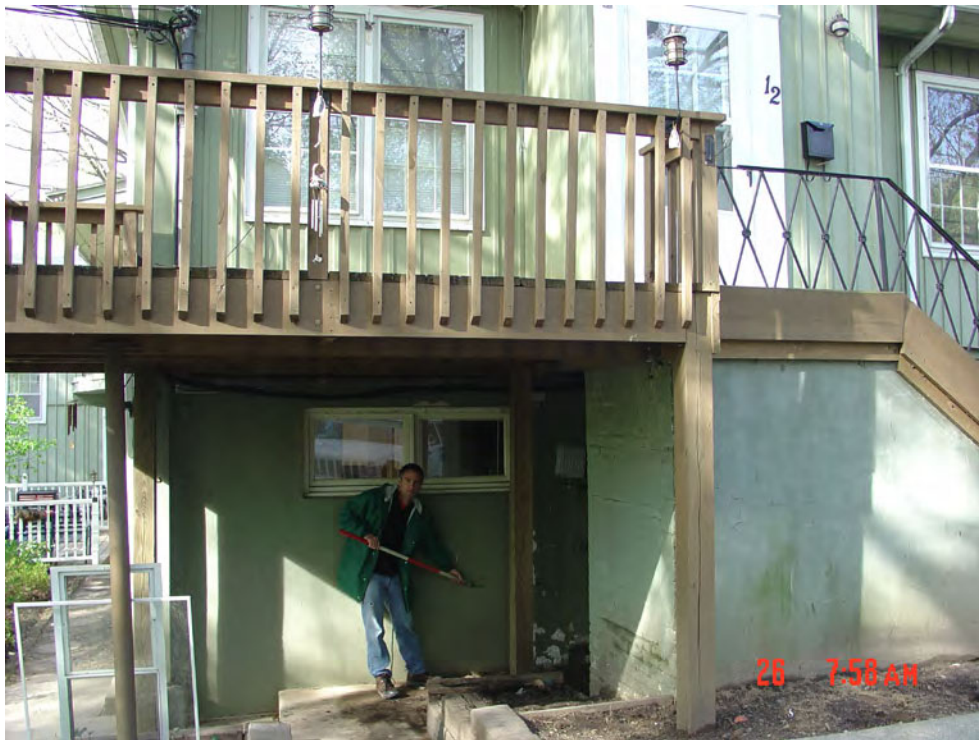
High-water mark PA 12.3 (lat 40° 42' 31.2", long 75° 11' 52.5"), at an elevation of 196.1 feet above NGVD 29, is a good seed line on a house on Boileau Avenue, 2.3 feet above the ground, 1.4 miles upstream from Lehigh River, and was marked with a black marker line.

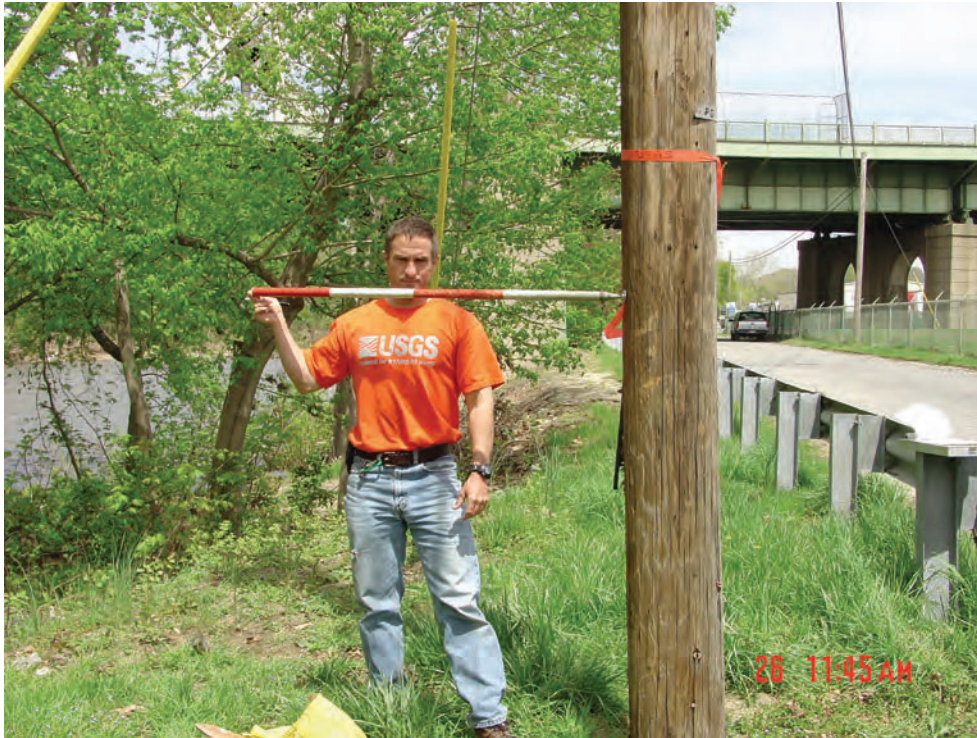
High-water mark NJ 11.1 (lat 40° 41' 38.3", long 75° 12' 09.8"), at an elevation of 192.6 feet above NGVD 29, is a good debris line on a utility pole, 4.8 feet above the ground, 183 feet downstream from US Route 22, and was marked with a metal USGS washer and nail.

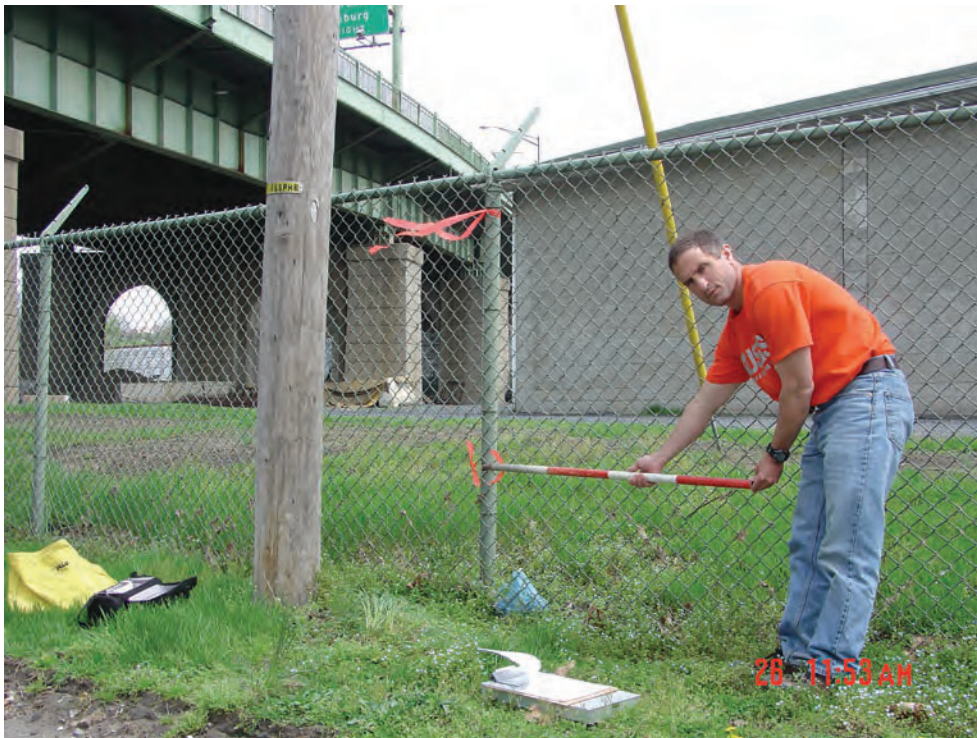
High-water mark NJ 11.2 (lat 40° 41' 39.6", long 75° 12' 09.9"), at an elevation of 192.4 feet above NGVD 29, is a fair debris line on a fence, 1.9 feet above the ground, 35 feet downstream from US Route 22, and was marked with a black marker line.

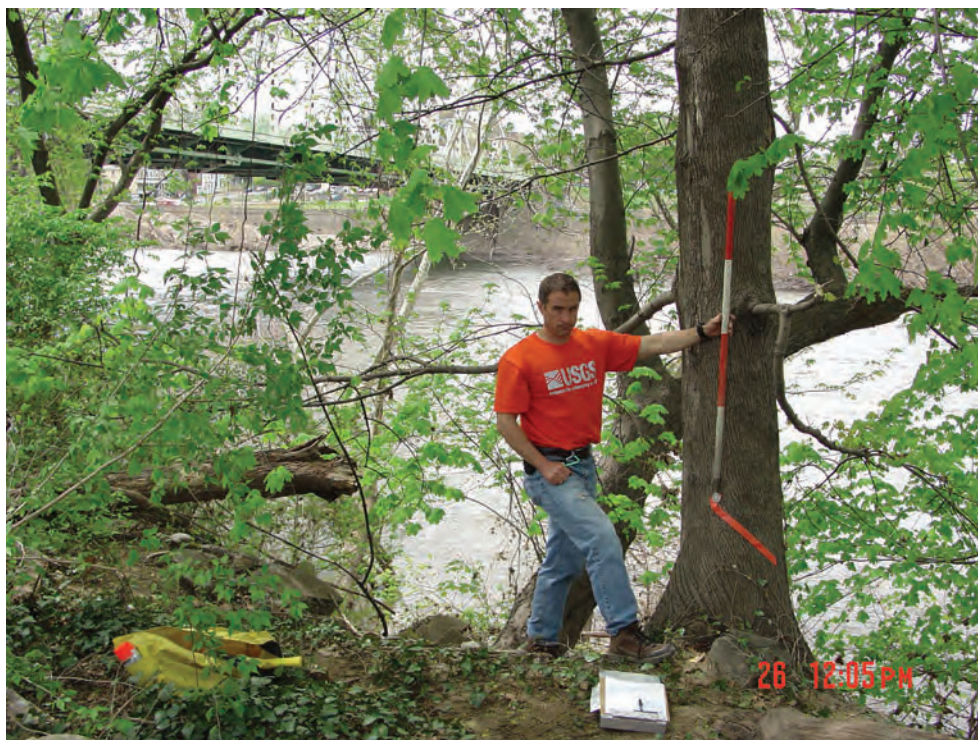
High-water mark NJ 11.3 (lat 40° 41' 42.7", long 75° 12' 08.4"), at an elevation of 192.2 feet above NGVD 29, is a poor seed line on a 1.5-foot diameter tree, 2 feet above the ground, 208 feet upstream from US Route 22, and was marked with a metal USGS washer and nail.

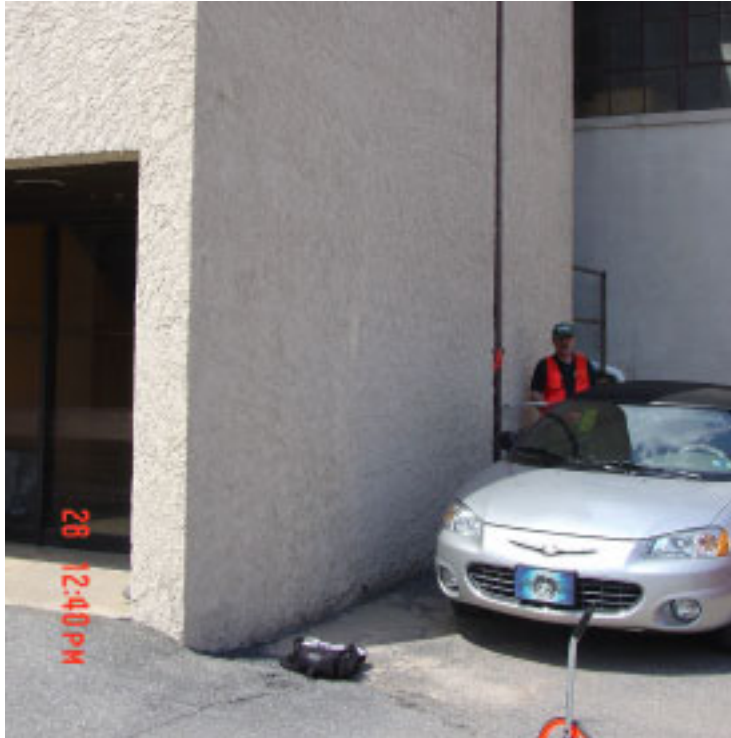
High-water mark PA 14.1 (lat 40° 41' 32.3", long 75° 12' 22.0"), at an elevation of 192.4 feet above NGVD 29, is a good mud line on the downspout of building on Larry Holmes Boulevard, 3.6 feet above the ground, 0.2 miles upstream from Lehigh River, and was marked with a black marker line.

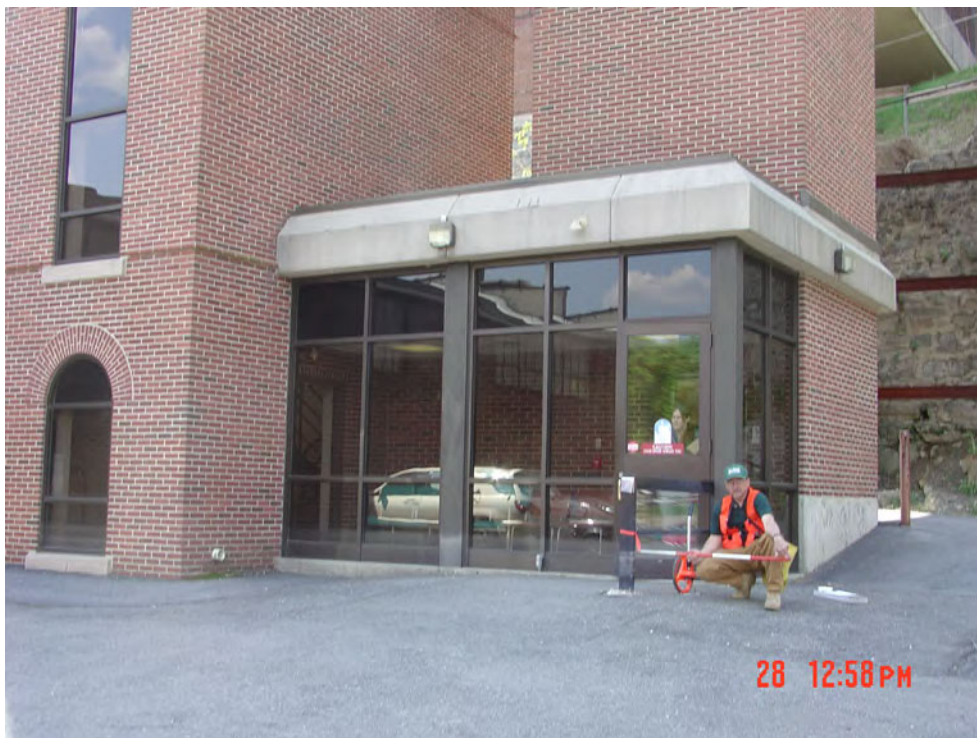
High-water mark PA 14.2 (lat 40° 41' 33.4", long 75° 12' 21.9"), at an elevation of 192.5 feet above NGVD 29, is an excellent mud line on a handrail of a building 1.1 feet above the ground, 0.2 miles upstream from Lehigh River, and was marked with a black marker line.

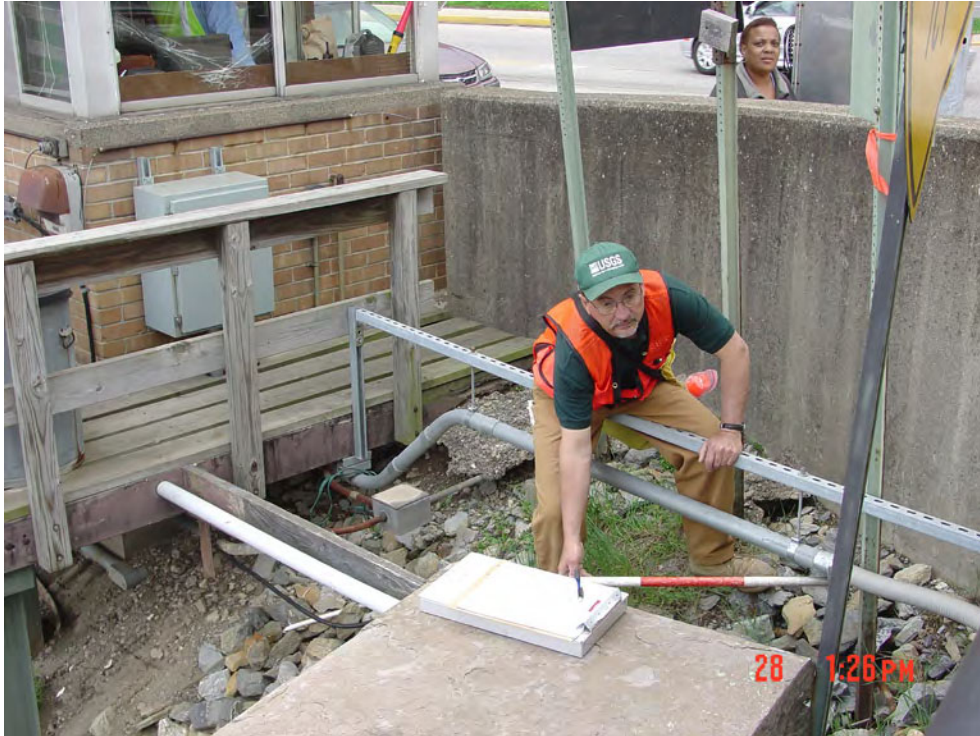
High-water mark PA 14.3 (lat 40° 41' 28.9", long 75° 12' 18.2"), at an elevation of 192.2 feet above NGVD 29, is a good mud line on a sign post by Southampton Street bridge guard house, 4.3 feet above the ground, 0.1 miles upstream from Lehigh River, and was marked with a black marker line.

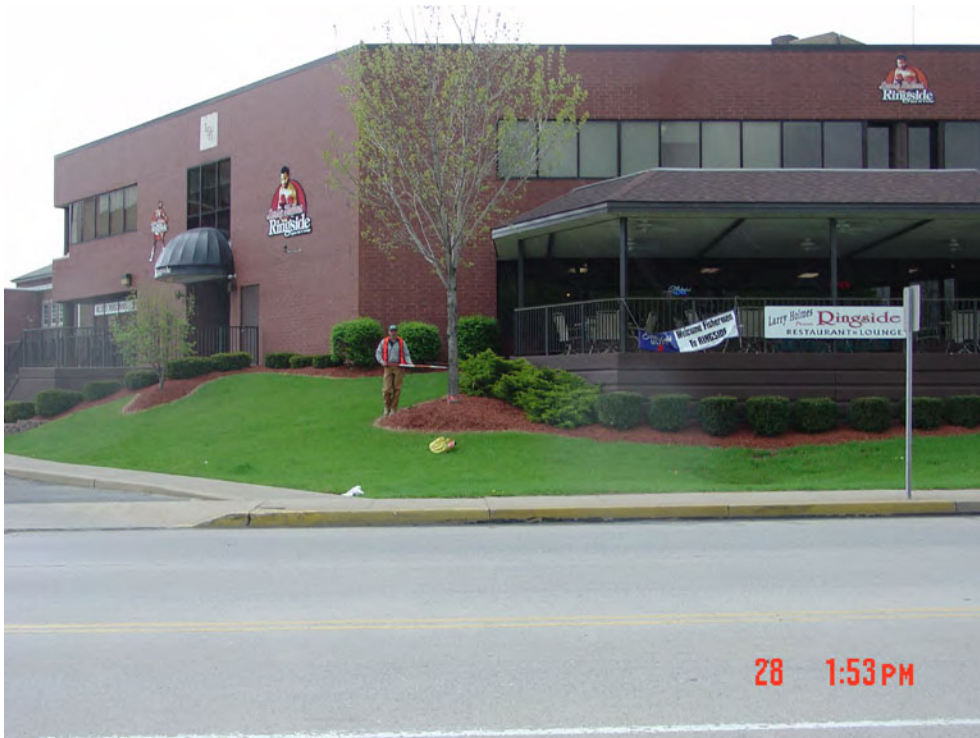
High-water mark PA 14.4 (lat 40° 41' 24.6", long 75° 12' 20.3"), at an elevation of 192.7 feet above NGVD 29, is a good debris line on a 7-inch diameter tree, 2.4 feet above the ground, 250 feet upstream from Lehigh River, and was marked with a black marker line.

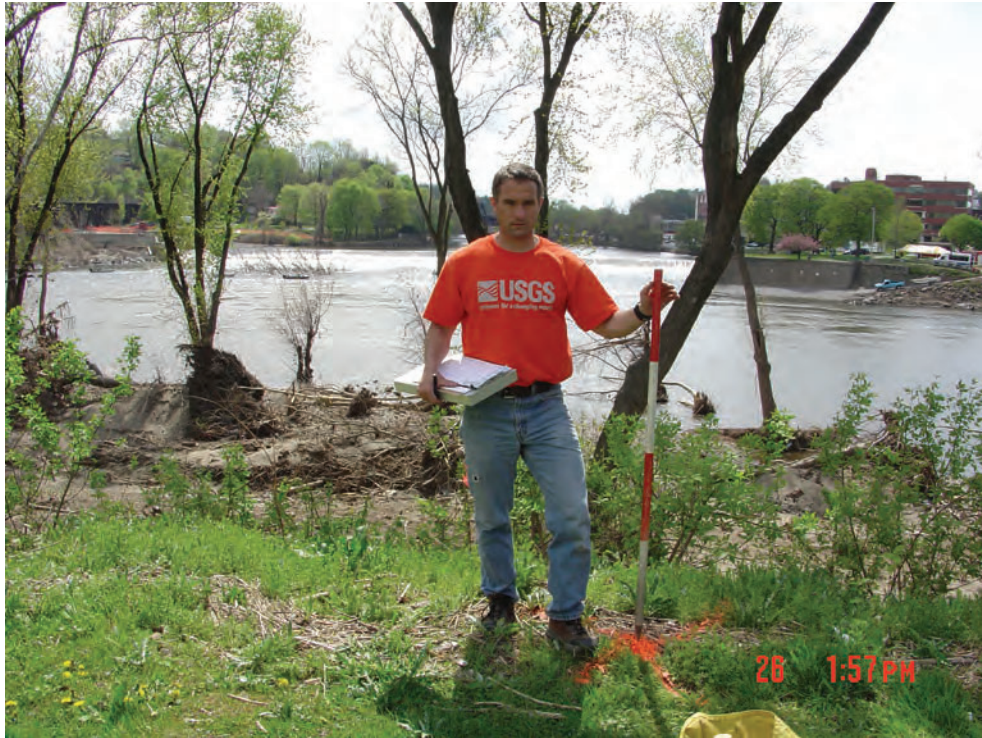
High-water mark NJ 12.1 (lat 40° 41' 25.5", long 75° 12' 09.2"), at an elevation of 191.2 feet above NGVD 29, is a good debris line on the ground, 390 feet downstream from Northampton Street bridge, and was marked with a metal rebar.

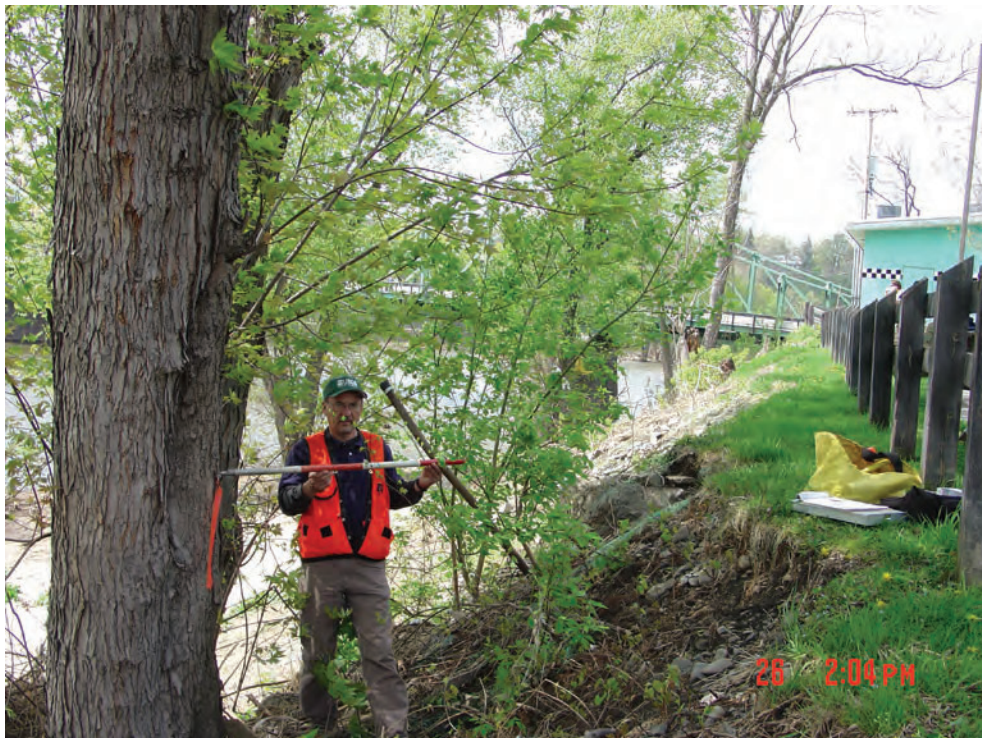
High-water mark NJ 12.2 (lat 40° 41' 26.2", long 75° 12' 09.9"), at an elevation of 191.4 feet above NGVD 29, is a fair seed line on a tree, 5.3 feet above the ground, 300 feet downstream from Northampton Street bridge, and was marked with a metal USGS washer and nail.

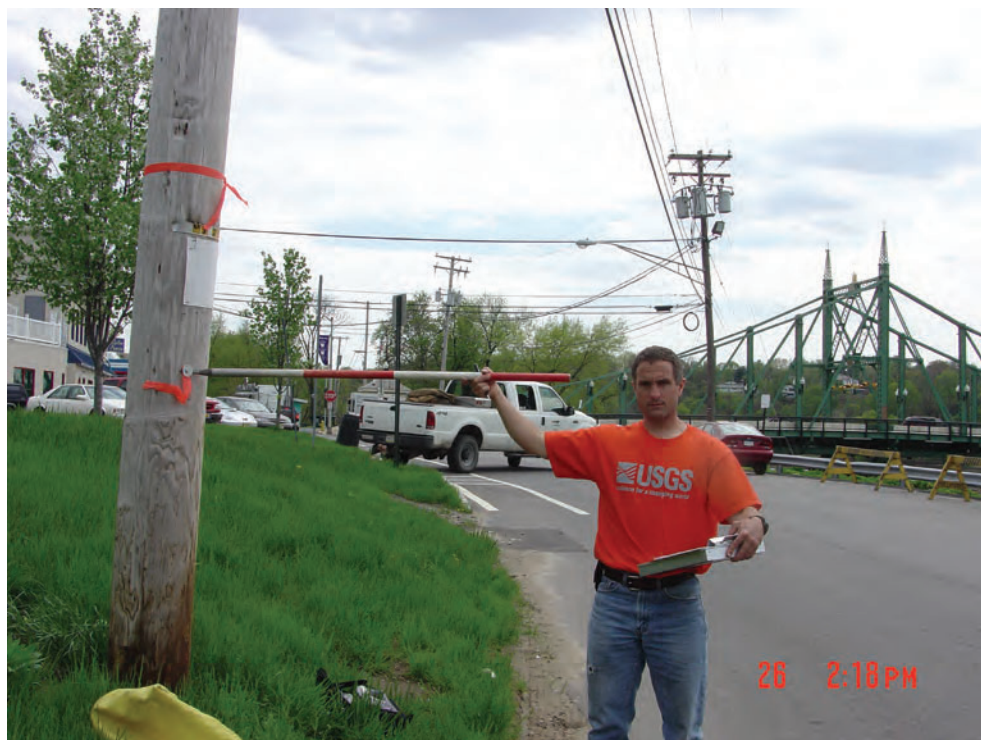
High-water mark NJ 12.3 (lat 40° 41' 32.7", long 75° 12' 10.6"), at an elevation of 191.2 feet above NGVD 29, is a fair debris line on a utility pole, 4.0 feet above the ground, 312 feet upstream from Northampton Street bridge, and was marked with a metal USGS washer and nail.

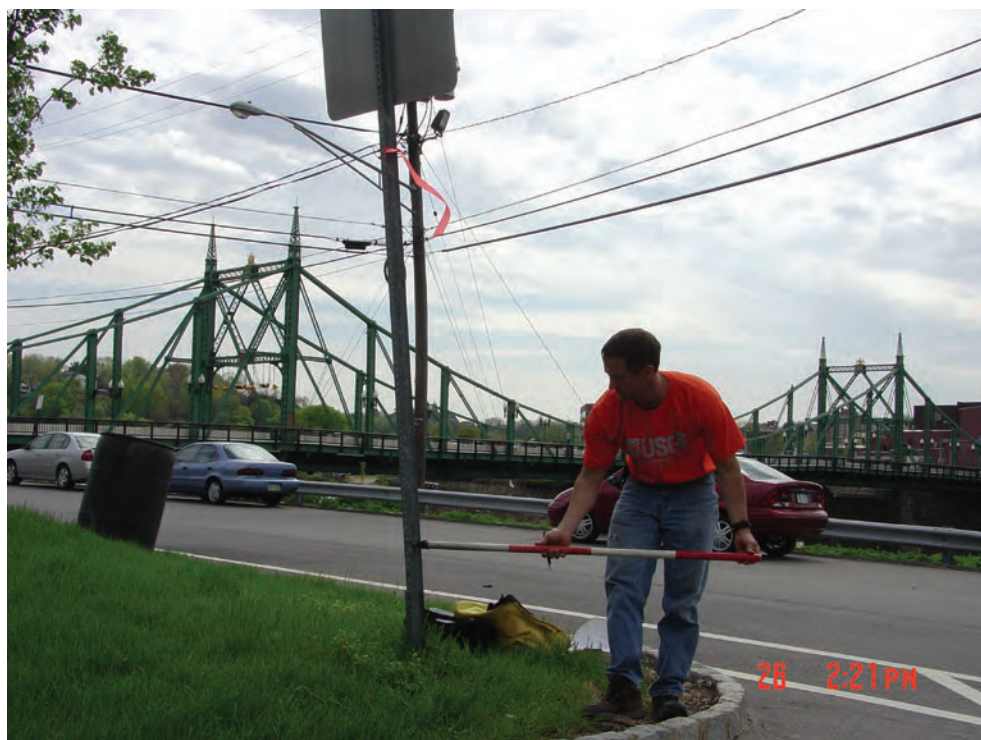
High-water mark NJ 12.4 (lat 40° 41' 32.1", long 75° 12' 10.1"), at an elevation of 191.2 feet above NGVD 29, is a fair debris line on a "DO NOT ENTER" sign post, 1.6 feet above the ground, 230 feet upstream from Northampton Street bridge, and was marked with a black marker line.

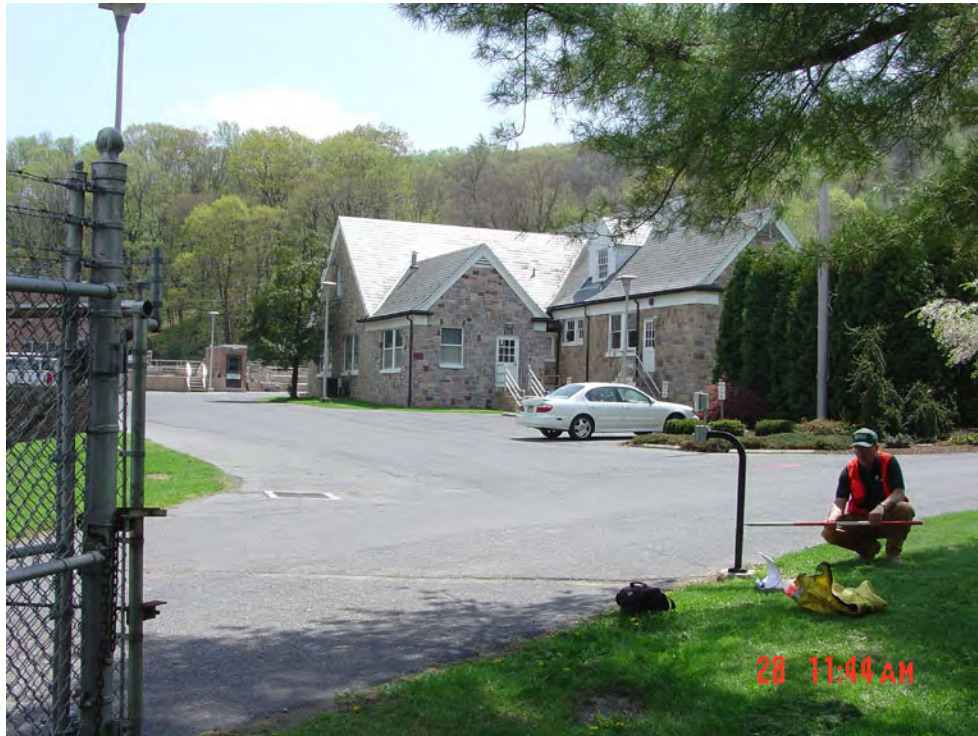
High-water mark PA 15.1 (lat 40° 40' 43.2", long 75° 11' 35.4"), at an elevation of 187.8 feet above NGVD 29, is a good mud line on the post for the gate exit control to Easton Area Joint Sewer Authority, 1.6 feet above the ground, 0.9 miles downstream from Lehigh River, and was marked with a black marker line.

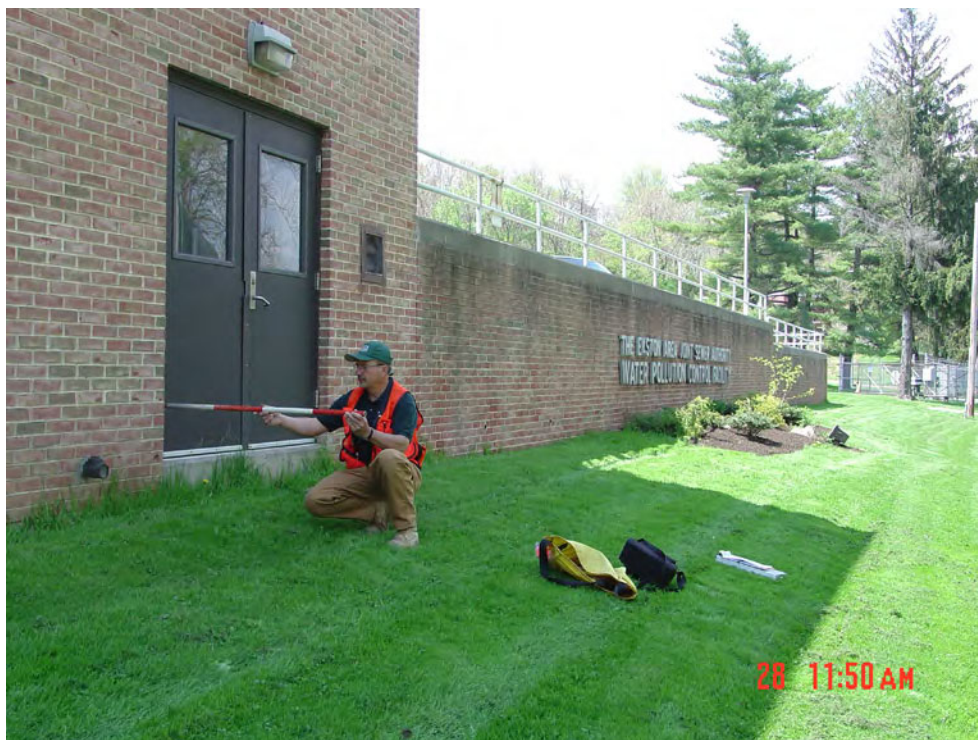
High-water mark PA 15.2 (lat 40° 40' 43.0", long 75° 11' 32.9"), at an elevation of 187.8 feet above NGVD 29, is a good mud line on a door of the Easton Area Joint Sewer Authority, 1.0 feet above the door threshold, 1.0 mile downstream from Lehigh River, and was marked with a black marker line.

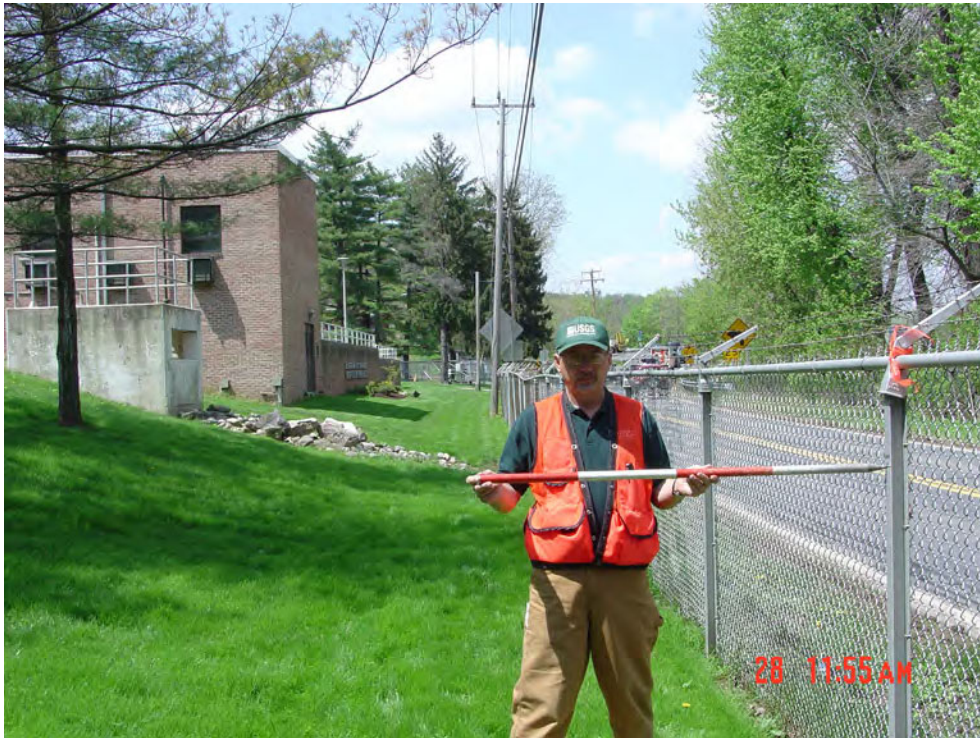
High-water mark PA 15.3 (lat 40° 41' 42.9", long 75° 11' 31.3"), at an elevation of 187.8 feet above NGVD 29, is a fair mud line on a fence post on PA State Route 611, 4.5 feet above the ground, 1.0 mile downstream from Lehigh River, and was marked with a black marker line.
