Flood of April 2-4, 2005, Delaware River Main Stem from Port Jervis, New York, to Cinnaminson, New Jersey

Scientific Investigations Report 2007-5067

**U.S. Department of the Interior
U.S. Geological Survey**

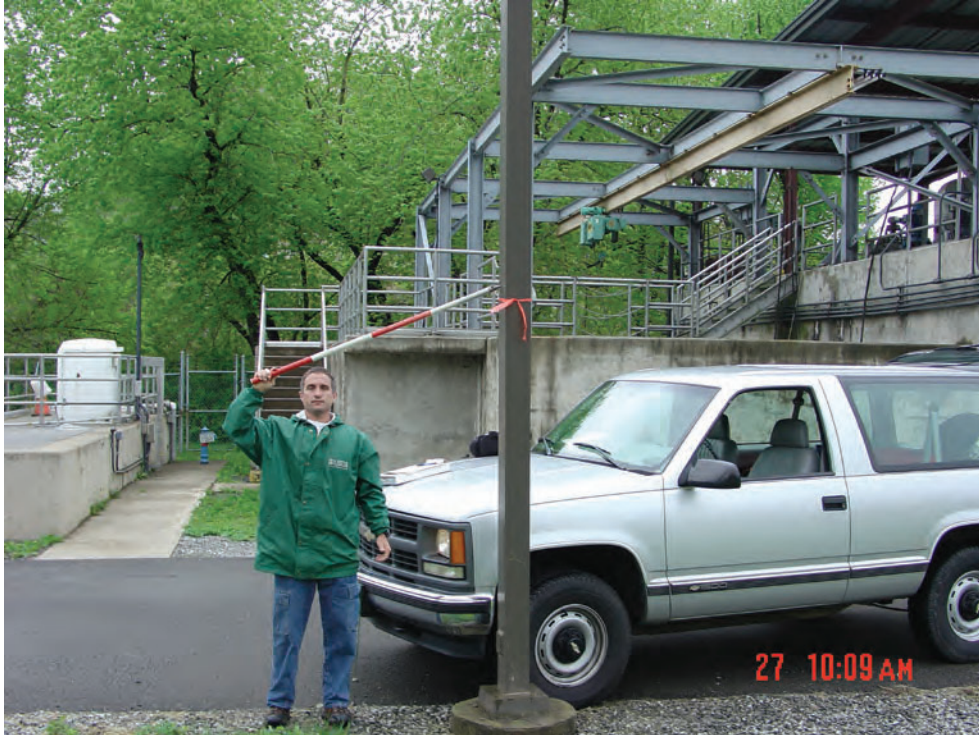
High-water mark NJ 13.1 (lat 40° 40' 50.2", long 75° 10' 39.4"), at an elevation of 185.7 feet above NGVD 29, is a fair mud line on a light pole in the Phillipsburg Wastewater Treatment Plant, and was marked with a black marker line.

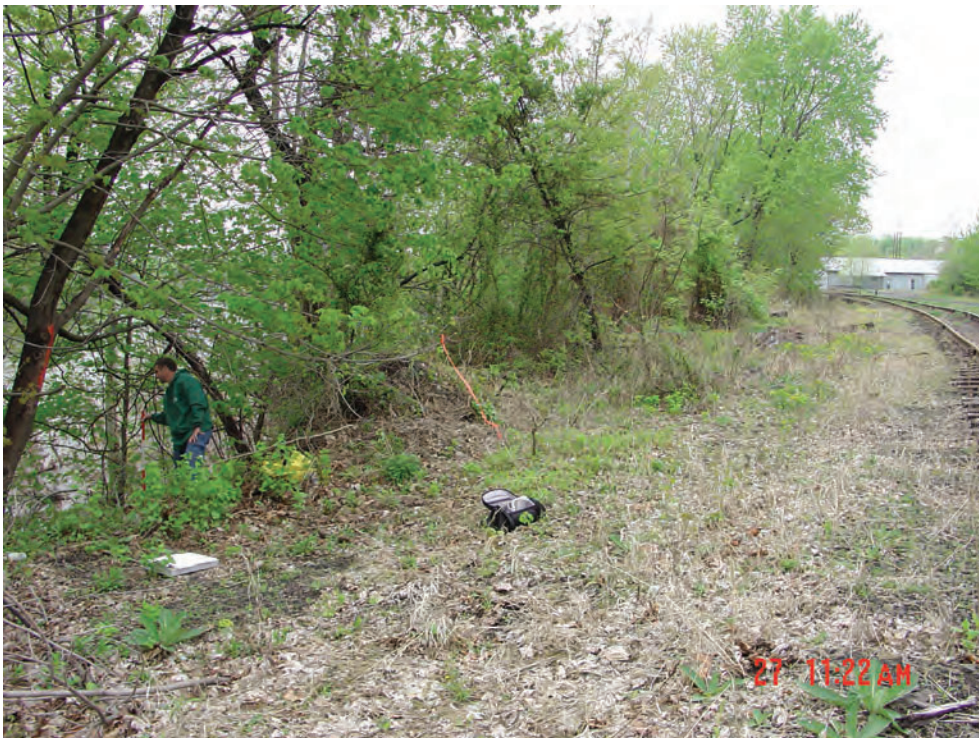
High-water mark NJ 13.3 (lat 40° 40' 43.9", long 75° 10' 39.3"), at an elevation of 186.2 feet above NGVD 29, is a poor debris line on the ground near top of bank, near the mouth of Lopatcong Creek, and was marked with a wooden stake.

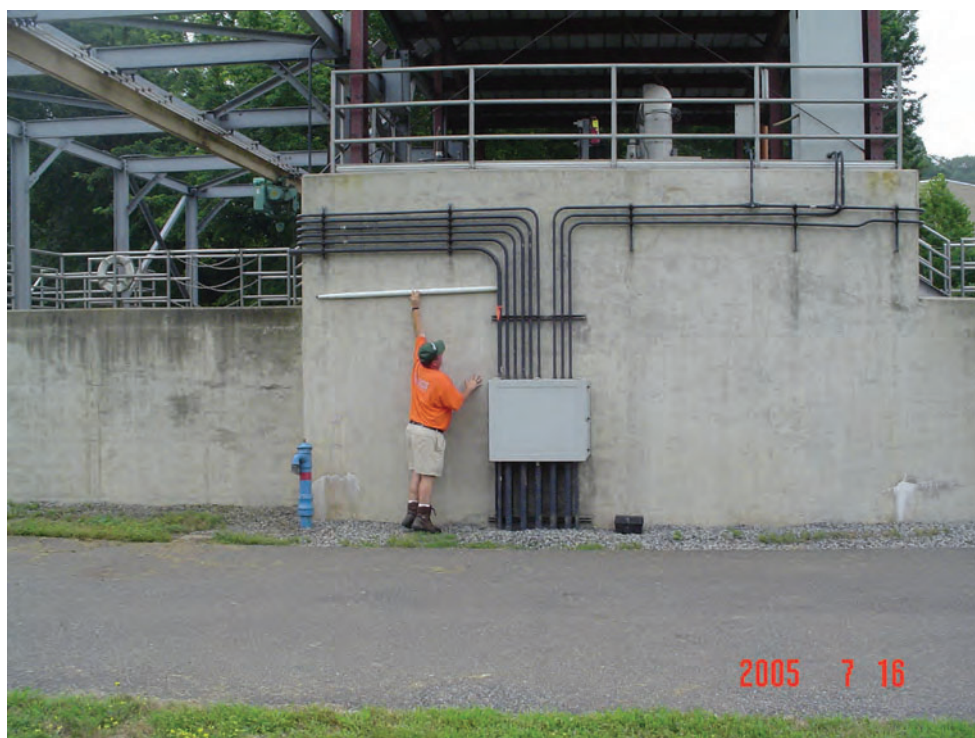
High-water mark NJ 13.4 (lat 40° 40' 50.0", long 75° 10' 39.0"), at an elevation of 186.2 feet above NGVD 29, is an unrated debris line on a wall in the Phillipsburg Wastewater Treatment Plant, 8 feet above the ground, and was marked with a black marker line.

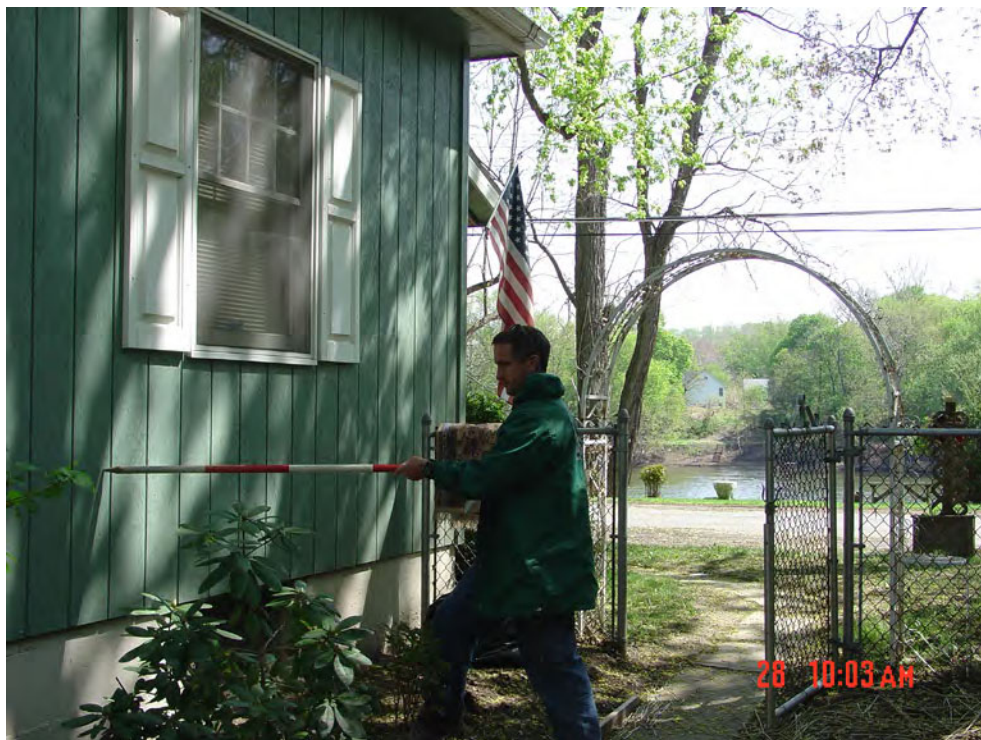
High-water mark PA 16.1 (lat 40° 38' 4.8", long 75° 11' 30.4"), at an elevation of 171.4 feet above NGVD 29, is an excellent seed line on a house on Canal Road, 3.8 feet above the ground, 1.6 miles upstream from Frya Run, and was marked with a pencil line.

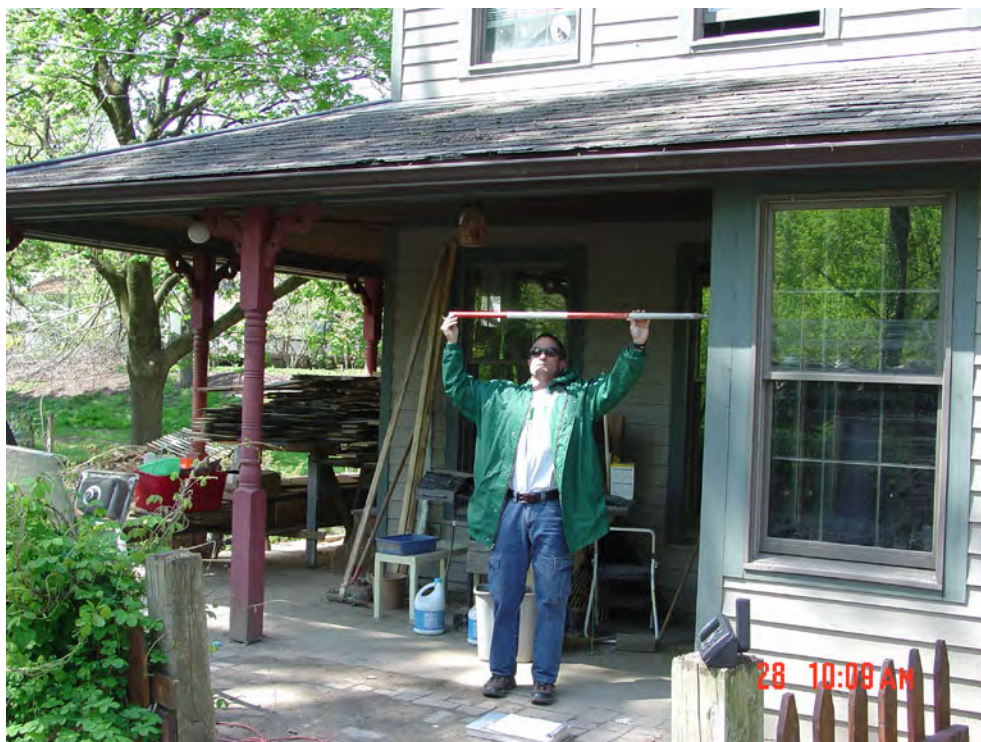
High-water mark PA 16.2 (lat 40° 38' 2.3", long 75° 11' 30.4"), at an elevation of 171.1 feet above NGVD 29, is an excellent mud line on a house on Canal Road, 6.0 feet above the ground, 1.6 miles upstream from Frya Run, and was marked with a pencil line.

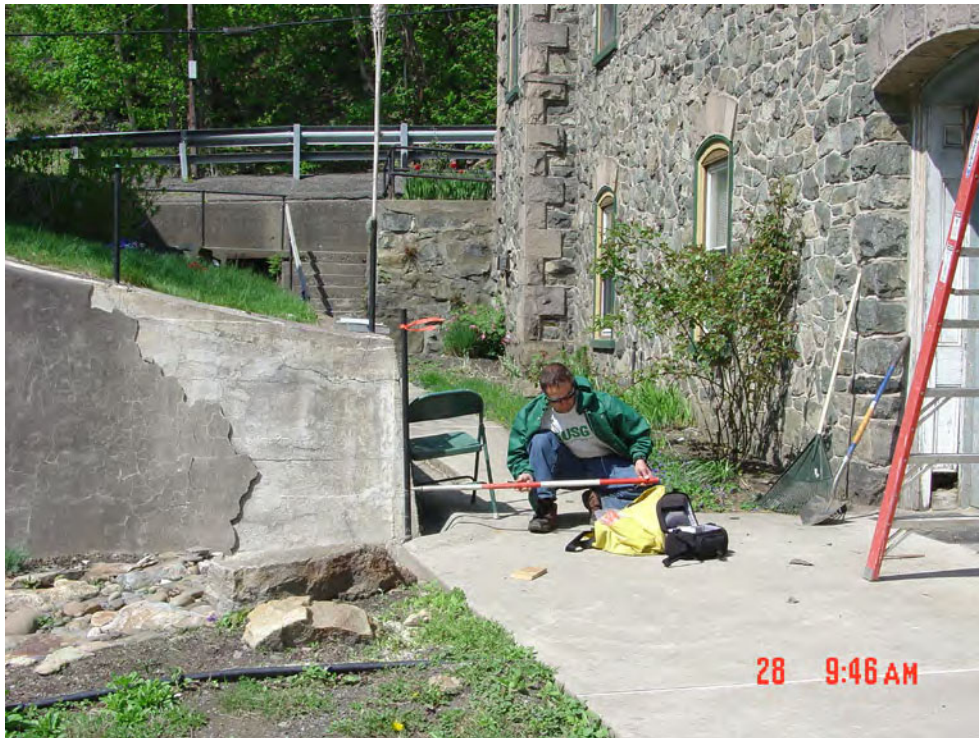
High-water mark PA 16.3 (lat 40° 38' 18.4", long 75° 11' 39.9"), at an elevation of 172.8 feet above NGVD 29, is a good mud line on a metal post next to a church on PA State Route 611, 0.9 feet above the ground, 2.0 miles upstream from Frya Run, and was marked with a black marker line.

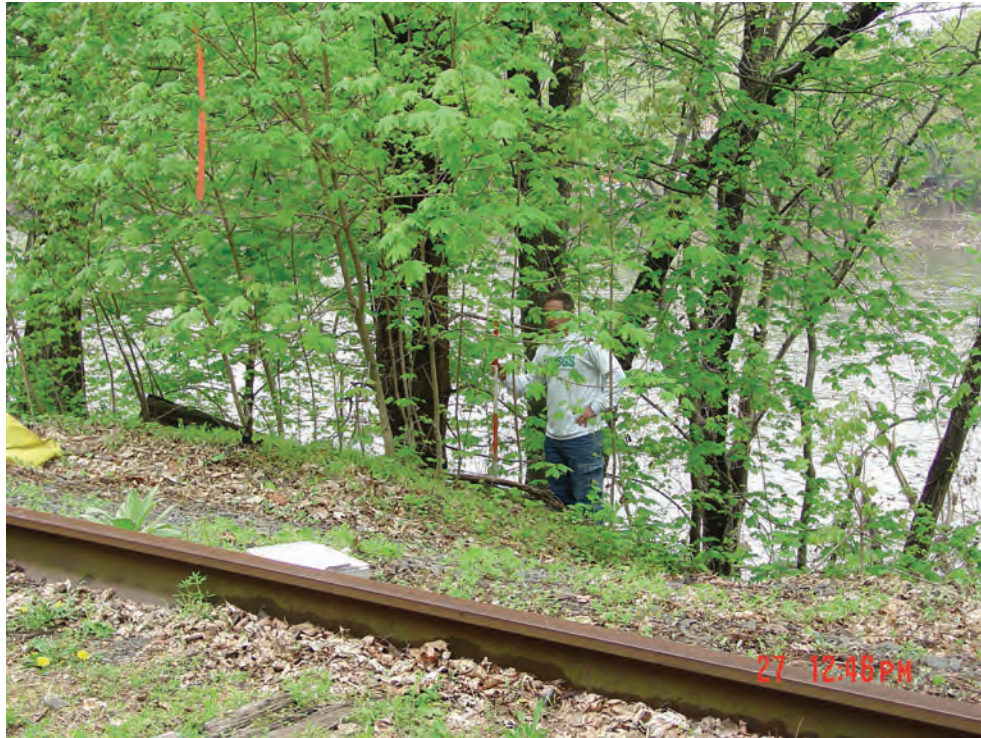
High-water mark NJ 14.1 (lat 40° 37' 59.9", long 75° 11' 20.2"), at an elevation of 171.0 feet above NGVD 29, is a fair debris line on the ground, 980 feet downstream from the intersection of Snyders Road and River Road, and was marked with a wooden stake.

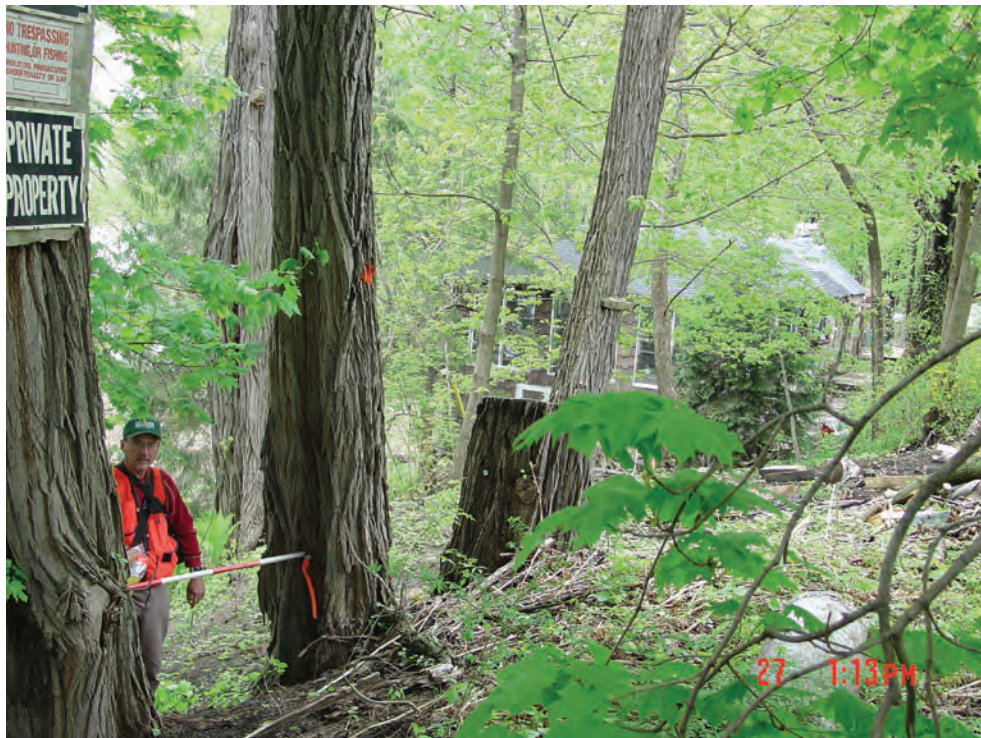
High-water mark NJ 14.2 (lat 40° 38' 09.2", long 75° 11' 21.4"), at an elevation of 172.1 feet above NGVD 29, is a good seed line on a 2-foot diameter tree, 2.2 feet above the ground, near the intersection of Snyders Road and River Road, and was marked with a metal USGS washer and nail.

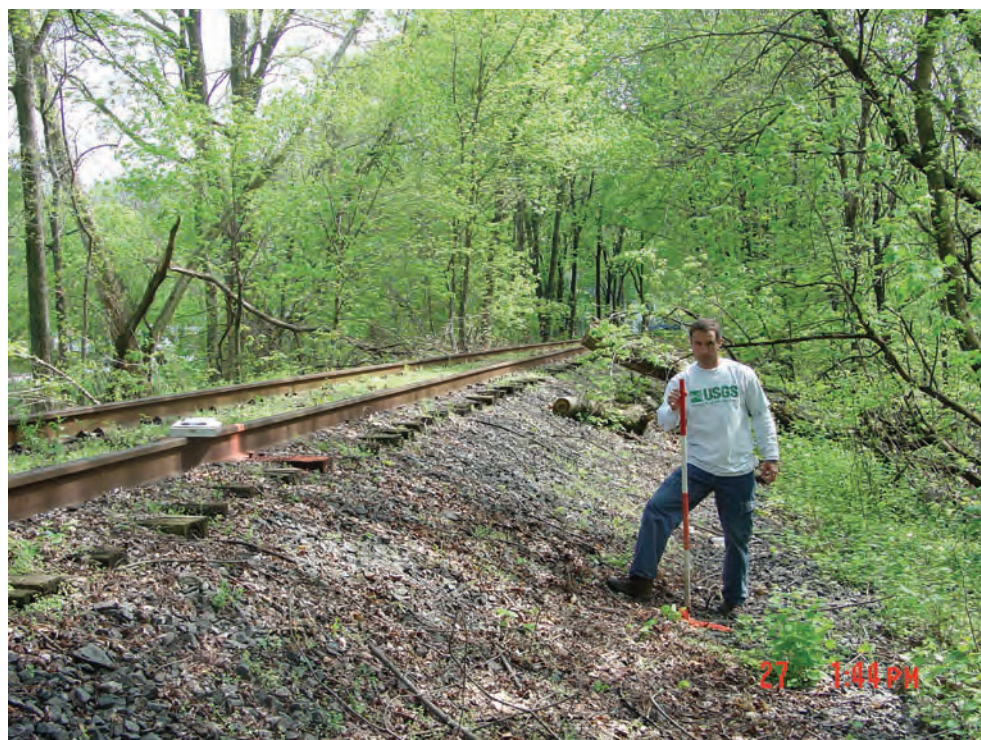
High-water mark NJ 14.3 (lat 40° 38' 14.7", long 75° 11' 22.3"), at an elevation of 172.4 feet above NGVD 29, is a debris line on the bank next to the railroad tracks, 490 feet upstream from the intersection of Snyders Road and River Road, and was marked with a metal rebar.

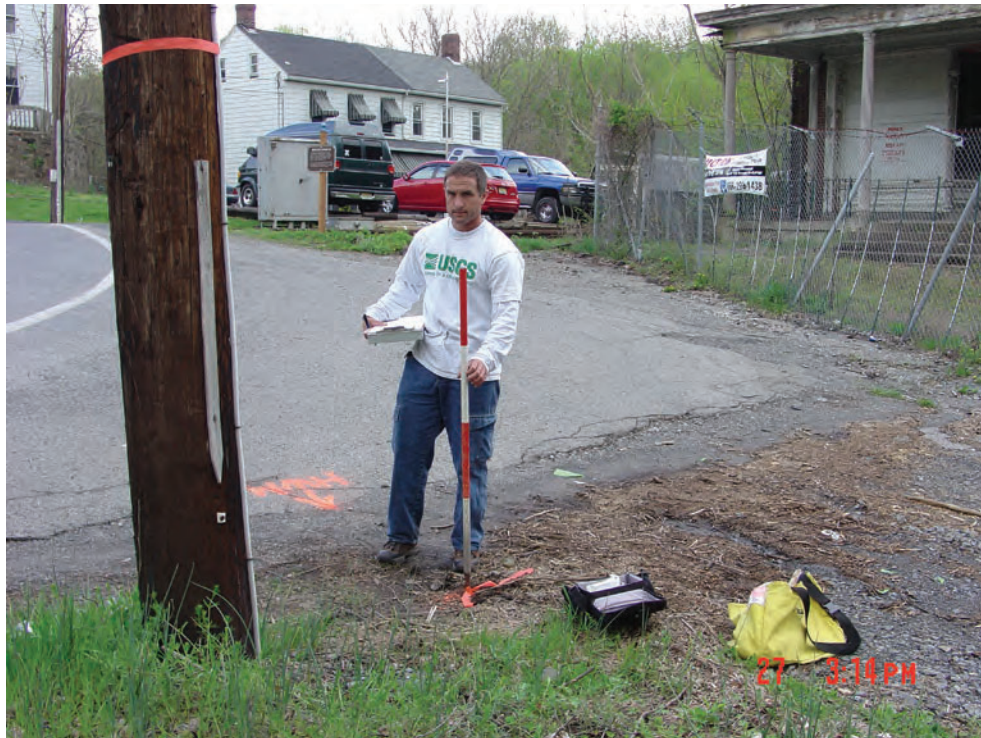
High-water mark NJ 15.1 (lat 40° 35' 37.3", long 75° 11' 20.1"), at an elevation of 160.5 feet above NGVD 29, is a good debris line on the ground, 300 feet downstream from the Riegelsville bridge, and was marked with a metal rebar.

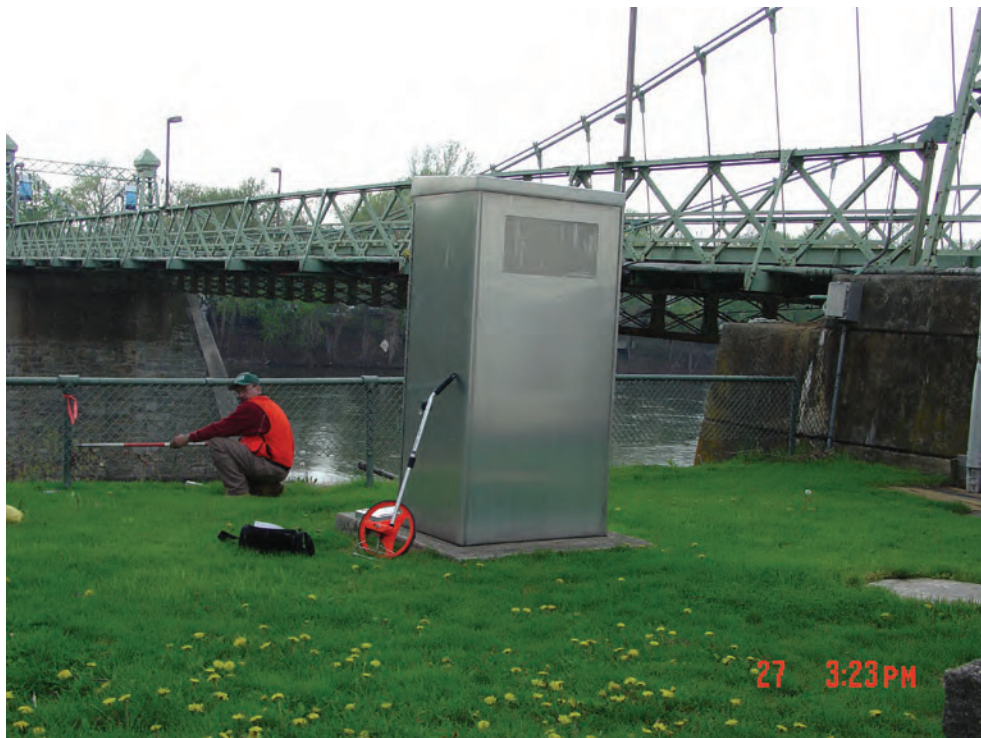
High-water mark NJ 15.2 (lat 40° 35' 39.9", long 75° 11' 23.0"), at an elevation of 158.7 feet above NGVD 29, is a good debris line on a chain link fence, 1.2 feet above the ground, near the Delaware River Joint Toll Bridge Commission guard house at the Riegelsville bridge, and was marked with a black marker line.

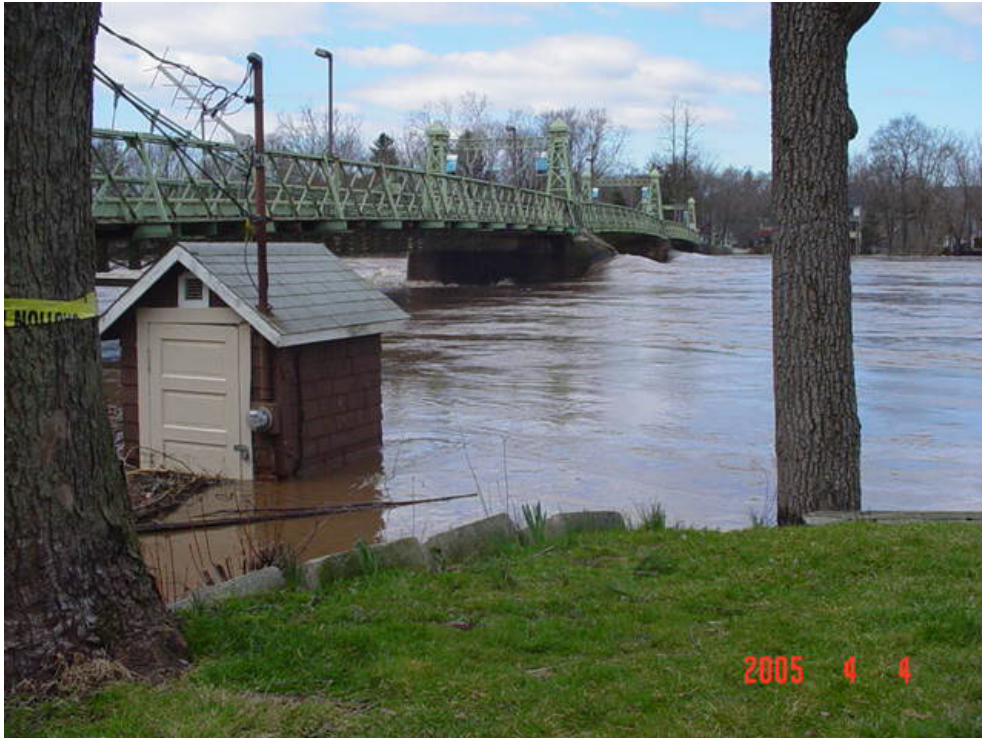
High-water mark NJ 15.3 (lat 40° 35' 41", long 75° 11' 24"), at an elevation of 159.1 feet above NGVD 29, is an excellent debris line on the door of the USGS stream gage house at the Riegelsville bridge, and was marked with a black marker line.

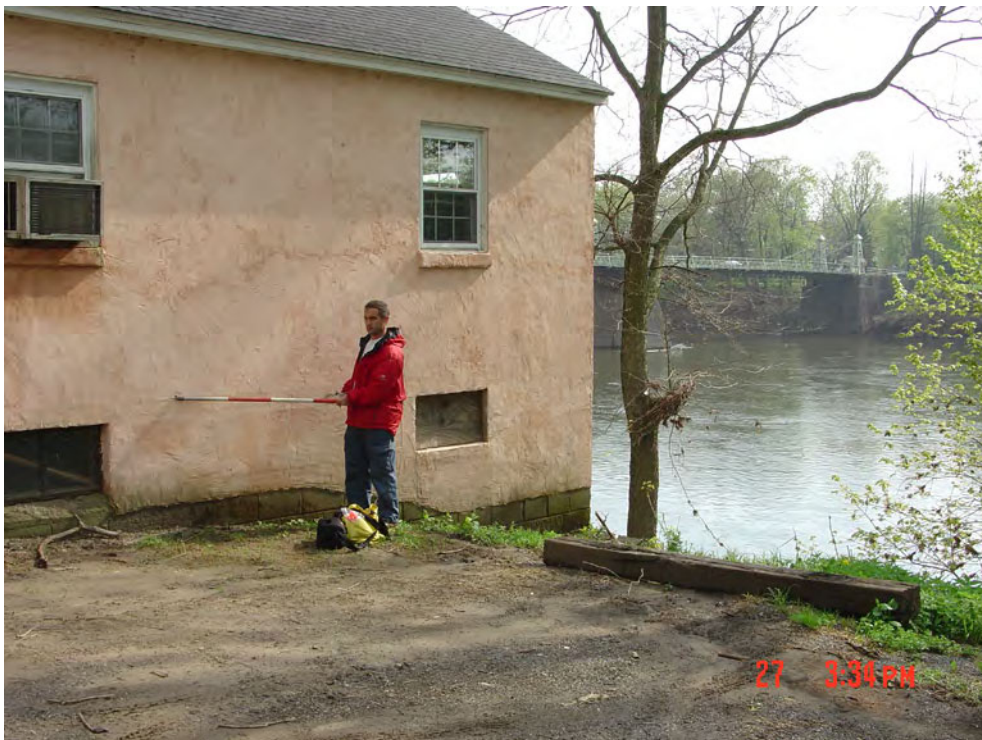
High-water mark NJ 15.4 (lat 40° 35' 43.5", long 75° 11' 24.2"), at an elevation of 159.4 feet above NGVD 29, is an excellent mud line on a house, 3 feet above the ground, 310 feet upstream from the Riegelsville bridge, and was marked with a black marker line.

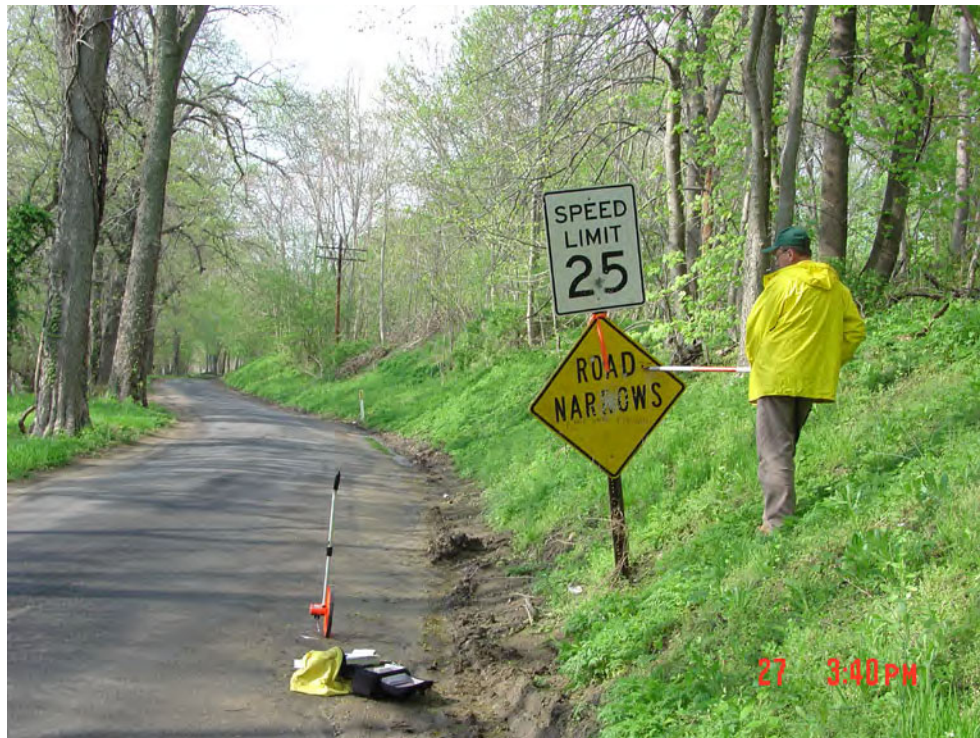
High-water mark NJ 15.5 (lat 40° 35' 45.7", long 75° 11' 24.8"), at an elevation of 156.7 feet above NGVD 29, is an excellent mud line on a "ROAD NARROWS" sign, 4.6 feet above the ground, 560 feet upstream from the Riegelsville bridge, and was marked with a black marker line.

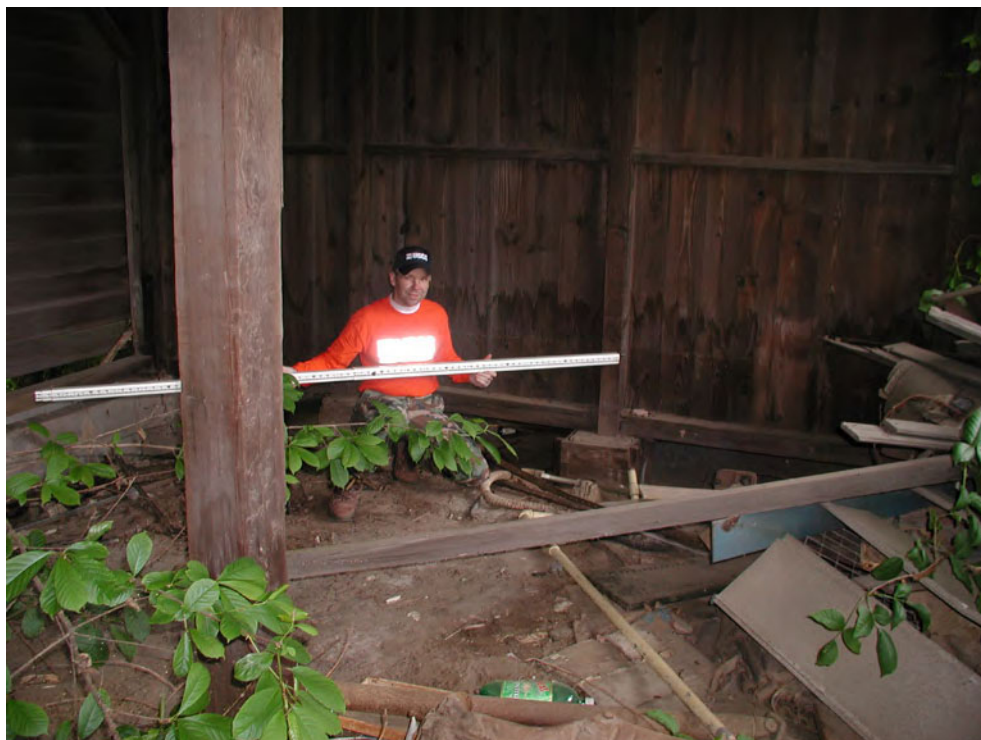
High-water mark NJ 16.1 (lat 40° 33' 59.3", long 75° 05' 48.1"), at an elevation of 134.4 feet above NGVD 29, is a good seed line inside a wooden stable, 300 feet downstream from the Bridge Street bridge, and was marked with a metal USGS washer and nail.

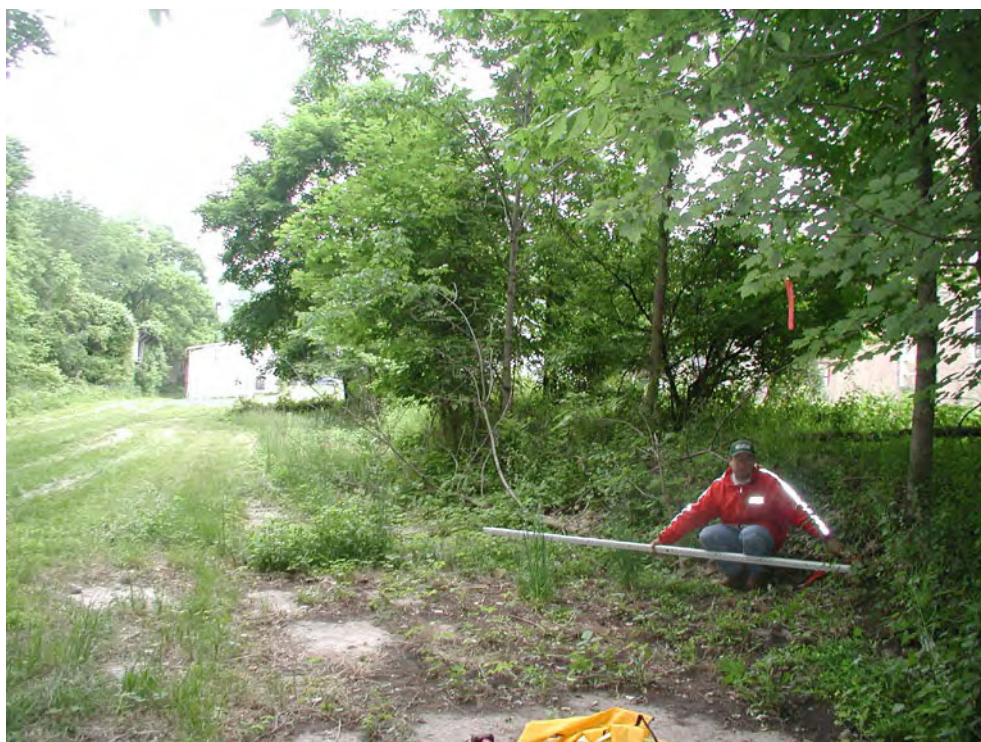
High-water mark NJ 16.2 (lat 40° 33' 58.1", long 75° 05' 45.8"), at an elevation of 134.4 feet above NGVD 29, is a good debris line on the ground, 547 feet downstream from the Bridge Street bridge, and was marked with a metal rebar.

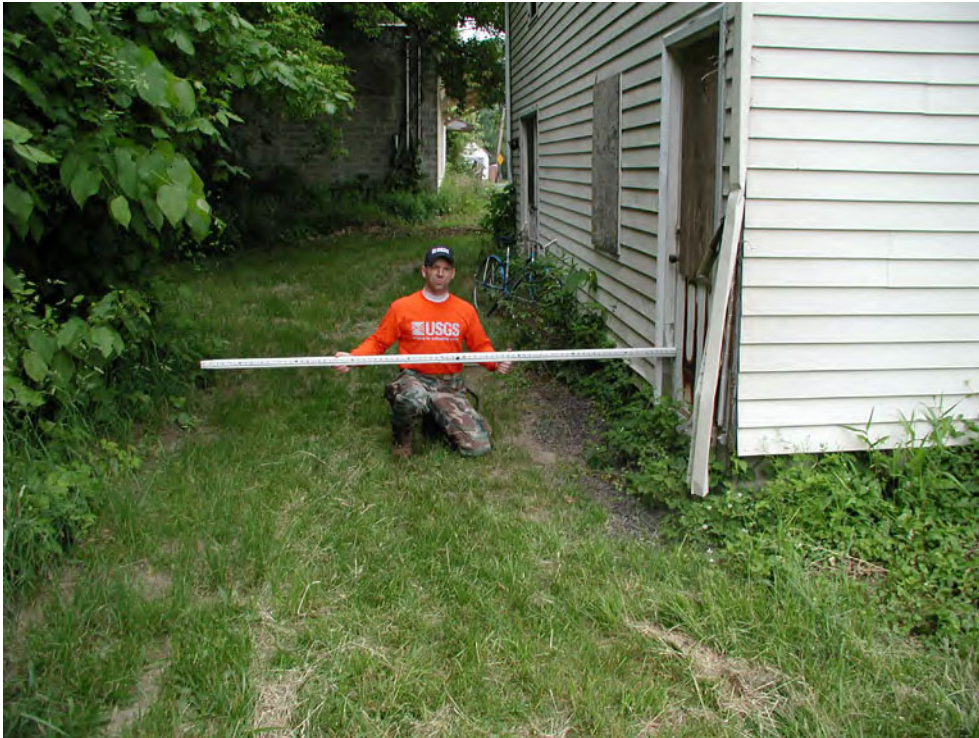
High-water mark NJ 16.3 (lat 40° 33' 59.8", long 75° 05' 48.4"), at an elevation of 134.5 feet above NGVD 29, is an excellent mud line on the door of a house, 2.0 feet above the ground, 290 feet downstream from the Bridge Street bridge, and was marked with a black marker line.

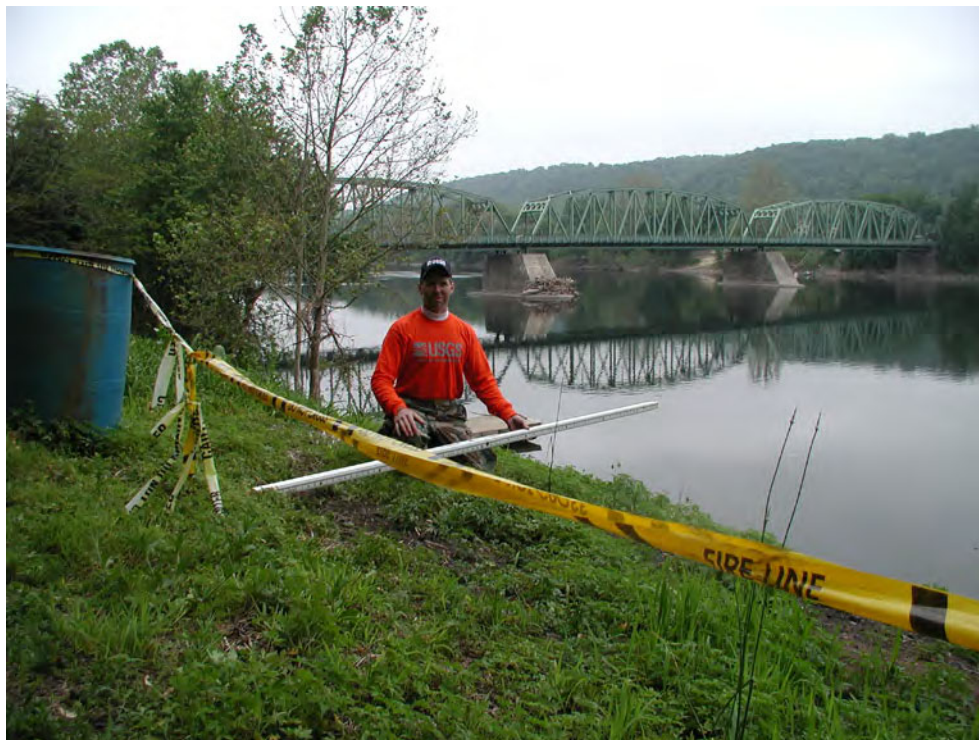
High-water mark NJ 16.4 (lat 40° 34' 05.1", long 75° 05' 54.9"), at an elevation of 135.5 feet above NGVD 29, is a good debris line at top of bank, 428 feet upstream from the Bridge Street bridge, and was marked with a wooden stake with a metal USGS washer and nail in the top of the stake.

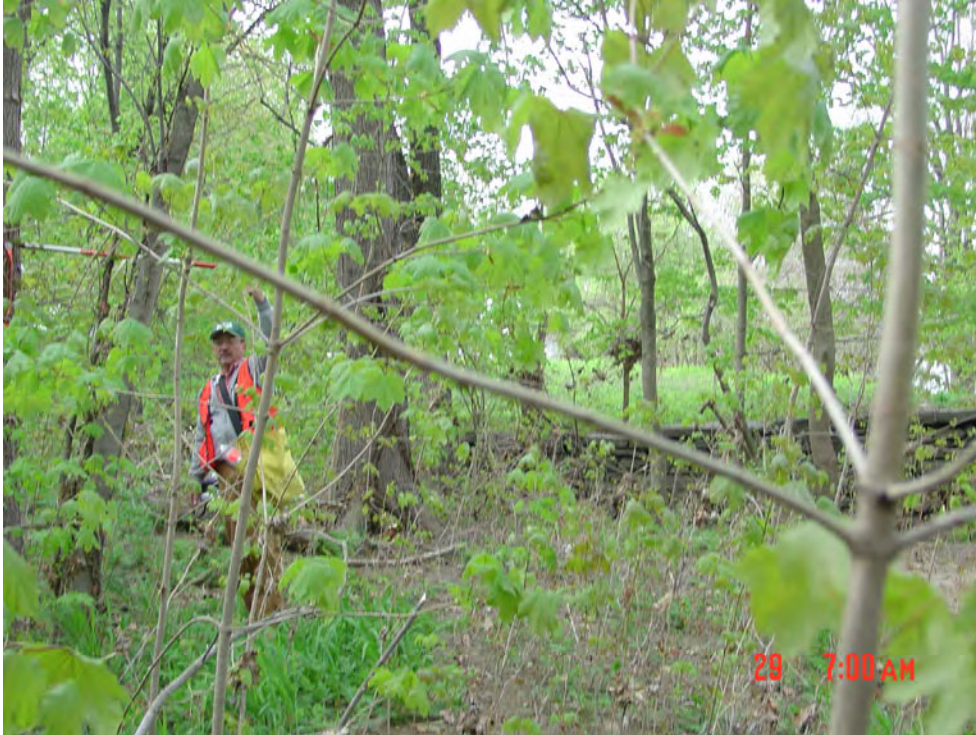
High-water mark NJ 17.1 (lat 40° 31' 38.1", long 75° 03' 48.3"), at an elevation of 123.6 feet above NGVD 29, is a fair seed line on a tree, 7 feet above the ground, 340 feet upstream from the Bridge Street bridge, and was marked with a metal USGS washer and nail.

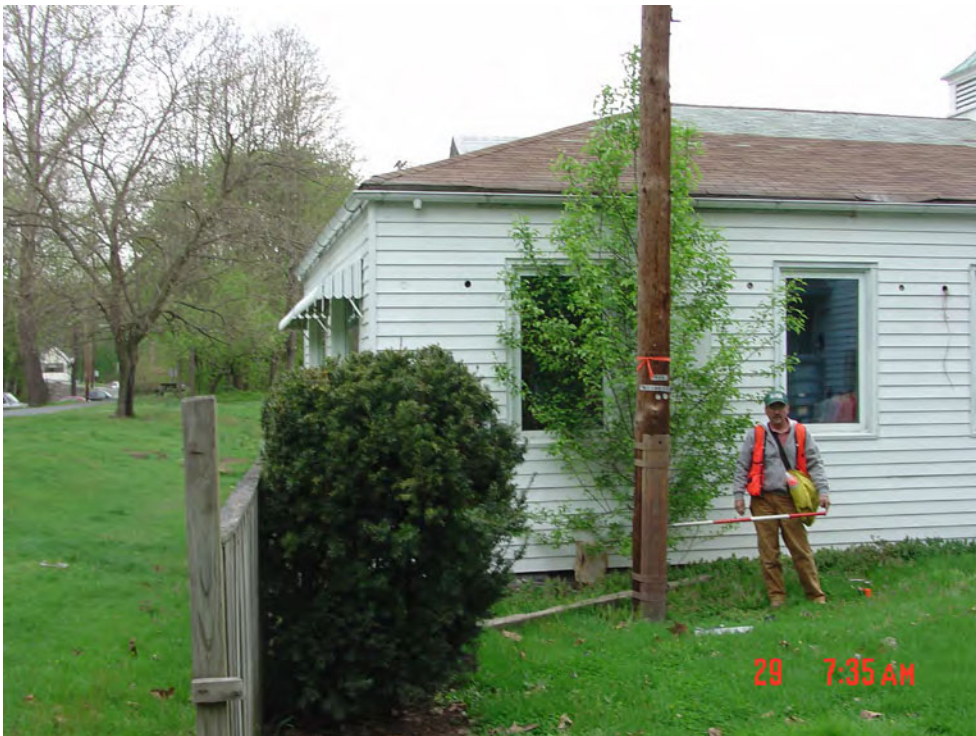
High-water mark NJ 17.2 (lat 40° 31' 29.4", long 75° 03' 46.1"), at an elevation of 123.3 feet above NGVD 29, is a fair seed line on a utility pole, 2.6 feet above the ground, 527 feet downstream from the Bridge Street bridge, and was marked with a metal rebar.

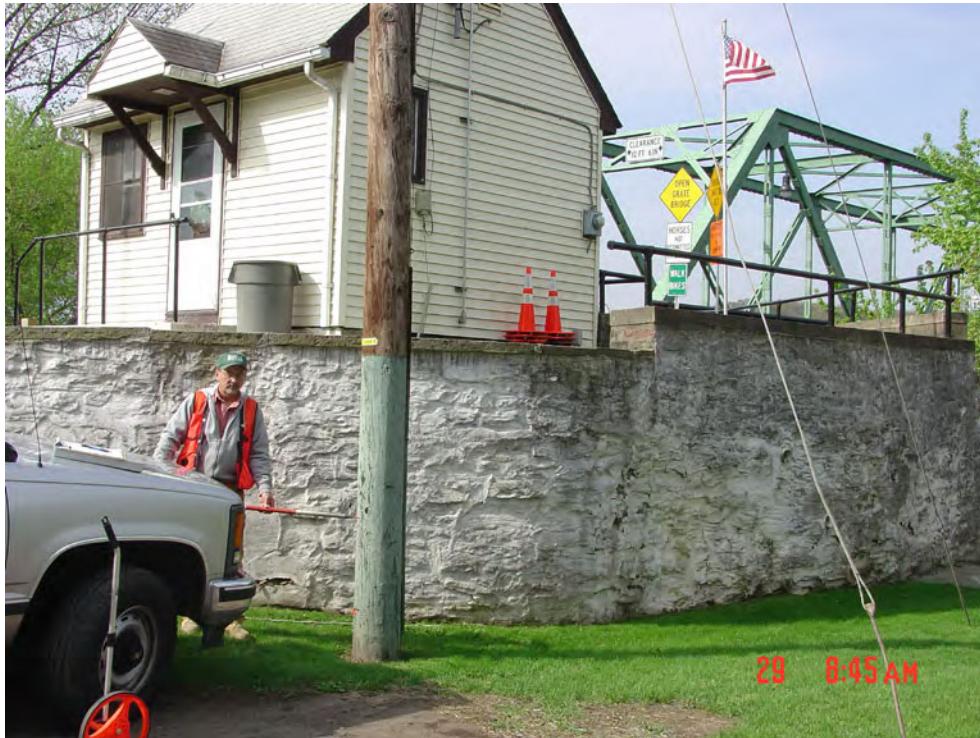
High-water mark NJ 17.3 (lat 40° 31' 35.3", long 75° 03' 47.5"), at an elevation of 123.5 feet above NGVD 29, is a nail with flagging set in a utility pole by unknown party, quality of high-water mark is unknown, 3.0 feet above the ground, several feet upstream from the Bridge Street bridge.

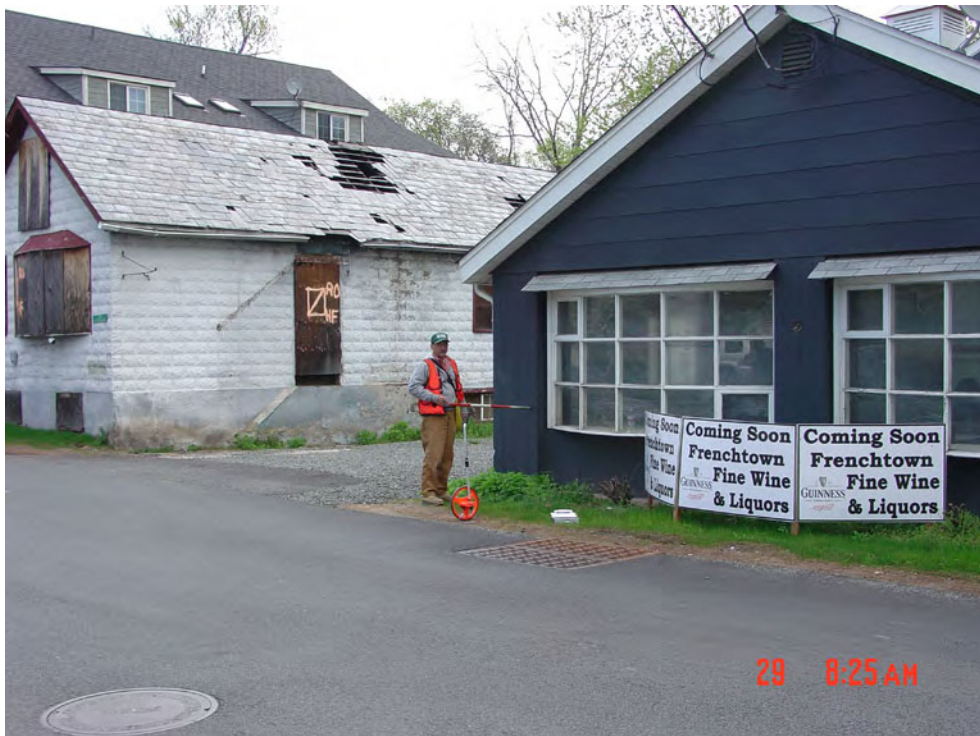
High-water mark NJ 17.4 (lat 40° 31' 31.3", long 75° 03' 40.0"), at an elevation of 123.2 feet above NGVD 29, is an excellent mud line on a building (Front Street Liquor Store), 3.1 feet above the ground, 375 feet downstream from the Bridge Street bridge, and was marked with a black marker line.

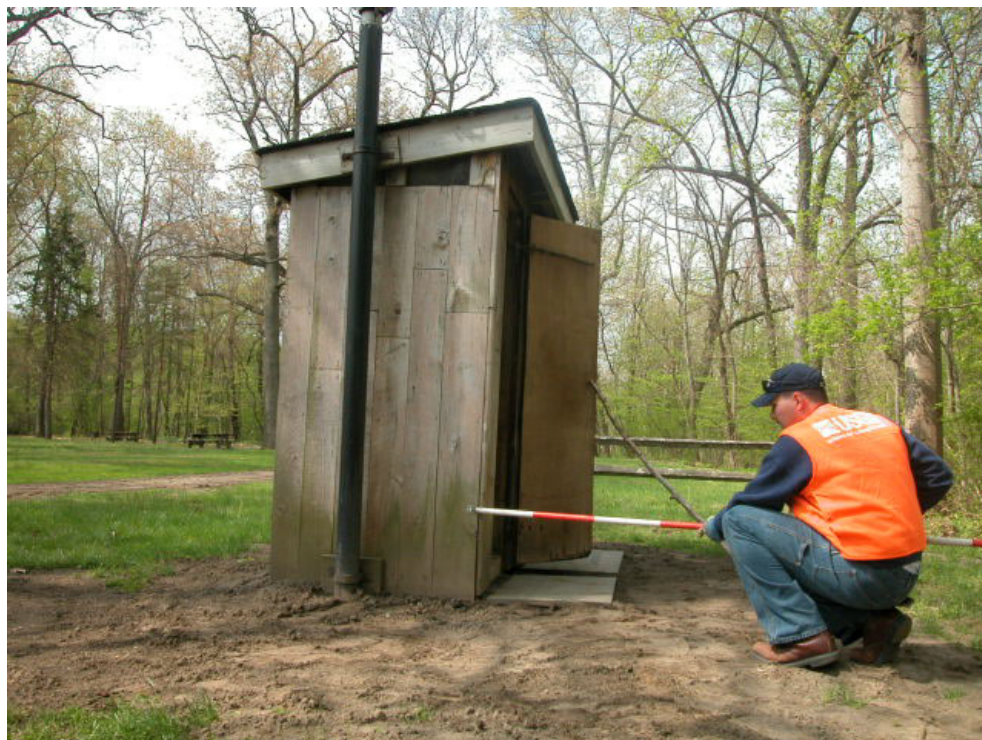
High-water mark NJ 18.1 (lat 40° 24' 36.1", long 75° 02' 14.0"), at an elevation of 95.84 feet above NGVD 29, is a good mud line on an outhouse at the Bulls Island Recreation Area, about 1.5 feet above the ground, 490 feet upstream from Quarry Road, and was marked with a metal USGS washer and nail.

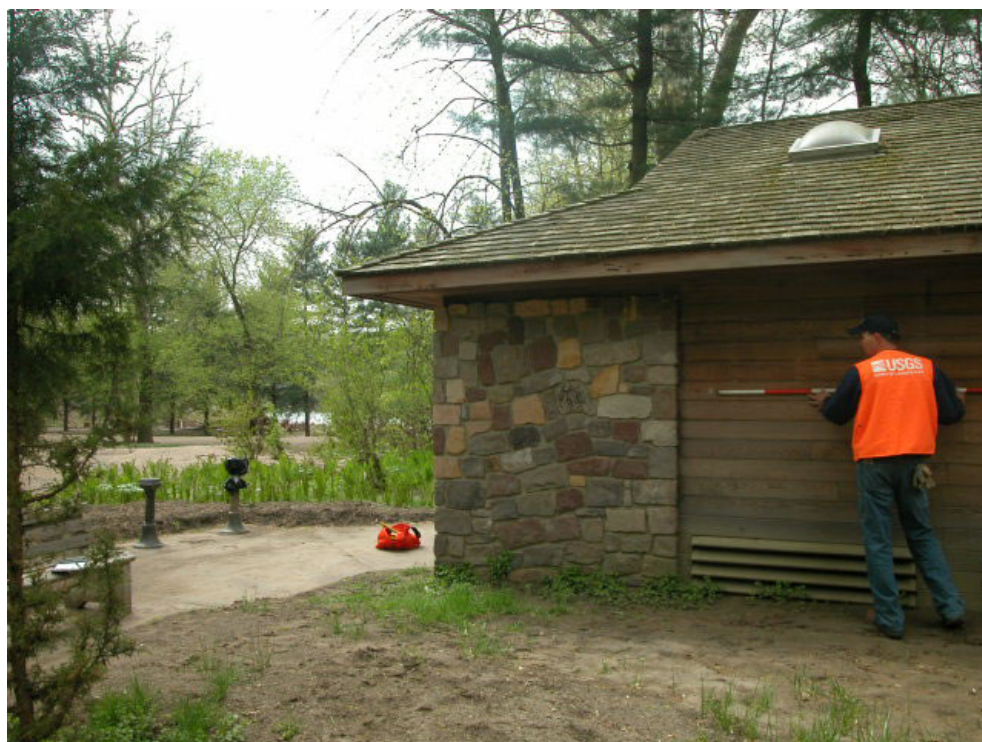
High-water mark NJ 18.2 (lat 40° 24' 50.4", long 75° 02' 33.4"), at an elevation of 96.8 feet above NGVD 29, is a good seed line on a comfort station on Bulls Island, 4.5 feet above the ground, 2,500 feet upstream from Quarry Road, and was marked with a metal USGS washer and nail.

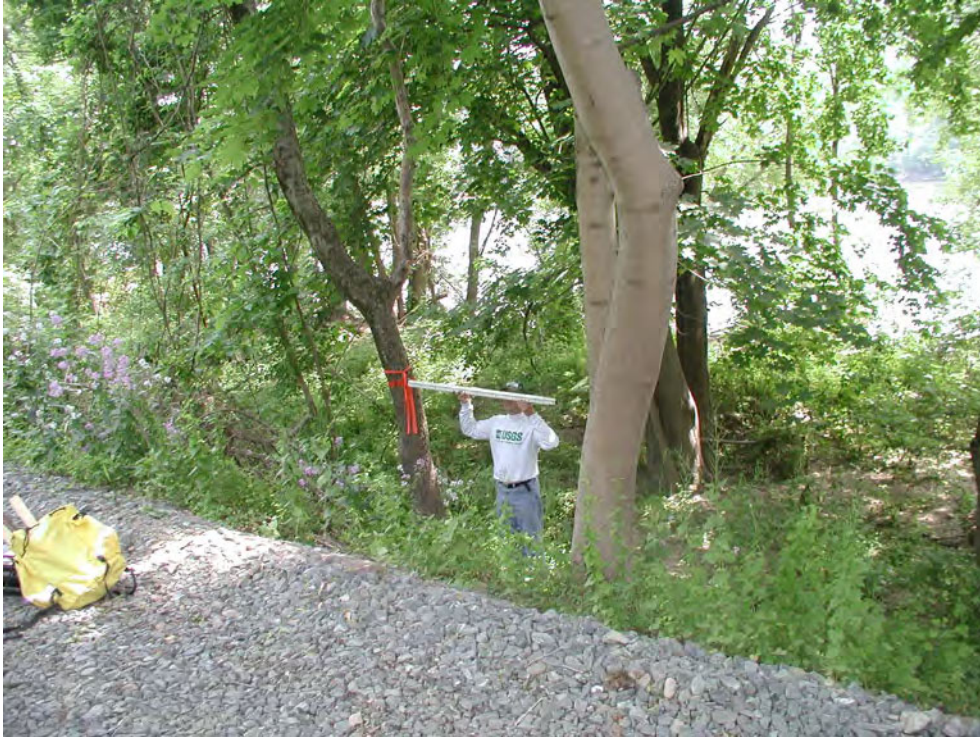
High-water mark NJ 19.1 for the Delaware River (lat 40° 24' 17.3", long 74° 58' 48.7"), at an elevation of 80.2 feet above NGVD 29, is a fair wash line on a 1-foot diameter tree on the streamward side of the canal path, 5.6 feet above the ground, 478 feet upstream from the Bridge Street bridge, and was marked with a metal USGS washer and nail.

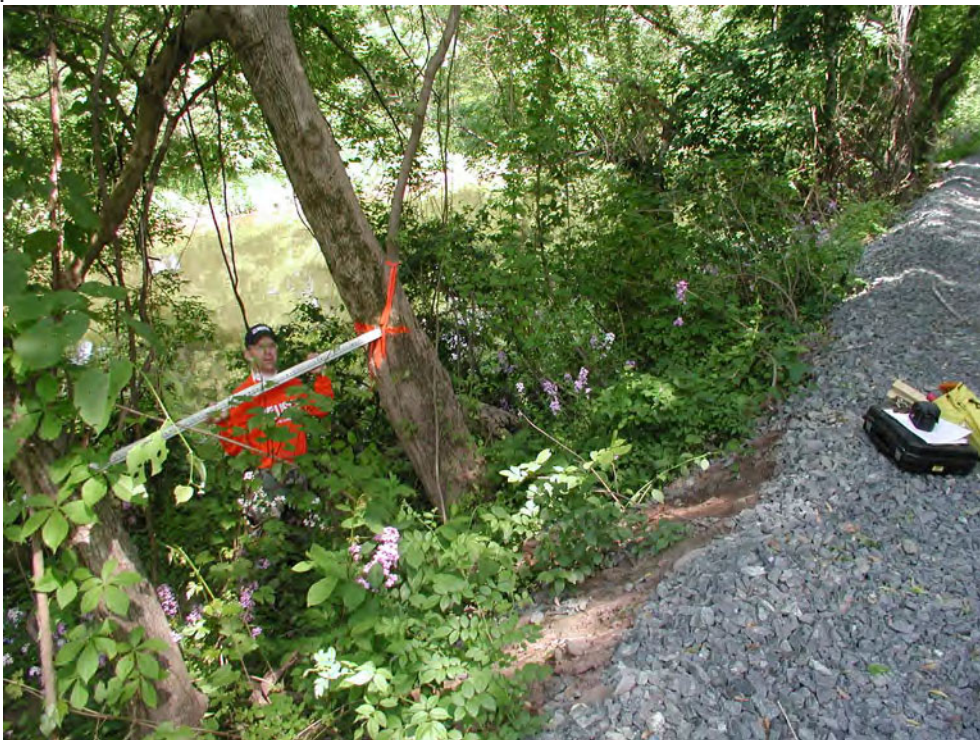
High-water mark NJ 19.2 for the Delaware and Raritan Canal (lat 40° 24' 17.1", long 74° 58' 49.6"), at an elevation of 79.5 feet above NGVD 29, is a good mud line on a 1.2-foot diameter tree, 5.1 feet above the ground, 579 feet upstream from the Bridge Street bridge, and was marked with a metal USGS washer and nail.

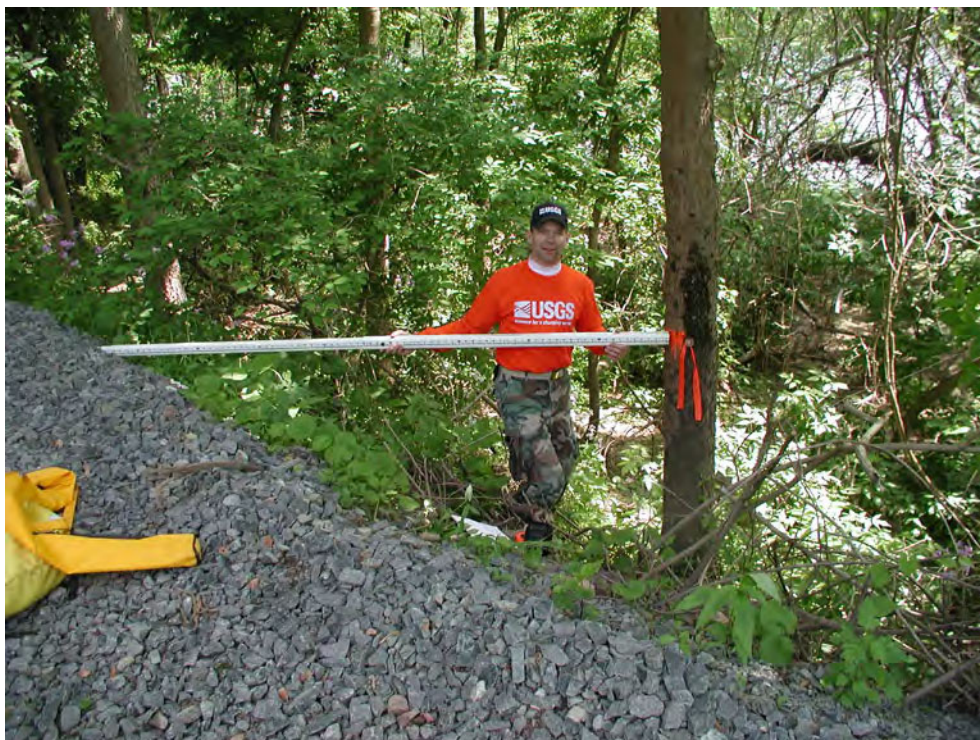
High-water mark NJ 19.3 for the Delaware River (lat 40° 24' 19.1", long 74° 58' 51.9"), at an elevation of 80.2 feet above NGVD 29, is a good mud line on an 8-inch diameter tree, 4.1-feet above the ground, 422 feet upstream from the Bridge Street bridge, and was marked with a metal USGS washer and nail.

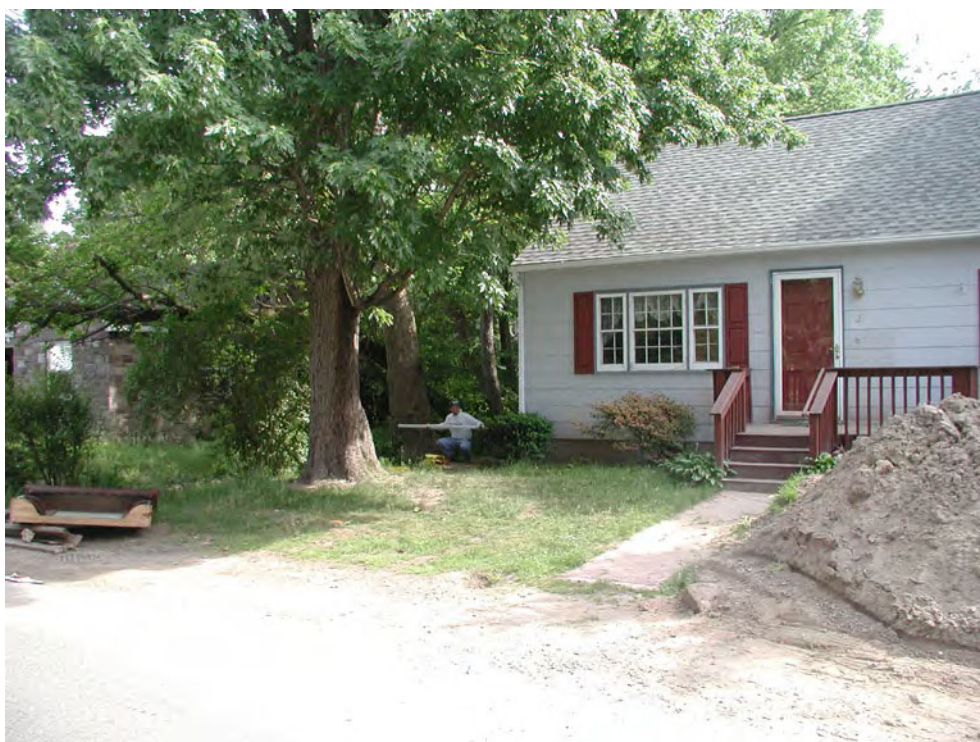
High-water mark NJ 19.4 for the Delaware and Raritan Canal (lat 40° 24' 16.4", long 74° 58' 39.3"), at an elevation of 79.0 feet above NGVD 29, is a good mud line on a house, 2.3 feet above the ground, 191 feet downstream from the Bridge Street bridge, and was marked with a black marker line.
