Flood of April 2-4, 2005, Delaware River Main Stem from Port Jervis, New York, to Cinnaminson, New Jersey

Scientific Investigations Report 2007-5067

**U.S. Department of the Interior
U.S. Geological Survey**

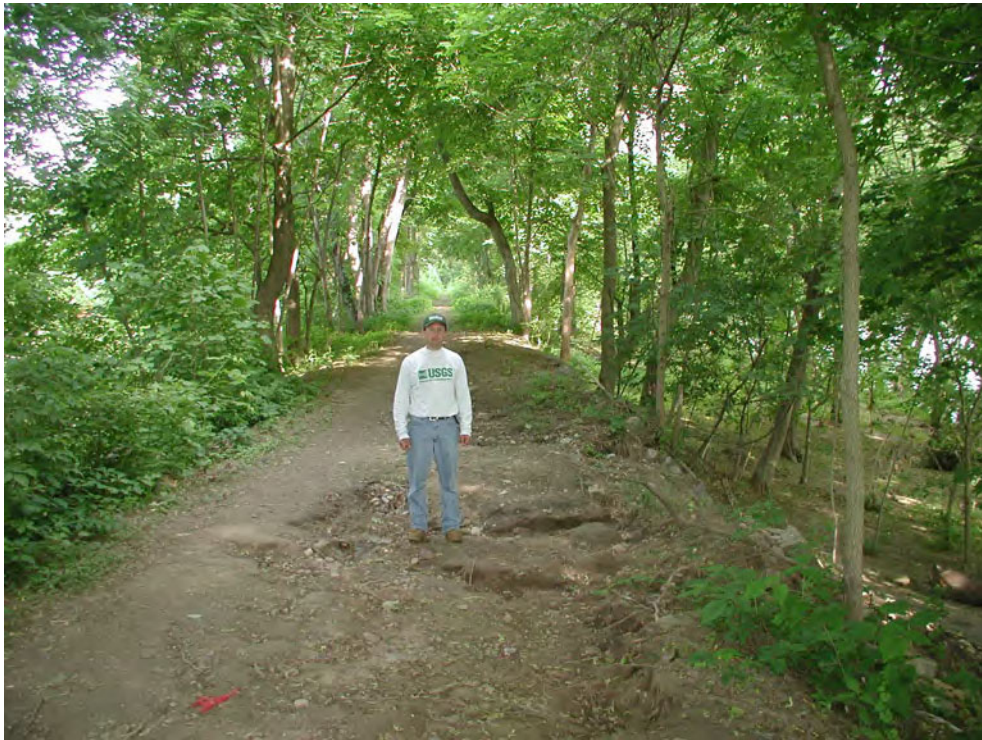
High-water mark NJ 19.5 for the Delaware River (lat 40° 24' 15.0", long 74° 58' 42.0"), at an elevation of 80.0 feet above NGVD 29, is a poor debris line on the ground at the canal path, 44 feet downstream from the Bridge Street bridge, and was marked with a metal rebar.

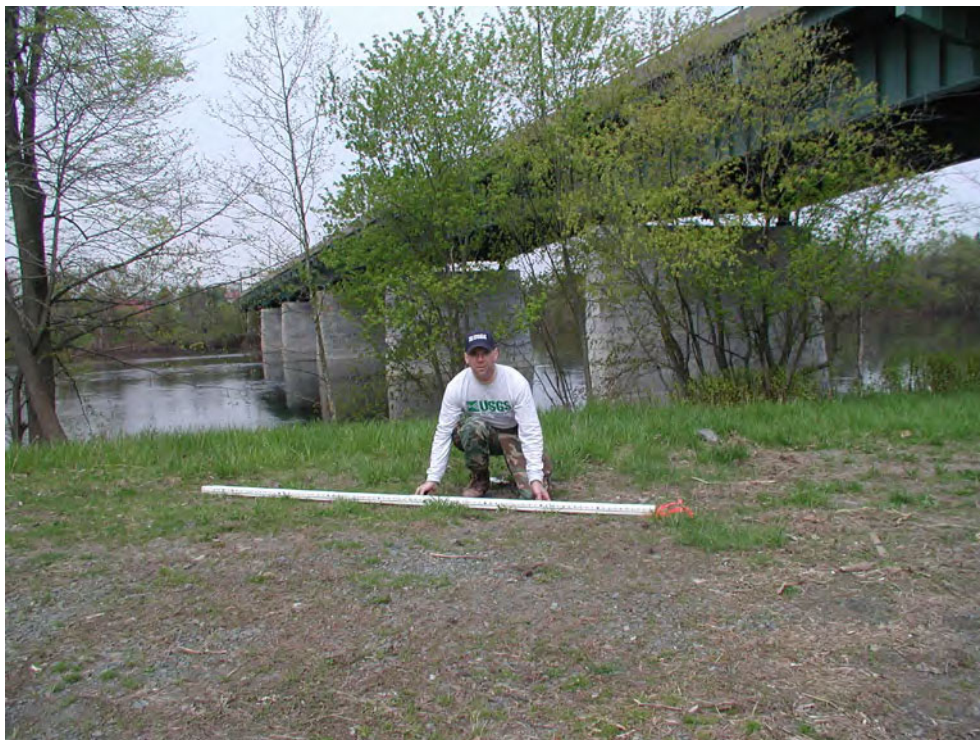
High-water mark NJ 20.1 (lat 40° 22' 46.7", long 74° 57' 13.5"), at an elevation of 71.4 feet above NGVD 29, is a good debris line on the ground at top of bank, 65 feet downstream from the US Route 202 bridge, and was marked with a metal rebar.

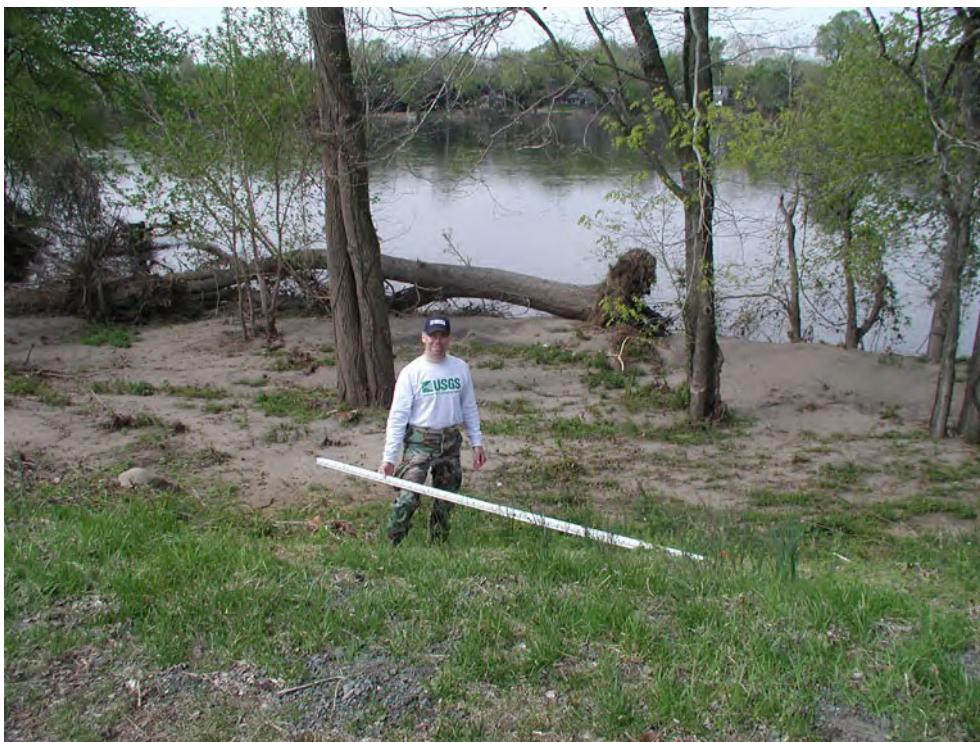
High-water mark NJ 20.2 (lat 40° 22' 40.6", long 74° 57' 09.2"), at an elevation of 71.4 feet above NGVD 29, is a fair wash line on embankment, 760 feet downstream from the US Route 202 bridge, and was marked with a metal rebar.

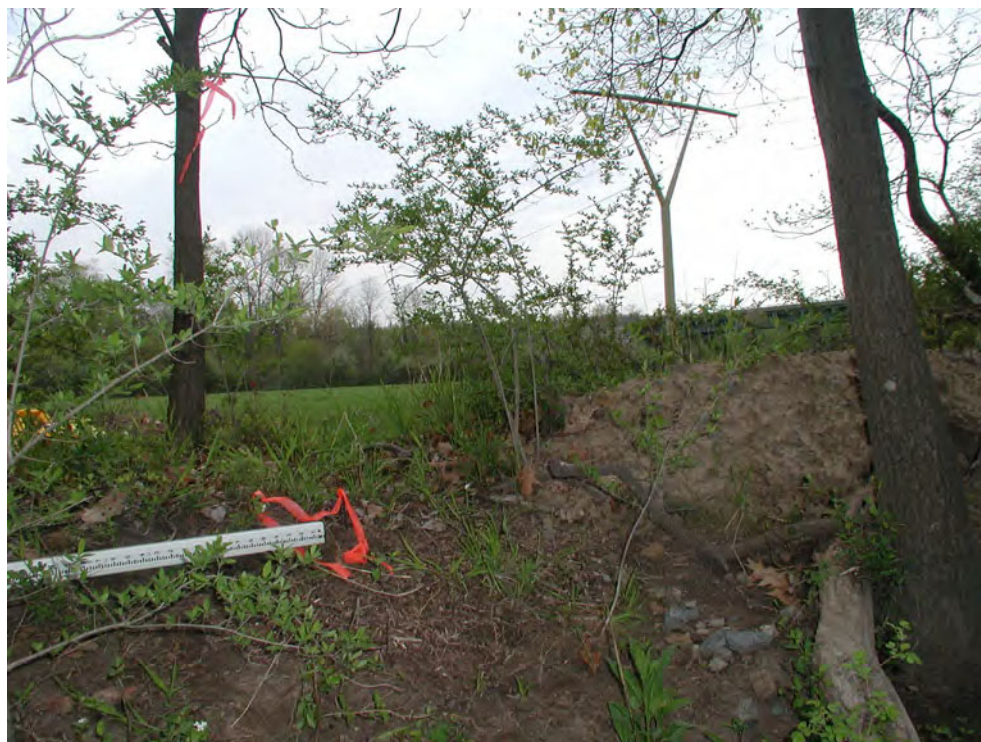
High-water mark NJ 20.3 (lat 40° 22' 53.3", long 74° 57' 17.7"), at an elevation of 71.9 feet above NGVD 29, is a fair debris line at the top of the bank, 600 feet upstream from the US Route 202 bridge, and was marked with a metal rebar.

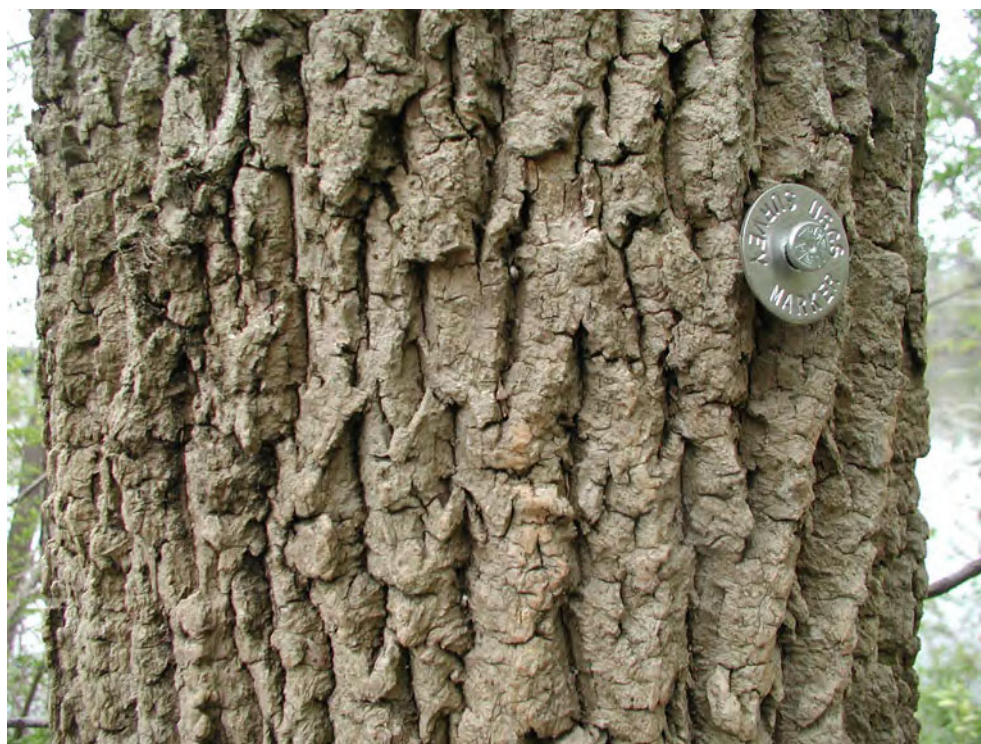
High-water mark NJ 20.4 (lat 40° 22' 52.5", long 74° 57' 17.1"), at an elevation of 71.7 feet above NGVD 29, is a fair seed line on a 1-foot diameter tree, 3.5 feet above the ground, 550 feet upstream from the US Route 202 bridge, and was marked with a metal USGS washer and nail.

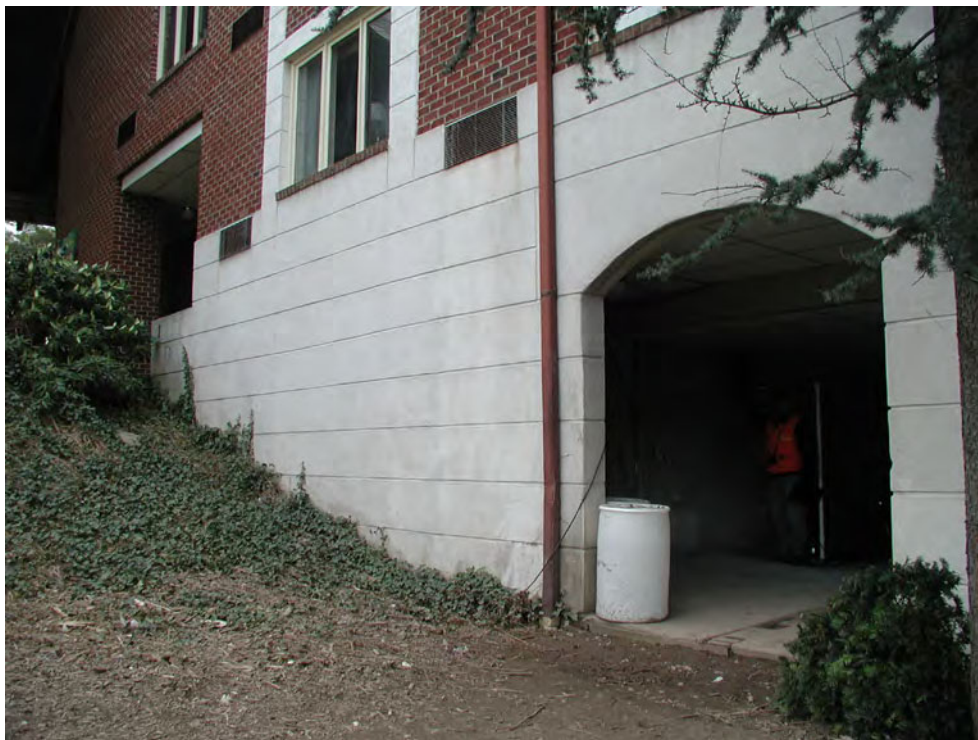
High-water mark NJ 21.1 (lat 40° 21' 51.7", long 74° 56' 46.4"), at an elevation of 68.5 feet above NGVD 29, is an excellent seed line on the Lambertville Inn, 5.7 feet above the ground, 473 feet downstream from the Bridge Street bridge, and was marked with a metal USGS washer and nail.

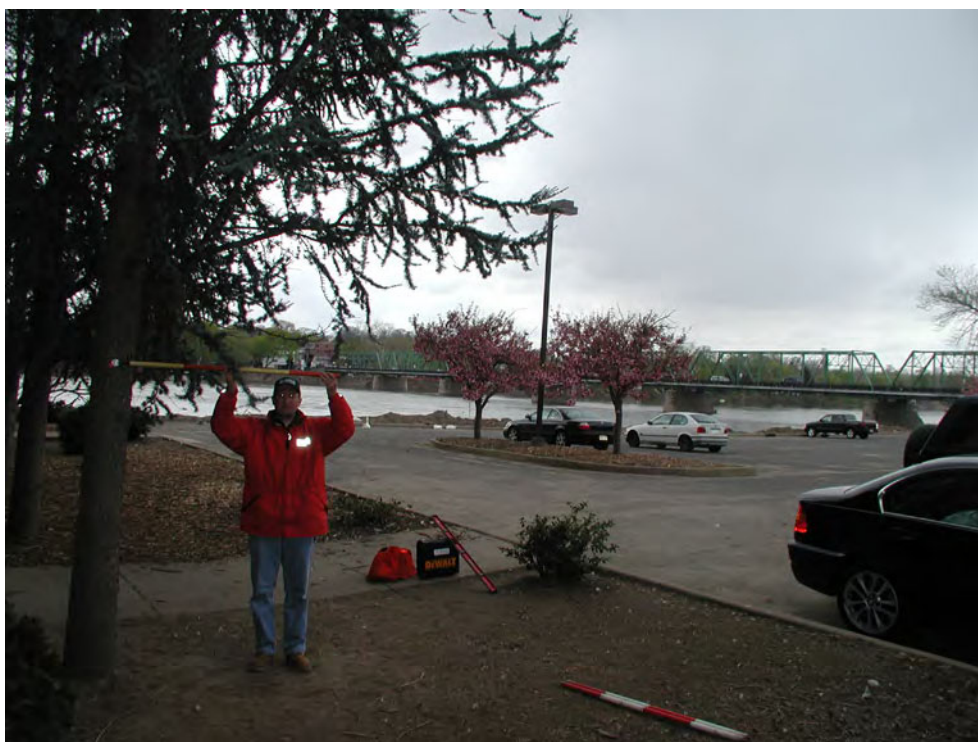
High-water mark NJ 21.2 (lat 40° 21' 51.7", long 74° 56' 46.4"), at an elevation of 68.7 feet above NGVD 29, is a good seed line on a tree between the Lambertville Inn and its parking lot, 457 feet downstream from the Bridge Street bridge, and was marked with a metal USGS washer and nail.

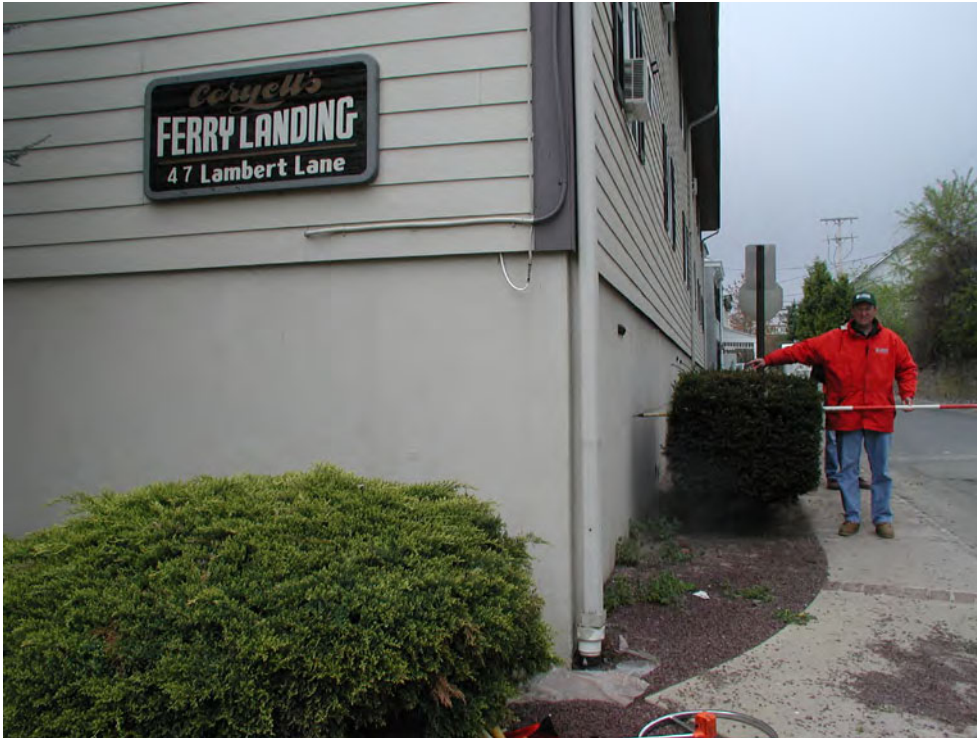
High-water mark NJ 21.3 (lat 40° 22' 00.8", long 74° 56' 49.5"), at an elevation of 69.0 feet above NGVD 29, is an excellent seed line on a building, 569 feet upstream from the Bridge Street bridge, and was marked with a black marker line.

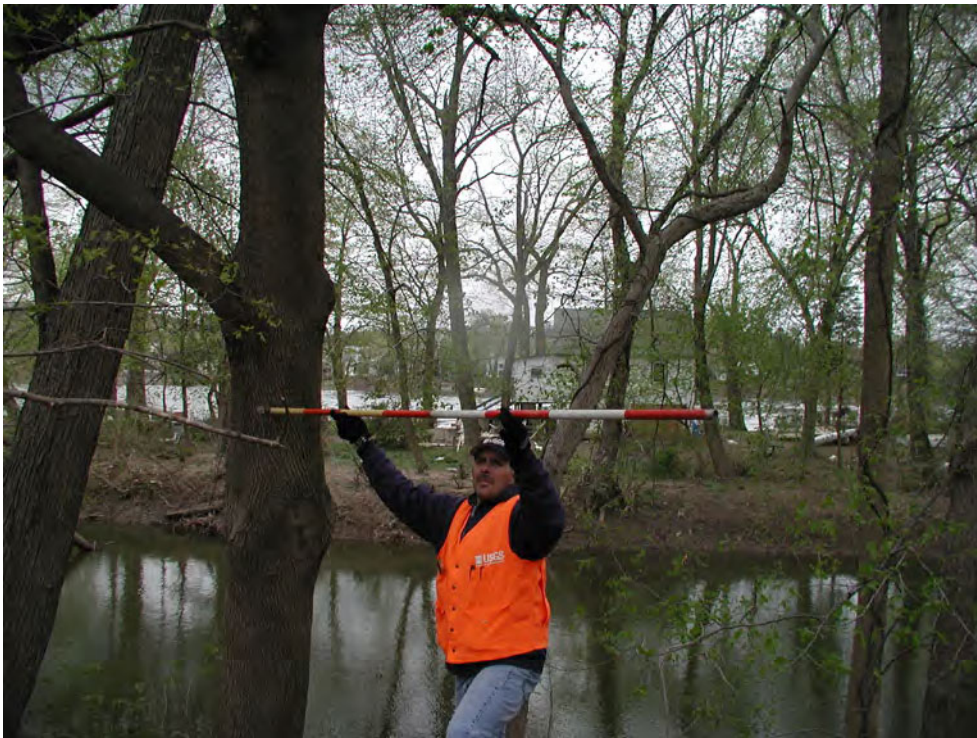
High-water mark NJ 21.4 (lat 40° 22' 03.4", long 74° 56' 51.0"), at an elevation of 69.2 feet above NGVD 29, is a fair seed line on a 1.4-foot diameter tree, 7.1 feet above the ground, 885 feet upstream from the Bridge Street bridge, and was marked with a metal USGS washer and nail.

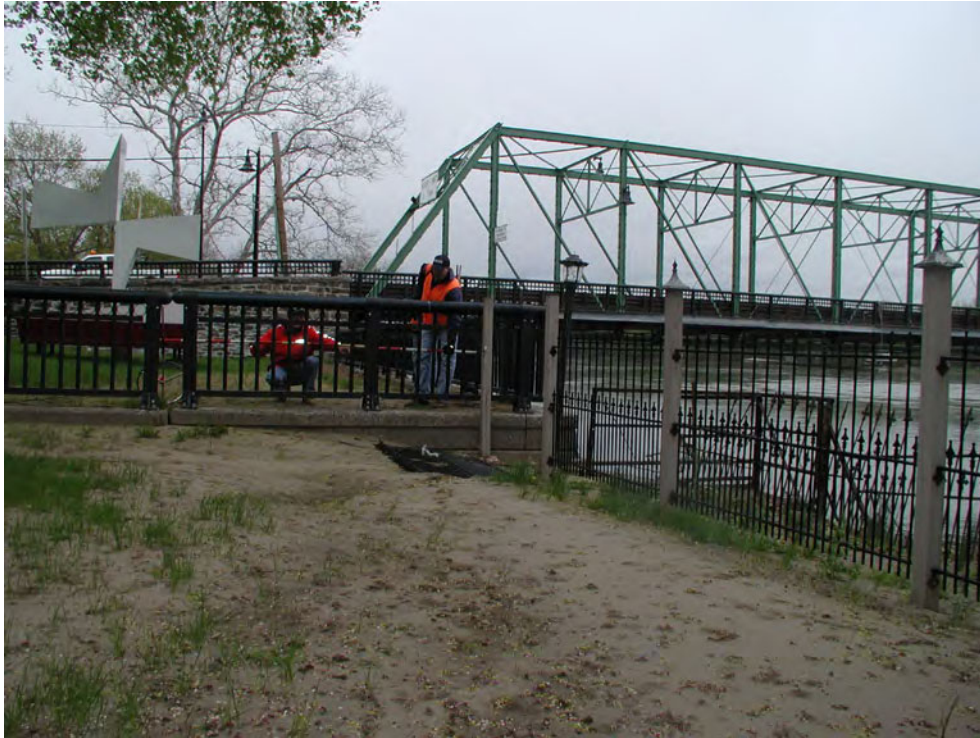
High-water mark PA 23.1 (lat 40° 21' 51.5", long 74° 57' 2.1"), at an elevation of 68.7 feet above NGVD 29, is an excellent mud line on a railing, 2.1 feet above the ground, 50 feet downstream from the East Bridge Street bridge, and was marked with a yellow grease pencil line.

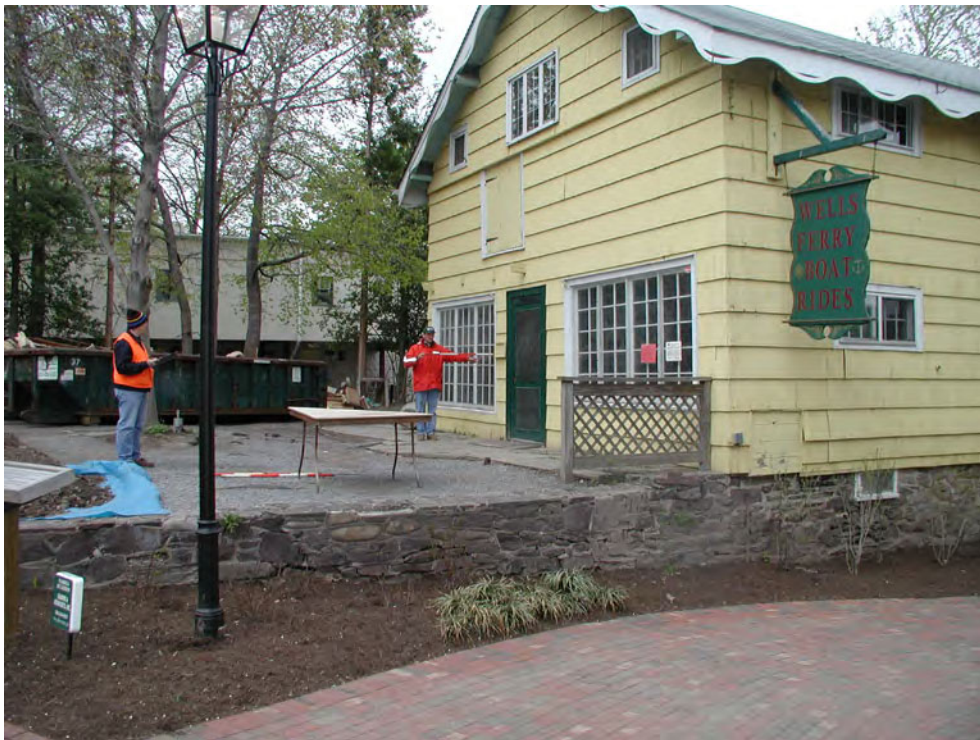
High-water mark PA 23.2 (lat 40° 21' 48.1", long 74° 57' 1.7"), at an elevation of 68.5 feet above NGVD 29, is an excellent mud line on a building on Ferry Street, 4.5 feet above the ground, 0.1 miles downstream from the East Bridge Street bridge, and was marked with a black marker line.

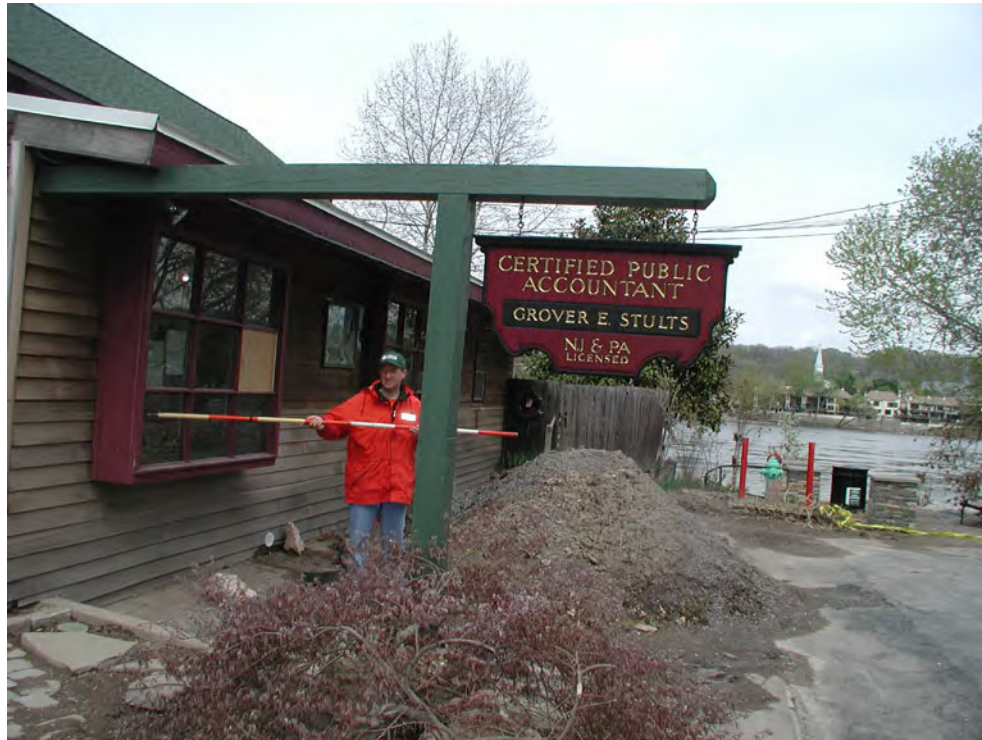
High-water mark PA 23.3 (lat 40° 22' 3.0", long 74° 56' 52.0"), at an elevation of 68.9 feet above NGVD 29, is an excellent mud line on a building on Randolph Street, 4.0 feet above the ground, 0.1 miles upstream from the East Bridge Street bridge, and was marked with a black marker line.

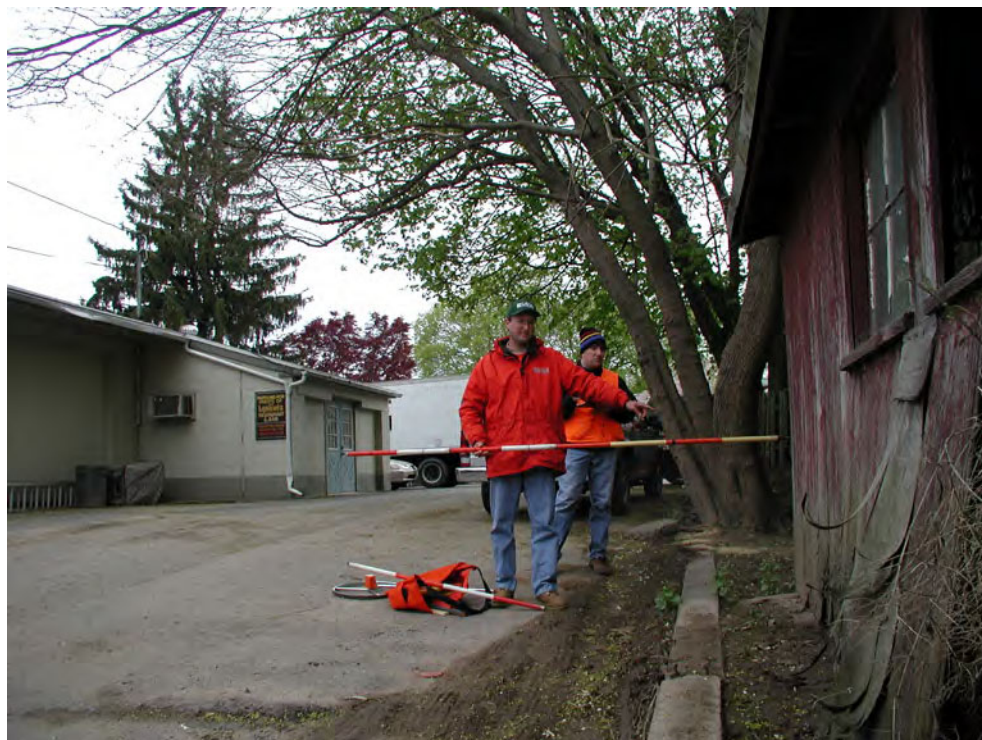
High-water mark PA 23.4 (lat 40° 22' 3.0", long 74° 56' 52.0"), at an elevation of 68.8 feet above NGVD 29, is an excellent mud line on a barn on Randolph Street, 3.9 feet above the ground, 0.1 miles upstream from the East Bridge Street bridge, and was marked with a black marker line.

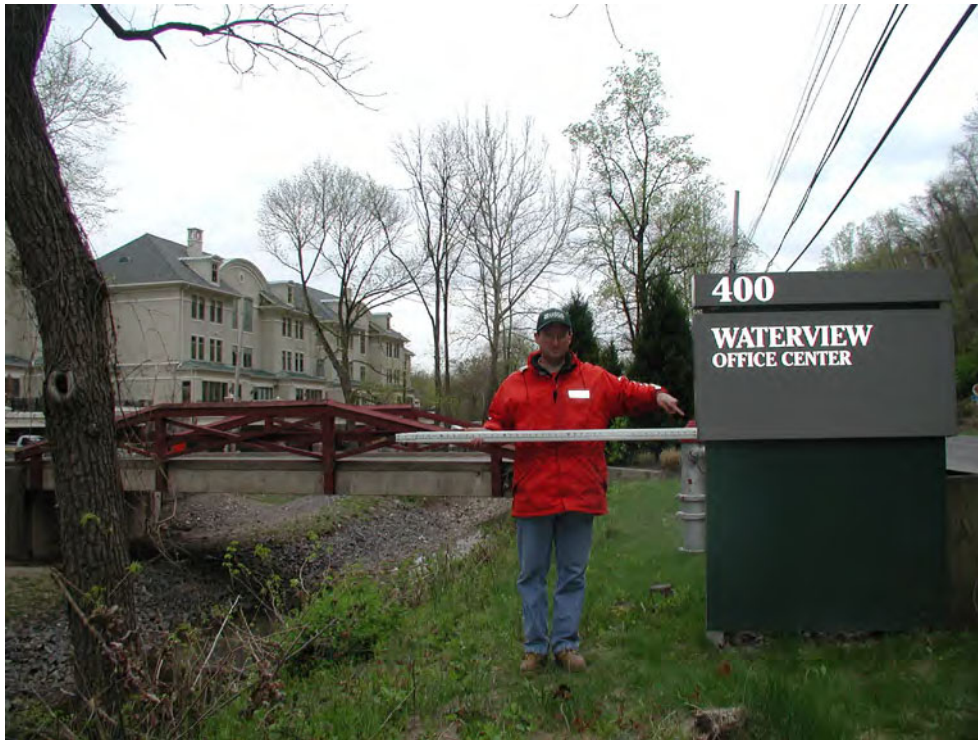
High-water mark PA 24.1 (lat 40° 21' 3.5", long 74° 56' 54.0"), at an elevation of 65.1 feet above NGVD 29, is an excellent mud line on a sign for an office park on State Route 32, 3.5 feet above the ground, 0.5 miles downstream from Dark Hollow Run, and was marked with a black marker line.

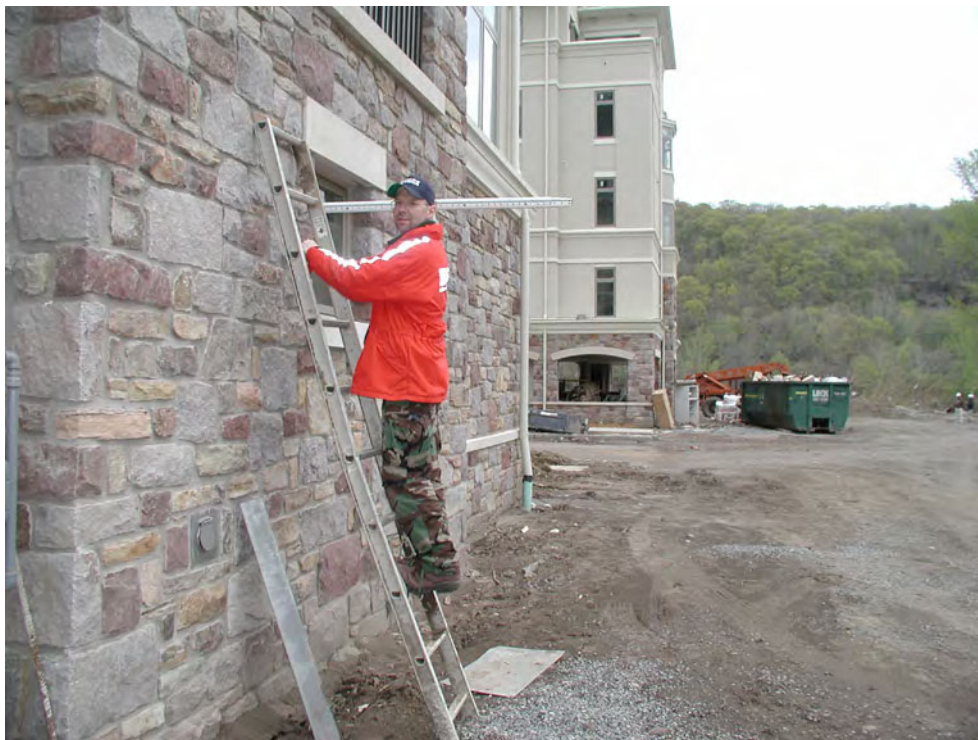
High-water mark PA 24.2 (lat 40° 20' 59.6", long 74° 56' 51.4"), at an elevation of 64.8 feet above NGVD 29, is an excellent mud line on a window frame of a building on State Route 32, 7.9 feet above the ground, 0.6 miles downstream from Dark Hollow Run, and was marked with a black marker line.

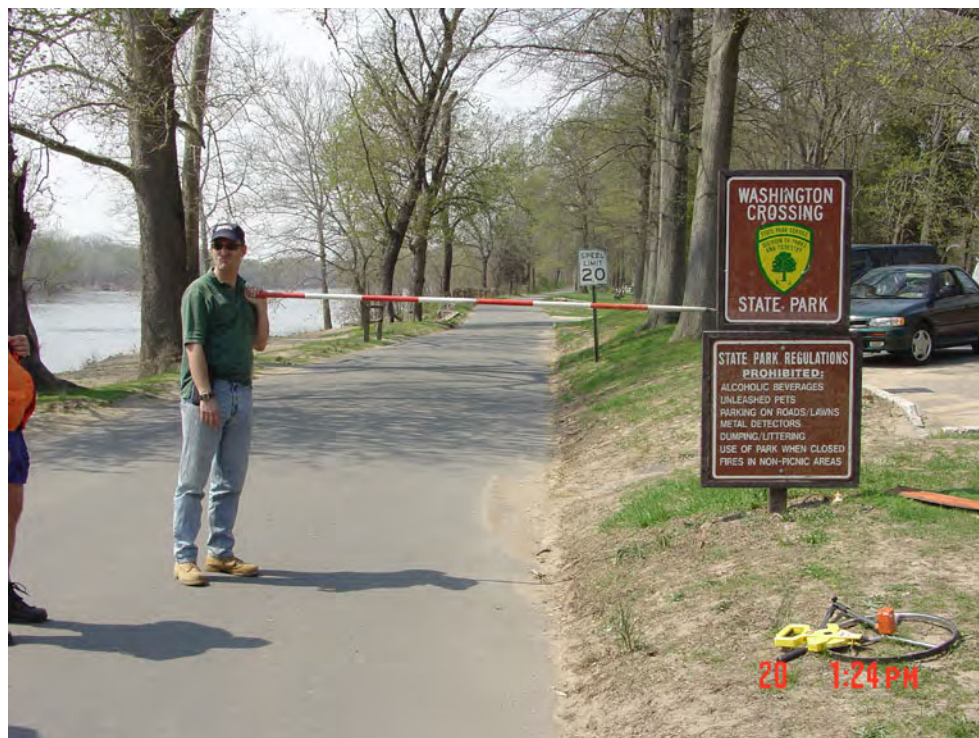
High-water mark NJ 22.1 (lat 40° 17' 48.7", long 74° 52' 03.6"), at an elevation of 49.6 feet above NGVD 29, is a good mud line on the Washington Crossing State Park sign, 3.9 feet above the ground, 308 feet upstream from the Washington Crossing bridge, and was marked with a black marker line.

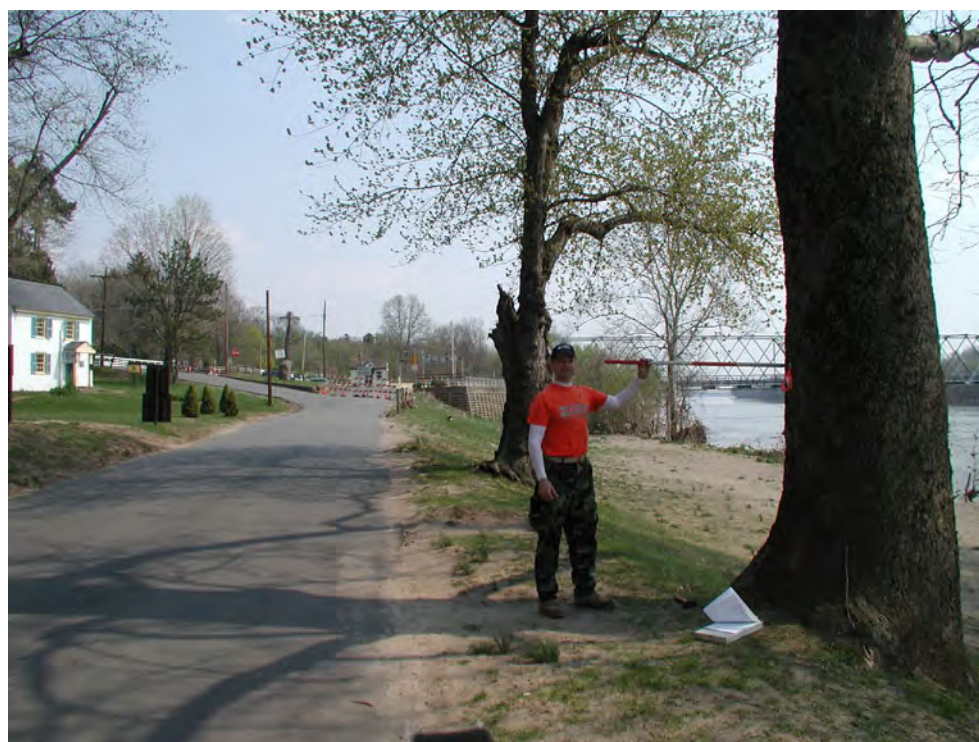
High-water mark NJ 22.2 (lat 40° 17' 49.1", long 74° 52' 04.6"), at an elevation of 49.2 feet above NGVD 29, is a fair mud line on a 40-inch diameter tree, 375 feet upstream from the Washington Crossing bridge, and was marked with a metal USGS washer and nail.

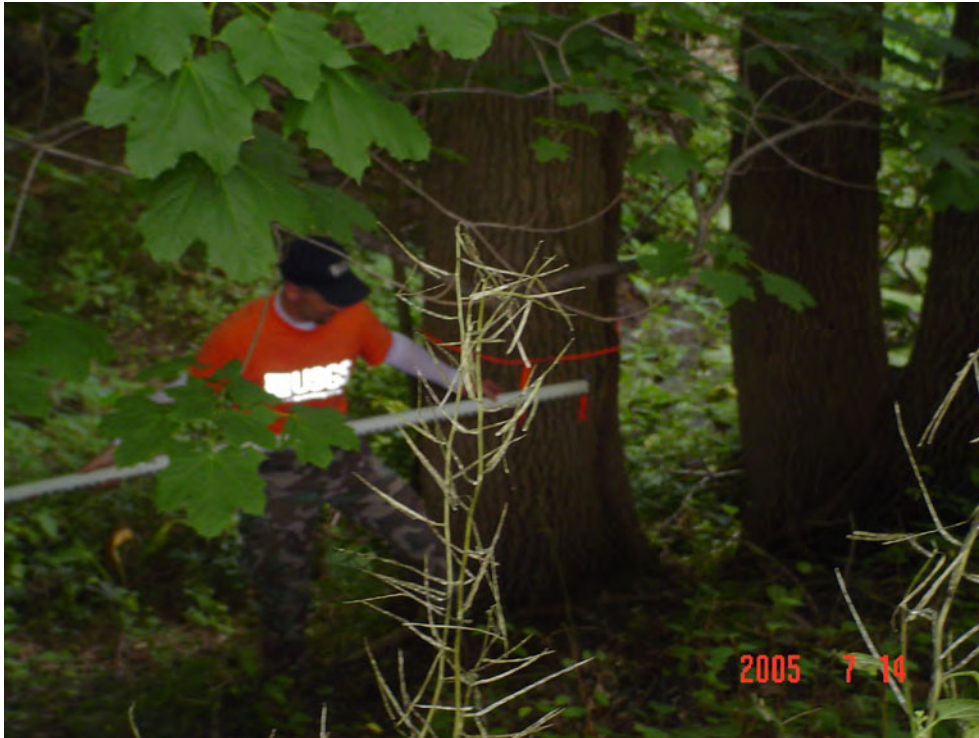
High-water mark NJ 22.3 (lat 40° 17' 42.4", long 74° 51' 57.5"), at an elevation of 49.2 feet above NGVD 29, is a fair seed line on a 26-inch diameter tree, 529 feet downstream from the downstream towpath gate near the Washington Crossing bridge, and was marked with a metal USGS washer and nail.

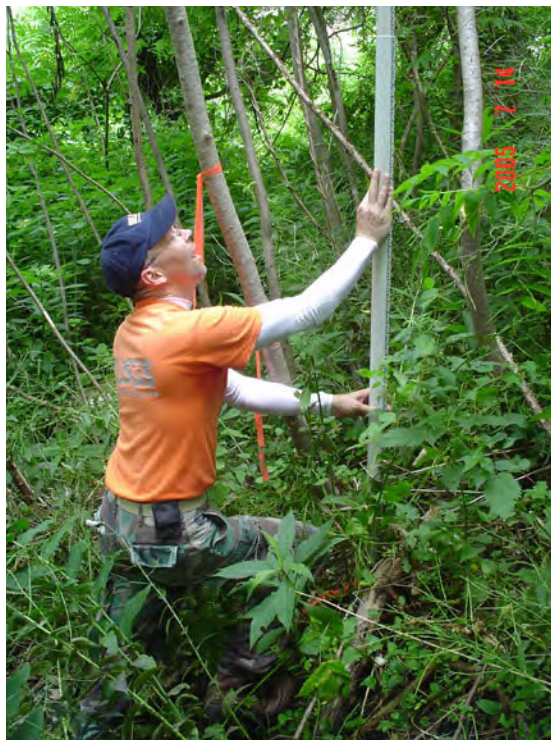
High-water mark NJ 22.4 (lat 40° 17' 44.7", long 74° 51' 59.0"), at an elevation of 49.8 feet above NGVD 29, is a good debris line on the ground, 283 feet downstream from the downstream towpath gate near the Washington Crossing bridge, and was marked with a metal USGS washer and nail.

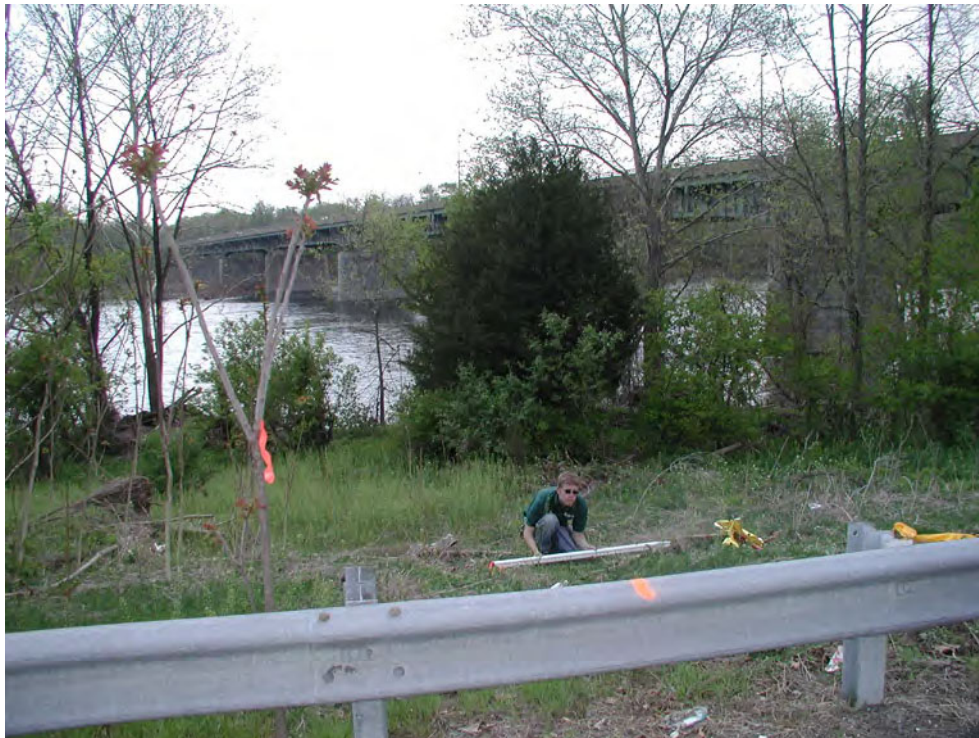
High-water mark NJ 23.1 (lat 40° 15' 33.2", long 74° 50' 43.1"), at an elevation of 42.2 feet above NGVD 29, is a fair debris line on the embankment, 177 feet downstream from the Interstate Route 95 bridge, and was marked with a metal rebar.

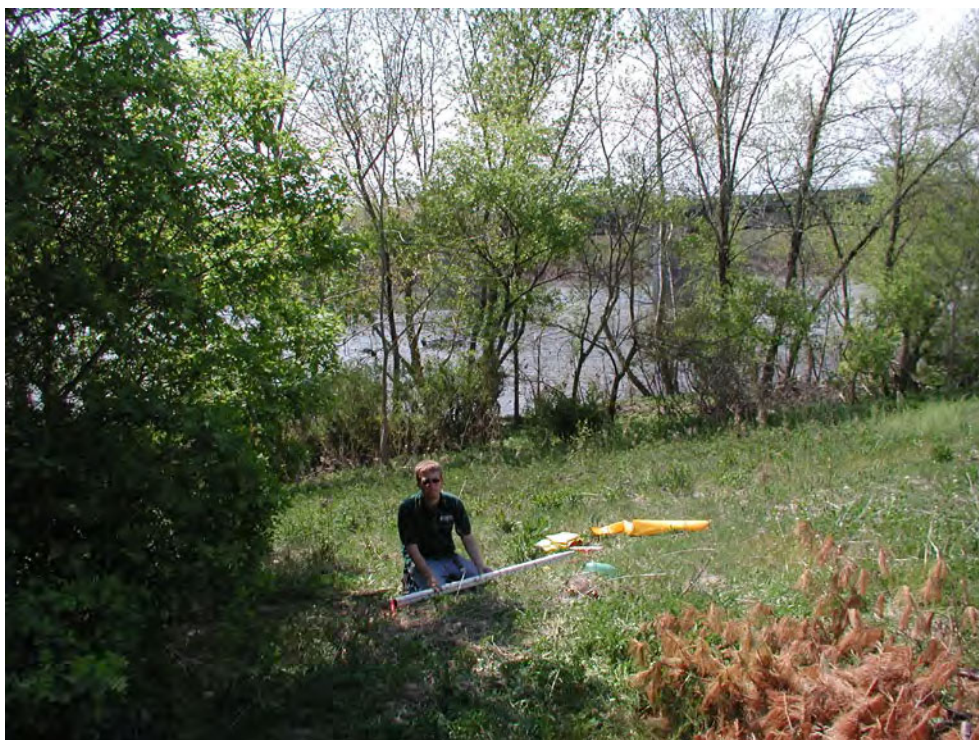
High-water mark NJ 23.2 (lat 40° 15' 31.6", long 74° 50' 42.0"), at an elevation of 41.4 feet above NGVD 29, is a fair debris line on the embankment, 367 feet downstream from the Interstate Route 95 bridge, and was marked with a metal rebar.

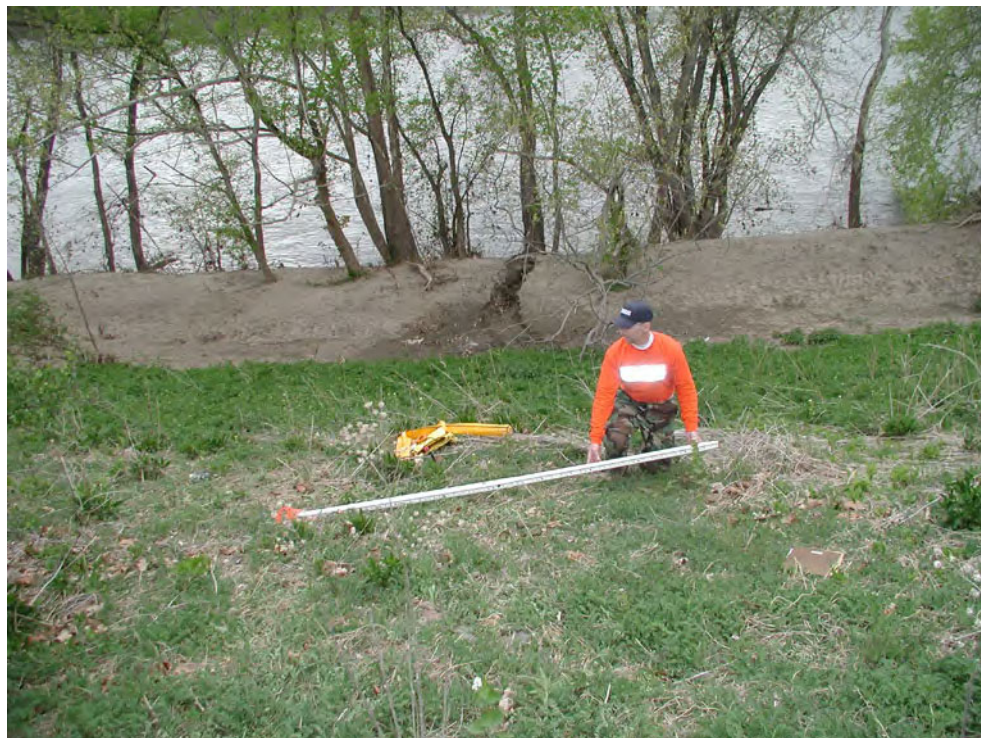
High-water mark NJ 23.3 (lat 40° 15' 39.1", long 74° 50' 46.3"), at an elevation of 42.4 feet above NGVD 29, is a fair debris line on the embankment, 409 feet upstream from the Interstate Route 95 bridge, and was marked with a metal rebar.

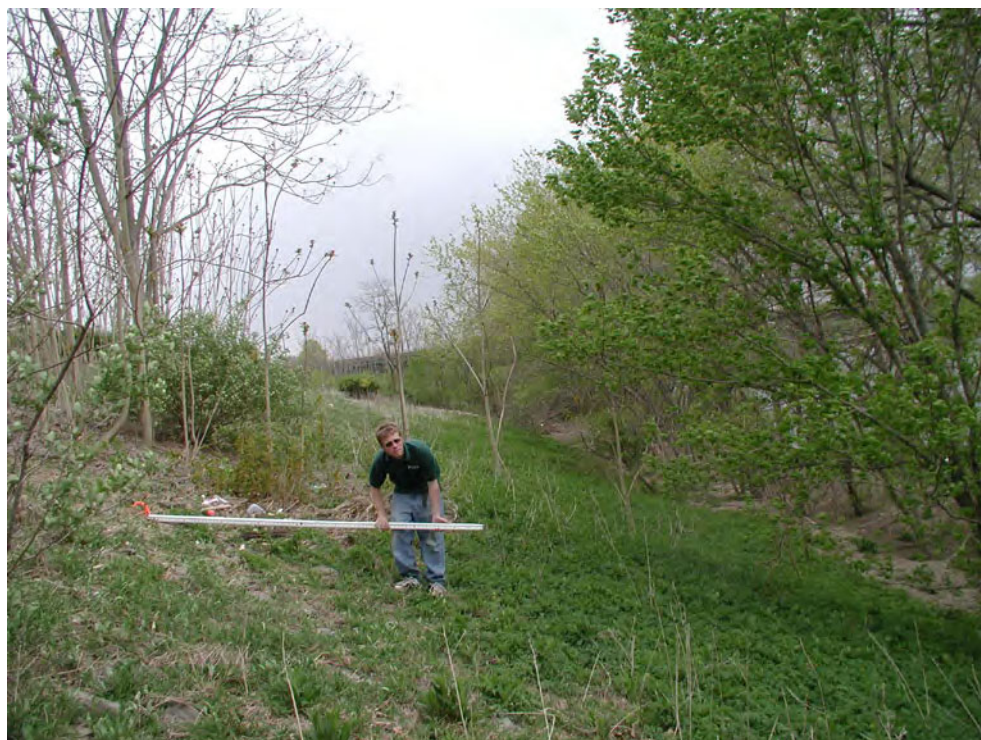
High-water mark NJ 23.4 (lat 40° 15' 40.8", long 74° 50' 47.2"), at an elevation of 42.4 feet above NGVD 29, is a fair debris line on the embankment, 590 feet upstream from the Interstate Route 95 bridge, and was marked with a metal rebar.

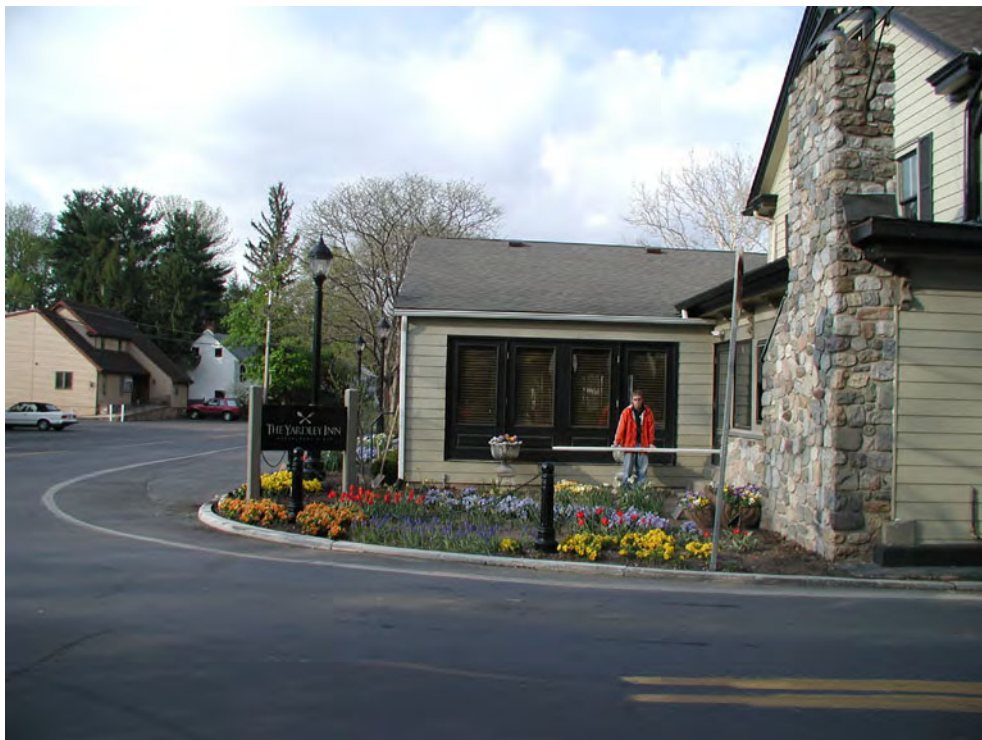
High-water mark PA 27.1 (lat 40° 14' 41.7", long 74° 50' 11.4"), at an elevation of 38.4 feet above NGVD 29, is an excellent mud line on the door of a building (Yardley Inn) on East Afton Avenue, 2.4 feet above the ground, 1.1 miles downstream from the Interstate Route 95 bridge, and was marked with a black marker line.

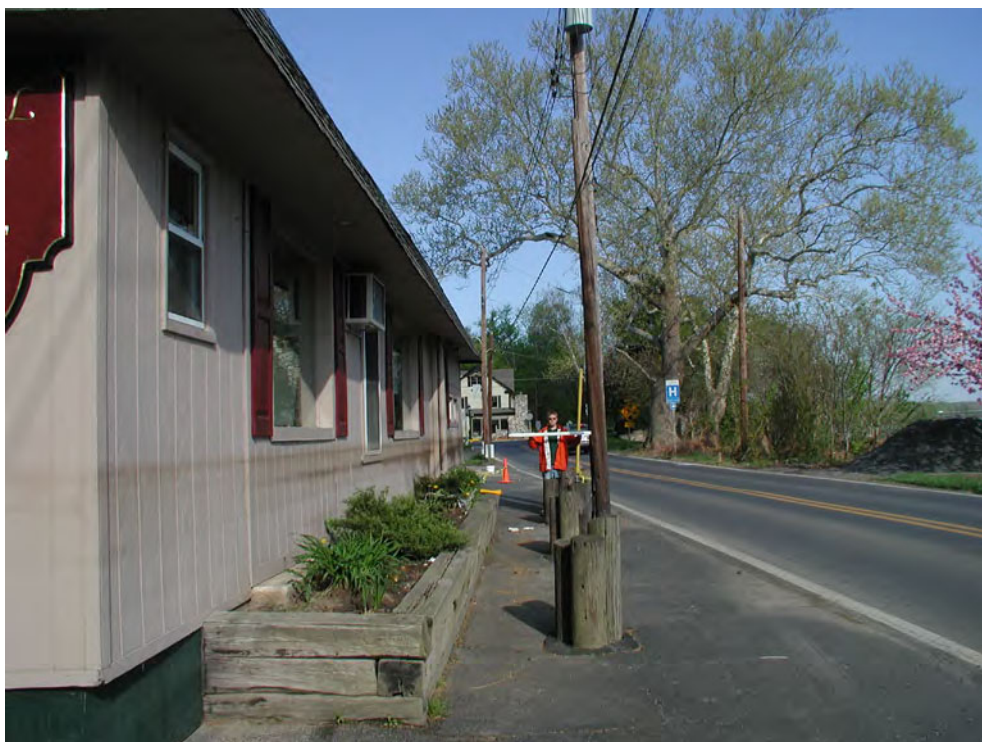
High-water mark PA 27.2 (lat 40° 14' 40.3", long 74° 50' 7.6"), at an elevation of 38.0 feet above NGVD 29, is an excellent mud line on a utility pole on State Route 32, 4.8 feet above the ground, 1.2 miles downstream from the Interstate Route 95 bridge, and was marked with a metal USGS washer and nail.

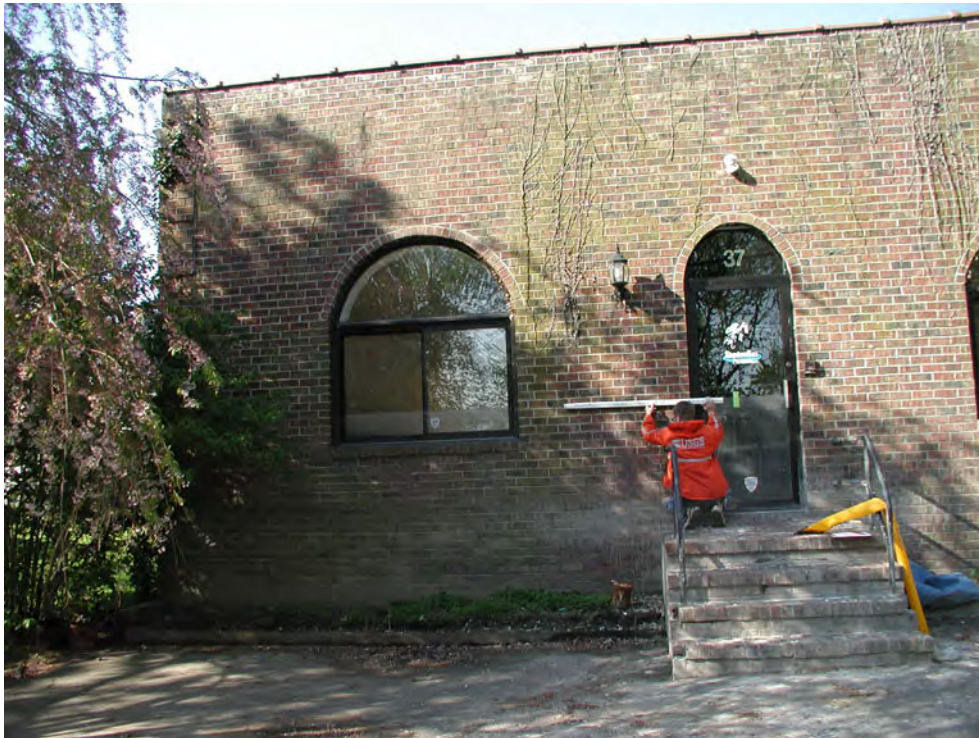
High-water mark PA 27.3 (lat 40° 14' 37.2", long 74° 50' 0.0"), at an elevation of 37.3 feet above NGVD 29, is an excellent mud line on the door of a building, 6 feet above the ground, 1.3 miles downstream from the Interstate Route 95 bridge, and was marked with a metal USGS washer and nail.

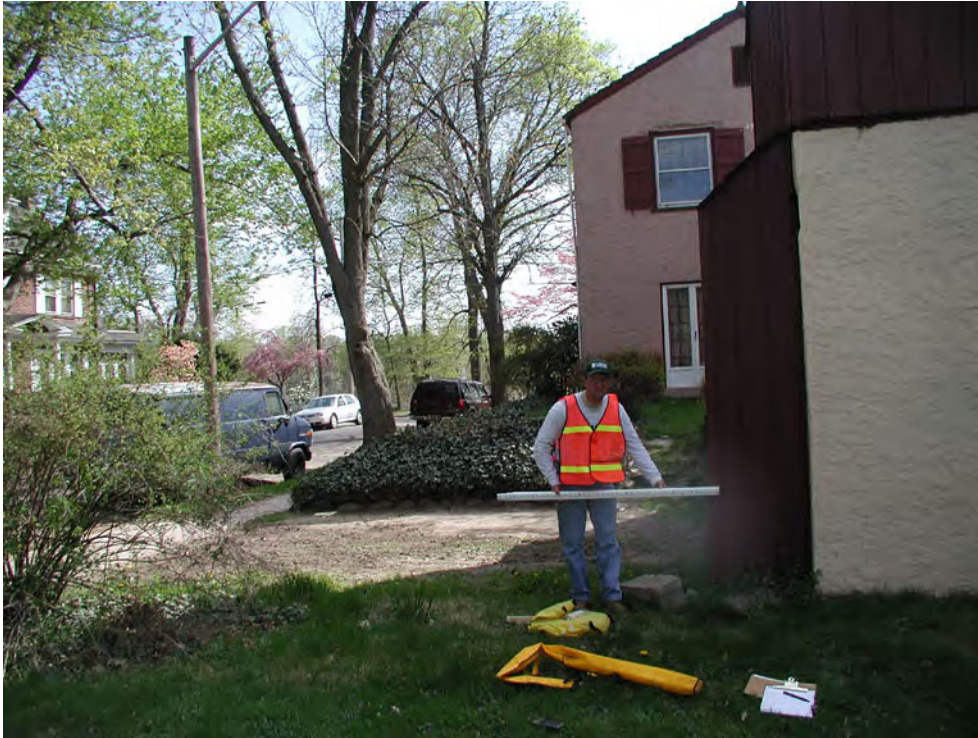
High-water mark NJ 24.1 (lat 40° 14' 10.8", long 74° 48' 15.6"), at an elevation of 31.6 feet above NGVD 29, is a good mud line on a garage at the intersection of Mount Vernon Avenue and Riverside Drive, 1.8 miles upstream from the Calhoun Street bridge, and was marked with a black marker line.

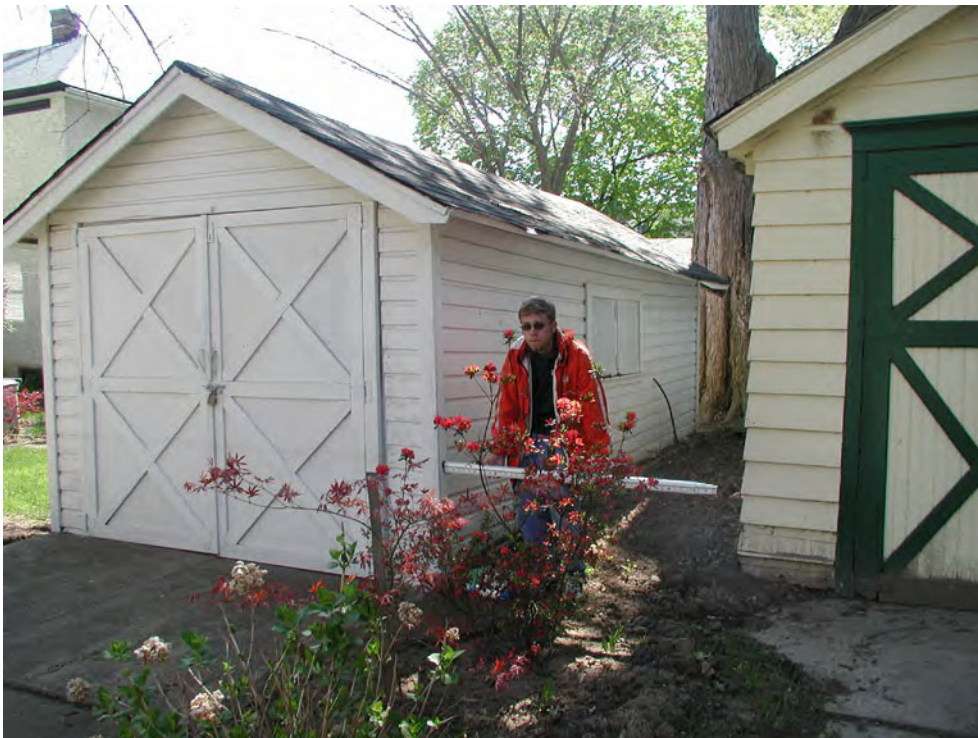
High-water mark NJ 24.2 (lat 40° 14' 05.5", long 74° 48' 04.4"), at an elevation of 30.9 feet above NGVD 29, is an excellent mud line on a garage at the intersection of Columbia Avenue and Bloomfield Avenue, 1.6 miles upstream from the Calhoun Street bridge, and was marked with a metal USGS washer and nail.

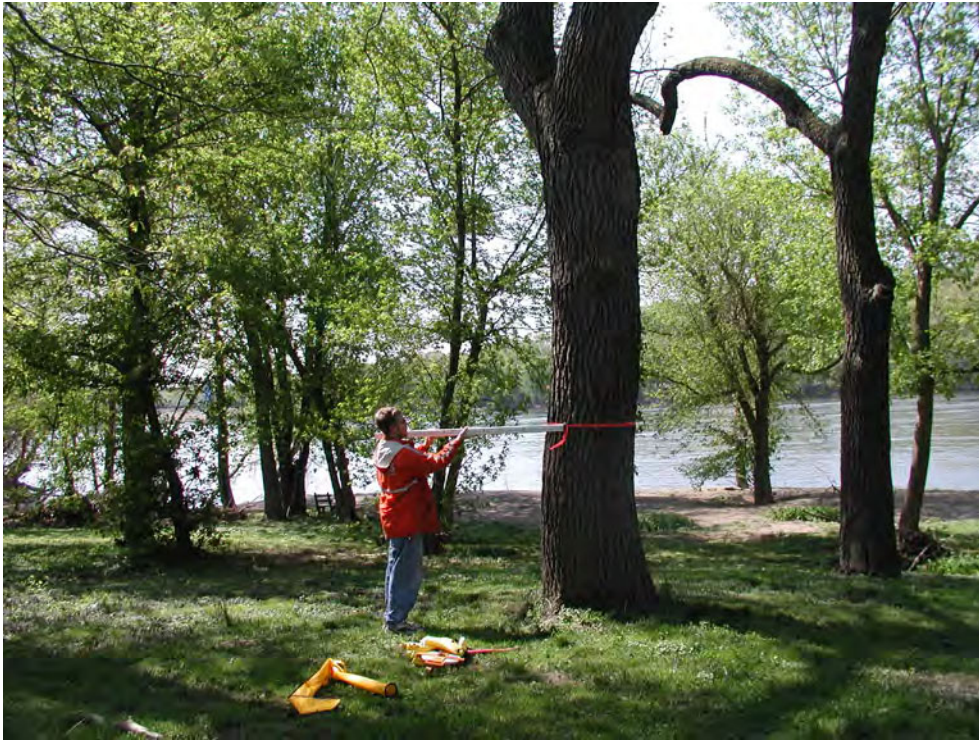
High-water mark NJ 25.1 (lat 40° 13' 24.0", long 74° 46' 50.0"), at an elevation of 26.5 feet above NGVD 29, is a fair seed line on a 2.3-foot diameter tree, 1,300 feet upstream from the Calhoun Street bridge, and was marked with a metal USGS washer and nail.
