Flood of April 2-4, 2005, Delaware River Main Stem from Port Jervis, New York, to Cinnaminson, New Jersey

Scientific Investigations Report 2007-5067

**U.S. Department of the Interior
U.S. Geological Survey**

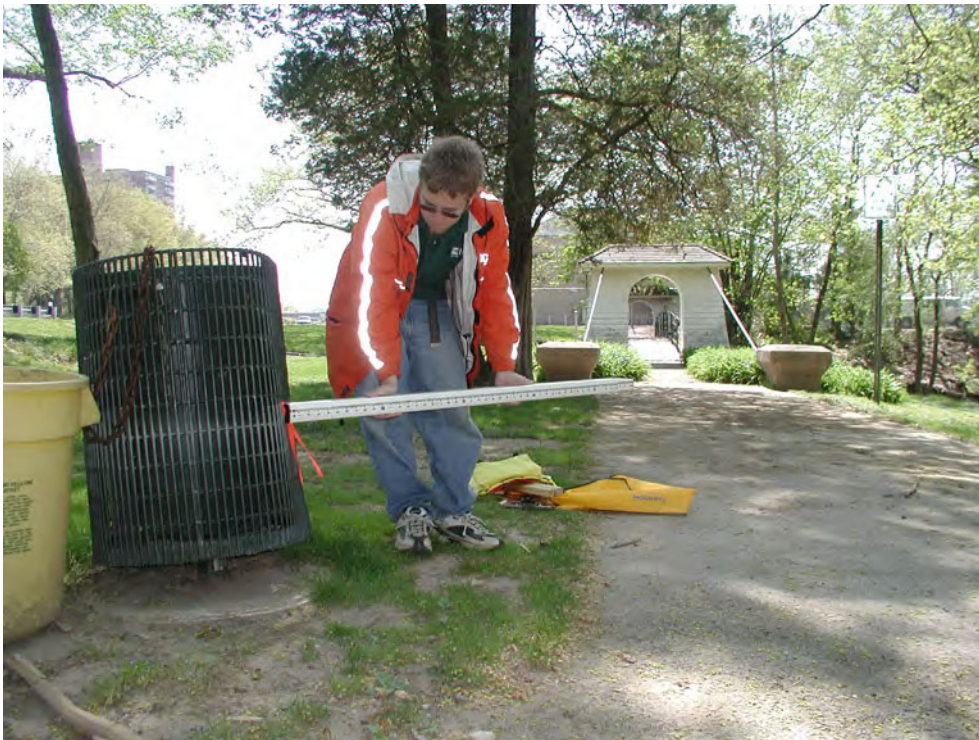
High-water mark NJ 25.2 (lat 40° 13' 24.4", long 74° 46' 48.8"), at an elevation of 26.6 feet above NGVD 29, is an excellent mud line on an anchored garbage can holder, 1,330 feet upstream from the Calhoun Street bridge, and was marked with a black marker line.

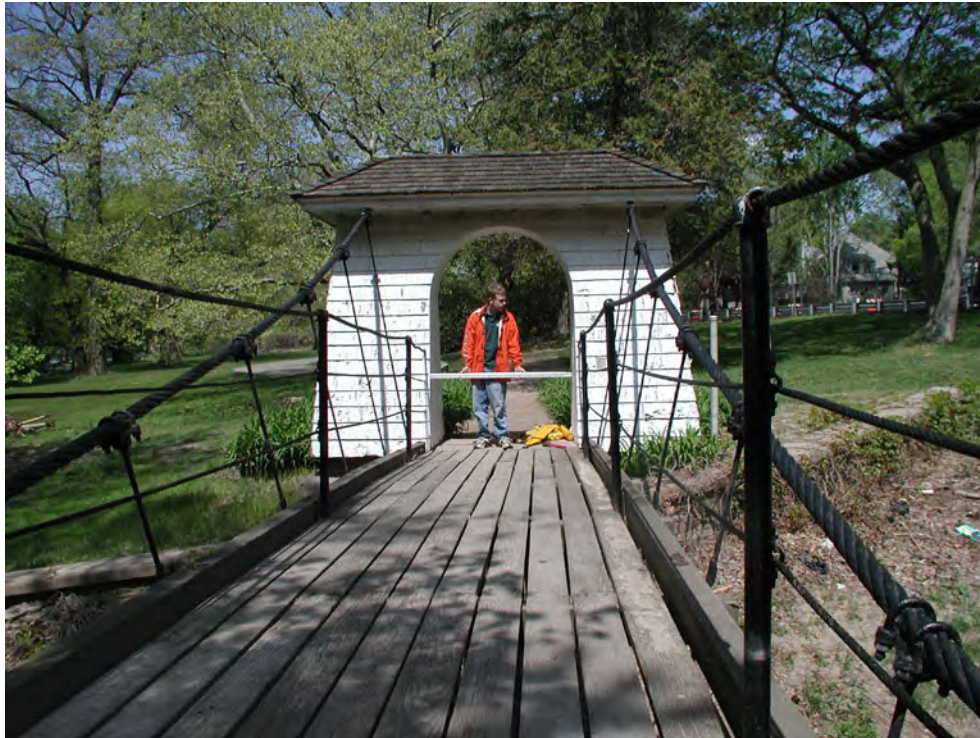
High-water mark NJ 25.3 (lat 40° 13' 23.4", long 74° 46' 48.0"), at an elevation of 26.7 feet above NGVD 29, is an excellent seed line on the upstream archway for foot bridge, 1,230 feet upstream from the Calhoun Street bridge, and was marked with a metal USGS washer and nail.

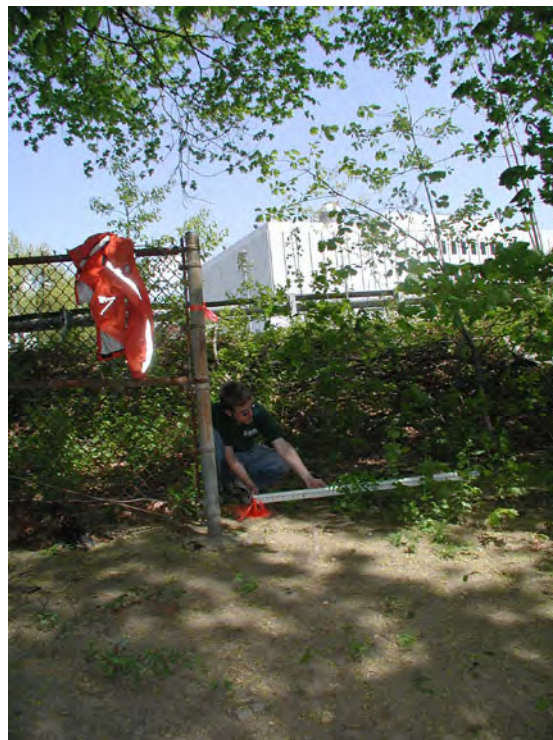
High-water mark NJ 25.5 (lat 40° 13' 14.1", long 74° 46' 27.6"), at an elevation of 24.7 feet above NGVD 29, is a good debris line on the embankment near State Route 29, 620 feet downstream from the Calhoun Street bridge, and was marked with a metal rebar.

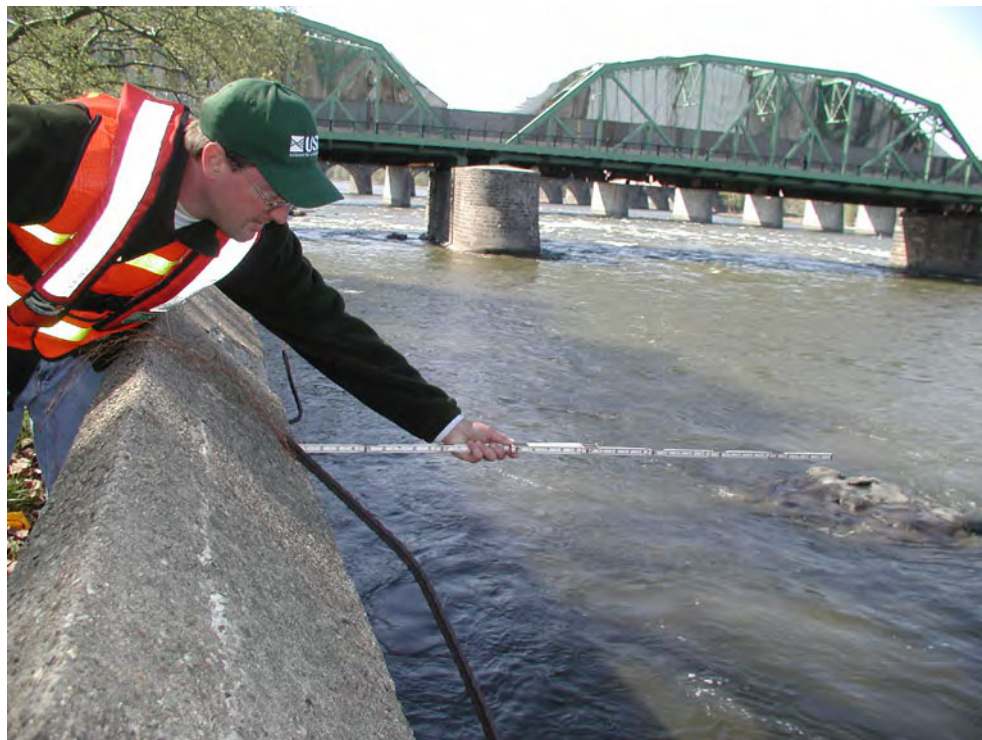
High-water mark NJ 26.1 (lat 40° 12' 41.0", long 74° 46' 02.2"), at an elevation of 21.3 feet above NGVD 29, is a poor debris line on a retaining wall, 680 feet upstream from the US Route 1 bridge, and was marked with a metal USGS washer and nail.

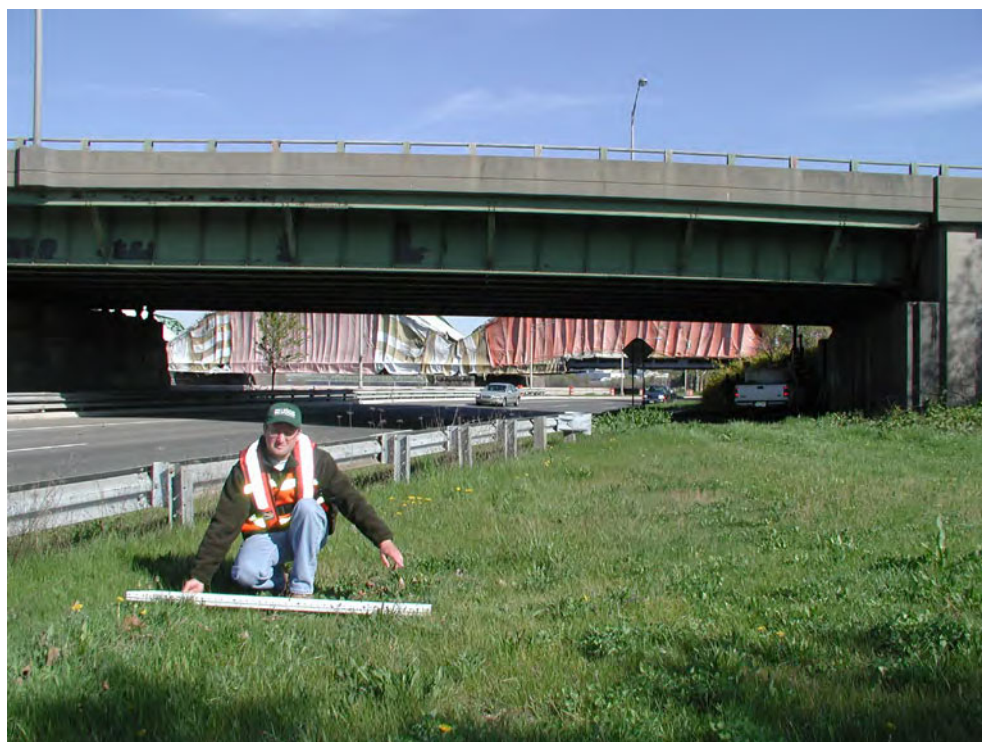
High-water mark NJ 26.2 (lat 40° 12' 33.9", long 74° 45' 59.3"), at an elevation of 17.9 feet above NGVD 29, is a fair debris line on the highway median, 81 feet upstream from the US Route 1 bridge, and was marked with a metal rebar.

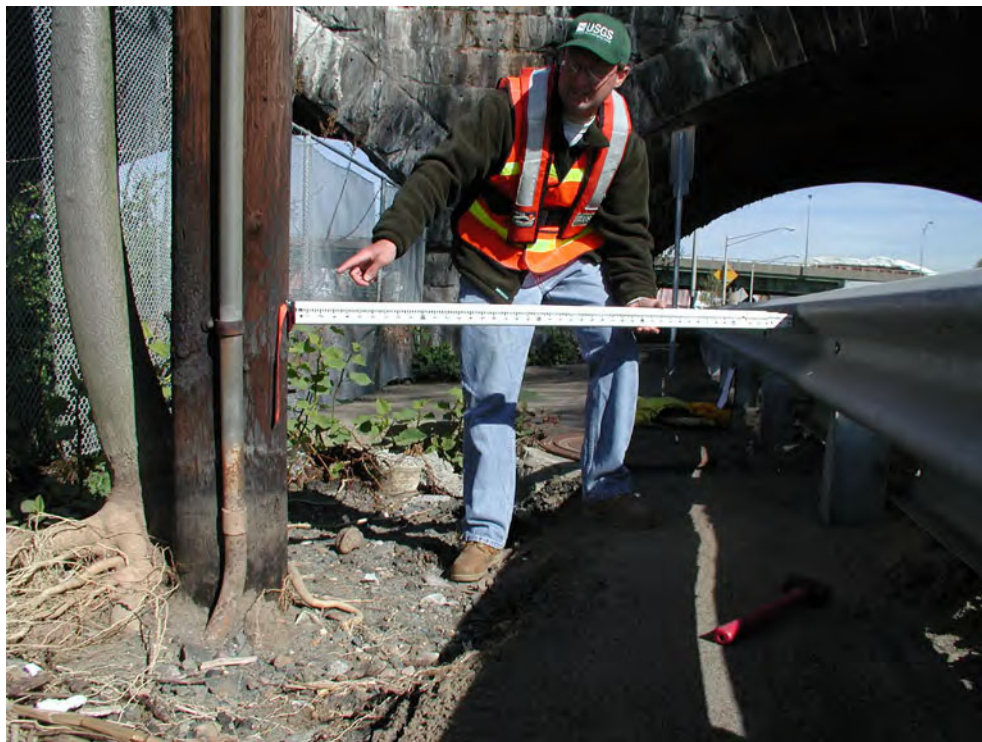
High-water mark NJ 26.3 (lat 40° 12' 31.1", long 74° 45' 58.4"), at an elevation of 17.9 feet above NGVD 29, is a fair debris line on a fence just downstream from the Amtrak rail line, and 310 feet downstream from the US Route 1 bridge. NOTE: The mark was transferred from the fence to utility pole # 12098TN and marked with a metal USGS washer and nail.

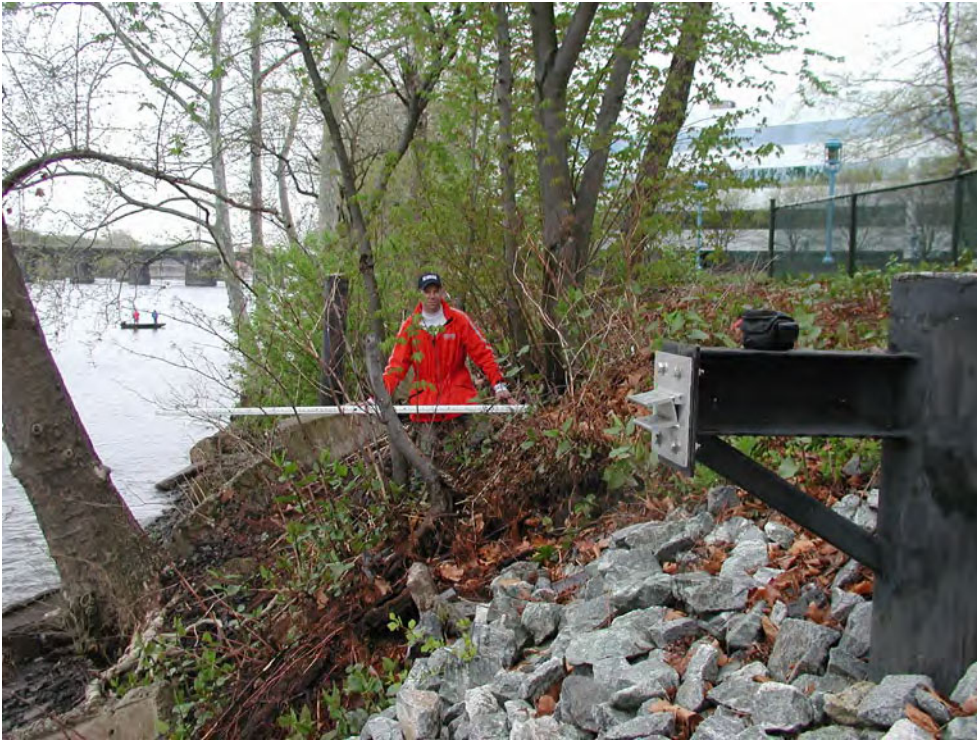
High-water mark NJ 27.1 (lat 40° 12' 17.1", long 74° 45' 48.1"), at an elevation of 17.3 feet above NGVD 29, is a fair debris line at the base of a 1.0-foot diameter tree near top of bank, 1,800 feet downstream from the US Route 1 bridge, and was marked with a metal USGS washer and nail.

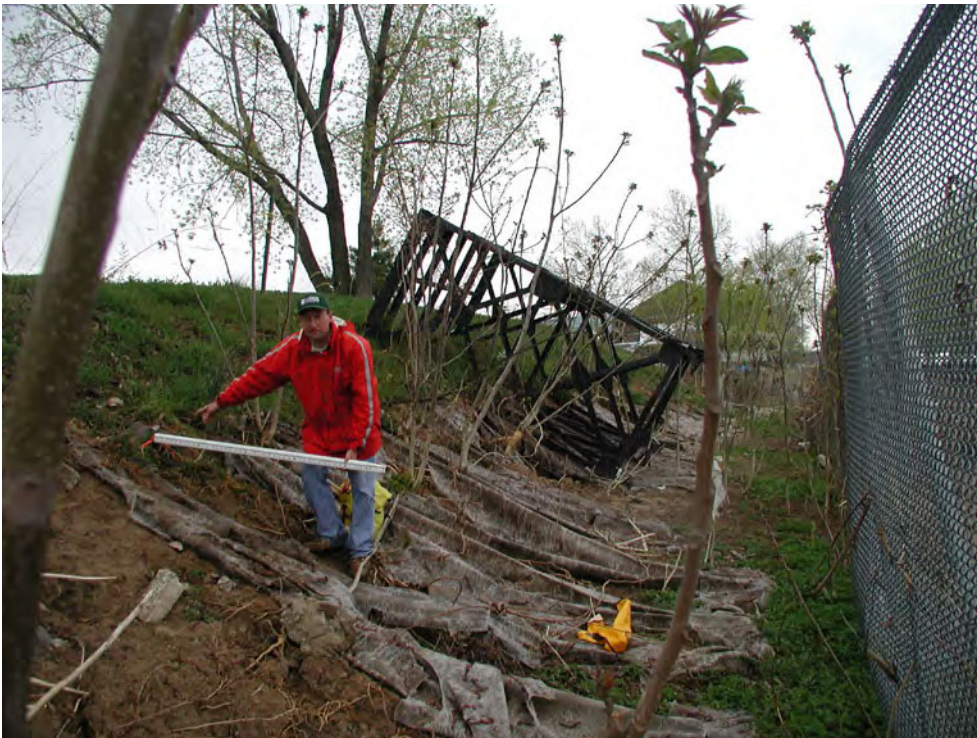
High-water mark NJ 27.2 (lat 40° 12' 28.9", long 74° 45' 57.4"), at an elevation of 17.8 feet above NGVD 29, is a fair wash line on embankment, 500 feet downstream from the US Route 1 bridge, and was marked with a metal rebar.

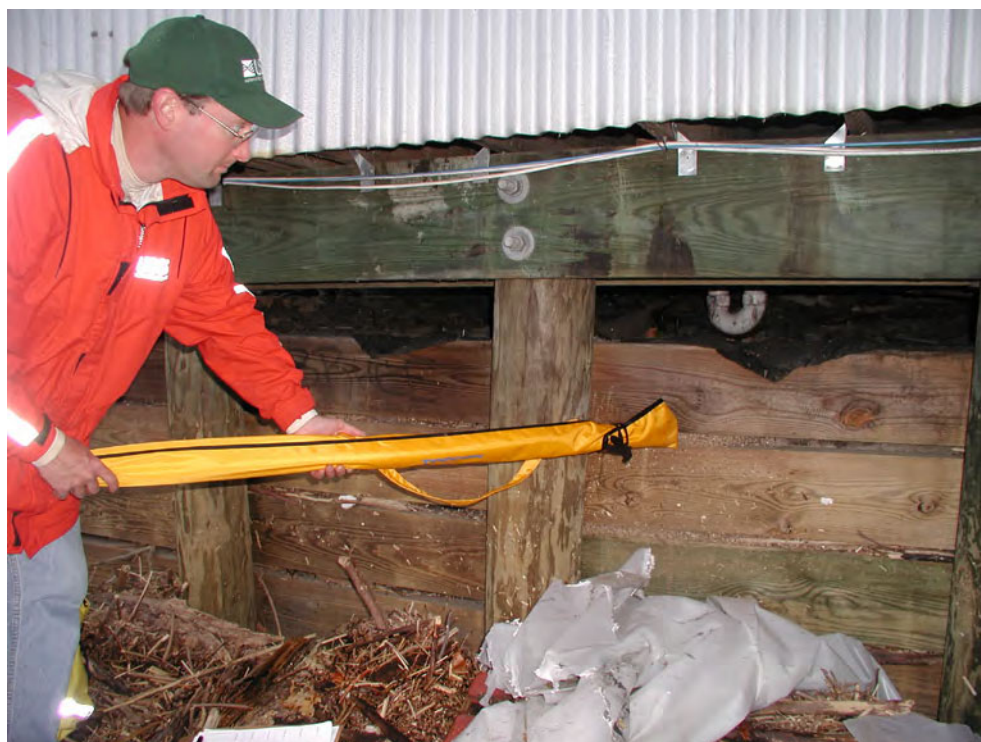
High-water mark NJ 27.3 (lat 40° 12' 25.2", long 74° 45' 55.1"), at an elevation of 16.9 feet above NGVD 29, is a good seed line on the deck of a restaurant (Kat Man Du), 1,000 feet downstream from the US Route 1 bridge. NOTE: The mark was transferred from under the deck to a 2-foot diameter tree nearby and marked with a metal USGS washer and nail (transferred mark on tree is about 7 feet above the ground).

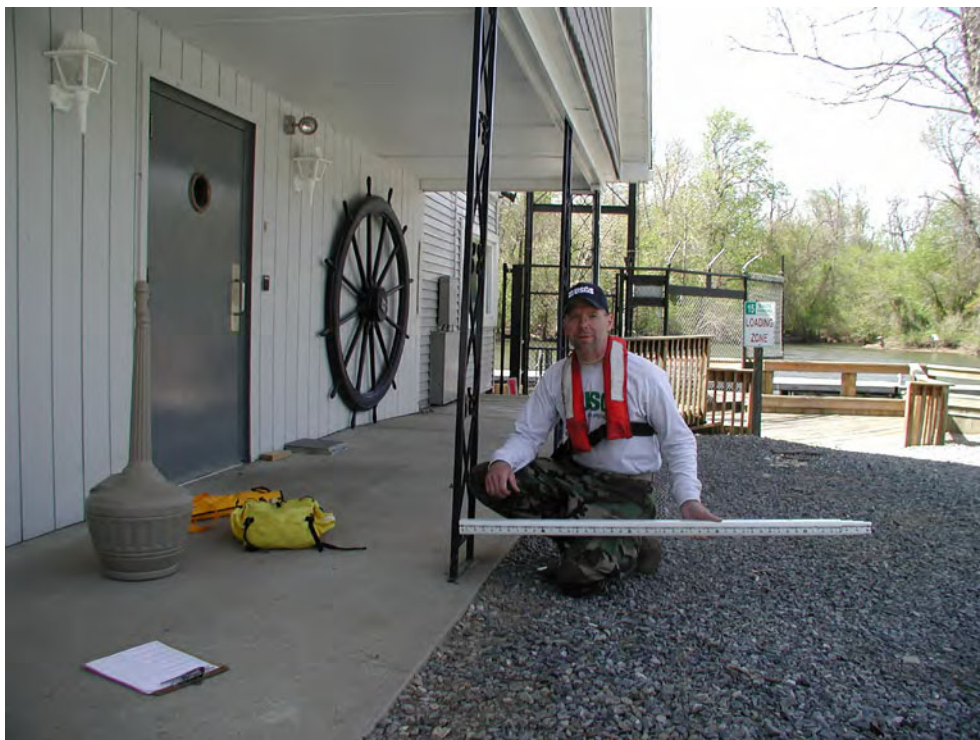
High-water mark NJ 29.1 (lat 40° 09' 03.7", long 74° 42' 56.0"), at an elevation of 11.1 feet above NGVD 29, is an excellent mud line on the overhang support at the Bordentown Yacht Club, 0.7 feet above the ground, near the mouth of Crosswicks Creek, and was marked with a black marker line.

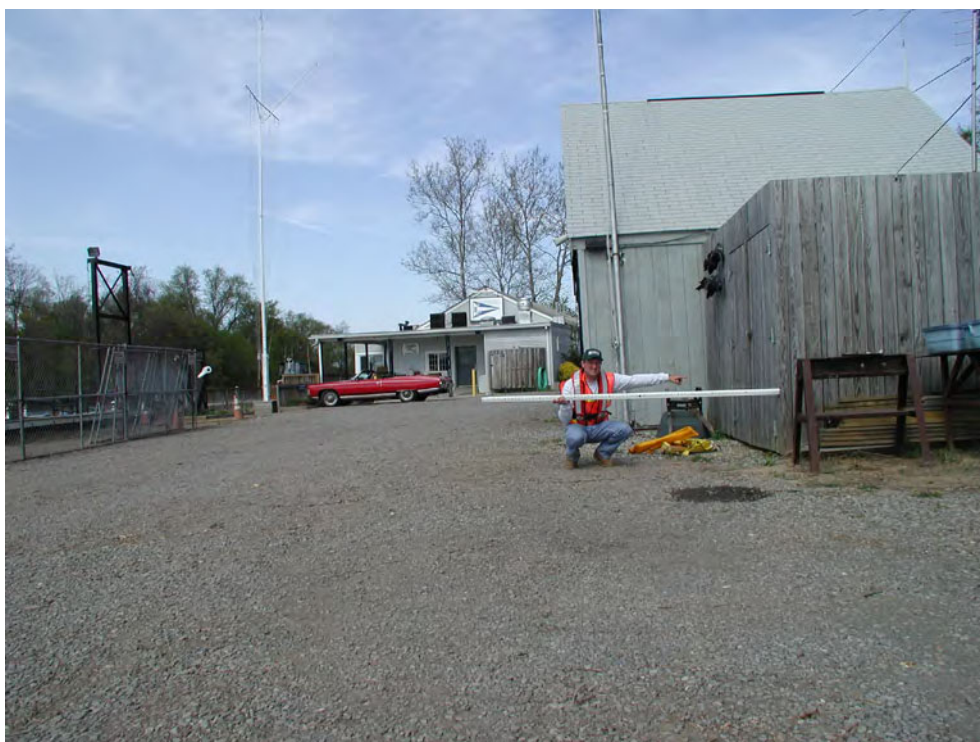
High-water mark NJ 29.2 (lat 40° 09' 02.0", long 74° 42' 57.8"), at an elevation of 11.0 feet above NGVD 29, is an excellent mud line on a storage facility at the Bordentown Yacht Club, 2.1 feet above the ground, across from the mouth of Crosswicks Creek, and was marked with a black marker line.

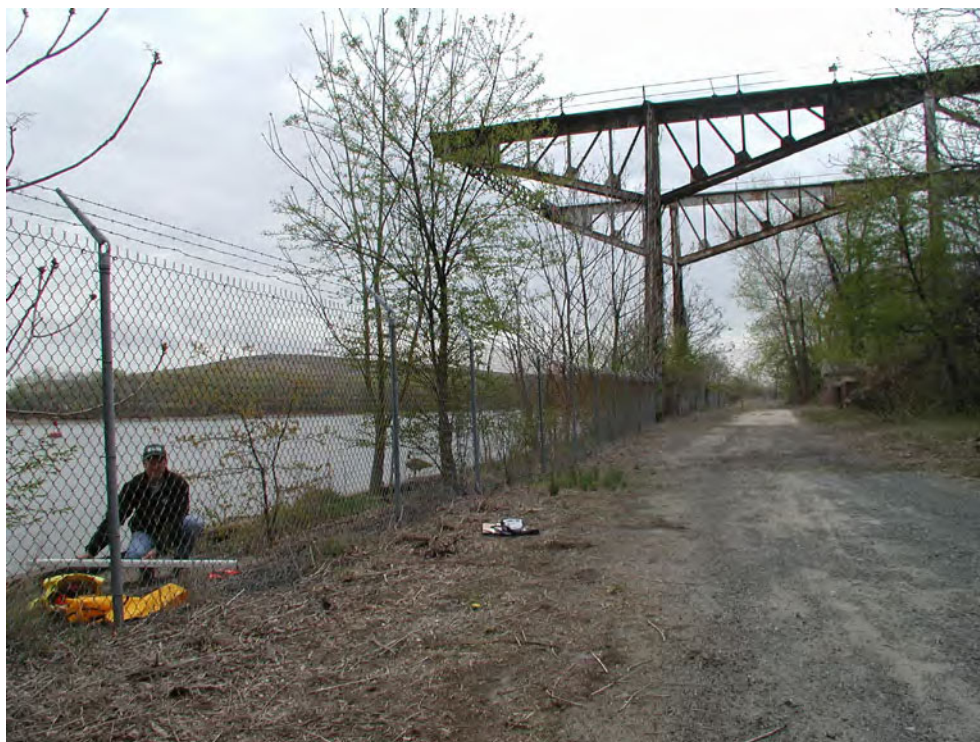
High-water mark NJ 30.1 (lat 40° 07' 34.4", long 74° 49' 02.0"), at an elevation of 9.54 feet above NGVD 29, is a good debris line on the ground just above the bulkhead at DC Fabricators, 1.0 miles upstream from the New Jersey Turnpike, and was marked with a metal rebar.

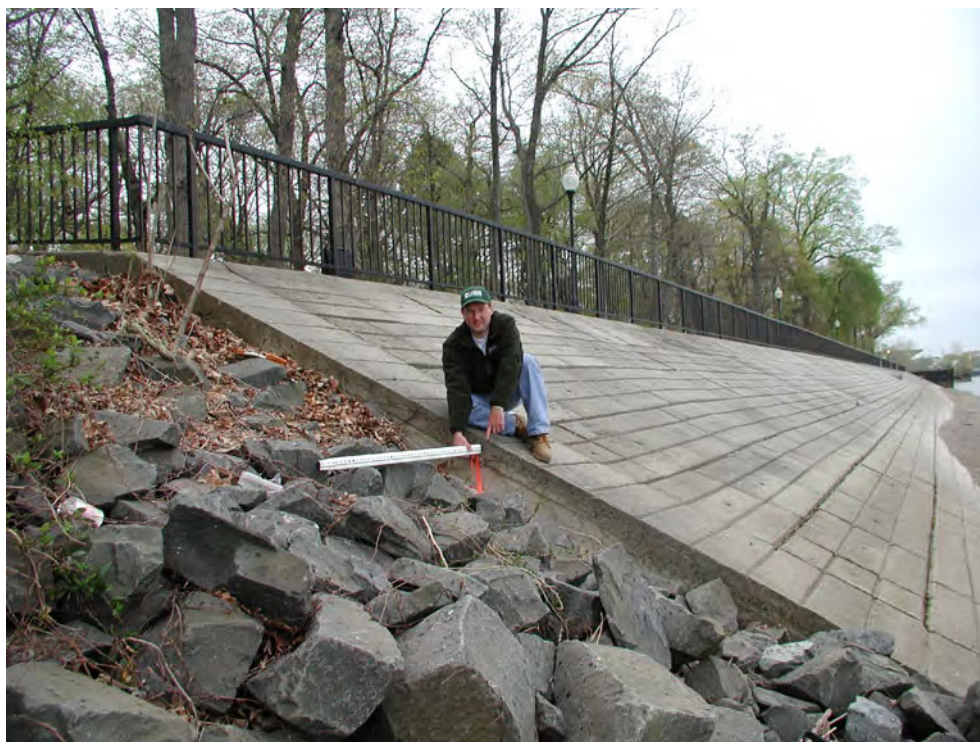
High-water mark NJ 30.2 (lat 40° 07' 30.0", long 74° 48' 40.5"), at an elevation of 9.4 feet above NGVD 29, is a fair debris line on a sloped retaining wall at H. Kenneth Wilkie Memorial River's Edge Park, 1.4 miles upstream from the New Jersey Turnpike, and was marked with a metal USGS washer and nail.

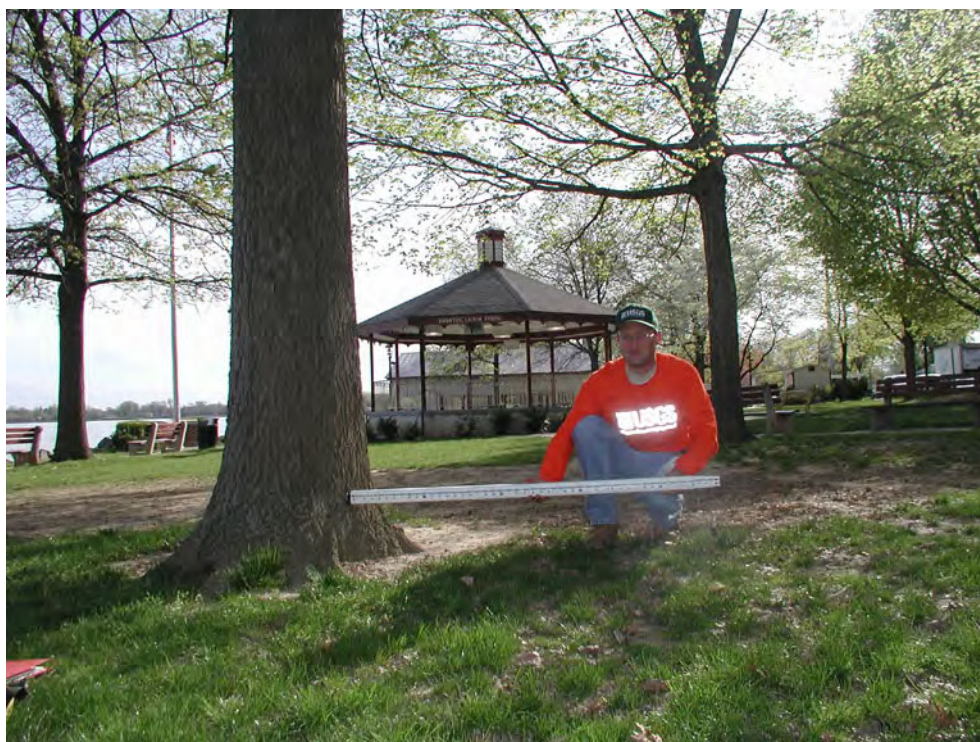
High-water mark PA 32.1 (lat 40° 05' 38.3", long 74° 51' 26.3") at an elevation of 9.1 feet above NGVD 29, is a good seed line on a 2.3-foot diameter tree at Bristol Lions Park, 2.4 feet above the ground, 1.2 miles upstream from Burlington-Bristol Bridge, and was marked with a metal USGS washer and nail.

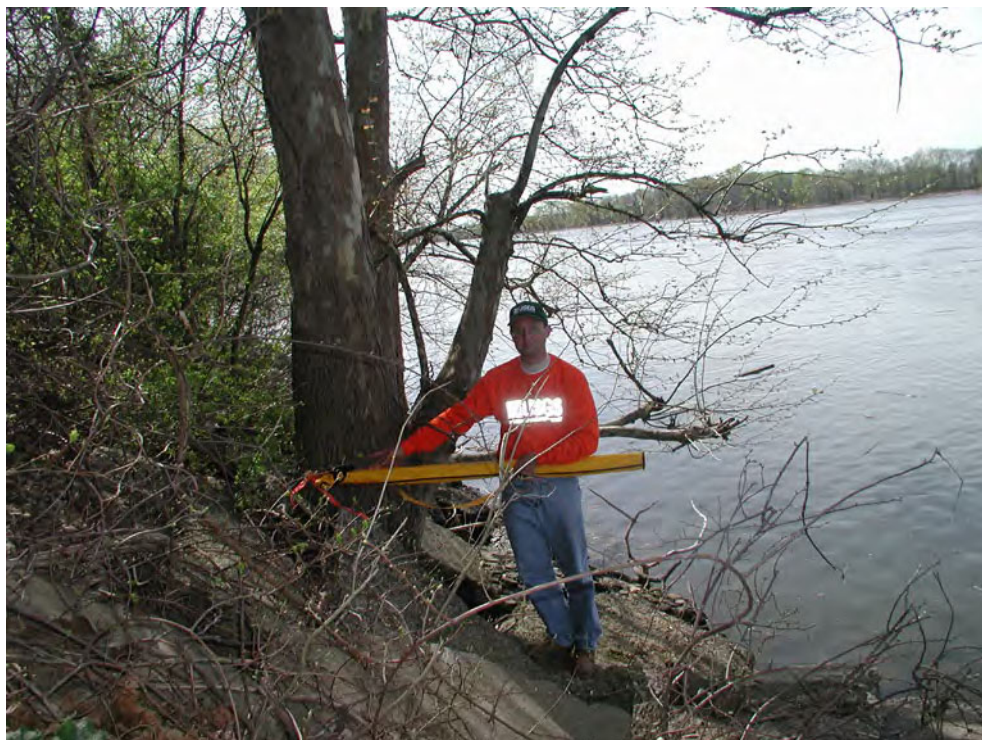
High-water mark NJ 31.1 (lat 40° 04' 48.4", long 74° 52' 08.8"), at an elevation of 9.0 feet above NGVD 29, is a fair seed line on a 2.7-foot diameter tree, 1.2 feet above the ground, 45 feet downstream from the Burlington-Bristol Bridge, and was marked with a metal USGS washer and nail. NOTE: This site is tide-affected. The high-water mark is most likely from the high-tide which actually occurred on April 2, 2005, before the peak of the flood, as recorded at the USGS continuous-record tide-gaging station 01464598, Delaware River at Burlington, NJ, which is 0.3 miles downstream.

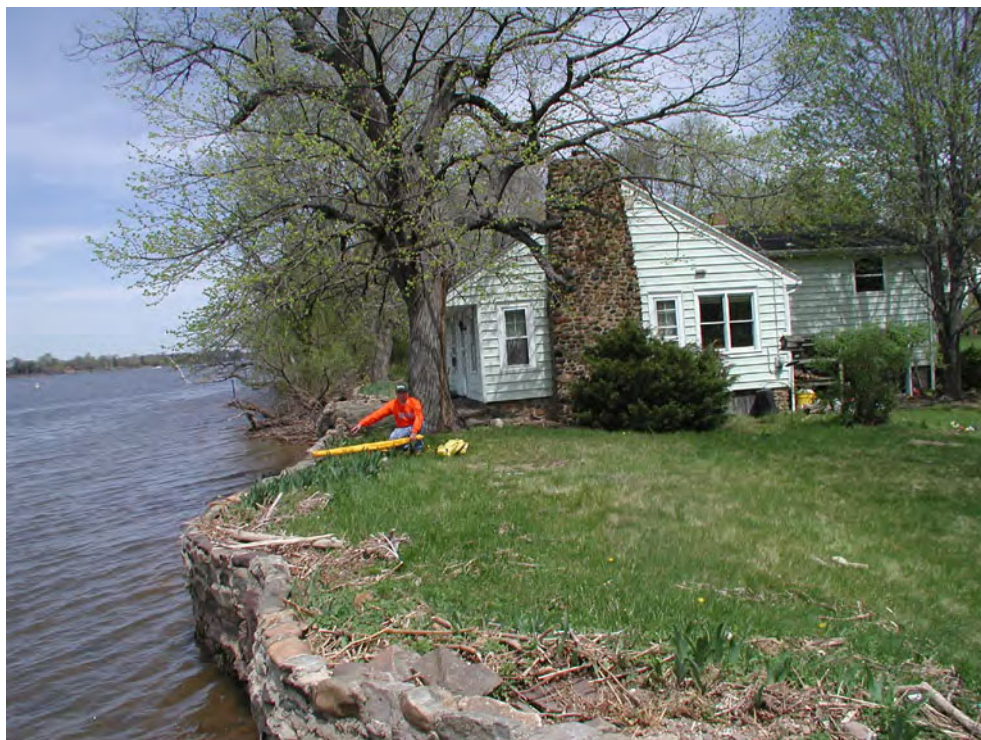
High-water mark NJ 32.1 (lat 40° 01' 47.8", long 74° 59' 36.2"), at an elevation of 8.6 feet above NGVD 29, is a good debris line on stone wall, next to house on Taylors Lane, and was marked with a black marker line.

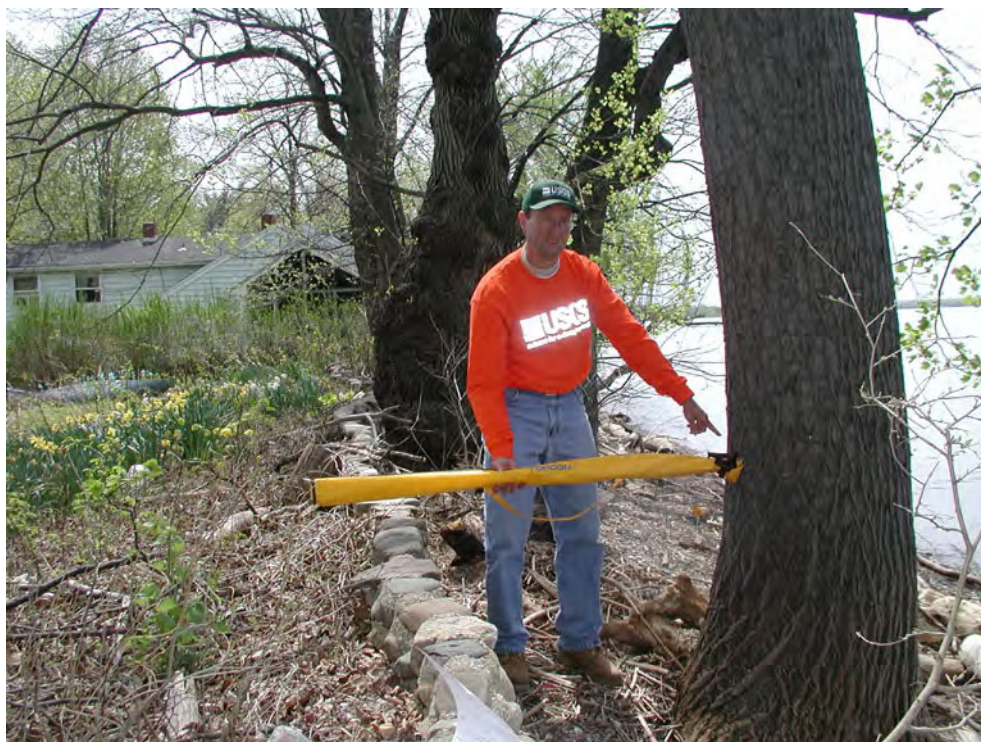
High-water mark NJ 32.2 (lat 40° 01' 49.3", long 74° 59' 35.1"), at an elevation of 9.4 feet above NGVD 29, is a fair seed line on a 2.9-foot diameter tree near house on Taylors Lane, and was marked with a metal USGS washer and nail. NOTE: This site is tide-affected. Marks are most likely from high tide, which occurred on April 2, 2005, before the peak of the flood.
