# Re-evaluation of the 1921 Peak Discharge at Skagit River near Concrete, Washington

Scientific Investigations Report 2007–5159

By M.C. Mastin

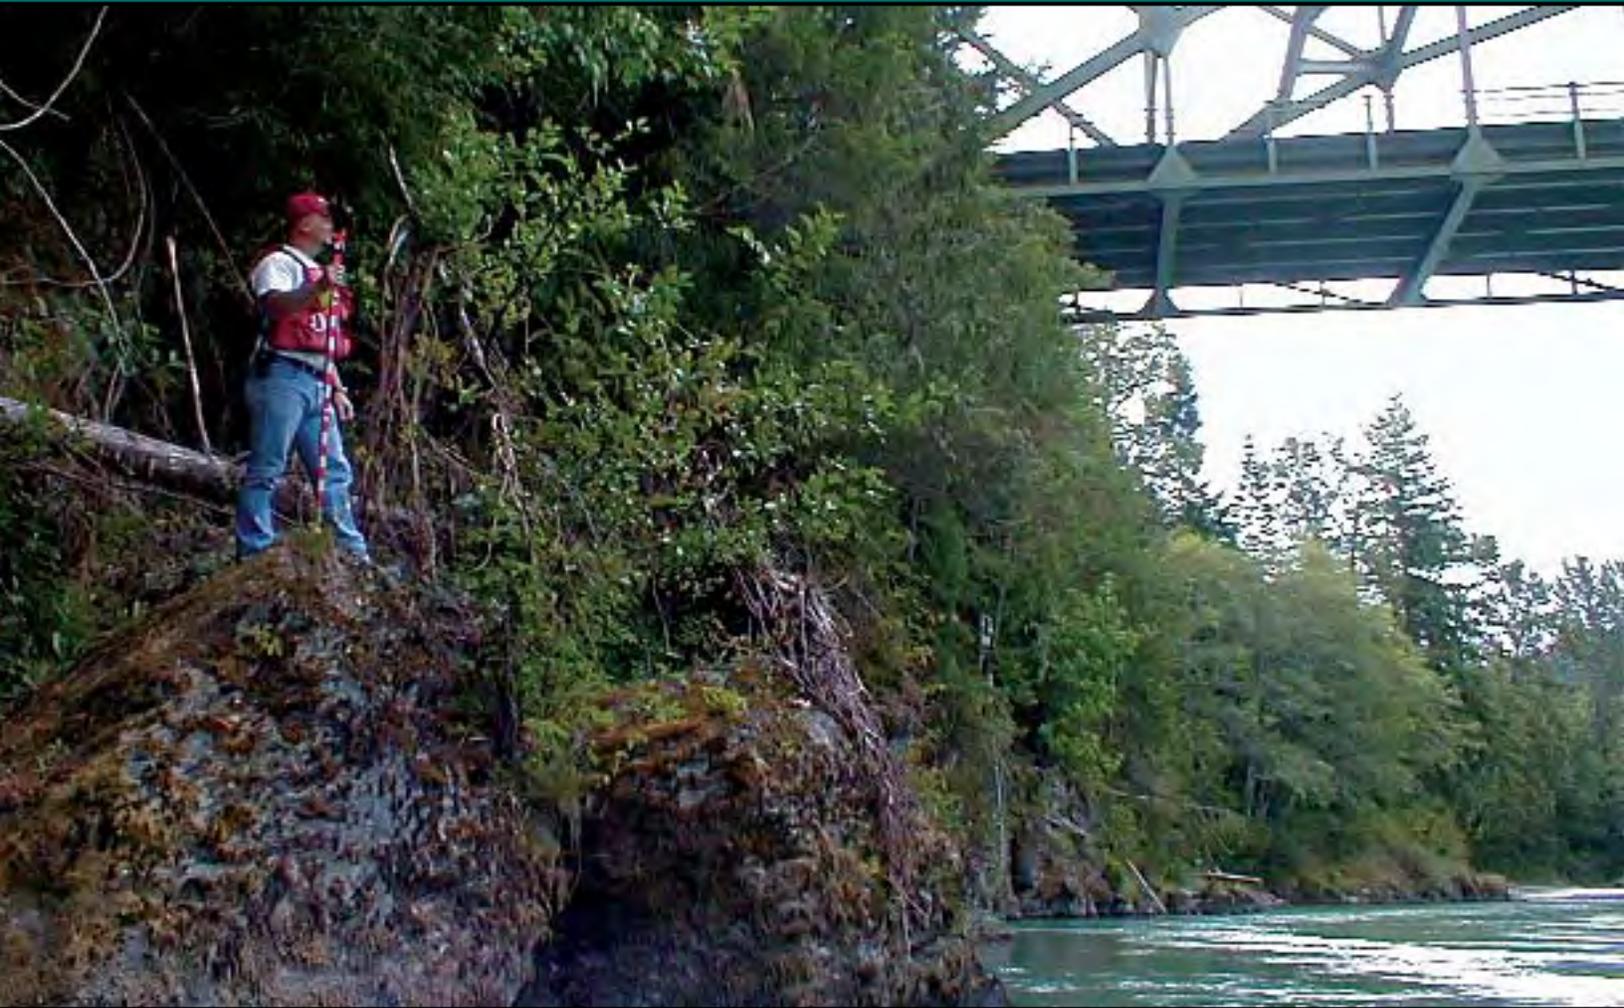
**Cover:** Photograph of Darrin Miller, U.S. Geological Survey, surveying a high water mark left from the 2003 flood on the right bank of the Skagit River on the mouth of the Dallas Gorge near Concrete, Washington. (Photograph taken by Jeffrey Paulat, U.S. Geological Survey, August 2004).

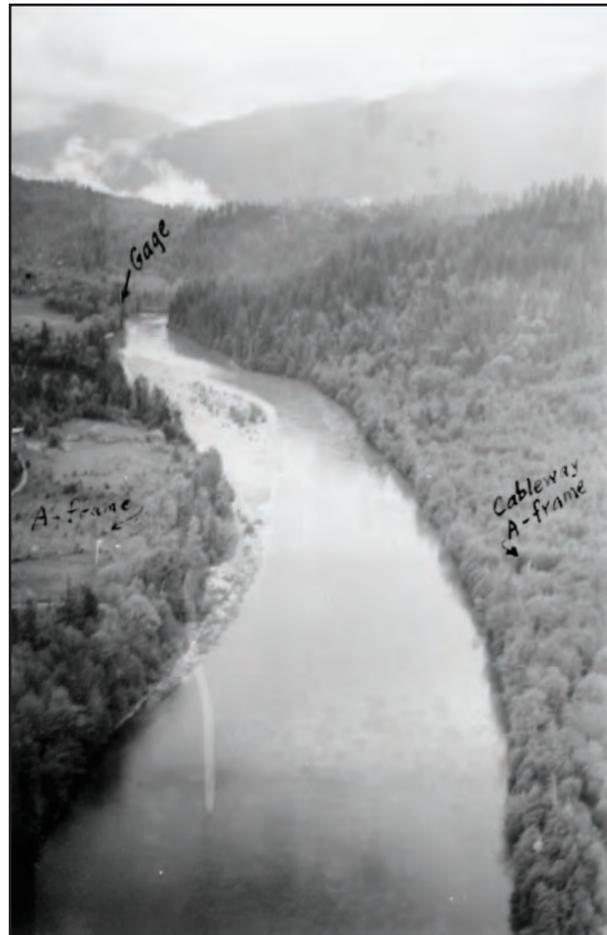
**A.** Skagit River near Concrete, Washington. Looking downstream from top of gage house. Photograph taken by J. Bonner, U.S. Geological Survey, June or July 1932.

**B.** Skagit River near Concrete, Washington. Looking upstream. Photograph taken from helicopter by F. Veatch., U.S. Geological Survey, May 8, 1948.

**Figure 4.** Historical photographs showing only small, sparse brush on the island/bar near cross section 2, Skagit River, Washington. Historical photographs on file at the U.S. Geological Survey, Washington Water Science Center.

lower stages) crossed by XS2. This island/bar was likely barren and void of vegetation during the 1920s due to the series of large floods from 1897 to 1921. A series of historical photographs beginning in 1937 (historical photographs on file at the U.S. Geological Survey, Washington Water Science Center) shows a barren island/bar that has gradually increased in the amount of established vegetation. This island/bar is now densely forested.
