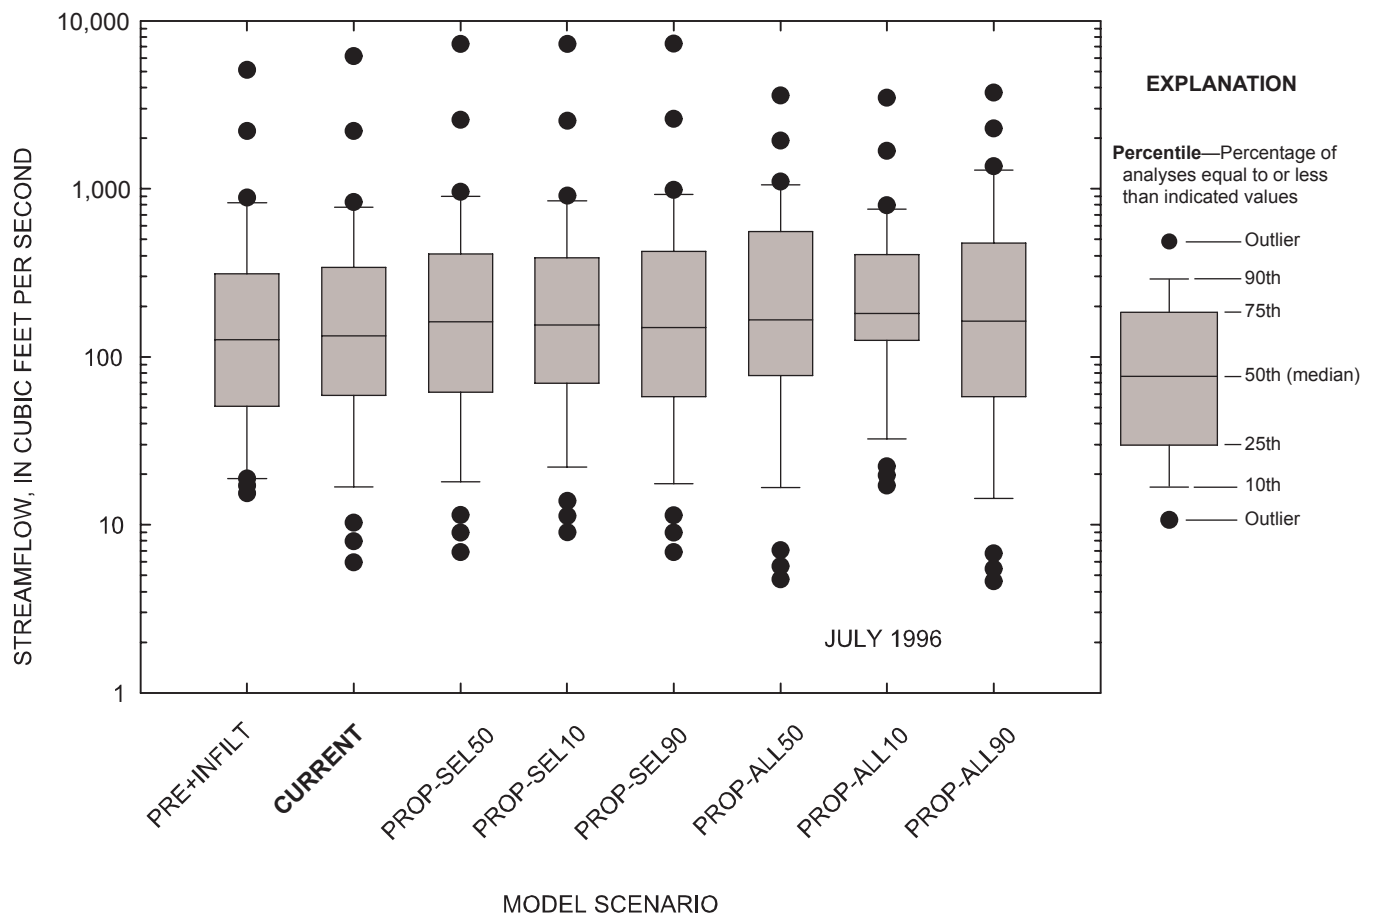
Figure 5-22. Comparison of daily streamflow for observed and simulated conditions at the Marmaton River near the Missouri-Kansas state line, Missouri, July 1996.
