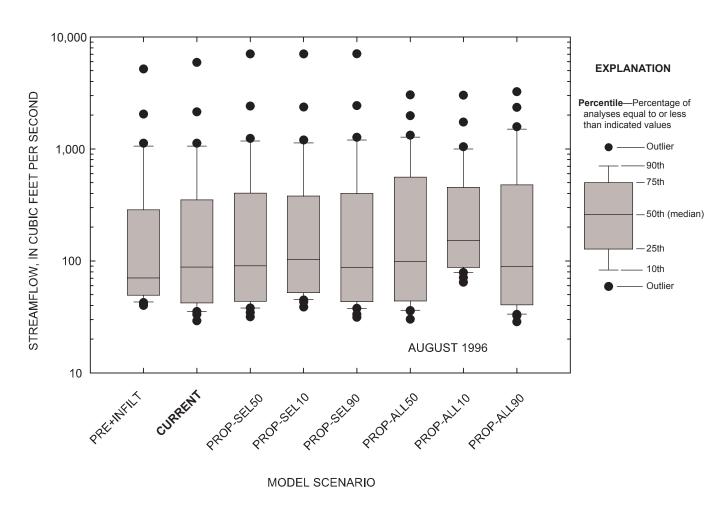
Figure 5-23. Comparison of daily streamflow for observed and simulated conditions at the Marmaton River near the Missouri-Kansas state line, Missouri, August 1996.
