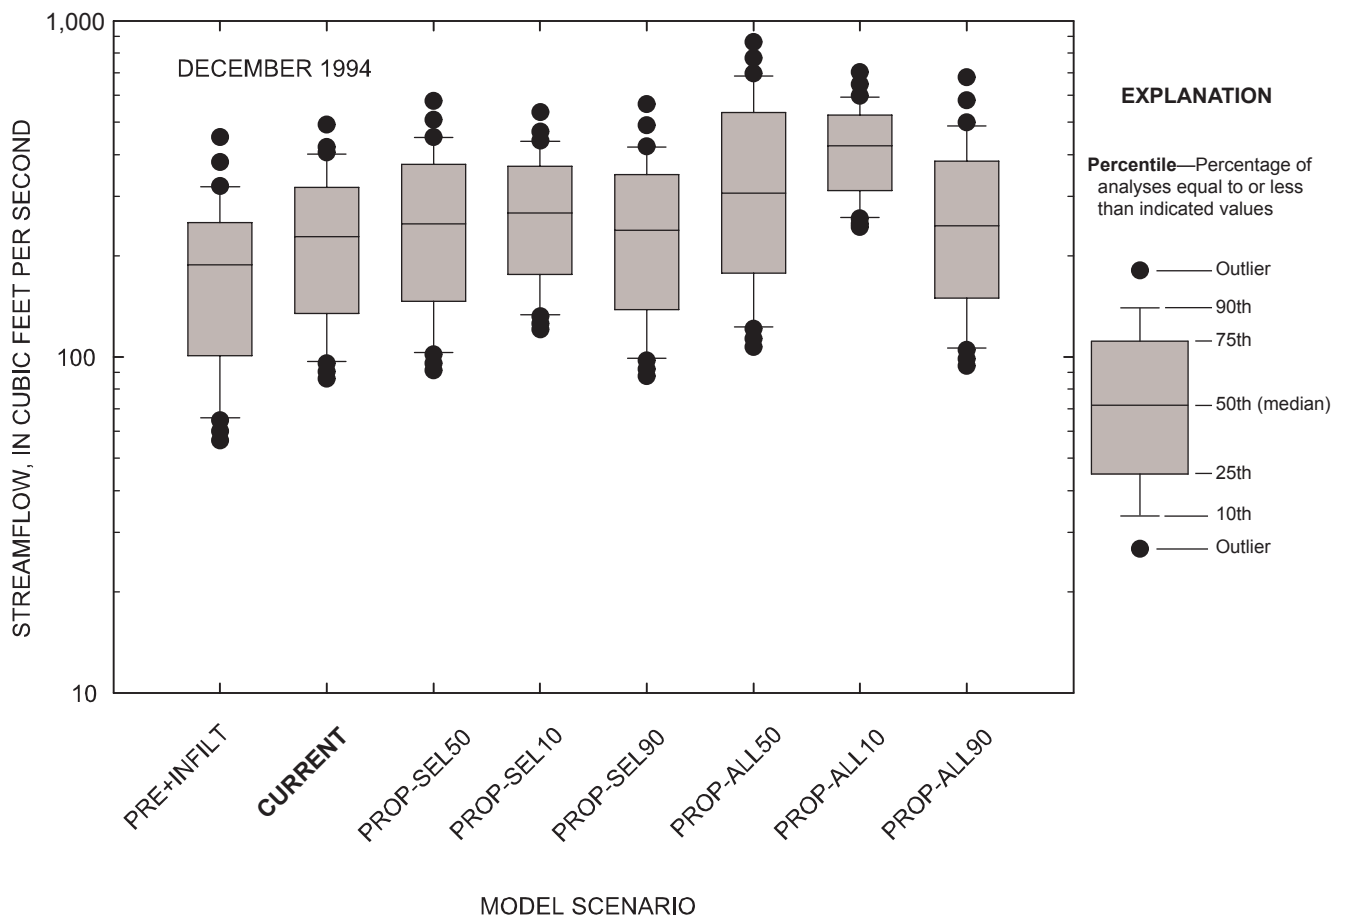
Figure 5-3. Comparison of daily streamflow for observed and simulated conditions at the Marmaton River near the Missouri-Kansas state line, Missouri, December 1994.
