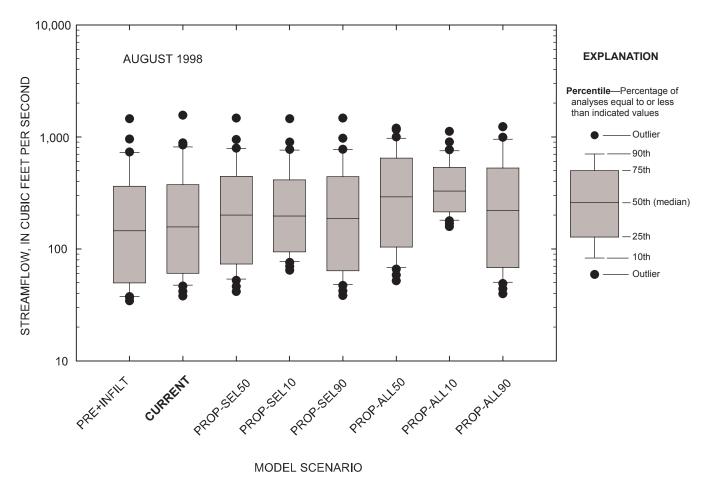
**Figure 5-47.** Comparison of daily streamflow for observed and simulated conditions at the Marmaton River near the Missouri-Kansas state line, Missouri, August 1998.
