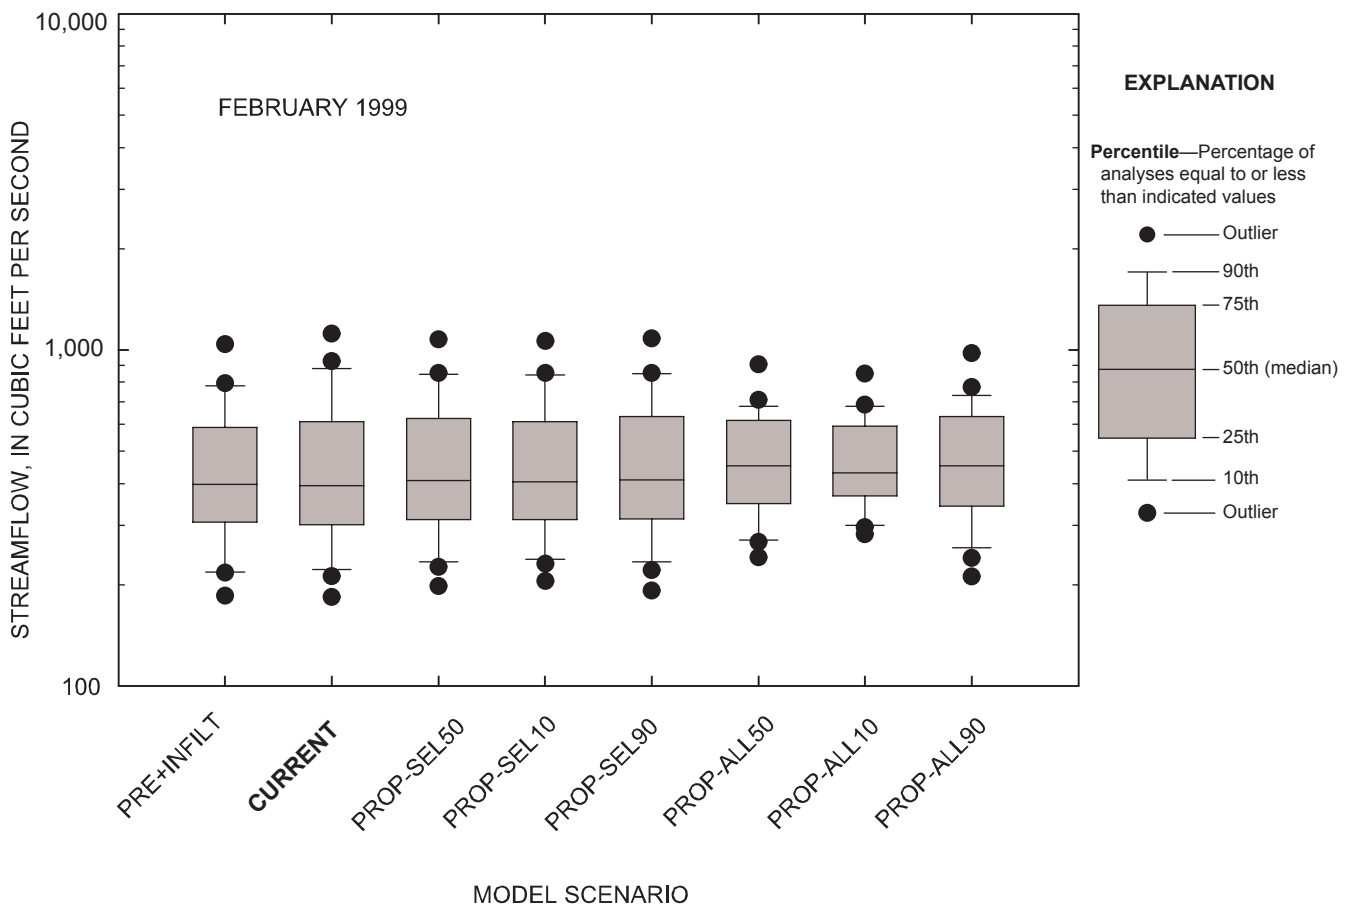
Figure 5-53. Comparison of daily streamflow for observed and simulated conditions at the Marmaton River near the Missouri-Kansas state line, Missouri, February 1999.
