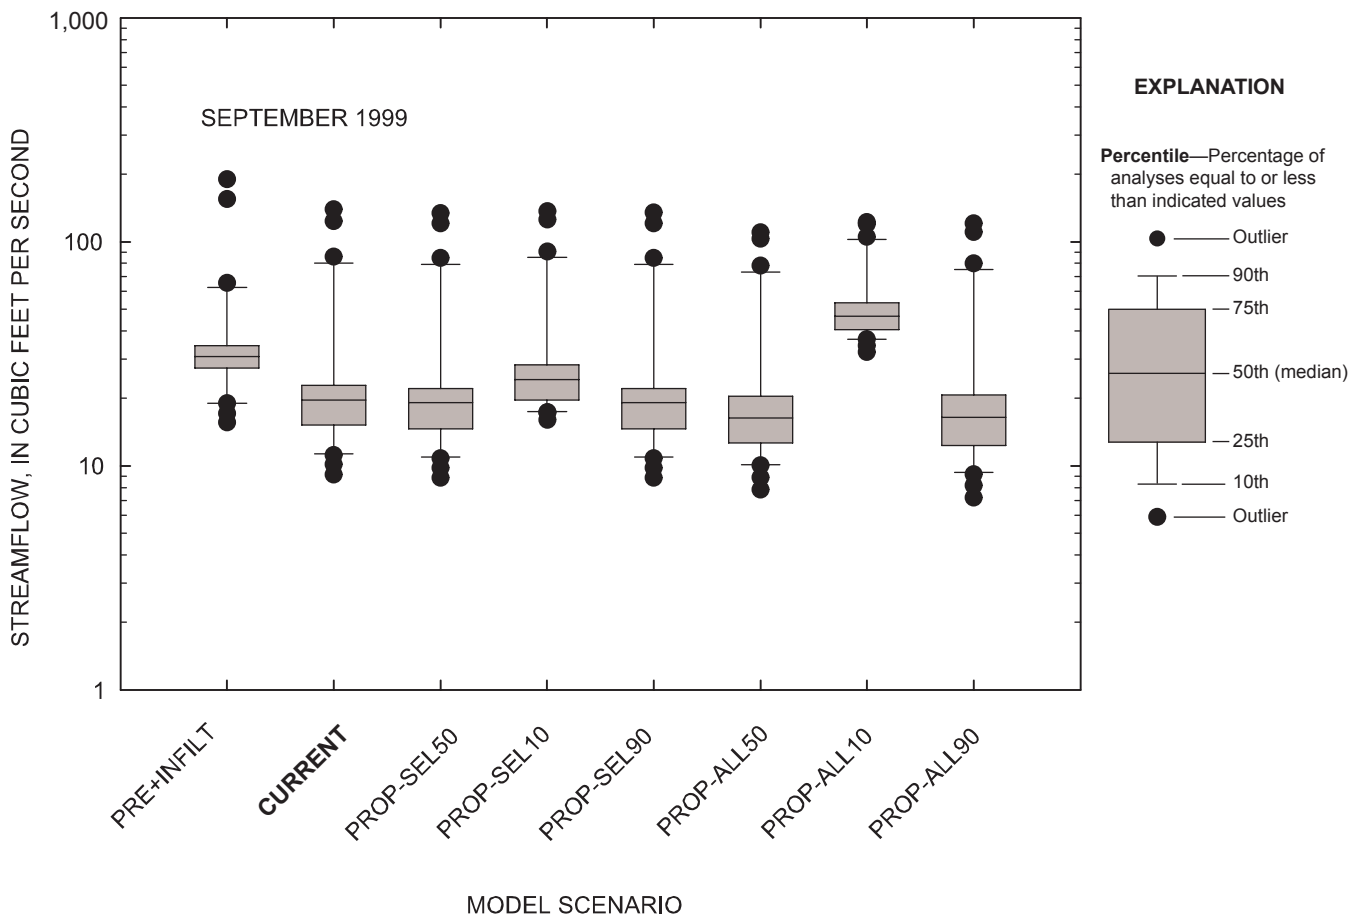
Figure 5-60. Comparison of daily streamflow for observed and simulated conditions at the Marmaton River near the Missouri-Kansas state line, Missouri, September 1999.
