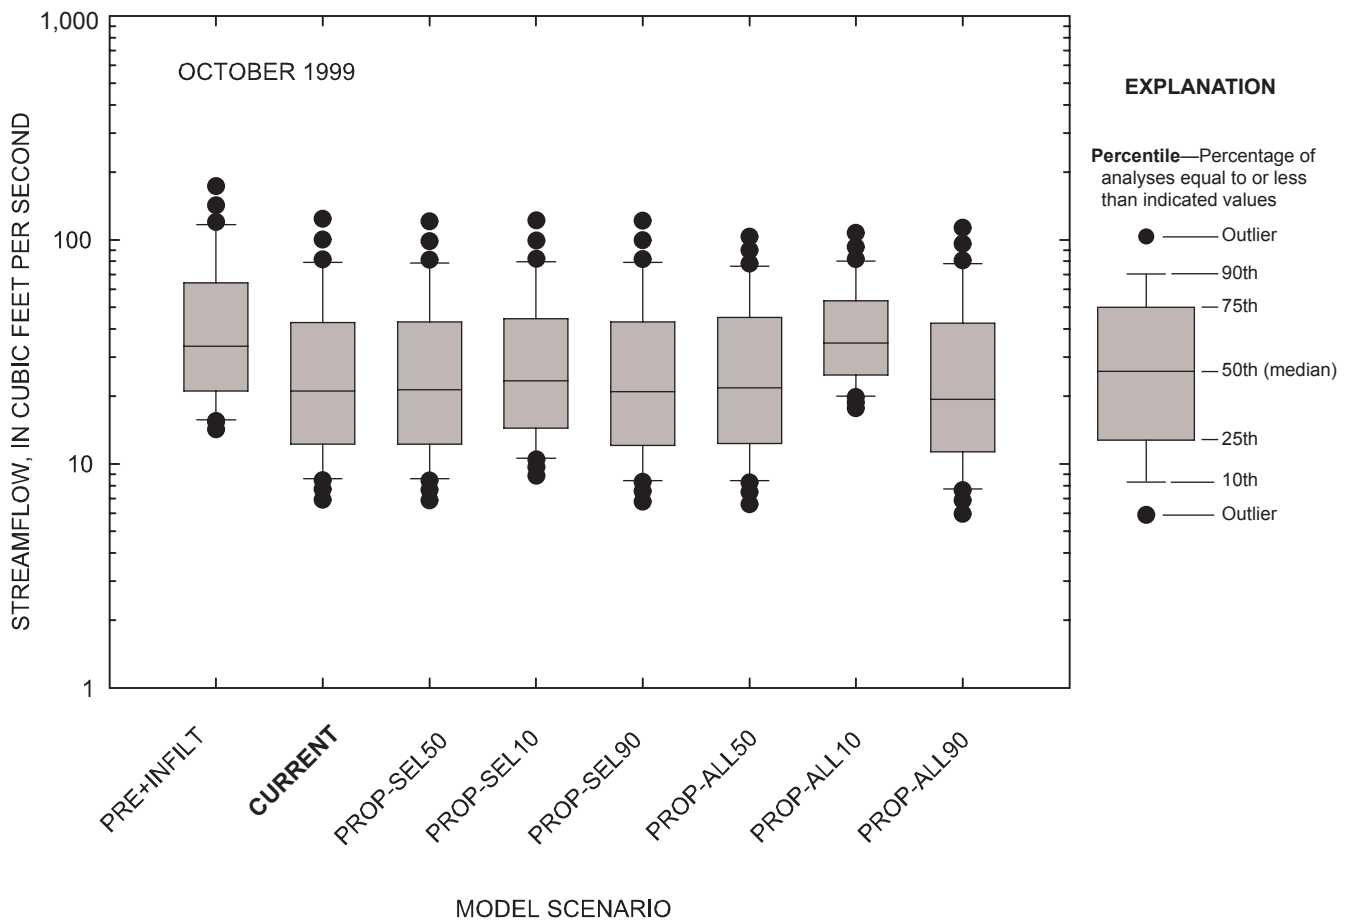
**Figure 5-61.** Comparison of daily streamflow for observed and simulated conditions at the Marmaton River near the Missouri-Kansas state line, Missouri, October 1999.
