**Appendix A. Individual Evaluations of 30 Peak Discharges from
28 Extraordinary Floods in the United States**

Seco Creek near D'Hanis, Texas

Review of peak discharge for the flood of May 31, 1935

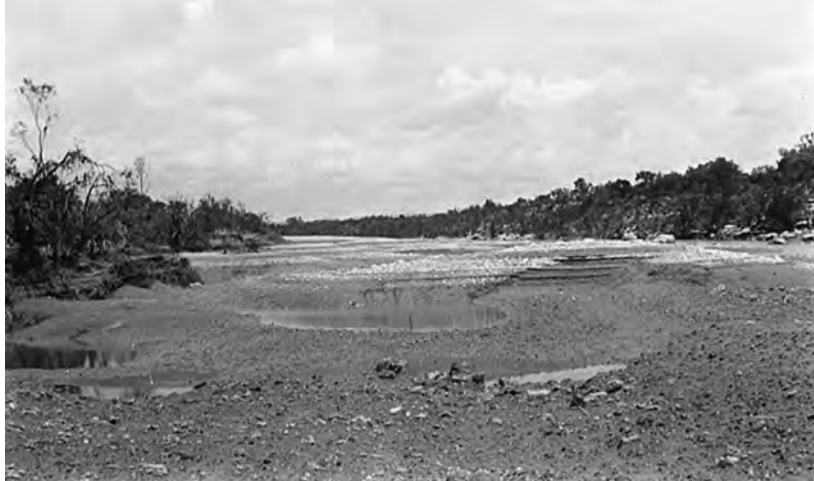
Figure A1. View looking upstream of lower cross section, Seco Creek, Texas, June 8, 1935.

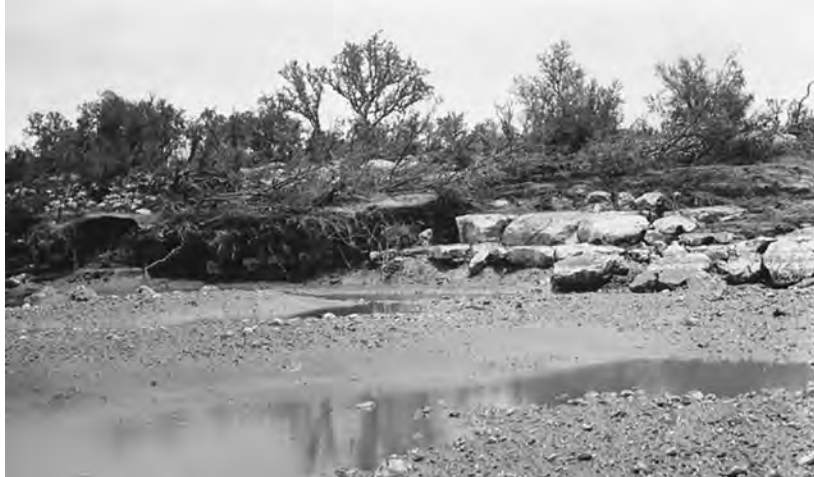
Figure A2. View looking upstream along right bank of lower cross section, Seco Creek, Texas, June 8, 1935.

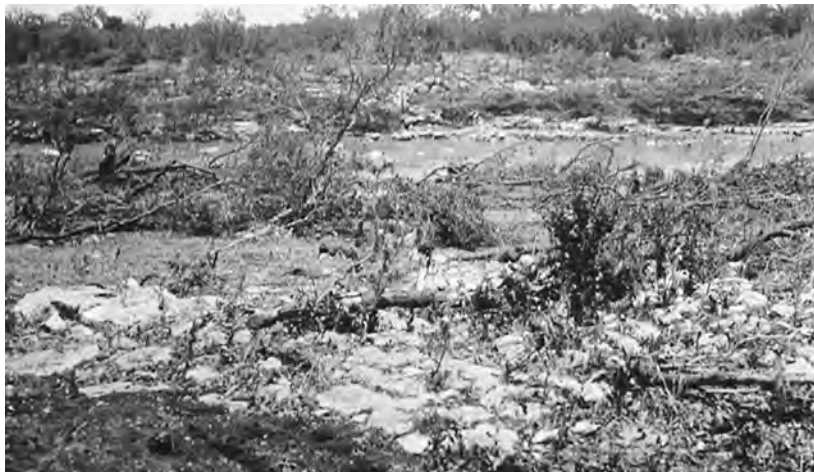
Figure A3. View looking toward left bank at lower cross section, Seco Creek, Texas, June 8, 1935.

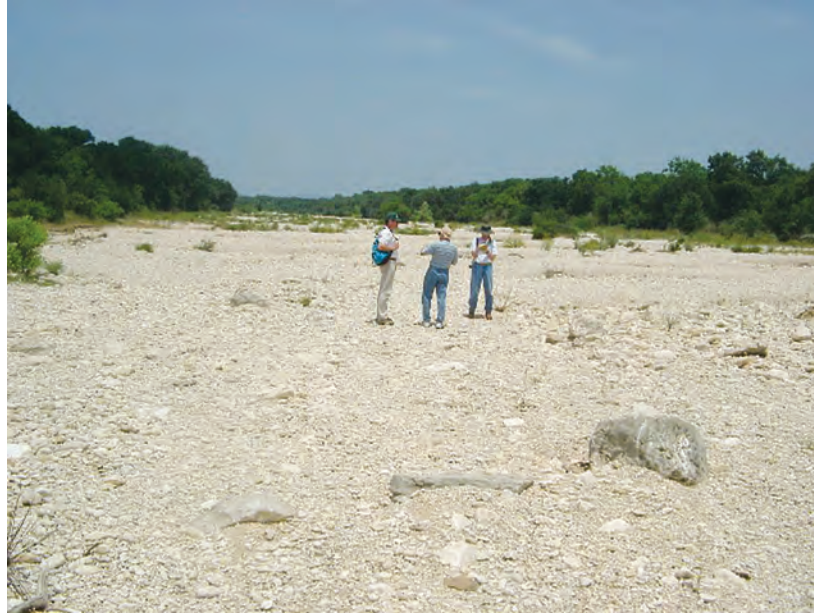
Figure A4. View from right to left bank near middle of slope-area reach, Seco Creek, Texas, June 8, 1935.

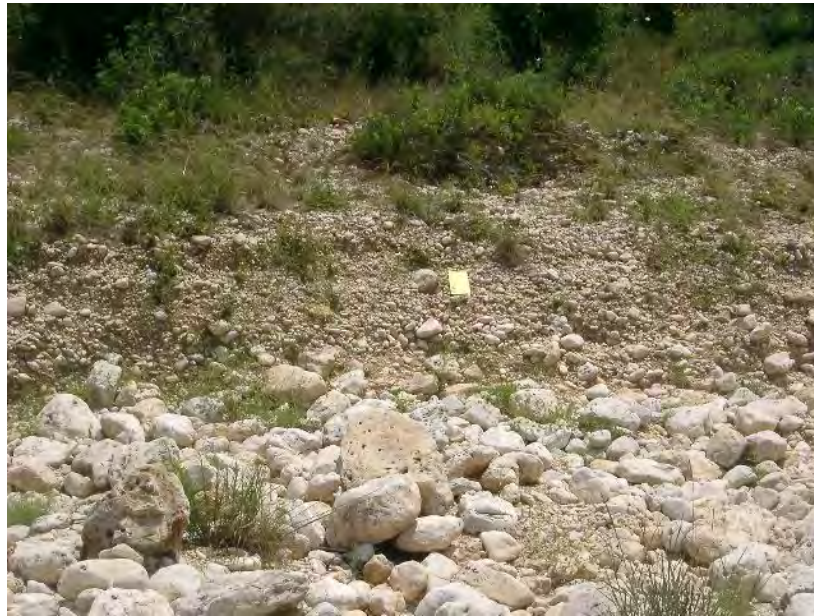
Figure A5. Slope-area reach of Seco Creek, Texas, looking upstream, June 2003.

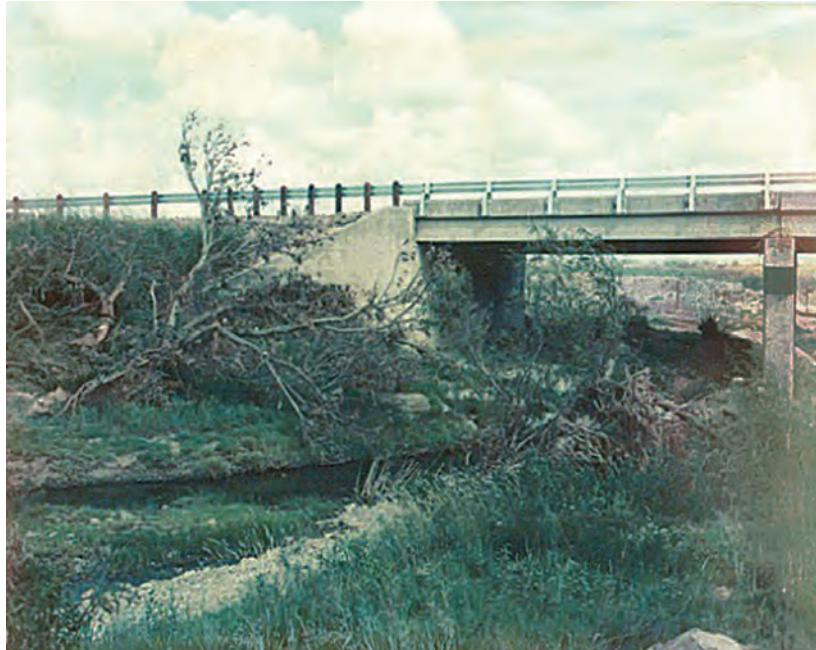
Figure A7. View from right end of bridge looking across bridge, North Fork Hubbard Creek near Albany, Texas, August 5, 1978. Flood of August 4, 1978, was about 2 feet over handrail.

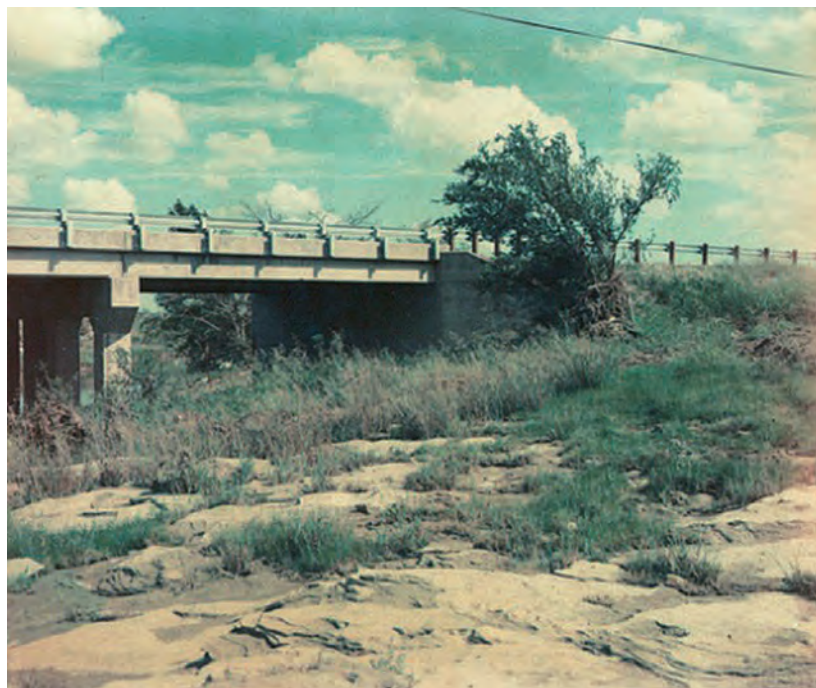
Figure A8 View of left abutment and upstream wingwall, North Fork Hubbard Creek near Albany, Texas, September 20, 1978.

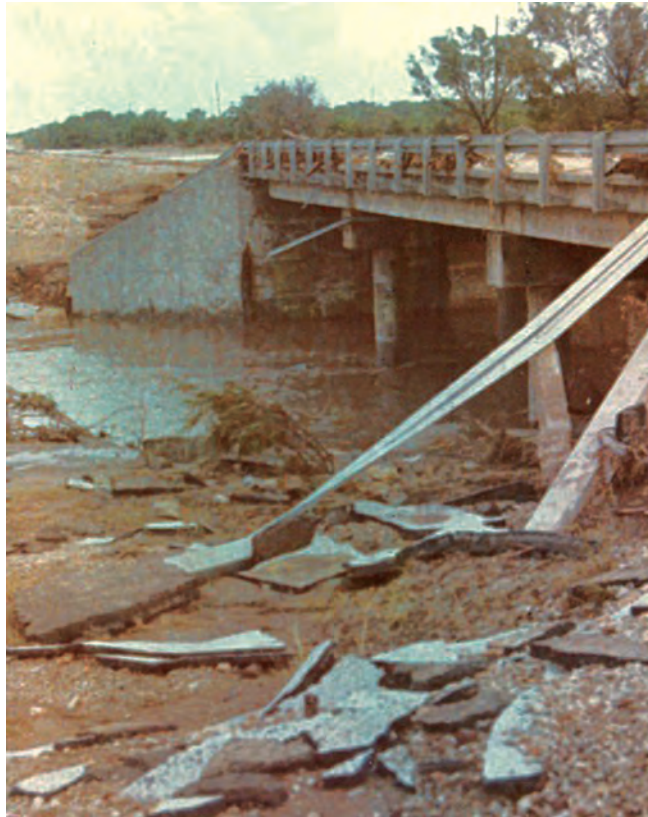
Figure A9. View of right abutment and upstream wingwall, North Fork Hubbard Creek near Albany, Texas, September 20, 1978.

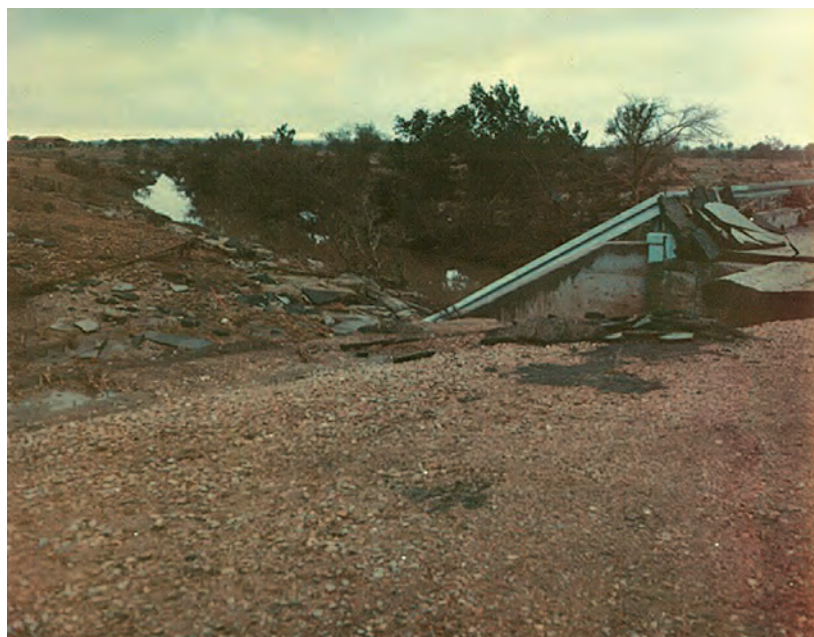
Figure A10. View looking downstream side of bridge from left bank, North Fork Hubbard Creek near Albany, Texas, August 4, 1978.

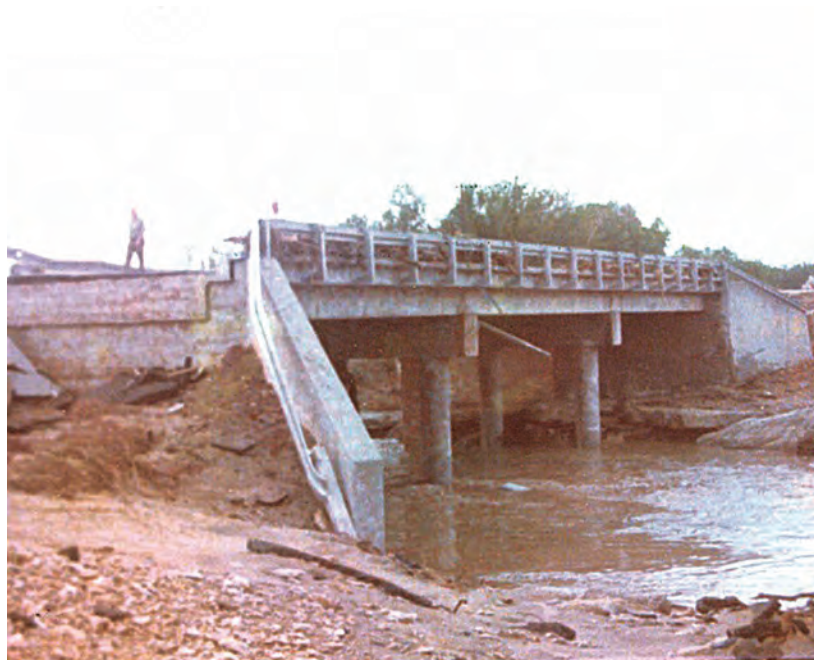
Figure A11. View from near left end of bridge at gaging station looking downstream, North Fork Hubbard Creek near Albany, Texas, August 5, 1978.

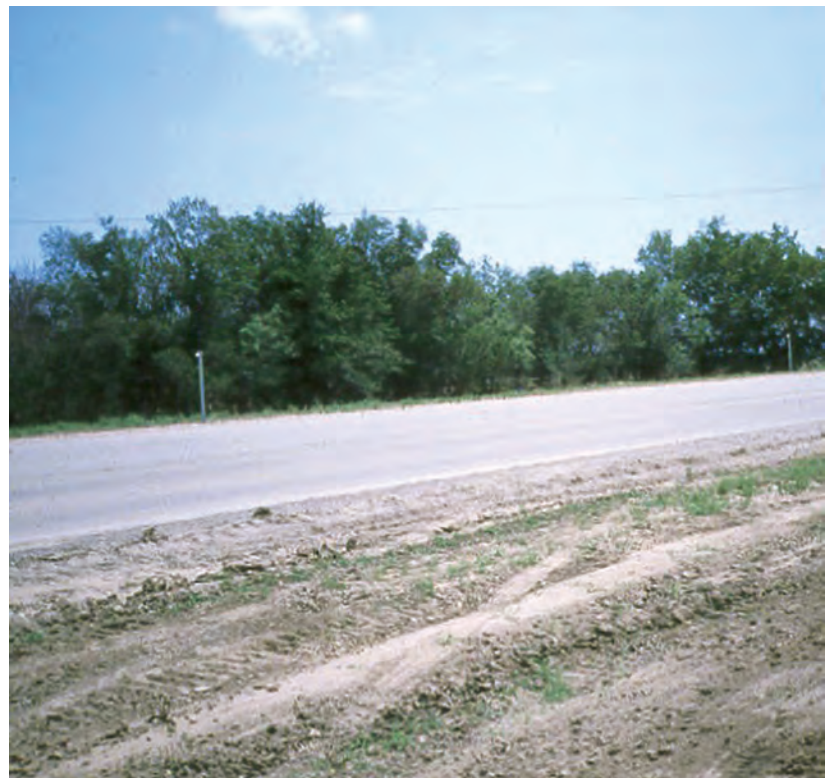
Figure A16. Upstream side of State Highway 6 overflow near right bank looking toward left bank with rod held near fence at the high-water mark in the approach section, North Fork Hubbard Creek near Albany, Texas, August 15, 1978.

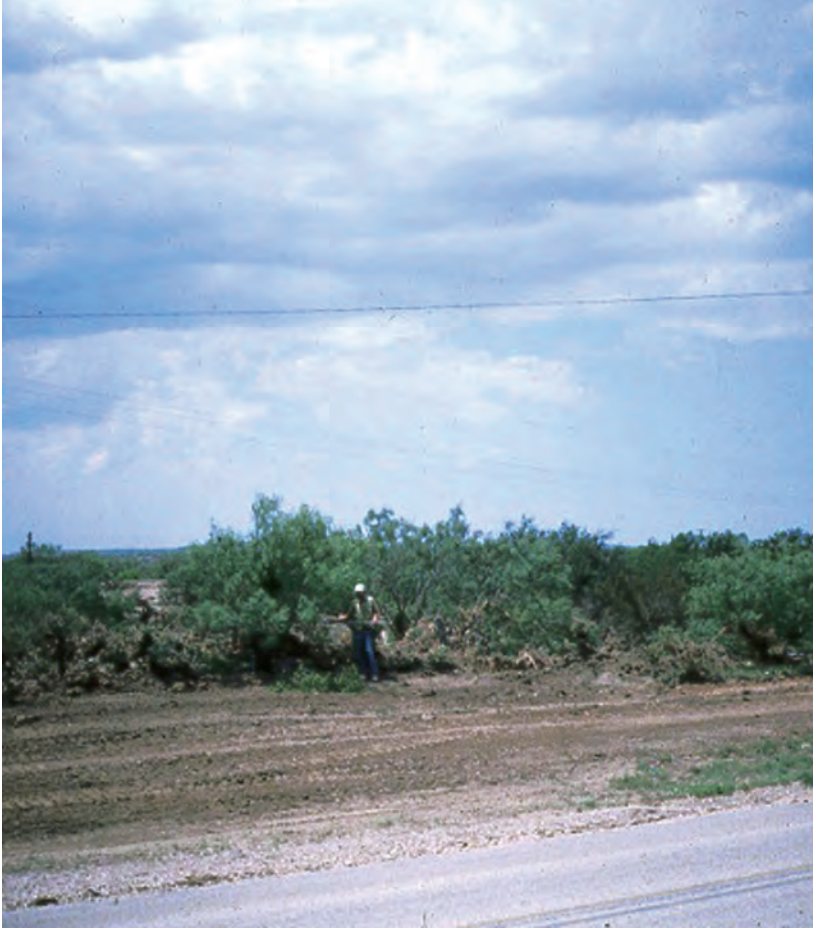
Figure A18. View near crest of State Highway 6 looking upstream with rod at high-water mark at approach section near left bank of main-channel overflow, North Fork Hubbard Creek near Albany, Texas, August 15, 1978.

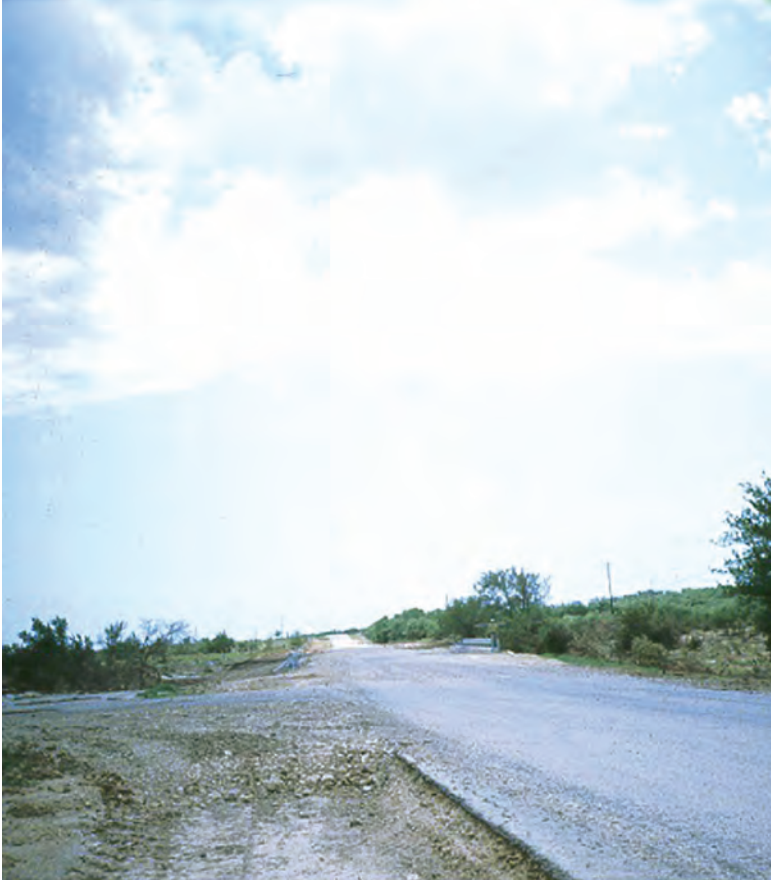
Figure A19. View from 200 feet to left of bridge and 25 feet downstream of State Highway 6 looking upstream across highway at approach section with rod held at high-water mark, North Fork Hubbard Creek near Albany, Texas, August 15, 1978.

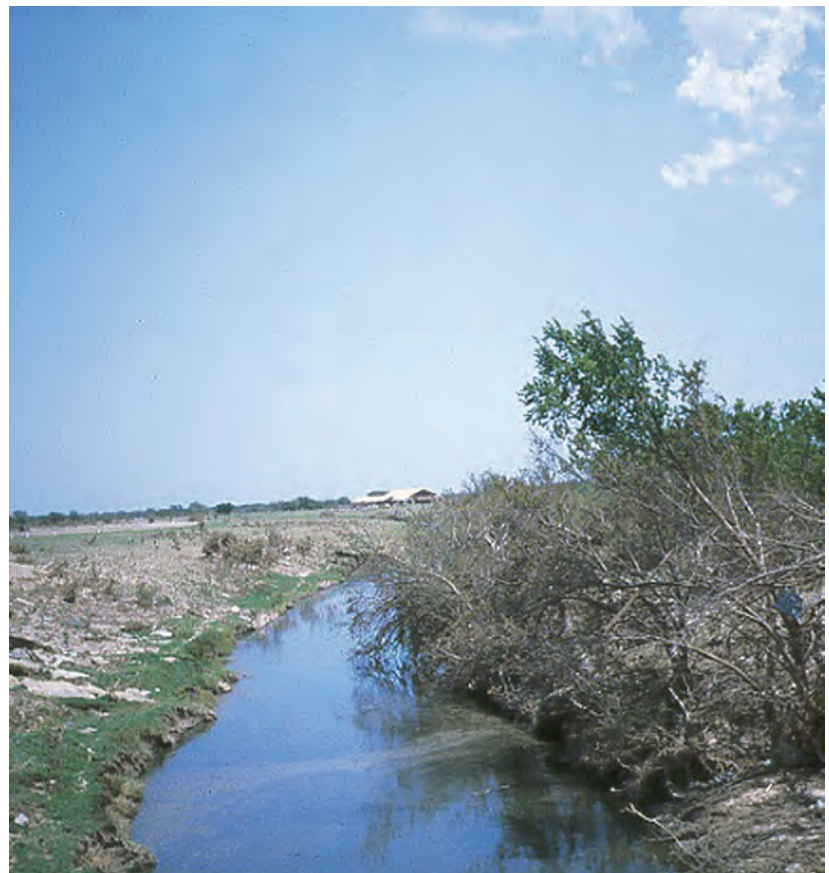
Figure A21. View from near gaging station at bridge looking downstream at channel, North Fork Hubbard Creek near Albany, Texas, August 15, 1978.

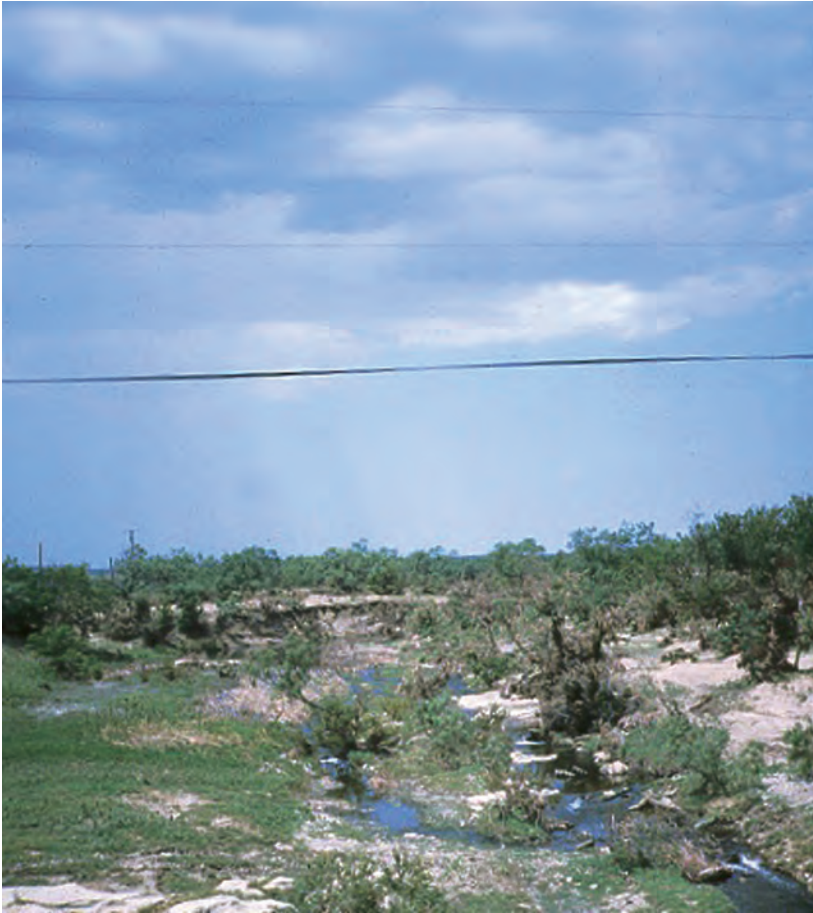
Figure A22. View from near gaging station on upstream side of bridge looking upstream, North Fork Hubbard Creek near Albany, Texas, August 15, 1978.

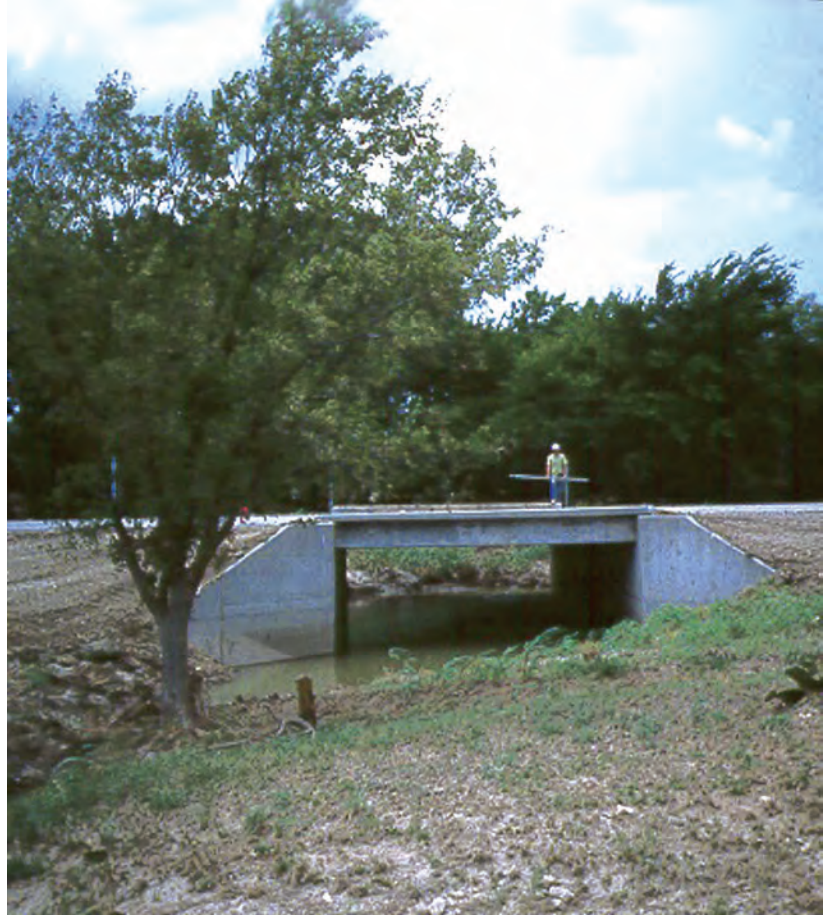
Figure A24. View from about 100 feet downstream of culvert located to right of gaging station looking upstream at culvert and approach section with rod held on upstream side of culvert near high-water mark in approach section, North Fork Hubbard Creek near Albany, Texas, August 15, 1978.

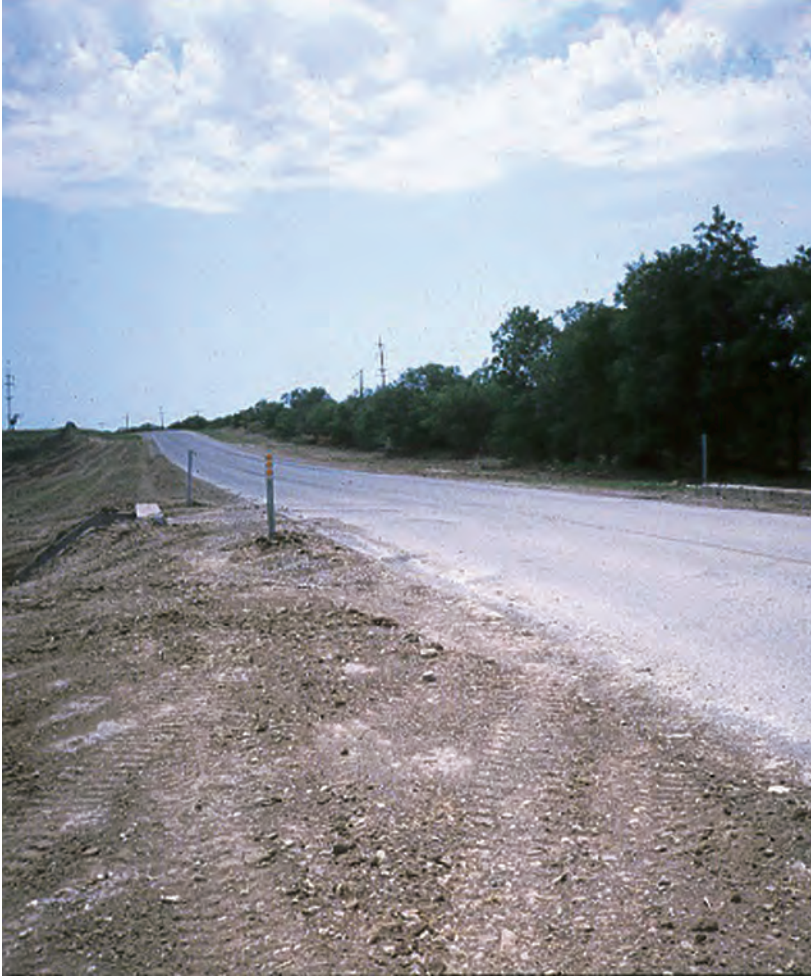
Figure A26. View about 100 feet to left of culvert on downstream shoulder of State Highway 6 looking across culvert at right bank and approach section. Rod held at high-water mark in approach, North Fork Hubbard Creek near Albany, Texas, August 15, 1978.

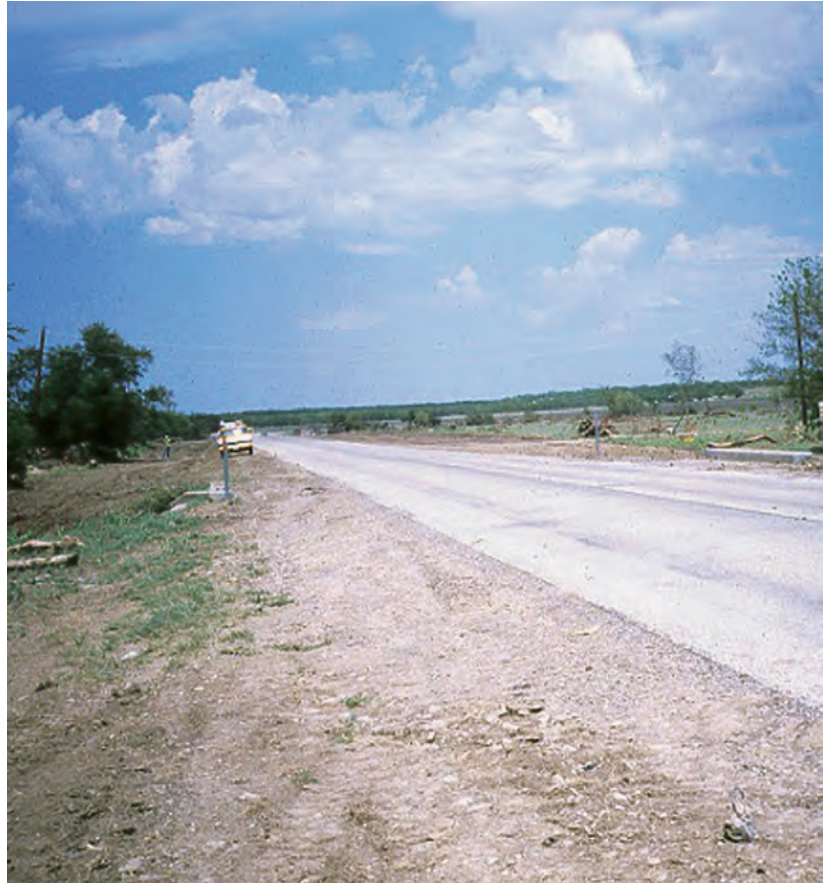
Figure A28. View about 100 feet to right of culvert on upstream shoulder looking slightly downstream and across to left bank. Rod held in approach section at high-water mark. The first string of trees is the main channel, North Fork Hubbard Creek near Albany, Texas, August 15, 1978.

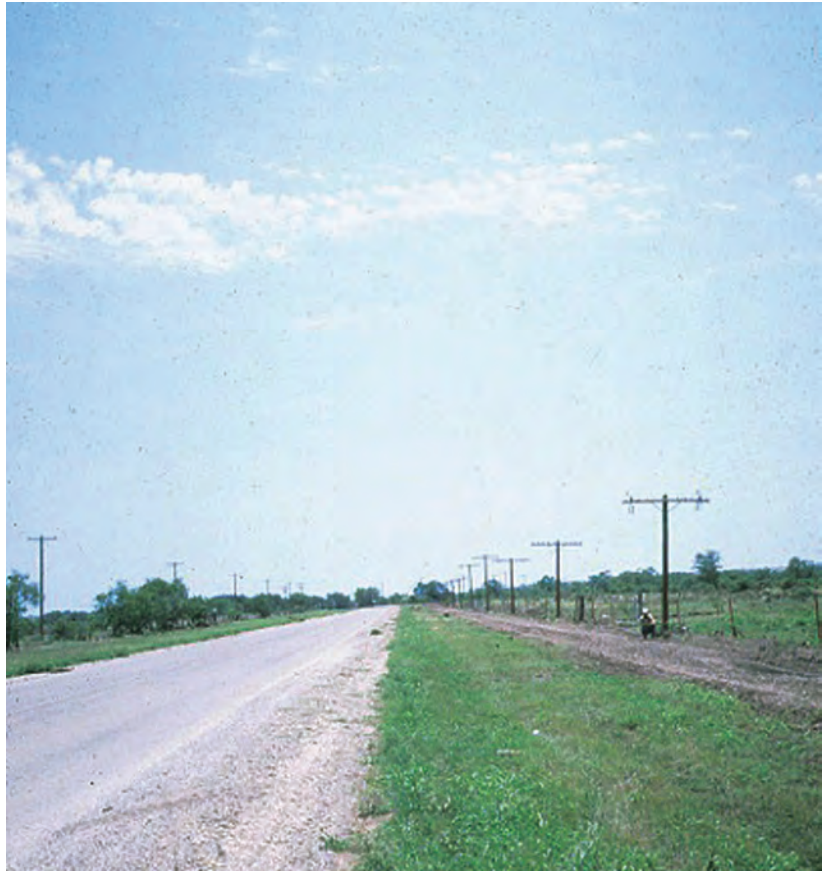
Figure A31. View looking downstream of bridge, North Fork Hubbard Creek near Albany, Texas, May 13, 2003.

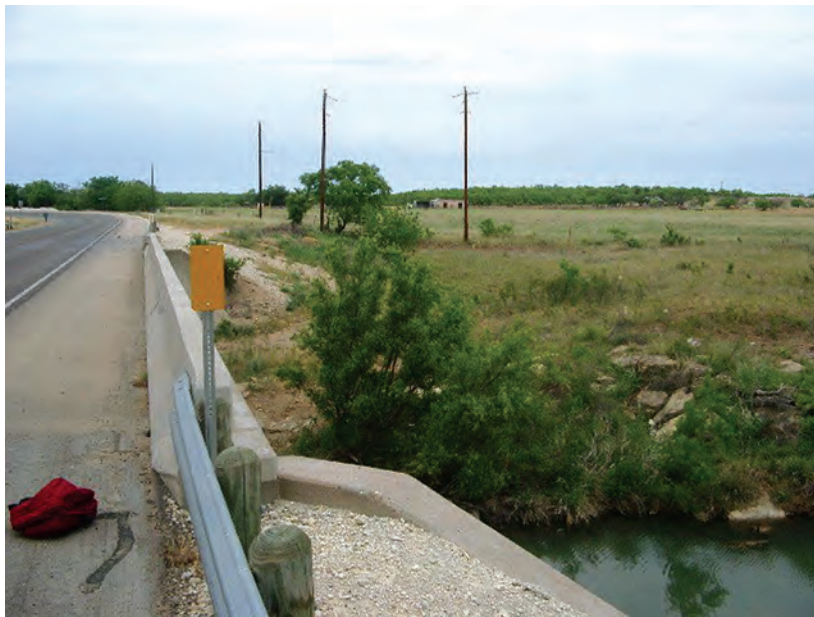
Figure A32. View looking upstream of bridge, North Fork Hubbard Creek near Albany, Texas, May 13, 2003.

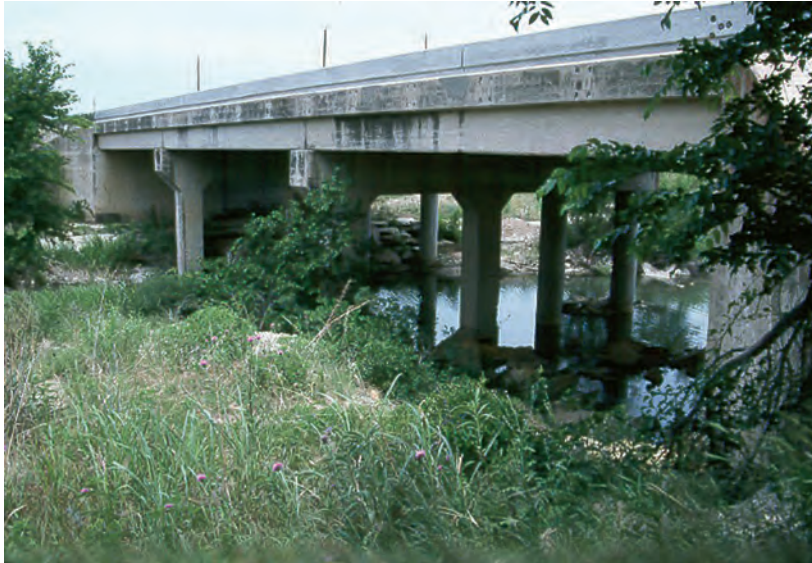
Figure A33. View looking across State Highway 6 and culvert toward left bank of flood plain, North Fork Hubbard Creek near Albany, Texas, May 13, 2003.

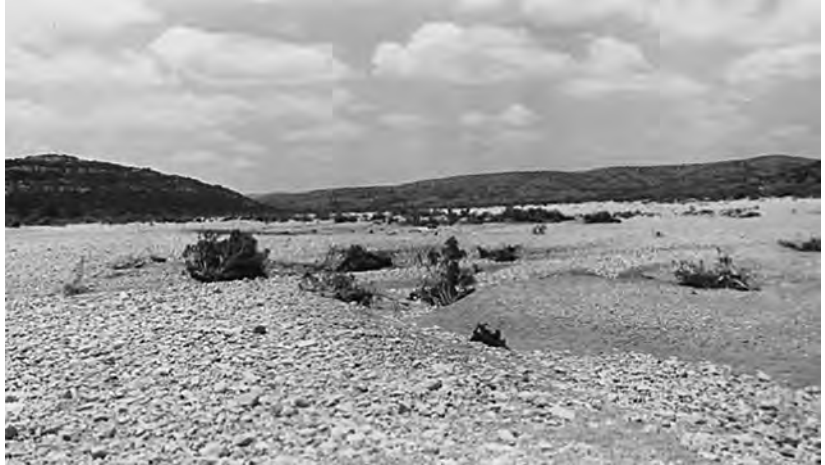
The channel appears to be much more densely vegetated in 2003 than it was in 1948 based on photographs taken when the slope-area measurement was made. There is no clearly defined main channel but rather a wide flood plain consisting of gravel, large cobbles, and small boulders. The main flow area is about 1,000 ft wide. A small bench or overflow area is indicated on the left side by the cross sections surveyed in 1948. The right side has steep banks. In 2003, a rather dense growth of scrub mesquite was observed throughout the site.

Figure A42. View looking downstream at downstream cross section from near center of channel, Mailtrail Creek near Loma Alta, Texas, flood of June 24, 1948.

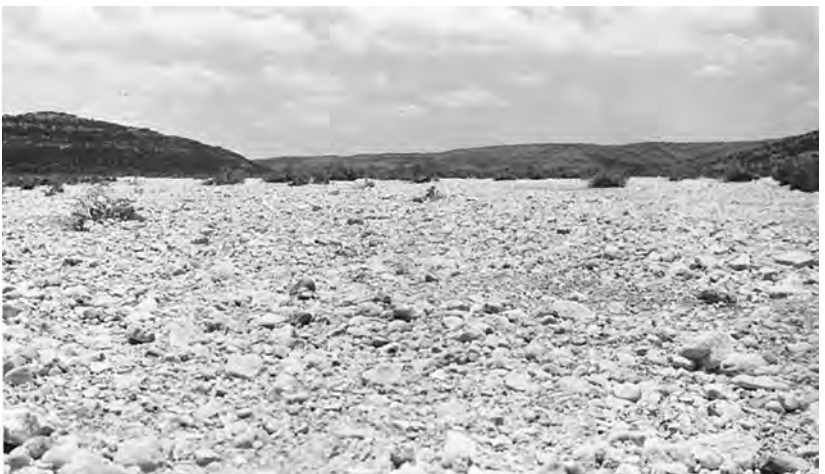
Figure A43. View looking downstream at downstream cross section from near right bank, Mailtrail Creek near Loma Alta, Texas, flood of June 24, 1948.

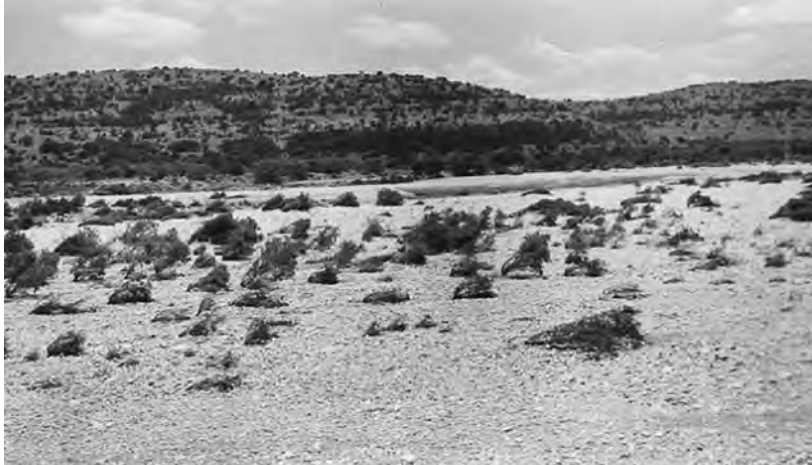
Figure A44. View looking downstream of downstream cross section to right of center of main channel, Mailtrail Creek near Loma Alta, Texas, flood of June 24, 1948.

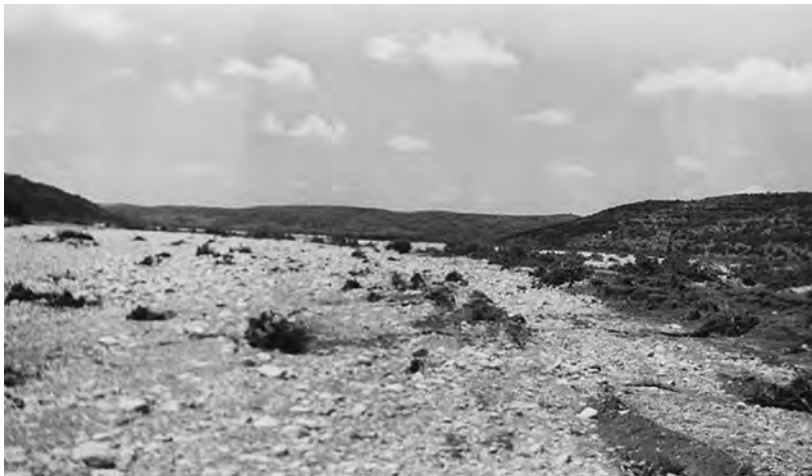
Figure A45. View looking across channel from right bank near downstream cross section, Mailtrail Creek near Loma Alta, Texas, flood of June 24, 1948.

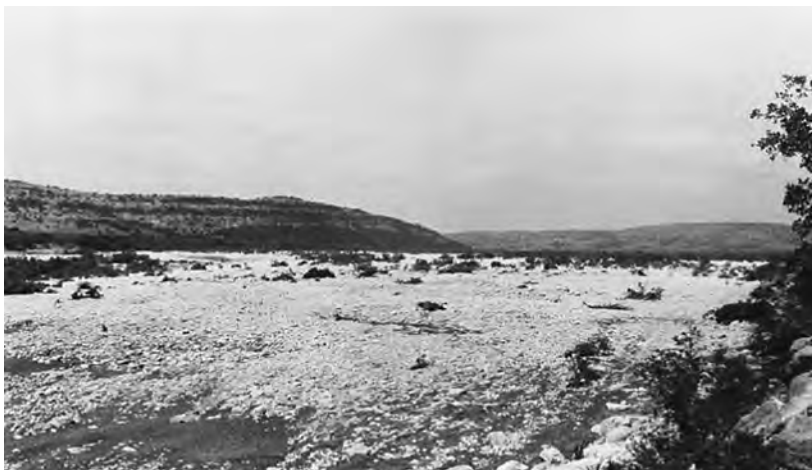
Figure A46. View looking downstream from center channel at upstream cross section, Mailtrail Creek near Loma Alta, Texas, flood of June 24, 1948.

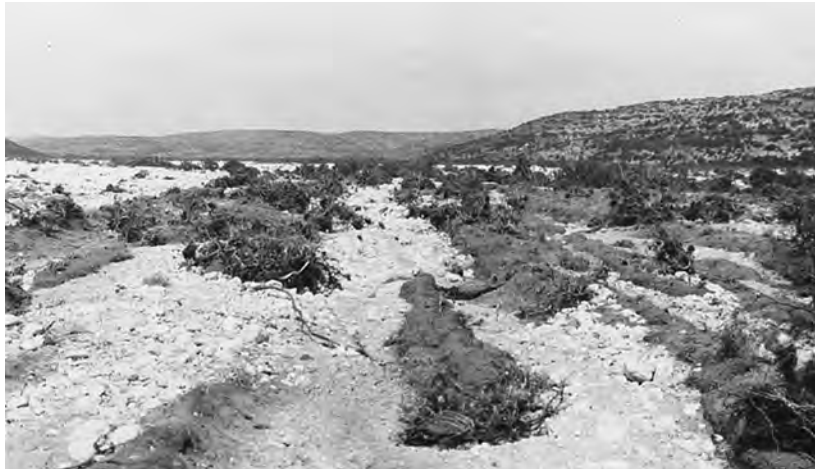
Figure A47. View looking downstream from right bank at upstream cross section, Mailtrail Creek near Loma Alta, Texas, flood of June 24, 1948.

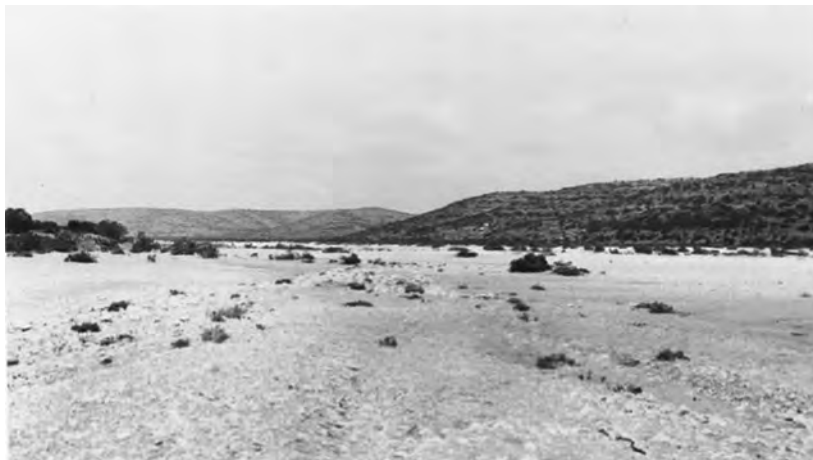
Figure A48. View looking downstream from near center of channel at upstream cross section, Mailtrail Creek near Loma Alta, Texas, flood of June 24, 1948.

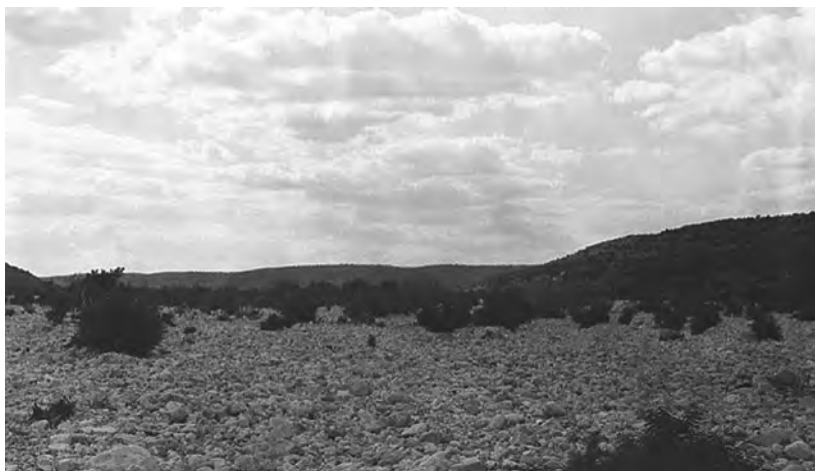
Figure A49. View looking downstream from left side of main channel at upstream cross section, Mailtrail Creek near Loma Alta, Texas, flood of June 24, 1948.

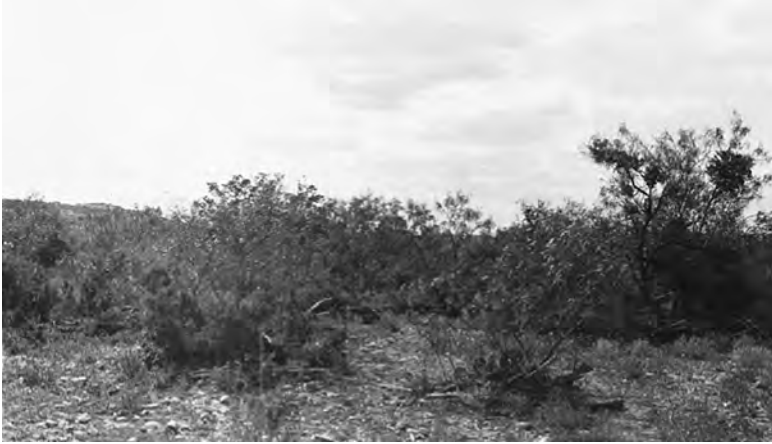
Figure A51. View looking downstream at middle cross section—left-bank overflow, Mailtrail Creek near Loma Alta, Texas, flood of June 24, 1948.

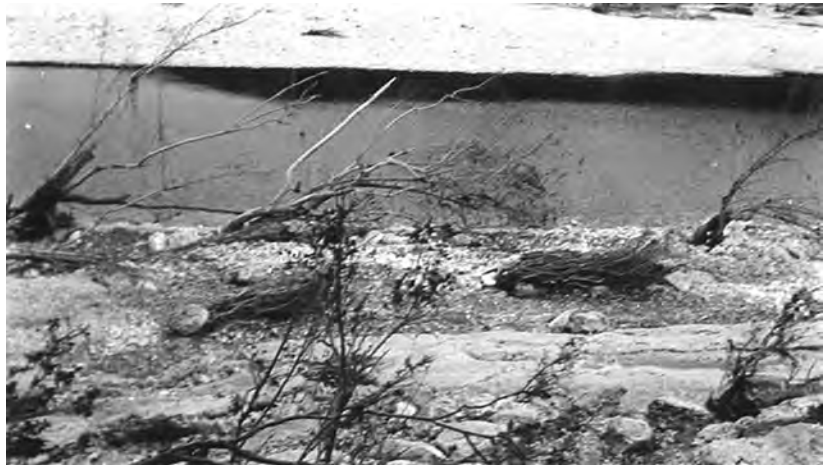
Figure A59. View looking across stream from right bank at upstream cross section, West Fork Nueces River near Kickapoo Springs, Texas, June 1935. Slope-area section for flood of June 14, 1935.

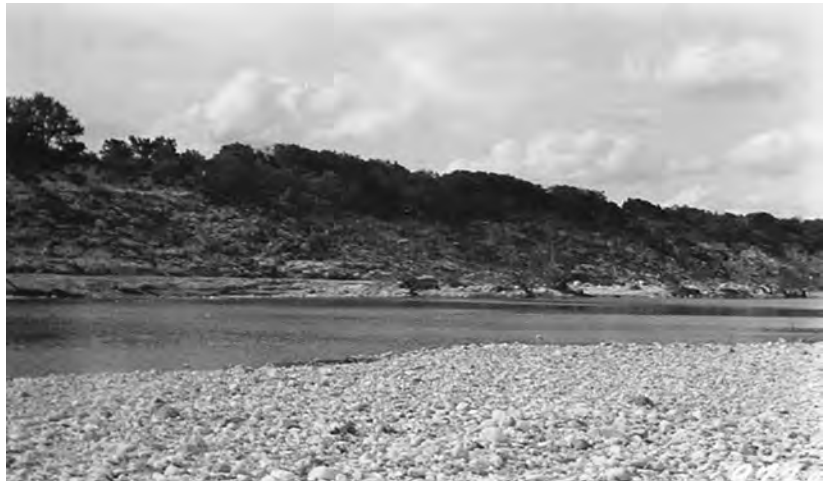
Figure A60. View looking across and upstream of downstream cross section, West Fork Nueces River near Kickapoo Springs, Texas, June 1935.

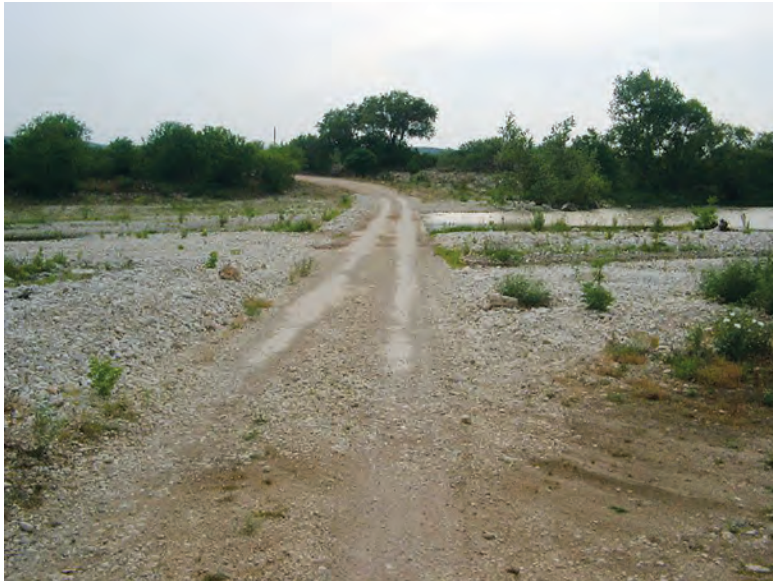
Figure A66. View looking from left to right bank, West Nueces River near Brackettville, Texas, May 13, 2003.

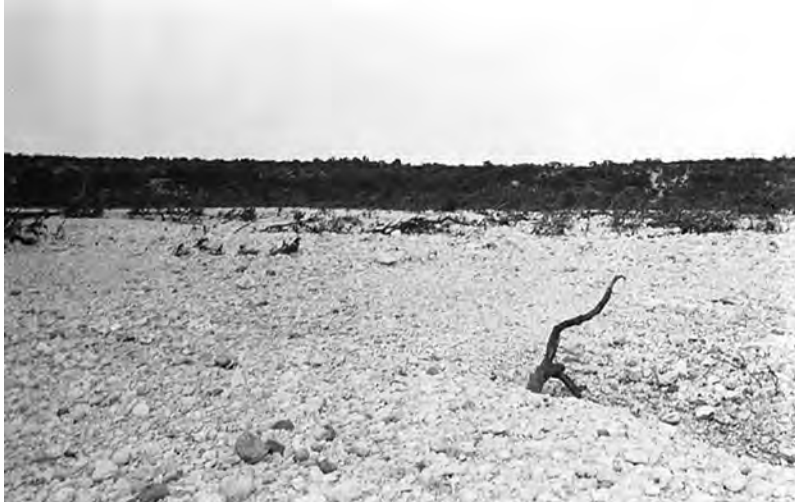
Figure A69. View looking across and upstream towards left bank from downstream cross section, West Nueces River 8 mi upstream of Cline, Texas. June 1935.

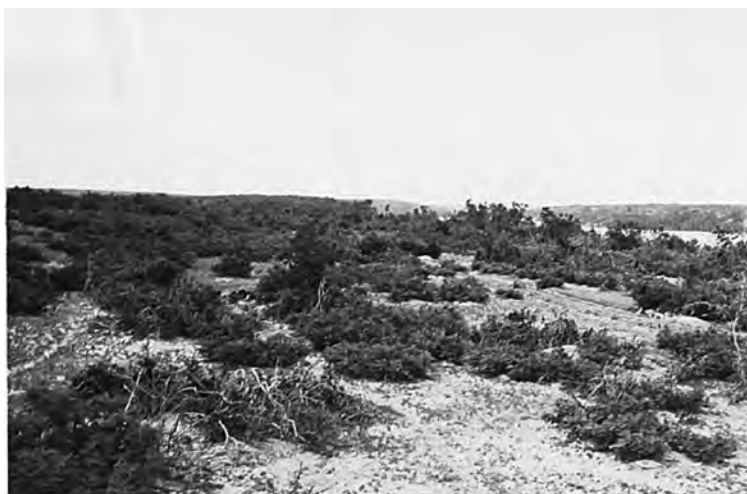
Figure A71. View looking upstream of downstream cross section at station 1, West Nueces River 8 mi upstream of Cline, Texas, June 1935.

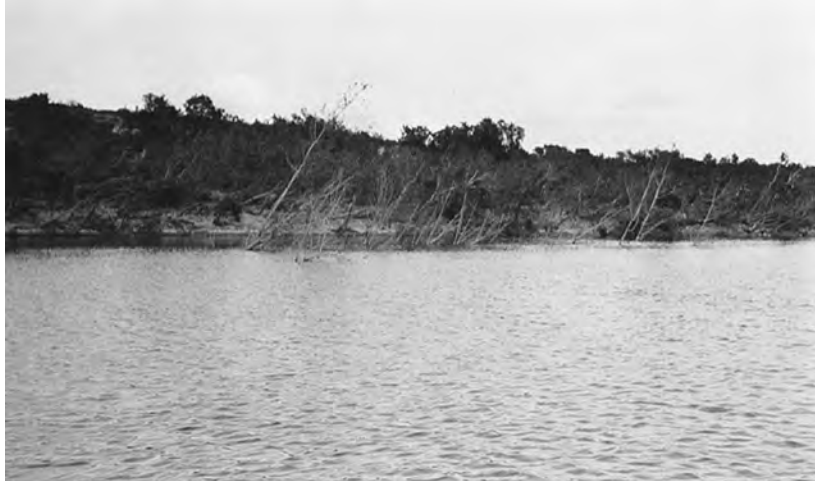
Figure A72. View looking toward left bank and downstream of upstream cross section, West Nueces River 8 mi upstream of Cline, Texas, June 1935.

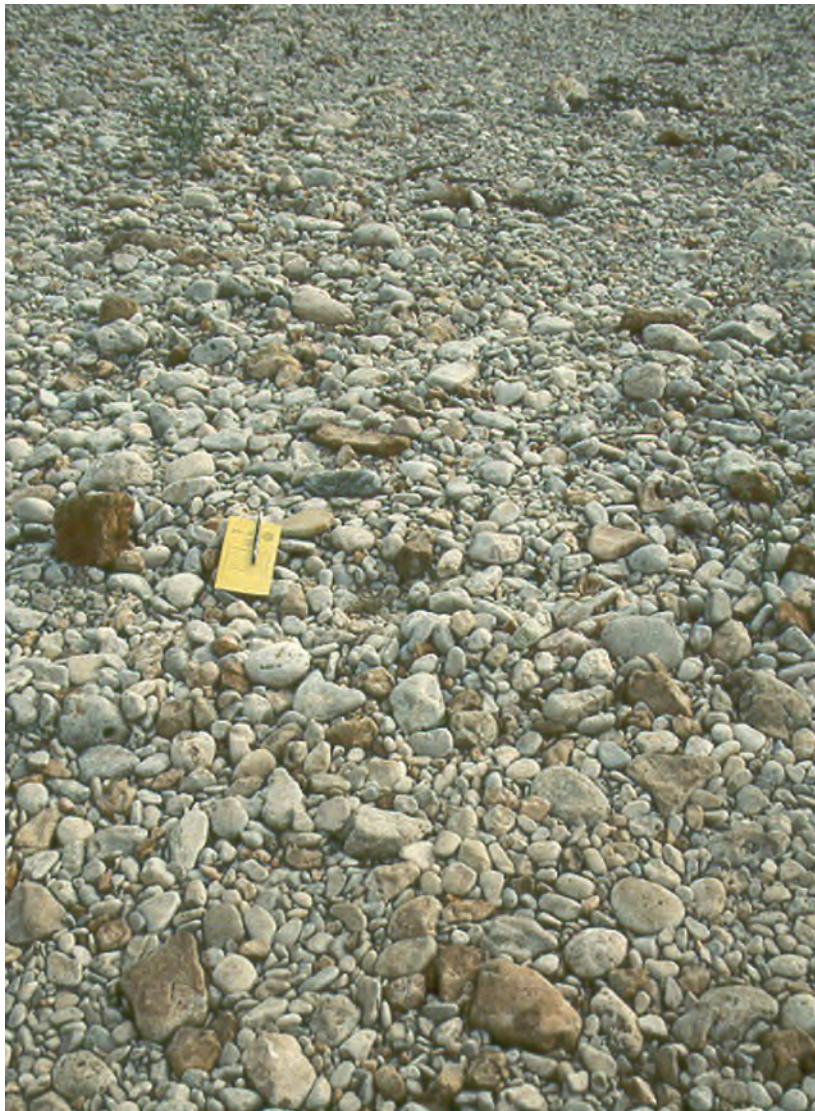
Figure A73. Coarse bed material in slope-area reach of West Nueces River 8 mi upstream of Cline, Texas, June 2003.

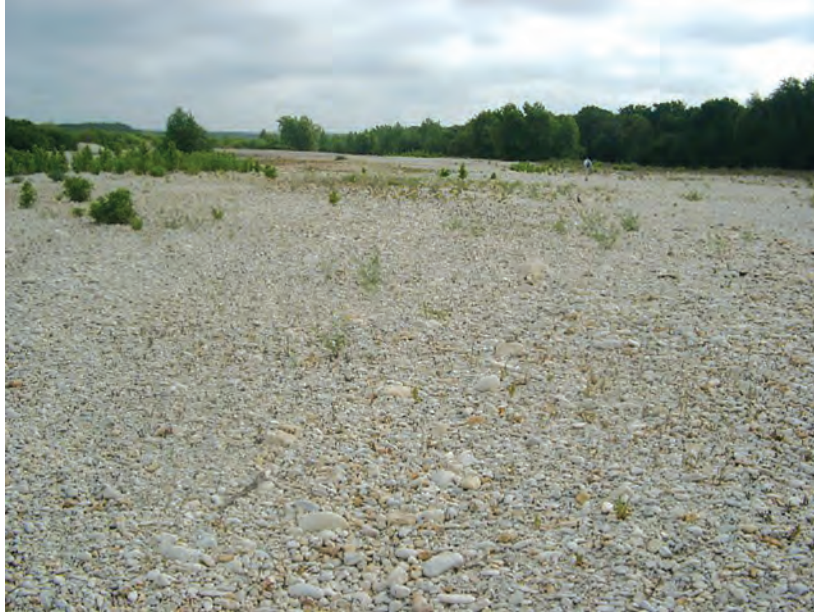
Figure A74. View looking upstream of slope-area reach, West Nueces River 8 mi upstream of Cline, Texas, June 2003.

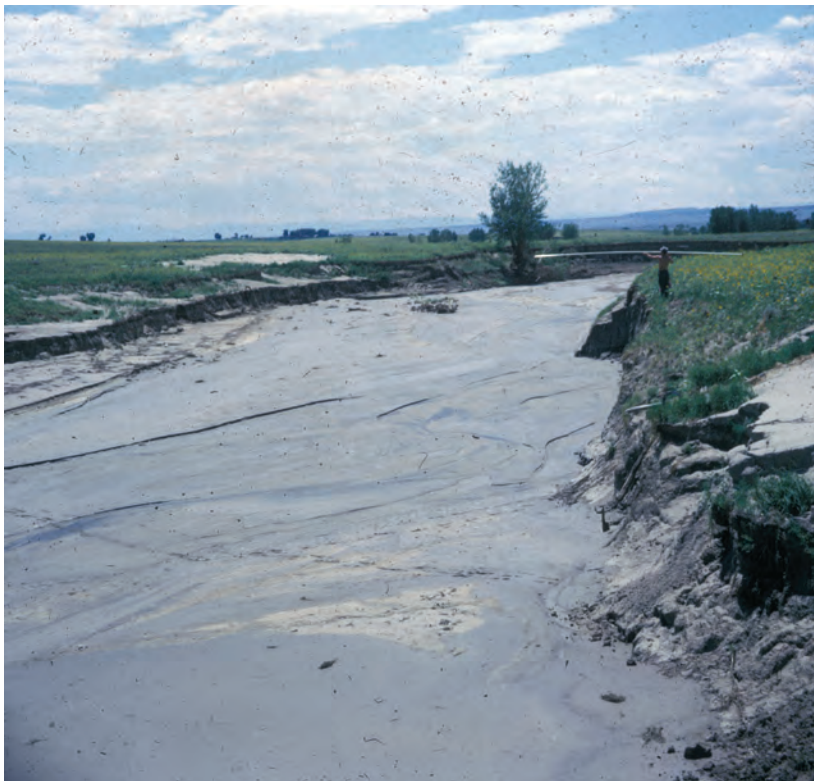
Figure A76. View looking downstream from about 200 feet above cross section 2, Jimmy Camp Creek at Fountain, Colorado, July 17, 1965. (Man is holding rod at high-water mark at cross section 2.)

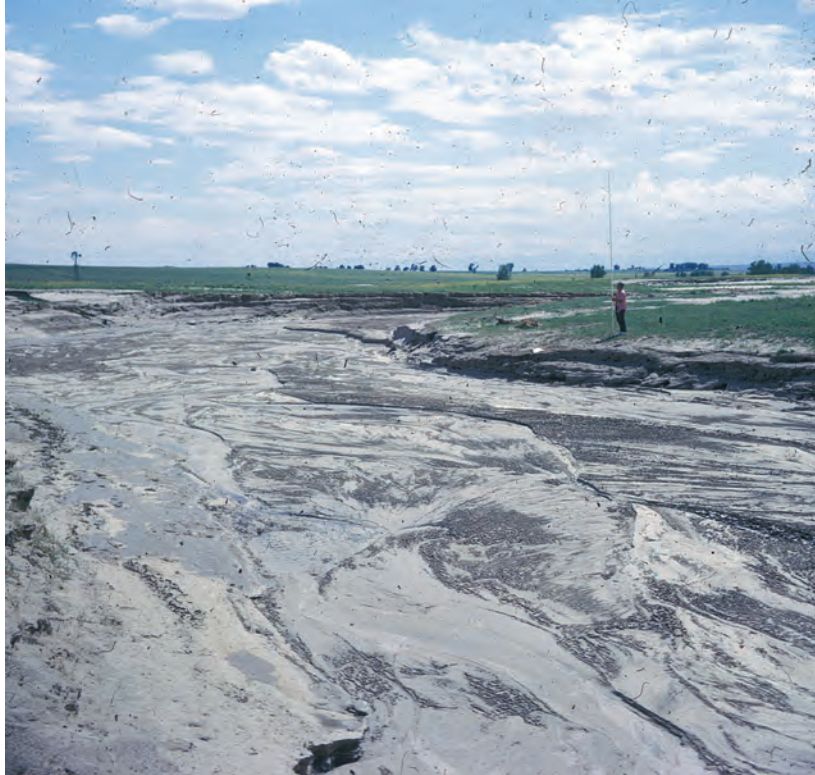
Figure A77. View looking downstream from about 200 feet above cross section 1, Jimmy Camp Creek at Fountain, Colorado, July 17, 1965. (Man is holding rod at cross section 1.)
