**Appendix A. Individual Evaluations of 30 Peak Discharges from
28 Extraordinary Floods in the United States**

Seco Creek near D'Hanis, Texas

Review of peak discharge for the flood of May 31, 1935

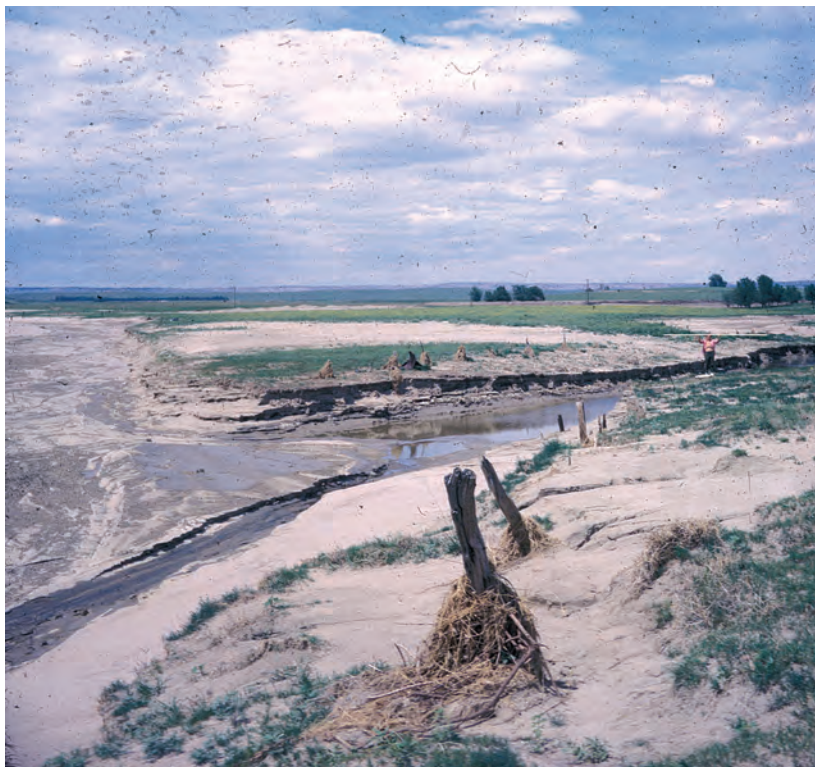
Figure A78. View looking upstream, Jimmy Camp Creek at Fountain, Colorado, July 17, 1965. (Man is holding rod at high-water mark at cross section 1, 250 feet right of left end of cross section.)

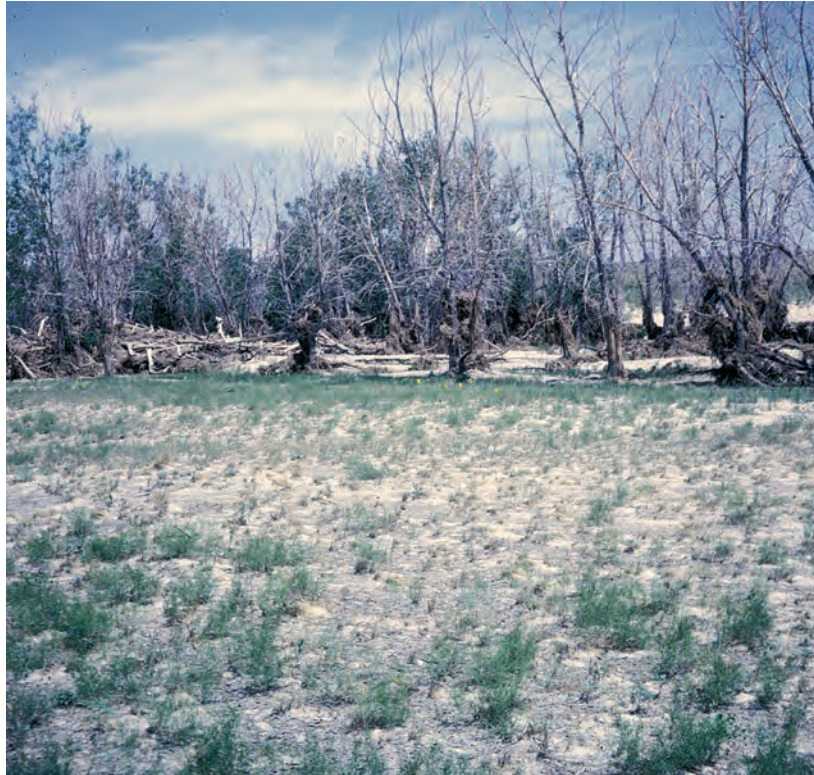
Figure A82. View looking upstream from cross section 3, Bijou Creek near Wiggins, Colorado, June 1965.

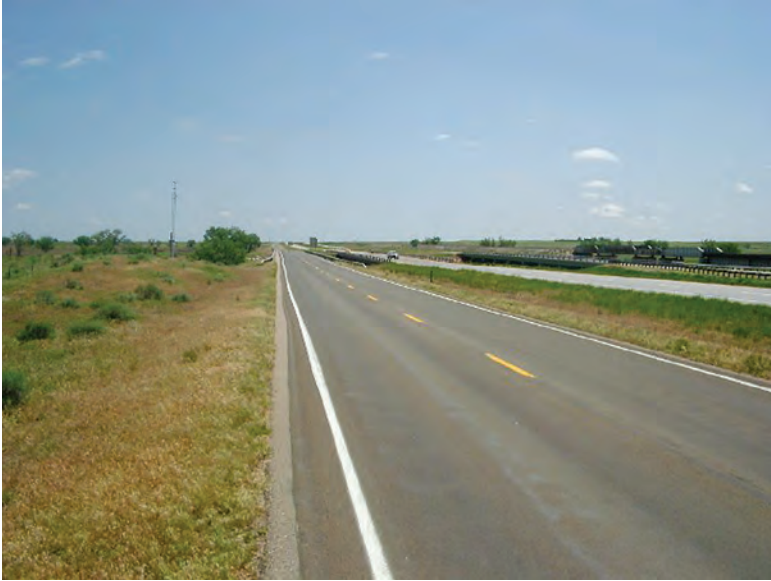
Figure A92. View looking north toward railroad wash-out, Bijou Creek near Wiggins, Colorado, June 3, 2003.

According to the measurement summary, the June 18 peak discharge at this site may have been amplified by a release of water that ponded upstream of the BNSF railroad. The railroad embankment to the right of the railroad bridge failed. The measurement summary speculates that the failure could have been rapid and notes an earlier failure in 1935 that is discussed by Follansbee and Sawyer (1948, p. 71). However, newspaper accounts of the 1965 peak discharge talk about a large crest passing the community of Hoyt (about 20 mi upstream) in the early morning hours. The size of peaks from upstream tributaries, the amount of railroad embankment that was subjected to overflow (about 4,000 ft) relative to the fairly modest amount of embankment failure (hundreds of feet) suggest that the failure probably contributed little to the actual peak discharge. Aerial photographs on the front page of the June 19 Fort Morgan Times and the Denver Post need to be seen to appreciate the scale of flooding and the amount of embankment overtopped. The photographs show only a very few trees in the reach downstream of the railroad/Interstate crossing; in 2003, nearly mature cottonwood trees were scattered in this reach.

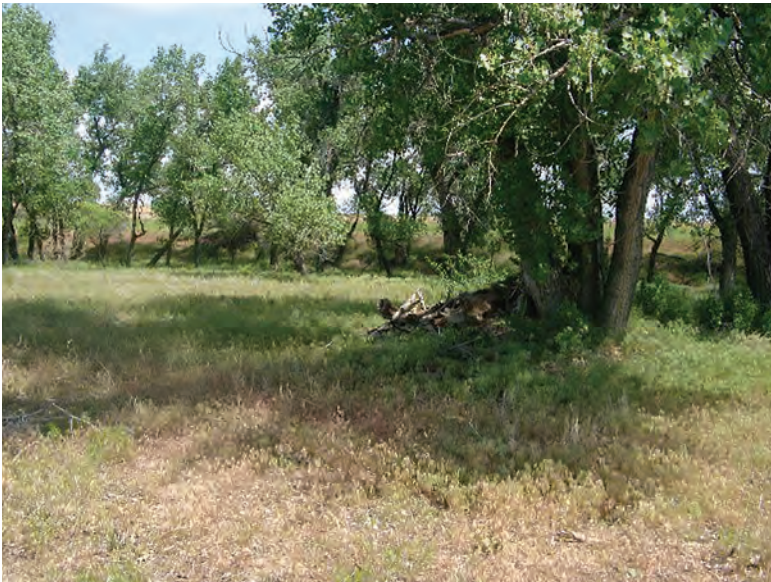
Figure A93. June 1965 flood debris in slope-area reach, Bijou Creek near Wiggins, Colorado, June 3, 2003.

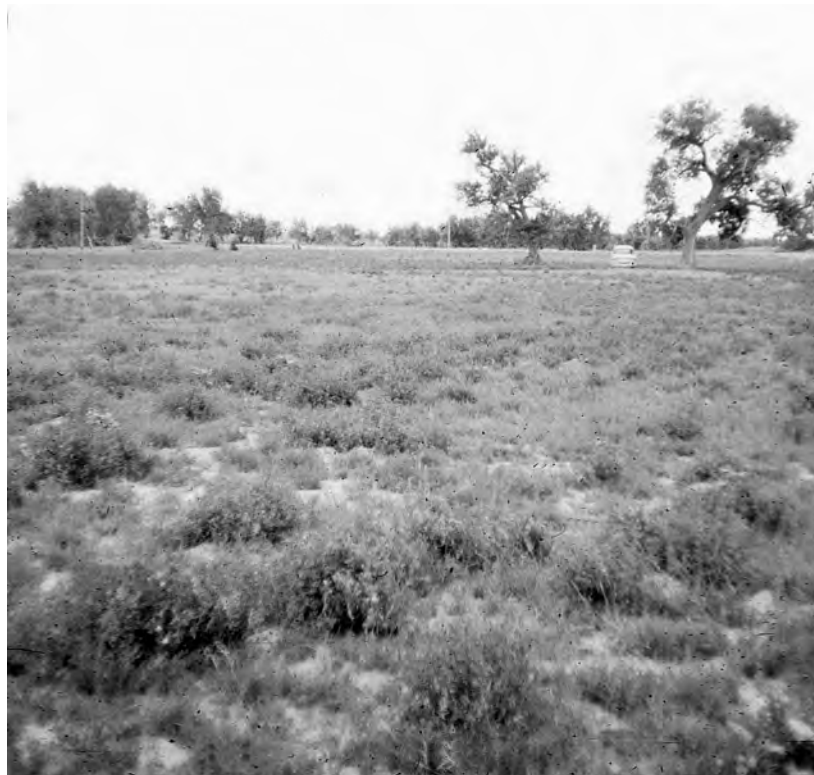
Figure A95. View of flood plain looking toward channel in slope-area reach, East Bijou Creek at Deertrail, Colorado, June 1965.

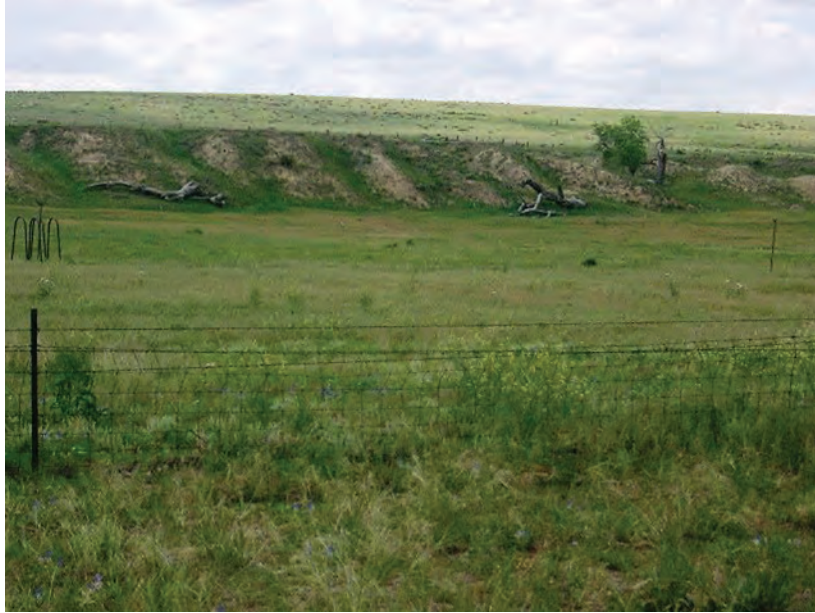
Figure A96. View looking across flood plain toward left bank high-water mark (woody debris), East Bijou Creek at Deertrail, Colorado, June 3, 2003.

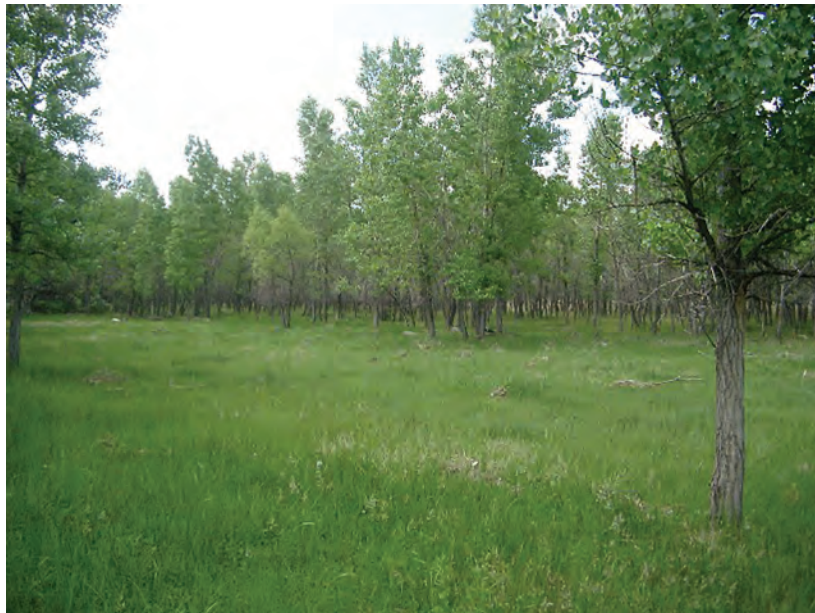
Figure A97. View of flood plain looking downstream with main channel in tree line, East Bijou Creek at Deertrail, Colorado, June 3, 2003.

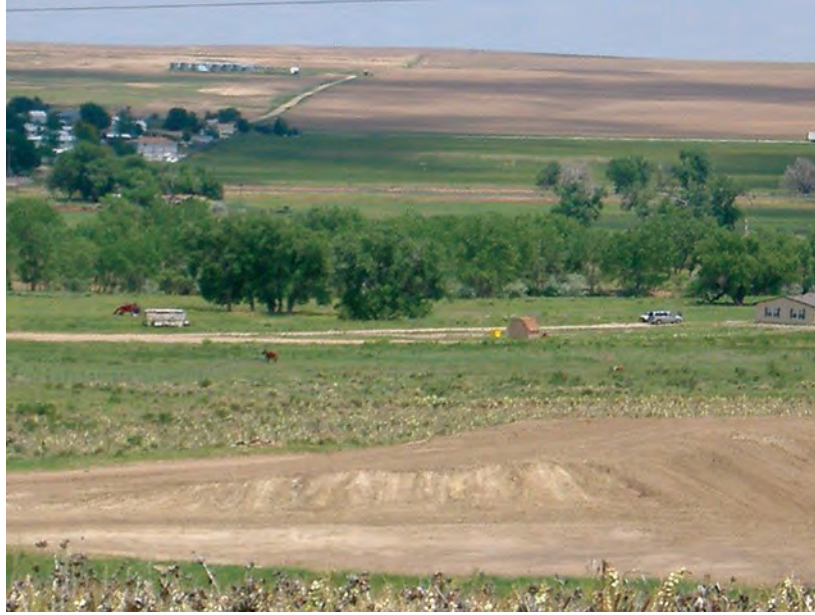
Figure A98. View from left valley side looking across flood plain and main channel toward slope-area reach, East Bijou Creek at Deertrail, Colorado, June 3, 2003. (Flow is from right to left.)

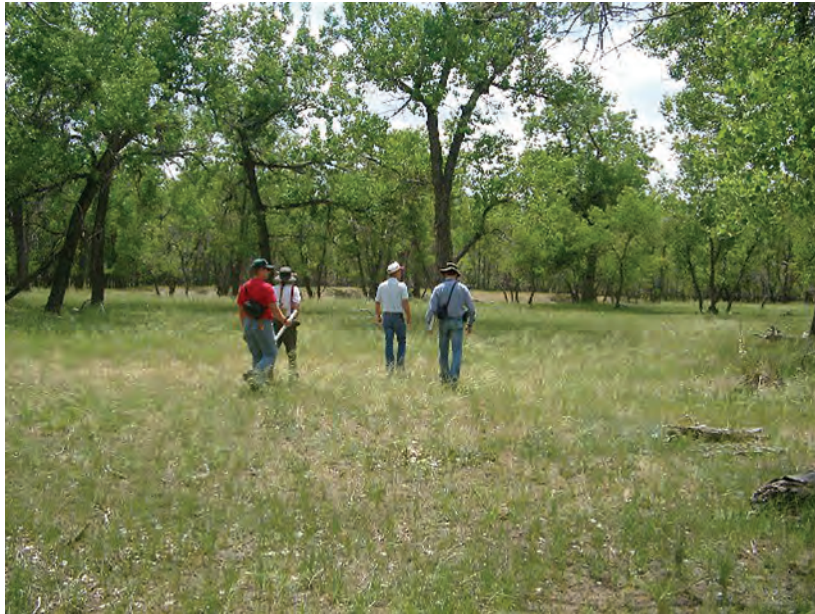
Figure A99. Walking on flood-plain surface toward main channel in slope-area reach, East Bijou Creek at Deertrail, Colorado, June 3, 2003. (Flow was 5-6 feet deep at this point during the 1965 flood.)

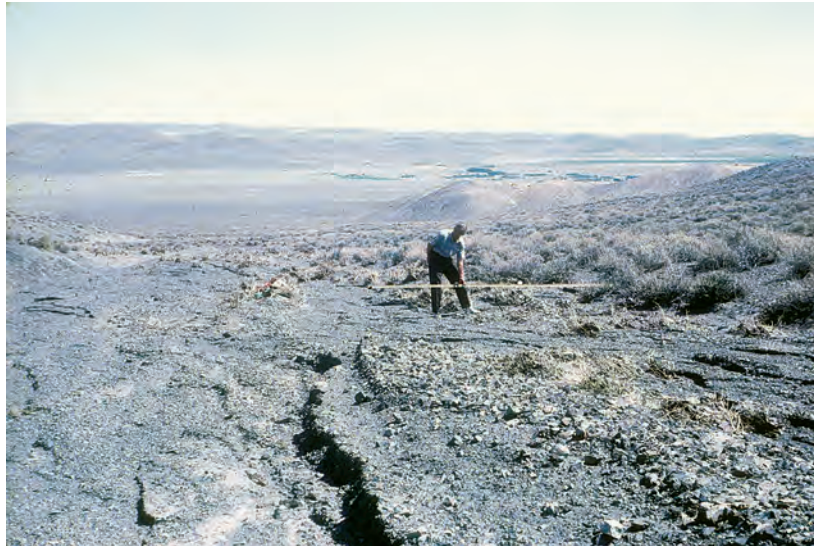
Figure A100. View looking downstream of slope-area reach, Lahontan Reservoir tributary no. 3 near Silver, Nevada, July 1971.

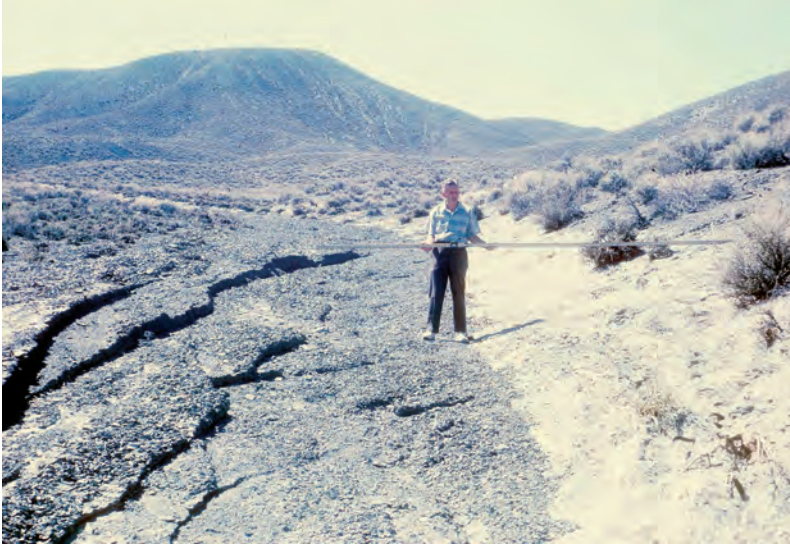
Figure A101. View looking upstream at cross section 2, Lahontan Reservoir tributary no. 3 near Silver, Nevada, July 1971.

Recommendations: The original peak discharge of 1,680 ft³/s should be updated to 1,840 ft³/s and the rating should be downgraded to “estimate” because of the unrealistically high Froude numbers and excessive expansion. This value agrees with results from the corrected hand calculation and the prior SAC analysis.

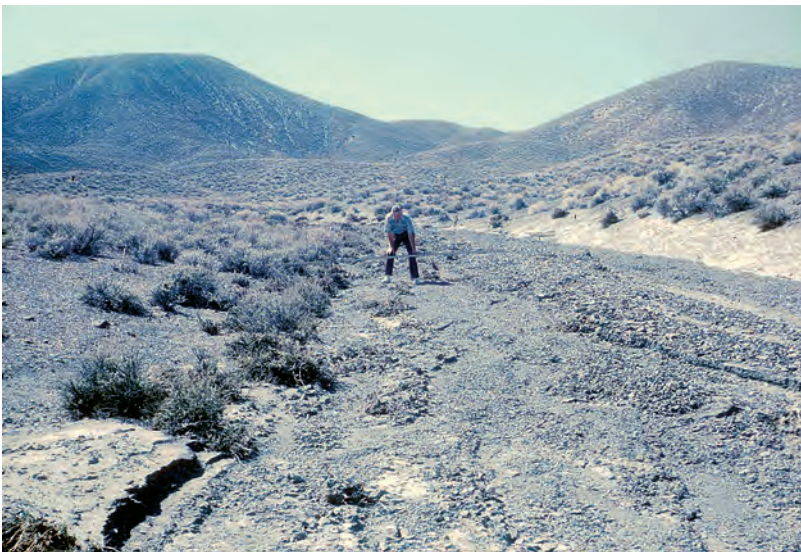
Figure A102. View looking upstream of slope-area reach, Lahontan Reservoir tributary no. 3 near Silver, Nevada, July 1971.

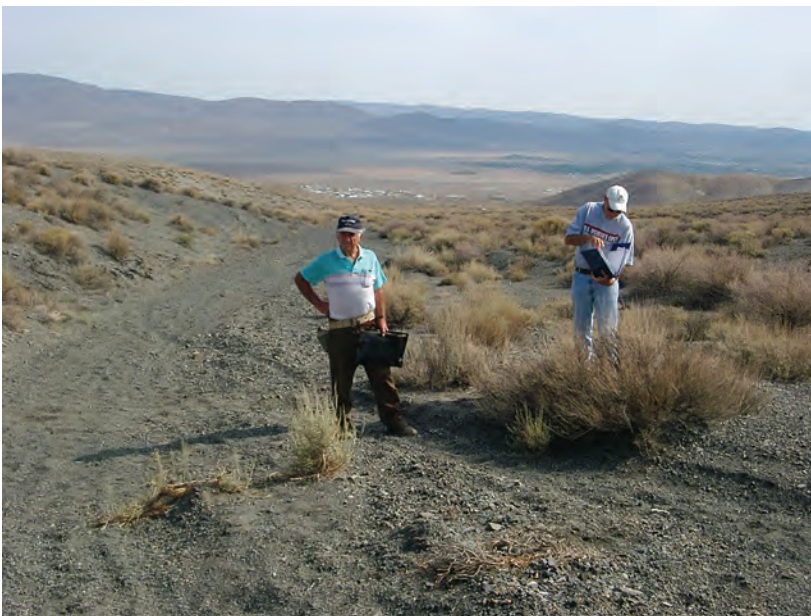
Figure A103. View looking downstream of slope-area reach, Lahontan Reservoir tributary no. 3 near Silver, Nevada, July 31, 2003.

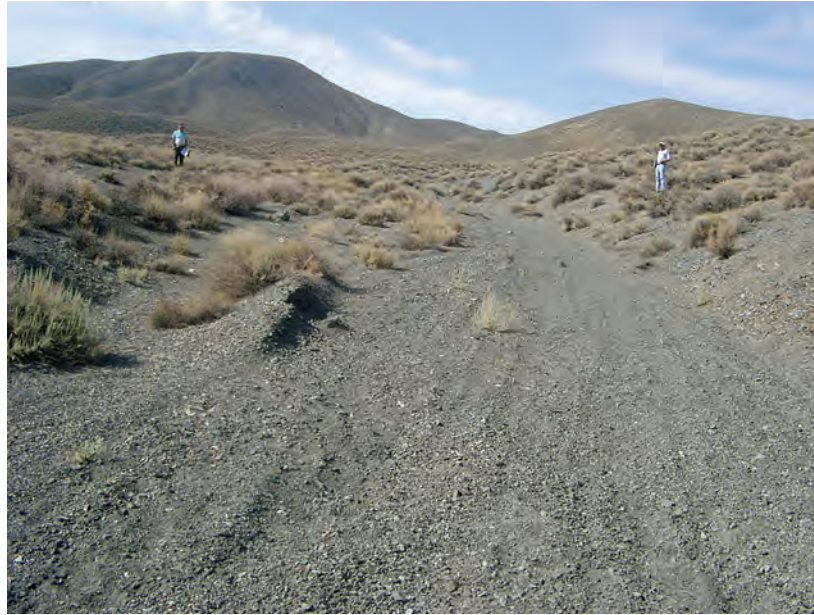
Figure A104. View looking upstream toward cross section 2, Lahontan Reservoir tributary no. 3 near Silver, Nevada, July 31, 2003.

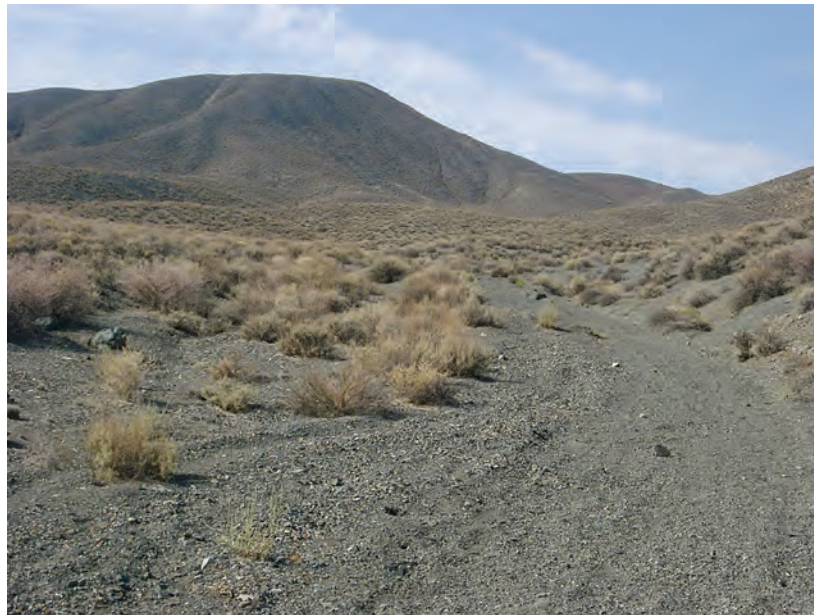
Figure A105. View looking upstream of slope-area reach, Lahontan Reservoir tributary no. 3 near Silver, Nevada, July 31, 2003.

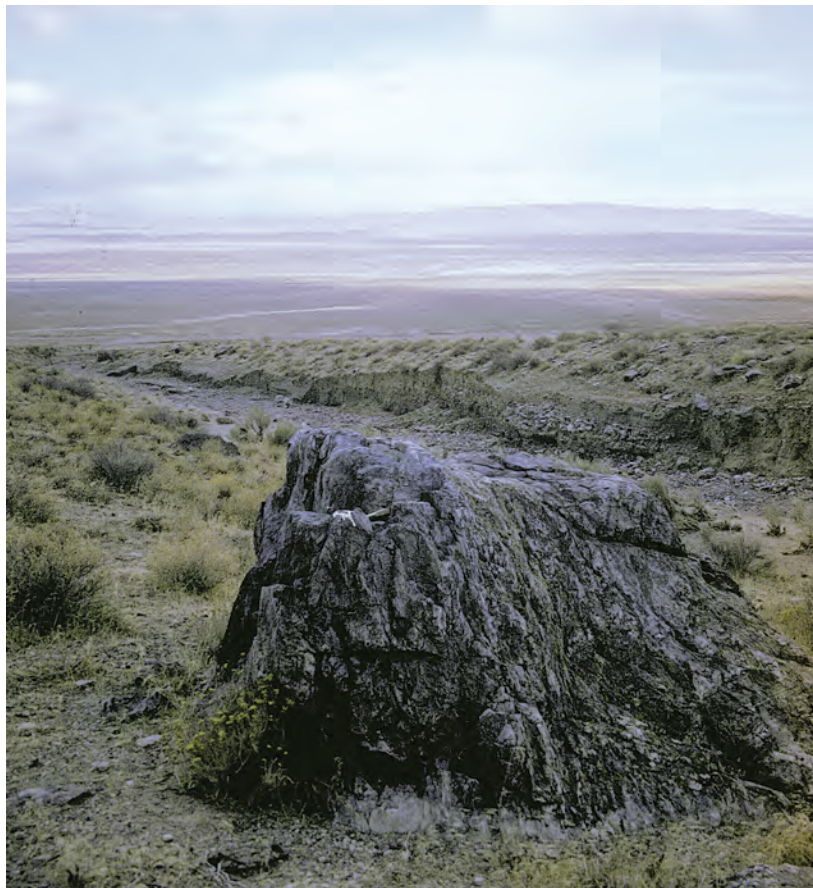
Figure A106. View looking downstream of range marker 1 (painted white spot on rock), Humboldt River Tributary near Rye Patch, Nevada, June 1973.

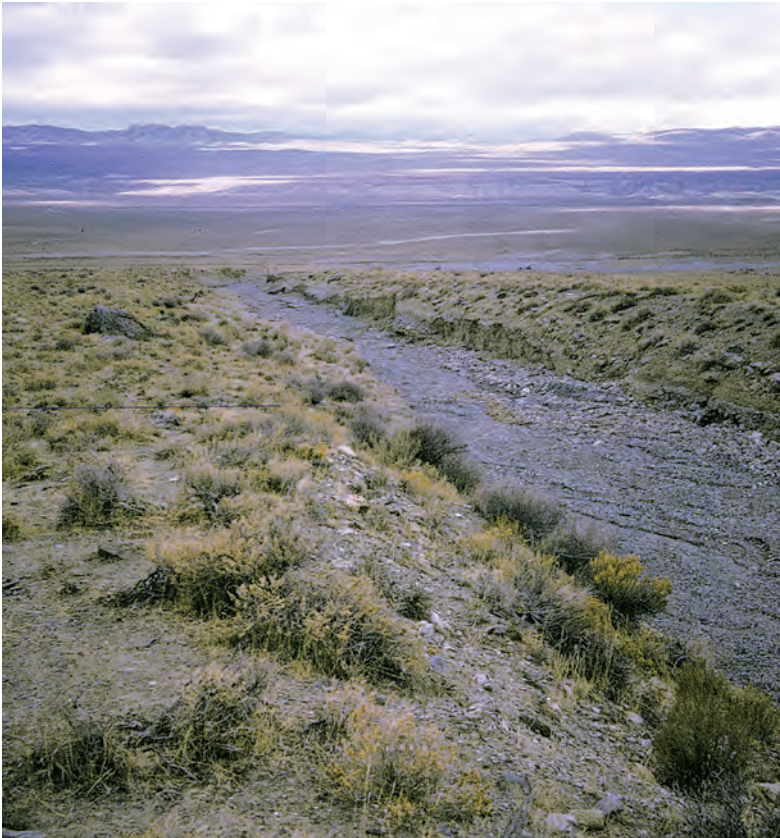
Figure A107. View looking downstream of hill near left end of cross section 3, Humboldt River Tributary near Rye Patch, Nevada, June 1973.

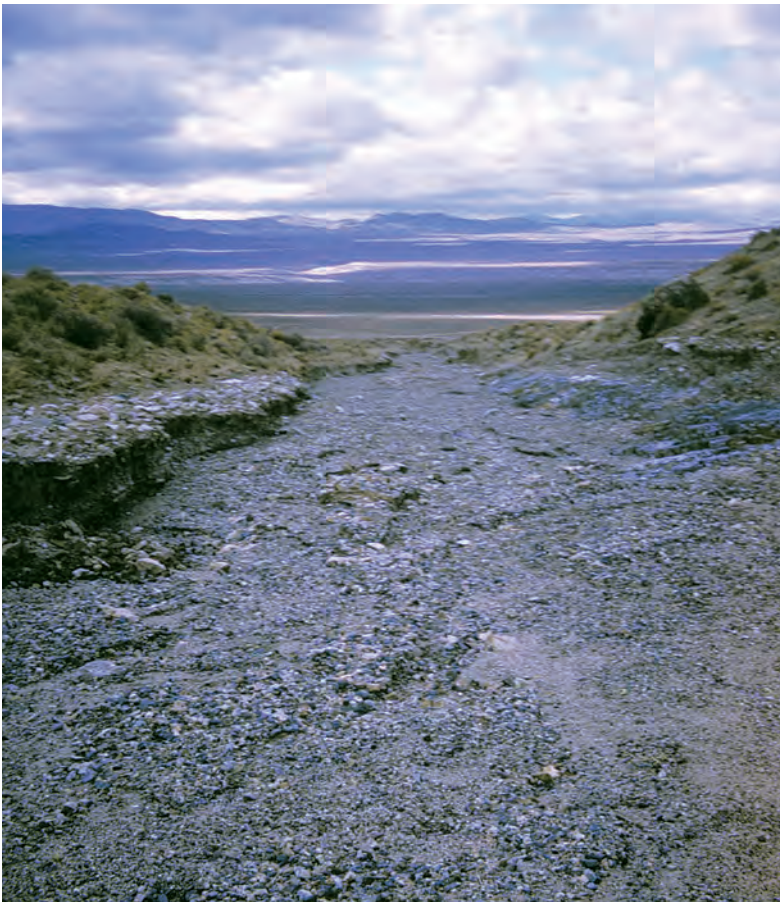
Figure A108. View looking downstream through slope-area reach, Humboldt River Tributary near Rye Patch, Nevada, June 1973.

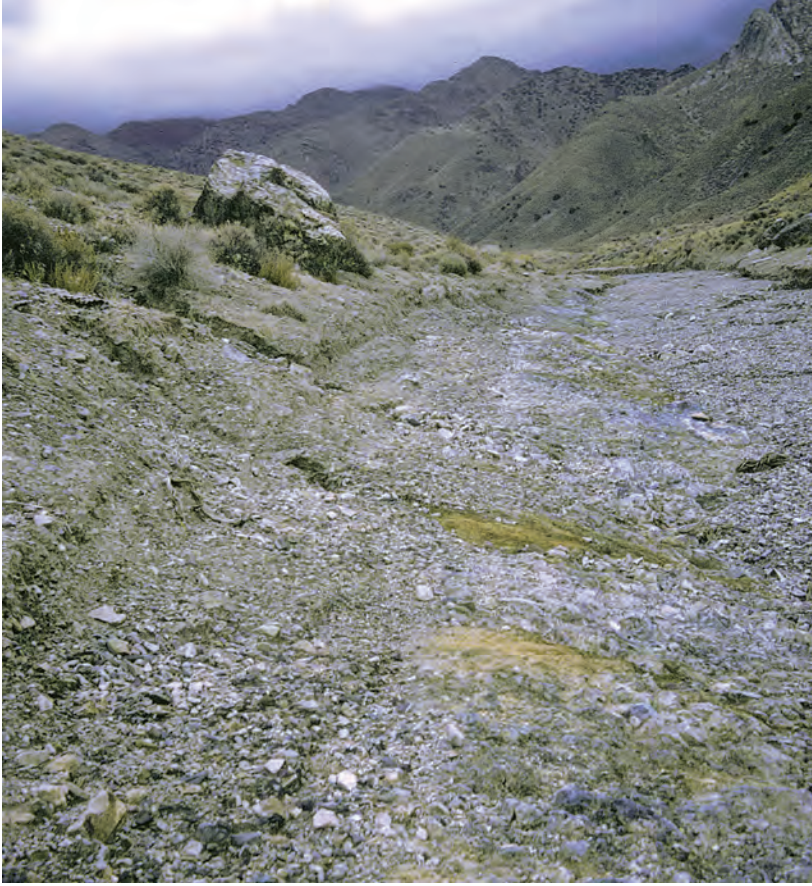
Figure A109. View looking upstream at right bank through cross section 3, Humboldt River Tributary near Rye Patch, Nevada, June 1973.

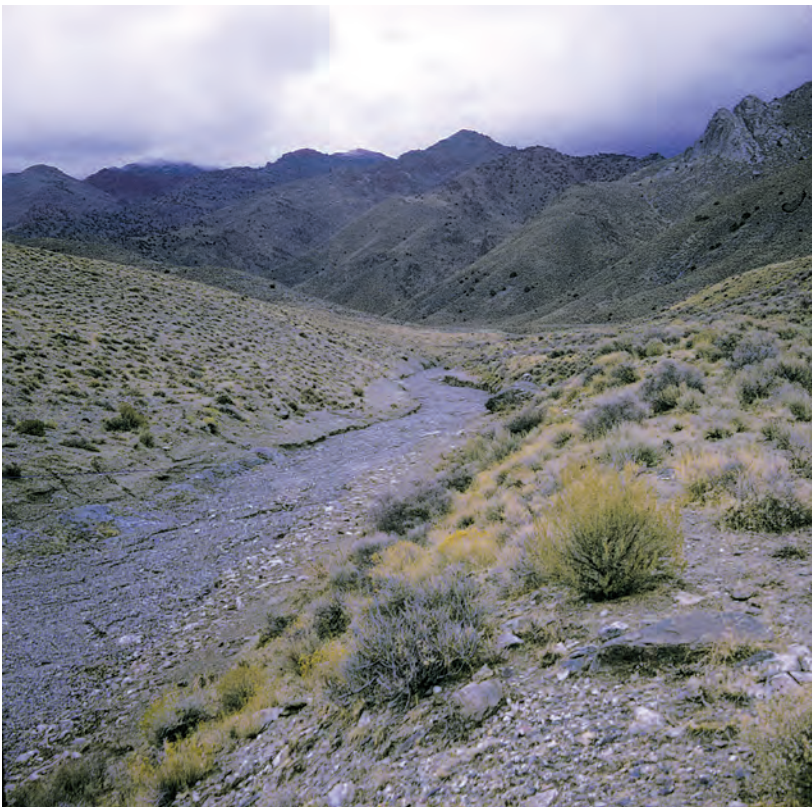
Figure A110. View looking upstream of hilltop near left end of cross section 3, Humboldt River Tributary near Rye Patch, Nevada, June 1973.

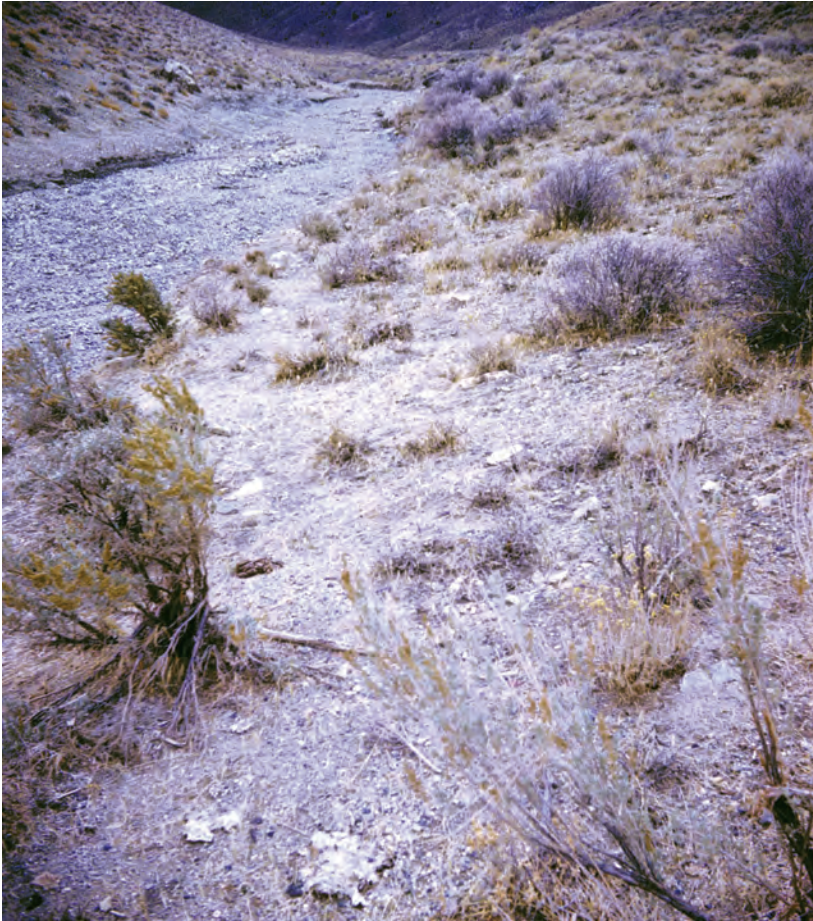
Figure A111. View looking upstream through cross section1 overbank flow area, Humboldt River Tributary near Rye Patch, Nevada, June 1973.

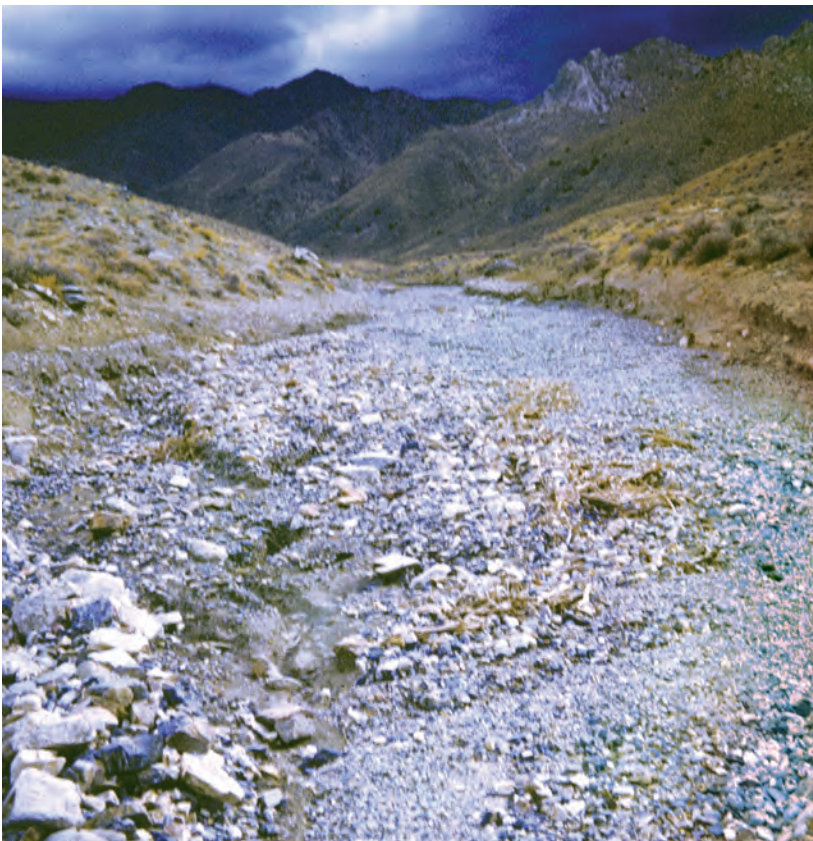
Figure A112. View looking upstream through slope-area reach, Humboldt River Tributary near Rye Patch, Nevada, June 1973.

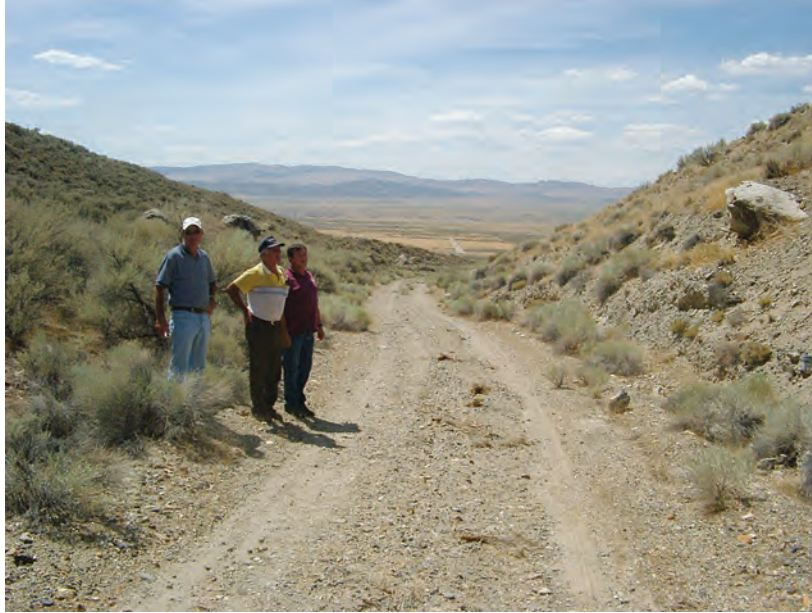
Figure A113. View looking downstream through slope-area reach, Humboldt River Tributary near Rye Patch, Nevada, July 30, 2003.

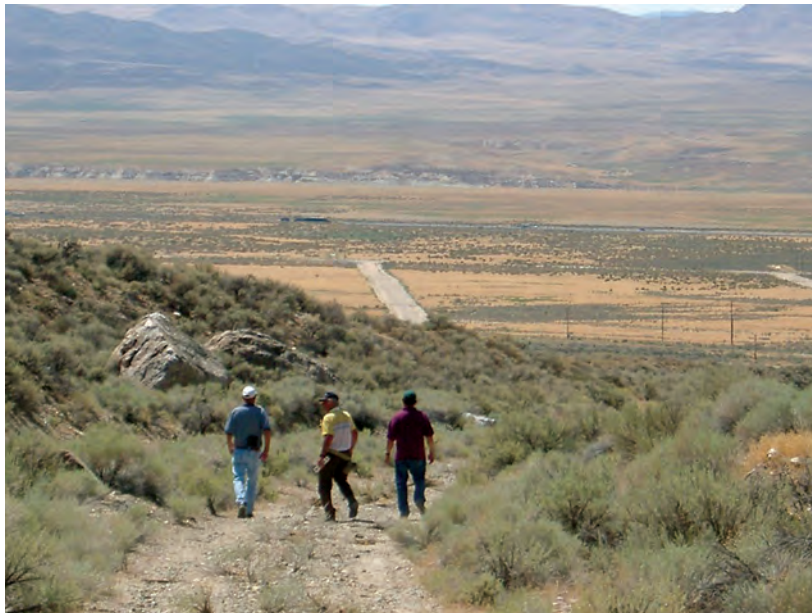
Figure A114. View looking downstream through slope-area reach, Humboldt River Tributary near Rye Patch, Nevada, July 30, 2003. Rock with painted registered mark shown on left.

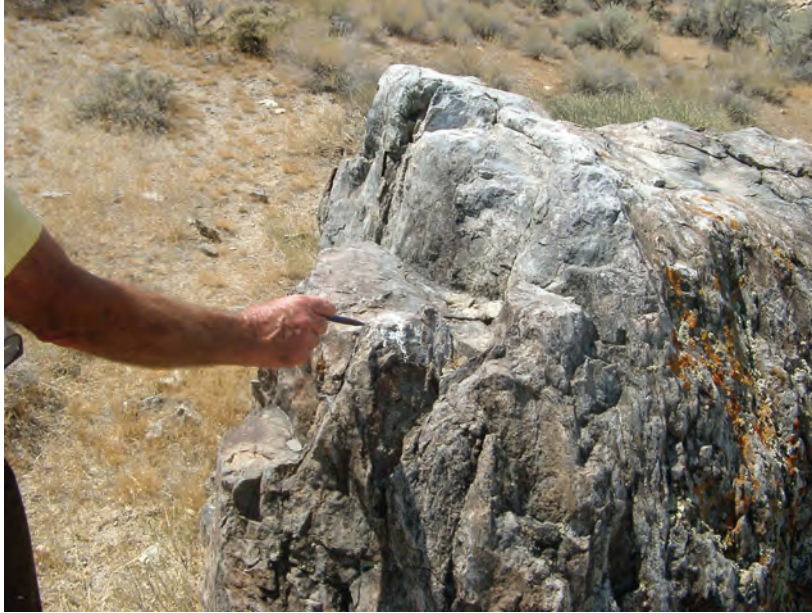
Figure A115. Original registered mark (white paint on rock) found 30 years later, Humboldt River Tributary near Rye Patch, Nevada, July 30, 2003.

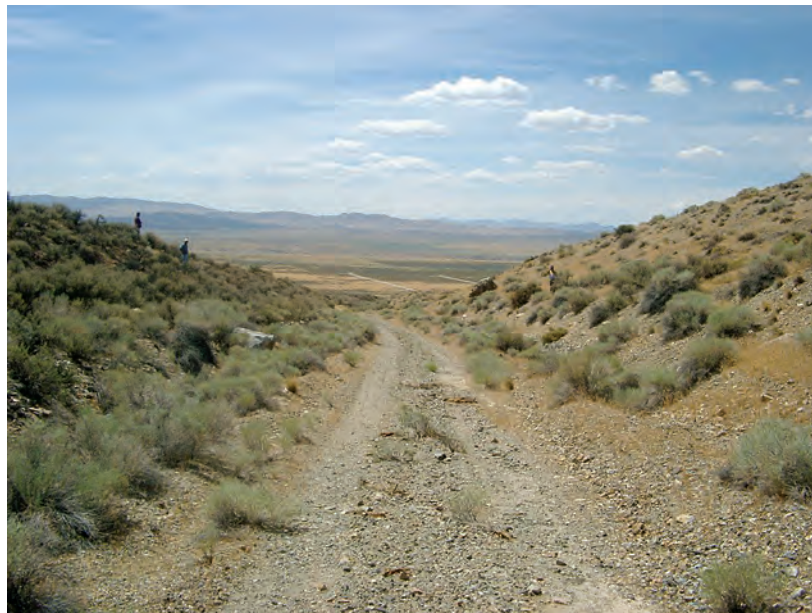
Figure A116. View looking downstream of top of slope-area reach, Humboldt River Tributary near Rye Patch, Nevada, July 30, 2003. People standing at cross sections.

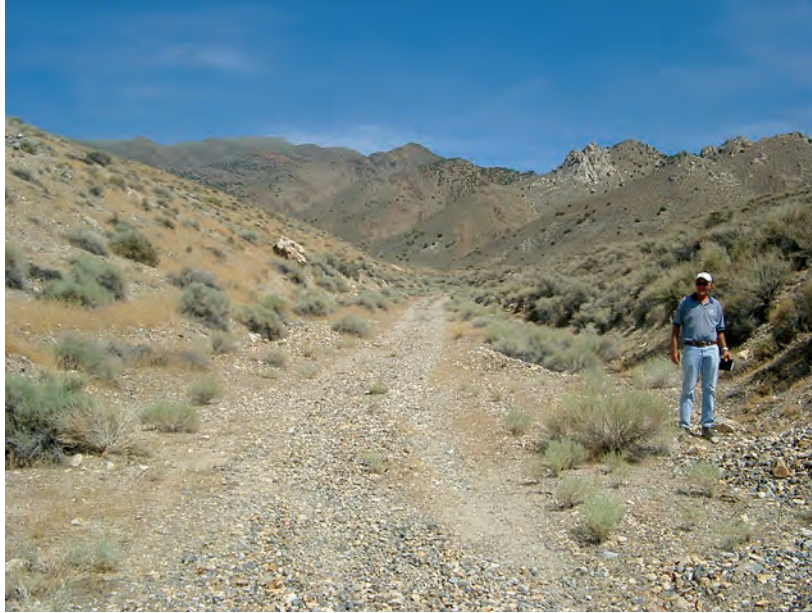
Figure A117. View looking upstream through slope-area reach, Humboldt River Tributary near Rye Patch, Nevada, July 30, 2003.

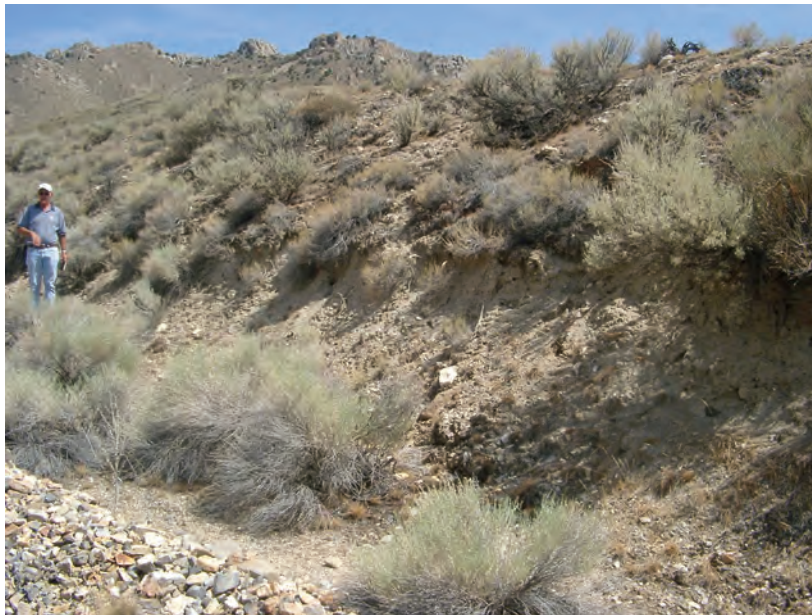
Figure A118. View of left bank near top of slope-area reach, Humboldt River Tributary near Rye Patch, Nevada, July 30, 2003.

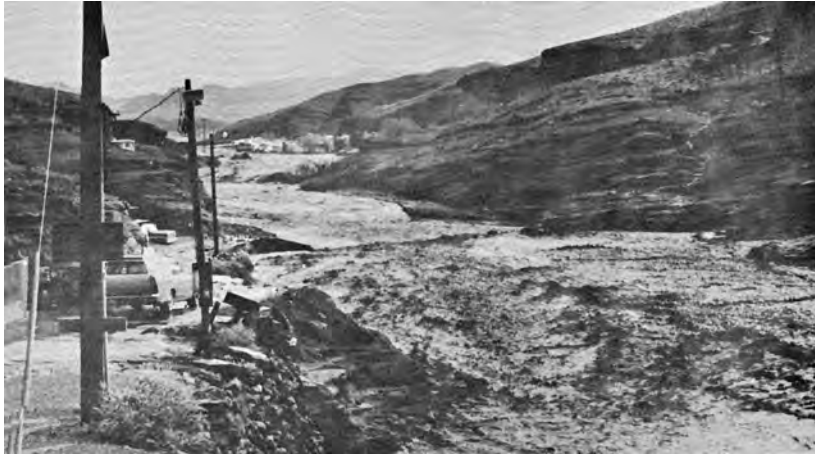
The photograph shows a water flood. However, the newspaper caption suggesting that the photograph was taken before the peak is in error. The restaurant is missing, giving graphic testimony that the photograph was taken after the destruction of the restaurant.

Figure A119. Flood in Eldorado Canyon at Nelson Landing, Nevada, September 14, 1974 (from Glancy and Harmsen, 1975, fig. 7A). Photograph taken by Kenneth E. Beales, Las Vegas, Nevada.

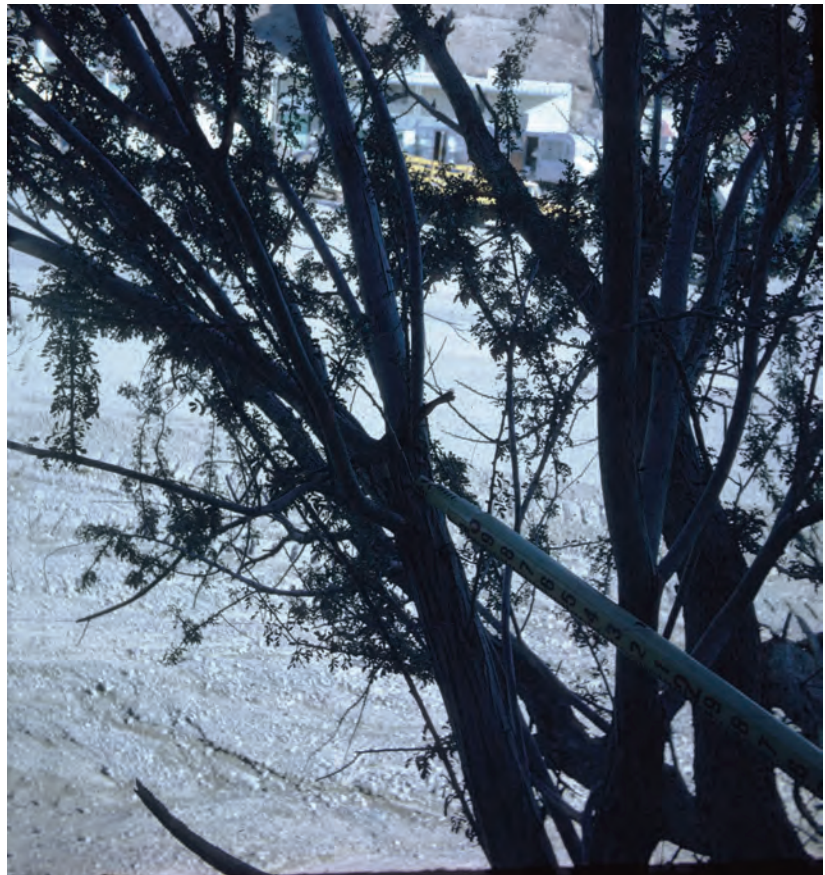
Figure A121. Mud marks in trees near right bank, Eldorado Canyon at Nelson Landing, Nevada, September 1974.

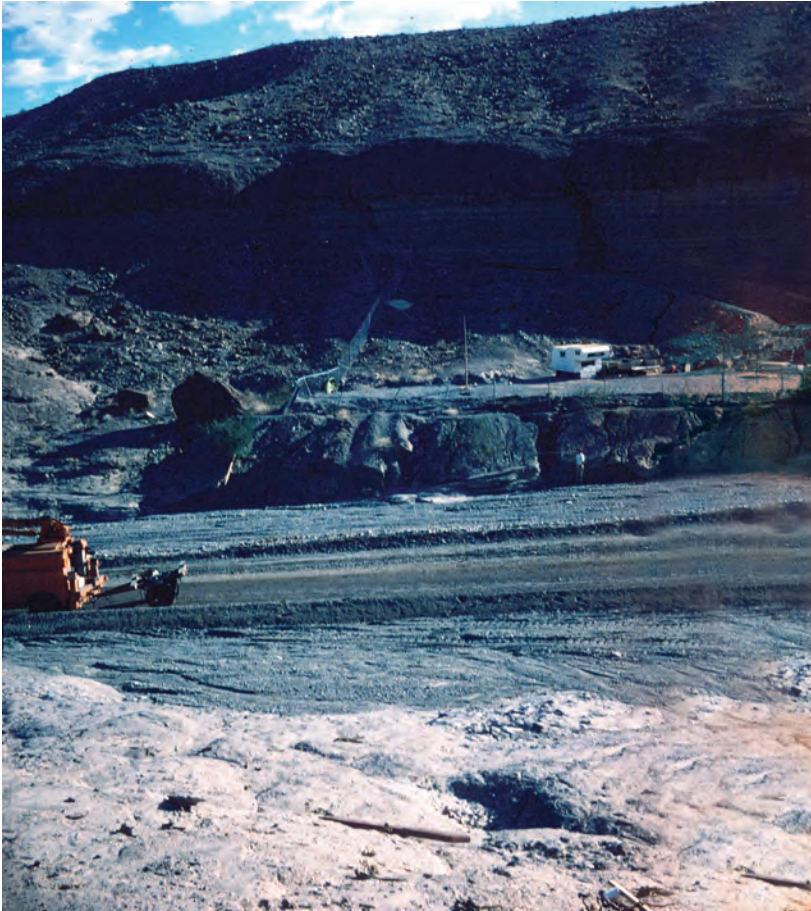
Figure A122. View of trailers from left bank to right bank, Eldorado Canyon at Nelson Landing, Nevada, September 1974.

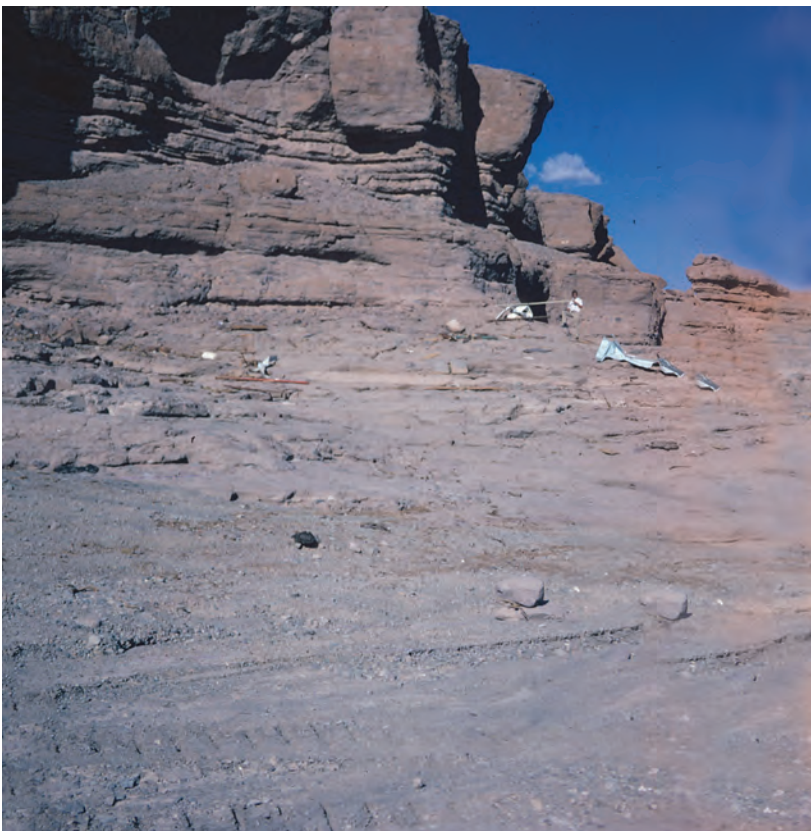
Figure A123. View of left bank high-water mark at trailer profile, Eldorado Canyon at Nelson Landing, Nevada, September 1974.

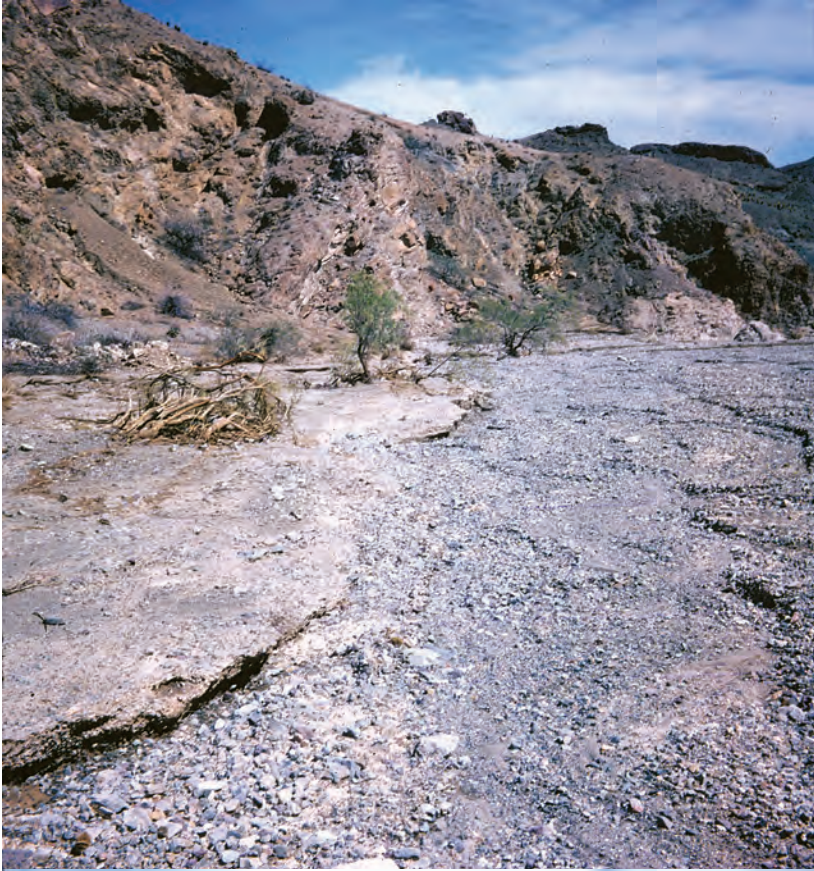
Figure A132. View downstream at upper slope-conveyance site, Eldorado Canyon at Nelson Landing, Nevada, September 1974.

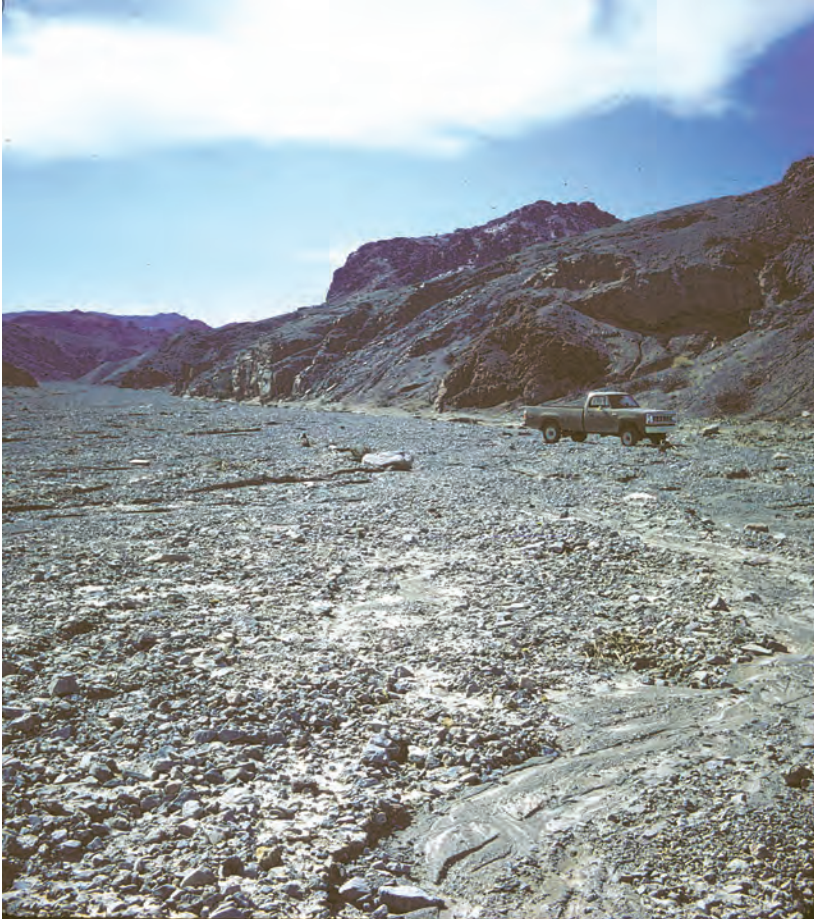
Figure A133. View upstream at lower slope-conveyance site, Eldorado Canyon at Nelson Landing, Nevada, September 1974.

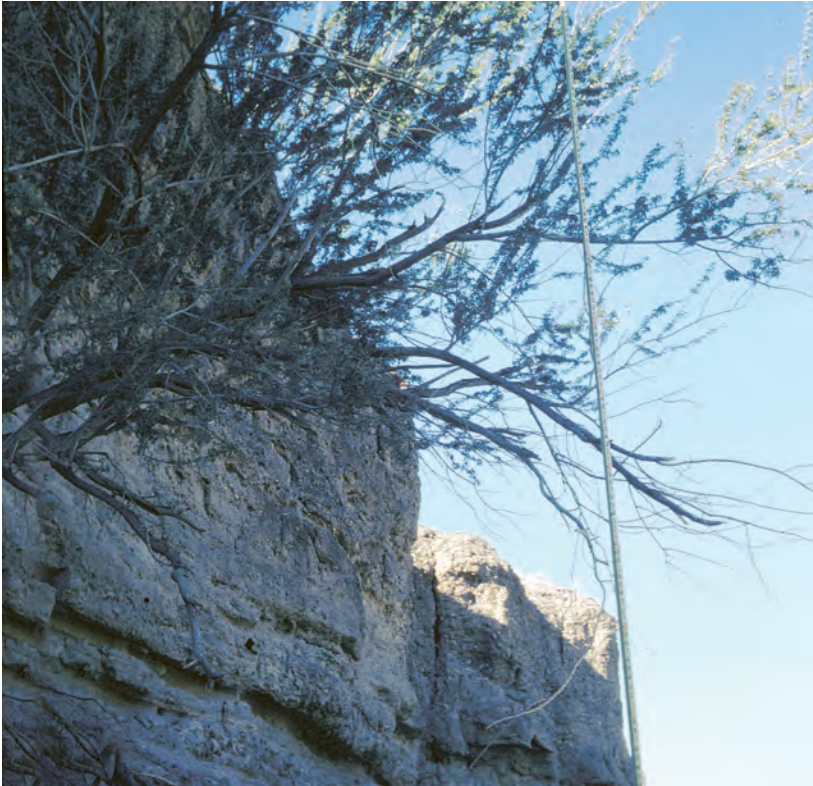
Figure A142. Mud on leaves of tree on right bank near trailers, Eldorado Canyon at Nelson Landing, Nevada, September 1974.
